**Galvanizing Crack Formation at Base Plate to Shaft Welds of High
Mast Illumination Poles**

Thesis

The University of Texas at Austin

August, 2011

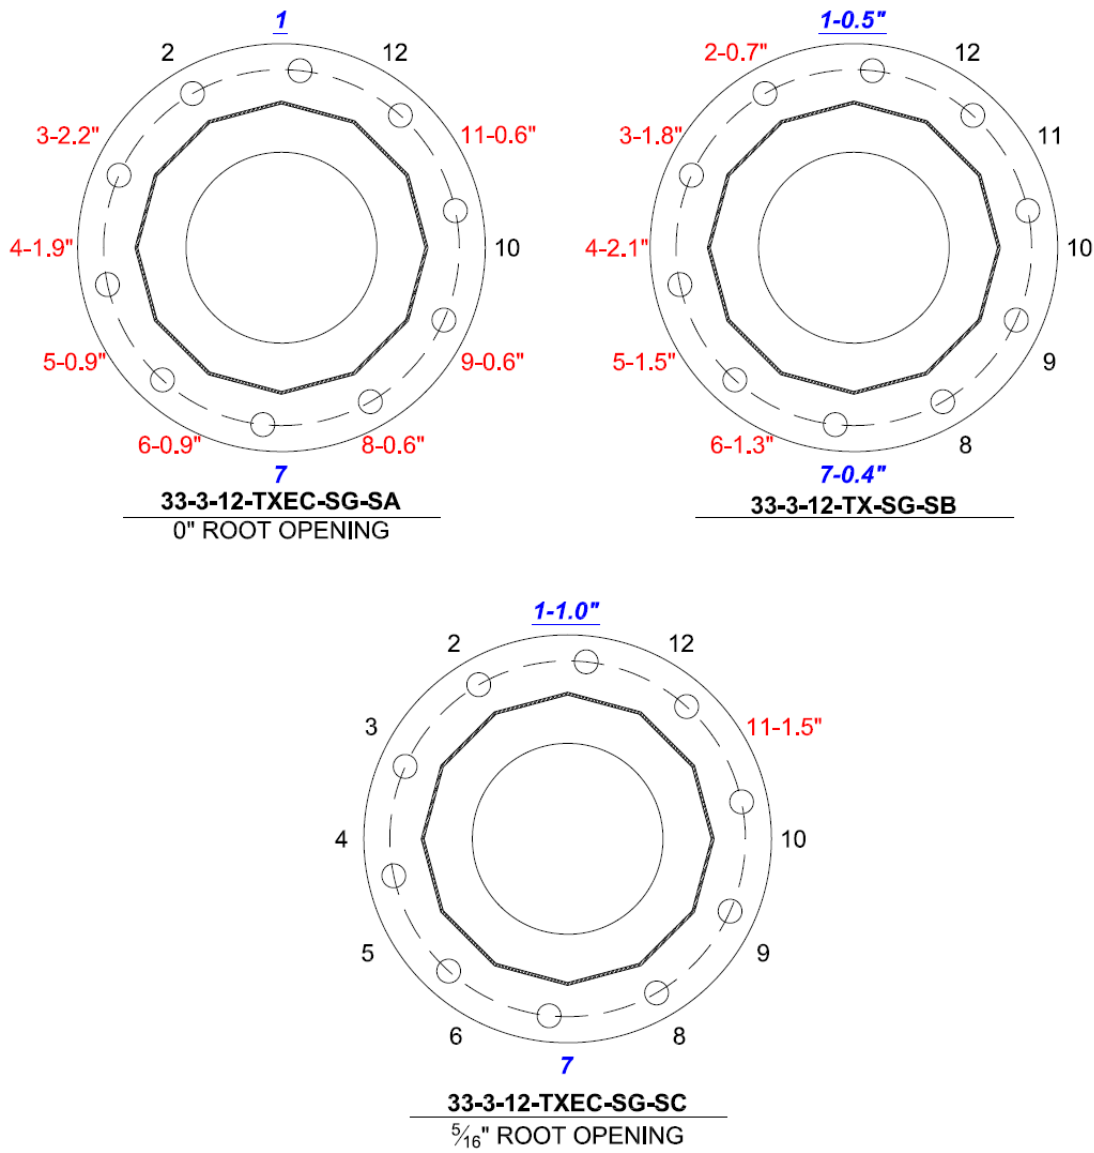
Figure 5-24: Initial crack locations after June 2010 galvanizing. Cracked bend and lengths marked in red.

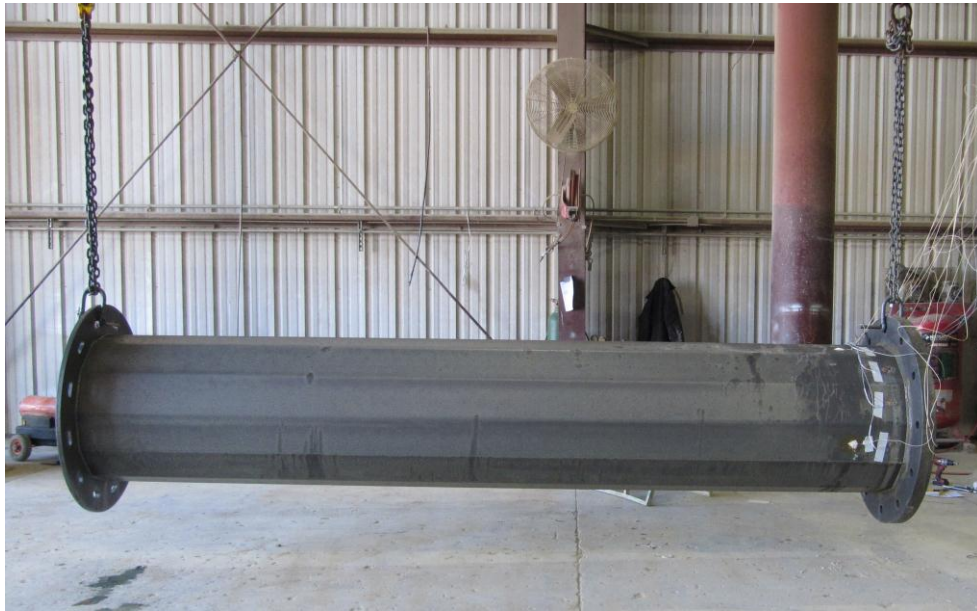
Figure 5-25: Fully instrumented HMP 33-3-12-TX-SG-C prior to galvanizing

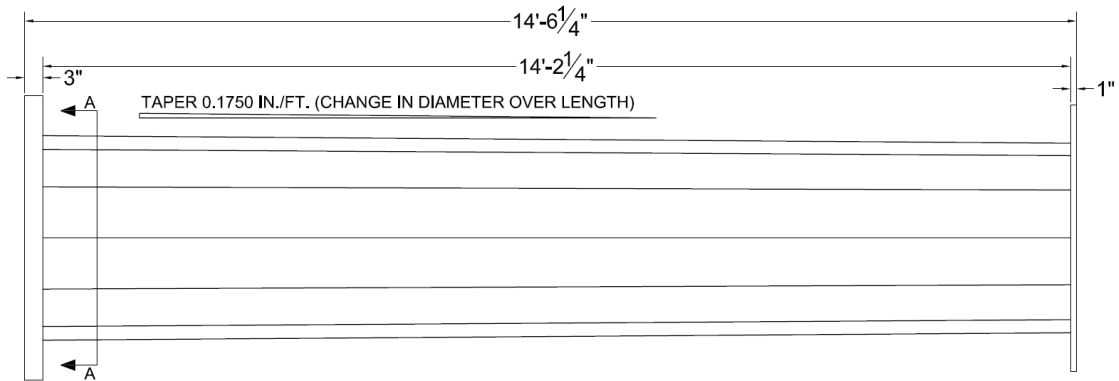
Figure 5-26: Profile of 33-3-12-TX-SG-C

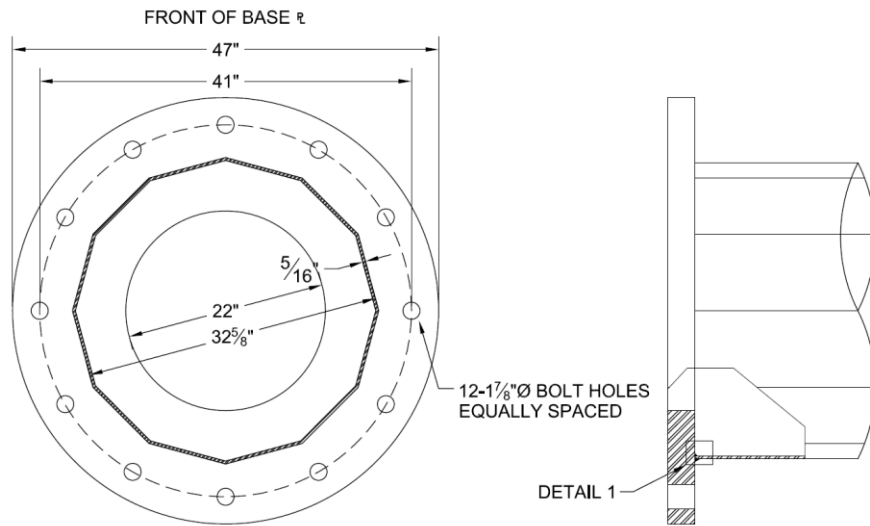
Figure 5-27: Section cut A-A of 33-3-12-TX-SG-C with dimensions as specified in Figure 5-26

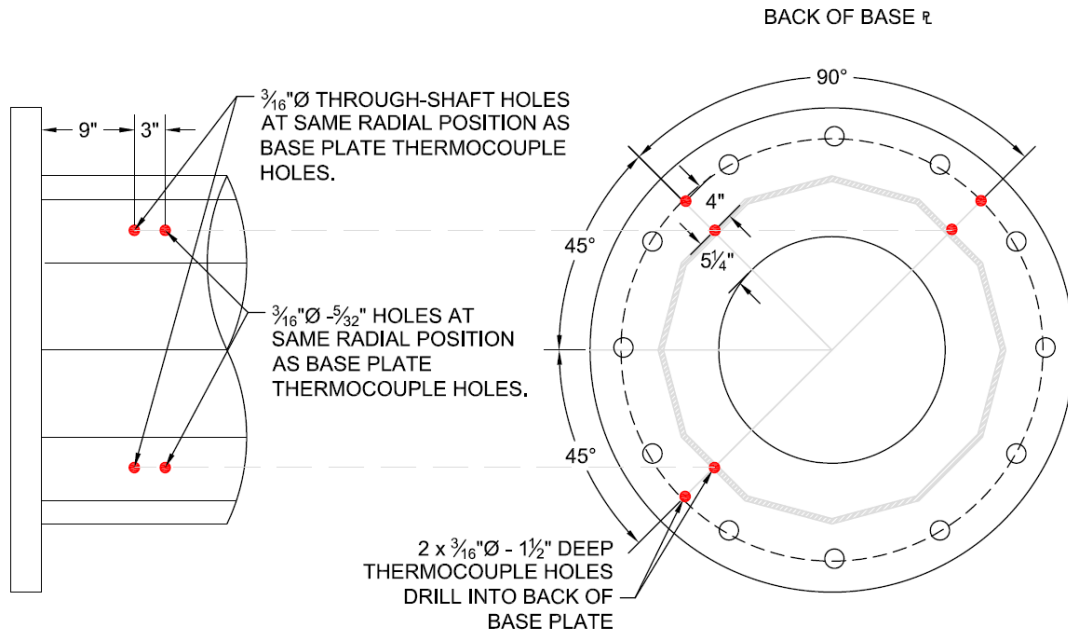
Figure 5-29: Drilled thermocouple locations for all tests from February 2011

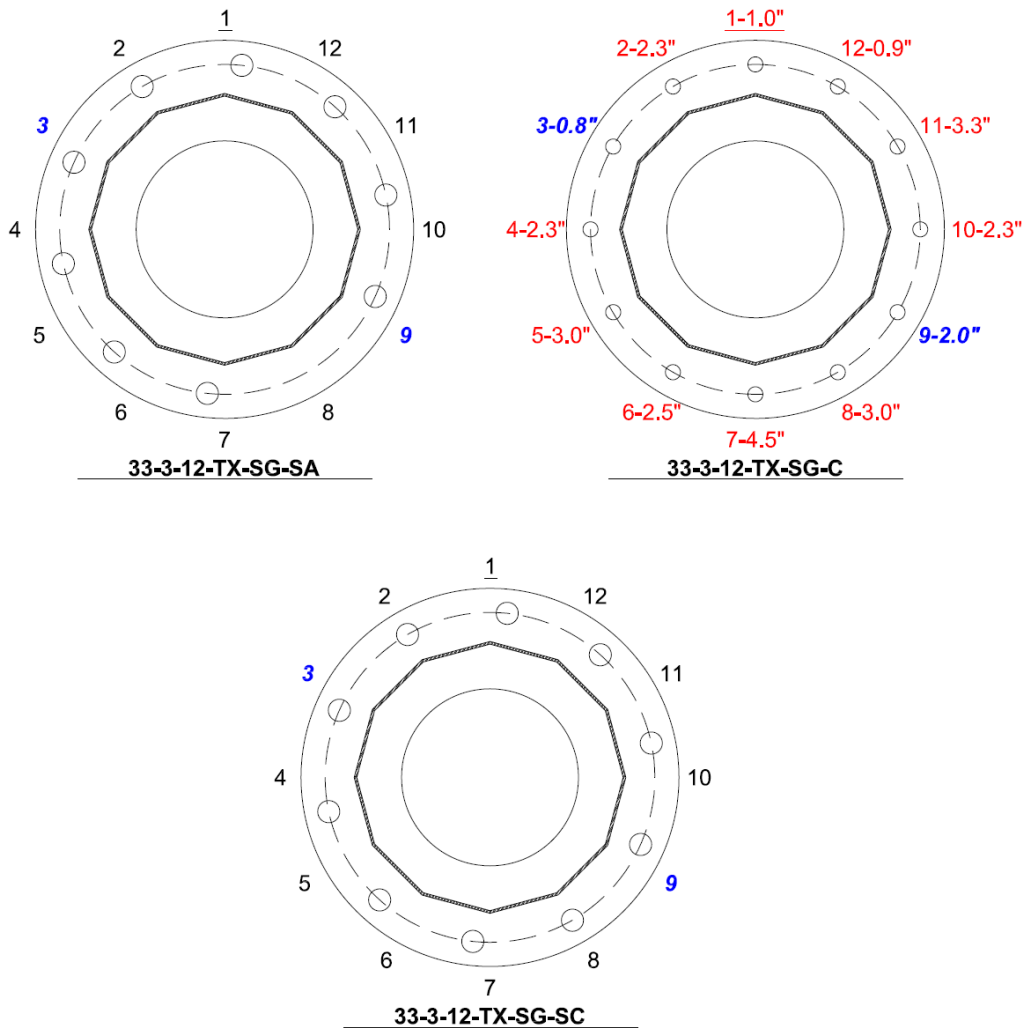
Figure 5-37: Initial crack locations after February 2011 galvanizing. Cracked bends and lengths are marked in red.

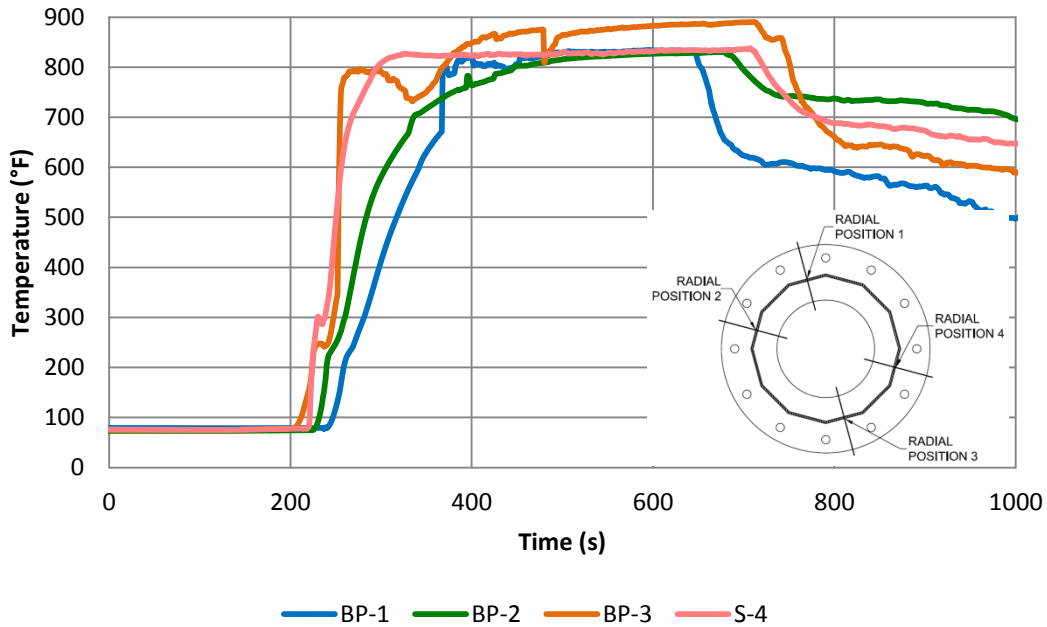
Figure 5-38: Temperatures as a function of time during galvanizing of 33-3-12-TXEC-

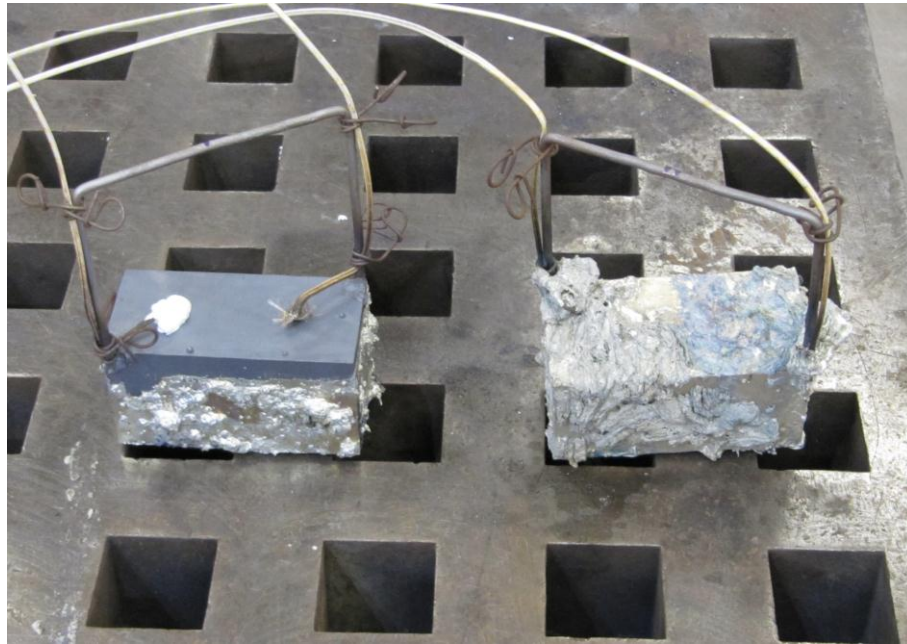
Figure 5-39: Thermocouple heating discontinuity test specimens after testing. Test 1 left, Test 2 right.

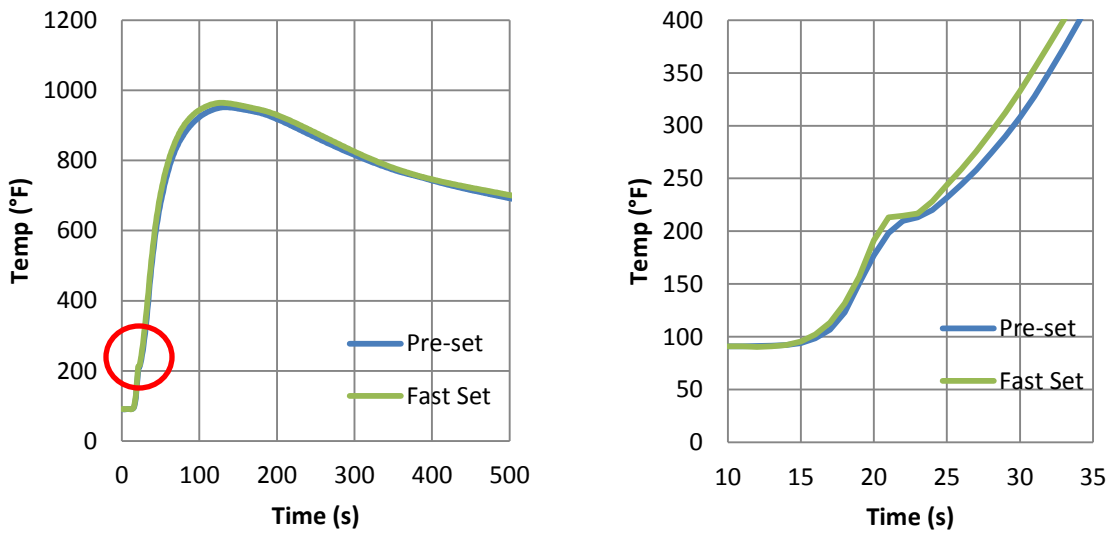
Figure 5-41: Test 2 heating results for a pre-set and fast-set thermocouple attachment

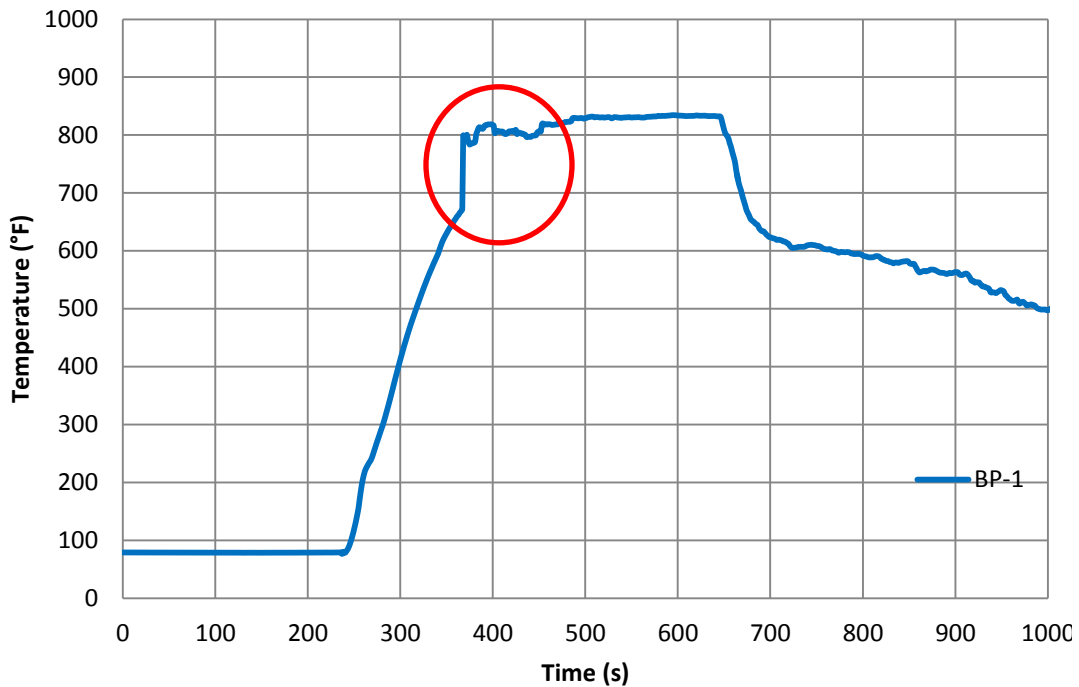
Figure 5-42: Temperature spike from temperature reading at BP-1 of 33-3-12-TXEC-

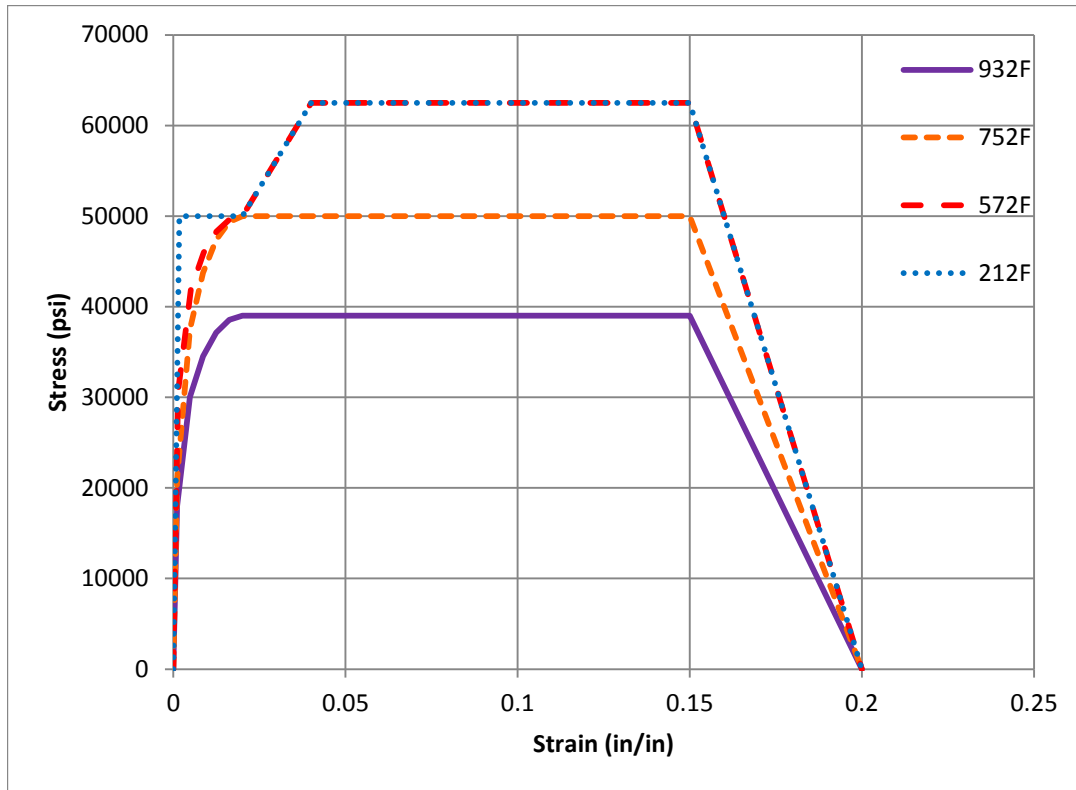
Figure 6-1: Temperature dependent stress vs strain relationship as defined by Eurocode 3

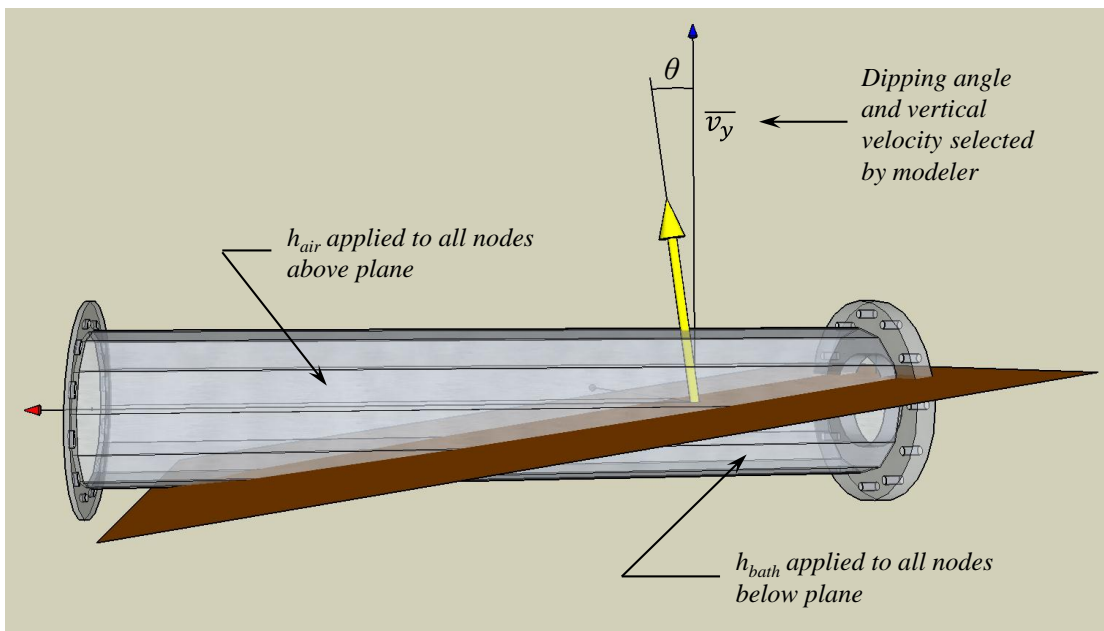
Figure 6-2: DFLUX subroutine schematic

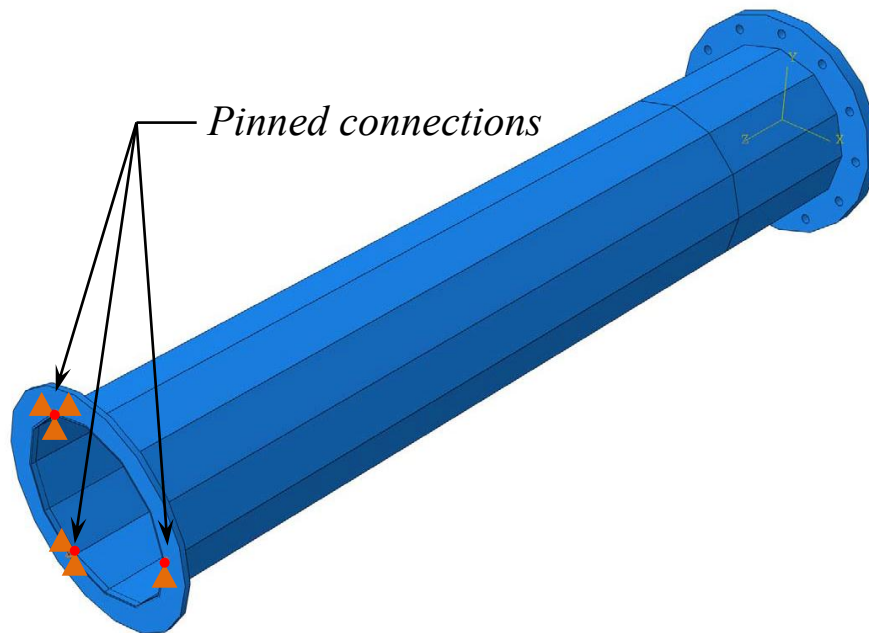
Figure 6-3: Boundary conditions applied to finite element model

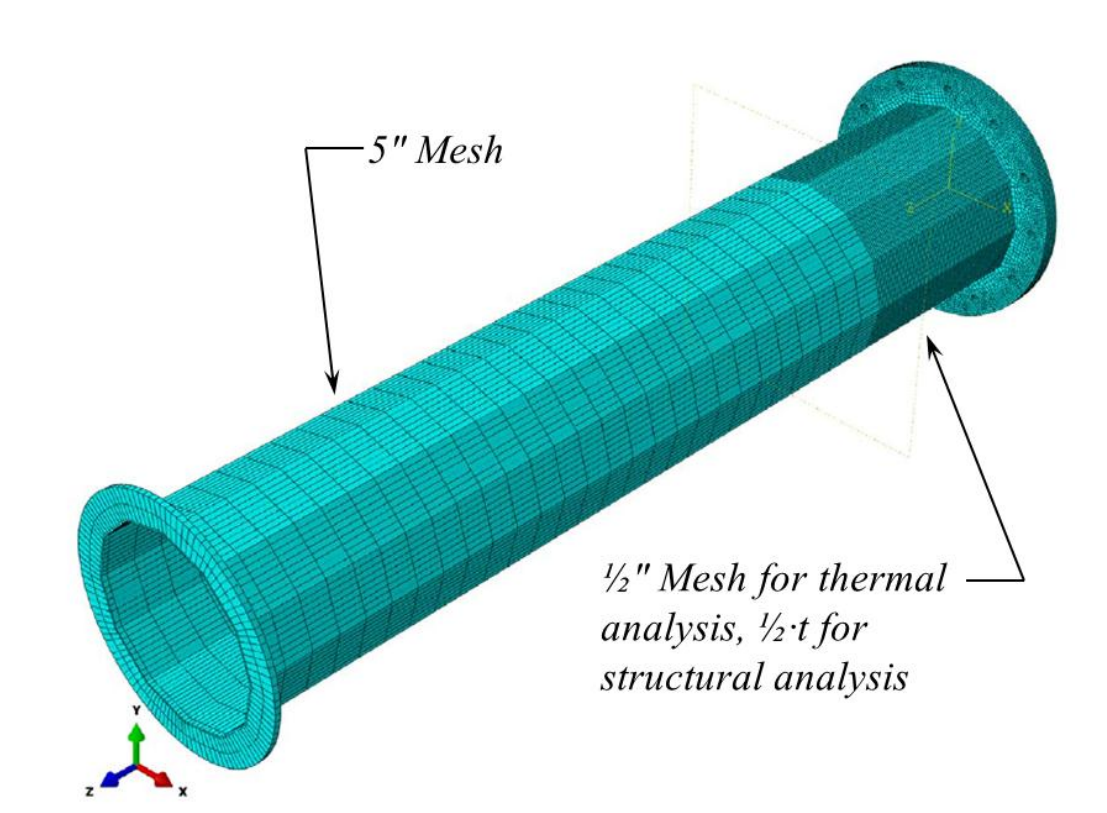
Figure 6-4: Meshed 14' fatigue specimen representing 33-3-12-TX-SG-C

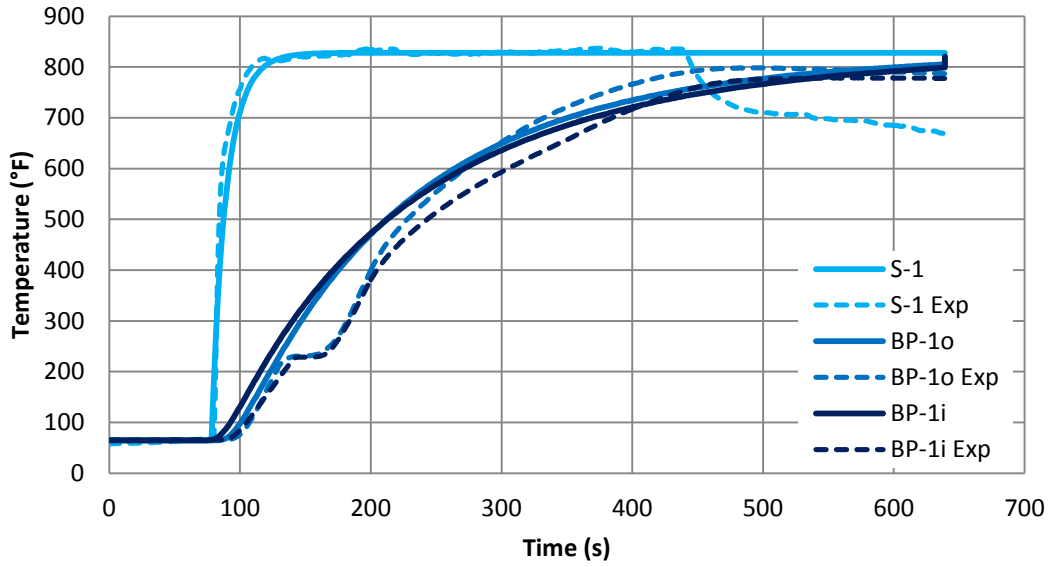
Figure 6-6: Experimental and analytical data for temperature vs. time relationship at radial position 1 of 33-3-12-TX-SG-C and SG-C

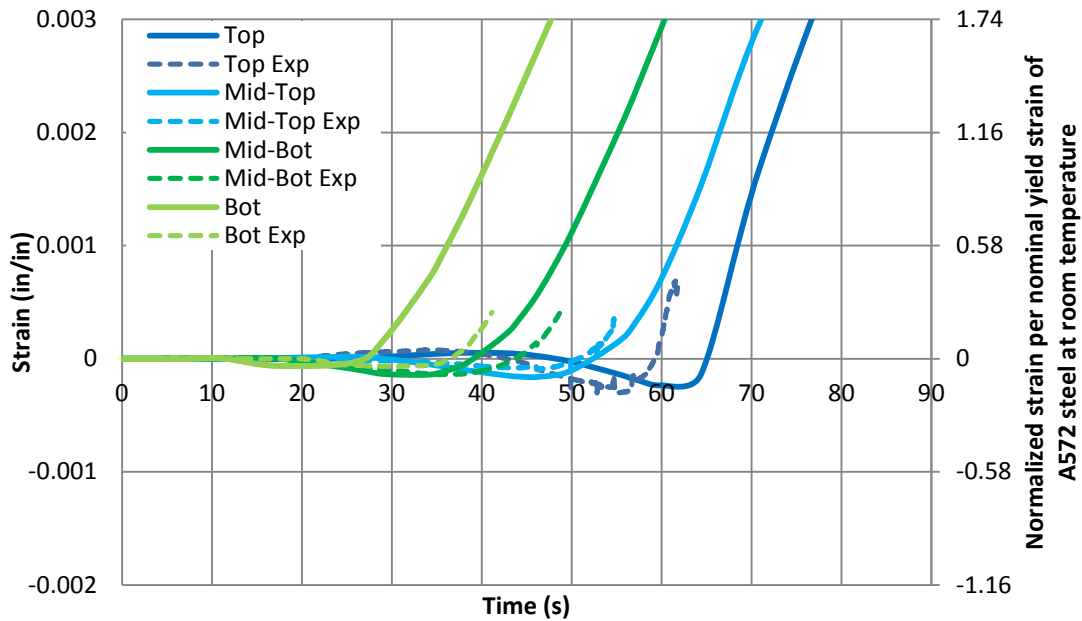
Figure 6-9: Experimental and analytical data for strain vs. time relationship at measured locations of 33-3-12-TX-SG-SA and SG-SA

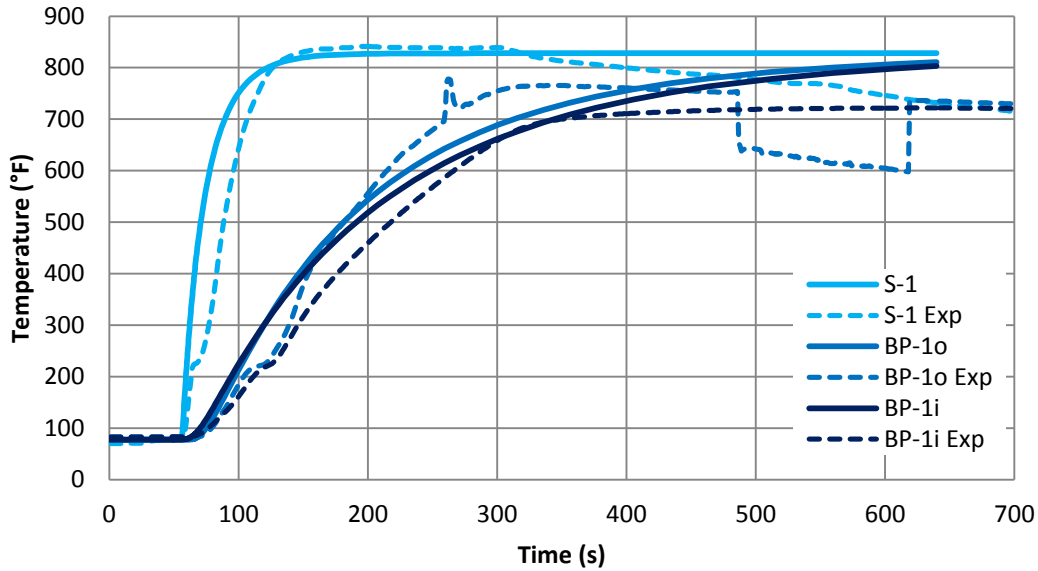
Figure 6-10: Experimental and analytical data for temperature vs. time relationship at radial position 1 of 33-3-12-TX-SG-SC and SG-SC

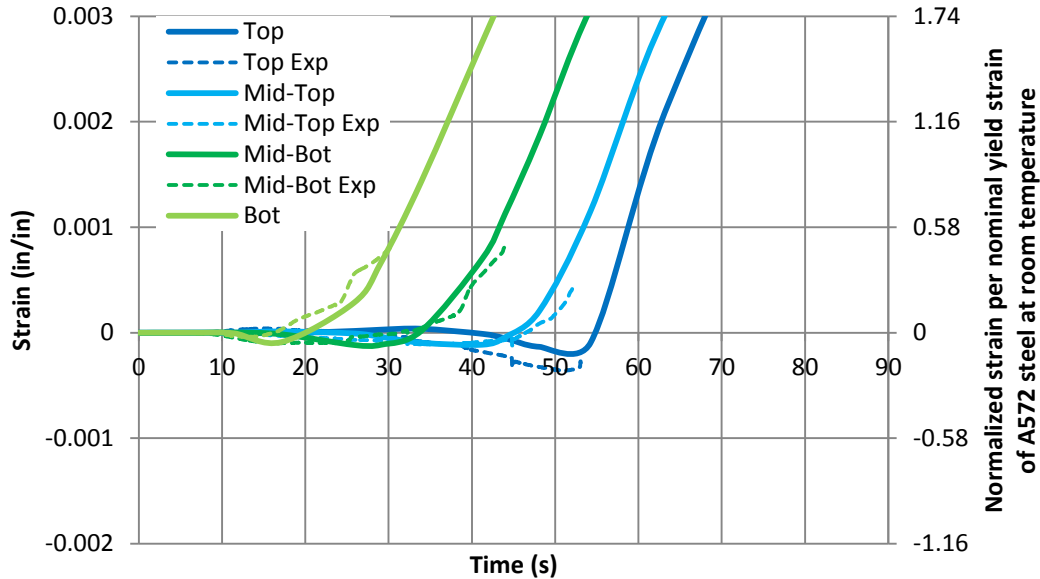
Figure 6-11: Experimental and analytical data for strain vs. time relationship at measured locations of 33-3-12-TX-SG-SC and SG-SC

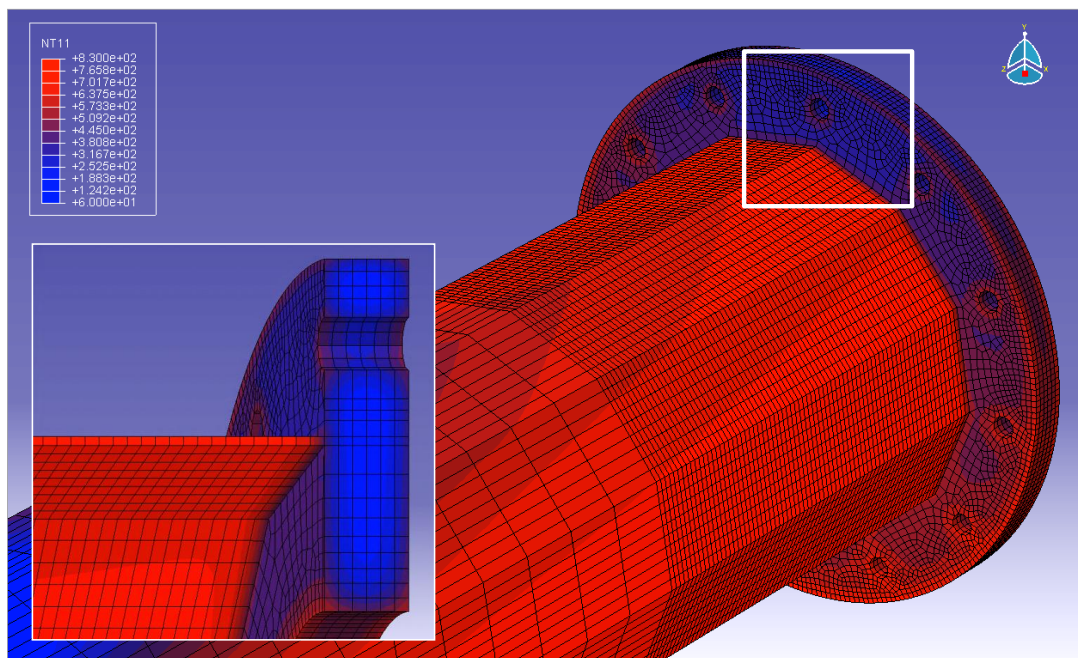
Figure 7-1: Thermal response of HMIP during galvanizing

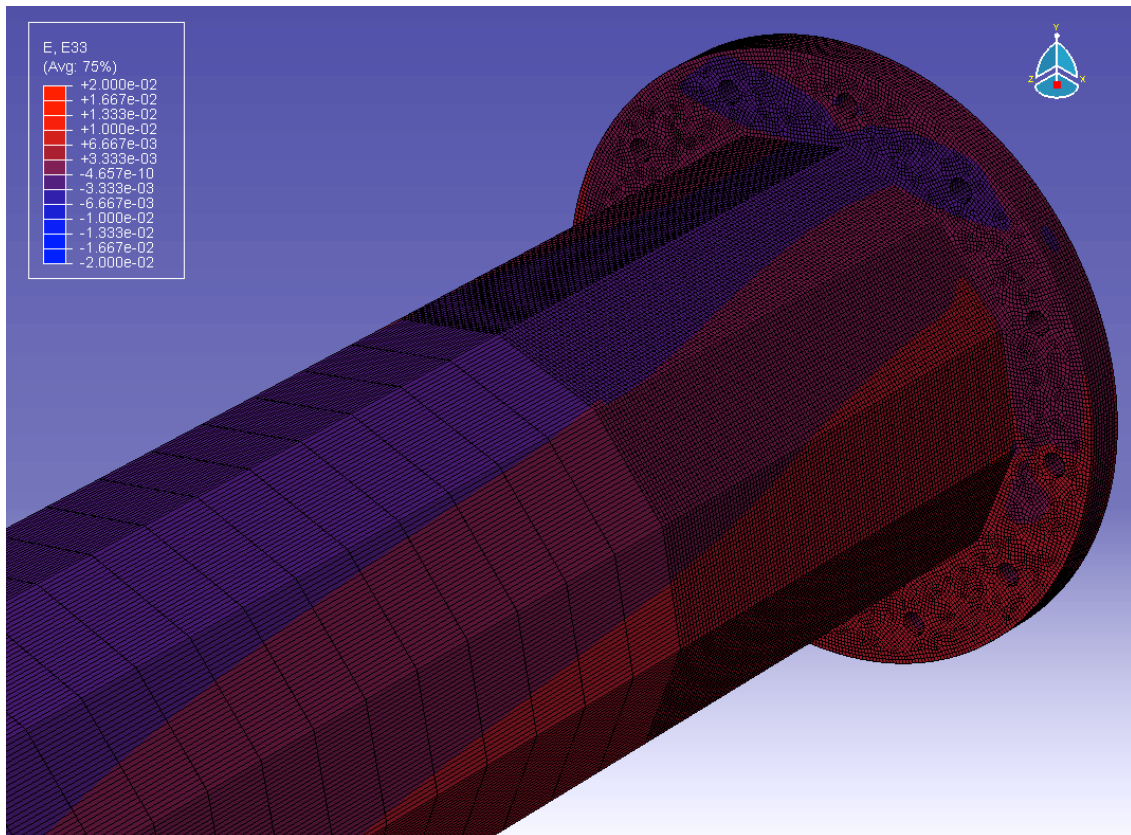
Figure 7-2: Development of longitudinal strains as the HMIP is dipped into the galvanizing bath

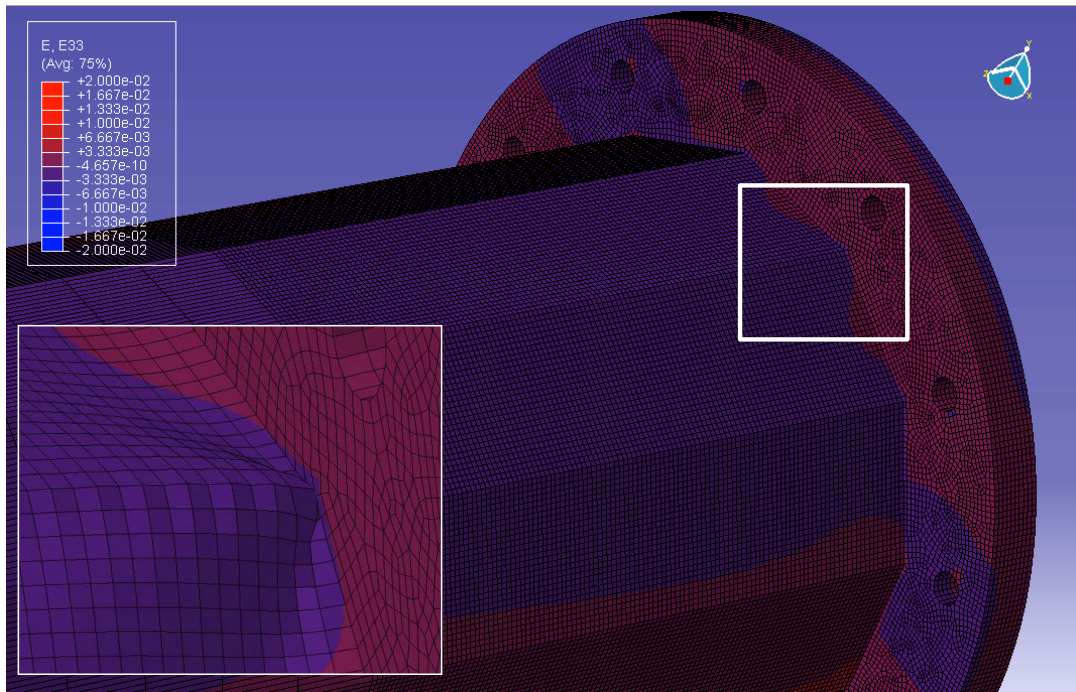
Figure 7-3: Hourglassing in global structural model

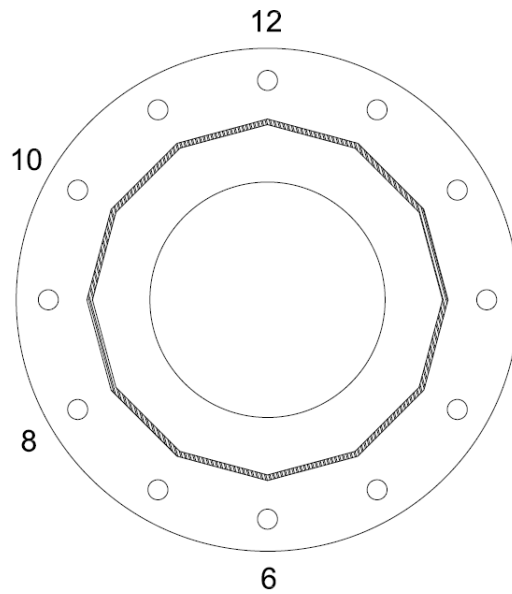
Figure 7-4: Submodel bend locations on each HMIP. Bend 12 is up during simulated dipping.

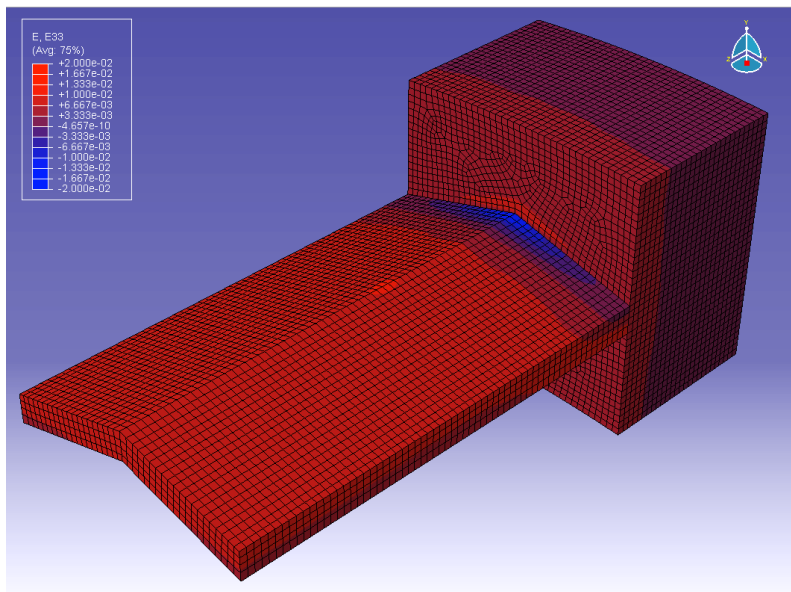
Figure 7-5: Submodel of bend 12 from SG-C showing concentration of forces at shaft to base plate connection

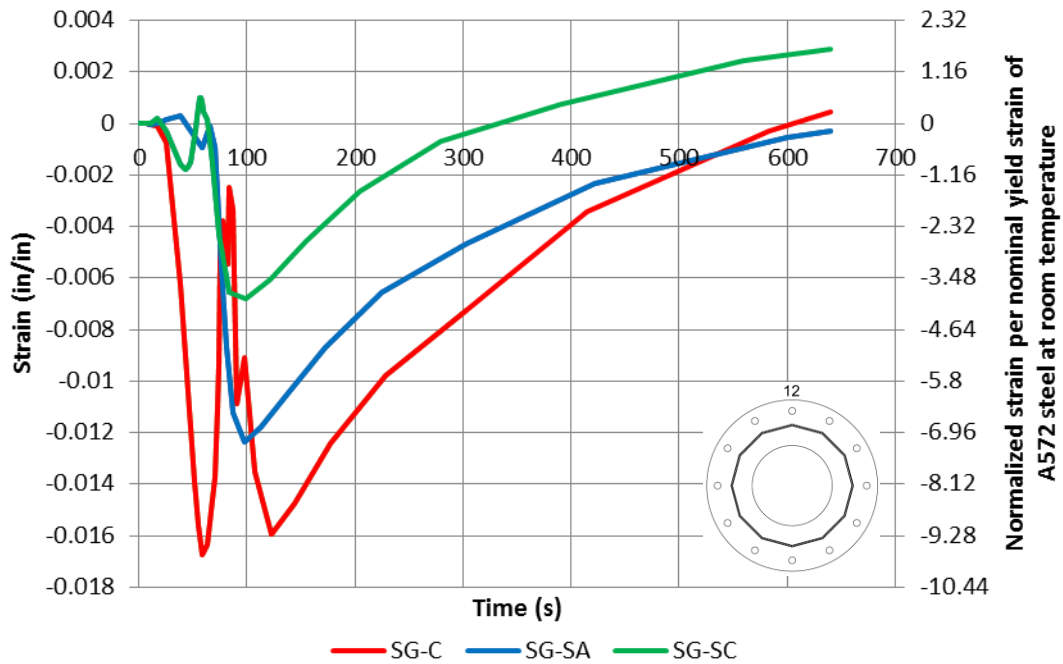
Figure 7-6: Comparative strains at pole shaft to base plate connection at bend 12

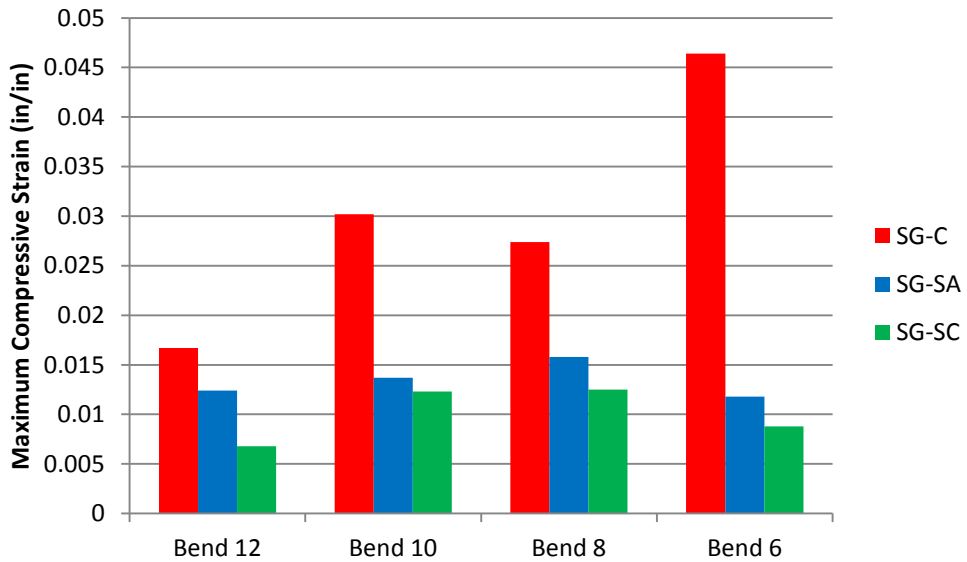
Figure 7-10: Maximum straining condition for each submodeled bend

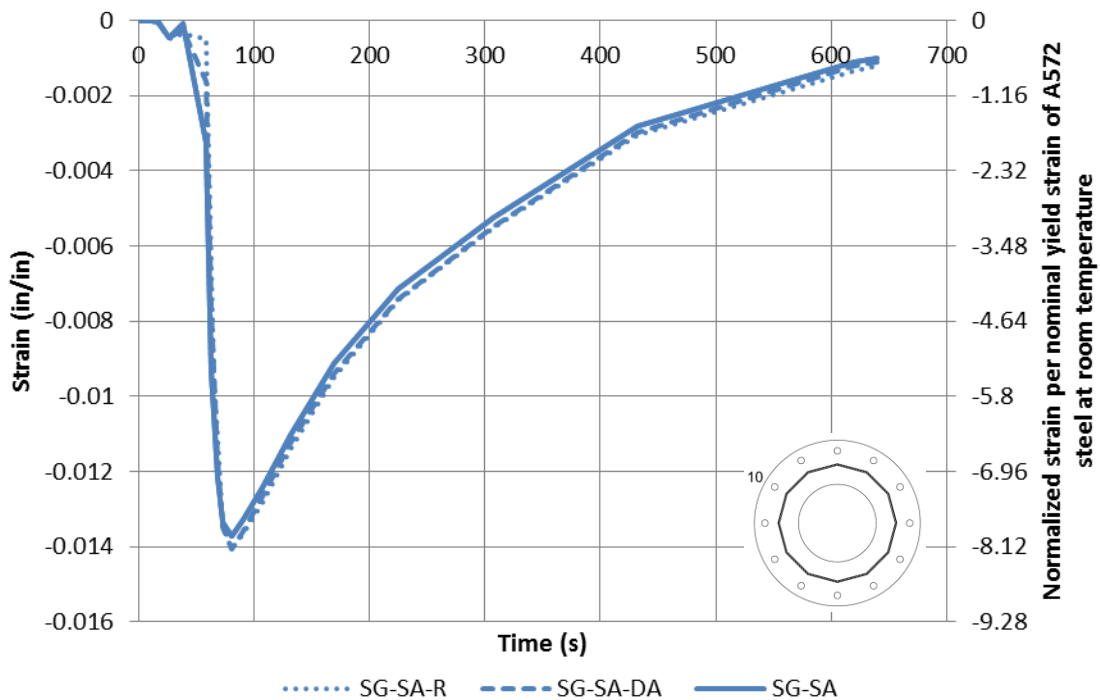
Figure 7-11: Parametric study on model SG-SA at bend 10

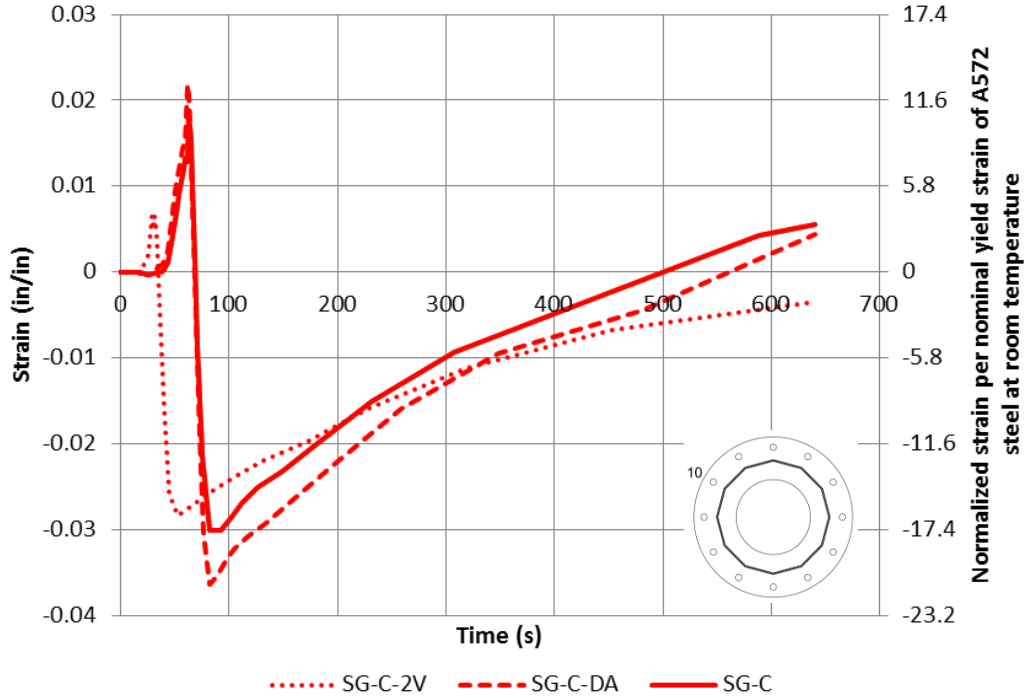
Figure 7-12: Parametric study results for SG-C

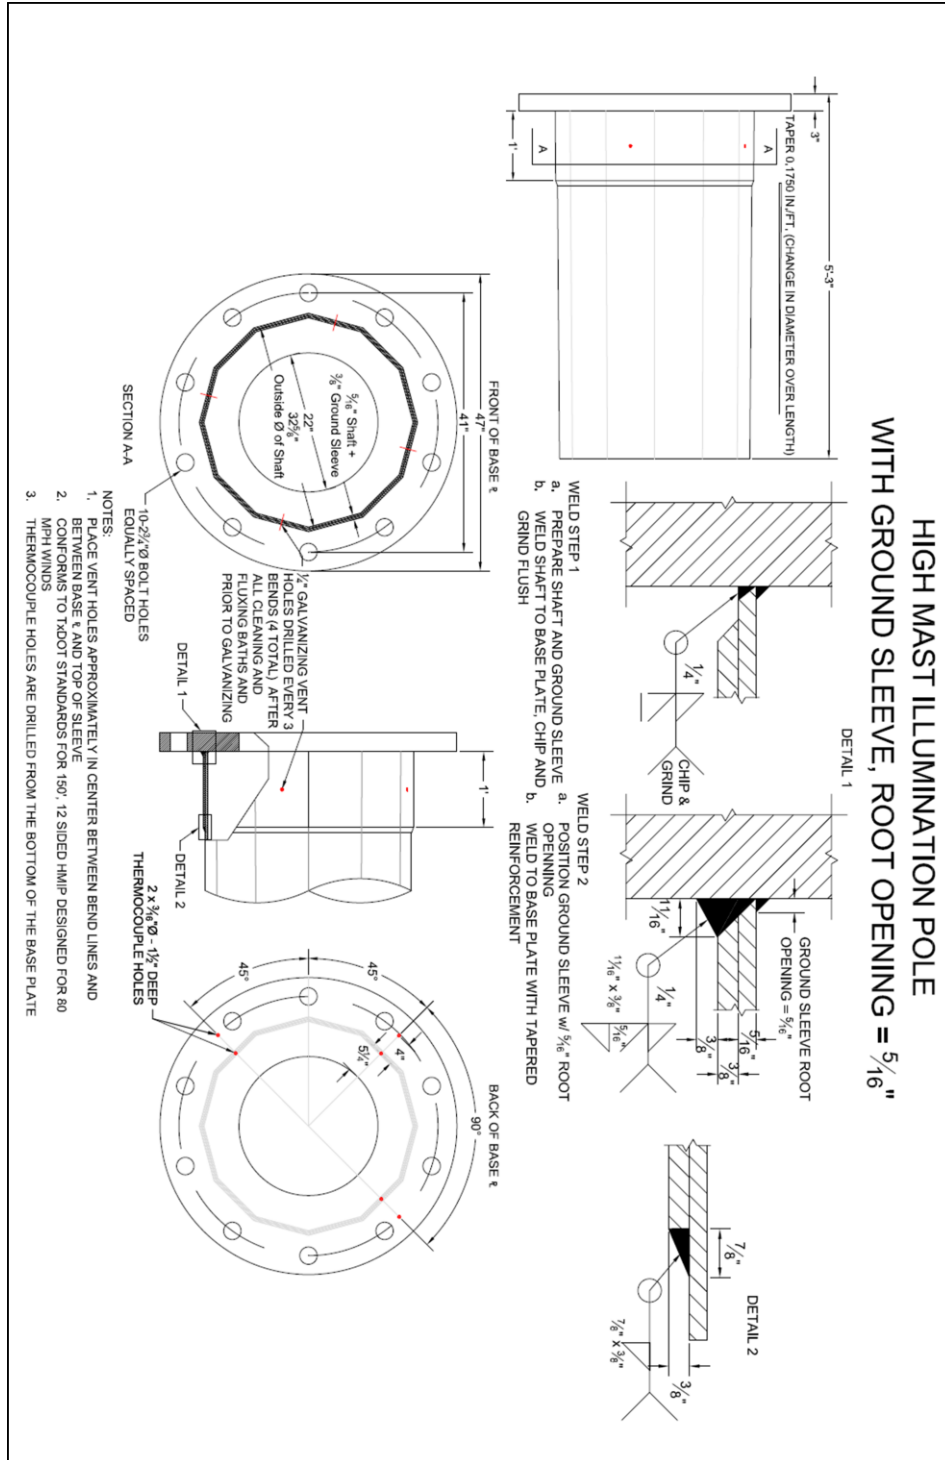
Figure A-3: Design drawing for specimen 33-3-12-TXEC-SG-SC

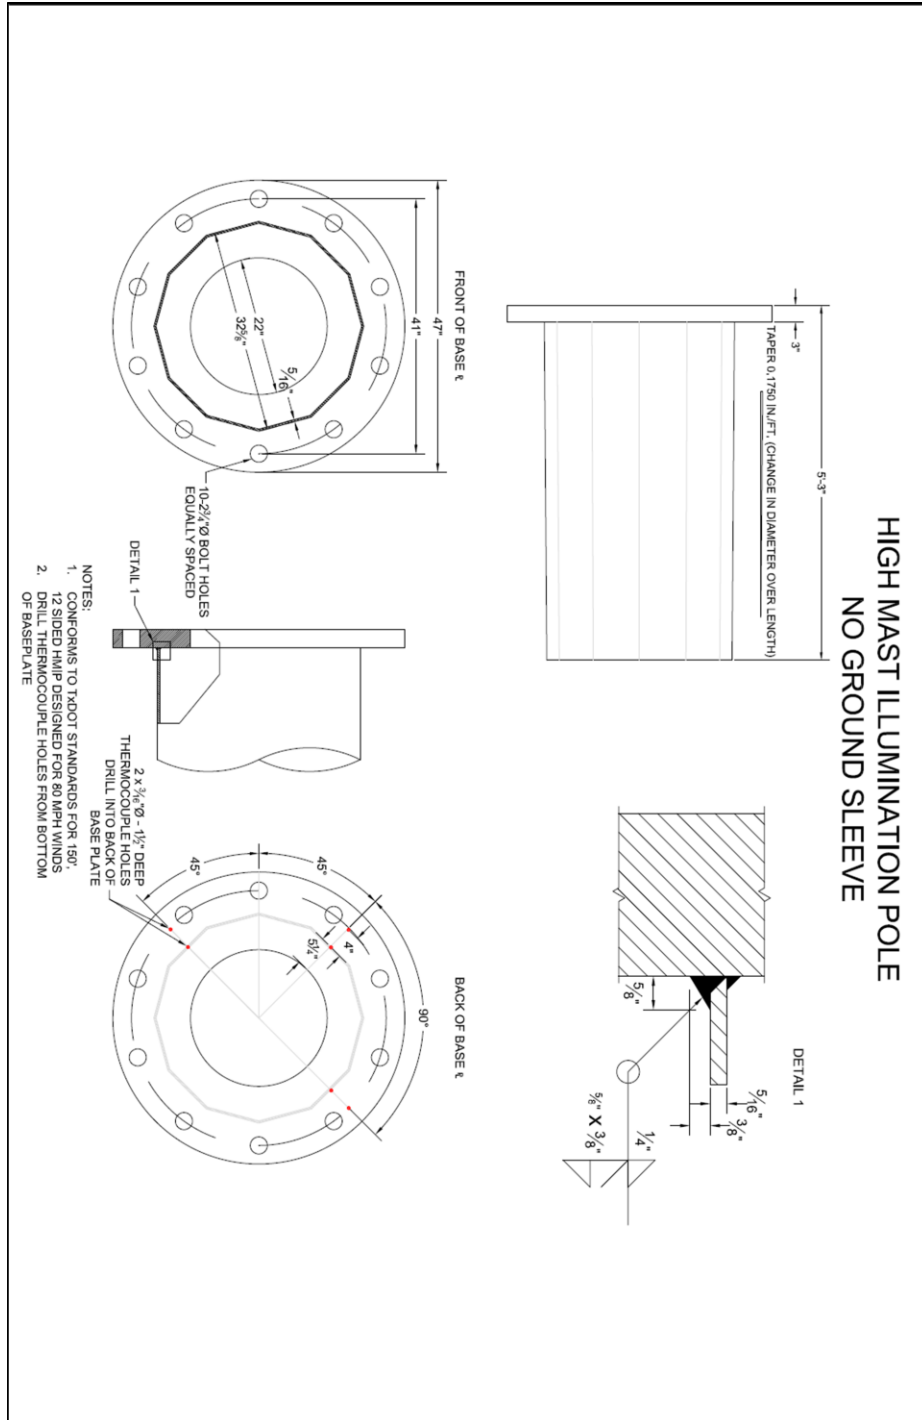
Figure A-4: Design drawing for specimen 33-3-12-TX-SG-SB

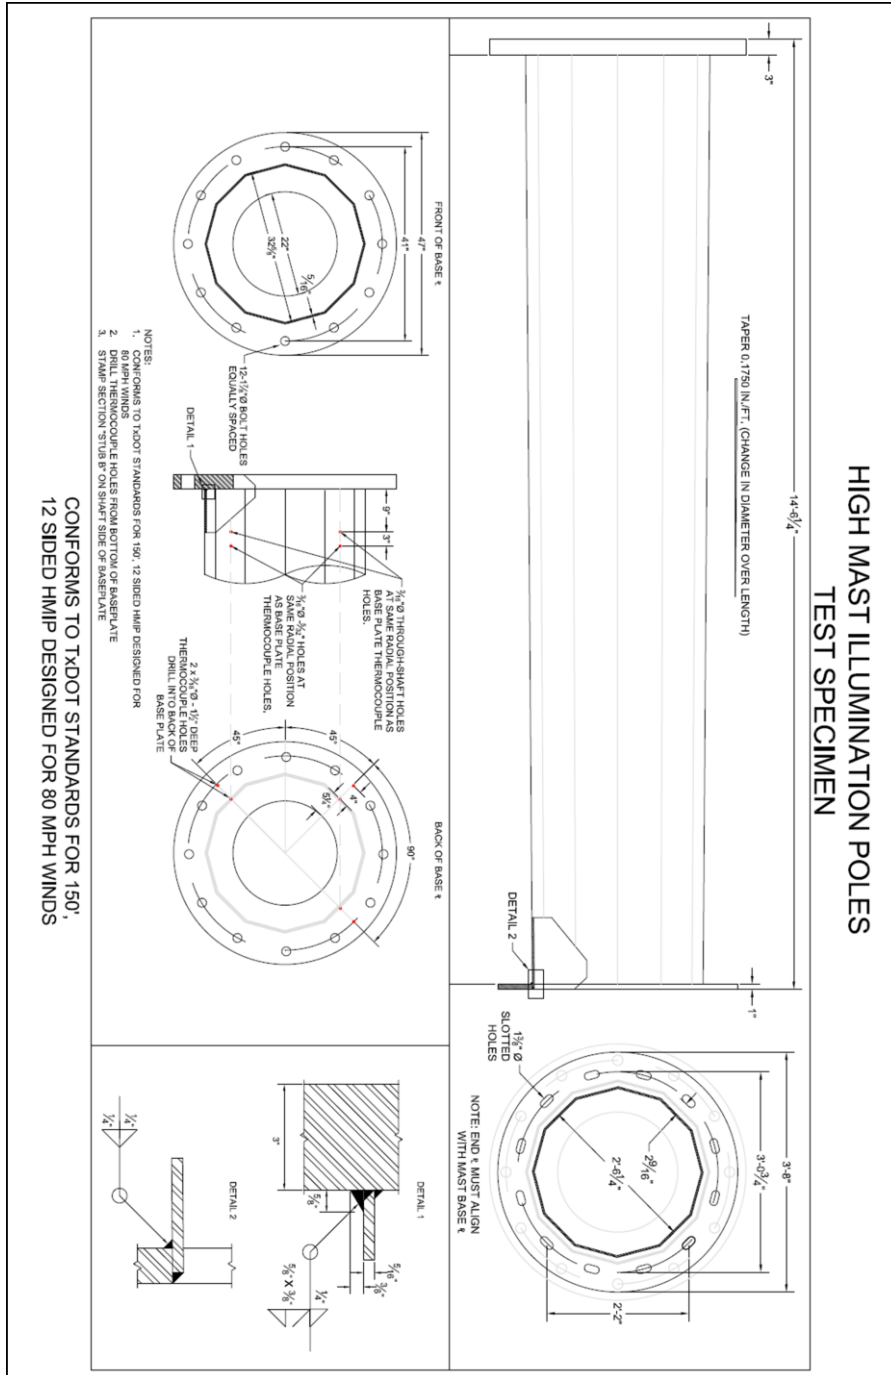
Figure A-5: Design drawing for specimen 33-3-12-TX-SG-C
