**Galvanizing Crack Formation at Base Plate to Shaft Welds of High
Mast Illumination Poles**

Thesis

The University of Texas at Austin

August, 2011

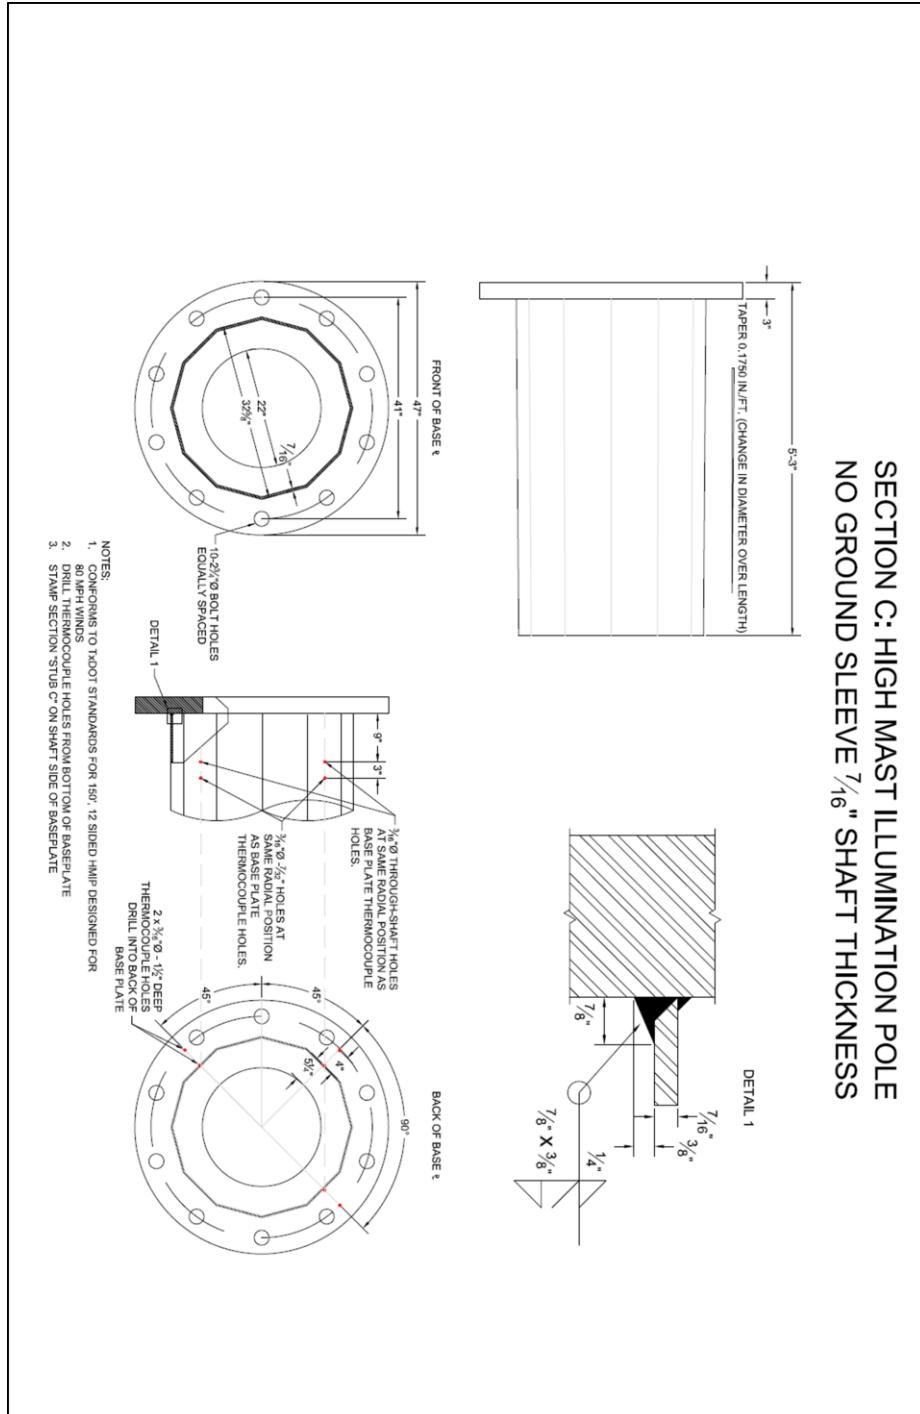
Figure A-6: Design drawing for specimen 33-3-12-TX-SG-SA

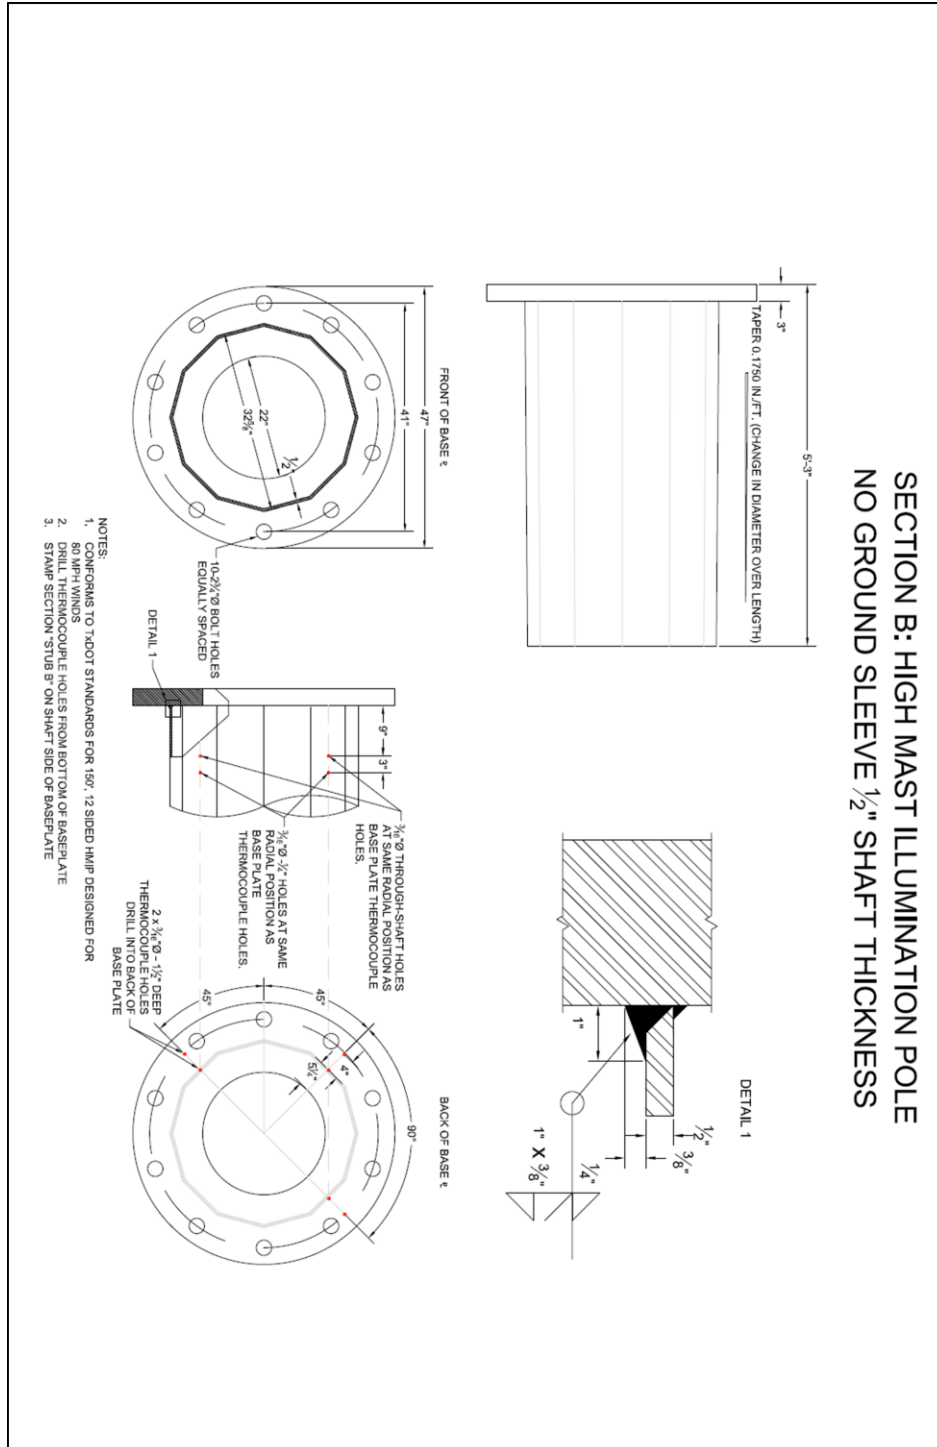
Figure A-7: Design drawing for specimen 33-3-12-TX-SG-SC

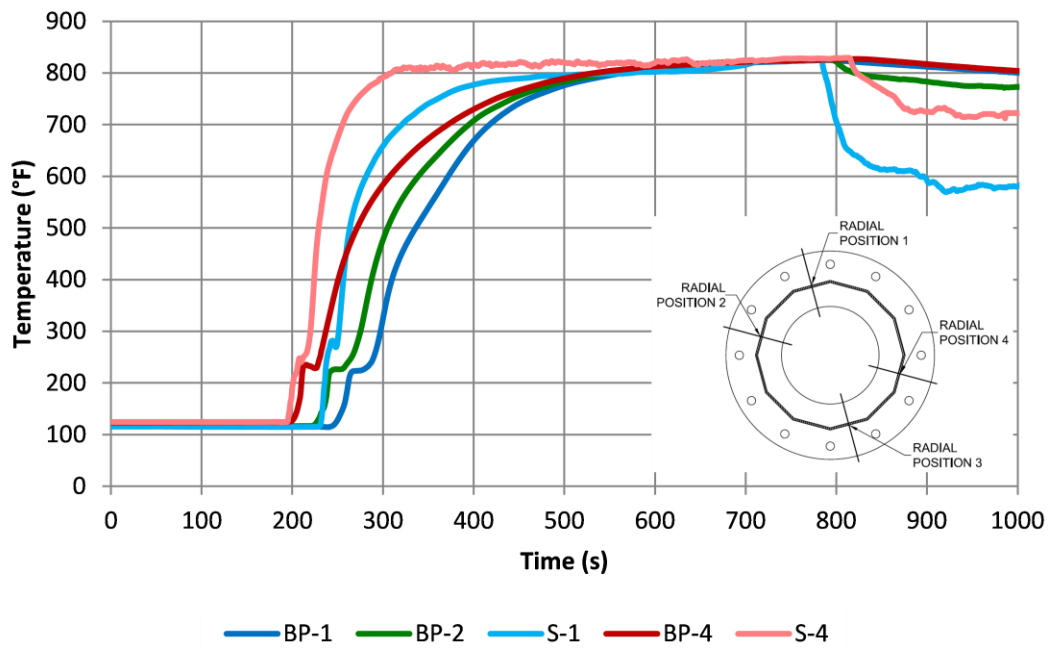
Figure B-2: Temperature vs. time graph of specimen 33-3-12-TXEC-SG-B during galvanizing

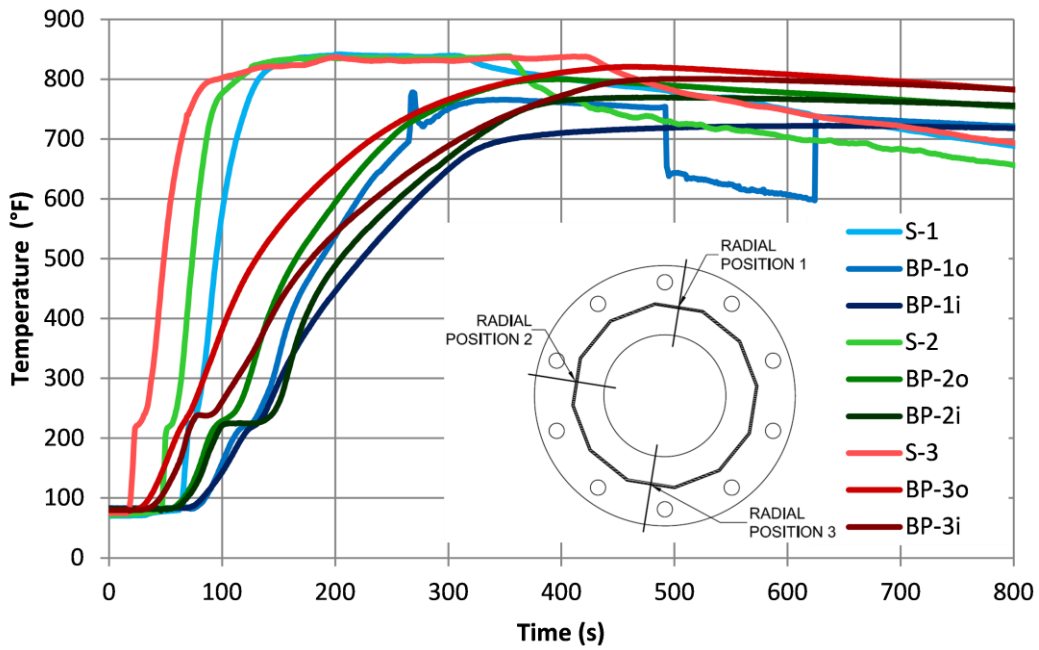
Figure B-17: Temperature vs. time graph of specimen 33-3-12-TX-SG-SC during galvanizing

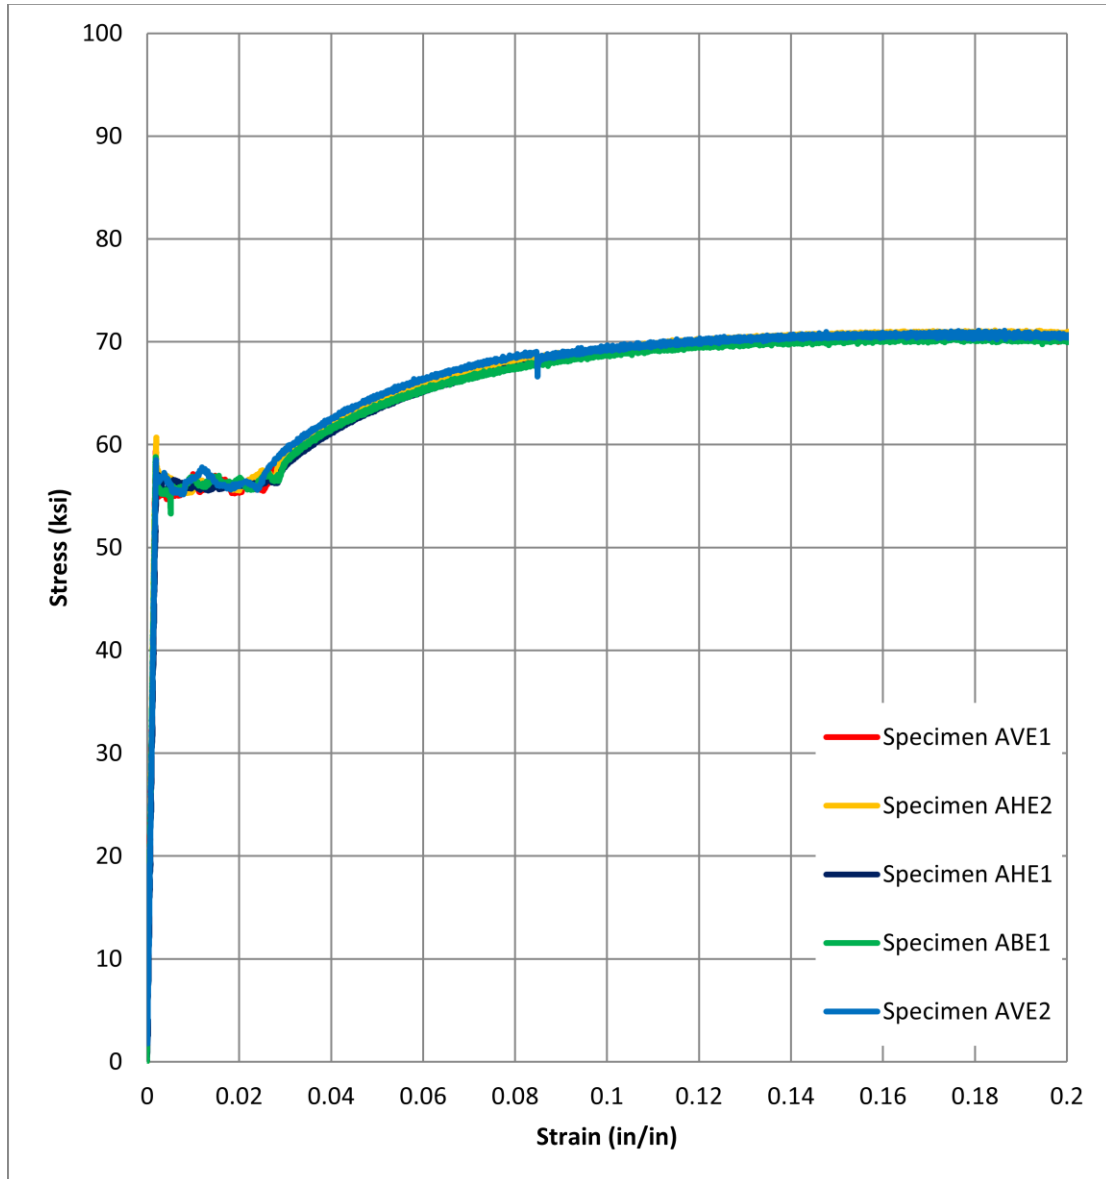
Figure C-1: Stress strain curve for specimen tested from 33-3-12-TXEC-SG-A external collar

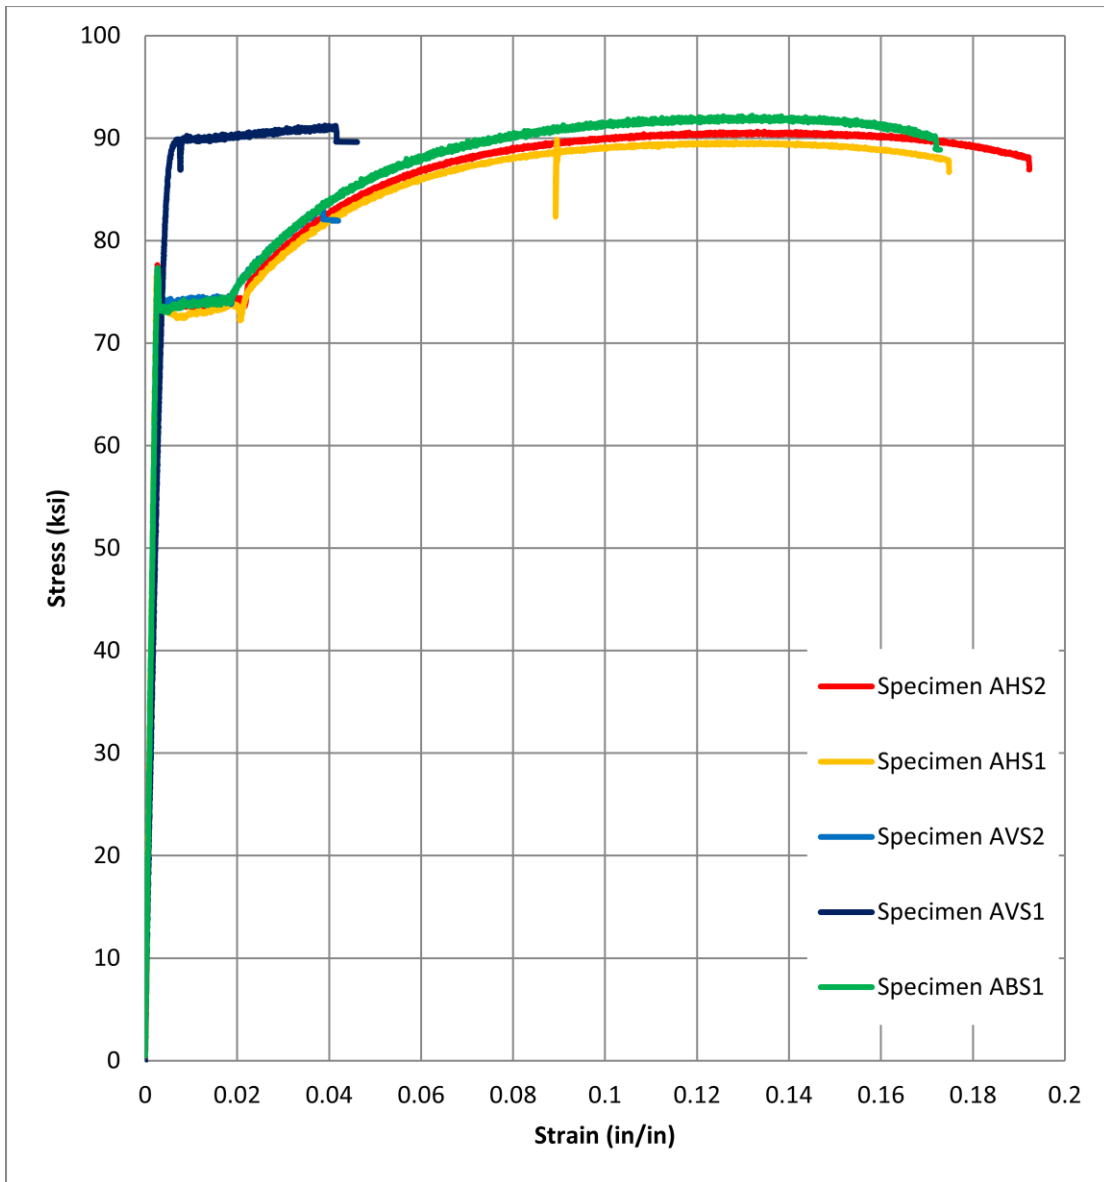
Figure C-2: Stress strain curve for specimen tested from 33-3-12-TXEC-SG-A pole shaft

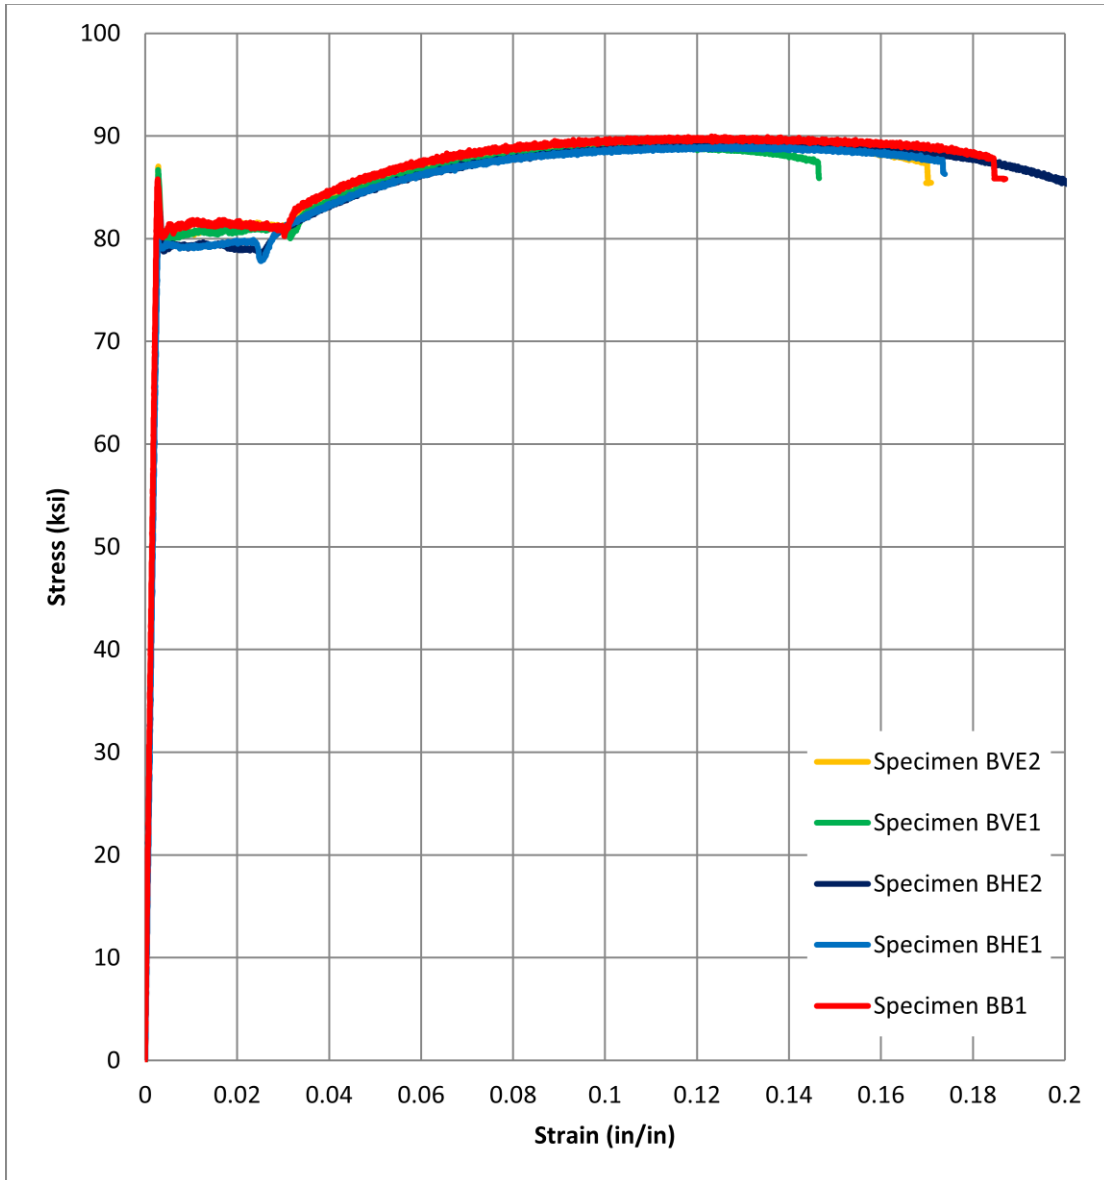
Figure C-3: Stress strain curve for specimen tested from 33-3-12-TXEC-SG-B external collar

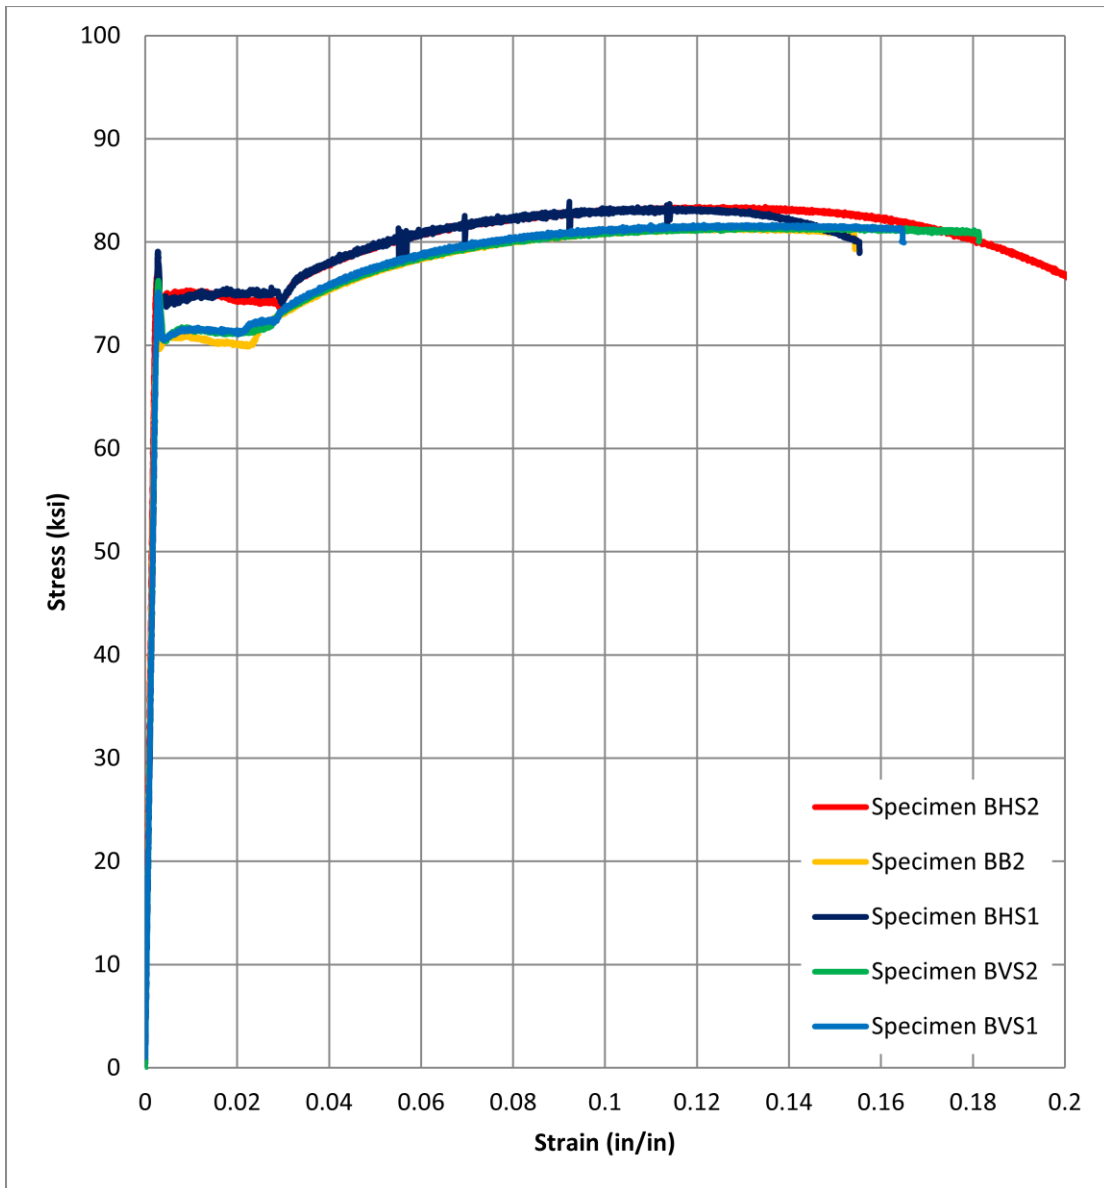
Figure C-4: Stress strain curve for specimen tested from 33-3-12-TXEC-SG-B pole shaft
