**CORROSION PERFORMANCE OF EPOXY-COATED  
REINFORCEMENT**

**DISSERTATION**

The University of Texas at Austin

May 1994

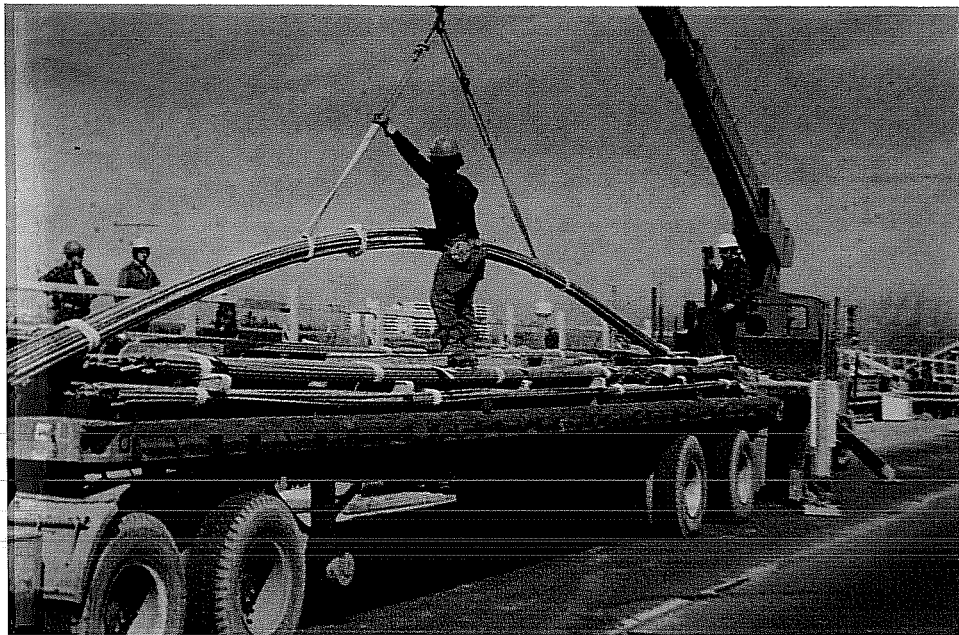
**Figure 3.15** Hoisting of Coated Bars with Multiple Lift Points.<sup>86</sup>

Loading and unloading the coated bars require close attention and proper precautions against damaging the coating. Skidding the bars from the truck bed could produce severe damage. Power-hoisting equipment should be used to move the bars. Bundled bars should be lifted with a strong back, a platform bridge, or a spreader beam that has multiple lifting points to prevent sagging of bundles during hoisting (see Fig. 3.15). In lieu of a spreader beam, spreader cables with at least two-point lifting can be used.<sup>86,95</sup> Wood cribbing minimizes damage and should be encouraged in place of chains or cable chokers.<sup>86</sup> Bundles should also be smaller than normally associated with uncoated bars.

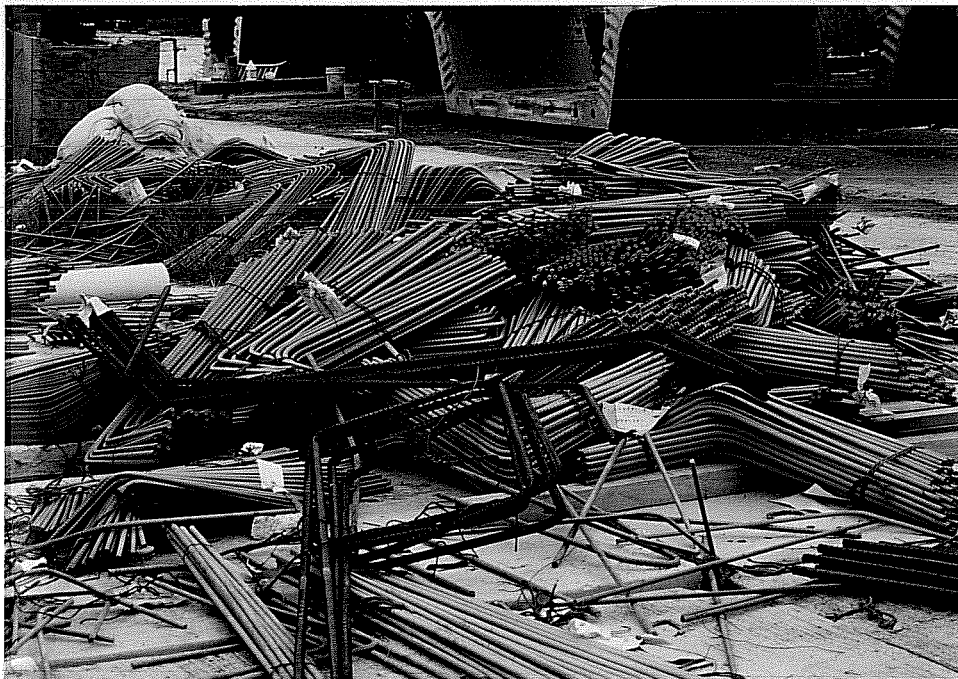
(b) Inadequate Storage of Coated Bars at the Job Site

To prevent direct physical damage during storage, it is important to specify where and how the coated bars are stored. Storage locations on the job site should be away from traffic and equipment, and close to final position of installation. The coated bars should be separated from uncoated bars and grouped in small manageable bundles. Access should be available to any group of bars without having to dislodge or move others. Bent bars should be stored with additional care to avoid damaging the bends. Situations such as the ones disclosed in Fig. 3.17 must be avoided. It requires effort on part of the contractor and the inspector to ensure proper storage of coated bars during the entire construction phase.

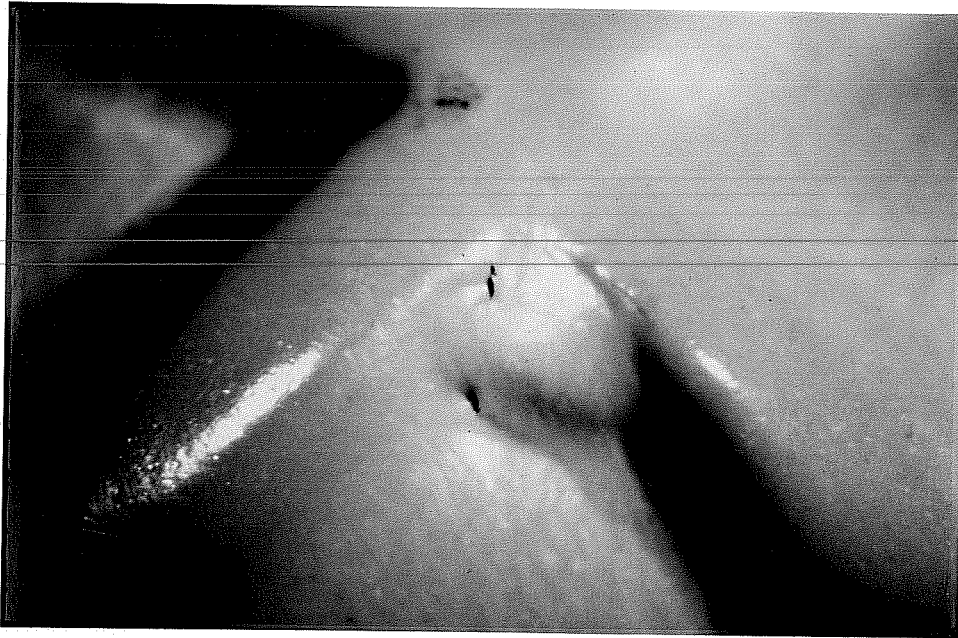
**Figure 3.22** Microscopically-Detected Pinholes on Coated Bar Surface.

The term frequently used to describe tiny discontinuities in the coating is "holiday". A holiday is a very small discontinuity (pinhole) of the coating that exposes the metal surface to the environment or exhibits electrical conductivity when exposed to a predetermined voltage. This means that holidays are openings in the coating capable of transmitting corrosion currents.<sup>94</sup> The size limits of holidays are not precisely defined but usually they are so small they cannot be detected with the unaided eye.

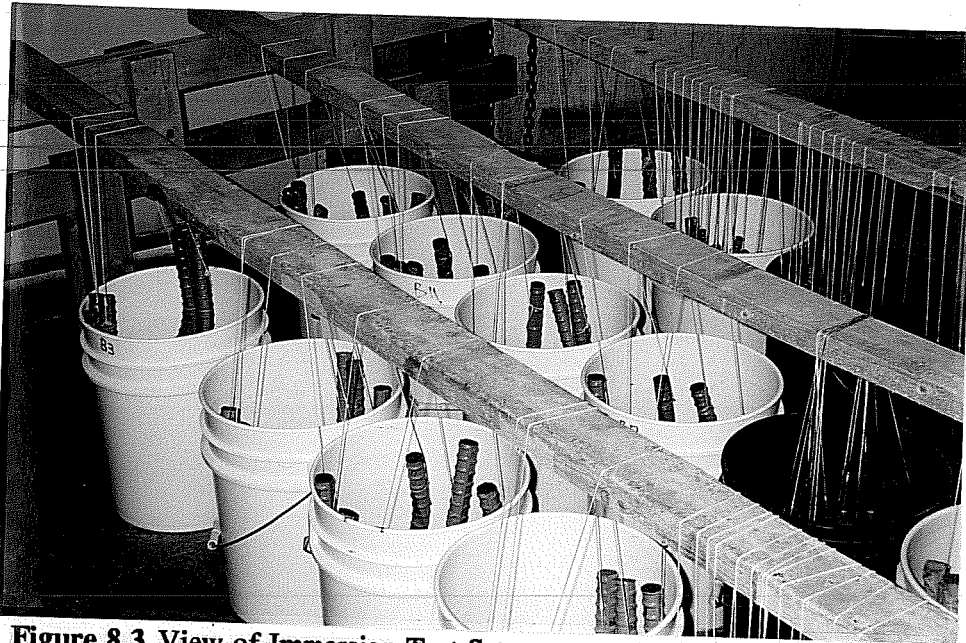
**Figure 8.3** View of Immersion Test Setup.

In order to prevent damage to coating during testing, the bars were hung from a wooden frame using nylon strings. The frame was built to permit lifting the bars out of the solution during drying periods. The bars were suspended above the saltwater level so that any solution on the bars would drop into the immersion bucket. To account for possible evaporation of water, a constant concentration of the solution was maintained by adding water to a fixed depth. Figures 8.2 and 8.3 show the test setup.

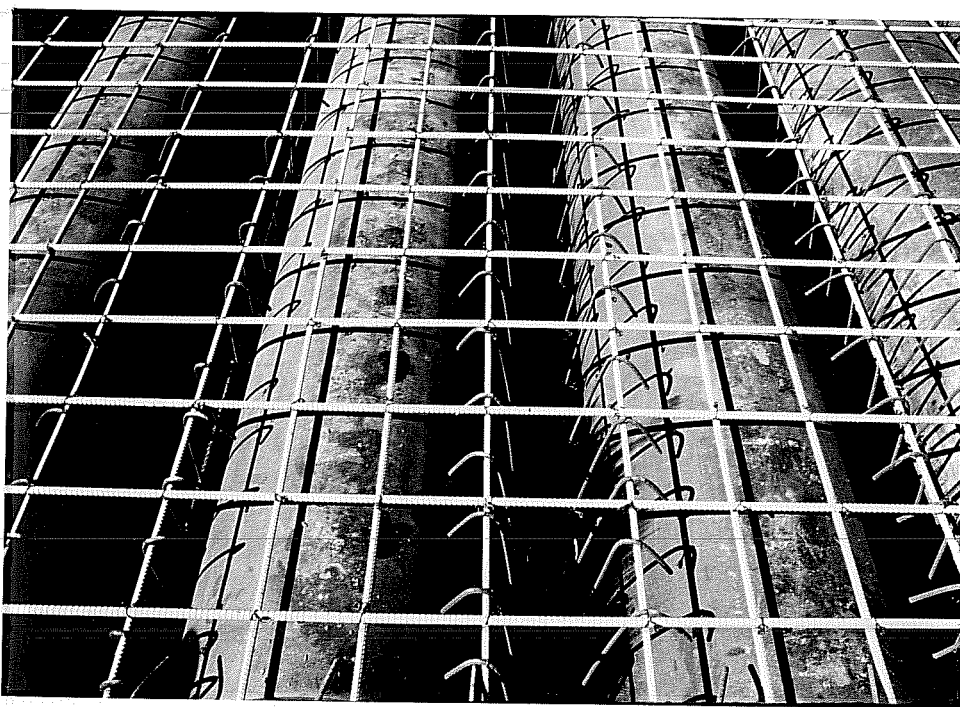
**Figure 9.1** Bridge Deck Slab with Coated (Top) and Uncoated (Bottom) Reinforcement.

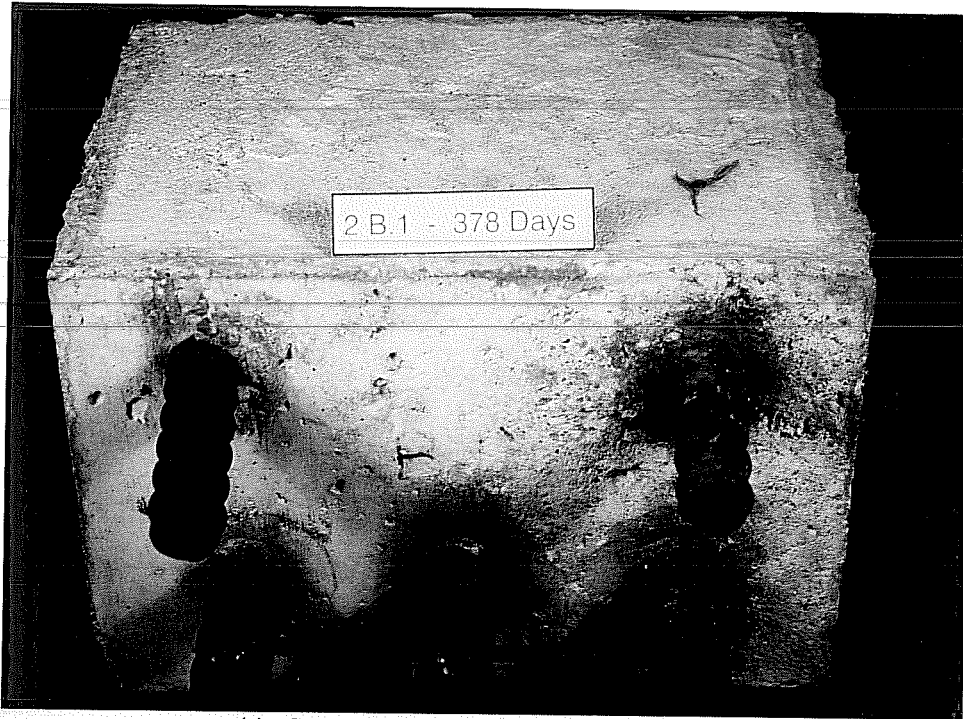
(a) Specimen 2 B.1, One year of Exposure

Figure 9.6 Examples of Autopsied Uncoated Steel Specimens.

The surface condition of the specimens after one and two years of exposure is depicted in the sketches presented in Section C.9. Figure 9.6 shows two examples of these specimens removed at different times for forensic examination.

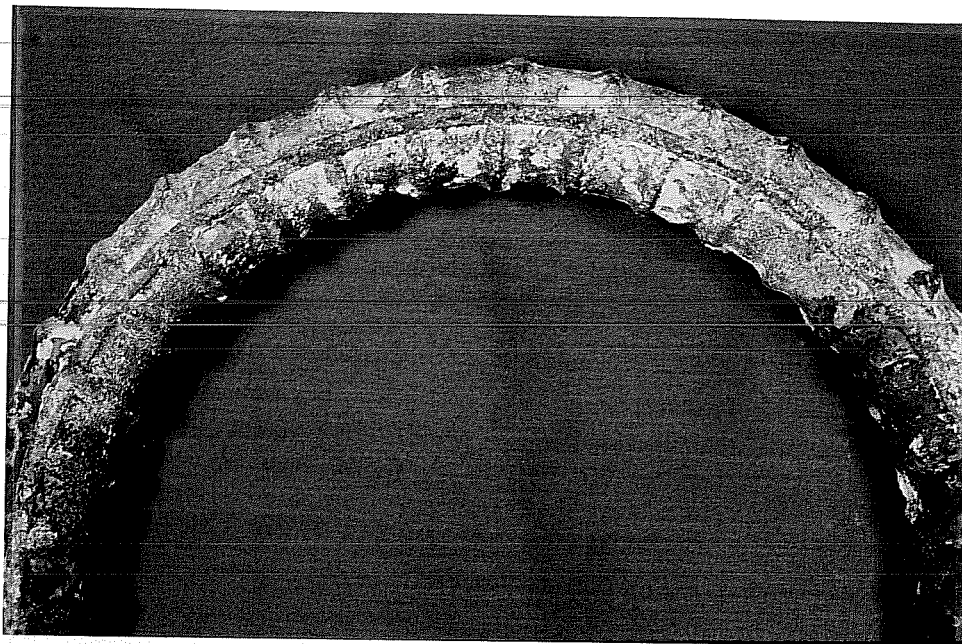
(a) Uncoated Bar Free of Rust at Bend

The anodic area increased in the debonded region due to migration of low pH solution. The acid solution nucleated new pits so large in number and closely spaced that a general corrosion state rather than localized pitting was approached. This condition was exactly opposite to that occurring on the uncoated bar which developed a second macrocell. In effect, the extra driving force of a second macrocell was eliminated on the coated bar and corrosion was distributed. Figure 10.21 shows a bend on a control bar free of rust (because localized severe pitting occurred at the straight ends), and a corroded bend after stripping the damaged coating.

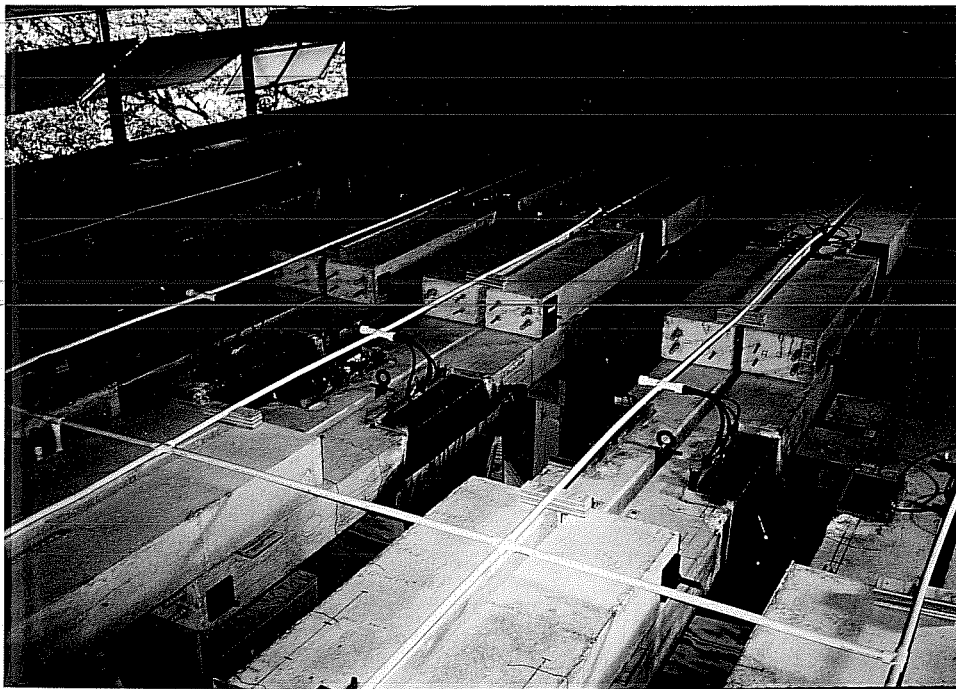
**Figure 11.4** Beam Exposure Test Setup.

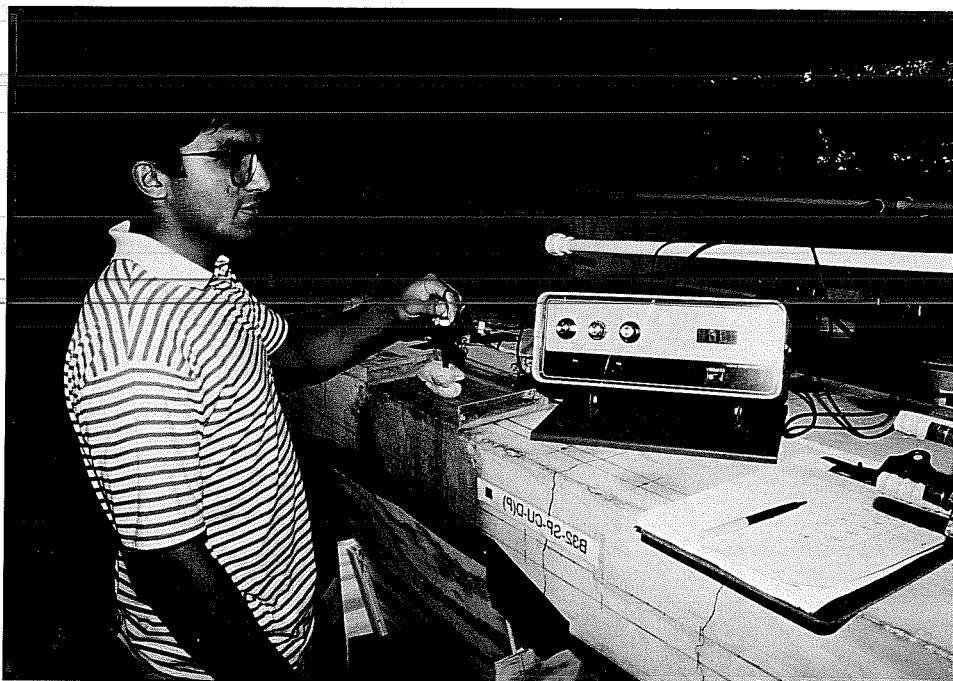
**Figure 11.6** Half-Cell Measurement.

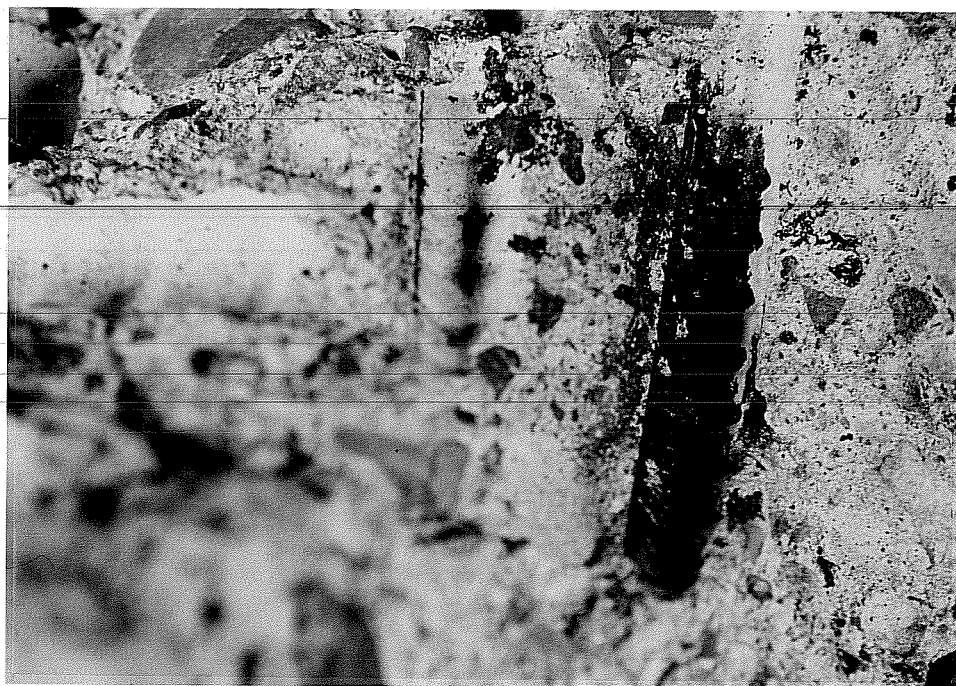
**Figure 12.4** Stirrup Trace in Concrete Adjacent to Crack.

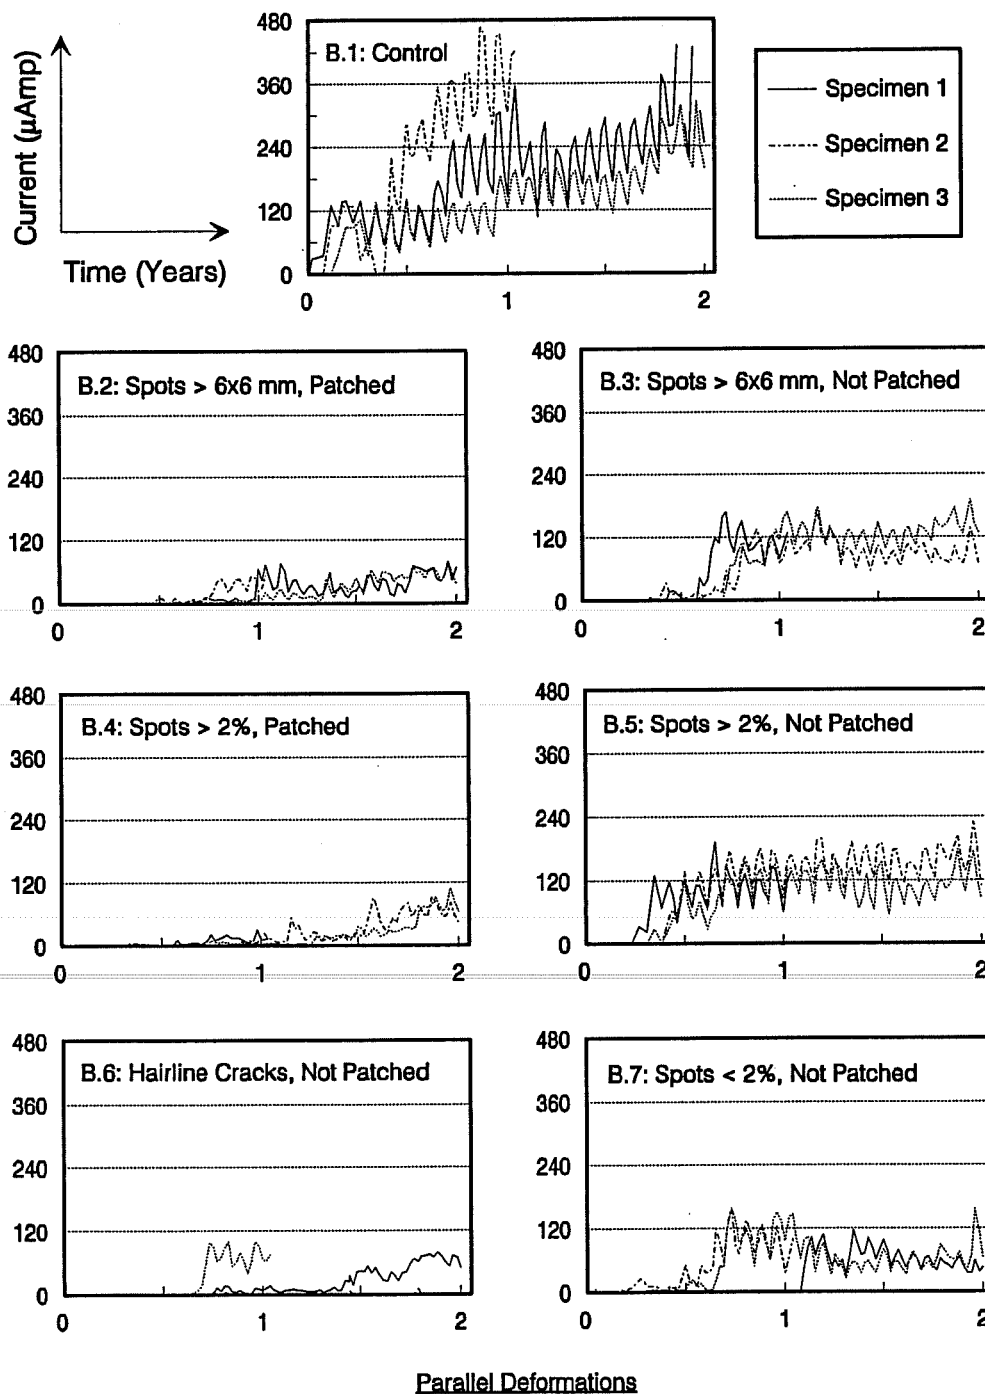
**Figure C.20** Macrocell Corrosion Currents for 25-mm Bars (Series B).

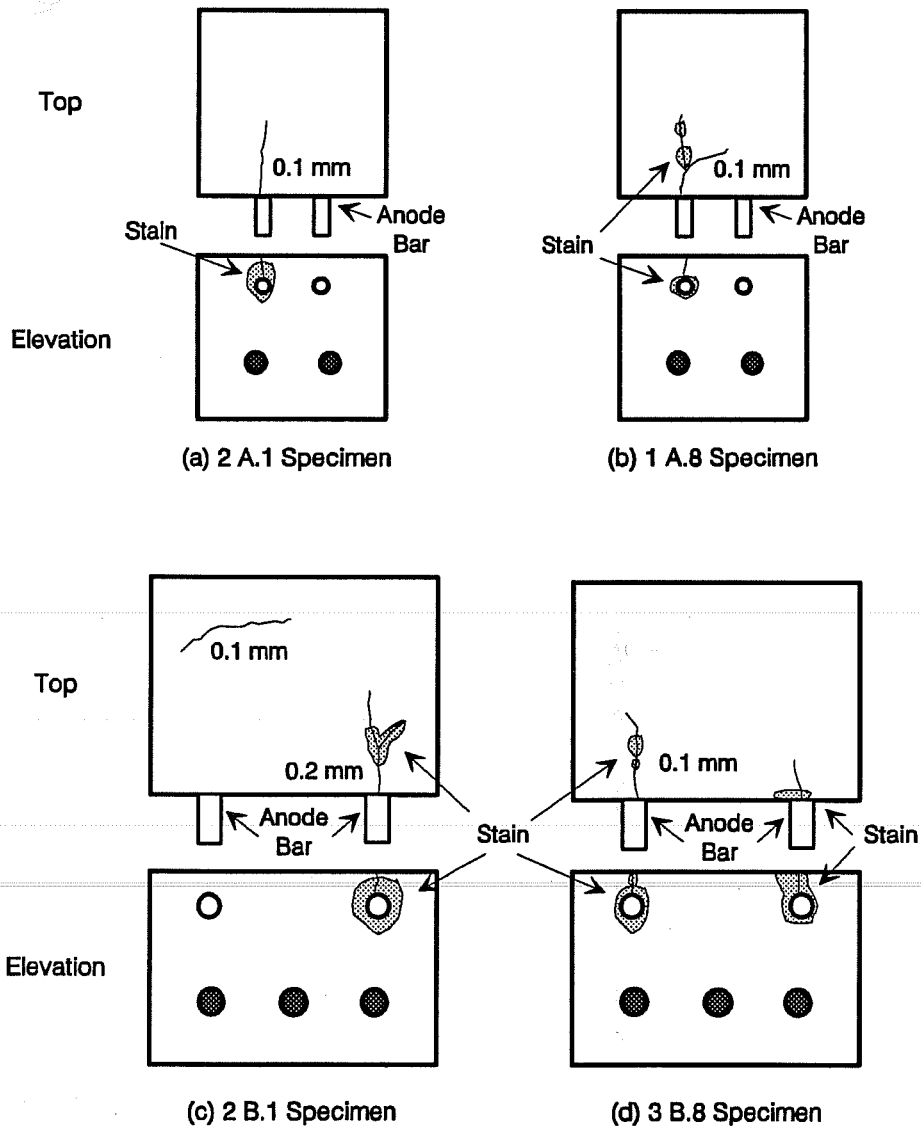
**Figure C.22** Cracks and Stains on Macrocell Specimens Autopsied After One Year of Exposure.

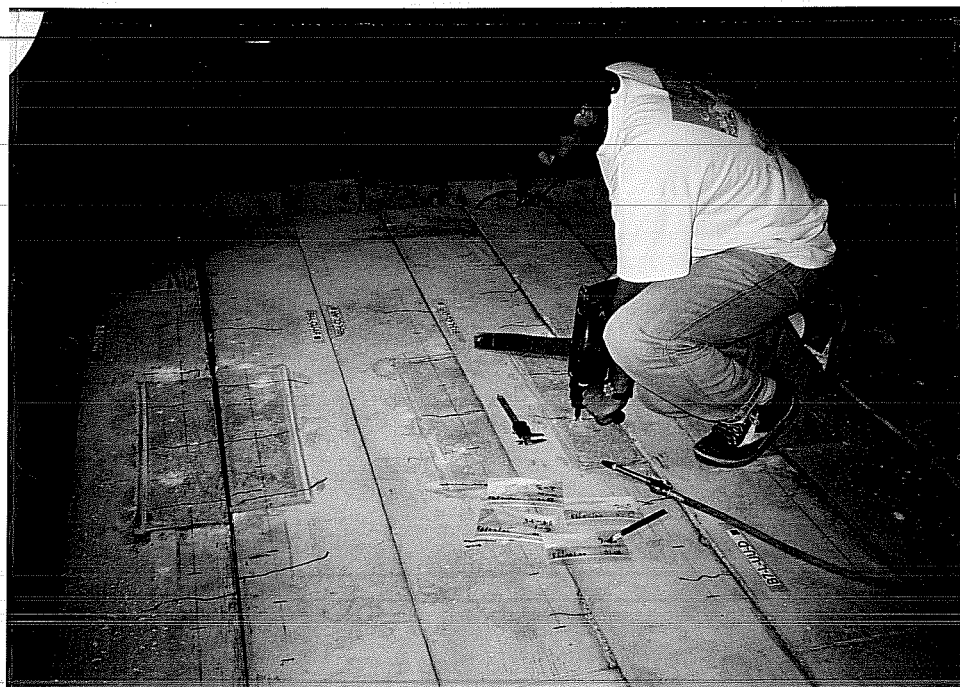
**Figure D.73** Sampling Chloride from Beams Before Autopsy.
