Experimental Investigation on the Effects of Power Actuated Fasteners on Open Web Steel Joists

Thesis

The University of Texas at Austin

A series of 10 full scale tests were conducted on roof subassemblages consisting of open web steel joists and roof deck. In these specimens the roof deck was fastened to the joists by using either 5/8 inch diameter puddle welds or by using power actuated fasteners (PAFs). PAFs are small high strength nails pneumatically or power driven through the roof deck into the joist top chord angles. In these tests, the joists and roof deck were loaded to failure under downward acting vertical loads. The purpose of the tests was to determine if the presence of the PAFs produced any detrimental effects on the gravity load capacity of a joist roof system. The test results showed essentially identical performance for specimens using puddle welds as for specimens using PAFs. The tests demonstrated that the use of PAFs had no detrimental effects on the joists.

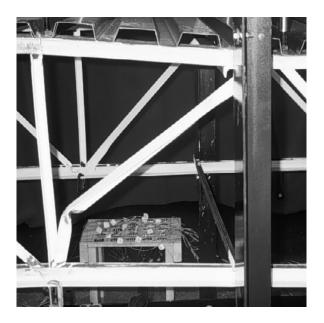
Figure 3.17 Failure Mode for 26K5-PW-2 West Joist

During the initial loading of the specimen, it was noticed that a small fracture was developing in the weld connecting one of the compression diagonals to the bottom chord of the west joist. The location of the affected diagonal on the west joist is shown in Figure 3.13. Upon further loading, the weld failed and the compression diagonal buckled, as shown in Figure 3.17. The west joist sustained a maximum load of 19.79 kips.

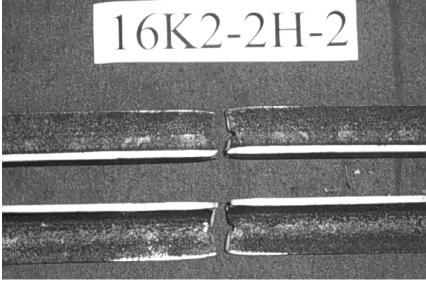
Figure 4.10 Failures in 16K2 Specimens with 2 Holes per Angle
