**Methods to Develop Composite Action in Non-Composite Bridge
Floor Systems: Fatigue Behavior of Post-Installed Shear
Connectors**

Thesis

The University of Texas at Austin

This thesis is a continuation of the work reported by Schaap (2004) and Hungerford (2004) as a part of TxDOT Project 0-4124. TxDOT Project 0-4124 aims to investigate structurally efficient, cost-effective, and practical ways to post-install shear connectors to increase the load carrying capacity of bridges originally designed as non-composite. Using a direct-shear test setup, the structural effectiveness of alternative post-installed shear connectors was evaluated through cyclic tests. Additional tests were conducted to examine the load-slip behavior of these post-installed shear connectors under monotonically increasing shear loads. The installation processes of each shear connection

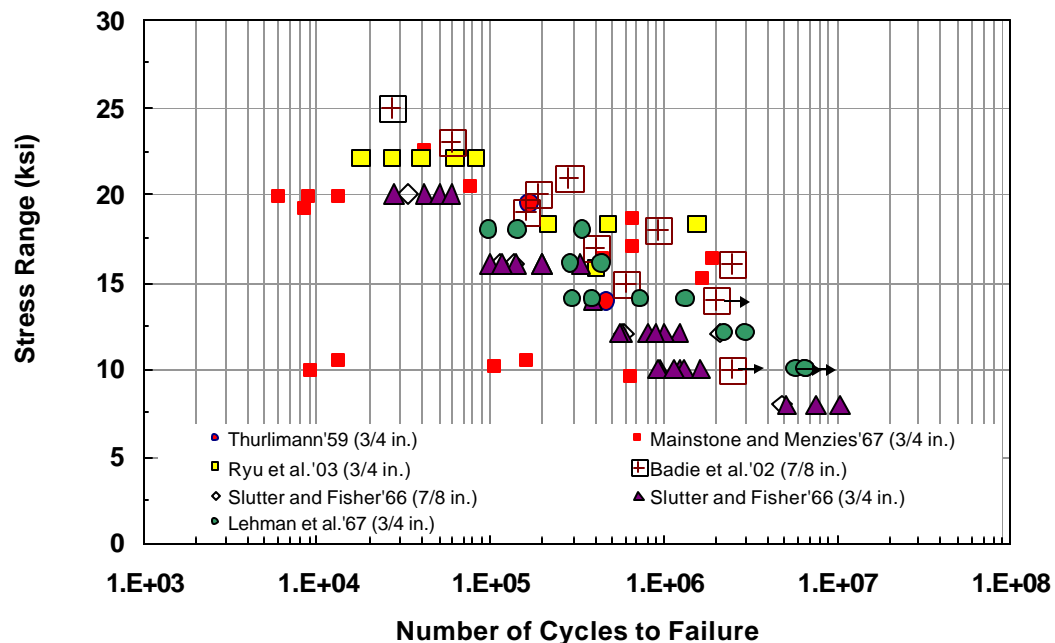
Figure 2.1: S-N data for push-out tests

Stress range (S)-number of cycles to failure (N) data reported by Thurlimann (1959), Slutter and Fisher (1966), Lehman et al. (1967), Mainstone and Menzies (1967), Badie (2002), and Ryu et al. (2003) are presented in Figure 2.1. This figure only includes data from uni-directional push-out tests conducted for high-cycle fatigue on 3/4-in. and 7/8-in. diameter studs. Data from push-out tests were used, since they are more conservative compared to beam tests. Both stud diameters are presented due to their similar behavior as suggested by Slutter and Fisher (1966). Stress ranges used by these researchers ranged between 8 ksi and 25 ksi with fatigue lives ranging from 6000 to over 10 million cycles. Specimens that did not experience fatigue failure are shown as runout tests with arrows adjacent to the corresponding data points. This S-N plot was used as a benchmark for high-cycle tests performed as a part of this thesis.

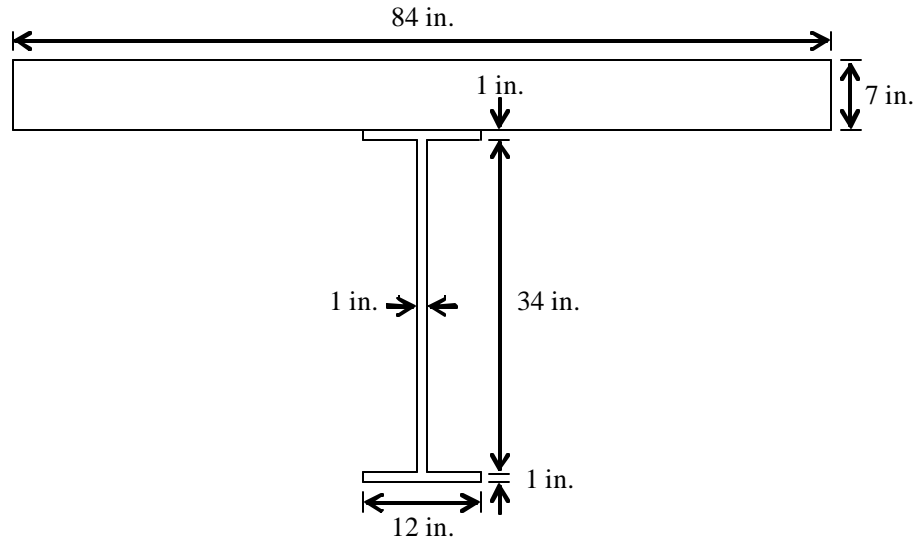
Figure 3.1: Cross section of prototype bridge (Hungerford 2004)

The bridges had 4 or 9 spans with span lengths varying from 50 to 60 ft. Slab thicknesses were observed to vary between 8 to 9 in. Girders were steel rolled wide flange shapes, with transverse spacing varying from 6.75 ft. to 8 ft. and with depths of 28 in. to 36 in. Based on the information gathered on the geometrical properties of these bridges, the researchers created a prototype bridge representative of a typical non-composite TxDOT bridge. This provided the researchers with a model on which test specimens were based. The prototype also aided in finite element analyses and construction cost comparisons. The prototype bridge was designed as a 50 ft. simply supported non-composite bridge with cross sectional properties shown in Figure 3.1 (Hungerford 2004).

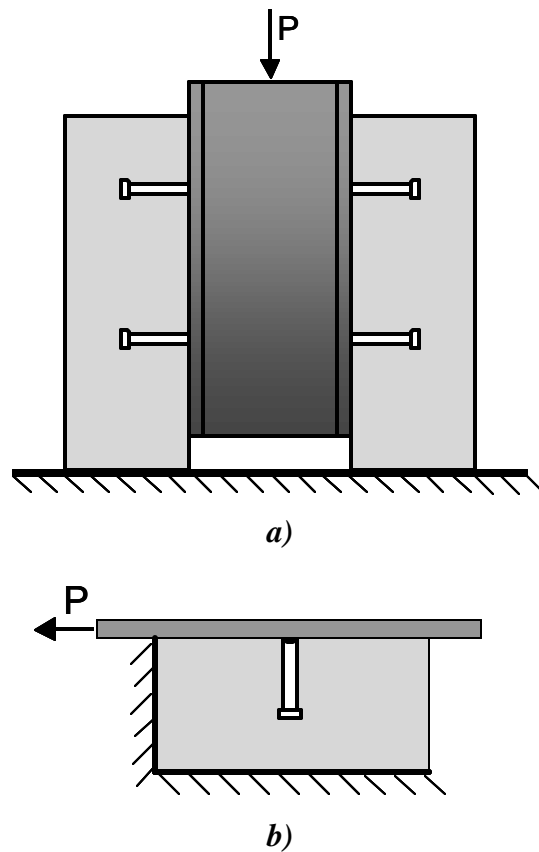
Figure 3.15: a) Push-out test b) Direct-shear test

misrepresent conditions in an actual composite beam. With a direct shear test setup, on the other hand, a group of connectors as well as individual connectors can be tested. The main advantage of the direct shear test is that it can be designed to minimize eccentricity between the applied load and the concrete. With this method the load is applied closer to the steel-concrete interface as shown in Figure 3.15b. Due to limitations associated with a push-out test, the direct-shear test setup shown in Figure 3.16 was chosen for the testing of individual shear connectors (Hungerford 2004).

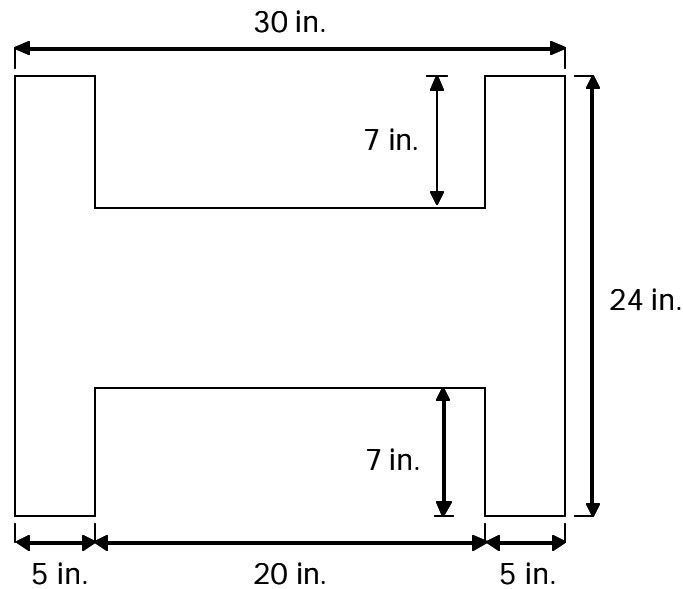
Figure 4.2: Base plate with dimensions

Base plate: The specimen rests on the base plate, which is welded on its edges to the test frame. The dimensions of the base plate are shown in Figure 4.2. The 7 in. x 20 in. open sections were intended to provide space for the protruding stirrups of each specimen.

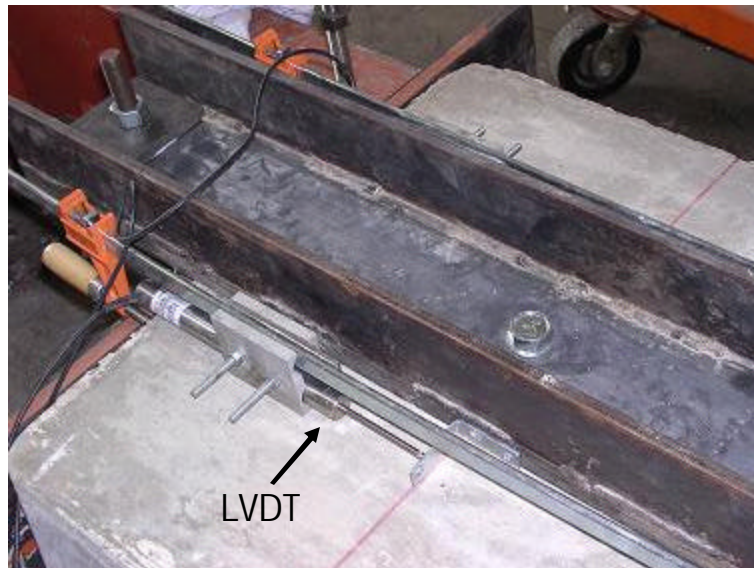
Figure 4.4: LVDT setup (second LVDT not shown)

The relative slip between the concrete block and steel plate (slip of the connector) was measured with two Sensotech Model Linear Variable Differential Transformers (LVDT). These LVDT's were actually direct-current differential transformers (DCDT) which initially convert a DC current into an AC current, and then back to a DC output current. The LVDT's had a total stroke of ± 1 in. and a precision of 1/10000 in.

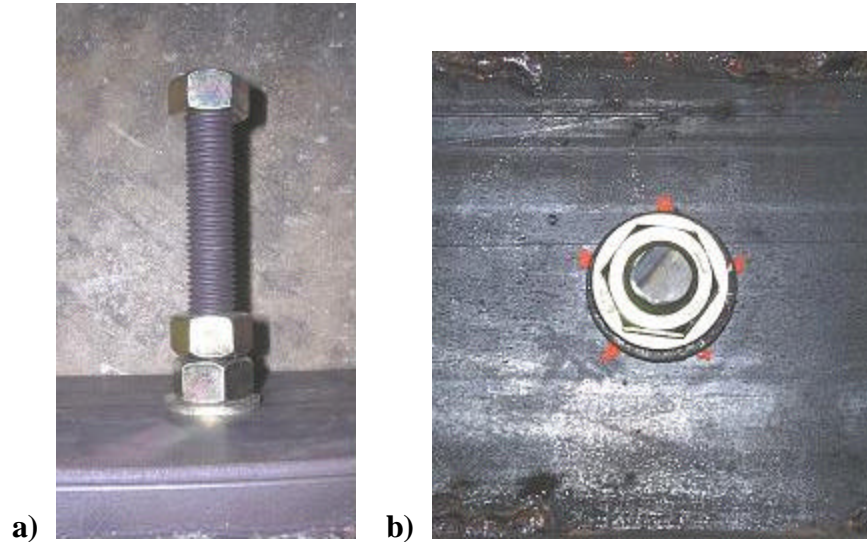
Figure 4.26: Double-Nut bolt attached to the steel plate: a) side of bolt to be embedded in concrete b) tightened side of bolt with SDTI washers

The Skidmore-Wilhelm Bolt-Tension Calibrator was used to determine the precision and reliability of SDTI washers. The pretension applied to a bolt was determined by inserting the bolt into the Skidmore and tightening it on to the plate of the calibrator, with a torque wrench. The pressure created from tightening the bolt is transmitted through the hydraulic fluid present in the calibrator to the gage of the calibrator. Meanwhile, the tension in the bolt is displayed in pounds. This helps determine the exact torque that needs to be applied to tighten a bolt to its recommended minimum pretension (Skidmore-Wilhelm 2006).

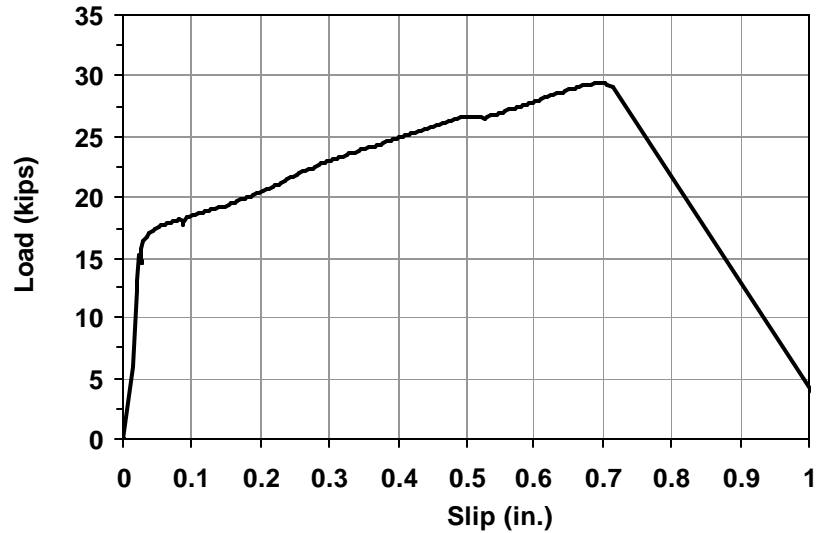
Figure 5.1: Load-slip curve for Specimen CIPST-ST

The load-slip curve of Specimen CIPST-ST is shown in Figure 5.1. The ultimate load of the connector reached 29.4 kips with a corresponding slip of 0.69 in.

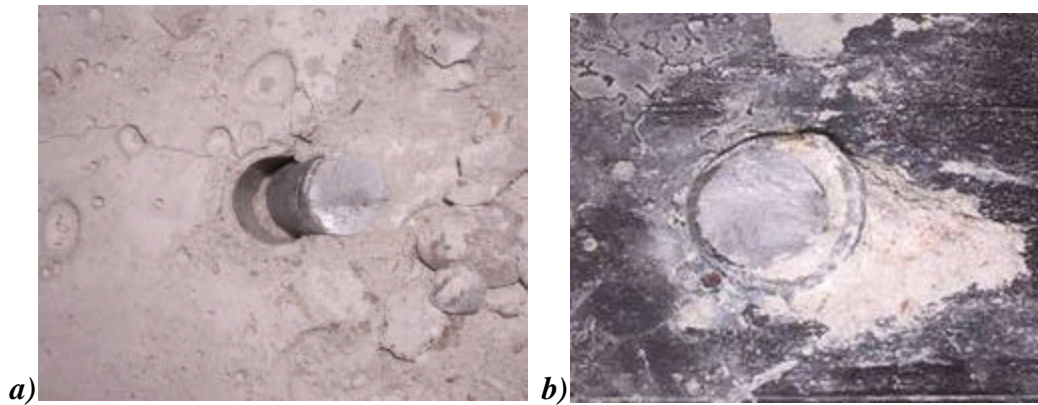
Figure 5.2: Failed Specimen CIPST-ST: a) concrete block, b) steel plate

The stud failed through the weld collar as shown in Figure 5.2 (b). In Figure 5.2 (a) the local crushing of concrete in front of the stud is shown. Longitudinal cracks were observed in the line of loading, both behind and in front of the connector as shown in Figure 5.3. Air voids in the concrete were also apparent at the surface underneath the steel plate. The voids at this location can be attributed to the rising of air bubbles to the surface of the concrete during casting of concrete. These air bubbles most likely were trapped underneath the steel plate, causing air pockets to form.

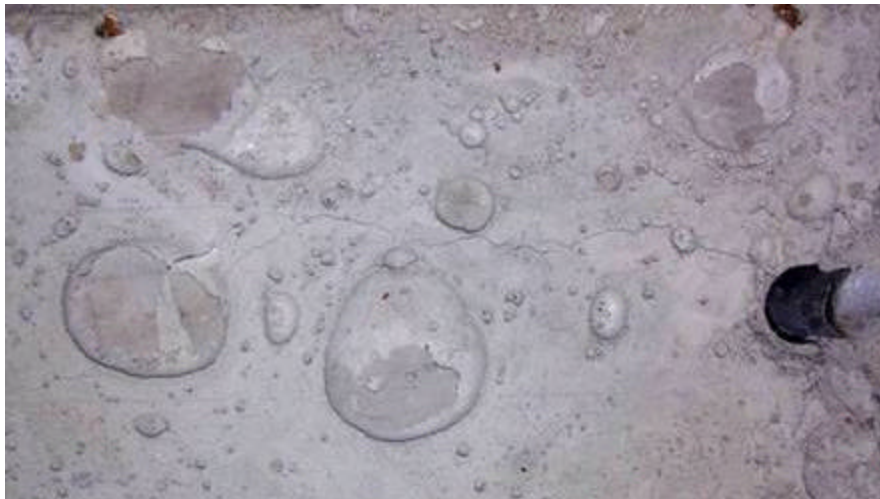
Figure 5.3: Voids and longitudinal crack behind stud (Specimen CIPST-ST)

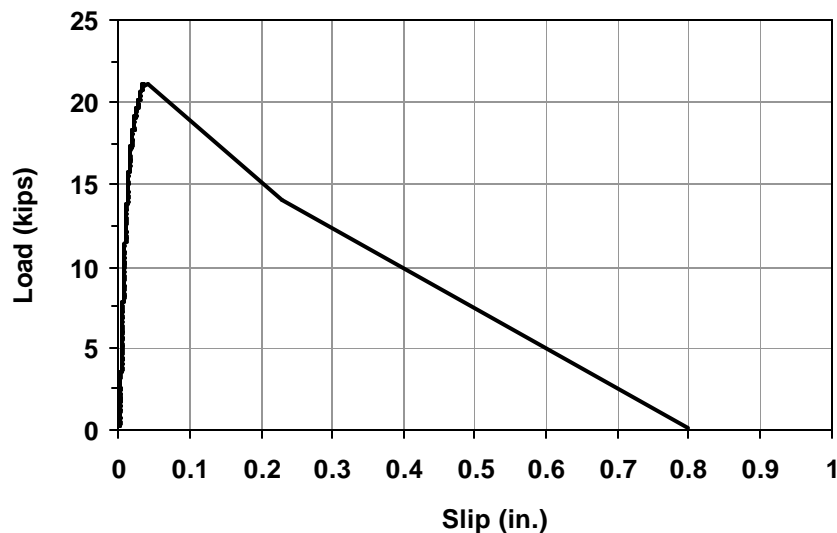
Figure 5.4: Load-slip curve for Specimen POSST-ST

The load-slip curve for Specimen POSST-ST is shown in Figure 5.4. The ultimate load of the connector reached 21.1 kips with a corresponding slip of 0.03 in. Specimen POSST-ST had a bent steel plate which left a gap relative to the concrete block at the connector level. A maximum gap size of approximately 1/8 in. was measured (Figure 5.5).

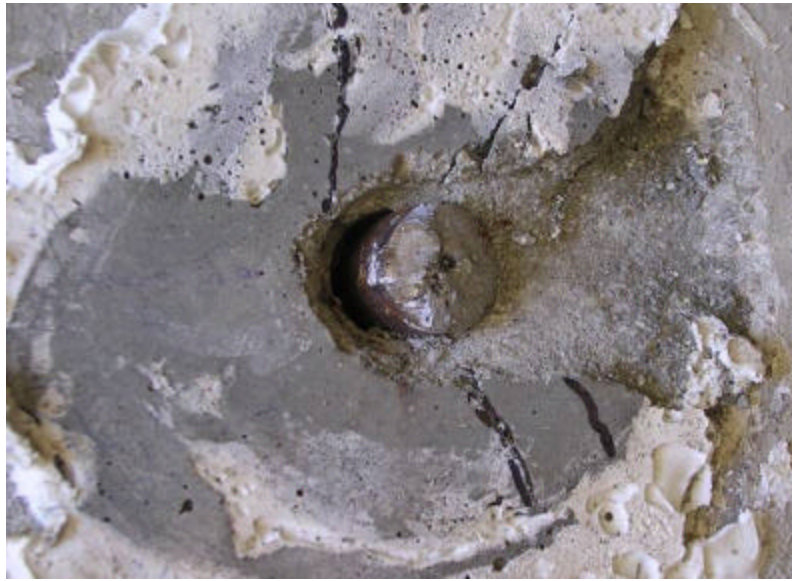
Figure 5.7: Crushing of grout in front of stud (Specimen POSST-ST)

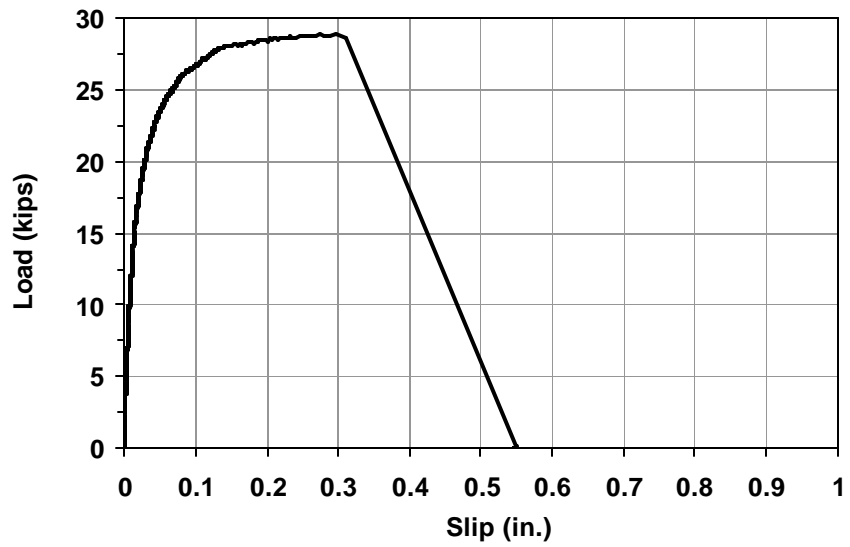
Figure 5.8: Load-slip curve for Specimen POSST-ST(F)

To determine the cause of the brittle failure of Specimen POSST-ST, a supplementary test specimen was built using a fillet-welded stud. For this specimen, a bent plate was used, similar to the one observed for Specimen POSST-ST. The load-slip curve for Specimen POSST-ST(F), shown in Figure 5.8, indicates increased strength and ductility due to the use of a fillet-weld. Based on this curve, it was concluded that the weld for Specimen POSST-ST was defective and caused the brittle failure of the specimen. The bent plate did not affect the failure mode.

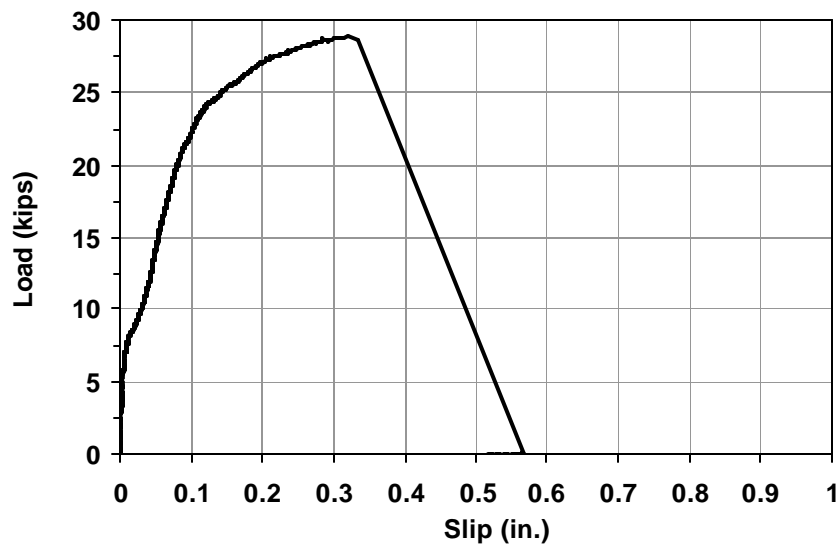
Figure 5.11: Load-slip curve for Specimen DBLNB-ST

Specimen DBLNB-ST reached an ultimate load of 28.9 kips with a corresponding slip of 0.32 in. Due to the pretension applied to this type of connector, the load-slip curve in Figure 5.11 shows an initial increase in load without any related slip. The pretension was eventually overcome after an applied load of about 5 kips, after which load and slip increased, accompanied by bearing of the connector against the steel plate.

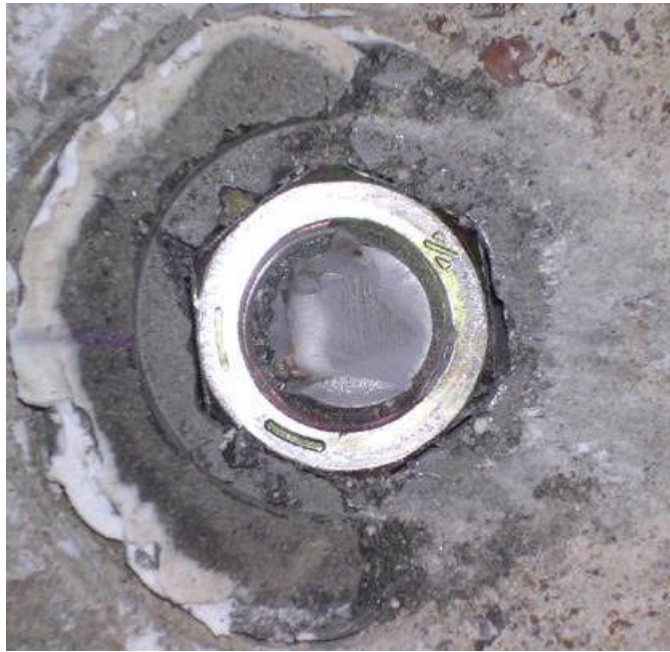
Figure 5.12: Failed connector at steel-concrete interface (Specimen DBLNB-ST)

The connector failed in shear at the steel-concrete interface (Figure 5.12), accompanied by local crushing of grout in front of the connector. In Figure 5.13 the section of the failed connector above the steel-concrete interface is shown. The bearing deformation in the steel plate is shown in Figure 5.14.

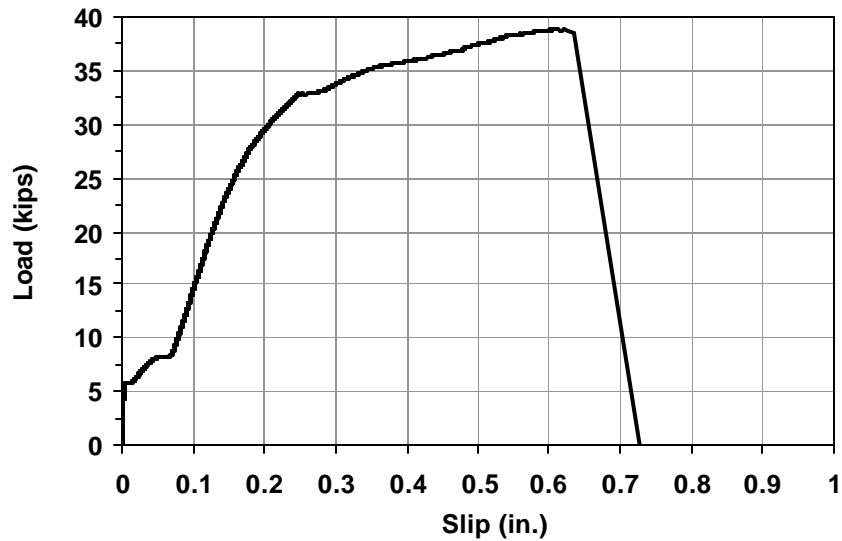
Figure 5.15: Load-slip curve for Specimen HTFGB-ST

Similar to Specimen DBLNB-ST, pretension was applied to the connector during installation. During testing, this resulted in an initial increase in load without slip until approximately 5 kips (Figure 5.15), followed by an increase in load due to bearing of the connector against the steel plate. Specimen HTFGB-ST reached an ultimate load of 38.8 kips with a corresponding slip of 0.61 in. The slip values were based on the readings from one LVDT only, because at the end of the test the second LVDT was found to not be in contact with the bracket adhered to the steel plate. During the initial stages of the test, the disregarded LVDT readings displayed slightly smaller slip values compared to the other LVDT. Therefore, the actual slip at ultimate in the line of the connector may be slightly less than the reported value.

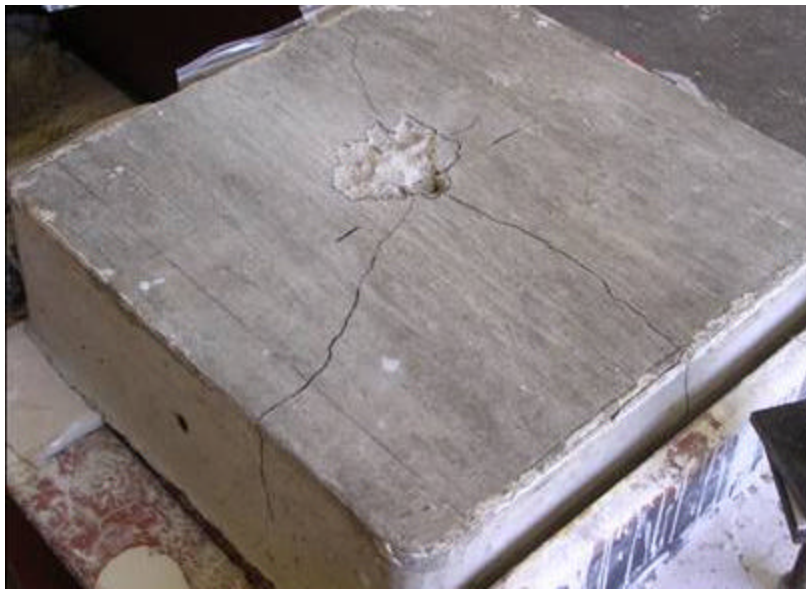
Figure 5.18: Shear failure of connector accompanied by cracking of the concrete block (Specimen HTFGB-ST)

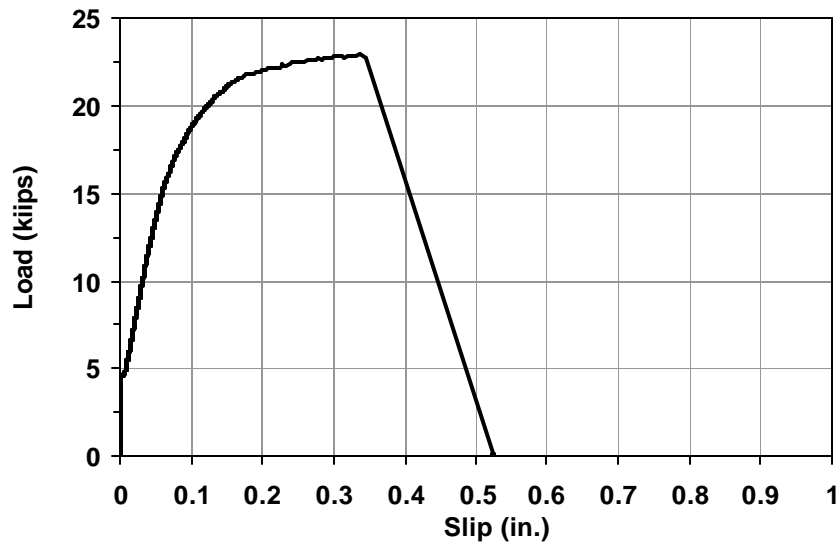
Figure 5.19: Load-slip curve for Specimen HASAA-ST

Specimen HASAA-ST reached an ultimate load of 22.9 kips at a slip of 0.33 in. The load–slip curve for this specimen, shown in Figure 5.19, indicates an initial loading without slip of up to approximately 5 kips. This is due to the pretensioning of the connector during installation. Once the friction force due to pretension was overcome, load and slip increased, and the connector slipped into bear against the steel plate.

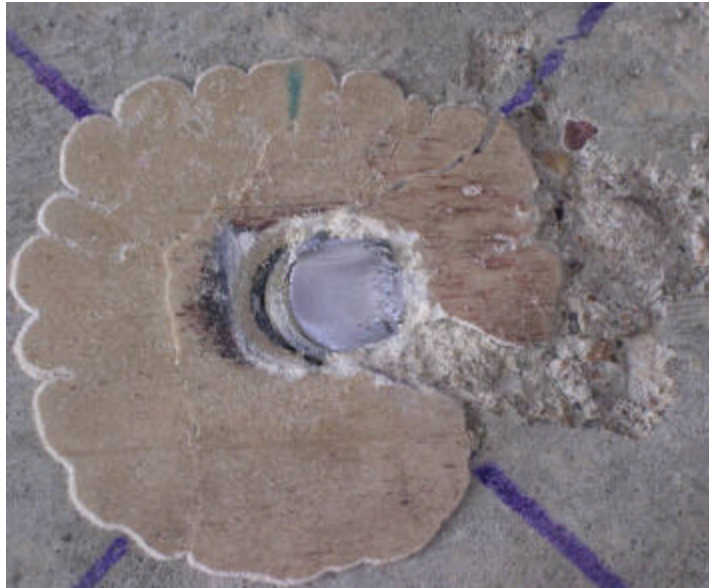
Figure 5.20: Shear failure of Specimen HASAA-ST at steel-concrete interface

The connector failed in shear at the steel-concrete interface. During installation, excess adhesive spread around the connector at the steel-concrete interface and in the hole in the steel plate. The local crushing of concrete and adhesive in front of the connector is shown in Figure 5.20. After failure, the section of the failed connector inside the steel plate could not be removed (Figure 5.21).

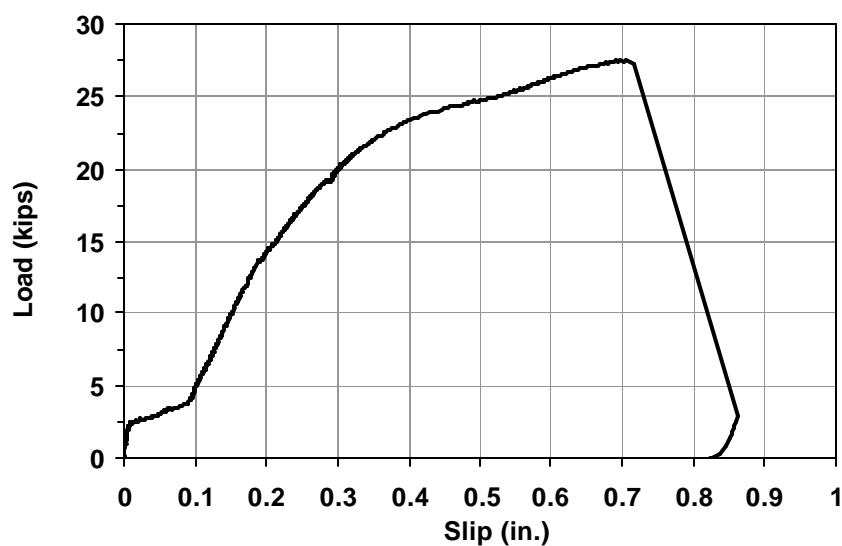
Figure 5.22: Load-slip curve for Specimen WEDGB-ST

connections tested. Specimen WEDGB-ST reached an ultimate load of 27.5 kips at a slip of 0.70 in. An initial increase in load without any slip is observed up to about 2.5 kips. This can be attributed to the fact that the locking teeth underneath the bolt head locked against the steel plate as the connector was tightened. Once friction forces between the bolt head and steel plate were overcome, the connector slipped into bearing with the steel plate, resulting in an increase in load and slip.

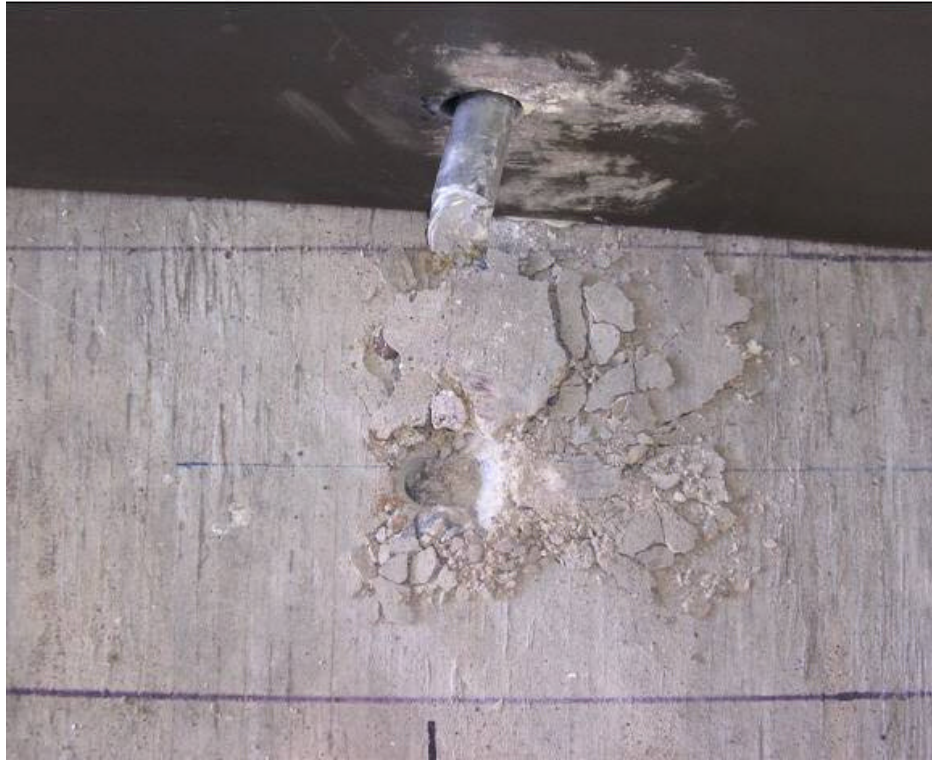
Figure 5.23 Failed Specimen WEDGB-ST

Specimen WEDGB-ST failed in a combination of shear and tension below the steel-concrete interface (Figure 5.23), accompanied by local crushing of concrete behind and in front of the connector (Figure 5.24), suggesting a possible pryout failure. In Figure 5.25, of the side and front view of the failed connector, the bearing location of the connector on the steel plate is shown, as well as cracks opposite the bearing side of the connector. The connector caused significant bearing deformation in the steel plate (Figure 5.26).

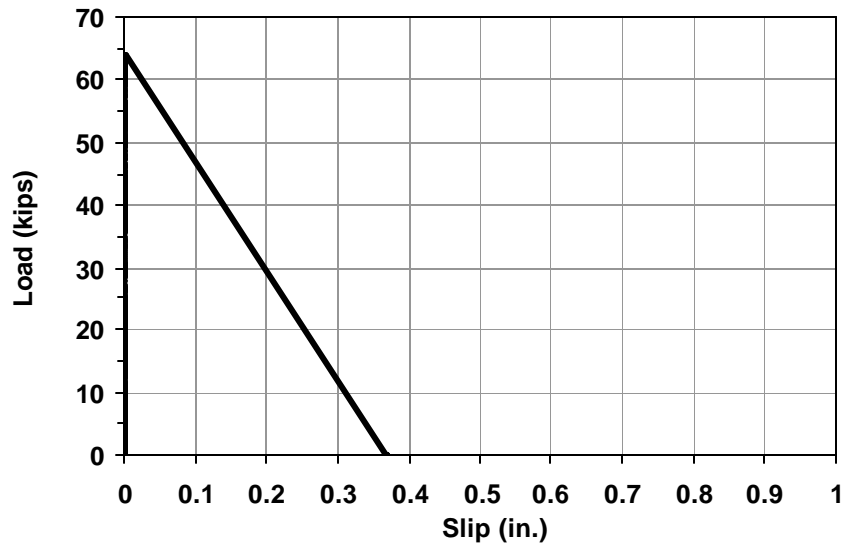
Figure 5.27: Load-slip curve for Specimen 3MEPX-ST

Specimen 3MEPX-ST showed the highest ultimate shear strength and the least amount of slip among all connectors tested. The load-slip curve of the specimen is shown in Figure 5.27. Specimen 3MEPX-ST reached an ultimate load of 63.8 kips without slip until failure.

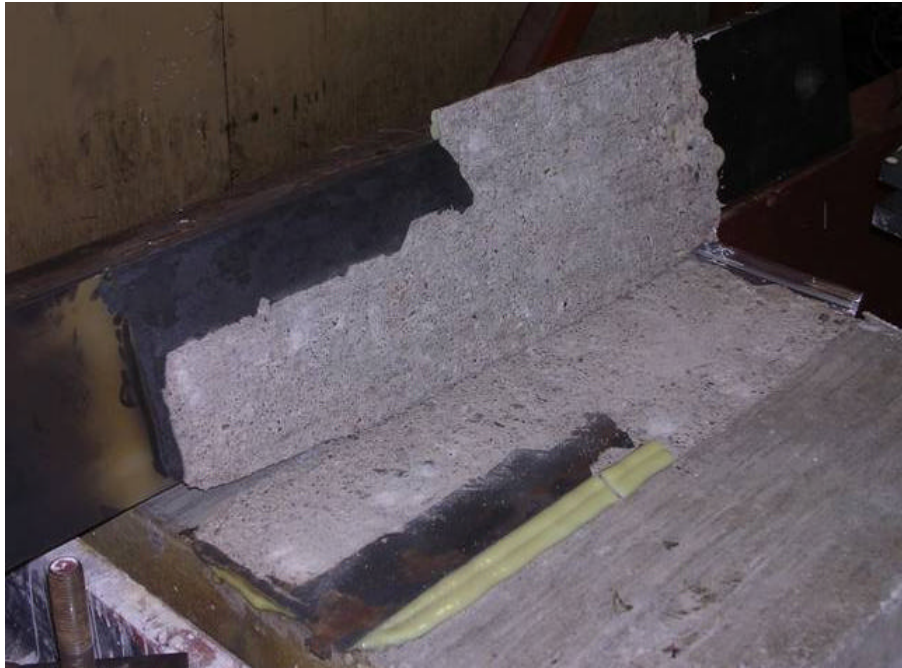
Figure 5.28: Failed Specimen 3MEPX-ST

Figure 5.28 shows Specimen 3MEPX-ST after failure. Shear failure occurred primarily below the adhered surface of the concrete. Less than one-quarter of the adhered surface failed at the steel-concrete interface, possibly due to insufficient bond between the epoxy and steel at those locations.

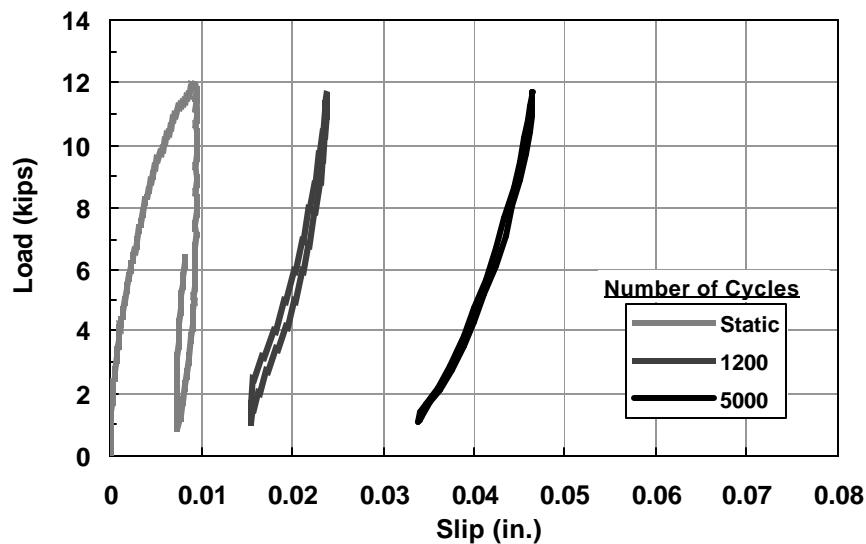
Figure 5.29: Static and cyclic load-slip curves for Specimen CIPST25

assess degradation in stiffness under high-cycle fatigue loading. The resulting load-slip curves showed increasing slip and decreasing stiffness with cycling for all connectors, with quantitative changes varying with stress range and connection type. In Figure 5.29 are shown the static and cyclic load-slip curves for Specimen CIPST25, representative of the general trend observed in the load-slip behavior of all investigated connectors. The load-slip curves of individual test specimens are presented in Appendix C, with the exception of Specimen CIPST20, for which the data acquisition system malfunctioned at the time of testing.

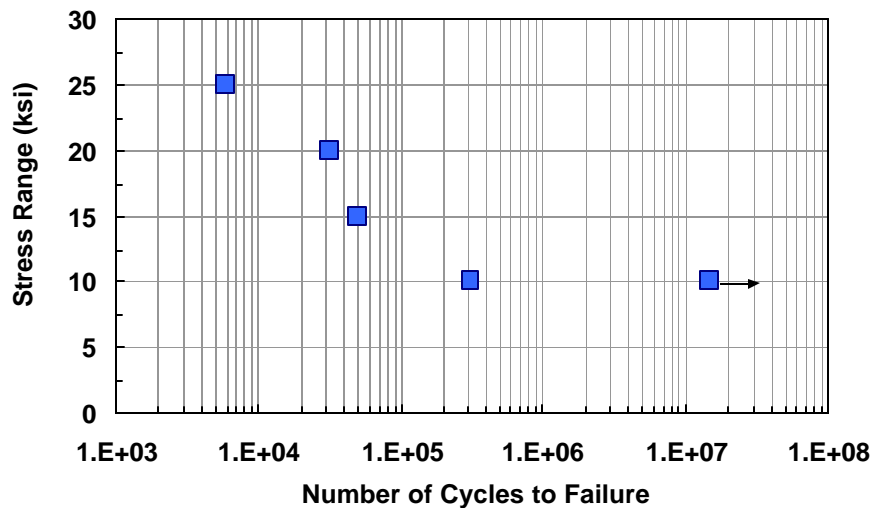
Figure 5.30: S-N curve for CIPST specimens

Five CIPST specimens were tested under high-cycle fatigue at four different stress ranges: 25 ksi, 20 ksi, 15 ksi, and two tests at 10 ksi. The resulting S-N plot is shown in Figure 5.30. The number of cycles to failure ranged between 5815 cycles for Specimen CIPST25 and 312094 cycles for Specimen CIPST10. Specimen CIPST10a did not fail before 14.7 million load cycles and is shown as a runout specimen with an arrow adjacent to the corresponding data point.

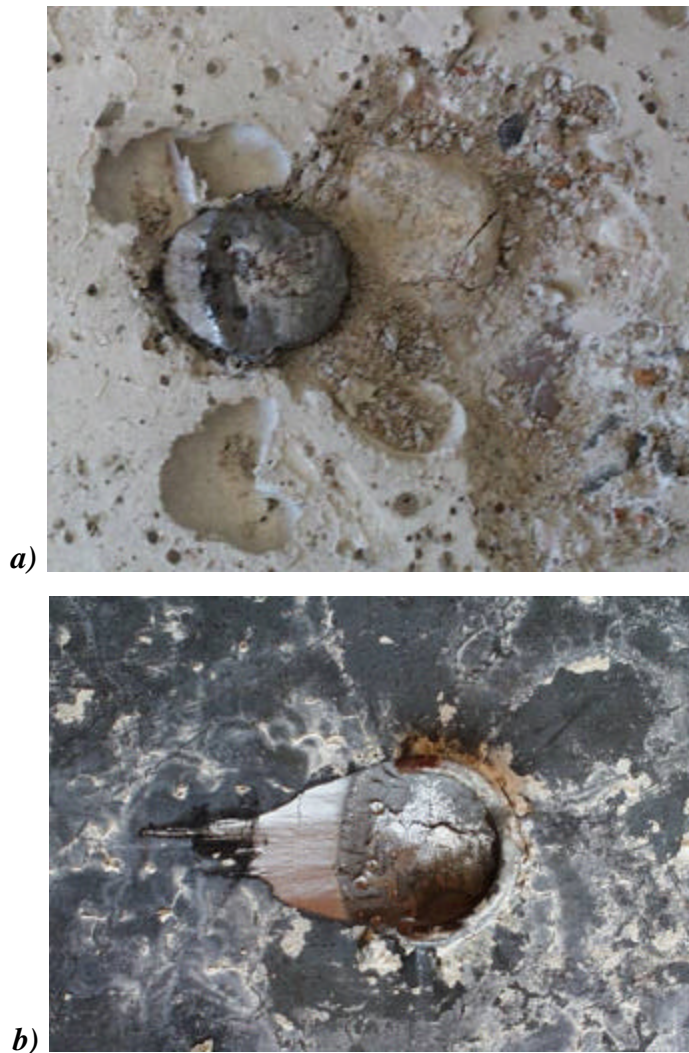
Figure 5.31: Failed Specimen CIPST15: a) concrete block, b) steel plate

Specimen CIPST15 is shown, and is representative of the typical failure mode observed for all CIPST specimens. Failure of shear studs was accompanied by local crushing of concrete in front of the stud. Voids on the concrete surface under the steel plate were also observed (Figure 5.31).

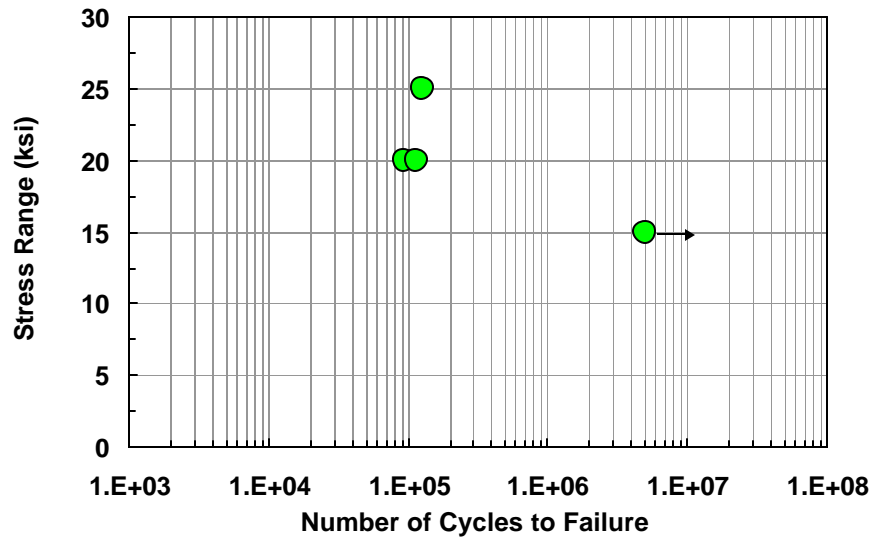
Figure 5.32: S-N plot for POSST specimens

Four POSST specimens were tested under high-cycle fatigue at three different stress ranges: 25 ksi, two specimens at 20 ksi, and 15 ksi. The resulting S-N plot is shown in Figure 5.32. The number of cycles to failure ranged between 124731 cycles for Specimen POSST25 and 94180 cycles for Specimen POSST20. Specimen POSST15(F) did not fail at 5 million cycles, and is shown with an arrow next to its data point. An additional test was conducted at a 20 ksi stress range, since Specimen POSST20 had a shorter fatigue life than Specimen POSST25 specimen. The similar fatigue lives of Specimens POSST20a and POSST20 confirms the reliability of the result for those specimens. The data point for POSST25 may also be reliable, even though it shows the scatter typically associated with fatigue data.

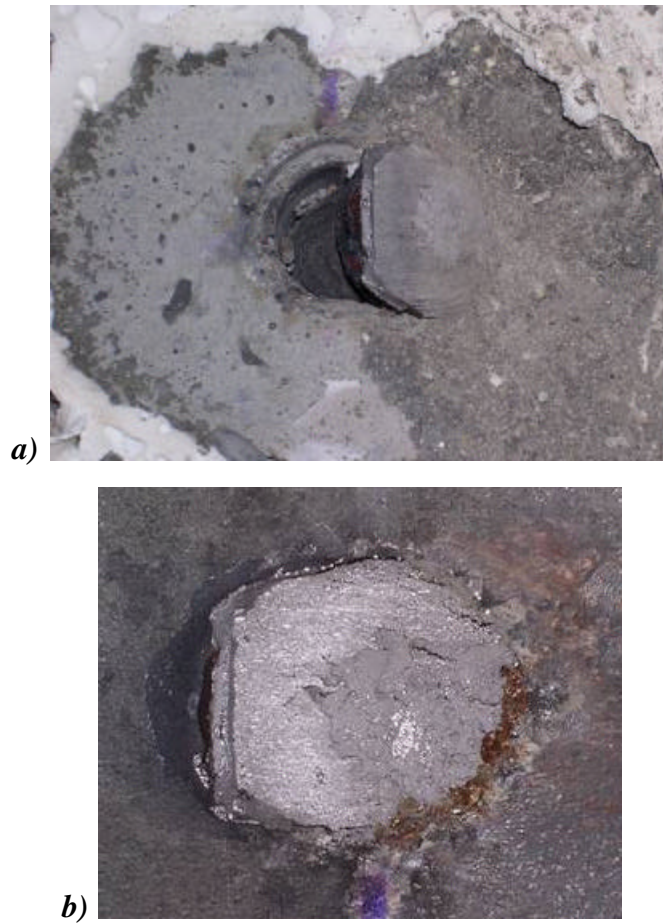
Figure 5.34: Failed Specimen POSST20: a) concrete block, b) steel plate

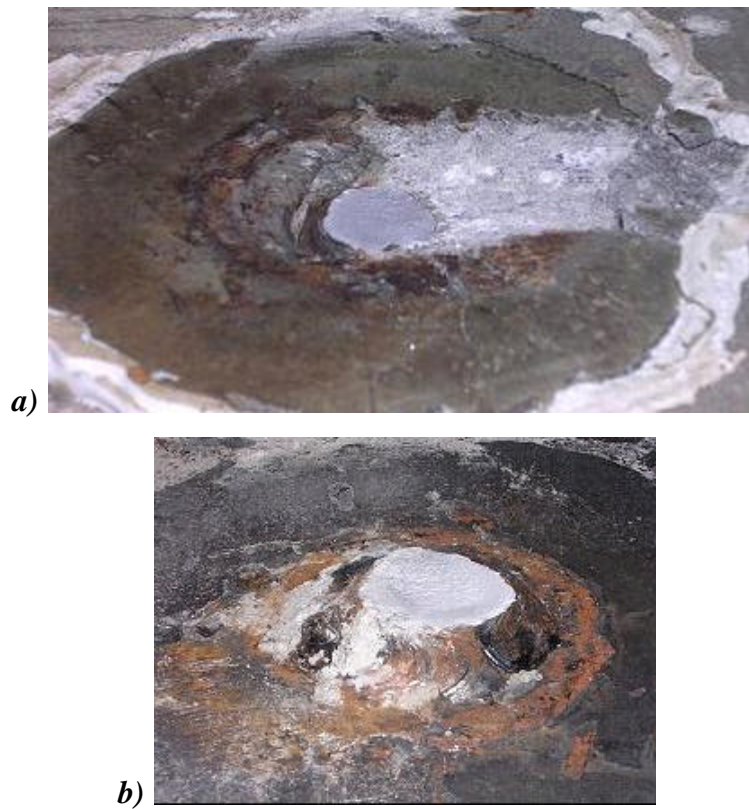
Figure 5.35: Failed Specimen POSST15(F): a) concrete block, b) steel plate

Specimen POSST15(F) was constructed at the same time as Specimen POSST-ST(F) and had a fillet-welded stud. After 5 million fatigue cycles, the connector was tested statically to determine its ultimate load, and a value of 29.0 kips was obtained. Specimen POSST15(F) failed, like Specimen POSST-ST(F), through the stem of the stud above the weld pool (Figure 5.35).

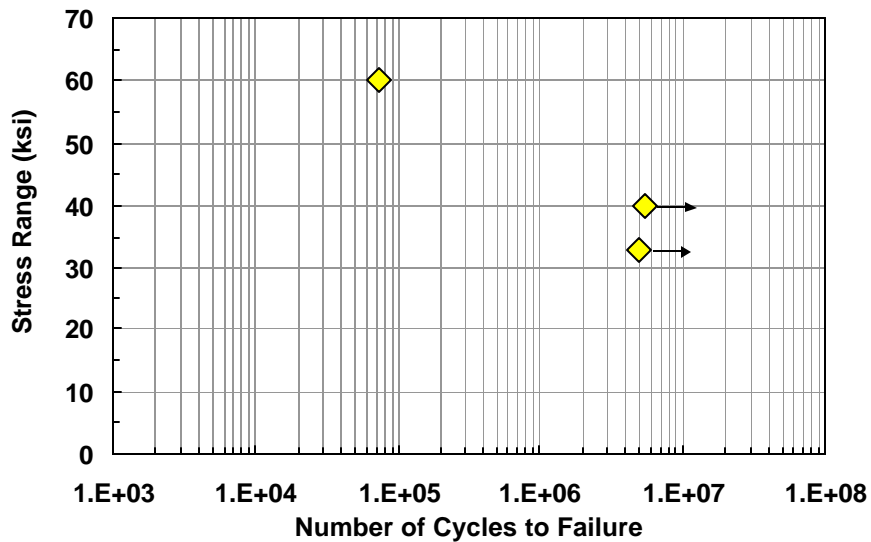
Figure 5.36: S-N curve for DBLNB specimens

Three DBLNB specimens were tested under high-cycle fatigue at three different stress ranges: 60 ksi, 40 ksi, and 33 ksi. The resulting S-N plot is shown in Figure 5.36. Fatigue failure was obtained only for Specimen DBLNB60. Specimens DBLNB40 and DBLNB33 remained intact up to 5 million loading cycles. The fatigue testing of these specimens was stopped and both specimens were loaded statically to obtain the ultimate load of the connectors.

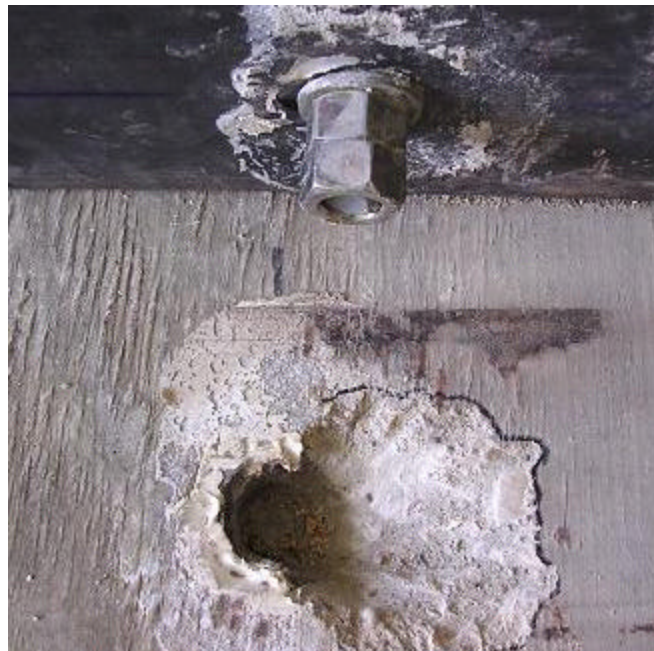
Figure 5.37: Failed Specimen DBLNB60

the level at which the second nut on the threaded rod ended (Figure 5.37). Significant crushing of both the grout and concrete was observed in front of the connector. This may be attributed to the layer of sealant between the grout and concrete at the steel-concrete interface. The sealant may have decreased the confinement around the grout, causing it to crush locally at early stages of loading. This may have shifted the reaction on the connector below the steel-concrete interface resulting in the observed failure mode.

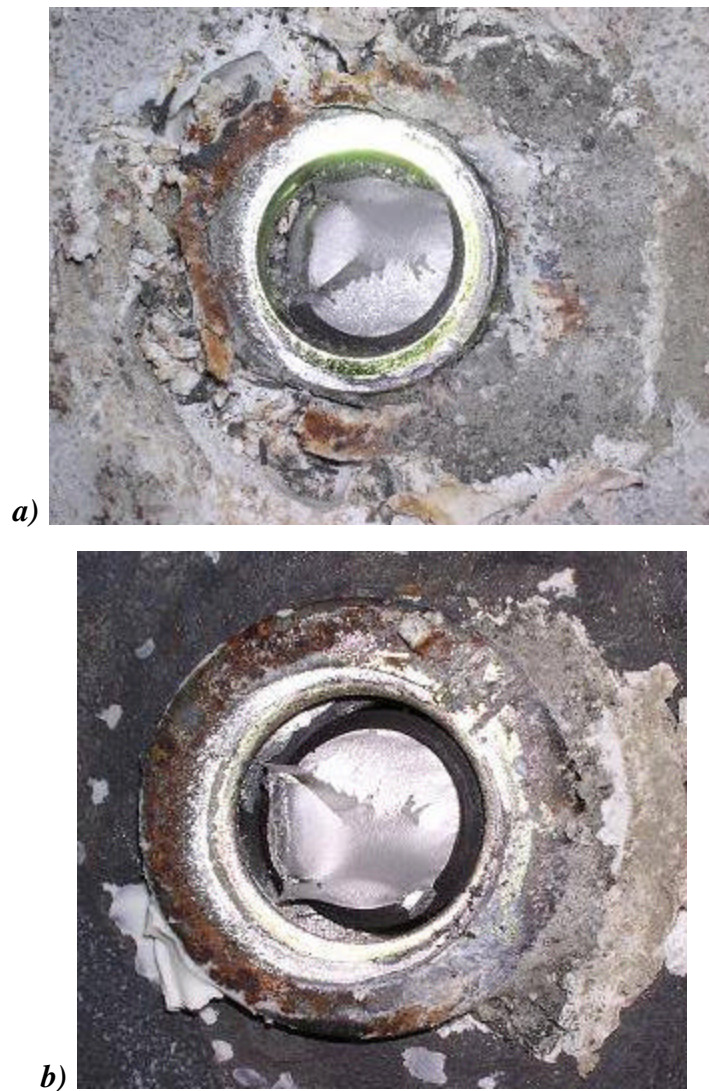
Figure 5.38: Failed Specimen DBLNB40: a) concrete block, b) steel plate

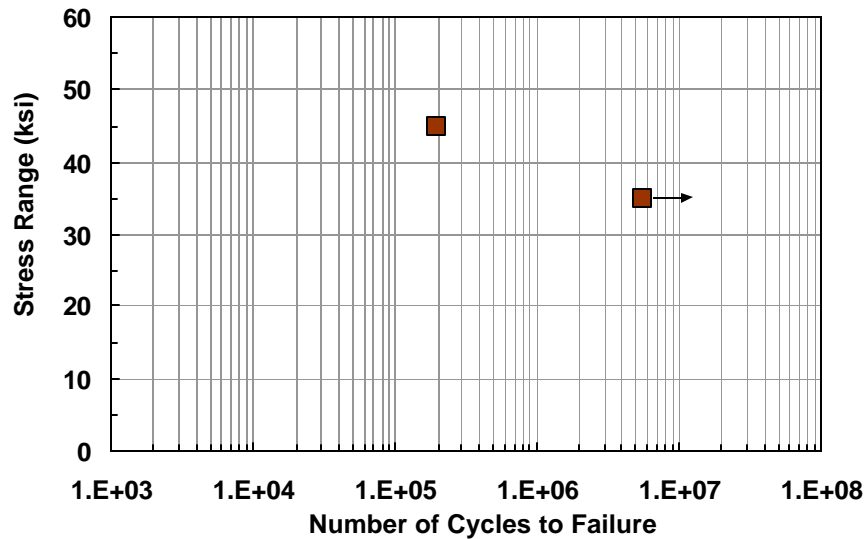
Figure 5.39: S-N curve for HTFGB specimens

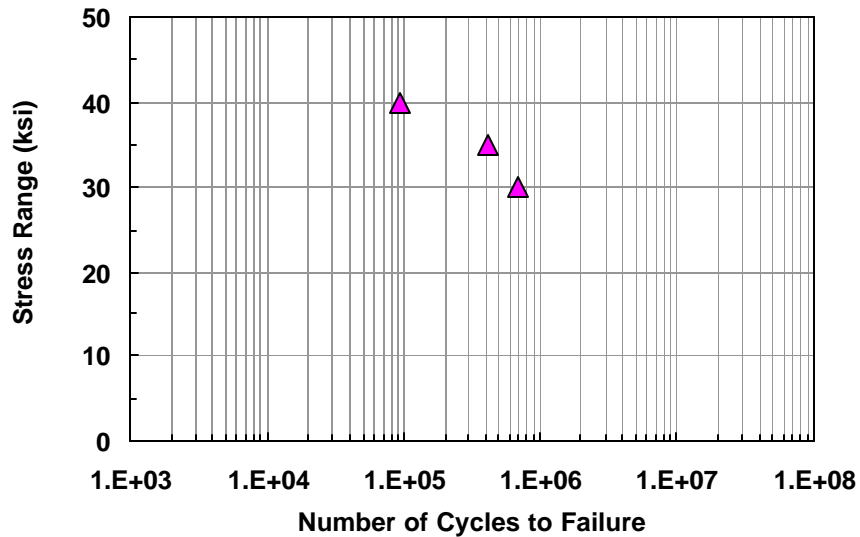
Figure 5.40: S-N curve for HASAA specimens

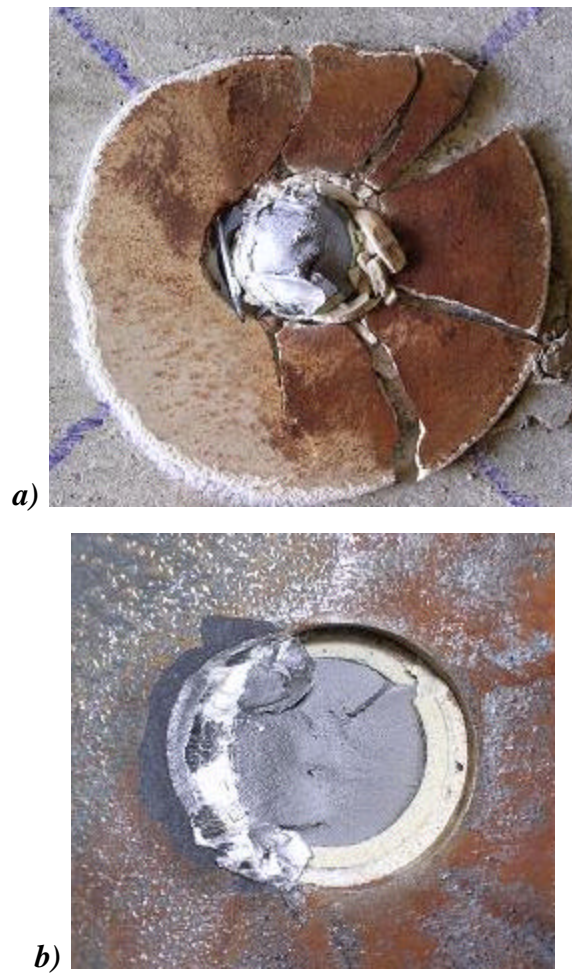
Figure 5.43: Failed Specimen HASAA30: a) concrete block, b) steel plate

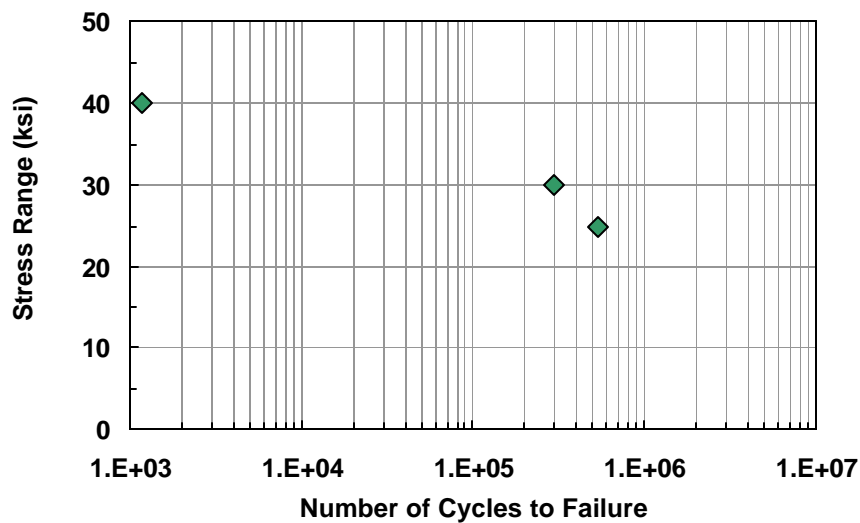
Figure 5.44: S-N curve for WEDGB specimens

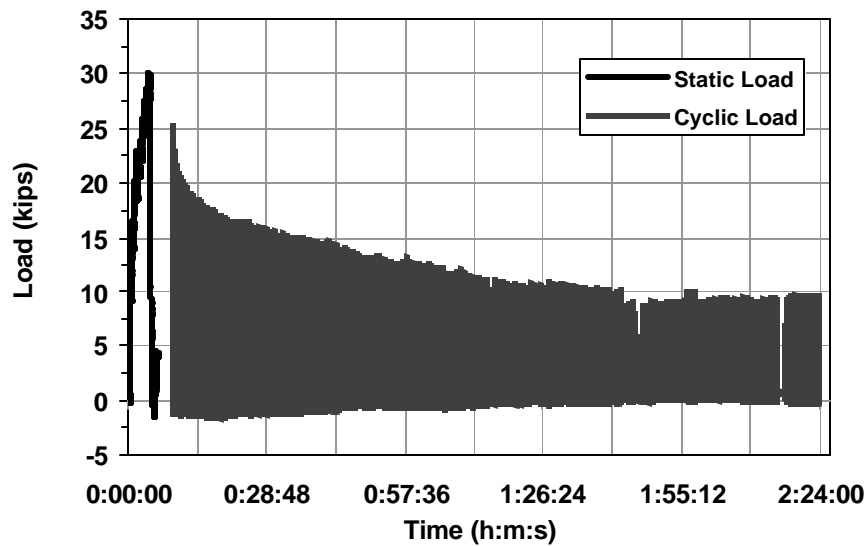
Figure 5.47: Change in load sustained by connector over time (Specimen DBLNBI)

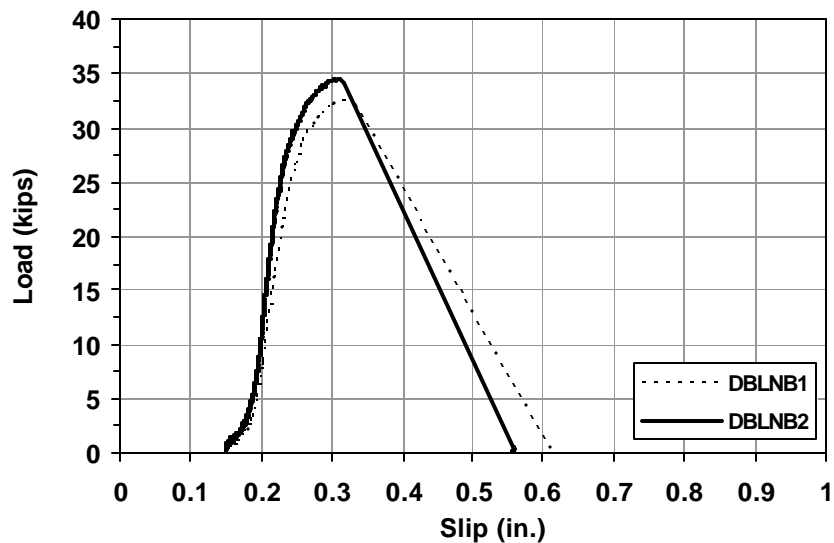
Figure 5.48: Load-slip curves for static strength tests of Specimens DBLNB1 and DBLNB2
