**Methods to Develop Composite Action in Non-Composite Bridge
Floor Systems: Fatigue Behavior of Post-Installed Shear
Connectors**

Thesis

The University of Texas at Austin

This thesis is a continuation of the work reported by Schaap (2004) and Hungerford (2004) as a part of TxDOT Project 0-4124. TxDOT Project 0-4124 aims to investigate structurally efficient, cost-effective, and practical ways to post-install shear connectors to increase the load carrying capacity of bridges originally designed as non-composite. Using a direct-shear test setup, the structural effectiveness of alternative post-installed shear connectors was evaluated through cyclic tests. Additional tests were conducted to examine the load-slip behavior of these post-installed shear connectors under monotonically increasing shear loads. The installation processes of each shear connection

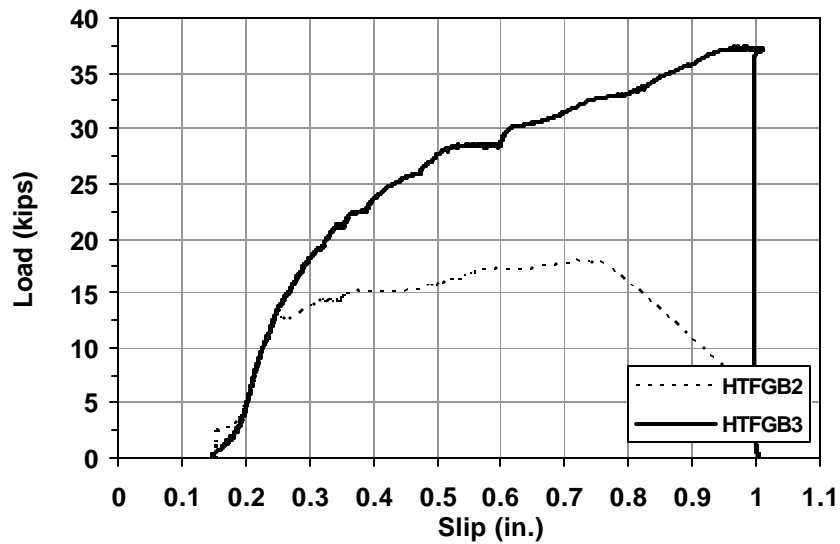
Figure 5.49: Load-slip curves for strength tests of Specimens HTFGB2 and HTFGB3

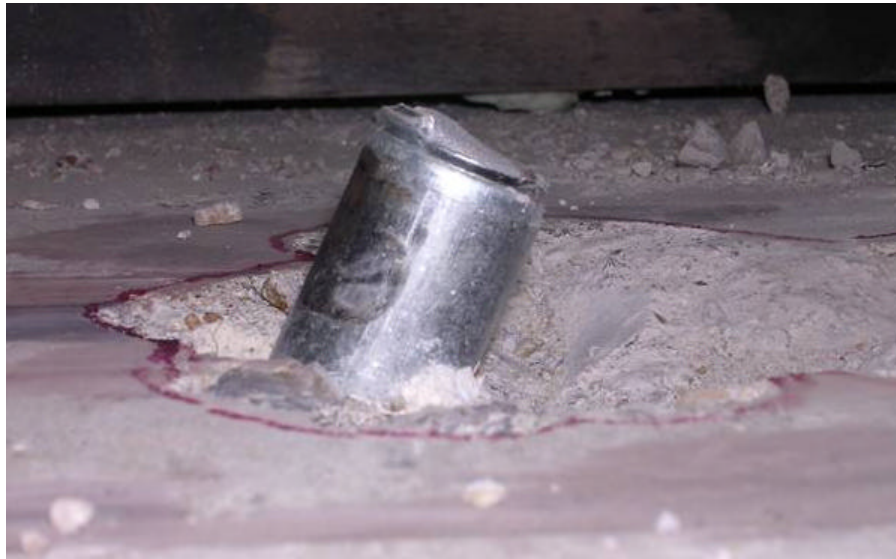
Figure 5.50: Failed Specimen HTFGB2

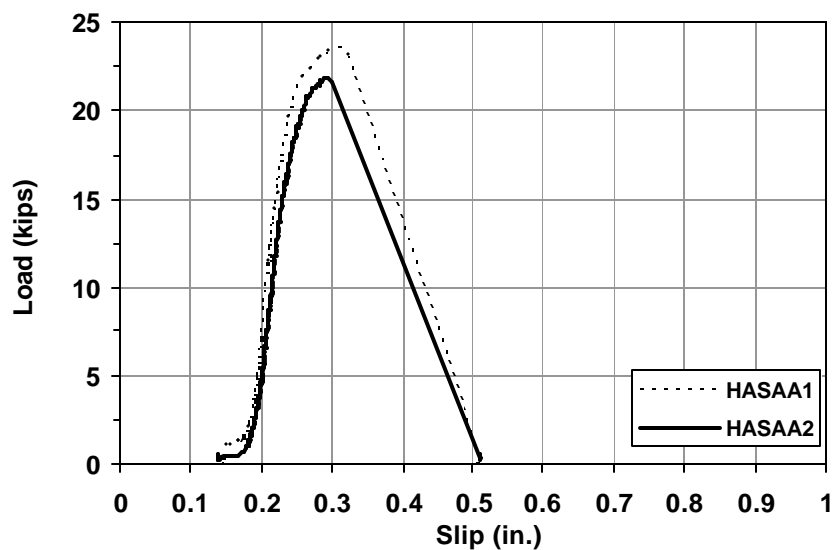
Figure 5.52: Static load-slip curves of Specimens HASAA1 and HASAA2

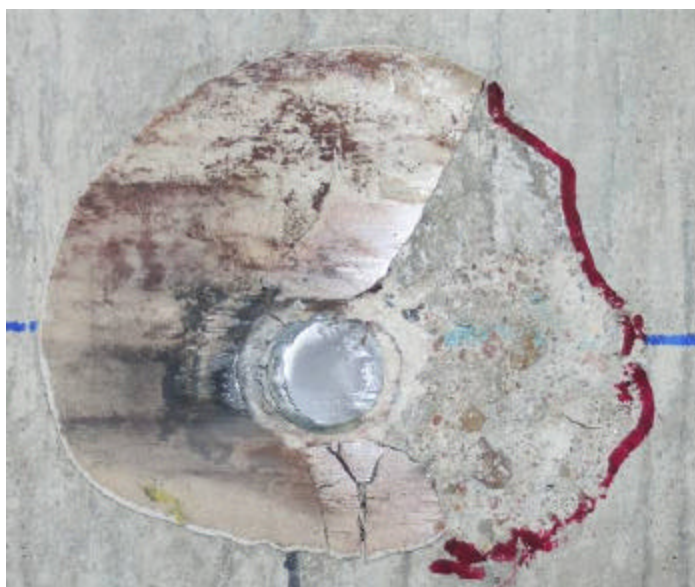
Figure 5.53: Failed Specimen HASAA2

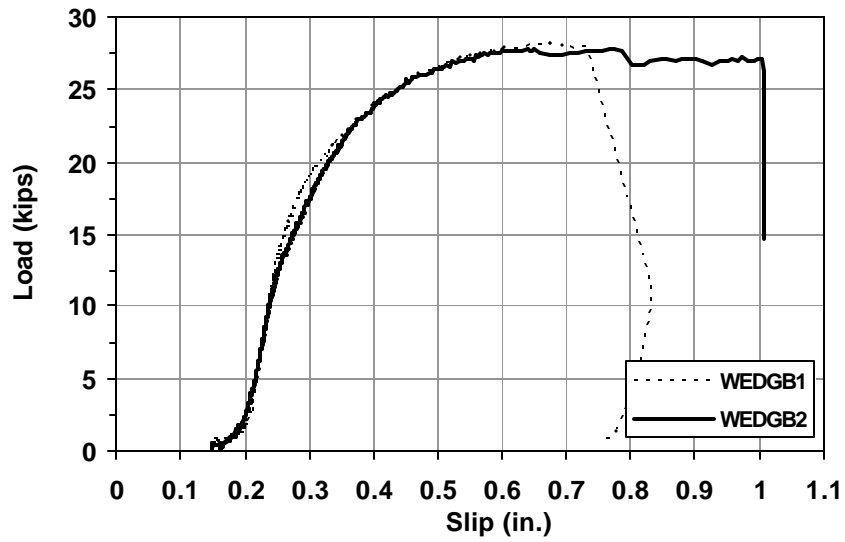
Figure 5.54: Static load-slip curves for Specimens WEDGB1 and WEDGB2

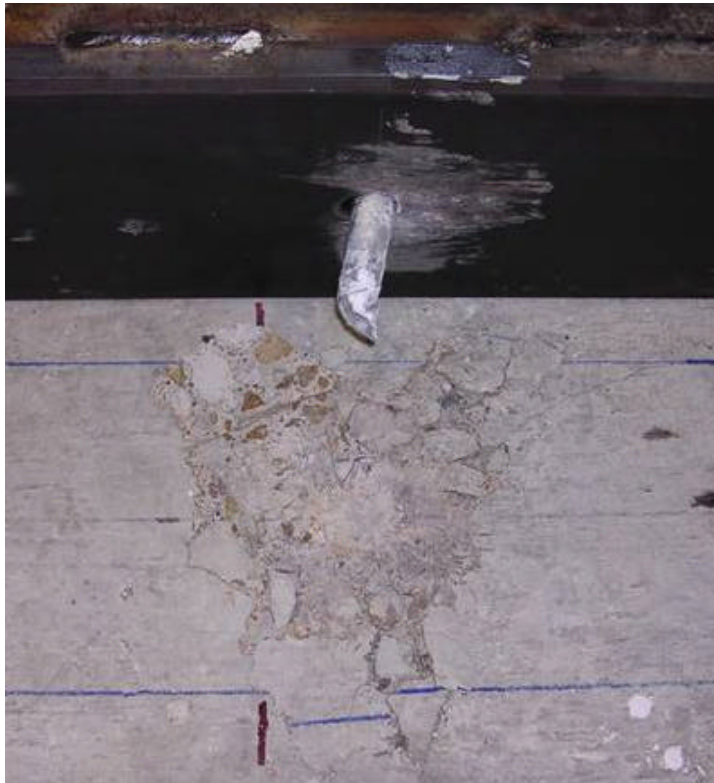
Figure 5.55: Failed Specimen WEDGB2

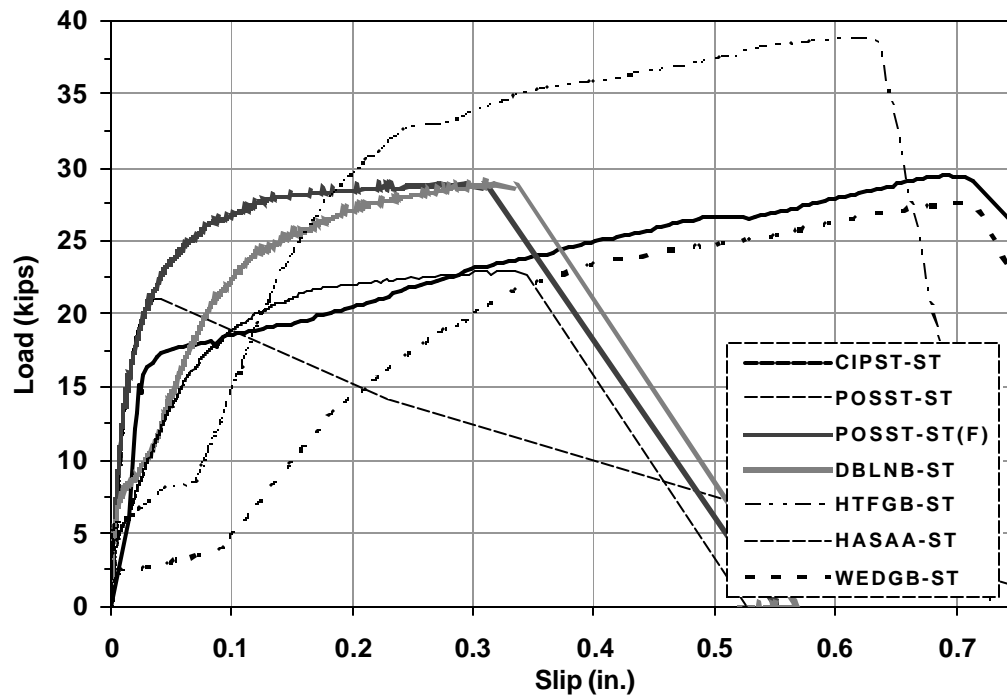
Figure 6.1: Load-slip curves of investigated shear connection methods

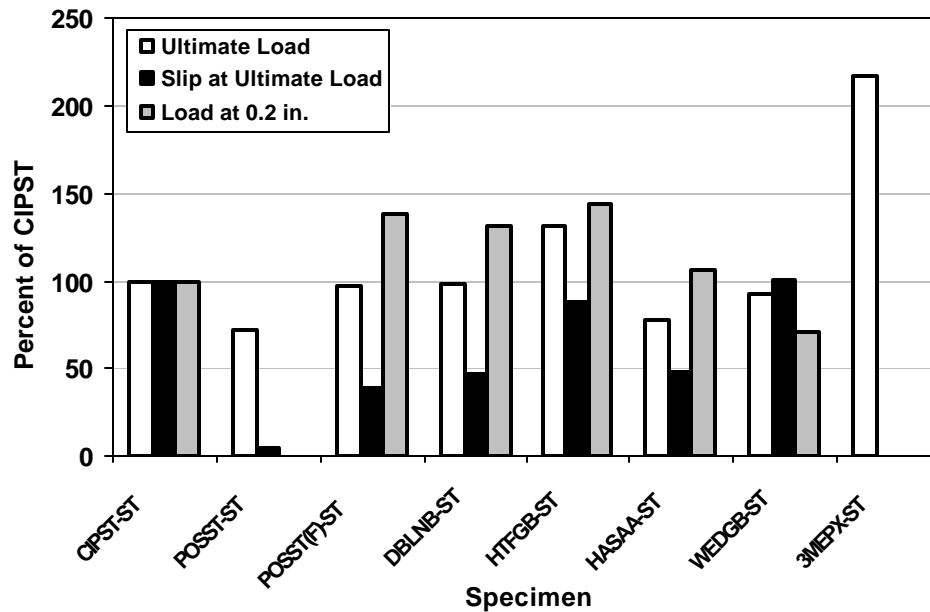
Figure 6.2: Comparison of load at 0.2 in. of slip and ultimate, and slip at ultimate load as a percentage of corresponding values for Specimen CIPST-ST

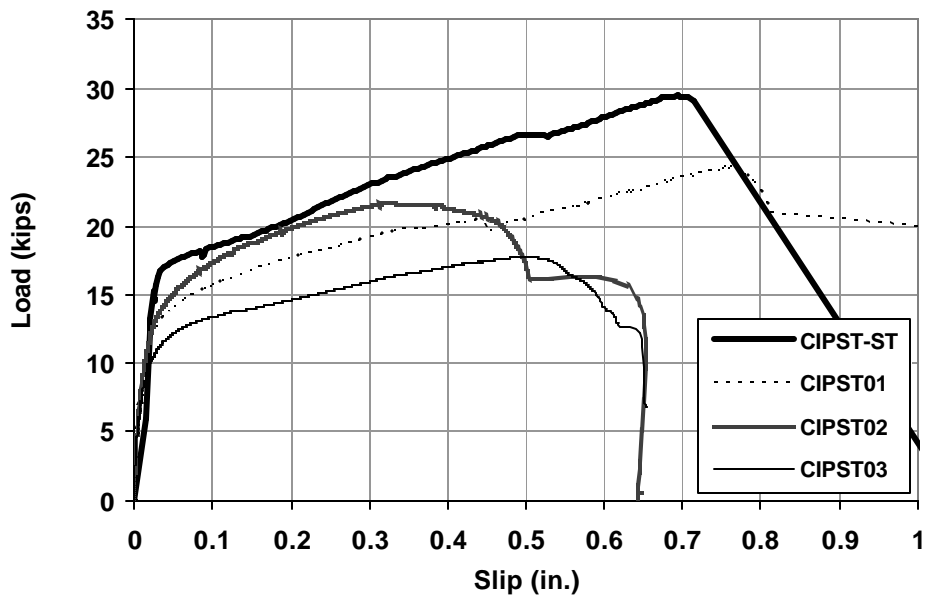
Figure 6.3: Comparison of load-slip curves for CIPST specimens

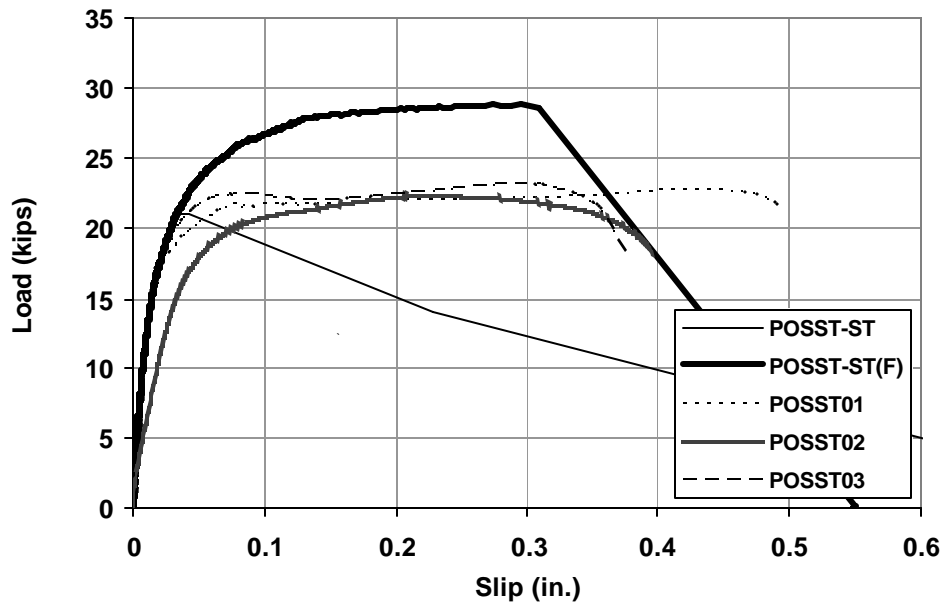
Figure 6.4: Comparison of load-slip curves for POSST specimens

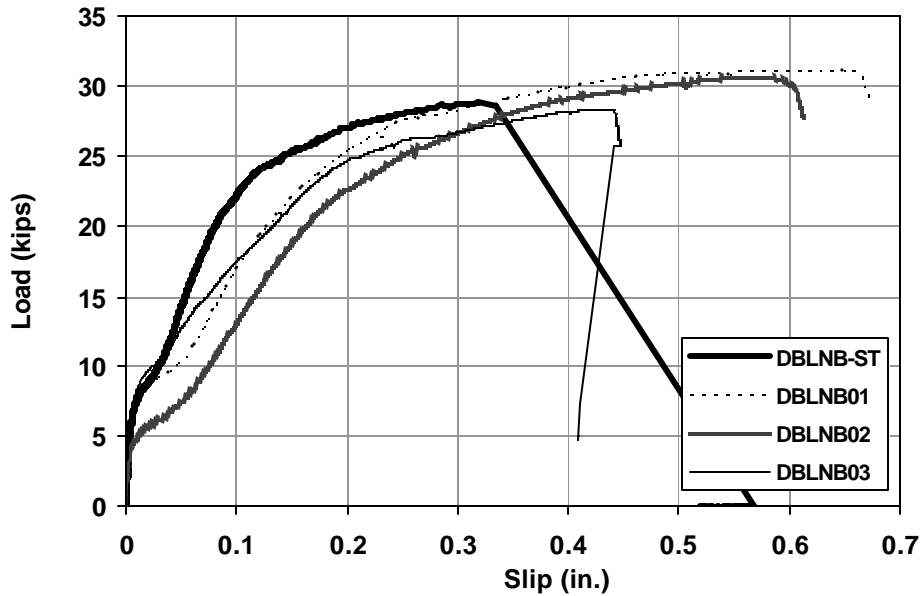
Figure 6.5: Comparison of load-slip curves for DBLNB specimens

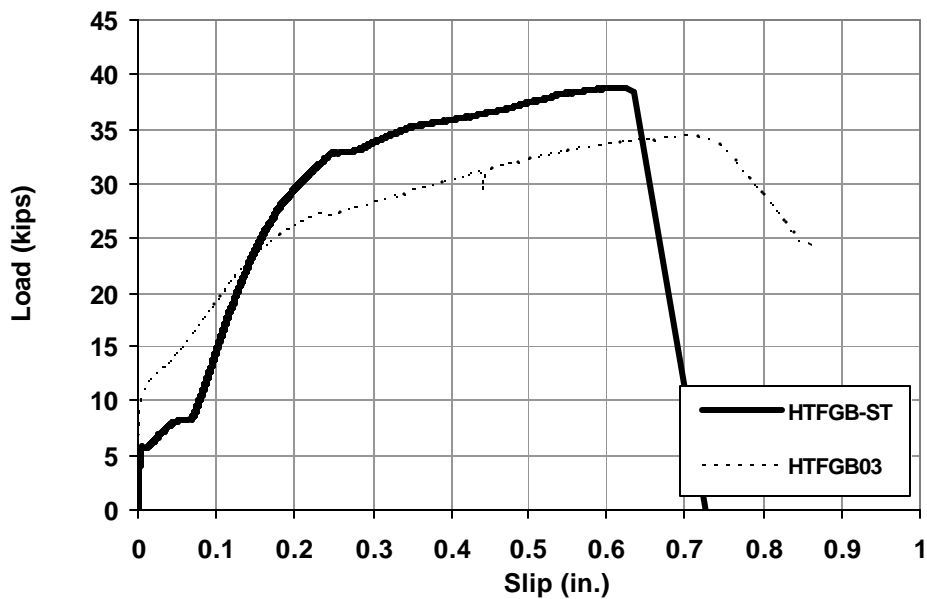
Figure 6.6: Comparison of load-slip curves for HTFGB specimens

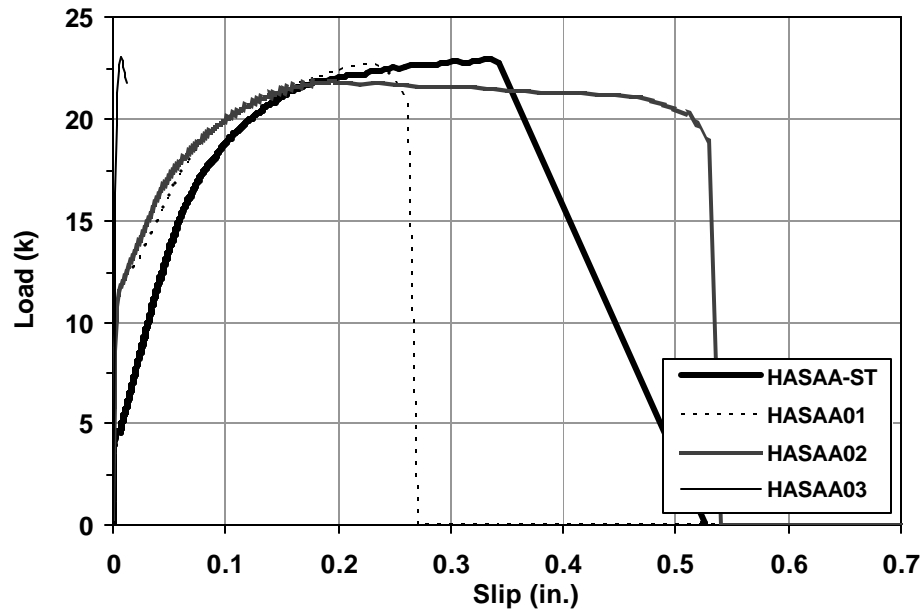
Figure 6.7: Comparison of load-slip curves for HASAA specimens

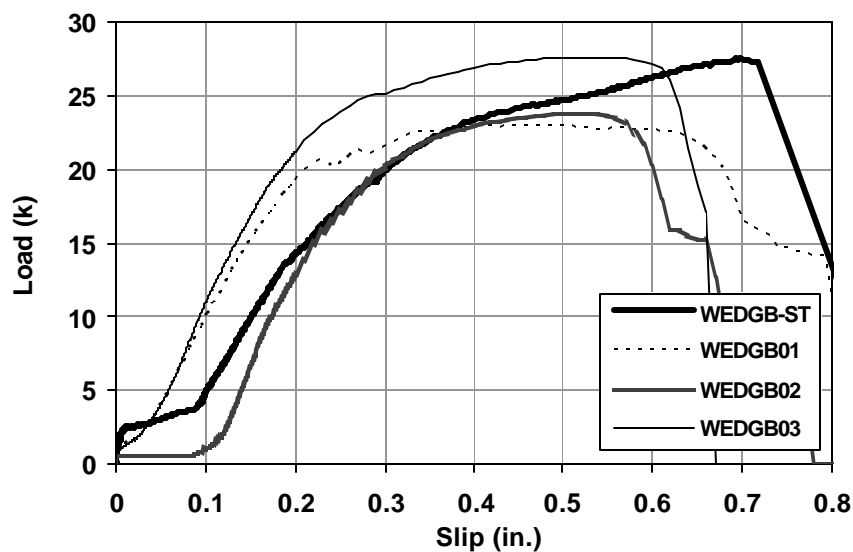
Figure 6.8: Comparison of load-slip curves for WEDGB specimens

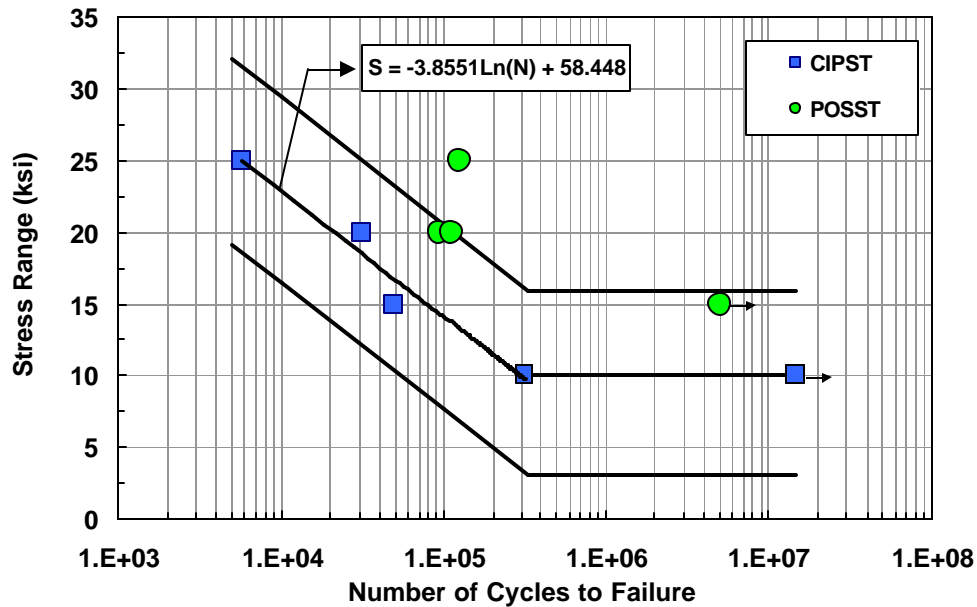
Figure 6.19: Comparison of fatigue data for POSST and CIPST specimens

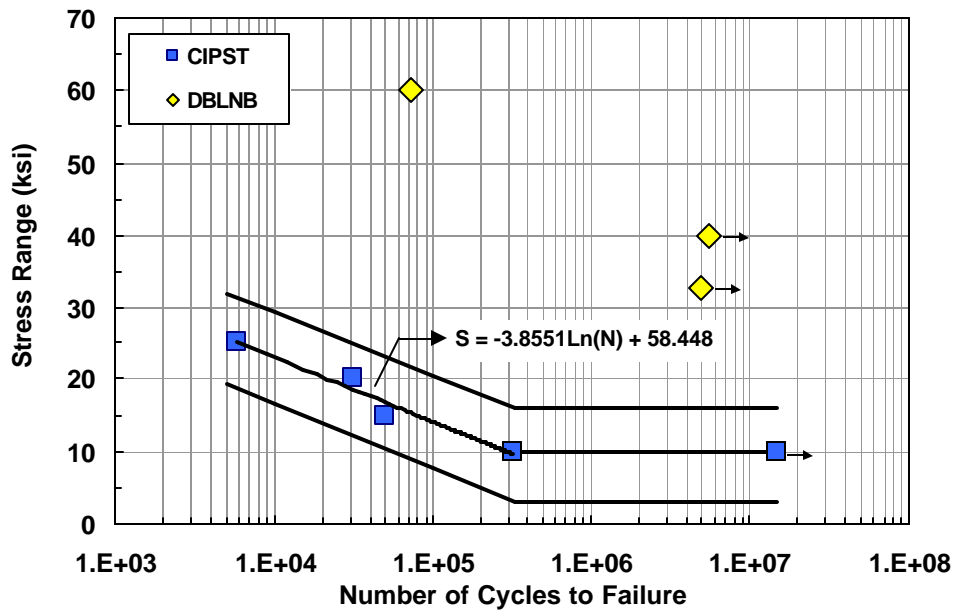
Figure 6.20: Comparison of fatigue data for DBLNB and CIPST specimens

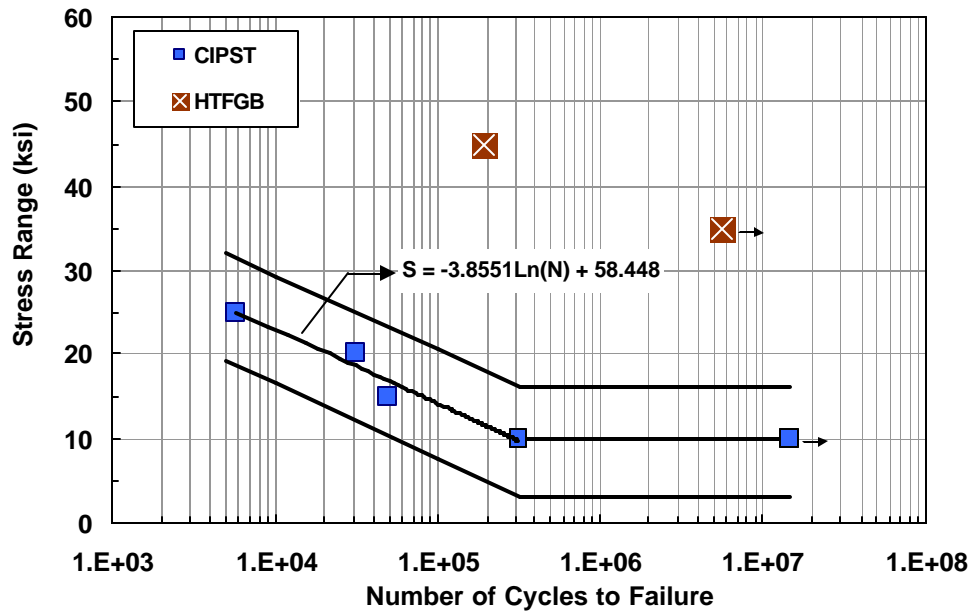
Figure 6.21: Comparison of fatigue data for HTFGB and CIPST specimens

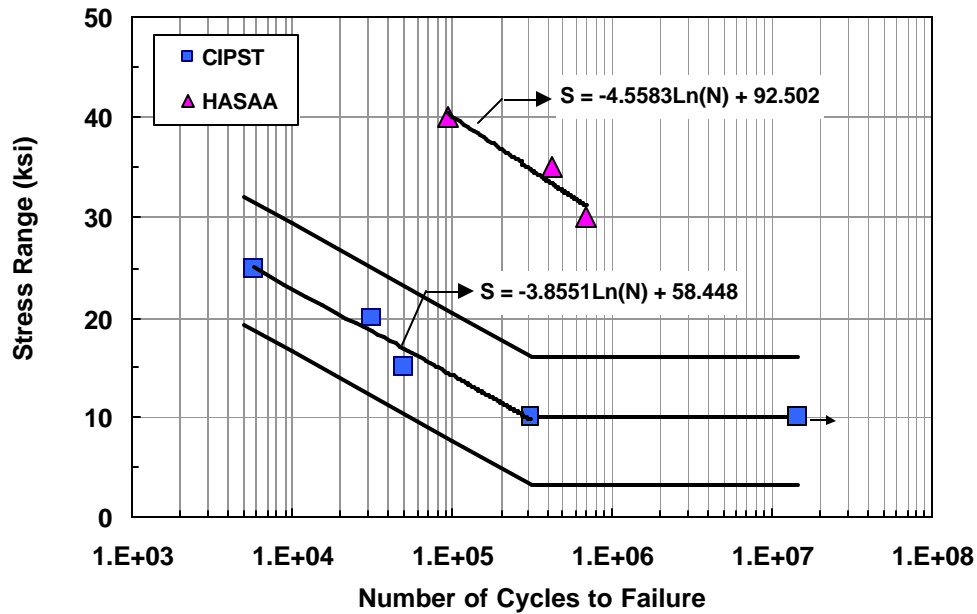
Figure 6.22: Comparison of fatigue data for HASAA and CIPST specimens

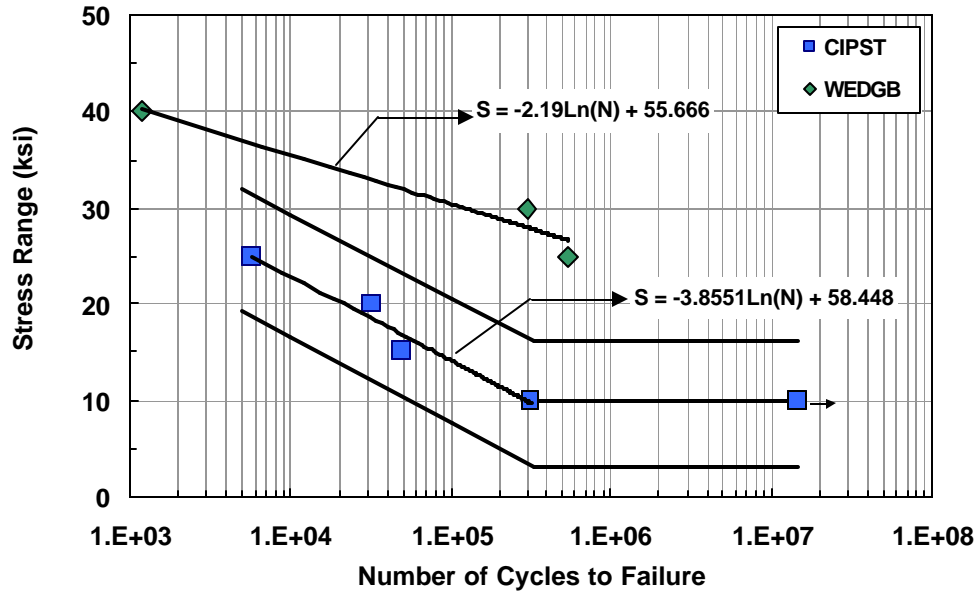
Figure 6.23: Comparison of fatigue data for WEDGB and CIPST specimens

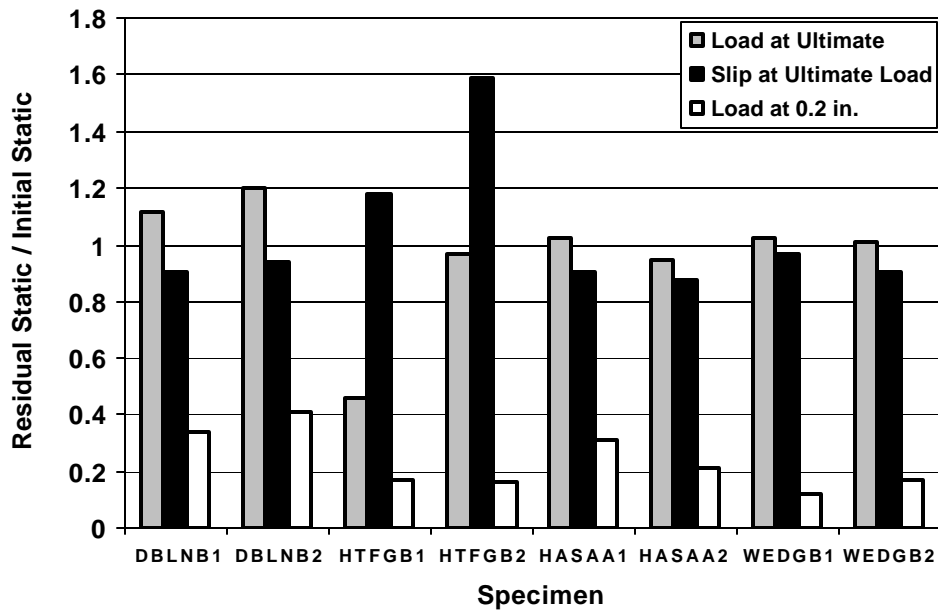
Figure 6.25: Ratios of values obtained in residual static tests divided by values obtained in initial static tests

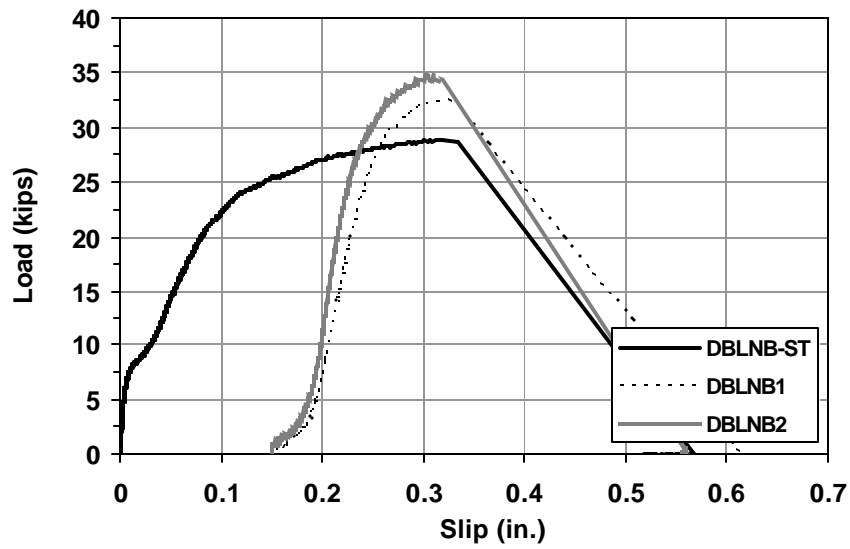
Figure 6.26: Comparison of initial static and residual load-slip curves for DBLNB specimens

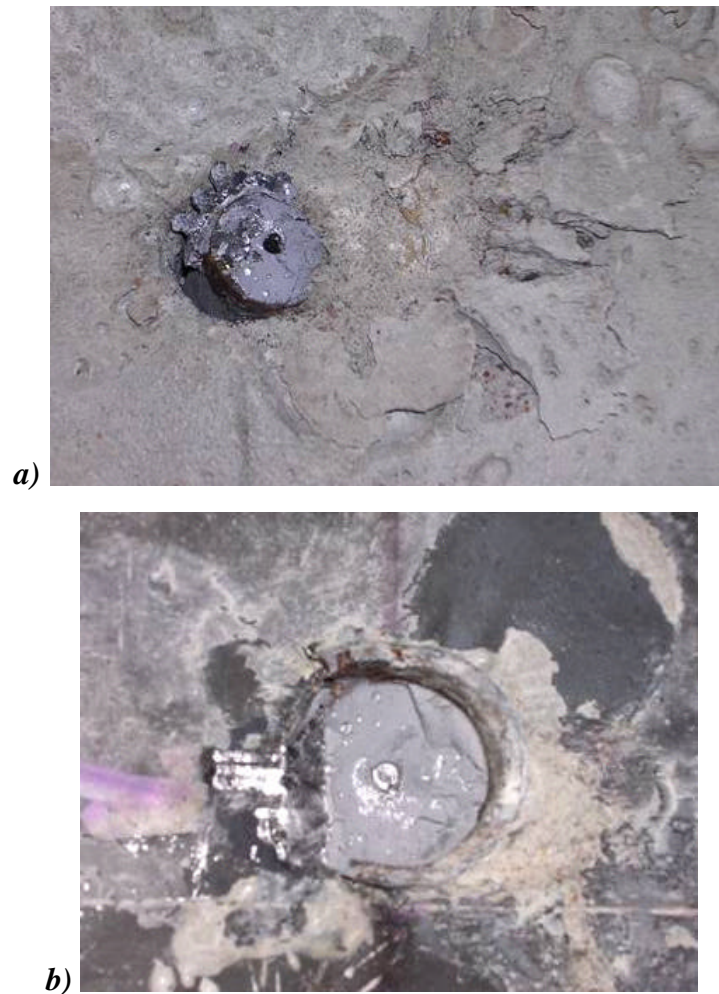
Figure B.1: Failed Specimen CIPST25: a) concrete block, b) steel plate

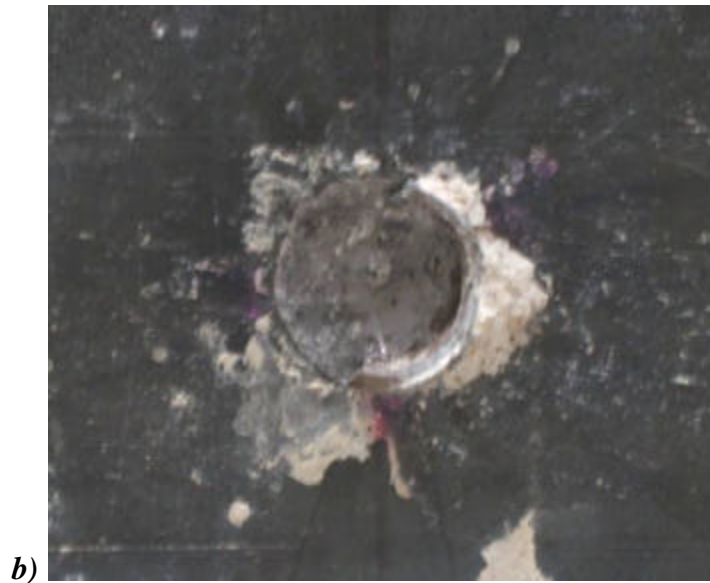
Figure D.1: Failed Specimen CIPST1: a) concrete block, b) steel plate

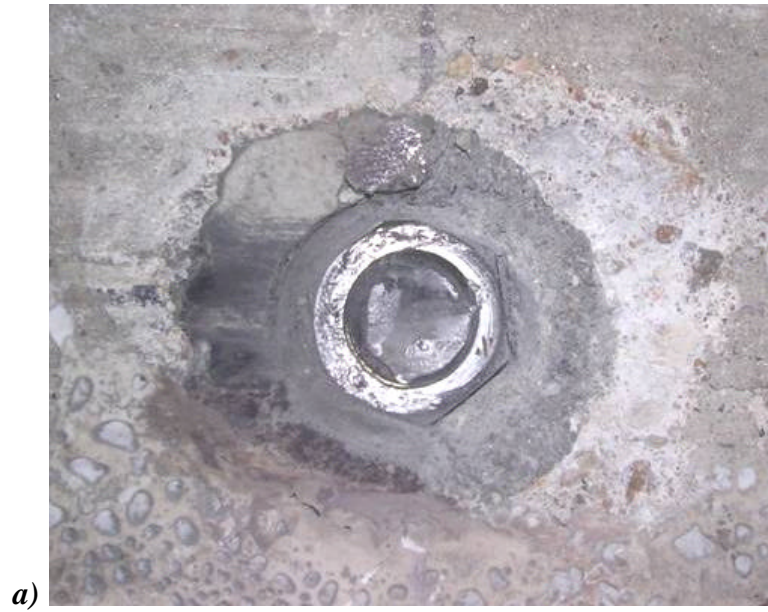
Figure D.2: Failed Specimen DBLNBI: a) concrete block, b) steel plate

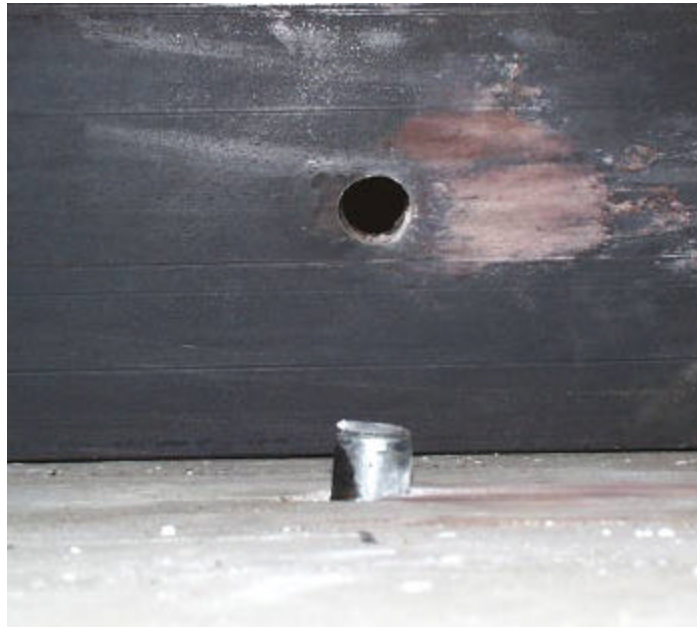
Figure D.4: Failed Specimen HTFGB1

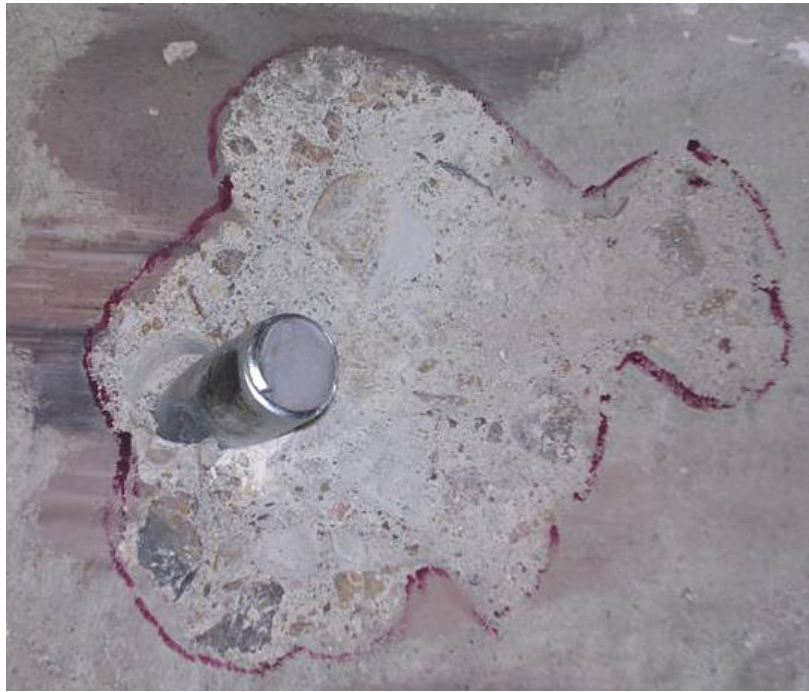
Figure D.5: Failed Specimen HTFGB2

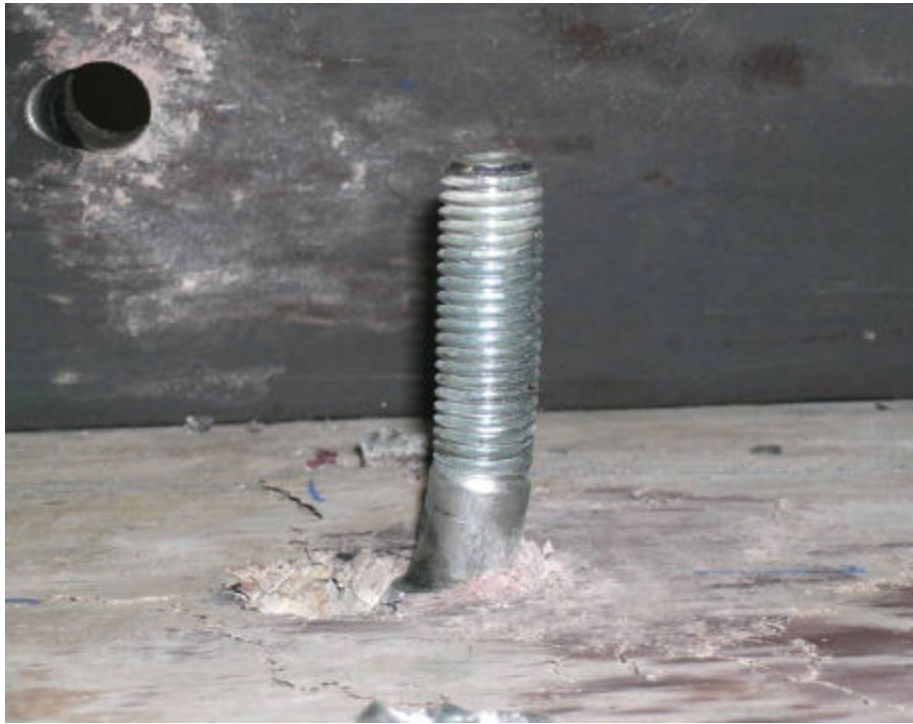
Figure D.6: Failed Specimen HTFGB3

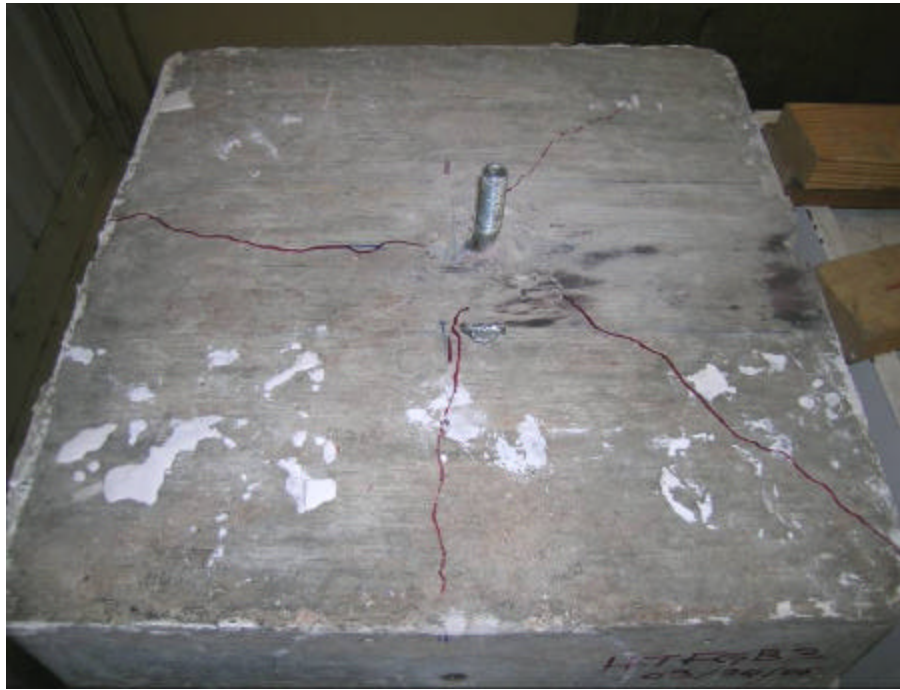
Figure D.7: Concrete failure of Specimen HTFGB3
