**A STUDY OF PIPE SPLICE SLEEVES
FOR USE IN PRECAST BEAM-COLUMN CONNECTIONS**

Thesis

The University of Texas at Austin

December, 2000

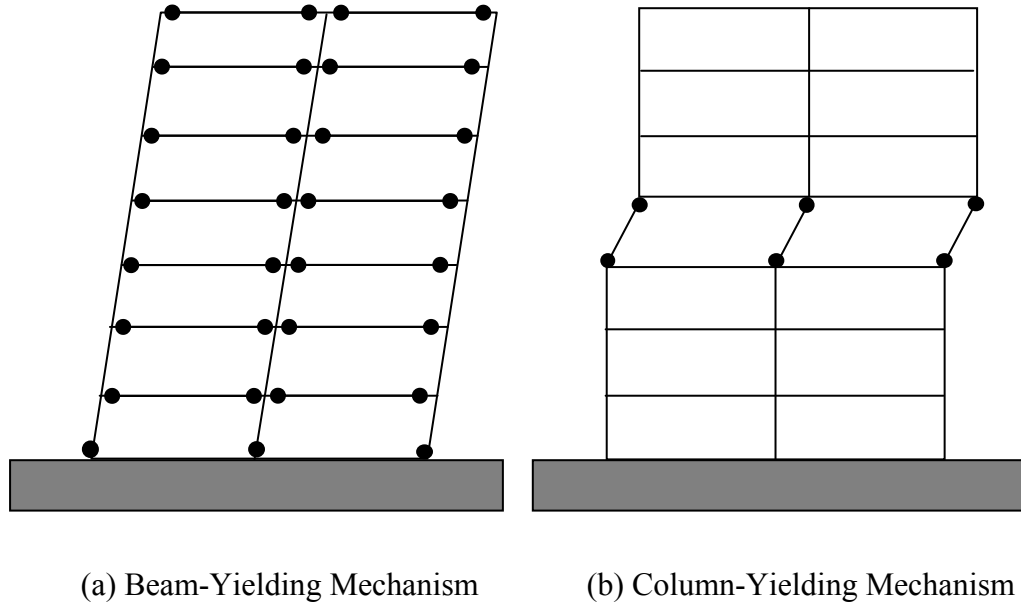
Figure 1.1: Yielding Mechanisms for Moment Frames

Because the amount of energy dissipated by a laterally-loaded frame generally increases with the number of flexural hinges formed, the most desirable mechanism for seismic resistance is a beam-yielding mechanism (Figure 1.1(a)). A single-story column-yielding mechanism (Figure 1.1(b)) does not dissipate nearly as much energy and is likely to result in collapse [5]. The black dots shown in Figure 1.1 represent the plastic hinge locations.

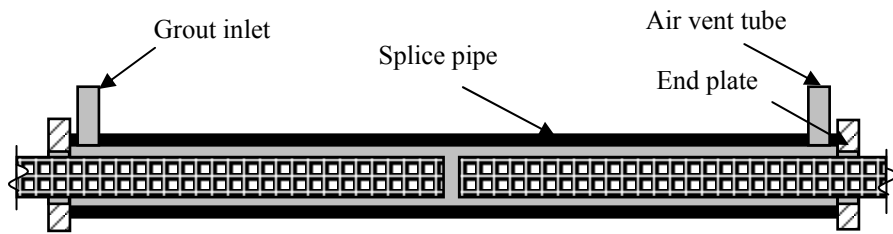
Figure 1.2: Prototype Splice

They investigated the effects of grout compressive strength, wall thickness and diameter of the pipe sleeve, diameter of the spliced bars, and confinement action on the bond strength of spliced bars. Figure 1.2 shows the prototype splice used in the study described herein.

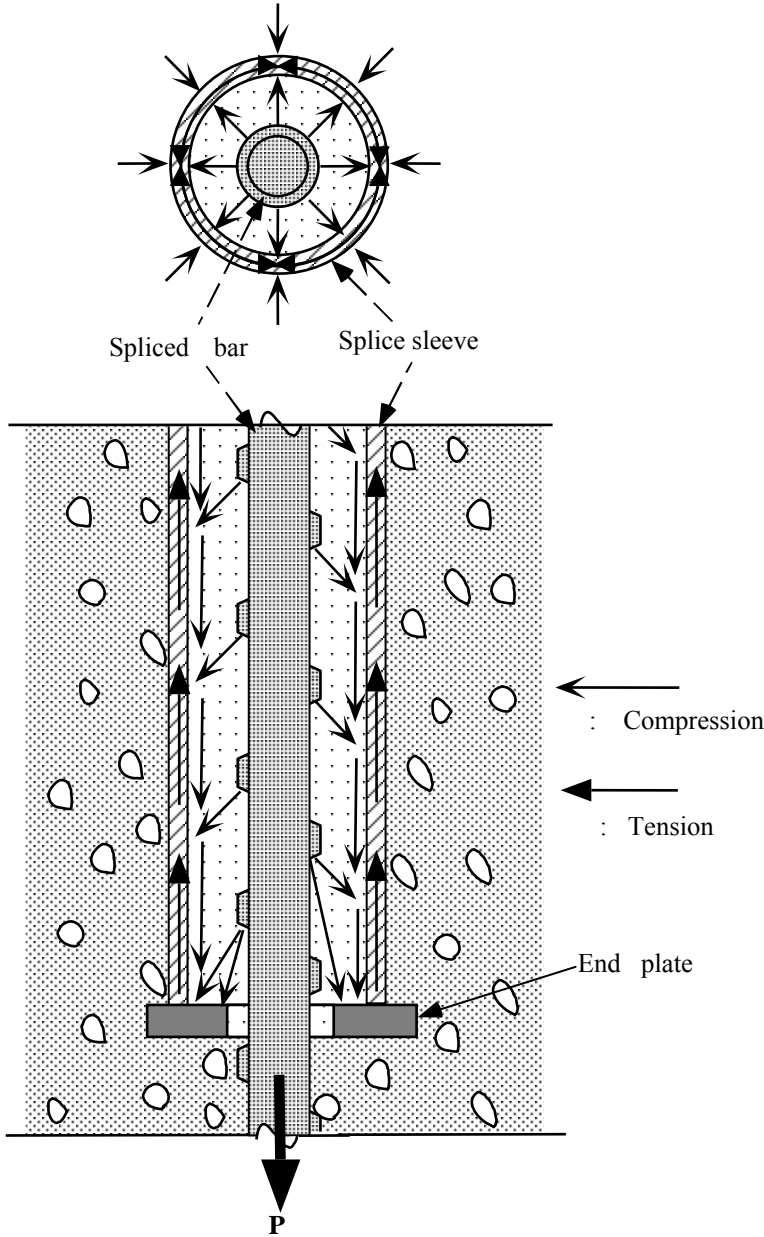
Figure 1.3: Flow of Internal Stresses in the Splice

In this research, the main objective of confining the grout was to increase the bond strength of bars spliced within the sleeve. The growth and widening of potential splitting cracks around the spliced bars can be restrained if the surrounding grout is effectively confined. With longitudinal and circumferential confinement of the grout, increased bond strength and ductile behavior are possible for the splice connection. The ultimate failure mode of the splice sleeve was expected to be a pullout failure of the bars in the splice sleeve at a load well beyond yield of the reinforcing bars. Figure 1.3 illustrates the expected flow of stresses in the splice sleeve, grout, reinforcement, and concrete.

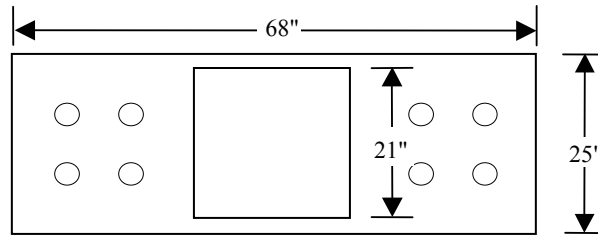
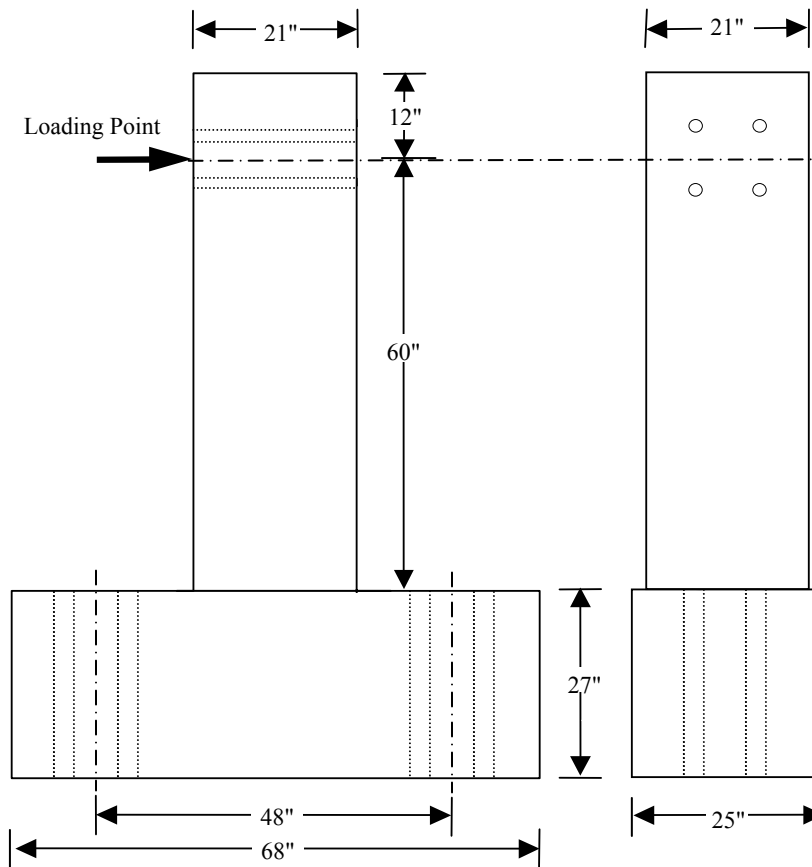
Because this study focused on the performance of the splice connection that would facilitate splicing column longitudinal reinforcement immediately above a continuous precast beam element, test specimens consisted of a half-length column element (effectively from top of beam to column mid-height) and a base element for anchoring column reinforcement and anchoring the specimen to the test floor. Overall dimensions for the specimens are shown in Fig. 2.1.

(a) Top view

(b) Elevation view

(c) Side view

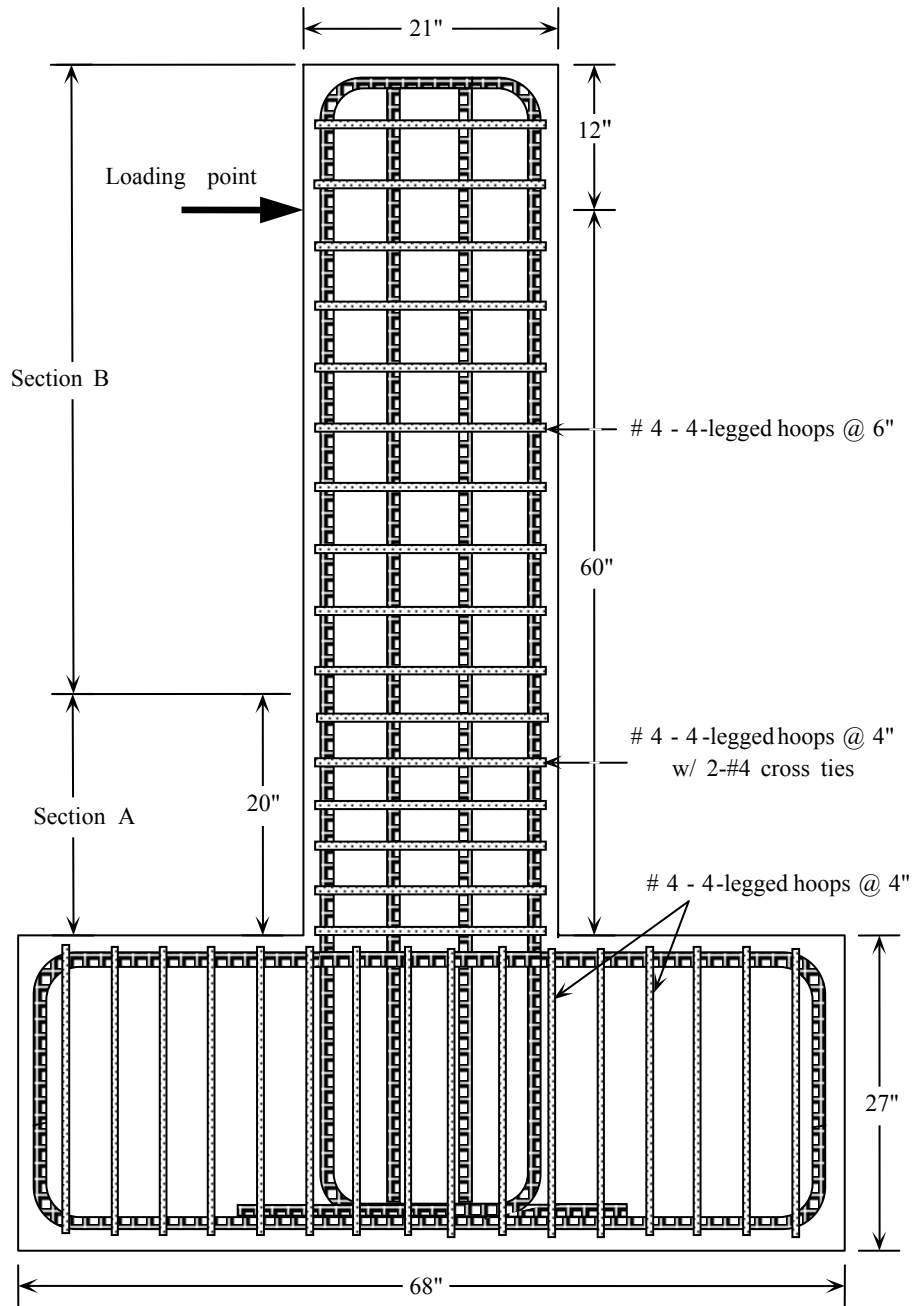
Figure 2.2: Reinforcement Details for Specimen MC1

Reinforcement details for Specimen MC1 and selected cross sections are shown in Figs. 2.2 and 2.3. The column longitudinal reinforcement used in this study was anchored at the top of the column and in the base element using 90-degree hooks, which resulted in significant congestion. Because the longitudinal bars were continuous in Specimen MC1, fabrication of the steel cage was much more difficult than for the precast specimens. Design of shear reinforcement for both the column and base element was carried out according to Chapter 21 of the ACI 318 Building Code [2]. Shear reinforcement details were the same for all specimens. For the base elements and the column sections in the plastic hinge region (which was assumed to range from the member interface to a height approximately 20 in. above the base), design for shear resulted in 4 in. spacing of two sets of #4 rectangular hoops. The same hoops with 6-in. spacing were used for the remainder of the column height. In the plastic hinge region, two #4 cross-ties were added to each set of hoops to provide additional concrete confinement.

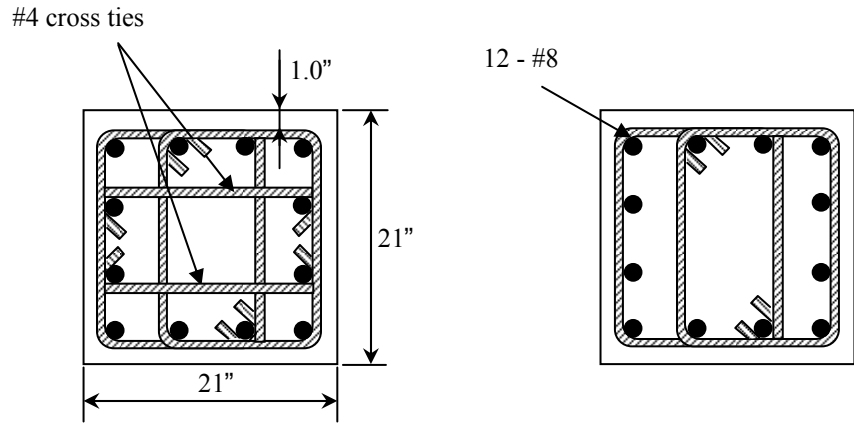
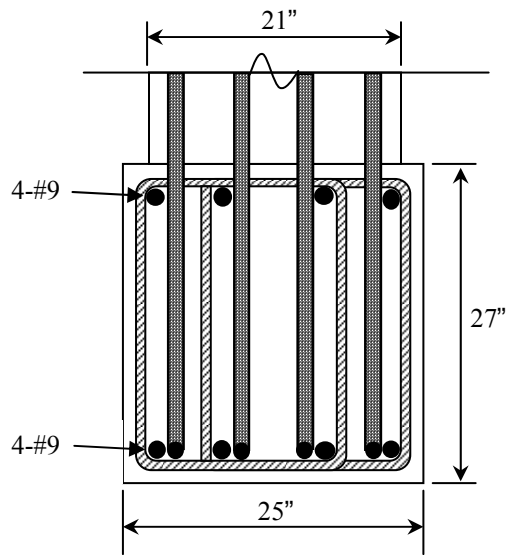
Figure 2.3: Cross Section Details for Specimen MC1

(a) Column cross section A

(b) Column cross section B

(c) Base cross section

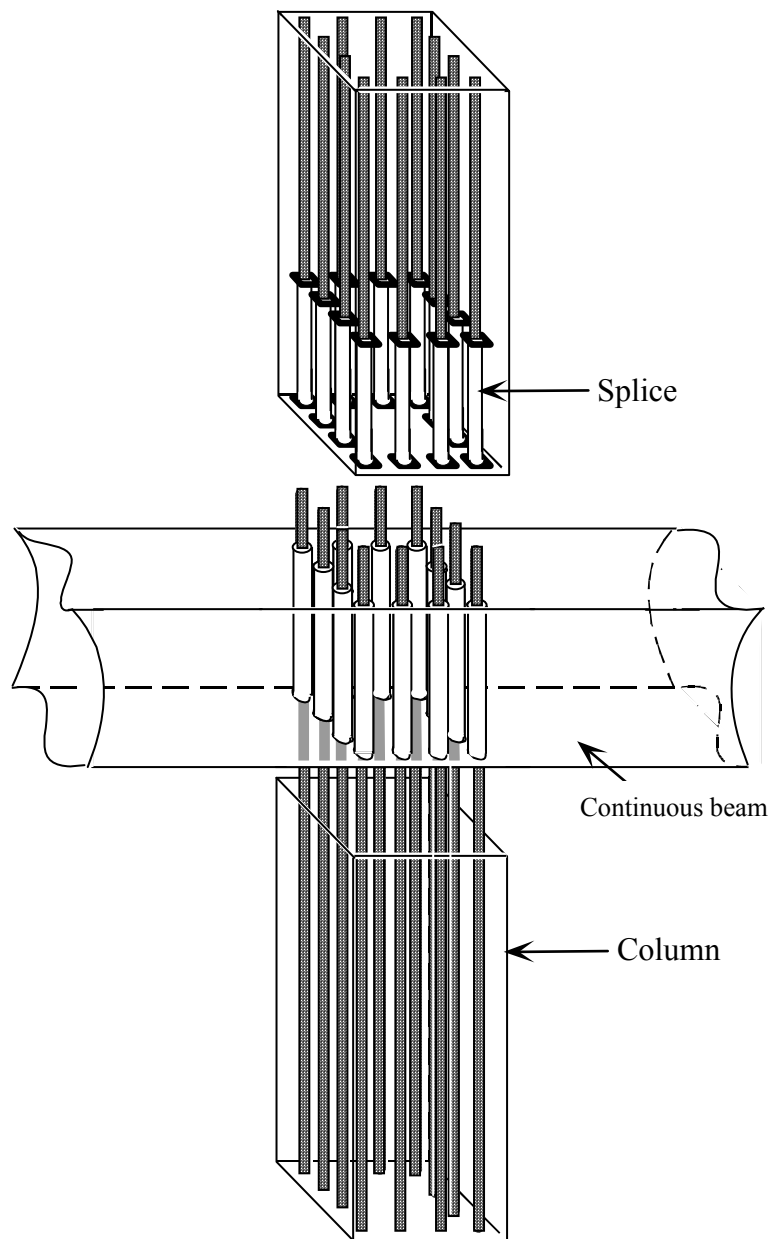
Figure 2.4: Schematic of Connection Concept and Connecting Elements

A precast continuous beam-column connection, like that shown in Fig. 2.4 which incorporates the splice-sleeve connection, would have column longitudinal reinforcement that passes through the beam element. Reinforcement details for the precast specimens, PC1 and PC2, are shown in Figs. 2.5 and 2.6. Details for the splice sleeves used in Specimens PC1 and PC2 are described in the following section. All other reinforcement details were the same as those used in Specimen MC1. The confinement and shear reinforcement details for the plastic hinge region of Specimens PC1 and PC2 are shown in Fig. 2.5. During the fabrication and casting of precast specimens, congestion caused by the longitudinal reinforcement, splice sleeves, and transverse reinforcement in the plastic hinge region required substantial attention.

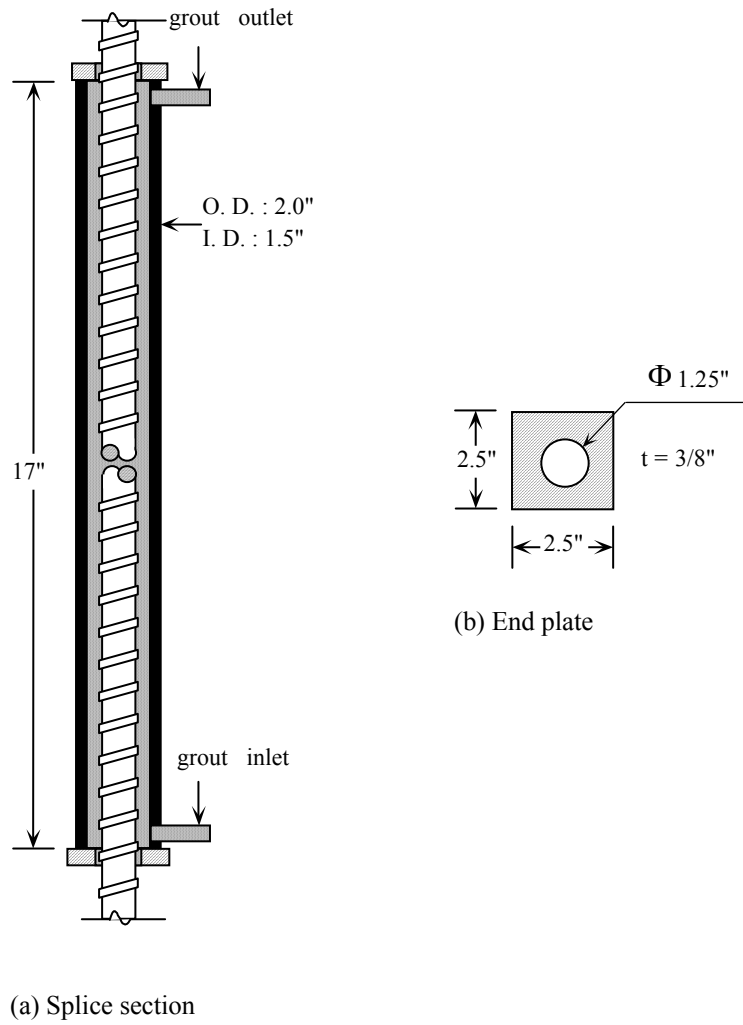
Figure 2.7: Details of the Splice Sleeve for Specimen PC1

The splice sleeve for Specimen PC1 had top and bottom grout holes drilled at both ends of the pipe. The diameter of the holes was 0.5 in. The grout holes were located approximately 3/8 in. away from the end of the pipe to avoid the weld metal between the pipe and the end plates. The location of the top grout outlet resulted in major problems for this splice sleeve. The problems will be discussed in Chapter 4.

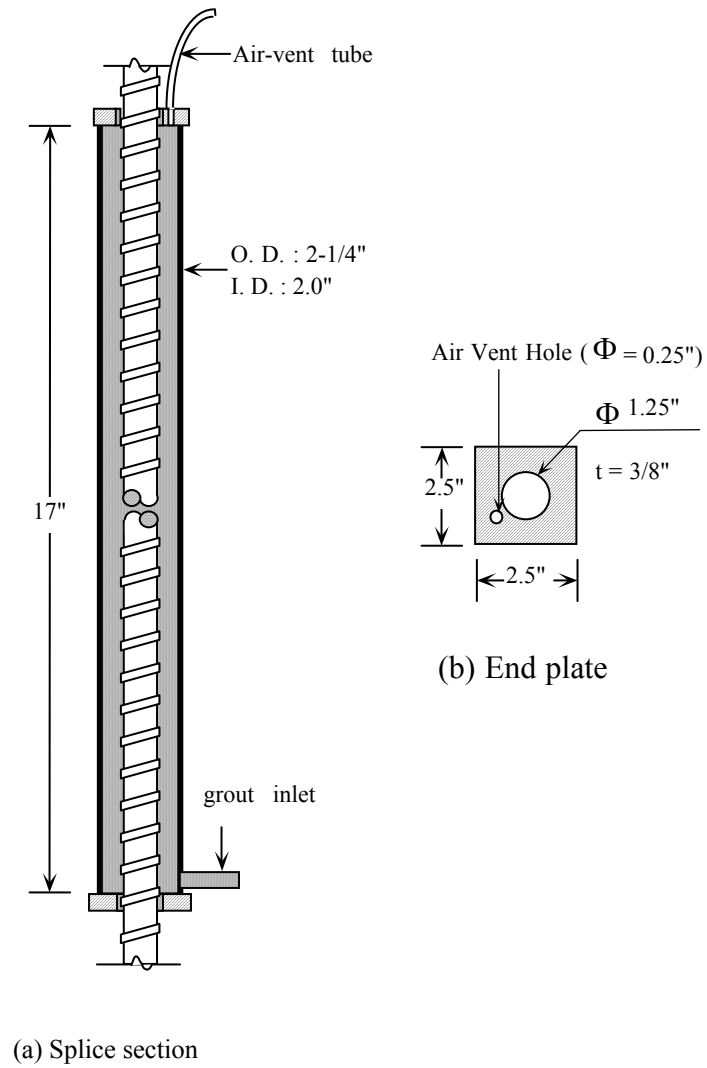
Figure 2.8: Details of the Splice Sleeve for Specimen PC2

The splice sleeves were revised after testing Specimen PC1. The first change was to increase the inside diameter of the pipe to facilitate injection of grout. The dimensions of the pipe section, as shown in Figure 2.8, were 2-1/4 in. outside diameter and 2.0 in. inside diameter. The increase of inside diameter, however, resulted in a loss of cross section area. Therefore, the material strength of the pipe had to be increased. As a result, a seamless DOM (Die-cast On Mandrel) structural tube with minimum yield stress 65 ksi and minimum tensile strength of 80 ksi was used. These values were obtained from the manufacturer's catalog.

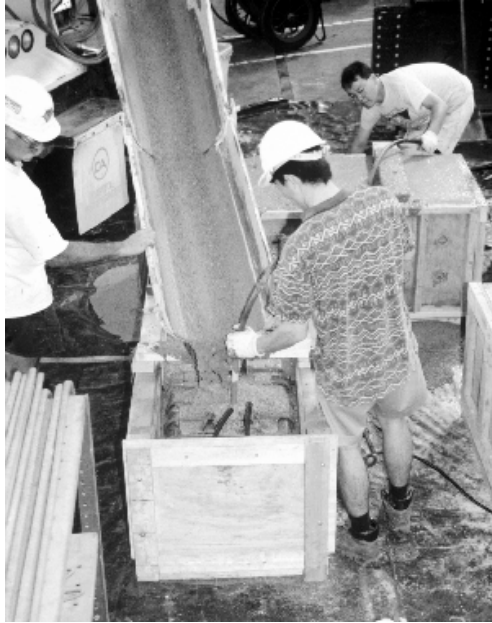
(a) Vibration of concrete

Figures 2.9 and 2.10 show the reinforcement cages and formwork for Specimens MC1 and PC2 prior to casting. Specimens were fabricated and cast at the laboratory. All strain gauges on reinforcing bars were attached after the cages were assembled. Wooden forms were coated with form oil prior to setting the reinforcing cages in the forms. Ready-mixed normal-weight concrete was used for all specimens. Consolidation of concrete was achieved using pencil vibrators. Figure 2.11 shows the casting procedure. In the erection process for Specimen

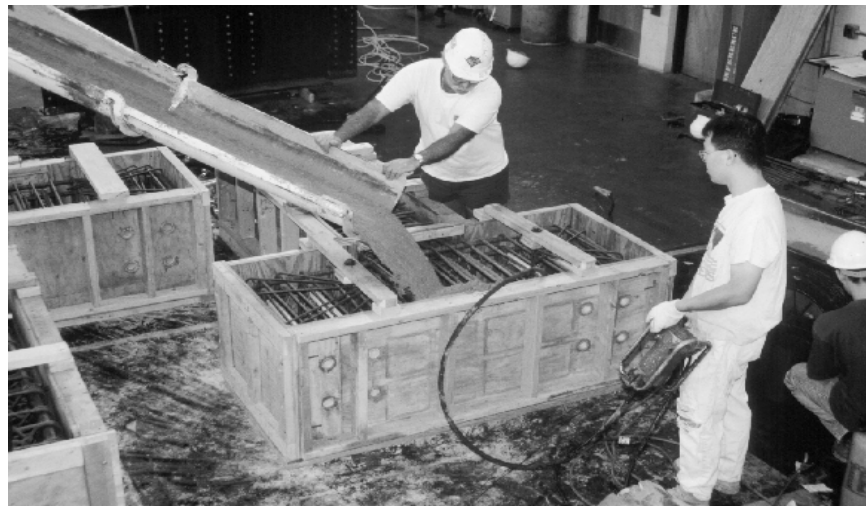
Figure 2.11: Casting Procedures

(b) Casting of concrete

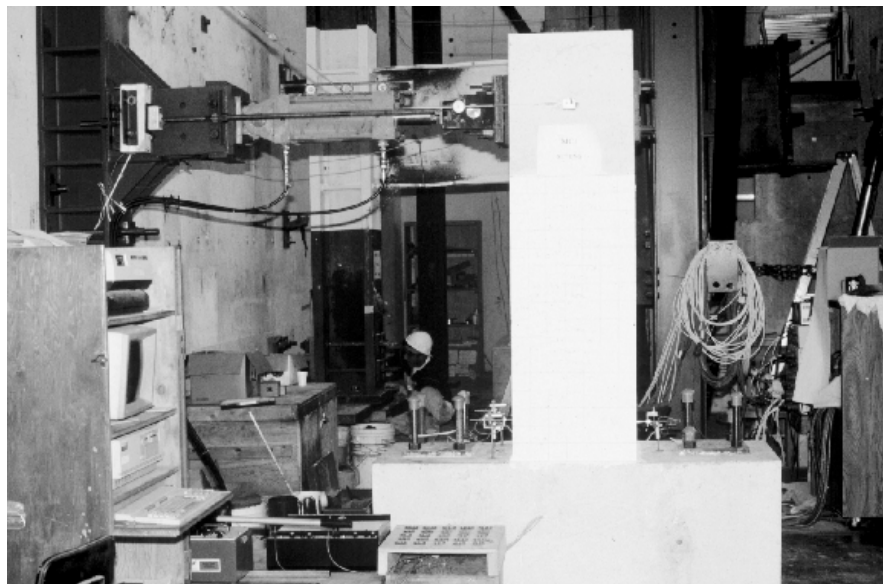
Figure 2.13: View of Test Setup

Figure 2.13 shows a specimen after assembly was complete. Details of the test setup are also illustrated in Figure 2.14. The primary loading frame, consisting of two wide flange beams, was attached to the strong reaction wall. The hydraulic ram was attached to this loading frame. Rotation of the column tip in the plane of the specimen was allowed by connecting the hydraulic ram with two horizontal pins to the frame and the specimen.

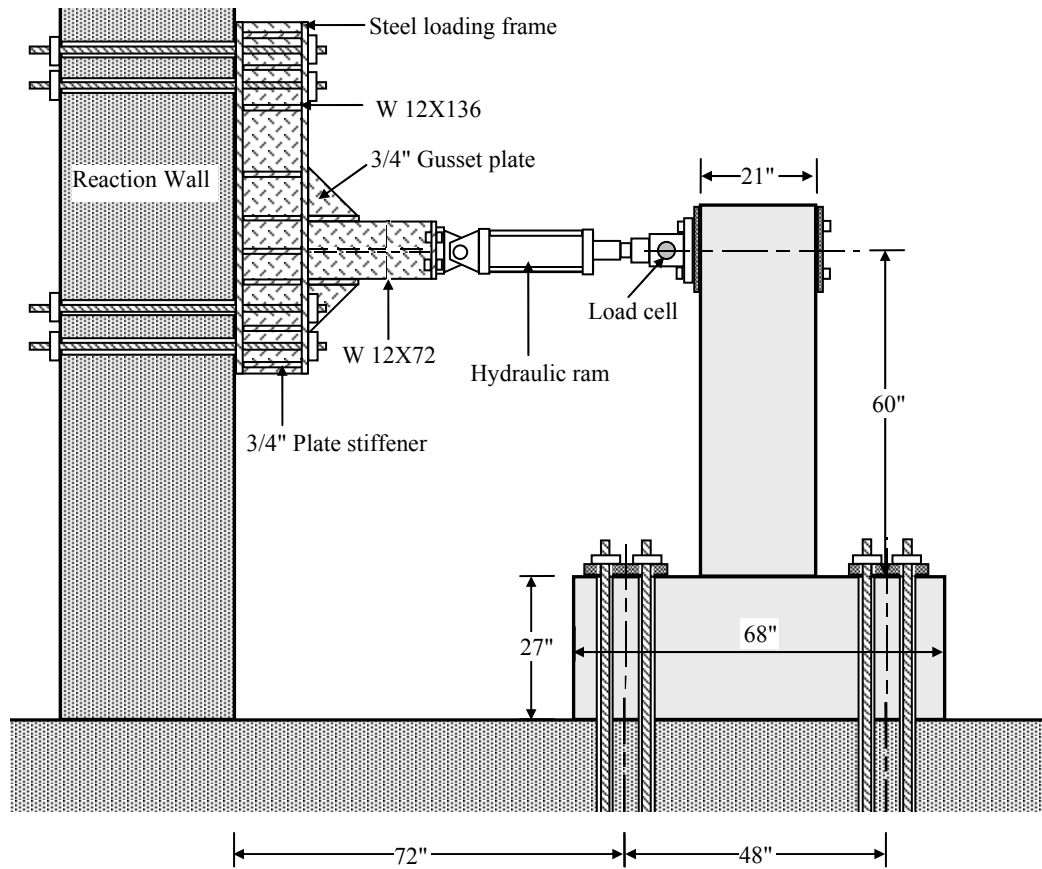
Figure 2.14: Test Setup Details

As shown in Figure 2.14, the loading frame was heavily stiffened with 3/4 in. thick steel plates to avoid local buckling of the frame. Two triangular-shaped gusset plates were used to strengthen the connection between the W shapes supporting the hydraulic ram. The column element of the complete specimen was connected to the ram, and the base element to the floor using the holes provided by the embedded plastic pipes. The base unit was tied to the floor with prestressed 1-1/2 in. dia. threaded bars, and the column was connected to the ram with four 5/8-in. diameter Dywidag bars.

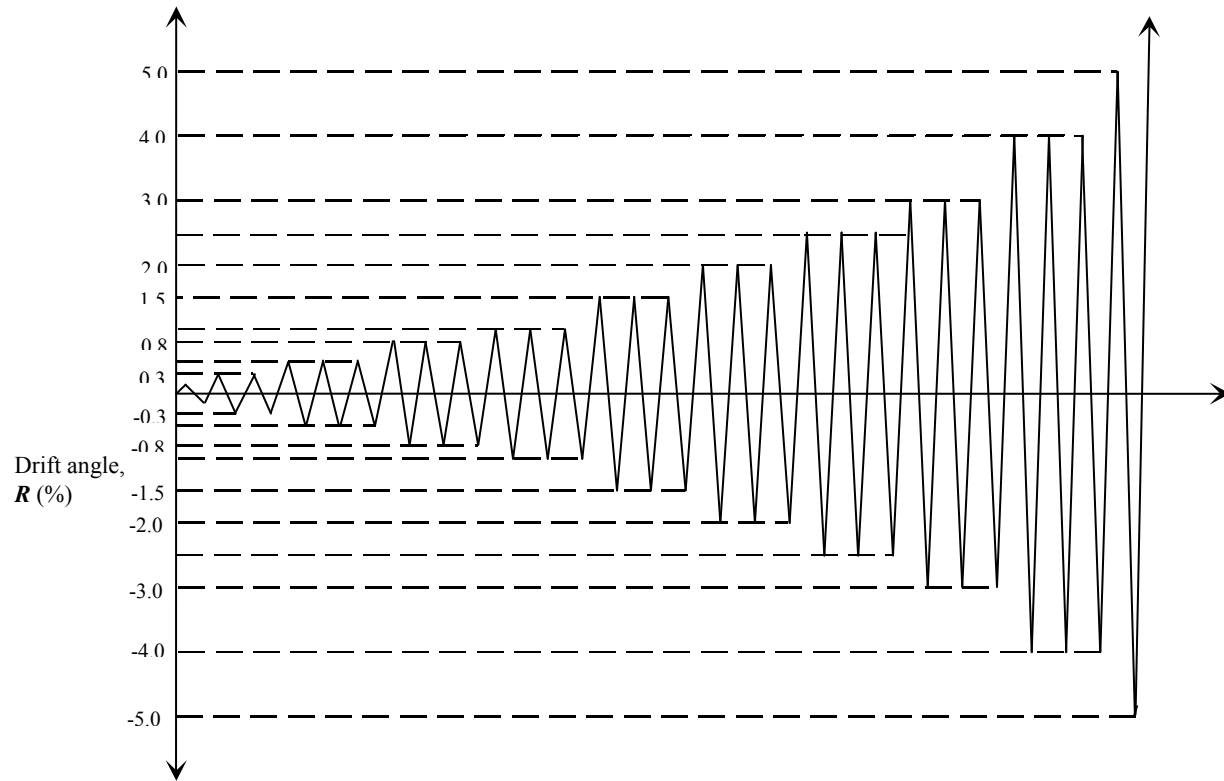
Figure 2.16: Displacement History

Each specimen was subjected to progressively increasing sets of drift reversals. A very small drift ratio such as 0.1 percent was initially applied to check the loading and data acquisition systems at the start of the test. This was followed by a cycle to 0.25 percent drift ratio. Drift ratios were increased by 0.25 percent up to 1.0 percent. The number of cycles for each drift ratio, starting at 0.5 % drift, was three. After reaching 1.0 percent drift ratio, testing progressed with 0.5 percent drift ratio increments until 3.0 percent, then testing continued with 1.0 percent drift ratio increments up to the maximum load.

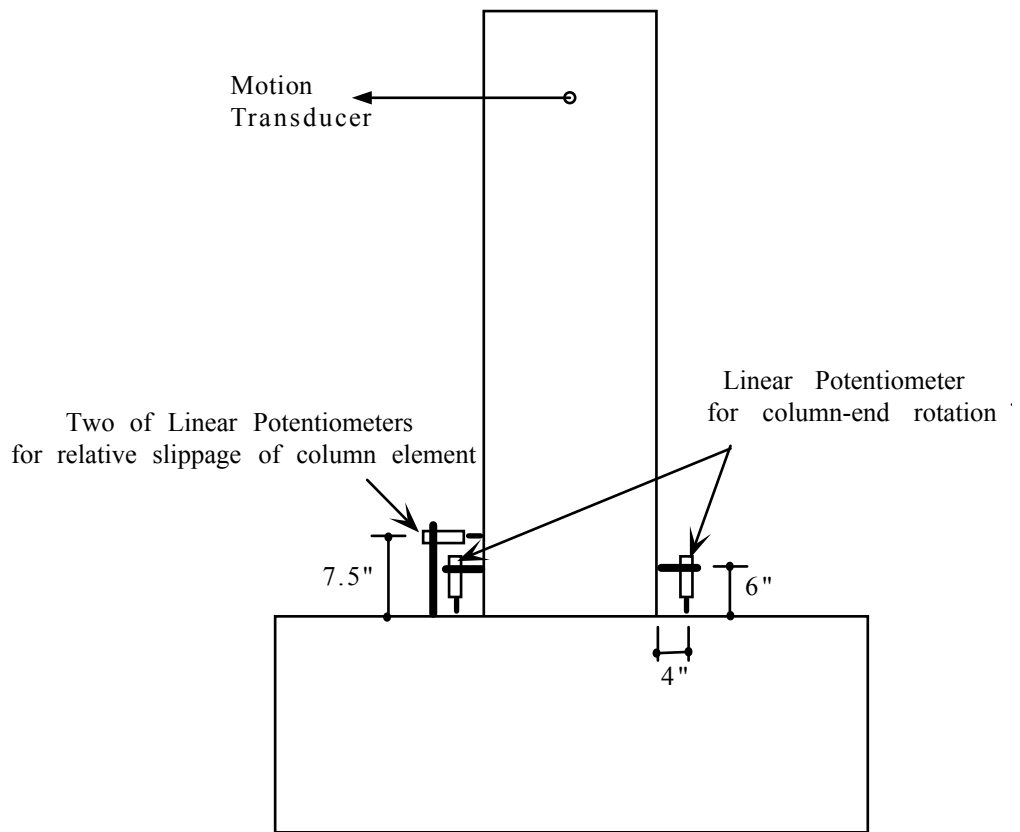
Figure 2.17: Linear Potentiometer Locations

The pin load cell mounted in the hydraulic ram measured the applied lateral load. The capacity of the load cell is 150 kips. In order to measure the lateral column end displacement, a 5-in. string transducer was used. One end of the string transducer was fixed to the loading frame and the other was connected to the mid-depth of the column. Two linear potentiometers on opposite column faces measured column rotations at the base (see Figure 2.17). There were also two additional linear potentiometers mounted on top of the base element to measure sliding of the column base. Selected longitudinal reinforcement in the columns and splice sleeves were instrumented with strain gauges (described below).

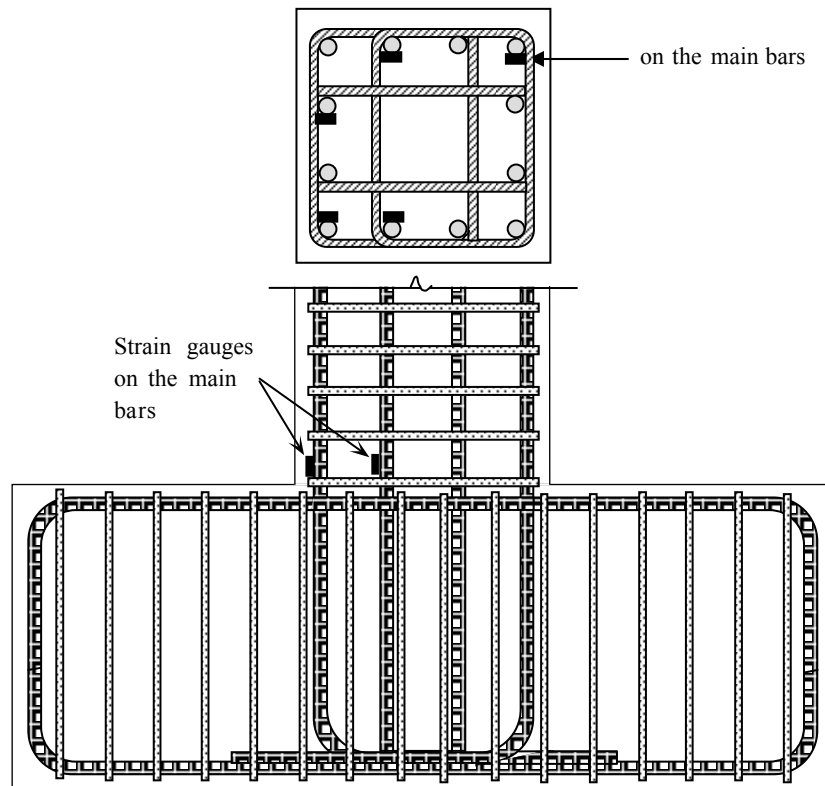
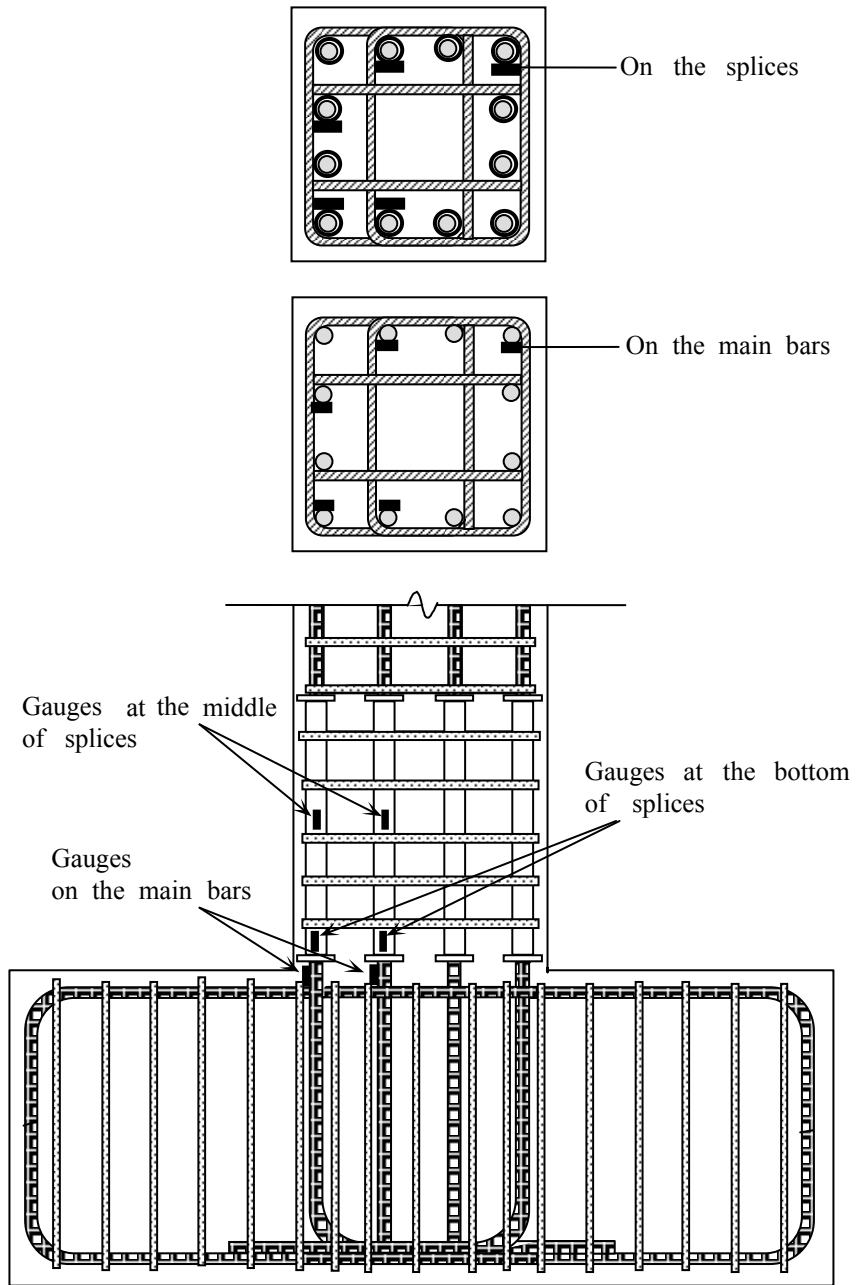
The locations of strain gauges in the specimens are shown in Figures 2.18 and 2.19. For all specimens, six strain gauges were attached on the longitudinal reinforcement at the interface. For Specimens PC1 and PC2, six pairs of strain gauges were attached on six splice sleeves in addition to the strain gauges on the column longitudinal bars. Each set was attached near the bottom end and at the middle of a splice sleeve. A mechanical dial gauge was also used to monitor the column-end deflections during testing.

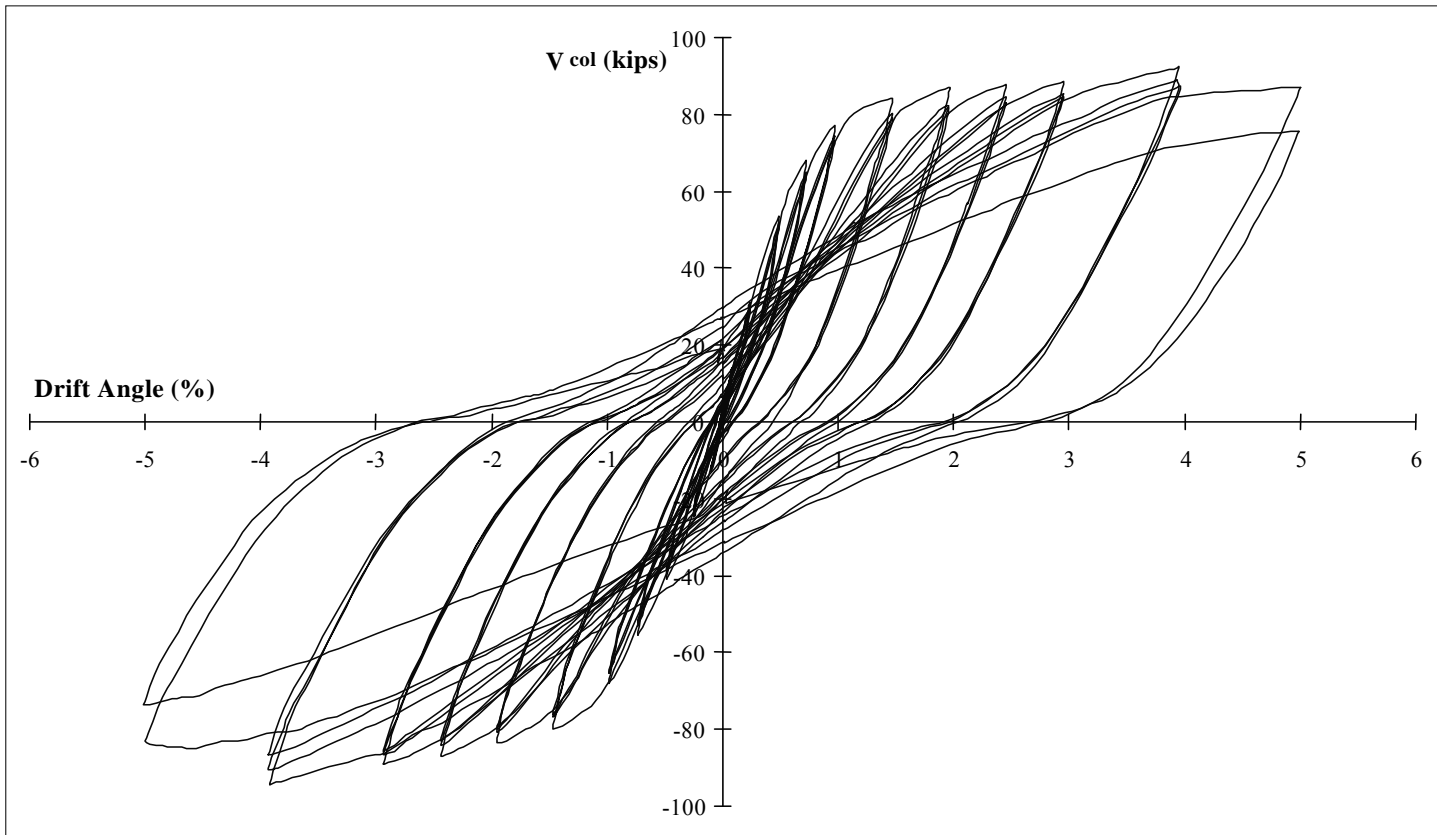
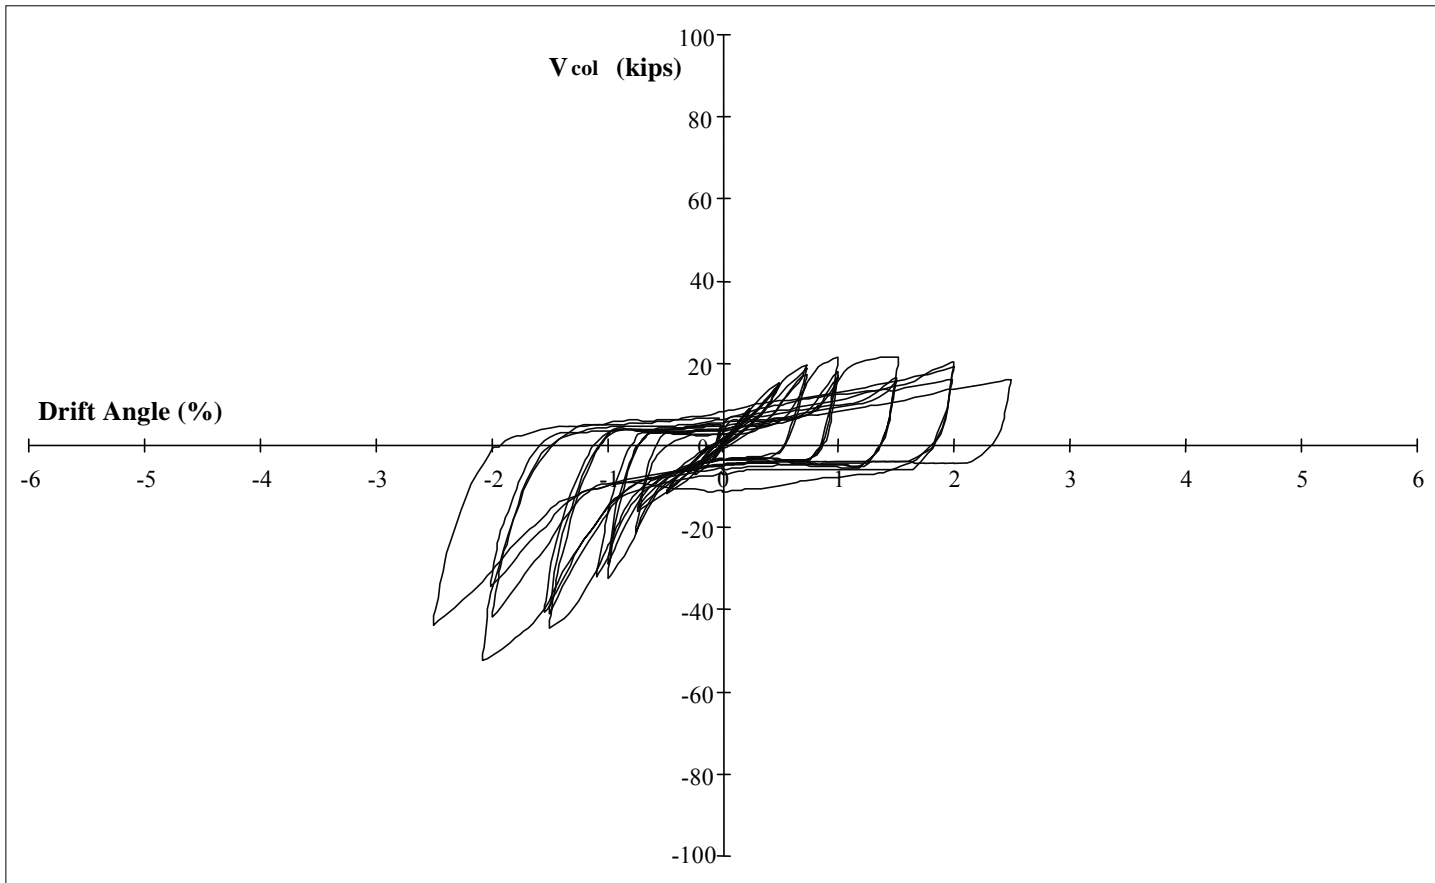
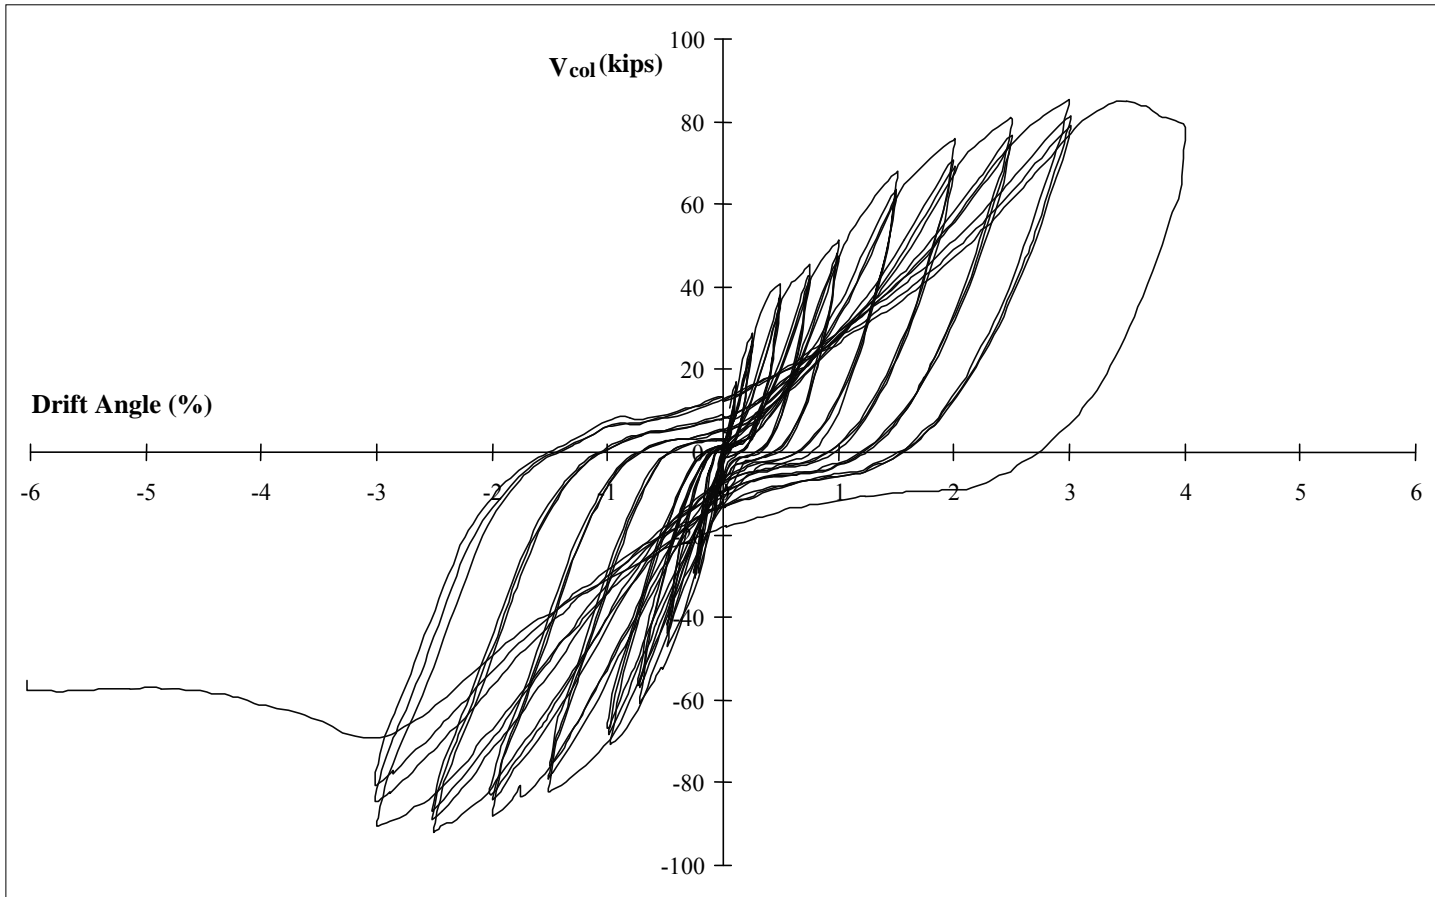
Overall behavior of the specimens is demonstrated graphically through story shear-drift angle relationships. Figures 3.1 through 3.3 show the story shear-drift angle relationships for Specimens MC1, PC1 and PC2, respectively.

For all the specimens there was noticeable stiffness degradation between the first and second cycles at each displacement level. This stiffness degradation generally stabilized during the third cycle. Pinching of hysteresis loops occurred for all specimens, but was most pronounced for precast specimens.

For Specimen PC1, cracks formed near the top of the splice sleeves, approximately 20 in. above the column-base interface. The hinge resulted primarily from slip of the column bars in the splice sleeves. Movement of the spliced bars was noticed even during very early drift ratios resulting in small peak loads for each cycle (see Fig. 3.2). Failure of Specimen PC1 was indicated by a discernible low strength during the first cycle to 2.5 percent drift ratio. This deterioration in stiffness and strength was accompanied by bond failure of the spliced bars in the splice sleeves.

For Specimen PC2, although there was gradual degradation of stiffness during the test, the shape of the hysteresis loops remained relatively stable up to drift ratios of at least 3 percent. The pinching of loops was mainly associated with

slip of the spliced bars, which resulted in an increase in the interface crack width between the column and base element. Stiffness deterioration in the column element became significant only when drift ratios were in excess of 3.0 percent. During the first half cycle to 4.0 percent drift ratio, a reduction in strength was noticed. While loading to 4.0 percent drift ratio in the negative direction, a substantial reduction in strength and stiffness was exhibited. Therefore, the scheduled loading cycle was terminated after the first cycle of 4.0 percent drift ratio. Thereafter the specimen was monotonically loaded to the displacement limit of the loading system, which corresponded with approximately 6 percent drift ratio. As shown in Figure 3.3, load stabilized at approximately 57 kips, which was 63 percent of the maximum load capacity.

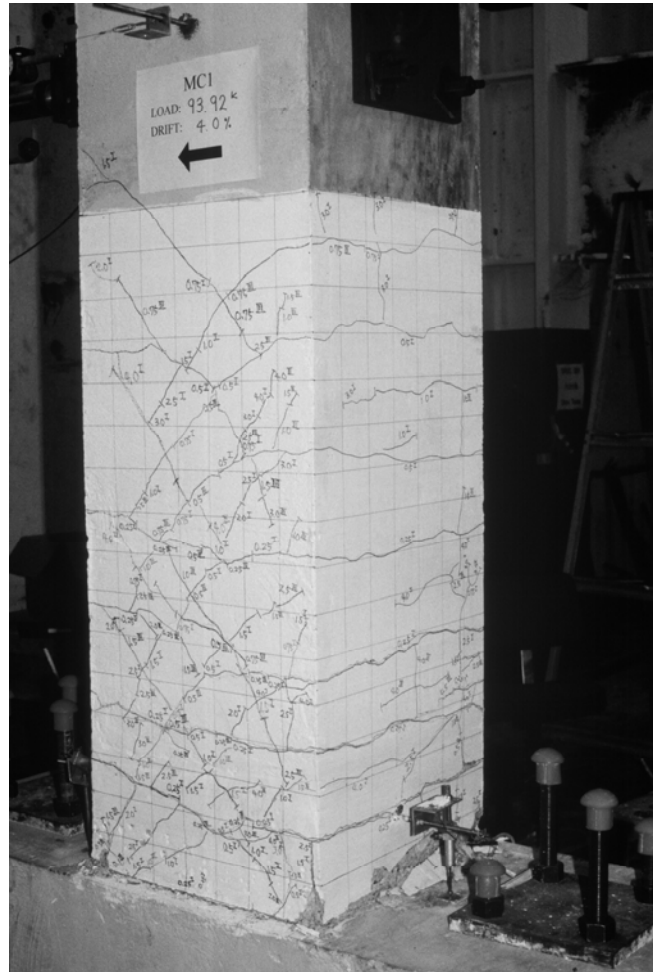
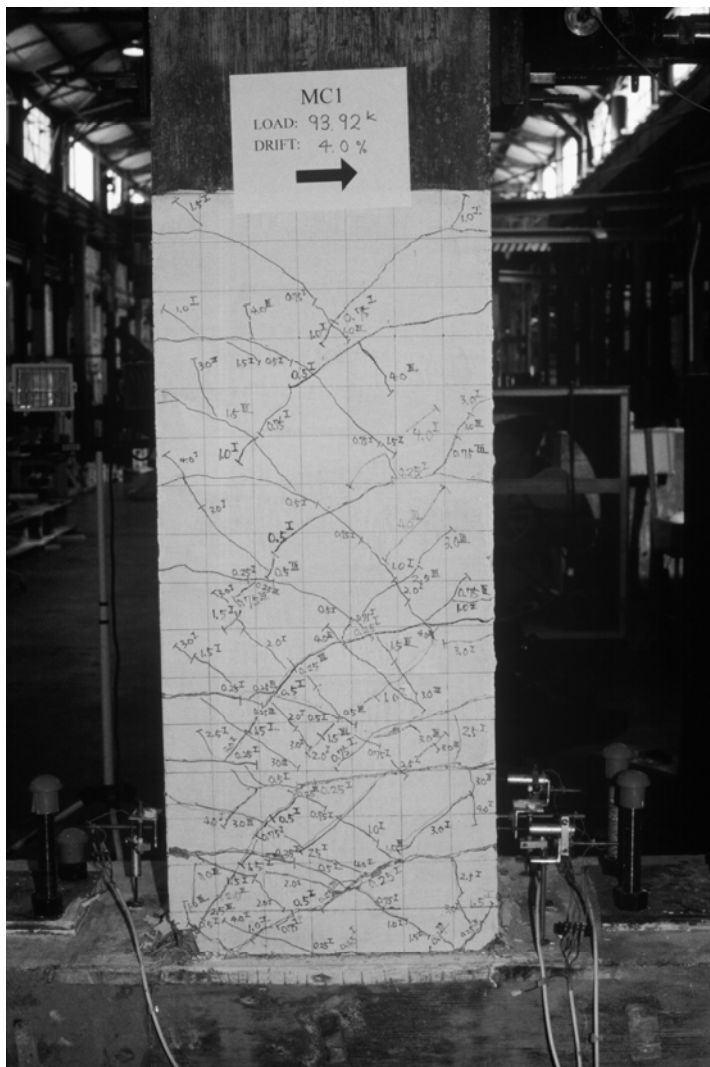
During testing there was no significant stiffness degradation noted until the end of the test. No visible cracks were found in the base element. Most concrete crushing and spalling, which occurred in the final stages of loading (5.0 percent drift ratio cycles), was concentrated along the flexural faces of the column near the base. Some column bars were even exposed at the end of the test. Figure 3.5 shows the crack patterns and damage sustained by the end of the test.

Crack patterns are sometimes helpful in visually assessing damage during a given loading cycle. Figures 3.4 through 3.9 show crack patterns on the column elements at selected drift ratios and at the end of each test.

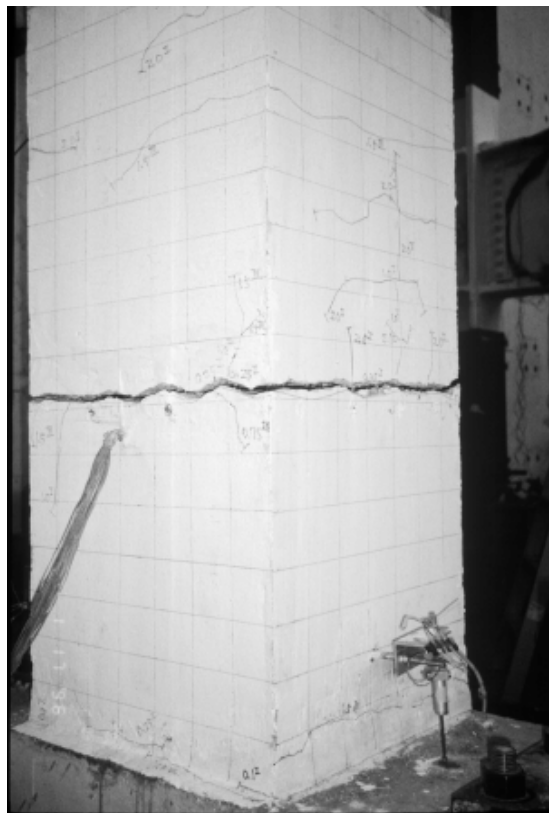
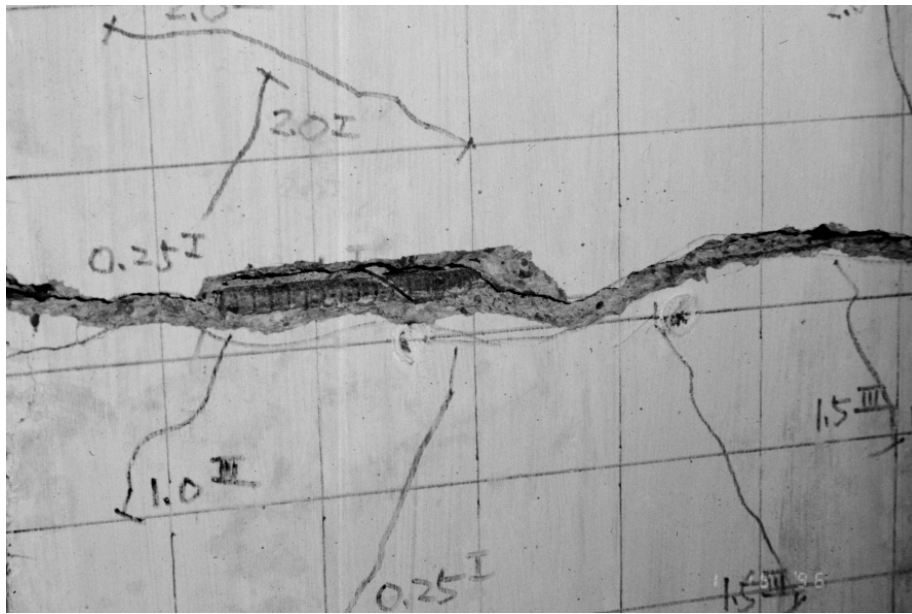
At the end of the test, the specimen showed clear indications of splice failure. No yielding of longitudinal reinforcement was detected. Figure 3.6 shows the specimen after completion of the test. In addition, Figure 3.7 shows the crack opening at the top of the splice sleeves.

After completion of the test, the portion of the column element above the splice sleeves was removed by cutting the longitudinal reinforcing bars. Two of the splice sleeves were separated from the remaining portion of the column by chipping away the surrounding concrete. Cutting open the grout sleeves indicated that the sleeves were not completely filled. There was a gap found between the top surface of the grout and the end plate of each sleeve that measured from $3/8$ to $1/2$ in. The location of the top grout outlet may have contributed to the failure to fill the sleeves.

Initial cracking was simultaneously developed at the column-base interface and near the top end of the splice sleeves during 0.1 percent drift ratio cycles. At 0.25 percent drift ratio, the width of the crack approximately 20 in. above the interface was approximately 0.03 in. Because this location was near the top end of the splice sleeves, it indicated that column longitudinal bars slipped in the splice sleeves. The opening of this crack almost doubled at 0.5 percent drift ratio, and almost 60 percent of the crack width remained after removal of load. Because a substantial portion of the column deformations was concentrated in this crack, no other significant crack except the interface crack developed.
