**A STUDY OF PIPE SPLICE SLEEVES
FOR USE IN PRECAST BEAM-COLUMN CONNECTIONS**

Thesis

The University of Texas at Austin

December, 2000

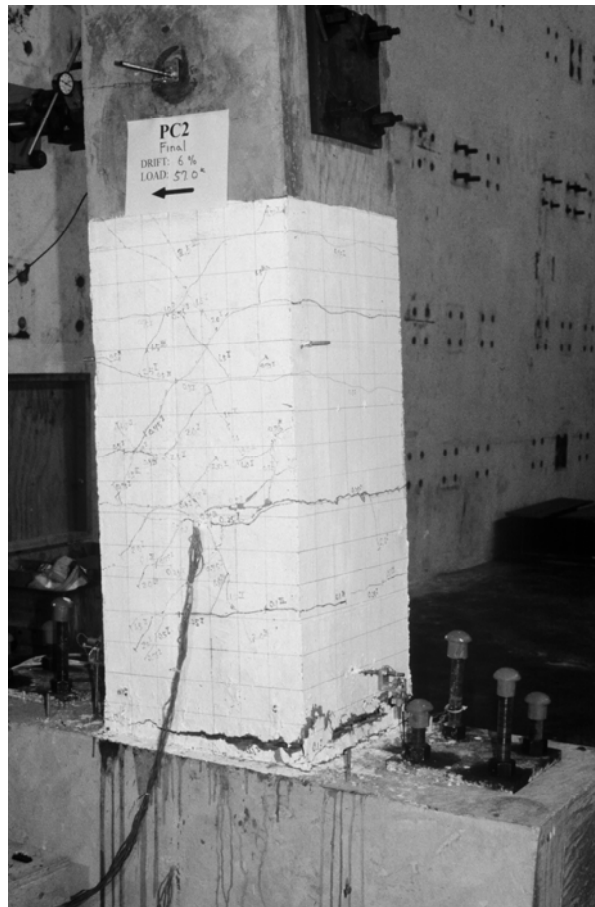
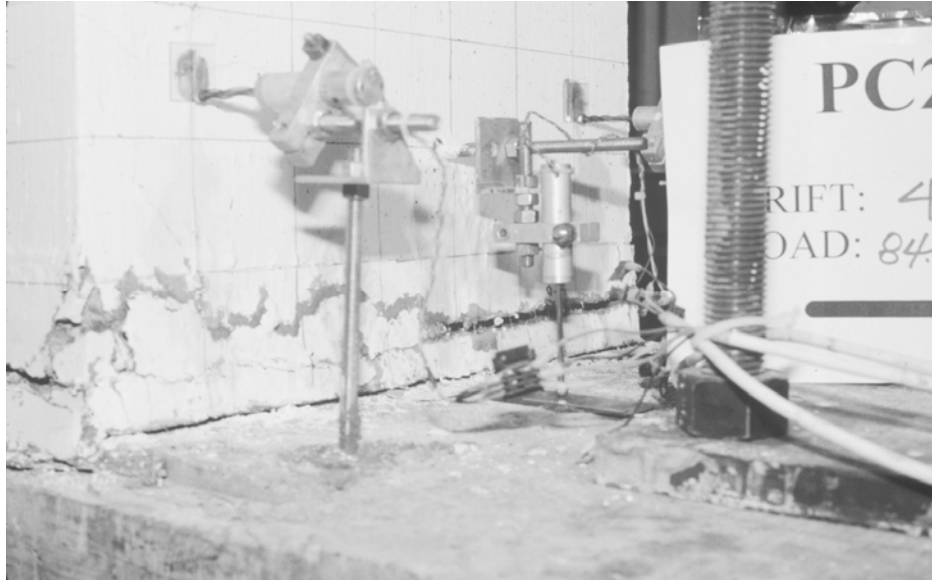
The maximum load achieved during the test was 92.2 kips at 2.5 percent drift ratio in the negative loading direction. This was nearly the same strength as developed by Specimen MC1. However, the strength of Specimen MC1 was developed at 4.0 percent drift ratio. The load at 5.0 percent drift ratio, which was 57.2 kips (approximately 37 percent less than the maximum load), remained unchanged until the end of the test.

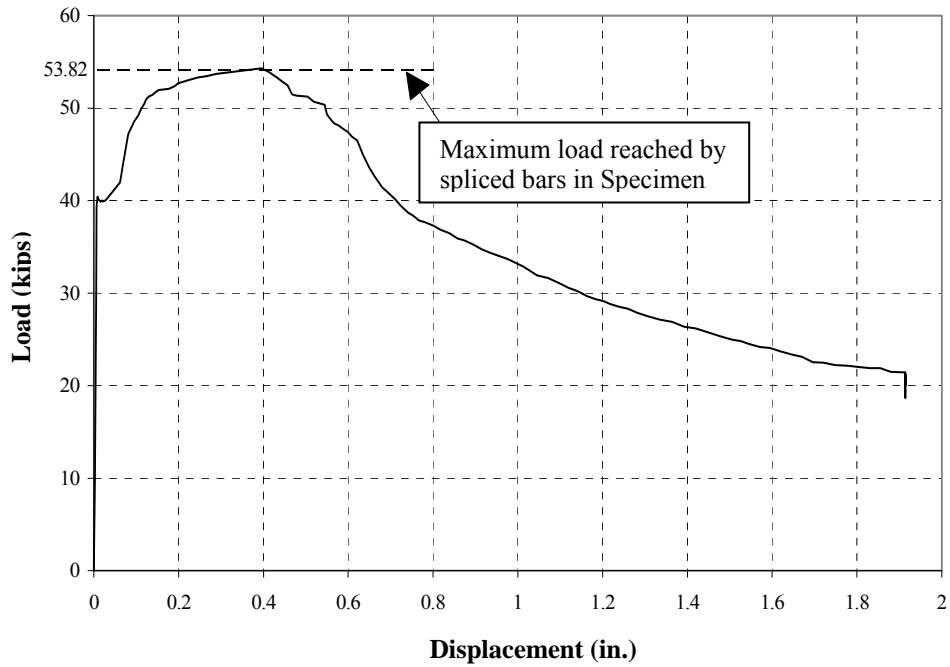
Figure 3.12: Load-Displacement Plot from Single Splice Sleeve Test

The plot also indicates that slip of the spliced bars initiated before yielding. The maximum load attained was approximately 14 percent higher than the load corresponding to nominal yield strength of the spliced bars, which was approximately 47 kips. The majority of elongation plotted in Fig. 3.12 was due to slip of the bars. Reduction in load after capacity was reached was quite gradual.

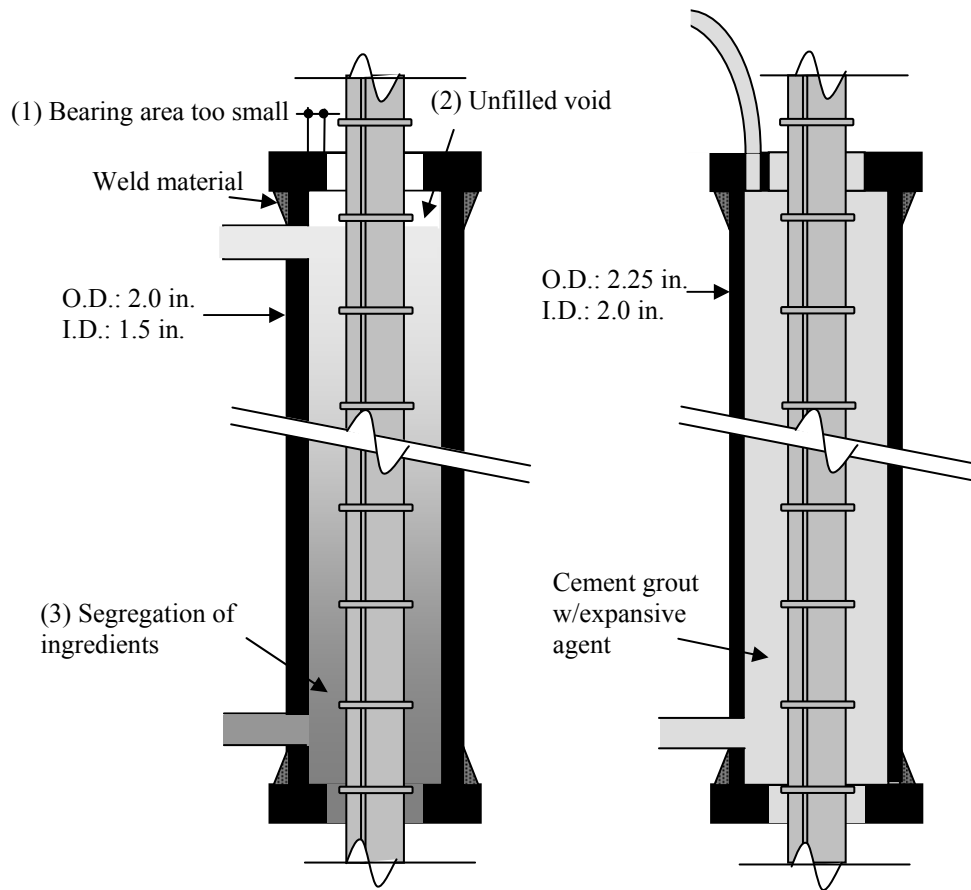
Figure 4.1 shows the problems encountered in the splice sleeve used for Specimen PC1. It also indicates the changes in the splice sleeve detail.

(a) Splice sleeve for Specimen PC1 (b) Splice sleeve for Specimen PC2

The problems mentioned resulted in a major crack near the top of the splice sleeves in Specimen PC1. As a result, modifications in the splice sleeve details were made as shown in Figure 4.1(b).

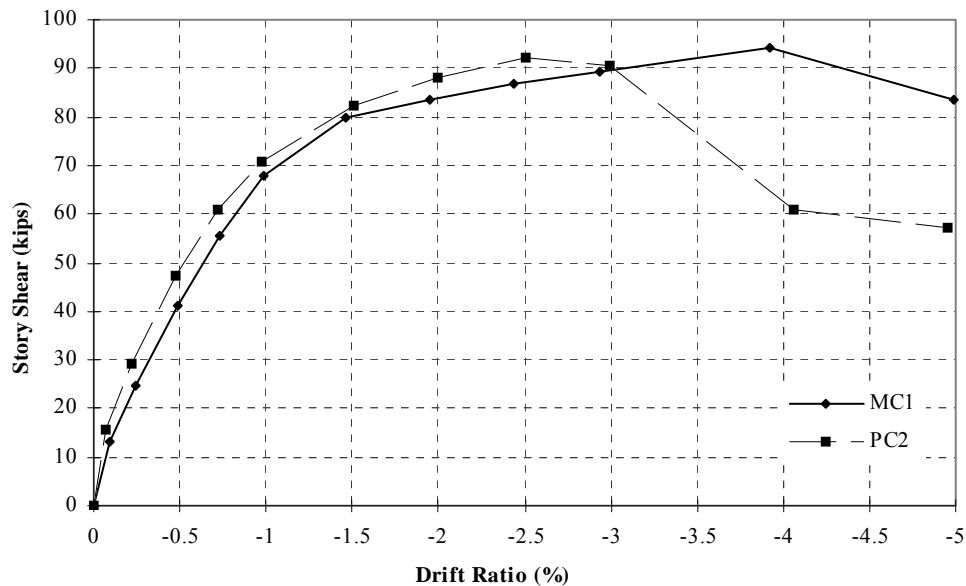
Figure 4.2: Response Envelopes

During testing, psuedo static reversed cyclic loads were applied to simulate dynamic cyclic loading during an earthquake. It is often useful to examine the monotonic response of a connection for insight into the strength, stiffness, and ductility. Response envelopes for Specimens MC1 and PC2 were constructed by connecting the points corresponding to peak response for the first cycle of each drift ratio to examine monotonic response.

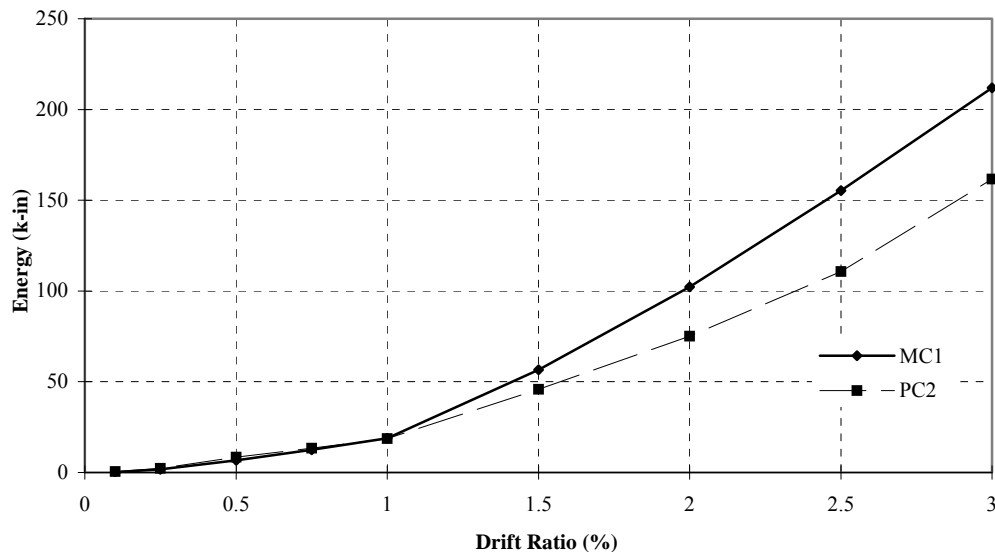
Figure 4.3: Cumulative Energy Dissipated

Figure 4.3 shows cumulative energy dissipated by Specimens MC1 and PC2 for the positive loading direction. As implied by the load-displacement relationships, Specimen MC1, which demonstrated more ductile behavior, dissipated more energy than Specimen PC2. Beyond 1.0 percent drift ratio, Specimen PC2 showed a slower increase in cumulative energy dissipation than Specimen MC1. This difference can be attributed primarily to the pinching observed in the load-displacement response of Specimen PC2. Pinching was primarily due to slip of the longitudinal bars through the splice sleeves. However, beyond 2.5 percent drift ratio, increases in cumulative energy dissipation were approximately the same for both specimens.

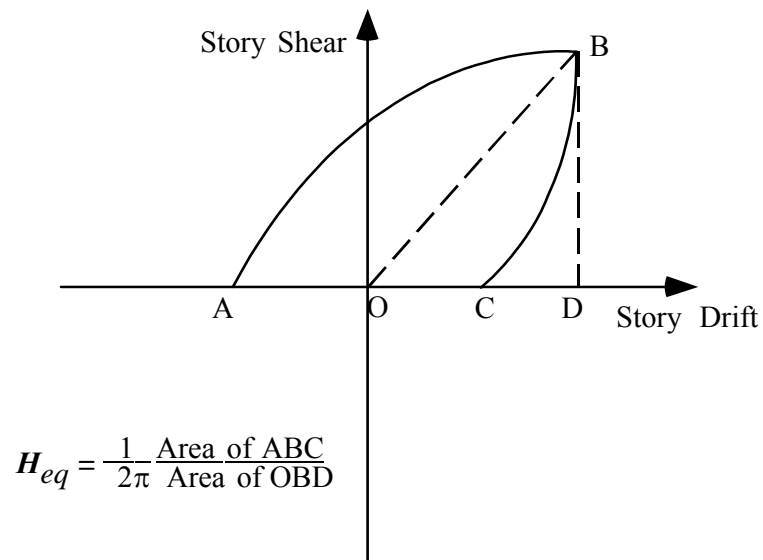
Figure 4.5: Definition of Equivalent Viscous Damping Ratio, H_{eq}

Hysteretic damping is an important parameter influencing the ability of a structure to dissipate energy during dynamic excitation. The equivalent viscous damping ratio H_{eq} can be obtained by computing the ratio of dissipated energy to strain energy of an equivalent linear system divided by 2π . This definition is illustrated in Figure 4.5. The equivalent viscous damping ratio normalizes hysteretic damping with respect to viscous damping, and reflects the amount of pinching in the hysteresis loops.

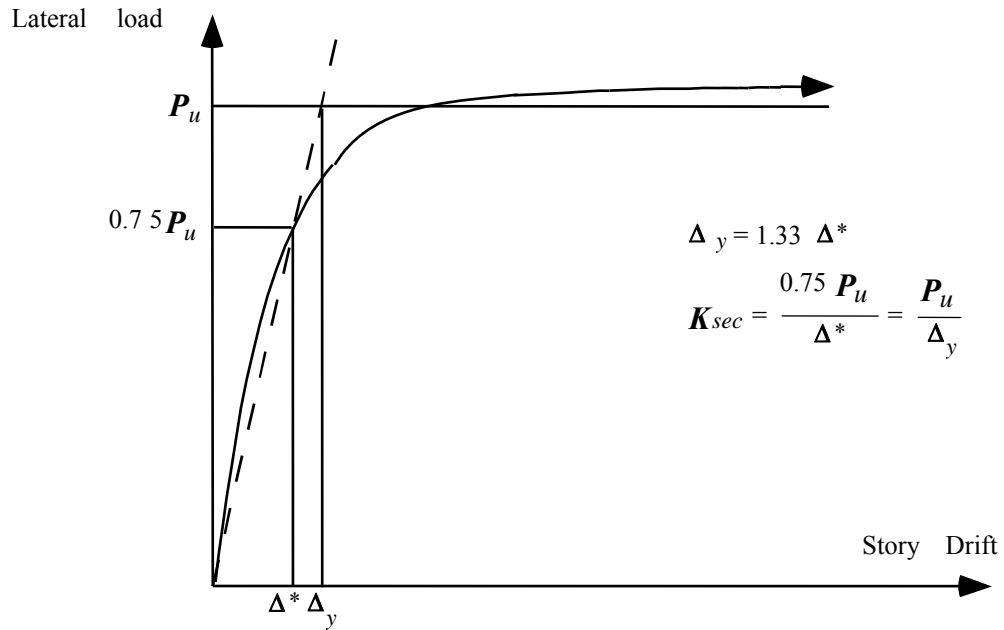
Figure 4.7: Definition of Secant Stiffness and Yield Displacement

The intersection of the extension of that line and a horizontal line corresponding to the calculated lateral load capacity P_u is taken as the yield displacement Δ_y . The yield displacements for Specimens MC1 and PC2 are listed in the fourth column of Table 4.2.

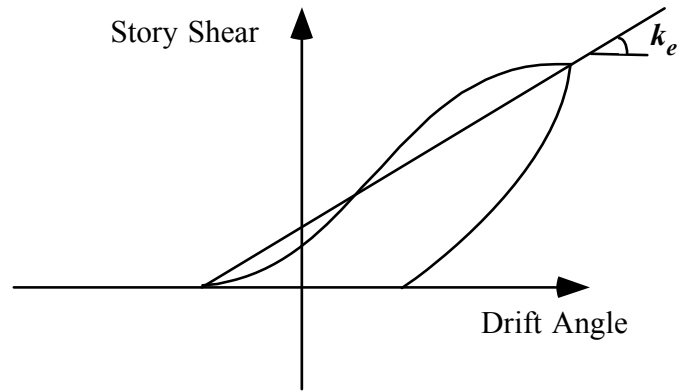
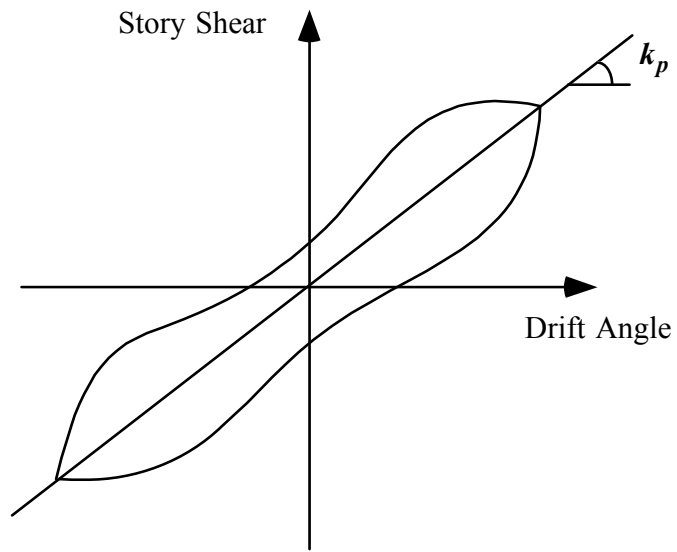
Figure 4.8: Definition of Stiffnesses

Peak-to-peak stiffness K_p can be computed for each loading cycle. Figure 4.8 (b) shows a line connecting points corresponding with maximum positive and negative drift angles. The slope of this line is the peak-to-peak stiffness. Due to the definitions for stiffness shown in Fig. 4.8 and the nature of the hysteresis loops, peak-to-peak stiffness values are typically larger than equivalent stiffness values. Equivalent stiffness facilitates comparisons between response half-cycles for a given loading direction, while peak-to-peak stiffness values provide for comparisons between full response cycles.

(a) Equivalent Stiffness

(b) Peak-to-Peak Stiffness

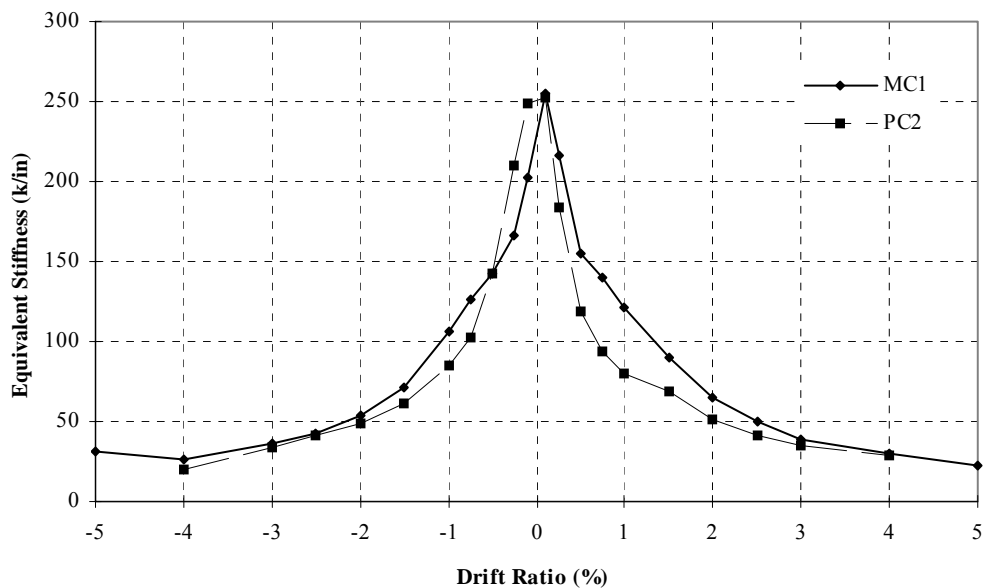
Figure 4.9: Equivalent Stiffness, K_e

Stiffness deterioration for Specimens MC1 and PC2 following each half cycle of response are shown through equivalent stiffness vs. drift ratio plots in Figure 4.9. The stiffness values presented are based on the first load cycle at each drift ratio. Both specimens consistently exhibited greater equivalent stiffness for the first positive half cycle compared with the first negative half cycle. For a given drift level, resistance in the negative loading direction was affected by damage induced during loading to a new maximum drift level in the positive loading direction. The first cycle to a new maximum drift level also induced a larger residual drift in the positive loading direction. Both of these affected the equivalent stiffness for the negative loading direction.

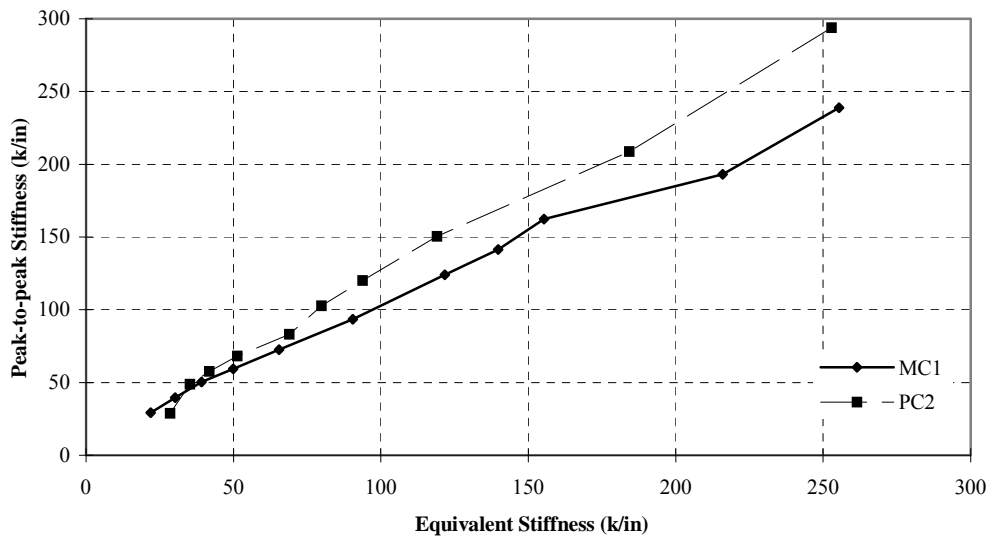
Figure 4.11: Comparison between Equivalent and Peak-to-Peak Stiffnesses

The comparison of peak-to-peak stiffness and equivalent stiffness illustrated in Figure 4.11 indicates that peak-to-peak and equivalent stiffness are approximately the same for Specimen MC1 throughout most of the testing program. Peak-to-peak stiffness was generally greater than equivalent stiffness for

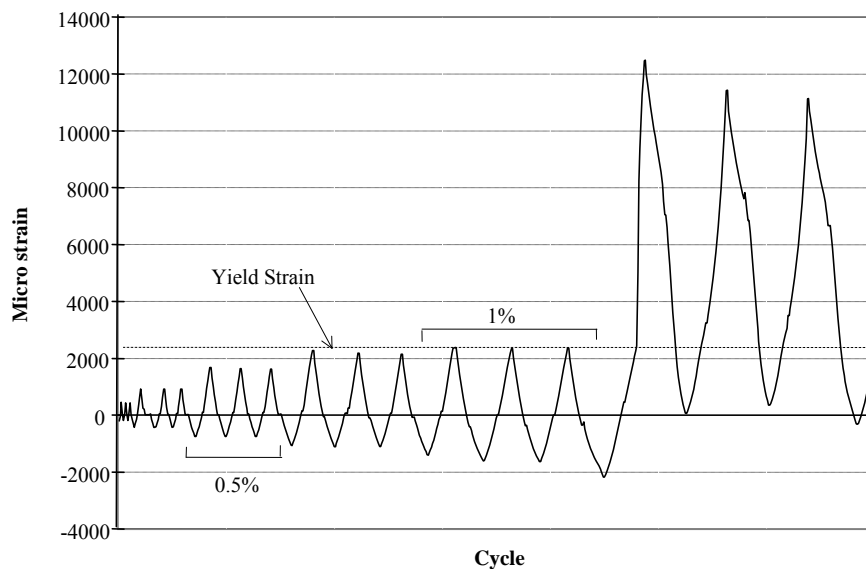
Figure 4.13: Strain History of Column Reinforcing Bar in Specimen MC1

As shown in Figure 4.13, strains increased as drift ratio increased, and reached the yield strain at 1.0 percent drift ratio. Up to yield, the maximum positive/tensile strain for each cycle was almost double the corresponding negative/compressive strain.

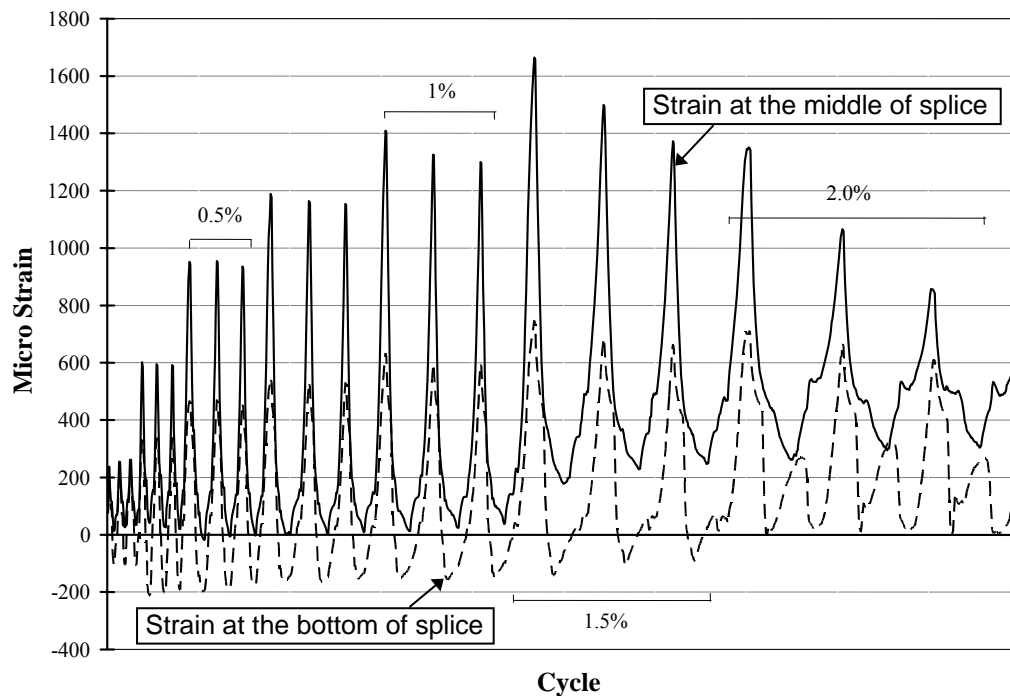
Figure 4.15: Strain History for Splice Sleeve

Figure 4.15 shows the strain history for a splice sleeve in Specimen PC2. The splice was designed to remain elastic throughout the test. The chemical bond between the splice sleeve and concrete outside the splice sleeve was ignored. Furthermore, the chemical bond between the splice and cementitious grout was also ignored.

As shown in Figure 4.15, strains at mid-height of the splice sleeve were approximately twice the strains measured near the lower end. At the lower end, the strain increase corresponding with increase in drift ratio was also relatively small. The strain history at mid-height of the splice shows that the highest strain was reached during the first cycle at each drift level and decreased during the following cycles. This implies that during the first cycle at each drift level, force in the spliced bar surpassed the previous maximum force level. During the following cycles, bond resistance was reduced due to damage incurred during the first cycle. This contrasts the strain data shown in Figure 4.14, which remains constant during cycles to the same drift ratio. Strain data from mid-height of the splice exhibited no signs of compression, even during early stages of loading. Also, strains measured at the lower end of the splice sleeve remained positive after 1.5 percent drift ratio. This implies that the crack opening at the column end did not fully close when the loading direction was reversed because of frictional resistance to closing and concrete debris inside the crack. Measured strains in the splice sleeve decreased when the spliced bars reached yield.
