**Survey of Costs, Economic Analysis, and Design Guidelines for
Corrosion Protection Methods for Post-Tensioned Concrete Bridges**

Thesis

The University of Texas at Austin

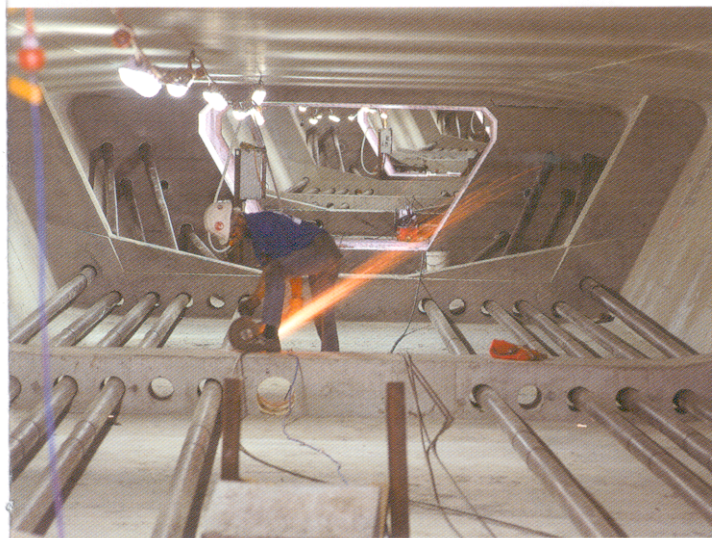
Figure 2.5 Interior of an Externally Post-Tensioned Box Girder⁷

Post-tensioning has a number of different forms. The ducts can be either completely inside the concrete element, which is called internal post-tensioning, or outside of the concrete but inside the envelope of the section, which is called external post-tensioning. External post-tensioned members are often box-like, hollow sections where the ducts run inside the hollow portion though not entirely within the concrete. The interior of an externally post-tensioned box girder is shown in Figure 2.5. Both the internal and external post-tensioning can be designed as either a bonded or unbonded system. In bonded tendon applications, after the tendons have been stressed grout is injected into the remaining space in the ducts. This step provides bond between the steel strands and the duct and can

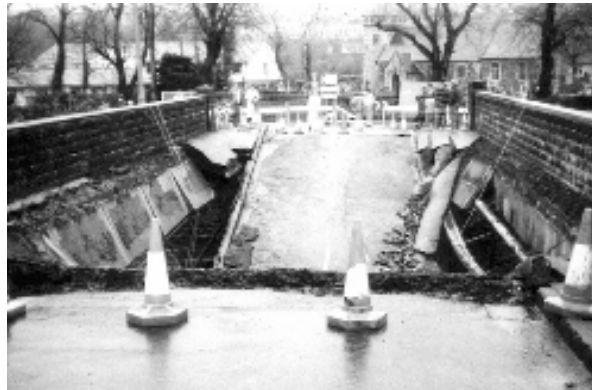
Figure 2.10 Ynys-Y-Gwas at Failure, 1985¹⁵

1985 brought the collapse of the Ynys-Y-Gwas bridge in Wales. This single-span, precast, segmental post-tensioned bridge had road salts penetrate the road slab¹⁶. When the chlorides reached the precast members, the buttering mortar at the joints proved unable to prevent further ingress¹⁷. The chlorides were then able to work through the joints to the tendons. The buttering mortar used was over an inch thick to accommodate the tolerances between the segments. Had the segments been match cast epoxy joints, as is the current common practice in US precast segmental construction, the joints would have been quite tight and the epoxy is less porous than the bulk concrete^{3,11}. This last disaster, shown in Figure 2.10, prompted the UK DOT to declare a moratorium on the construction of post-tensioned bridges. After significant research and improved corrosion protection, the moratorium was partially lifted in 1996 to allow cast-in-place post-tensioned construction. In the UK, precast segmental construction is still disallowed pending further research¹⁷.

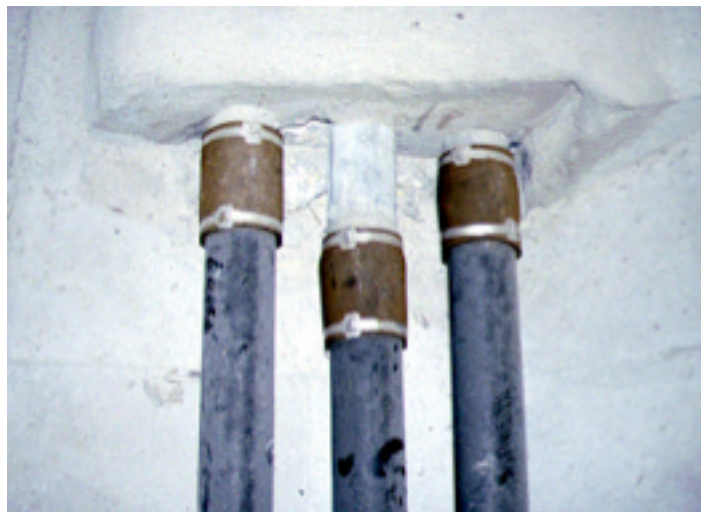
Figure 2.11 Tendon Slip at Deviation Block¹⁹

This bridge, built in 1981, which carries the only roadway to the Florida Keys, was discovered during routine inspection in the summer of 1999 to have lost one of its post-tensioning tendons. Resulting from the force imbalance after fracture, the tendon had moved 9 inches, as shown in Figure 2.11. There are six tendons supporting each span, so the loss of one was a significant reduction in available capacity for that span. As there are 39 spans in the 4557-FT bridge, this single tendon failure represents only 0.4% of the 234 total tendons present¹⁸. The fractured tendon had voids in the grout at the anchorage and the steel strands were actively corroding at this location. Salt bearing water had leaked through the joints, run down the joint diaphragm wall, and seeped into the anchorages located in these diaphragms. Autopsy of the failed tendon revealed that there had been cyclic recharge of the grout void with salt water, initiating the corrosion of the tendon. The span-by-span precast segmental construction of the Niles Channel Bridge was pioneered in Florida on the Long Key Bridge construction two years earlier. The Long Key Bridge has suffered from corrosion in the precast support piers, but not of the post-tensioned superstructure. The Niles Channel corrosion discovery lead to the replacement of the fractured tendon and the vacuum

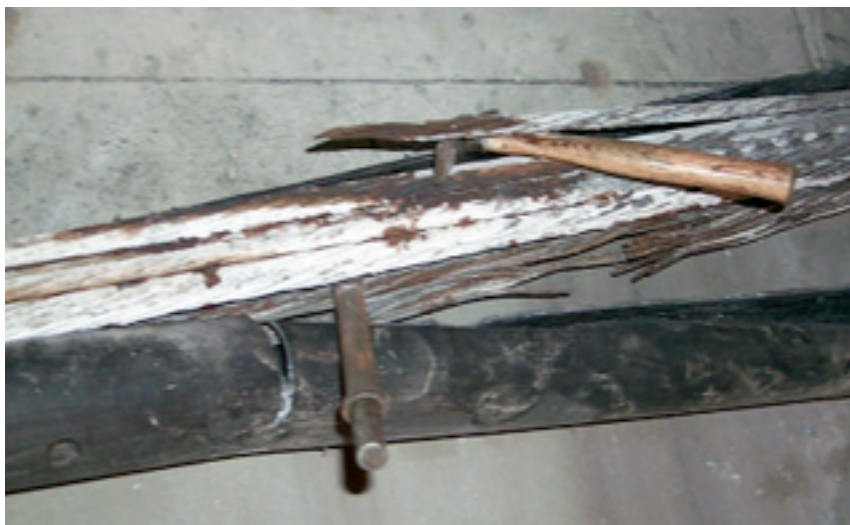
Figure 2.12 Corrosion in the Free Length¹⁹

Therefore, the two failures represented only 0.2% of the total tendon count. The two failures were also located in different spans. After assessing the damage, the bridge was reopened under reduced load capacity while repairs were made¹⁹. Further investigation led to the replacement of eleven tendons in the bridge that had significant corrosion. These total of eleven tendons still only accounted for 1.3% of all the post-tensioning tendons in the bridge. One of the failed tendons had corroded in its free length where the high-density polyethylene duct had split, as shown in Figure 2.12. The other failure was a total fracture near the anchorage in a grout void. Chloride laden moisture was found to have penetrated through the anchorage, despite the presence of a bituminous protection coating. The investigation, which involved the inspection of every anchorage with a fiberscope, showed a number of anchorages that had undergone corrosion of the anchorage itself. A number of splits in the duct were also found due to a material deficiency in the plastic used during construction¹⁷. Grout voids were found at the anchorages and in the free length of the tendons. The anchorage voids in tendons not replaced were vacuumed grouted and anchor head protection was reapplied. The external tendons were wrapped to increase protection. As a result of the extensive corrosion problems it had experienced, the FDoT issued a design memorandum to improve durability in post-tensioning tendons. The new recommendations include requiring the use of pre-bagged grout, bottom up grouting, and inspection of the anchorages after grouting. As well, anchorages on the segment face were disallowed for balanced cantilever construction unless the contractor inspected and grouted the anchorage before erecting additional segments. Instead the anchors should be located in anchorage blisters¹⁹. As well, new AASHTO specification updates have disallowed the further use of dry joint segmental construction²⁰. Without the now-required epoxy match casting, salt

water was able to enter the box girder through the dry joints along the tendons length as well as through the expansion joints to reach the anchorage.

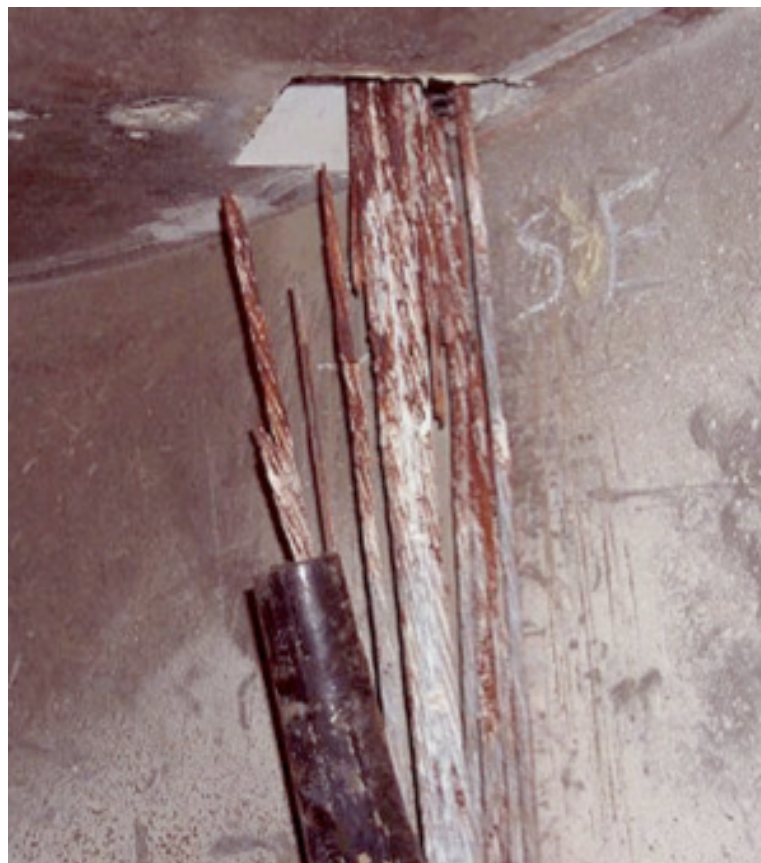
Figure 2.13 Corrosion of Vertical External Tendon¹⁹

The main spans of this Florida bridge are cable stayed, with the approach spans supported by post-tensioning. Constructed by balanced cantilever precast segmental methods in 1987, the bridge also has vertical post-tensioning used to join the precast segmental support columns. A routine inspection in September 2000 revealed that a vertical external tendon had fractured in one of the support columns¹⁹. Other vertical tendons showed signs of corrosion in grout voids, and a quarter of the external tendons had splits in the plastic duct. Many of these columns had leaks in their joints that resulted in large amounts of salt water filling the hollow columns. In addition, the grout in the external post-tensioning had numerous voids. The combination of pervasive salt water, breaks in the plastic

ducts, and extensive voids resulted in corrosion of the vertical tendons. An example of this corrosion is shown in Figure 2.13. The longitudinal tendons of the superstructure appeared intact. Several tendons were replaced and the hollow pilings were filled with concrete to a point above the water line. The replacement tendons were double sheathed as a precaution against future chloride attack. As well, the Florida Department of Transportation amended its allowed design procedures to eliminate post-tensioning in submerged members with very limited exceptions. Other FDOT design recommendations issued, which were prompted by both the Mid-Bay Bridge and this incident, include requiring pre-bagged grout and bottom up grouting²¹.

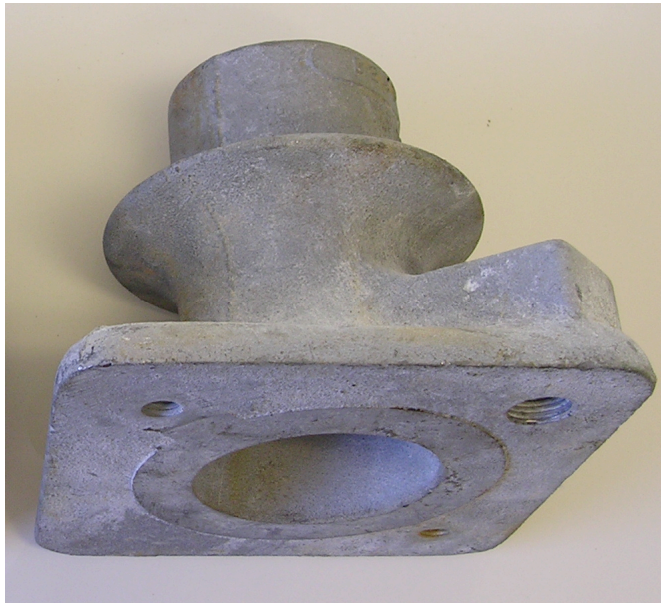
Figure 3.2 Galvanized Anchorage²⁵

For increased corrosion protection, the anchorages can also be galvanized. Some state codes are requiring this practice for all new bridge construction. The geometry and design of these anchorages are the same as for the basic black steel variety. In practice, they are the same anchorages that have simply been hot dipped in zinc to galvanize them. The zinc coating corrodes preferentially to the underlying steel, thus increasing time to corrosion initiation for the steel anchorage¹⁰. A galvanized version of the anchorage from Figure 3.1 is shown in Figure 3.2.

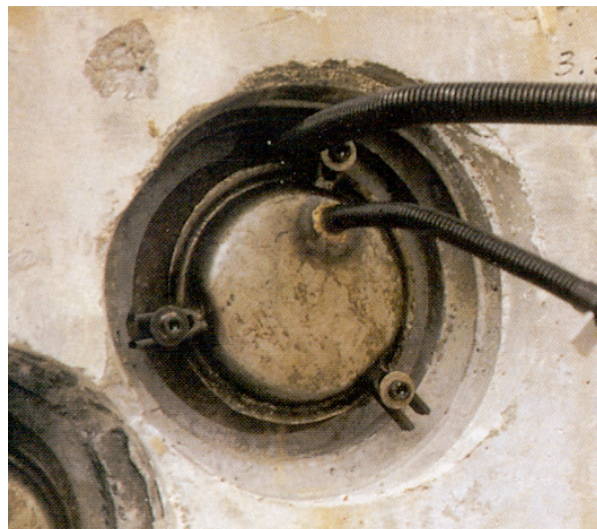
Figure 3.4 Metal Grout Cap²⁷

It has been recent practice to use temporary grout caps over the anchorage during grouting to ensure grout encapsulation of the strand tails and anchor head. Once the grout is set these caps would be removed and reused in another grouting operation. The remaining grout block, however, did not provide the corrosion protection desired. Moisture was able to diffuse through the grout and reach the steel. For increased protection there are now permanent caps used to add an additional layer of protection to the anchor. Permanent caps can be either metal or plastic, as shown in Figures 3.4 and 3.5. With metal caps there is the possibility that they will eventually corrode themselves. However these pieces are generally thick metal castings that will take a significant time period to corrode through. Plastic caps do not corrode. However, plastic has been known to degrade from exposure to UV rays. Thus, the particular grout cap selection should be considered based upon the needs of the individual structure.

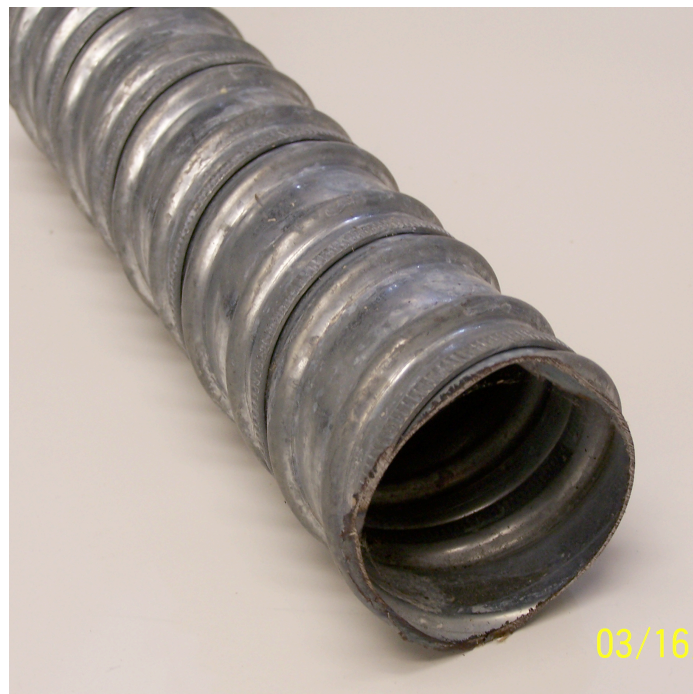
*Figure 3.6 Corrugated Galvanized Steel Duct*²⁵

Galvanized thin walled steel ducts made out of spirally wound steel strips are the most commonly used duct type in current internal tendon post-tensioning construction. An example of this duct type is shown in Figure 3.6. These corrugated tubes are easily bent on site to fit the detailed tendon layout. However, they have not performed well in aggressive exposure studies^{3,11}. In macrocell testing, some of the steel ducts corroded through in 4.4 years of continuous imposed electrical current with an alternating chloride solution exposure. This extremely aggressive testing environment is probably equivalent to several decades of actual exposure. Thus, this duct type offers very little corrosion protection to the enclosed tendon when compared with plastic ducts that behaved very well in the same study^{3,11}. Splices between two lengths of steel duct is

commonly accomplished through the use of a sleeve of oversized steel duct that is duct taped on either end to seal the opening. The length of the sleeve is proportional to the diameter. A heat activated shrink wrap has also been used. Both of these splices behaved poorly in these aggressive exposure studies¹¹.

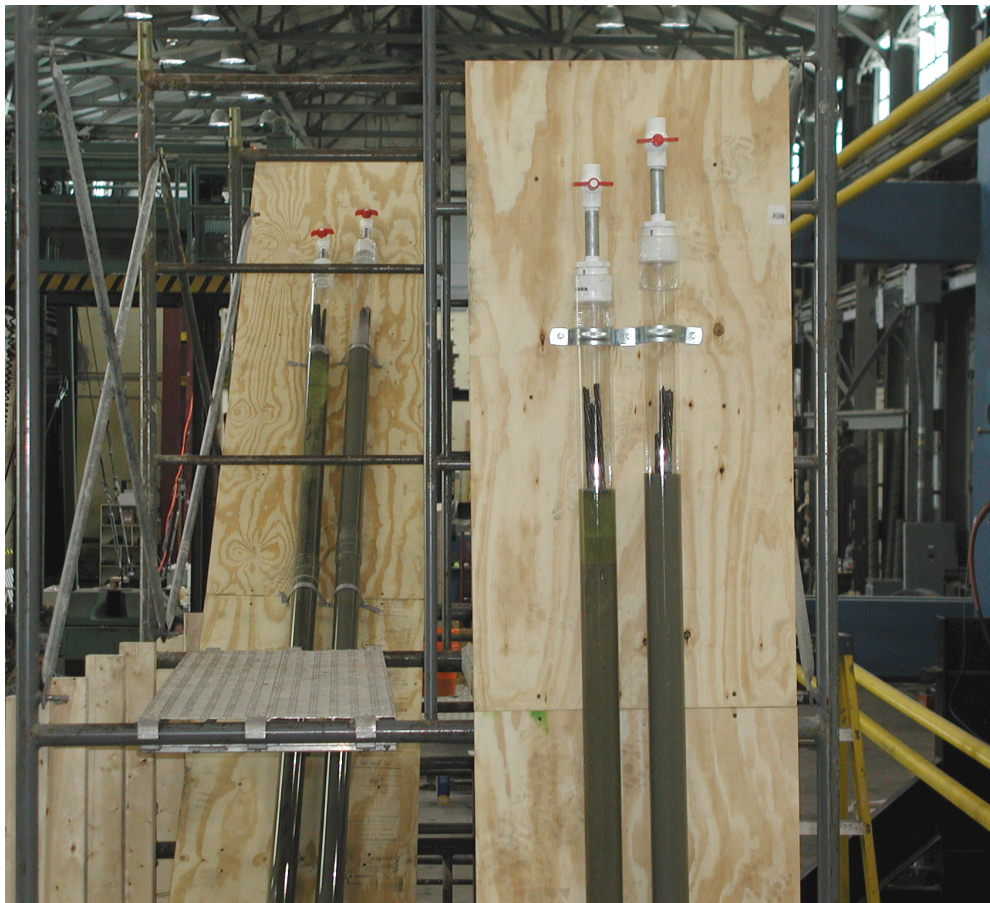
Figure 3.11 Grouting Demonstration at ASBI training³⁶

Schokker's research on the development of grouts stressed the reduction of bleed water to reduce the voids in the duct²⁴. The current prepackaged grouts have shown superior performance in completely filling the ducts when used by a properly trained crew. Additional training of crews had also been proven essential to quality grouting. American Segmental Bridge Institute (ASBI) now offers Grouting Certification Training for grout technicians and members of the post-tensioning industry to help improve overall grouting quality³⁵. Several states require all grouting to be done by ASBI certified grout technicians. Photographs from the 2005 ASBI training course grouting demonstration are shown in Figure 3.11 and 3.12. Figure 3.11 is an overview picture of the inclined and vertically grouted tendons. For each pair, the grout used in the left tendon is a plain cement and water grout and the grout in the right tendon is from a prepackaged mix.

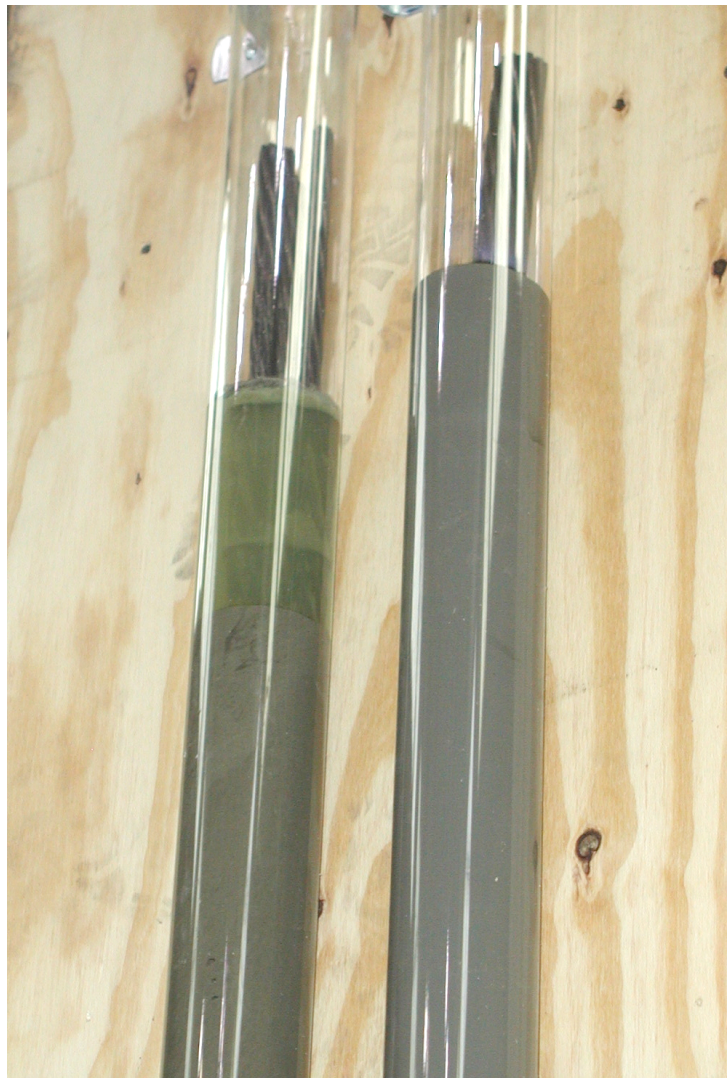
Figure 3.12 Closer View of Vertically Grouted Tendons³⁶

Figure 3.12 is a close up of the bleed lens developing in the plain cement grout in the vertical tendon. Other grouting technique improvements include bottom up grouting, locating grout vents at high points in the duct profile, and mock-ups to ensure a particular grouting plan will work as planned¹⁹.
