**Fatigue Resistance of  
Traffic Signal Mast-Arm Connection Details**

**Thesis**

**The University of Texas at Austin**

**May 2003**

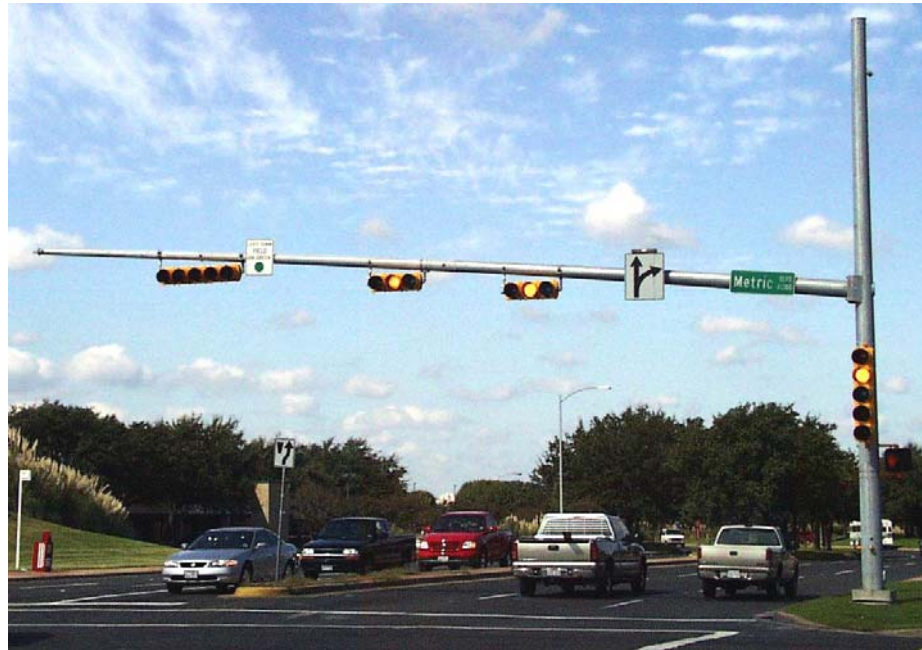
*Figure 1.1 Typical Cantilever Mast-Arm Traffic Signal Support Structure*

The traffic signal shown in Figure 1.1 is a cantilever tapered mast-arm, which is a typical traffic signal structure used by many transportation departments throughout the U.S. This cantilever mast-arm design, as shown, has many advantages over the other structures described above. The single column structure provides fewer collision hazards and vision obstacles for drivers. The cantilever mast-arm is cost efficient and relatively simple to design. The overall

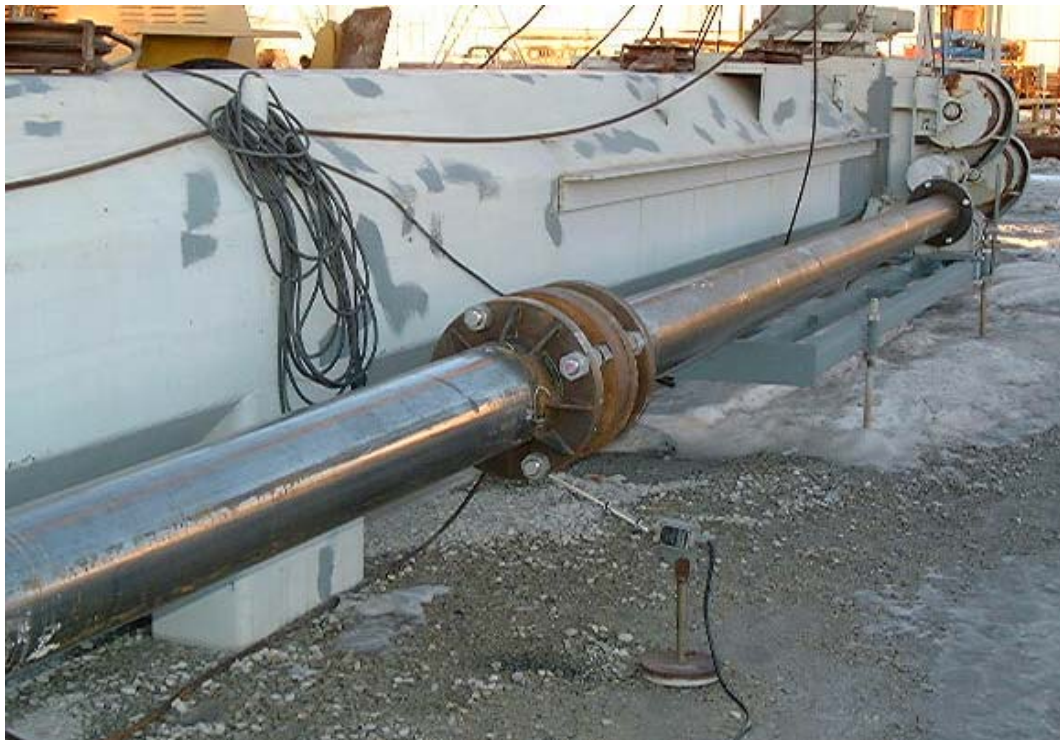
*Figure 1.8 Test Setup for Tests Performed at Valmont Industries, Valley, NB.*

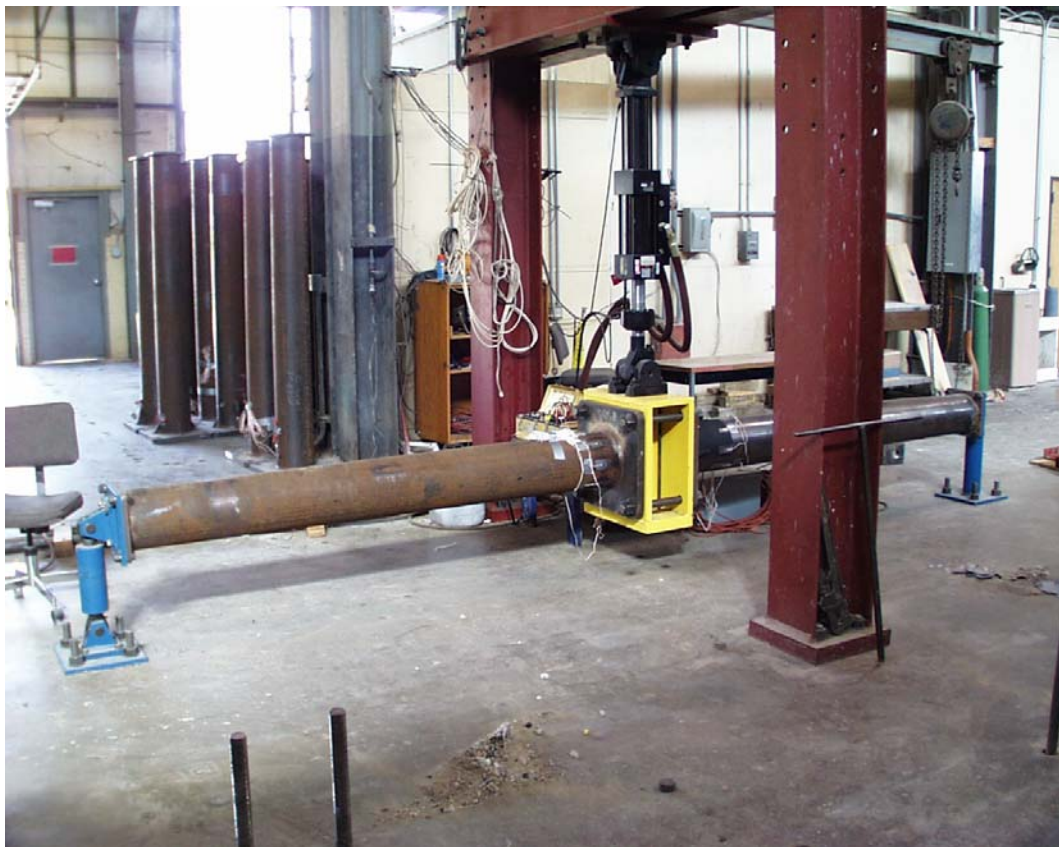
*Figure 2.3 Test Setup*

box to a standard test frame. The connections at both ends of the ram consisted of spherical ball joint clevises to allow for slight alignment imperfections. The ram used in this system was an MTS hydraulic actuator controlled by an MTS 407 Controller. Hydraulic pressure was provided by an external pump supplying 3000 psi constant pressure. This pressure was then tamed by an MTS 290 Hydraulic Service Manifold.

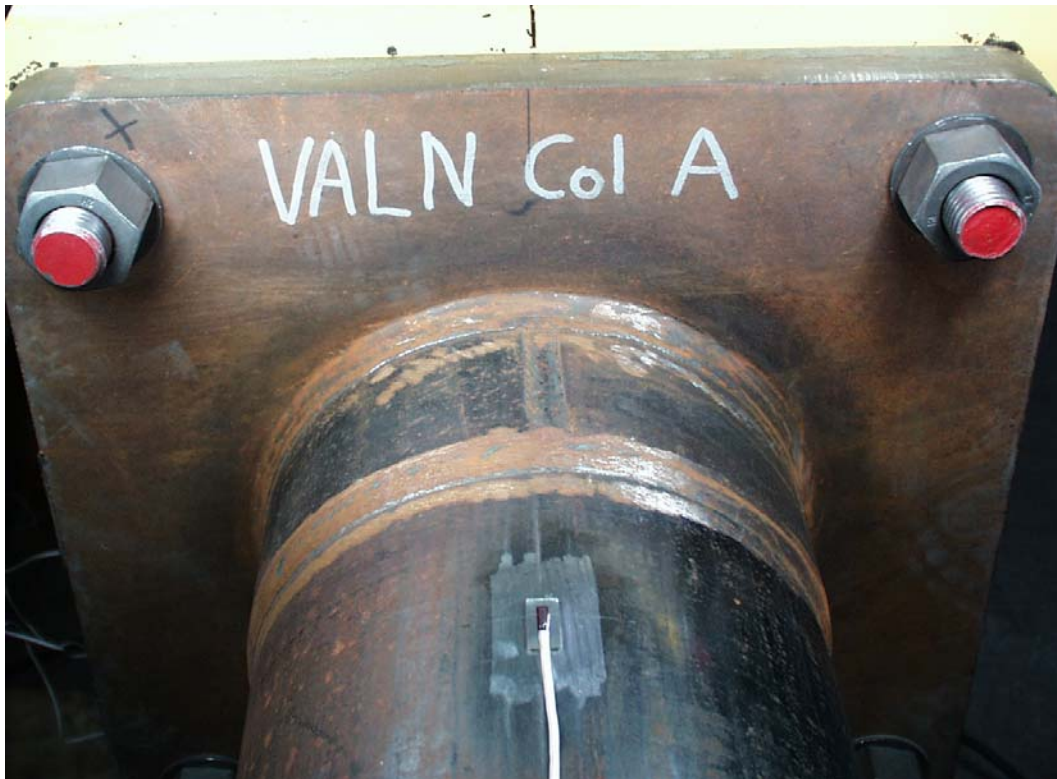
*Figure 3.8 External Collar Stiffened Specimen*

Carl Macchietto of Valmont Industries designed the external collar. The fabrication drawings for these specimens are shown in Figure 3.7, and a picture of a completed specimen is included in Figure 3.8. The fabrication drawing indicates that the collar to pole weld should be ground concave to produce a better weld profile. A set of two specimens with the external collar connection was fabricated. The ground areas on the test specimens were observed to be roughly ground with the ground area extending beyond the toe of the weld and into the pole in several locations.

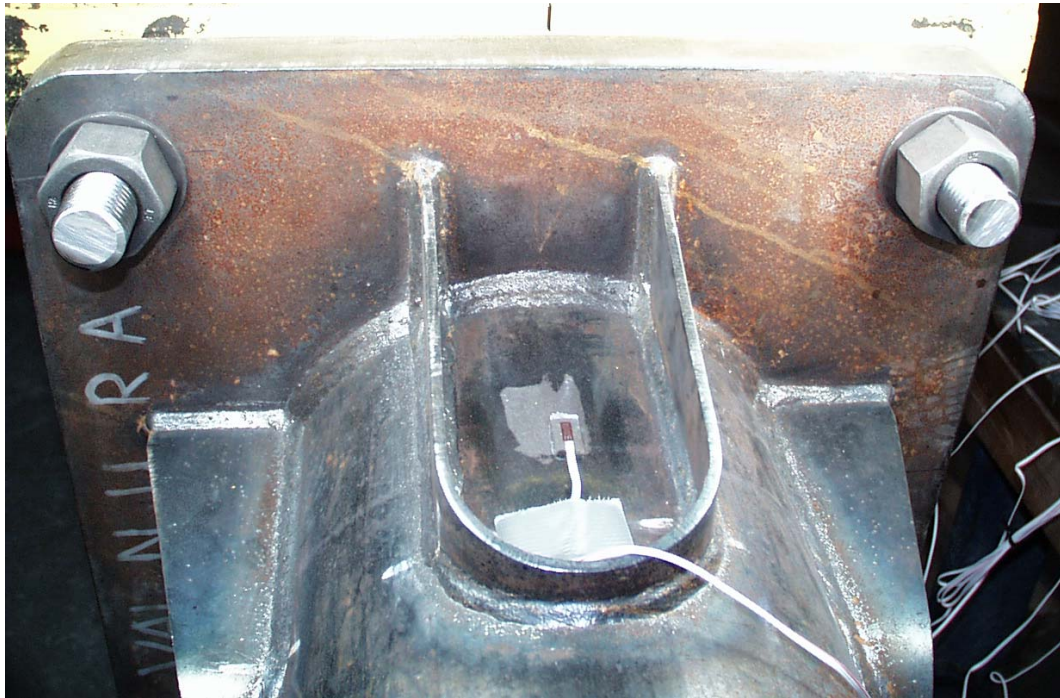
*Figure 3.13 U-Rib Stiffened Specimen*

Masakazu Sugimoto of Nippon Steel Corporation performed the design of the U-Rib stiffeners. Since this connection detail is a proprietary design, the basic design equations and fabrication procedure will not be discussed. However, it is important to note that the stiffeners were attached to the pole following a very detailed weld procedure that was designed to create residual stress fields in the proper locations along the stiffener. The fabrication drawings for these connection details are provided in Figure 3.10 and Figure 3.11. A set of two specimens was fabricated with U-rib Stiffener connection details. Two pictures of a completed specimen are included in Figure 3.12 and Figure 3.13.

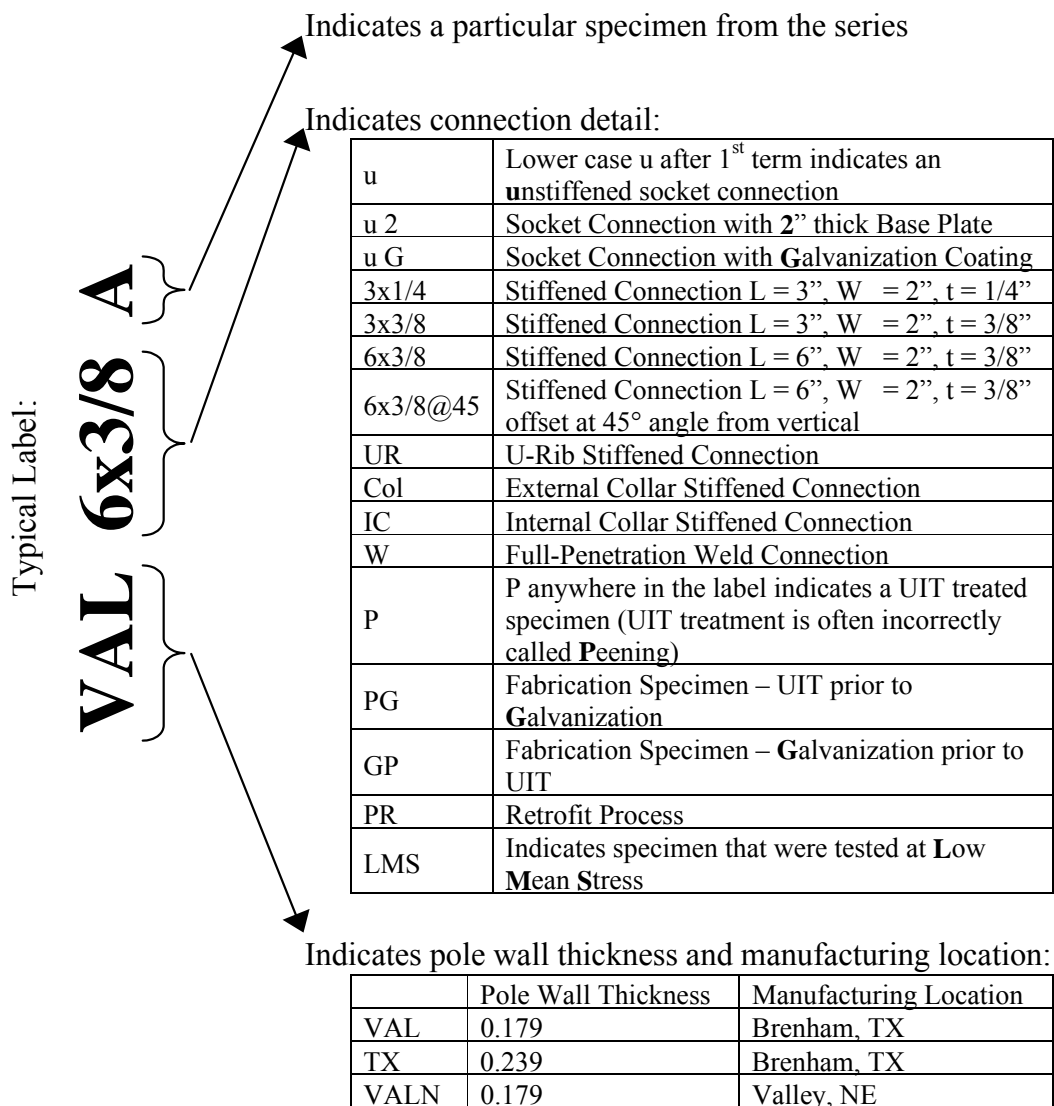
**Figure 3.15 Specimen Label Explanation Chart**

Specimen **TX 3x3/8 A** is the first specimen from the stiffened series with a 3" long by 3/8" thick stiffener. The pole wall thickness is 0.239" and it was manufactured in Brenham, TX.

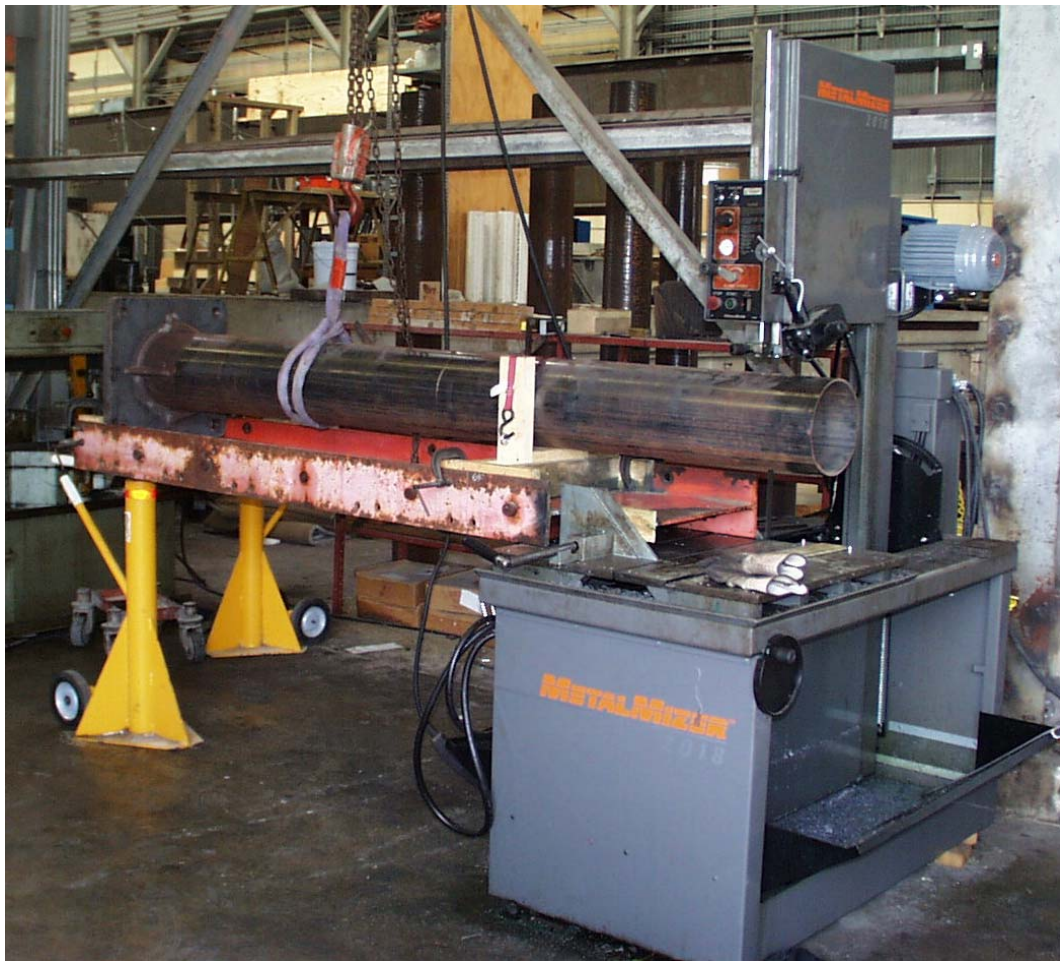
*Figure 4.1 Cutting Jig*

To facilitate the cutting process, a jig was constructed to hold the specimen in the proper position and insure the cut was performed at the proper length. The base of the cutting jig was a wide flange shape turned on its side. The web of the wide flange was deep enough so that the base plate of the test specimen fit between the flanges. Fixtures were constructed to hold the specimen in the proper position and to provide a stop that fixed the length of the cut. The cutting jig is shown in Figure 4.1.

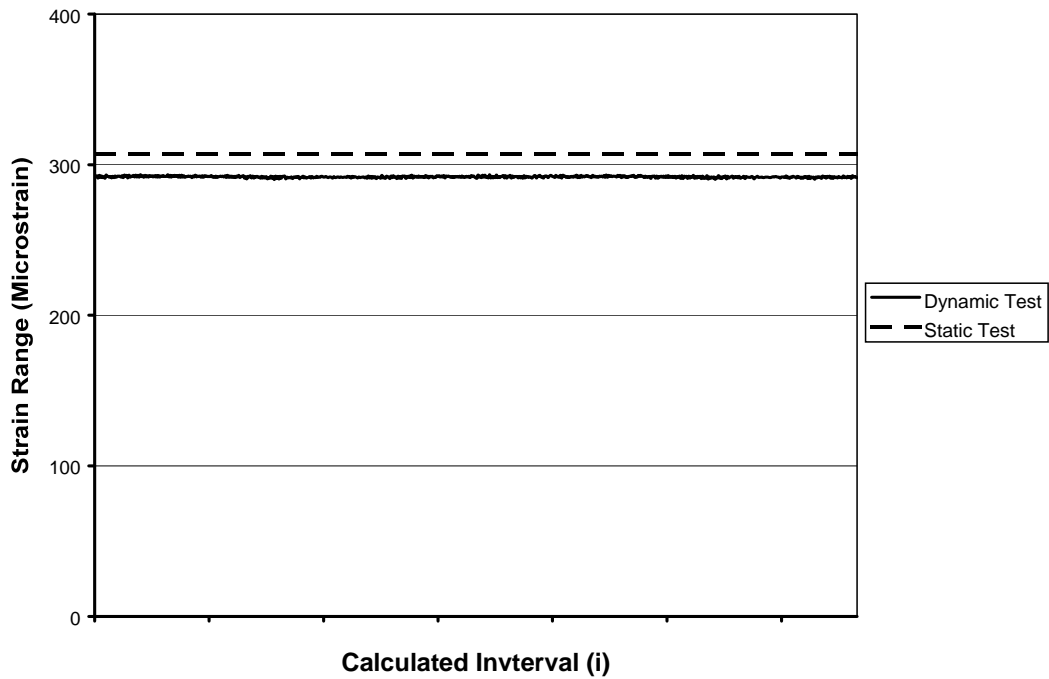
**Figure 5.3 Dynamic Strain Monitoring of Top Gauge on Specimen VALN IC A**

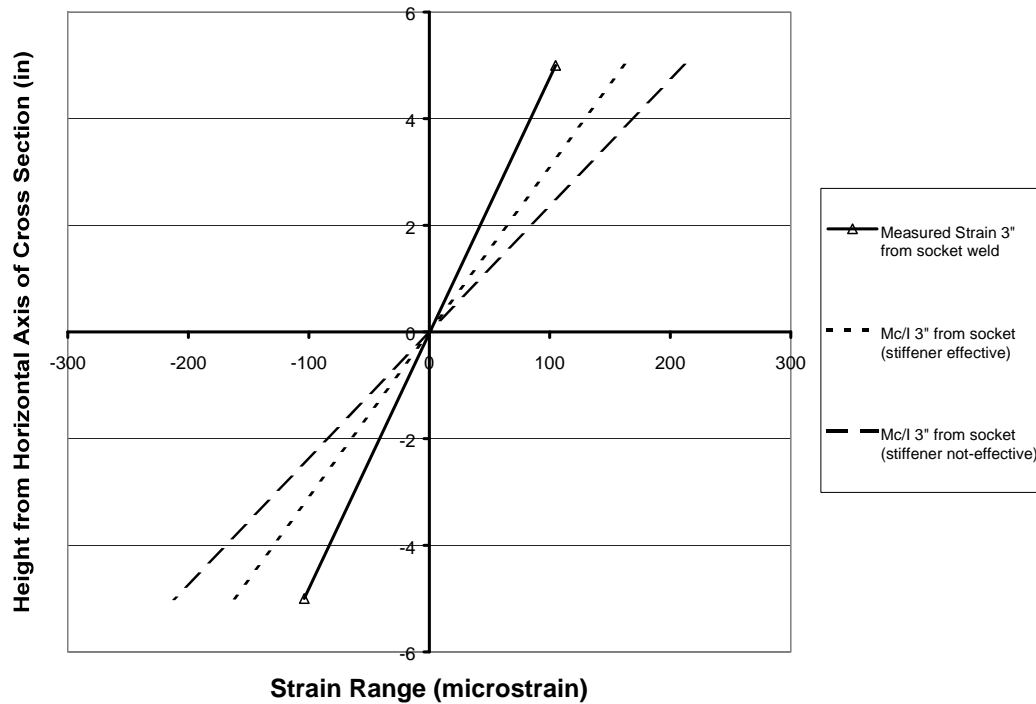
*Figure 6.12 Plot of Static Test Results for VALN 6x3/8@45 D*

One of the other specimens in this series was instrumented with strain gauges 3" from the socket connection on the top and bottom of the test specimen. The results of this static test are presented in Figure 6.12. Only the results from these two gauges are included in this plot. Along with the measured readings, the figure shows the expected strain values for the case that the stiffener is fully effective at reducing the stress in the connection detail, and for the case in which the stiffener is not effective at reducing the stress. This latter condition is identical to that of an unstiffened socket connection. The plot shows that the measured values are less than the expected values calculated by either method. The values are approximately 35% less than the expected values for the fully effective condition. This indicates that the stiffeners reduce the stress in the critical socket connection area by more than just the effect of the addition of the stiffener to the moment of inertia calculation.

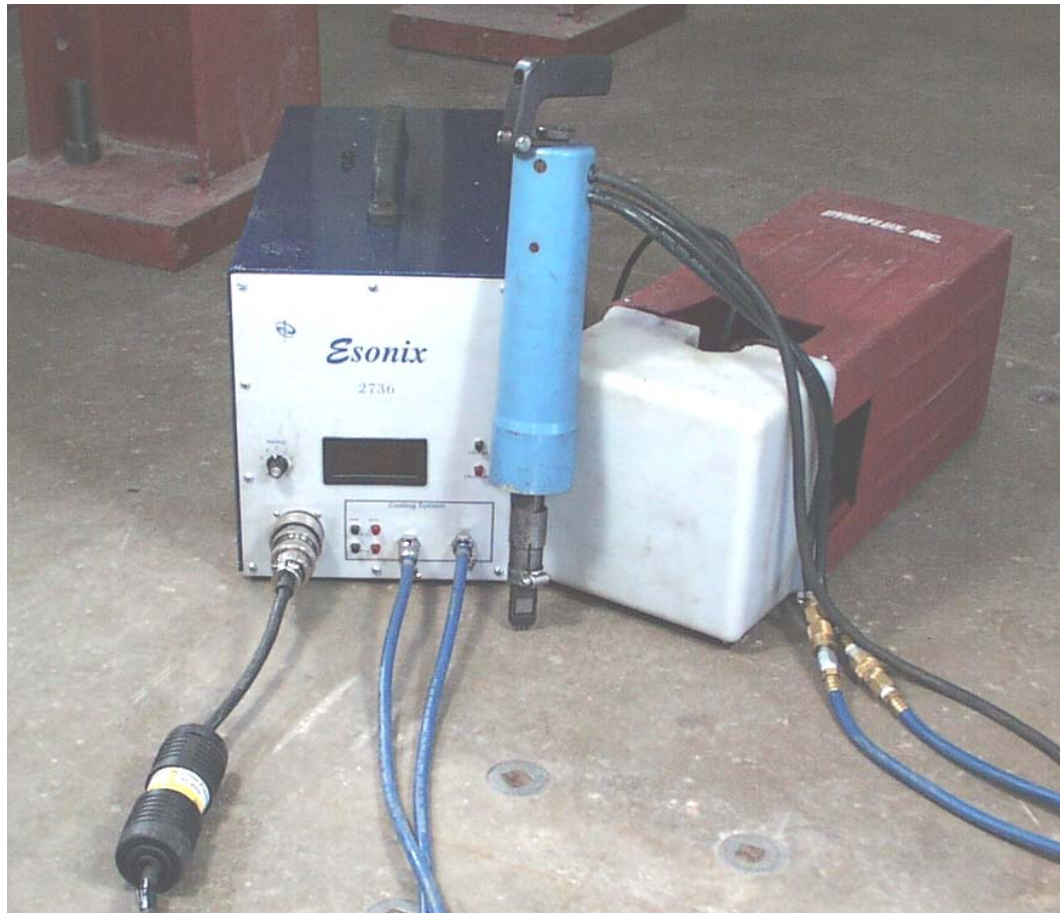
***Figure 6.13 UIT Equipment***

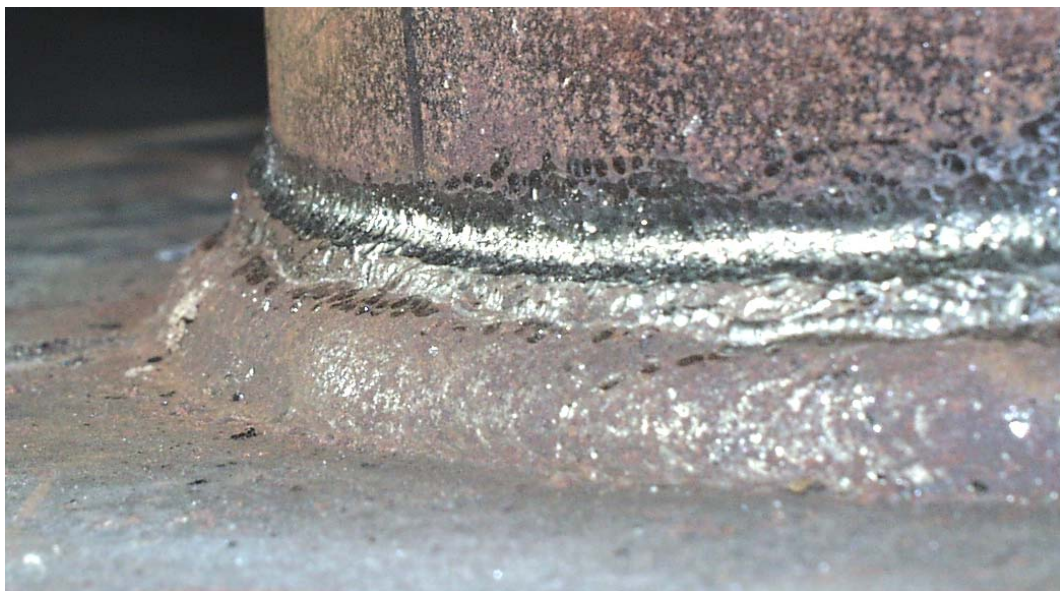
*Figure 6.17 UIT Treated Socket Connection Specimen prior to testing.*

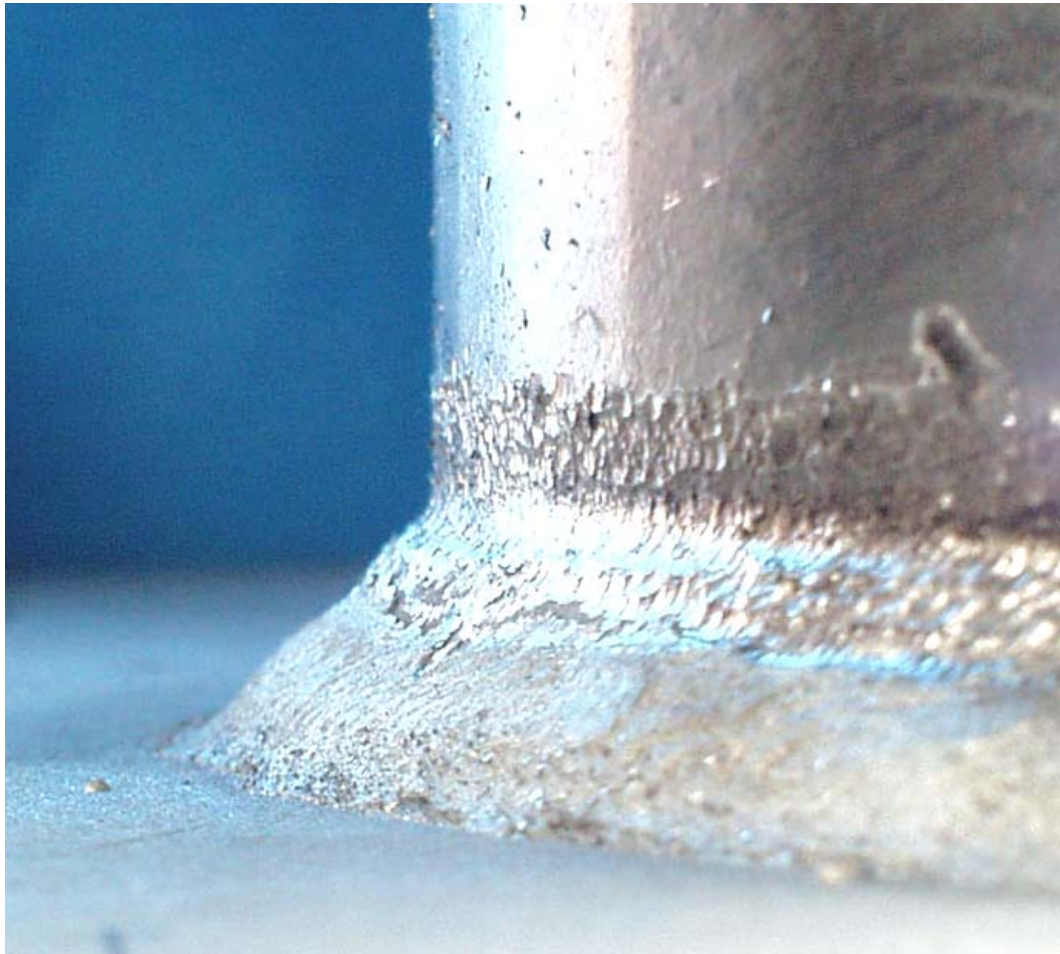
*Figure 6.21 UIT Treated Region of a VALNu PR Specimen*

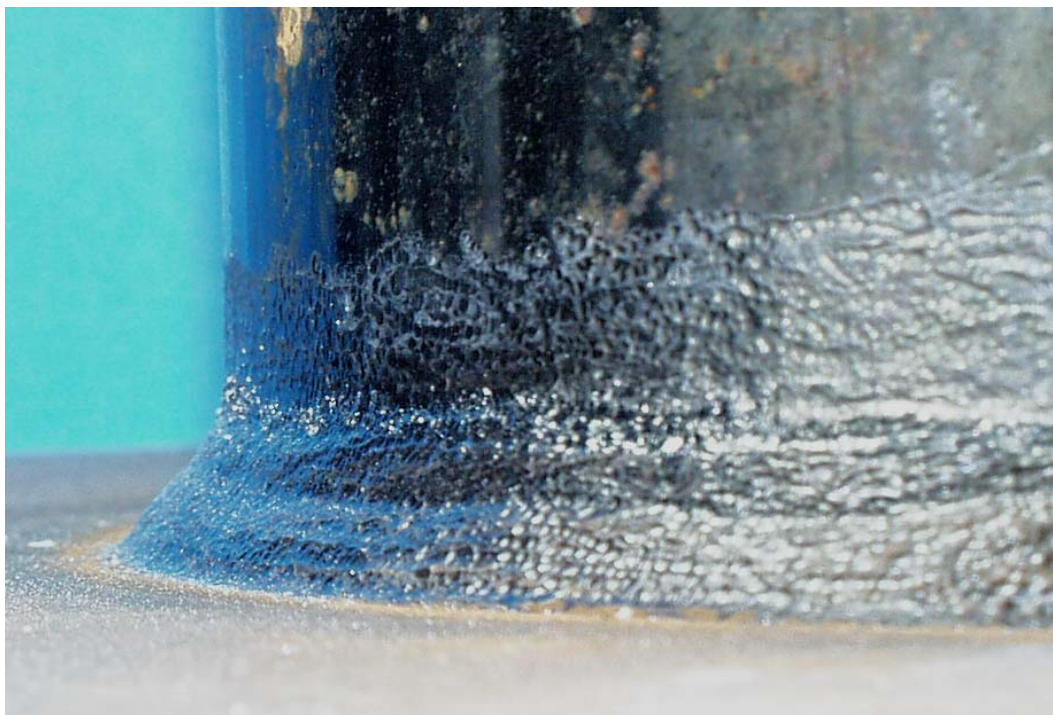
***Figure 6.22 UIT Treatment of Heat Affected Region on VALNu PG Series***

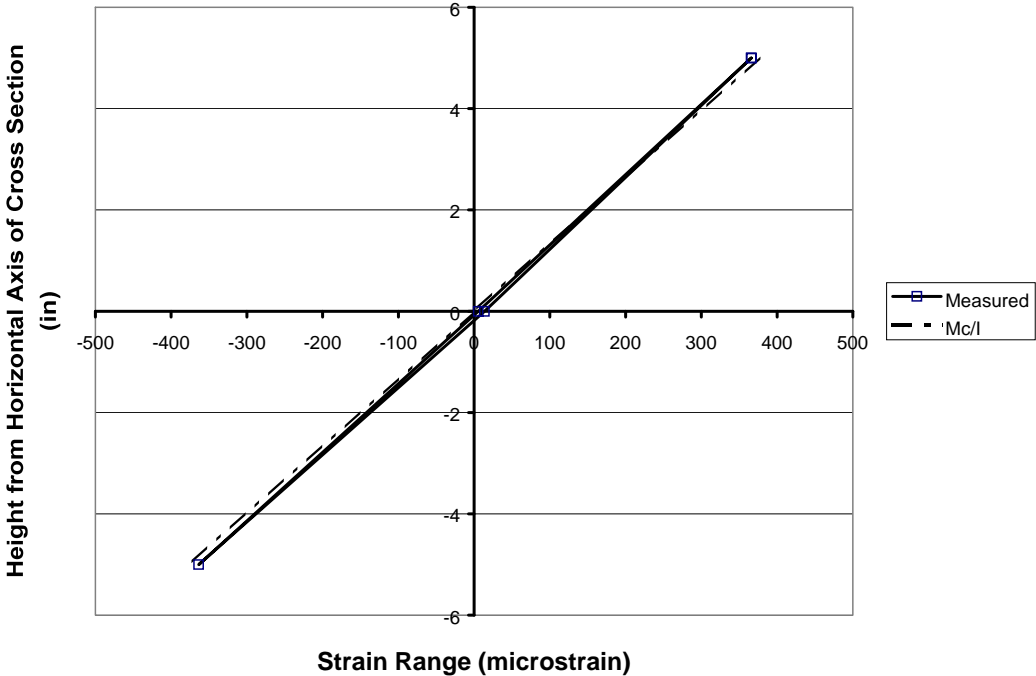
**Figure 6.24 Static Test Results for Strain Gauges Located 3" from Termination of Stiffener on Specimen VALN UR A**

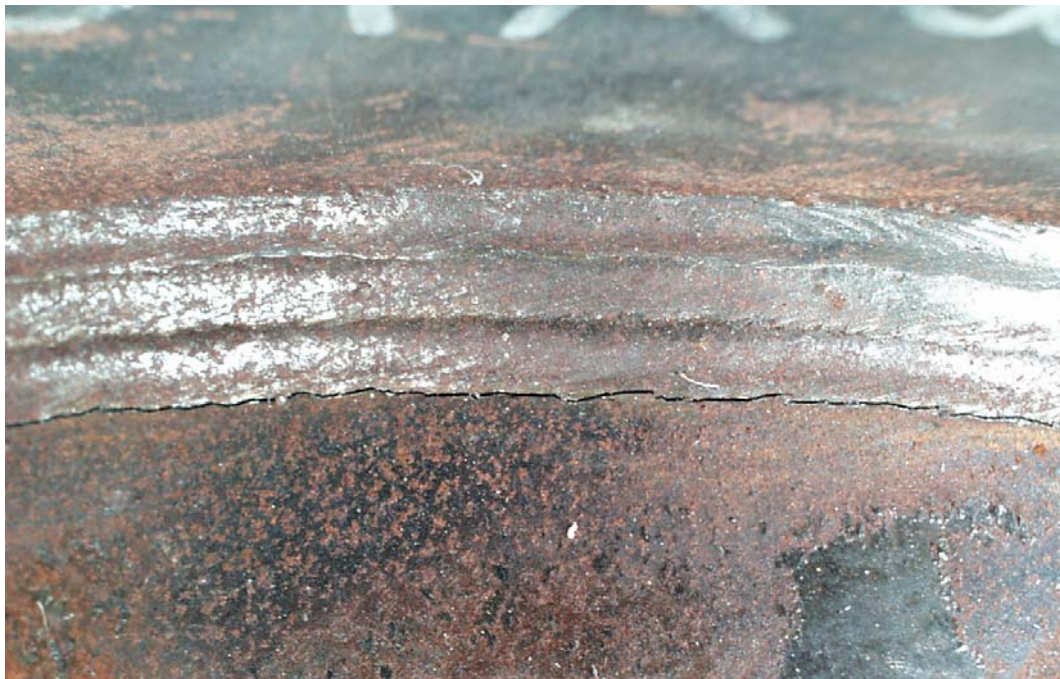
*Figure 7.1 Failure of Socket Weld Connection Specimen*

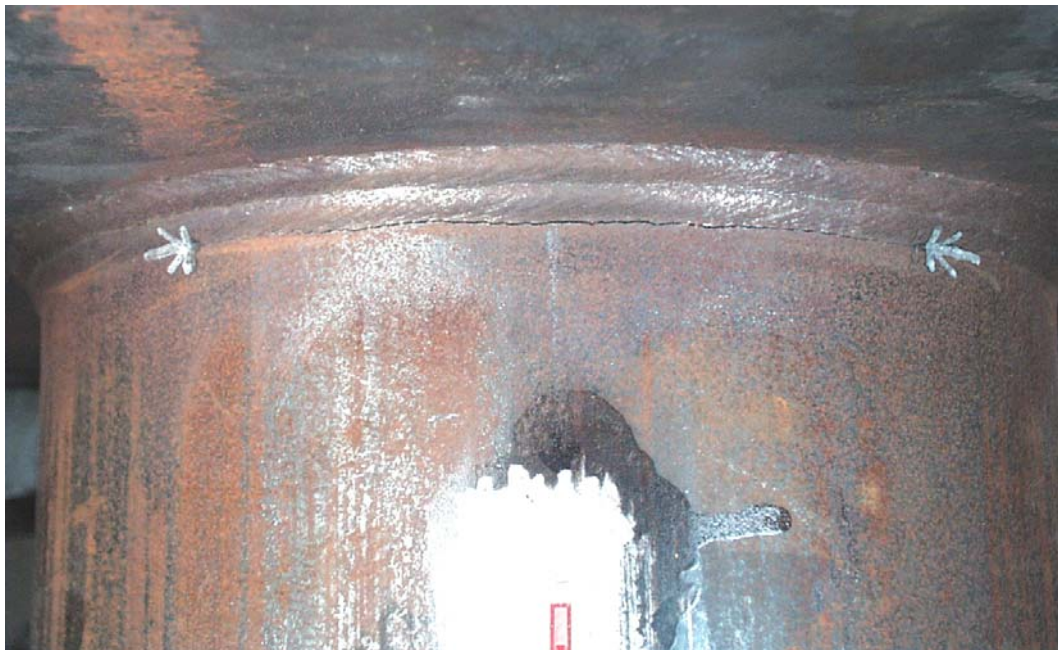
***Figure 7.2 Failure of Socket Connection Specimen – Painted arrows indicate extents of visible cracking.***

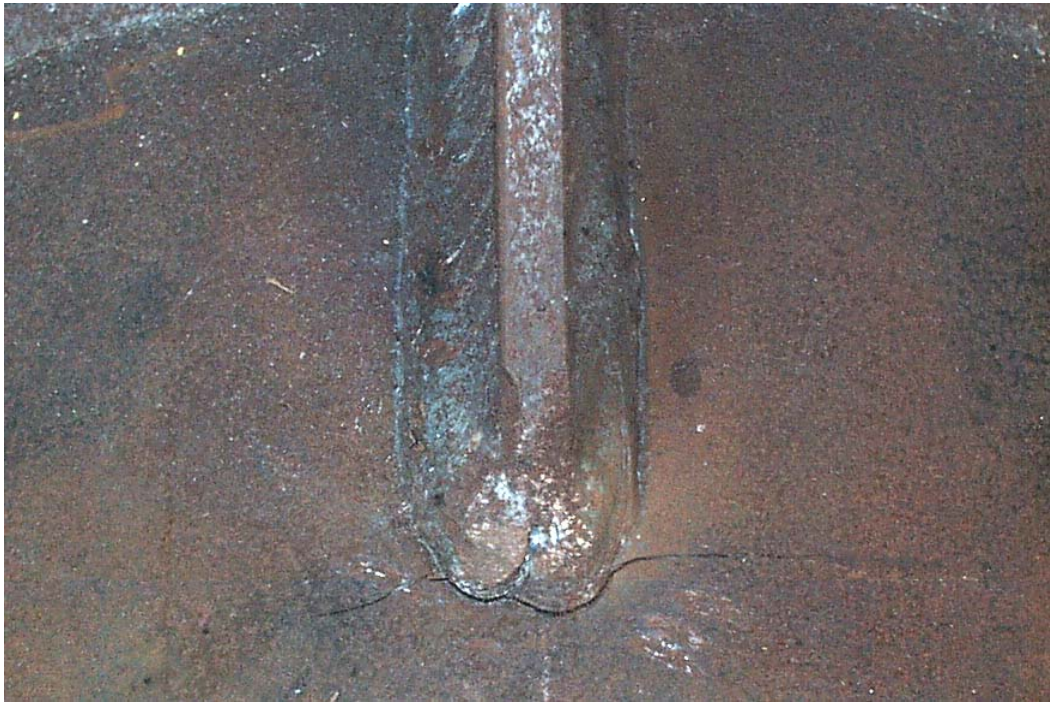
*Figure 7.4 Failure of VAL 3x1/4 Specimen*

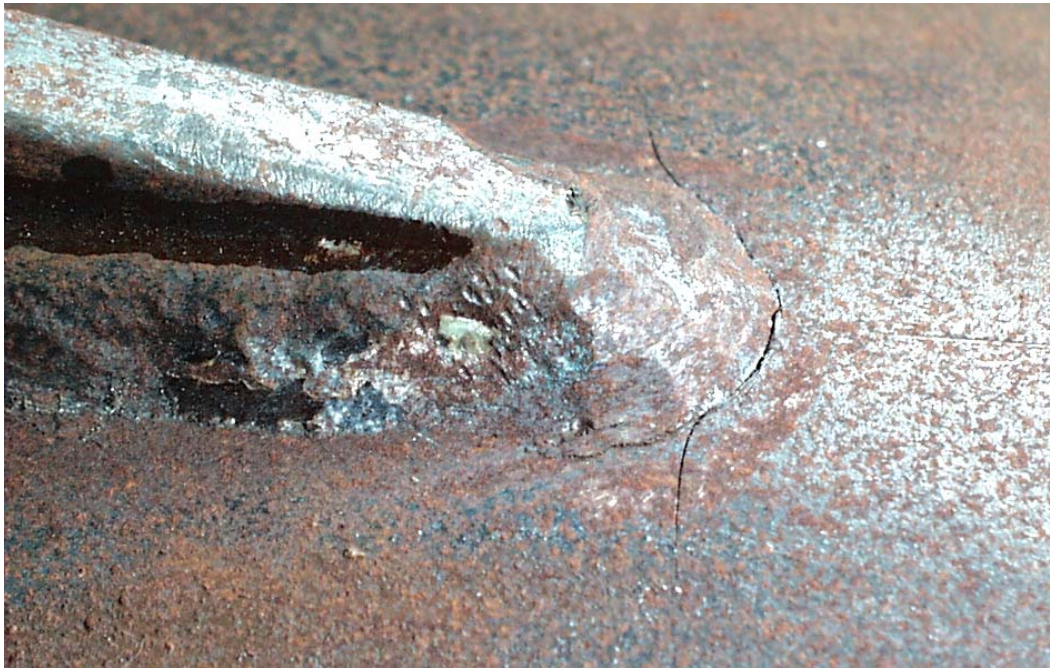
*Figure 7.5 Failure of VAL 6x3/8 Specimen*

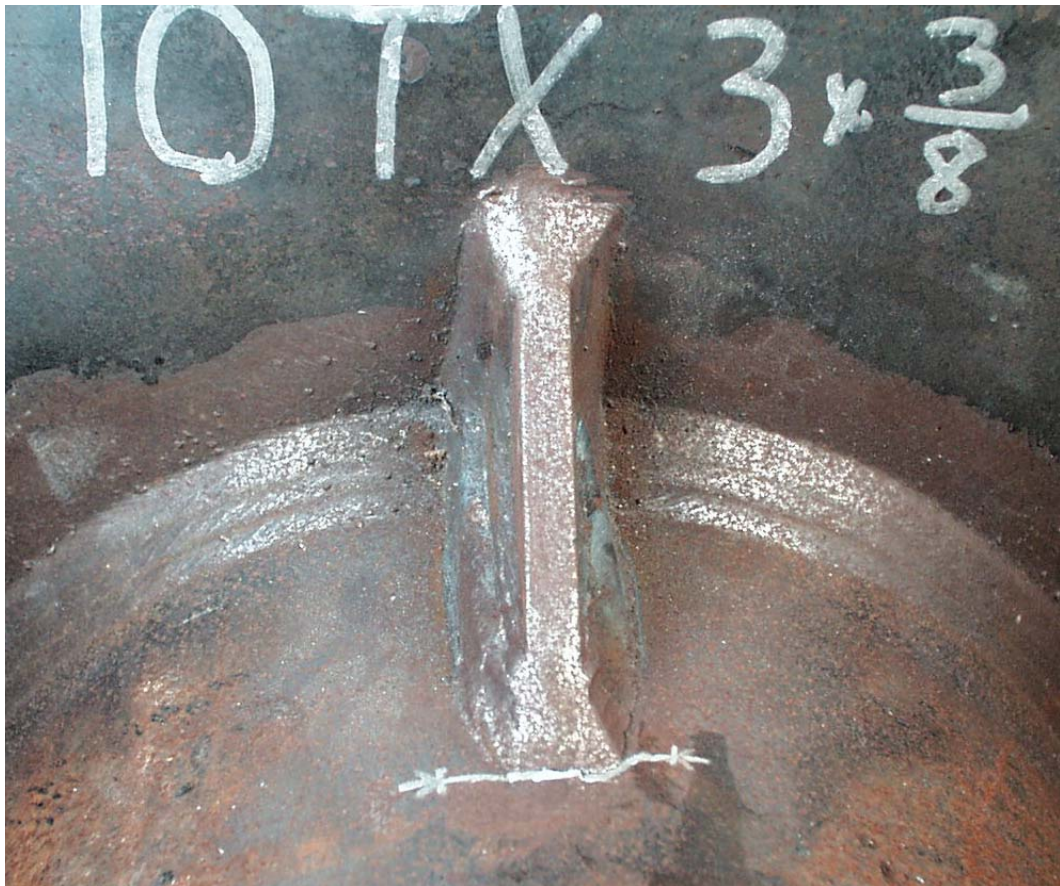
**Figure 7.6 Failure of TX 3x3/8 Specimen – Note: Paint line represents extent of visible cracking.**

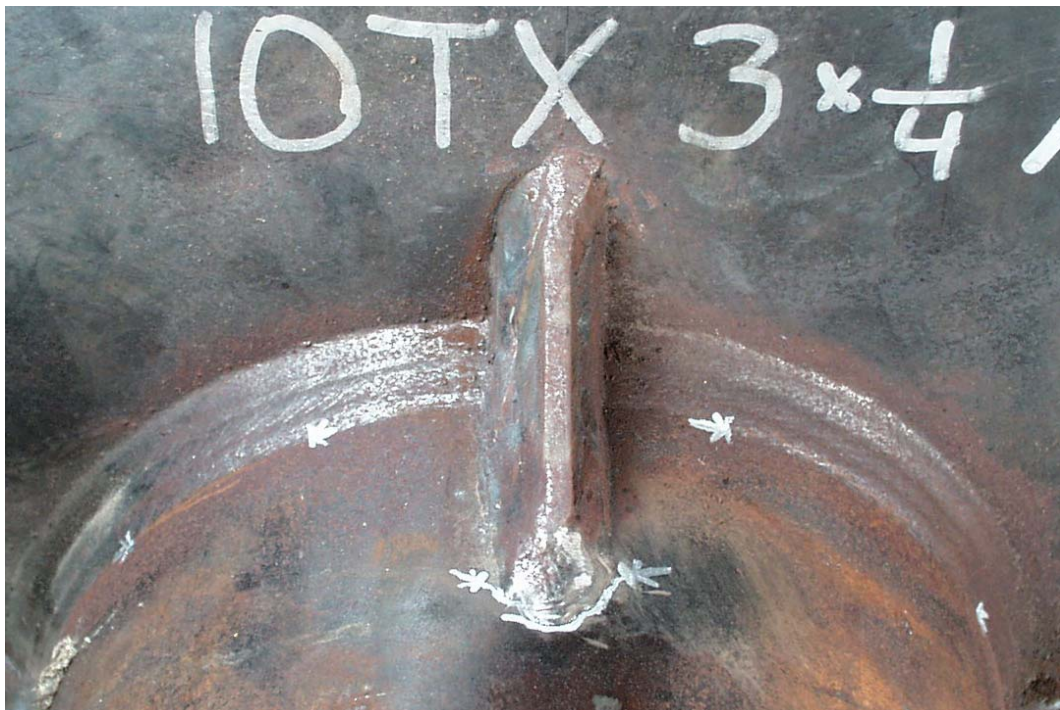
***Figure 7.7 Failure of TX 3x1/4 Specimen – Note: Paint line at termination of stiffener represents extent of visible cracking, and painted arrows indicate visible crack tips in socket weld toe.***

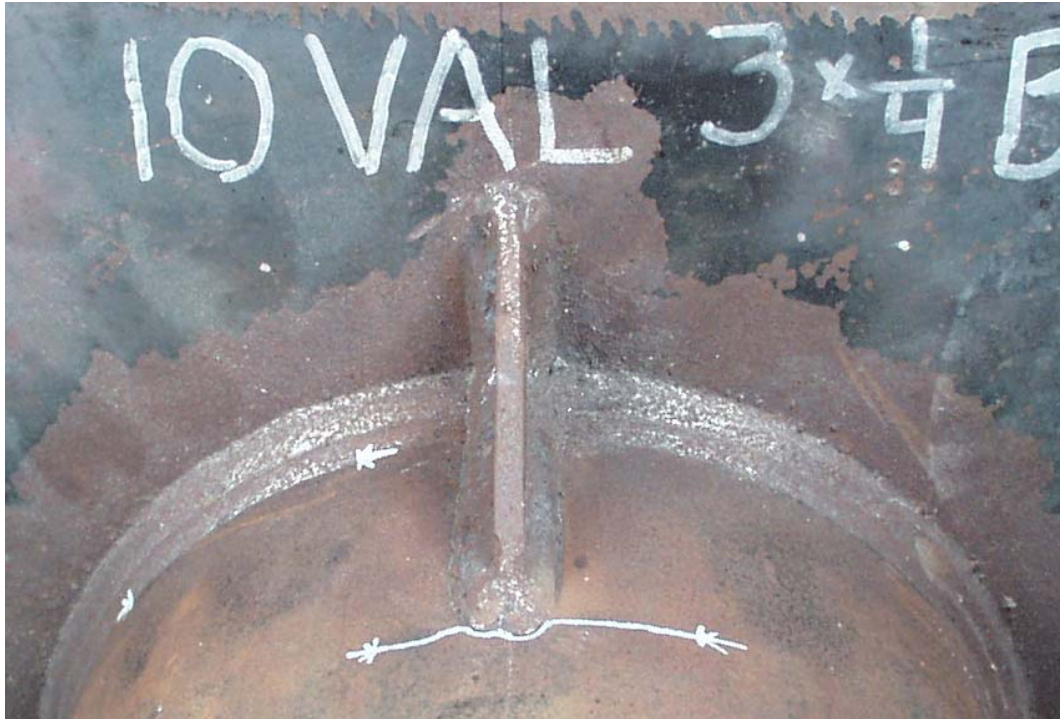
***Figure 7.8 Failure of VAL 3x1/4 Specimen – Note: Paint line at termination of stiffener represents extent of visible cracking, and painted arrows indicate visible crack tips in socket weld toe.***

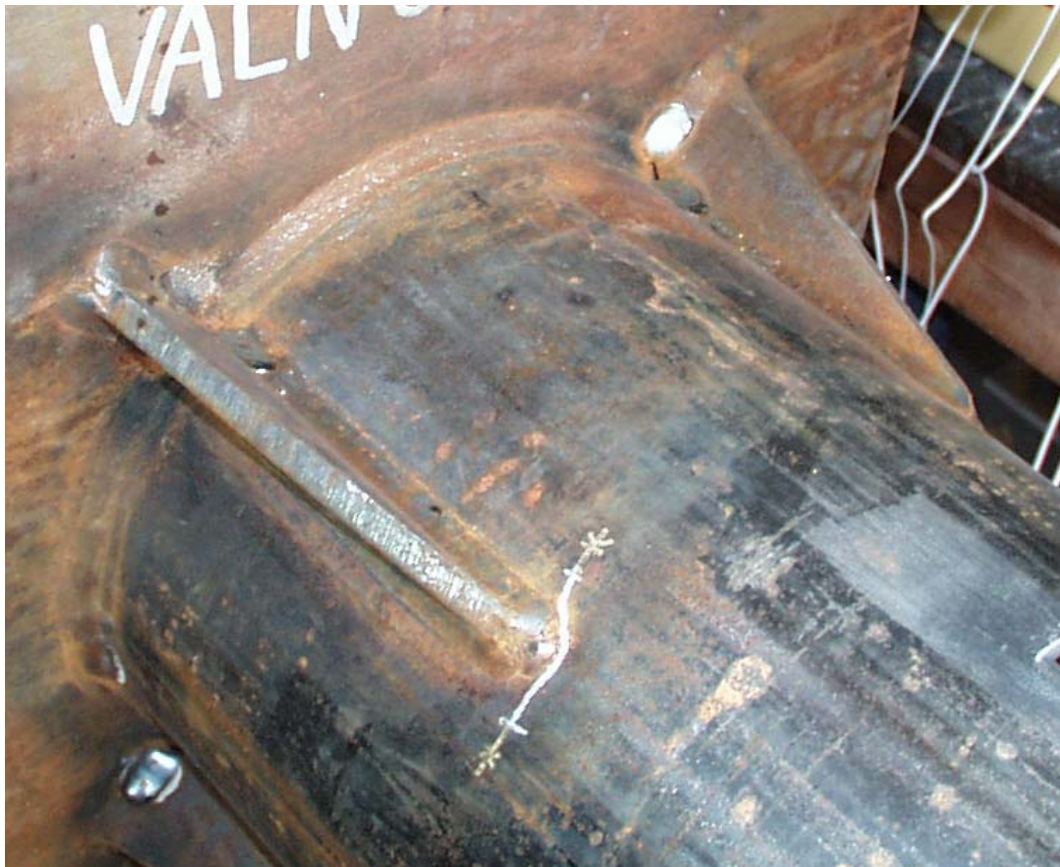
***Figure 7.11 Failure of VALN 6x3/8@45 Specimen – Painted line indicates extent of visible cracking. Specimen tested at 6 ksi stress range.***

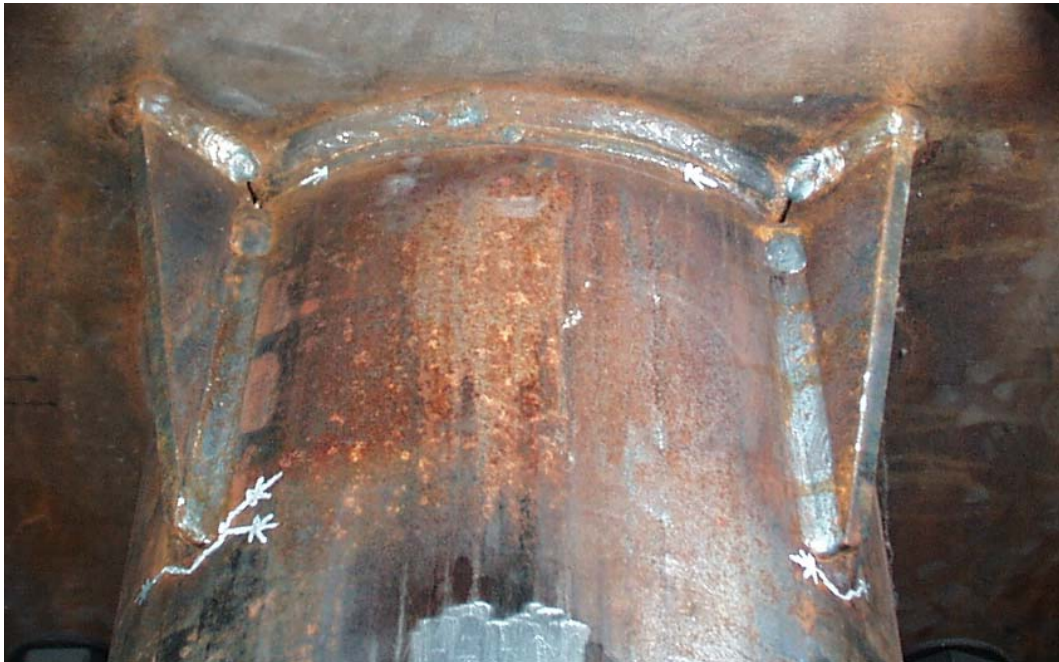
***Figure 7.12 Failure of VALN 6x3/8@45 Specimen – Paint lines at termination of stiffeners represent extents of visible cracking, and painted arrows indicate visible crack tips in socket weld toe. Specimen tested at 12 ksi stress range.***

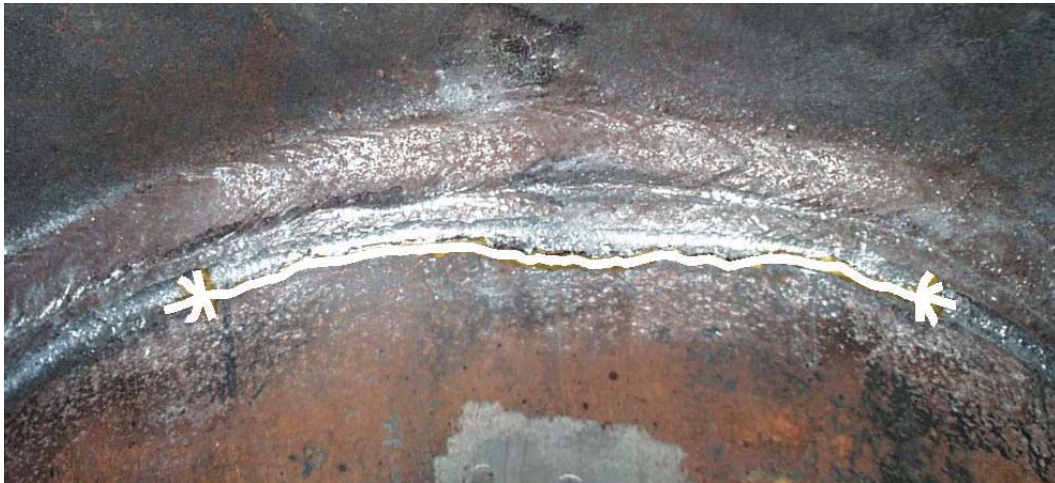
*Figure 7.14 Failure of UIT Treated Socket Connection Specimen – Painted line indicates extent of visible cracking.*

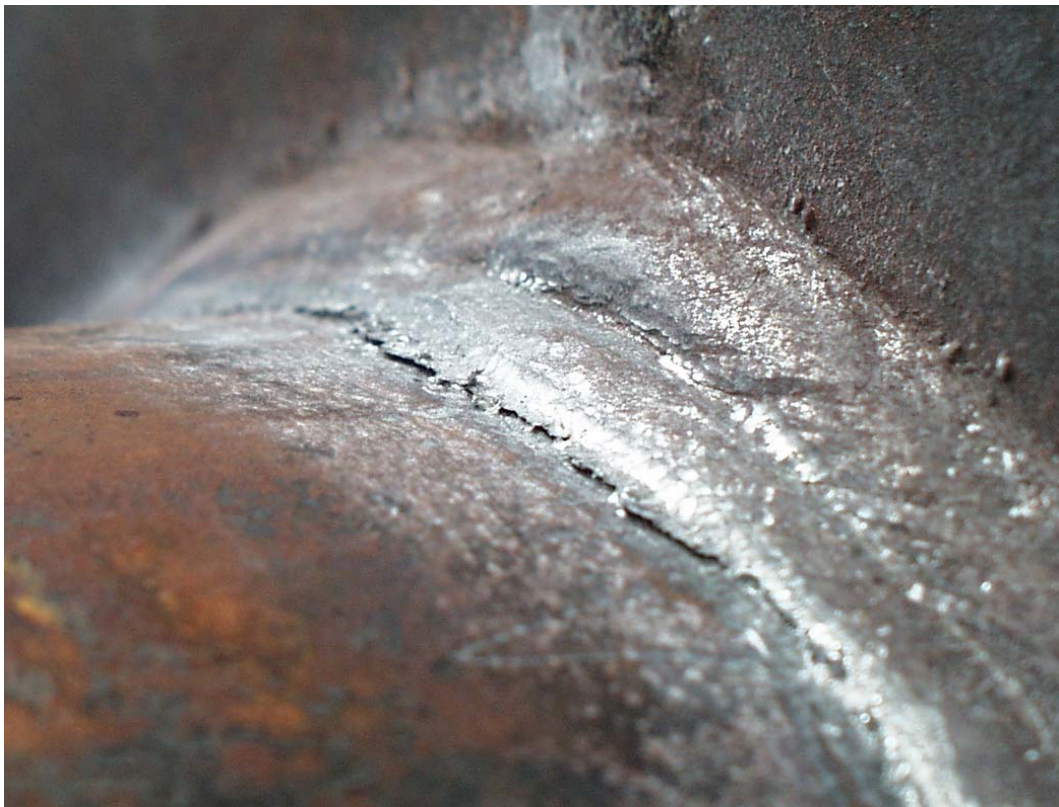
*Figure 7.15 Failure of UIT Treated Socket Connection Specimen*

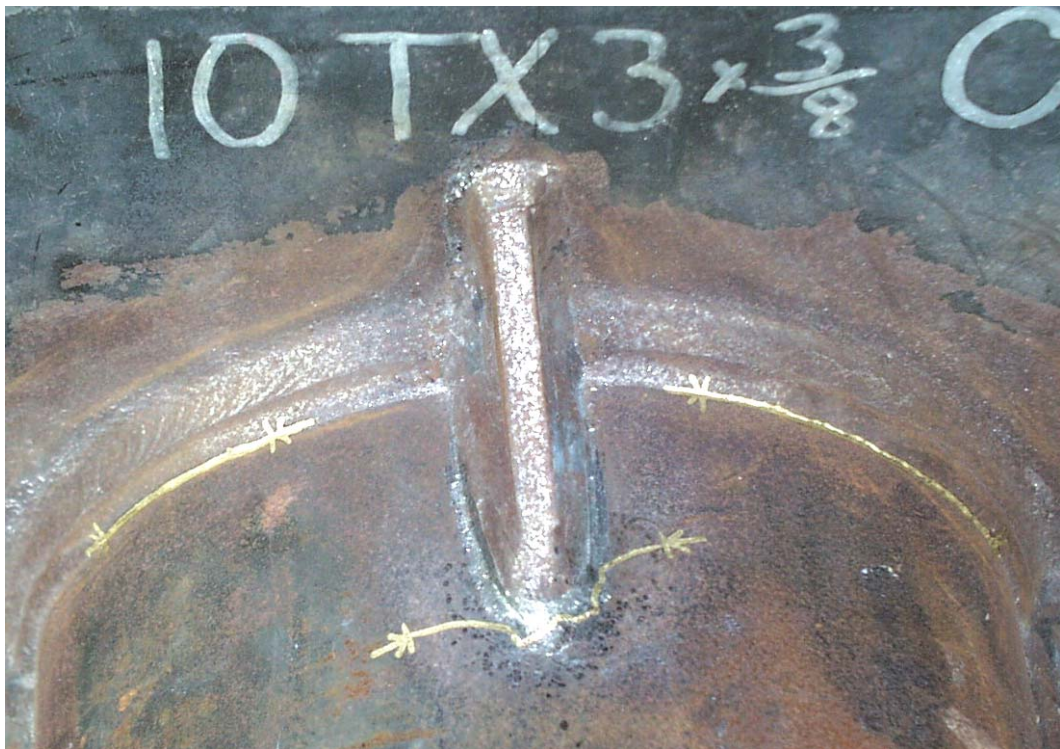
***Figure 7.17 Failure of TX 3x3/8 CP Specimen – Note: Paint lines represent extent of visible cracking at termination of stiffener and socket weld toe.***

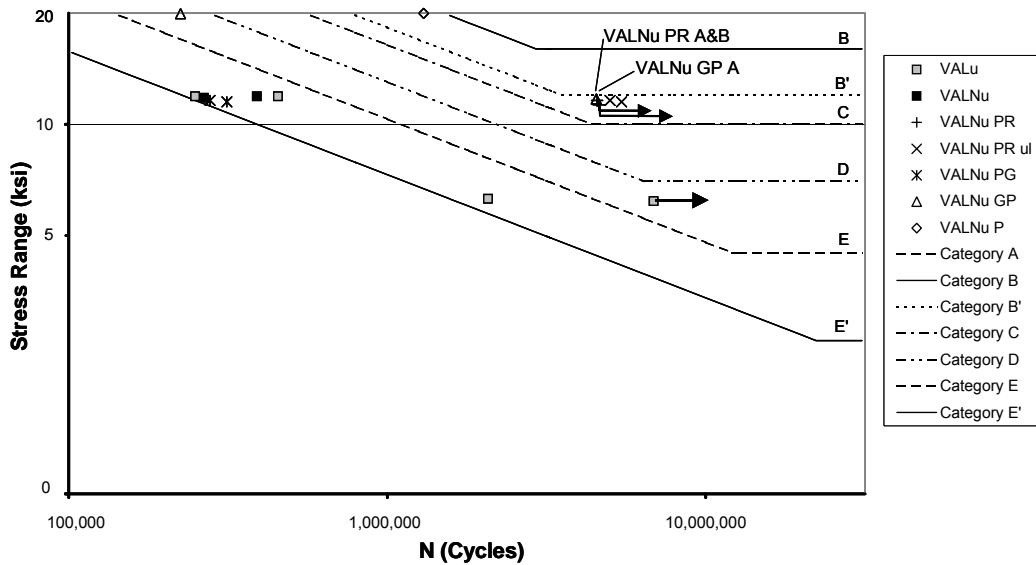
**Figure 7.18 S-N Plot of UIT Specimen Phase 2**
