**Fatigue Resistance of  
Traffic Signal Mast-Arm Connection Details**

**Thesis**

**The University of Texas at Austin**

**May 2003**

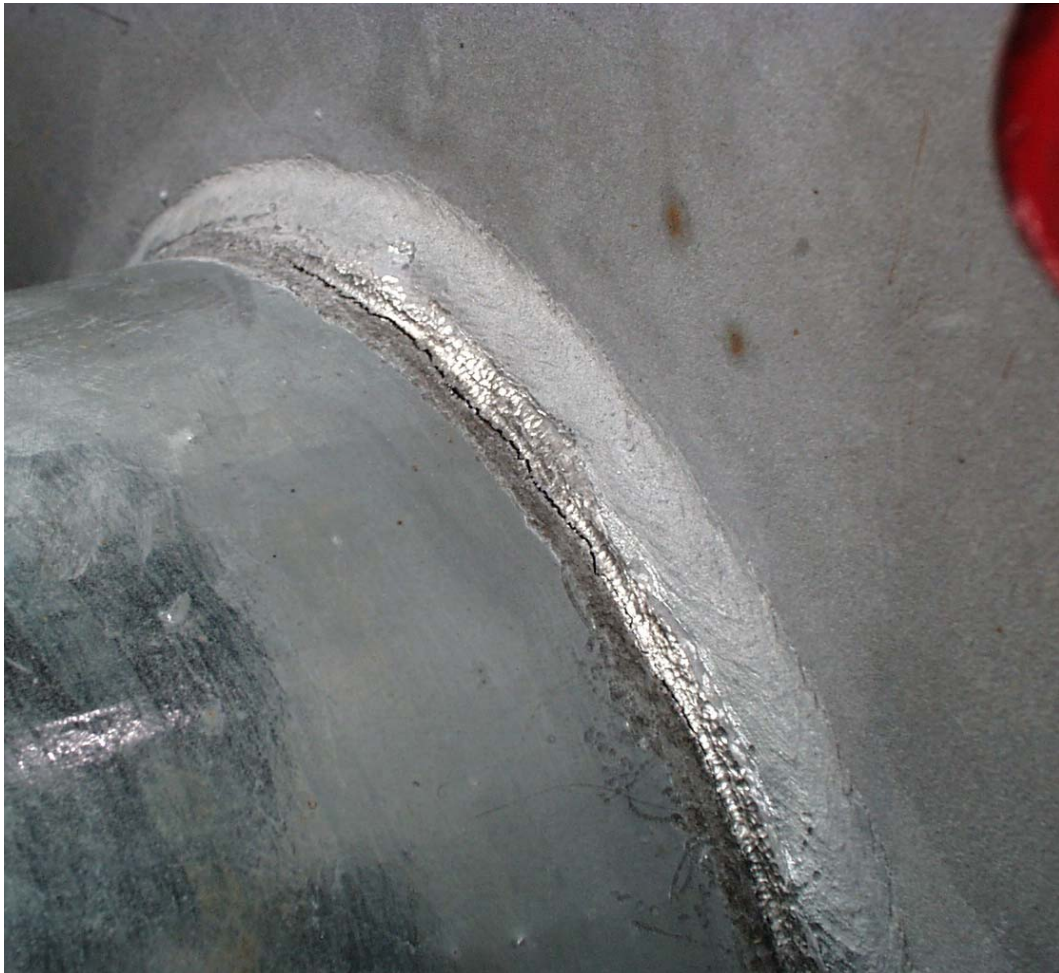
*Figure 7.19 Failure of UIT Retrofit Specimen After Unloading and Retesting – VALNu PR ul Specimen*

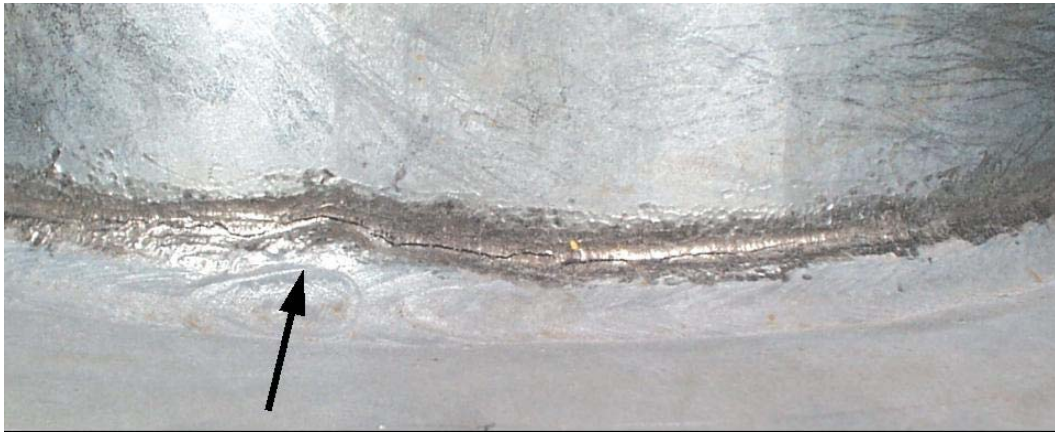
*Figure 7.20 Failure of Specimen VALNu GP B - Arrow points to weld start/stop in critical location.*

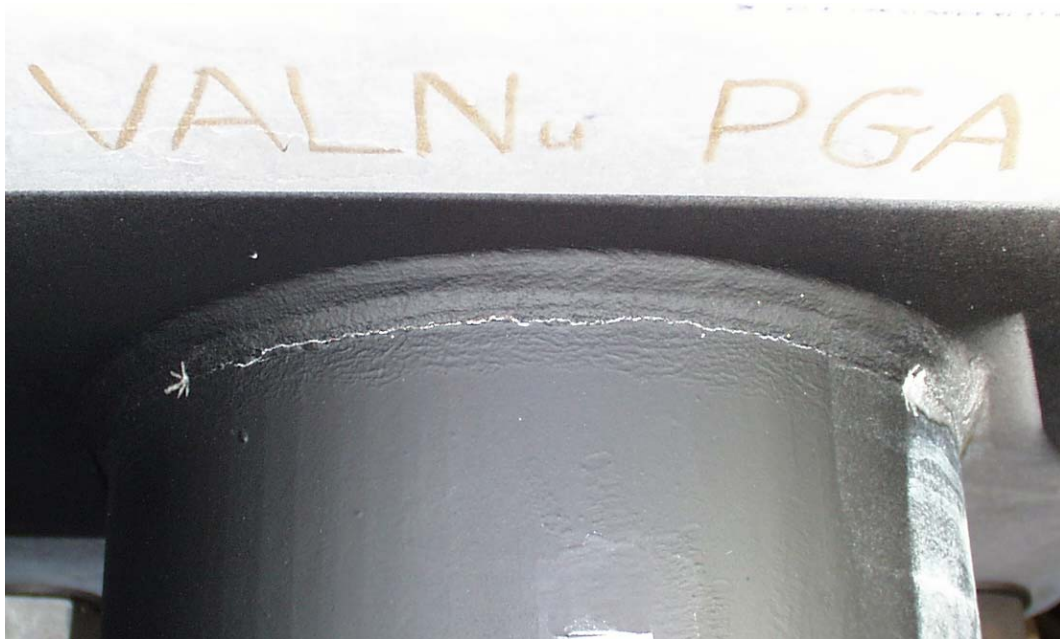
*Figure 7.21 Failure of UIT Prior to Galvanization Specimen*

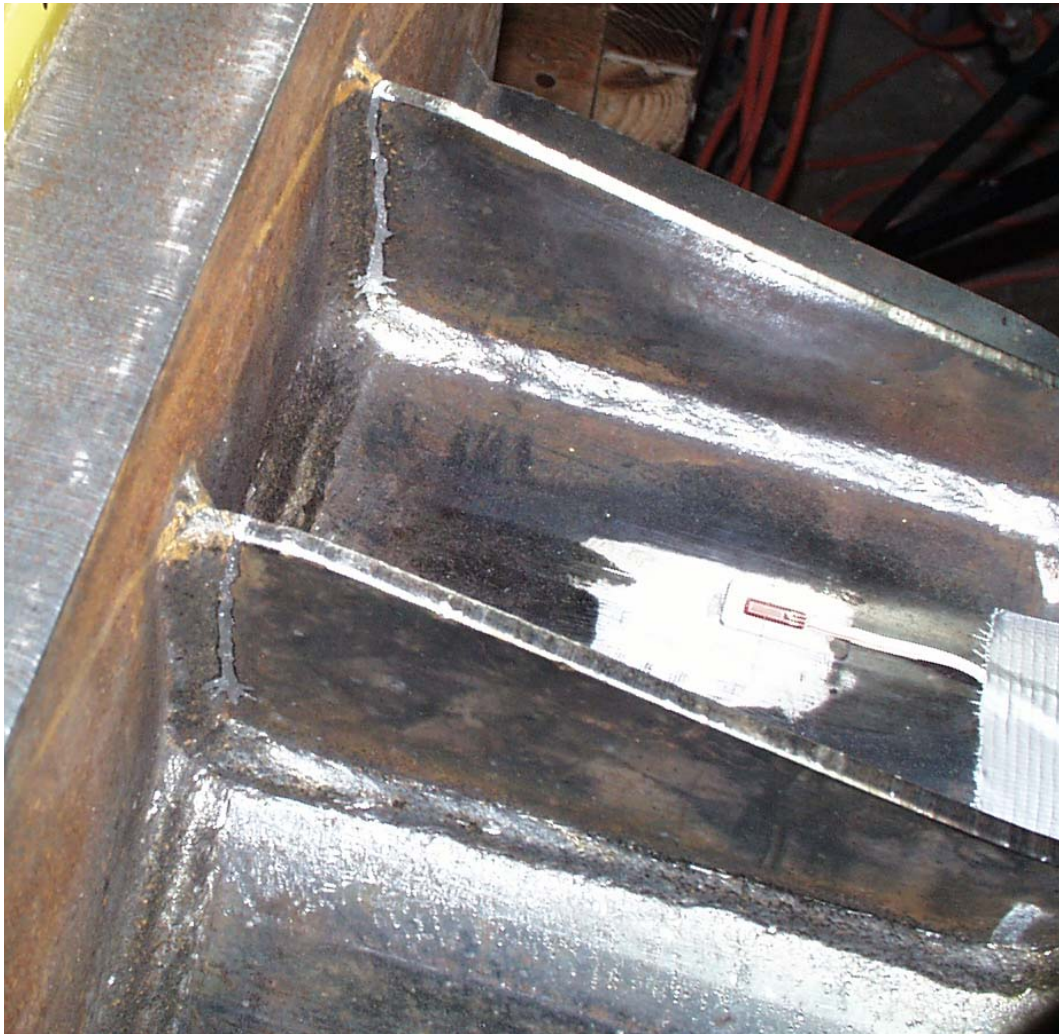
*Figure 7.24 Failure of U-Rib Stiffened Specimen – Note: Painted lines represent extent of visible cracking.*

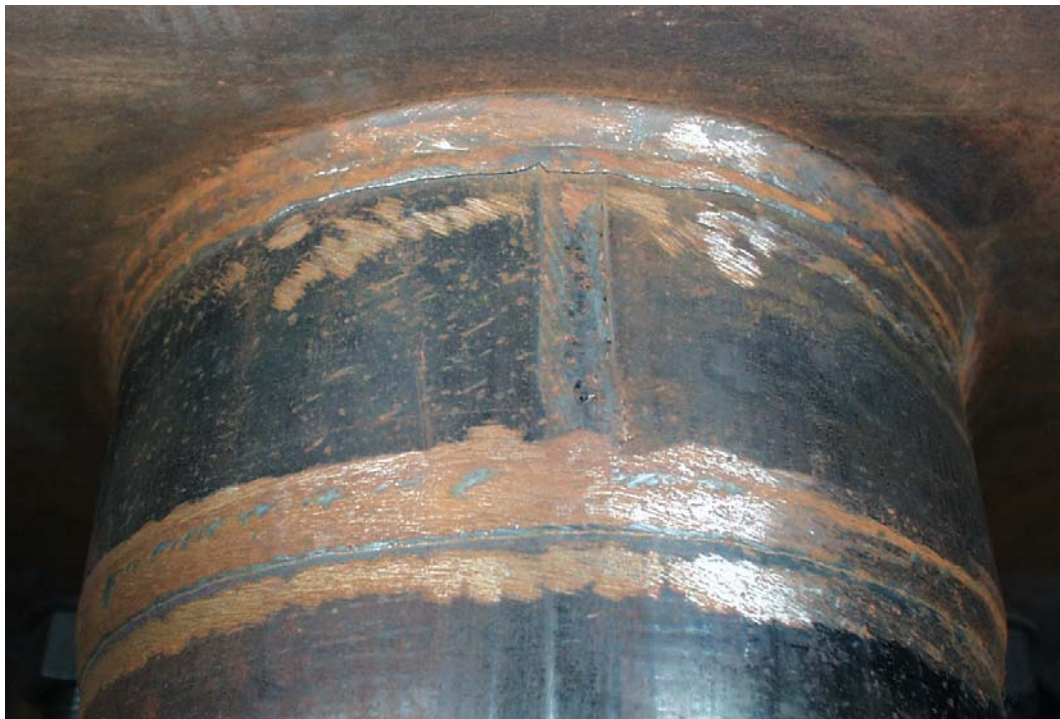
*Figure 7.27 Failure of Externally Stiffened Collar Specimen*

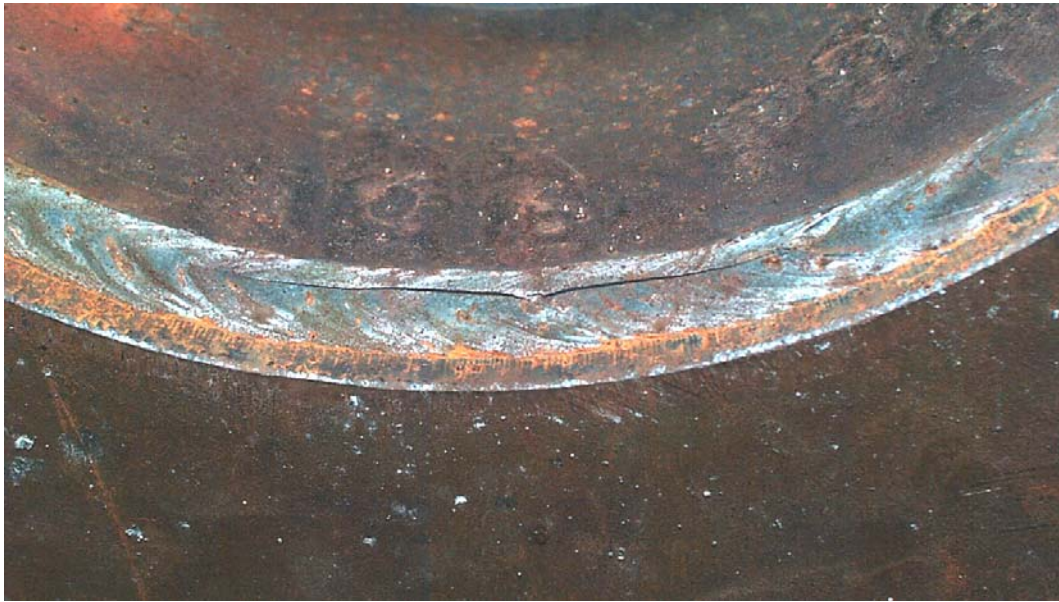
*Figure 7.28 Crack Observed in Interior Weld of External Collar Stiffened Specimen*

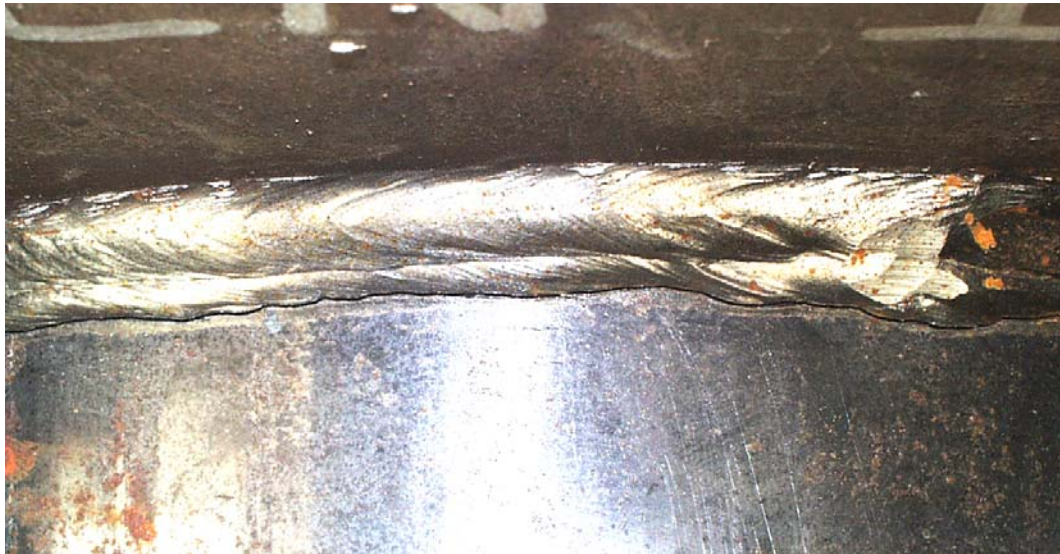
*Figure 7.30 Failure of Internal Collar Stiffened Specimen*

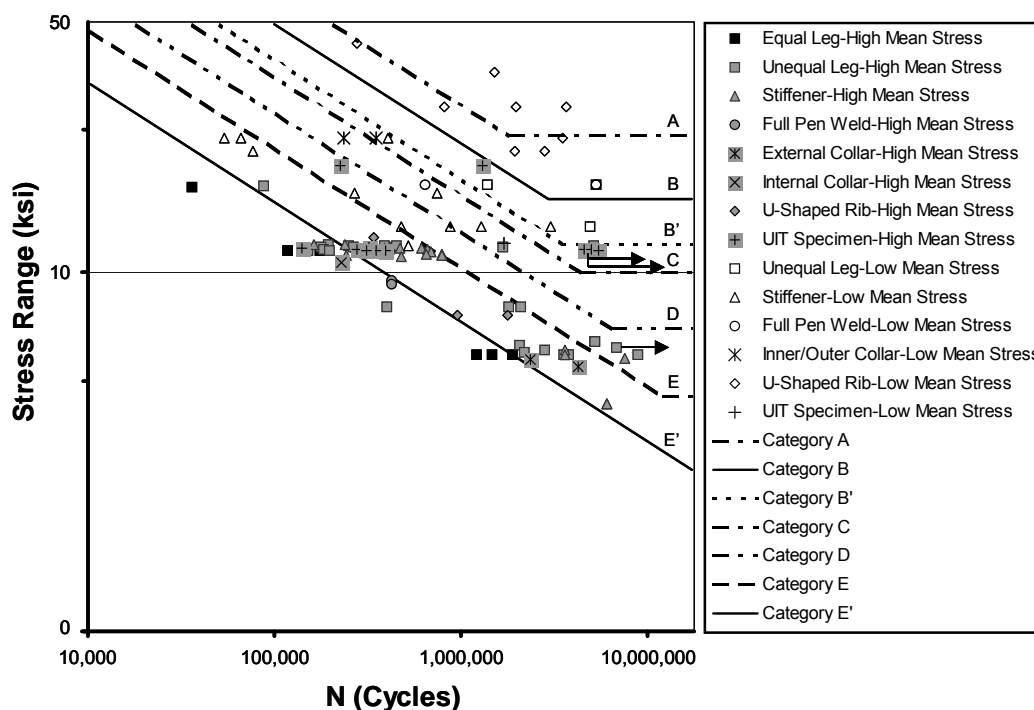
Figure 7.33 S-N Plot of All Available Test Results.
