**Structural Performance of ASR/DEF Damaged  
Prestressed Concrete Trapezoidal Box Beams with Dapped Ends**

**Thesis**

The University of Texas at Austin

**August 2010**

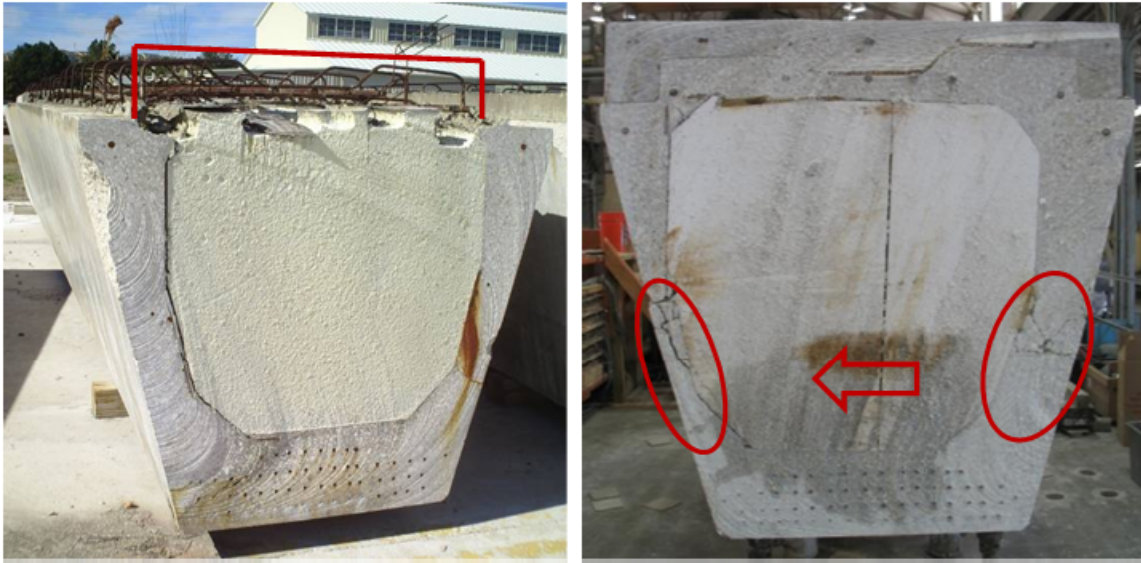
Placement of the styrofoam void during the multi-stage cast was challenging and could lead to void floatation and consolidation issues (shown respectively in Figure 3-7 and Figure 3-8). In order to exclude segments with significant defects from the dapped-end testing program, all surfaces of each segment were thoroughly examined.

*Figure 3-7: Examples of Vertical and Horizontal Void Misalignment*

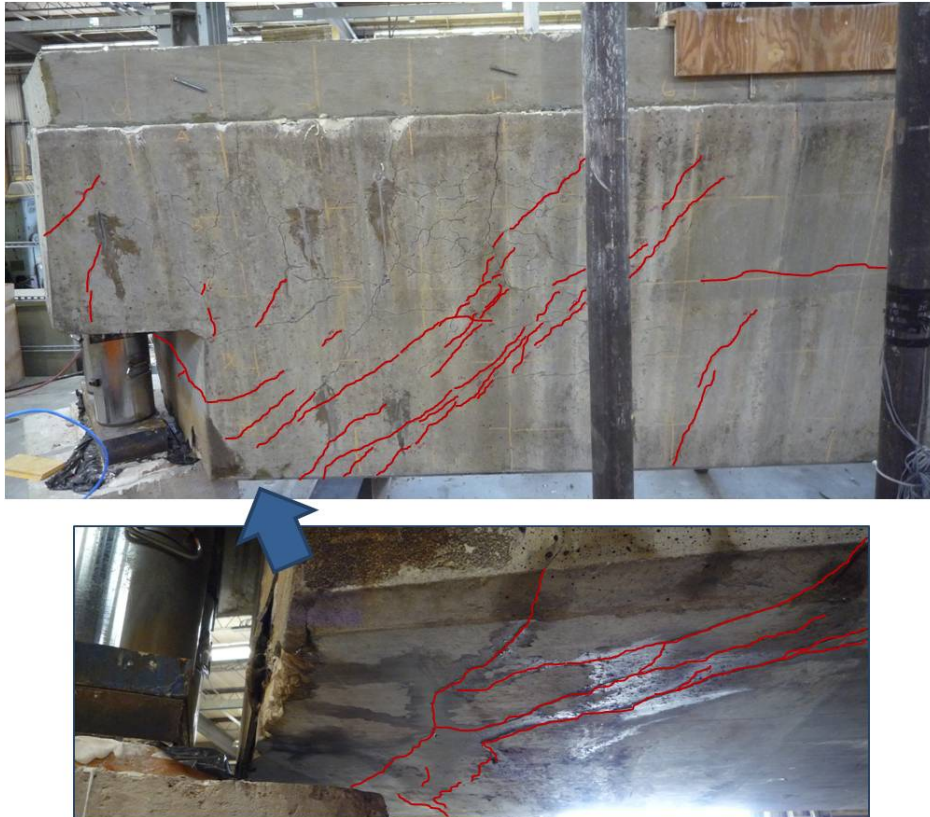
Closer examination of the load-induced cracking revealed wide cracks which ran along the bottom side of the beam (see Figure 4-6). The nature of the cracking suggested that the tie anchoring the lower end of the diagonal strut was no longer capable of maintaining equilibrium. Due to the limited length available for anchorage of the flexural reinforcement, this explanation was most logical. The failure mechanism was therefore classified as a shear-induced anchorage failure.

***Figure 4-6: Post-Failure Cracking in Segment N-II***

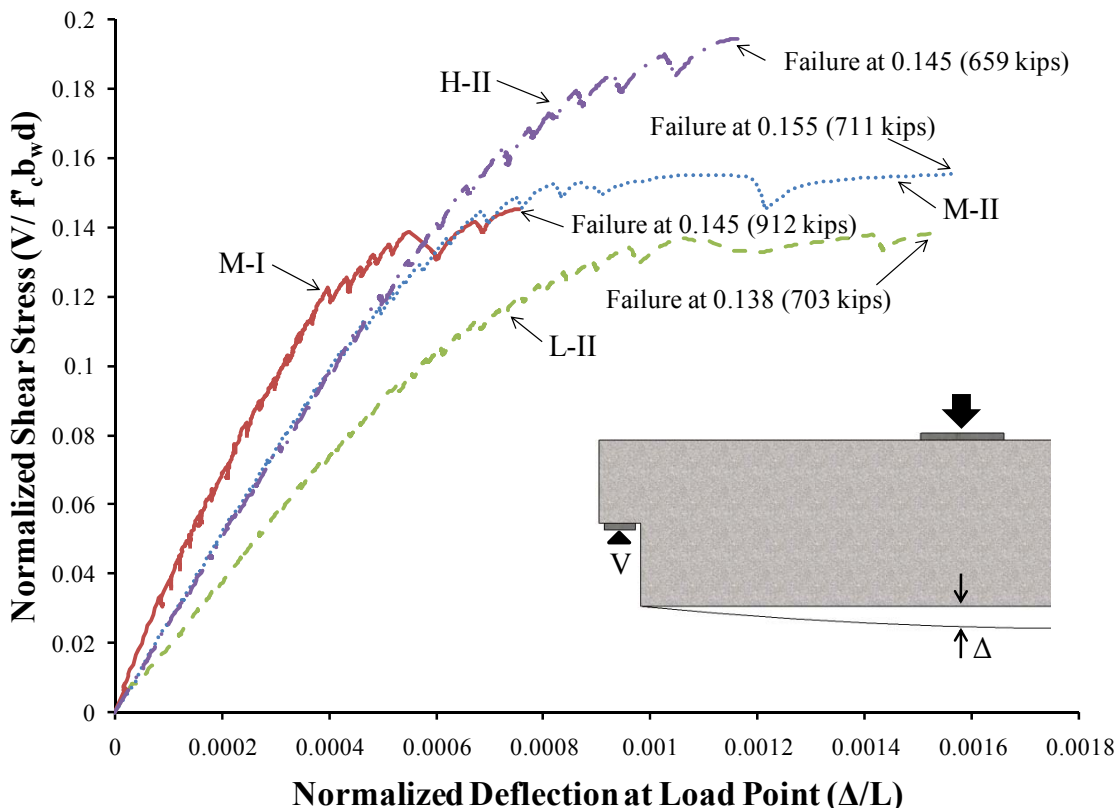
portion of the beam end. The load-deflection response of segment M-I is plotted along with the results of the other damaged segments in Figure 4-7. The linear-elastic response of the segment is markedly stiffer than the other damaged segments due to the shorter shear span-to-depth ratio. Degradation of the beam stiffness due to the growth and development of cracking was not apparent until the load exceeded 80 percent of the maximum applied shear. Audible strand slip and rapid crack growth at the bottom corner of the dapped end signaled the unexpected: shear-induced anchorage failure at a maximum applied shear of 912 kips.

**Figure 4-7: Load-Deflection Responses of Segments L-II, M-I, M-II, and H-II**

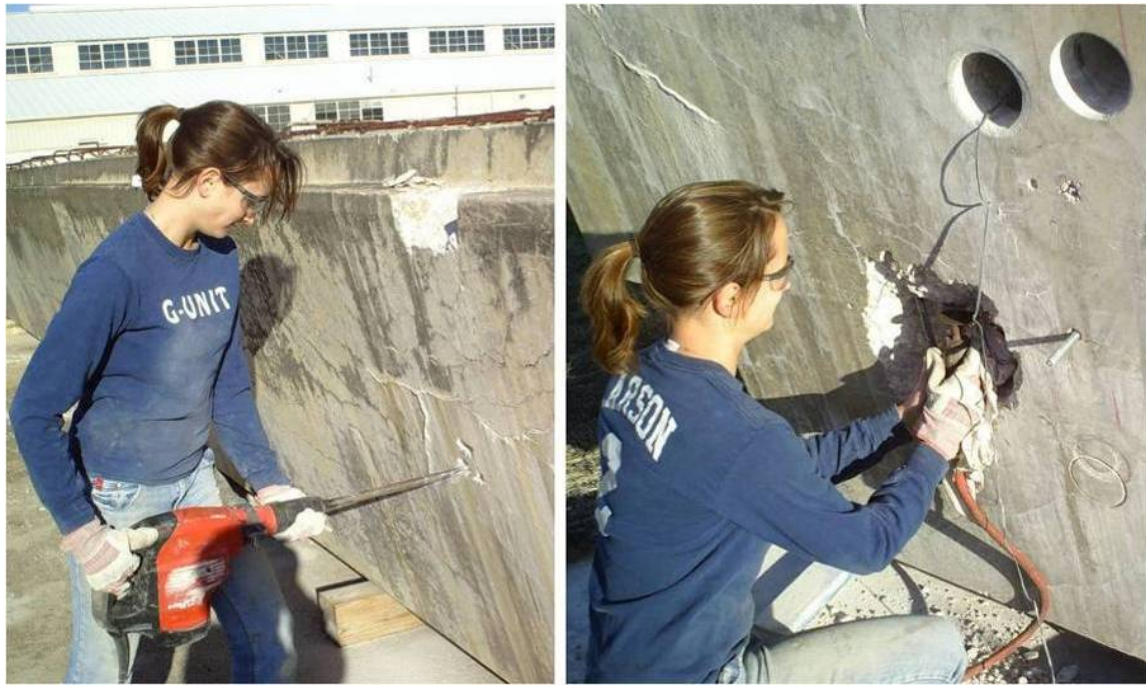
***Figure 5-11: Exposing and Cutting the Transverse Reinforcement***
