**The Design and Behavior of Bolted Beam-to-Column  
Frame Connections Under Cyclical Loading**

Thesis

Master of Science in Engineering

The University of Texas at Austin

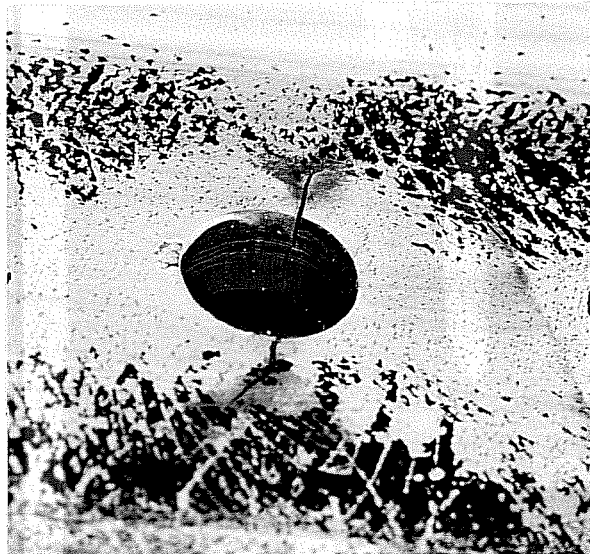
displacement of 3 inches and 221 kips the fracture became severe and at each load cycle the end load was reduced. Figures 4.11 and 4.12 shows the extent of the fracture and Figure 4.13 shows the fracture in the adjacent hole.

**Figure 4.13 Beam Fracture in the Non-Bolted Hole**
