**Evaluation of External Post-Tensioned Tendons using Vibration  
Signatures**

**Dissertation**

The University of Texas at Austin

**May 2007**

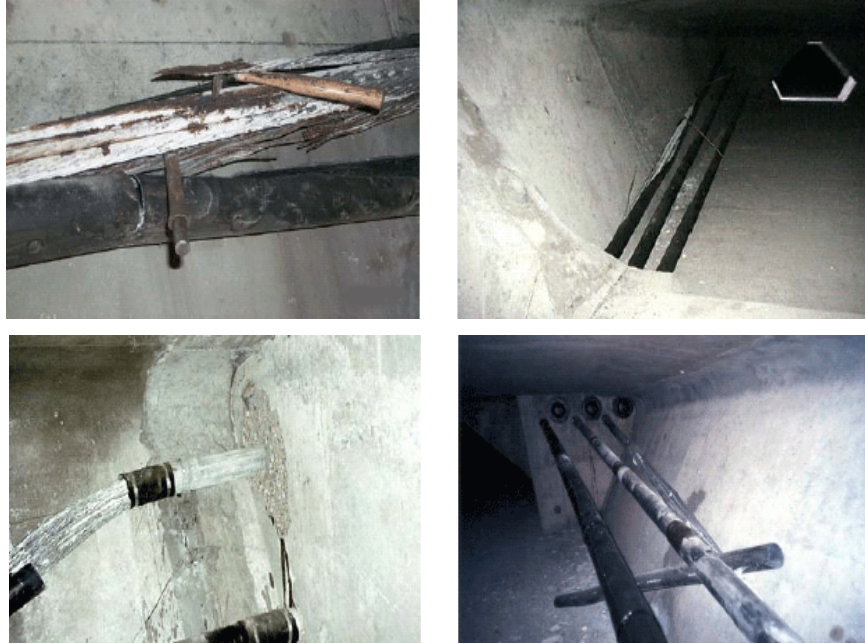
*Figure 1.3 Corrosion Damage Observed on the Mid-Bay Bridge (FDOT 2001)*

integrity of the bridges, the durability concerns were considered to be serious enough to initiate a state-wide inspection program (Freyermuth 2001).

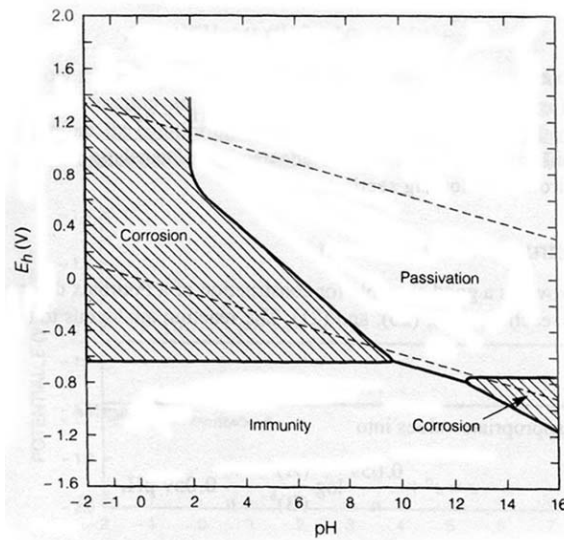
In general, the equilibrium phases of a metal may be separated into three regions: immunity, corrosion and passivation. If the system reaches equilibrium within the immunity region, the metal stays intact and no loss of metal ion occurs. However, if the system reaches equilibrium within a corrosion region, electrons are exchanged and corrosion products are generated. If this system reaches equilibrium within a passivation region, the chemical reaction is favored within the given environment, but the corrosion rate is significantly reduced due to the formation of a protective film on the surface of the metal.

**Figure 2.1 Schematic Pourbaix Diagram (Jones 1996)**

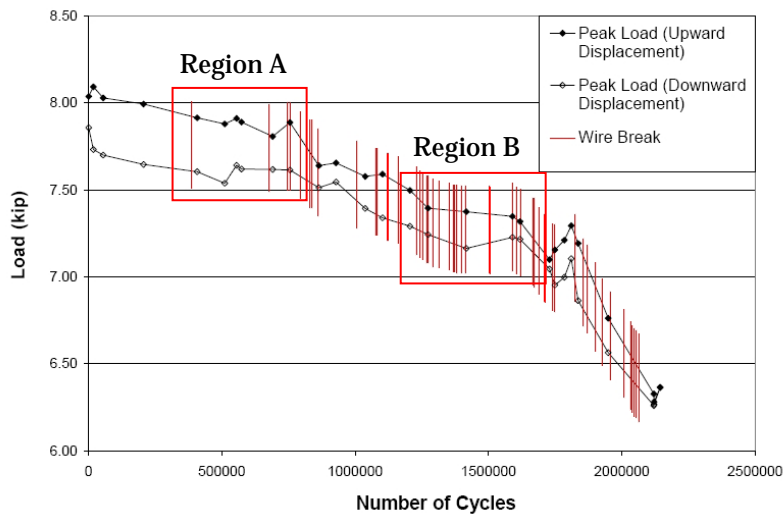
The specimens were subjected to constant-amplitude displacement cycles at midspan and were monitored continuously for wire breaks using acoustic sensors. In Figure 2.8, the peak loads applied to achieve the designated positive and negative displacements for Specimen 9 are shown. For the constant amplitude of  $\pm 1.6$  in., the required load decreased as damage accumulated. The variation of required load was interpreted as the variation of transverse stiffness. The vertical lines on this plot represent wire breaks reported by the acoustic sensors. During the test, wire breaks were concentrated at each end and near midspan of the specimen. The test was terminated after 76 wire fractures were reported over 2,566,000 cycles.

**Figure 2.8 Peak Load during Fatigue Test for Specimen 7 (Ridd 2004)**

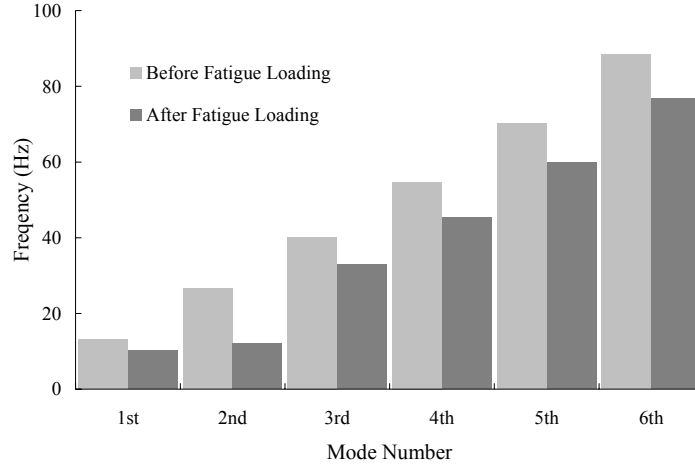
The natural frequencies of another specimen, which had nominally the same geometry as Specimen 7, were measured before and after the fatigue tests. The first six modes are plotted in Figure 2.9. During the fatigue tests, the natural frequencies decreased by approximately 20% in each mode, but the second frequency decreased nearly 55%. Because the mass and length of the specimen did not change during the fatigue tests, the differences in the natural frequencies were interpreted as a reduction in the applied tension.

**Figure 2.9 Variation of Natural Frequencies in Cable-Stay Specimen**

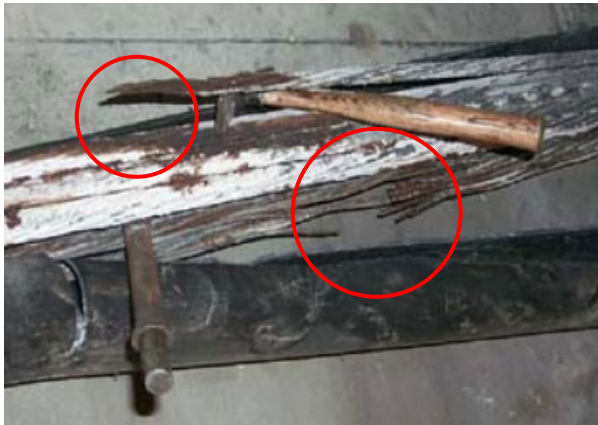
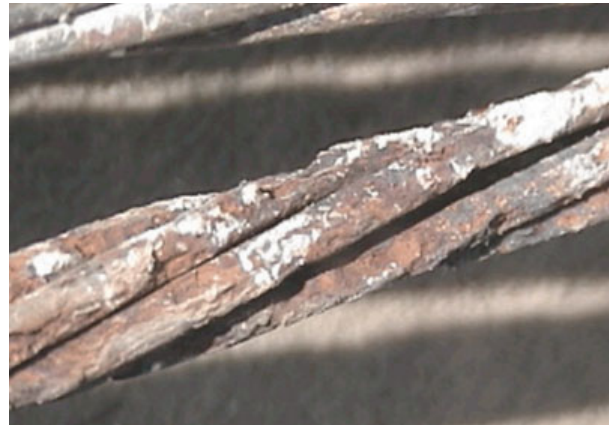
***Figure 2.10 Degradation of Strand due to Corrosion (Corven Engineering 2001; Poston et al 2003)***

In order to conduct a direct investigation of the corrosion potential, electrical inspection technologies, such as the half-cell potential, require that the flow of electrons be measured. Direct contact to the prestressing steel is required to measure the half-cell potential. However, most post-tensioned tendons were not constructed with direct access to the strands. As a result, NDT technologies are generally designed to detect other relevant properties that can be used to infer the condition of the strand, rather than the presence of corrosion itself. Typical corrosion damage of strands (wire breaks and severe pitting) is shown in Figure 2.10.

(a) Fractured Wires

(b) Severe Pitting

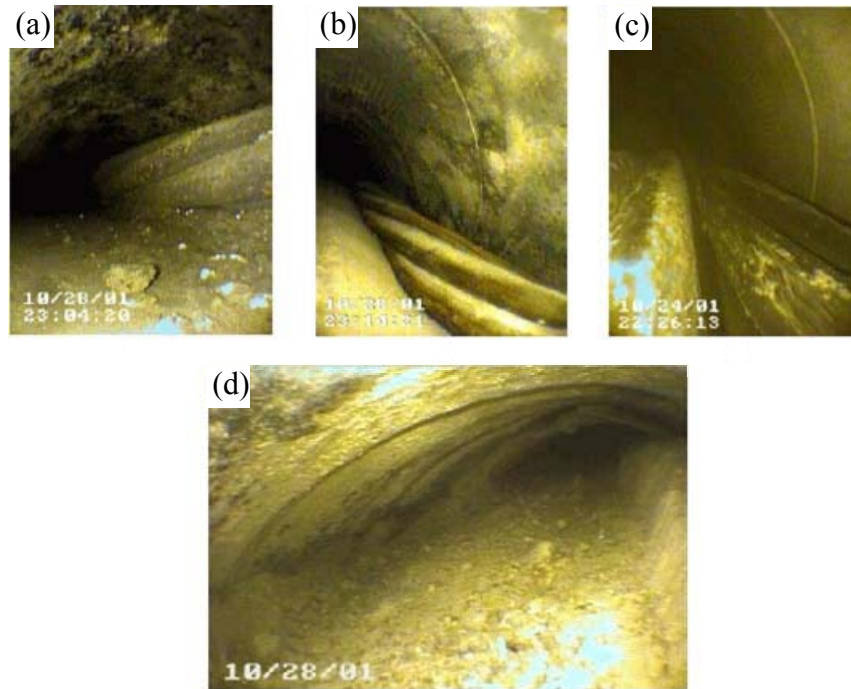
**Figure 2.11 Visual Grout Void Results from Bore Scope: (a),(b) Partial strand exposure, (c) Complete strand exposure, (d) No strand exposure (DMJM Harris 2003)**

In 2001, the Florida Department of Transportation initiated a state-of-the-art inspection program for detecting corrosion damage in external tendons in the Mid-Bay Bridge (Corven Engineering 2001). Three techniques including the borescope inspection, the vibration technique, and the magnetic-flux method were used. In addition, visual inspection and soundings were used to identify tendons with likely corrosion problem (Figure 2.12).

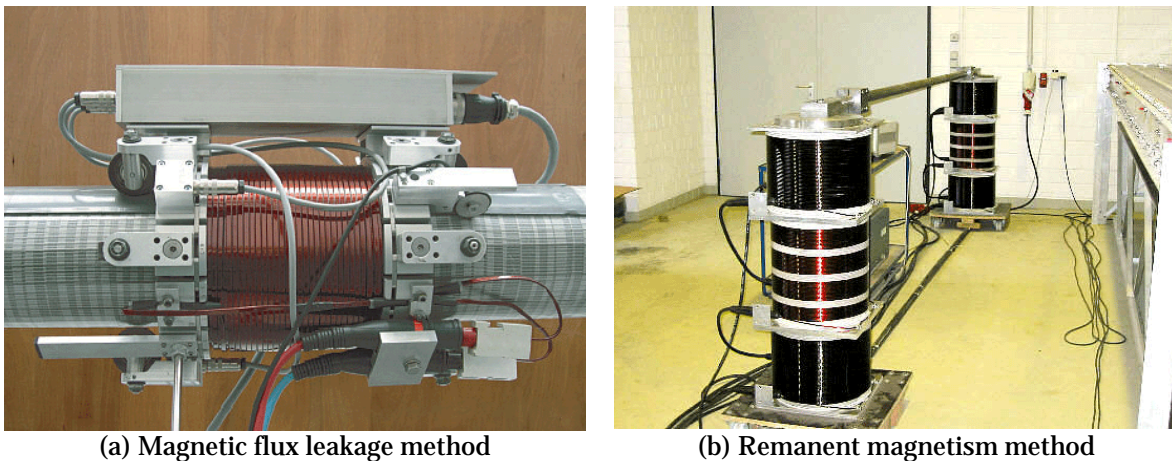
At present, it appears that the reliability of NDT techniques for the evaluating external tendons is still not sufficient. Currently, each NDT technique provides partial information about the extent of damage within the tendon. Additional research to detect corrosion in the external tendons is underway. In 2003, various advanced technologies, such as the magnetic flux leakage method and remanent magnetism method, were suggested during an international symposium in Berlin (Figure 2.13). Time domain reflectometry techniques, where a probe is embedded in the external tendon during construction, are being developed by Chajes et al. (2003).

*Figure 2.13 Equipment used for NDT of Tendons  
(Bergamini et al 2003; Scheel et al 2003)*

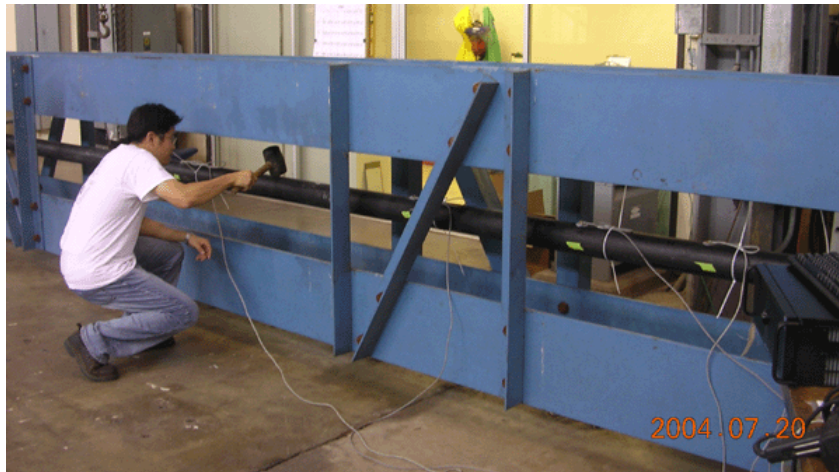
Because external tendons are enclosed within a concrete box girder, the inspector typically has access to the duct along the length of the external tendon. This provides flexibility in selecting the locations of sensors and the locations where the vibrations are induced (Figure 2.15). The measured natural frequencies are sensitive to the corresponding mode shapes; therefore, direct access permits the most efficient sensor locations to be selected.

***Figure 2.15 Preliminary Vibration Test for Cable Specimen***

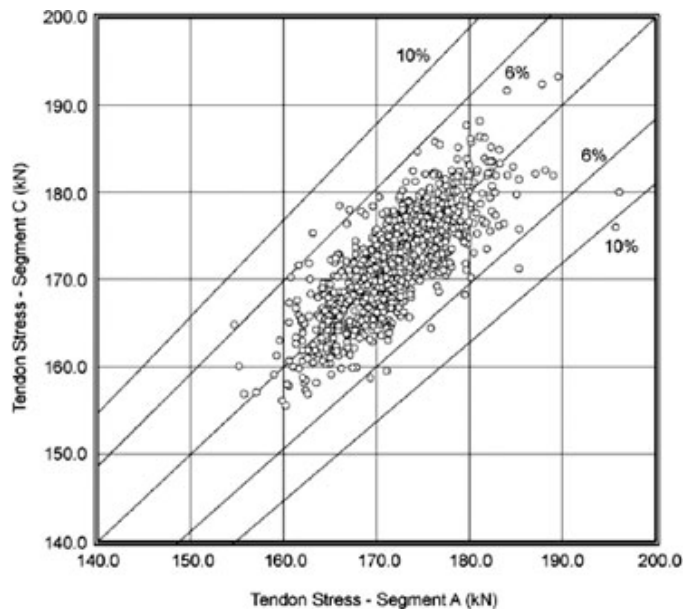
In the absence of corrosion damage, the calculated value of the applied tension was expected to be equal in the three segments of each tendon. However, minor variations were observed. The results from 140 spans, each containing six tendons, are plotted in Figure 2.16. In all tendons, segment A corresponds to the section of tendon between the south diaphragm and the south deviator, segment B corresponds to the middle section of tendon, and segment C corresponds to the section of tendon between the north deviator and the north diaphragm (Figure 2.14). Variations in the calculated tension on the order of  $\pm 6\%$  were common, and interpreted to mean that significant damage had not occurred within the tendon. In contrast, differences on the order of 25% were observed in one tendon from Span 9 (Figure 2.17). Subsequent investigation of the north segment of this tendon indicated the presence of severe corrosion and wire breaks (Corven Engineering 2001).

**Figure 2.16** *Tensile Stress per Strand Extracted from Measured Frequencies in Tendons on the Mid-Bay Bridge (Corven Engineering 2001)*

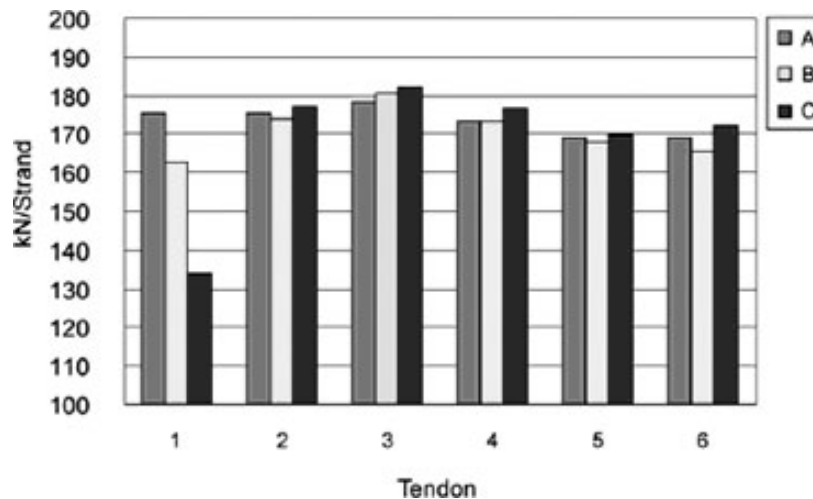
**Figure 2.17** *Variations in Tensile Forces Calculated for Each Segment of Tendon in Span 9 of Mid-Bay Bridge (Corven Engineering 2001)*

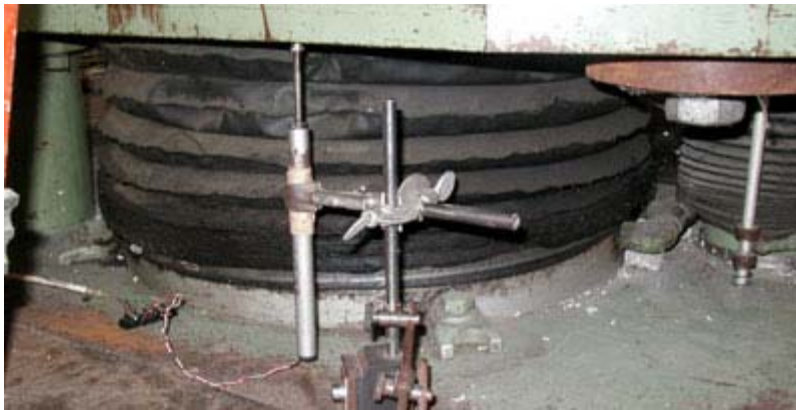
The relative displacement between the top and middle cross heads was monitored using a linear potentiometer (Figure 3.5) which was located on the floor and measured the vertical displacement of the bottom cross head. The recorded displacement was equivalent to the relative displacement between the top and middle cross heads because the bottom and top cross heads are linked rigidly and the specimen was loaded by moving the top cross head only.

***Figure 3.5 Linear Potentiometer Used to Measure Relative Displacement between Cross Heads***

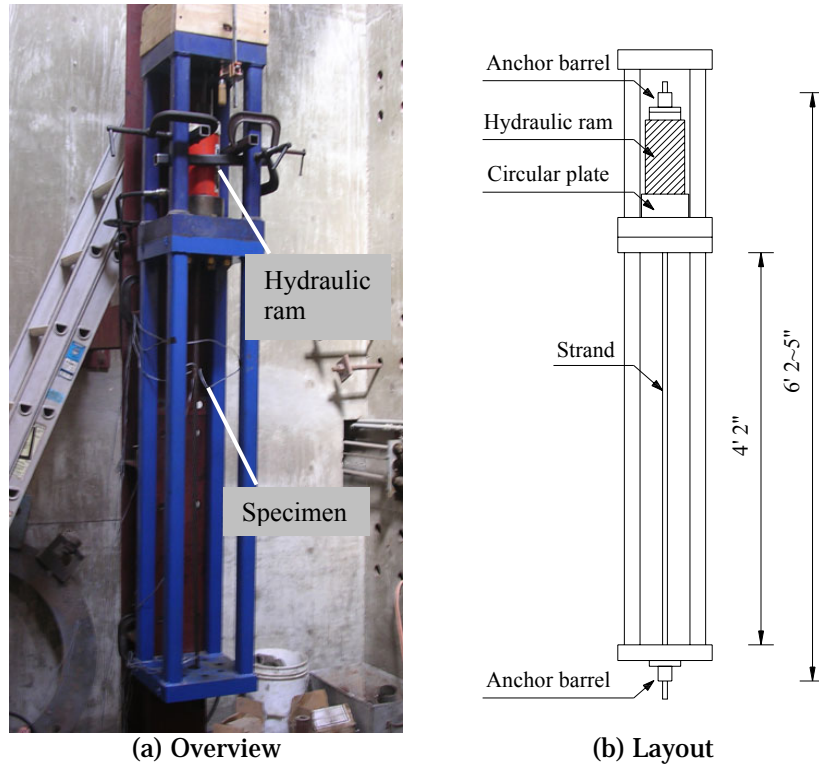
In phase 3, the strands were tested in an assembly comprising four steel plates supported by four posts (Figure 3.6). Each plate had a 1.5-in. diameter hole at the center to accommodate the strand and the posts were welded to the plates. The test frame consisted of two parts. A 60-kip hydraulic ram was positioned in the upper frame where a 3-in. thick circular plate was located to distribute stress evenly. The specimens were positioned in the lower frame, which accommodated a specimen free length of 50 in. The specimen was gripped using the mono strand anchors used in Phase 2 at each end.

**Figure 3.6 Test Setup Used in Phase 3**

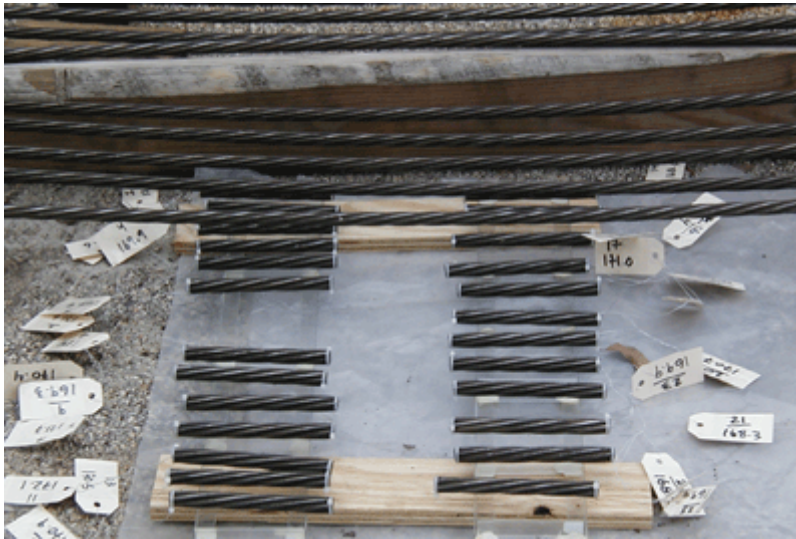
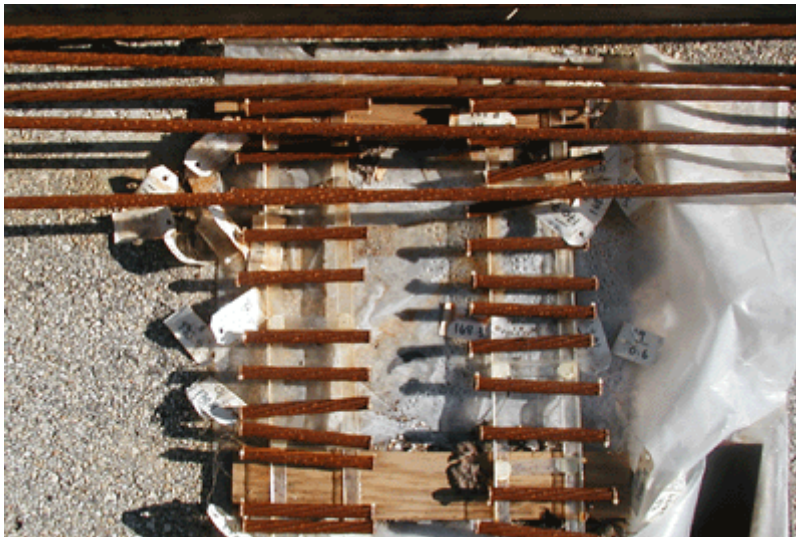
The uniformly corroded specimens were intended to provide information about how the structural properties were influenced by corrosion products and the corresponding reduction of cross-sectional area. Photographs of the test specimens and companion 6-in. specimens, which were exposed to the same environmental conditions, are shown in Figure 3.7.

(a) Specimens on February 16, 2006

(b) Specimens after first month exposed to salt water

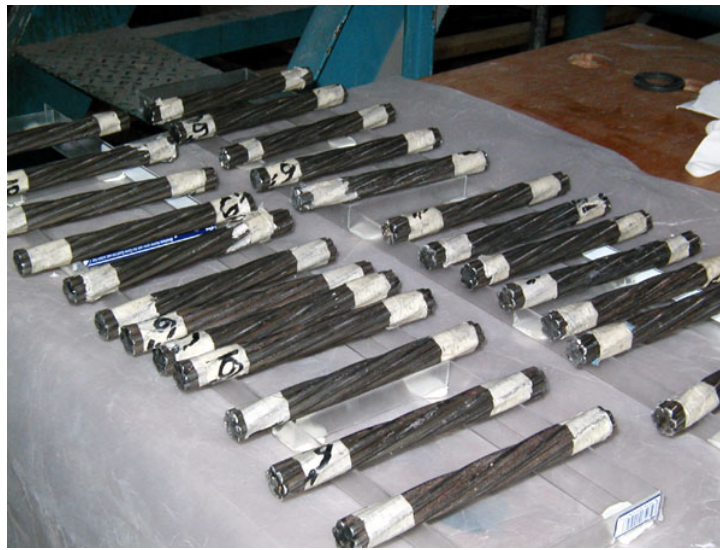
The ends of the specimens were restrained with tape and zip ties to protect the wires from unraveling (Figure 3.8) and a transparent plastic sealant was used to protect the ends of the wires from corrosion. The weight of each specimen was recorded before the exposure tests were started and at the end of the exposure tests.

*Figure 3.8 Specimen Preparation*

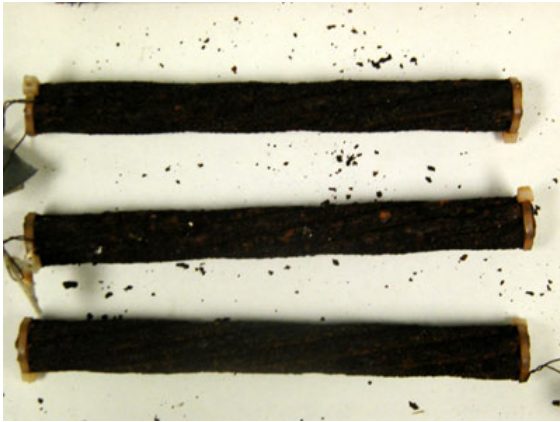
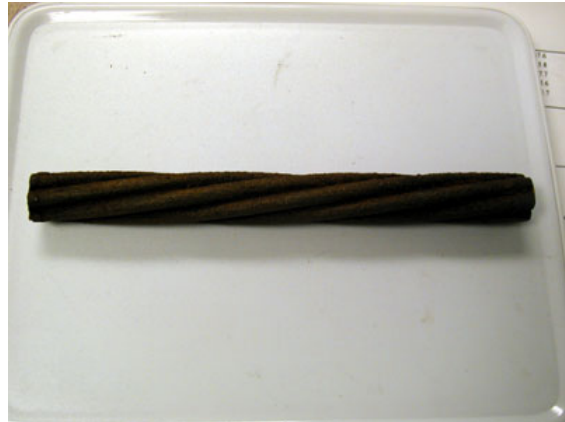
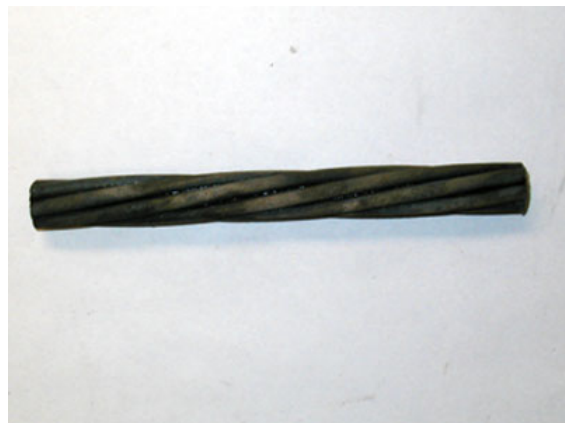
***Figure 3.9 Procedures Used to Remove Corrosion Products***

The final procedures are summarized below and photographs of the specimens are shown in Figure 3.9.

- Remove cable ties from ends of specimens
- Remove corrosion products from surface of strand using brass wire brush
- Submerge specimen in the hydrochloric acid for 20 minutes
- Rinse specimen with distilled water
- Rebrush if necessary
- Evaporate remaining water using heat gun
- Measure weight of specimen using electric balance

(a) Specimens after 2 mo exposure

(b) After cleaning with wire brush

(d) After acid immersion of 20 min

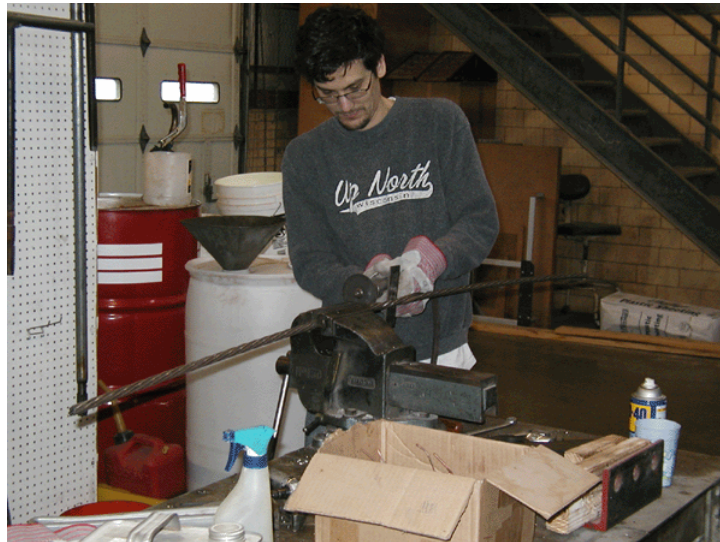
In order to avoid damaging adjacent wires when cutting wires in Phase 2, the specimens were supported in a vise and vise grips were used to unravel all outer wires along approximately one-half the length (Figure 3.10). A small steel plate was wedged between wires and the strand was retightened. A grinder was used to cut the desired number of wires, and then the steel plate was removed.

*Figure 3.10 Simulation of Broken Wires in Phase 2*

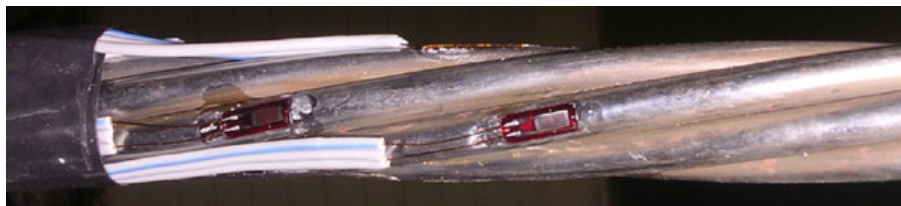
For the 0.6-in. diameter strand used in this investigation, the longitudinal axes of the outer wires were rotated approximately  $10^\circ$  from the longitudinal axis of the strand (Figure 3.16). The strain gages were attached to the outer wires of the strand and aligned along the axis of the individual wires (Figure 3.12c, Figure 3.17). The number of strain gages varied from six for specimen UND 1 to two for specimen UND 2. The results are summarized in Table 3.5 and measured data are plotted in Figure 3.18 through Figure 3.20.

*Figure 3.17 Strain Gages Positioned along Longitudinal Axes of Wires*

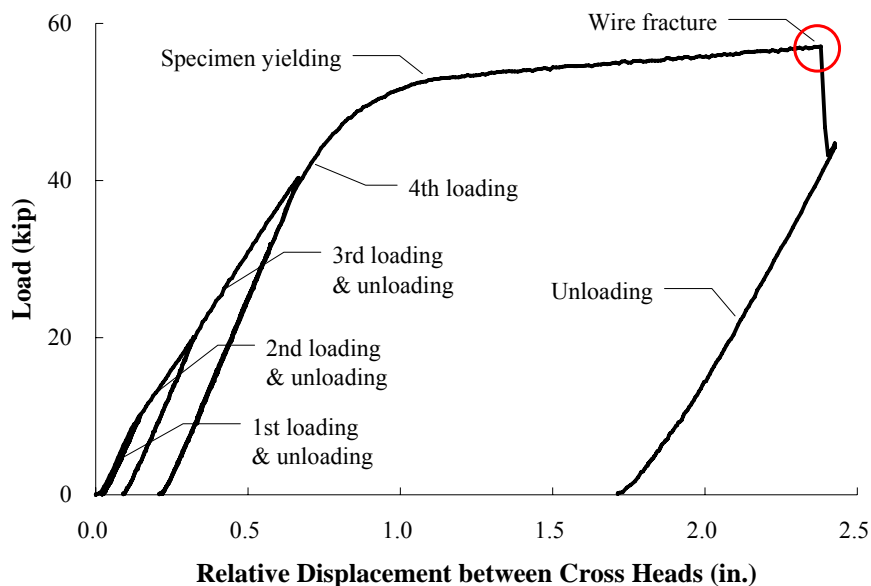
Unlike the tests in Phase 1, where hydraulic pressure was used to grip the specimens, which could be released without damaging the specimens, the anchors used in Phase 2 could not be released. Therefore, most of specimens in Phase 2 were tested to failure.

*Figure 3.21 Representative Load and Displacement Relationship in Test Series 2*

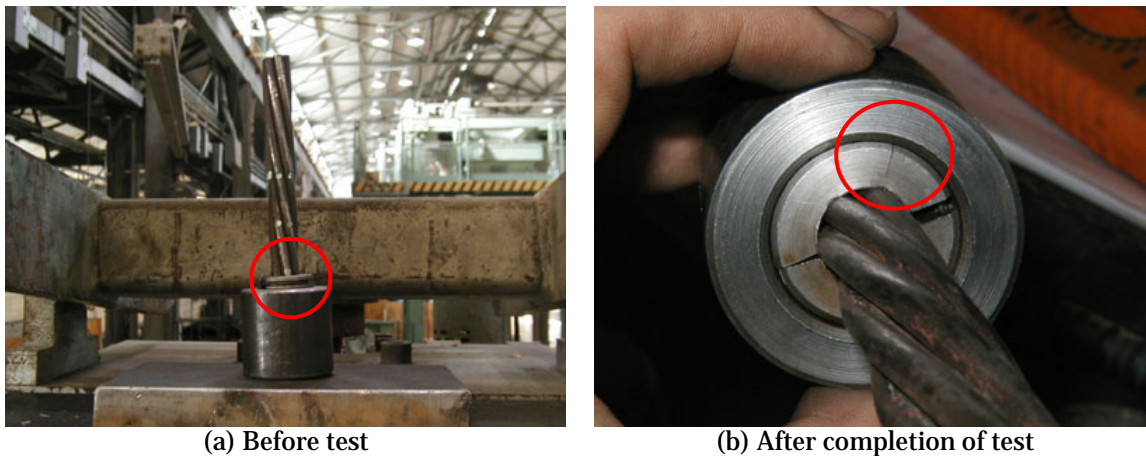
The wedges typically cracked before the specimen failed (Figure 3.22). Due to the slip of the anchors, the recorded data from the linear potentiometer were not used to calculate the elastic modulus but were used to monitor the overall behavior of the test specimens.

***Figure 3.22 Slip of Strand at Anchors***

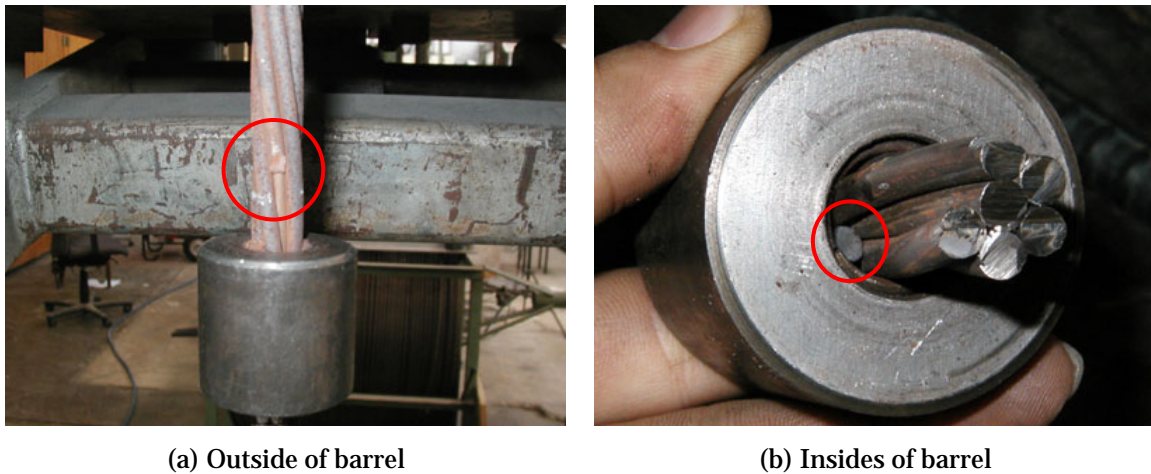
The wire breaks typically occurred within the bottom barrel anchor. After the specimen yielded, one of the six outer wires fractured and then the applied axial load dropped due to slip of the specimen. The fractured surface was typically oriented approximately  $45^\circ$  from the longitudinal axis of the wire (Figure 3.23). This surface indicates that the fracture was influenced by shear stress, which probably developed due to friction between the wedges and the strand.

***Figure 3.23 First Wire Fracture***

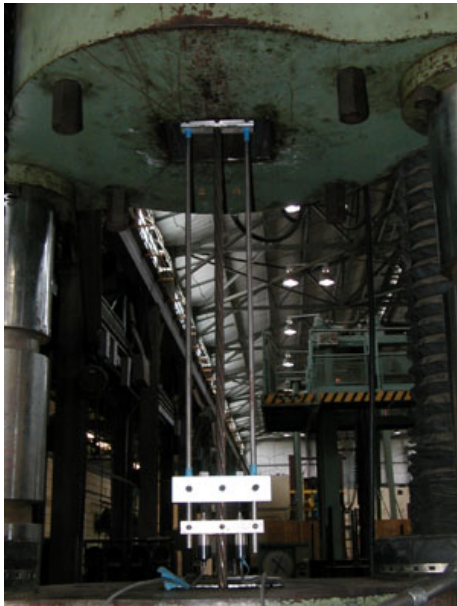
***Figure 3.24 Instrumentation Used to Measure Elongation of Strand in Phase 2***

The axial elongation of the strand was measured using the apparatus discussed in Section 3.3.1. In phase 2, however, the apparatus was modified by adding adjustable screws to the middle aluminum block to permit easier adjustment of the transducers (Figure 3.24). At the beginning of the test, the apparatus was attached to the strand without the transducers. The transducers were installed before the fourth loading cycle and were removed before the specimen yielded to prevent possible damage caused by the wire fracture. In general, the elongation of the strands was measured in the range of 10 to 30 kip.

(a) Apparatus for supporting displacement transducer

As discussed previously, the apparatus used to measure axial elongation (Figure 3.24) was attached to the specimen using two screws. For the undamaged strand specimens, this method was effective because the stress and strain were uniformly distributed among the outer wires. Therefore, the position of the apparatus was not critical for the elongation measurement. However, for the specimens with cut wires, the stress was less in the cut wires. In addition, the cut wires moved relative to the other wires at midspan. Therefore, the location of the apparatus and placement of the screws influenced the recorded response.

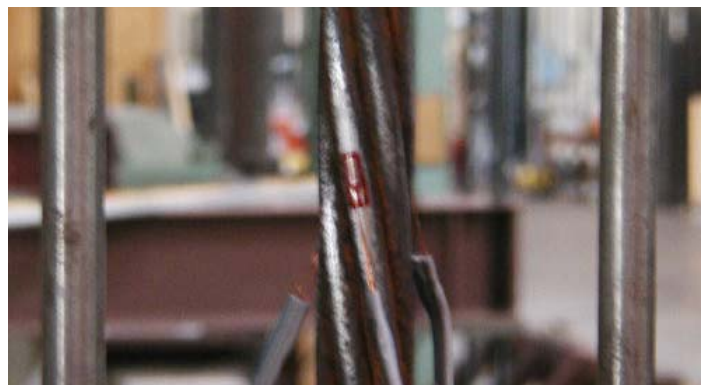
As in the phase 1 tests, the strain distribution in the outer wires was measured using strain gages. The axes of the gages were aligned along the longitudinal axes of the outer wires (Figure 3.25). The position and number of gages varied with the specimen. Most of gages malfunctioned after the first wire fractured.

***Figure 3.25 Strain Gages in Phase 2***

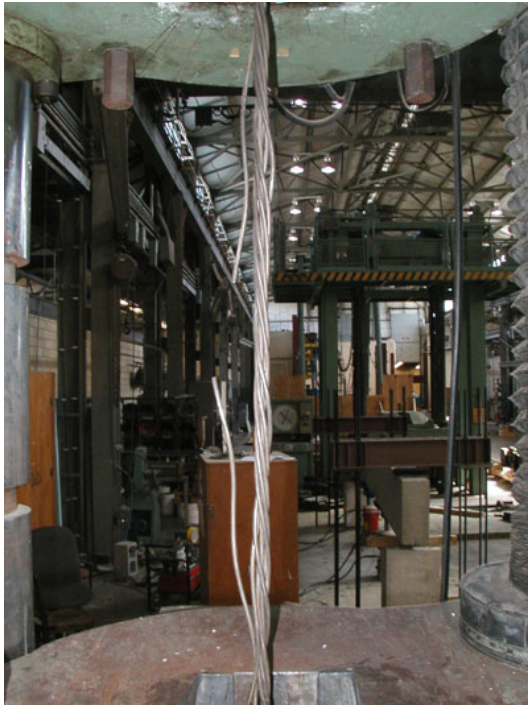
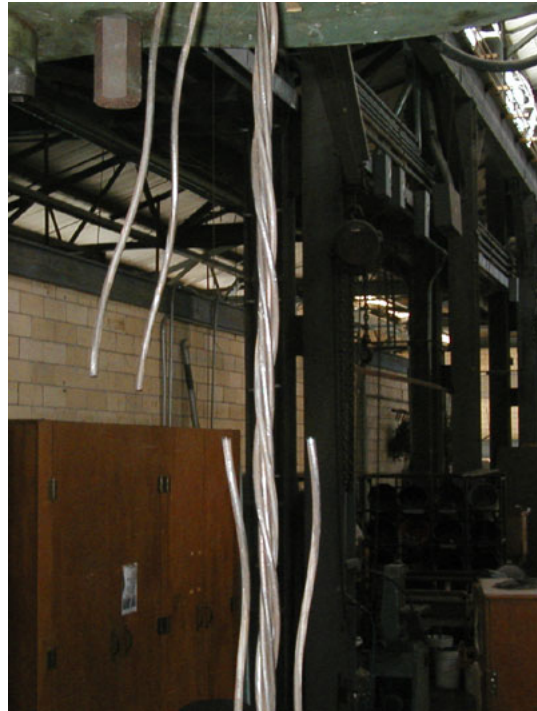
The CUT specimens unraveled violently after the wire fracture (Figure 3.27). Cut wire(s) separated from other wires along the full length of the specimen such that the initial geometry of strand was not maintained.

(a) Failure of CUT 1

(b) Failure of CUT 3

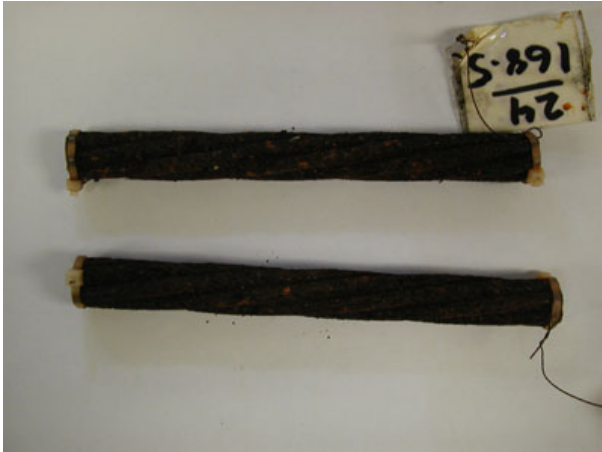
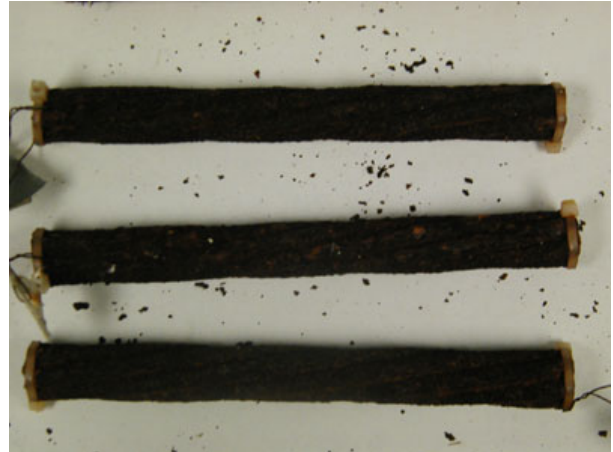
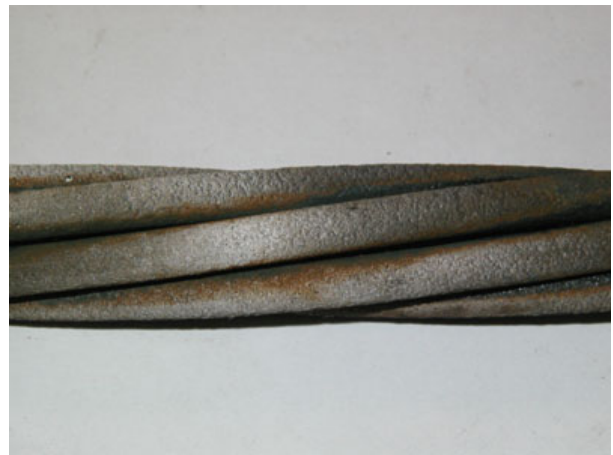
***Figure 3.28 Observed Corrosion on Surface of 6-in. Specimens***

In spite of the visual evidence of corrosion damage, the maximum percentage of weight loss during the 5.5-month exposure was only 3.5%. Furthermore, estimated results indicated that amount of the corrosion did not increase between 4 months and 5.5 months. It is likely that accumulated corrosion products on the surface of the specimens interrupted the reaction between chloride ions and the steel. When corrosion products were removed by chemical cleaning procedure, mild pitting was evenly distributed on the surface. The test results are summarized in Table 3.7 and displayed in Figure 3.28.

(a) 2-month exposure

(b) 4-month exposure

(d) After cleaning

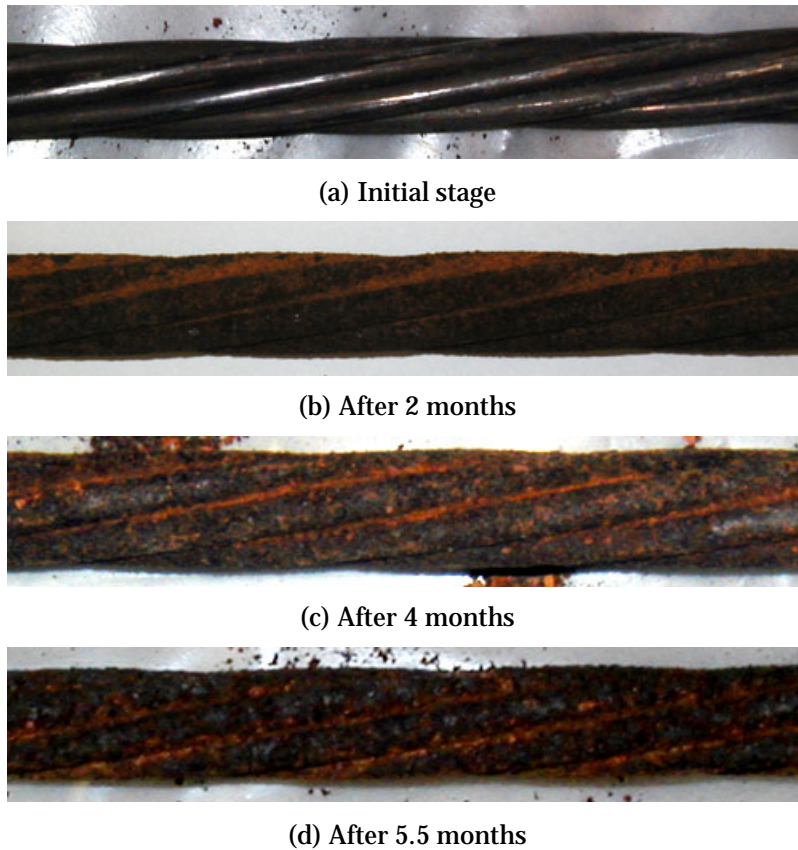
The elastic modulus was measured for all corroded specimens. Corrosion products were visible on the surface of all specimens (Figure 3.29). The values of elastic modulus calculated from the measured stress-strain response are reported in Table 3.8. The applied stress was calculated using the cross-sectional area of the strand reported on the mill certificates, and no adjustment was made to reflect the 1 to 3% weight loss. The moduli for the corroded specimens ranged from 27,600 to 28,200 ksi, which were approximately 5% less than the modulus of undamaged specimens.

**Figure 3.29 Surface Conditions for Corroded Specimens**

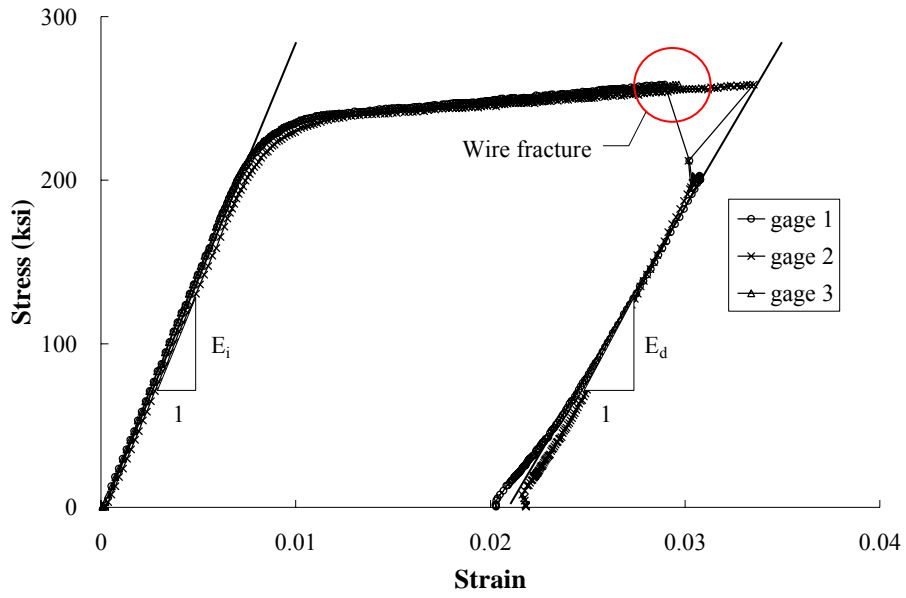
**Figure 3.32 Representative Apparent Stress-Strain Relationship (COR 4)**

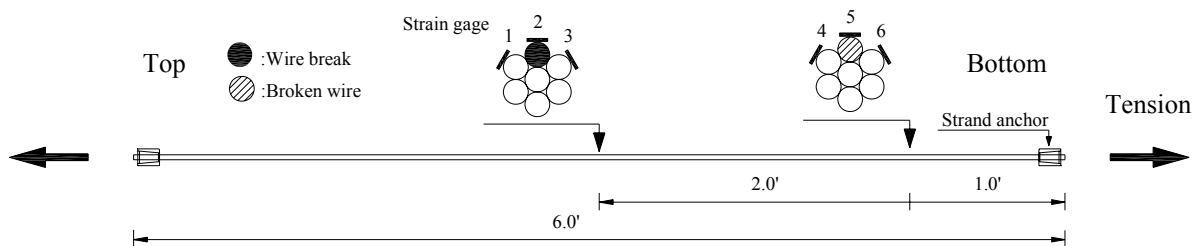
One wire in specimen CUT 2 was cut at midheight before the specimen was tested. The objective of this test was to determine the distribution of stress among the wires and the residual axial capacity of the strand. A total of six strain gages were attached to the specimens. Three strain gages were positioned at midspan where the wire had been cut, and the other three strain gages were positioned 2 ft from midspan. The arrangement of the strain gages is shown in Figure 3.34. The specimen was loaded to failure and the recorded data are presented in Figure 3.35.

**Figure 3.34 Arrangement of Strain Gages for Specimen CUT 2**

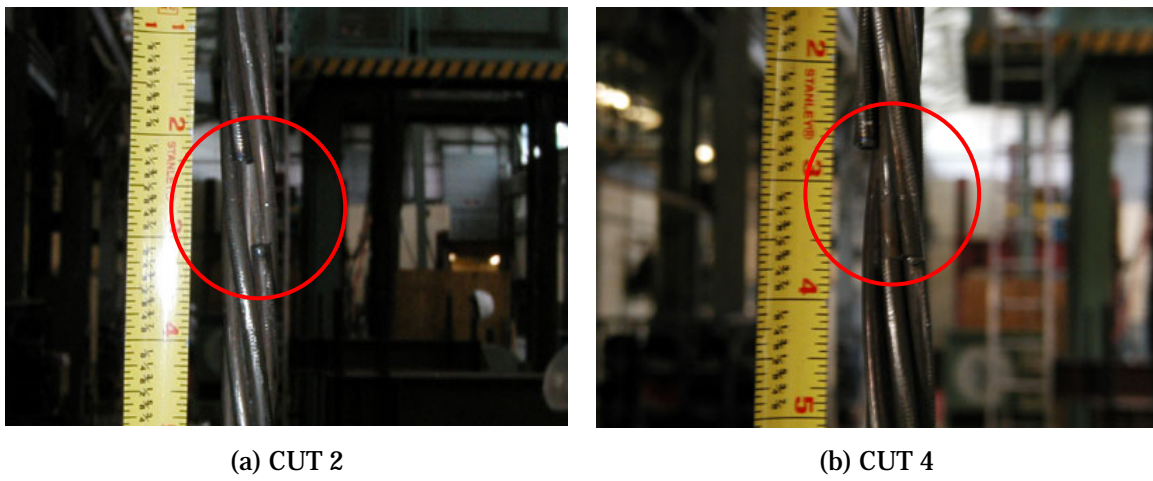
***Figure 3.36 Opening of Gap between Cut Wires***

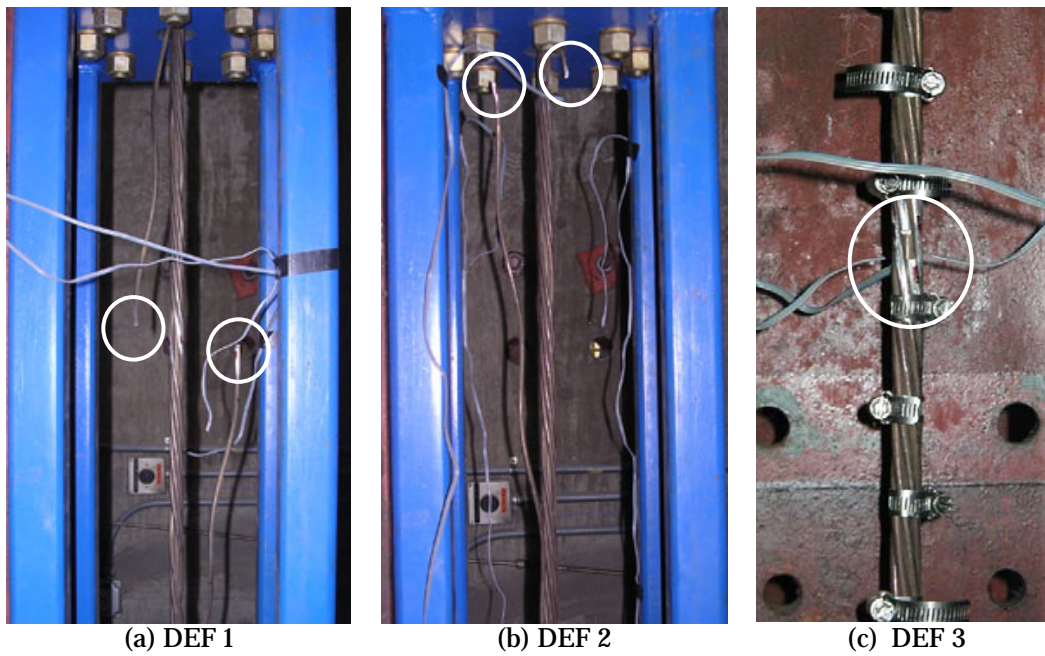
The sudden release of energy caused by fracture of the damaged wire in DEF 1 and DEF 2 caused the wires to unravel (Figure 3.40). The broken wire separated from the other six wires in the strand and broke the lead wires attached to all the strain gages positioned near the initial defect. In subsequent tests, metal hose clamps were positioned along the free length at a 2-in. spacing. The clamps prevented the broken wire from unraveling and simulated the restraint provided by the grout in external tendons. All the strain gages, except the gage attached the wire with the initial defect, survived the first wire fracture for specimens DEF 3 and DEF 4.

**Figure 3.40 Specimens after Initial Wire Fracture**

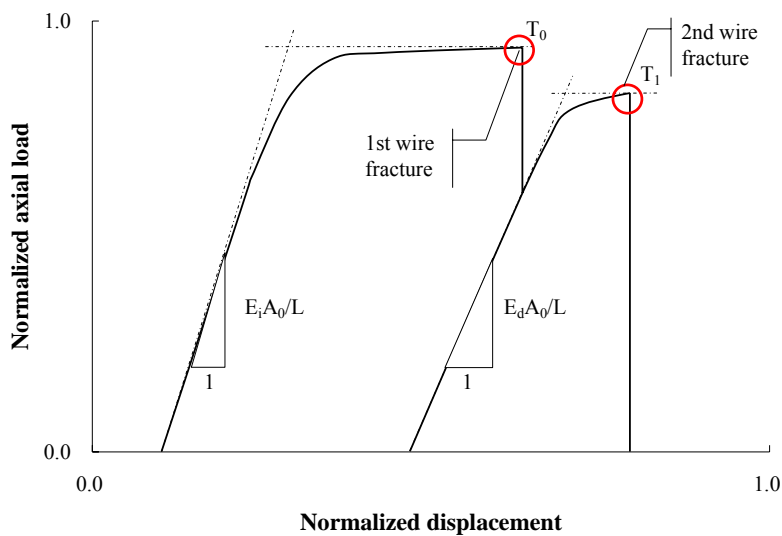
Based on observations made in this chapter, an idealization of the elongation behavior of strand including the first and second wire fractures is shown in Figure 3.42. The overall behavior of strand is considered without including stress redistribution among wires. This figure suggests that the strand maintains a considerable portion of its original tensile strength and stiffness after the first wire fractures. Considering test results, the damaged elastic modulus ( $E_d$ ) is approximately 20% less than the initial elastic modulus ( $E_i$ ). Also, the tensile strength of the strand with one broken wire ( $T_1$ ) is approximately 6/7 of the tensile strength of undamaged strand ( $T_0$ ).

**Figure 3.42 Schematic Elongation Behavior of Strand**

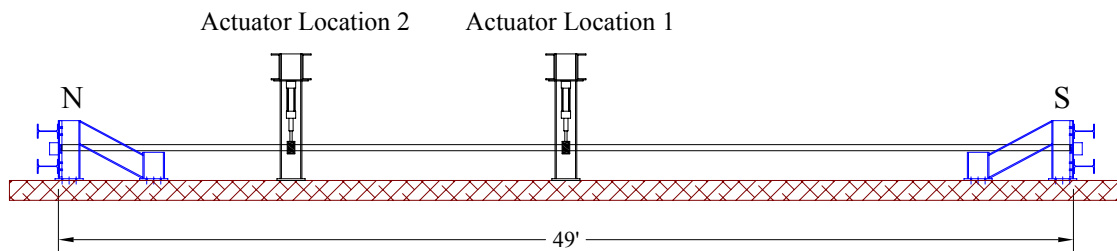
During the fatigue tests, the specimens were loaded transversely at one location along the length. Initially, the actuator was positioned at midspan (Location 1), but the actuator was positioned near the quarter-span (Location 2) for most of the cycles.

*Figure 4.1 Test Setup for Cable Specimens*

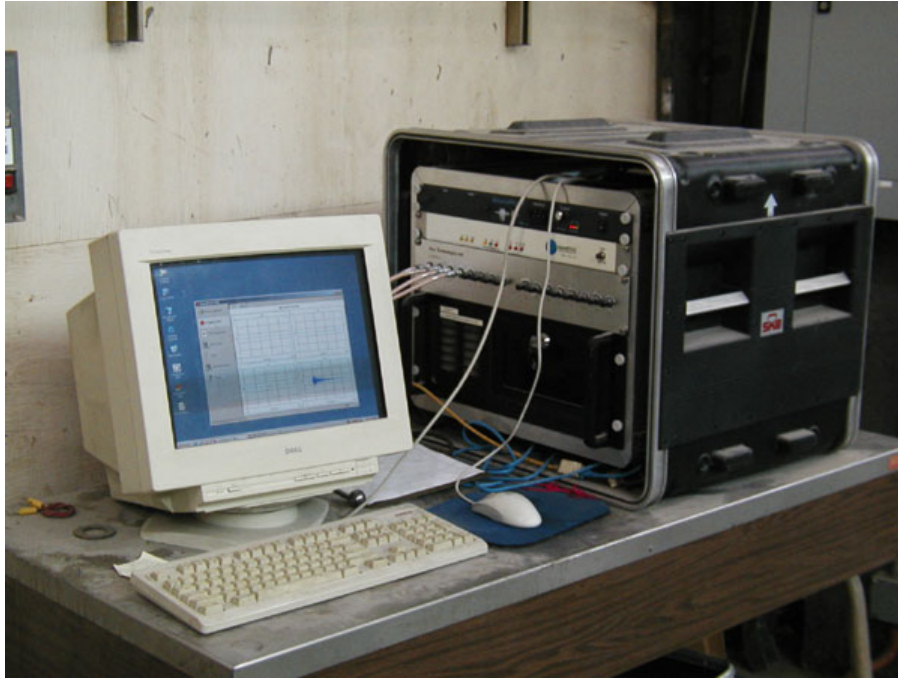
*Figure 4.4 Watch Dog-PS6 (SoundPrint™) Hardware*

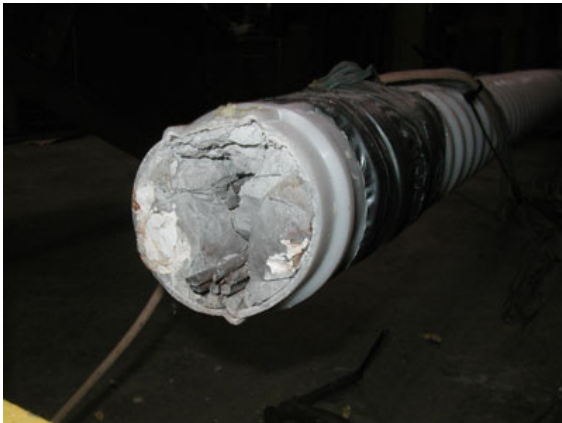
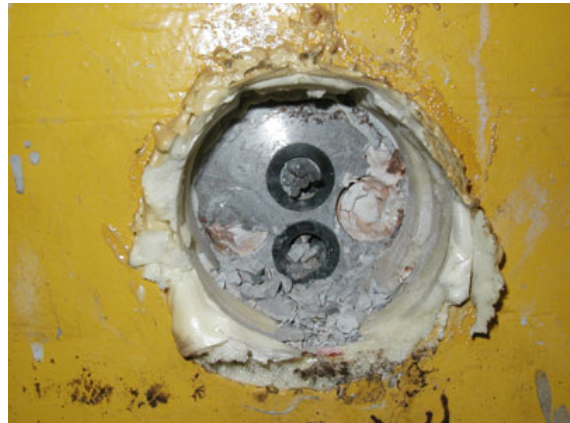
**Figure 4.14 Specimen Collapse of Cable 01**

The specimen was disassembled after the test was completed. The specimen collapsed after all the wires fractured (Figure 4.14). The failure occurred near the north anchor head. The top strand failed within 2-in. of the outside face of the anchor head and the bottom strand failed inside the anchor head. Thirteen wires at this section failed due to fatigue, but one wire yielded prior to failure.

(a) Overall collapse

(b) Separated section

(c) Collapsed section (toward duct)

(d) Collapsed section (toward anchor head)

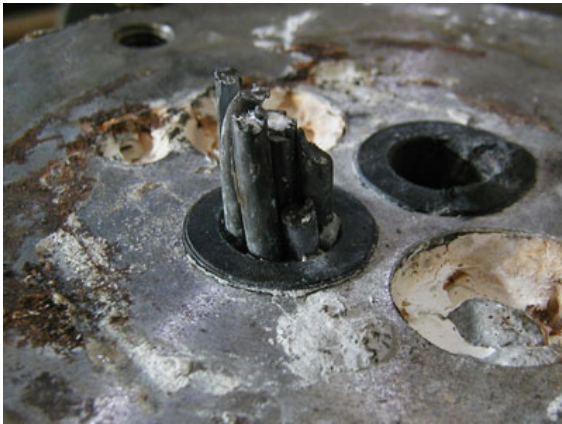
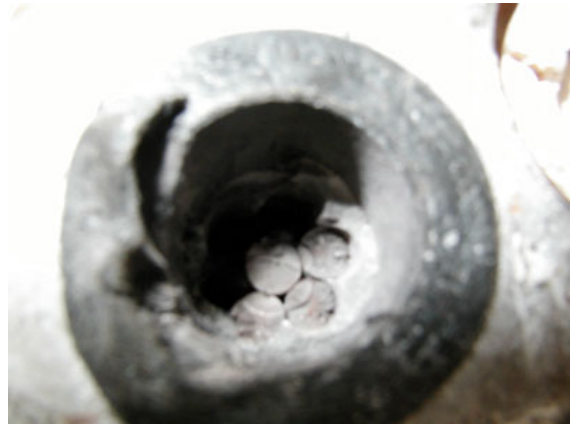
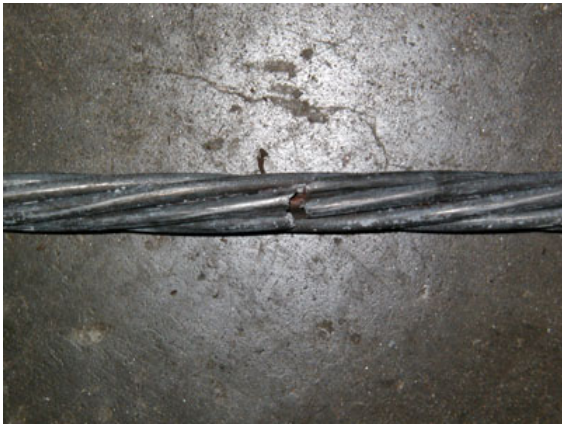
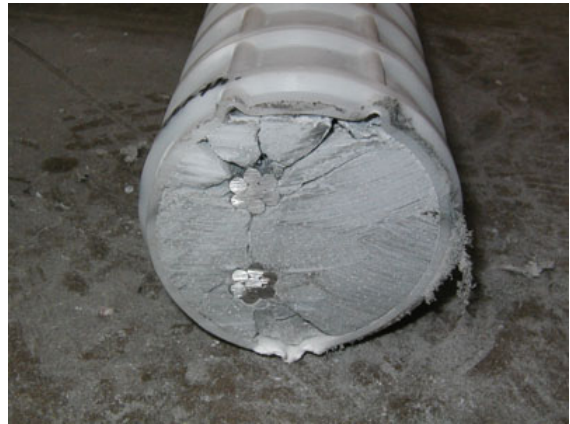
***Figure 4.15 Wire Breaks and Typical Section for Cable 01***

A total of 16 wire breaks were identified during the autopsy. Two adjacent wires fractured near midspan and 14 wires fractured near the north anchor head (Figure 4.15). Two wire breaks at midspan appeared to occur before the load frame was relocated because the number and location of the wire breaks coincided with the SoundPrint™ system report.

Grout at the north end of the specimen was fragmented. The energy generated by wire breaks appeared to pulverize the grout. Grout also cracked vertically at many sections. The crack developed from the top and bottom of the sections and continued through both of strands (Figure 4.15d). The relative movement between strands and grout during the cyclic loading probably resulted in compression and tension of the grout and caused the vertical crack.

(a) Anchor head top strand

(b) Anchor head bottom strand

(c) Wire fracture at the midspan

(d) Typical section

A total of 16 wire breaks were observed in comparison to the 14 wire breaks reported by the acoustic sensors. The first two wire breaks at midspan were detected properly, but 2 wire breaks at the north end of the specimen were not detected. The transferred energy from wire breaks to the sensors was significant and 14 wire breaks

occurred in a narrow region in the vicinity of the anchor head. It is likely that the SoundPrint™ system was not able to distinguish between single and simultaneous wire fractures. However, the location of the wire fractures identified by the acoustic sensors was in general agreement with the observed wire breaks.
