**Evaluation of External Post-Tensioned Tendons using Vibration  
Signatures**

**Dissertation**

The University of Texas at Austin

**May 2007**

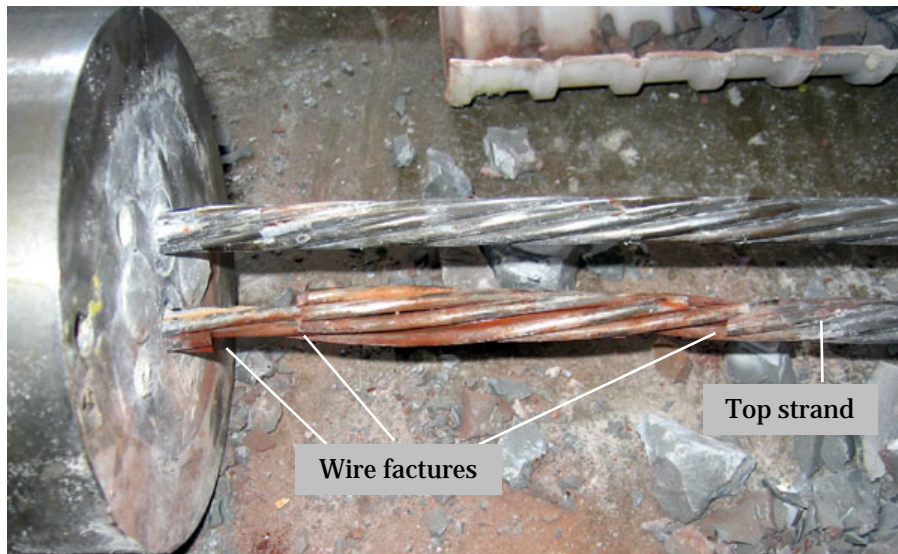
The specimen was disassembled to investigate the extent of damage after the test was terminated. A total of eight wire breaks were identified along the top strand and no wire breaks were observed along the bottom strand. Six wires fractured within 8 in. of the outside face of the anchor head and two wires fractured inside the anchor head (Figure 4.20). The center wire fractured twice. Therefore, the top strand was completely separated from the anchor head. Mild corrosion was observed in the region where wires fractured. This corrosion indicated that severe abrasion and friction occurred at this region.

*Figure 4.20 Wire Fractures at North Anchor Head for Cable 02*

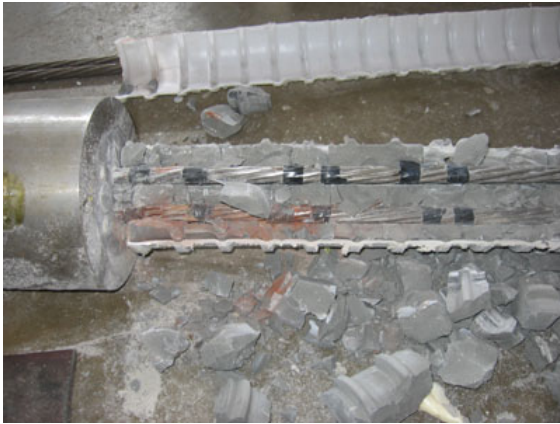
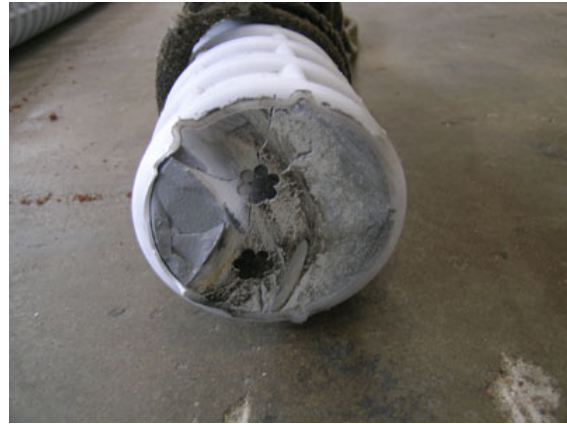
***Figure 4.21 Grout Condition of Cable 02***

Grout near the north end was completely fragmented. Vertical cracks were also identified along the entire length as shown in Figure 4.21. The observed condition of the grout was similar to Cable 01.

(a) North anchor region

(b) Typical section

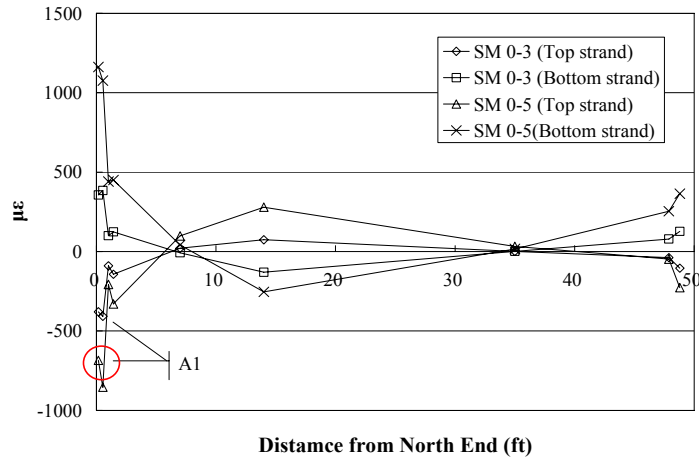
**Figure 4.25 Strain Distribution along the Length of Cable 03**

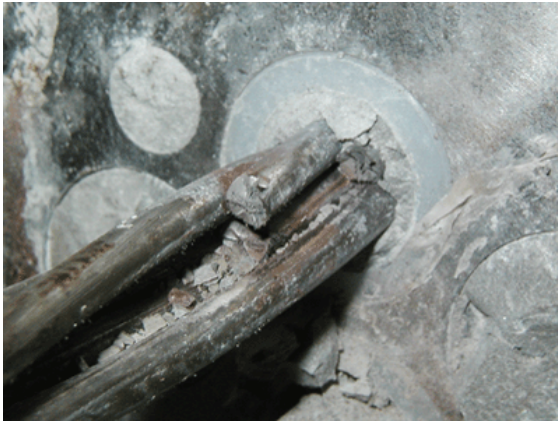
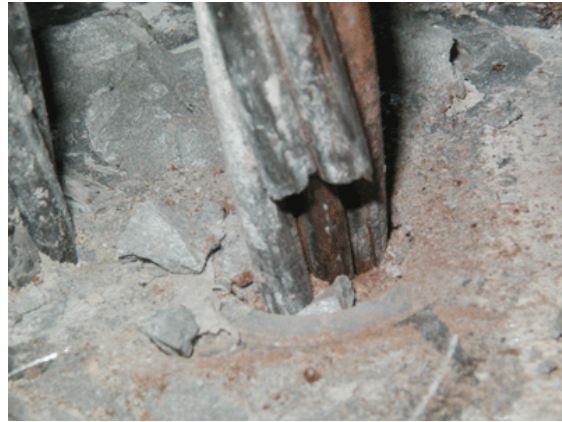
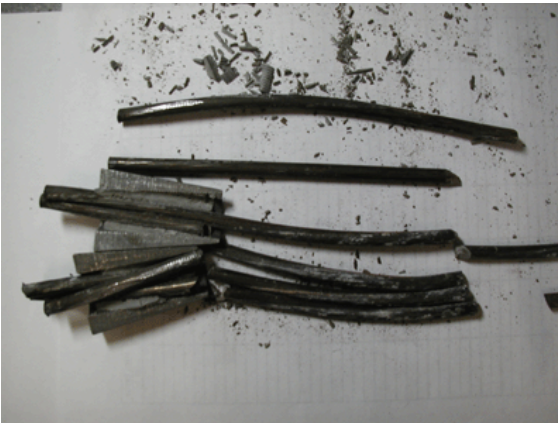
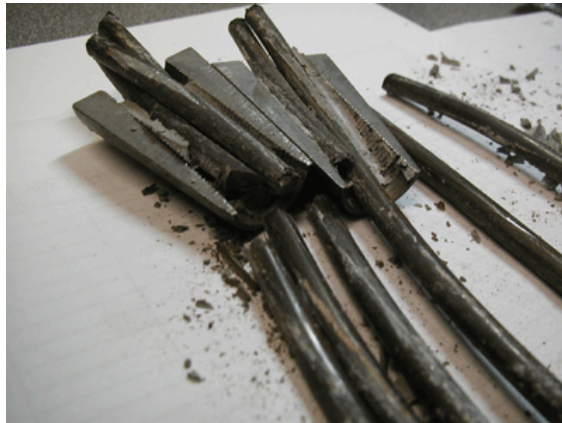
***Figure 4.28 Wire Fractures for Cable 03***

After the test was completed, the specimen was disassembled to determine the extent of damage. A total of twelve wire breaks were identified at the north end of the specimen. Six wires fractured within 1 in. of the outer face of the anchor head and six wires fractured inside the anchor head. Outside the anchor head, three wire breaks were identified in each strand (Figure 4.28a and b). Three wires fractured in the top strand but two wires fractured in the bottom strand – one outer wire experienced two wire breaks. Inside the anchor head, six wires fractured only in the bottom strand. Two wires including the center wire fractured within 0.25 in. of the outer face of the anchor head. Four wires fractured at the wedge (Figure 4.28c and d).

(a) Outside of anchor head (Top strand)

(b) Outside of anchor head (Bottom strand)

(c) Inside of anchor head (Bottom strand)

(d) Wire fracture at wedges (Bottom strand)

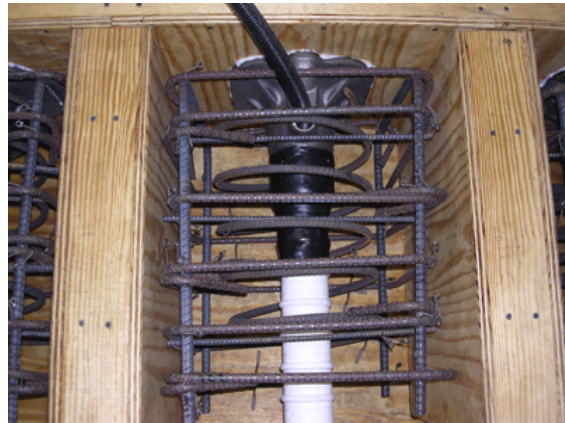
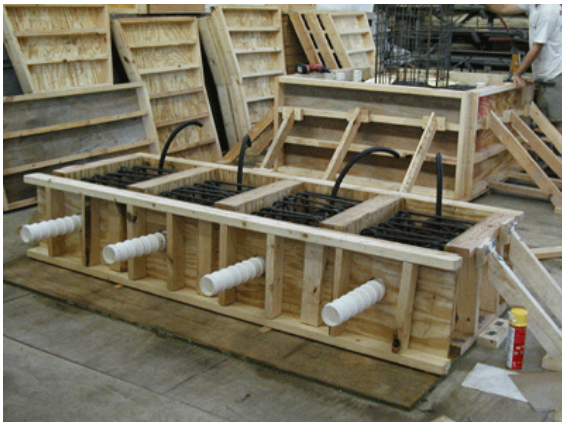
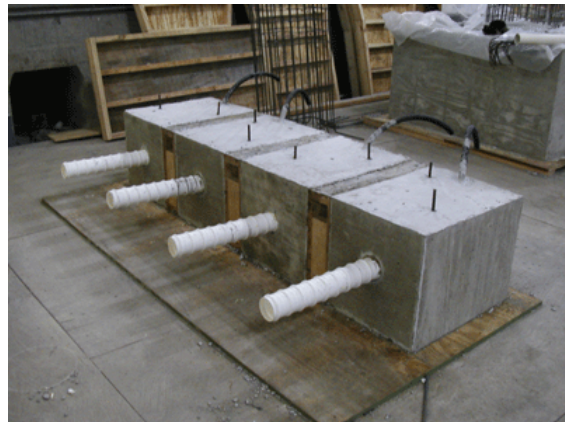
***Figure 5.2 Construction of Concrete Anchor Blocks***

Four concrete blocks were constructed to enclose the post-tensioning hardware used to anchor the strands (Figure 5.2). Each block was 24 in. long with an 18×18-in. cross section. The reinforcement in the blocks was designed to resist the prestressing forces and the corresponding local bursting stresses (Figure 5.2a). Two U-shaped bars were used as the longitudinal reinforcement. Closed hoops with 135° hooks were used as the transverse reinforcement. Spirals were positioned in the middle of the cage to resist bursting forces. Design calculations for the anchor blocks are presented in Appendix I.

Commercial, post-tensioning hardware was used. VSL Type E 6-12 is designed to accommodate twelve, 0.6-in. diameter strands and includes an anchor head, bearing plate, anchor cap, and high density polyethylene (HDPE) duct (Figure 5.2b). The HDPE duct extended 4 ft beyond the outer face of the concrete blocks (Figure 5.2c) to facilitate construction of the specimen. The measured compressive strength of the concrete (Figure 5.2d) was 4500 psi at 28 days.

(b) Anchor plate within reinforcement

(c) Concrete form

(d) Completed blocks

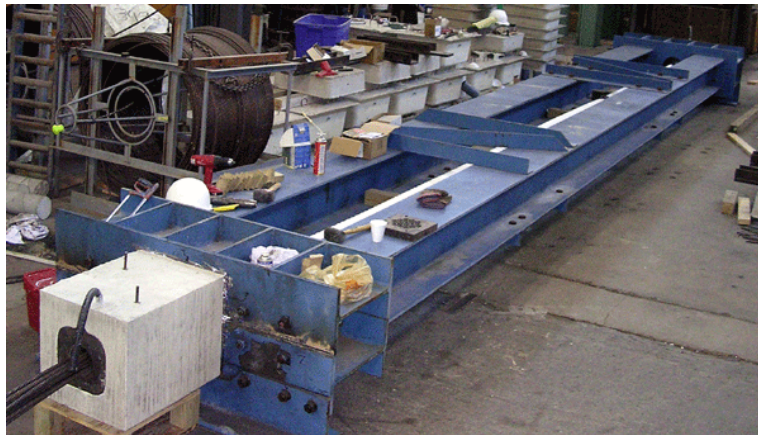
**Figure 5.3 Configuration of Tendon Specimens**

After curing, a concrete anchor block was placed at each end of the steel reaction frame (Figure 5.3). Additional sections of duct were attached to the anchor blocks using

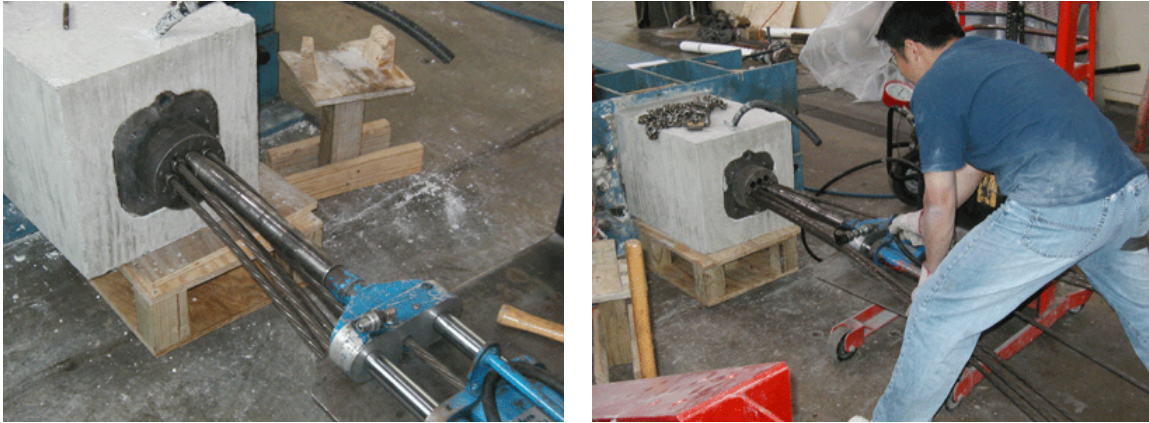
Due to the congestion of strands at the anchor head, a 2-ft long steel pipe with a tapered nose was used to transfer axial compression to the wedges. Two springs were positioned at the nose of the pipe to prevent the movement of wedges when the force was released.

**Figure 5.5 Initial Prestressing Procedure**

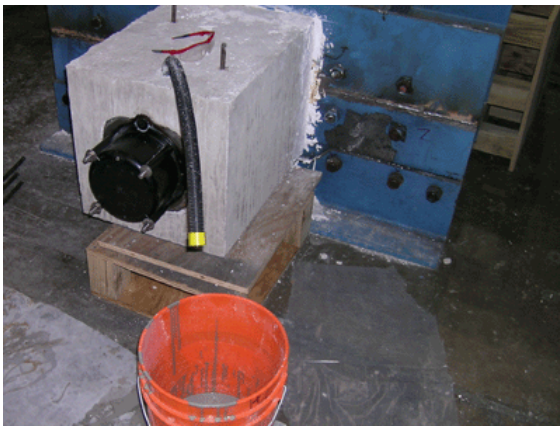
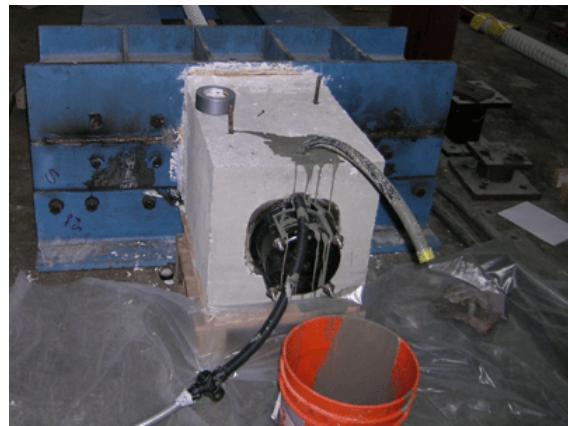
*Figure 5.8 Arrangement of Grout Inlet and Vents*

(b) North end

(c) South end

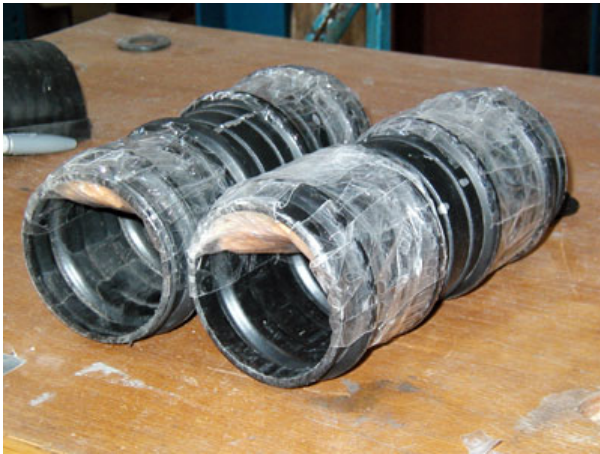
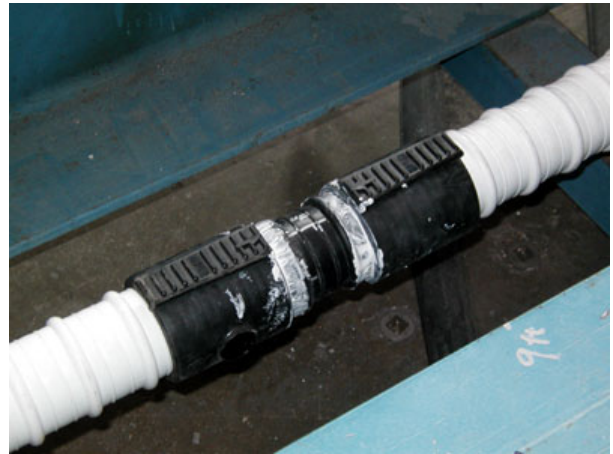
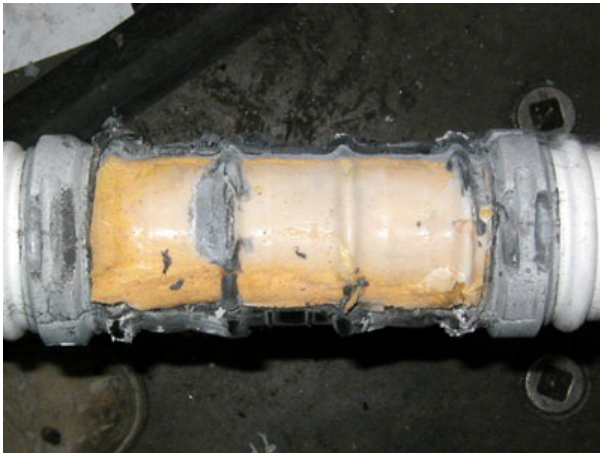
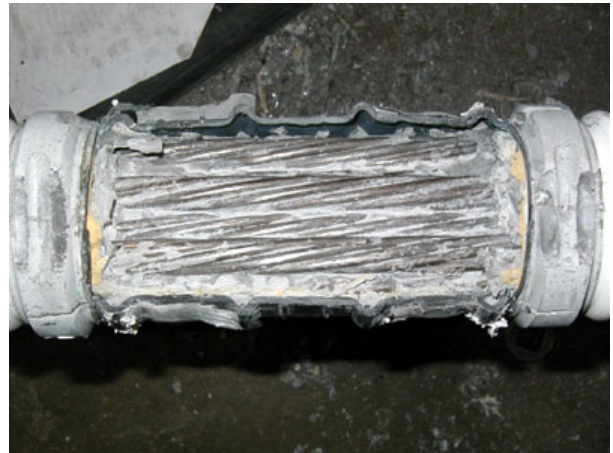
**Figure 5.10 Construction of Grout Voids – Tendon 02**

**(a) Sponge attached to sections of duct**

**(b) Assembly of duct**

**(c) Sponge after grouting**

**(d) Strands after removal of sponge and grout**

After grouting, the top half of the sections of duct in the vicinity of the voids were removed (Figure 5.10c). The sponges were then removed, and the thin layer of grout that covered the strand was chipped away. Four to six strands were visible in each void (Figure 5.10d) at the completion of the process.

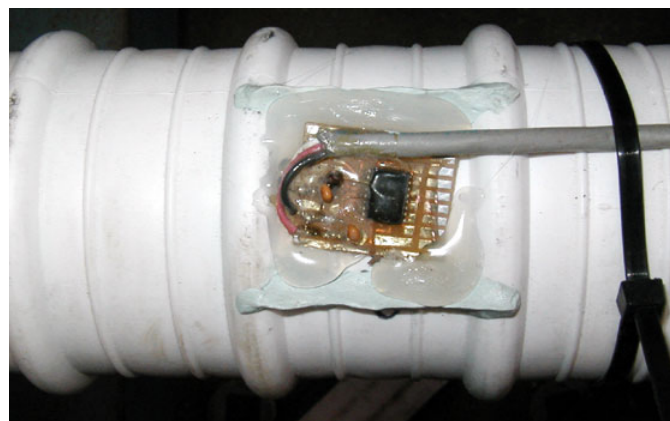
The accelerometers were attached to the post-tensioning ducts using hot-melt glue for Tendon 01 (Figure 5.14). Because Tendon 02 was outside during the exposure test, the accelerometers were potted and then attached to the post-tensioning duct for Tendon 02 (Figure 5.15).

**Figure 5.14 Accelerometer Attached to Tendon 01**

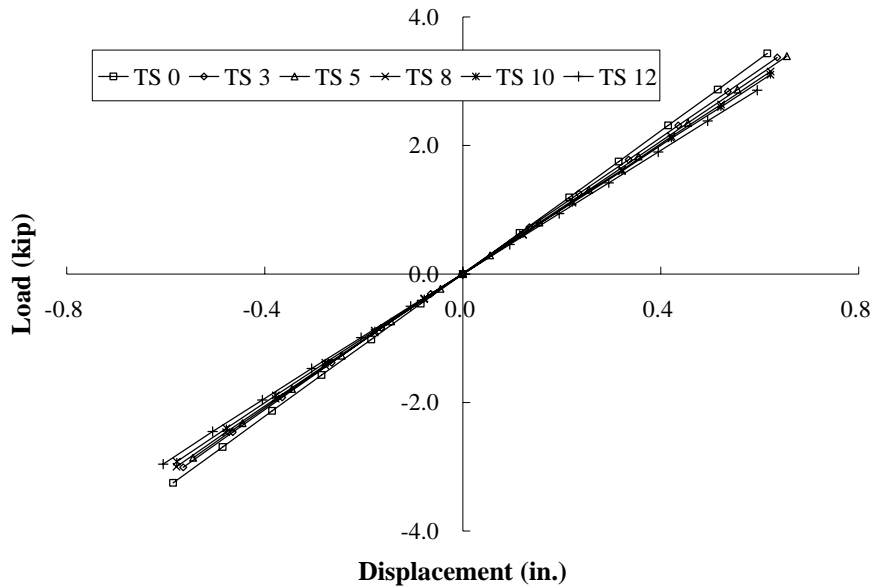
The variation of recorded stiffness is displayed in Figure 5.17 and summarized in Table 5.4. The load-displacement relationship was linear in all tests and the transverse stiffness decreased gradually from 5.6 to 4.8 kip/in. as damage accumulated.

*Figure 5.17 Transverse Stiffness of Tendon 01*

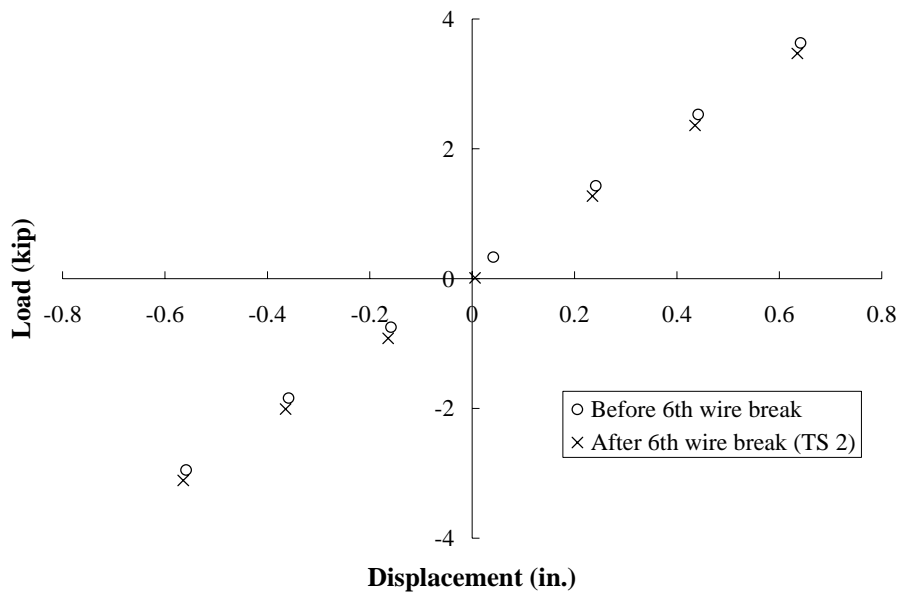
Two wires fractured during static tests (TS 2 on 1/10/06 and TS 3 on 1/11/06). In both cases, the specimen was being loaded toward the maximum displacement of 1.5 in. The sound of the wire fracture was clearly audible and was detected by the acoustic sensors. However, these wire breaks did not influence the measured load-displacement response. Recorded data before and after the wire break indicated the same stiffness and no indication of nonlinear response was observed. Therefore, the data recorded immediately after the wire breaks are designated as TS 2 and TS 3, respectively. Recorded load-displacement relationships before and after the wire breaks are plotted in Figure 5.18 and Figure 5.19.

**Figure 5.18 Recorded Load-Displacement Response on January 10, 2006**

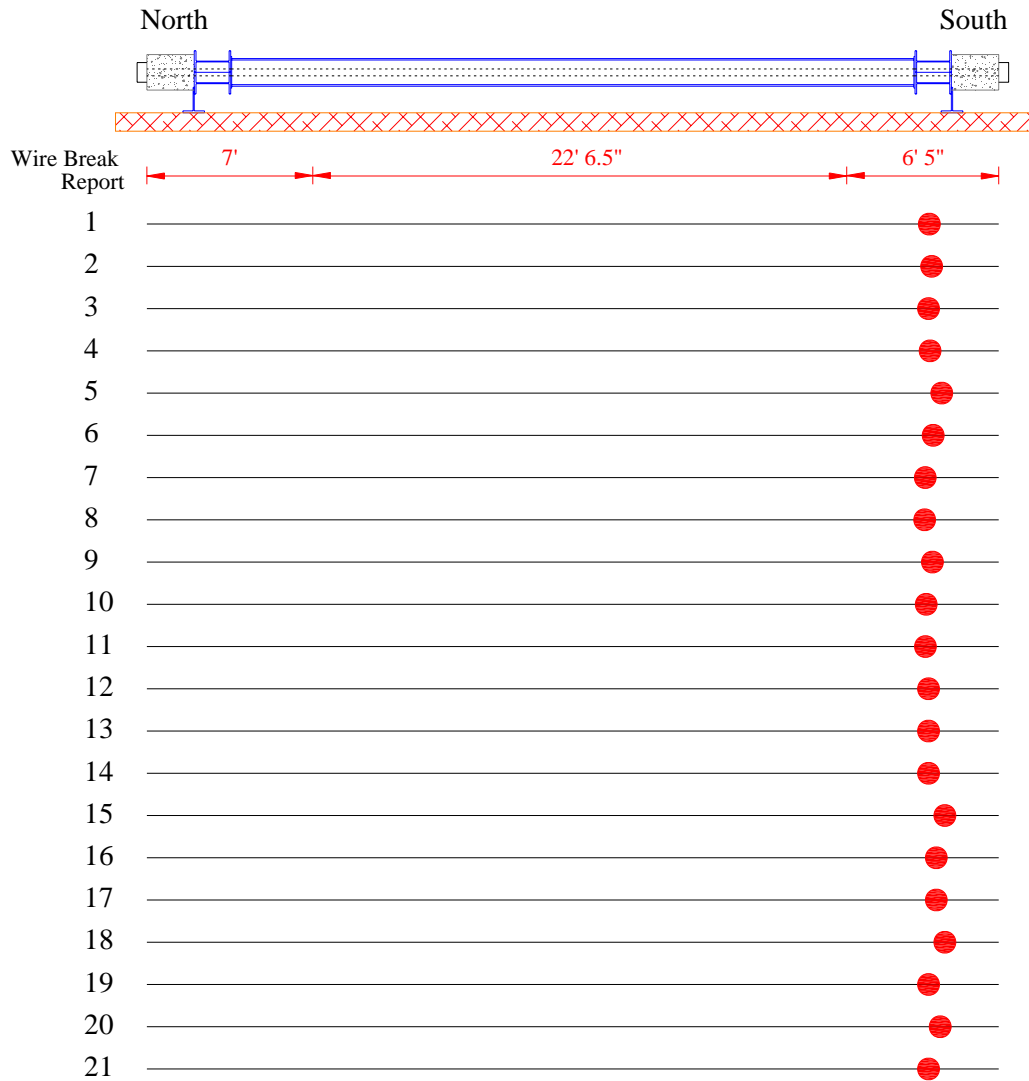
A total of 21 wire breaks was detected by the acoustic monitoring system. All 21 wire breaks were located near north end of the south anchor block. The reported locations of the wire breaks are displayed in Figure 5.22 and summarized in Table 5.6.

*Figure 5.22 Location of Wire Breaks Detected by Acoustic Sensors*

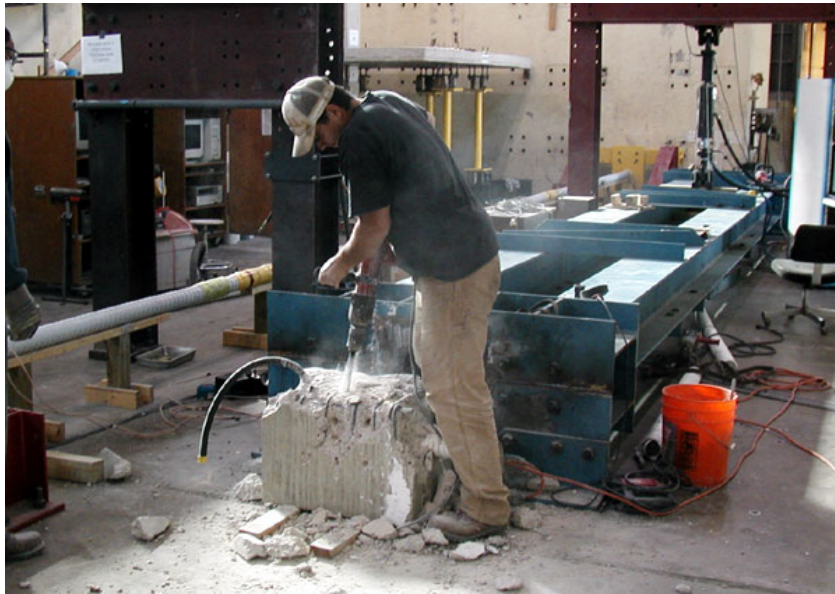
After the fatigue test was terminated, the specimen was disassembled to determine the extent of damage. The autopsy focused initially on wire fractures along the length of the specimen. However, extensive corrosion of the anchor heads was observed, and the scope was extended to include the post-tensioning anchorage system. The concrete anchor blocks were demolished and all the post-tensioning components were retrieved to assess the propagation of corrosion (Figure 5.23).

**Figure 5.23 Demolition of Concrete Anchor Block for Tendon 01**

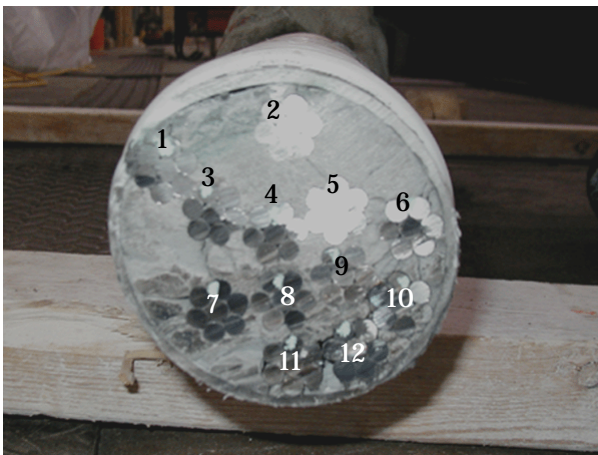
**Figure 5.24 Wire Fractures at Face of Concrete Block**

**(a) Typical section**

Twenty-five wire breaks was identified during the autopsy. All wire breaks occurred in strands positioned toward the bottom of the cross section near the north face of the south anchor block. The locations of wire fractures are shown in Figure 5.24. All seven wires fractured in strands 7, 11, and 12. Two wires fractured in the strands 8 and 10. The grout surrounding the fractured wires was severely fragmented, but no voids were observed in the grout (Figure 5.25).

Twenty-one wire breaks were reported by the acoustic sensors; but 25 wire breaks were identified during the autopsy. The location of the wire breaks identified by the acoustic sensors was in general agreement with the observed distribution of wire breaks.

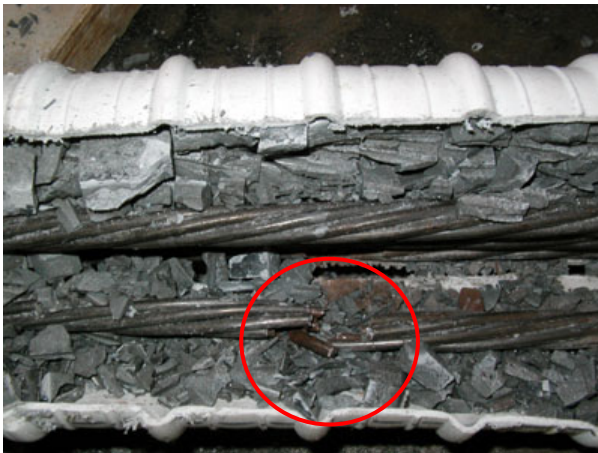
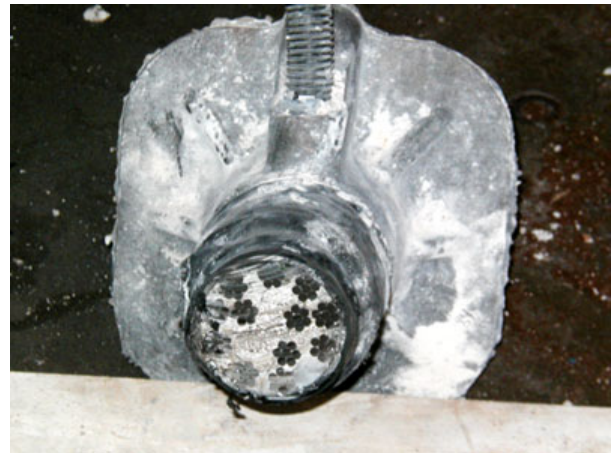
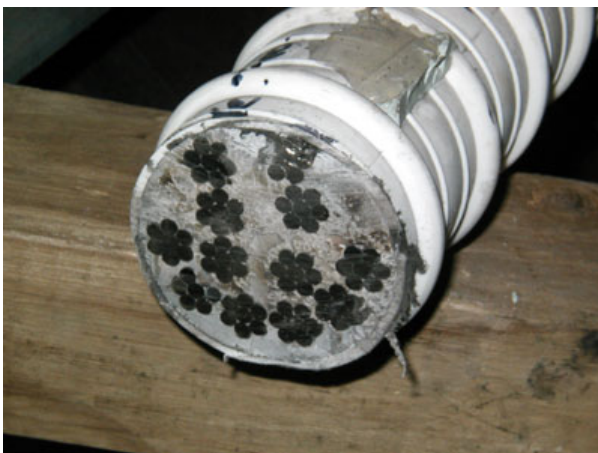
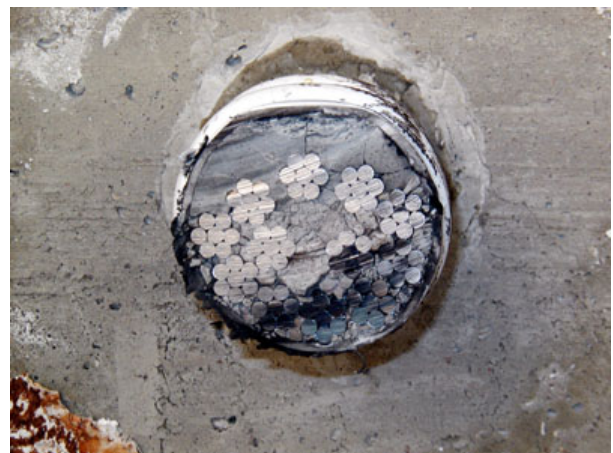
**Figure 5.25 Condition of Grout – Tendon 01**

(a) Condition of grout near fractured wires

(b) South anchor head

(c) Free length at north end of specimen

(d) North anchor block

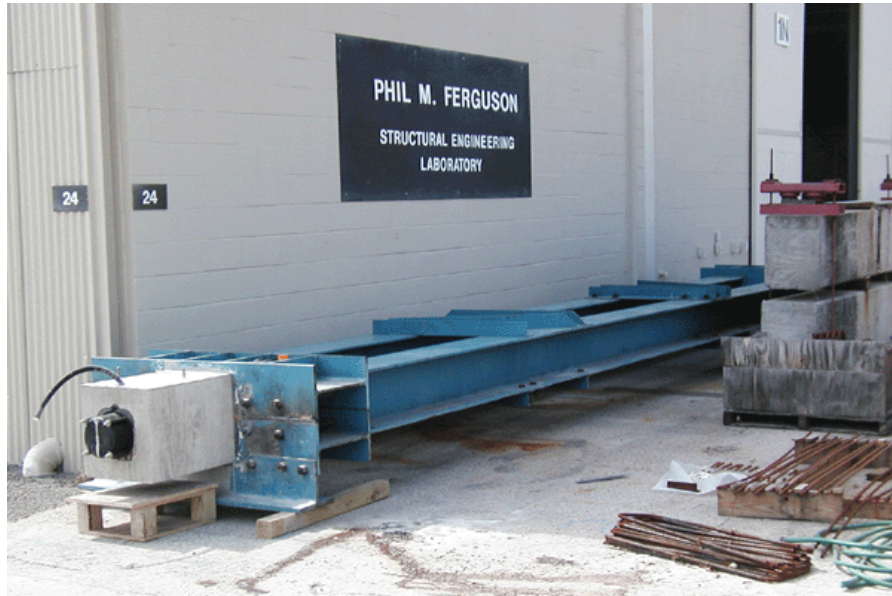
*Figure 5.26 Overview of Tendon 02*

The measured response of Tendon 02 is discussed in this section. Damage was induced in Tendon 02 by exposing the strand to acid over a five-month period (Figure 5.26). Wire breaks occurred at three locations along the length of the tendon where grout voids had been intentionally created. The natural frequencies of Tendon 02 were measured periodically during the exposure test.

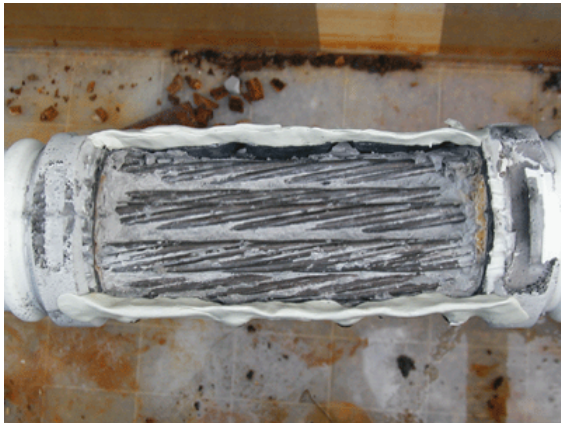
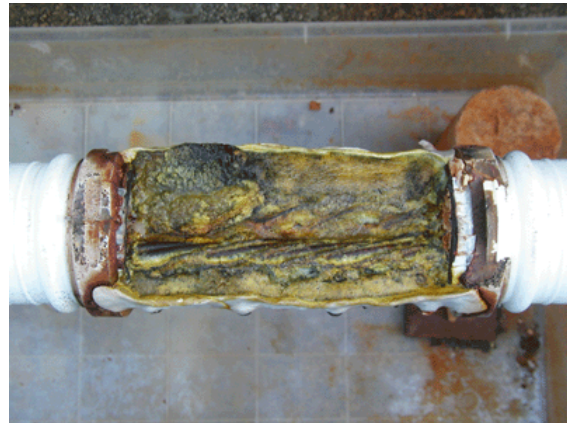
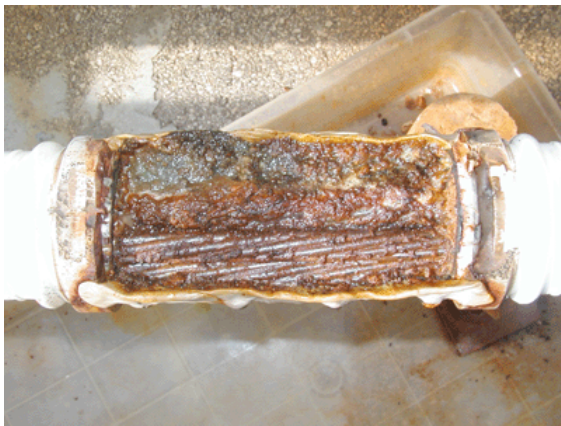
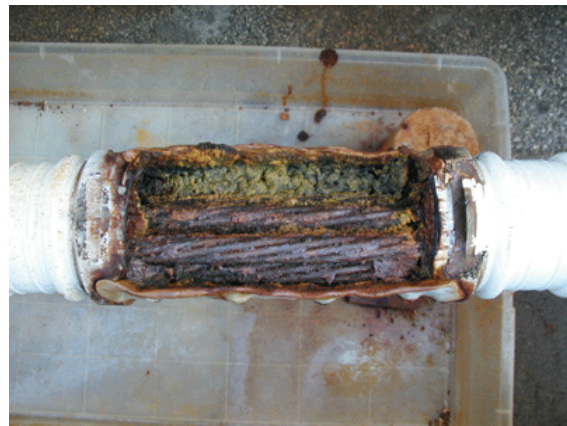
***Figure 5.27 Observed Response of Tendon 02 during Exposure to Acid***

Before the acid was ponded in the grout void, the grout was intact and no corrosion was observed on the surface of the strand (Figure 5.27a). When the acid was poured into the void, the solution immediately reacted with the grout and formed green bubbles (Figure 5.27b). These bubbles turned dark brown within 2 to 4 hours (Figure 5.27c). The bubbles were only generated during the first two to three weeks of exposure to the acid. These bubbles were not produced during the preliminary tests discussed in Appendix M; therefore, it is believed that the bubbles were a byproduct of the reaction between the acid and the cement grout, which has a high pH. The residue of these reactions was observed on the surface of the strand (Figure 5.27d).

(a) Before acid attack

(b) Chemical reaction: phase 1

(c) Chemical reaction: phase 2

(d) Residue from bubble

Most of the damage in Tendon 02 was detected by visual observation. Photographs taken when the acid was applied to Void 2 are shown in Figure 5.27 and are considered to be representative.

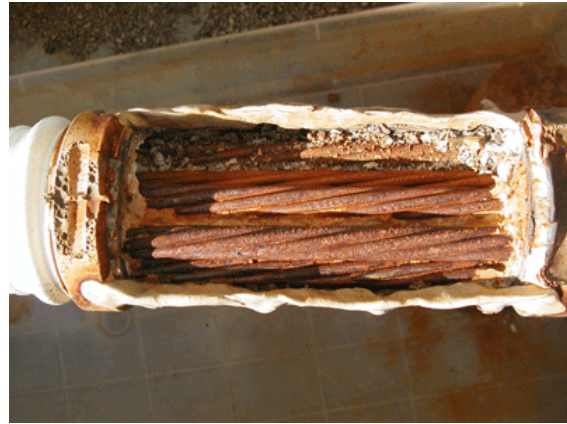
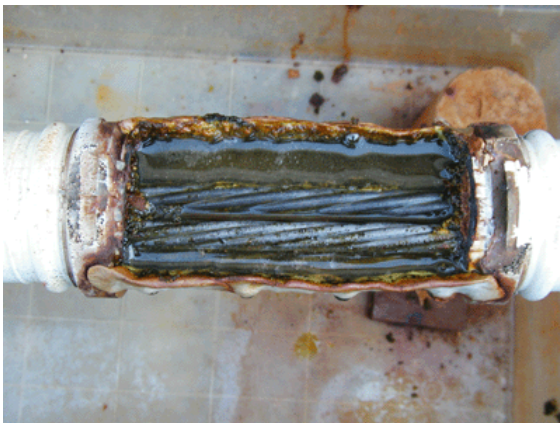
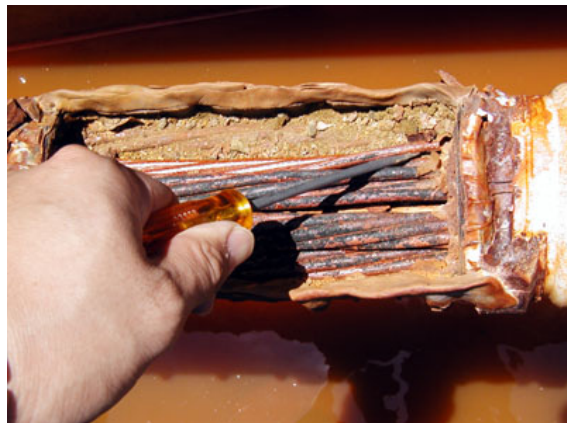
***Figure 5.27 (cont.) Observed Response of Tendon 02 during Exposure to Acid***

(f) Corrosion products after rain evaporated

(g) Void filled with acid

(h) Visual observation of broken wire

Because the voids were exposed to the environment, rain water also accumulated in the ponding regions. After rainfall, acid was not poured into the void to avoid overflow (Figure 5.27e). After the surface of the strand dried, corrosion products were visible (Figure 5.27f).

After several weeks, pouring acid into the void did not generate green bubbles and the surface of the strand appeared to be cleaned (Figure 5.27g). When the acid dried, corrosion products were once again visible on the surface of the strand (Figure 5.27h). A screwdriver was wedged into the strand to detect the presence of broken wires.

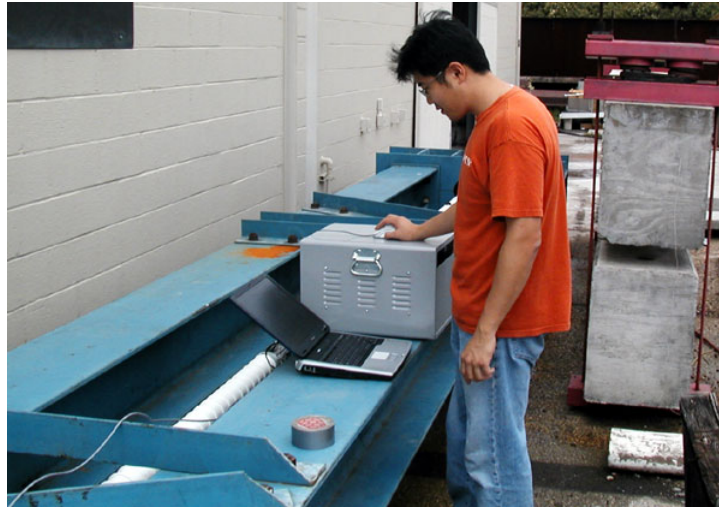
**Figure 5.28 Natural Frequency Measurement of Tendon 02**

The natural frequencies (Figure 5.28) of the test specimen were recorded twenty one times during the exposure test. The data are divided into three groups, based on the void where the acid was ponded at the time of the dynamic test. The test results are summarized in Table 5.10 through Table 5.12.

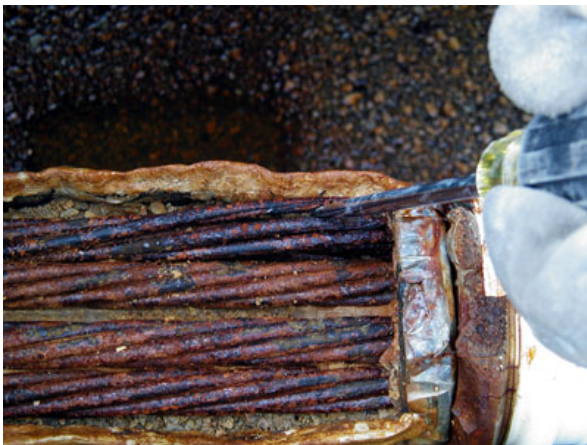
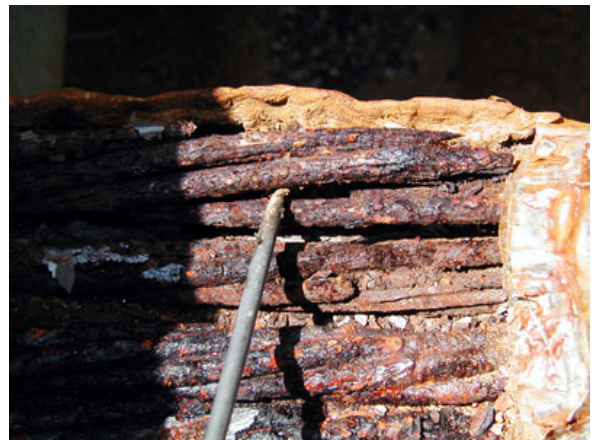
***Figure 5.30 Observed Wire Breaks at Void 1 at Conclusion of Exposure Test***

Following the completion of the exposure test on 8/6/06, additional wire breaks were identified in the vicinity of Void 1 (Figure 5.30) and Void 2 (Figure 5.31). Because

(a) First observation (4/12/06)

(b) Second observation (8/06/06)

these locations were only inspected while acid was ponded in these voids, nothing is known about when these wires fractured.

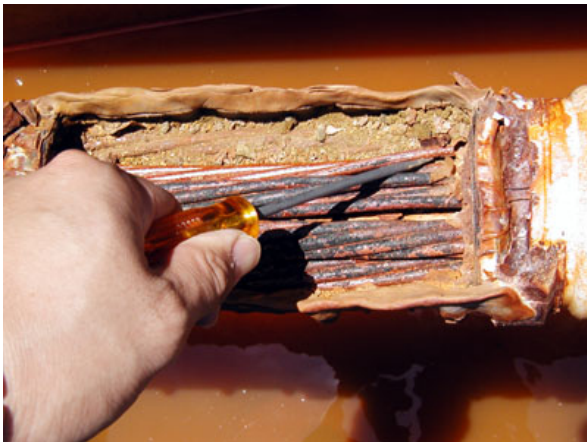
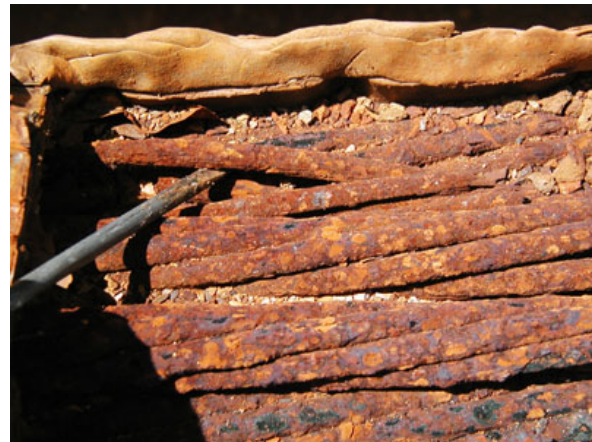
***Figure 5.31 Observed Wire Breaks at Void 2 at Conclusion of Exposure Test***

(a) First observation (6/25/06)

(b) Second observation (8/06/06)

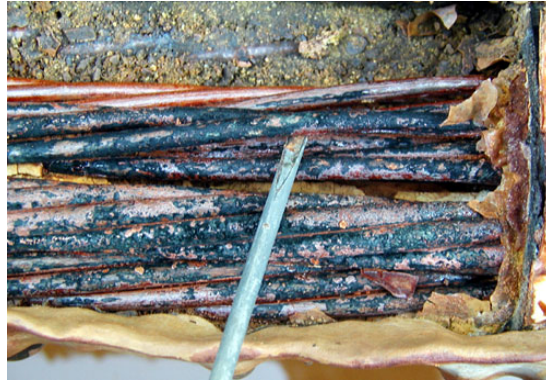
*Figure 5.32 Observed Wire Breaks at Void 3 at Conclusion of Exposure Test*

The condition of the strand in the vicinity of Void 3 is shown in Figure 5.32. Significant corrosion was observed on the surface of exposed strands in all voids and the surface of strands was blistered and roughened. Corrosion products were easily removed by tapping the strand with a screwdriver. In spite of the presence of severe corrosion products, severe pitting was not observed. Therefore, the strands appeared to fail by HIC.

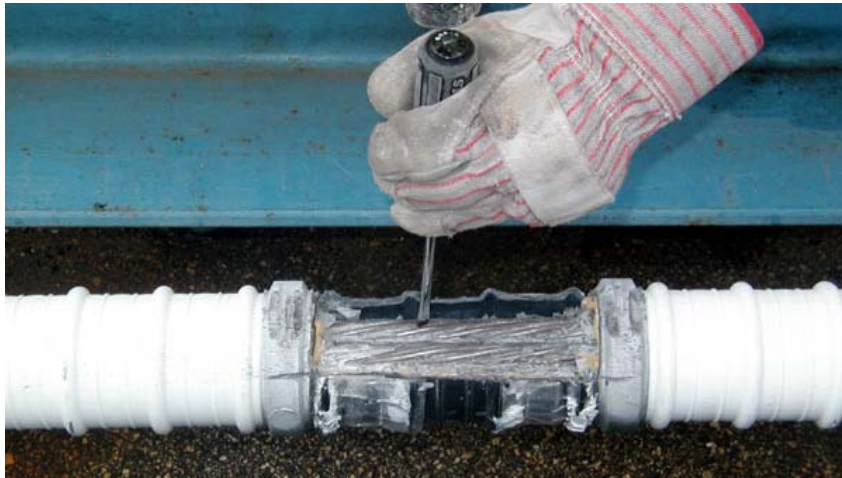
***Figure 5.34 Screwdriver Penetration Test***

The tests were conducted by testing the soundness of the strand within in Void 3 (Figure 5.33). The first test was performed between NF 6 and NF 7 and the second test was performed between NF 16 and NF 17 (Figure 5.34). In spite of numerous wire fractures observed in Voids 1 and 2 at the time of these tests, broken wires were not identified using the screwdriver penetration test. The grout appeared to absorb the energy from the wire fractures and maintain the original geometry of strands. In the case of the grouted tendon, the broken wire is expected to recover a portion of the original axial stress, such that the screw driver cannot penetrate between wires several feet from the wire break.

The screwdriver penetration test was originally developed to detect wire fractures in unbonded tendons. For this situation, the stress in the broken wire is released and the wire unravels from the strand. A screwdriver struck by a hammer can be pushed beneath the broken wire. The same approach was used to determine if stress in a broken wire in a grouted tendon recovers with distance from the wire break.

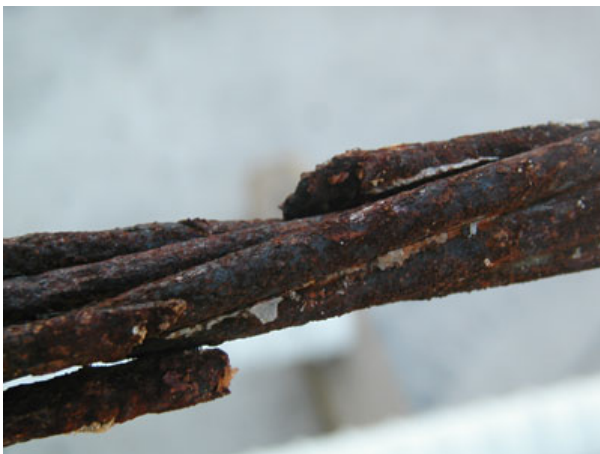
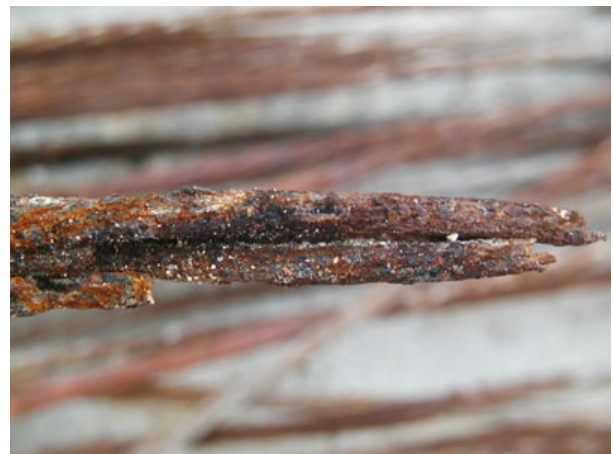
***Figure 5.35 Condition of Strand Observed during Autopsy***

Tendon 02 was disassembled at the end of the exposure test to determine the extent of damage. Thirty wire breaks were identified (Figure 5.35): 16 in the vicinity of Void 1, 11 in the vicinity of Void 2, and 3 in the vicinity of Void 3. Nine of these wire breaks occurred in the second layer of strands, which is why the breaks were not observed in the visual inspection conducted at the end of the exposure test. The grout was fragmented along nearly the entire length of the tendon. The grout in the vicinity of the voids was nearly completely pulverized (Figure 5.36).

(a) Fractured wires

(b) Completely fractured strand

While 30 wire breaks were identified in the three voids, it is expected that this number over-estimated the loss of cross-sectional area in the tendon. Because the same strand were exposed in each void, it is likely that wires in the same strand fractured in more than one void. Therefore, the loss of cross-sectional area of the strands was conservatively expected to higher than a maximum number of wire breaks in single void: 16 wire fractures in Void 1.

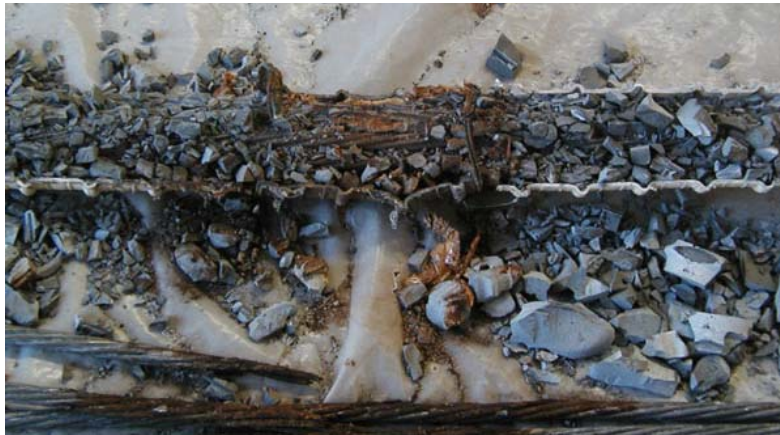
*Figure 5.36 Condition of Grout in Vicinity of Void 1 after Autopsy*

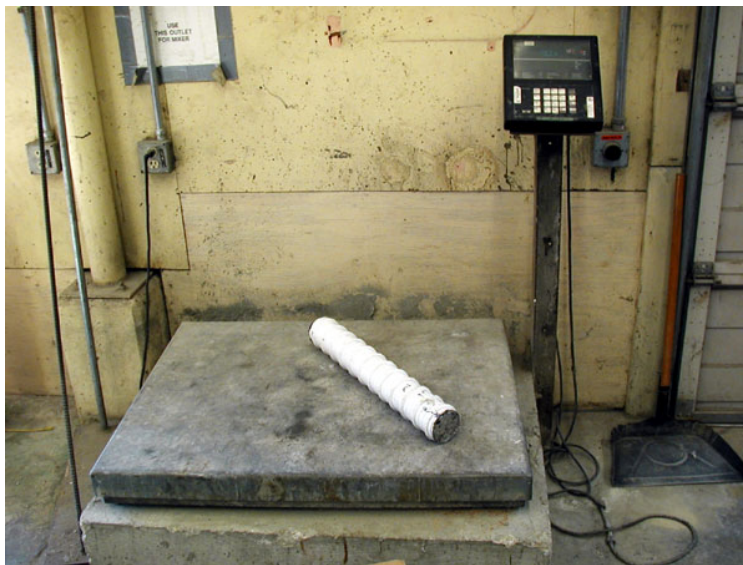
**Figure 6.2 Portion of Test Specimens used to Determine Weight per Unit Length**

During the autopsy, the weight of a short length of each specimen, except Cable 01, was measured (Figure 6.2). The measured weight per unit length is compared with the calculated weight in Table 6.1. The calculated weight of the cable specimens was approximately 6% percent less than the measured unit weight, and the calculated weight

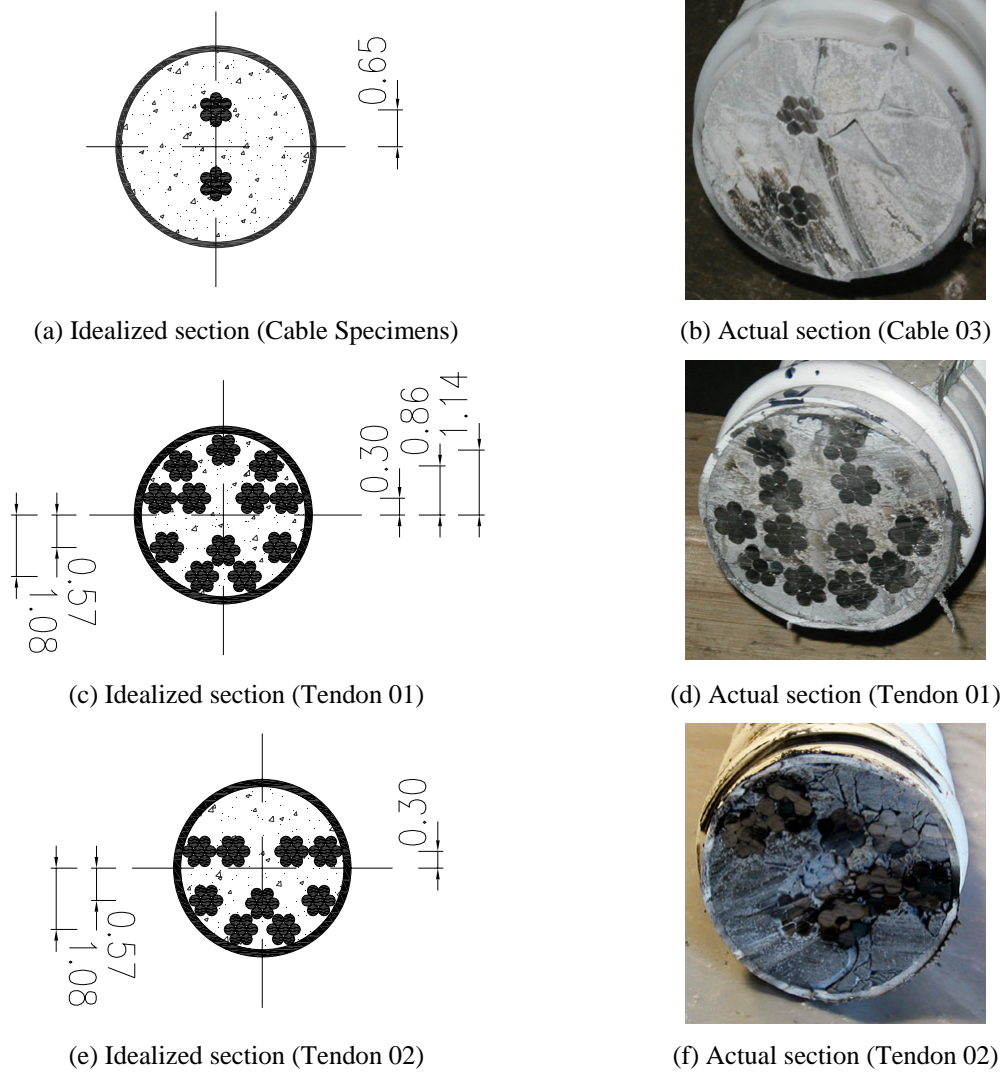
**Figure 6.3 Idealized and Observed Locations of Strands within Cross Sections**

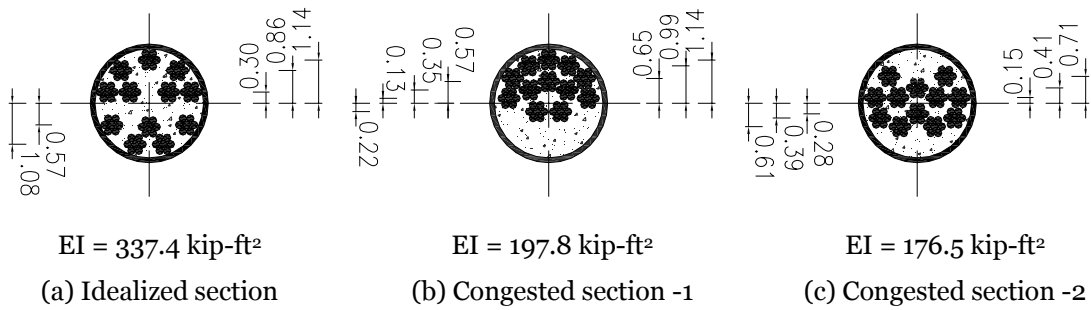
**Figure 6.12 Possible Arrangements of Strands in Tendon 01**

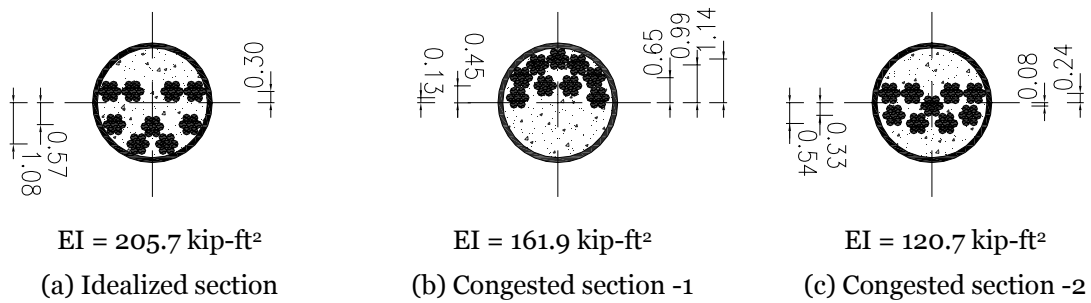
**Figure 6.13 Possible Arrangements of Strands in Tendon 02**

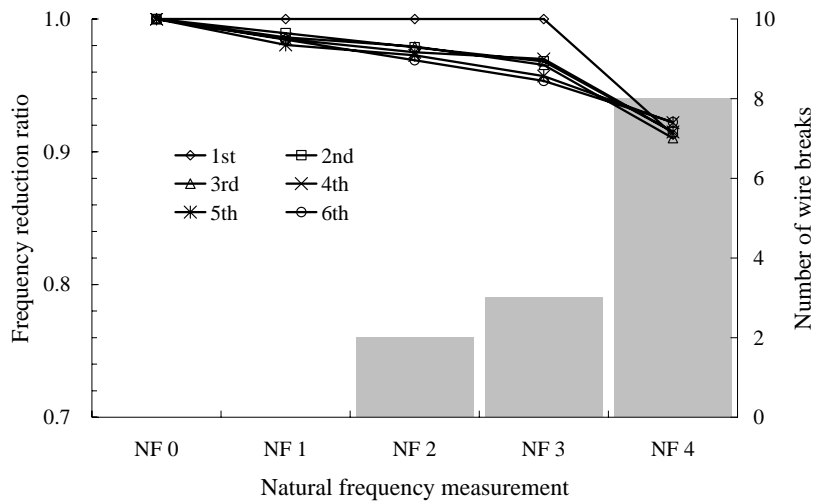
**Figure 7.1** Frequency Reduction Ratio for Cable 01

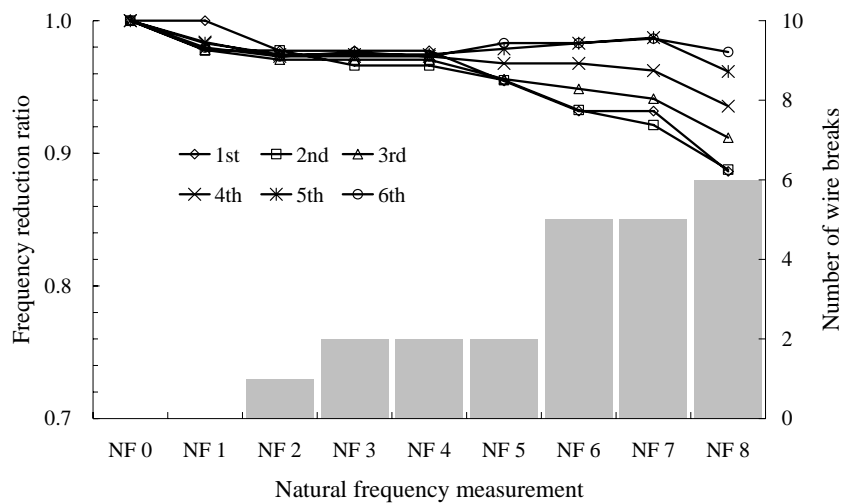
**Figure 7.2 Frequency Reduction Ratios for Cable 02**

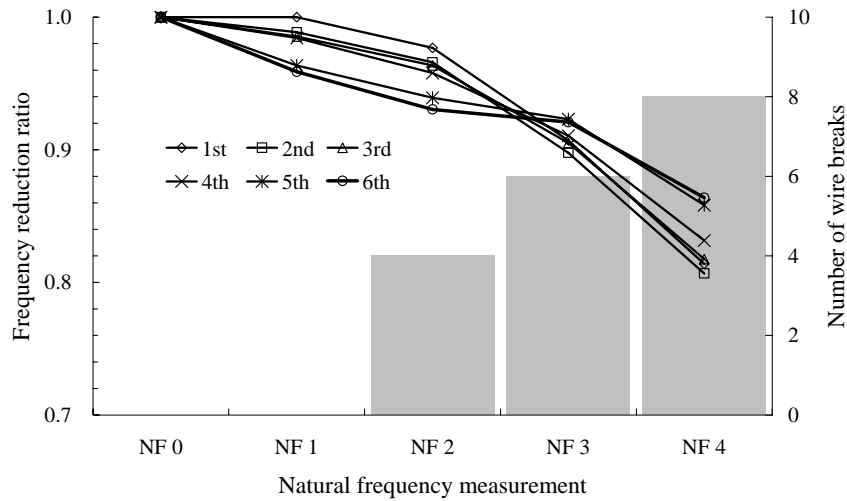
**Figure 7.3 Frequency Reduction Ratio for Cable 03**

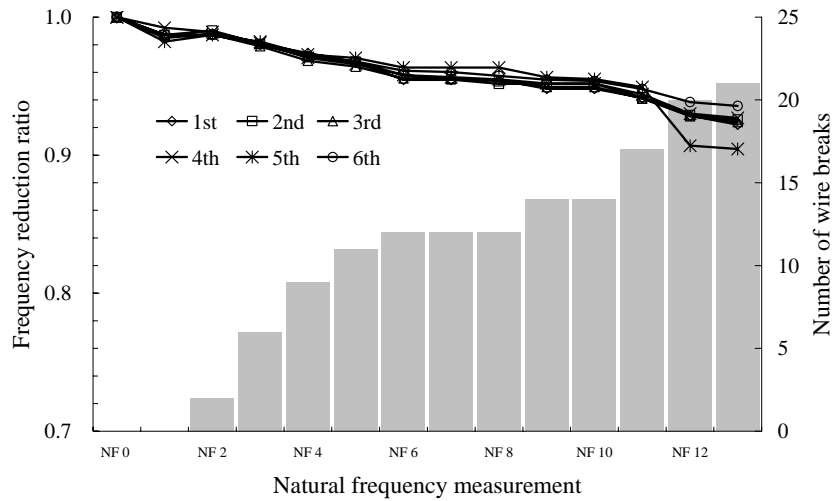
**Figure 7.4 Frequency Reduction Ratios for Tendon 01**
