**Evaluation of External Post-Tensioned Tendons using Vibration  
Signatures**

**Dissertation**

The University of Texas at Austin

**May 2007**

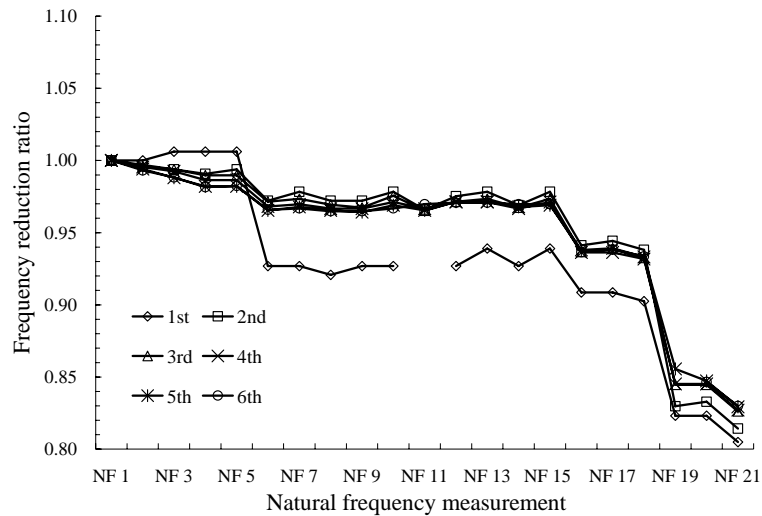
**Figure 7.5 Frequency Reduction Ratios for Tendon 02**

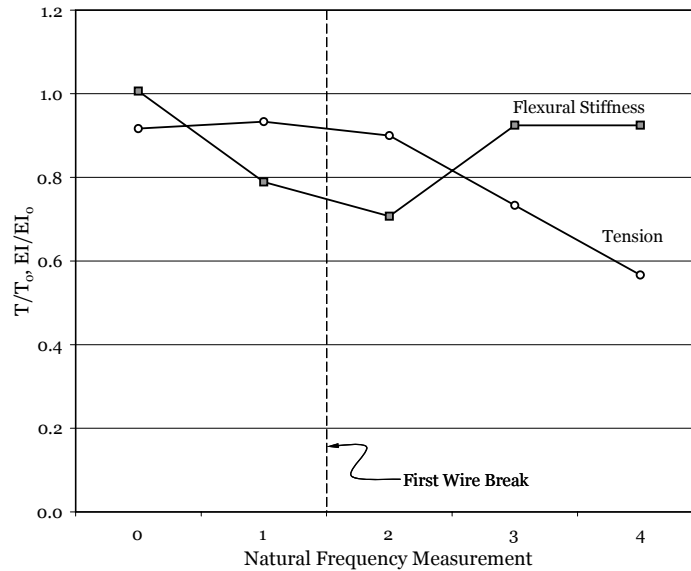
**Figure 7.13 Variation of  $T$  and  $EI$  during Fatigue Test for Cable 03**

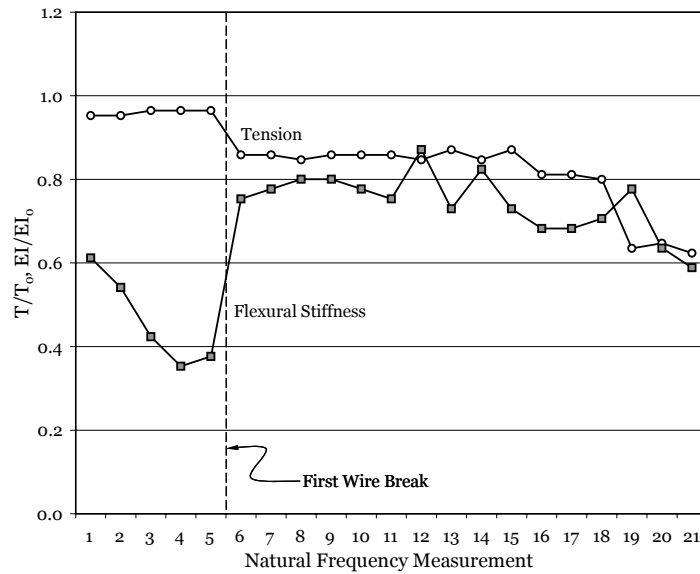
**Figure 7.15 Variation of  $T$  and  $EI$  during Exposure Test for Tendon 02**

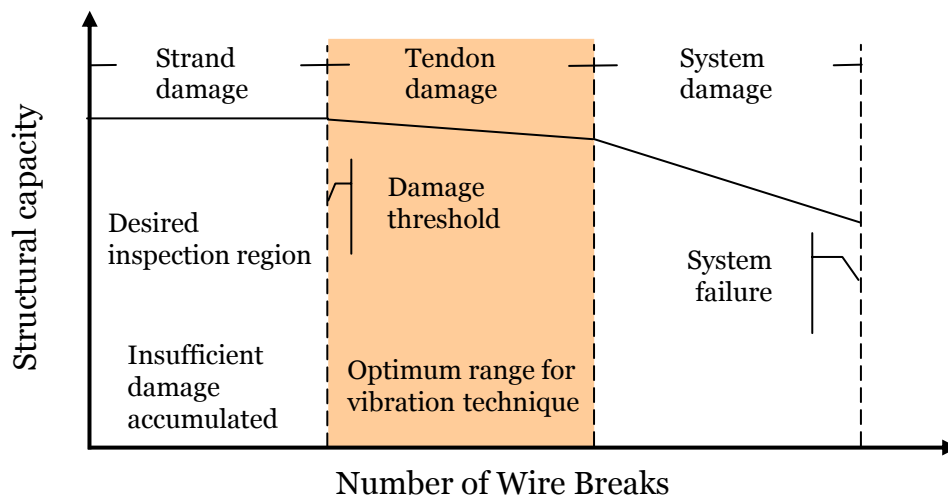
**Figure 7.17 Idealization of Variation in Structural Capacity with Increasing Damage**

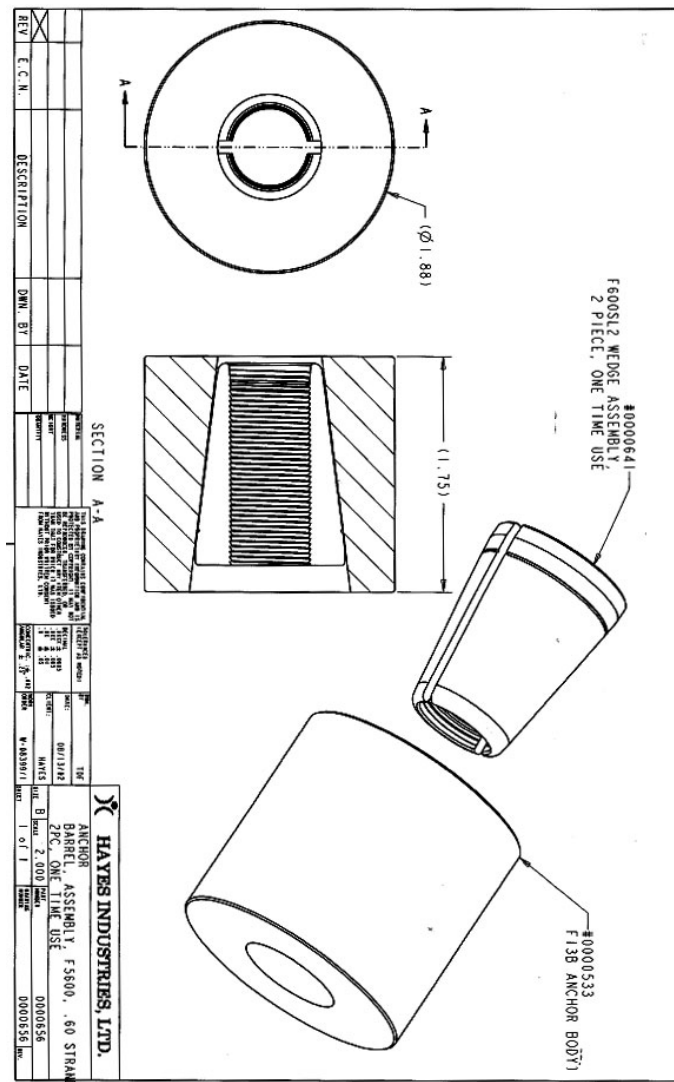
Figure A.1 Drawing of Anchor Barrel

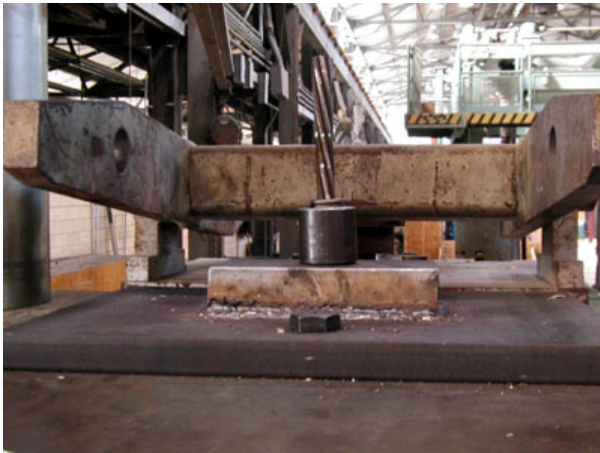
In each cross head, the steel plate was positioned to accommodate the anchor barrel. A shim and jaw of the uniaxial machine was removed and replaced with the steel plate (Figure A.2). The steel plate was fabricated using two plates and attached by welding (Figure A.3). The plate had a 5/8-in diameter hole in center and a total thickness was 2.5 in. This steel plate was fixed to the cross beam by two bolts.

(a) Top cross head

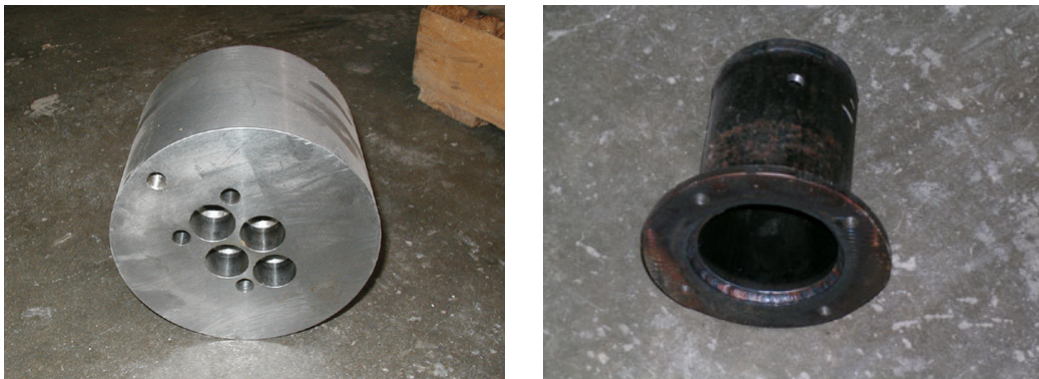
*Figure C.1 Anchor Head and Grout Cap*

The anchor heads and the grout caps were manufactured to grip two, 0.6-in. strands and contain grout as shown in Figure C.1. The anchor head had 7-in. diameter and 5-in. thickness. The anchor head was originally designed with four holes. Later the two extra holes were sealed with an epoxy or silicone. The grout cap was fabricated from a steel plate and pipe. Grout vents were located near the end of each cap. The grout cap was connected to the anchor head by four bolts on the flange.

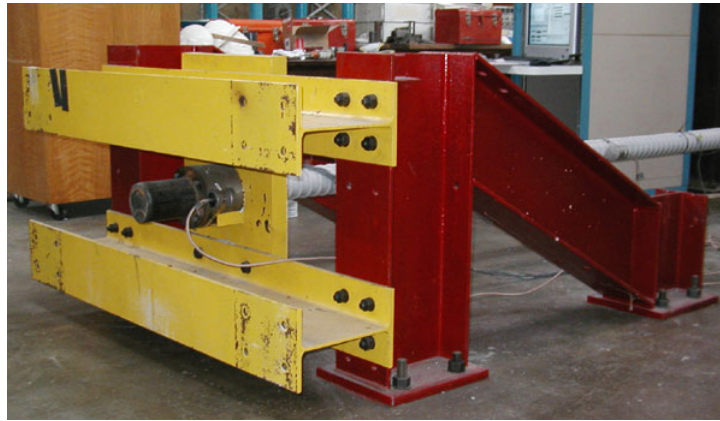
*Figure C.2 Reaction Frame and Anchorage Assembly*

The anchor heads were supported by two buttresses, which were constructed from W 12×40 sections. The buttresses were bolted to the laboratory floor and were positioned about 50 ft apart. Two beams spanned between the buttresses and a 2-in. plate spanned between the beams (Figure C.2).

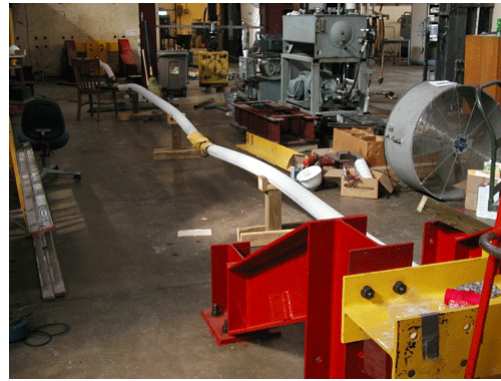
*Figure C.3 Assembly of Cable Specimen*

(b) Initial assembly of the specimen

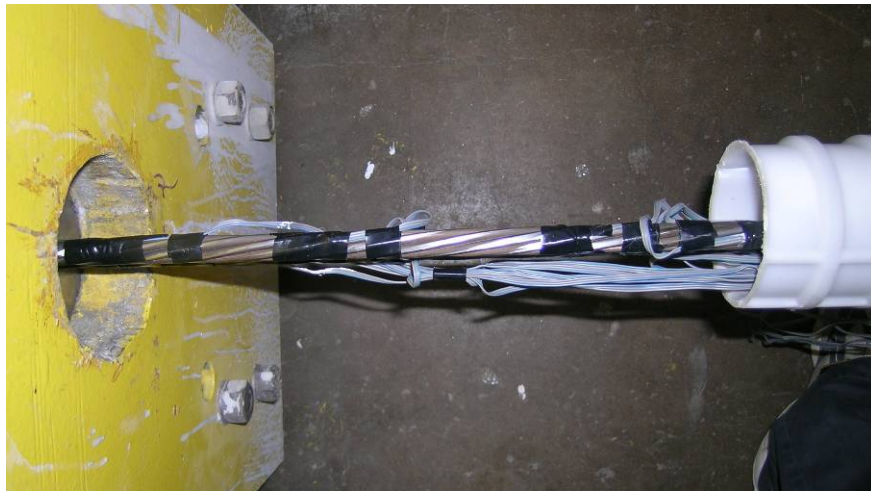
*Figure C.5 Strain Gage Installation*

After the stressing procedure was completed, strain gages were attached to the strand (Figure C.5). The strain gages were manufactured by the Tokyo Sokki Kenkyujo Company (model FLA-3-11-5LT). The gages were attached at desired locations using a cyanoacrylate adhesive and wrapped by an insulated tape. The strain gages were positioned along the longitudinal axes of outer wires. The number and location of gages varied for each specimen.

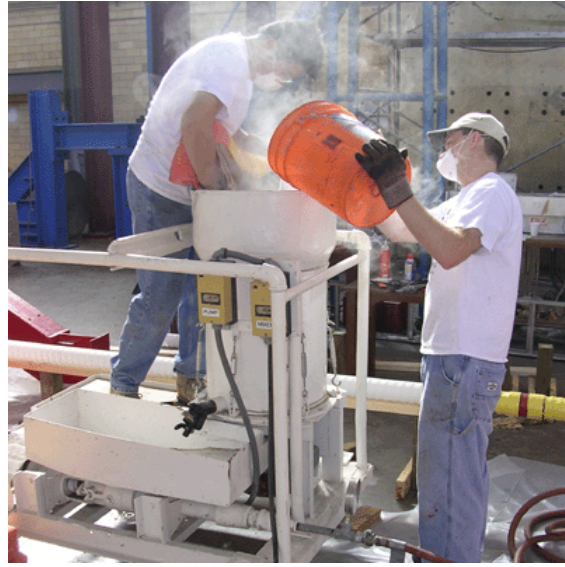
***Figure C.7 Grouting Procedure***

(b) Grout mixing and pumping

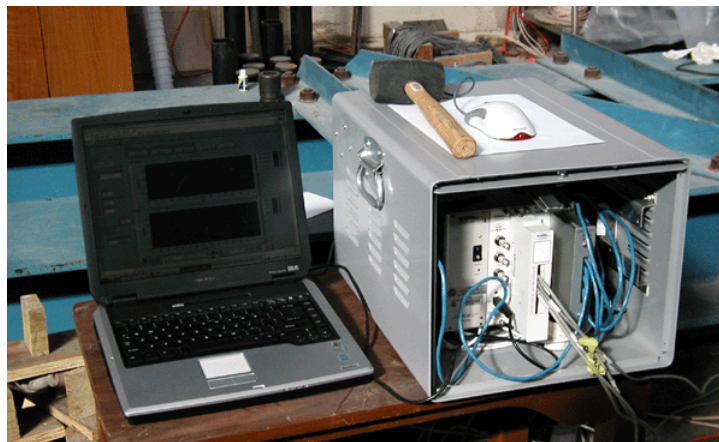
*Figure E.1 DAQ System*

The portable DAQ system consisted of a signal conditioning box manufactured by National Instruments<sup>TM</sup> and a laptop computer with a LabView 7.1 software. The signal conditioning box was composed of a chassis, an input module, and a terminal block (Figure E.1). The chassis (NI SCXI-1000) offered the sampling rate of 333 kS/sec. Inside of this box, the input module (NI SCXI-1520) was plugged to conduct signal conditionings such as filtering and signal amplification. At the end of this module, the terminal block (NI SCXI-1314) was connected to link an accelerometer to the signal conditioning box. The signal conditioning box was enclosed by a 2×2×1 ft metal box for protection against external impact. This system was connected a laptop using a USB cord and operated by a PC based software.

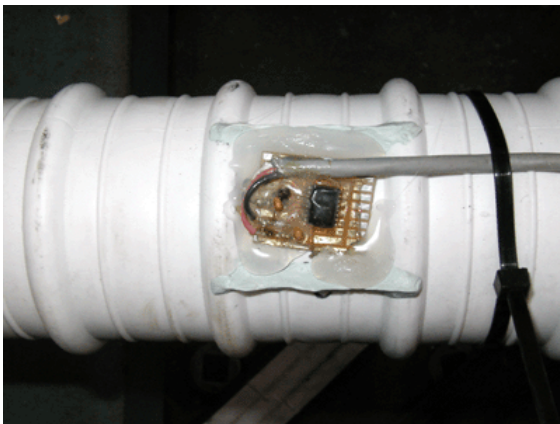
The product was purchased in parts and assembled in the laboratory. After assembly and the sensor was covered with a transparent epoxy. This type of accelerometers was attached to all cable specimens and Tendon 01 using a hot-melting glue (Figure E.2a). Later, the dimension of the accelerometers was minimized by removing unused circuit plate. The sensors were also enclosed in a plastic cubic box and covered with a chemical compound (Figure E.2b). This type of sensors was applied for the outdoor test; Tendon 02.

(a) Original accelerometer (Tendon 01)

The low G micro machined accelerometer (model MMA 1220D) from the Freescale Semiconductor<sup>TM</sup> was used for dynamic measurements. This sensor had various advantageous features for the vibration test. This sensor could measure a amplitude of acceleration to  $\pm 8g$  and hold without permanent damage against 1.2-m drop. This sensor offered the typical bandwidth of 250 Hz and valued about \$ 30.

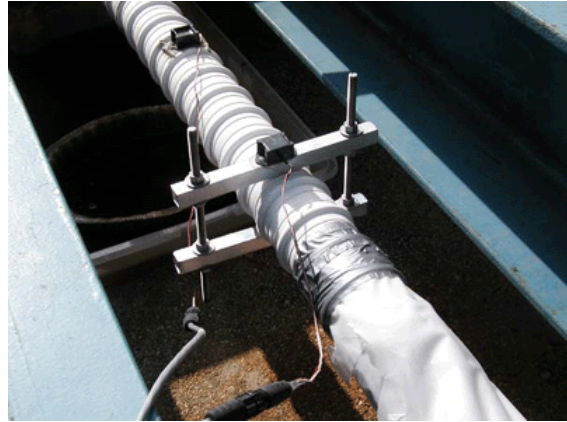
***Figure E.3 Portable Sensor and Connector***

(b) Portable frame

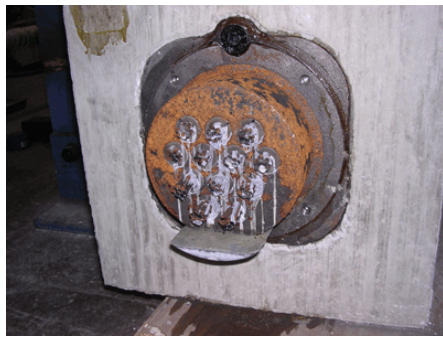
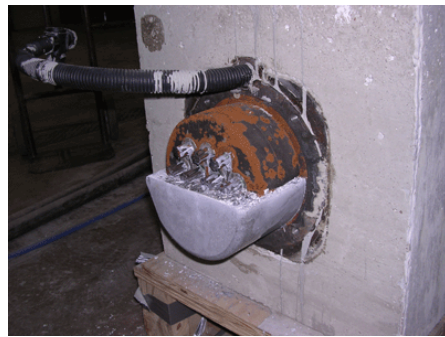
***Figure L.2 Anchor Head Status***

(c) Anchor head (north)

(d) Anchor head (south)

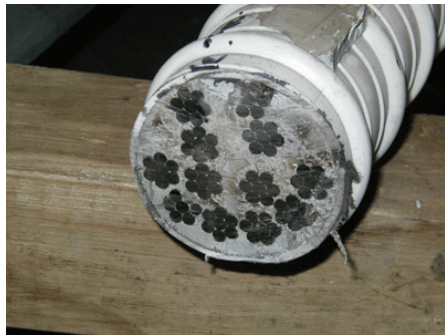
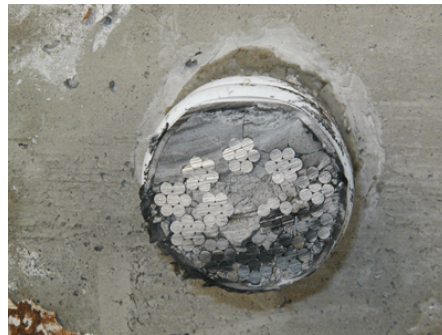
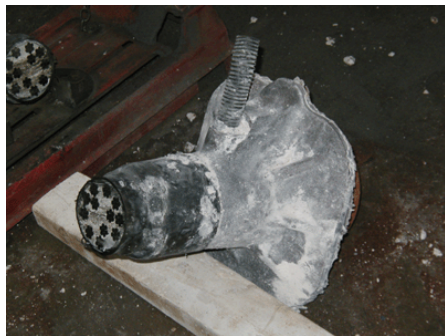
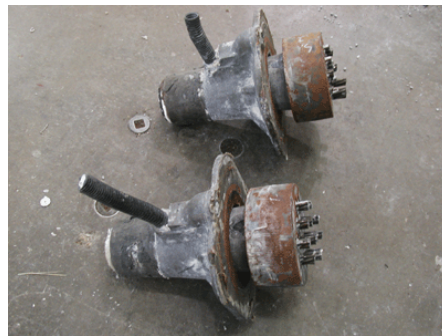
***Figure L.3 Grouting Condition at Various Locations***

No grout void was identified along the length of the specimen (Figure L.3), which indicated that grout did not flow over the anchor heads during the grouting. The existence of the transparent water in the anchor cap proved that the material separation between grout paste and water occurred; the grout bleeding. However, considering that condition of grout was intact along the length, the grout bleeding was unlikely to result from grout

(a) Middle section

(b) Concrete block

(c) Anchor plate

(d) Anchor head

material. Further disassembling of the specimen concluded that corrosion developed only at the exposed surface of the anchor heads and the anchor plates (Figure L.4).

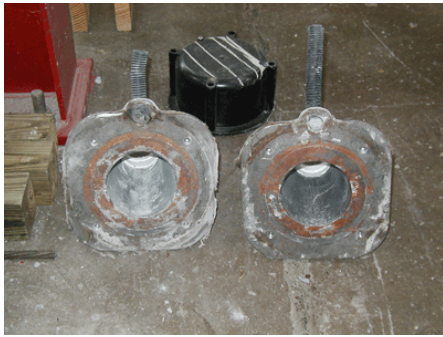
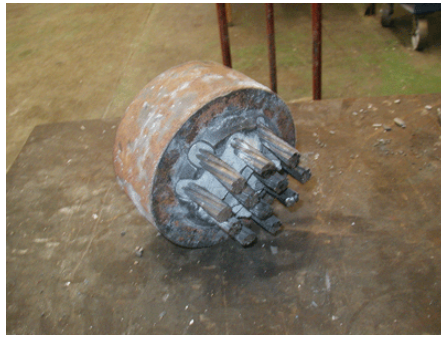
The grout bleeding generally occurs soon after the grouting procedure before the grout is hardened. In Tendon 01, the grout appeared to not penetrate into the holes in the anchor heads and rather separate into paste and water. The grout was pumped from the south end to north end. The grout inlet was located at the face of the anchor plate and two grout outlets were located on top of each concrete block (Figure L.5). The pumping was terminated after considerable grout flowed from the outlets.

(a) Bearing plate

(b) Anchor head (north)

The observations made during the autopsy suggest that the pressure of the pump was not sufficient to flow grout over the anchor head. The grout covered more the surface of the anchor head in south end where the electric pump was located than north end; thus, higher pressure was expected in south end than north end.

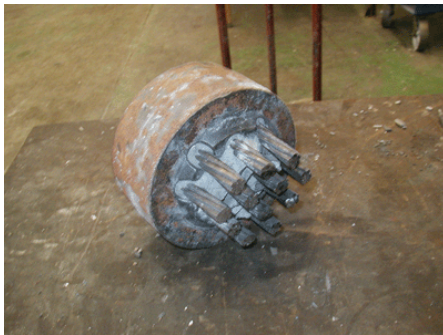
(c) Strands and wedges (south)

***Figure L.4 Corrosion Extent on Anchor Head and Plate***

Aggressive corrosion was identified from the anchor heads of Tendon 01 when the test was terminated. The surface of the anchor head was originally designed to be covered with grout. However, the space in the anchor cap was not filled with grout and more than half of surface of the anchor head was exposed to the air. This observation was considered to be important in three points:

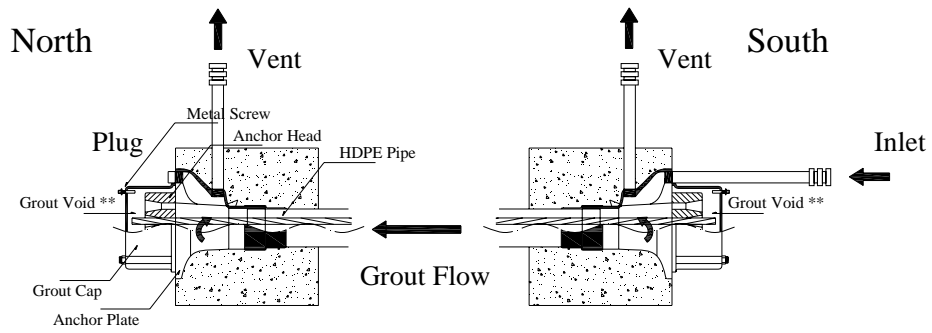
**Figure L.5 Grout Flow of Tendon 02**

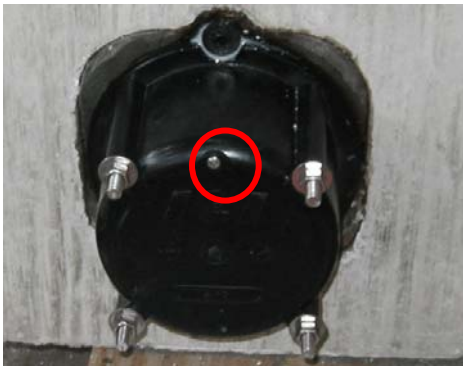
(a) Metal screw

The modified type of the anchor cap was recognized from the another project in the Ferguson Structural Engineering Laboratory (Figure L.6b). The cylinder was positioned on top of the anchor cap to provide air path and a small cap was designed to function as the metal screw in Tendon 01.

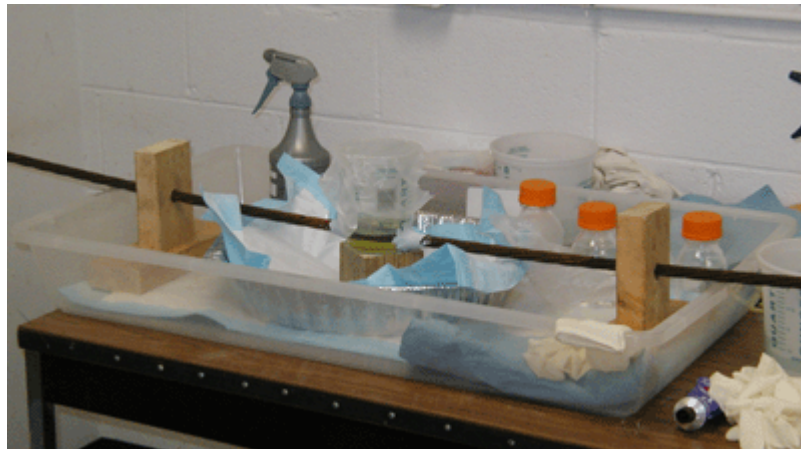
*Figure M.1 Acid Immersion Test*

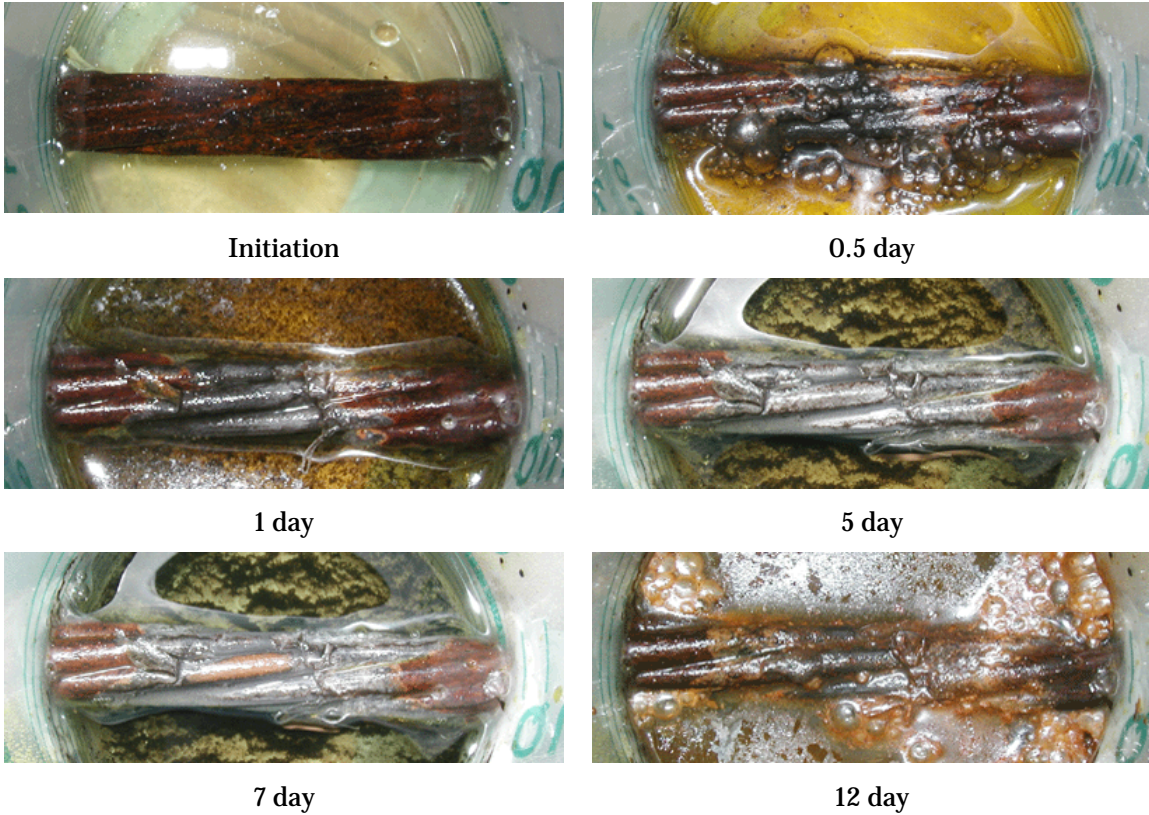
***Figure M.2 Preliminary Strand Immersion in Hydrochloric Acid Solution***
