**NONLINEAR TIME HISTORY AND PUSH-OVER ANALYSES
FOR SEISMIC DESIGN AND EVALUATION**

Dissertation

the University of Texas at Austin

December 1996

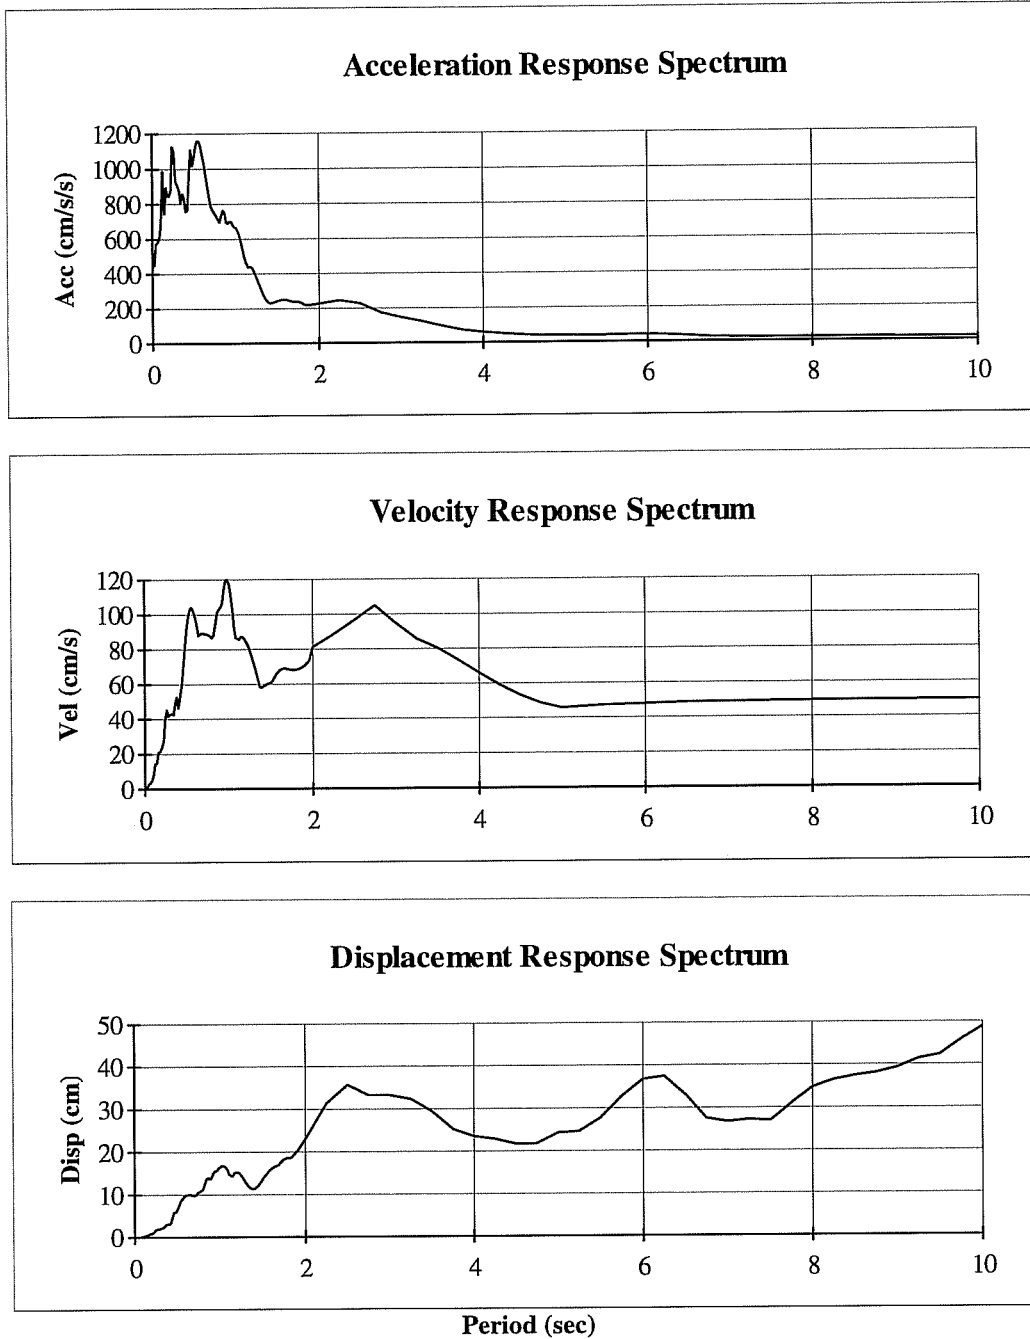
Figure 2.2 Computation of Deformation (or Displacement) Response Spectrum¹⁵

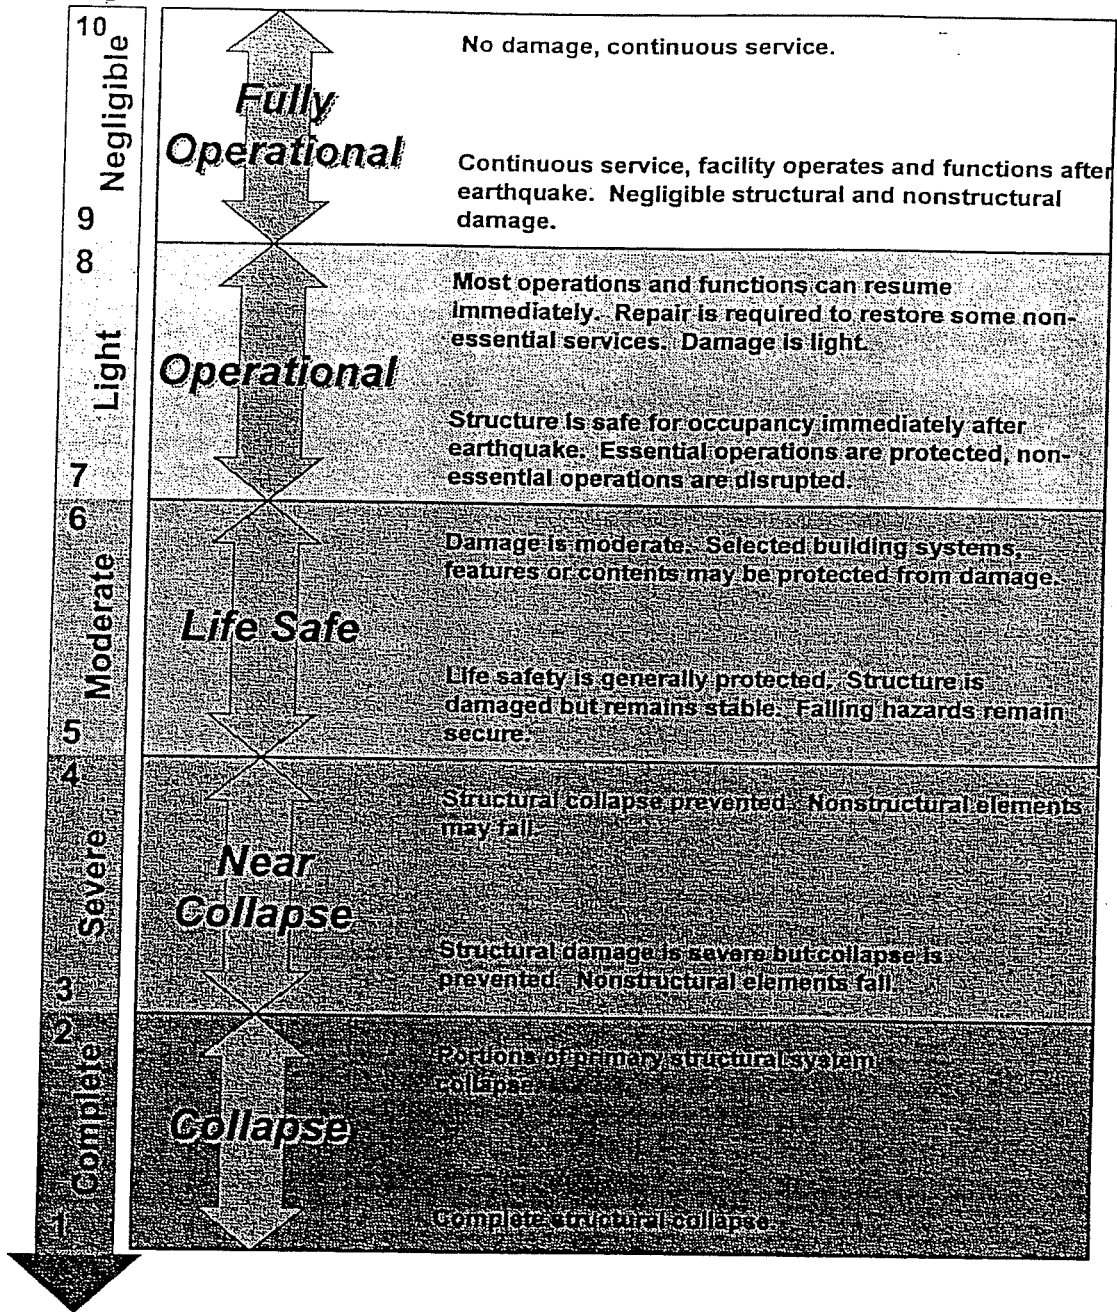
Damage States and Performance Level Thresholds

Figure 2.12 Spectrum of Damage States⁵⁹

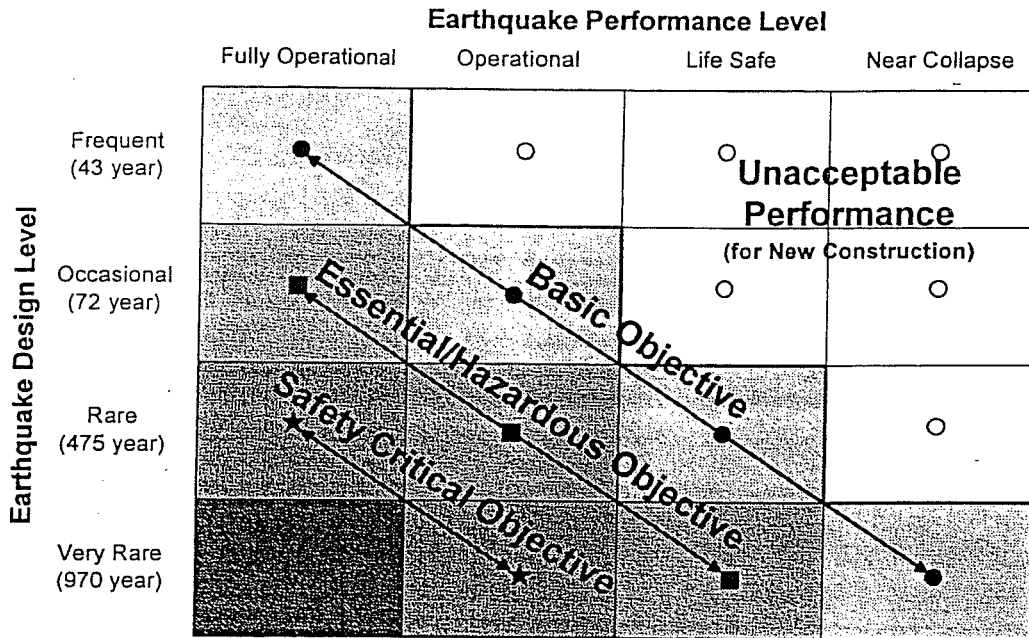
Earthquake Design Level	Recurrence Interval	Probability of Exceedance
Frequent	43 years	50% in 30 years
Occasional	72 years	50% in 50 years
Rare	475 years	10% in 50 years
Very Rare	970 years ^{10,44}	10% in 100 years ^{10,44}

Figure 2.13 Recommended Performance Objective for Buildings⁵⁹

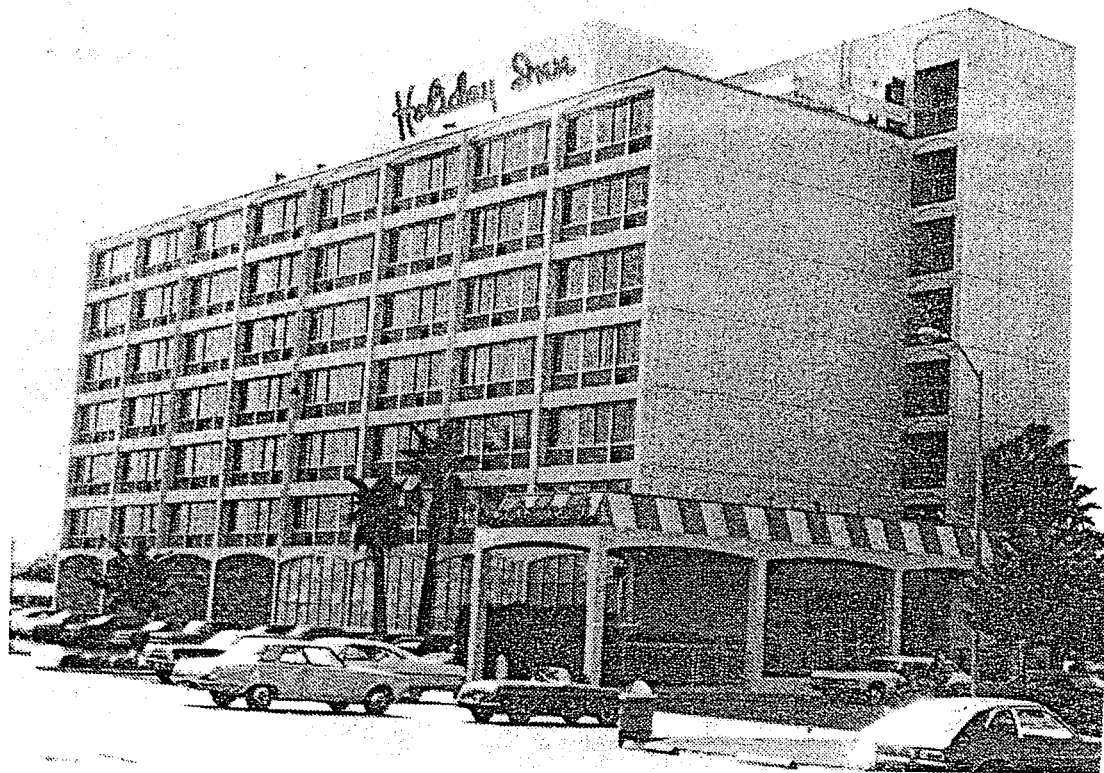
The seven-story hotel is a reinforced concrete frame structure designed in 1965 at a construction cost of 1.3 million dollars. An elevation of the building is shown in Figure 3.1. The building is located in the center of the San Fernando Valley. Geologic source data show that the site lies on recent alluvium. The typical soil boring logs show the underlying soil to be primarily fine sandy silts and silty fine sands⁴⁶.

Figure 3.1 Seven-Story Hotel at Orion Avenue. Northwest Elevation⁶⁸

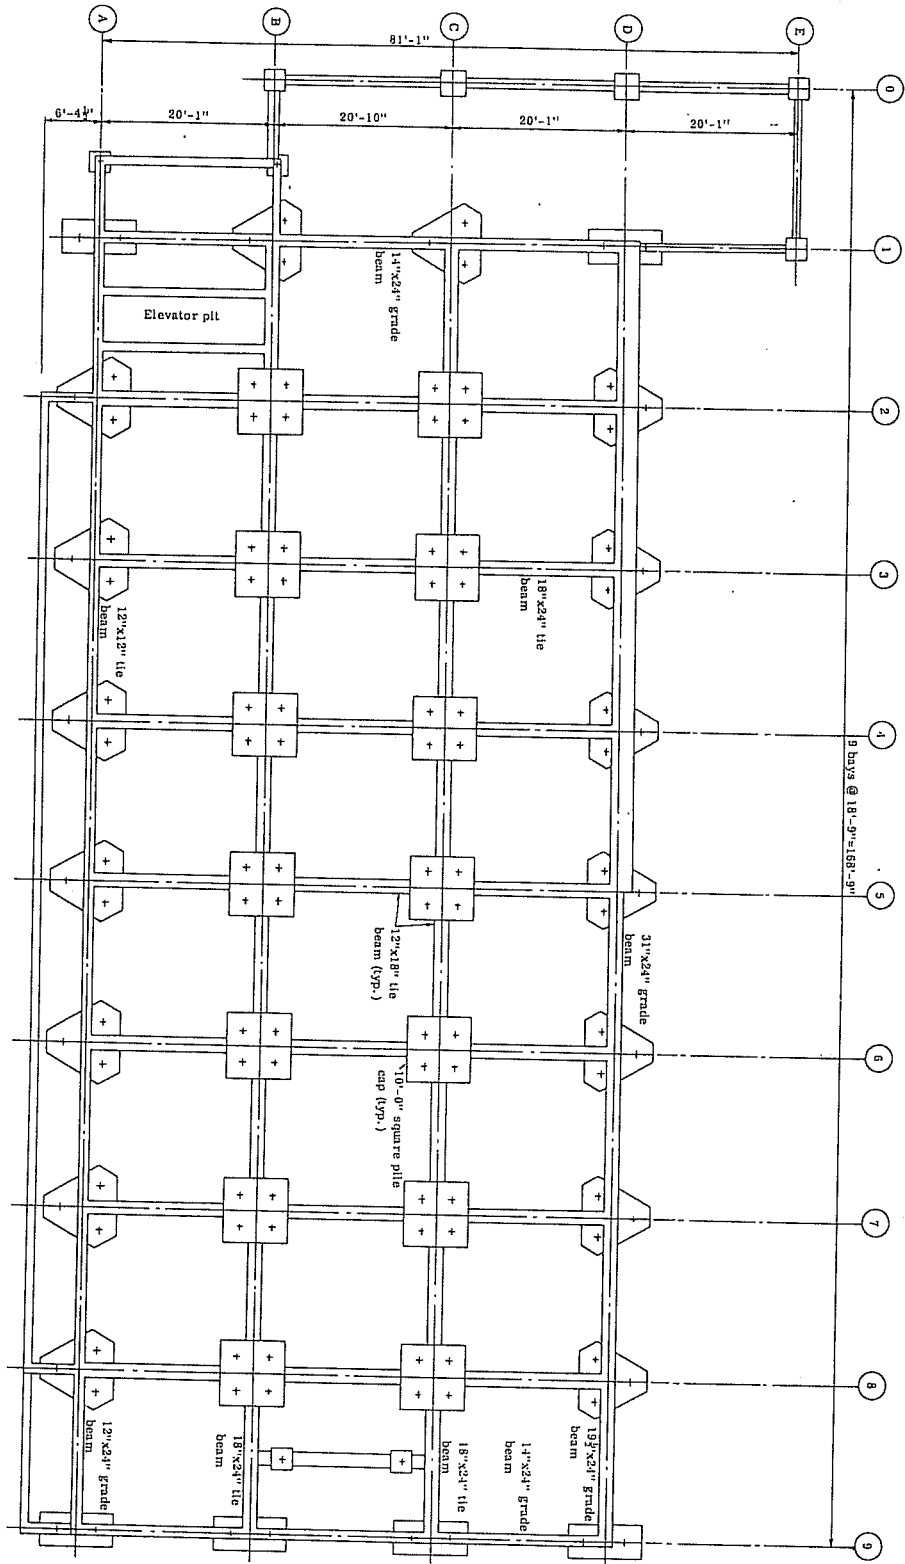
Figure 3.2 Seven-Story Hotel. Foundation Plan⁶⁸

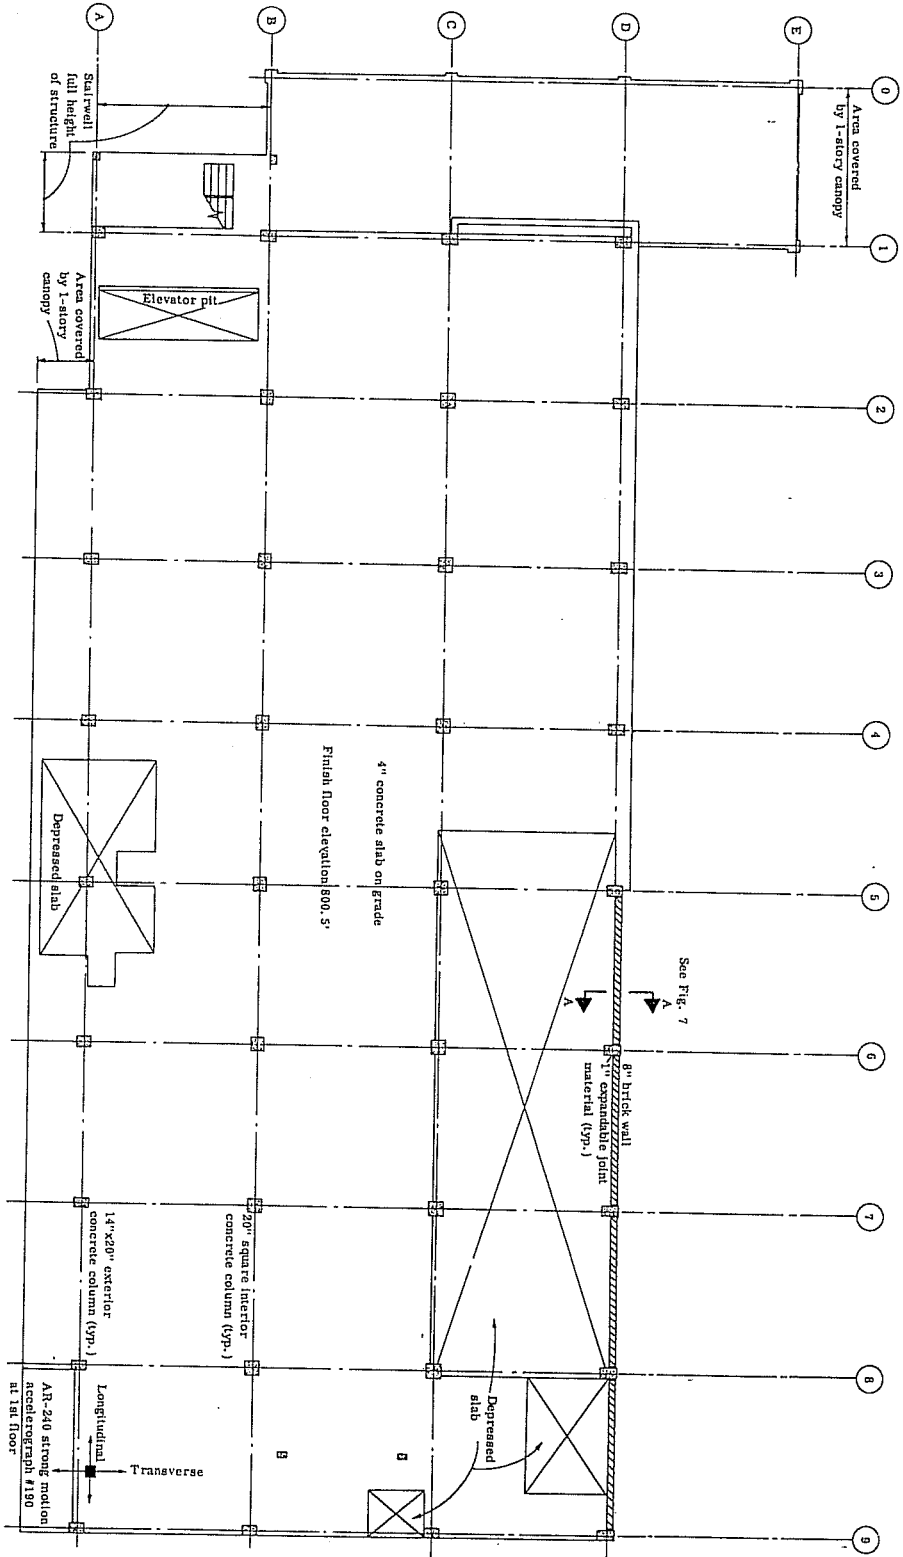
Figure 3.3 Seven-Story Hotel. First-Floor Plan⁶⁸

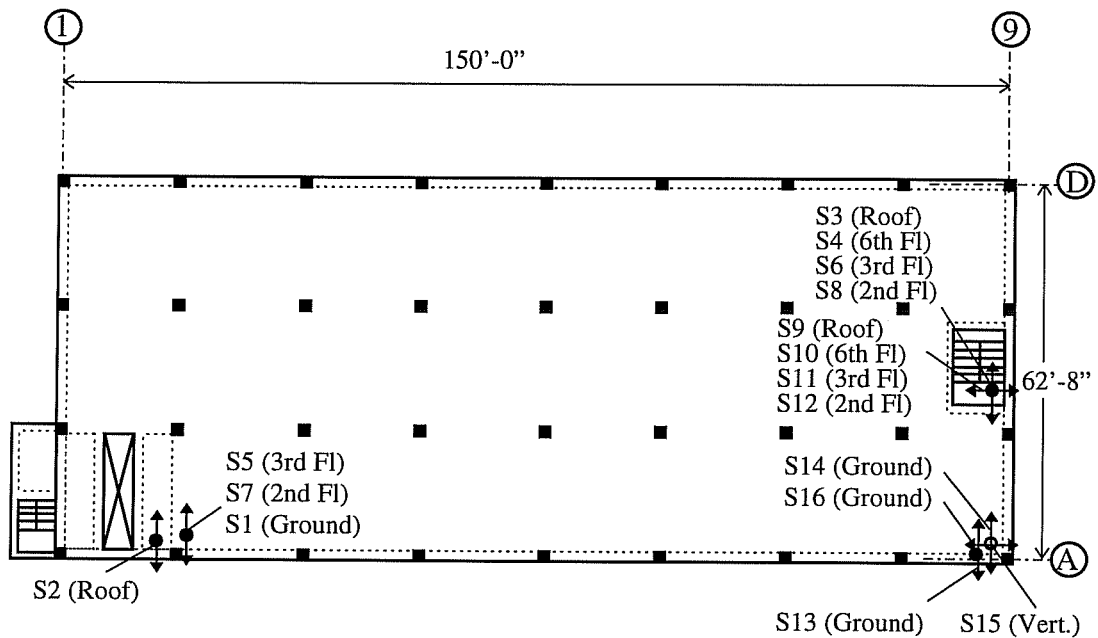
Figure 3.10 Seven Story Hotel Sensor Location at the 1994 Northridge Earthquake

The building is located approximately 4.5 miles east of the epicenter. It suffered severe damage during the earthquake and was red-tagged after post-quake inspection. The building was extensively instrumented at the time the earthquake struck and motions were recorded by sixteen sensors. Among these sensors, ten sensors recorded North-South motion, five sensors recorded East-West motion, and one recorded vertical motion. The sensor locations are shown in Figure 3.10.

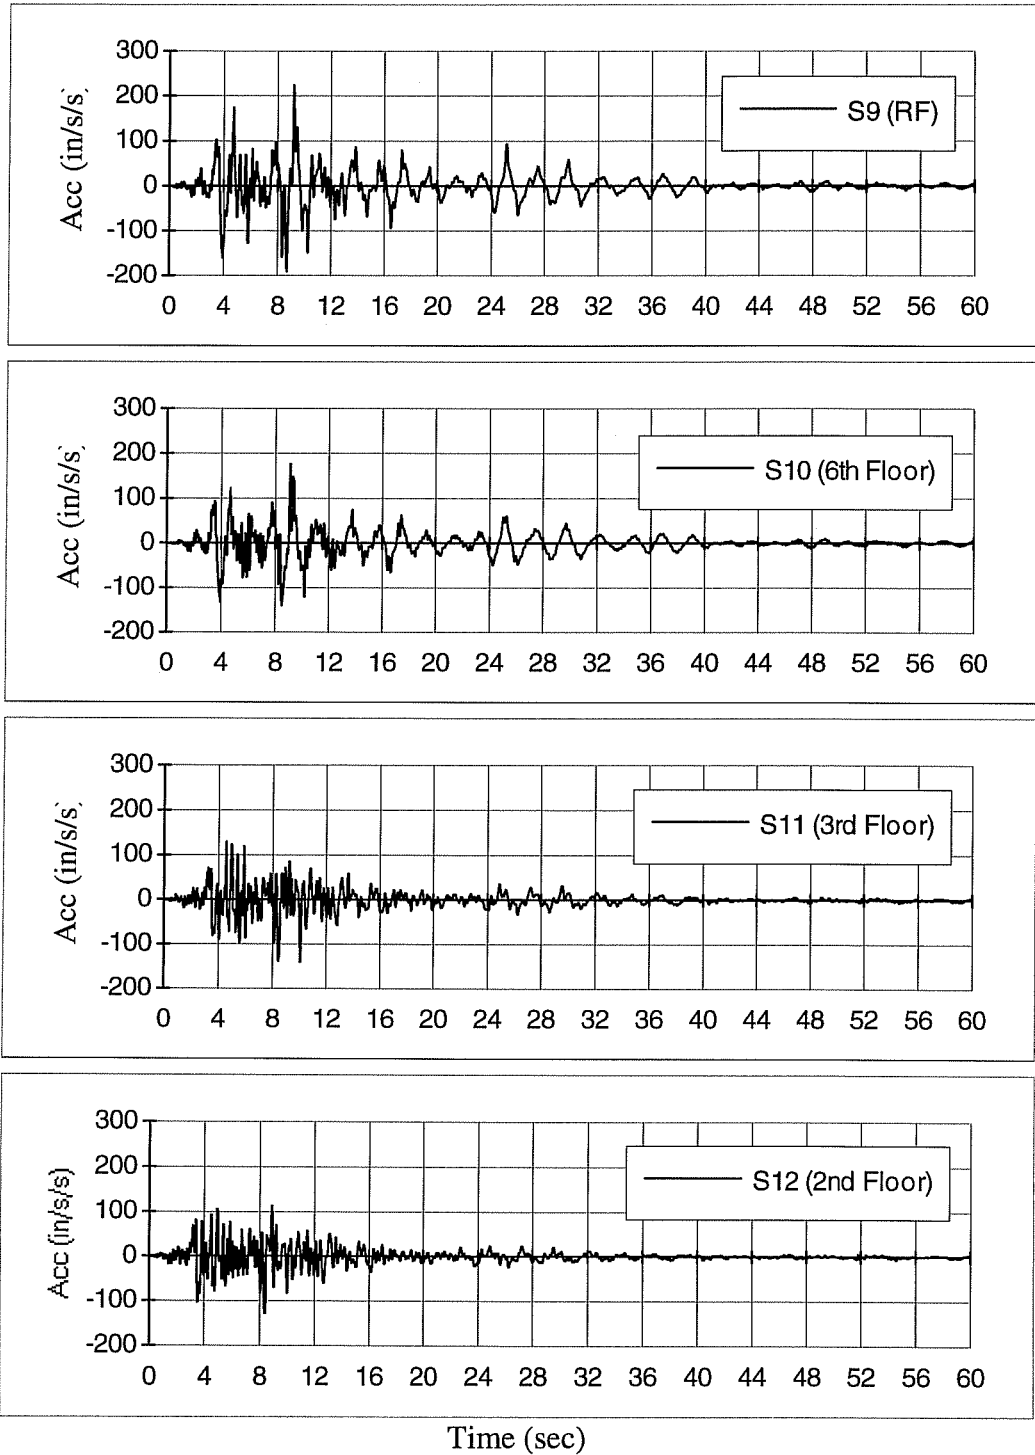
Figure 3.14 Acceleration Recorded at East End in East-West Direction

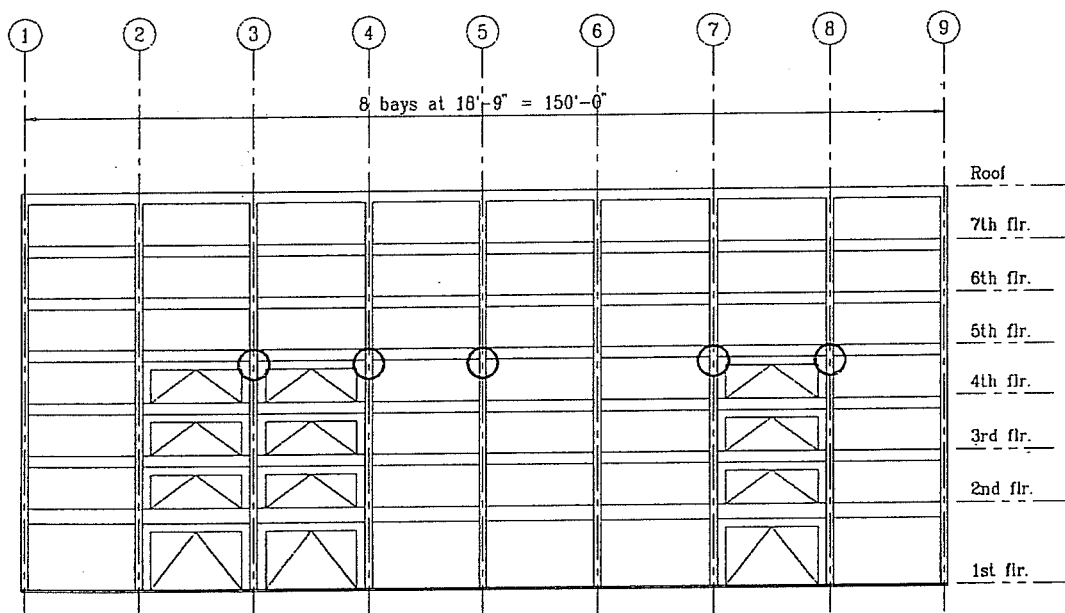
Figure 3.15 South Perimeter Frame Elevation after the 1994 Northridge Earthquake⁴⁵

The building suffered extensive structural damage during the Northridge Earthquake. Several columns between the fourth and fifth floors failed in shear (Figures 3.15 and 3.16) and temporary shoring was provided to prevent collapse.

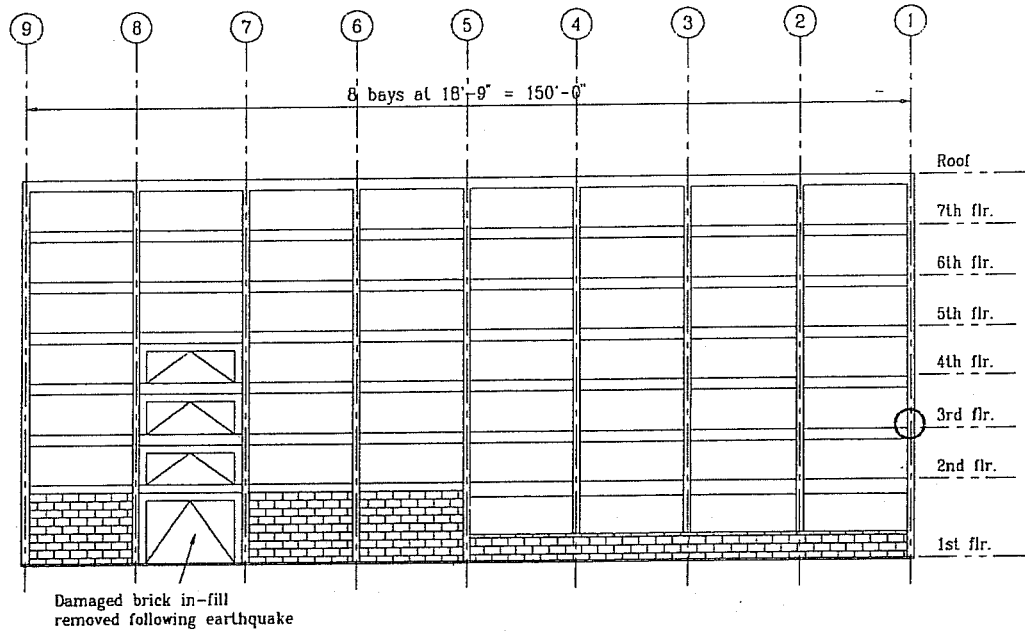
Figure 3.16 North Perimeter Frame Elevation after the 1994 Northridge Earthquake⁴⁵

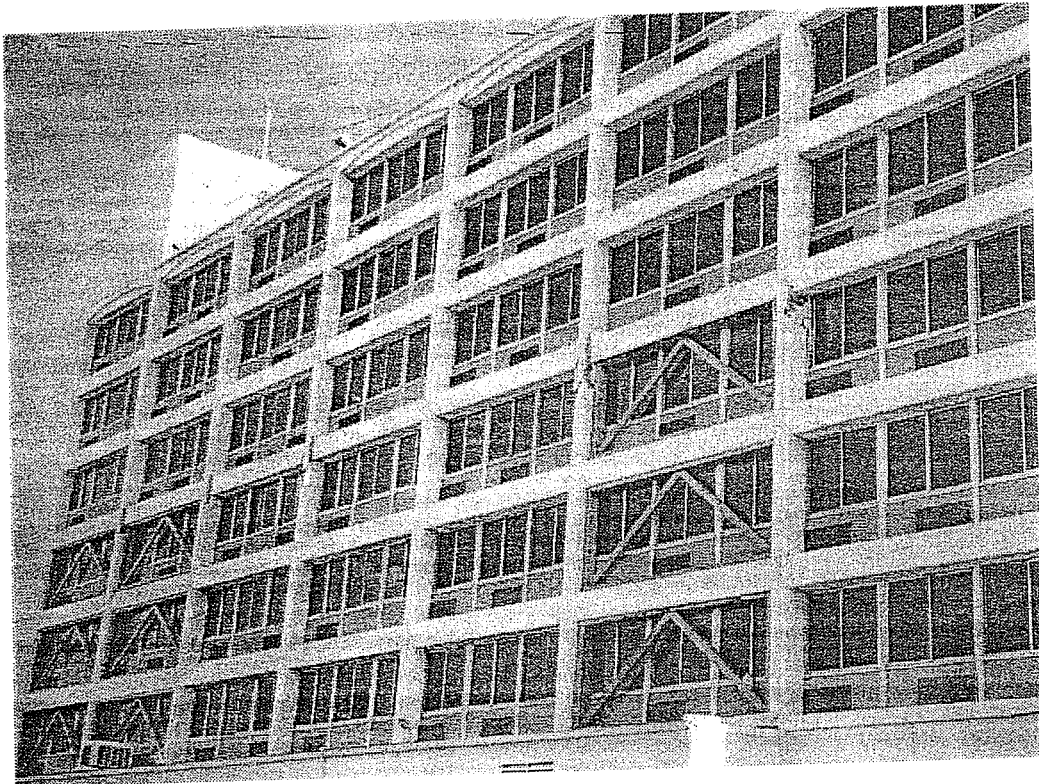
Figure 3.17 South Perimeter Frame Elevation with Temporary Shoring after the 1994 Northridge Earthquake⁴⁵

loss of confinement after the column failed in shear. Figure 3.17 shows temporary shoring in the south perimeter frame of the building and Figure 3.18 shows the north perimeter frame after the earthquake. Most of the shear failures occurred between the fourth and the fifth floors in south perimeter frame. Figure 3.19 is a close up view of

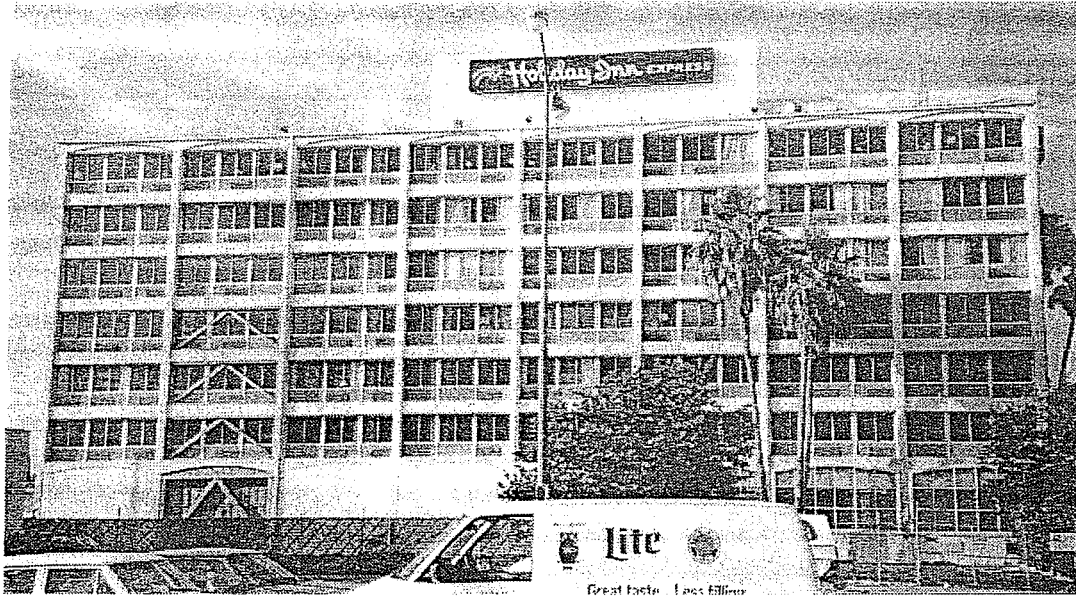
Figure 3.18 North Perimeter Frame Elevation with Temporary Shoring after the 1994 Northridge Earthquake⁴⁵

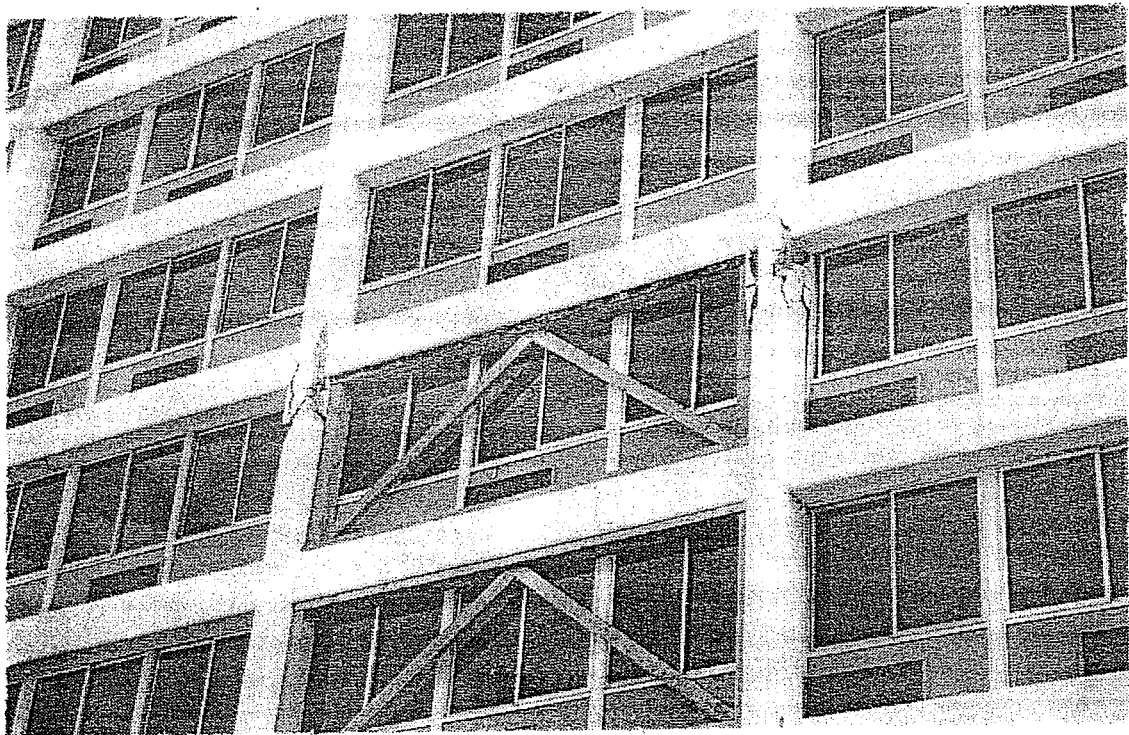
Figure 3.19 Close View of Damaged Columns Below fifth Floor Spandrel Beam
(Column A-7 and A-8)⁴⁵

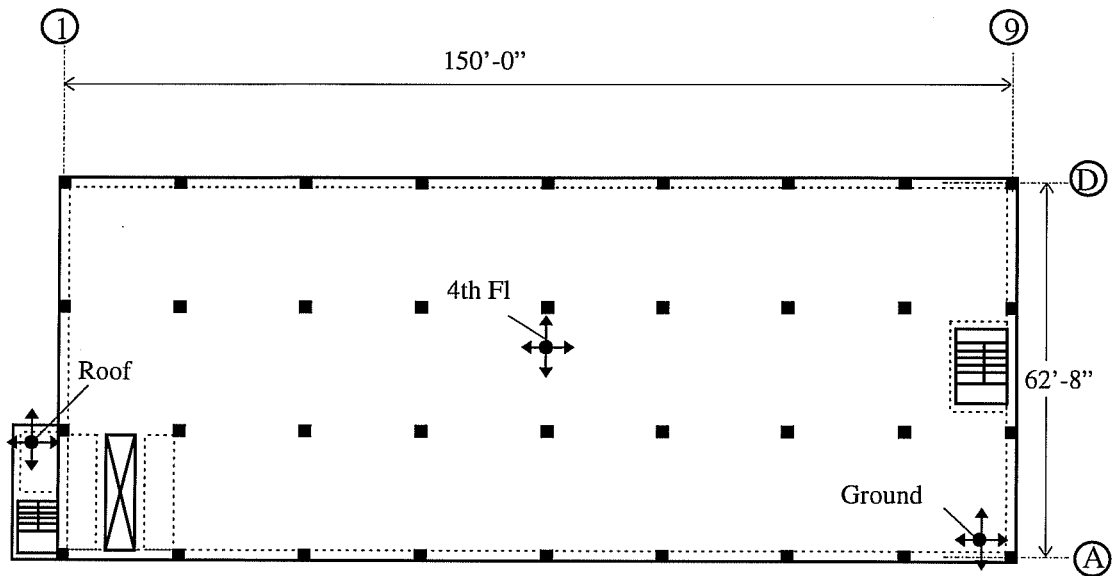
Figure 3.21 Seven-Story Hotel Sensor Location at the 1971 San Fernando Earthquake

Motions caused by the San Fernando Earthquake were recorded by Earth Sciences AR-240 strong-motion accelerographs located at the roof, fourth floor, and ground level (Figure 3.21).

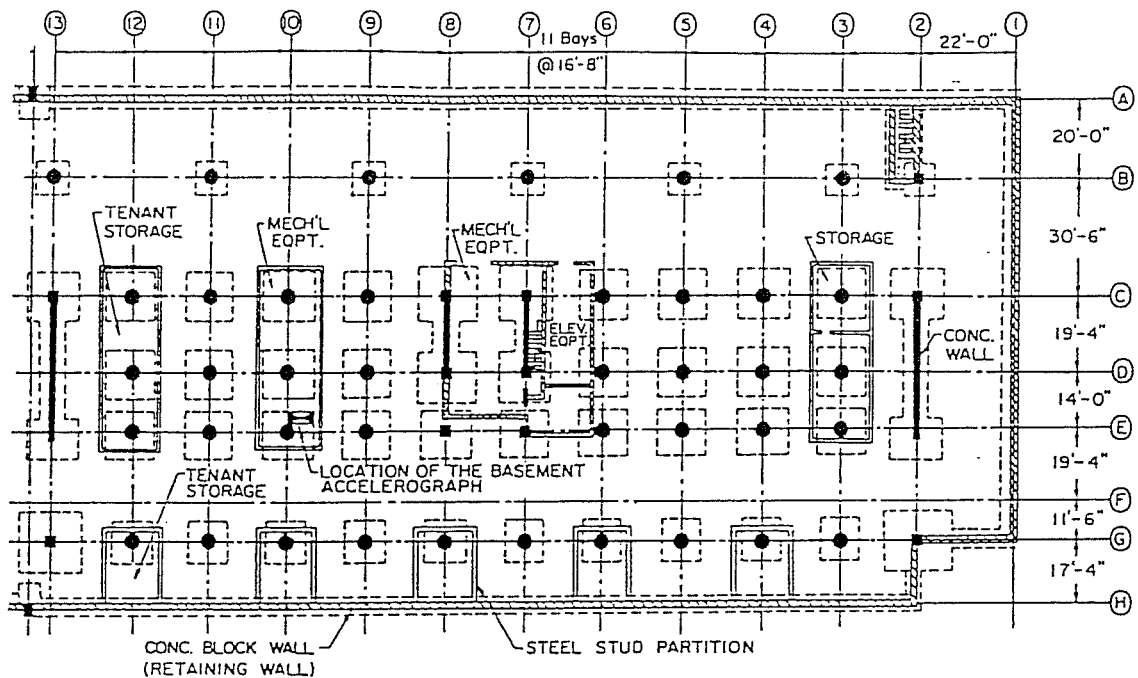
Figure 3.27 Basement-Foundation Plan³⁶

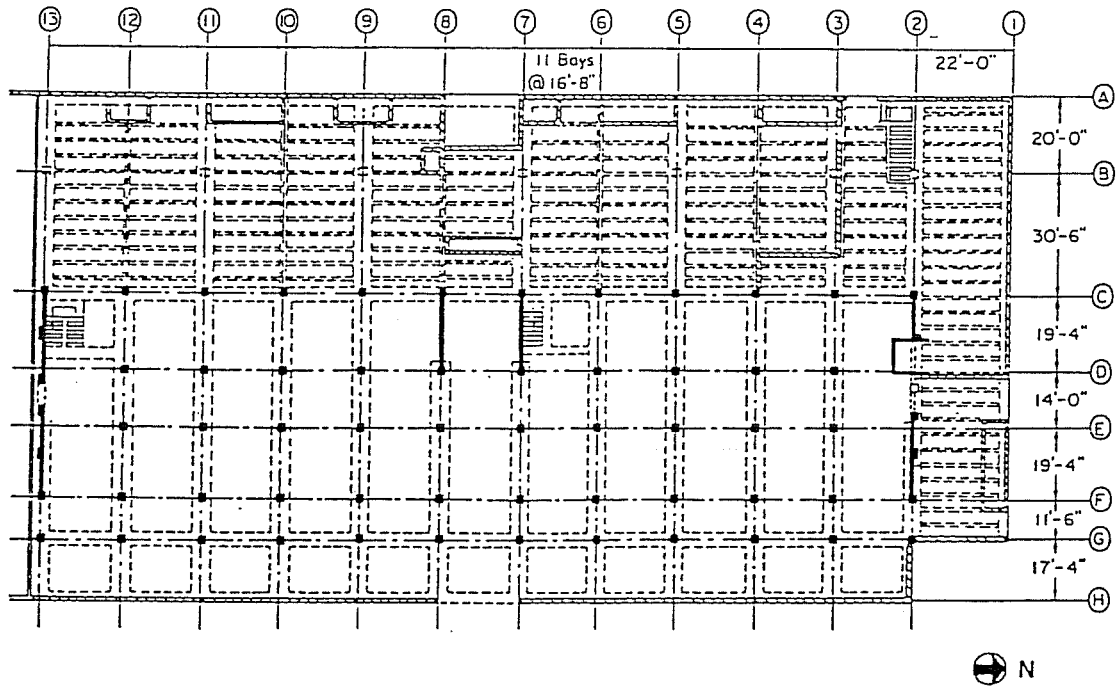
Figure 3.28 First Floor Framing Plan³⁶

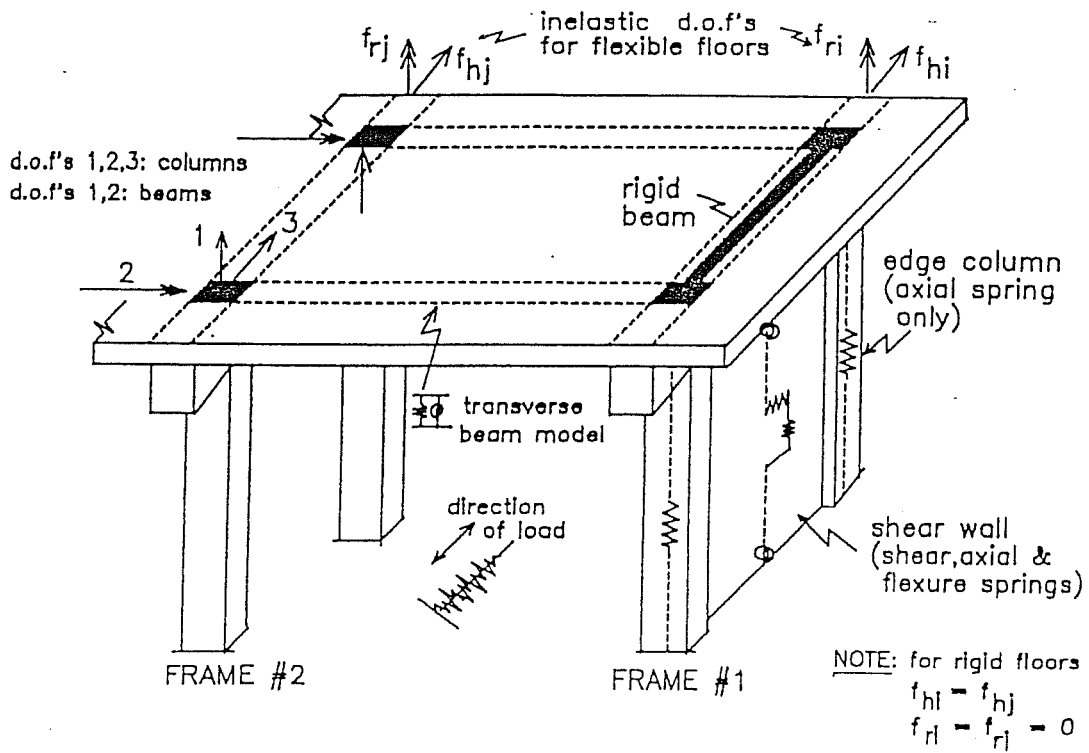
Figure 4.5 Structural Modeling Illustration⁶¹

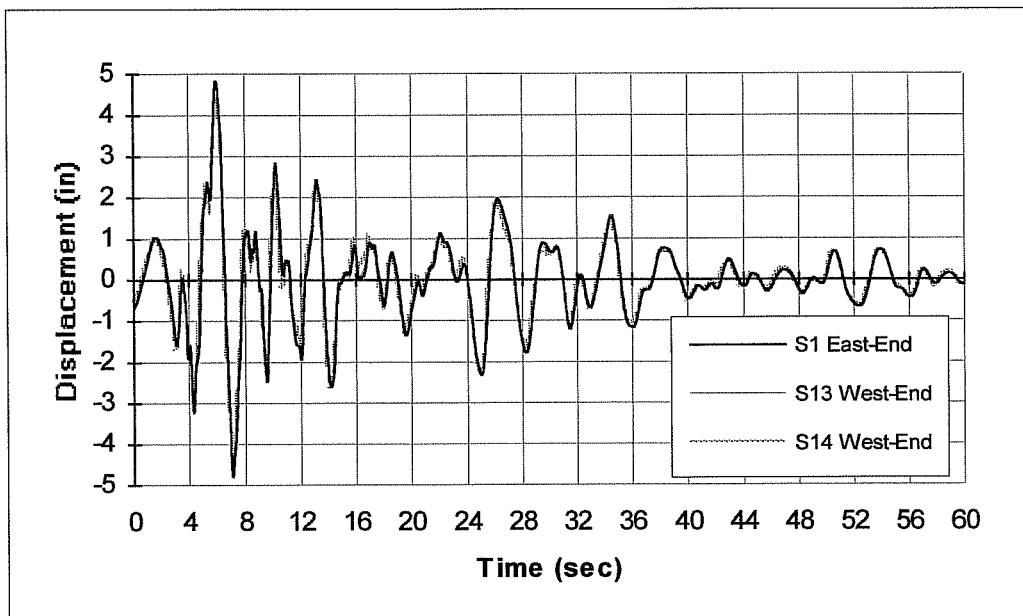
Figure 5.5 Horizontal Ground Movement in North-South (Transverse) Direction at East and West Ends

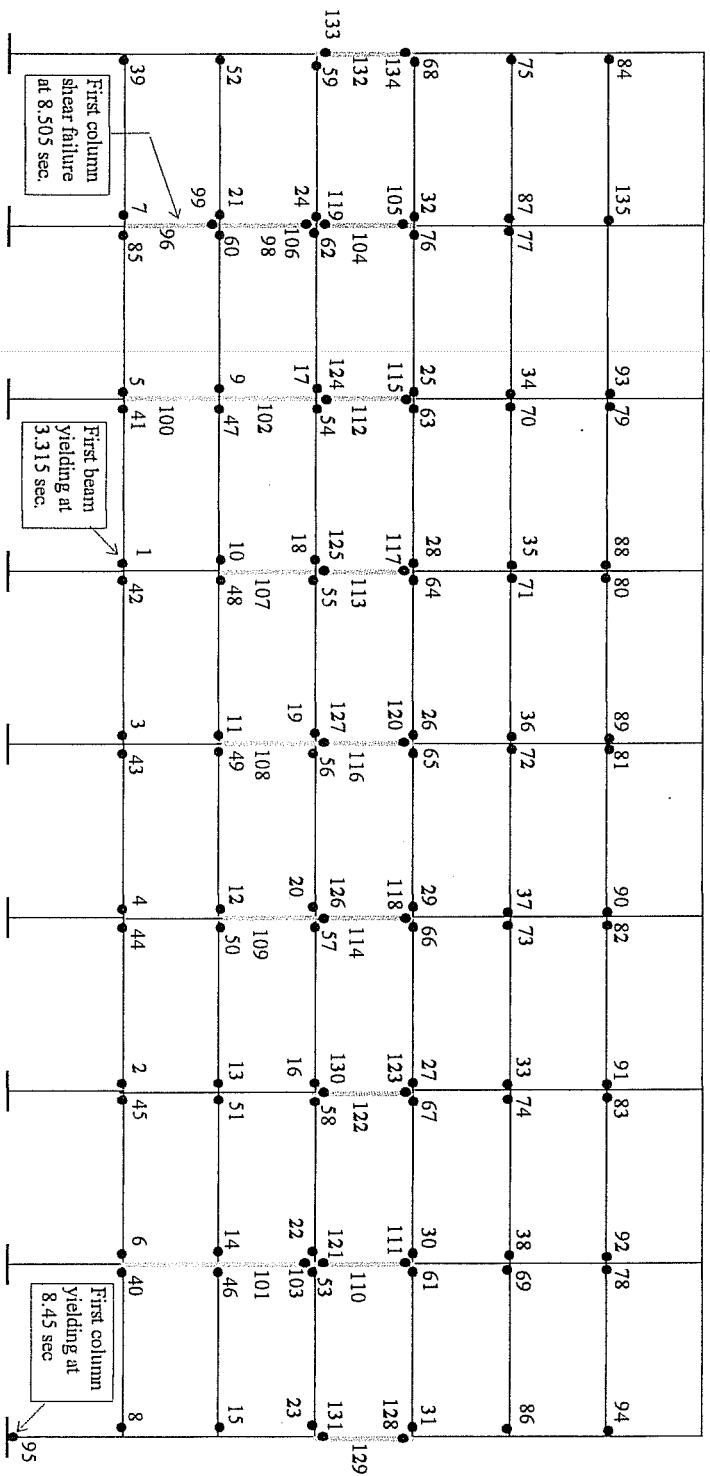
- yielding at member end
- column failure in shear

Figure 5.1.6 Failure Sequence from DRAIN-2D Time History Analysis. Seven-Story Hotel

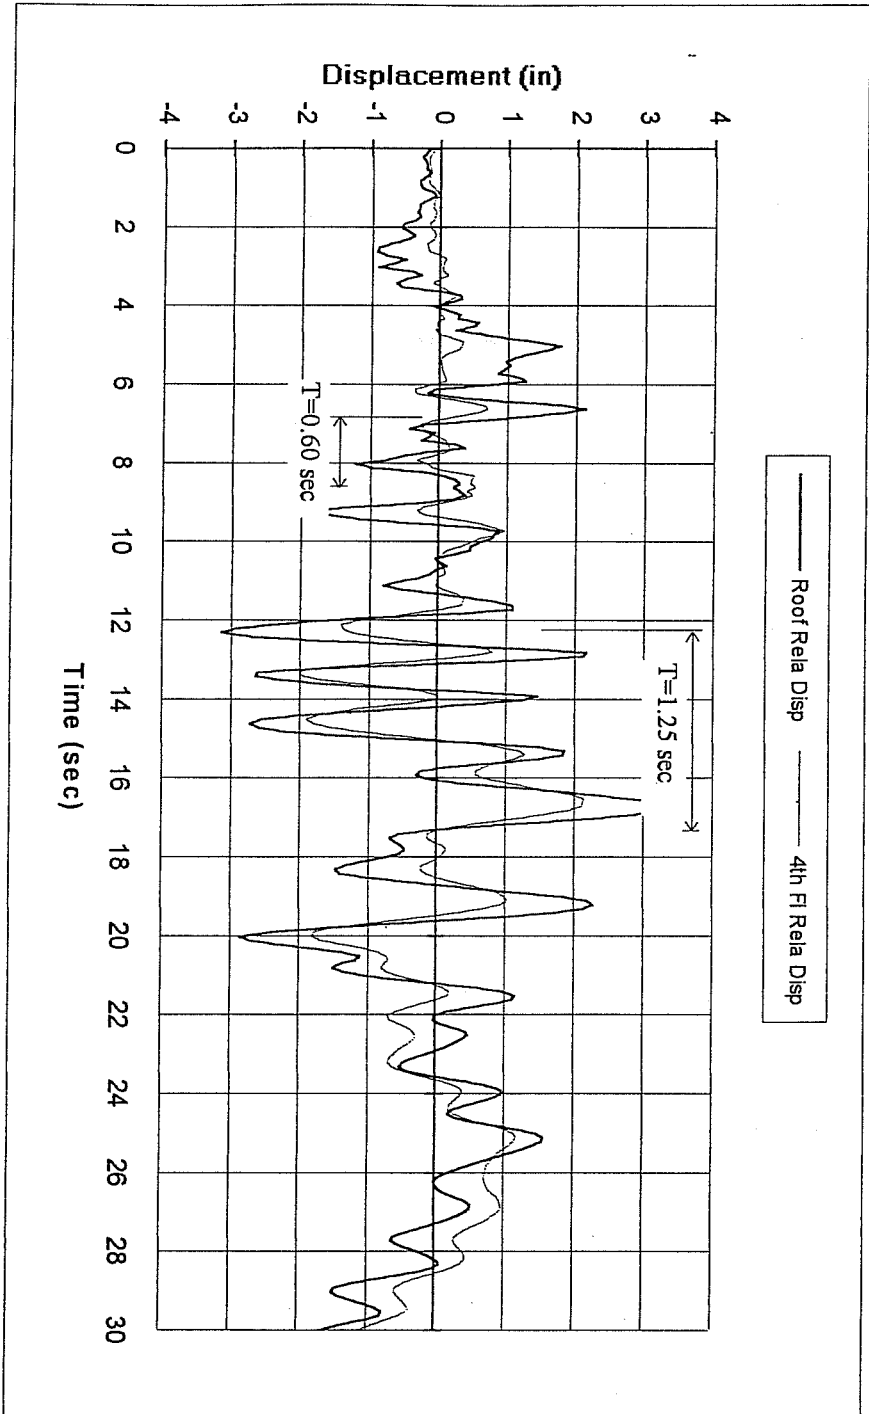
Figure 5.19 Recorded Floor Relative Displacement Time History in East-West (Longitudinal) Direction at 1971 San Fernando Earthquake

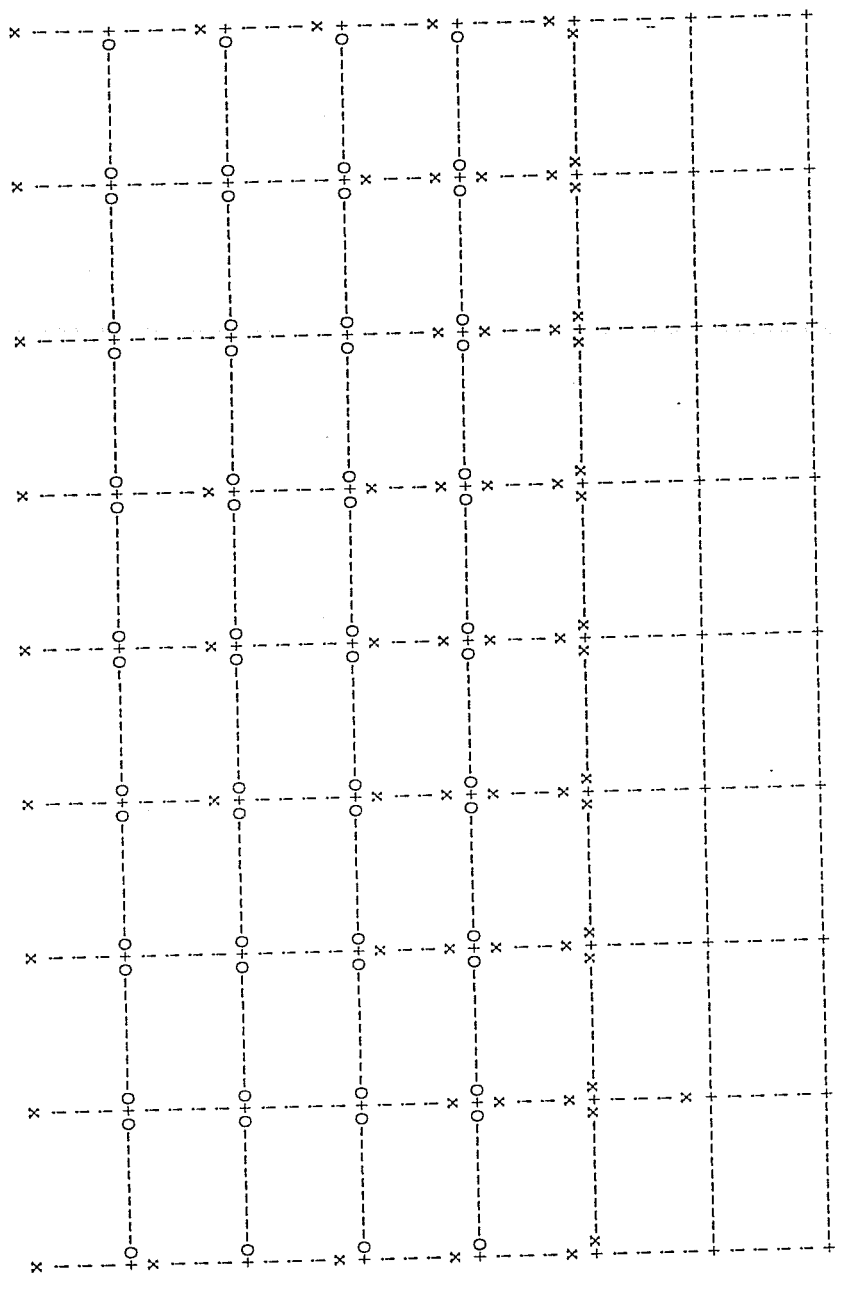
Figure 5.28 Failure State of the Seven-Story Hotel Subject to the 1971 San Fernando Earthquake from IDARC Calculation

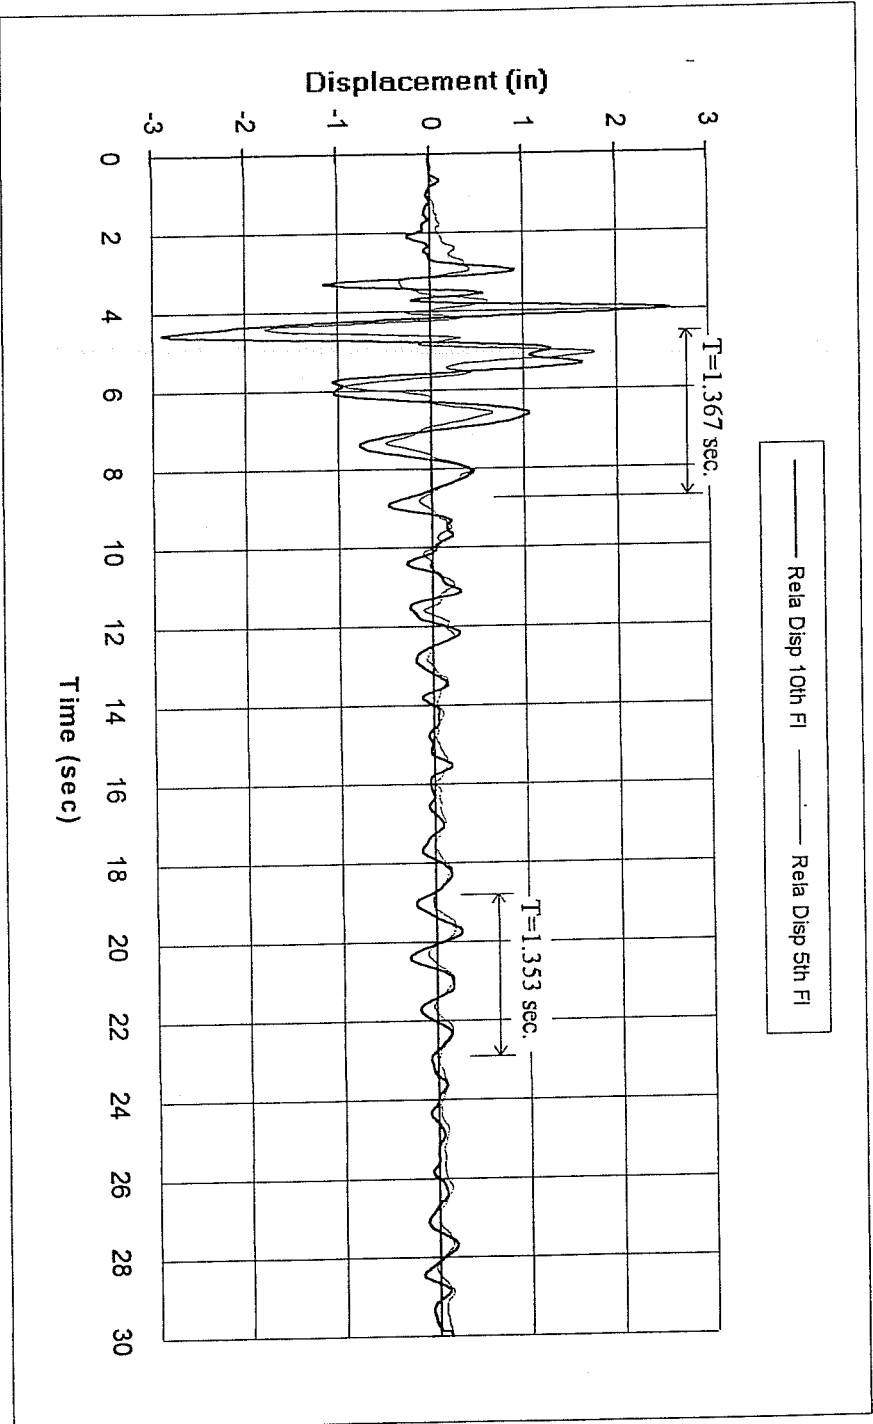
Figure 5.30 Recorded Floor Relative Displacement Time History
 in North-South (Longitudinal) Direction. 1987 Whittier Narrows Earthquake
