**NONLINEAR TIME HISTORY AND PUSH-OVER ANALYSES
FOR SEISMIC DESIGN AND EVALUATION**

Dissertation

the University of Texas at Austin

December 1996

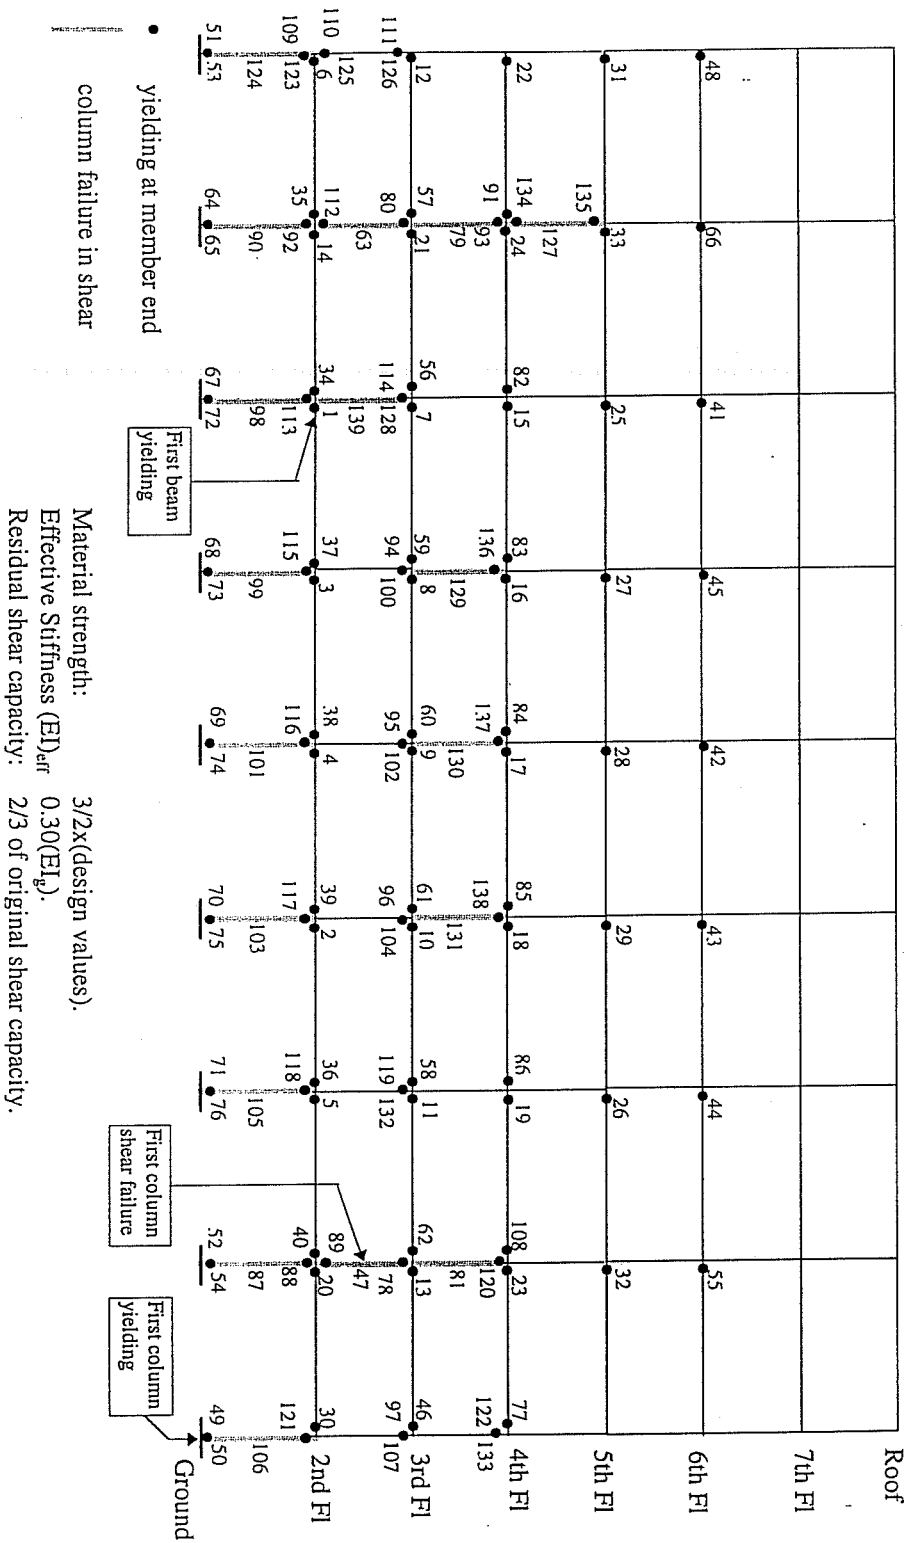
Figure 6.3 Failure Sequence from Push-Over Analysis with Uniform Lateral Load Distribution

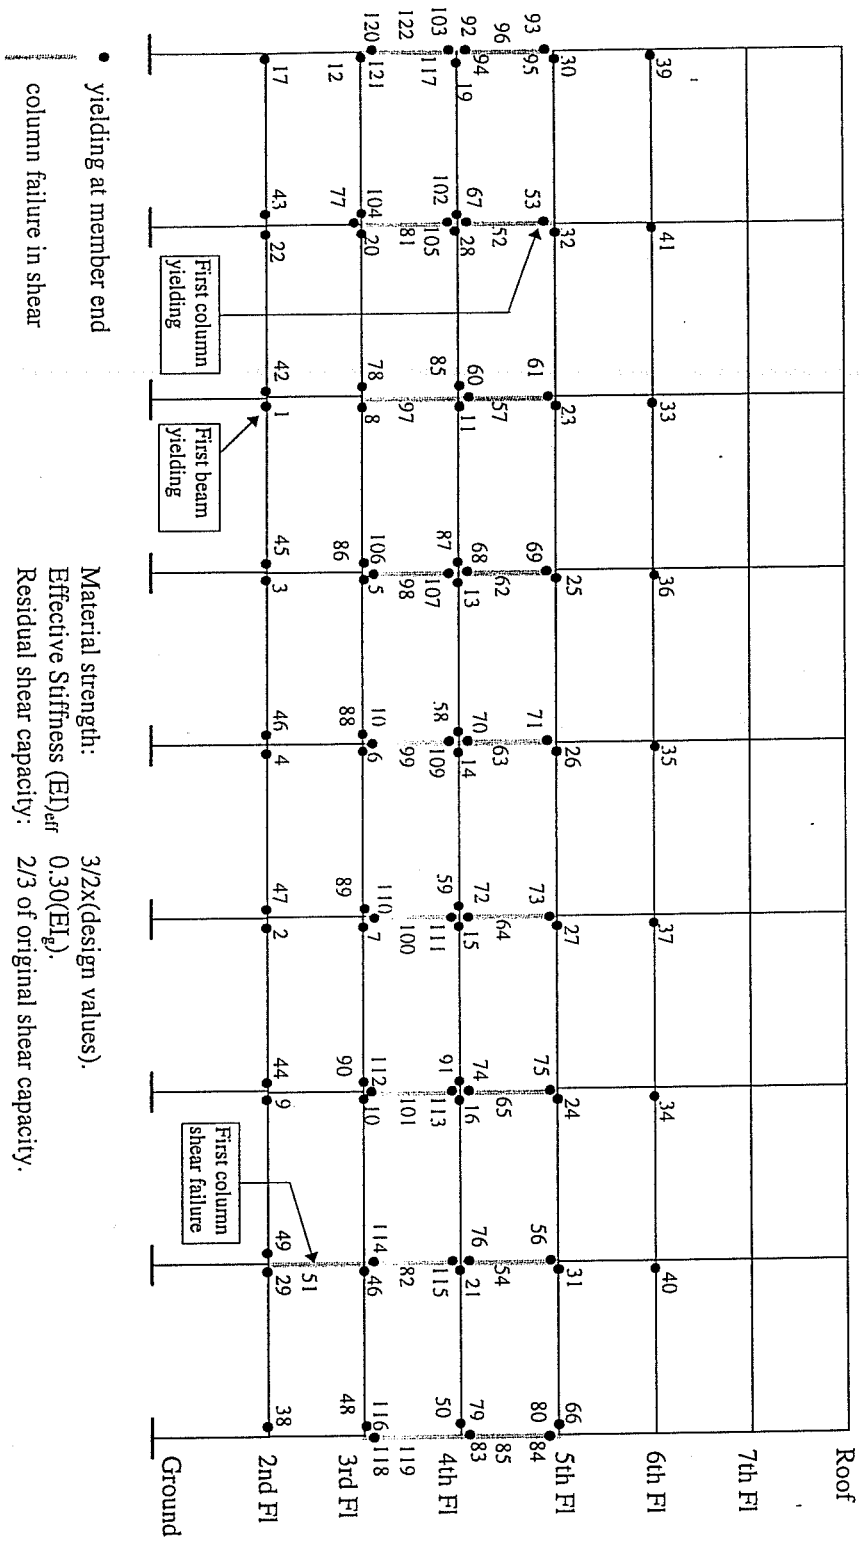
Figure 6.4 Failure Sequence from Push-Over Analysis with Triangular Lateral Load Distribution

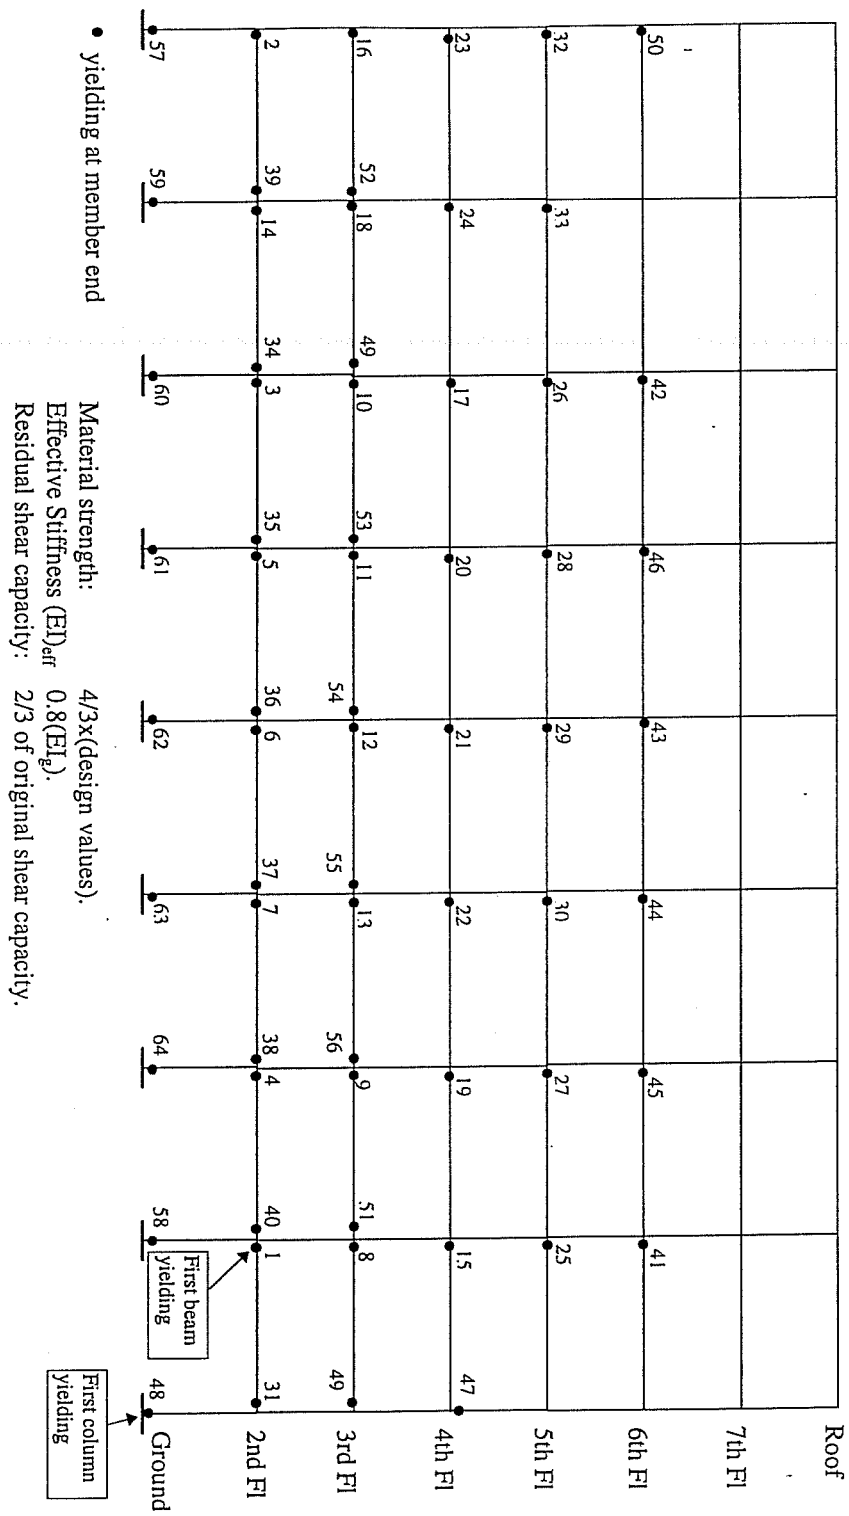
Figure 6.10 Failure Sequence Up to Roof Displacement of 3.421 inches from the Push-Over Analysis with the Uniform Lateral Load Pattern

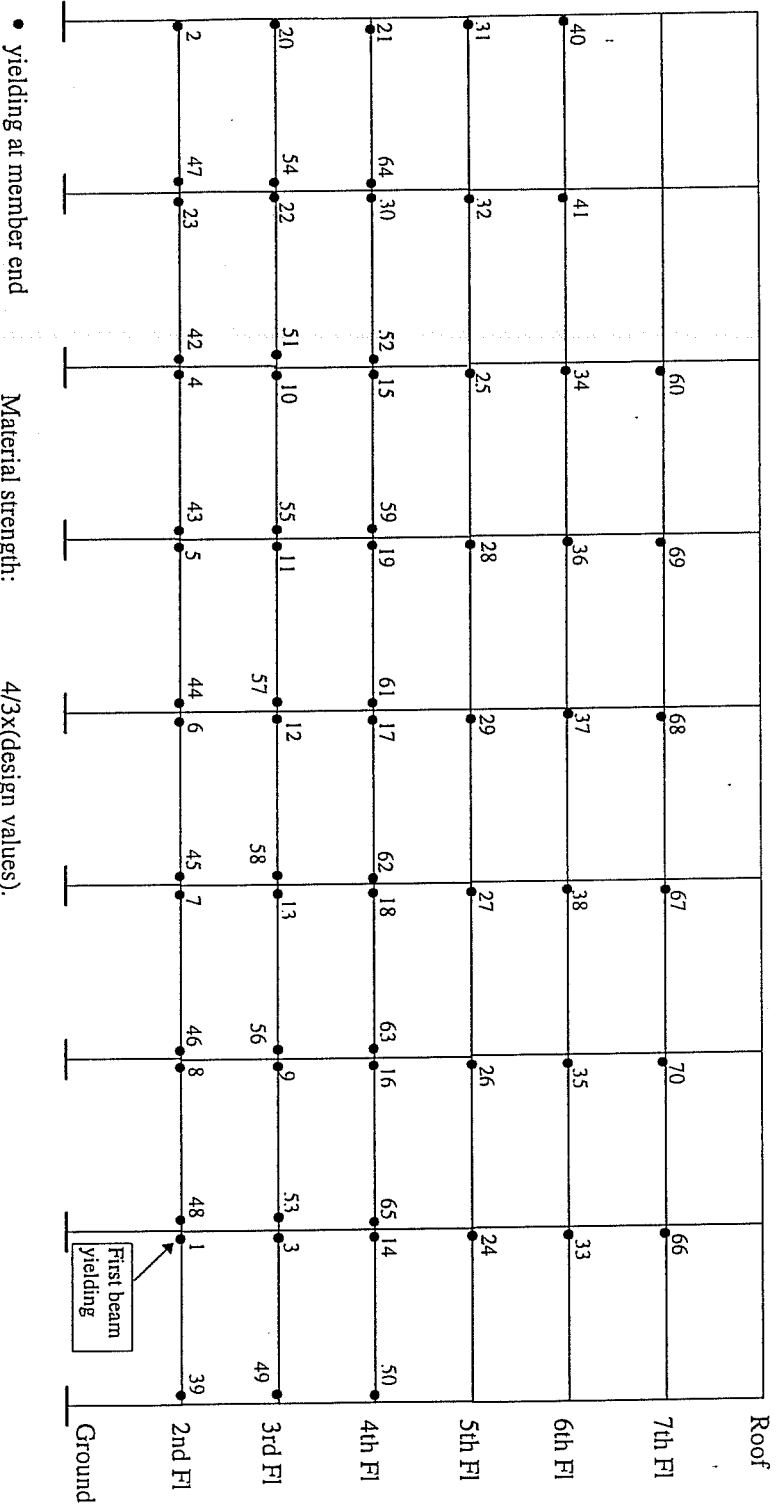
Figure 6.11 Failure Sequence Up to Roof Displacement of 3.421 inches from the Push-Over Analysis with the Triangular Lateral Load Pattern

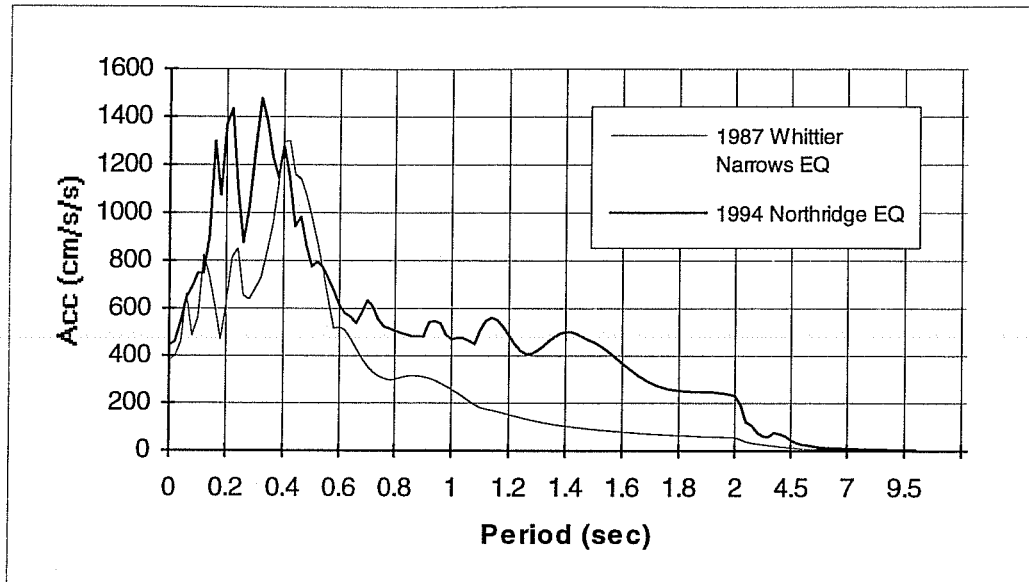
Figure 7.3 Comparison of Acceleration Response Spectra between 1994 Northridge Earthquake and 1987 Whittier Narrows Earthquake

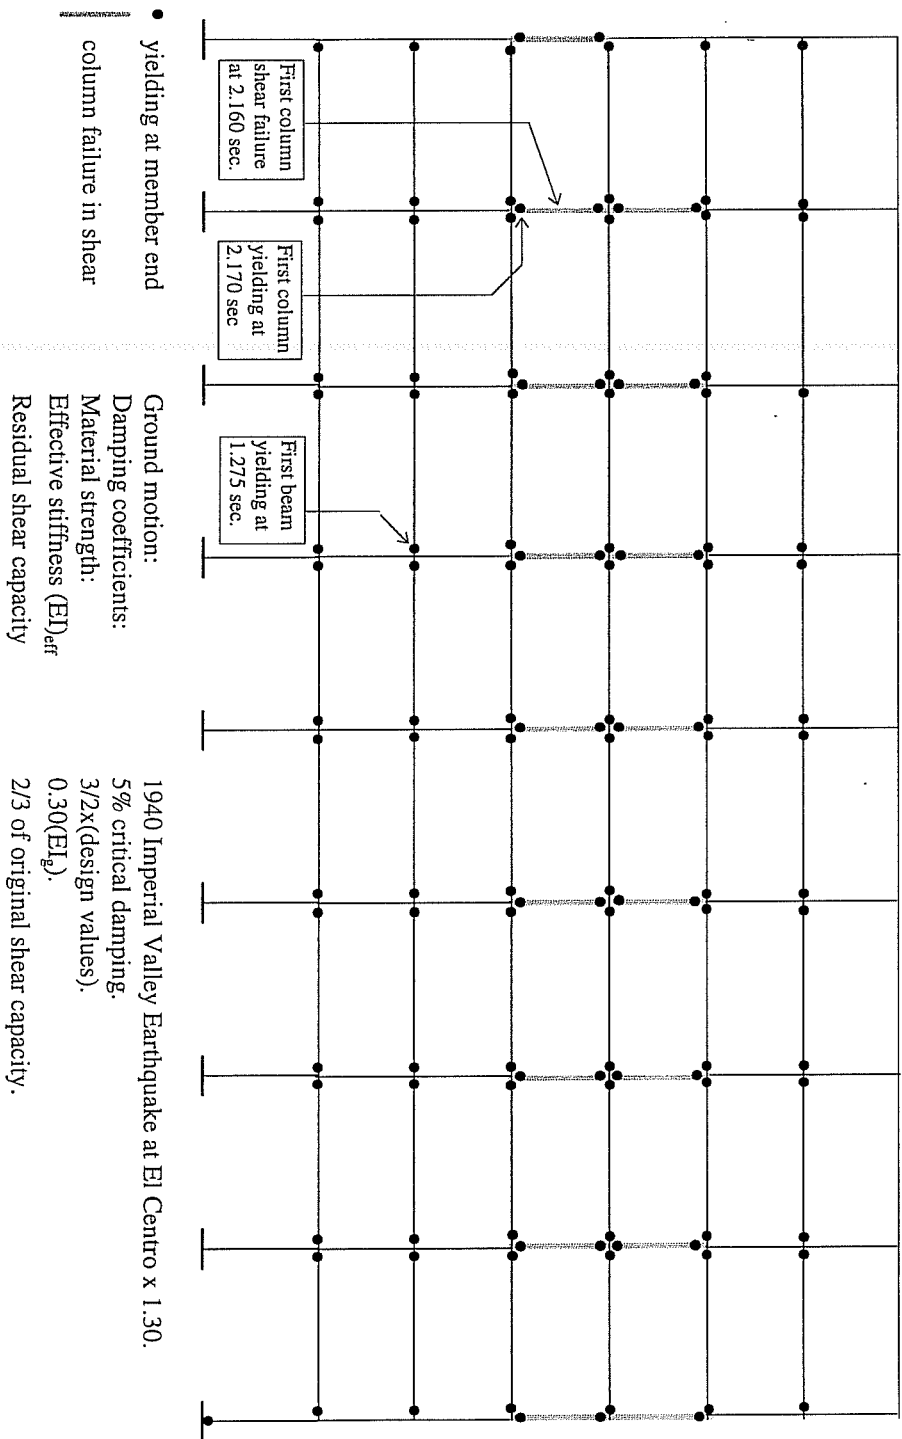
Figure 7.14 Failure state of the Seven-Story Hotel Subject to 1940 Imperial Valley Earthquake
 Recorded at El Centro Scaled to Peak Acceleration of 175.0 in/s/s.

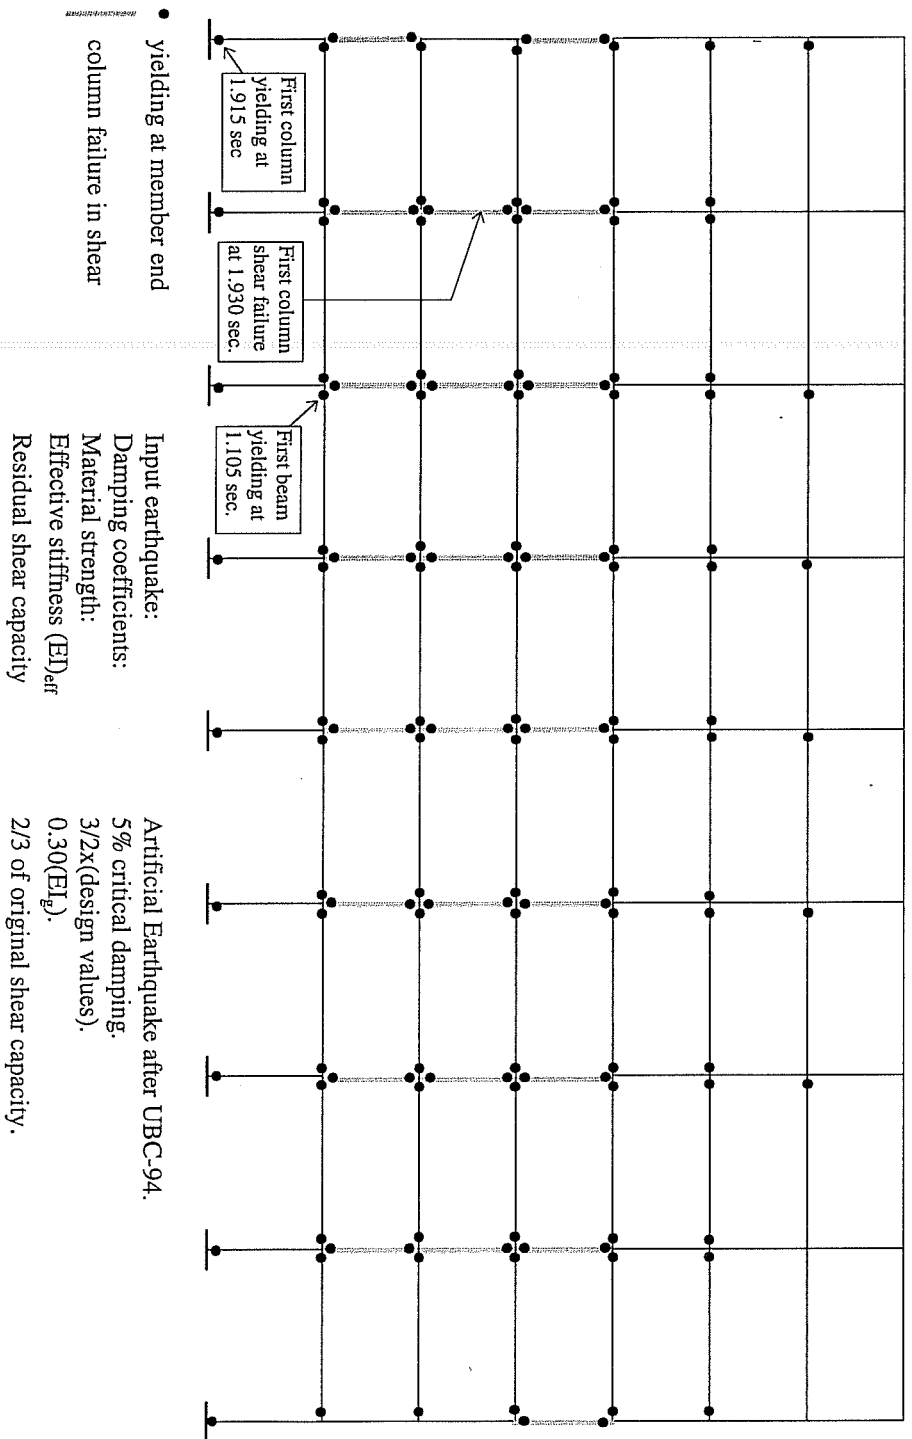
Figure 7.16 Failure state of the Seven-Story Hotel Subject to UBC-94 Design-Spectrum Compatible Earthquake Scaled to Peak Acceleration of 175.0 in/s/s.

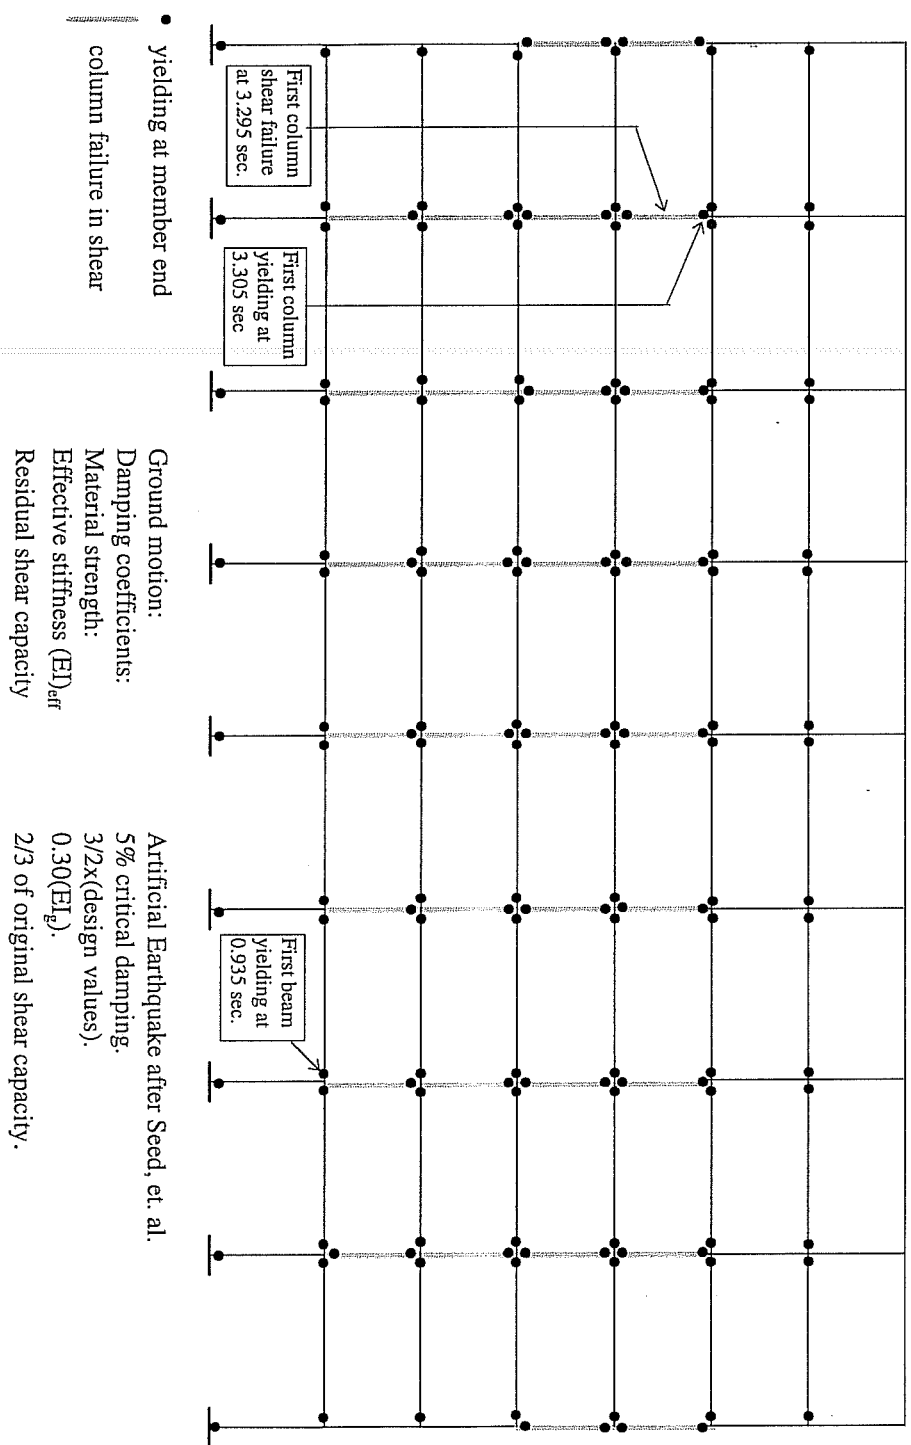
Figure 7.17 Failure state of the Seven-Story Hotel Subject to Site-Dependent, Spectrum-Compatible Earthquake after Seed, et. al. Scaled to Peak Acceleration of 175.0 in/s/s.

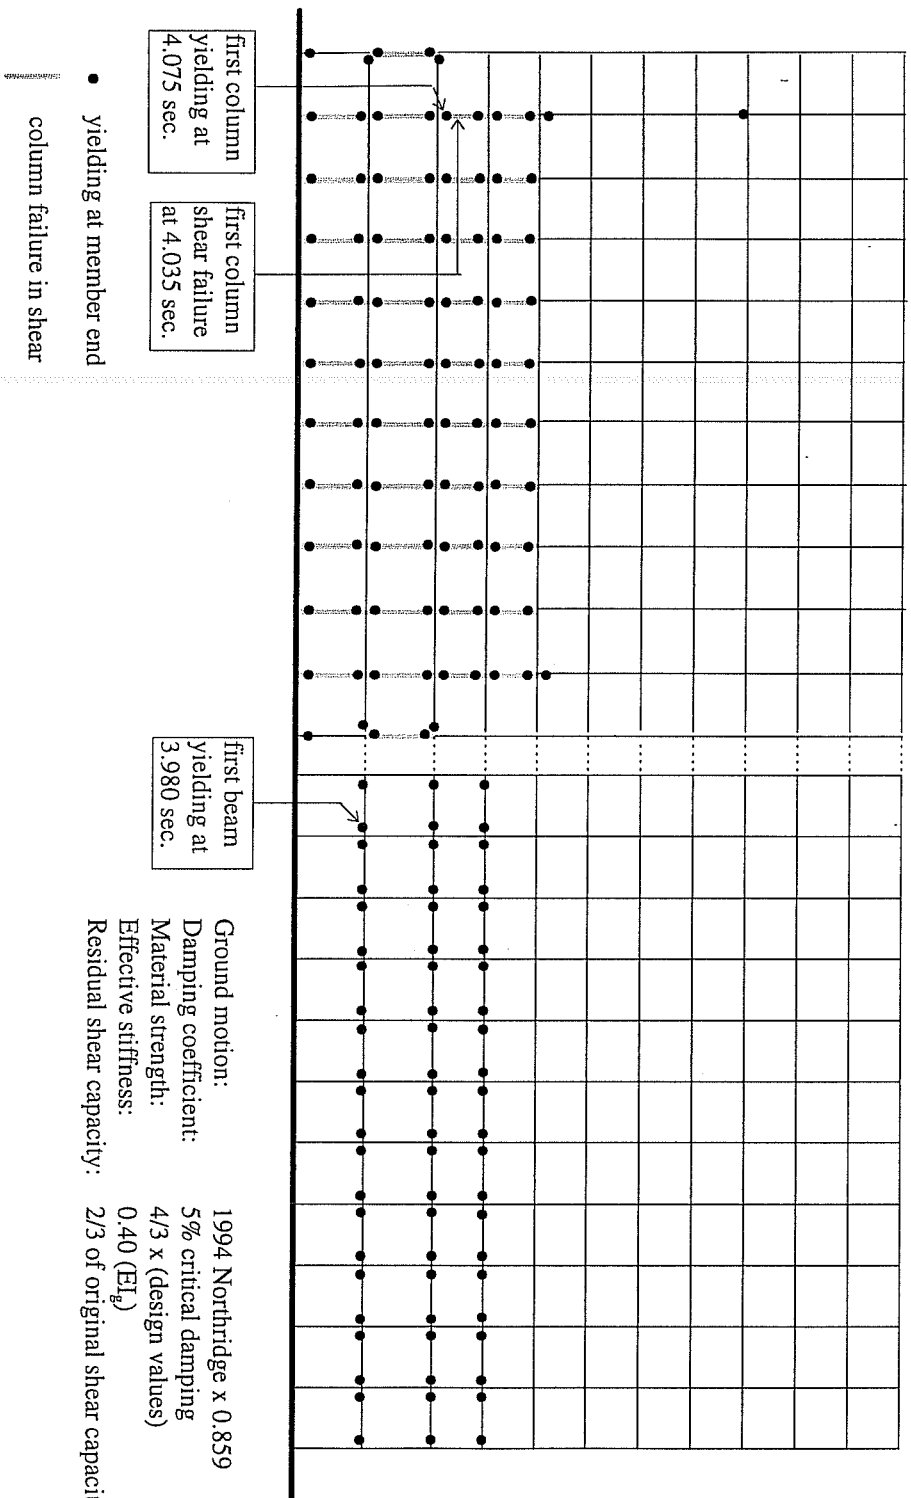
Figure 7.22 Failure state of the Ten-Story Building Subjected to 1994 Northridge Earthquake Recorded at the ground floor of the seven-story hotel Scaled to Peak Acceleration of 150.3 in/s/s

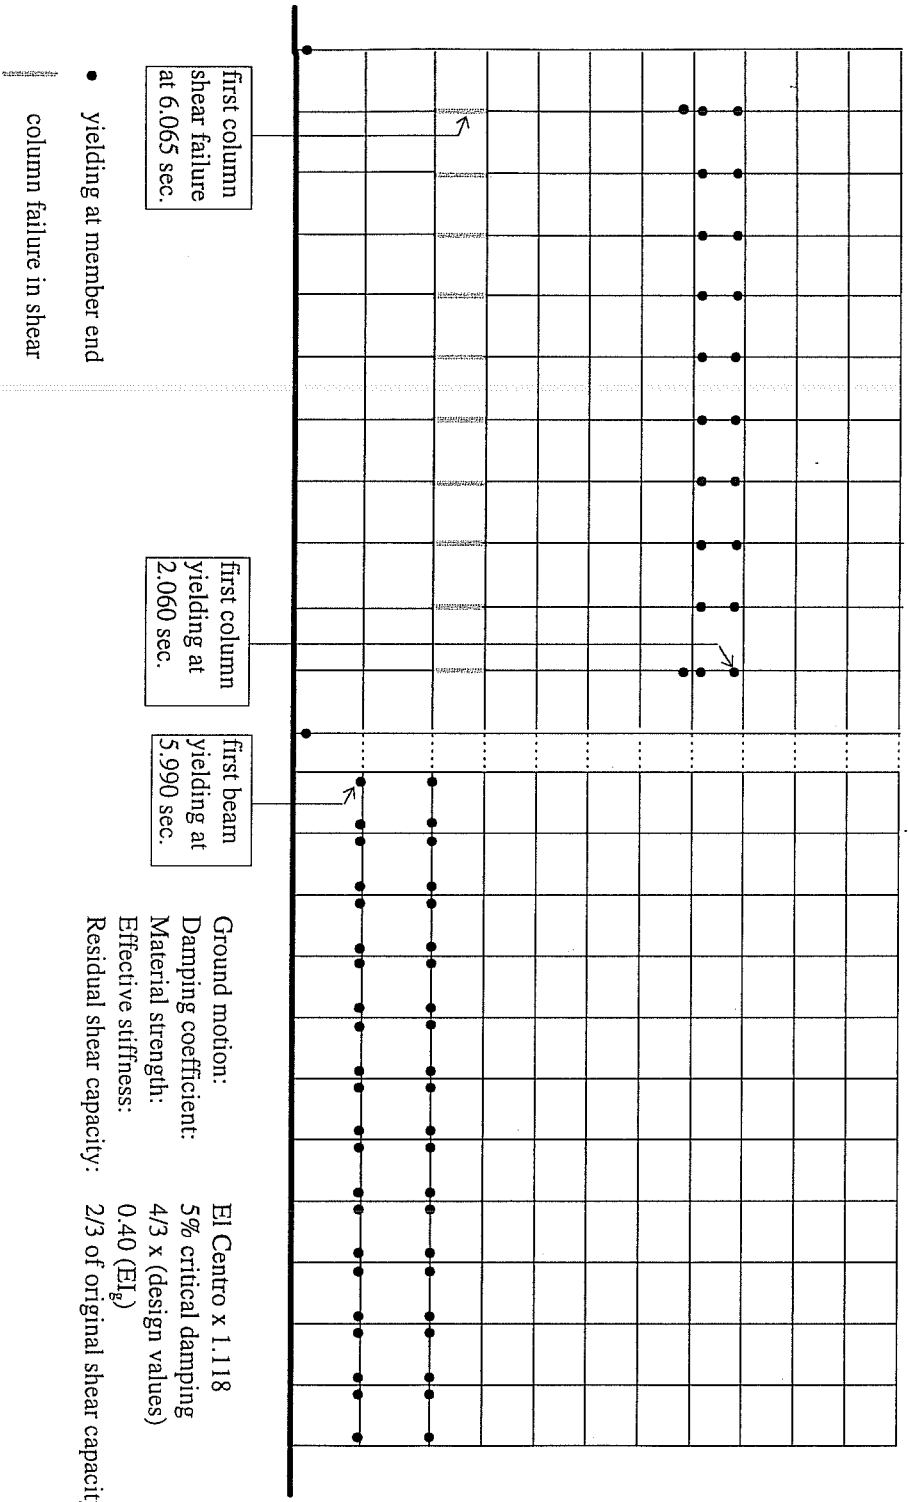
Figure 7.23 Failure State of the Ten-Story Building Subjected to 1940 Imperial Valley Earthquake
 Recorded at El Centro Scaled to Peak Acceleration of 150.3 in/s/s

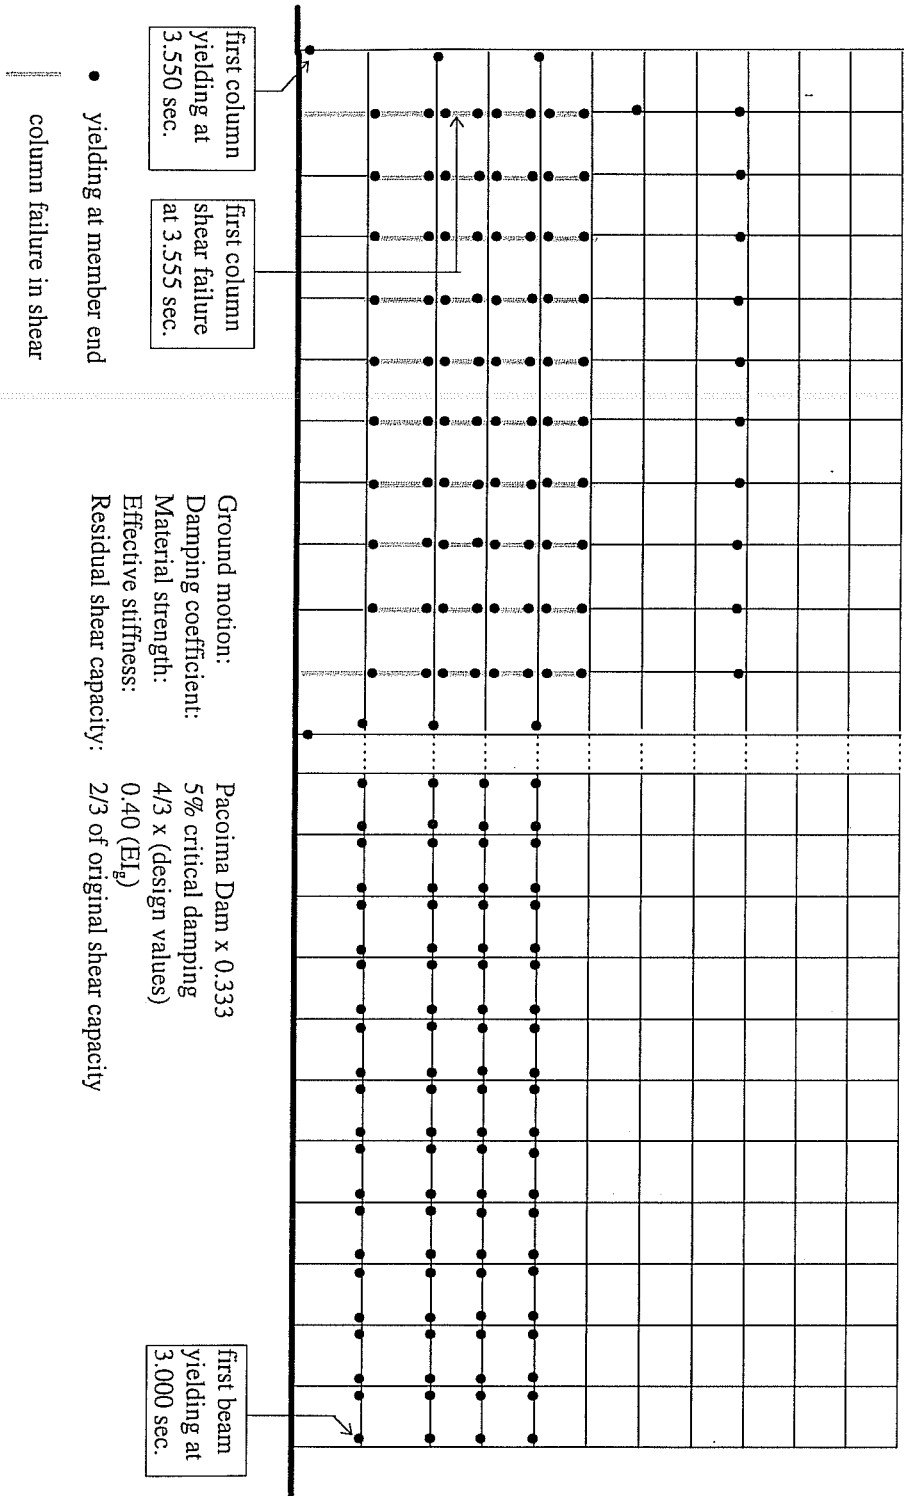
Figure 7.24 Failure State of the Ten-Story Building Subjected to 1971 San Fernando Earthquake
Recorded at Pacoima Dam Scaled to Peak Acceleration of 150.3 in/s/s

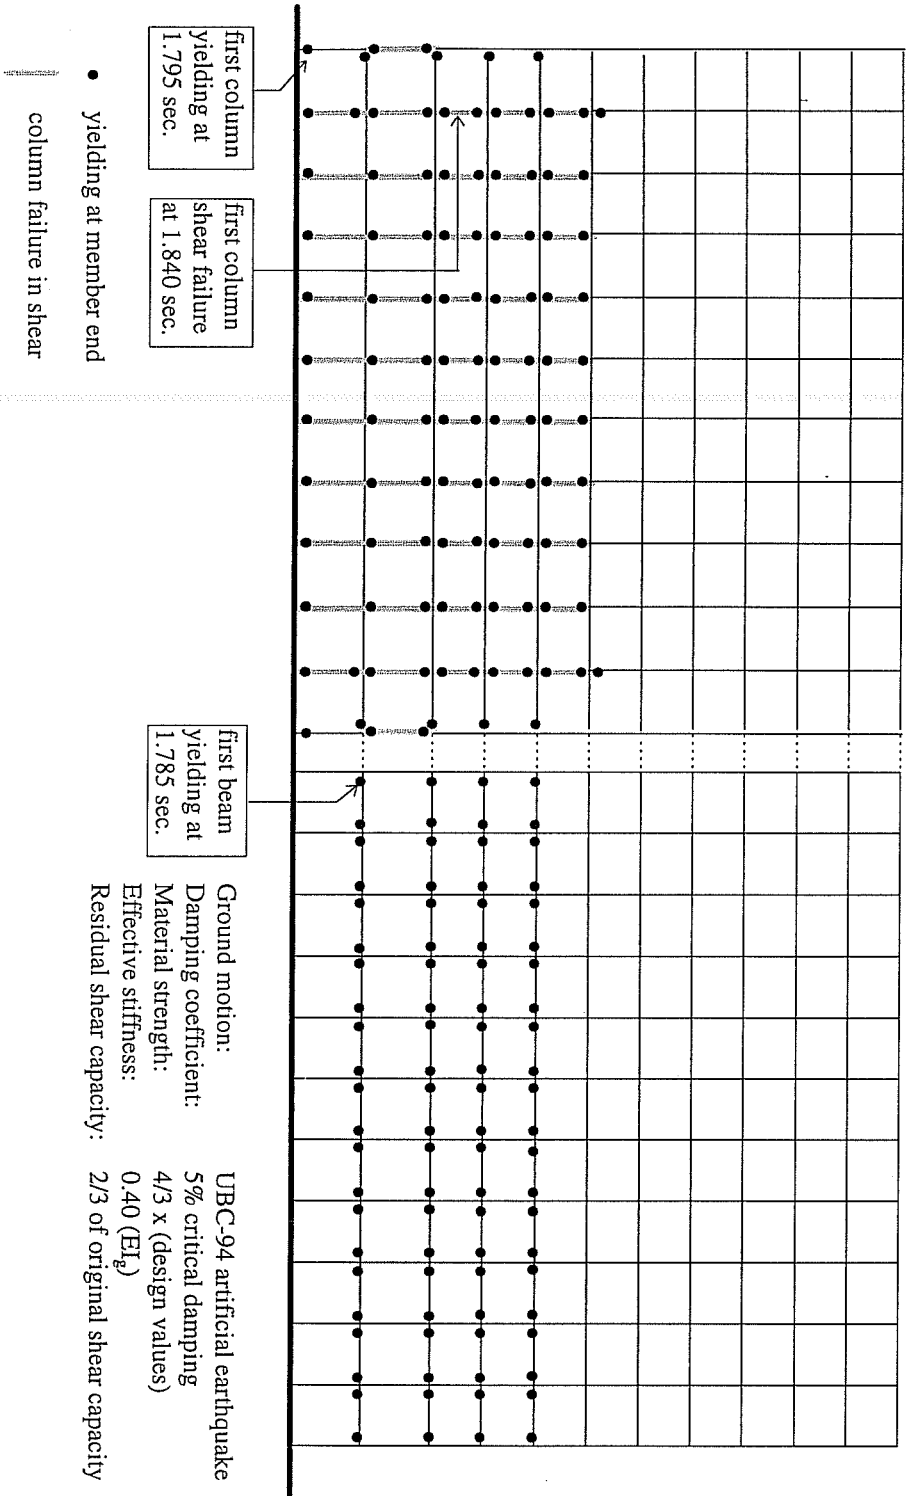
Figure 7.27 Failure State of the Ten-Story Building Subjected to UBC-94 Design-Spectrum Compatible Earthquake Scaled to Peak Acceleration of 150.3 in/s/s

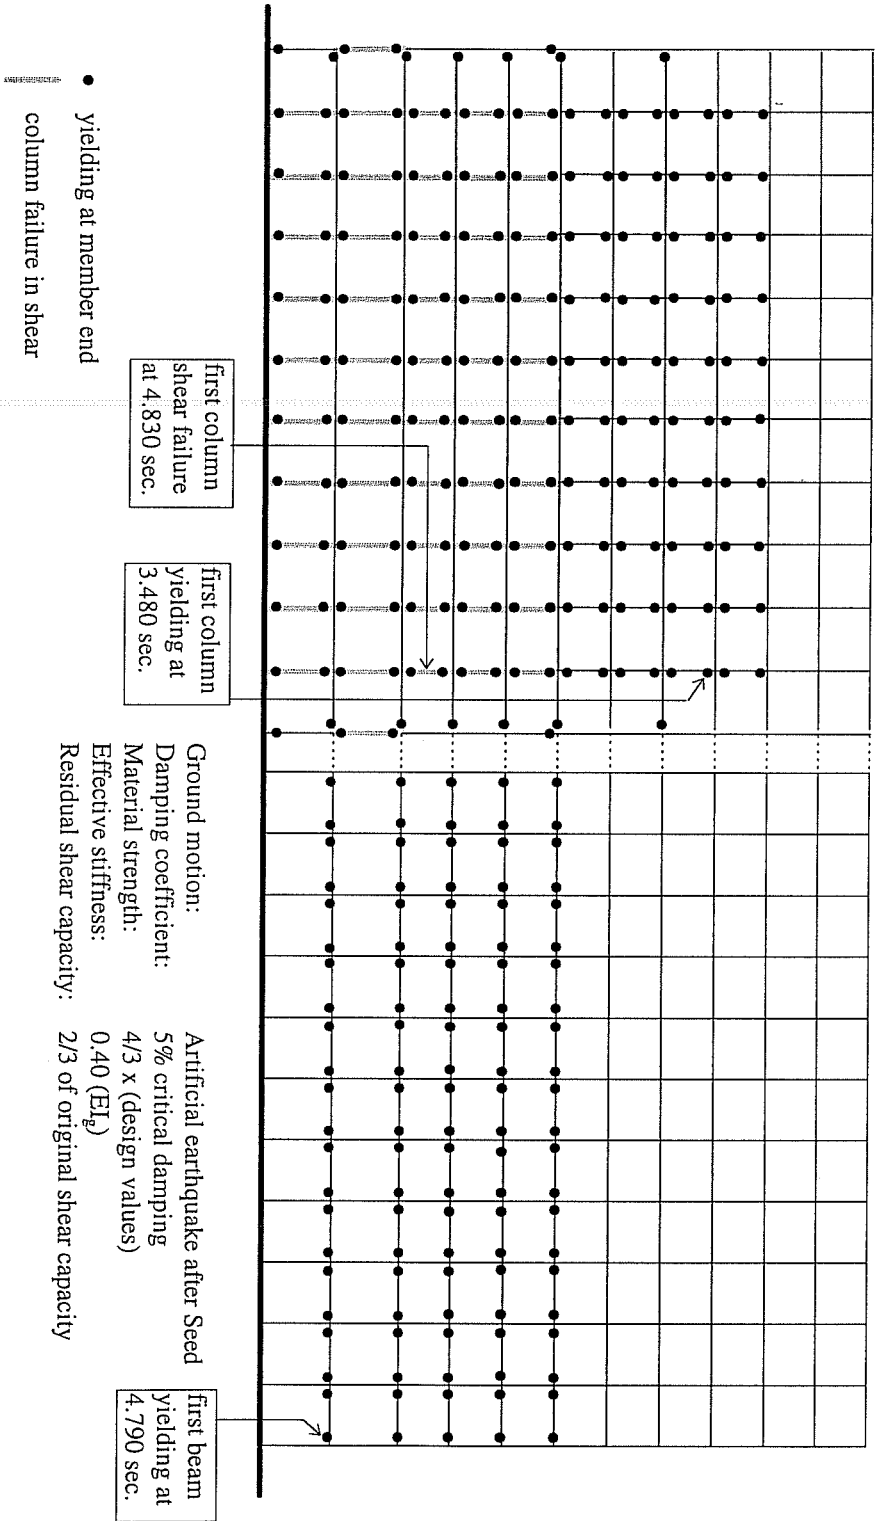
Figure 7.28 Failure State of the Ten-Story Building Subjected to Site-Dependent, Spectrum-Compatible Artificial Earthquake Scaled to Peak Acceleration of 150.3 in/s/s
