**Frequency Response of Damaged External Post-Tensioned Tendons**

**Thesis**

**The University of Texas at Austin**

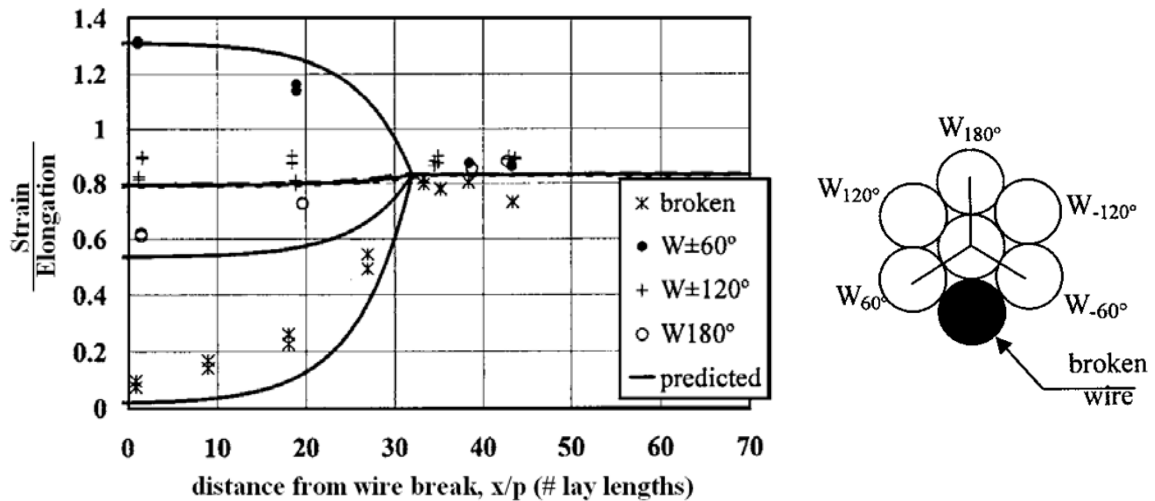
**Figure 2.1: Predicted and Measured Outer Wire Strain, 0.6-in Diameter Strand**  
(MacDougall and Bartlett, 2006)

Before the single wire was cut, strain gages were attached to the outer wires in the strand at varying distances along the length in order to measure the distribution of strain after damage. The comparison between the predicted and experimental individual wire strains for the 0.6-in. diameter strand is displayed in Figure 2.1.

The calculated strains are generally consistent with the measured values. The model indicates that after an outer wire breaks in a strand, tensile forces are redistributed among the wires in the immediate vicinity of the wire break. The tensile force increases in the two outer wires adjacent to the broken wire, while the tensile force in the

remaining three wires decreases. At a distance of approximately 32 lay lengths from the wire break, the strains in all six outer wires (intact and fractured) converge to the same value.

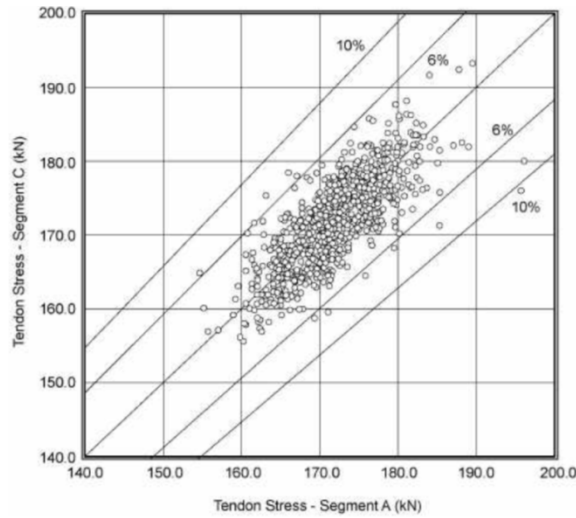
**Figure 2.8: Comparative Tendons Forces from Vibration Testing of the Mid-Bay Bridge (Corven, 2001)**

For each tendon, the results of the three free lengths were compared against one another. In the absence of any damage, the calculated tension in the three individual segments was expected to be equal. Slight variations existed in the calculated tension, and variations of  $\pm 6\%$  were interpreted to mean that no significant damage had occurred within the tendon. The results are plotted in Figure 2.8. Differences of  $\pm 25\%$  were observed in one tendon (Figure 2.9), and upon further investigation, inspectors determined that the tendon had experienced severe corrosion and multiple wire breaks.

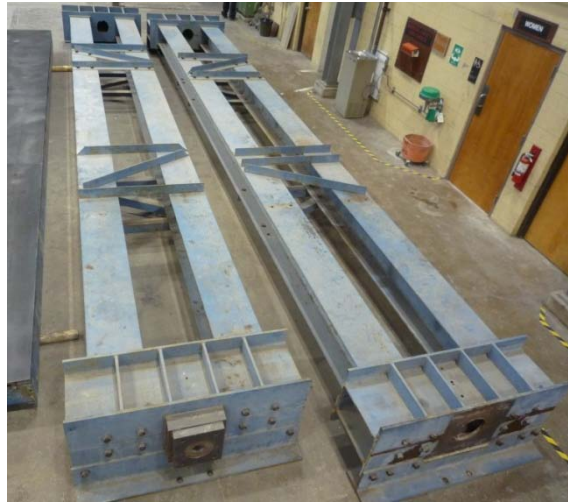
*Figure 3.1: Reaction Frames*

Two, 32-ft steel reaction frames were used to resist the prestressing force in the post-tensioned tendons. Information of the design of the frames can be found in Poser's thesis on full-scale bending fatigue tests of grouted stay cables (2001). The frames (Figure 3.1) are made of two longitudinal W14X90 columns with built up cross beams at both ends. Slight modifications were made to each frame to accommodate the anchorage blocks used for this research. Steel plates with a 3.25" diameter opening in the center were welded to one end of the frame used to test specimens with the concrete anchorage blocks and both ends of the frame used to test specimens with the steel anchorage blocks. The plates reduced the size of the openings at the ends of the frame to ensure that each specimen had adequate bearing area.

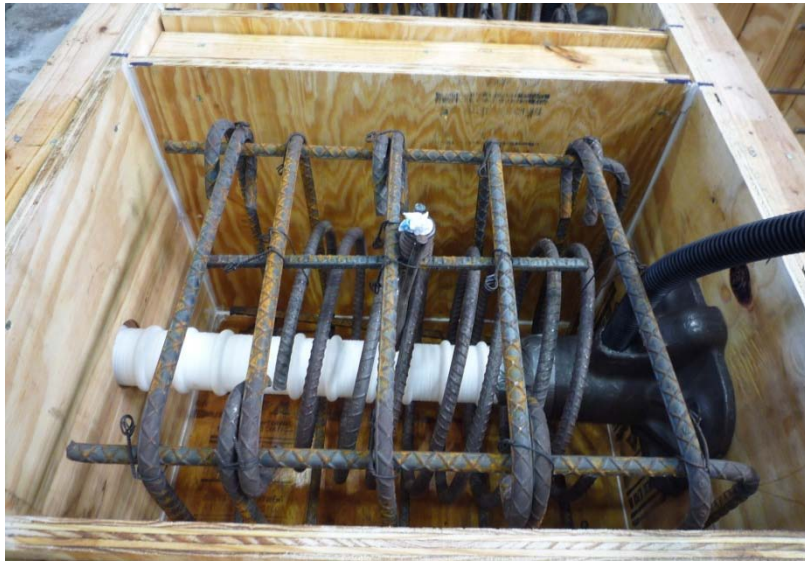
*Figure 3.2: Reinforcement in Concrete Anchor Block*

Each concrete block measured 18” by 18” in cross section and 24” in length. The design compressive strength of the concrete was 3500 psi. Reinforcement in the concrete blocks was designed to resist the prestressing forces, local bursting, and side-face blowout stresses. Longitudinal, transverse, and VSL-specified spiral reinforcement were provided. VSL type ECI 6-7 stressing bearing plates, along with the reinforcement, were placed inside the formwork of the concrete blocks as shown in Figure 3.2. A diagram of the concrete anchor block is shown in Figure 3.3 and the finished concrete anchor block is shown in Figure 3.4. A 1-in. steel plate was bonded to the inside face of the anchor block with hydro-stone to provide a smooth surface and alignment pocket for the center-hole load cell.

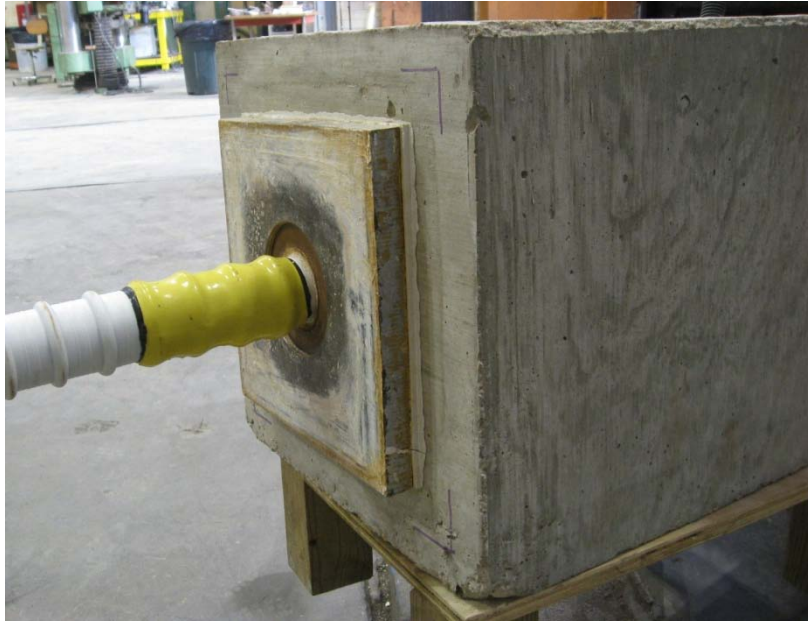
(a) Bearing Plate, Duct Exiting Anchor Block

Concrete anchor blocks were constructed to enclose the commercial post-tensioning hardware. All hardware was purchased from VSL. Type ECI 6-7 anchor heads, which can accommodate seven, 0.6-in. strands, were used to construct all specimens.

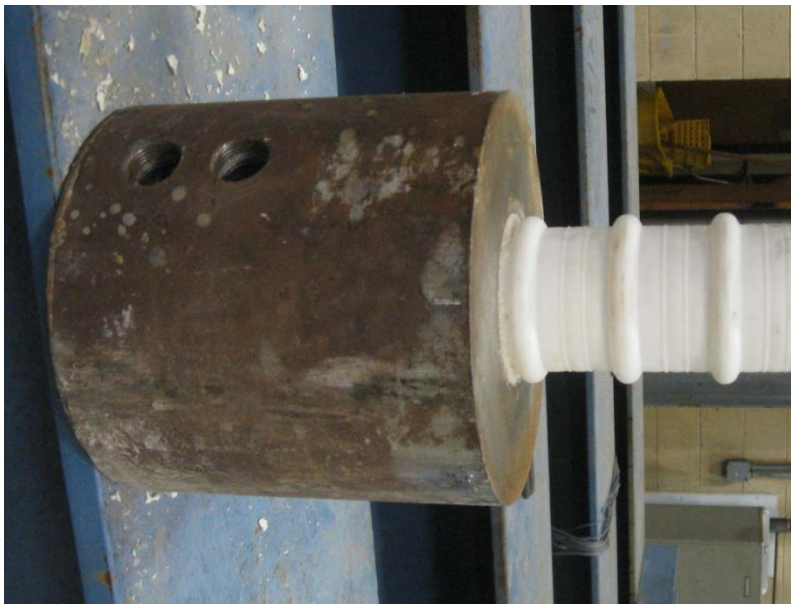
(a) Duct Exiting Anchor Block (north end)

The steel anchor blocks held the anchor heads securely when stressed and resisted the transverse forces induced by the splaying of the strands. The strand spacing at the anchor head is larger than the strand spacing along the free length. Therefore, the center hole in the steel anchorage blocks had a conical profile (Figure 3.6). Ports were also machined in the top of the steel anchorage blocks for grouting. Two ports were machined at the north end of the specimen and one at the south end. This provided one inlet at the north end and a vent at each end of the specimen. The steel anchor block is shown in Figure 3.7.

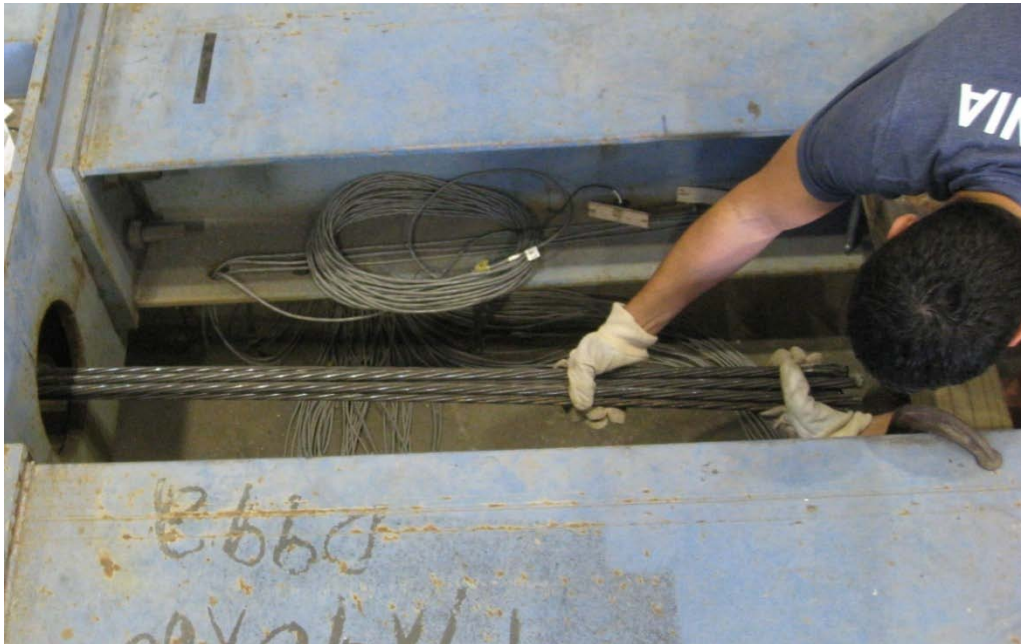
*Figure 3.9: Pulling Strands Through Frame*

Specimen construction began by pulling seven, 45-ft sections of strand through the length of the frame, as shown in Figure 3.9. All seven strands were pulled at the same time. The strands were longer than the overall length of the specimens, because additional length was required for the stressing process. Once the strands were in place, strain gages were applied to every strand. This procedure is discussed in Section 3.4.2.1.

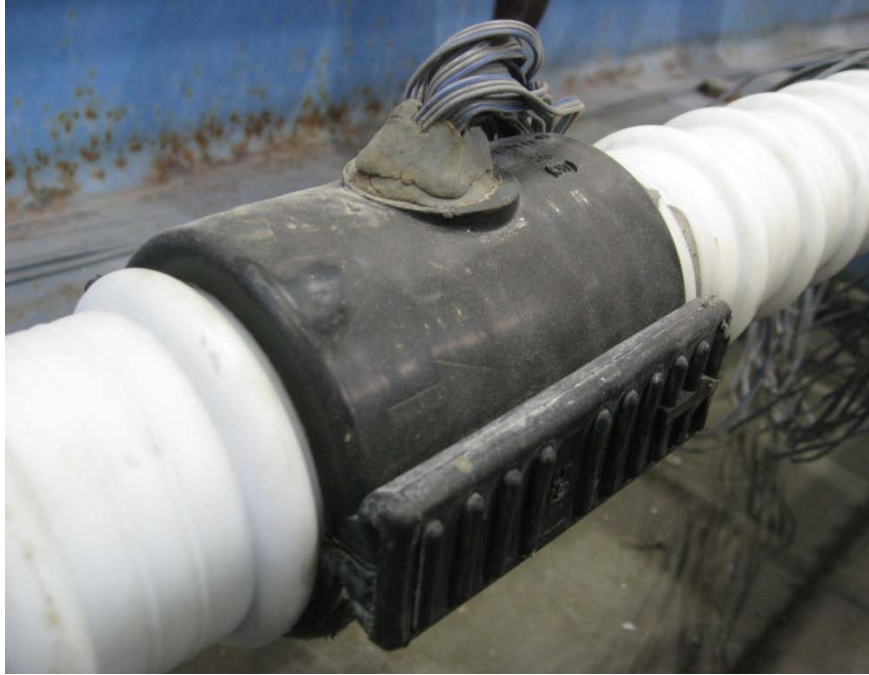
*Figure 3.10: Coupler for HDPE Duct*

means of routing the strain gage wires to the outside of the specimen (Figure 3.10) and creating a 1-ft section where the duct and grout could be easily removed to expose the strand for accelerated corrosion testing.

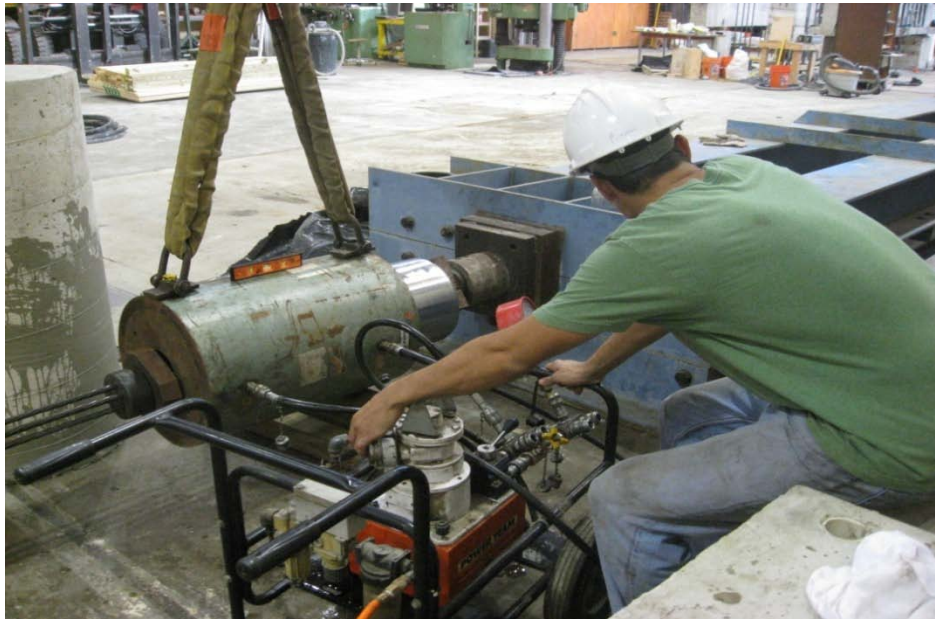
*Figure 3.12: Tendon Stressing*

A hydraulic, center-hole ram was used to stress the tendons. All seven strands were pulled simultaneously during stressing. The stressing ram was positioned between the outside face of the “live end” anchor head (north anchor head) and the inside face of an additional anchor head, which was used only for the stressing operation (Figure 3.11). Figure 3.12 shows the ram and the pneumatic pump during the stressing operation.

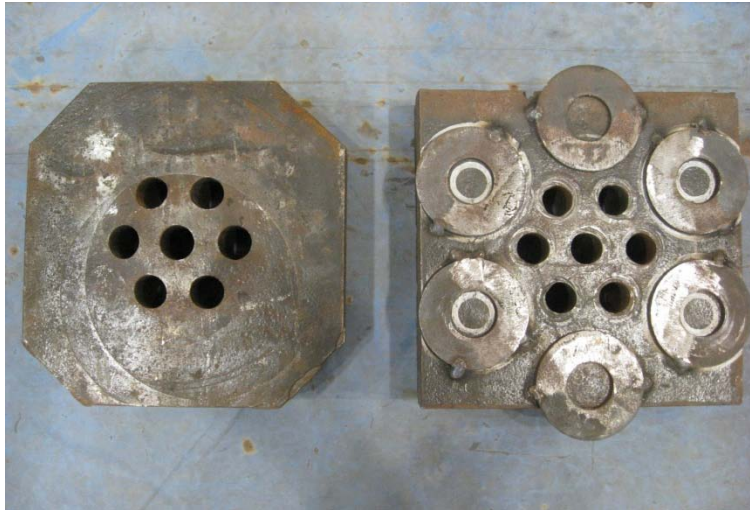
*Figure 3.13: Steel Plates Used During Stressing*

Two steel plates were machined with seven holes, replicating the strand pattern at the anchor head, for use during the stressing operation. The plates are shown in Figure 3.13. The purpose of the plates was to provide a bearing surface for the stressing ram against the anchor heads. One of the plates was retro-fitted with 1/8-in. thick washers that were welded around the strand pattern. The washers were placed in such a manner to allow the stress plate to bear against the anchor head at the live end of the specimen, but prevent the stress plate from bearing against the individual wedges.

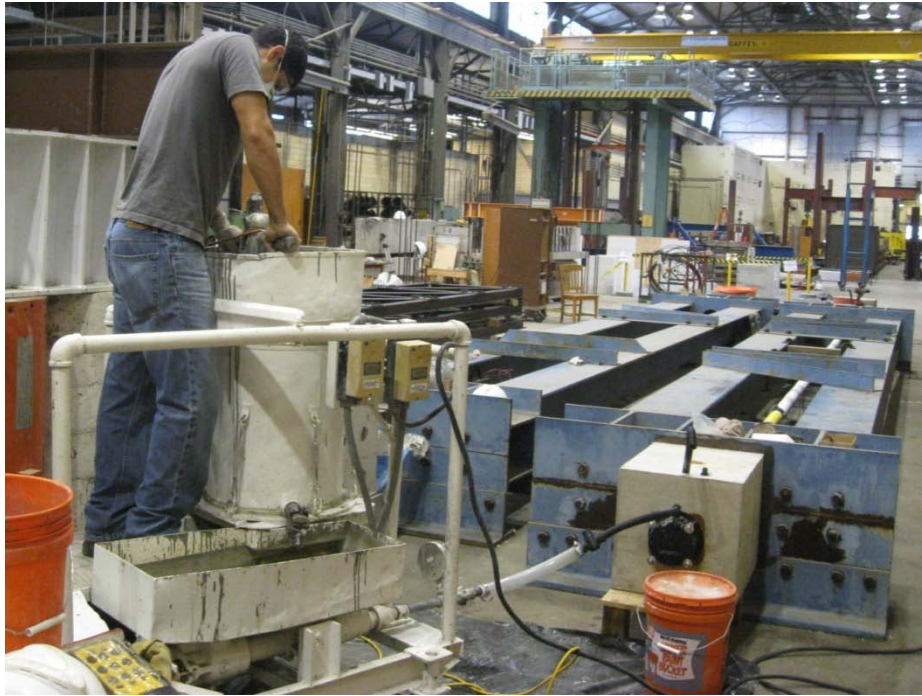
***Figure 3.14: Grouting***

The amount of water was measured and added to the grout mixer. With the mixer turning, dry grout material was slowly added. Once all the grout had been added, the components were mixed approximately ten minutes in the disc mixer before being released into the storage trough. From there, the grout was pumped into the inlet at the north end of the specimen. The grout mixer is shown in Figure 3.14.

Vents were provided at both anchor ends to minimize grout voids and allow air to escape. Once roughly a gallon of grout had escaped from the north air vent, it was sealed. The grouting process continued until grout had escaped from the south air vent, which was then sealed. After both vents were sealed, the valve between the mixer and specimen entrance was closed. The grout was allowed to cure for seven days before beginning any tests.

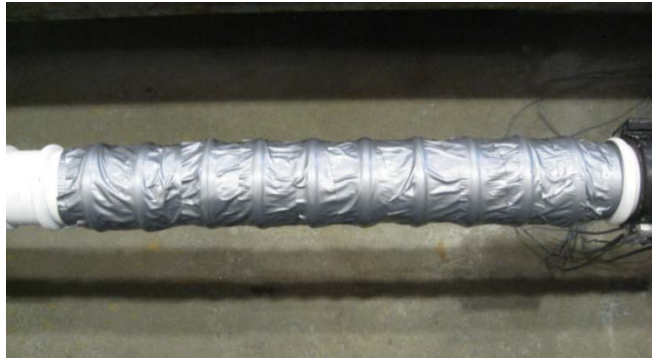
***Figure 3.15: Damage Location***

shown in (Figure 3.15c). The wires protruding from the duct in Figure 3.15c were attached to the individual strands before grouting to provide an electrical connection during the corrosion phase of the experiment. Specimen 2 is shown here, but a less tedious method of attaching the wires to the strands was used for Specimens 3, 4, and 5. After the strands were exposed, a copper wire was wrapped around the entire stand in those specimens, which provided the same level of electrical connectivity as the method used for Specimen 2.

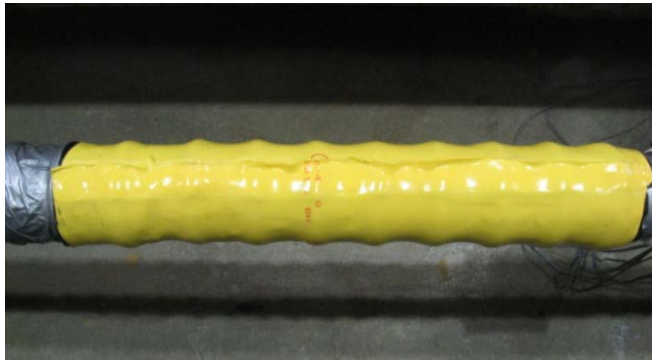
(b) with Heat-Shrink Wrap

In order for the corrosion to take place, a section of strand had to be exposed. When installing the duct over the strands, a 1-ft gap was intentionally left open. This gap was covered with two half-sections of duct that were duct-taped together (Figure 3.15a). This made it easier to remove the duct after the grouting process. The region was also covered with heat shrink material in order to provide a watertight seal (Figure 3.15b). Once the grout hardened for 24 hours, the heat shrink, duct tape, and duct were removed, and the grout was chipped away with a hammer and chisel. Full removal of the grout is

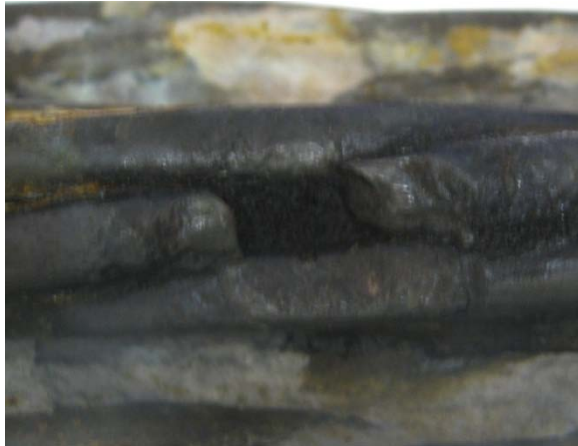
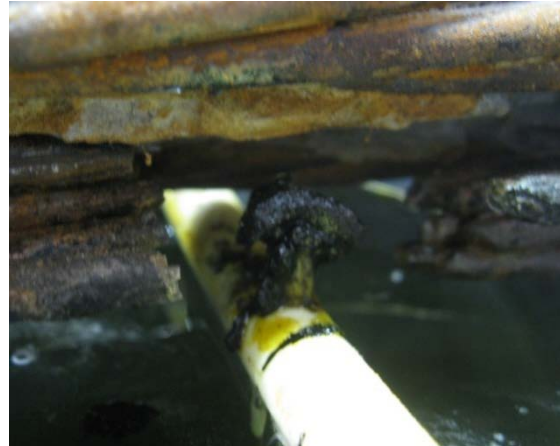
After several preliminary tests, it was determined that the most effective method to corrode the specimen was to position the wick such that it was in contact with only one wire in a strand at a time. Because the specimen was under tension, an individual wire would fracture once enough wire area had been corroded that the tensile stress exceeded the strength of the wire. Figure 3.17 shows a strand at various stages along the corrosion process.

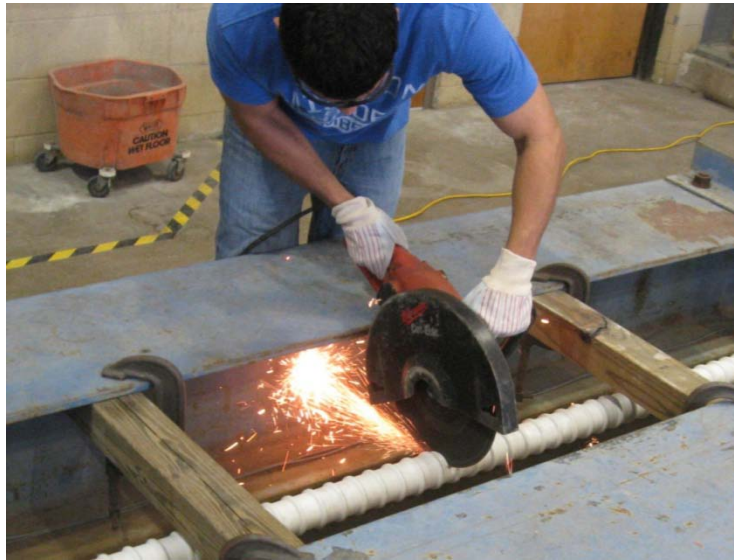
**Figure 3.19: Cutting Specimen**

When the residual prestress force dropped below 60% of the initial prestress, testing was discontinued. At this point, the specimen could be disassembled. Using a circular saw, the strands were slowly cut at one location of the specimen, as shown in Figure 3.19. Multiple cross-sectional cuts along the length of the specimen were made, each showing no evidence of grout voids.

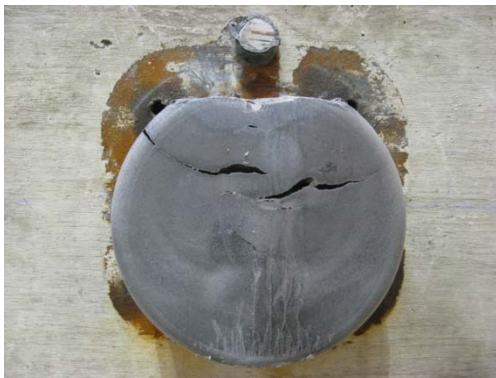
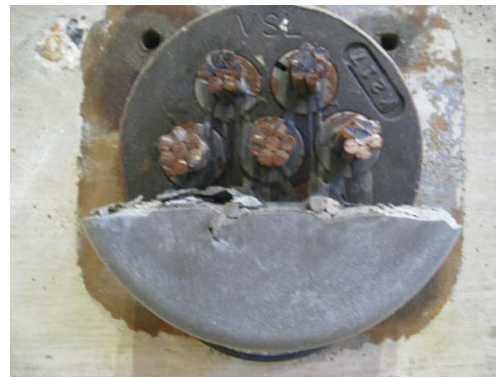
**Figure 3.20: Specimen 3 – Anchor Heads After Grout Cap Removal**

Disassembling the specimens allowed for the grout caps to be removed, which exposed the anchor heads. This gave a good idea of how well the specimen was grouted. Figure 3.20 shows both anchor heads of Specimen #3. The north end anchor was located where the grout was pumped into the specimen. The north end filled with grout while the south end only partially filled up with grout. Grout began to escape from the south vent before the south cap could fill completely.

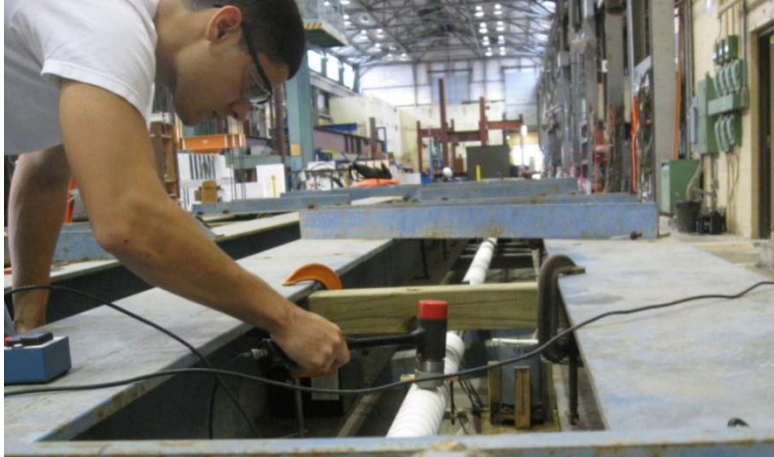
*Figure 4.5: Vibration Test*

Free vibrations were induced in the test specimens using an impact hammer (Figure 4.5). The acceleration response was measured at several locations along the specimen.

Data from the impact hammer and accelerometers were captured at 2000 Hz during each free-vibration test. A triggered acquisition mode was used such that 20 seconds of data were recorded, with 0.5 seconds before the impact.

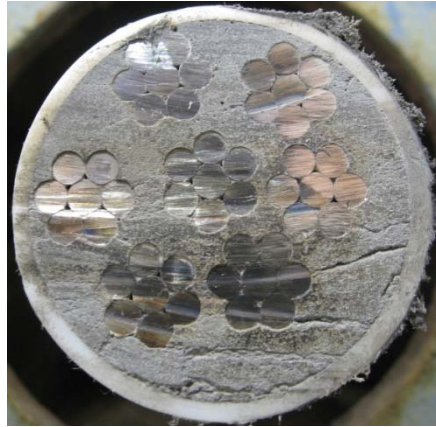
*Figure 4.9: Tendon Cross Section - Specimen 3 (near south anchor end)*

In an ideal environment, the cross section of the strands in a tendon would be symmetrical about the horizontal and vertical longitudinal axis. After Specimens 2 and 3 were disassembled, it was observed that the strands (Figure 4.9) were not symmetrically placed within the cross section. As a result, the flexural stiffness may not be the same in the horizontal and vertical directions.

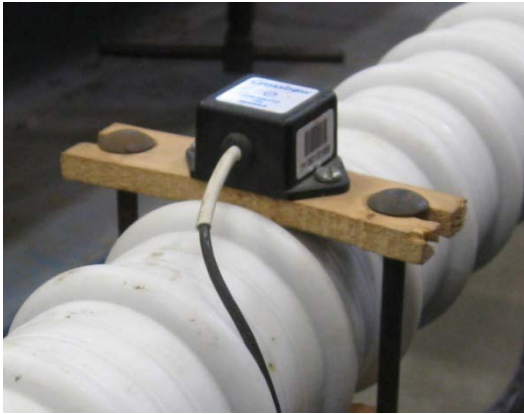
**Figure 4.10: Orientation of Accelerometers**

In order to understand the influence of the flexural stiffness on the measured natural frequencies, the orientation of two of the accelerometers were rotated. For Specimen 4, accelerometers 1 and 3 were oriented horizontally (Figure 4.10). For Specimen 5, accelerometers 5 and 7 were rotated in the same fashion.

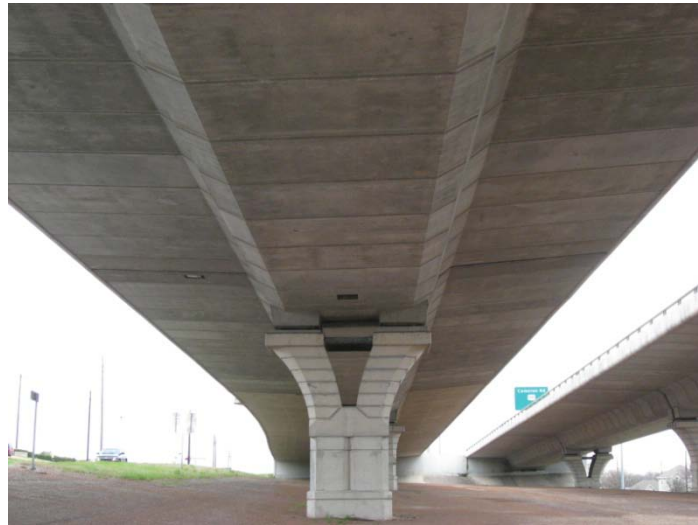
*Figure 6.1: US 183 Bridge, Austin, Texas*

U.S. Route 183 is a highway running across the United States from Texas to South Dakota. A portion of the highway in Austin, Texas is supported on a segmental bridge with external post-tensioned tendons (Figure 6.1). The bridge, constructed in 1997, consists of 218 spans ranging in length from 90 ft to 115 ft. The bridge was designed in accordance with the AASHTO Standard and Interim Specifications for Highway Bridges and the AASHTO Guide Specifications for Design and Construction of Segmental Concrete Bridges.

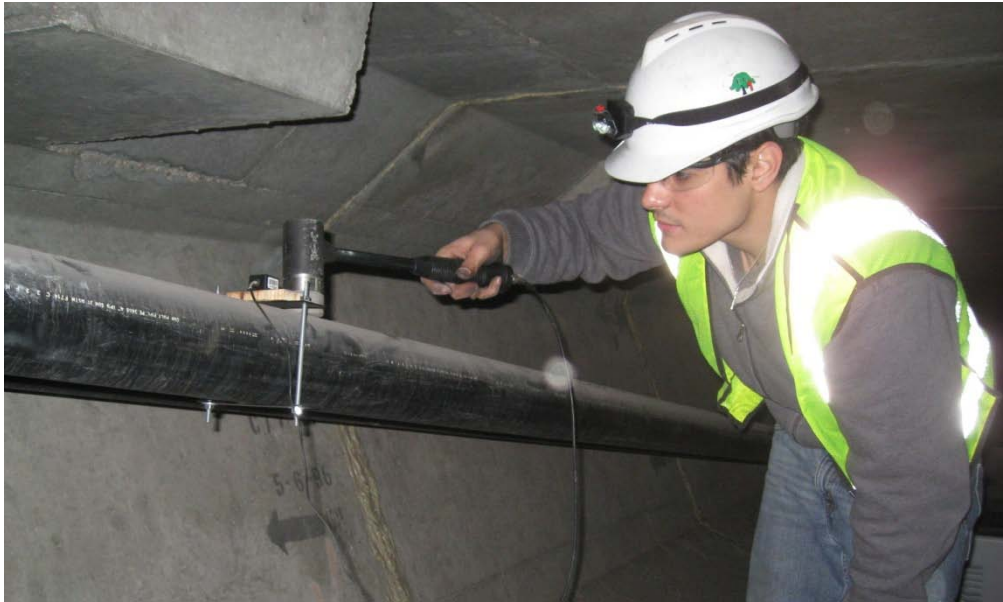
*Figure 6.3: Vertical Vibration Test, US 183 Bridge*

The response of the span was measured during ninety-six free-vibration tests. A three-dimensional accelerometer, placed  $L/6$  from each end of each segment, was used to measure the response of each tendon. For each deviated section of each tendon, eight free-vibration tests were conducted with four free-vibration tests performed at each end of the tendon segment. An impact hammer was used to induce either horizontal or vertical accelerations in the tendon (Figure 6.3). Each free-vibration test was repeated two times.
