STAY CABLE ANCHORAGE SYSTEM TESTS

THESIS

MASTER OF SCIENCE IN ENGINEERING

THE UNIVERSITY OF TEXAS AT AUSTIN

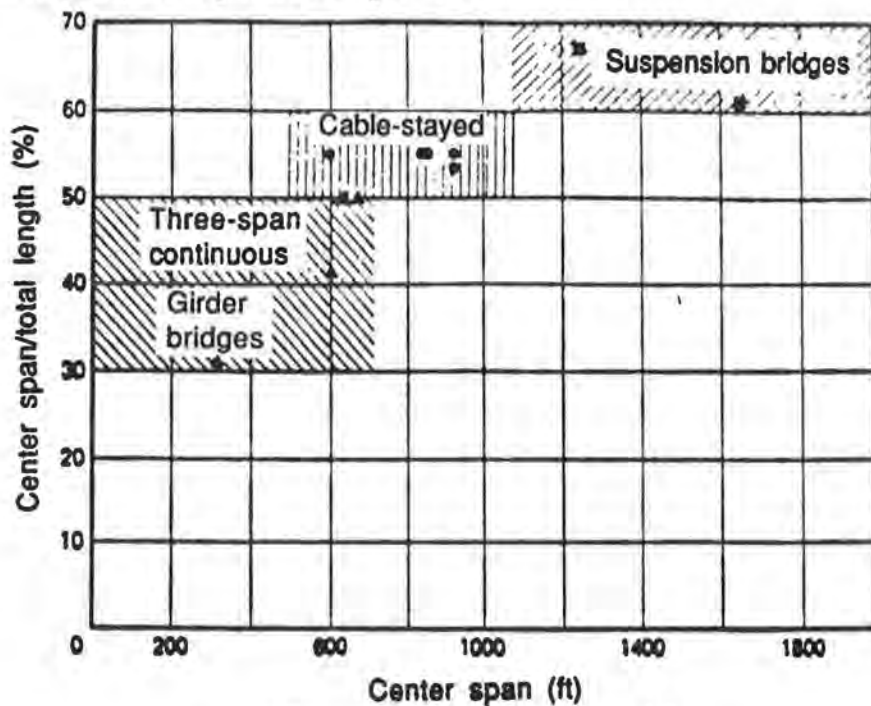
Figure 1.1 Studies by Thul [1]

compiled by Thul does implicitly reflect on the economics involved in choosing a particular bridge type to meet span requirements. The results of Thul's study would indicate that continuous girder bridges are the most economical alternative in the shorter span range up to about 700 feet. Suspension bridges become the more economical choice with required center spans a minimum of 1000 feet. However, Thul found that cable-stayed bridges provide the most economical alternative in the intermediate range of center spans, from 700 to 1000 feet. This corresponded to a center-to-span-total-length range of 50 to 60%. The results of Thul's study, completed in 1966, are depicted in Figure 1.1.

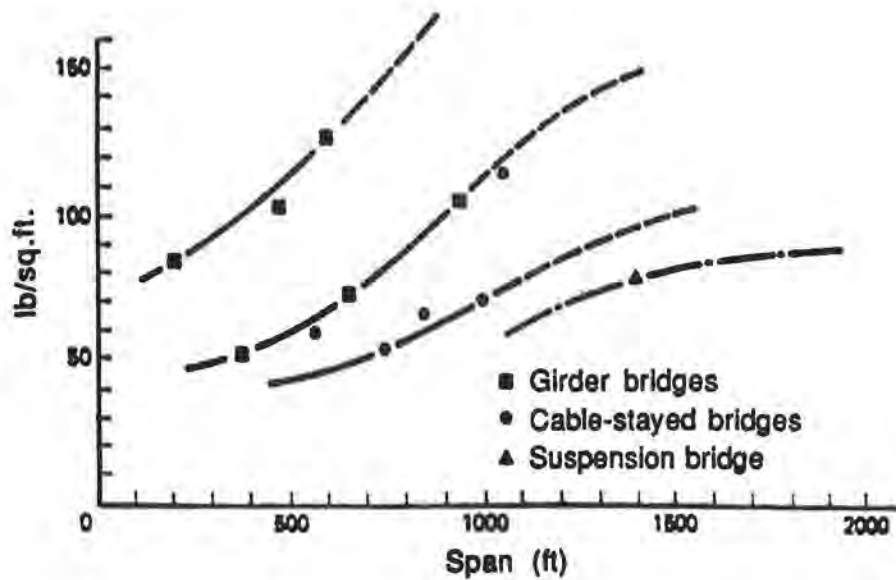
Figure 1.2 Studies by Taylor [1]

A study by Taylor in 1969 correlated center span lengths to required weight of steel per square foot of deck space for the same alternative designs as Thul. Taylor determined that, once again, cable-stayed bridges prove to be the most economical

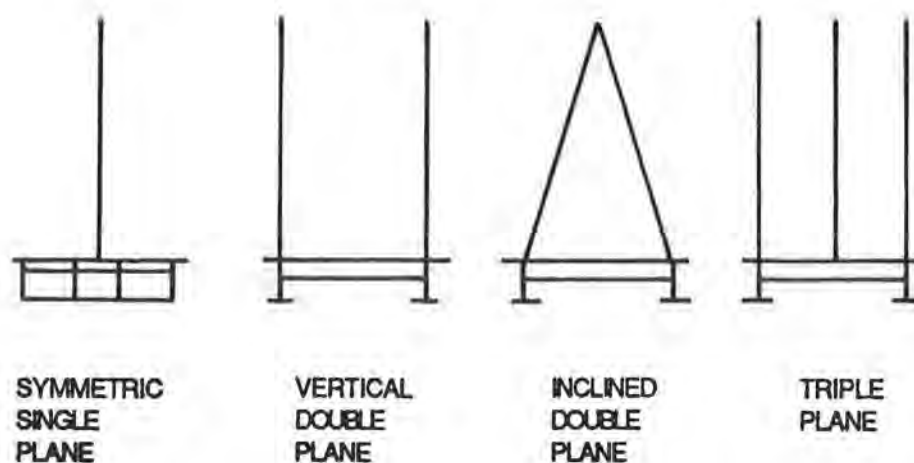
Figure 2.2 Typical transverse arrangements for bridge stays [7]

2.1.2 Transverse cable arrangements. Bridge cable stays may lie in either a single, double, or triple plane configuration in the transverse direction. They may also lie in oblique or vertical planes. The choice of transverse configuration depends to a great extent on aesthetics, the types of loads to be encountered (their magnitudes and direction), and the torsional stiffness of the bridge deck utilized. Figure 2.2 shows the typical transverse arrangements of cable stays.

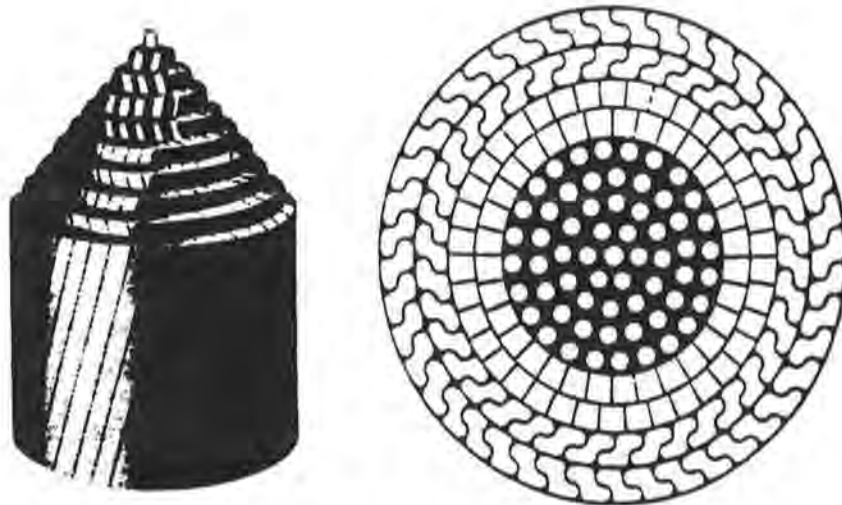
Figure 2.4 Locked coil strand [4]

2.2.2 Locked coil strand stays. Locked coil strands consist of an inner core made up of round wires, surrounded in turn by several layers of wedge- or keystone-shaped wires, which are in turn surrounded by several layers of Z- or S-shaped wires. This arrangement is shown in Figure 2.4. The main advantage of this cable arrangement is the inherent corrosion protection provided by the tightly interlocked wire layers [4]. These cables have been used in conventional suspension bridge construction. They have also been used extensively in many early european cable-stayed bridges, but have not been utilized in this country to date.

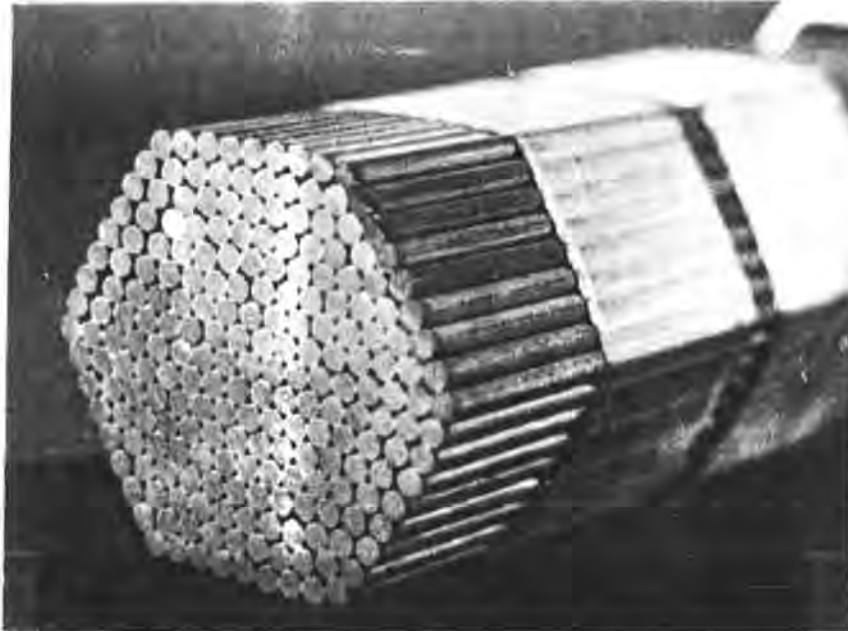
Figure 2.5 Parallel wire stay with hexagonal arrangement [3]

allows for equal wire lengths. This in turn allows for a more uniform stressing of the wires in the stay [1]. Figure 2.5 shows a parallel wire stay with the hexagonal arrangement.

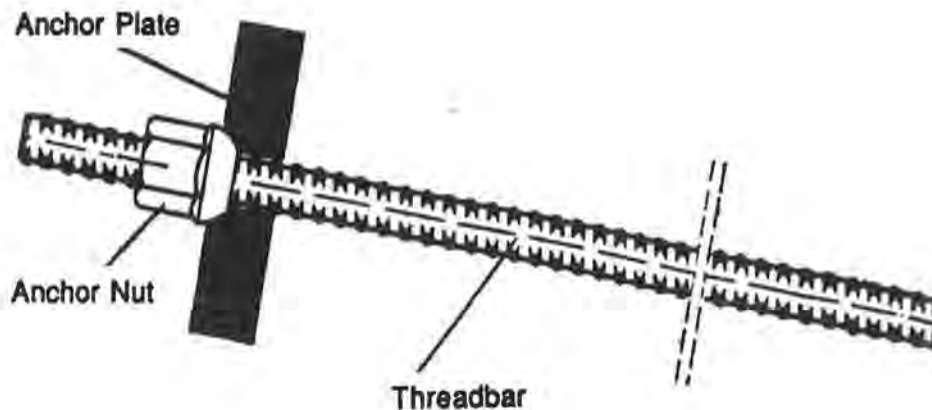
Figure 2.8 Typical threaded bar anchorage [8]

2.3.1 Threaded bar anchorages. This anchorage is exclusive to stay systems using threaded bars. Threaded bars may be anchored individually or as a group in a common anchorhead. A typical anchorage for a single threaded bar is shown in Figure 2.8. Load transmittal with this type of anchorage system is mechanical, i.e. through the threads, and not dependant on wedging action, as with most strand anchorages.

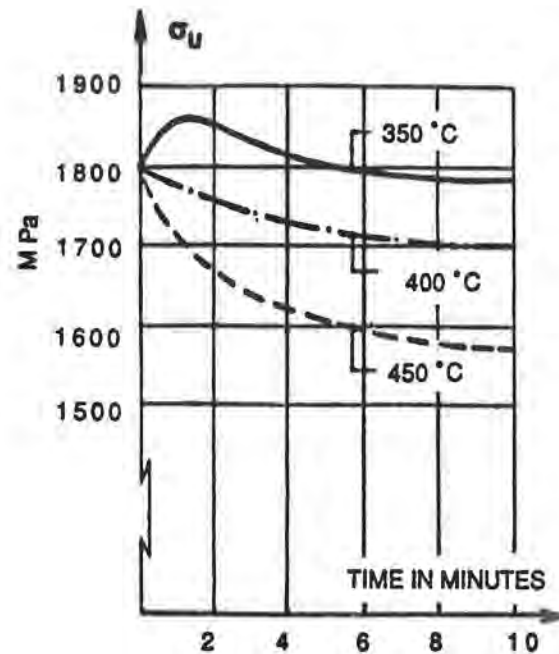
Figure 2.10 Effects of casting temperature on wire ultimate strength [3]

One of the major shortcomings of this type of anchorage is the hot casting temperature of the socket. Studies have shown that high casting temperatures reduce both the ultimate strength of the wires in the vicinity of the socket and the fatigue life of the wires [3]. Figure 2.10 shows the effects of casting temperature on the wire ultimate strength. A reason for the reduction in the ultimate strength of the wires has been suggested by Gimsing [3]; the wires derive their high strengths from the cold drawing process, and the increase in wire temperature during casting relieves some of the stresses built in from the cold working process. The effects of pouring temperature on the fatigue resistance of wires are discussed in Chapter 3. Using lead alloys as the base metallic compound, cooler pouring temperatures of around 350°C are possible. The unfavorable creep properties associated with lead, however, have resulted in its lack of use. Instead, alloys with a zinc base are used. Zinc alloy

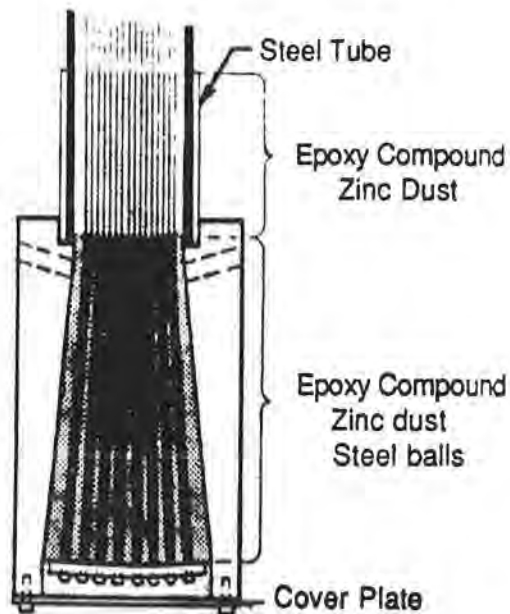
Figure 2.11 Hi-Am anchorage [3]

required socket diameter that is smaller in comparison to the hot poured socket. By virtue of ambient pouring temperature and relatively low curing temperature, wires in the Hi-Am anchorage have higher fatigue resistance and no reduction in ultimate strength.

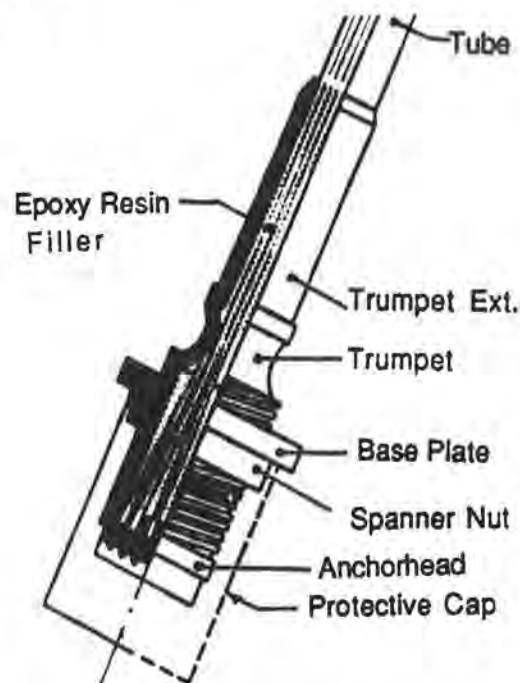
Figure 2.12 Wedge-trumpet anchorage details [3]

2.3.4.1 Wedge-trumpet anchorage. A manufacturer has developed a stay using seven wire parallel prestressing strands which are individually anchored in a common anchorhead using a wedge system. The anchorage system shown in Figure 2.12 consists of the following main components: a trumpet, which accommodates the flare of the strands within the anchorage, heavy steel pipe, trumpet extension, base plate, anchorhead with wedges, spanner nut, and epoxy resin, cement, or similar grout filler material. The strands are anchored in the anchorhead using a typical three-piece wedge system. The steel pipe is filled with the filler material under full dead load stress. Fluctuations in the total stay force due to live loads are transmitted from the strand through the hardened filler material to the steel pipe and into the bearing plate. This removes the fatigue-prone strand anchorages from cyclic load ranges. The ring nut is provided to adjust the tension in the stay. This anchorage system may be either preassembled under controlled conditions, or it may be assembled on site [1, 3].

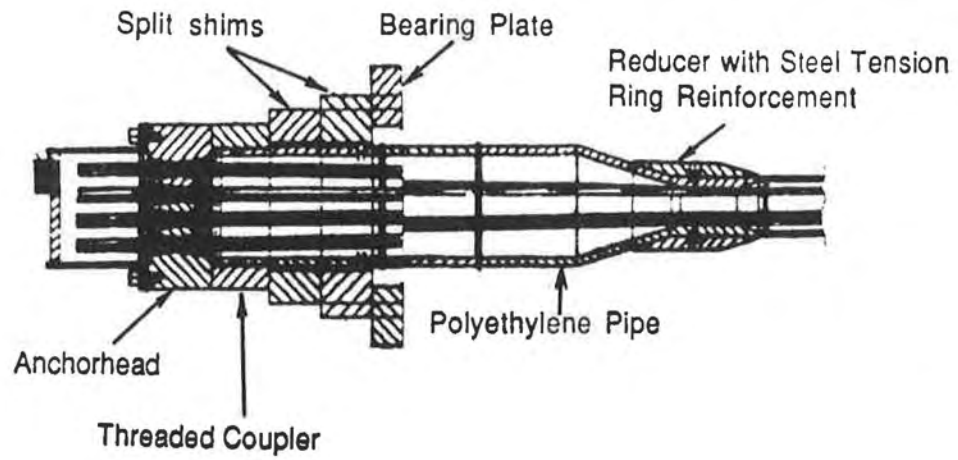
Figure 2.13 Wedge anchorage details [9]

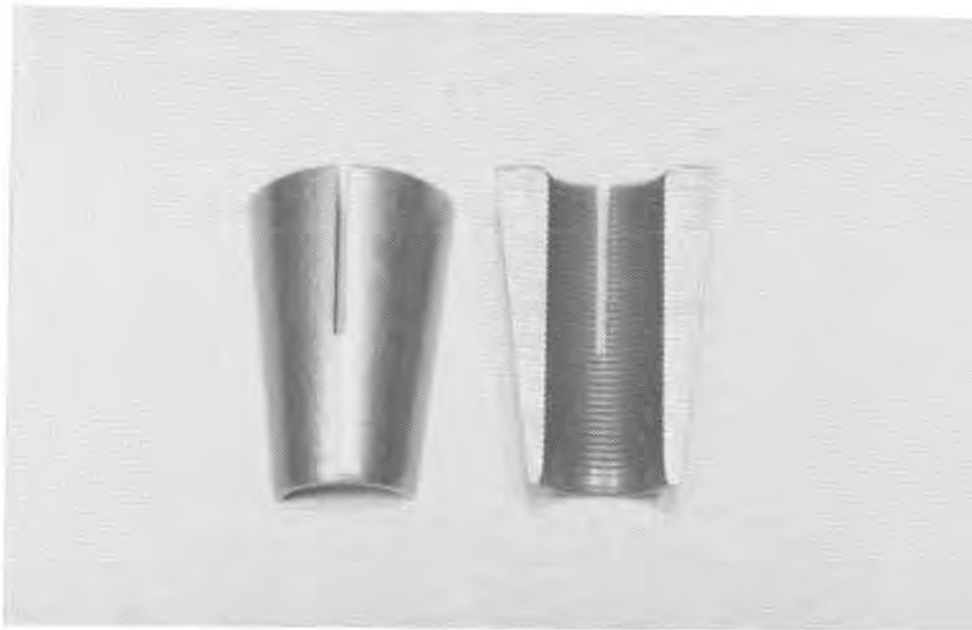
Figure 2.14 Two-piece wedge system for wedge anchorage

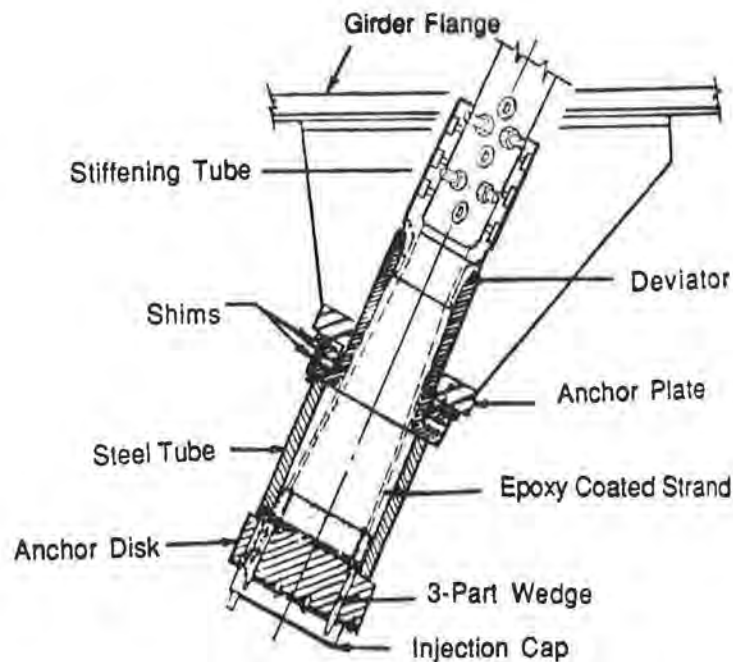
Figure 2.15 Wedge-stiffening tube anchorage with coated strands [11]

2.3.4.3 Wedge-stiffening tube anchorage with coated strands. A third strand anchorage technique has been proposed recently for use. Shown in Figure 2.15, it consists of the following main components: epoxy coated strands, steel tube extension, steel stiffening tube, anchor plate, anchorhead with wedges, steel shims, and filler material. The strands are anchored individually in the anchorhead using a special three-piece wedge system to grip the epoxy-coated strands. The steel stiffening tube is positioned with respect to the steel tube extension with machine screws. Under full dead load stress the steel pipe is filled with the filler material through the injection cap, and any fluctuations in total stay force due to live loads are transmitted from the strand to the hardened filler material and into the bearing plate through shear studs in the stiffening tube. With this alternative the shear transfer is mechanical rather than being dependant on the bond formed between the filler material and pipe. This transfers any superimposed cyclic load away from the fatigue-prone strand anchorages and into the steel pipes. The steel shims are provided to properly tension the stay. This anchorage system may be either preassembled under controlled conditions, or it may be assembled on site.

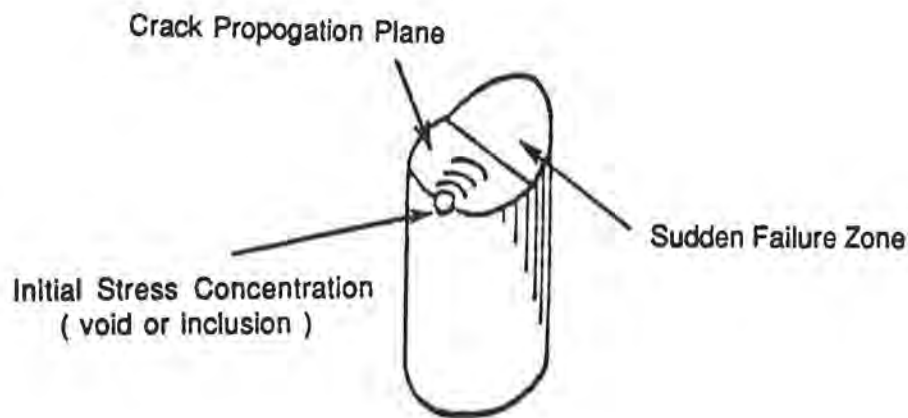
Figure 3.1 Fatigue crack initiation in wire [7]

Fatigue failure in a wire occurs when a fatigue crack initiates and propagates through the cross-section to such a point that the stress in the wire exceeds its ultimate tensile strength. The result is a sudden type of failure, which occurs in shear. The wire fatigue crack and subsequent failure generally occurs as the result of a stress concentration at that point. These stress concentrations are due to

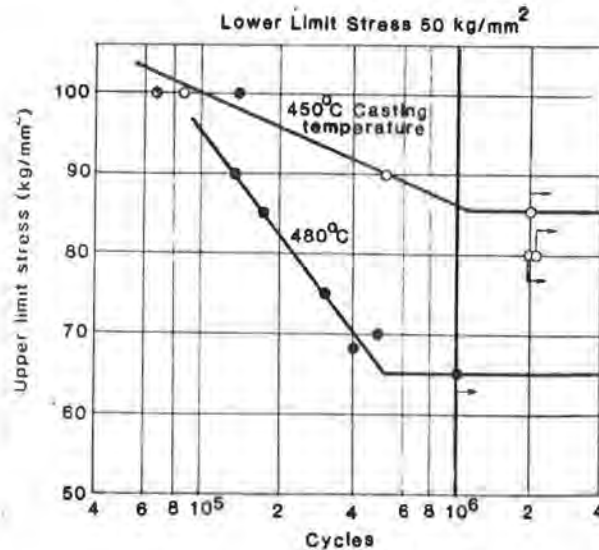
Figure 3.2 Pouring temperature vs. wire fatigue life [1]

The degrading effects of hot-pouring on the ultimate strength of wires near the anchorage zone have already been discussed in section 2.3.2. Furthermore, these studies have shown that the consequences of hot pouring extend to the fatigue resistance of the wires as well [1]. Studies conducted on parallel wire stays with zinc-copper alloy anchorages for the Toyosata-Ohashi Bridge in Japan have demonstrated the effects of hot pouring temperature on wire fatigue life. The study results, which shows a marked decrease in fatigue life for an increase of pouring temperature from 450°F to 480°F, are shown in Figure 3.2.

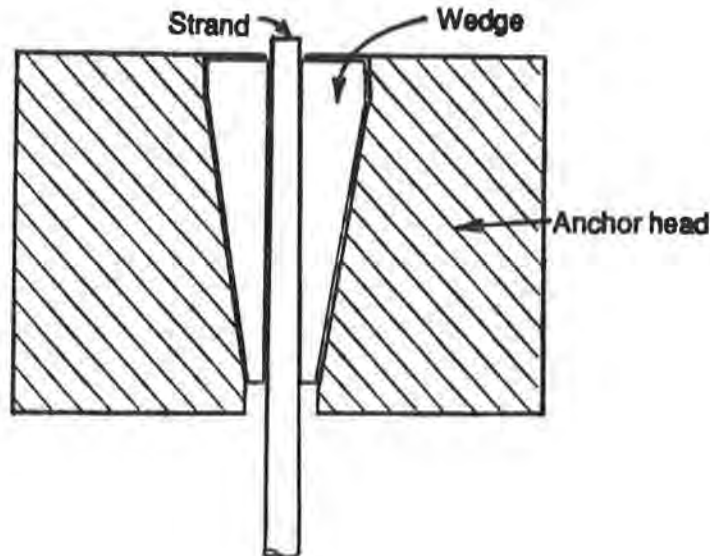
Figure 3.3 Friction-type anchorage system for strand

Both single prestressing strand and parallel strand stays have been shown through testing to be fatigue-prone in the anchorages [1, 21, 22, 23]. These stays employ friction-type anchorages to anchor each strand individually, as shown in Figure 3.3. The anchorages rely on wedging action and generally consist of three main elements: the strand, wedge (typically two, three, or four pieces), and the strand group anchorhead. Tensile load in the strand is transferred to the wedges and then into the anchorhead. Transfer of the strand tensile force takes place mechanically in

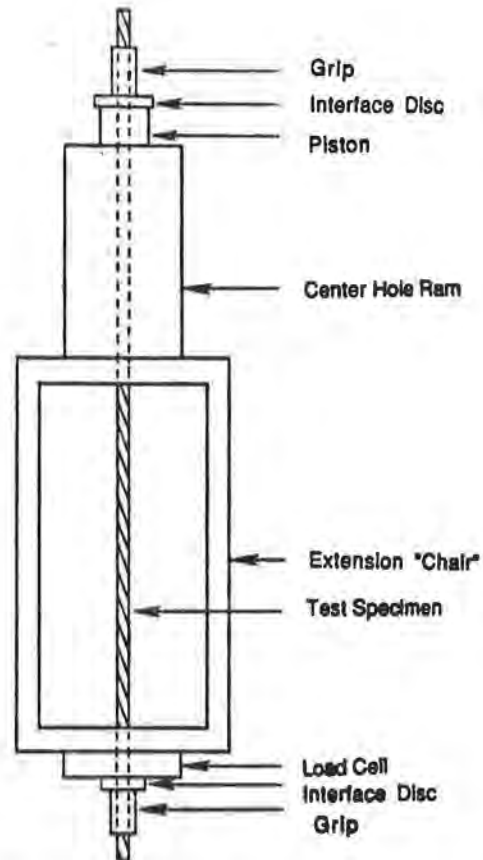
Figure 4.1 Strand fatigue setup [21]

4.1.1 Testing apparatus. A test system concept developed previously for a cable stay fatigue study [17, 18] was used for the single strand static and fatigue tests in this chapter. The test system consisted of a centerhole ram and extension chair with a hollow load cell to allow passage of the strand through the system. The strand was anchored with grips at both ends. This arrangement (shown in Figure 4.1), when centered with interface discs, ensured that all elements of the load system were either in tension or compression; essentially no moment was introduced into the

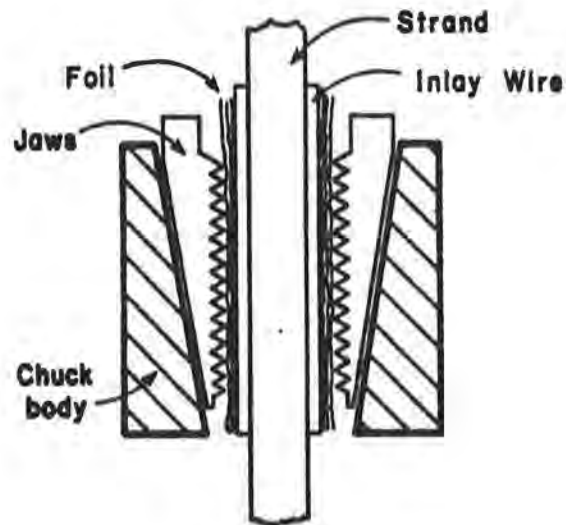
Figure 4.2 Protective gripping measure employed [21]

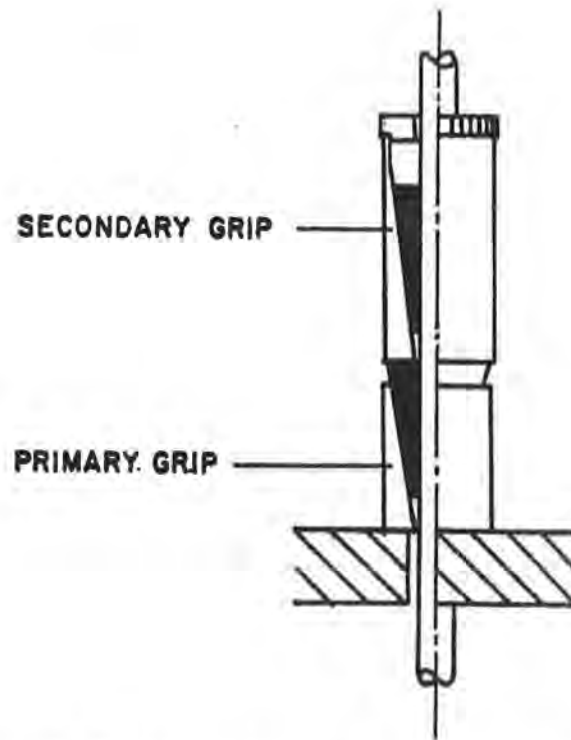
Figure 4.3 Double chuck system for anchoring strand [21]

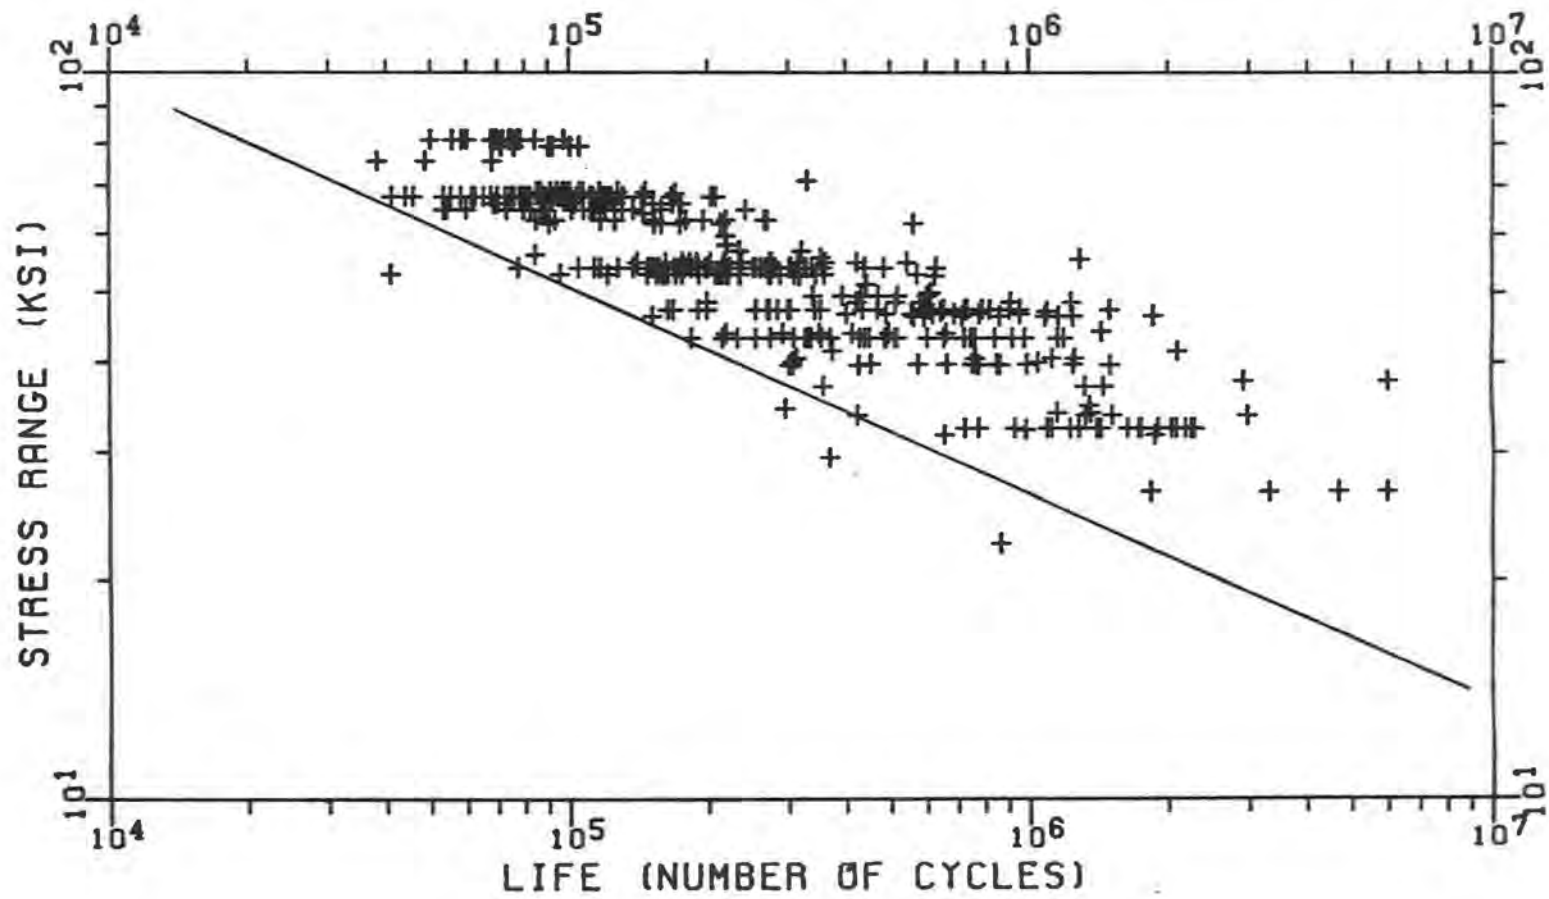
Figure 4.4 Design model and its test data, recommended by Paulson, Frank and Breen [21]

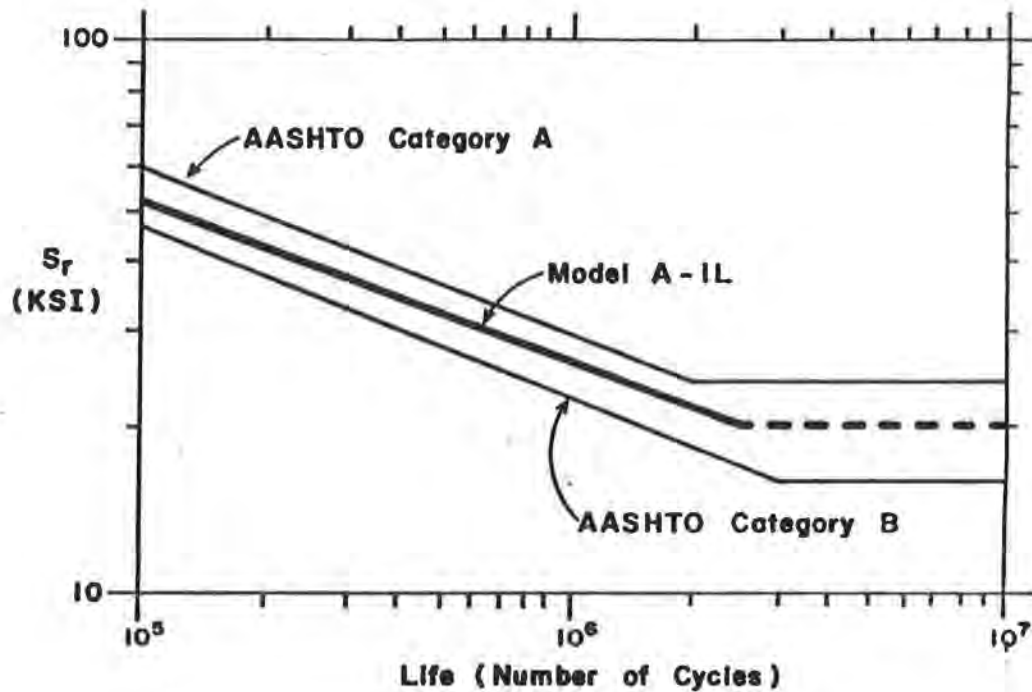
Figure 4.5 Developed S-N curve versus AASHTO Category A and B curves [21]

This relation is also plotted in Figure 4.5, along with the AASHTO specifications for Category A and B structures.

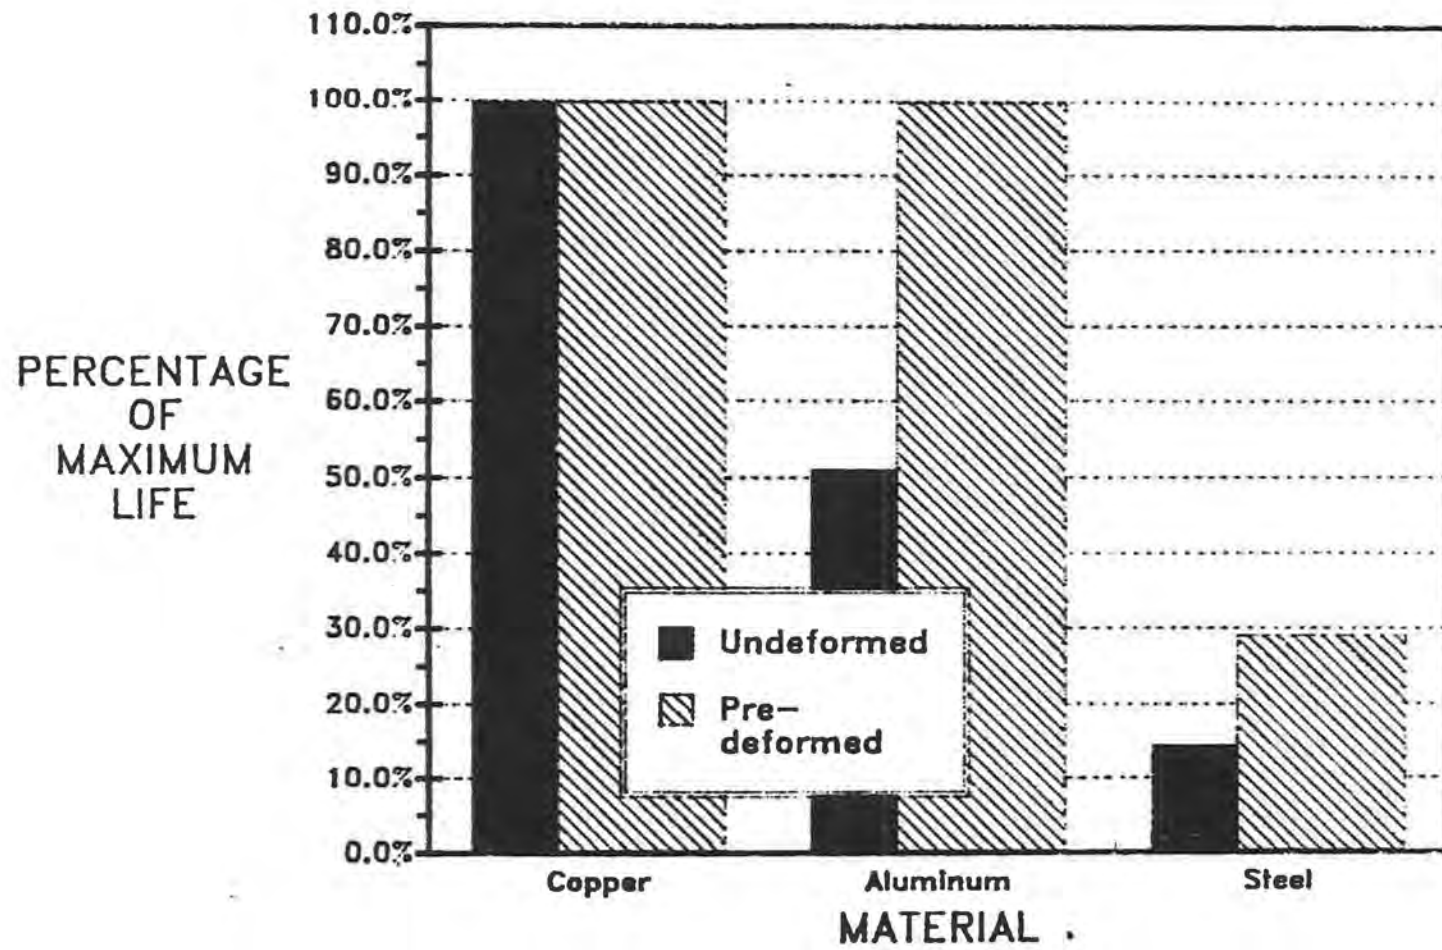
Figure 4.6 Effect of wedge type on fatigue strength for tests, 33.8 ksi stress range [22]

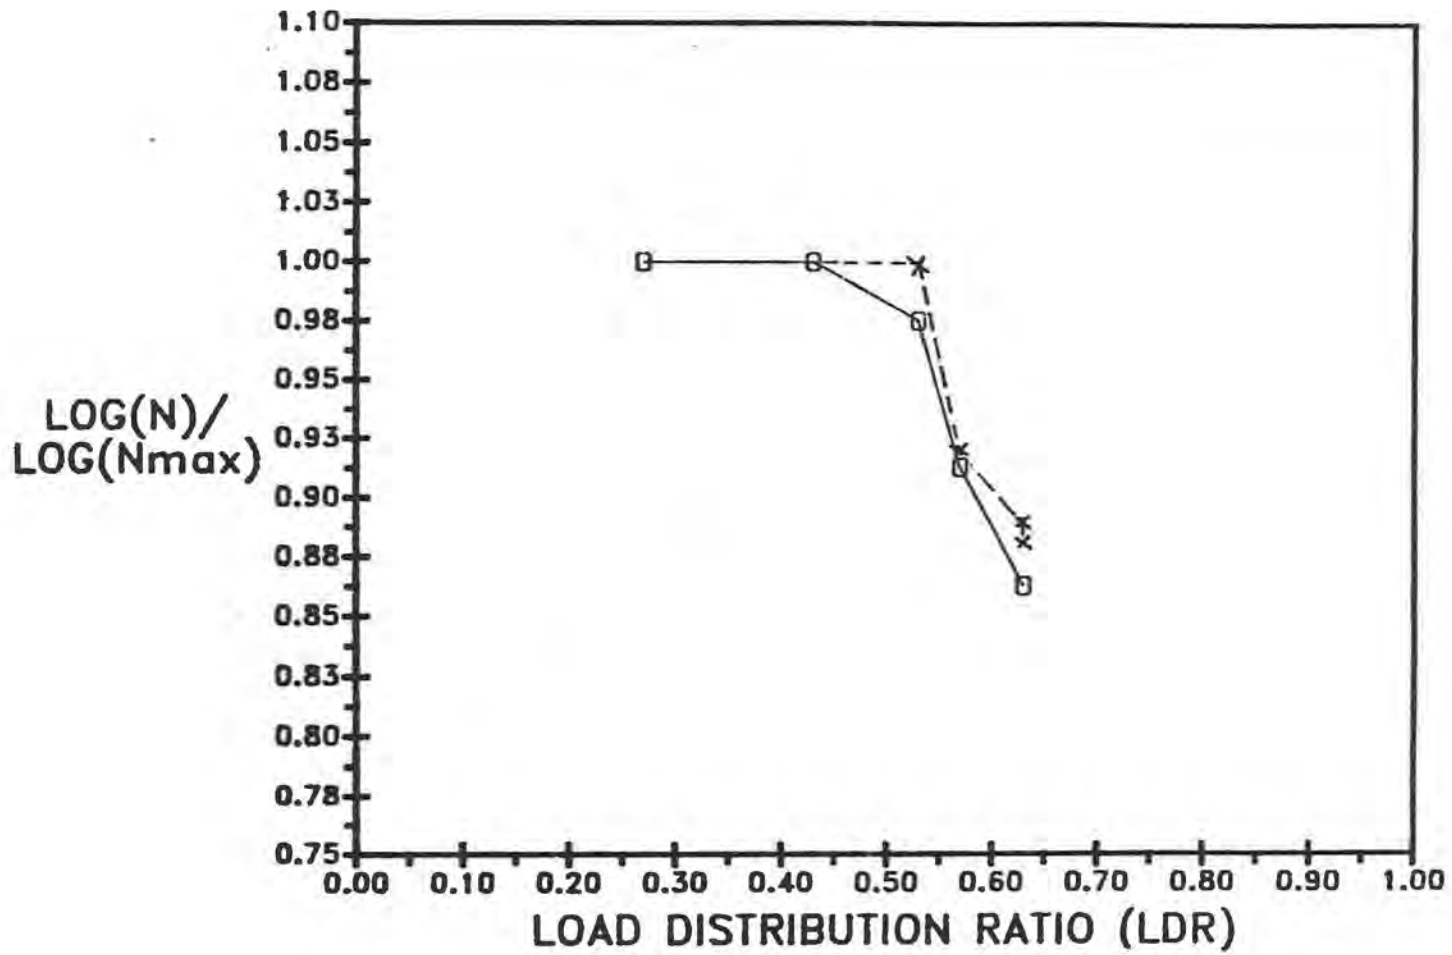
Figure 4.7 $\text{Log}(N)/\text{Log}(N_{\text{max}})$ versus LDR for 47.2 and 33.8 ksi stress ranges [22]

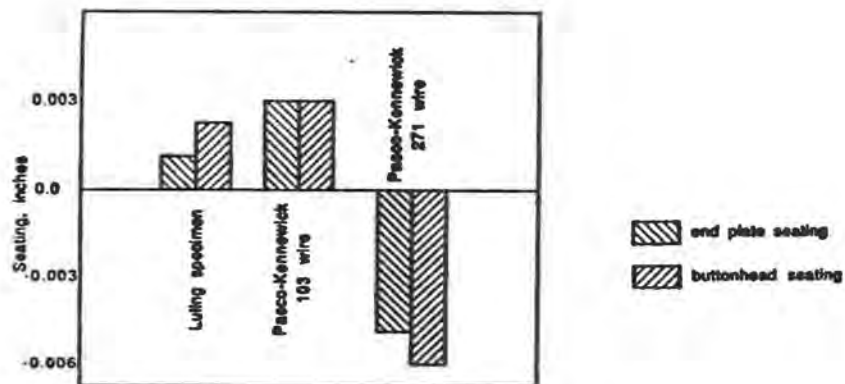
Figure 4.9 Center buttonhead and end plate seating during fatigue test

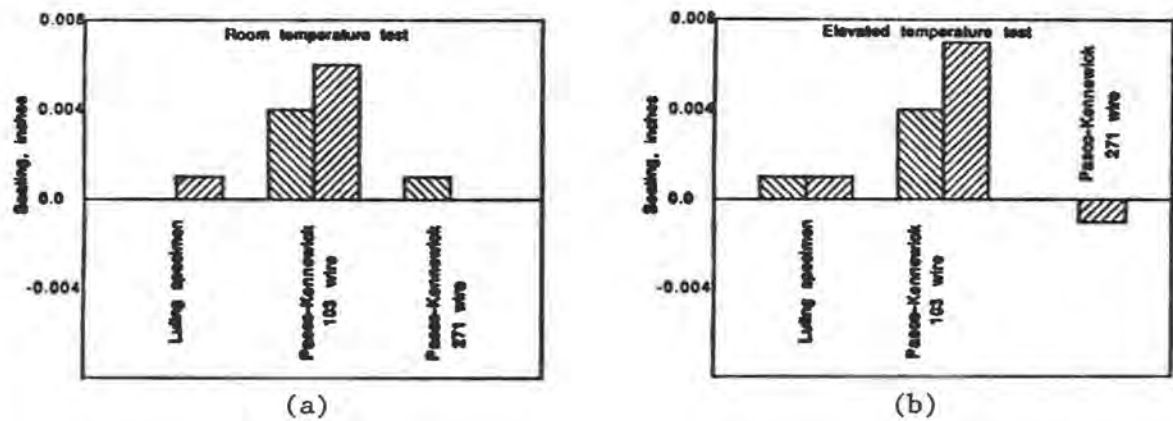
Figure 4.10 Center buttonhead and end plate seating during creep tests

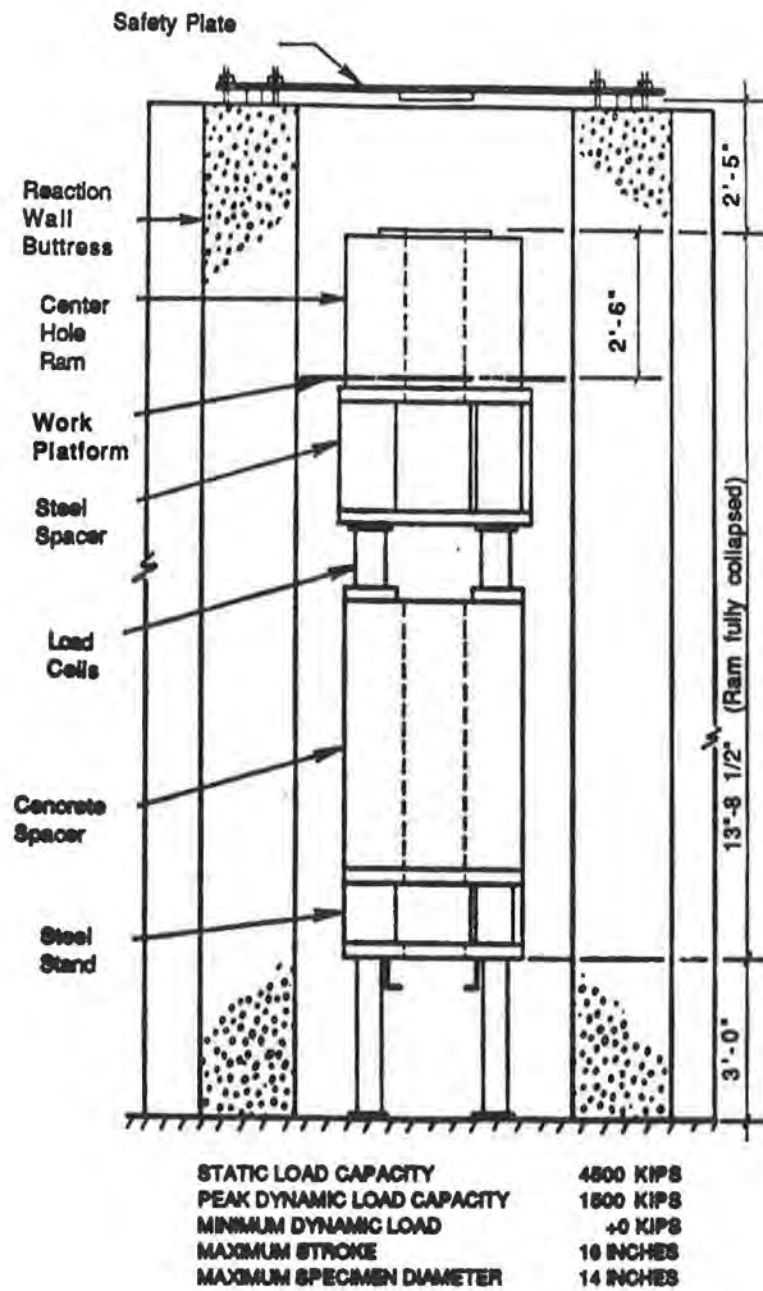
Figure 4.11 FSEL large scale fatigue and tensile test machine [29]

4.3.1.2 Testing apparatus. The test frame, shown in Figure 4.10, consists of a concrete spacer block and two steel spacers. The load cells used to monitor the loads were located between the concrete spacer and upper steel spacer. Loads were applied with a 4.5 million pound capacity centerhole ram situated atop the upper steel spacer. The load controlling system and data acquisition system are described in detail in Chapter 5. No measurements of center wire or wedge seating were recorded during the testing. The specimen was assembled in the test frame by threading each strand through the top and bottom anchorheads. The strands were uniformly tensioned with a prestressing monostrand jack to a load of approximately 6 kips. The top wedges were power seated. Under a load of 1608 kips (121.5 ksi, or

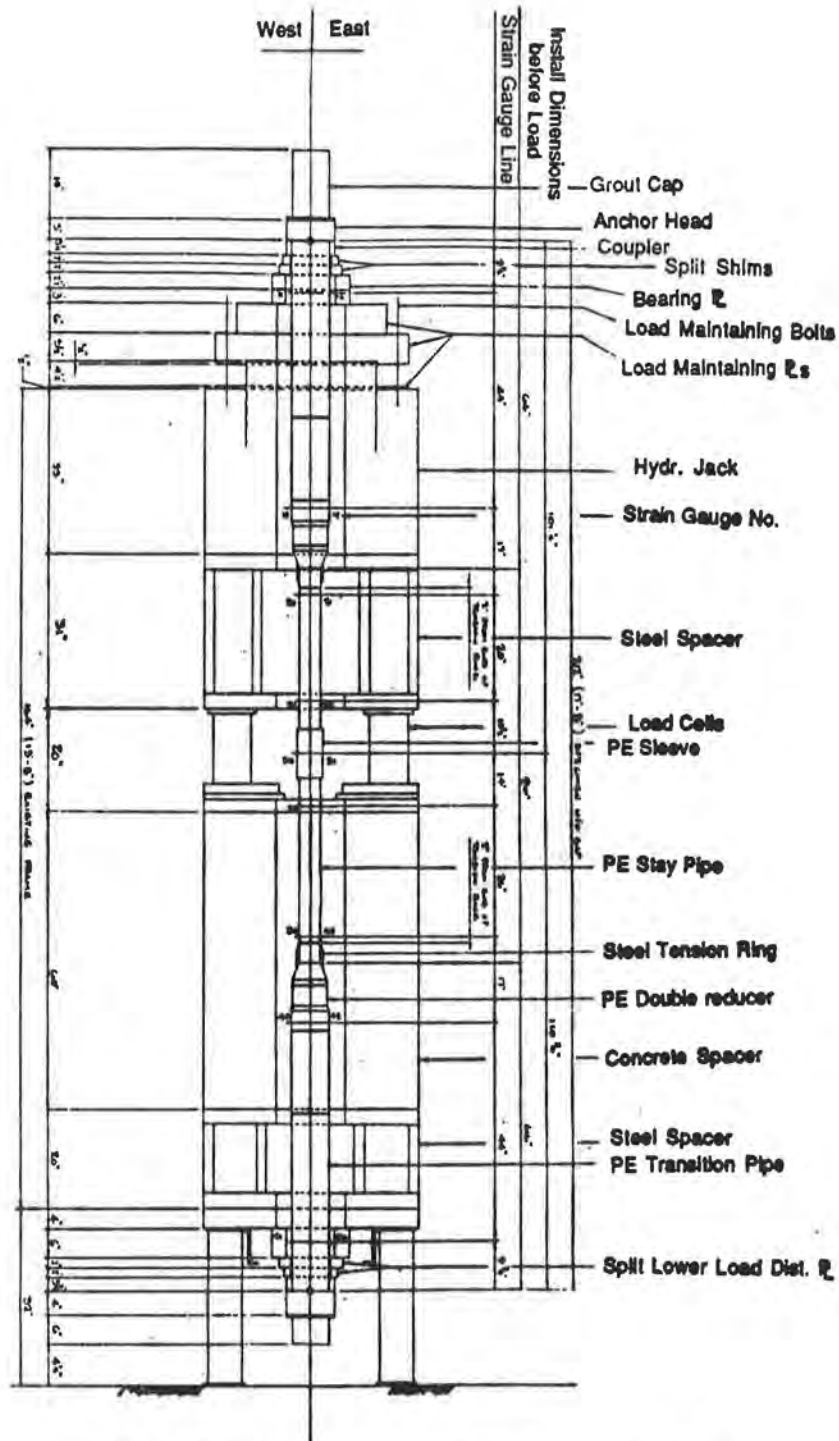
Figure 5.1 Test set-up and strain gage locations

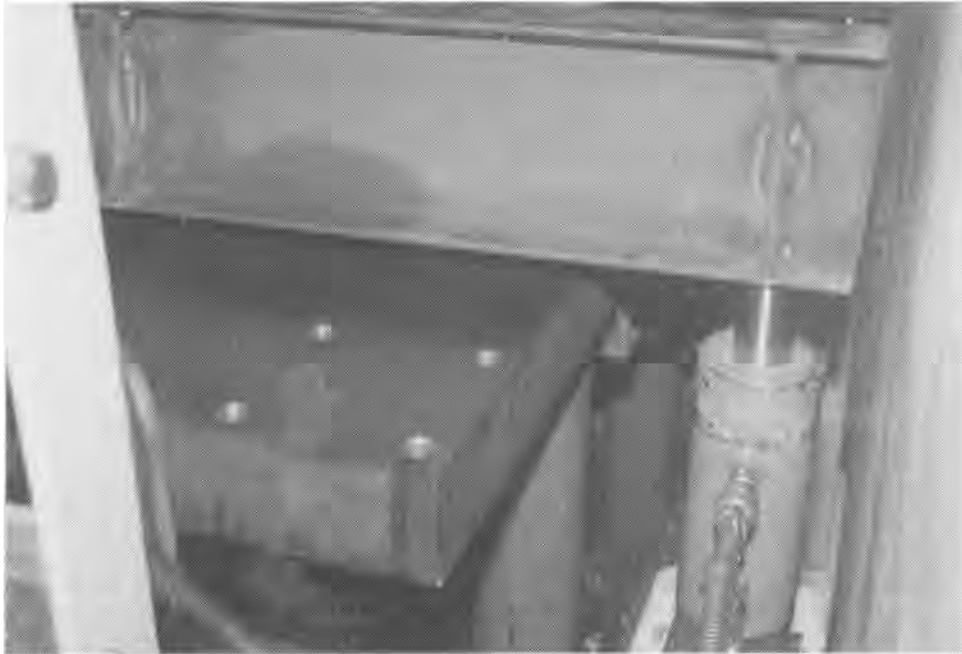
Figure 5.2 Four-inch steel plate slid into position

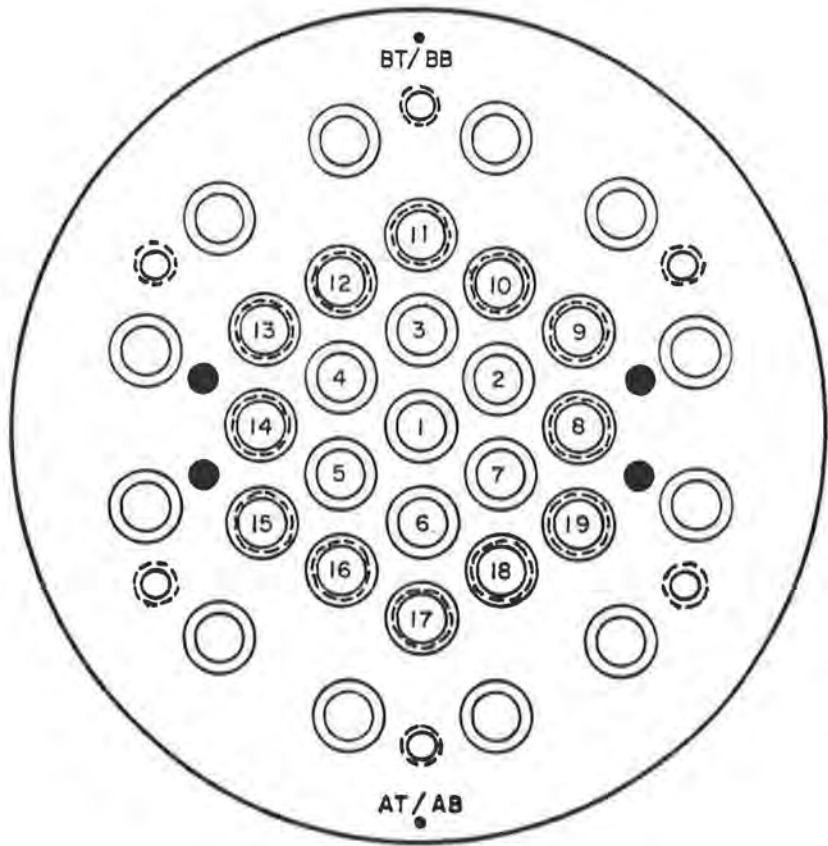
Note:
Anchorhead Reference
Points AT/AB and BT/BB

Figure 5.3. Strand/Wedge references for anchorhead

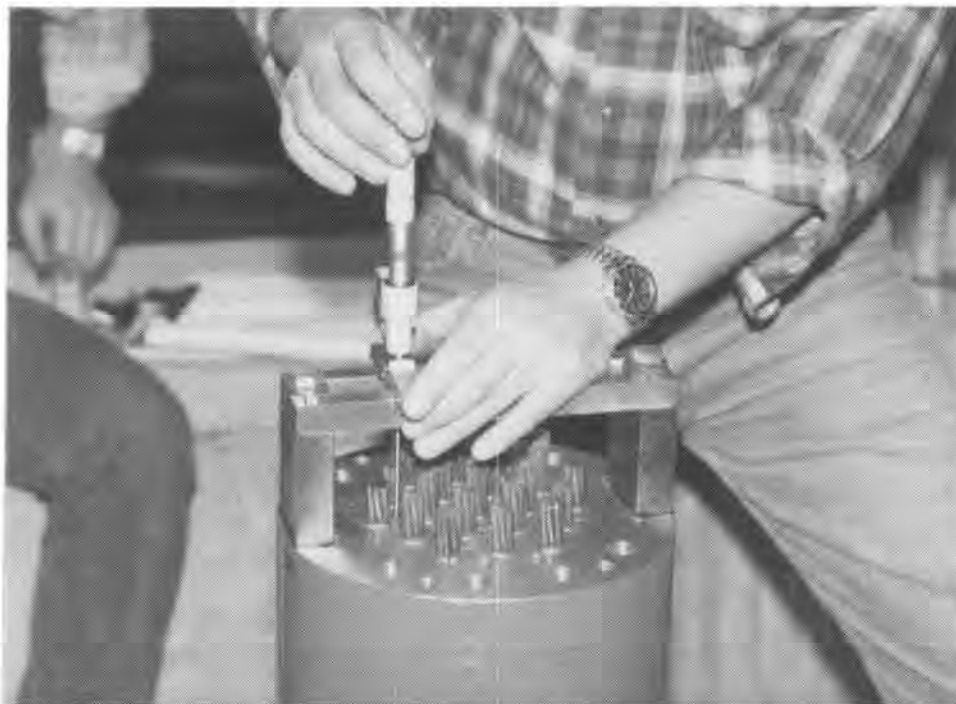
Figure 5.4. Measurement of center wire and wedge seating with a depth gage and stationary fixture

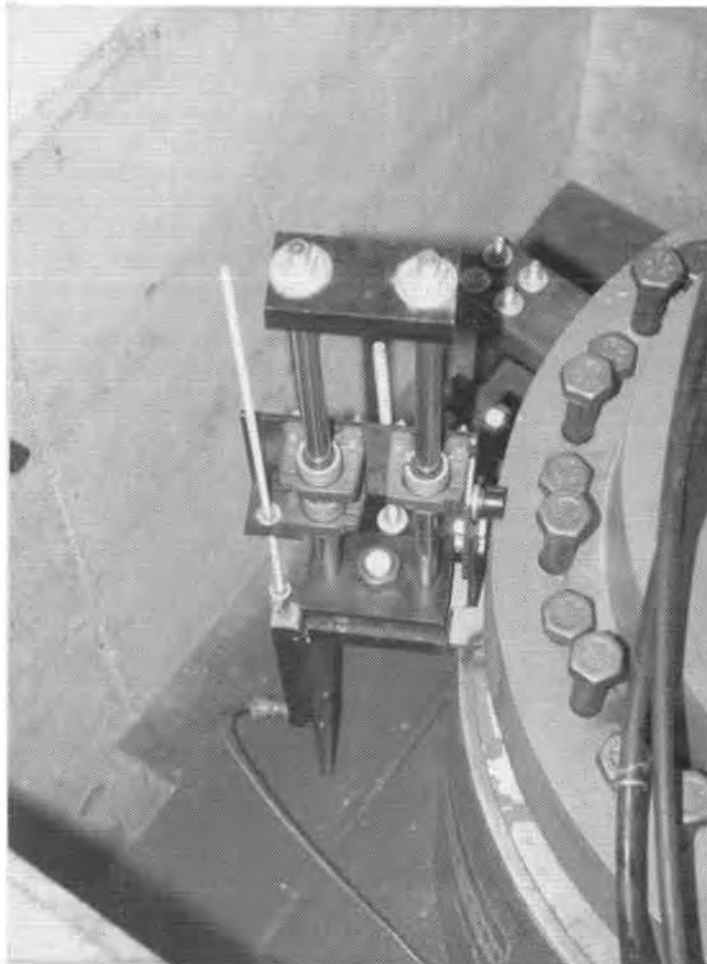
Figure 5.5 Linear potentiometer to measure specimen elongation

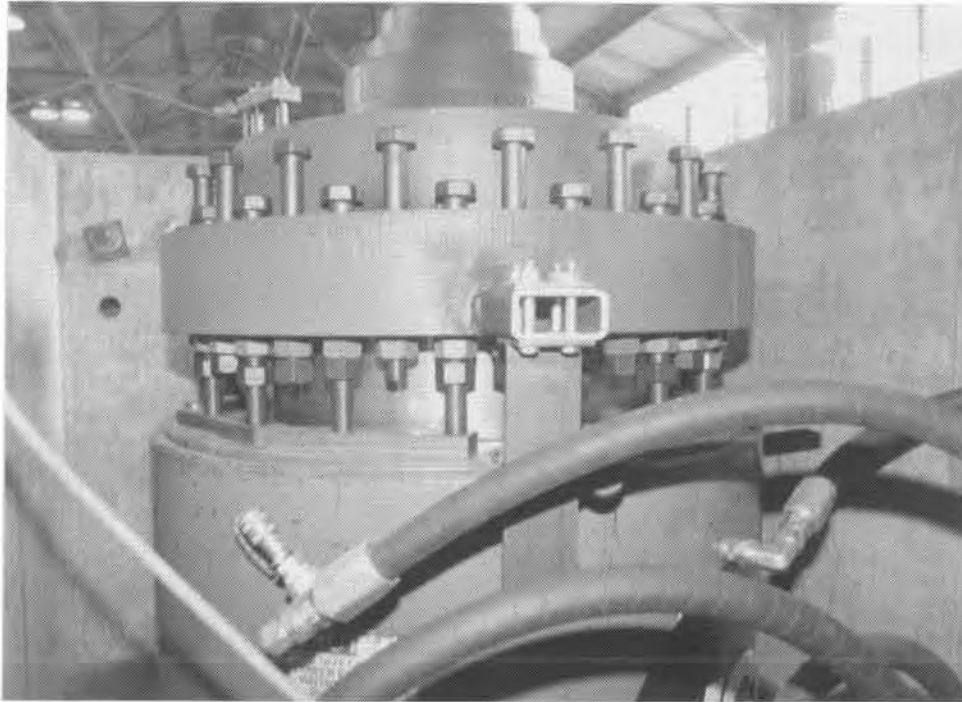
Figure 5.6 Load-maintainer plate holding grout load

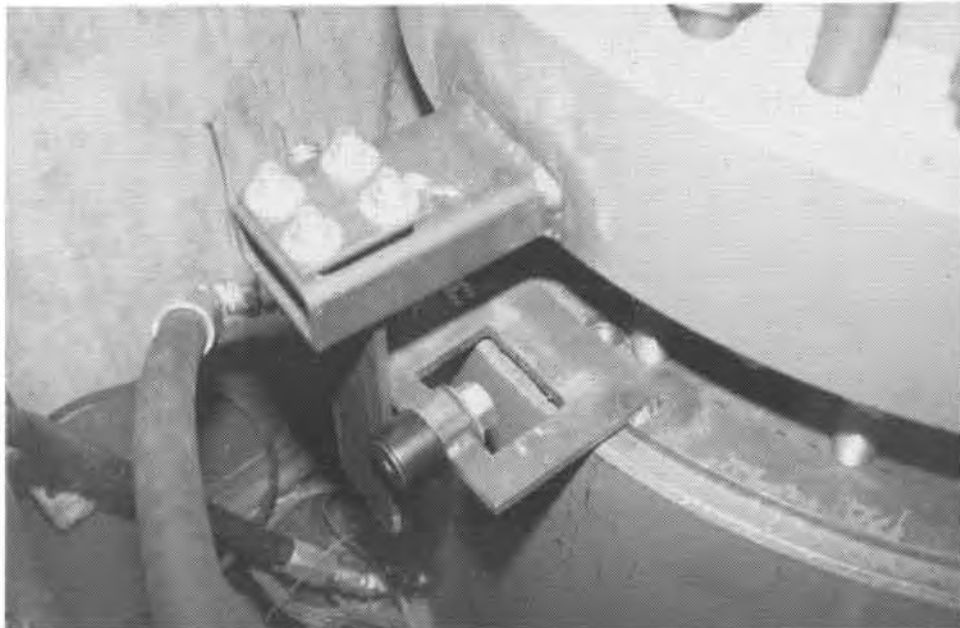
Figure 5.7 Rotation restraint device

Twisting of the specimen during testing was prevented with a device consisting of a stationary roller bearing and travel surface, as shown in Figure 6. Two rotation restraint devices were attached to the load maintainer plate on opposite sides of the specimen to reduce the lateral force applied to the centerhole ram.
