STAY CABLE ANCHORAGE SYSTEM TESTS

THESIS

MASTER OF SCIENCE IN ENGINEERING

THE UNIVERSITY OF TEXAS AT AUSTIN

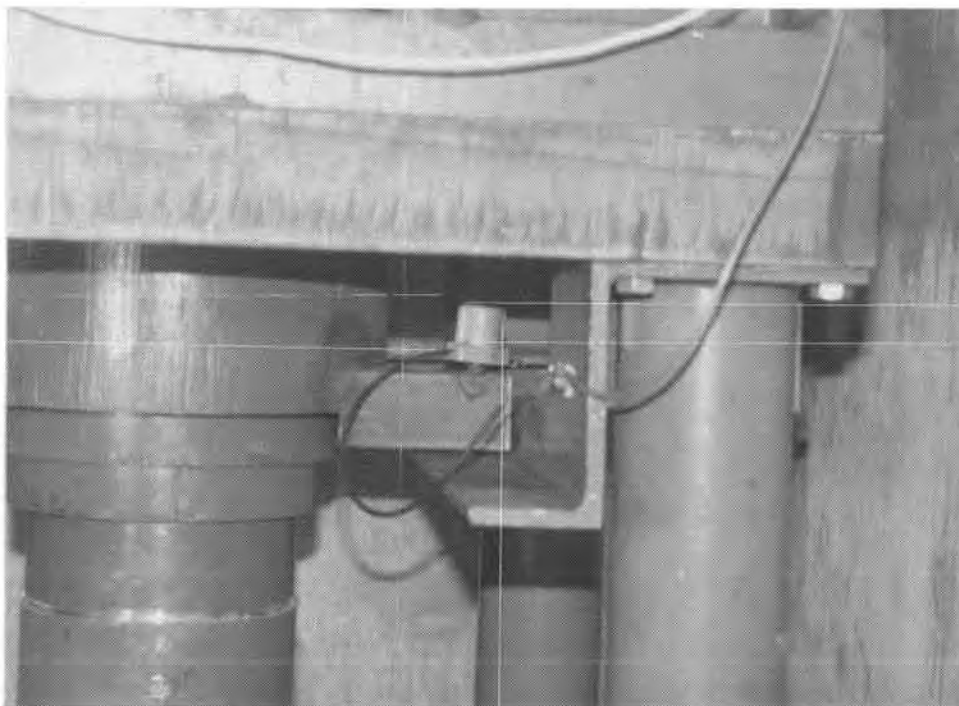
Figure 5.8 Velocity transducer attached to lower anchorage

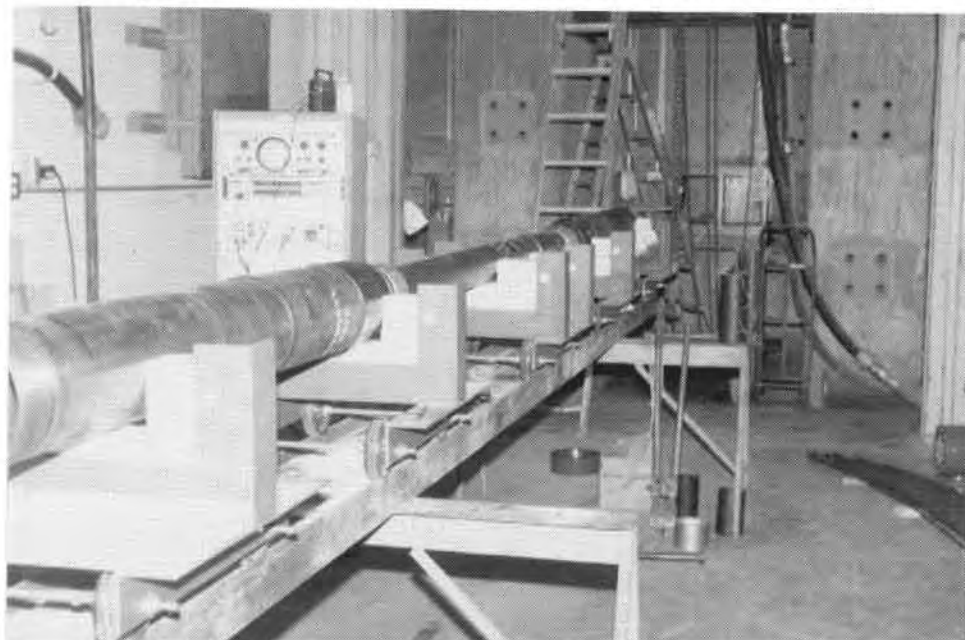
Figure 5.9 Specimen assembly station

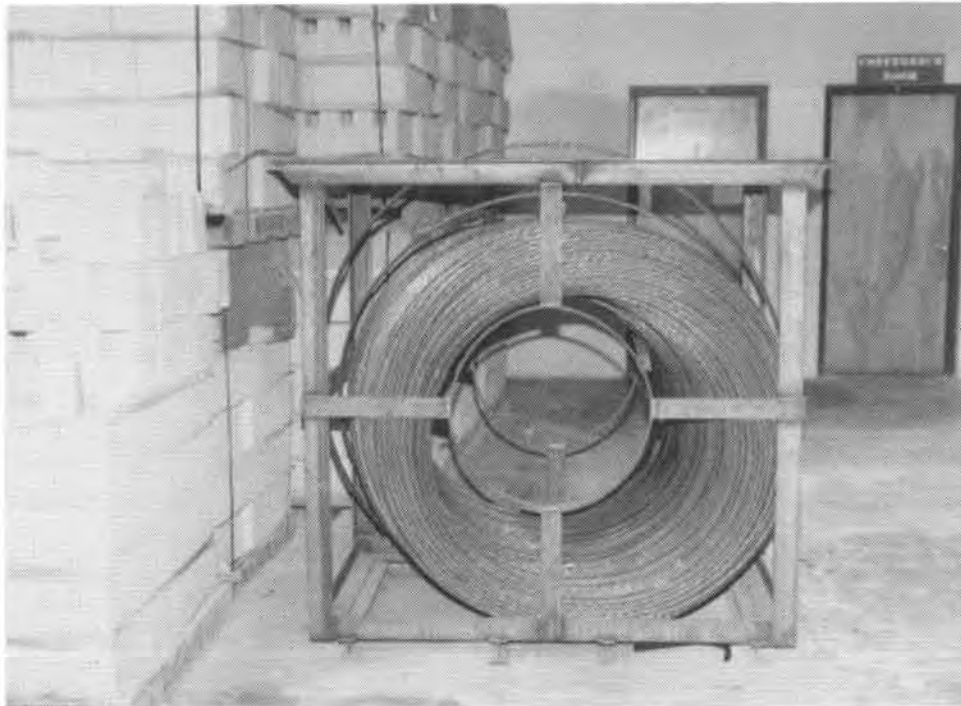
Figure 5.10 Strand supplied for testing, with steel cage

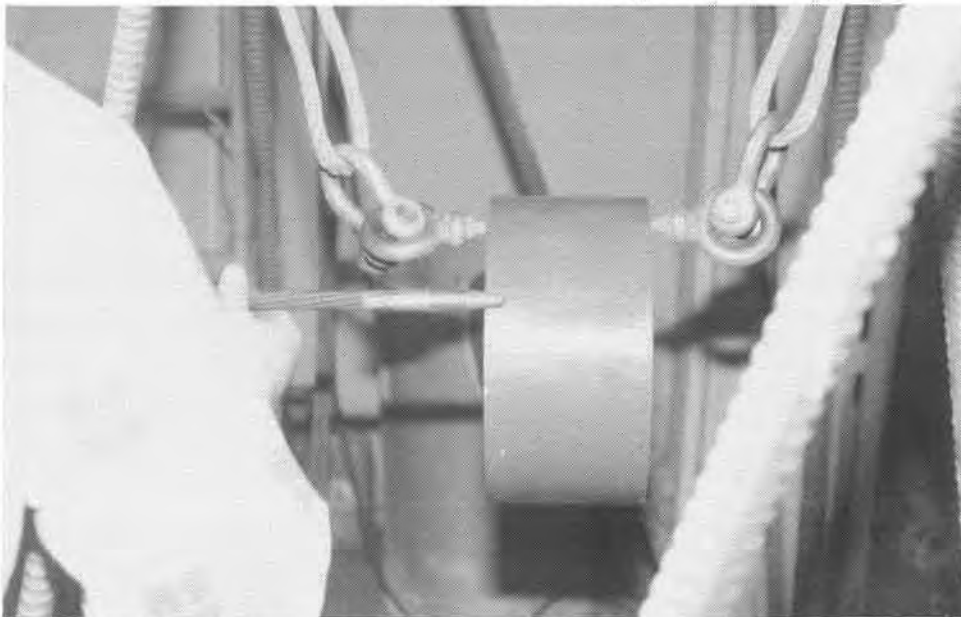
Figure 5.11 Hollow steel "bullet" to aid strand in passing through pipe assembly untangled

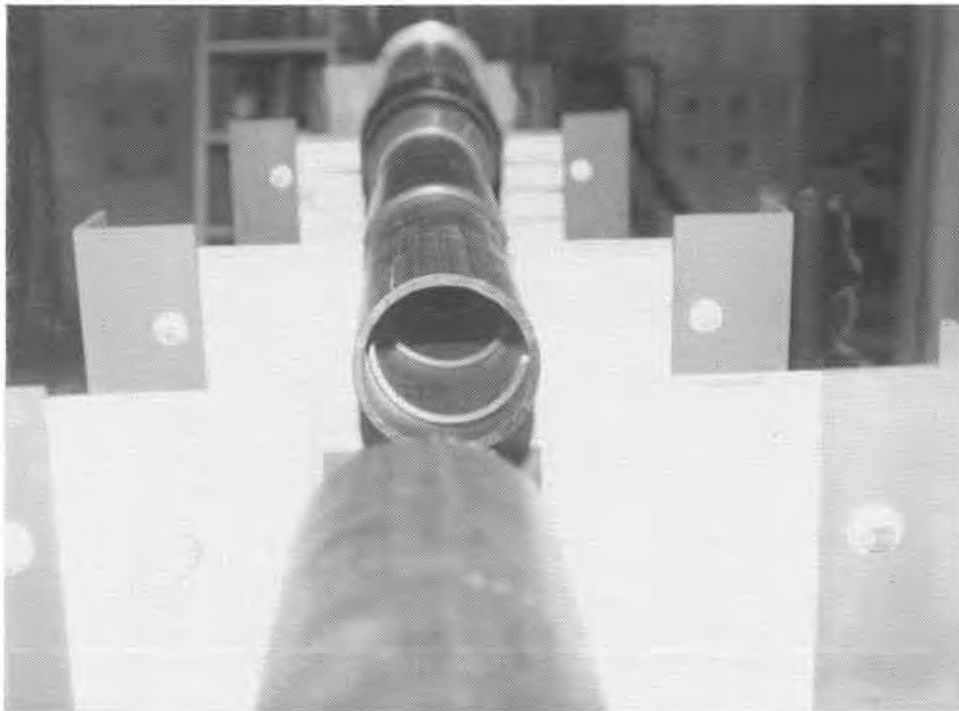
Figure 5.12 Steel helical spacer inserted in polyethylene stay length

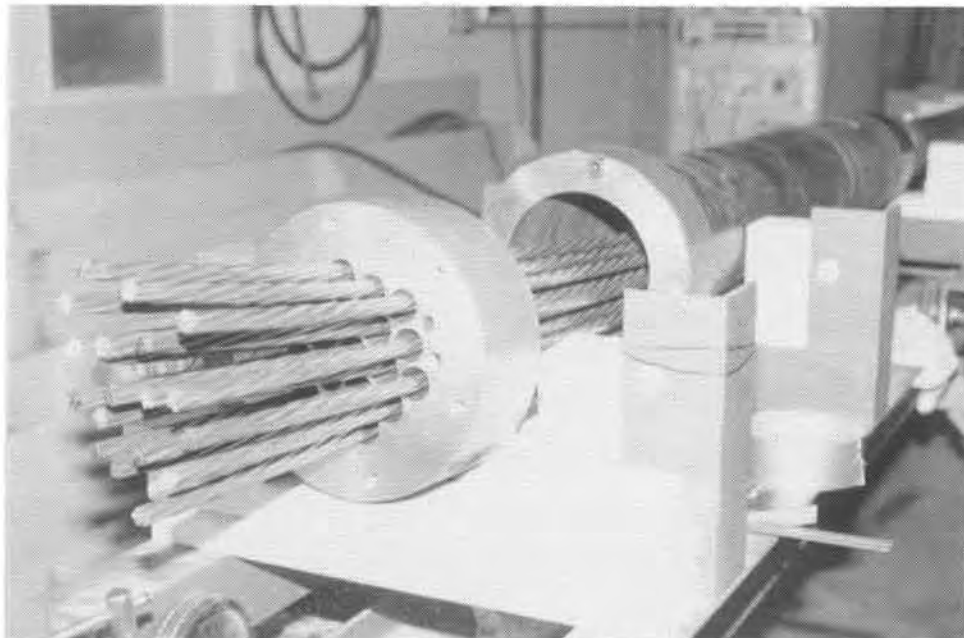
Figure 5.13 All 19 strands installed

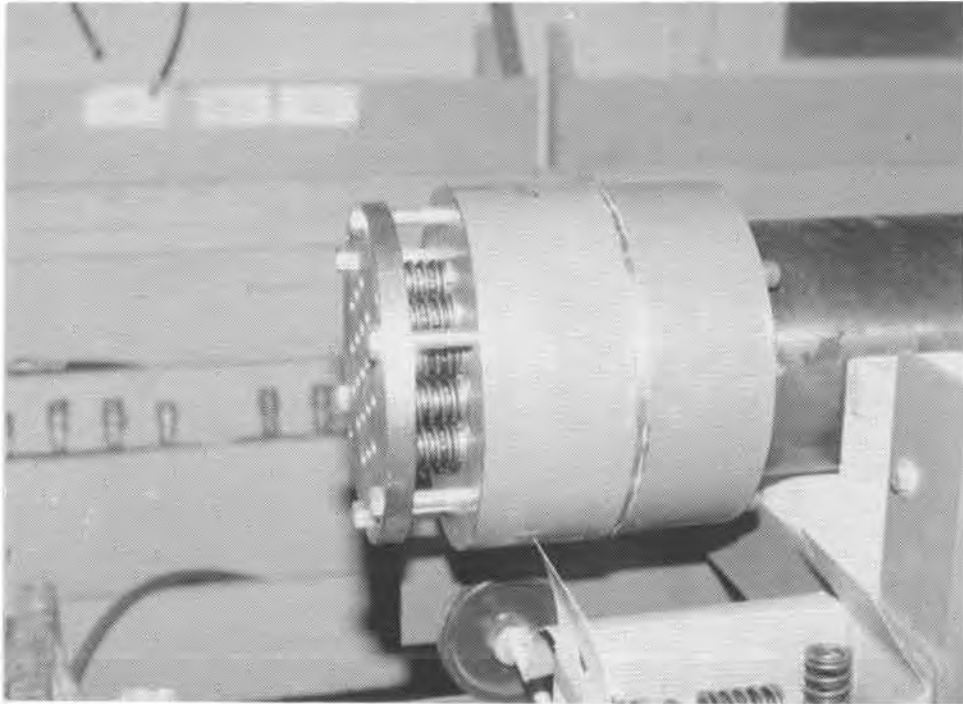
Figure 5.14 Spring plate mounted on lower anchorhead

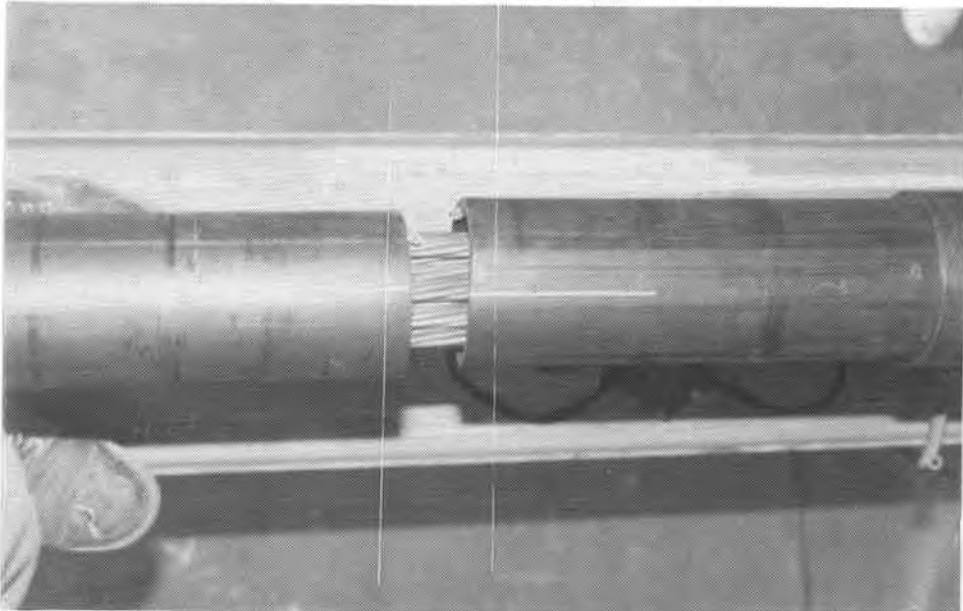
Figure 5.15 Gap in polyethylene stay pipes to allow bending during installation

Reference lines were marked at the mating region of the two stay lengths to ensure that the specimen did not twist during installation. A gap of 2 inches remained at the mating region of the stay pipes, as shown in Figure 5.15. This gap enabled the specimen to bend at that point during installation in the test machine. With the aid of both newly installed overhead crane and existing laboratory traveling

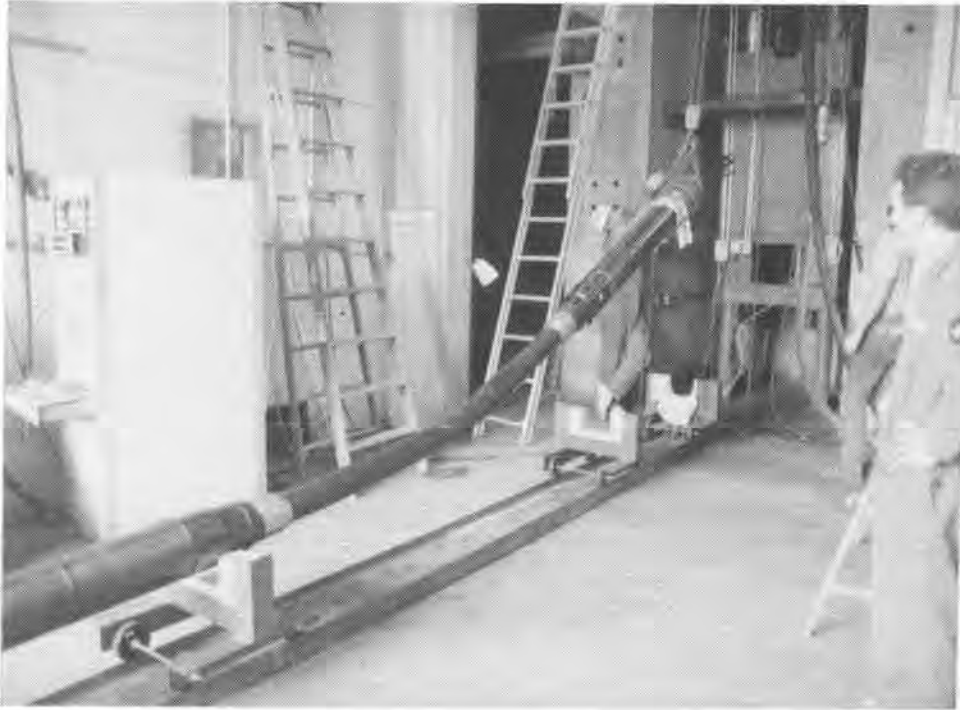
Figure 5.16 Lifting of specimen

crane the ungrouted specimen was then installed in the test machine by passing it through the centerhole ram at the top of the test machine. Figure 5.16 shows the bending that occurred at the gap during lifting of the specimen. Once installed, the ends of the two stay pipes were mated with a polyethylene pipe sleeve that was slid over the two ends. This sleeve was strapped in place.

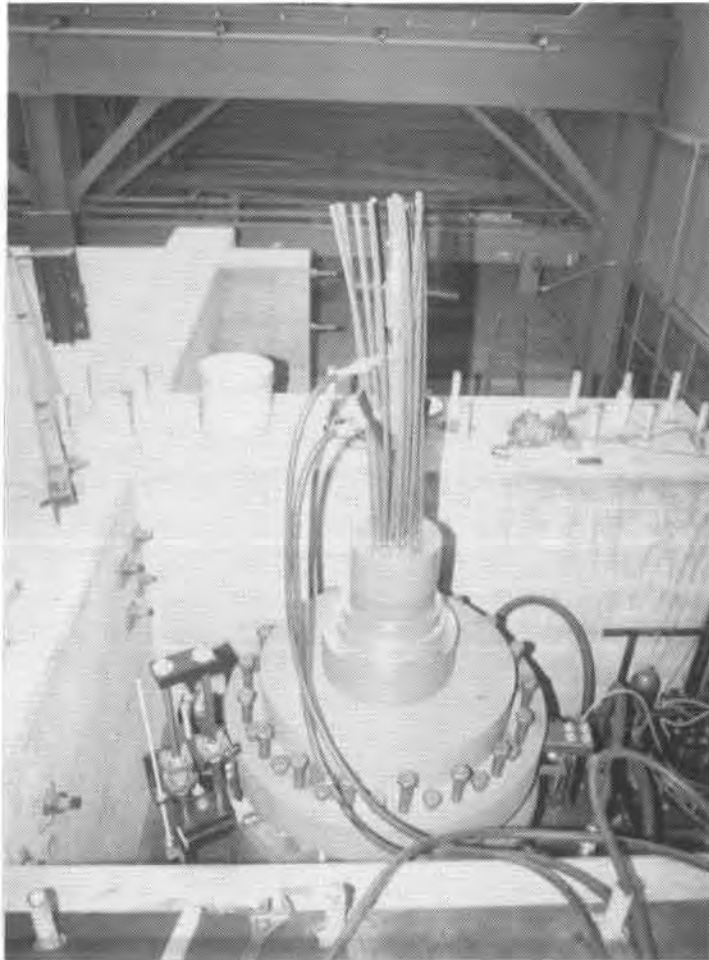
Figure 5.17 Preseating of wedges with monostrand jack

The wedges were then preloaded to a load of 3 kips using a monostrand jack as shown in Figure 5.17. They were visually inspected for equal engagement depth. The final tested specimen length, measured between bearing ends of the anchorheads, was 213 inches.

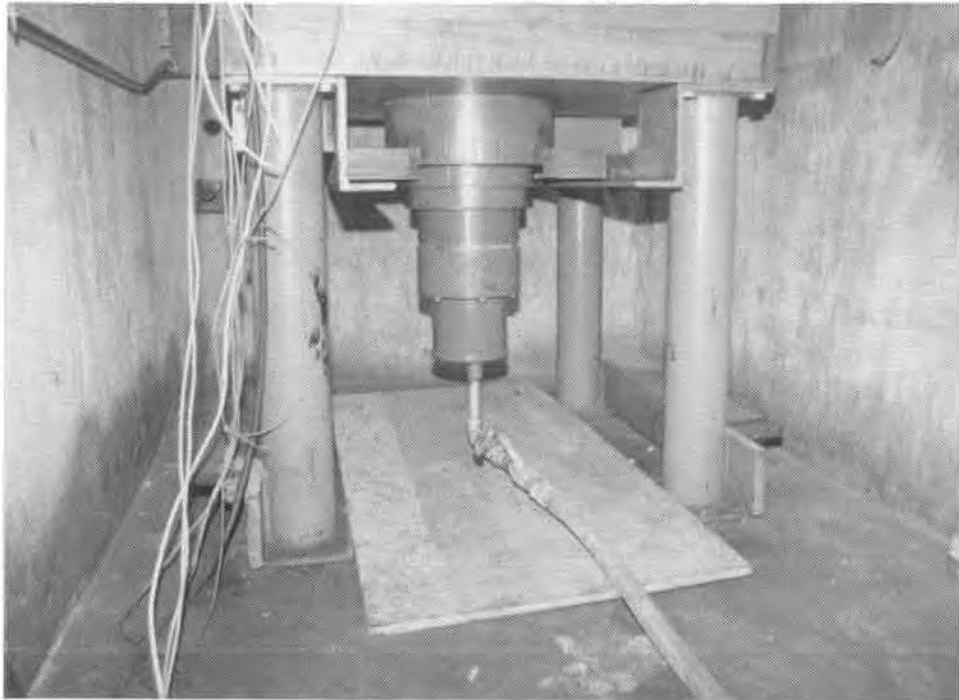
Figure 5.18. Primary grouting from lower anchorage

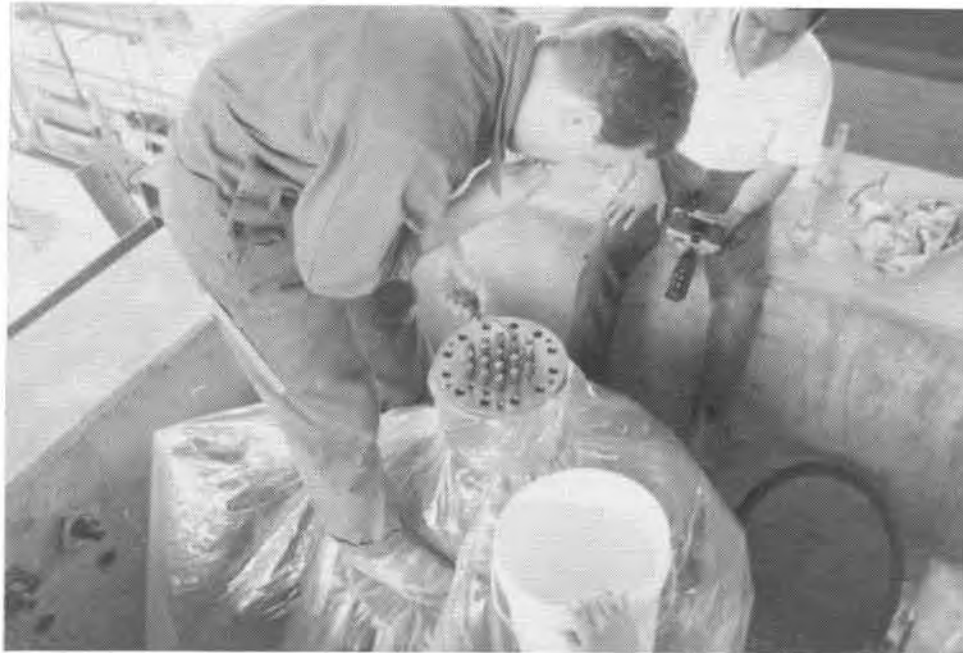
Figure 5.19. Siphoning of bleed water from top anchorage

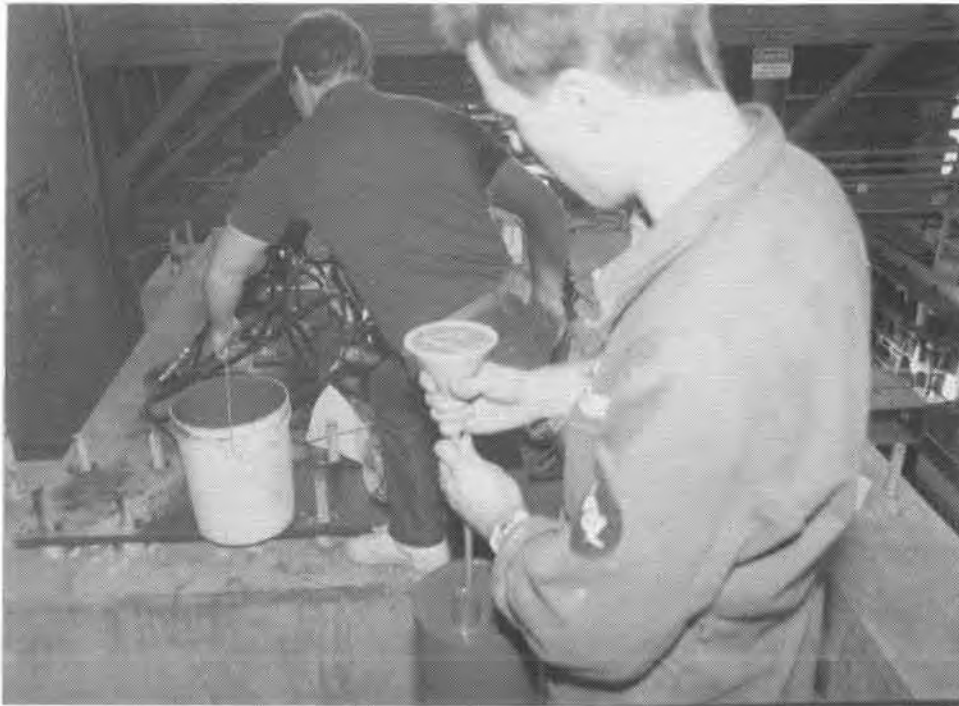
Figure 5.20. Secondary grouting procedure

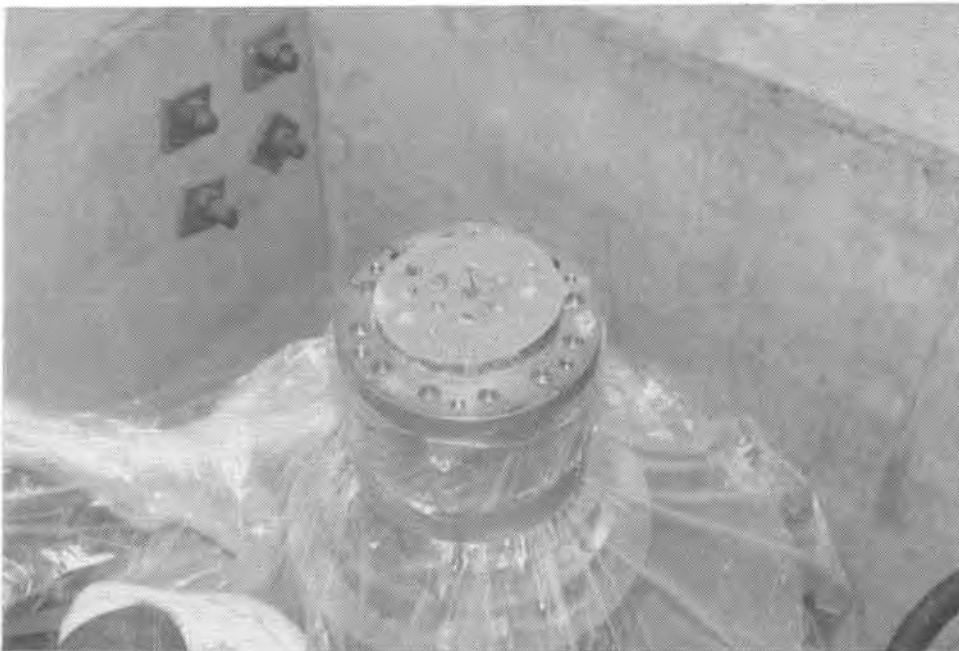
Figure 5.21. Grout cap removed; break occurred at top of strand extensions

The grout was allowed to cure for 3-1/2 days. The top and bottom grout caps were then removed from the anchorheads. The grout fractured during removal of the caps at the level of the strands as shown in Figure 5.21. Grout was removed from the strand and wedge measurement points to allow center wire and wedge seating checks during the remainder of the test.

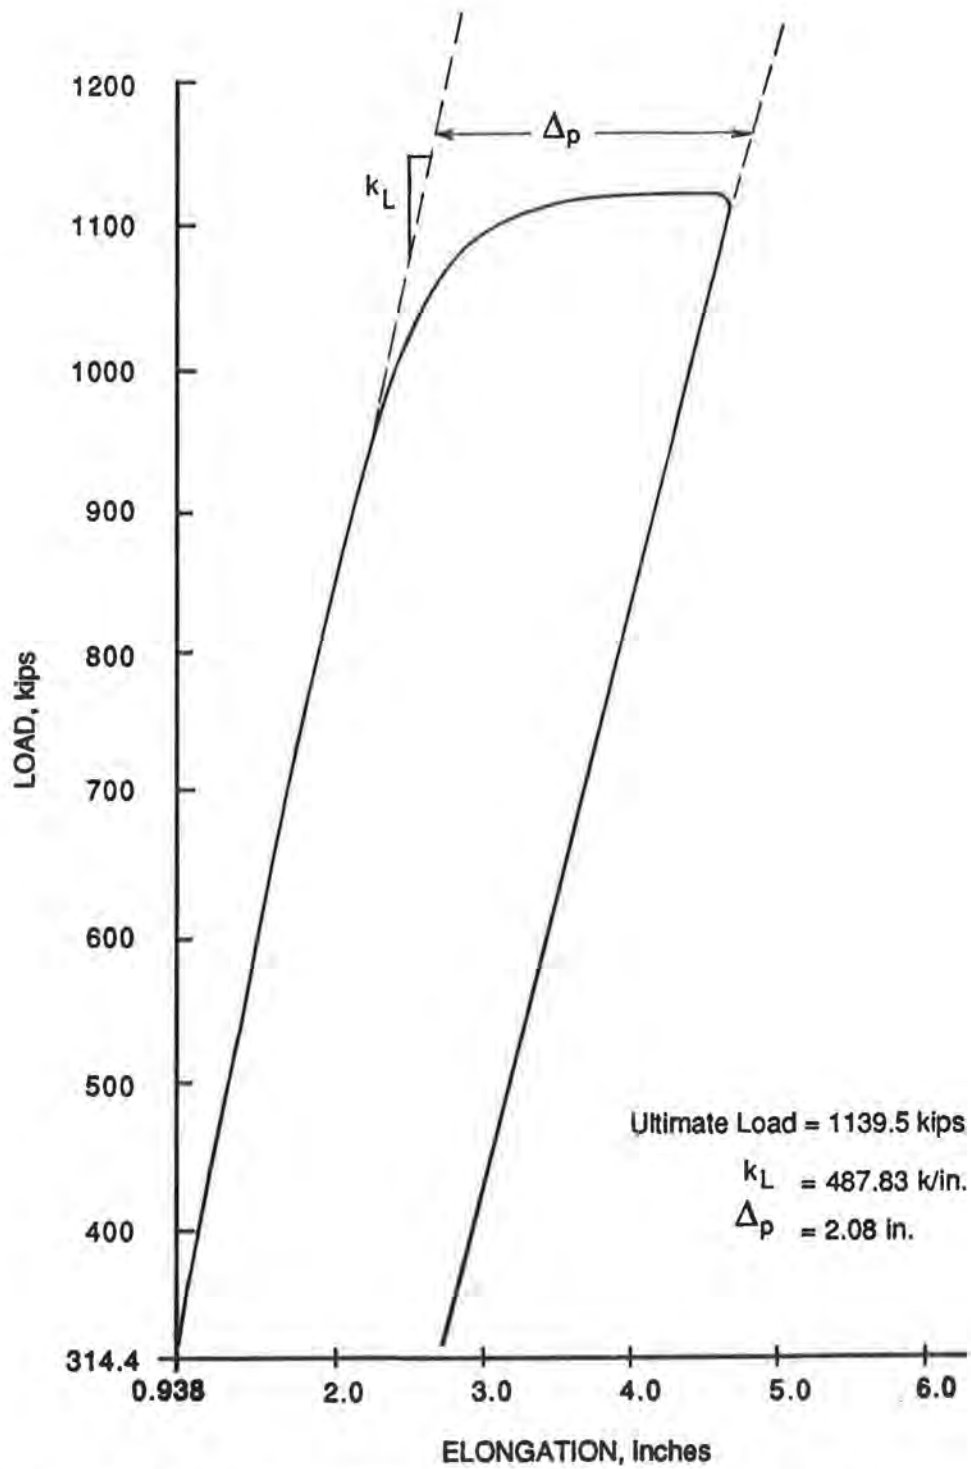
Figure 5.22 Load-elongation curve for 19 strand cable stay specimen

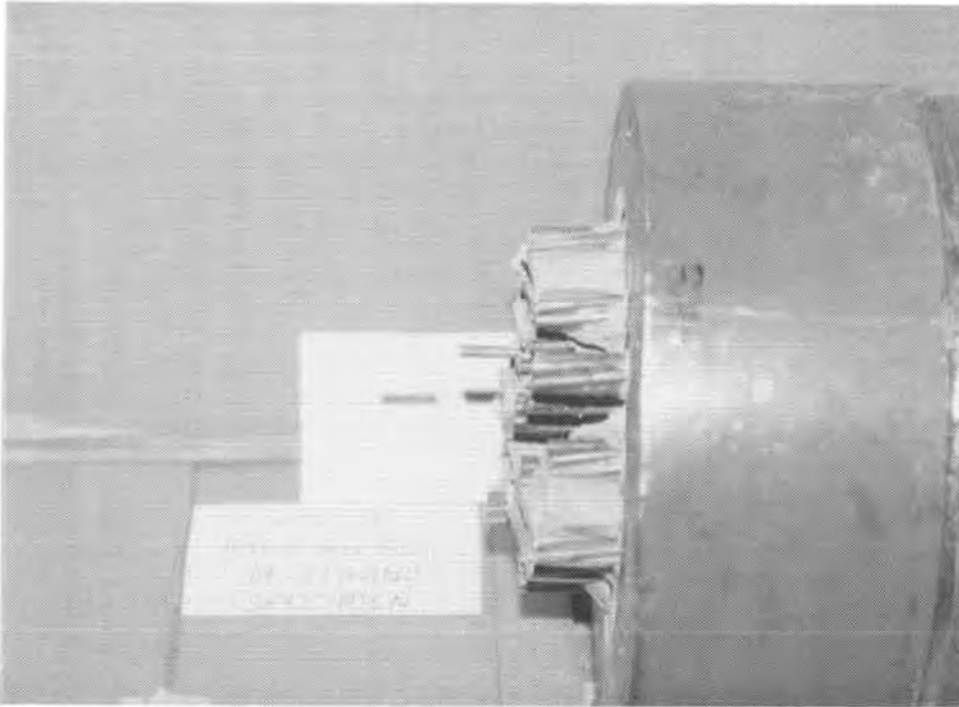
Figure 5.23 Center wire slip in strand 4 at bottom anchorhead

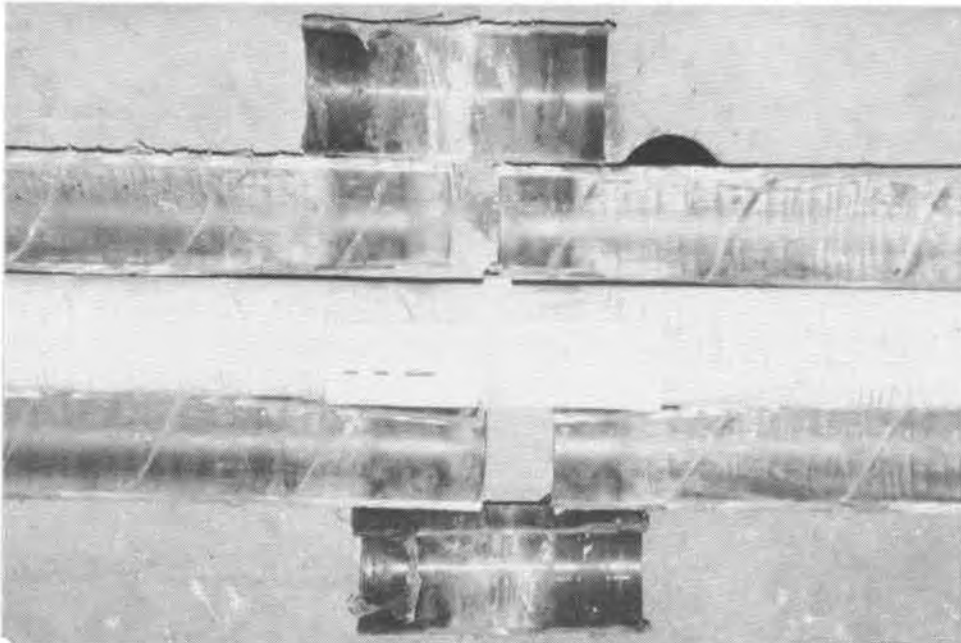
Figure 5.24 Circumferential crack distribution in grout

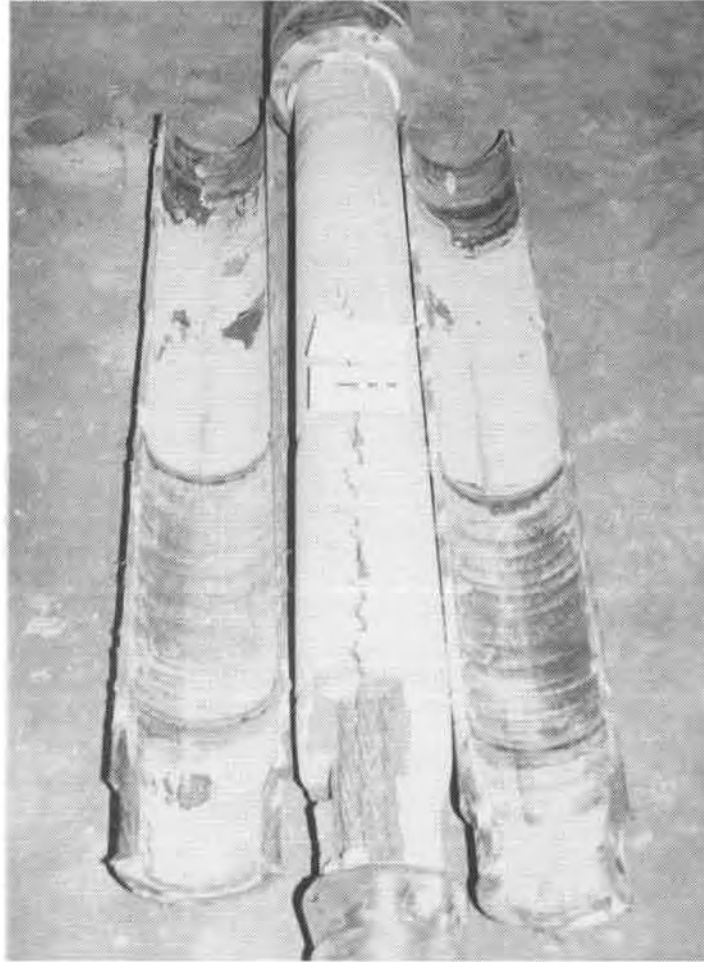
Figure 5.25 Longitudinal cracking of grout

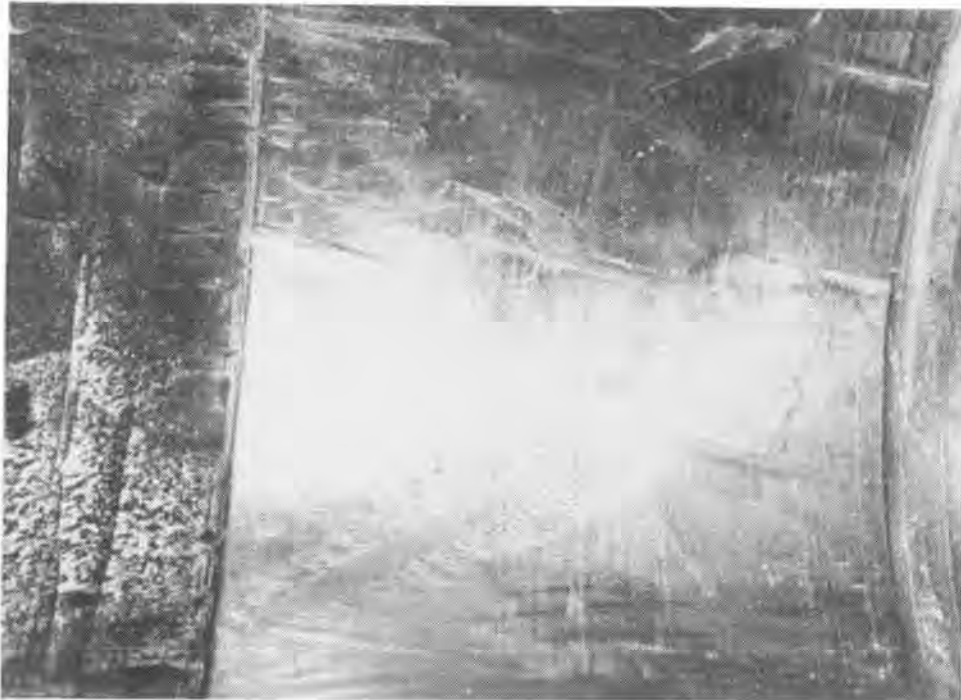
Figure 5.26 Strand contact points on polyethylene pipe

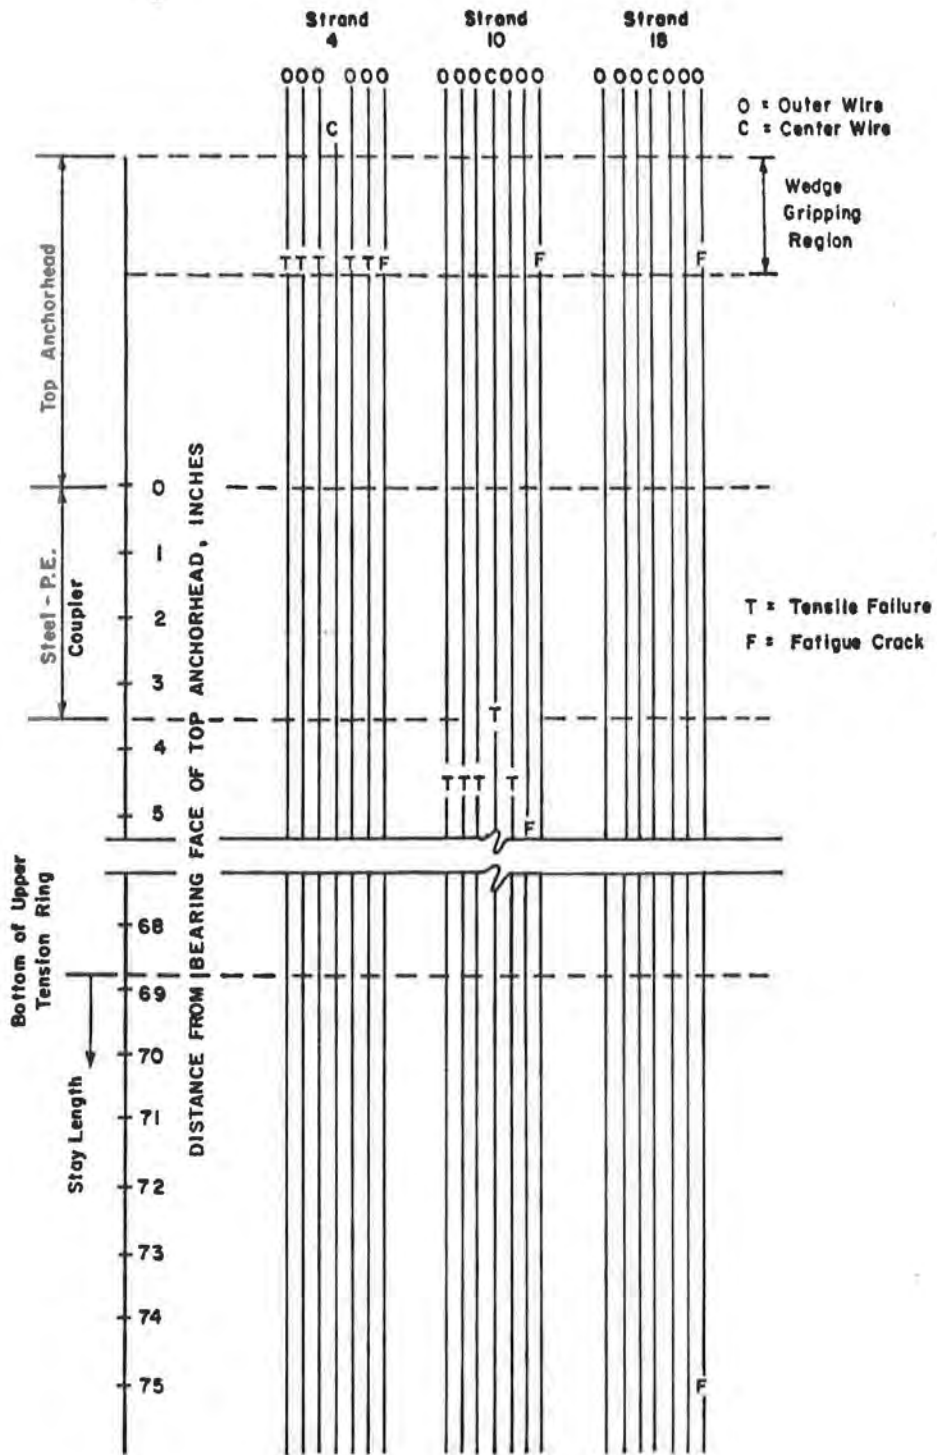
Figure 5.27. Wire break locations

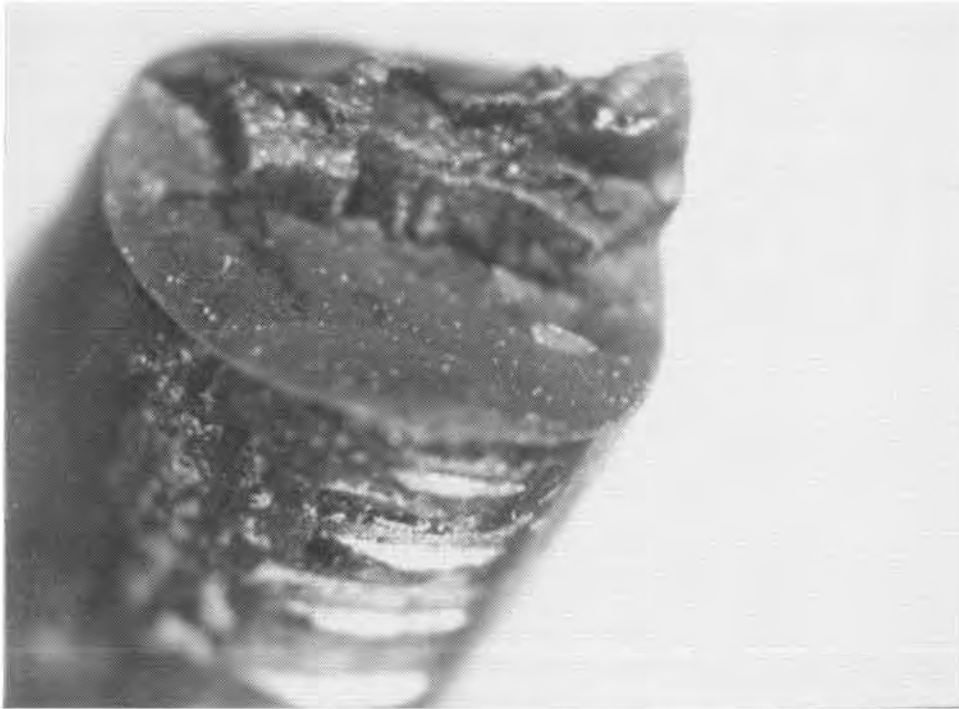
Figure 5.28. Outer wire failure in wedges of top anchorhead, strand 4

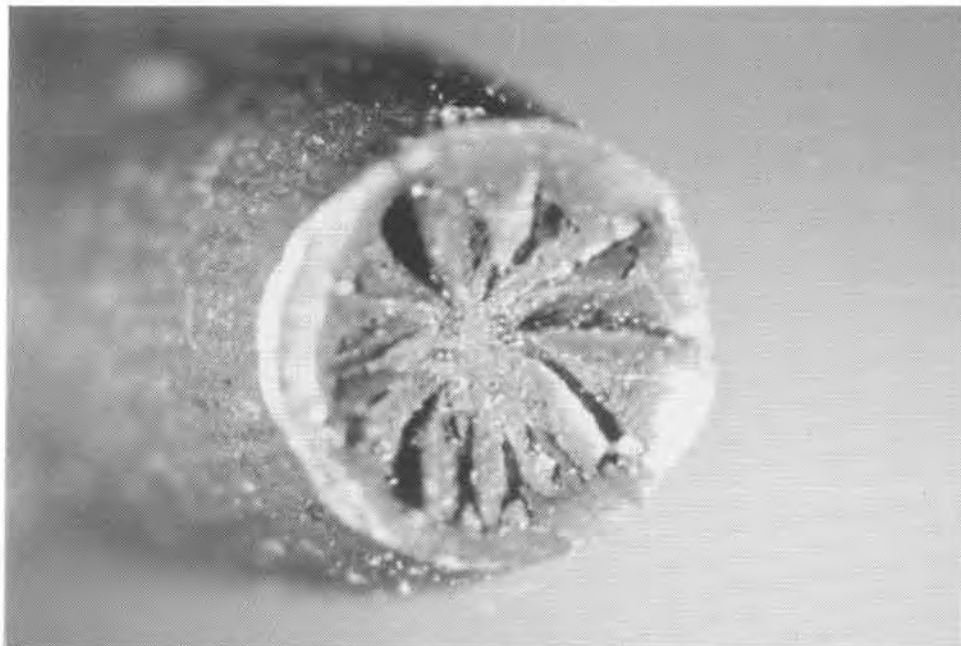
Figure 5.29. Ductile wire break in strand 4

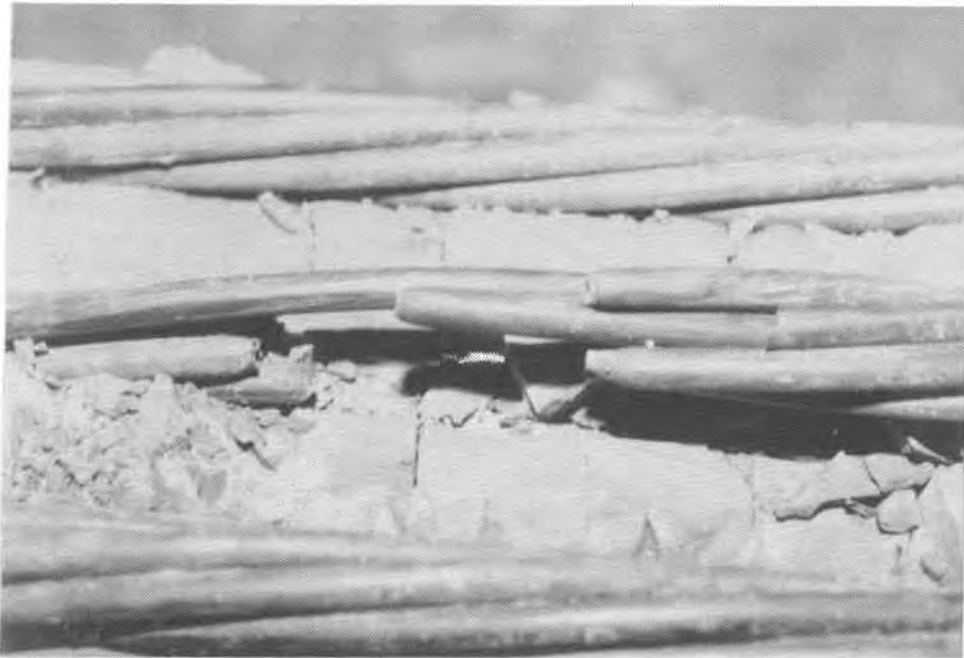
Figure 5.30 Wire breaks near top anchorhead in strand 10

Strand 10: Six wire failures were discovered approximately 3 to 6 inches below the bearing face of the top anchorhead as shown in Figure 5.30. One of the fractured outer wires had a fatigue crack. The fracture is shown in Fig. 5.31. The other five wires showed no evidence of fatigue cracking. The remaining outer wire failed within the grip region of the top anchorhead and contained a fatigue crack. The fractured surface of this wire is shown in Fig. 5.32.

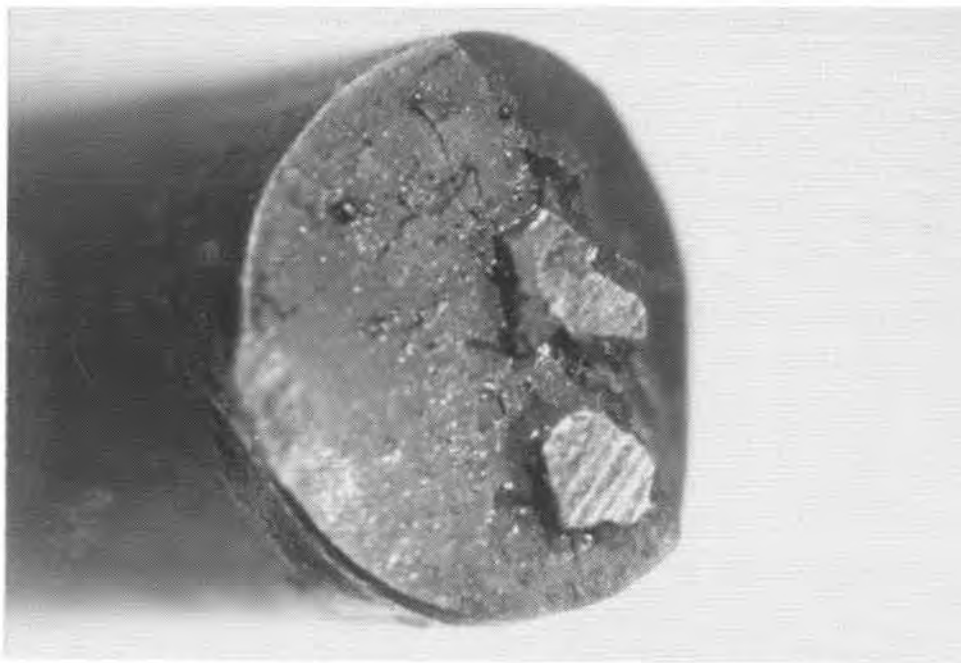
Figure 5.31. Outer wire failure 3 to 6 inches from bearing face of top anchorhead, strand 10

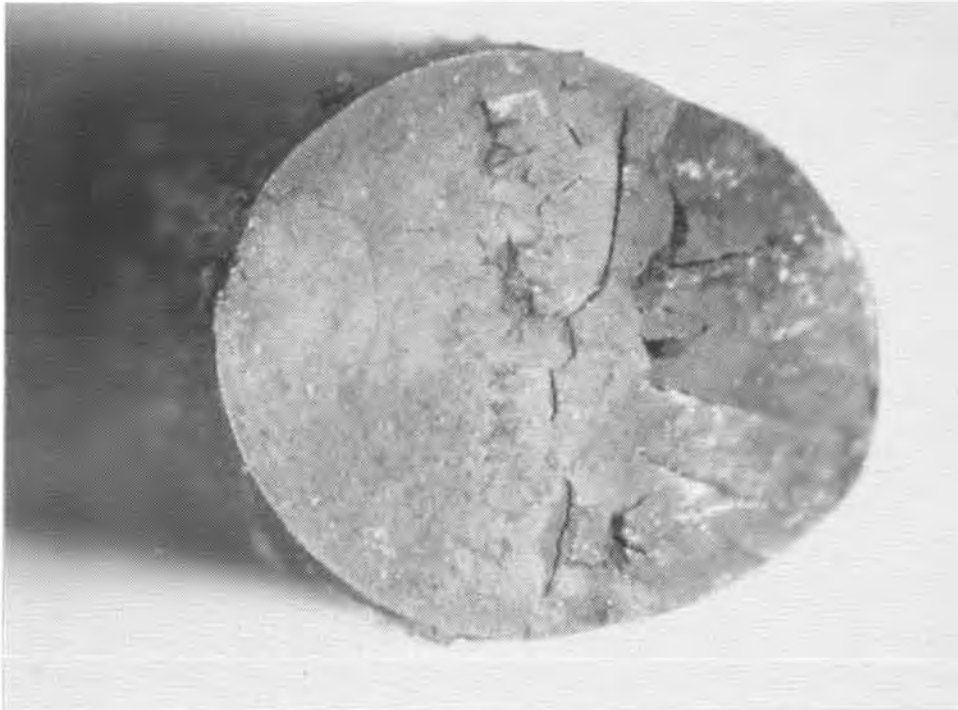
Figure 5.32 Outer wire failure in wedges of top anchorhead, strand 10

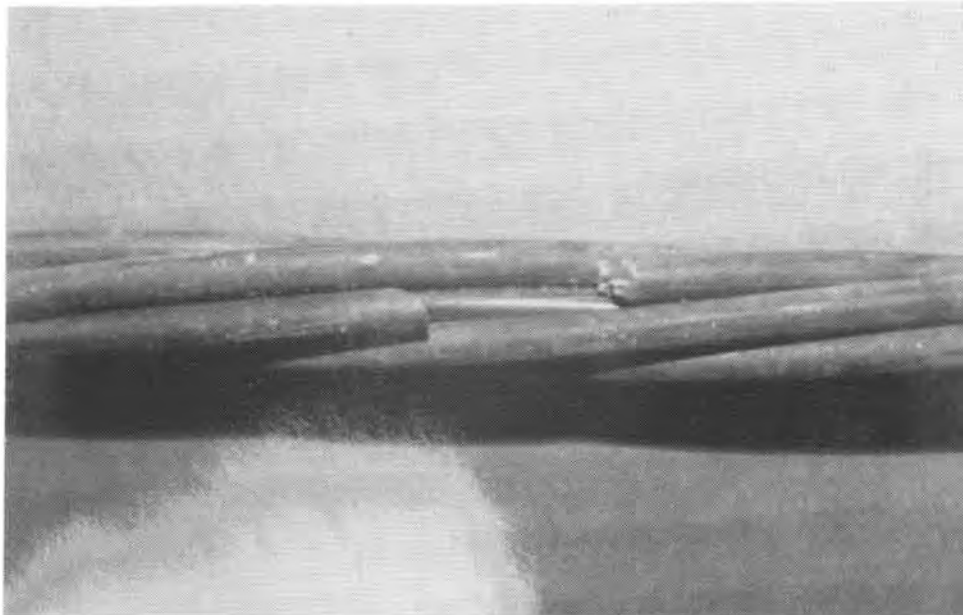
Figure 5.33 Wire break in strand 18 in stay length

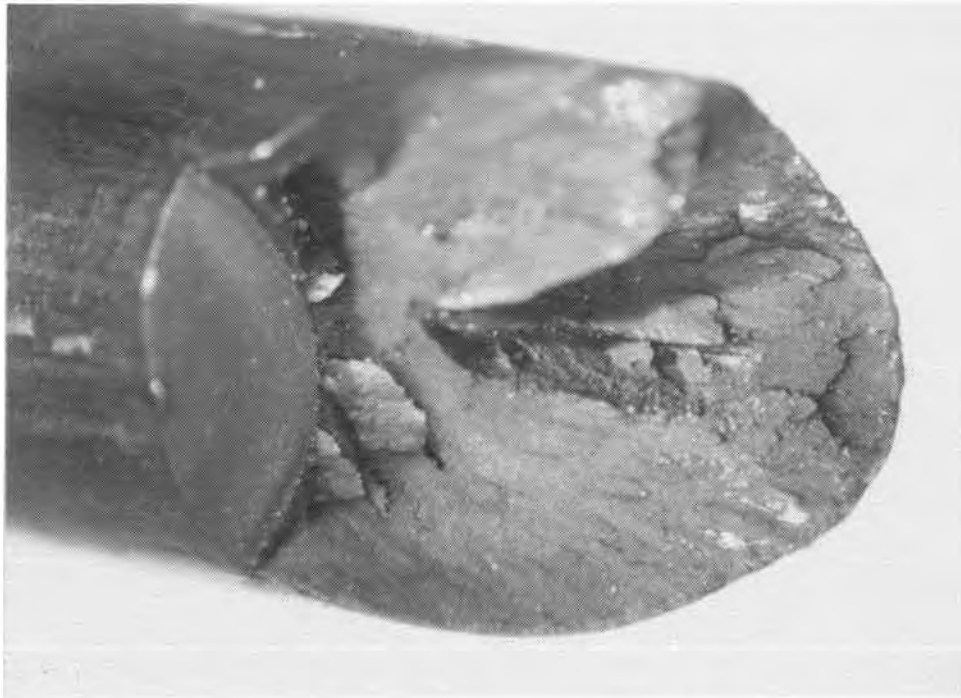
Figure 5.34 Outer wire failure in stay lengths, strand 18

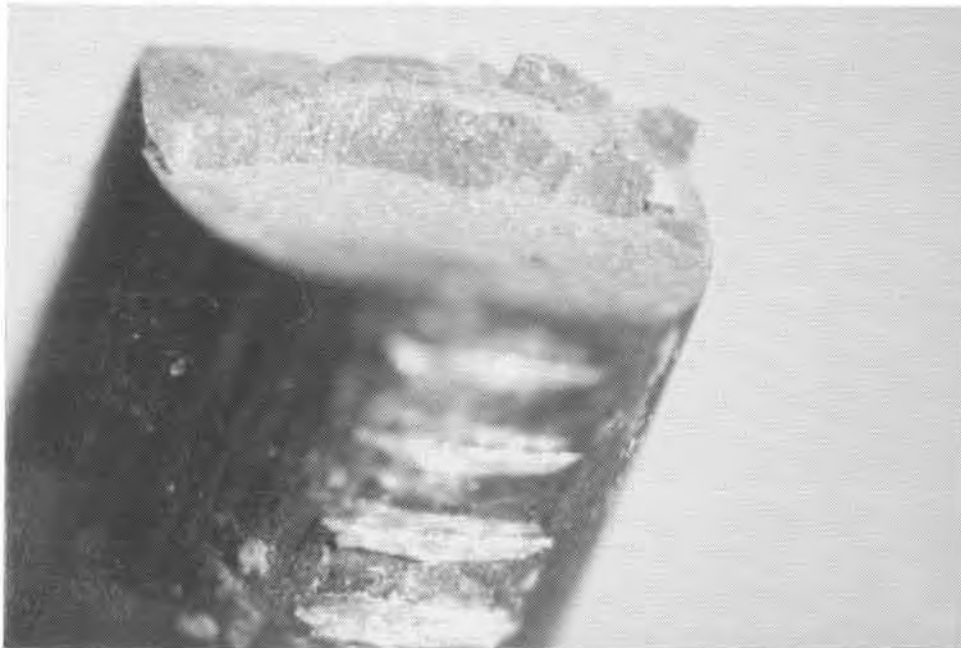
Figure 5.35 Outer wire failure in wedges of top anchorhead, strand 18

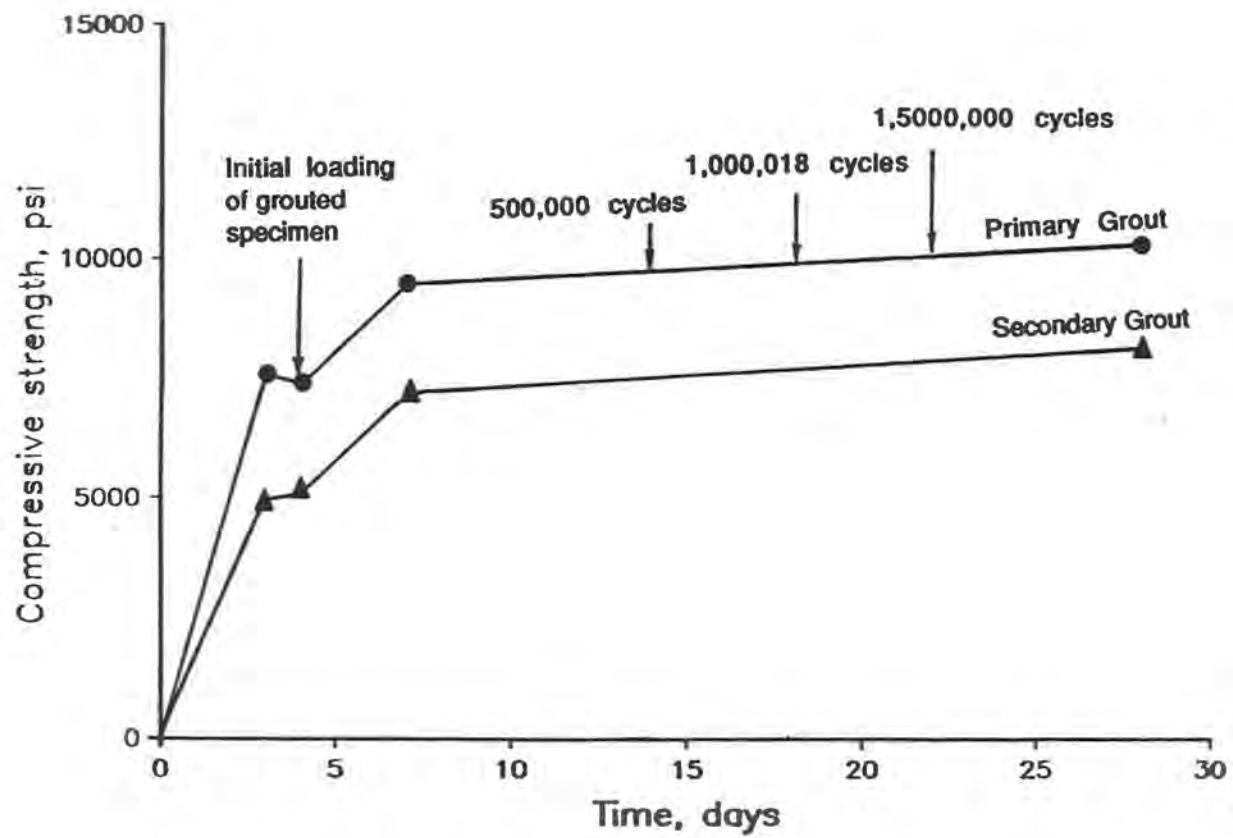
Figure 5.36 Grout cube strength over time

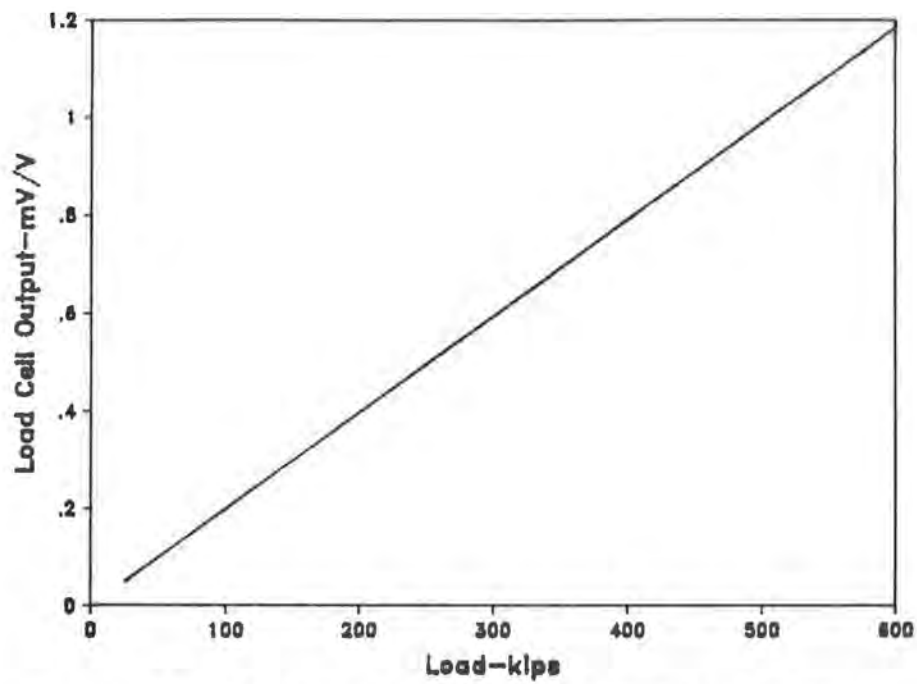
Figure A.1 Calibration of load cell SN 850326C UT 397640

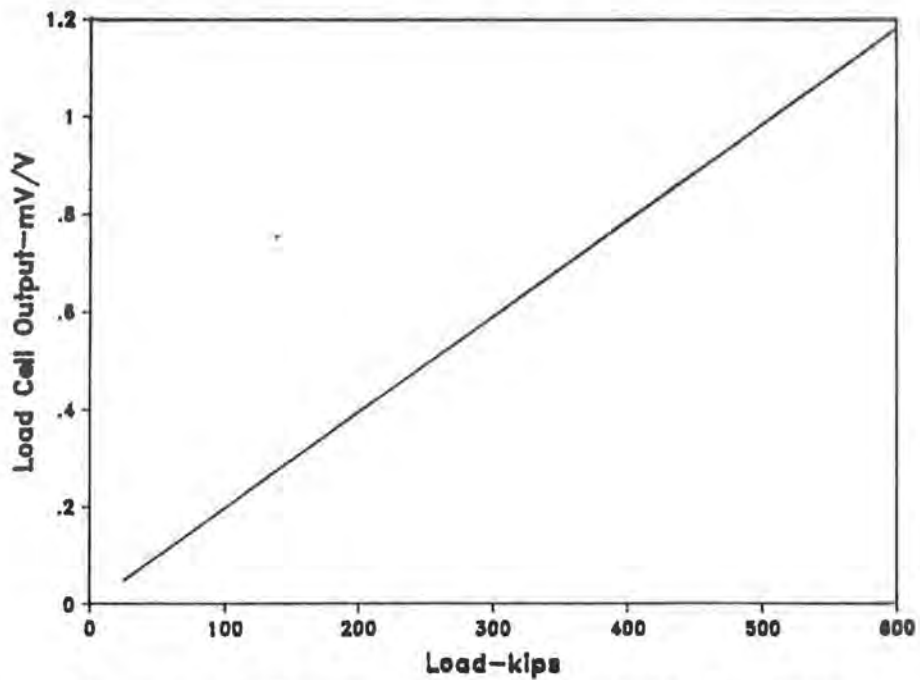
Figure A.2 Calibration of load cell SN 850326A UT 397642
