STAY CABLE ANCHORAGE SYSTEM TESTS

THESIS

MASTER OF SCIENCE IN ENGINEERING

THE UNIVERSITY OF TEXAS AT AUSTIN

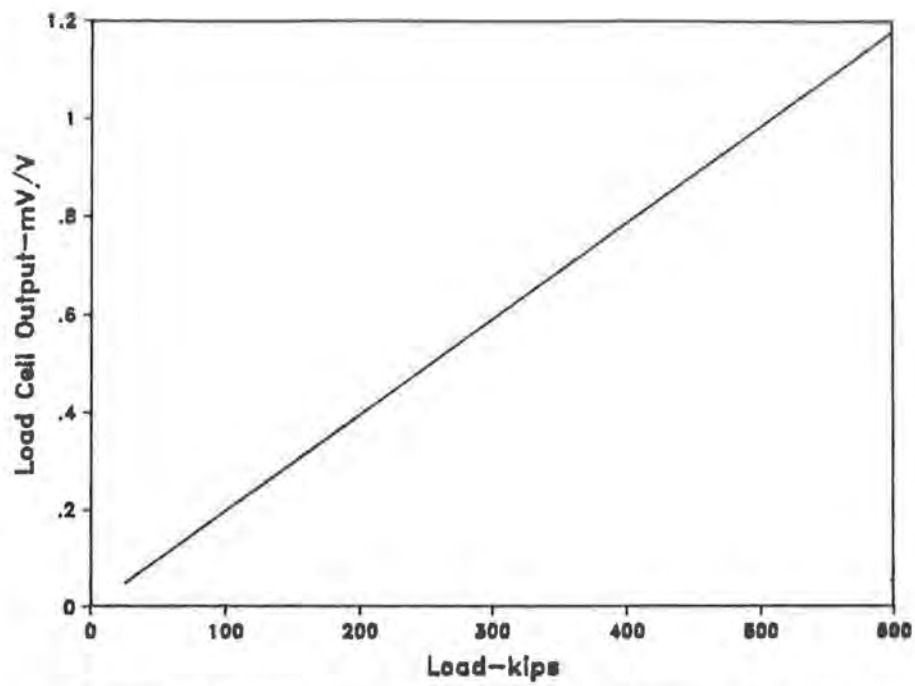
Figure A.3 Calibration of load cell SN 850326D UT 397641

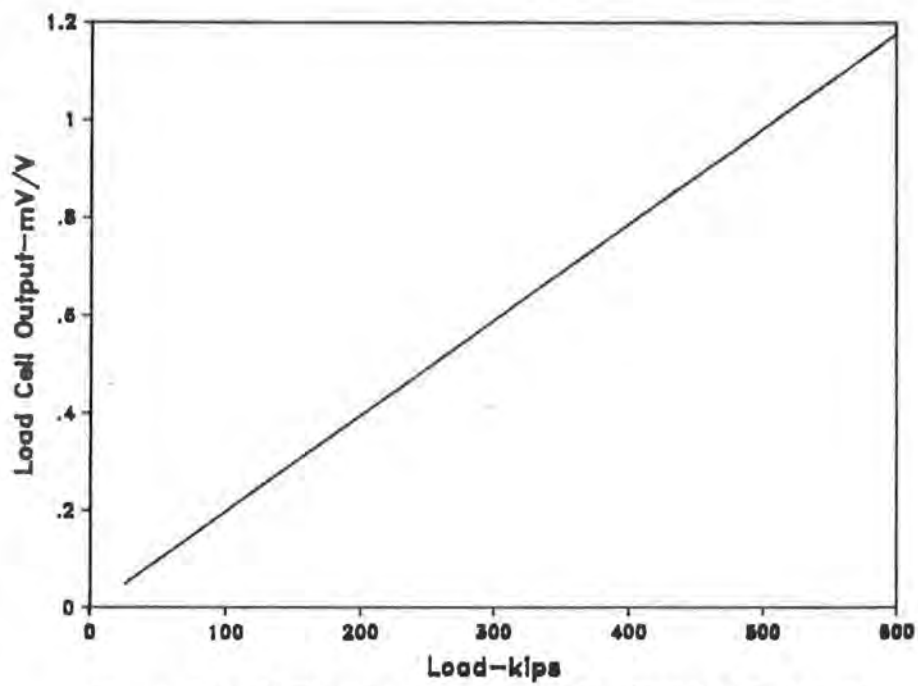
Figure A.4 Calibration of load cell SN 850326B UT 397639

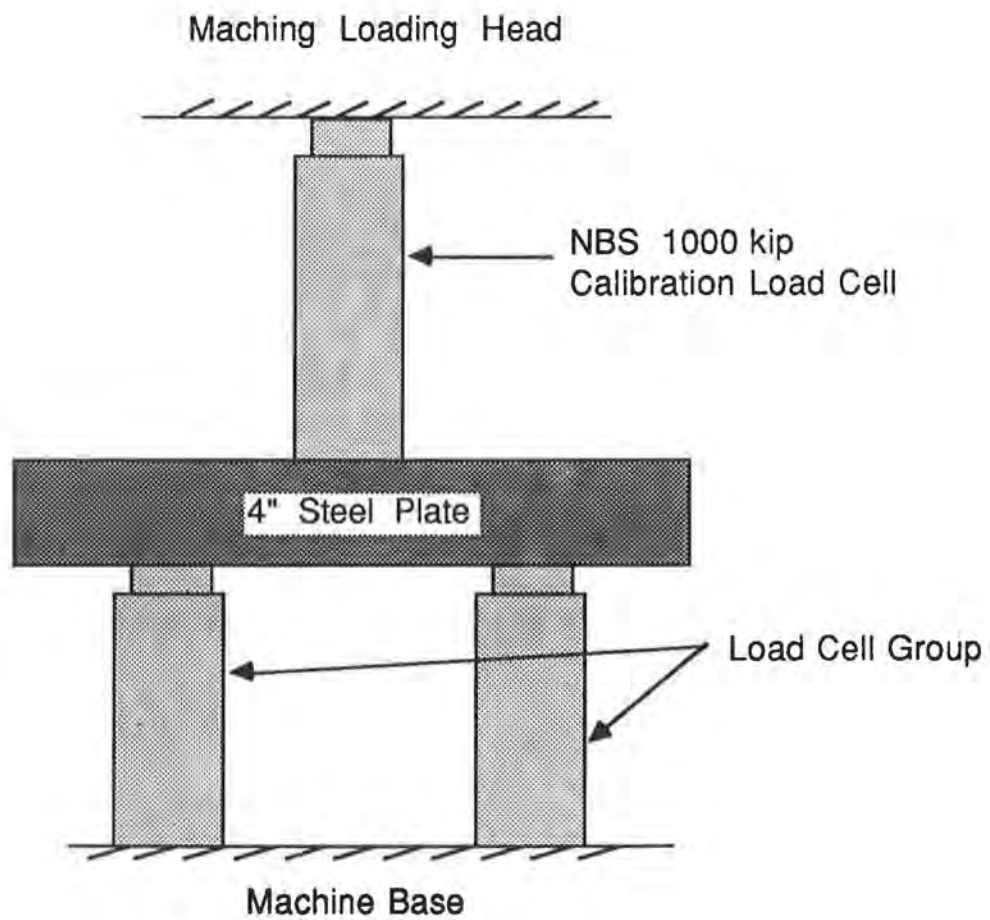
Figure A.5 Load cell group calibration

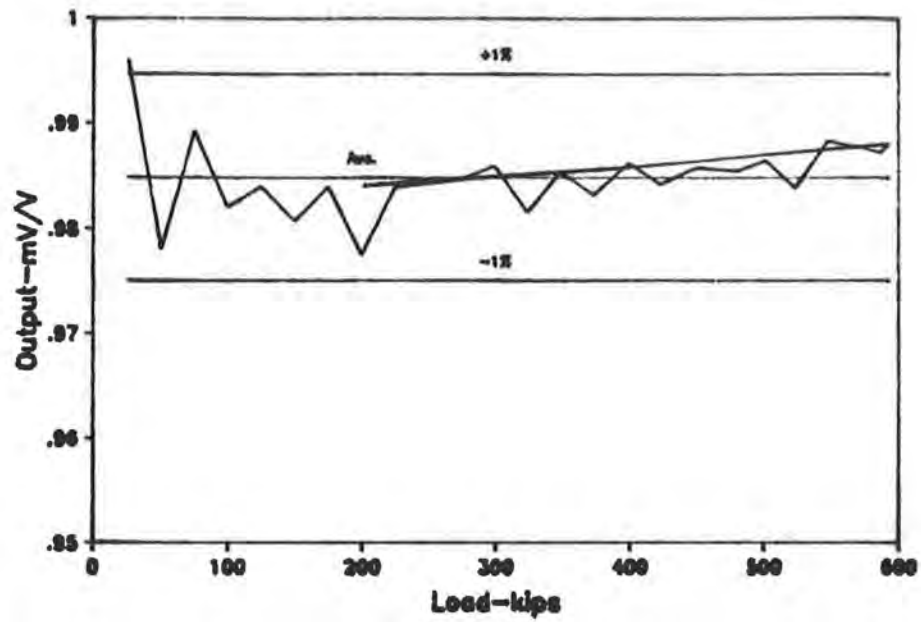
Figure A.6 Group calibration with strain indicator

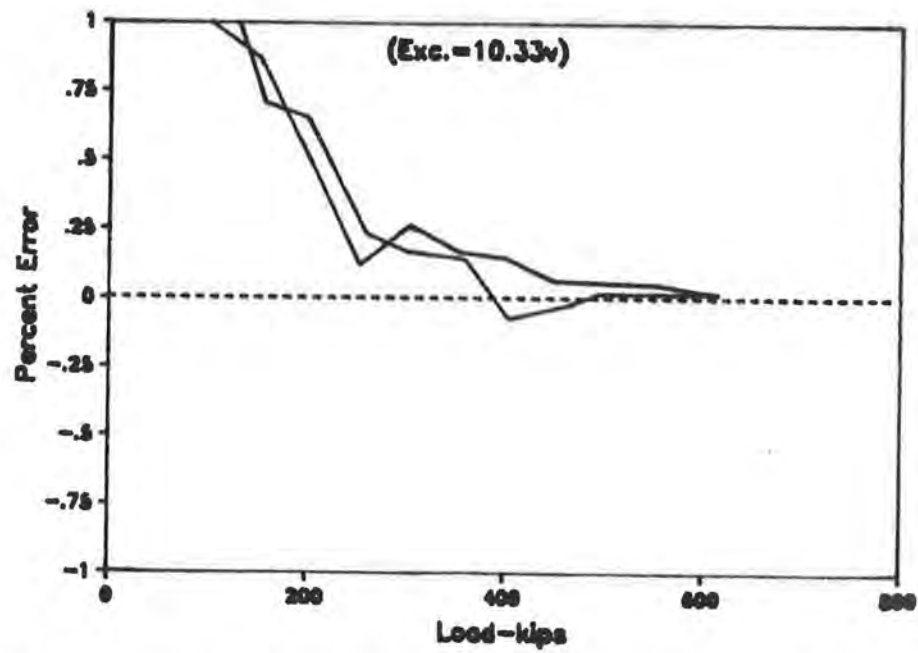
Figure A.7 Group calibration with closed loop test control unit
