A STUDY OF BEAM-COLUMN JOINTS UNDER SEISMIC LOADS:
COMPONENT TESTS VERSUS BUILDING RESPONSE

THESIS

The University of Texas at Austin

August 1982

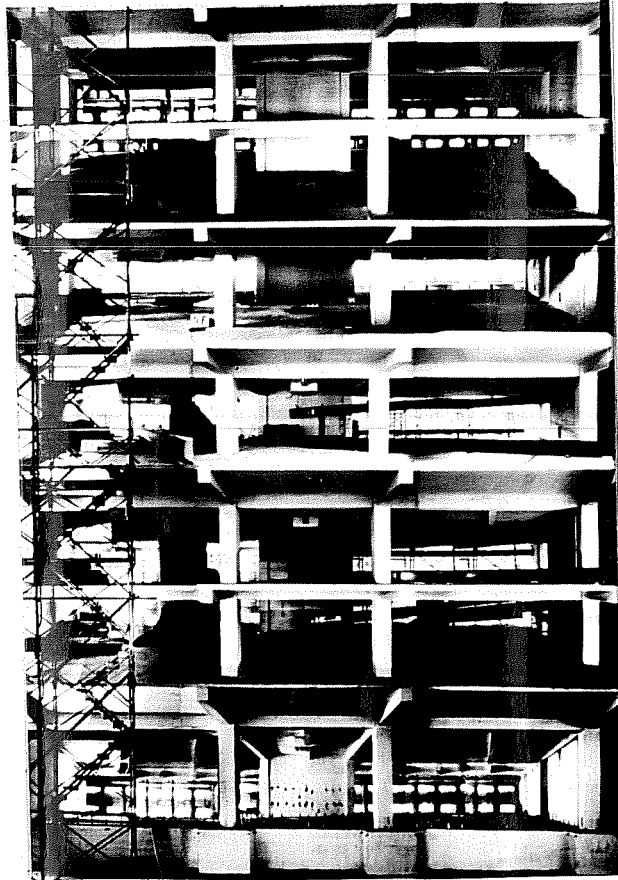
Fig. 1.1 Full-scale seven-story structure

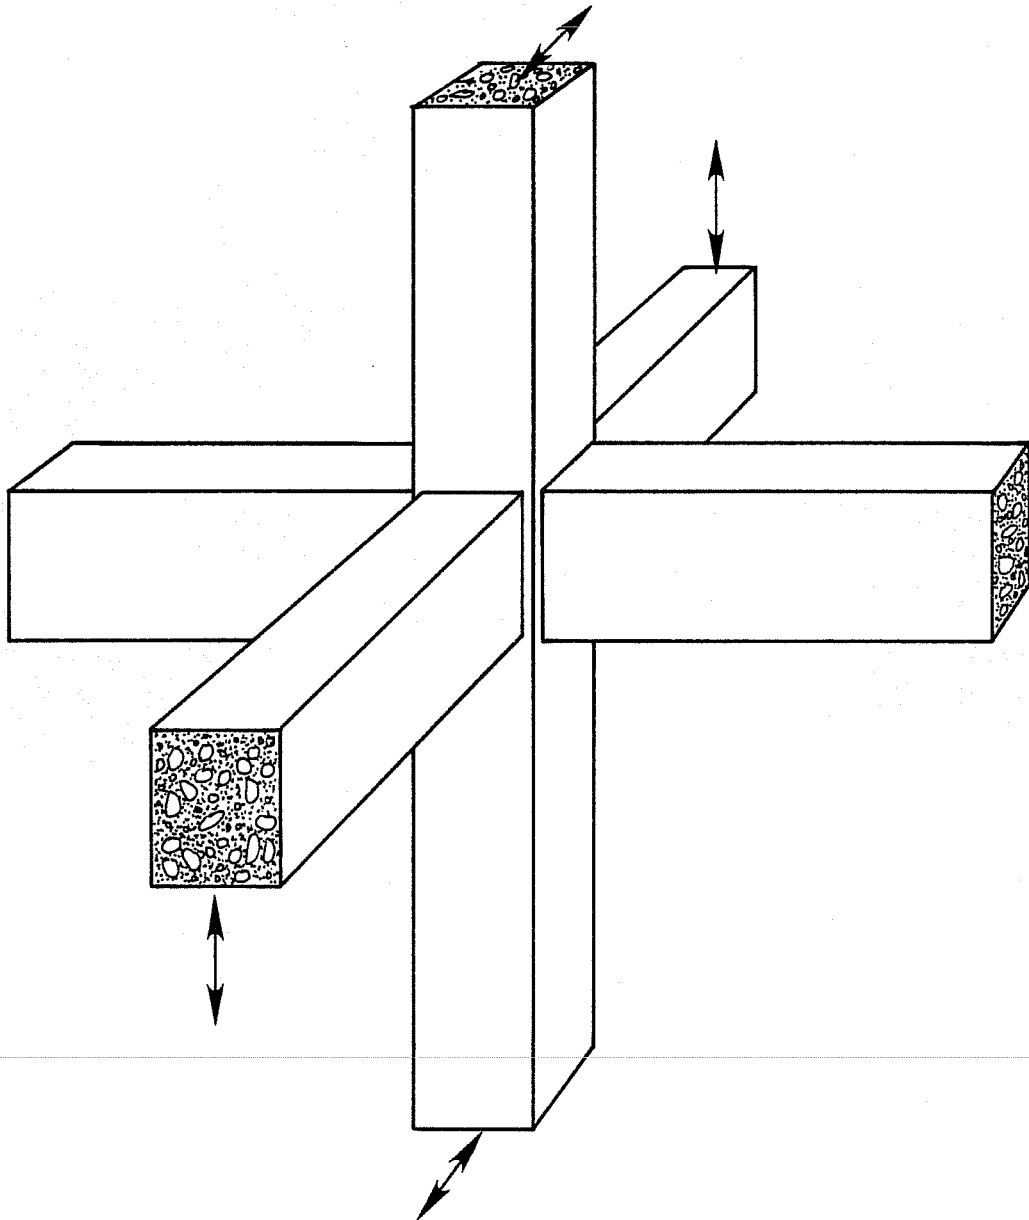
Fig. 1.5 Interior beam-column joint assembly

1.3.1 Test Program. The experimental work conducted at the University of Texas, Austin in the Ferguson Structural Engineering Laboratory involves the fabrication and testing of full-scale reinforced concrete beam-column joint specimens. The proposed test program includes plans for two interior and two exterior joint assemblies with geometries identical to the beam-column joints at the second level in the prototype structure. The locations of typical interior and exterior joints in the full-scale building are indicated in Fig. 1.2. Typical interior and exterior joint specimens are shown in Figs. 1.5 and 1.6, respectively.² For

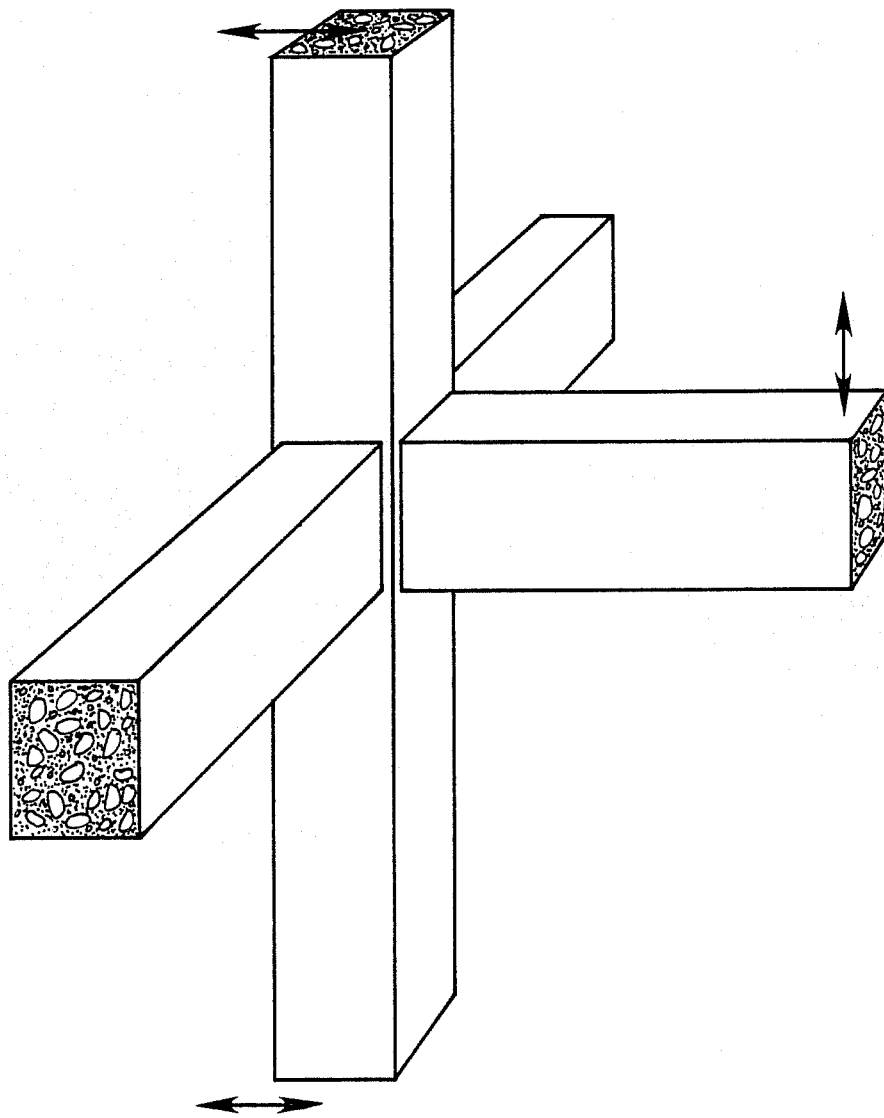
Fig. 1.6 Exterior beam-column joint assembly

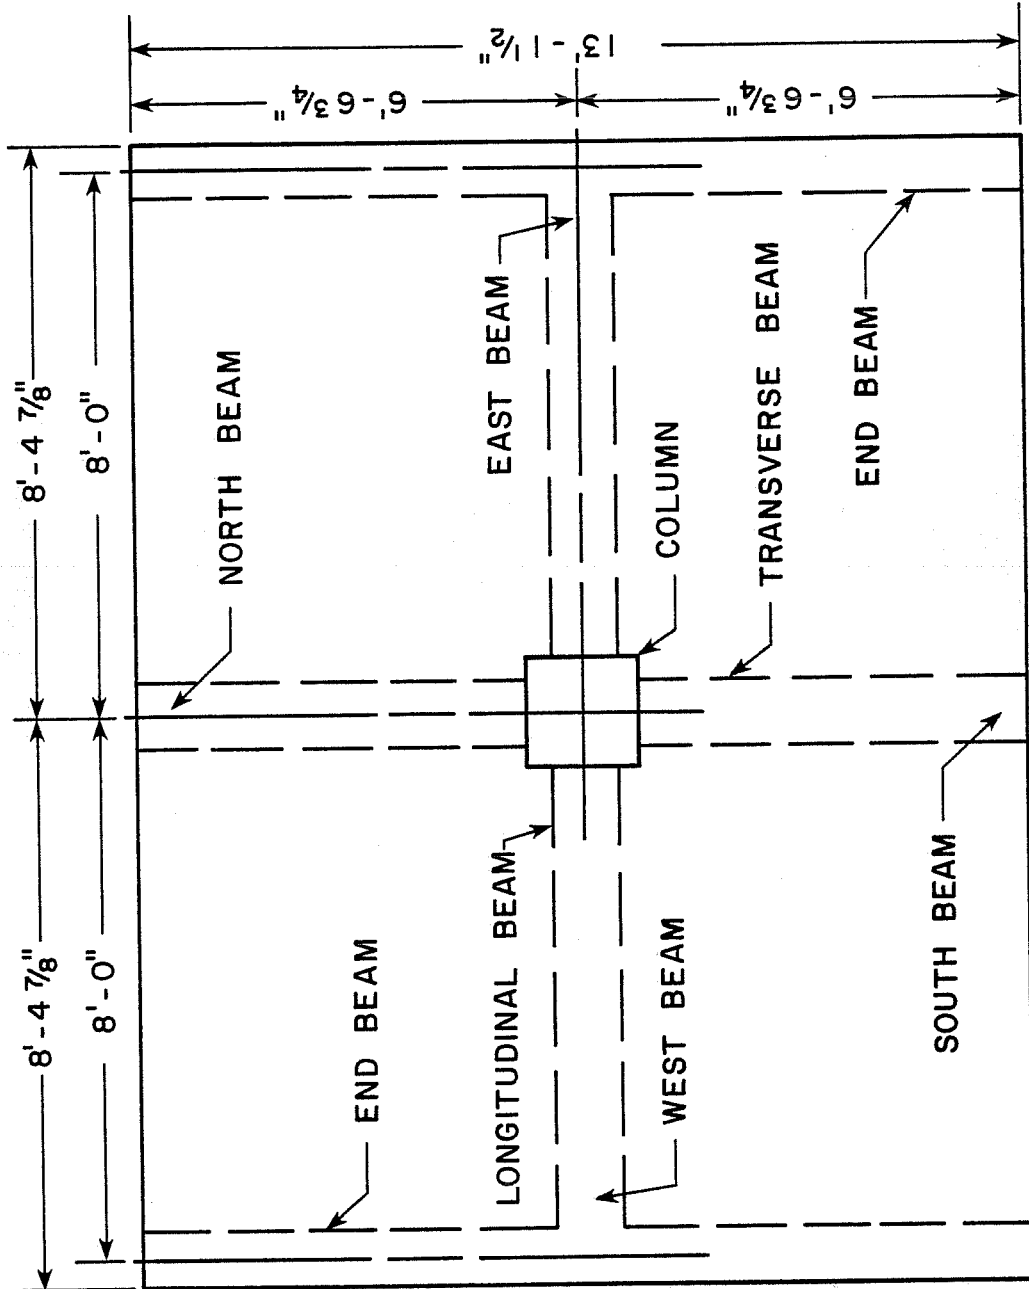
Fig. 2.1 Plan view of interior joint specimen

The as-built dimensions of the test specimen are shown in plan and elevation views of the interior joint assembly, Figs. 2.1 and 2.2, respectively. The longitudinal beam refers to the single beam in the long direction of the specimen intersecting the joint region. Since racking loads were applied only at either end of this beam, the beam is parallel with the direction of loading for the specimen. The beam which intersects the joint region in the orthogonal direction is called the transverse beam. The two beams parallel to the transverse beam, at opposite edges of the specimen, are referred to as end beams. The orientation (north, east, etc.) of the joint assembly, as positioned in the test set-up is shown in Fig. 2.1. These directions were utilized during testing to

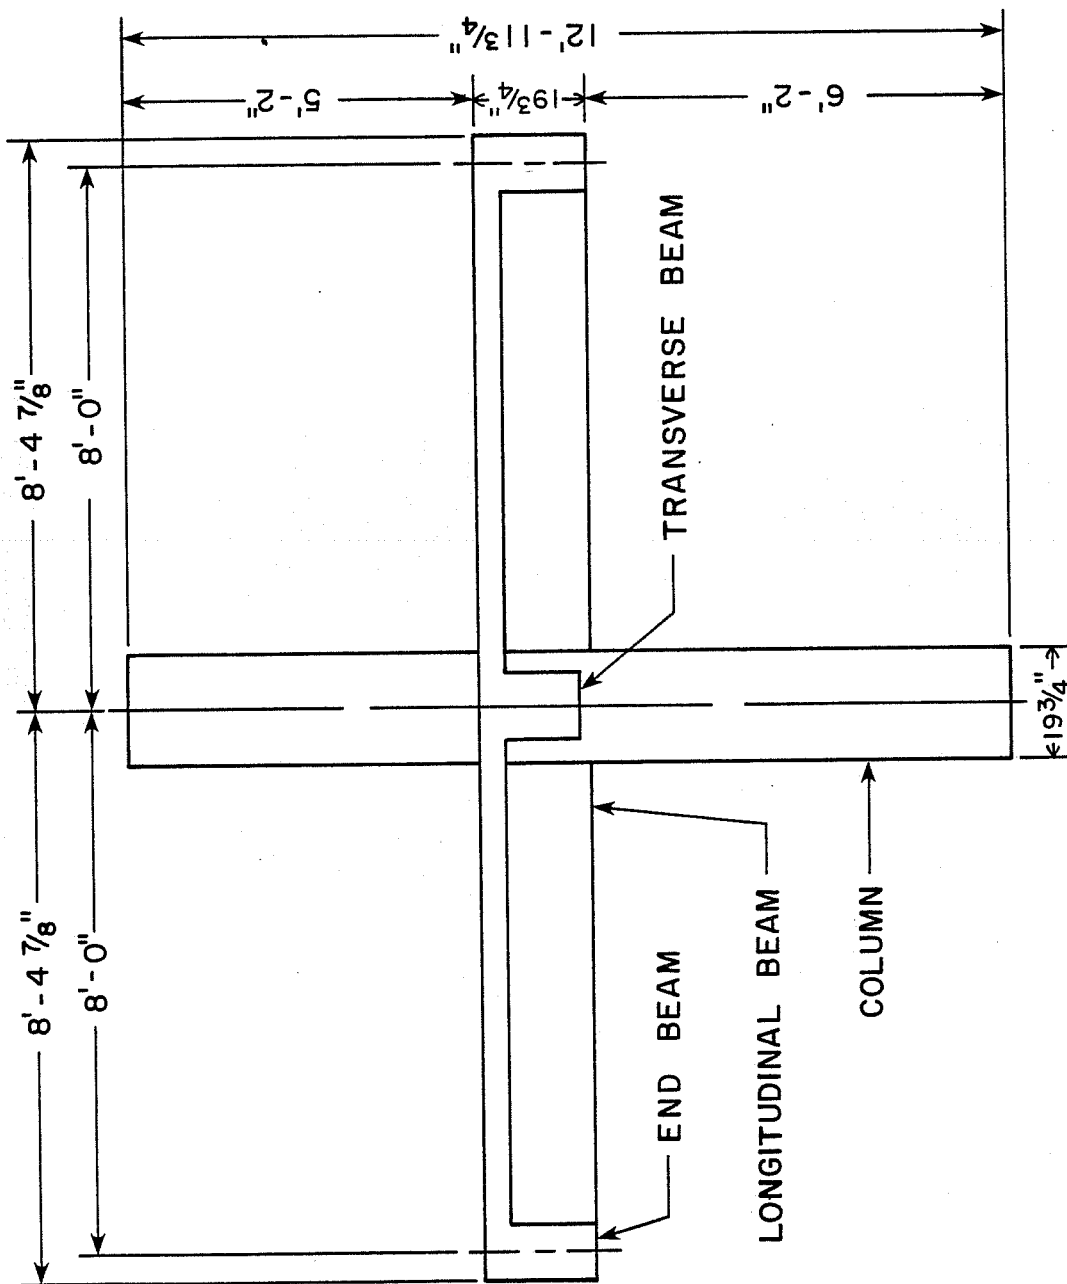
Fig. 2.2 Elevation view of interior joint specimen

Ideally, the column height of the test specimen should be equal to the story height from mid-story to mid-story assuming zero-moment conditions at those points. Figure 2.2 shows, however, that the lower column was 12 in. longer than the upper column. Two considerations led to the column geometry. First, the existing casting bed and the loading actuator height in the planned test set-up imposed restrictions on the dimensions. Secondly, the first story height in the full-scale structure was 3.75 meters compared to a 3 meter height for the remaining six stories. Therefore, although the upper and lower column dimensions were different, they reflected the geometry of the prototype structure.

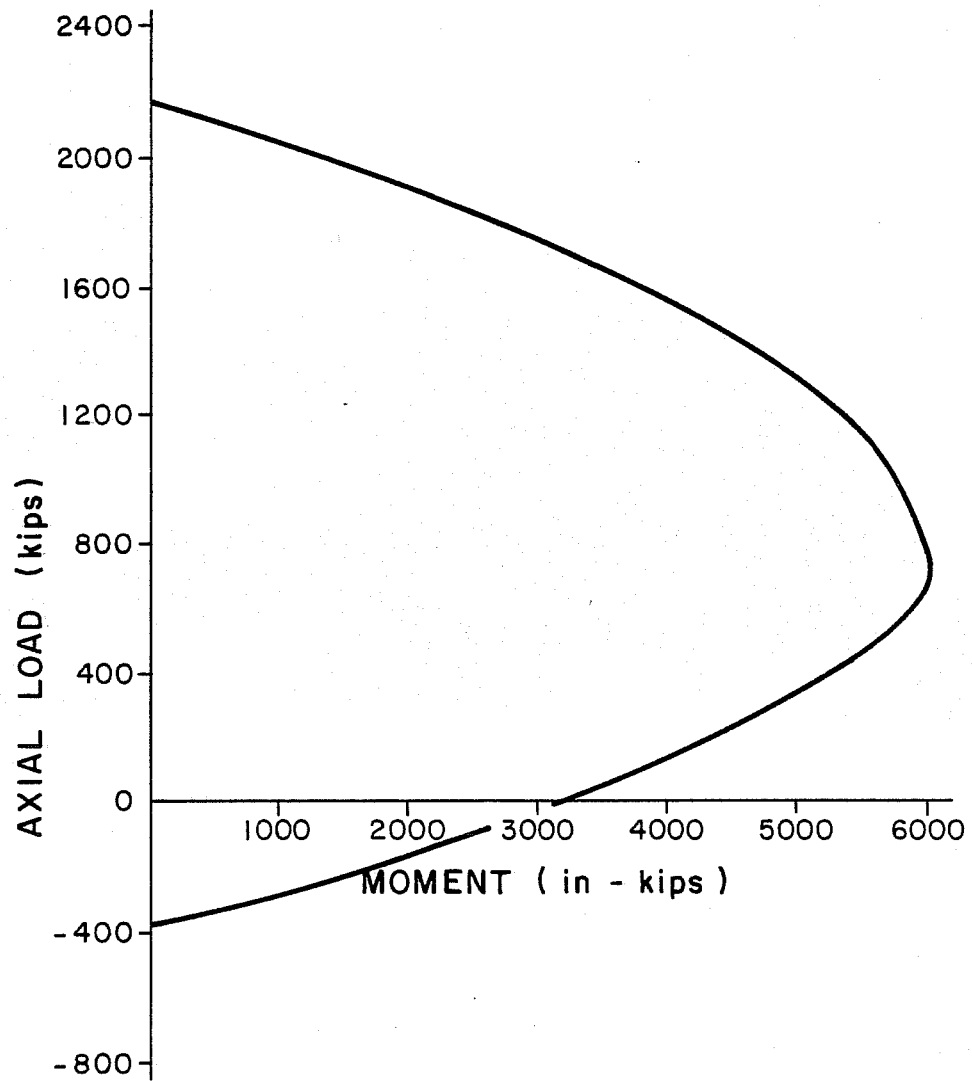
Fig. 2.8 Column interaction curve

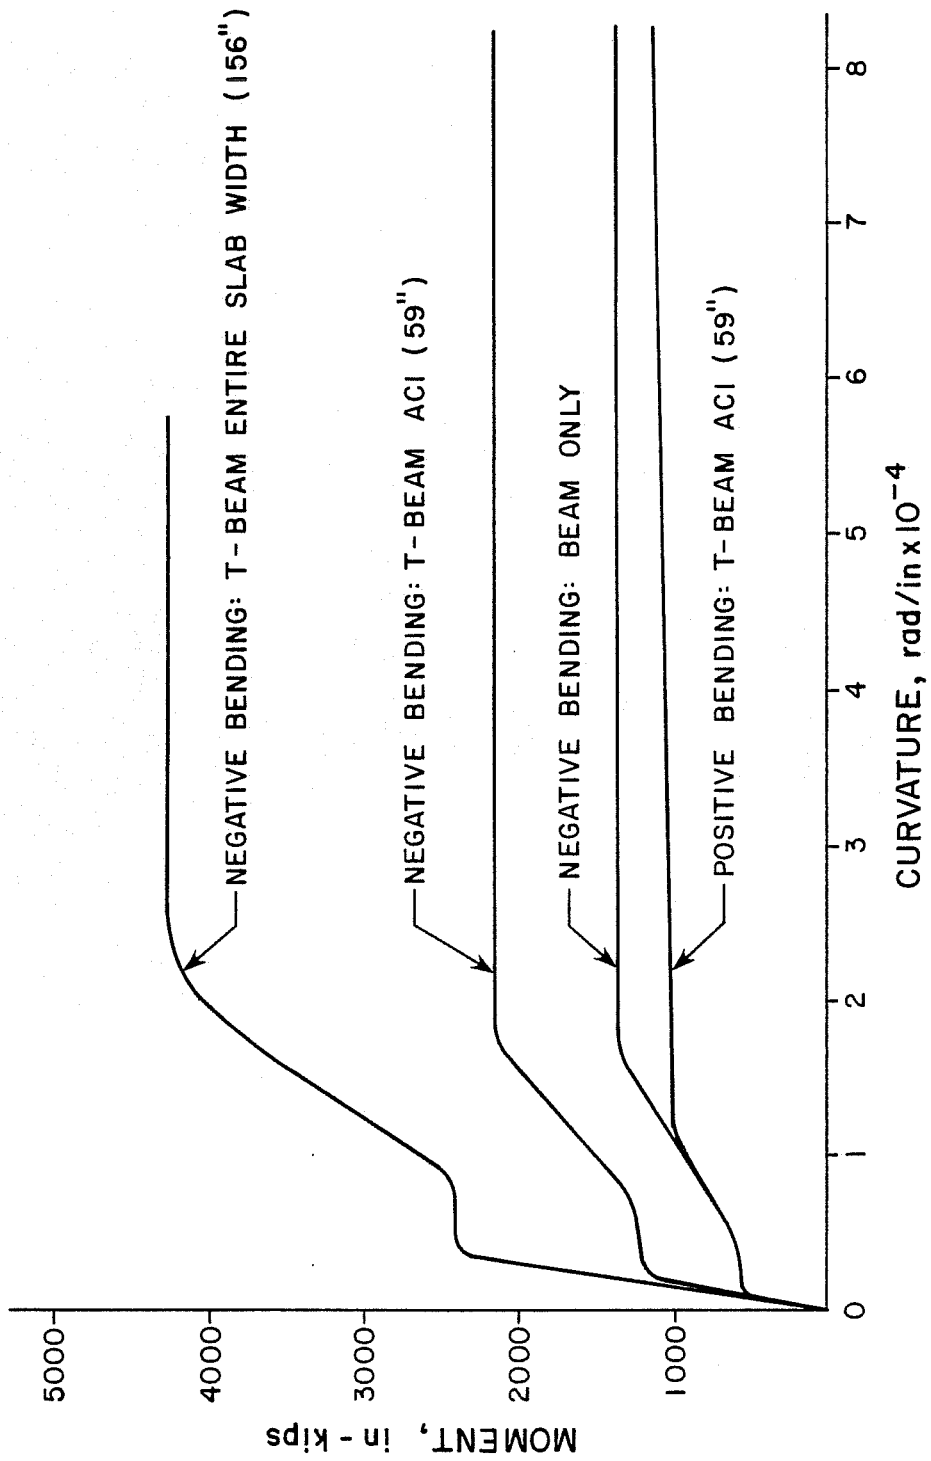
Fig. 2.9 Longitudinal beam moment-curvature relationships

beam hinging near the column face. In seismic-resistant structures such behavior is ideal where energy dissipation is provided by beam hinging, and the formation of hinges in critical column elements is prevented. Note, however, that as the contribution of the slab steel increases and the negative beam moment becomes larger, the moment ratio, calculated above, decreases. The design moment ratio may in fact be unconservative, less than 1.4, if the negative moment capacity approaches the maximum value in Fig. 2.9.

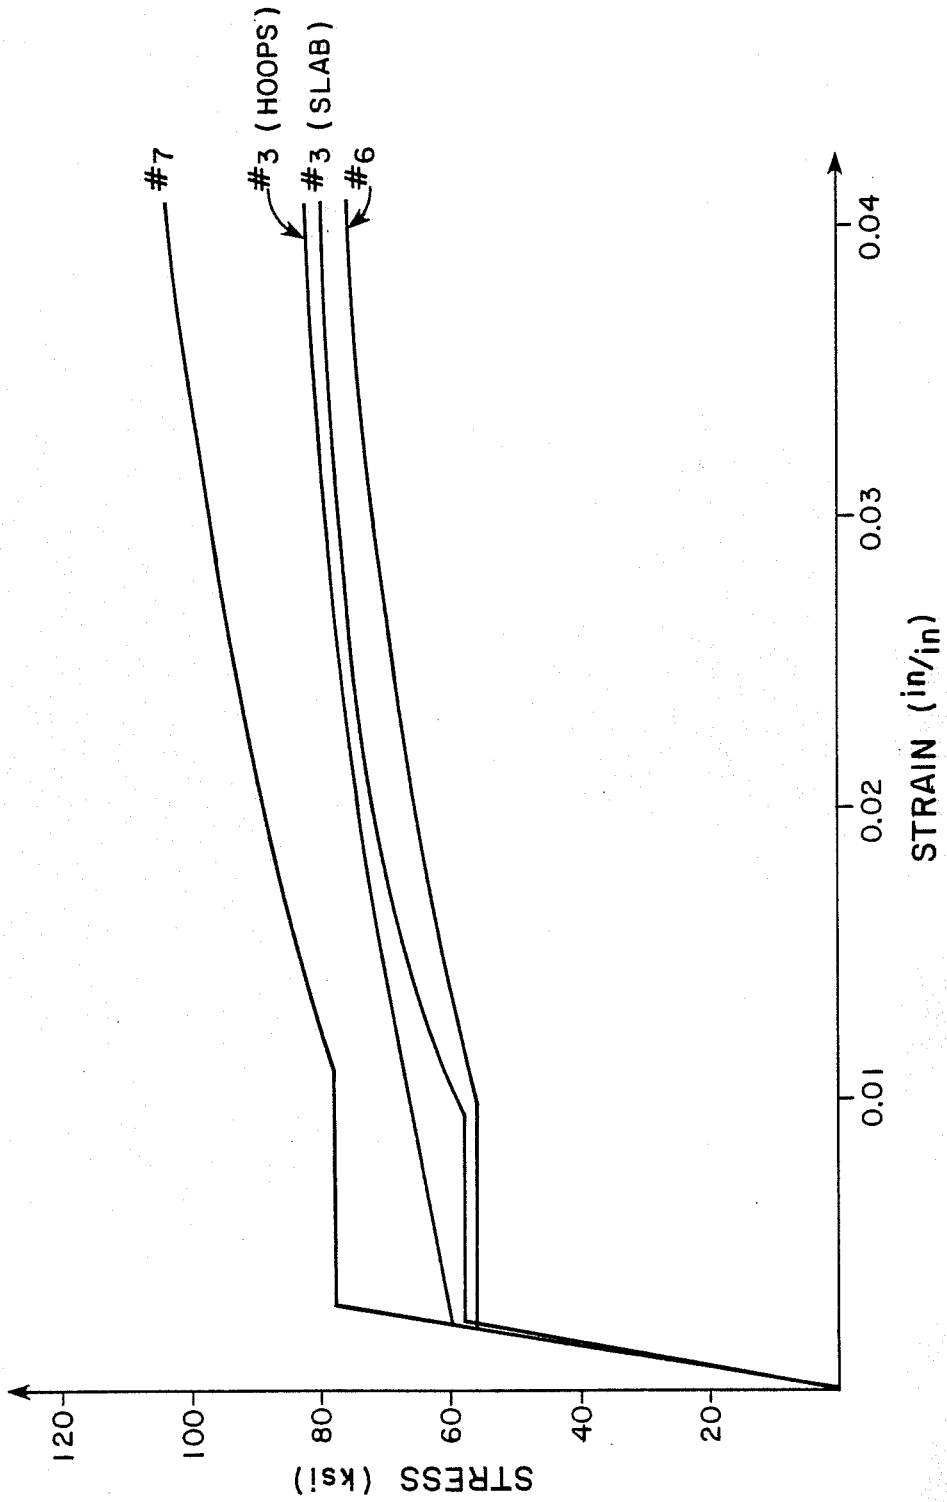
Fig. 3.11 Stress-strain relationships for reinforcement

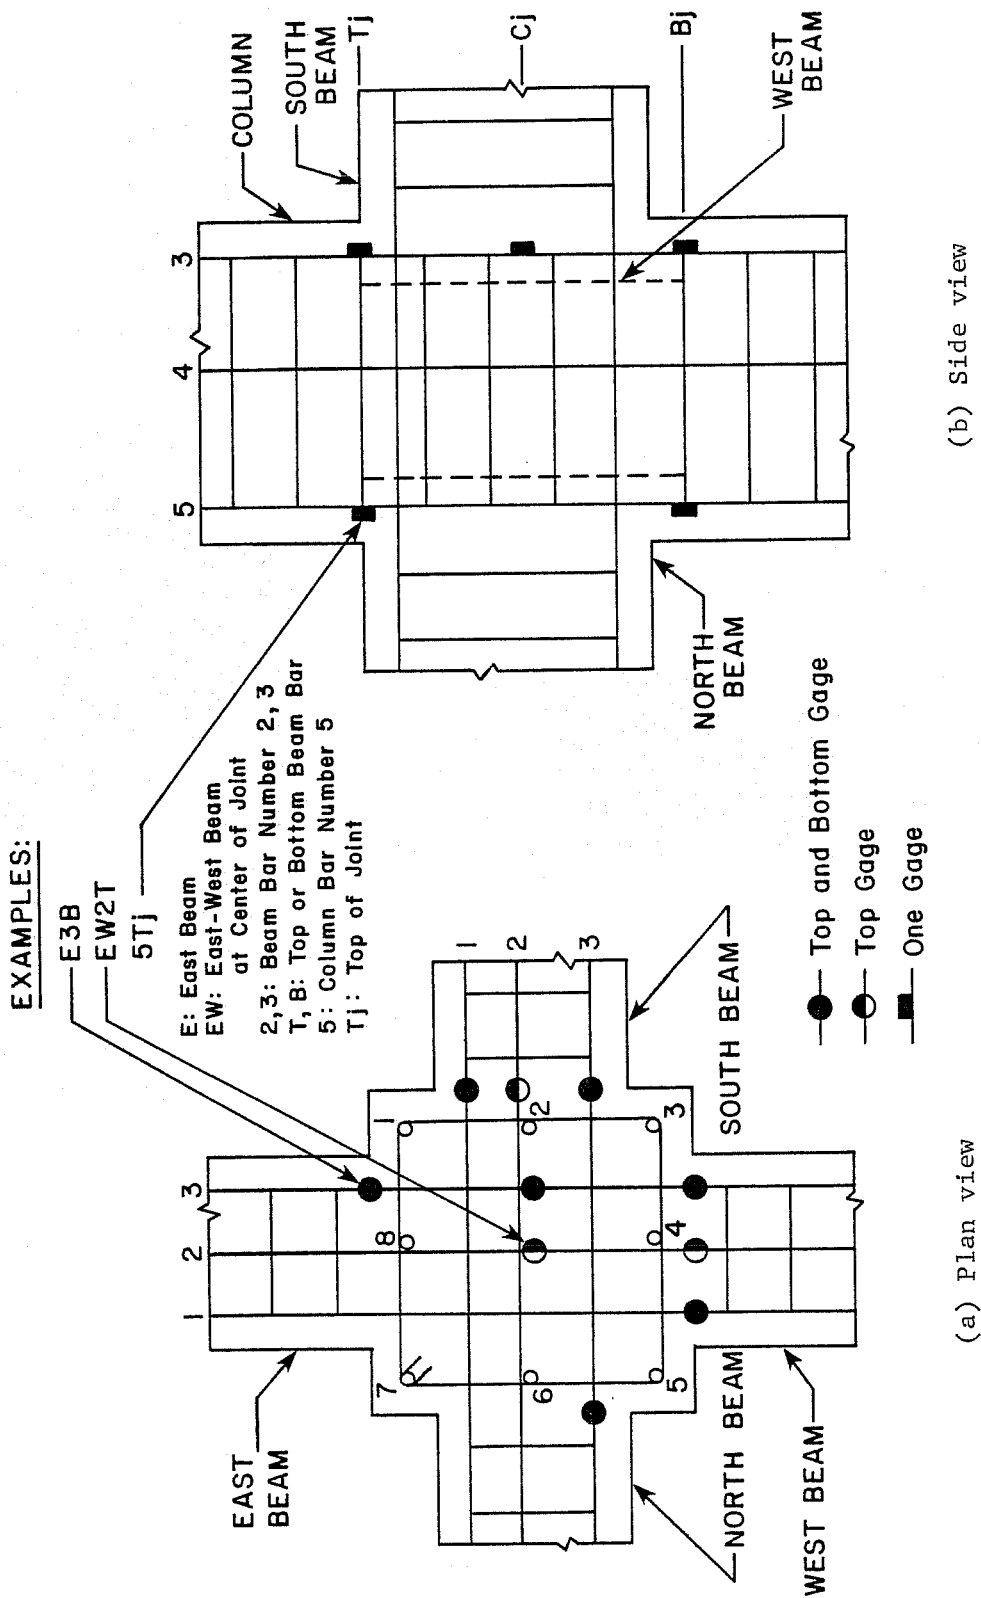
Fig. 3.13 Beam and column bar gage locations

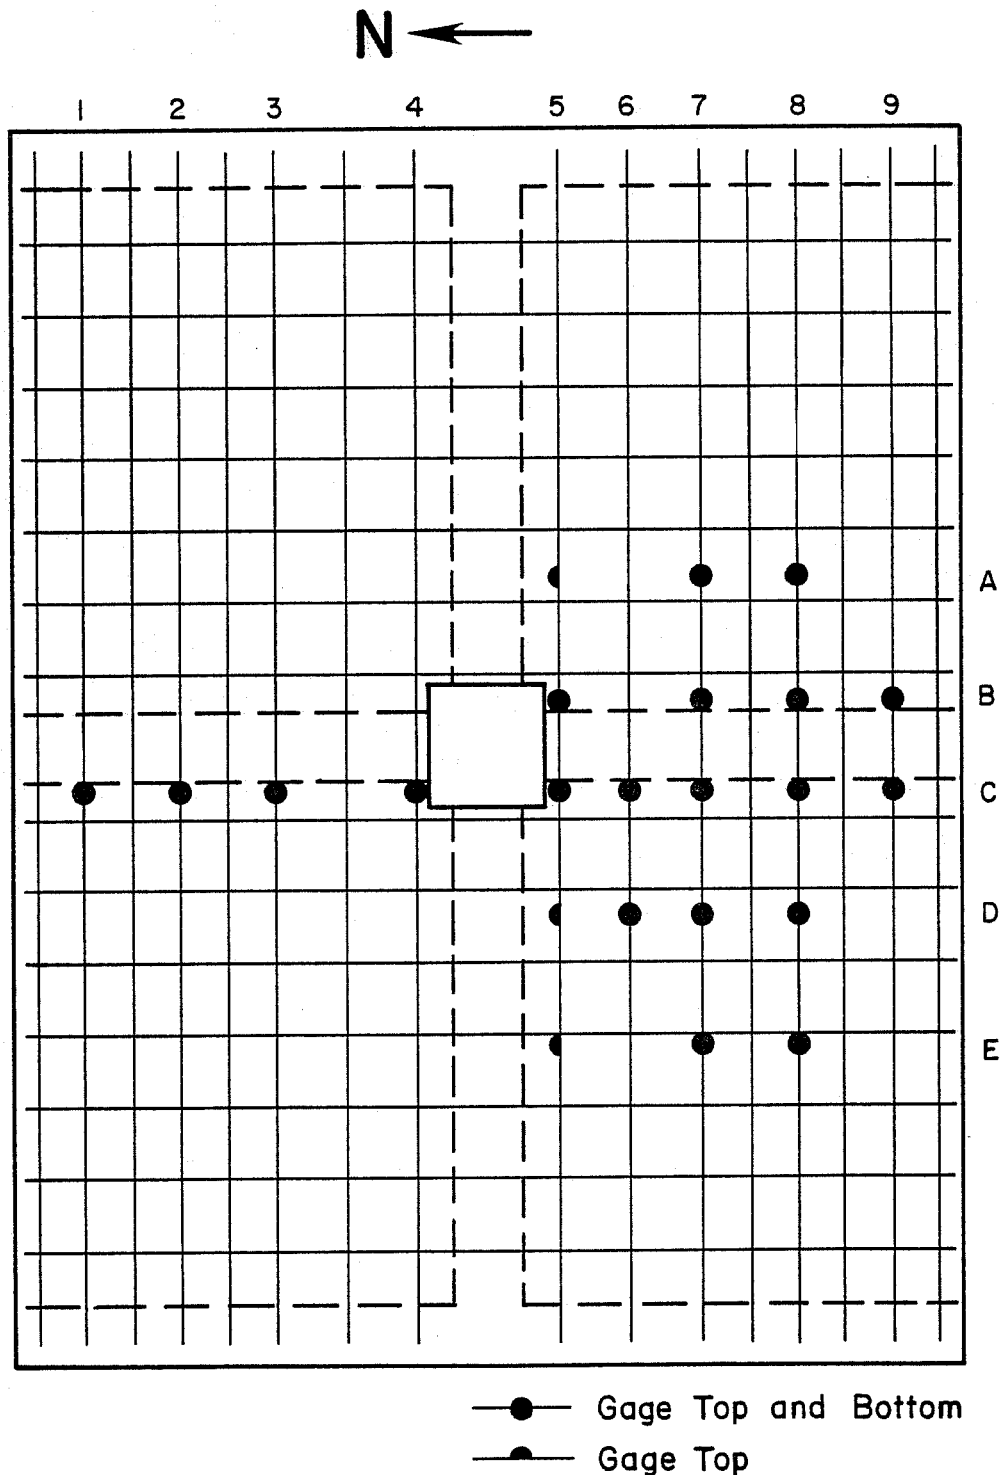
Fig. 3.14 Slab gage locations

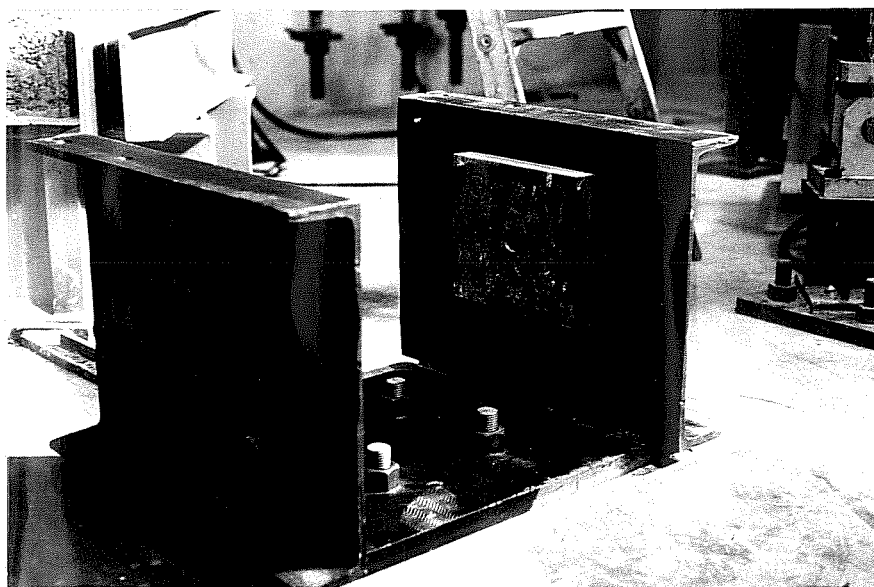
Fig. 3.22 Floor fixture

3.4.2 Pin Connections. The pin connections at the top and bottom of the column were very similar in design and detail so only the lower assembly will be discussed further. The floor fixture, shown in Fig. 3.22, was fabricated with two 18-in. deep channel sections and a large rectangular 1-1/4 in. floor plate. To facilitate positioning the specimen in the testing frame, only one of the channels was welded to the floor plate and the other bolted after the specimen was in place. Two clamping plates, one between the column face and the channel and the second on the outside of the channel, were firmly bolted to each channel after the pin was inserted through the entire assembly, including the column, to secure the specimen (see Fig. 3.23). Oversized holes, for the pin and the four clamping bolts were drilled in each channel section to offset any alignment problems due to fabrication errors.

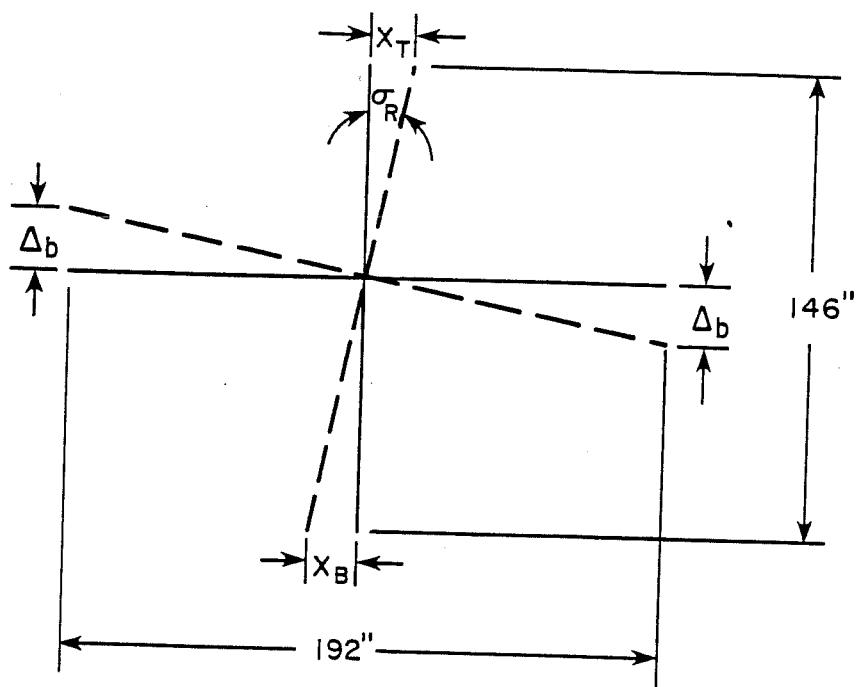
X_T = measured slip at top, in.

X_B = measured slip at bottom, in.

Fig. 4.1 Slip correction

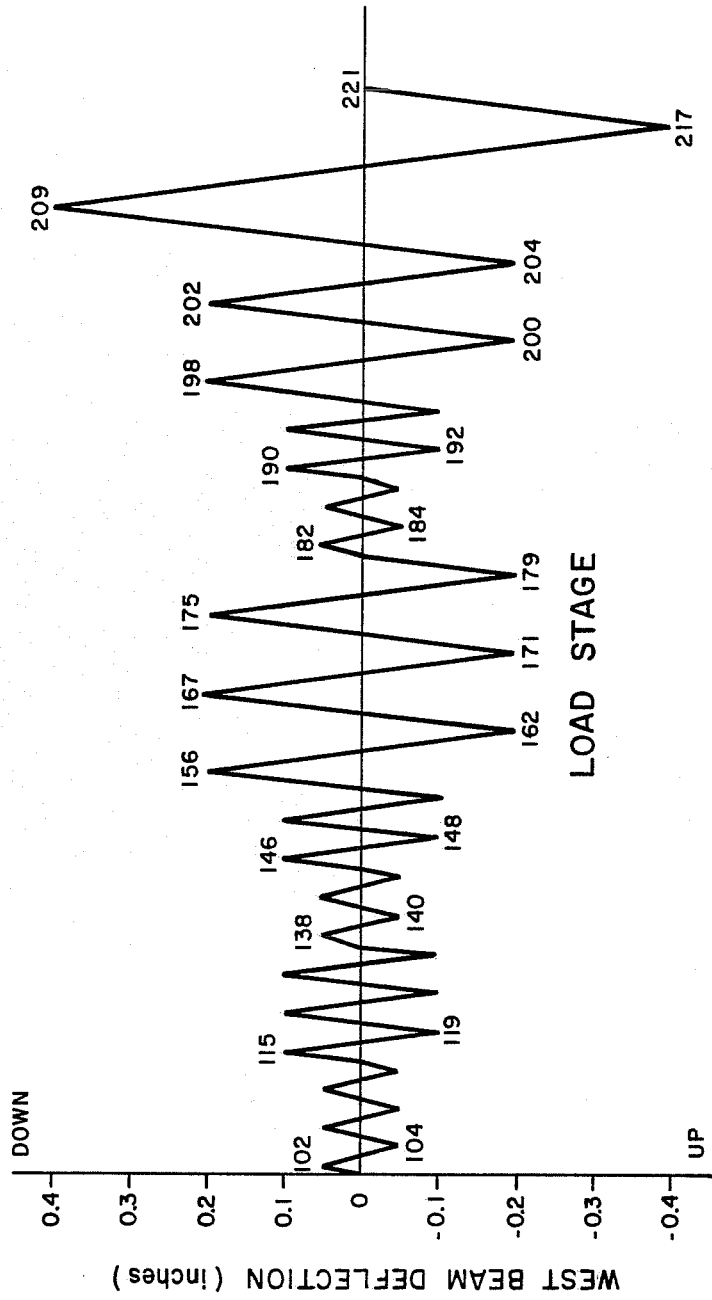
Fig. 4.2 Load history, Test 2

4.2.2.1 Load History. The load history for Test 2 is shown in Fig. 4.2. Note, a downward beam displacement is defined as a positive deflection. The initial beam displacement of 0.05 in. was estimated to be the deflection corresponding to torsional cracking of the transverse beam; however, this was not the case. Subsequent peak deflections were selected by simply doubling the previous peak displacements to a maximum of 0.4 in., calculated as the yield deflection for the bottom longitudinal beam steel. The smaller deflection cycles were repeated prior to each new displacement peak so comparisons of load-deflection behavior, at various

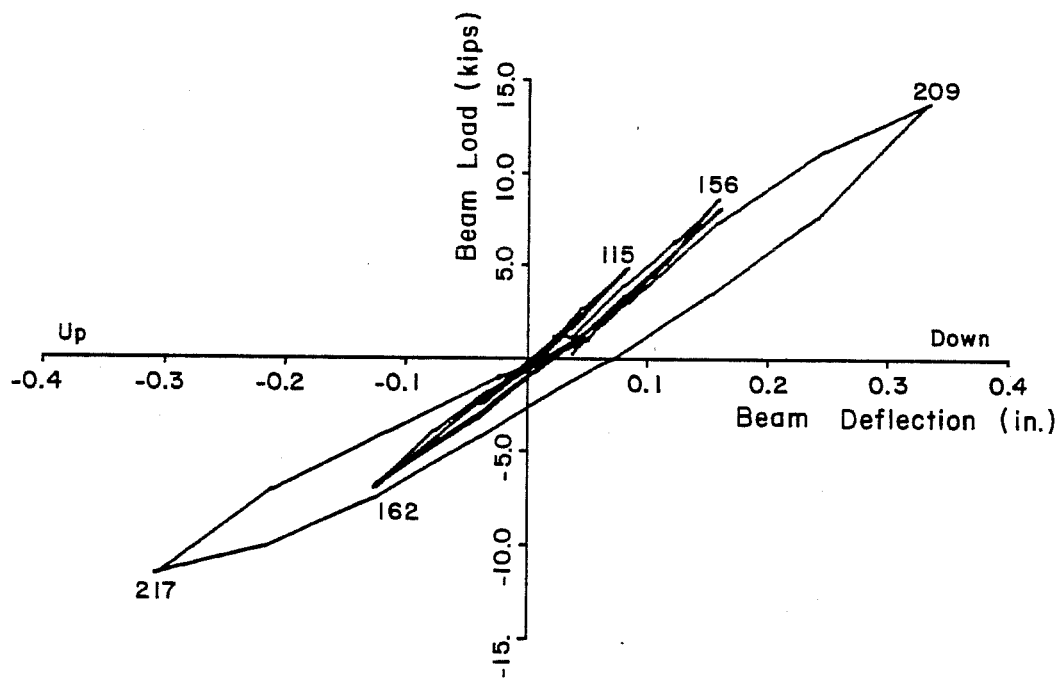
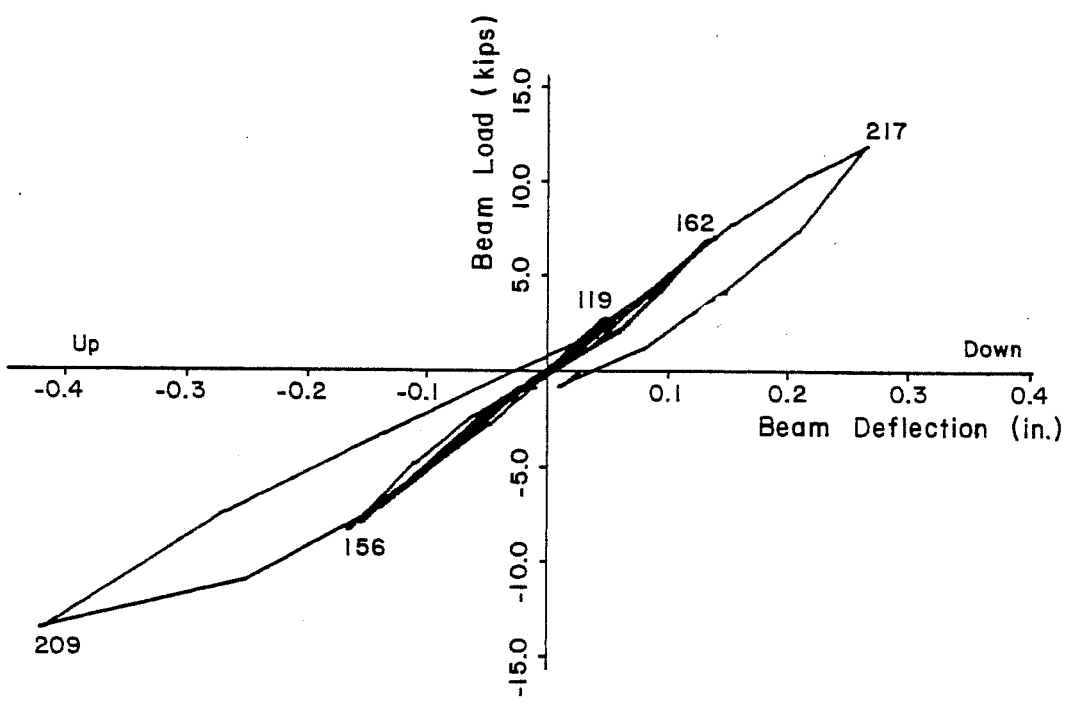
(a) West beam

(b) East beam

Fig. 4.3 Load versus deflection behavior, Test 2

4.2.2.2 Load-Deflection Behavior. The beam load versus beam-end deflection plots, shown in Fig. 4.3, indicate that the behavior of the specimen, prior to the last deflection cycle, was relatively elastic during Test 2. As the displacement levels were increased, the stiffness deteriorated slightly, primarily due to the initial flexural cracking in the beams and slab. At the peak beam displacement, a small hysteresis loop was observed (see Fig. 4.3). The west and east beam deflections varied somewhat, particularly during the last displacement cycle, because the loading system was inadvertently operated by load control. The positive and negative deflections of the west beam were nearly identical since the displacement of the west ram was monitored during testing.

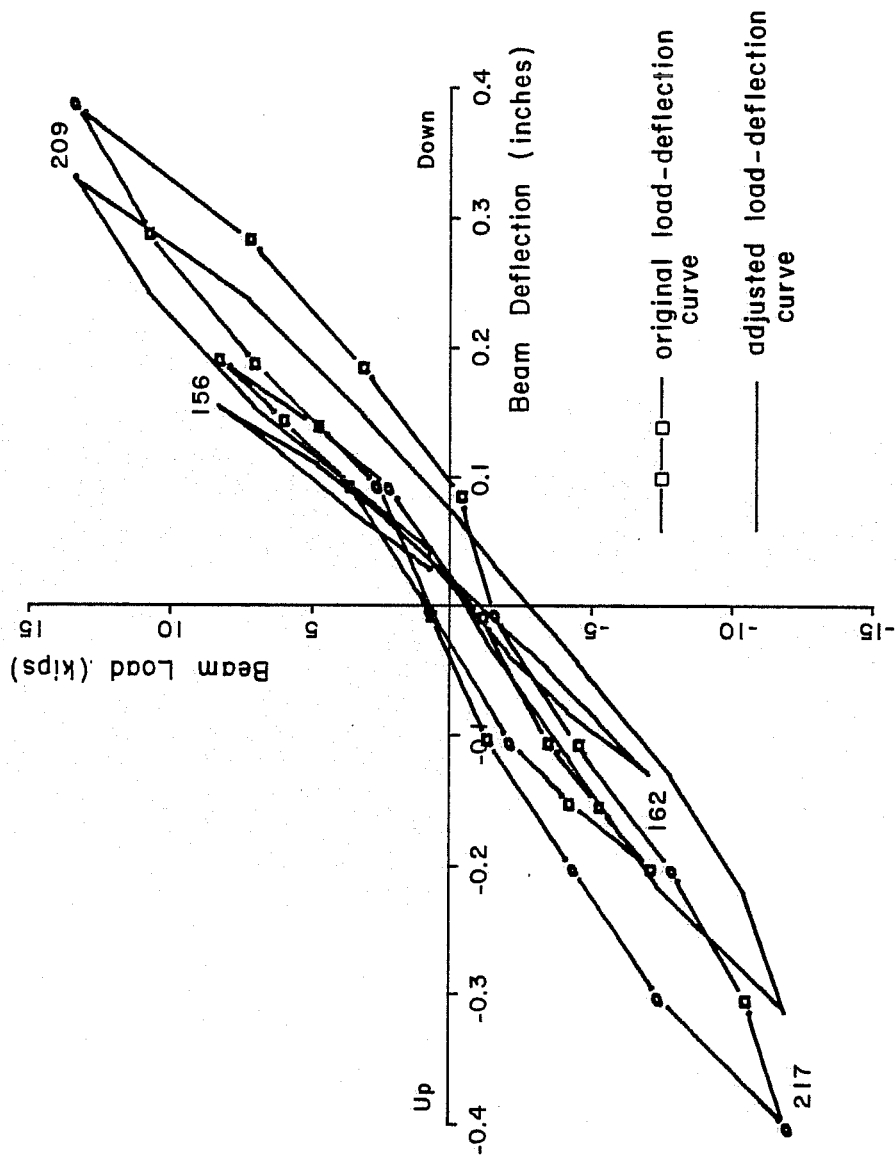
Fig. 4.4 Slip correction for load-deflection behavior, Test 2

The adjustments made to the load versus deflection plots using the calculated slip corrections are illustrated in Fig. 4.4. The misleading increase in beam stiffness which was characteristic of crack closure with load reversal was no longer evident once the slip was removed.

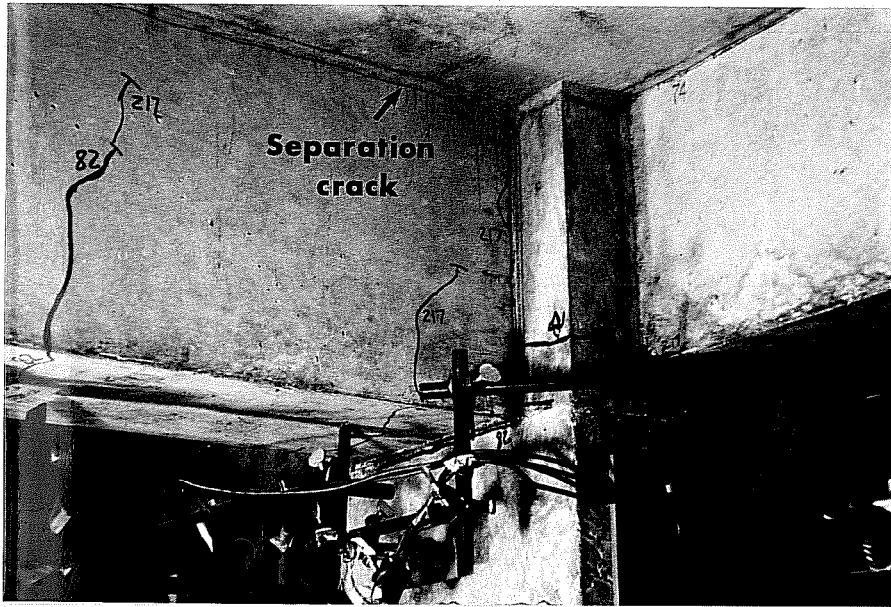
Fig. 4.5 Initial flexural cracks in west beam

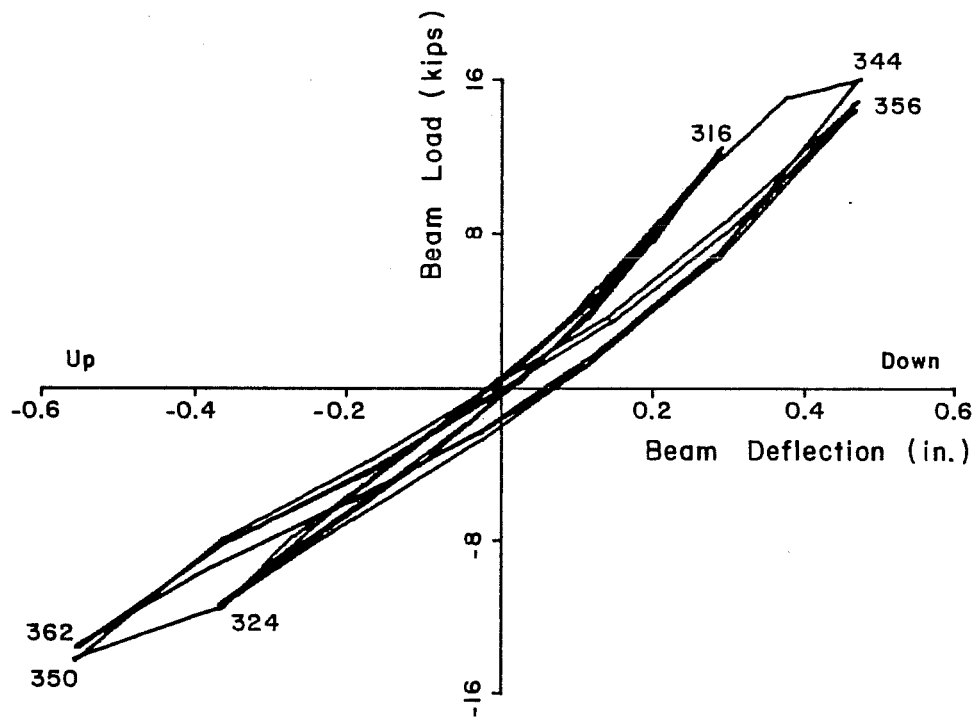
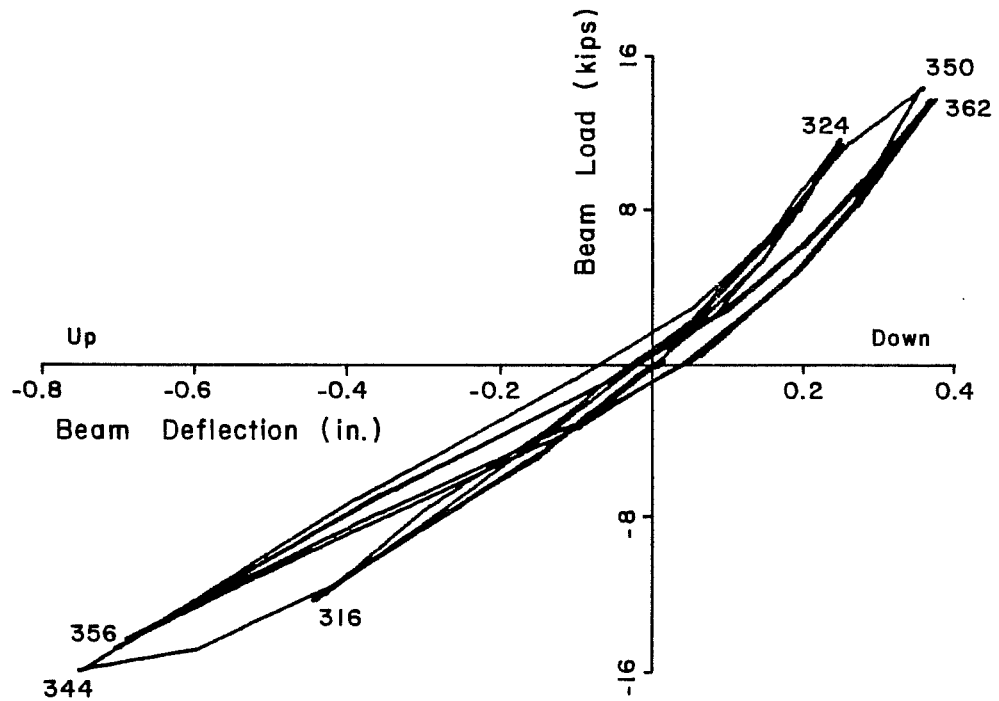
Fig. 4.8 Stiffness deterioration, Test 3

Figure 4.8 shows load-deflection plots for several cycles of loading prior to and including the $\Delta_i/2$ deflection level in Test 3. Some deterioration of the initial beam stiffness due to cracking in the specimen occurred since Test 2 (refer to Fig. 4.3). The stiffness increased, however, as the beam deflections became larger and the cracks closed. Finally, the adverse effect of cyclic loading on stiffness, even at relatively small displacements, is apparent in Fig. 4.8. Note the degradation in stiffness between the first (load stages 344 and 350) and second (load stages 356 and 362) cycles at $\Delta_i/2$.

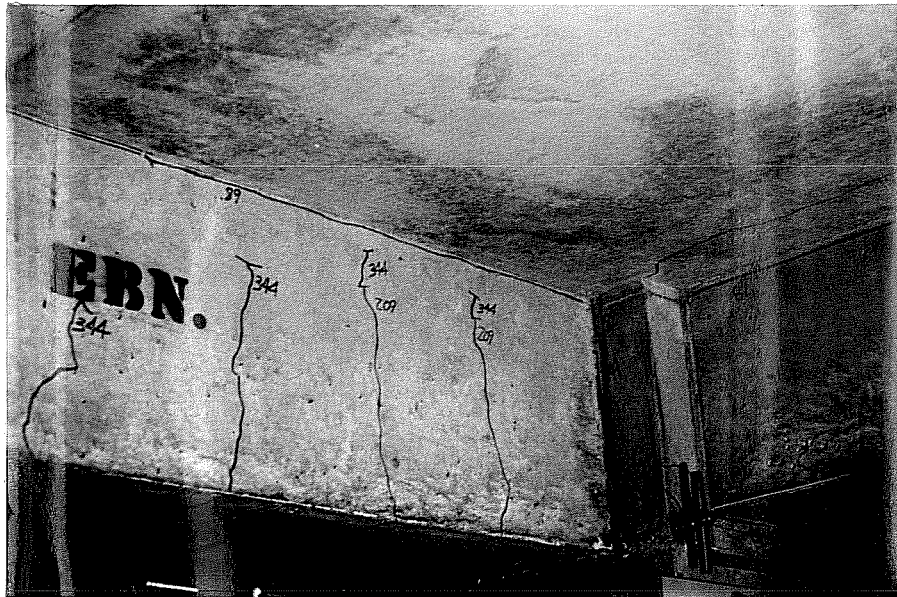
Fig. 4.9 Flexural cracking in east beam

4.2.3.3 Cracking Patterns. Several new flexural cracks were initiated in the longitudinal beams and column during the first cycle of deflection to $\Delta_i/2$ (see Fig. 4.9). Although the west and east beam deflections differed, the cracking patterns were nearly symmetric about the centerline of the transverse beam. The flexural cracks originating at the bottom of the longitudinal beams extended nearly to the slab. Flexural cracks in the slab propagated in the transverse direction toward the edge of the slab on top and bottom (see Fig. 4.10). Two of these cracks, one on either side of the transverse beam approximately 12 in. from the column face, extended through the slab and into the longitudinal beam. No new cracks and minimal crack propagation, primarily in the slab, were observed as cycling continued at this deflection level.

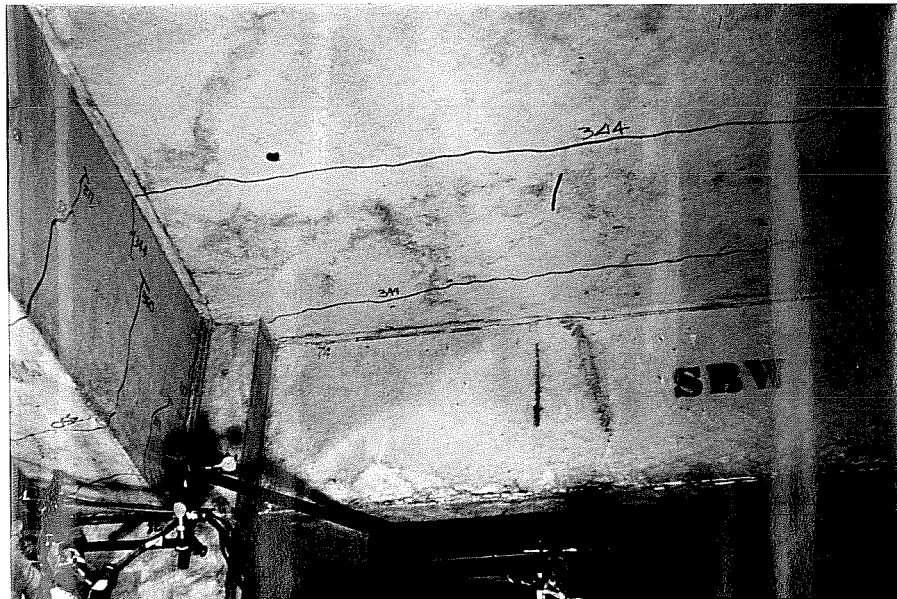
Fig. 4.10 Flexural cracking in the slab

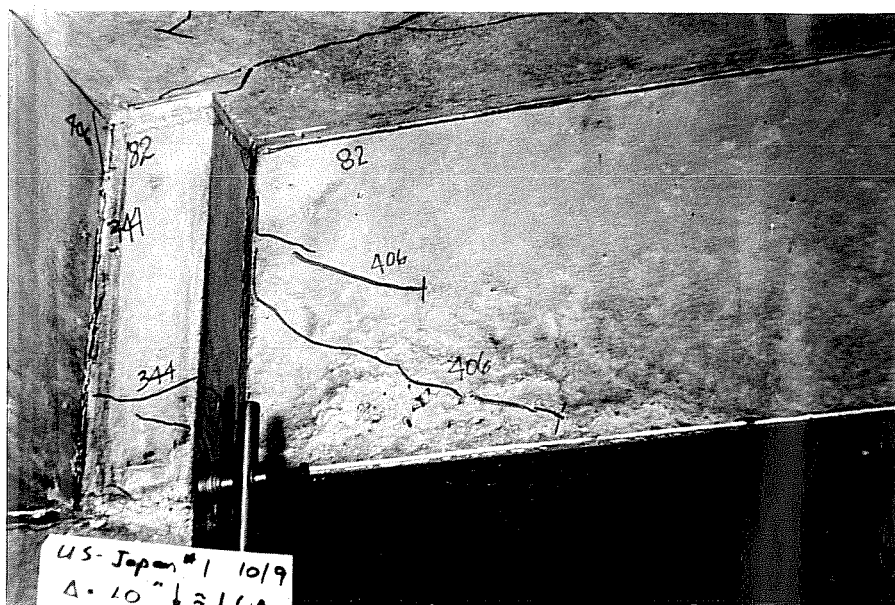
Fig. 4.11 First torsional cracks in transverse beam

Torsional cracks on the east face of the transverse beam near the column first appeared at load stage 406 (see Fig. 4.11). The corresponding west and east beam deflections were 0.85 in. and -1.8 in., respectively; and a load of 22 kips was measured on each beam. A wide separation crack between the east beam and the lower east column face developed during load stages 406 to 408, attributed to the large beam displacements. Some new flexural cracking was present in the east beam and the slab, as well as extensions of existing cracks. Finally, note the crack propagating diagonally,
