A STUDY OF BEAM-COLUMN JOINTS UNDER SEISMIC LOADS:
COMPONENT TESTS VERSUS BUILDING RESPONSE

THESIS

The University of Texas at Austin

August 1982

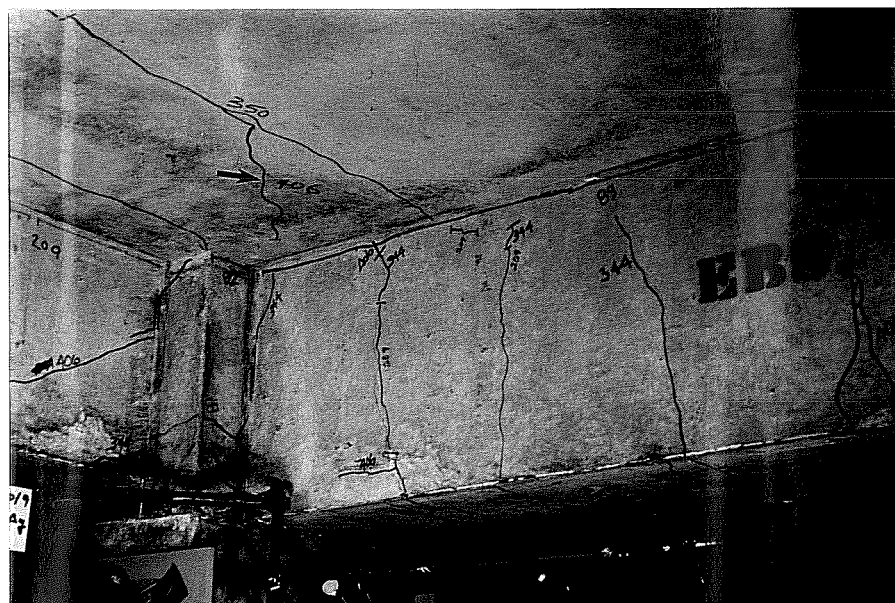
Fig. 4.12 Crack propagating diagonally in slab

at approximately 45° , from the southeast column corner in the bottom of the slab (see Fig. 4.12). A similar crack appeared on the opposite side of the east beam, also at load stage 406.

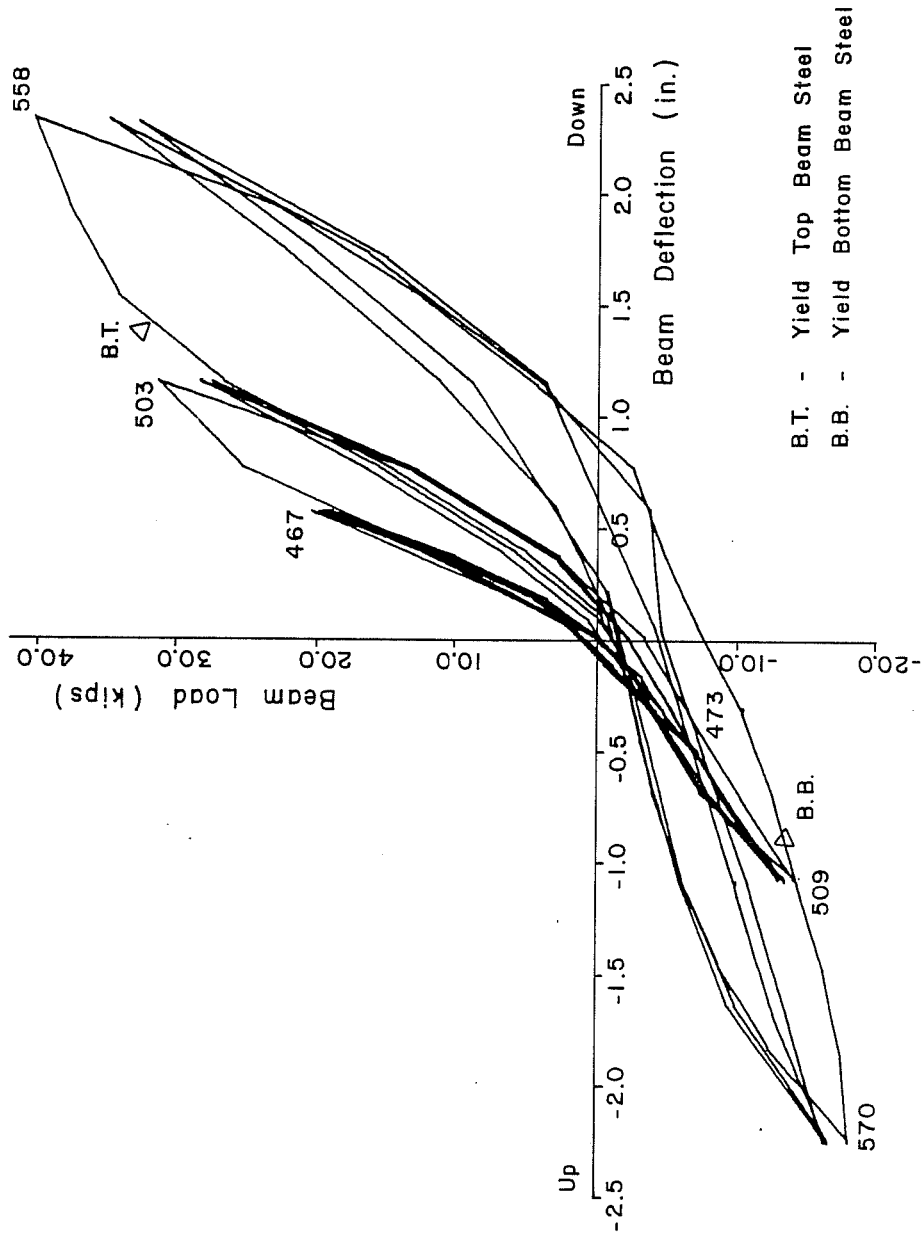
Fig. 4.14 Load versus deflection behavior, west beam (Test 4)

4.2.4.2 Load-Deflection Behavior. The load-deflection plots for the west and east beams (see Figs. 4.14 and 4.15) illustrate the transition from predominantly elastic to inelastic behavior as the deflection level was increased. Figures 4.14 and 4.15 indicate that significant degradation in beam stiffness occurs with cyclic loading at larger deflection levels. Observe that the stiffness of the east beam was less than the west beam in both loading directions, particularly at $1\Delta_i$ and $2\Delta_i$ (see Fig. 4.16). This softness in the east beam was attributed to the damage suffered in Test 3 and the influence of the loading direction. At the $2\Delta_i$ deformation level, pinching of the hysteresis loops in the second and third cycles suggests beginning signs of shear distress in both beams.

The yield point of the beams in the strong direction, positive displacement, is not well defined in Figs. 4.14 and 4.15. However, from measured beam strains, yielding was estimated to occur at a load of 30-32 kips for the west beam and 26-28 kips for the east beam at a deflection of 1.4 in. The west beam load was approximately 25 percent greater than the predicted yield load of 25 kips which was calculated assuming an effective slab width of

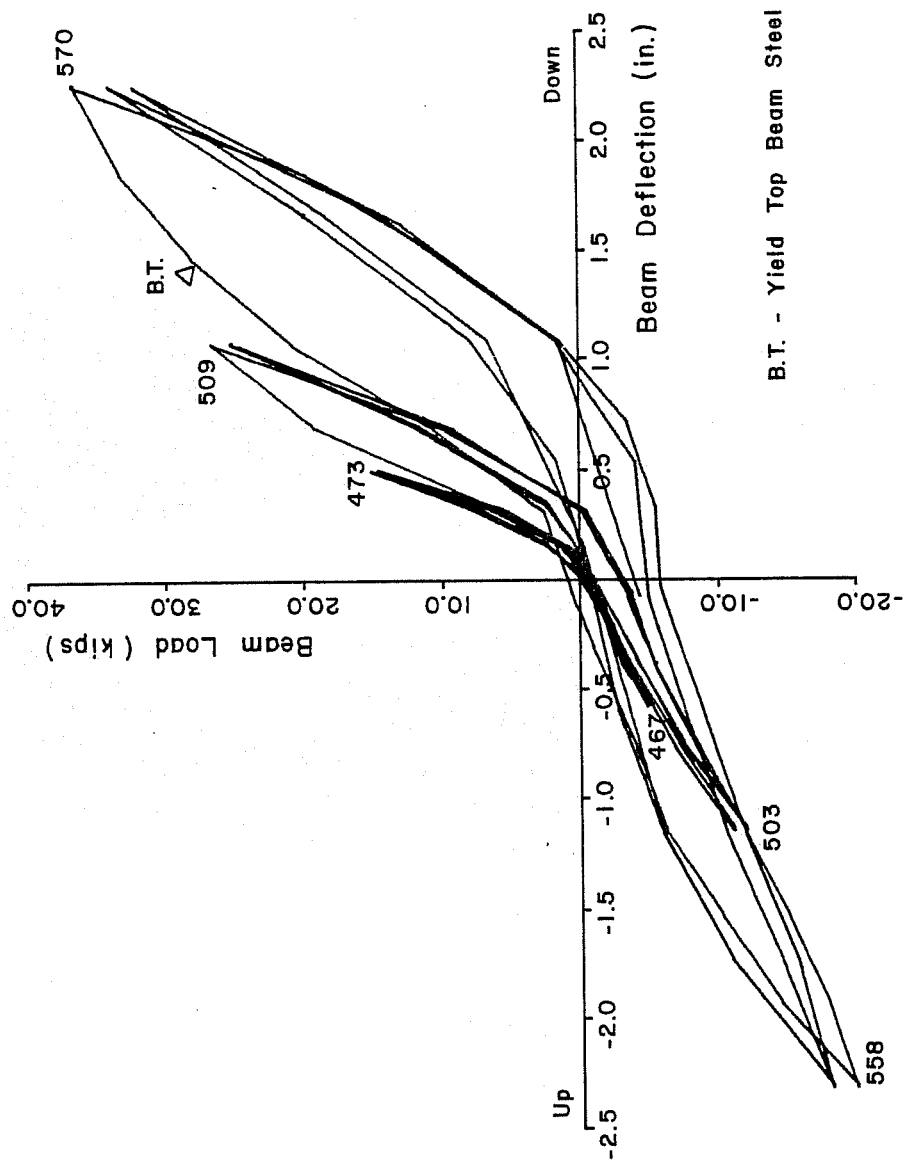
Fig. 4.15 Load versus deflection behavior, east beam (Test 4)

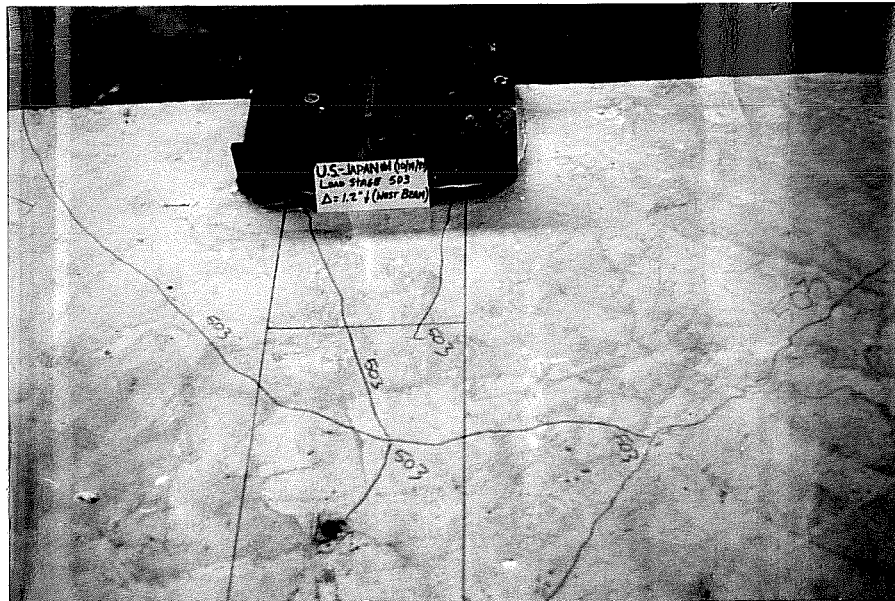
Fig. 4.18 Cracking in slab near loading points

4.2.4.3 Cracking Patterns. Extensive cracking in the longitudinal beam, slab, and column was observed at the higher deflection levels of Test 4. The flexural cracks initiated in the slab at $1\Delta_1$, and the existing cracks, propagated diagonally into the west and east beams (see Fig. 4.17). Another set of cracks developed near the longitudinal ends of the slab at load stages 503 and 509, and extended in a semi-circular pattern around the loading points (see Fig. 4.18). Torsional cracking in the west face of the transverse beam and cracks extending diagonally in the slab from the northwest and southwest column corners appeared at load stage 509 (see Fig. 4.19), similar to the crack patterns observed during Test 3 on the east side of the specimen.

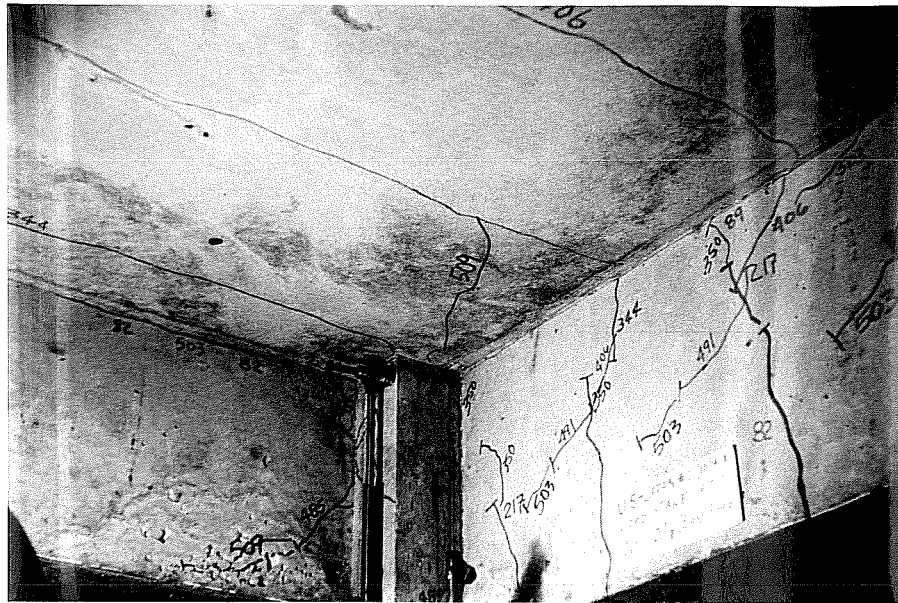
Fig. 4.19 Crack patterns at load stage 509

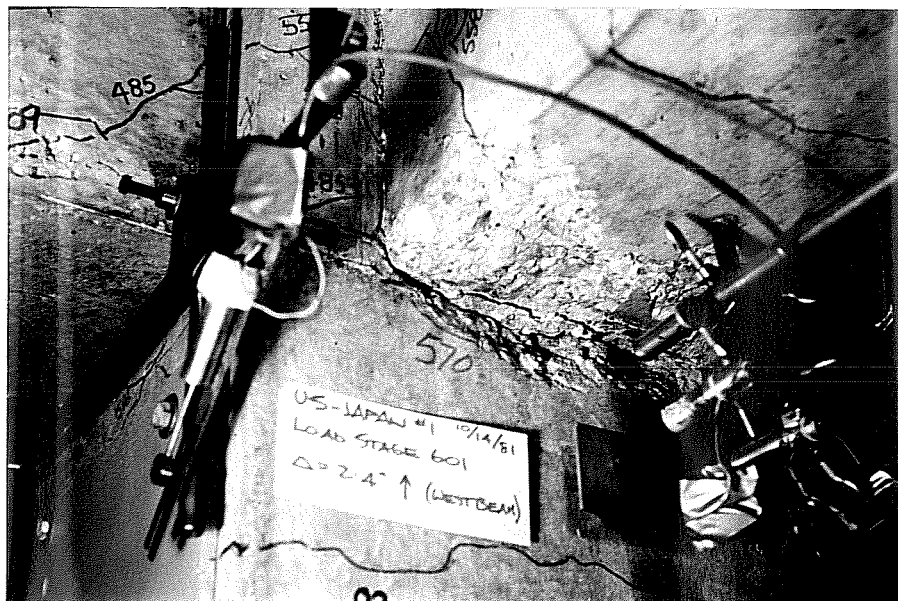
Fig. 4.20 Deterioration in hinging zones, west beam

As cycling continued to $2\Delta_1$, very few new cracks were initiated, but extensions of existing cracks were observed, particularly in the slab. Splitting cracks along the longitudinal reinforcement of the beams and column appeared at load stages 558 and 570. Figure 4.20 shows the initial development of a longitudinal beam hinge at the column face. Note the wide cracking at the beam-column interface and the concrete that spalled when the loading direction was reversed. There was some evidence of joint shear distress in Test 4 indicated by a few shear cracks located on the column corners in the joint region.

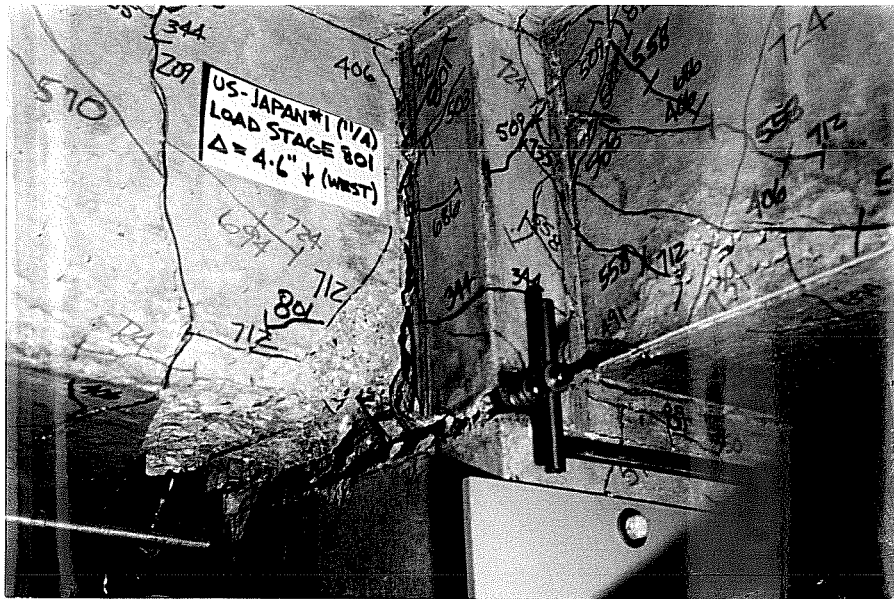
Fig. 4.25 Cracking near NE corner of joint, Test 5

bottom of the west and east beams indicating that the compression zones had become smaller and highly stressed. The crushed and spalled concrete observed near the joint was a further indication of the high compressive stresses present in the beams (see Fig. 4.25). As the load was reversed, very wide separation cracks opened between the longitudinal beams and column faces (see Fig. 4.25). Similar cracking, but accompanied by much less spalling, was observed on top at the slab-column interfaces. The spread of torsional cracking was apparent due to the orthogonal crack patterns on the transverse beam faces and the propagation of cracking to the bottom of the beam (see Fig. 4.25). In addition, several joint shear cracks are present in Fig. 4.25 on the northeast-column corner.

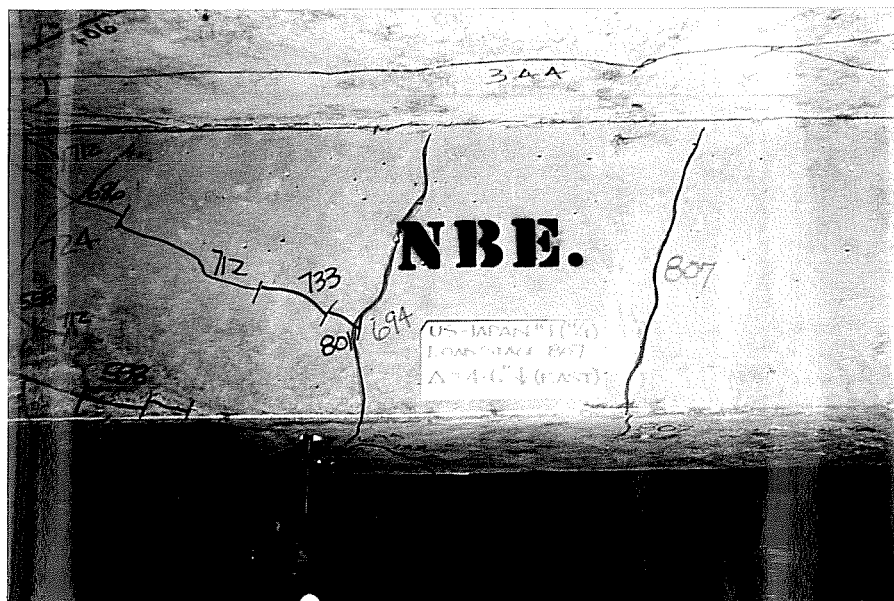
Fig. 4.26 Vertical cracks in north beam

At load stages 686 and 801, two cracks, nearly vertical, appeared on the west face of the south beam approximately 24 in. and 36 in. from the column face. Similar cracks on the other three faces of the transverse beam were also observed at the $2\Delta_1$ and $3.8\Delta_1$ deflection levels (see Fig. 4.26). The cracks extended only partially across the bottom of the beam and likely were the result of a combination of bending and torsion in the transverse beam.

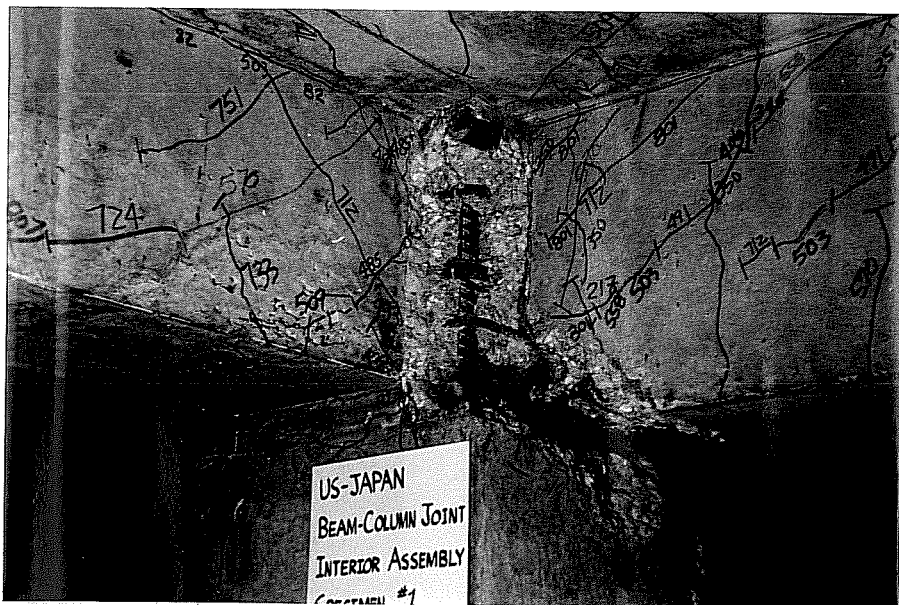
Fig. 4.28 Deterioration of NW joint region

The extent of cracking and damage to the specimen, particularly near the joint, after testing was complete and the loose concrete removed is illustrated in Figs. 4.27 and 4.28. Most of the deterioration in the joint region was concentrated below the slab in the beam hinging zones and the column corners.

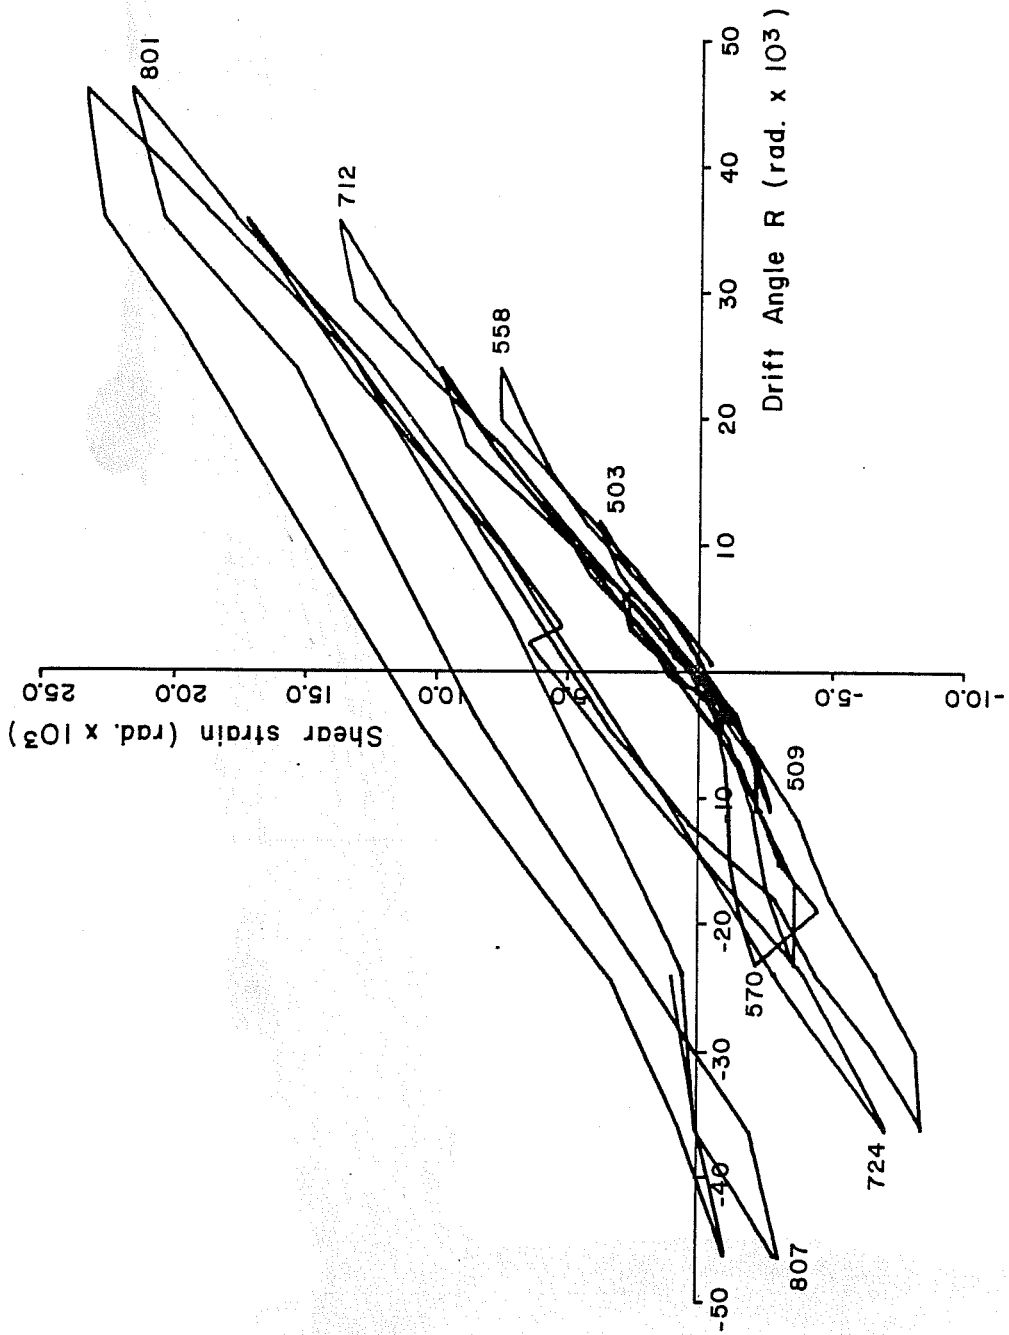
Fig. 4.40 Joint shear strain-drift angle relationships, Tests 3 through 5

4.3.5 Joint Shear Strain. In general, the joint shear strain versus drift-angle relationships were linear for Tests 3 through 5 (see Fig. 4.40). Note, however, that the curves were displaced from the origin, up the y-axis, as the load levels increased in Tests 4 and 5. The steady increase in positive shear strain and decrease in negative shear strain was likely an indication of the deterioration which occurred in the joint due to the cyclic load history and to the high shears transferred to the joint as the resistance of the slab increased. The initial direction of loading and the orientation of the shear strain instrumentation (see Sec. 3.3.5) may have accounted for this difference in positive and negative shear strain magnitude, as well. Another indication of the inelastic behavior of the joint was the ratio of beam deflection due to shear distortion of the joint, which increased from a range of 20 to 25 percent to 30 to 33 percent in the latter stages of testing.

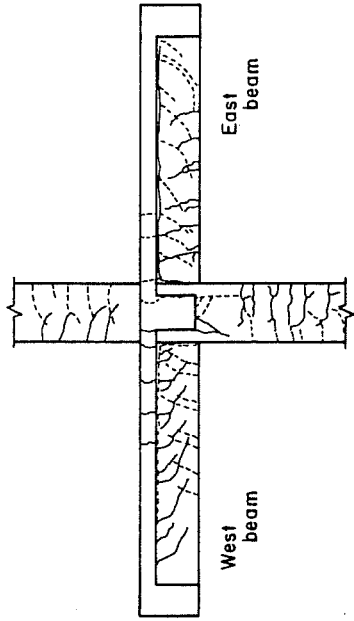
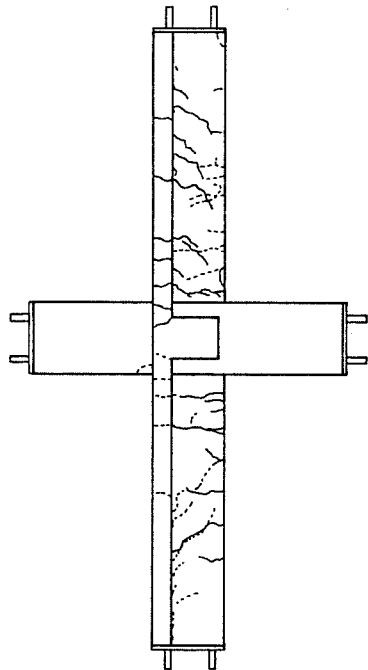
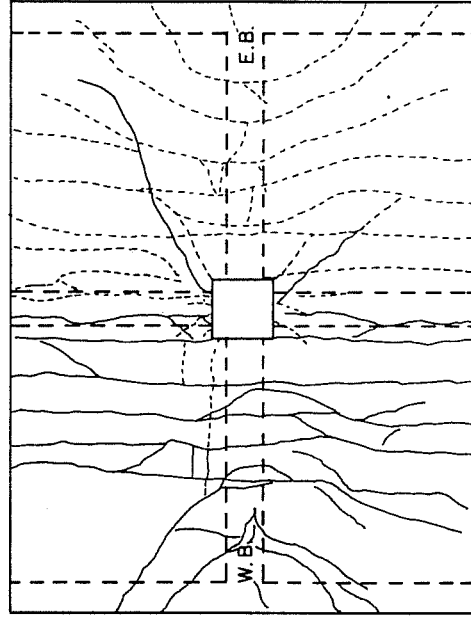
Fig. 5.3 Cracking patterns for half-scale and full-scale joint specimens

The after-test crack patterns of specimen I-2 and the documented crack patterns of USJ-1 at the completion of Test 4 are shown in Fig. 5.3. The maximum level of deformation applied in each test corresponded to a drift angle of approximately 0.025 (1/40), excluding the last load cycle in the half-scale tests. Flexural cracking was extensive in both joint specimens. Several diagonal shear cracks appeared in the longitudinal beams and propagated into the lower portion of the beams, indicating the presence of high beam shears. In the negative (up) loading direction, beam shears were not large enough to initiate diagonal cracks at the bottom of the beams in either specimen. Wide flexural cracks opened in the longitudinal beams near the lower column faces in the half-scale and full-scale joint specimens. No concrete crushing or spalling was observed in specimen I-2; however, after three cycles at the

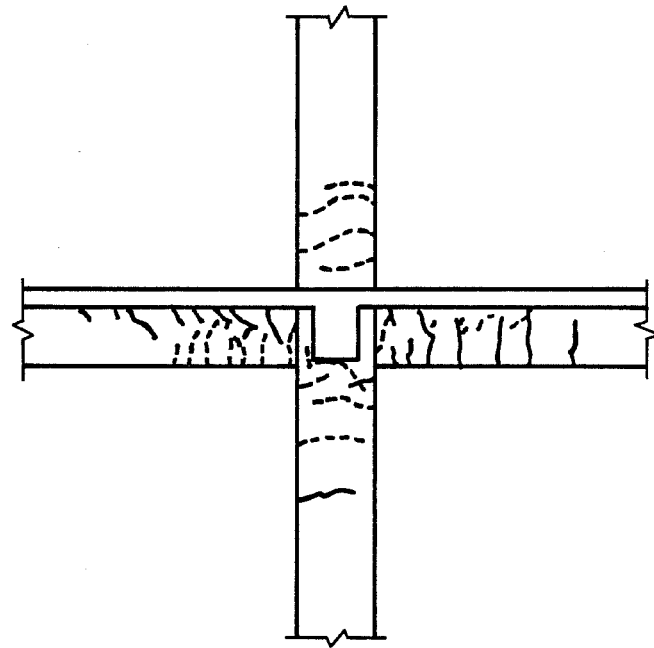
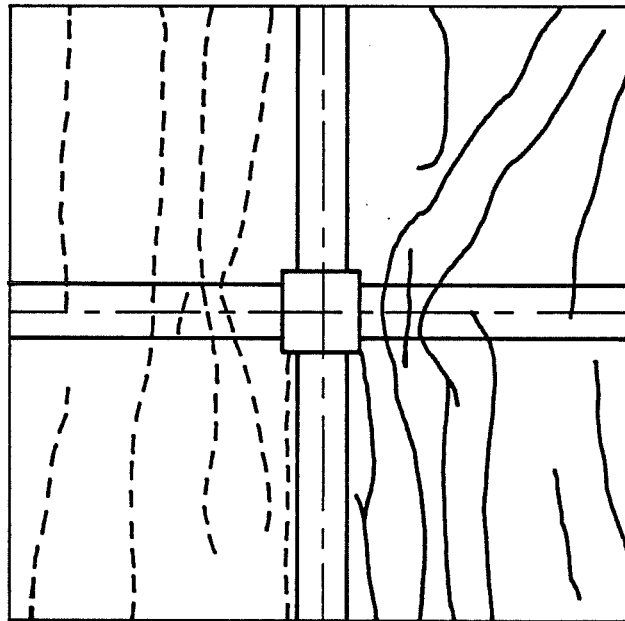
Fig. 5.7 Cracking patterns of the full-scale structure

The interior columns in frames A and C of the full-scale structure were cracked in only one loading direction because of shear-wall deformations which lifted one end of the structure. This uplifting reduced or possibly eliminated the compressive forces due to gravity loads which inhibited flexural cracking in the columns. When the loading direction was reversed, compressive forces were present in the columns and cracking did not occur. In addition, the uplift of the center frame B, which contained the shear wall, was greater relative to frames A and C, and therefore bending moments were introduced into the transverse beams and flexural cracking was observed.

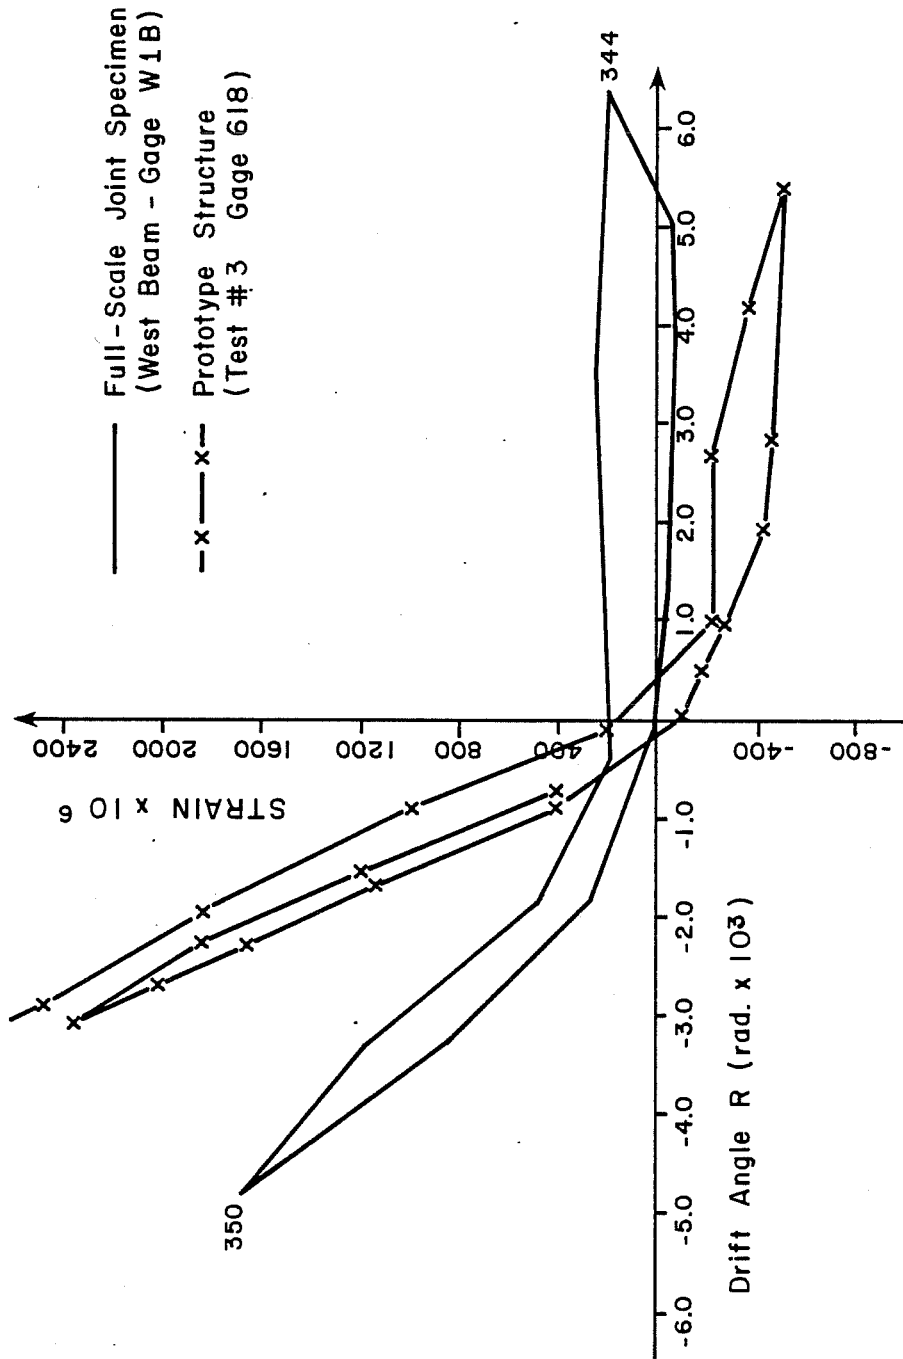
Fig. 5.10 Strain versus drift-angle relationships, bottom beam bars

Figure 5.10 indicates a generally poor correlation for the strains measured in the bottom beam bars of the full-scale structure and the joint specimen. In the negative loading direction, the slope of the strain-drift angle relationship was much steeper for the prototype structure. The bottom beam bars yielded at a drift angle of approximately 0.0027 (1/370) compared to 0.0095 (1/105) for USJ-1. However, at this point, twice as many load cycles had been applied to the interior joint specimen as had been applied to the full-scale structure. Bond deterioration of the bottom beam bars developed in the joint of USJ-1 as a result of the large number of applied load cycles. The unfavorable bond condition of the bottom bars and the reduced stiffness of the component specimen with testing, probably

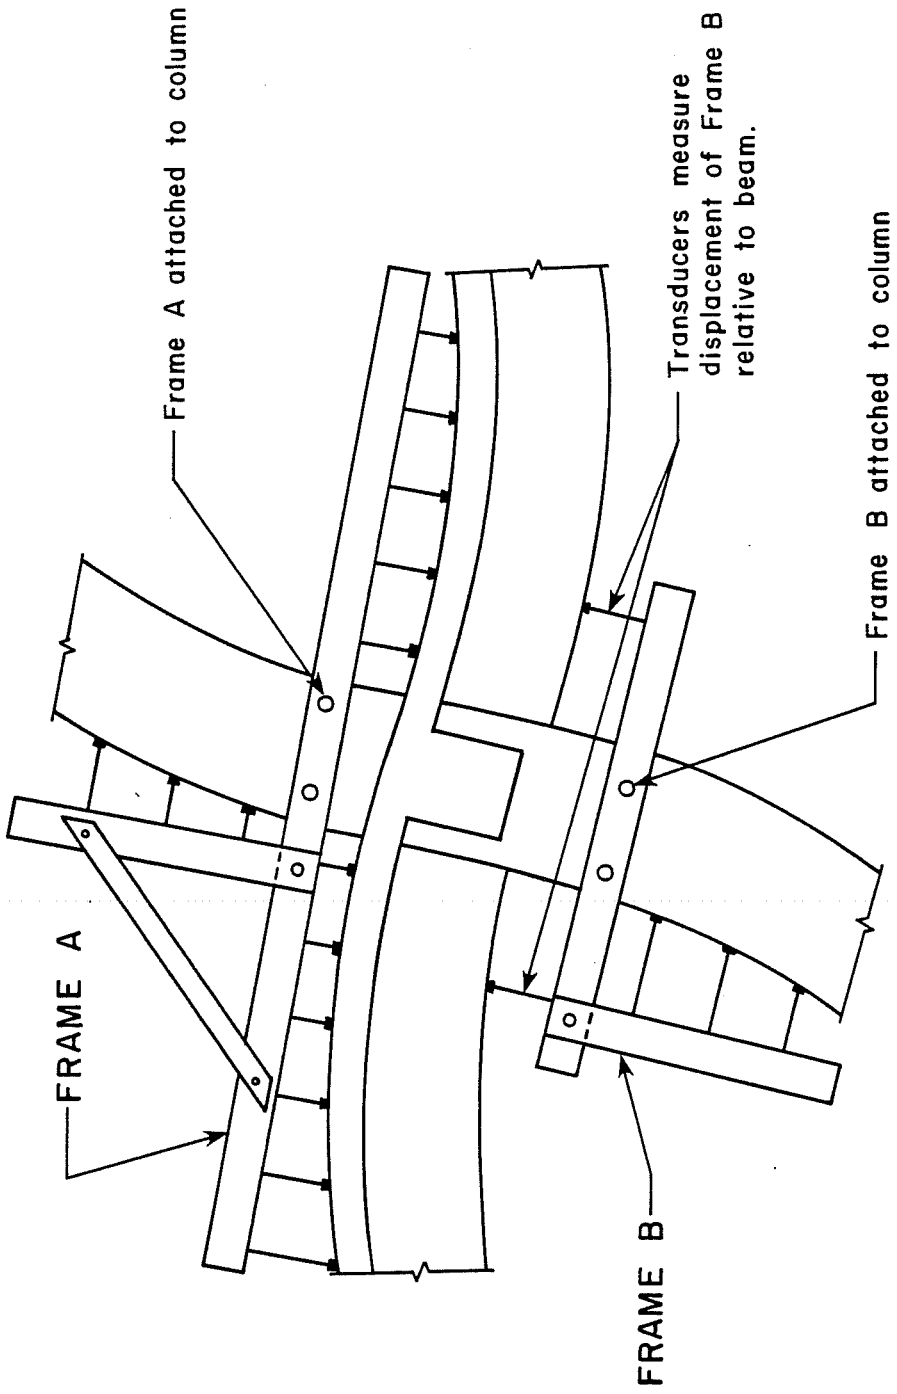
Fig. 5.13 Schematic of suggested instrumentation

Furthermore, it is recommended that a joint located near the top of the structure, say the fifth or sixth level, be fully instrumented, identically to the joint at the second level. Since the lateral drifts along the height of the structure increased nonlinearly, due to the influence of the wall deformations, larger element (beam, column, etc.) deformations were imposed near the roof level. If test measurements; strains, rotations, etc., would have been available from a joint near the roof level, it is quite possible that a much
