**Development of a CFRP System to Provide Continuity in Existing  
Reinforced Concrete Buildings Vulnerable to Progressive Collapse**

**Dissertation**

The University of Texas at Austin

**August 2007**

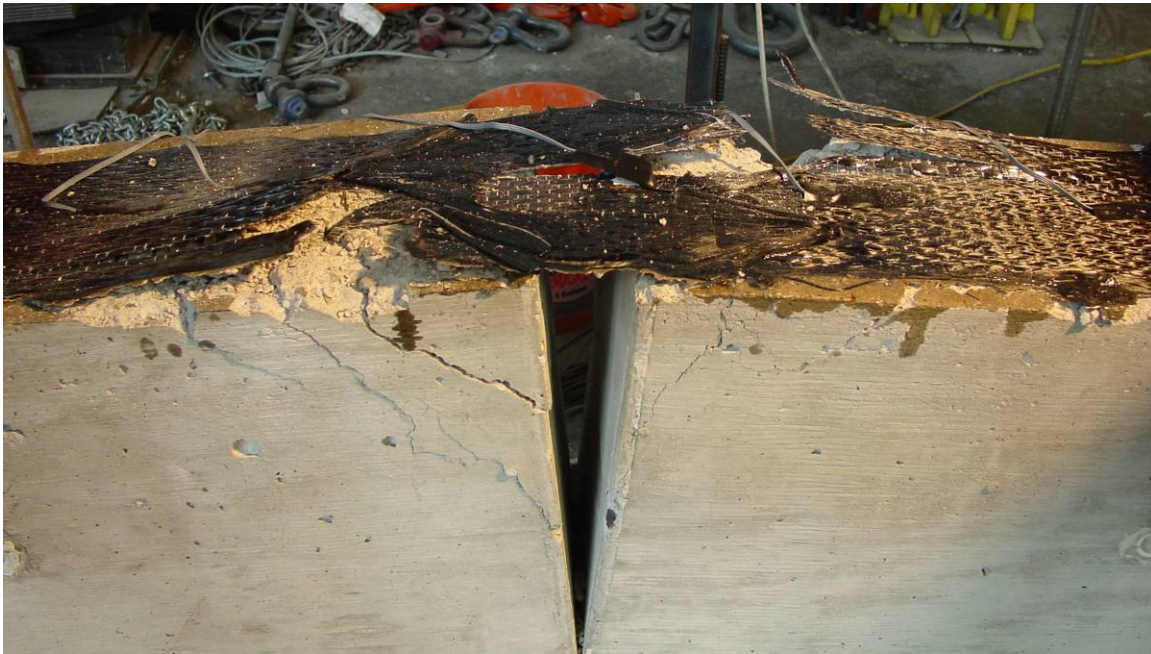
**Figure 4-18** Failure by FRP fracture of retrofit with two anchors per row (00-4s2)

Two ½ in. diameter anchors in each row increased the tension in the CFRP sheet at failure to 79% of ultimate tensile capacity (00-4s2). Although the failure occurred by CFRP fracture, the specimen only reached 25 k of tension in the CFRP sheet. The reduced tension at fracture may be due to the fact that the fracture occurred along half of the CFRP sheet on one side of the block then along the other half on the other side of the block, Figure 4-18. The splitting of the fracture between two blocks could be indicative of a lack of uniform stress distribution across the CFRP sheet, with fracture occurring on one side followed by fracture on the other side. The reduced capacity could also be due to the fact that SCH-41 fabric was used in the anchors rather than SCH-35 in the previous tests (see Section 4.3.2.2).

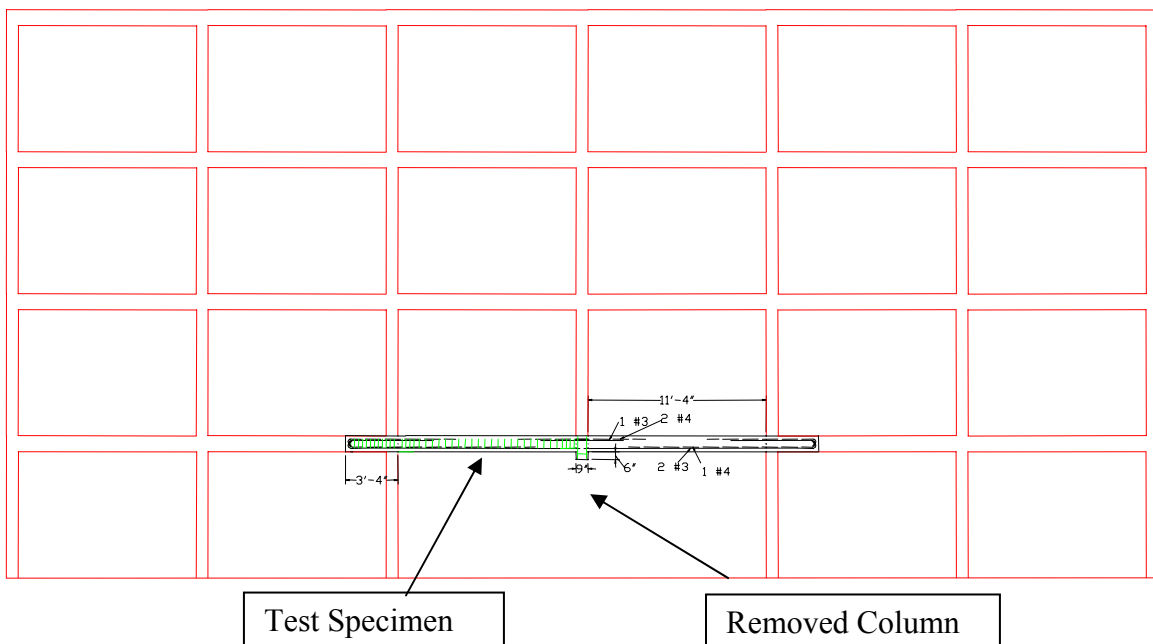
**Figure 5-3** Relationship of test specimen to prototype building

The tests were designed to simulate the behavior of adjacent spans after removal of a non-corner perimeter column. The relationship of test specimen to the full scale structure is shown in Figure 5-3. The 3 ft sections on the ends of the test specimen were designed to simulate the support from the rest of the structure. The support from the structure does not include the effect of the slab or the upper story column. During a blast event the slab may be damaged, or depending on the design may not be connected to the beam in such a way that it can resist vertical loads. The upper story column may not be able to resist tension loads depending on the splicing of the reinforcement. Therefore, the test specimen only considered the resistance of the beam itself.

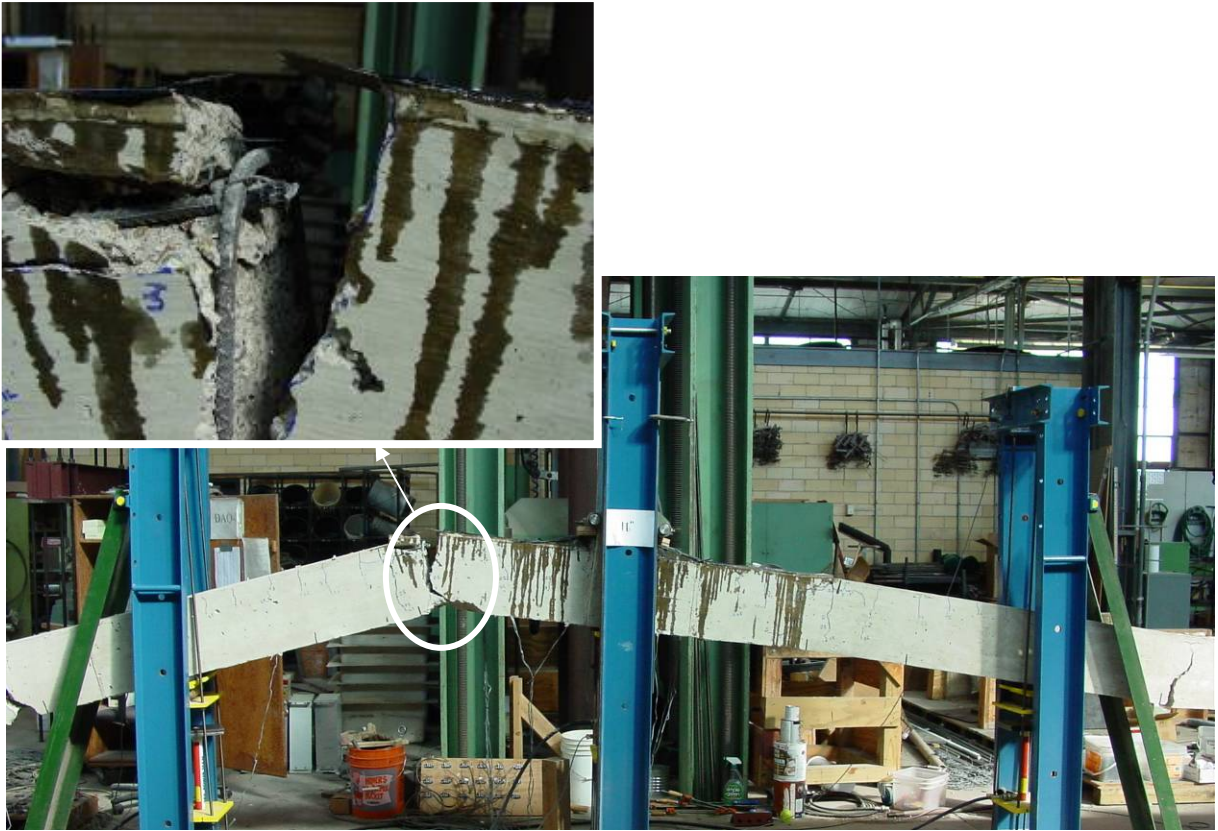
**Figure 5-25** Failure of PM-1 by fracture of rebar

The load then dropped and the beam eventually went into catenary action similar to that of specimen NR-2, but with hinges at the end of the CFRP sheet rather than at the column. The test was stopped at 24 in. of displacement when the vertical load rams became misaligned due to excess rotation of the center column.

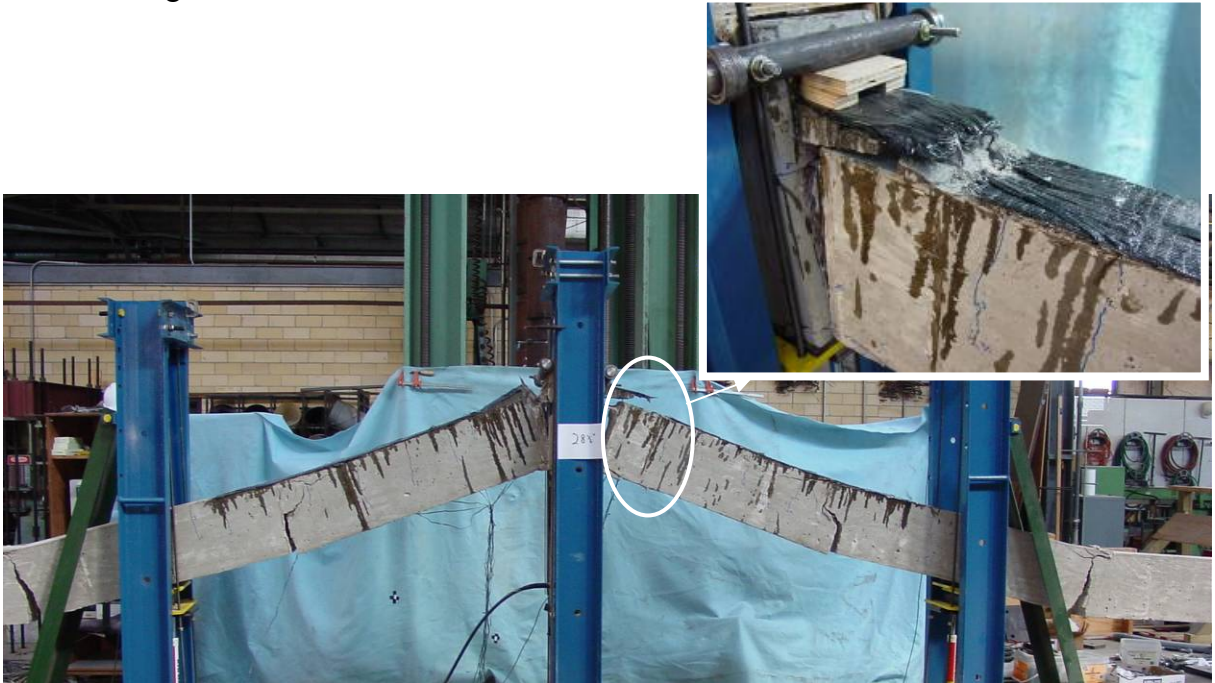
Figure 5-31 Final state of PM-2

of the CFRP was not necessarily premature, but more CFRP was needed in the design to force the hinge to form at the end of the CFRP sheet.

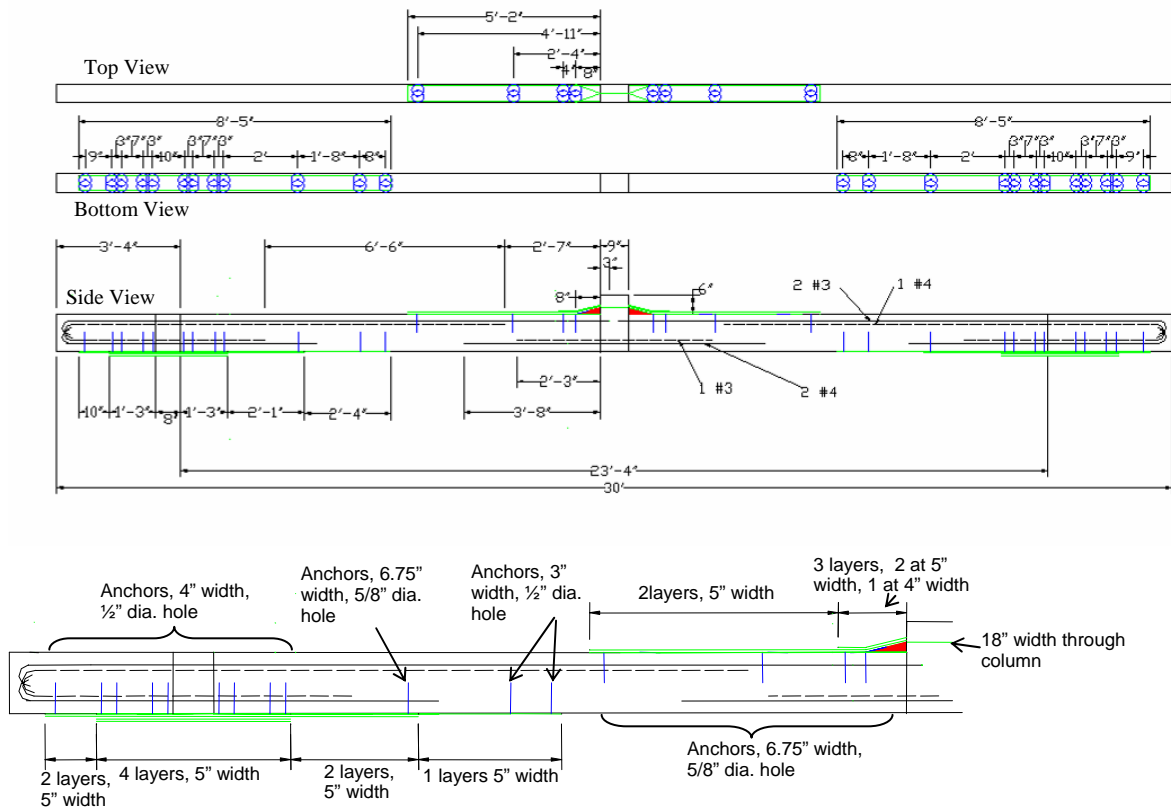
**Figure 5-54** Design of CFRP retrofit for FR-1

The design procedure for the beam is given in Appendix B and the final design is shown in Figure 5-54. The design required numerous layers of CFRP sheets and rows of anchors to nearly double the moment capacity of some sections. The total area of CFRP applied on this beam was 54 ft<sup>2</sup>, or 4.5 times the amount required for NM-2.

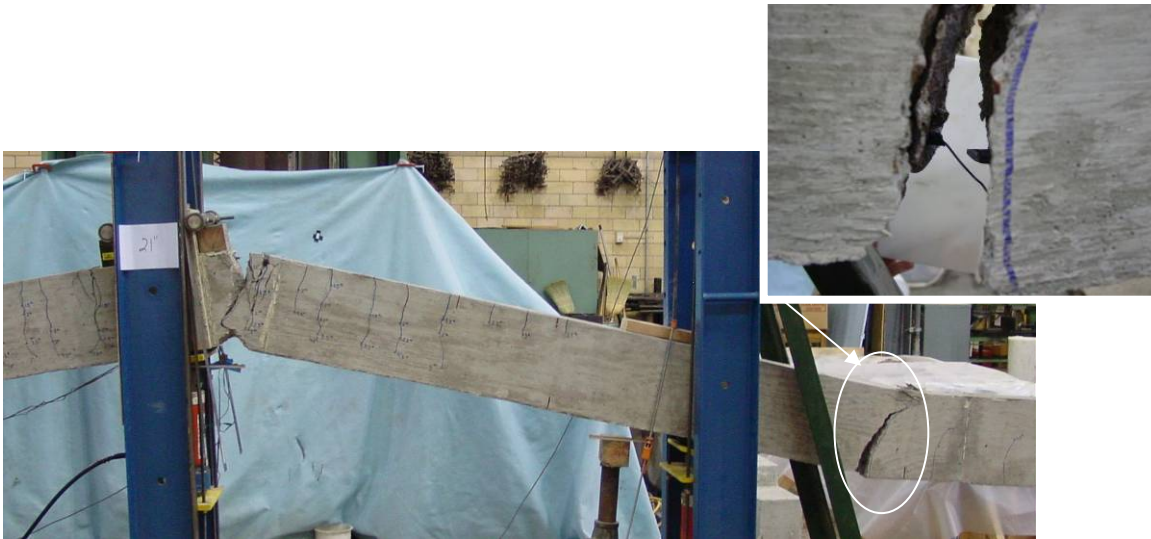
**Figure 5-67** Fracture of negative moment rebar

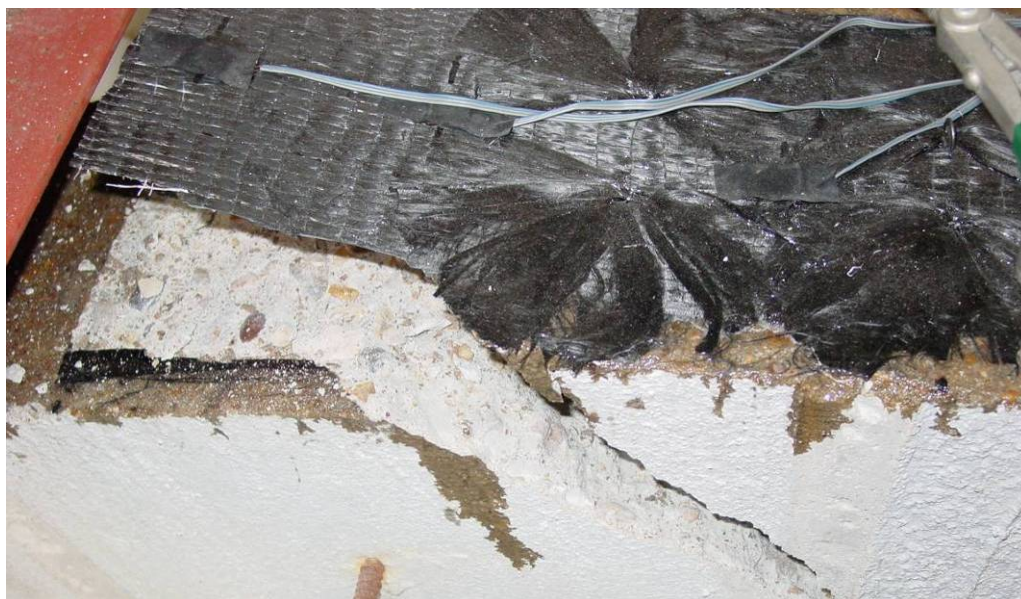
After Testing: Failure by shear in concrete block

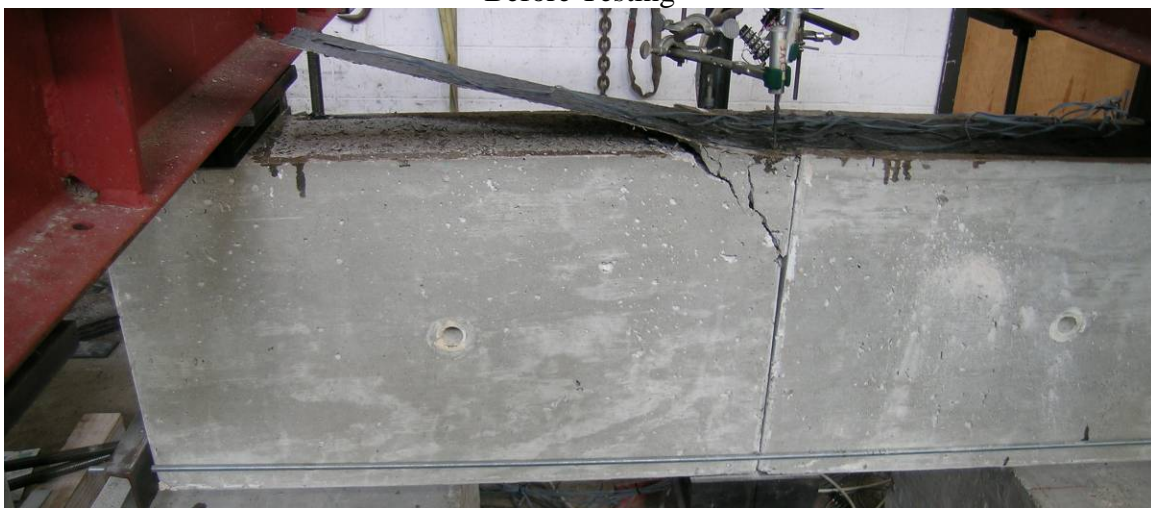
After Testing: Failure by corner crack and debonding

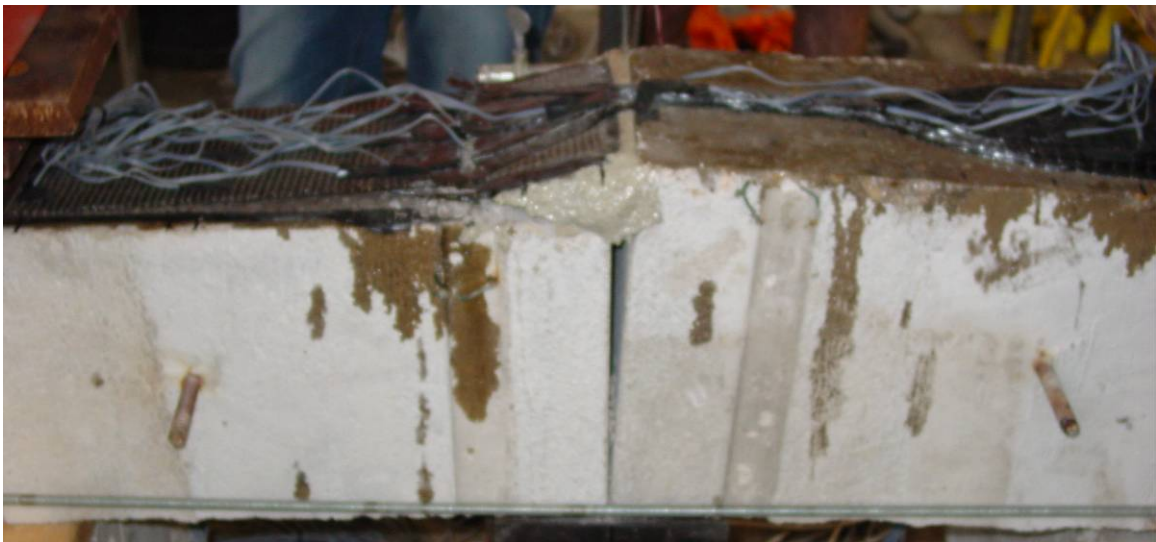
After Testing: Failure by Debonding

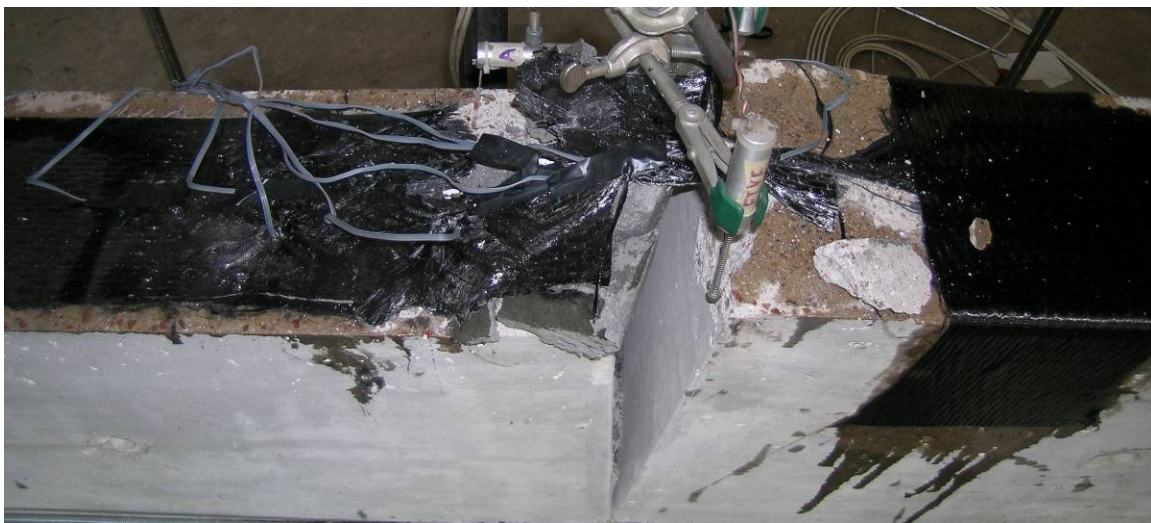
After Testing: Failure by FRP Fracture

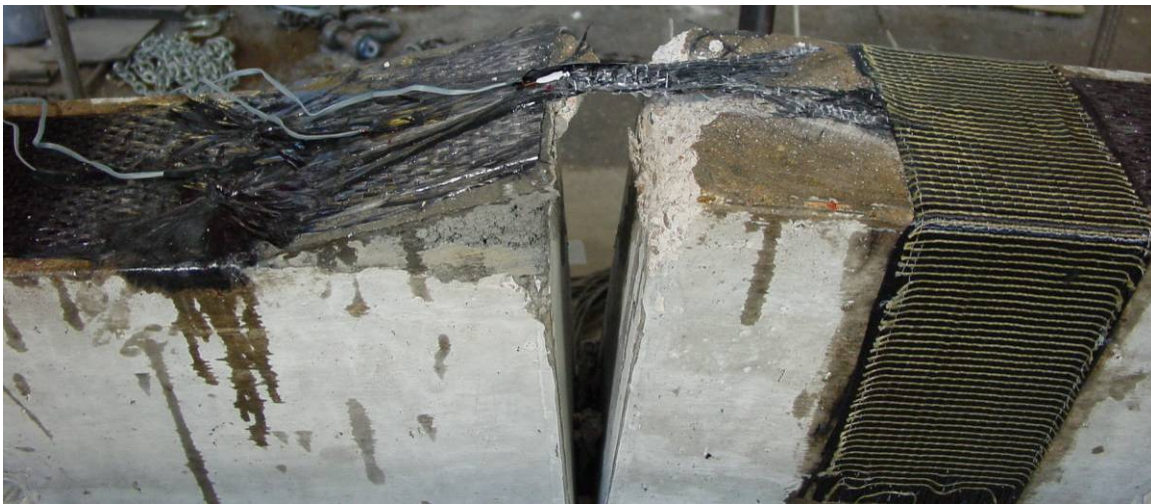
After Testing: Failure by premature fracture in column part

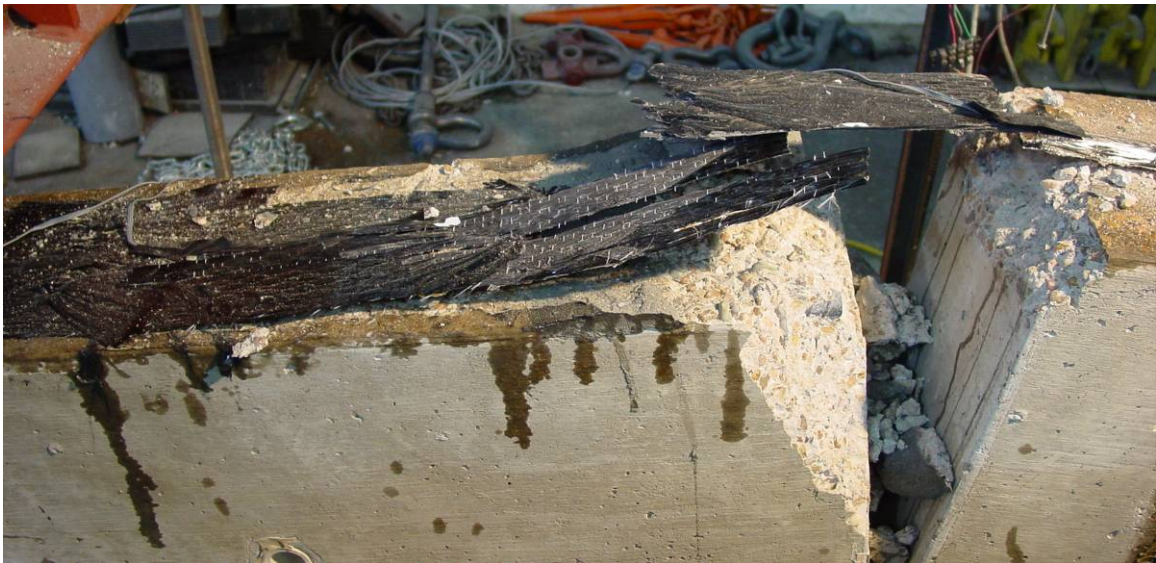
After Testing: Failure by FRP fracture

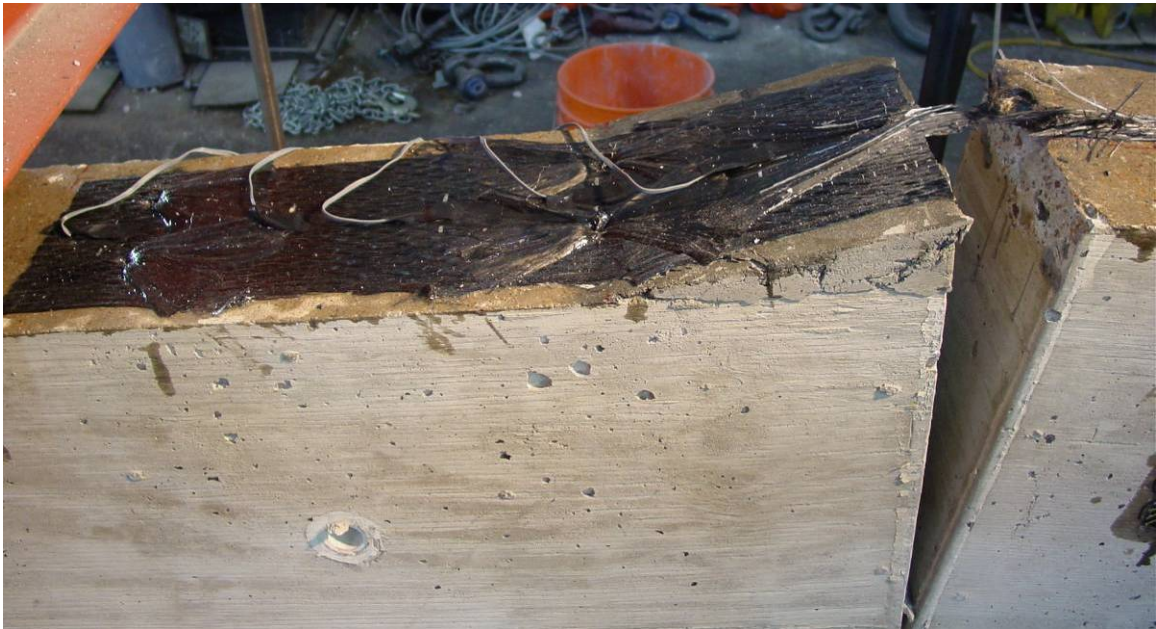
After Testing: Failure FRP fracture in column bundle, insufficient saturation

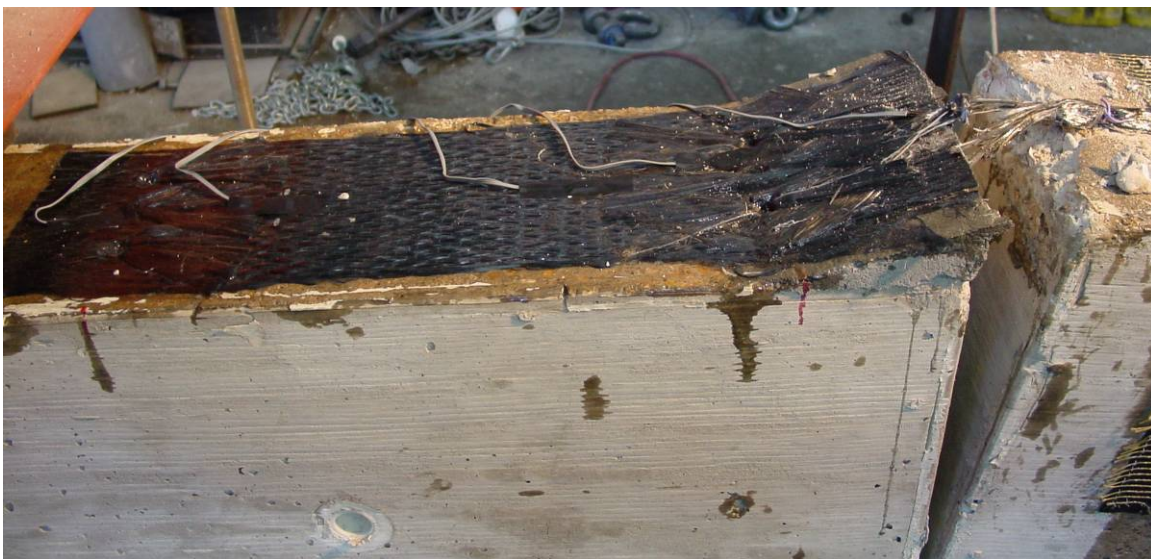
After Testing: Failure by FRP fracture

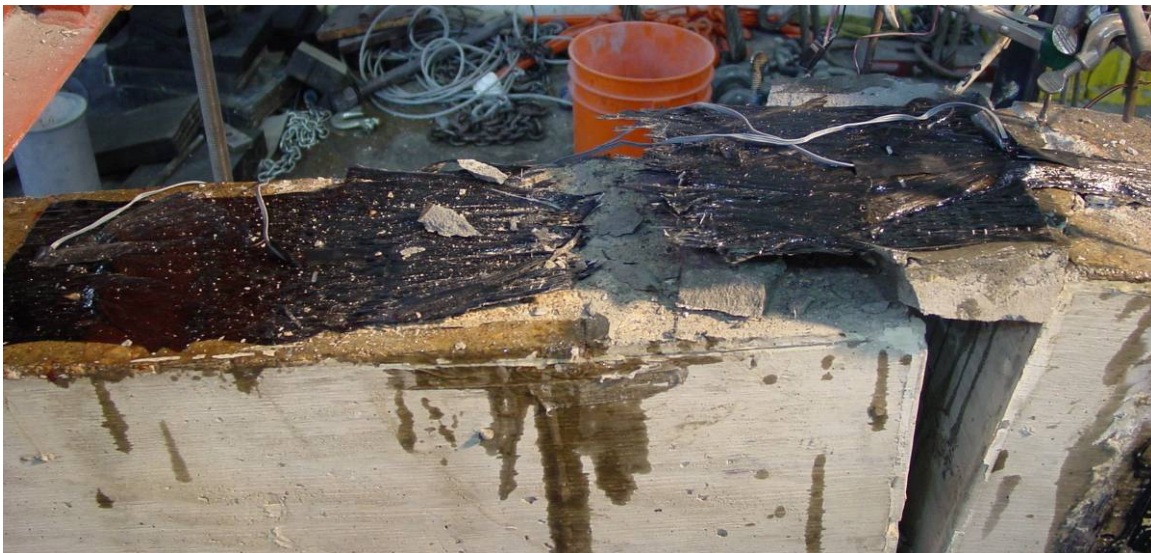
After Testing: Failure by FRP fracture

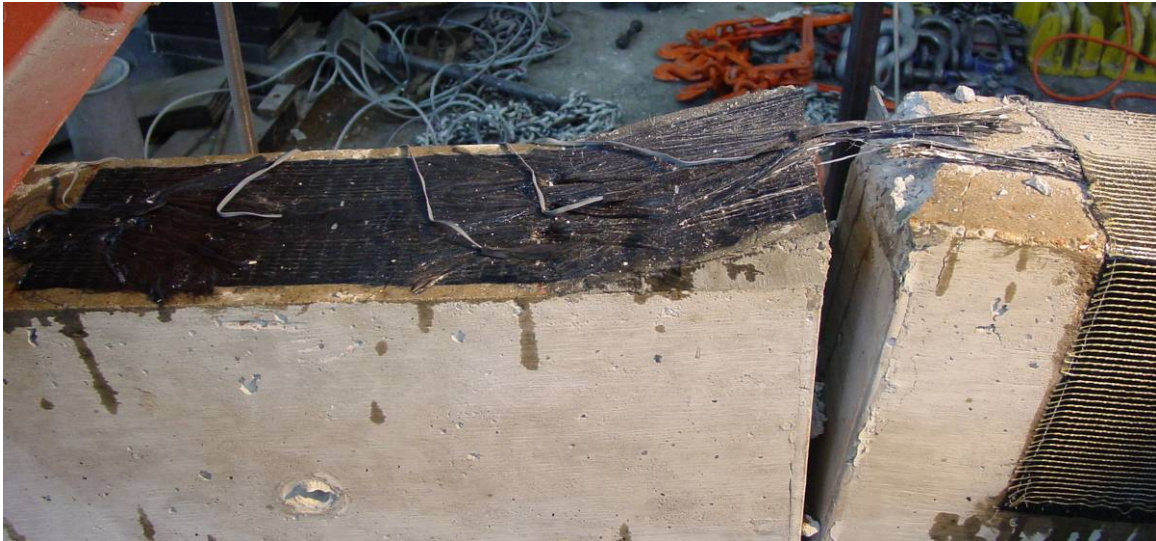
After Testing: Failure by FRP fracture

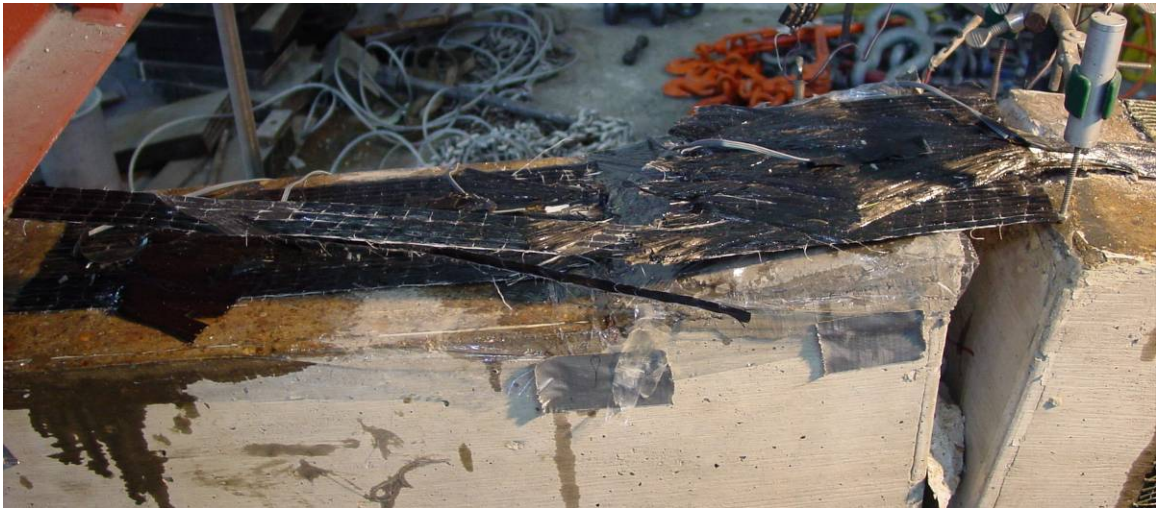
After Testing: Failure by FRP fracture

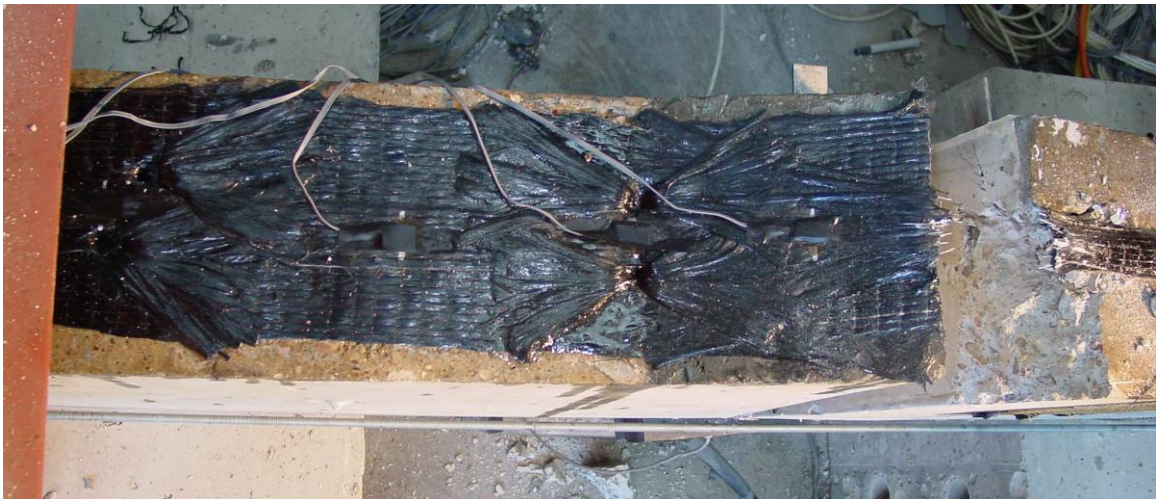
After Testing: Failure by FRP fracture

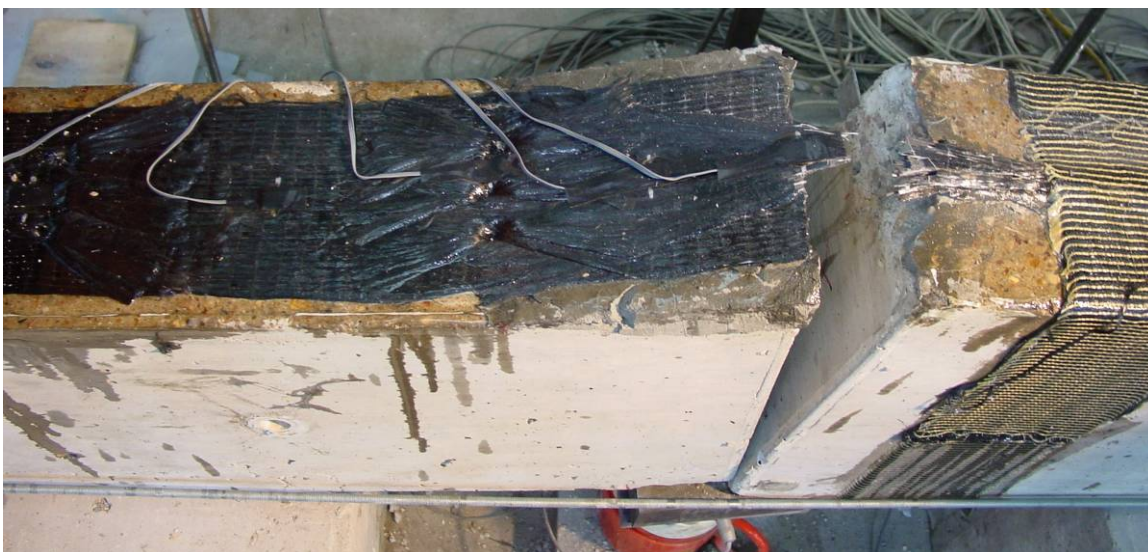
After Testing: Failure by FRP fracture

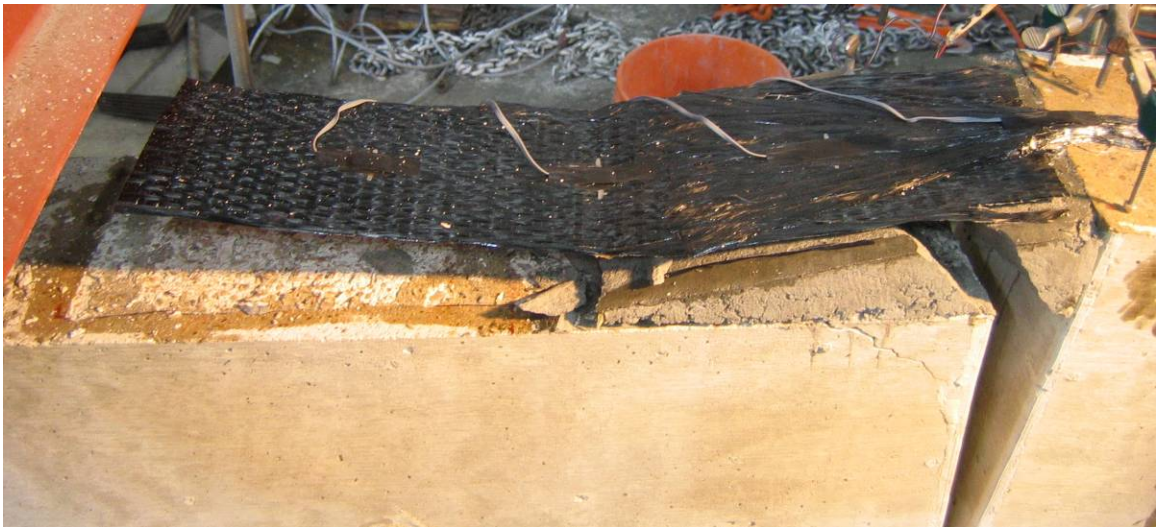
After Testing: Failure by debonding

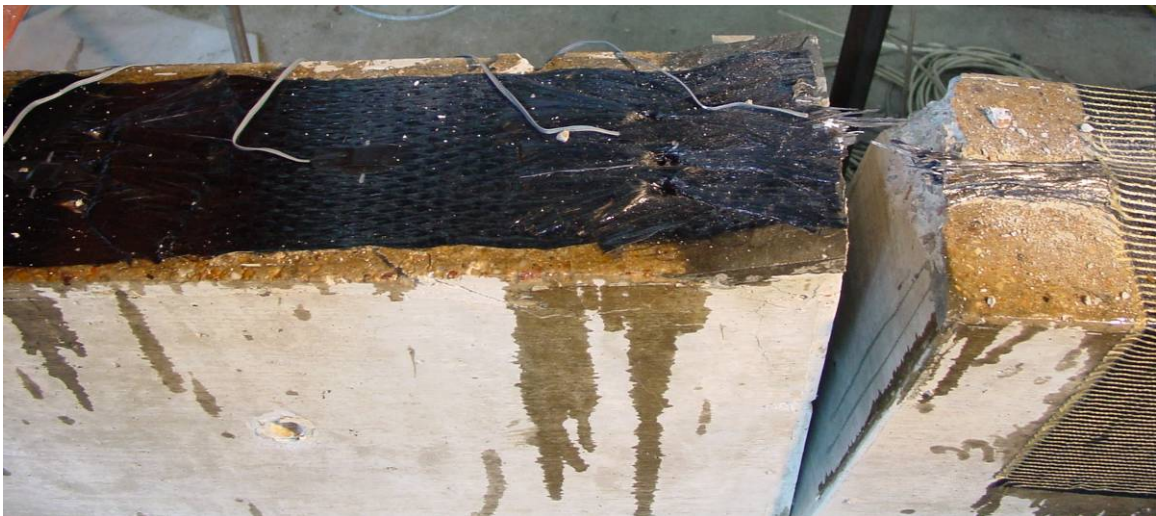
After Testing: Failure by FRP fracture

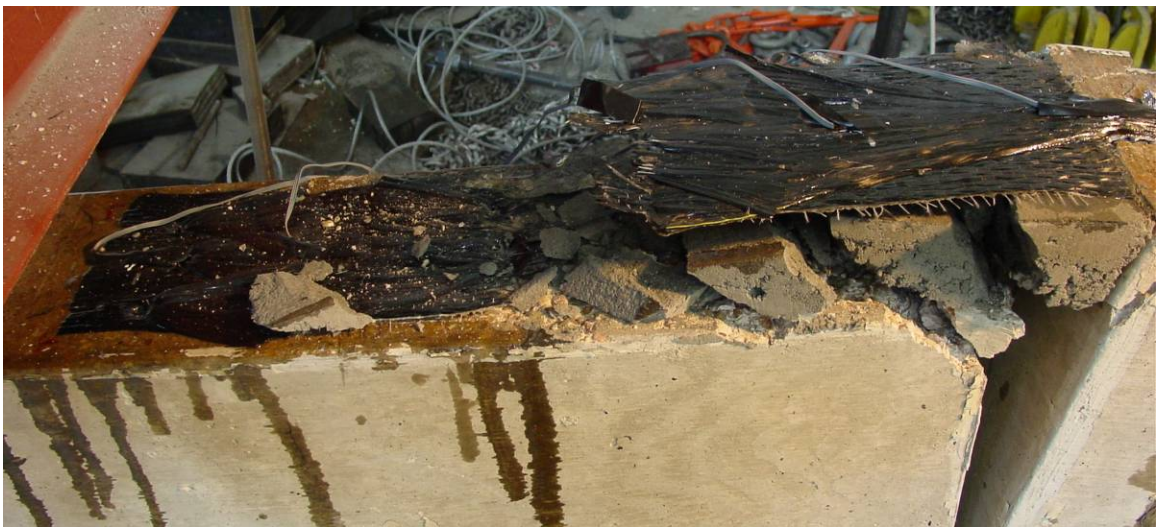
After Testing: Failure by FRP fracture

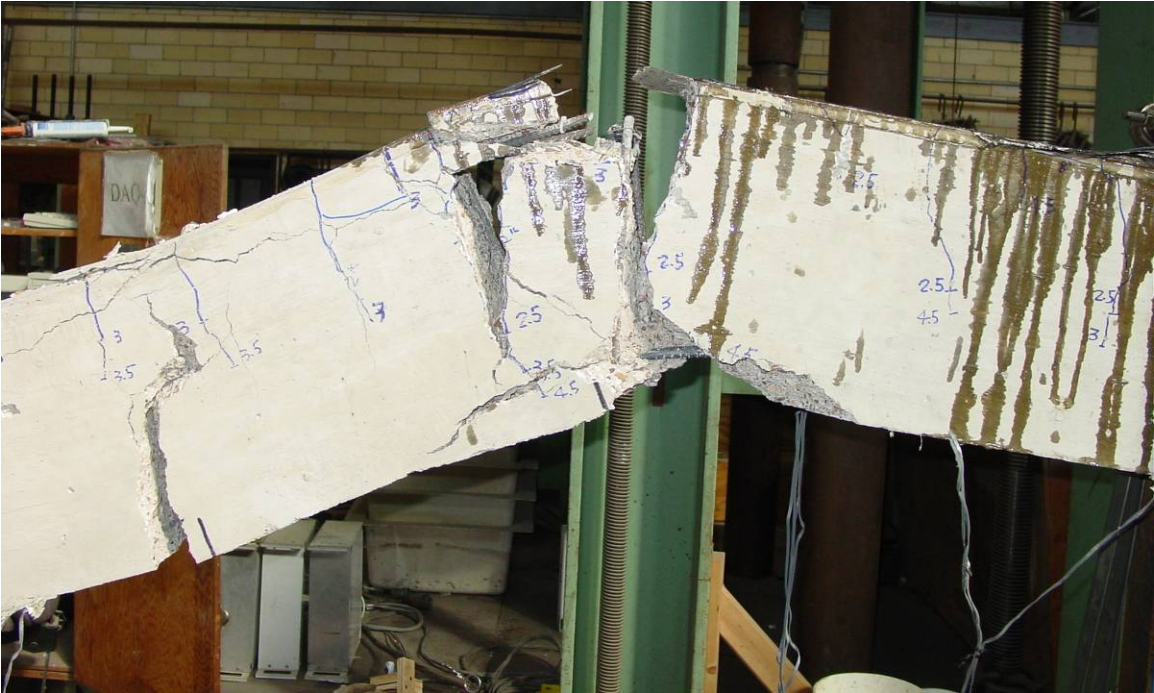
Rebar fracture
