**Passive, Wireless Corrosion Sensors for  
Reinforced Concrete Structures**

**Thesis**

The University of Texas at Austin

**August 2007**

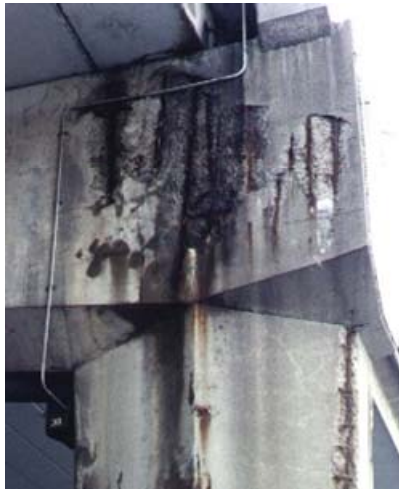
***Figure 1-1 Damage to a Reinforced Concrete Structure  
([www.corrosion-club.com](http://www.corrosion-club.com))***

Corrosion of steel in concrete, shown in Figure 1-1, is a costly problem. The Transportation Research Board (1991) has estimated that deicing and sea salts have caused \$150 billion worth of corrosion damage to interstate highway bridges. In addition, the Transportation Research Board (1991) has calculated the annual cost of corrosion damage to American bridges and car parks to be as much as \$450 million. Raising the large amount of capital required to build and maintain infrastructure requires long-range planning. However, planning for the replacement of a structure cannot begin until the structure is known to be damaged. Conventional techniques for assessing the health of a reinforced concrete structure — half-cell potentials, chloride concentration of concrete, concrete resistivity, electrochemical impedance spectroscopy, and linear polarization — involve considerable uncertainty and expense. The result is that, in the case of many structures, outward indications of structural damage, such as pitting and spalling, are the first indications that corrosion has initiated. By that time, the structure may be near failure and require immediate replacement. Time spent planning and raising capital to replace the structure can have high economic costs, especially if the structure is a key component of infrastructure. What is needed to avoid this economic loss is a technique for determining the initiation of corrosion that is both economical and reliable.

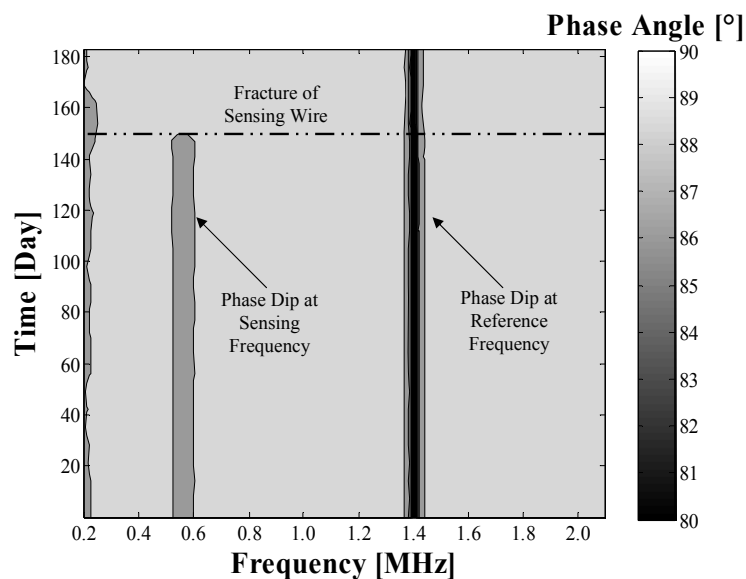
*Figure 2-29 Response of Coplanar Sensor as Contour Plot*

Figure 2-29 illustrates the response of a coplanar sensor as a contour plot. As in the case of the concentric sensor, phase dips of constant amplitude exist at both the sensing and reference frequencies initially. At approximately day 150, the sensing phase dip disappears, indicating that the sensing wire has fractured. Notably, however, there is no discernible change in the amplitude of the phase dip at the reference frequency or in the reference frequency itself. Again, this independence is due to a lack of mutual inductance between the sensing and reference inductors.

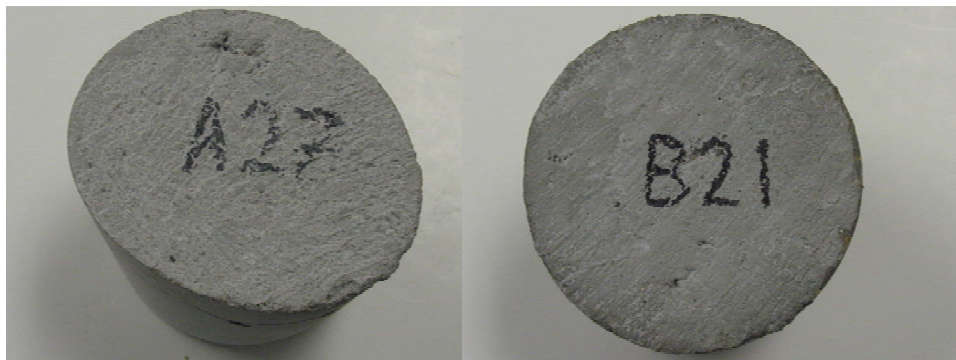
(a) Coplanar Sensor A27

(b) Concentric Sensor B21

Though a complete description of this experiment appears in Dickerson (2005), a summary of its design is given below. Twenty-two sensors — twelve concentric (B19-B30) and ten coplanar (A21-A30) — were fabricated using 26-gage (0.0159-in. diameter) steel sensing wire. Subsequent chemical analysis of the wire indicated that it was alloy type AISI-ASE 1005. The chemical composition of the 1005 wire is given in Section 4.2. Each sensor was cast in a 4-in. diameter cylindrical mold with a height of 3 in. The dimensions of the coplanar sensors required some deformation of the cylindrical mold for the sensor to fit inside. The effect on the shape of the prism is shown in Figure 3-1, where a prism containing a coplanar sensor is compared with a prism containing a

concentric sensor. Despite this deformation, the dimensions of the prisms afforded 1 in. concrete cover over the sensing wire in all cases.

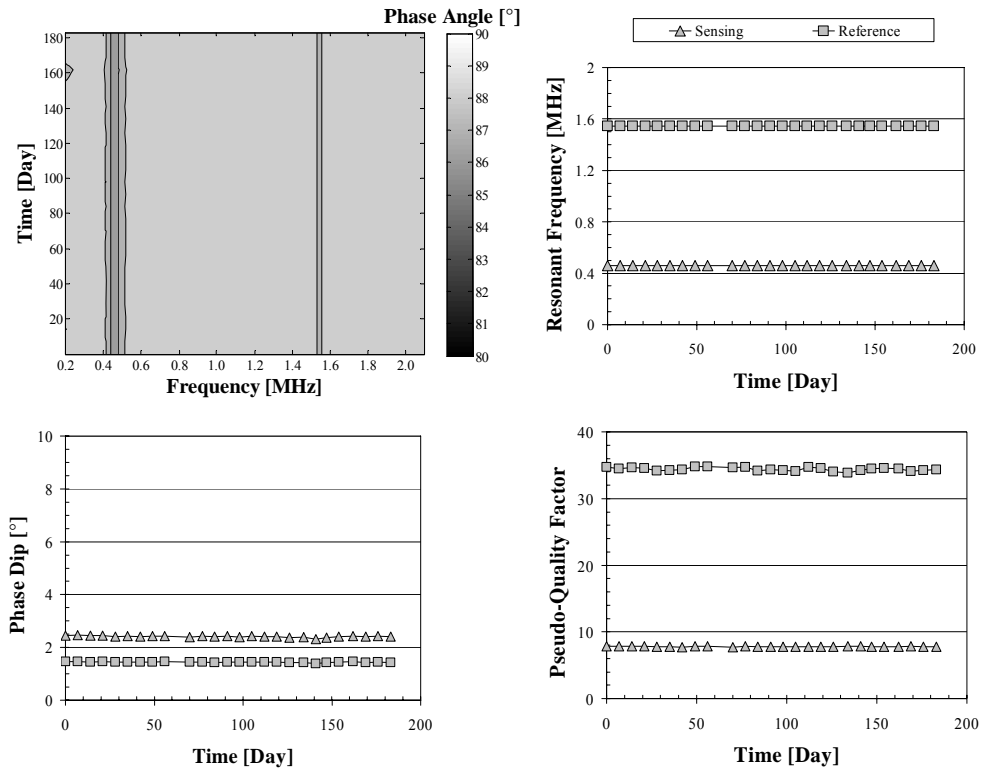
**Figure 3-4 Response of Sensor B22**

Figure 3-4 shows that the response of sensor B22 remained constant throughout the testing period. The mean value of the sensing frequency was 0.46 MHz, while that of the reference frequency was 1.54 MHz, both with coefficients of variation less than 0.05%. The mean value of the sensing phase dip was  $2.4^\circ$  with a coefficient of variation of 1.3%, and the mean value of the reference phase dip was  $1.4^\circ$  with a coefficient of variation of 1.2%. Finally, the pseudo-quality factors of the sensing and reference circuits, respectively, were 7.8 and 34.4. Both factors had coefficients of variation less than 1%. All of these trends indicate that the state of the sensor did not change during the testing period, implying an intact sensing wire.

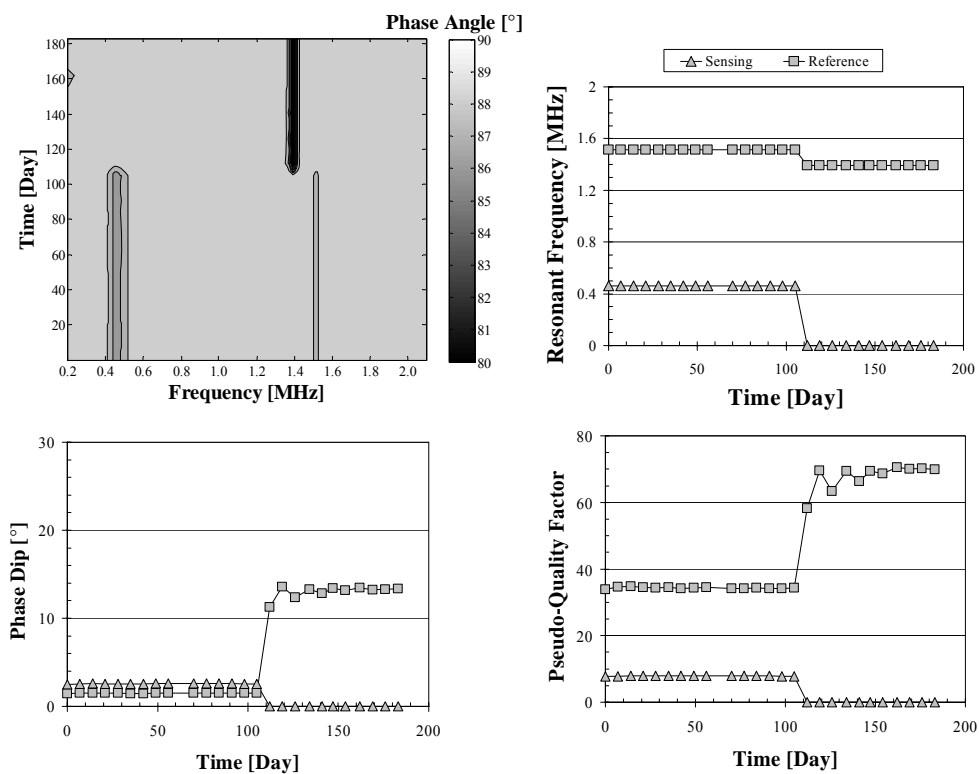
**Figure 3-5 Response of Sensor B27**

pseudo-quality factor was inferred to be zero for the sensing circuit. This condition is identical to the sensing circuit being an open circuit, having an infinite resistance. All of these indicated that the sensing wire fractured during the environmental cycle ending on day 105.

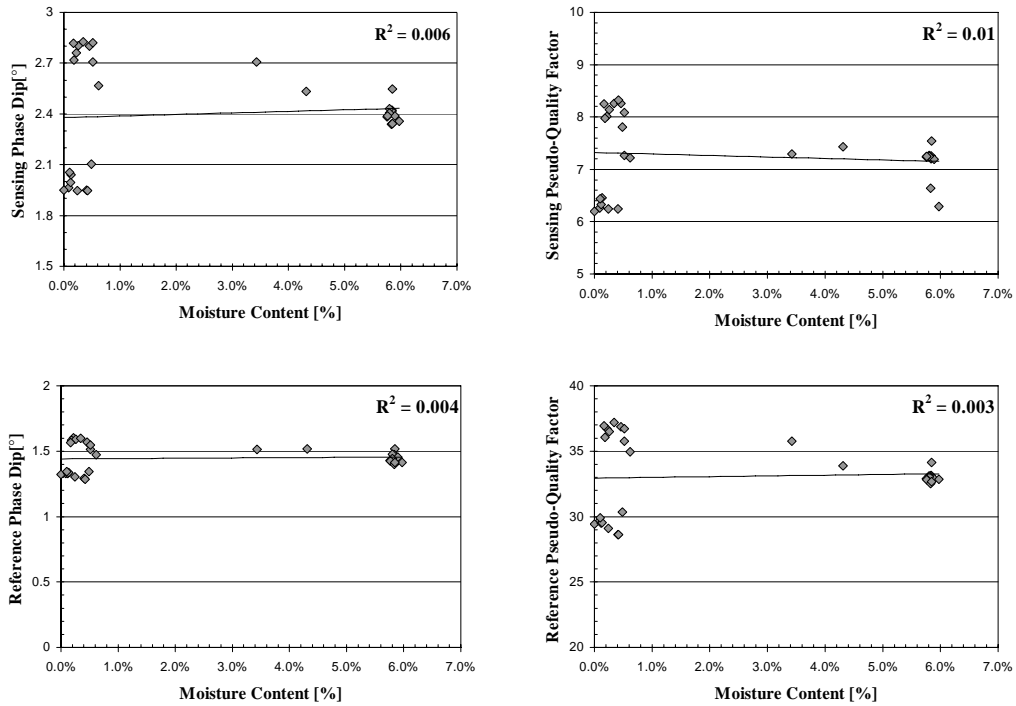
**Figure 3-9 Lack of Correlation between Moisture Content of Concrete and Phase Dip and Pseudo-Quality Factor**

content was calculated with respect to the oven-dry weight. Figure 3-9 shows that, just as with B19, there was no linear correlation between moisture content of the concrete and the phase dip and pseudo-quality factor at either the sensing or reference frequencies. A lack of correlation holds for numerous other curves that were fitted to the data.

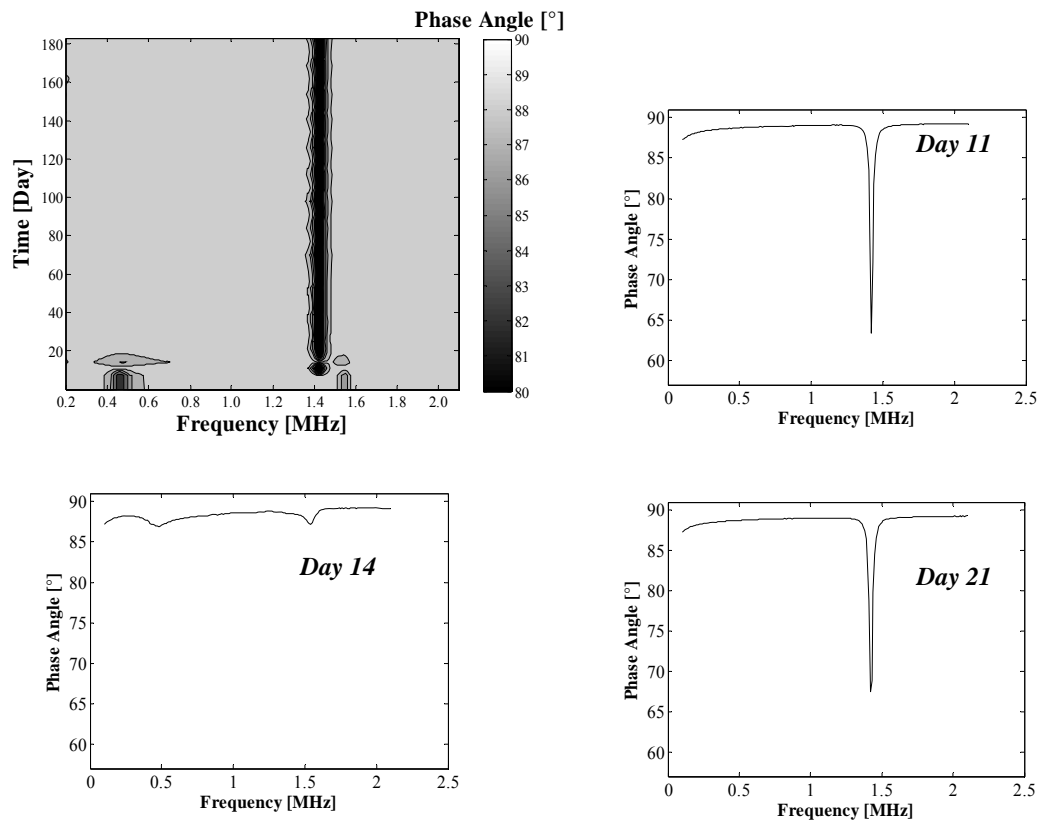
**Figure 3-11 Reversal of Sensor B23 Response**

As was noted by Dickerson (2005), the only sensor to have its sensing phase dip reappear after the phase dip had disappeared was sensor B23. Otherwise, B23 behaved similarly to B24 because both were subjected to combined moisture and thermal cycles. Figure 3-11 presents measured response of B23, identified as reversal of response. From the contour plot, the sensing phase dip disappeared on day 11, reappeared on day 14, and then disappeared permanently thereafter. The sensing wires seems to have fractured due to differential thermal expansion during the oven cycle, only for the two parts of the fractured wire to come in contact during the freezer cycle, briefly completing the circuit. Fractures due to differential thermal expansion will be discussed thoroughly in the Section 3.4, but what is of interest here is that reversal in response took place at all. However, because B23 was the only instance of reversal and its reversal only lasted one cycle, its behavior does not diminish the reliability of the sensors in general.

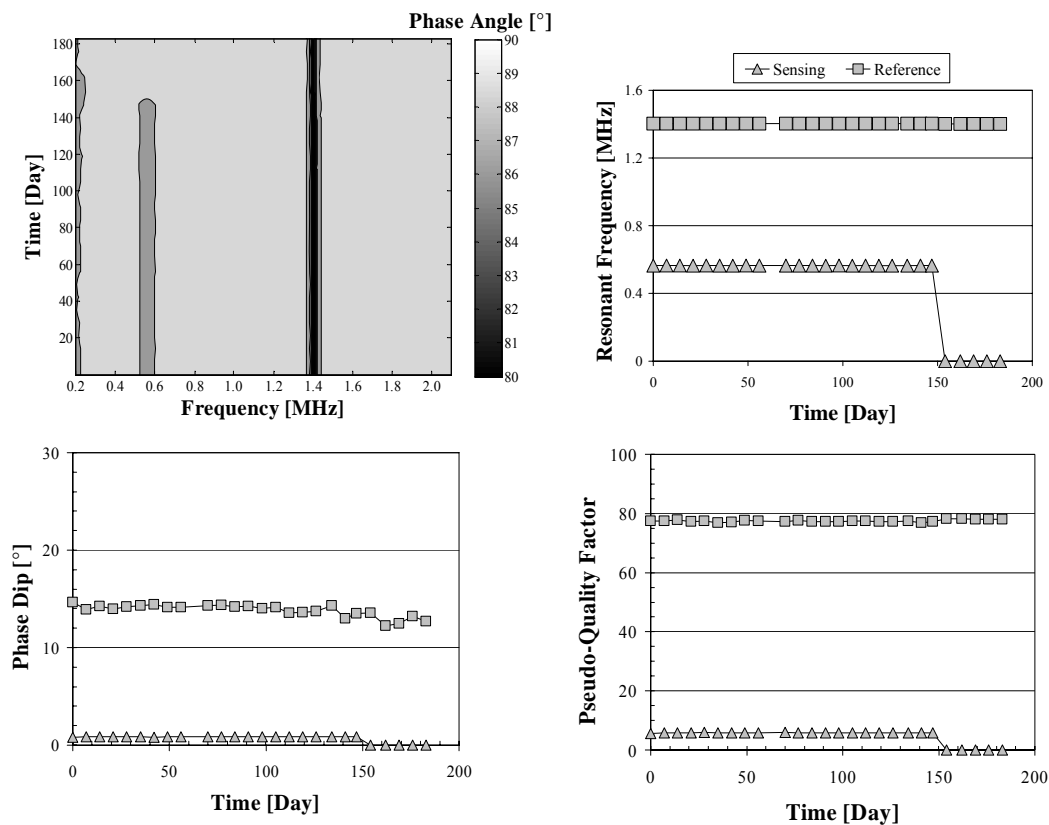
**Figure 3-12** Response of A27

The smaller sensing phase dip of the coplanar sensors is a consequence of the geometry of the sensor itself. In Chapter 2, it was discussed that the sensing and reference circuits were placed beside one another in order to minimize their mutual inductance. Minimal mutual inductance would allow the circuits to respond independently. That is, whether or not the sensing circuit is intact, the reference circuit would have a more or less constant response. As can be seen in Figure 3-12, the design was successful in that respect. Fracture of the sensing wire had minimal effect on the response of the reference circuit, much in contrast to the behavior of the concentric sensors.

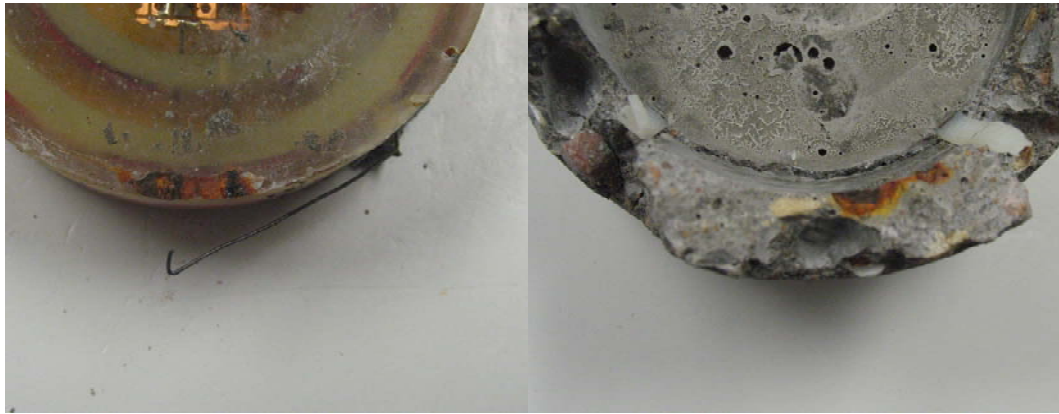
***Figure 3-14 Autopsy of Prism Containing B27***

Photographs of sensor B27 after it was exhumed from the prism and the surrounding concrete are shown in Figure 3-14. As is evident in the photograph, the wire was highly corroded at the point where it entered the epoxy. This corrosion fractured the sensing wire, a state again consistent with the measured response of the sensor. In fact, the corrosion was extensive enough to stain the concrete adjacent to this entry point.

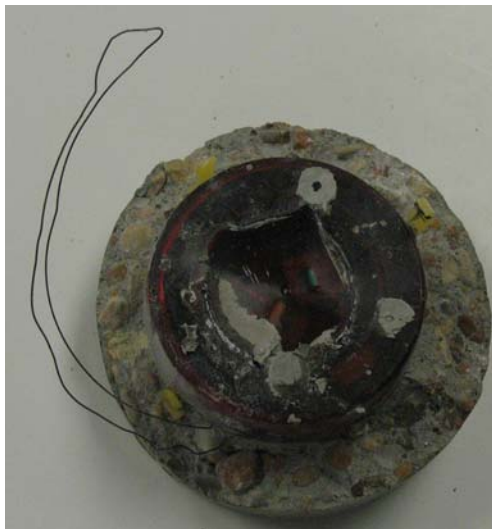
***Figure 3-15 Discolorization of Sensor B19***

Examination of the sensing wire of B19 confirmed that it was intact, at the conclusion of testing, as the response of the sensor indicated. No evidence of corrosion found on the wire or on the concrete in which the wire was embedded. There was, however, discolorization of the epoxy housing that occurred during testing, shown in Figure 3-15. This discolorization was due to the epoxy being placed in the oven at 230 °F. At such high temperatures, the marine epoxy tended to become discolored, though its structure remained intact.

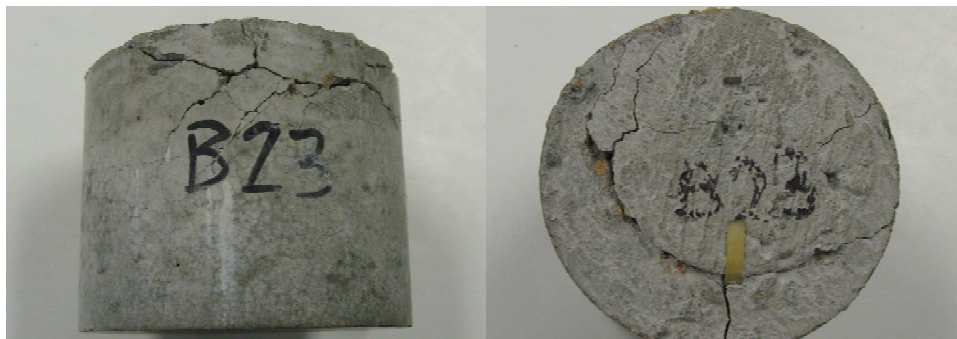
***Figure 3-17 Cracks due to Differential Thermal Expansion***

It was noted in Section 3.3 that the sensing wire of B23 fractured earlier than would have been expected had corrosion been the cause. Instead, the early fracture was due to differential thermal expansion between the epoxy and steel and concrete. That is, the epoxy had a much greater coefficient of thermal expansion than both the concrete and steel. Consequently, the first time the prism was placed in the oven, large cracks developed, and the steel wire, which spanned one of the cracks, fractured. Figure 3-17 shows the large-width cracks that developed in the prisms due to the thermal cycles.

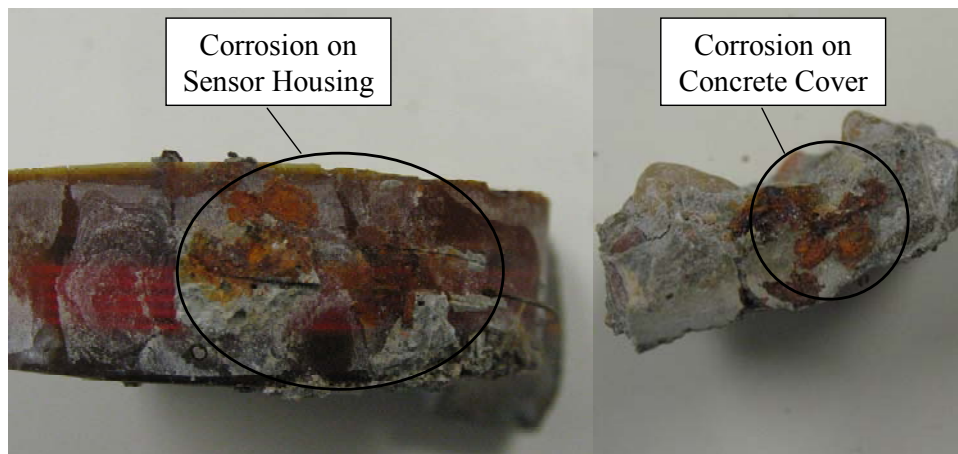
*Figure 3-18 Corrosion Products from Sensing Wire of B23*

Despite early fracture of the wire, the prism continued to undergo environmental cycles and interrogations in order to determine whether the sensing phase dip would reappear due to the sensing circuit being completed by moisture or some other means. As discussed in Section 3.3, the phase dip did briefly reappear. Because the prism continued to undergo testing, it was not possible to confirm the conjecture that the sensing wire was fractured due to differential thermal expansion. By the time of autopsy, there was a significant amount of corrosion on the sensing wire adjacent to where the cracks in the prism had formed and where the sensing wire enters the epoxy. This corrosion presumably took place in the weeks of testing, following the initial fracture of the sensing wire. Figure 3-18 shows corrosion on the sensor housing and concrete cover adjacent to the sensing wire.

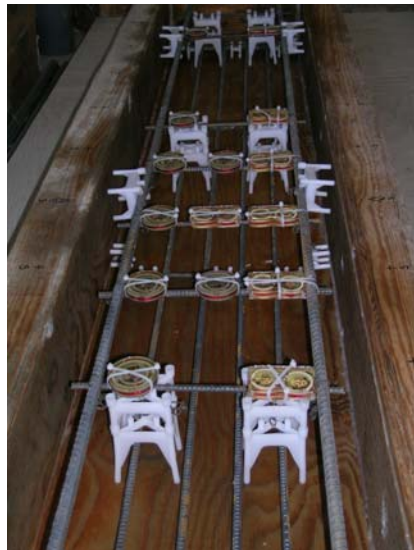
**Figure 4-4 Layout of Sensors and Steel Reinforcement**

The top and bottom reinforcement were electrically isolated from one another — no steel connected the two layers — in order to prevent the development of macrocell corrosion. To minimize the time to initiation of corrosion, both the sensors and top reinforcement had a nominal clear cover of 1 in. A photograph of the sensor and reinforcement is provided in Figure 4-4.

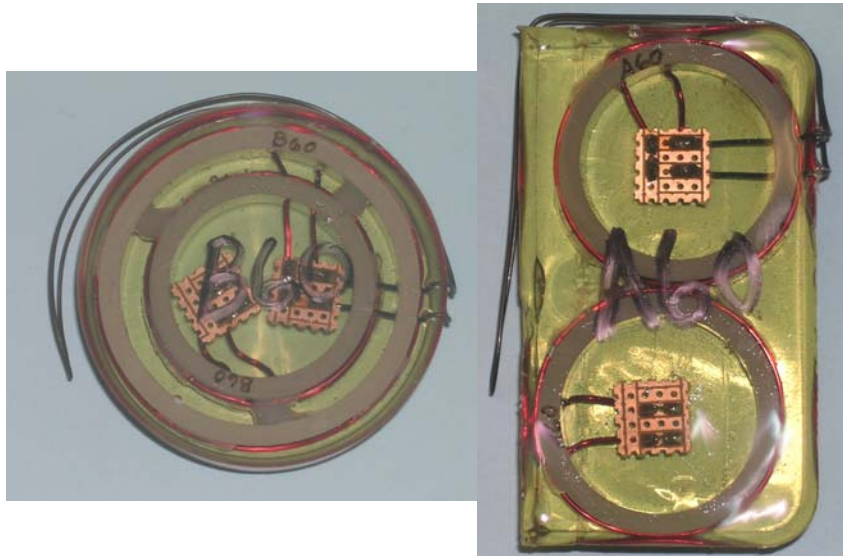
***Figure 4-5 Position of the Sensing Wire of Isolated Sensors***

shown in Figure 4-5. In this way, the position of the sensing wire and the position of the edge of the sensor were identical.

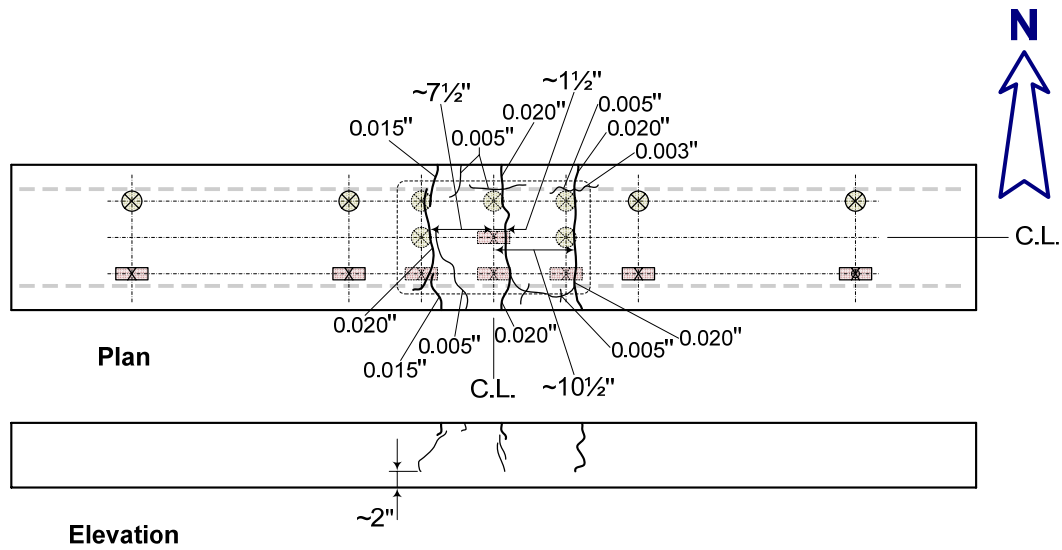
**Figure 4-7 Crack Map of Slab 1 Immediately After Loading (Dickerson 2005)**

The concrete was placed on 16 December 2004, and the specimens were allowed to cure for three weeks. The specimens were draped in plastic to facilitate moist curing. The slabs were then loaded at both ends with concentrated loads. Flexural cracks formed on the top surface of the specimens and were most pronounced in the constant moment region at the center of the specimens. Measured crack widths — 0.02 in. on average — were deemed sufficient to accelerate corrosion of the reinforcement. A salt-water reservoir was fixed at the middle of both slabs with an epoxy. The salt water was 3.5 % NaCl by weight. A plan view of the reservoirs is shown in Figure 4-1 and Figure 4-2. Figure 4-6 provides an elevation view of the loaded slab with the reservoir in place. Maps of cracks on the surface of Slabs 1 and 2, 24 hours after loading, are shown in Figure 4-7 and Figure 4-8, respectively.

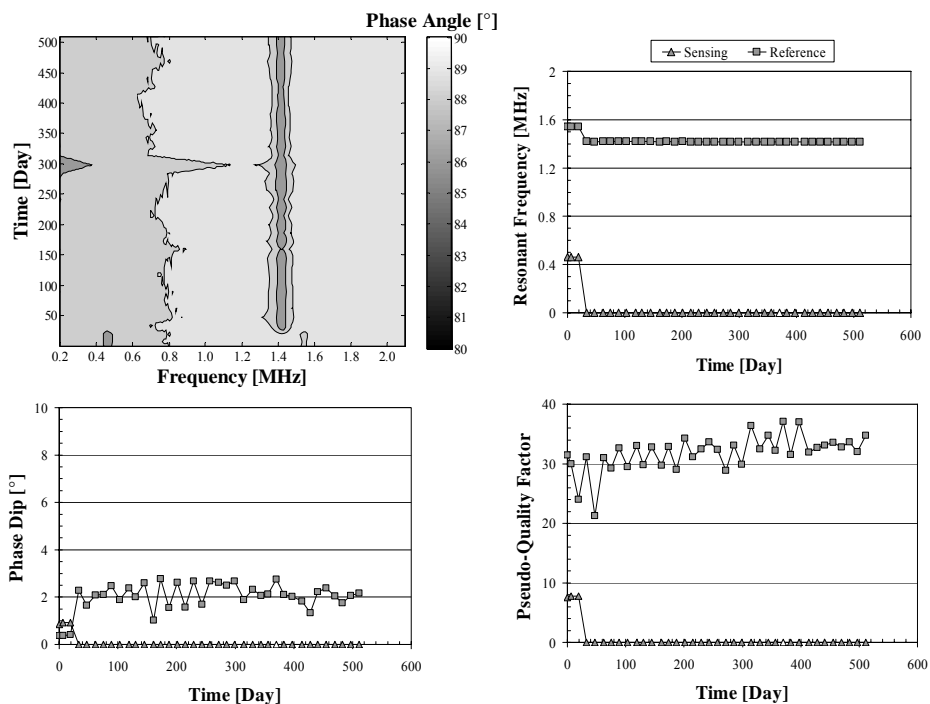
**Figure 4-13 Response of Sensor B05**

B05, the contour lines were placed at 80°, 82°, 84°, 86°, 88.1°, 88.9°, and 90°. Spurious values for the response parameters returned by the curve-fitting algorithm were not reported and were replaced with inferred values, colored white in Figure 4-13. A detailed discussion of spurious values and conventions for reporting replacement values is given in Appendix B.

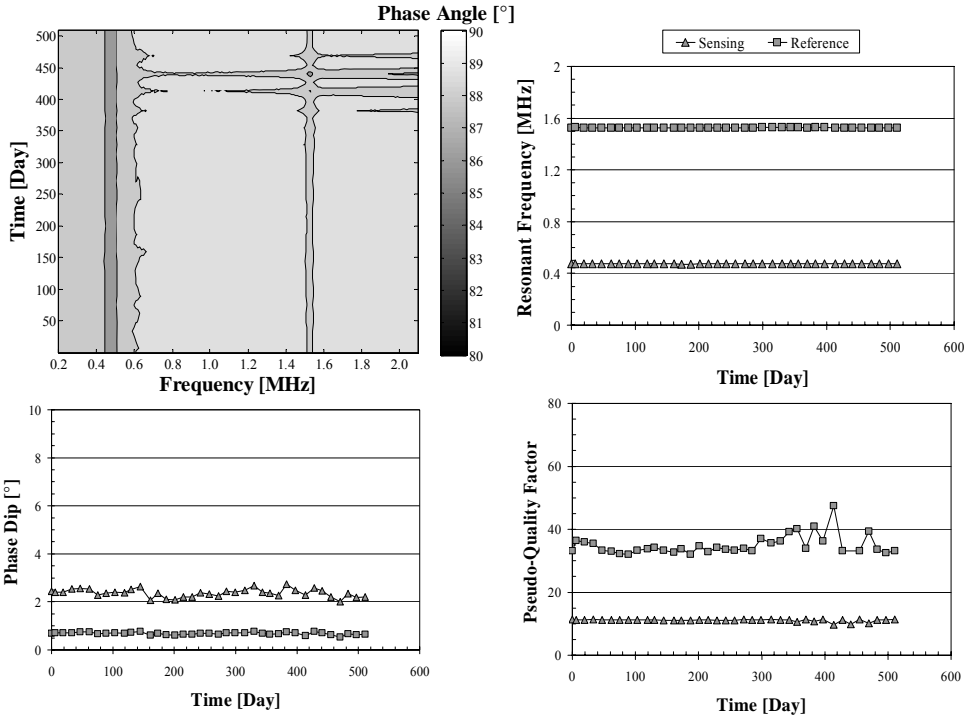
*Figure 4-22 Response of B57*

As was noted in Section 4.2, two gages of wire were tested in Slabs 1 and 2 in order to optimize detection of corrosion threshold. Sensor B01, the response of which was discussed in Section 4.3.3, had a 26-gage sensing wire. By way of comparison, the response of sensor B57, which had a 21-gage sensing wire, is given in Figure 4-22. The contour lines in the plot of B57 were placed at the same values of phase angle as for B01.

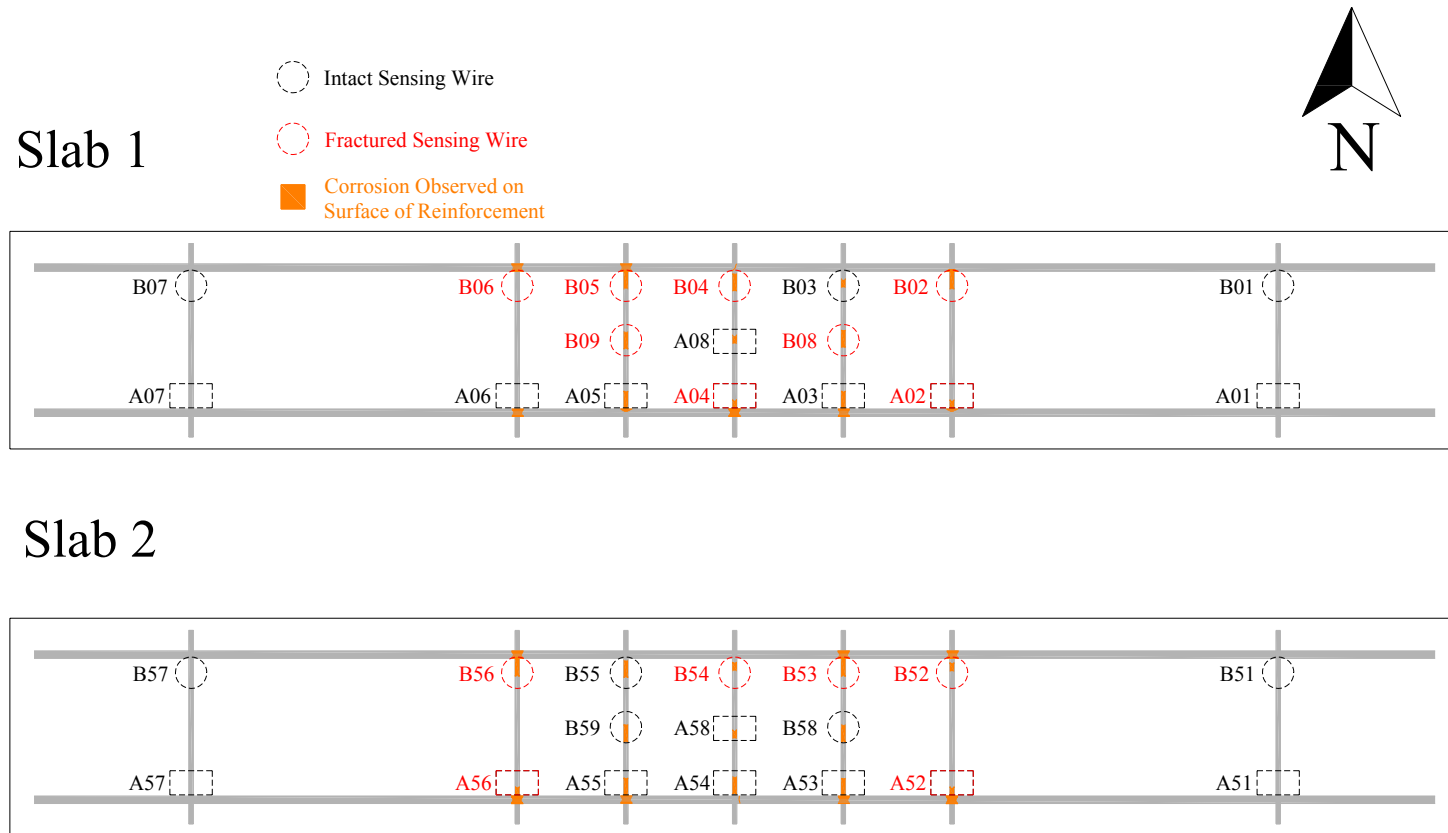
**Figure 4-23** *Extent of Corrosion on Reinforcement Adjacent to Sensors*

Corrosion on the reinforcement is depicted on the surface of the steel in orange, though corrosion on steel below the salt-water reservoir tended to be darker in color due to deaeration of the concrete. Sensors with fractured sensing wires at the conclusion of testing are labeled with red text, whereas those with intact sensing wires are labeled in black text.

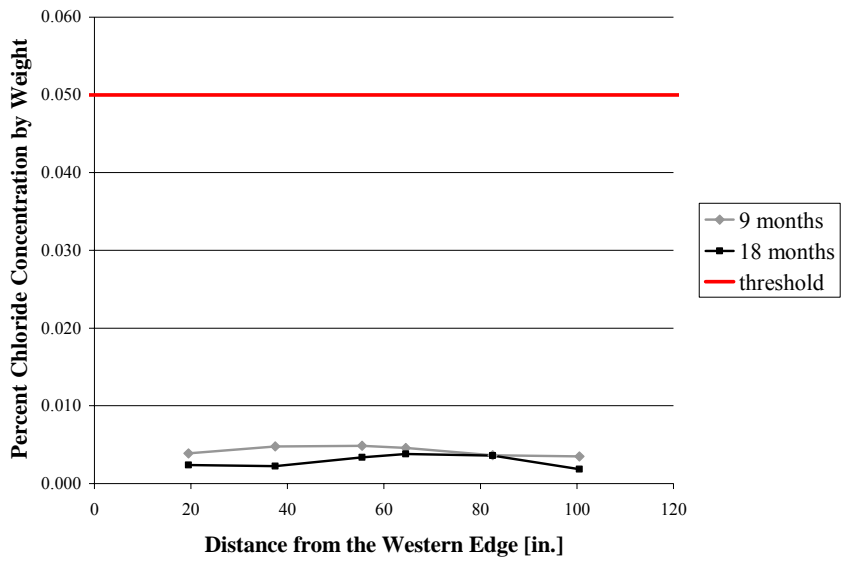
**Figure 4-30 Chloride Concentration of Slab 1**

Figure 4-30 and Figure 4-31 are plots of chloride concentration with respect to position on the slab. In terms of Figure 4-1 and Figure 4-2, the coordinate 0 in Figure 4-30 and Figure 4-31 corresponds to the western edge of the slab, and coordinate 120 corresponds with the eastern edge of the slab. A chloride threshold value of 0.05% by weight of pulverized concrete is plotted along with the data. This value, specified by Comité Euro-Internationale du Béton (CEB), is a commonly used as the threshold for initiation of corrosion but is by no means the only proposed value. For an extended literature review of research into chloride threshold values, see West (1999).

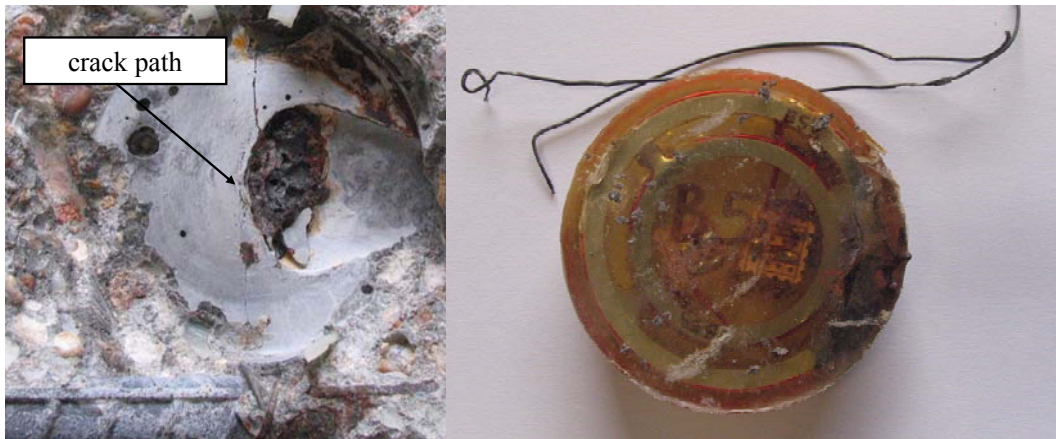
***Figure 4-34 Crack Path Intersecting Sensing Wire of B53 and Reinforcement, Causing Corrosion of Both***

A likely example of a path of a crack intersecting a sensing wire and causing the sensor to signal corrosion initiation was B53. Because of the loading, a transverse crack developed over the sensor B53, allowing chlorides conveyed by the salt water to penetrate through the concrete cover. Because the crack likely passed over the sensing wire, the wire fractured due to corrosion. Corrosion was also observed on the reinforcement near the sensor, along the path of the crack, as shown in Figure 4-34.

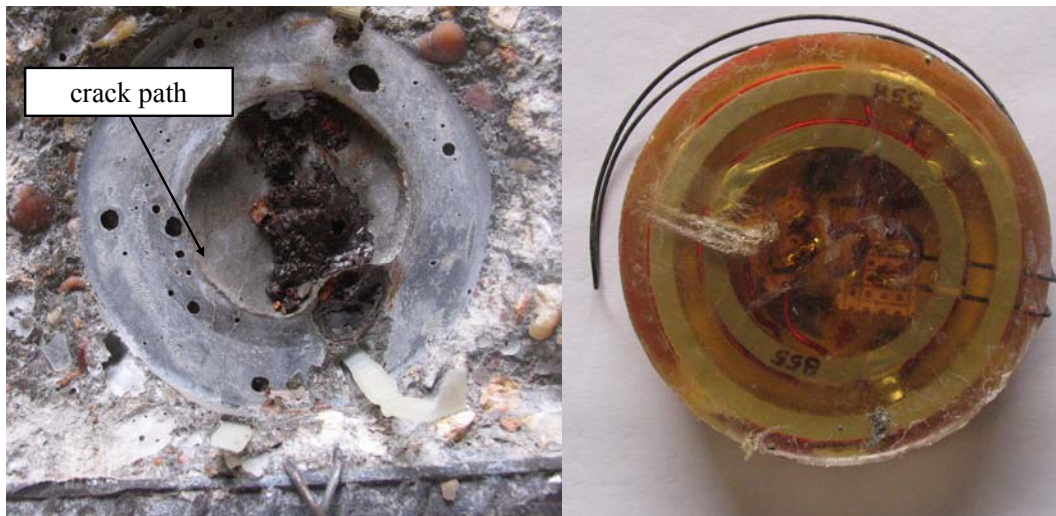
***Figure 4-35 Crack Path Failing to Intersect Sensing Wire of B55 but Causing Corrosion of Reinforcement***

In other cases, as was mentioned in Section 4.4.1, corrosion developed near a sensor without the sensor signaling corrosion initiation. For example, a transverse crack likely developed over sensor B55 in such a way that the transverse reinforcement corroded but the sensing wire did not. Figure 4-35 shows this outcome.

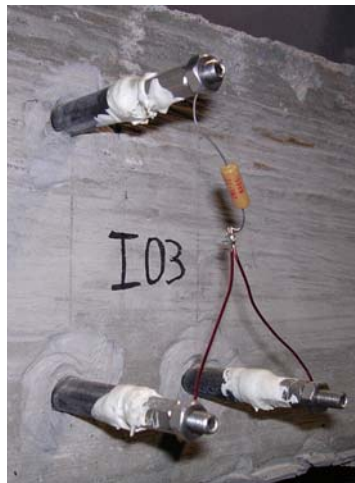
*Figure 5-6 Resistor Connecting Top and Bottom Reinforcement*

In contrast to the reinforcement of Slabs 1 and 2, the top and bottom layers of Slabs 3 and 4 were electrically connected in order to facilitate the development of macrocell corrosion. As shown in Figure 5-1 and Figure 5-2, at five locations along the length of the specimens, a single length of W5 wire extended beyond the edge of the concrete on the top, and two lengths of W5 wire extended beyond the edge of the concrete on the bottom. On one side of the specimen, the ends of the bars were threaded, and stainless steel couplings were attached to the bars. The remainder of the exposed bar, including a 1 1/2-in. segment extending into the concrete, was wrapped with electroplating tape and covered with heat shrink in order to prevent atmospheric corrosion from developing and influencing the internal corrosion of the specimen. A 100-Ohm resistor, as shown in Figure 5-5 and Figure 5-6, was connected to the top transverse reinforcement extending from the slab to the bottom transverse reinforcement extending from the slab, using 18-

gage copper magnet wire. The amount of corrosion current flowing from the anode on the top of the specimen to the cathode on the bottom was determined by measuring the voltage over the 100-Ohm resistor. The segments of W5 wire extending from the specimens on the side opposite the resistors were wrapped in electroplating tape and completely covered with heat shrink, as shown in Figure 5-7, to prevent corrosion due to the atmosphere.

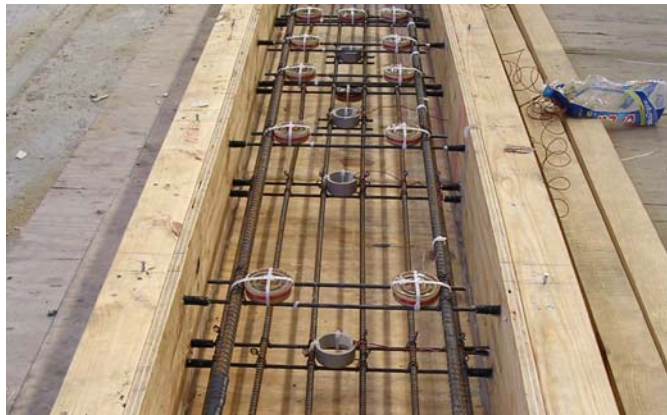
***Figure 5-9 Layout of Sensors and Steel Reinforcement***

The sensors were zip-tied to platforms composed of two lengths of W5 wire. The second length of W5 wire, as shown in Figure 5-1 and Figure 5-3, did not extend beyond the edge of the concrete. Rather, it was attached to the longitudinal steel simply to serve as a platform for the sensors. The sensing wires were secured to the steel reinforcement using zip-ties in such a way that the sensing wire was in electrical contact with the reinforcement. Figure 5-9 shows the sensors zip-tied to the transverse reinforcement and their sensing wires connected to the upper layer of reinforcement. As was observed in Section 4.4.4, the path of cracks significantly influenced which sensing wires corroded, and cracks tended to develop where the transverse reinforcement was placed. Therefore, in the case of half of the sensors, their sensing wires were placed along

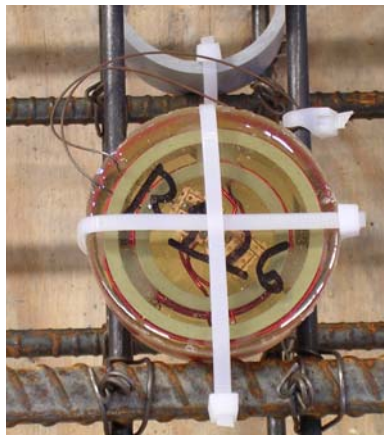
***Figure 5-10 Sensing Wire Placed in the Expected Path of the Crack***

the expected path of the cracks, in the same section as the sensor. In the case of the other half of the sensors, the sensing wire was placed out of the expected path of the cracks. Figure 5-10 shows a sensor with sensing wire placed in the expected path of the cracks. Figure 5-11 shows a sensor with sensing wire placed out of the expected path of the cracks.

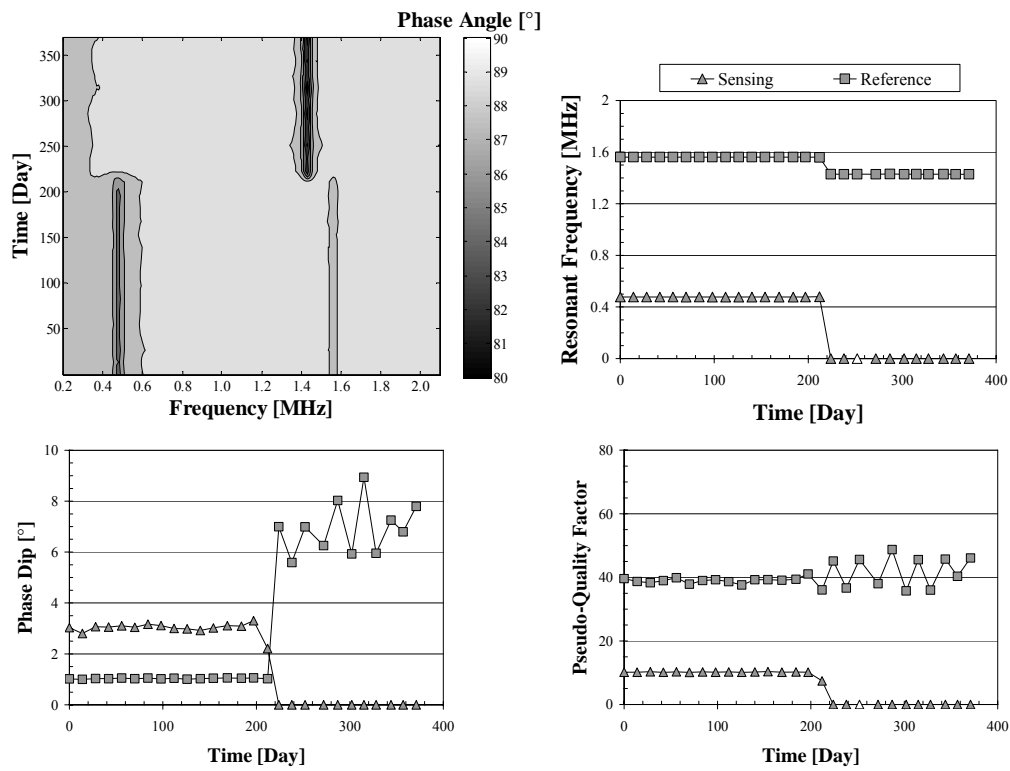
**Figure 5-17 Response of Sensor B155**

The response of sensor B155, given in Figure 5-17, illustrates that the internal environment of the concrete likely participated in the response of the sensor. Contour lines were placed at 80°, 82°, 84°, 86°, 87.4°, 88.6°, and 90°. As mentioned in Section 4.3.1, spurious values for the response parameters returned by the curve-fitting algorithm were replaced with inferred values, colored white in the following figures. The conventions for redacting the response of the sensors are discussed in Appendix B. The change in the response of the sensor on day 224 of testing signaled that the sensing wire fractured on that day or a day shortly before it. After the response of the sensor changed, the phase dip and pseudo-quality factor at the reference frequency cycled between higher and lower values. As shown in Figure 5-18, a detail of the response of B155, these cycles correspond with the wet and dry cycles to which the specimen was subjected. Therefore, changes in the response of the reference circuit of the sensor, after the sensing wire had fractured, correlated with changes in the moisture content of the concrete.

Figure 5-17 shows that prior to the sensing wire of B155 fracturing, the phase dip and the pseudo-quality factor of the sensing circuit decreased gradually. Through mutual inductance of the sensing and reference circuits, the phase dip and pseudo-quality factor of the reference circuit decreased gradually in a similar way. The response of sensor B134, shown in Figure 5-24, exhibited a more lengthy gradual decrease in its phase dips and pseudo-quality factors. The lines of the contour plot were placed at  $80^\circ$ ,  $84^\circ$ ,  $85^\circ$ ,  $87^\circ$ ,  $88.5^\circ$ , and  $90^\circ$ . This gradual decrease in phase dip and pseudo-quality factor is possibly a result of uniform corrosion of the sensing wire. Specifically, if uniform corrosion is taking place, the sensing wire gradually loses cross section, increasing the resistance of the sensing circuit. This increase in resistance causes a decrease in the phase dip and pseudo-quality factor of the sensing circuit. Through mutual inductance, there is an accompanying decrease in the phase dip and pseudo-quality factor of the reference circuit. A shift in the resonant frequency of the reference circuit does not take place until the sensing wire fully fractures.

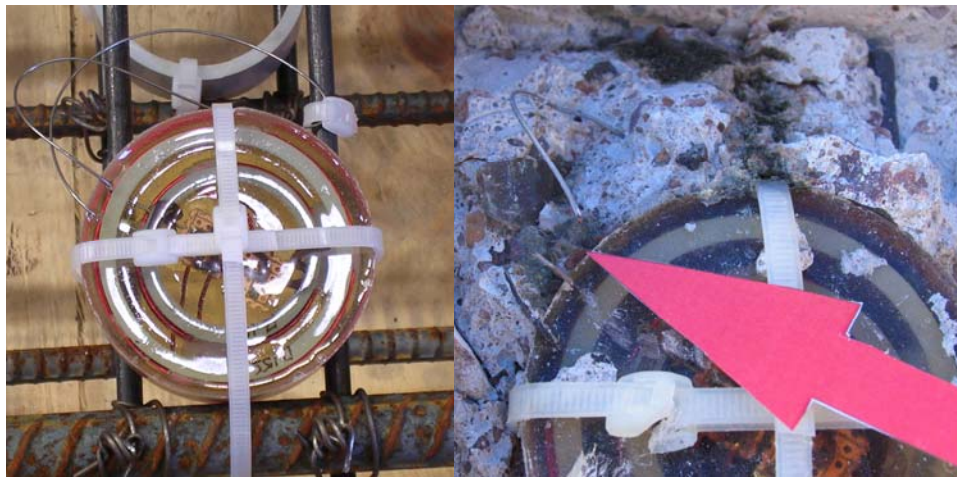
***Figure 5-21 Fracture in the Sensing Wire of B155***

Influence of the internal environment of the concrete on the response of the sensor once its sensing wire had fractured was not more likely for coupled sensors. That is, connecting the sensing wire of sensor to the steel reinforcement did not appear to render the response of the sensor more dependent on the internal environment of the concrete. For example, at the time of autopsy of Slab 4, the portion of the sensing wire of B155 that was connected to the steel reinforcement showed no evidence of corrosion. Rather, the fracture in the sensing wire occurred elsewhere along its length. Therefore, the reinforcement was not completing the sensing circuit; moisture elsewhere along the length of the sensing wire likely was. Figure 5-21 shows how the sensing wire of B155 was secured to the reinforcement and where the sensing wire fractured.

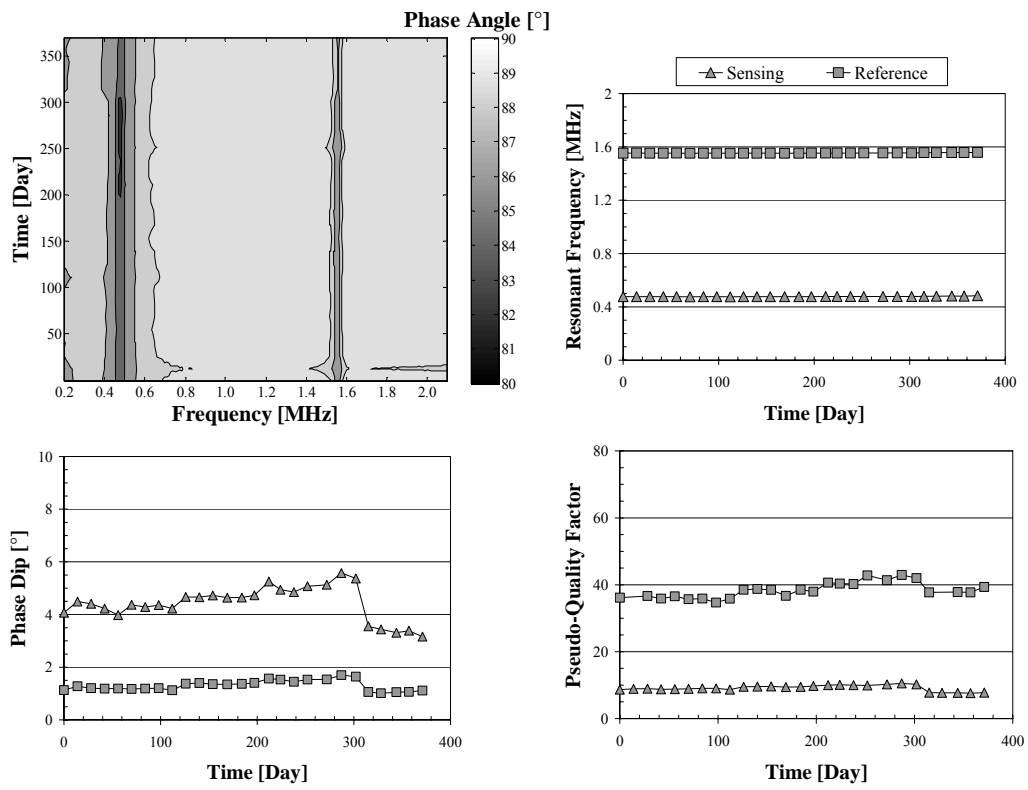
**Figure 5-25 Response of Sensor B148**

Because Slab 3 has yet to be autopsied and B134 was cast in Slab 3, it was not possible to confirm uniform corrosion along the sensing wire of B134. The response of sensor B148 also exhibited a decrease in phase dips and pseudo-quality factors without the sensing wire fracturing, although the decrease was less gradual than in the case of B134. The response of sensor B148 is shown in Figure 5-25. Contour lines were placed at the same values of phase angle as in the case of B154. After day 300 of testing, there is a decrease in the phase dips and pseudo-quality factors of both the circuits composing B148. At the time of autopsy, a segment of fairly uniform corrosion was observed on the sensing wire of B148, as shown in Figure 5-26. Therefore, the response of sensor B148, which includes a change in the phase dips and pseudo-quality factors of the circuits, corresponded with somewhat uniform corrosion of the sensing wire.

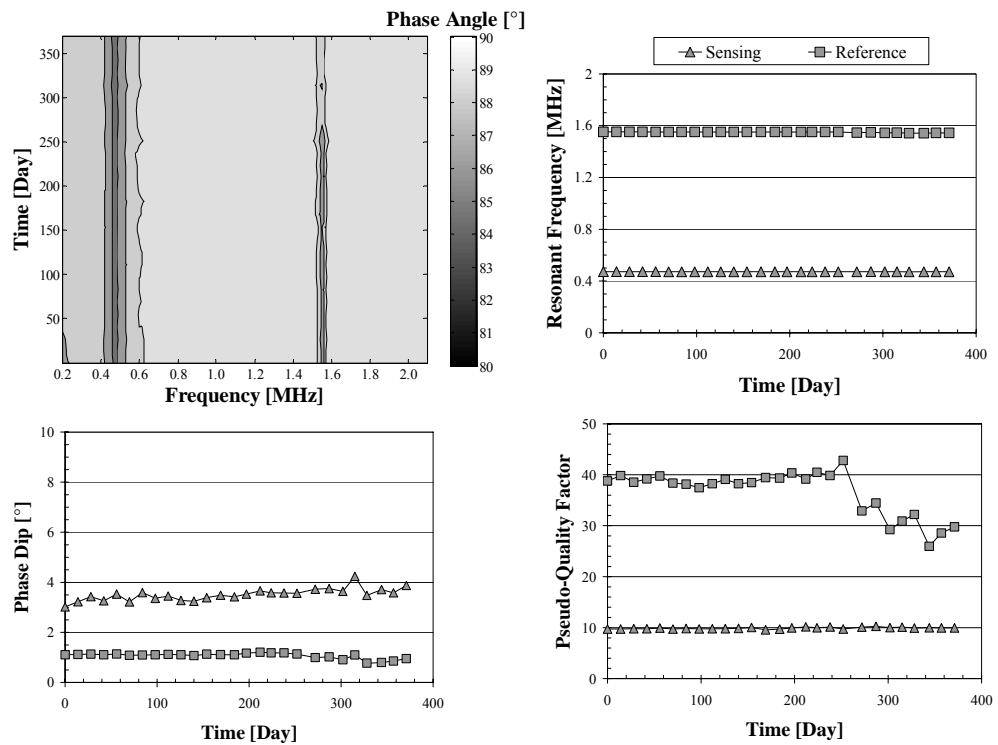
**Figure 5-27 Response of Sensor B152**

Figure 5-27 is the response of sensor B152. Contour lines were placed at the same values of phase angle as in the case of B154 above. What is apparent from the response of B152 is that the phase dip at the reference frequency decreased over time. The decay of the reference circuit is especially evident in the plot of the pseudo-quality factor with respect to time. In contrast to the situation in Section 5.3.4, this decrease in the phase dip at the reference frequency was not accompanied with significant change in the phase dip at the sensing frequency. Rather, the quality of the reference circuit was decaying independently of the sensing circuit.

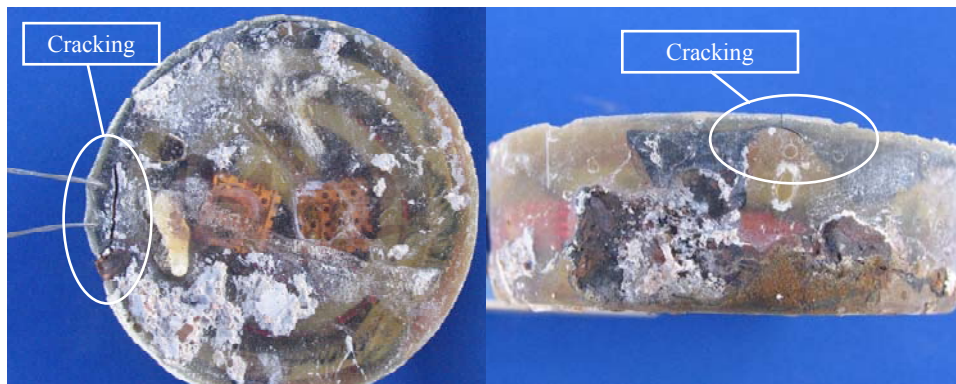
***Figure 5-28 Cracking of Epoxy Housing of B152***

When Slab 4 was autopsied, large amounts of black corrosion were observed within the epoxy housing of B152. As shown in Figure 5-28, cracks developed in the epoxy housing of the sensor, likely exposing the circuitry to corrosive agents. This exposure lead to a decay of the circuitry, which was reflected in the response of the sensor.

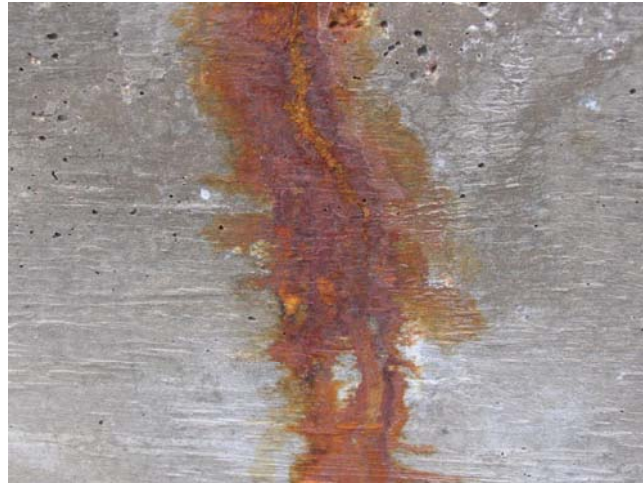
***Figure 5-34 External Corrosion on the North Face of Slab 4***

After 371 days of testing, Slab 4 was autopsied and the state of the sensors and condition of the steel reinforcement were documented. Slab 4 was presumed to be in an advanced state of corrosion because corrosion products were visible on the surface of the concrete. Figure 5-34 is a photograph of the north face of Slab 4, beneath the salt-water reservoir. In all cases for sensors embedded in Slab 4, the observed state of the sensing wire was consistent with the state of the sensing wire detected during testing. That is, B154 and B155 signaled that their sensing

wires had fractured, and the wires had fractured. The remaining sensors signaled that their sensing wires were intact, and their wires were observed to be intact. Therefore, the sensors reliably signaled the state of their sensing wires.
