**Passive, Wireless Corrosion Sensors for  
Reinforced Concrete Structures**

**Thesis**

The University of Texas at Austin

**August 2007**

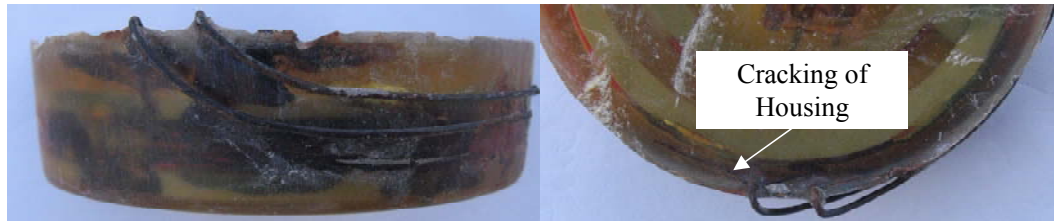
***Figure 6-1 Black Corrosion in the Housing of Sensor B52***

Black corrosion was observed within the epoxy housings of many of the sensors embedded beneath the salt-water reservoirs in Slabs 1, 2 and 4. Figure 6-1 provides an example of severe black corrosion within sensor B52, which was tested in Slab 2. Cracks in the epoxy housing, as shown in Figure 6-1, were observed in several sensors and likely increased the extent of black corrosion by providing a path of ingress into the circuitry of the sensors. The cause of the cracks was likely not the corrosion itself because, as noted by Broomfield (1997), black corrosion does not result in the development of expansive forces. Rather, likely causes of the cracking of the epoxy housings were imperfections in the

potting of the epoxy housing and differential thermal expansion between the epoxy and concrete.

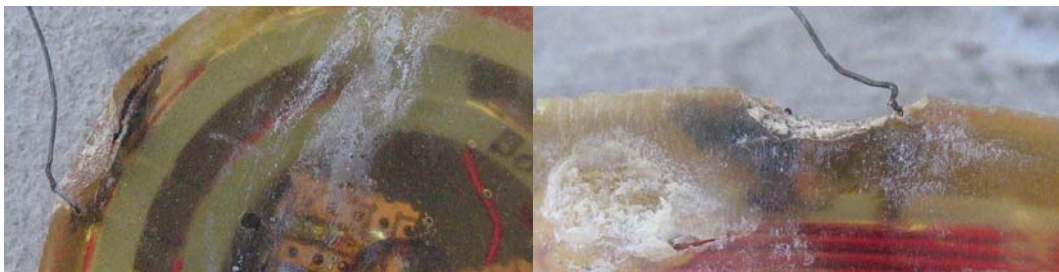
**Figure 6-13 Black Corrosion in B04**

The fact that, in several cases, the sensing wires of sensors tested in Slabs 1 and 2 fractured within the epoxy, rather than outside of the epoxy, is consistent with either lack of passive layer on the surface of the steel embedded within the epoxy or differential aeration of the sensing wire being the cause of the black corrosion. An example of a sensing wire that fractured within the epoxy was the sensing wire of B04, shown in Figure 6-13. B04 signaled a fractured sensing wire, but the sensing wire outside the epoxy was intact.

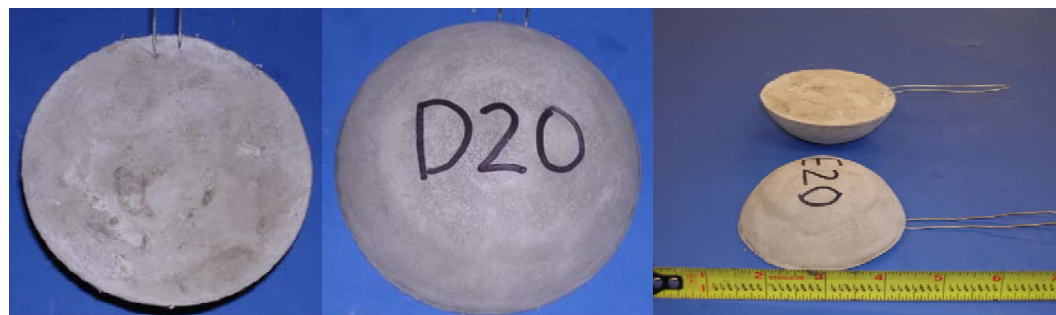
**Figure 7-7** *Sensor with Fiber-Reinforced Cement Paste Housing*

The sensors embedded in a given specimen were nominally identical except for type of housing. As shown in Figure 7-1 and Figure 7-3, most of the sensors in each specimen had a fiber-reinforced cement paste housing, while several had a fiber-reinforced cement paste housing with an epoxy core. For brevity in subsequent sections, the types of housing are distinguished by whether or not they have an epoxy core. The fiber-reinforced cement paste housing was cement paste reinforced with polypropylene fibers. A sensor with such a housing is illustrated in Figure 7-6 and shown in Figure 7-7. The mold used had a convex

Fiber-reinforced cement paste was used for the sensor housing for two reasons. First, fiber-reinforced cement paste is permeable, in contrast to epoxy. Therefore, all of the steel sensing wire, both what is within the housing and what is outside the housing, would become passivated at the time of hydration. Furthermore, the development of a differential aeration cell on the sensing wire due to the internal environment of the sensor housing being distinct from the internal environment of the concrete is unlikely. Second, the fiber-reinforced cement paste was found to have a coefficient of thermal expansion similar to that of concrete. Appendix E includes a discussion of tests that support this claim. Comparable coefficients of thermal expansion between the fiber-reinforced cement paste housing and concrete minimize the possibility of the cement paste housing cracking the concrete due to temperature changes. Extreme cases of epoxy housings causing concrete to crack were discussed in Section 3.4.5.

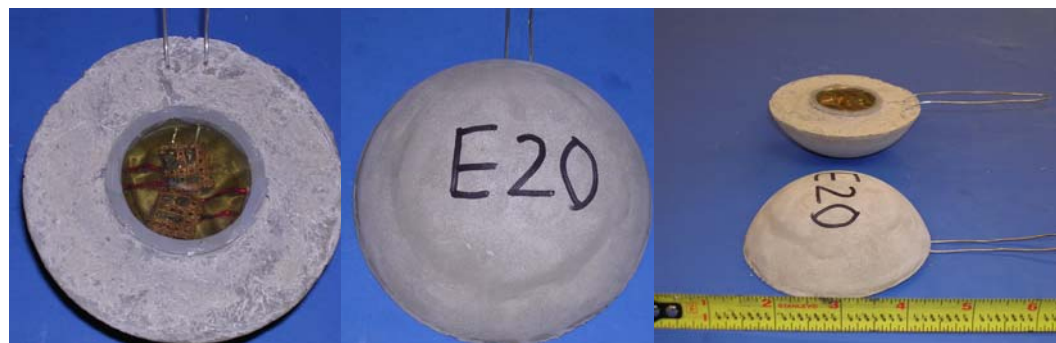
**Figure 7-9** *Sensor with Fiber-Reinforced Cement Paste Housing with Epoxy Core*

Because the housing of sensor D11 had an epoxy core, the only components of the circuitry exposed to the internal environment of the concrete by the permeable fiber-reinforced cement paste housing were the inductors for both the sensing and reference circuits. This condition is illustrated in Figure 7-8 and Figure 7-9. Sensors with intact sensing wires in Slabs 1 through 4 did not, on the whole, exhibit distinct cyclic response. In addition, the only way in which sensor D11 differed from sensors tested in Slabs 1 through 4 was that its inductors were exposed to moisture variations due to the permeability of the fiber-reinforced cement paste. Therefore, variability in the response of D11 was likely introduced by changes in the amount of moisture in contact with its inductors.

There were two likely causes of the decrease of the reference pseudo-quality factor in sensors with epoxy-core housings and intact sensing wires. As shown in Figure 7-8 and Figure 7-9, all of the circuit components of a sensor with an epoxy-core housing were materially separated from the alkaline environment of the concrete. Even though the inductors were exposed to the alkaline environment, they were materially isolated because the copper magnet wire used to fabricate the inductors had an intact finish. Thus, the inductors could not chemically react with environment around them. Rather, the inductors only interacted with their surrounding environment by magnetic coupling. Furthermore, a testing period of 14 weeks was likely too short a period for black corrosion to develop within the epoxy core. Indeed, sensors B152 and B135, discussed in Section 5.3.5, did not indicate the presence of damage due to internal black corrosion until after nearly a year of testing. Therefore, decay of the circuitry of the sensor due to chemical reaction with the surrounding environment was likely not a cause of the decrease in the reference pseudo-quality factor of sensors with epoxy-cores housings.

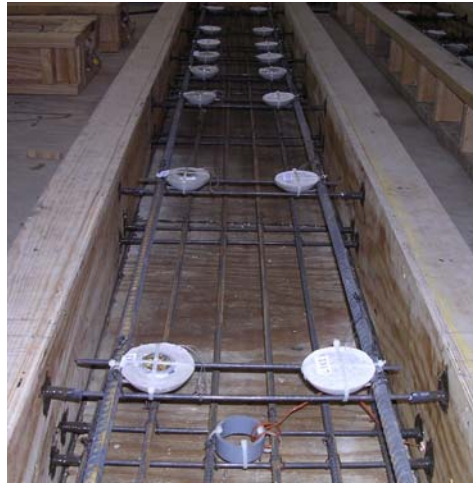
***Figure 7-10 Layout of Sensors and Steel Reinforcement***

this arrangement, the concrete cover over the sensors was nominally 1 1/4 ". Figure 7-10 is a photograph of the layout of the sensors and steel reinforcement. As was done in the case of Slabs 3 and 4, the sensing wires of different sensors were placed in the expected path of the cracks in the concrete cover and out of the expected path of the cracks, as shown in Figure 7-11 and Figure 7-12, respectively. The sensing wires were secured to the longitudinal reinforcement with steel tie wire in order to ensure electrochemical coupling between the sensing wire and steel reinforcement.

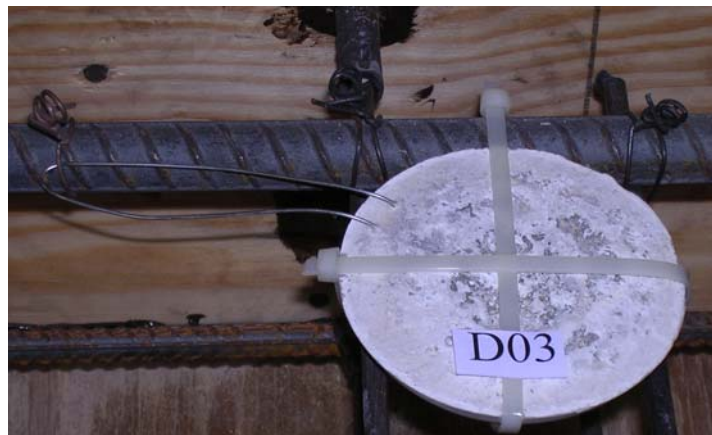
*Figure 7-12 Sensing Wire Placed out of the Expected Path of the Crack*

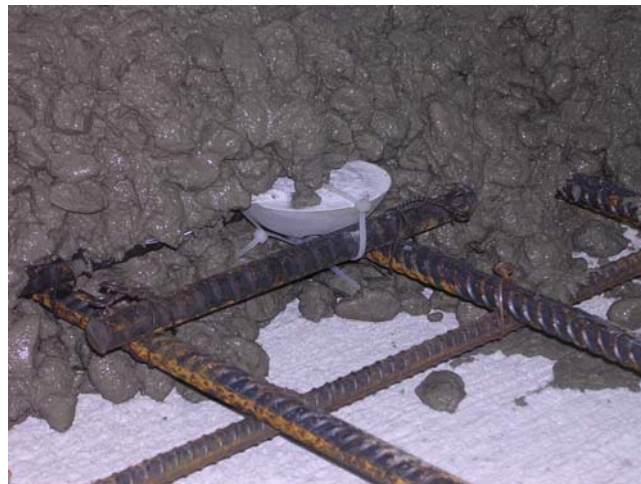
*Figure 8-4 Placing of Concrete*

Concrete was placed on 9 November 2006. Figure 8-4 is a photograph of fresh concrete being poured over a sensor. After one week of curing, interrogation of the sensors began and has continued for 29 weeks, on two-week intervals. A Solartron Impedance/Gain-Phase Analyzer was used to interrogate the sensors. The reader coil was 4 in. in diameter with five turns of 18-gage copper magnet wire. Interrogation of the sensors is ongoing. Initially, the

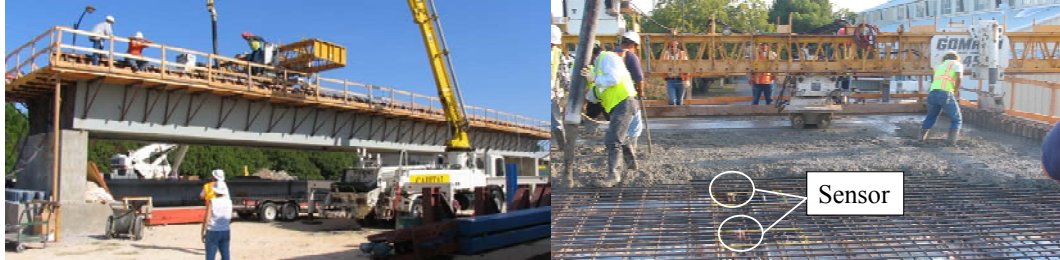
**Figure 8-7 Sensors Embedded in Full-Scale Bridge Deck**

A set of six sensors was embedded in the deck of the full-scale bridge shown in Figure 8-7 and Figure 8-8. The responses of the sensors B160 through B165 are reported in Appendix F. Again, although the bridge deck has been exposed to wide ranges of temperature and exhibited plastic shrinkage, no cracks were observed in the bridge deck near the sensors.

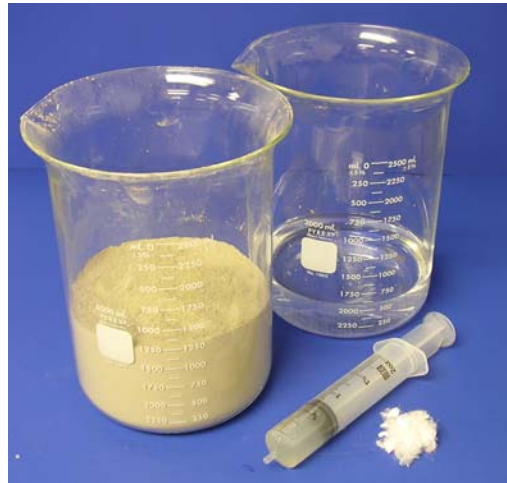
The fiber-reinforced cement paste itself is composed of cement paste and ¼-in. long polypropylene fibers, which are used to stabilize stucco. The potting material is produced by mixing cement, water, polypropylene fibers, and a polycarboxylate-based high-range water reducer, ASTM type F. These components are shown in Figure E-1, and the amounts of each component to be combined for the potting material are shown in Table E-1. The water reducer is added to the mixture in order to decrease its viscosity. Low viscosity is essential to the potting material encompassing all the circuitry of the sensor.

***Figure E-1 Components of Fiber-Reinforced Cement Paste Housing***

<b>Component</b>	<b>Amount</b>
Cement	1361 g
Water	545 g
Fibers	5.3 g
Superplasticizer	4 mL

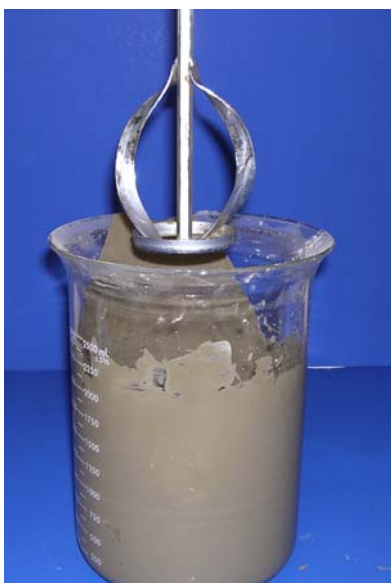
The components were combined in two steps. First, the cement was gradually added to the water, and the resulting mixture was stirred with a plastic spatula. Second, the fibers and superplasticizer were added to the mixture. The superplasticizer lowered the viscosity of the cement paste sufficiently for the mixture to be stirred with a mortar paddle attached to an electric drill, as shown in Figure E-2.

***Figure E-2 Mortar Paddle Used to Stir the Mixture***

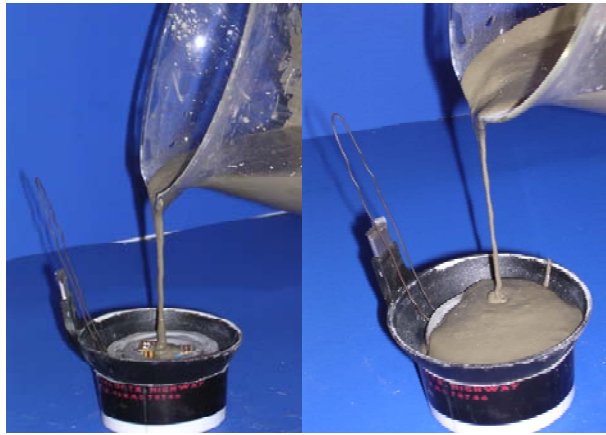
***Figure E-4 Mixture Poured into Mold Containing Sensor***

After the mold has been filled with potting material, it was vibrated by hand to remove any air voids from beneath the sensor. The fresh housing was then covered with plastic to facilitate moist curing, as shown in Figure E-5. Once the housing has hardened sufficiently to be removed from the mold, it was submerged in water for one week for continued moist curing.

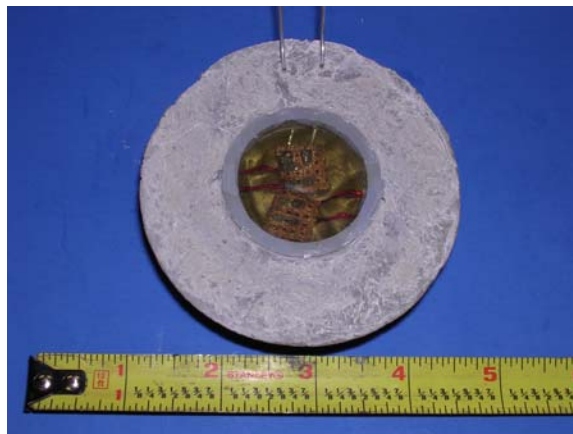
*Figure E-9 Epoxy Core Visible on Top of Sensor*

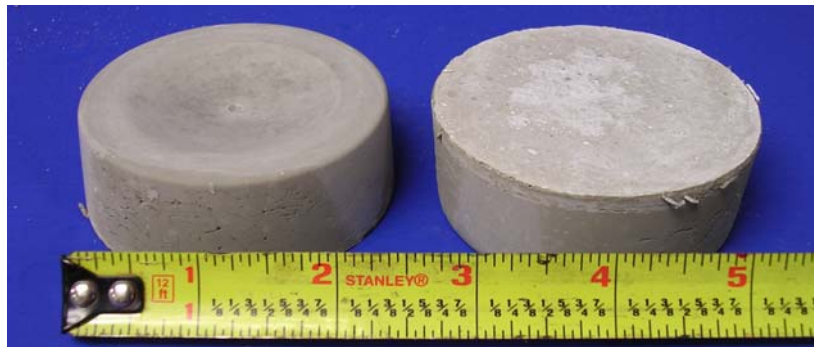
As was observed in Chapter 3, differential thermal expansion of the epoxy housing and the concrete caused complications in the functioning of the sensor. Therefore, the following brief experiment was conducted to determine whether the coefficient of thermal expansion of the fiber-reinforced cement paste housing was comparable to that of concrete. Six fiber-reinforced cement paste discs, as shown in Figure E-10, were potted. The discs had a 2½-in. diameter and a 1-in. thickness. Each of the six discs was cast in a concrete prism having a 6-in. diameter and a 3½-in. height. A prism is shown in Figure E-11.

*Figure E-10 Fiber-Reinforced Cement Paste Discs*

The prisms, with embedded discs, were subjected to extreme thermal cycles. One thermal cycle consisted of the prisms being placed in an oven at 210 °F for one week and then stored in air for two weeks. The prisms underwent four such thermal cycles. At the end of the cycles, the prisms were examined, and no cracks were observed on their surface. Therefore, the coefficient of thermal expansion of the fiber-reinforced cement paste was concluded be comparable to that of concrete.

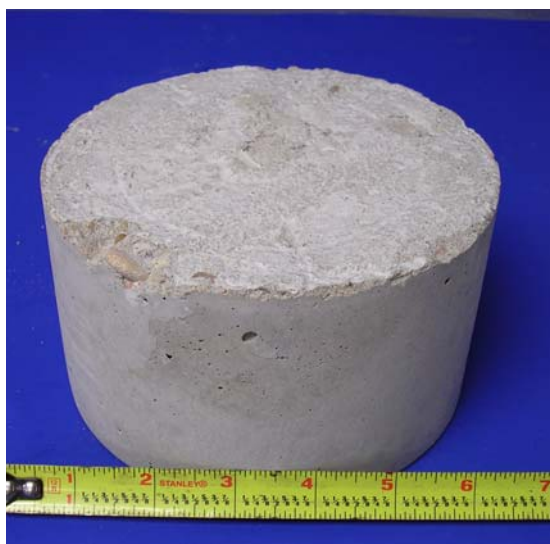
*Figure E-11 Concrete Prism*
