**Development of an Experimental Setup for Testing Scaled  
Versions of AASHTO Type IV Girders under Dynamic Impact  
Loadings**

**Departmental Report**

**The University of Texas at Austin**

**August 2006**

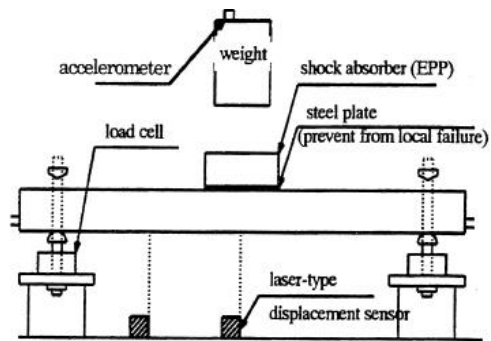
*Fig. 2-3: Impact test setup (Jones, 2000).*

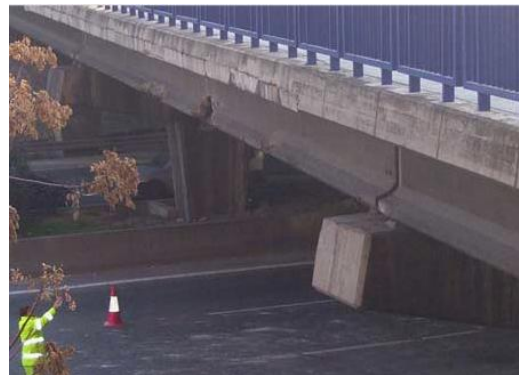
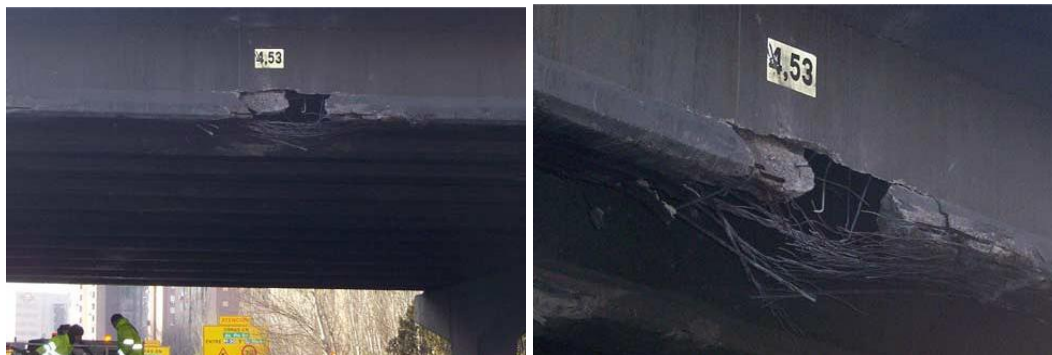
***Fig. 2-5: Collision of an oversize load truck with a prestressed girder bridge in Madrid, Spain (elmundo.es, 2005).***

Figures 2-5 and 2-6 show damage caused to prestressed girder bridges by trucks carrying oversize loads. The first figure shows a bridge over an important highway in Madrid, Spain that was impacted by an oversize truck at a high speed. The external prestressed beam lost all of its strands due to the impact, and the

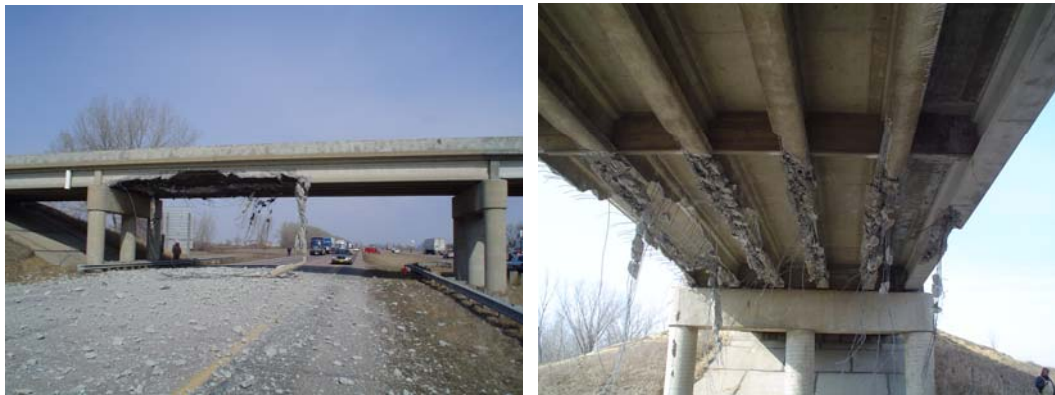
***Fig. 2-6: Damage to a prestressed girder bridge caused by a truck in Iowa on 2005 (source is unknown).***

beam had to be replaced. Figure 2-6 shows a prestressed girder bridge in Iowa in which a truck carrying a large steel cylinder impacted the girders at a speed of about 70 mph. For this case, the external girder that was impacted first did not suffer extensive damage. However, in the zone of impact, the last two prestressed beams are essentially gone. The bridge did not collapse because of the redundancy provided by the slab and guardrail.

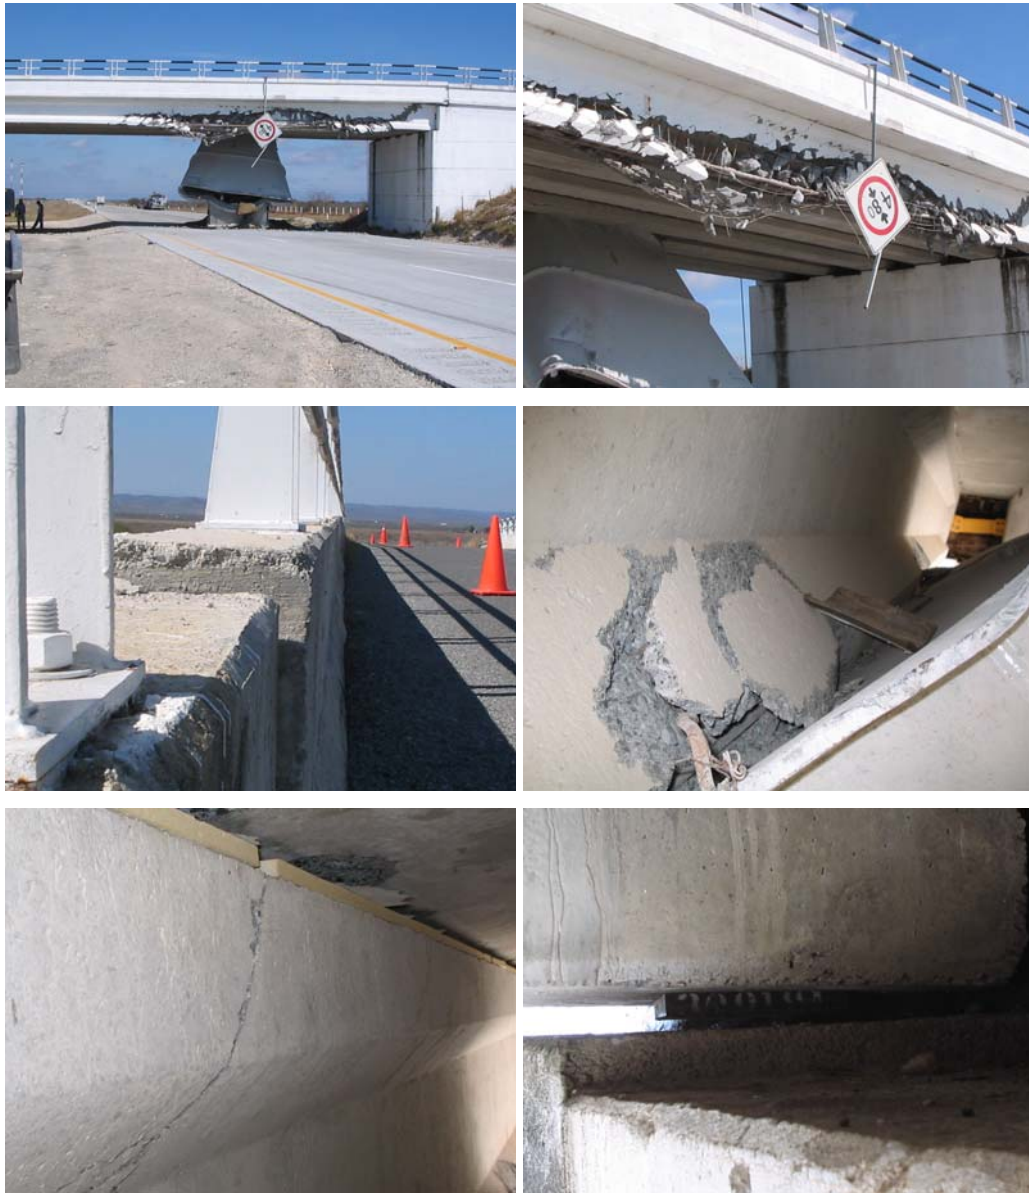
***Fig. 2-7: Damage to a prestressed girder bridge caused by a truck near Monterrey, Mexico on 2005 (courtesy of Gutierrez Ingenieros).***

Figure 2-7 shows a prestressed girder bridge in Monterrey, Mexico composed of post-tensioned girders. In a situation similar to the one presented in the previous figure, a truck carrying an oversize steel cylinder slammed into the bridge. In this case, the external beam was seriously damaged, and the strand profile was exposed. The whole span was displaced horizontally by more than an inch after the impact. It can also be seen that steel cylinder produced an upward load to the post-tensioned beams causing tension cracks at the top of the section. This upward force was strong enough to lift the beam, and, as can be seen from the picture, the neoprene pad is no longer in contact with the abutment.

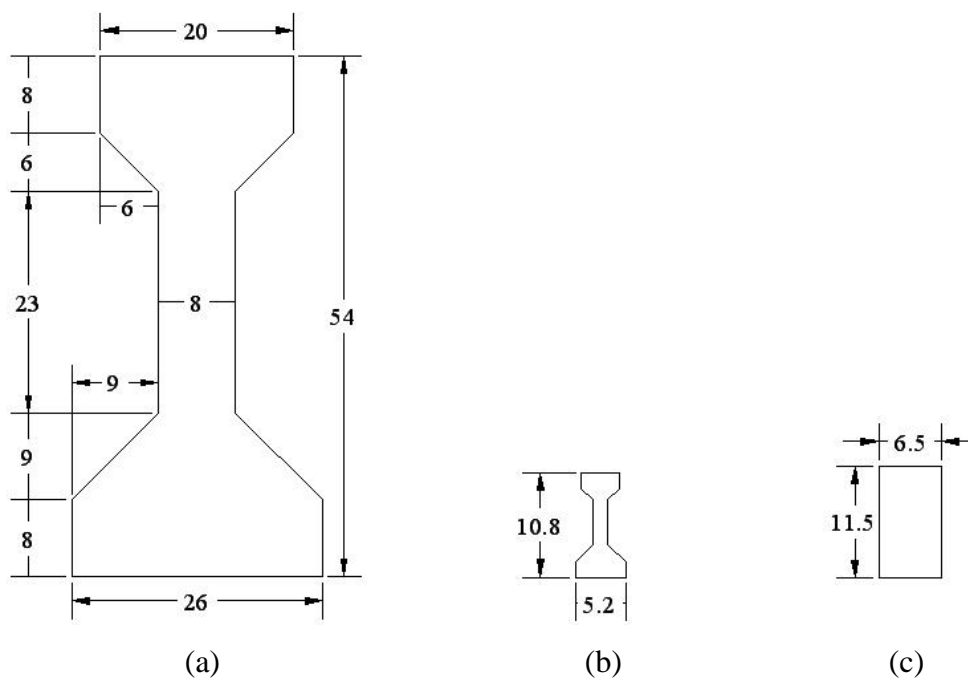
**Fig. 3-1: (a) Type IV beam, (b) 1:5 scaled Type IV beam. (c) 6.5in x 11.5in specimen (units in in.).**

model, and the proposed specimen. Table 3-1 shows a comparison between selected properties of an AASHTO Type IV beam and the proposed specimen, including the distance to the top outer fiber ( $Y_t$ ) and to the bottom outer fiber ( $Y_b$ ). The area of the Type IV section is approximately ten times bigger than that of the specimen due to the modifications done for construction purposes. This will roughly double the shear capacity of a Type IV girder for 1:5 scale. However, this will not affect the results, because the specimen is expected to fail in flexure.

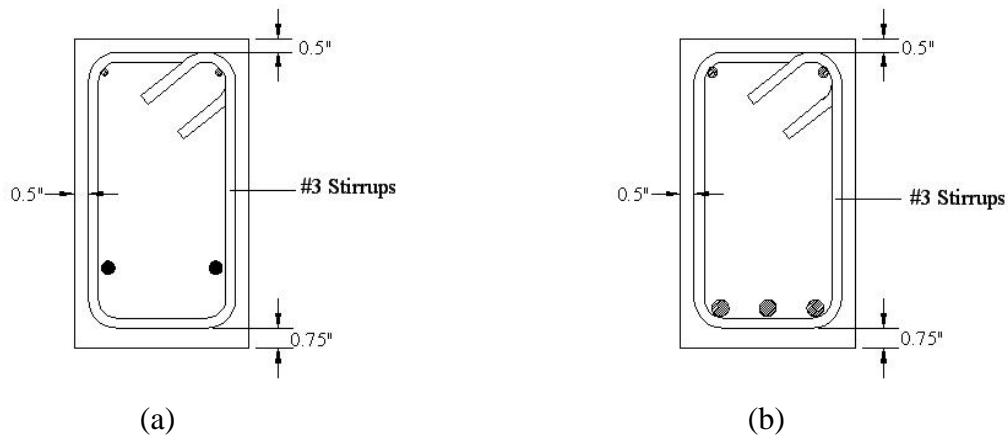
**Fig. 3-4: Cross section of (a) prestressed beam (b) reinforced beam.**

was not based on an AASHTO Type IV girder but rather on providing sufficient reinforcement so that the specimen would fail in flexure under gravity loads. The same applies to the reinforced beams. For both types of beams, #3 grade 60 stirrups were used, but the spacing was different for each type of beam. Figure 3-4 shows the final cross section of the two types of specimens

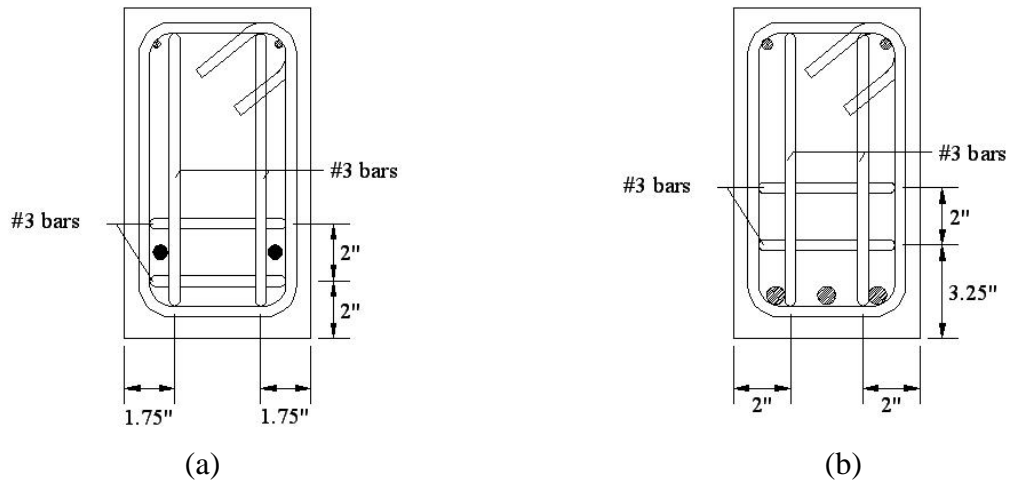
**Fig. 3-5: End cross section of (a) prestressed beam (b) reinforced beam.**

In addition to the transverse reinforcement, the ends of the prestressed beams included extra reinforcement known as bursting steel. The purpose of this steel is to prevent local failure at the ends when releasing the strands. In the case of the reinforced beams, this steel is not required. However, as will be explained in Chapter 5, results from the first test suggested that steel should also be added to the ends of the other reinforced beam. This additional steel was added in order to prevent local failures at the ends due to the support conditions of the test setup. For this reinforcement, #3 rebars were employed. Figure 3-5 shows the beam end cross sections, and Figure 3-6 shows the stirrup spacing used for each type of specimen.

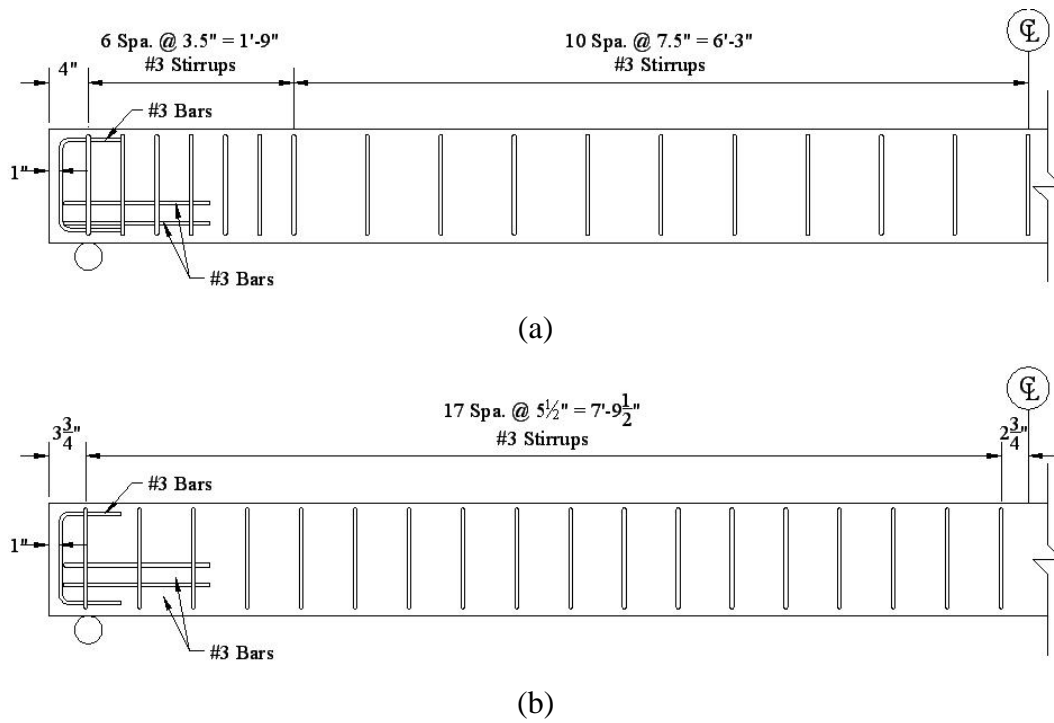
**Fig. 3-6: Stirrup spacing for (a) prestressed beam (b) reinforced beam.**

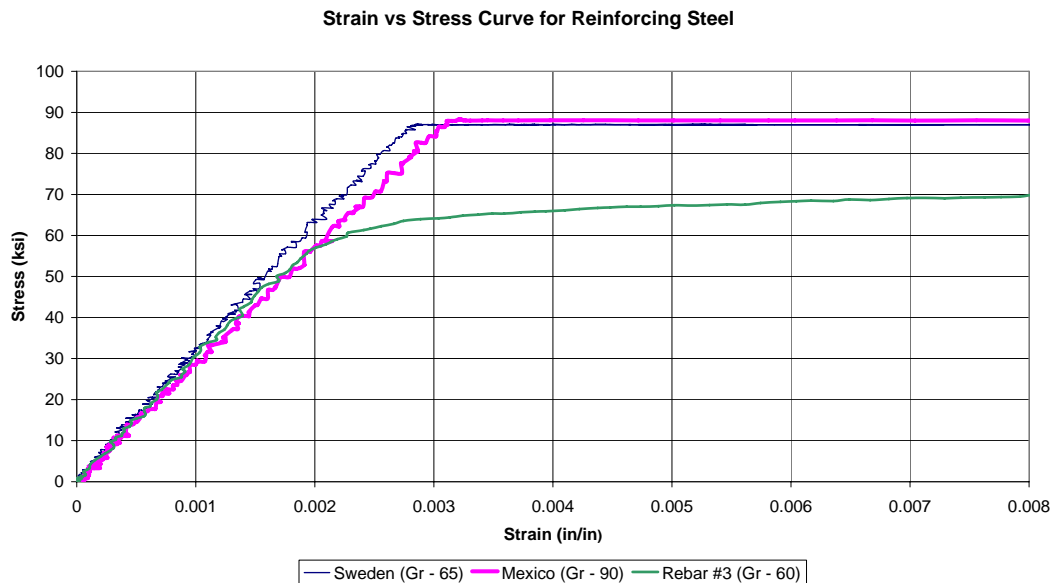
**Fig. 3-7: Stress vs. Strain curve for 6 mm and #3 rebar.**

The longitudinal reinforcing bars used for the top layer of the prestressed specimens are a non-standard size and are not easily found commercially. Ferguson Laboratory has two stacks of this rebar, which were manufactured in two different countries, Mexico and Sweden. Both bars are deformed 6-mm rebar, which makes it difficult to distinguish between them upon visual inspection. However, they have different yield stresses ( $f_y$ ) according to the manufacturers; the rebar from Mexico yields at 90 ksi while the one from Sweden yields at 65 ksi. Because it was difficult to distinguish one from the other, tension tests were performed in accordance with ASTM A615/A in order to obtain the actual yield stress. Tests were also performed for the rebar used as shear reinforcement for both types of specimens to verify that it actually was grade 60. Figure 3-7 shows a typical stress-strain relationship for the two types of non-commercial rebar as well as for the #3 rebar used as stirrups.

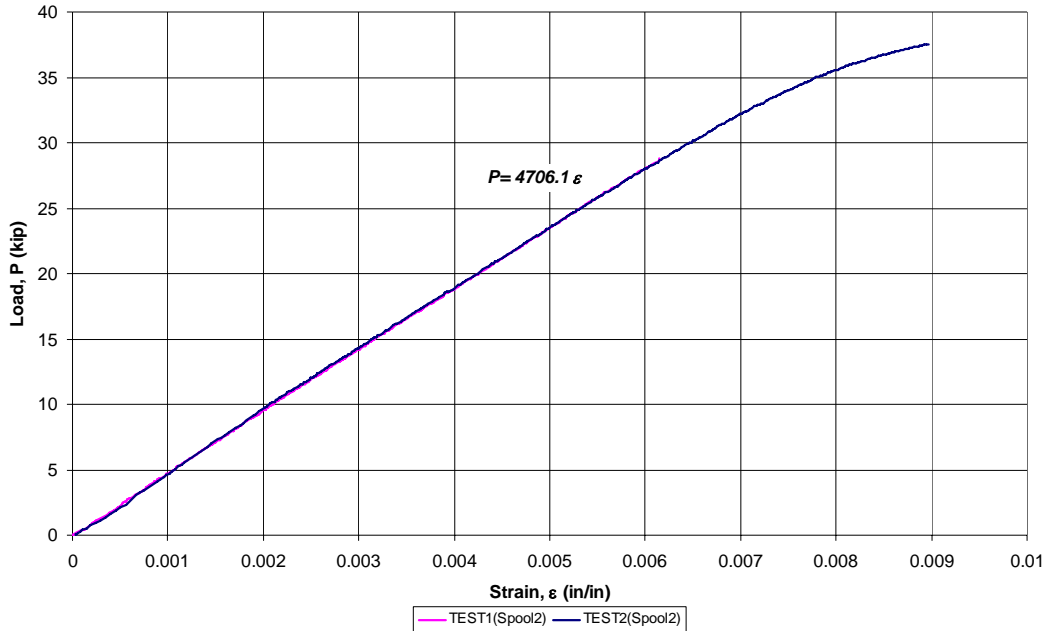
*Fig. 3-10: Load vs. Strain curve for low relax. 1/2-in seven wire strand (Tuchscherer, 2006).*

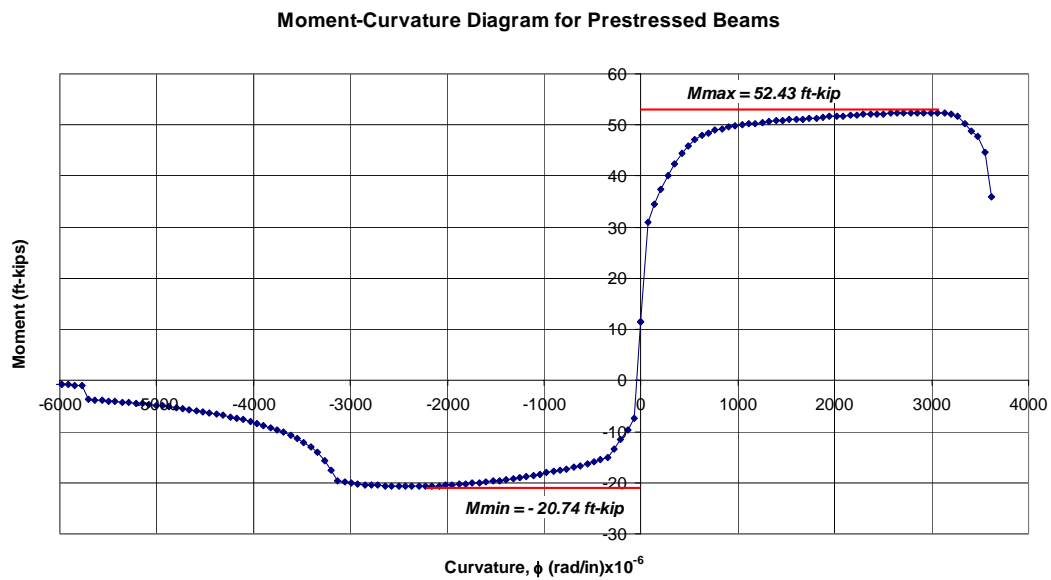
**Fig. 3-11: Moment-curvature diagram for prestressed beams.**

Once the beam dimensions and material properties are established, the capacities of the beams can be calculated. To compute the response of the prestressed beams, a moment-curvature diagram (Figure 3-11) was constructed using a software package called RESPONSE (Felber, 1990).

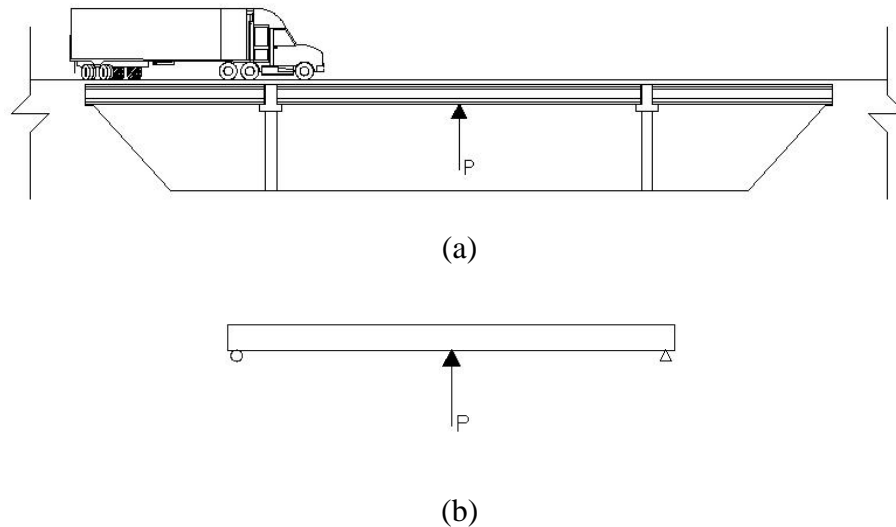
**Fig. 4-1: (a) Typical prestressed bridge. (b) Ideal test setup.**

This chapter addresses all issues related to the test setup, starting from the main components involved and moving on to the development of the final setup and instrumentation used. The main objective of the test setup is to reproduce the conditions of a prestressed beam in a bridge when subjected to loading from the bottom. Generally, bridges are not designed for this type of loading, but interest in loading a bridge from the bottom has increased in recent years, not only to resist accidental impact loading but also to resist a possible explosion in case the bridge is targeted by terrorists. Therefore, the test setup had to be able to hold a beam from the ends without producing moment restraint, because most prestressed girders used in bridges are simply supported. The setup also had to allow a dynamic load to be applied to the bottom of the beam.

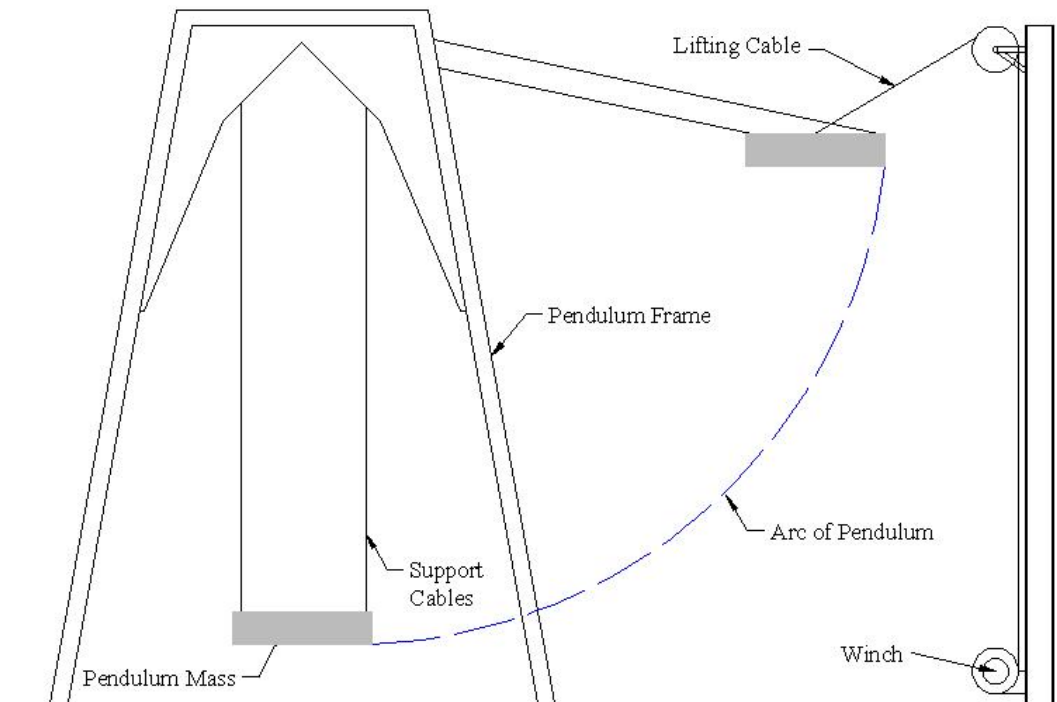
***Fig. 4-2: Main components of the impact test pendulum.***

In this section, a description of the impact test pendulum is presented because it is one of the main components of the test setup. However, the author of this report did not participate in the design or construction of this piece of equipment. The pendulum was designed by Geoffrey T. Mitchell (Mitchell, 2005), and details not presented here can be found in his thesis. The impact test pendulum consists of an 855-kg mass made up of steel plates suspended by four steel cables from a 22-ft tall steel frame. The pendulum mass can be lifted up to a 16-ft drop height using a winch. A sketch of the pendulum's main components is shown in Figure 4-2.

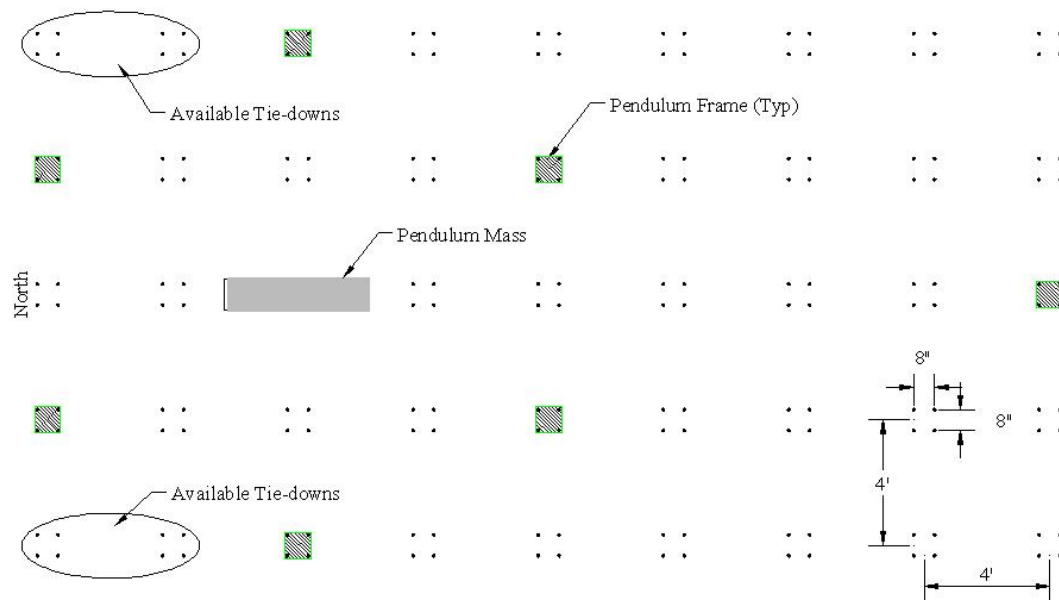
**Fig. 4-4: Plan view of the laboratory's tie-down floor (pendulum area only).**

For the purposes of the current study, the impact test pendulum required only a minor modification, which was the addition of a load cell in front of the mass to record the impact force. However, the load cell was only added after two tests were performed and the need for an accurate way to obtain the impact load was identified. The reasons for this need will be discussed in a subsequent section. There were also some other additions done to the surrounding area of the pendulum. For the barrier tests, a slab was anchored to the laboratory's structural tie-down floor, and a barrier was installed on top of this slab. But for testing beams, a frame was needed to serve as a support to hold the beams at a specific height and to allow the beams to span 16-ft. The support also needed to be anchored to the tie-down floor with 1-in diameter threaded rods. Hence, the design was largely based on the clusters of bolts available in the pendulum area (Figure 4-4).

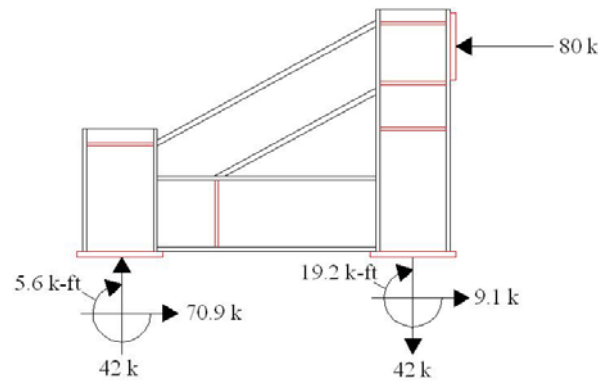
**Fig. 4-5: Reactions produced on A-frame due to 80-kip load.**

As mentioned previously, the design process for the A-frames was iterative, and several models were developed, compared, and abandoned. The comparison was mainly based on constructability, capacity to resist load, and the frame's ability to distribute forces to the tie-down floor. By this point, it is already known that the maximum static capacity of the beam, if loaded in the direction of the gravity, is of 12.5 kips. However, the loading will be done in the opposite direction for this project, which means that the load is smaller than this value (5.2 kips in the case of the prestressed beam). This load, however, could not be used to design the buttresses because other types of beams with different capacities might be tested in the future using the same setup. It was also known from tests performed by Mitchell (Mitchell, 2005) that the maximum acceleration registered when testing concrete barriers was approximately 25-g ( $805 \text{ ft/sec}^2$ ). If multiplied by the mass of the pendulum ( $58.4 \text{ lbs-sec}^2/\text{ft}$ ), a force of 47 kips is obtained. This force could not be used either because, when testing barriers, a crushable package that absorbed some energy was used. So an 80-kip force was selected because it was thought to be conservative when compared to the capacity of the beam and to the forces produced by the pendulum on previous tests. If the designed model was not able to resist an 80 kip force, it was discarded. In order to compare the distribution of forces, the same 80 kip load was applied to all models at the location where the beam was going to make contact with the buttress, and then the buttress reactions were calculated. Figure 4-5 shows the reactions produced by the applied load on the selected model.

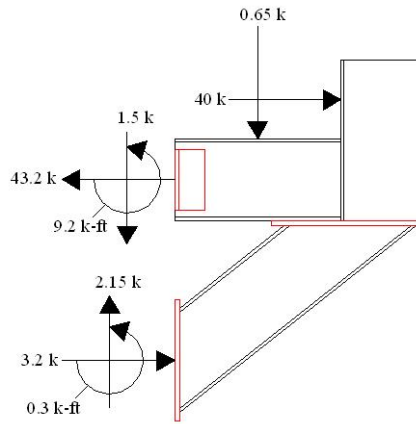
**Fig. 4-6: Reactions produced on nose of support due to the specimen's self-weight and a 40-kip rebound load.**

The front part of the support, which will be referred to as the nose, will hold the beam at a specific height and also prevent it from bouncing out of position after the initial impact. The dimensions of this part of the support played a big role in the design. This section could not be too long because it would hit the cables that hold down the pendulum frame, but it could not be too small because it would not be strong enough. Most of the design was based on geometry and the sections available at the scrap yard, and then it was checked by applying half of the load for which the A-frame was designed for acting as a rebound force. A 0.65 kip load was also applied to the design to account for half of the weight of the specimen. Figure 4-6 shows the reactions produced by these forces on the selected model. These same reactions were then applied with opposite magnitude to the buttress to verify the performance, which demonstrated the ability of the selected buttress to carry the maximum anticipated loads.

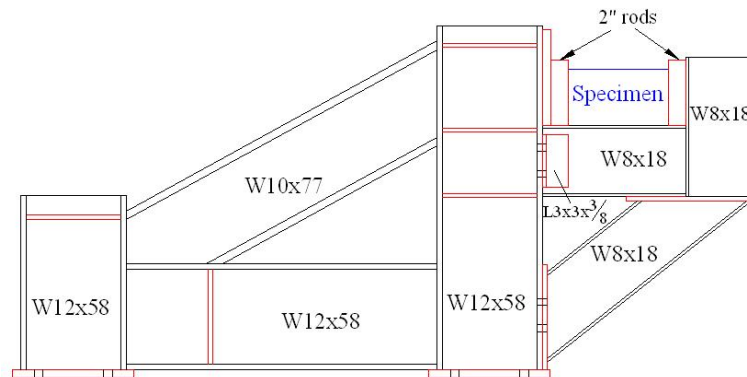
**Fig. 4-7: Final drawing for A-frames and nose (for more details refer to Appendix B).**

After obtaining the reactions and checking that the bolts to be used would not fail, 1/2-in stiffeners were added to those areas that might buckle due to the impact force. Figure 4-7 shows the final drawing for the A-frame and nose selected. More detailed information on the buttress design can be found in Appendix B. Once the design was put together, the fabrication process could begin (Figure 4-8).

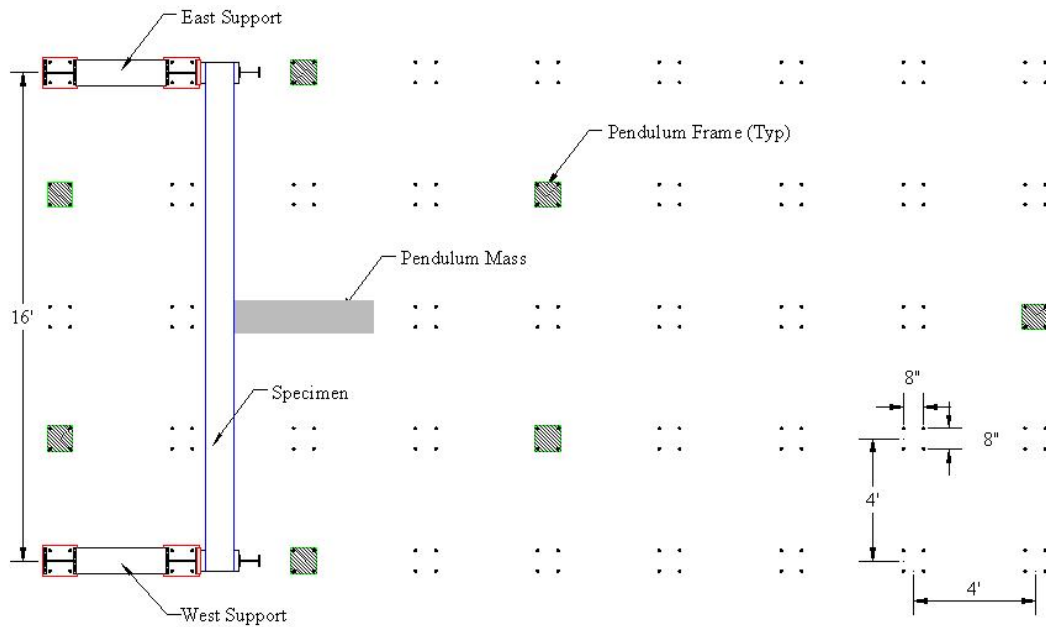
**Fig. 4-9: Plan view of test setup.**

Finally, with the two supports welded together and painted, the test setup could be assembled in the pendulum area. Each buttress was anchored to the tie-down floor using eight 1-in threaded rods (ASTM A320/A193) with a tensile stress capacity of 105 ksi. Figures 4-9 and 4-10 show a plan drawing and a picture, respectively, of the test setup configuration with a reinforced concrete beam in place.

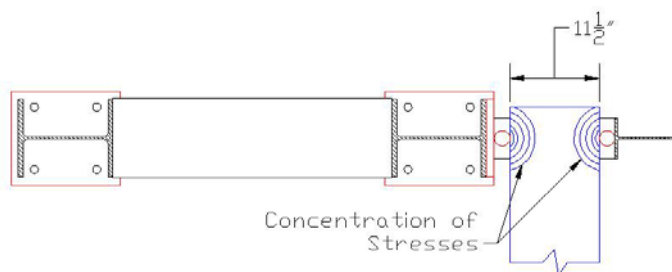
**Fig. 4-11: Concentration of stresses due to conditions of supports (plan view).**

The distance between these rods was fixed to 11.5 in, which is the depth of the specimens to be tested. However, after setting the beam in place, it was clear that there was going to be localized crushing of the concrete during an impact test due to the concentration of forces in one small location (Figure 4-11). Therefore, it was decided to insert several ½-in steel plates between the rod and the beam to increase the bearing area. In order to make this adjustment, the nose had to be separated 1 in from the A-frame. To accomplish this, some spacers were fabricated out of 1-in thick steel plates and were placed between the nose and the A-frame (Figure 4-12).

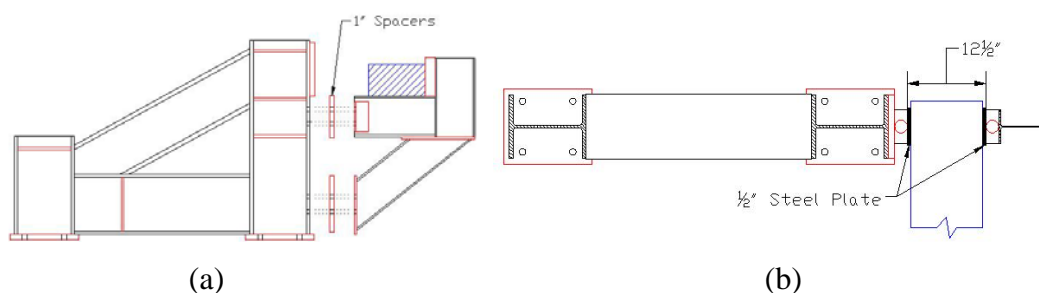
**Fig. 4-12: (a) 1-in spacers between nose and A-frame (b) ½-in plates between rods and beam (plan view).**

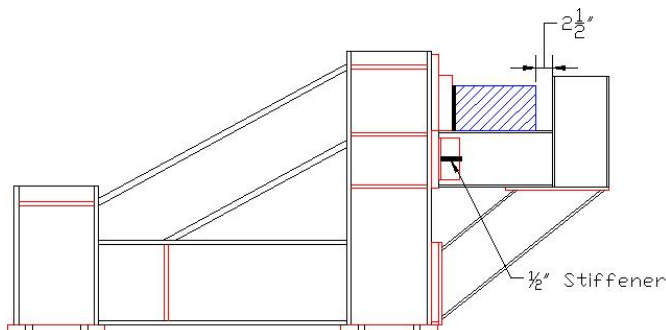
**Fig. 4-13: Modifications to the supports after the first test.**

moment restraint to the specimen. This restraint occurred because the rotation of the specimen was very large, and the space in between the rods was 12.5 in, which is exactly the depth of the beam plus the two ½-in plates. Thus, when the beam deformed there was not adequate space to allow the beam to rotate without the nose providing some restraint. The moment restriction not only caused some minor damage to the nose of the supports, but there were also some effects on the specimen that will be discussed in the next chapter. The first measure taken to correct the support conditions was to remove one of the rods in order to have a gap of 2.5 in between the specimen and the front of the nose. At first, it was thought that leaving this gap would allow the specimen to bounce or vibrate after the initial impact, but after witnessing the first test, this possibility was ruled out. The second measure taken was to strengthen the support by adding stiffeners to the angles used to bolt the nose to the rest of the A-frame. Figure 4-13 shows the modifications done to the support after the first test.

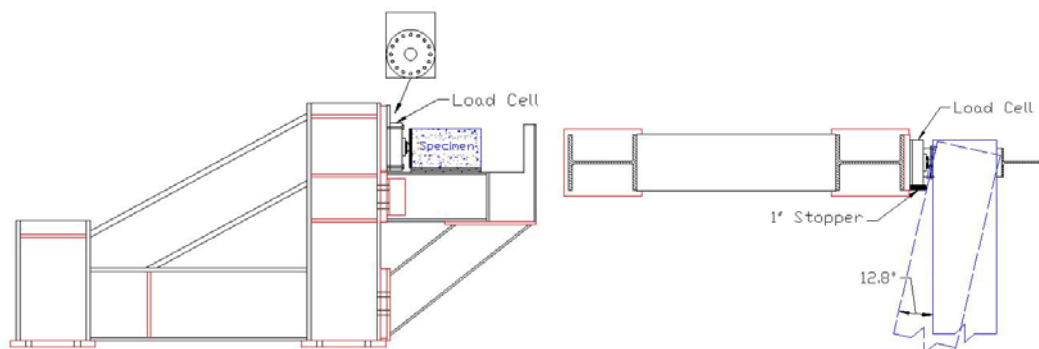
**Fig. 4-14: Modifications to the supports after the second test.**

Once the modifications were implemented, a second specimen was tested. Results from this test showed that no damage occurred to either the supports or the specimen ends. However, the supports still required some modifications in order to be able to add load cells to each of them. The first modification for adding a load cell consisted of removing the remaining rod and adding a ½-in

steel plate with tapped holes to the front part of the A-frame so the load cell could be bolted securely to the support. The second modification consisted of increasing the space where the beam is situated to be able to add a 100-kip load cell and still maintain the required gap to allow for free rotation of the specimen. In order to make this change, part of the front of the nose had to be removed (using a torch). The third measure was to add a stopper to prevent the beam from striking the load cell after the initial impact. This modification was done by welding a 1-in thick steel plate to the front part of the A-frame. The length of this plate was calculated based on allowing the beam to rotate  $12.8^\circ$  which is equivalent to a midspan deflection of 21.5-in. This rotation was the result of using the smallest possible stopper, which was 4 in in length. Anything smaller than 4 in would not protect the load cell, and anything bigger would limit the maximum allowable rotation.

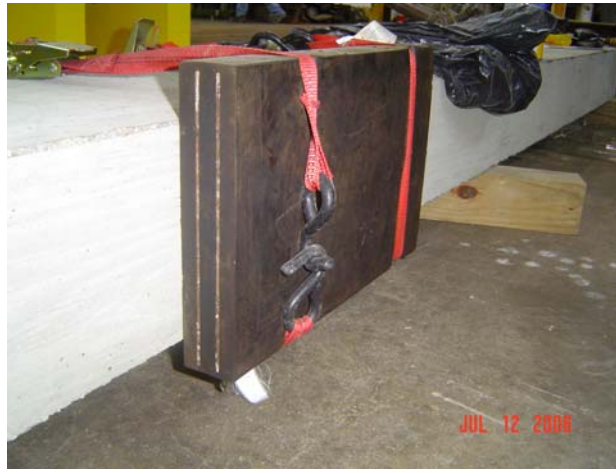
*Fig. 5-1: Neoprene pad bonded to beam; straps are only used while epoxy sets.*

The first specimen tested was a reinforced concrete beam. The main purpose of this test was to verify that all the instrumentation worked properly and that the supports behaved in an adequate manner. Because this was the first test of its kind with the impact test pendulum, there was some concern about damaging the pendulum mass due to a direct impact with the beam. As a result, a 2-in neoprene pad was bonded to the beam using a high-strength epoxy (Figure 5.1). This problem did not exist when using the pendulum to test concrete barriers because a crush package that absorbed some of the energy before the impact was welded to the pendulum mass. The drop height used for testing the reinforced concrete beam was 15 ft with respect to the ground; this height is equivalent to 12 ft with respect to the pendulum mass.

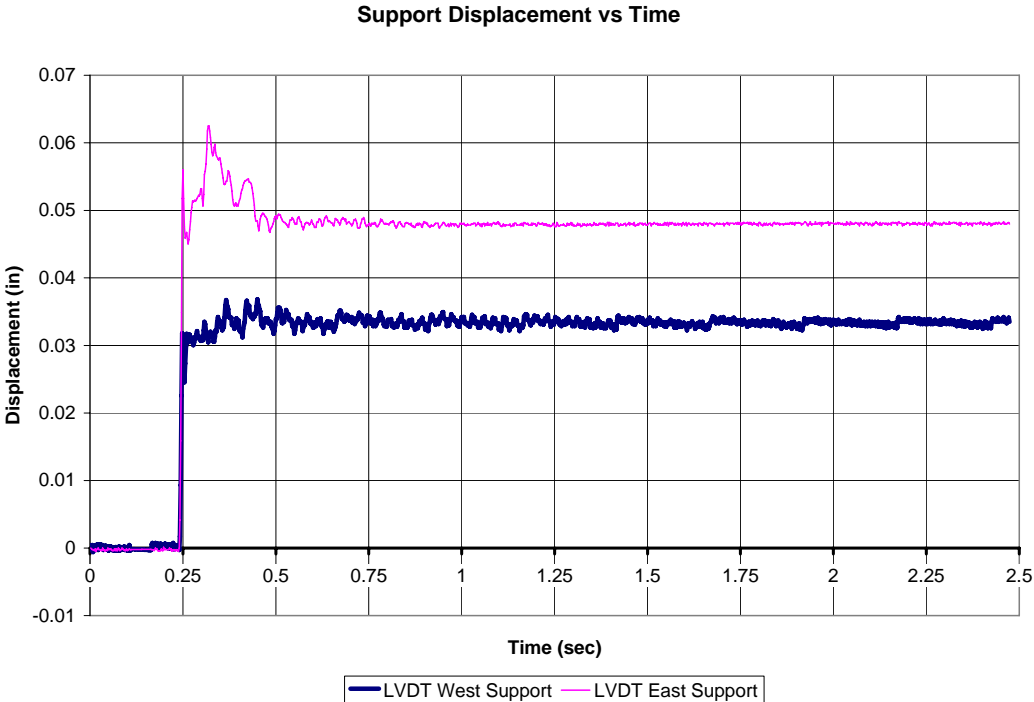
*Fig. 5-2: Support displacement obtained from the first test performed.*

After performing the test, there were many significant observations. The neoprene pad served its purpose, and the pendulum mass suffered no damage. In addition, the neoprene pad fell after the initial impact without any damage and could be easily reused. An important limitation of this test was that there was not much information obtained regarding the instrumentation used because the data acquisition system was set to a sampling rate of 500 cycles per second (Hz), instead of 5000 Hz, which is the rate typically used when testing with the pendulum. Using a high sampling rate ensures that there will be enough data points collected during the short duration of the impact of the pendulum, which only lasts approximately 0.05 seconds. Even with the small amount of data obtained from the LVDTs at the supports, it was clear that the support displacement (Figure 5-2) was insignificant compared to the amount of displacement occurring at midspan. It is difficult to know the exact displacement that occurred at midspan because the pendulum not only failed the beam, but it also pushed it until it fell from the supports. However, by inspecting the video recorded from the overhead traveling crane, it is possible to make a rough

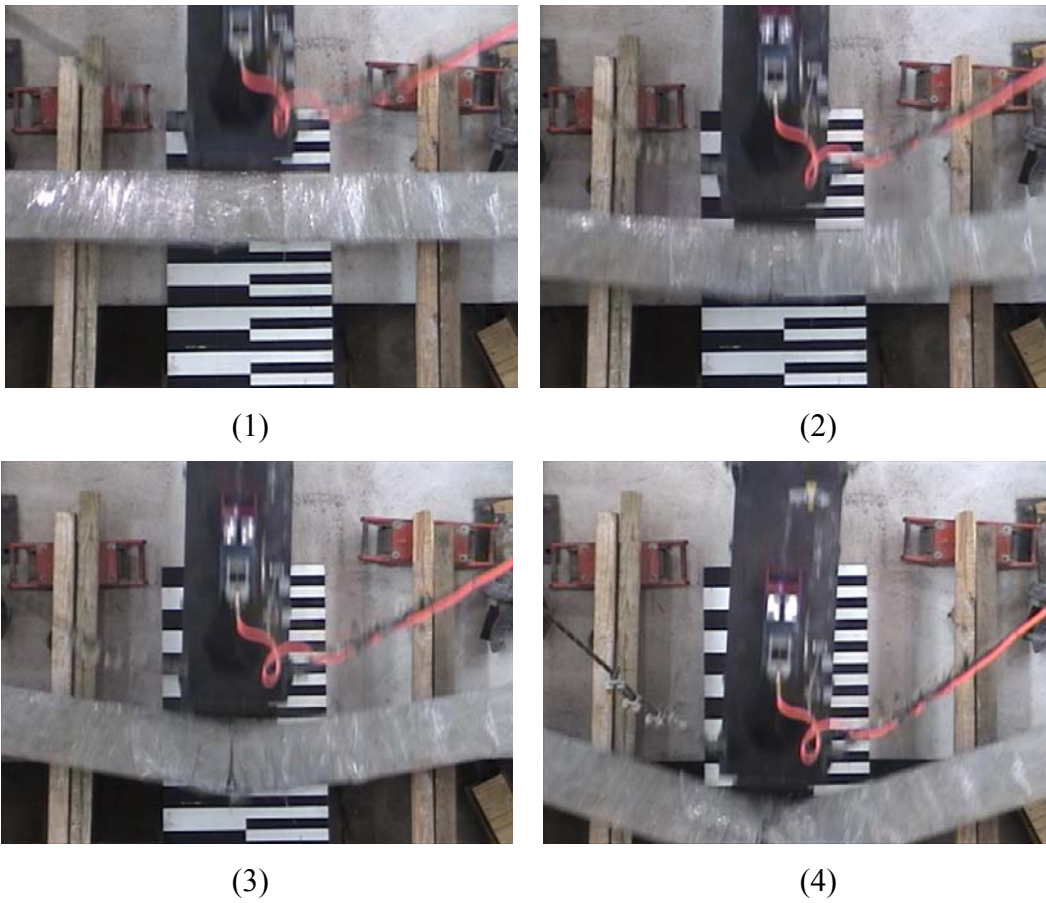
***Fig. 5-3: Video frames recorded from the overhead traveling crane.***

estimate of the magnitude. Figure 5-3 shows four frames obtained from the video of the test. The large black and white rectangles each measure 4 in, and the small ones measure 2 in. Based on this scale, it can be determined that the midspan deflection was larger than 28 in.

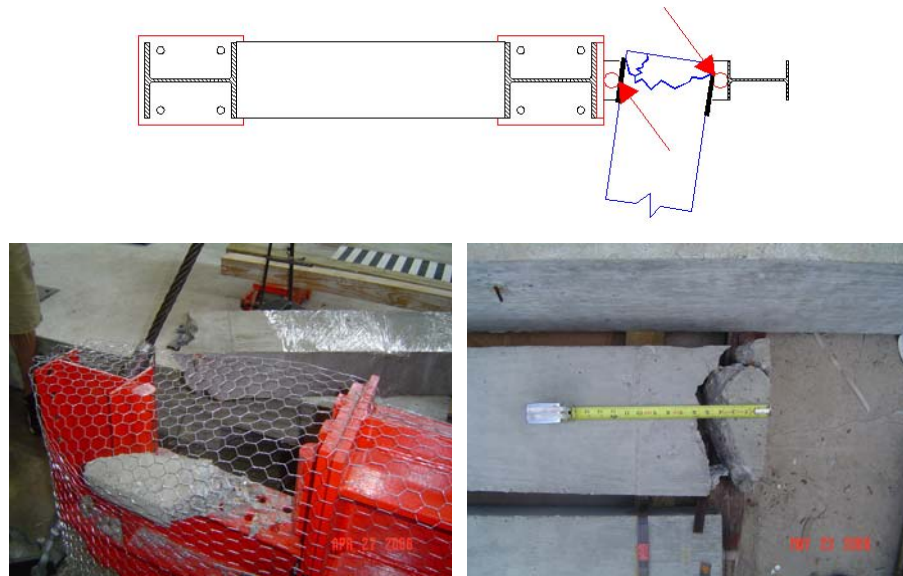
***Fig. 5-4: Local damage to east end of the beam.***

Although the A-frame supports performed well, the nose of the supports restricted rotation at the ends of the beam, and some minor damage occurred to the nose of the east support. As mentioned in the previous chapter, this problem was corrected by removing a roller, but the specimen also suffered a local failure at one of the ends (Figure 5-4), which required another modification.

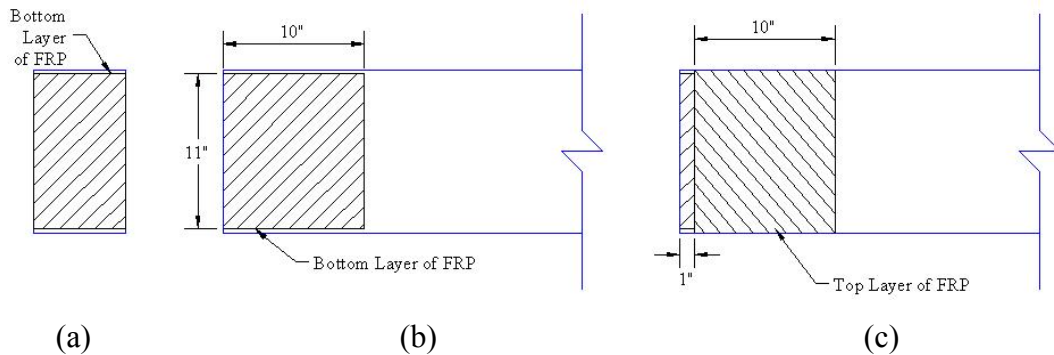
**Fig. 5-5: (a) Bottom layer of FRP cross section view. (b) Bottom layer of FRP longitudinal view. (c) Top layer of FRP longitudinal view.**

To prevent local failure at the ends, additional steel was included in the second reinforced concrete specimen as mentioned previously in Chapter 3. Because it was unknown if the additional steel was going to be sufficient to prevent failure at the ends, it was decided to add external reinforcement. Several options were considered, but most of them involved the purchase of material and adequate construction time. One of the options included the use of Fiber Reinforced Polymer (FRP), which is an expensive material. However, Ferguson Laboratory had adequate supplies in stock that were available for use. In addition, FRP can be easily installed in a short period of time. Therefore, it was decided to use this material on the next specimen to evaluate its behavior. As can be seen from Figure 5-5, two layers of FRP were used; the bottom layer wrapped the beam 10 inches in the longitudinal direction, and the top layer wrapped the beam 10 inches in the transverse direction.

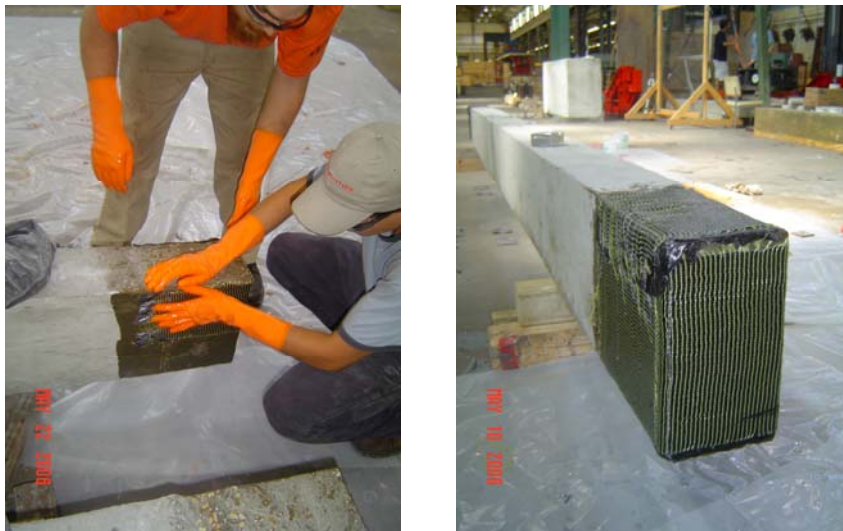
***Fig. 5-6: Placing of FRP fibers on reinforced concrete beam.***

The second specimen tested was also a reinforced concrete beam. This specimen was reinforced at the ends with FRP as shown in Figure 5-6. The purpose of this test was to verify that the modifications to the supports eliminated the moment restraint observed during the first test, that the FRP installed would prevent local failure at the ends, and that the instrumentation used worked properly since on the first test this could not be verified due to the small sampling rate used. The drop height used for this test was also 15 ft with respect to the ground.

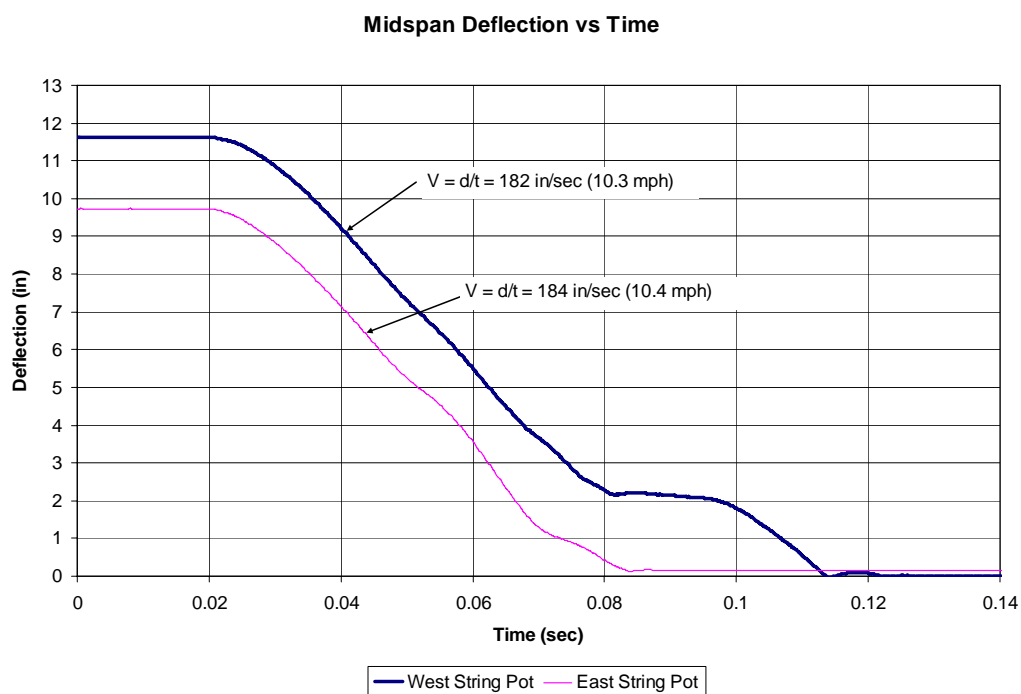
***Fig. 5-7: Midspan deflection registered by string potentiometers.***

On this occasion, enough data points were obtained from the data acquisition system, and most instruments provided some useful information. The LVDTs located on the supports indicated that there were insignificant support displacements. Therefore, the displacement registered on the previous test can be interpreted as the settling of the supports after which there will be no additional considerable movement. The string potentiometers located at midspan registered the data used to obtain the chart presented in Figure 5-7. The difference in the initial condition is due to the fact that the string potentiometer on the west side has a 15-in run and was initially extended about 11.5 in while the one on the east has a maximum capacity of 10 in and was extended approximately 9.75 in. After the impact, the string potentiometer cables reeled back all the way to zero

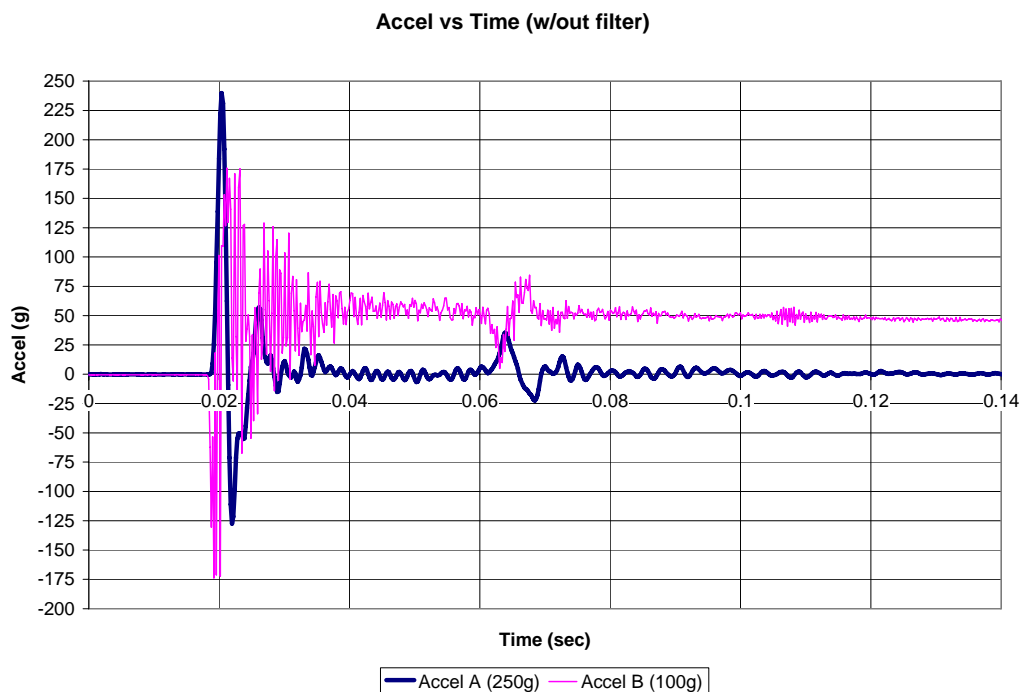
***Fig. 5-9: Unfiltered acceleration profile.***

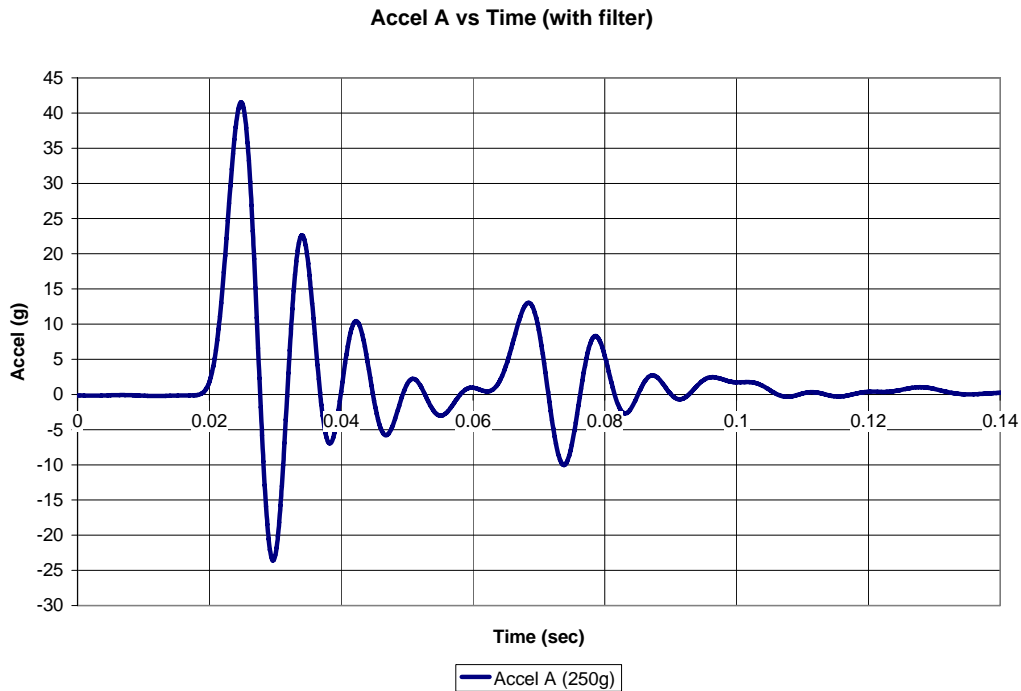
***Fig. 5-10: Filtered acceleration profile.***
