**Development of an Experimental Setup for Testing Scaled  
Versions of AASHTO Type IV Girders under Dynamic Impact  
Loadings**

**Departmental Report**

**The University of Texas at Austin**

**August 2006**

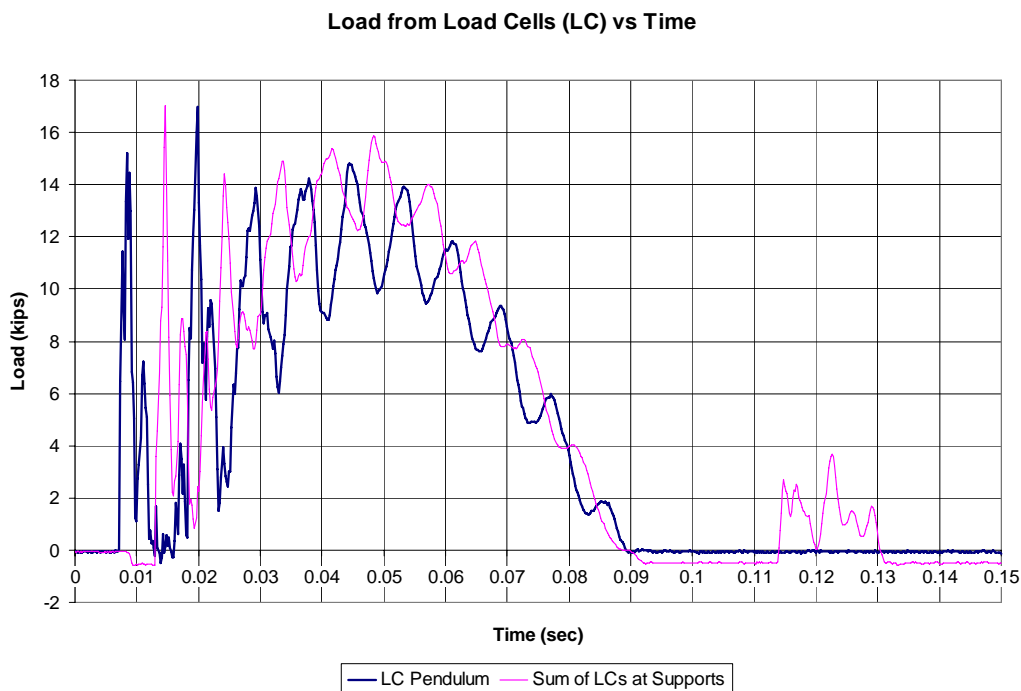
**Fig. 5-11: Load profile obtained from load cells (LC) at supports and front of pendulum mass.**

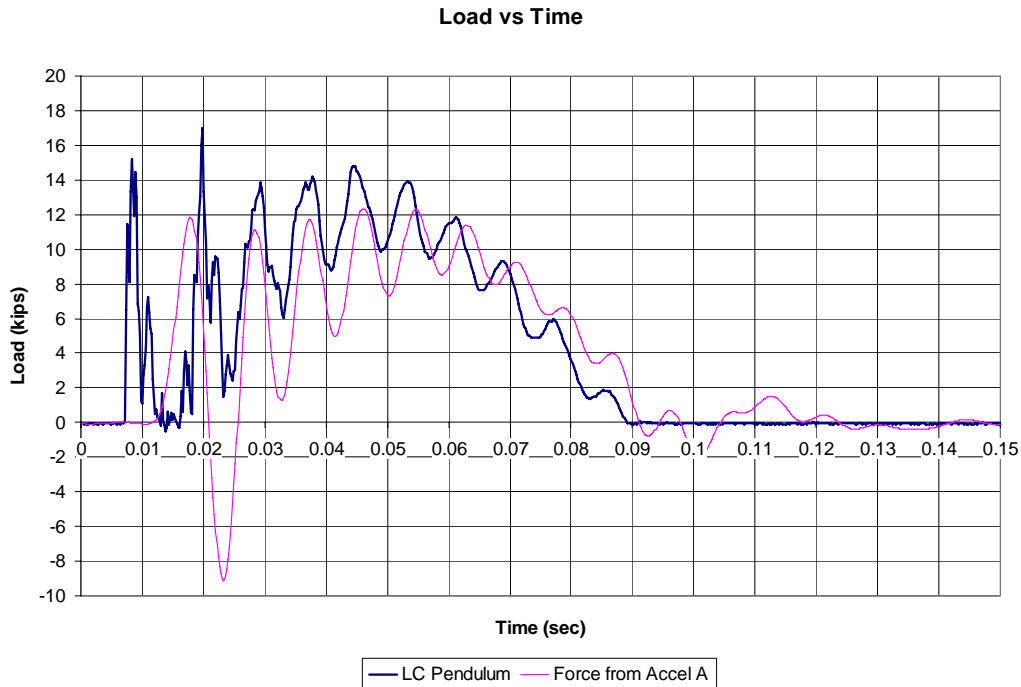
***Fig. 5-12: Load profile obtained from load cell (LC) in front of pendulum and from acceleration profile (6-in drop height).***

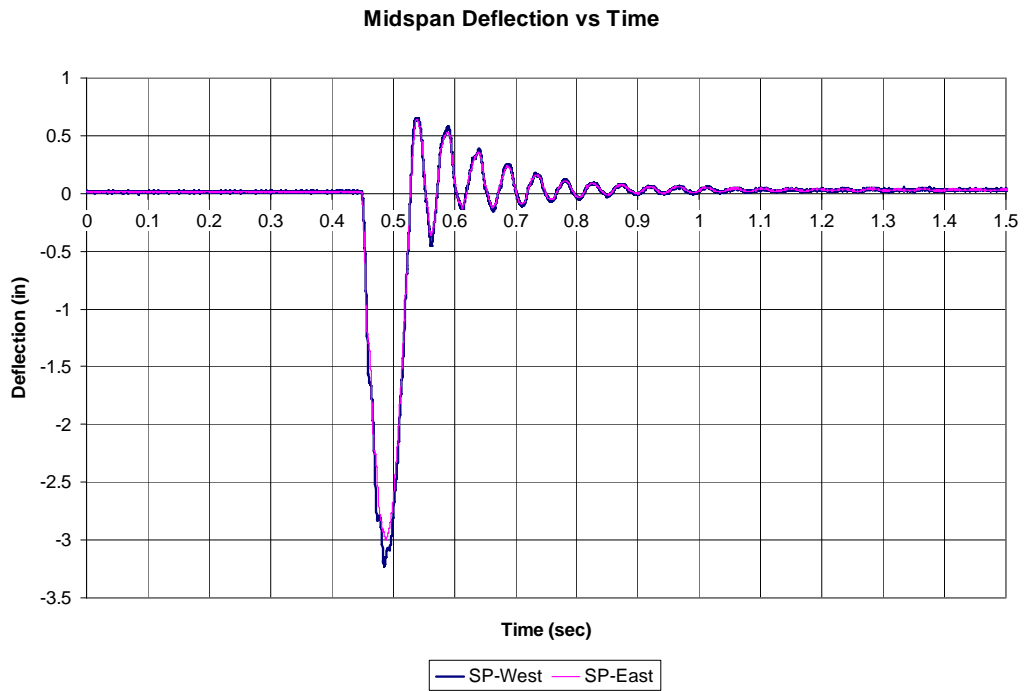
**Fig. 5-13: Midspan deflection measured using string potentiometers (SP).**

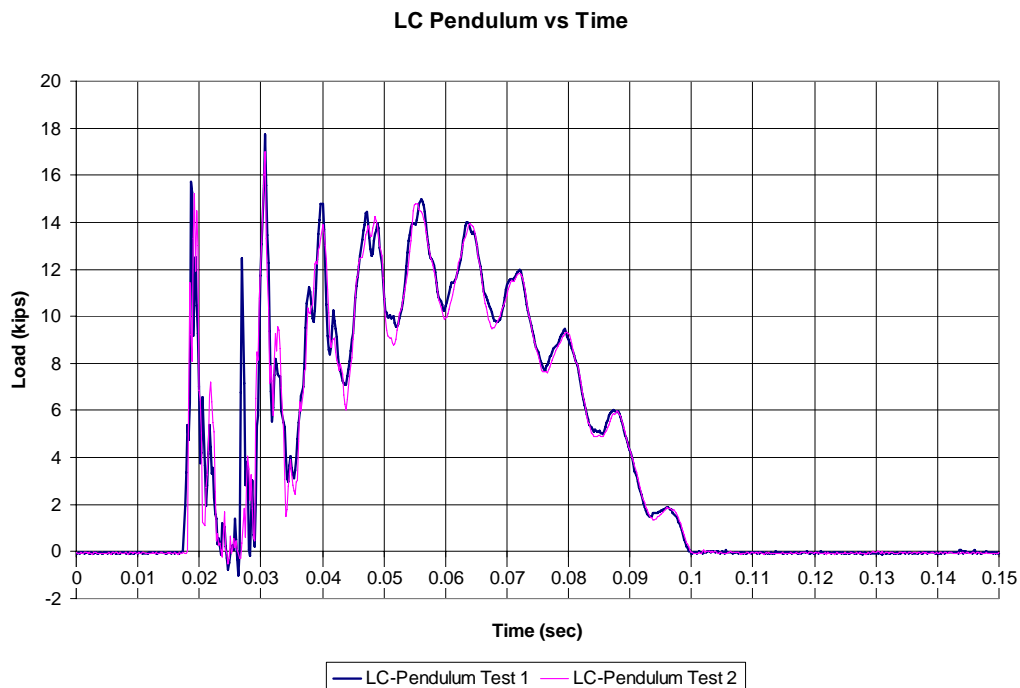
**Fig. 5-15: Load comparison between first two tests.**

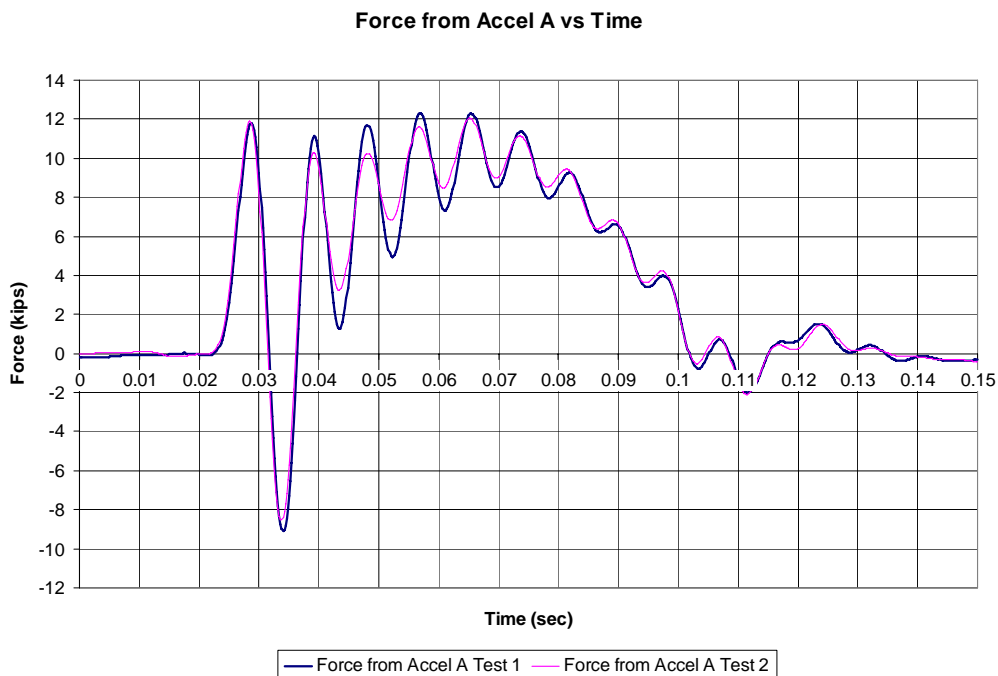
**Fig. 5-16: Force profile for first two tests obtained from acceleration data.**

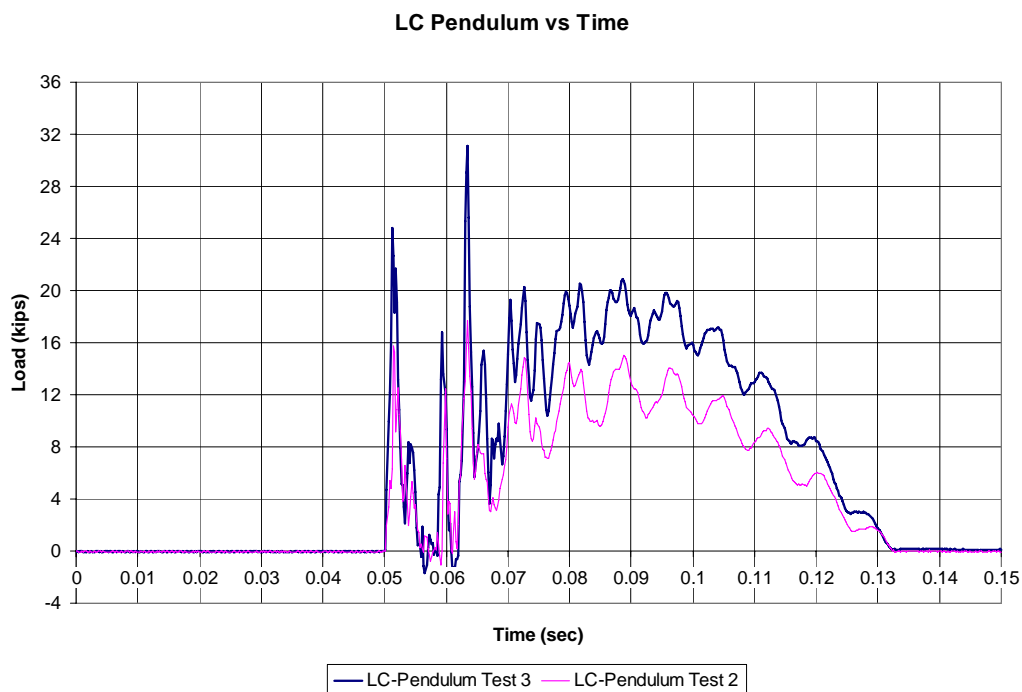
**Fig. 5-18: Load comparison between test 2 (6-in drop height) and test 3 (12-in drop height).**

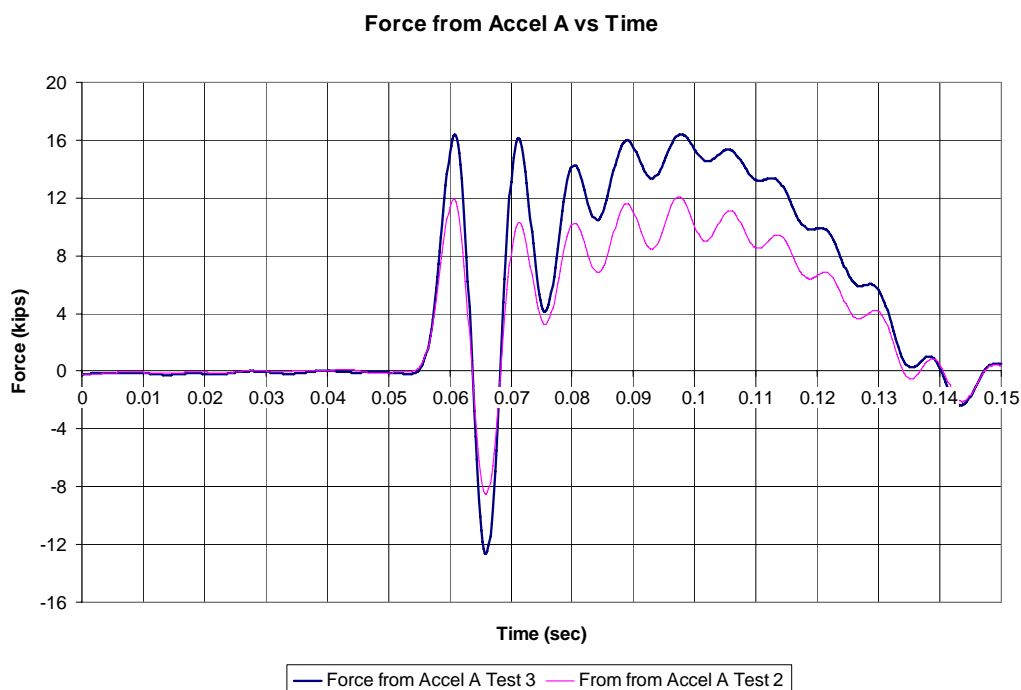
**Fig. 5-19: Force profile for test 2 (6-in drop height) and test 3 (12-in drop height).**

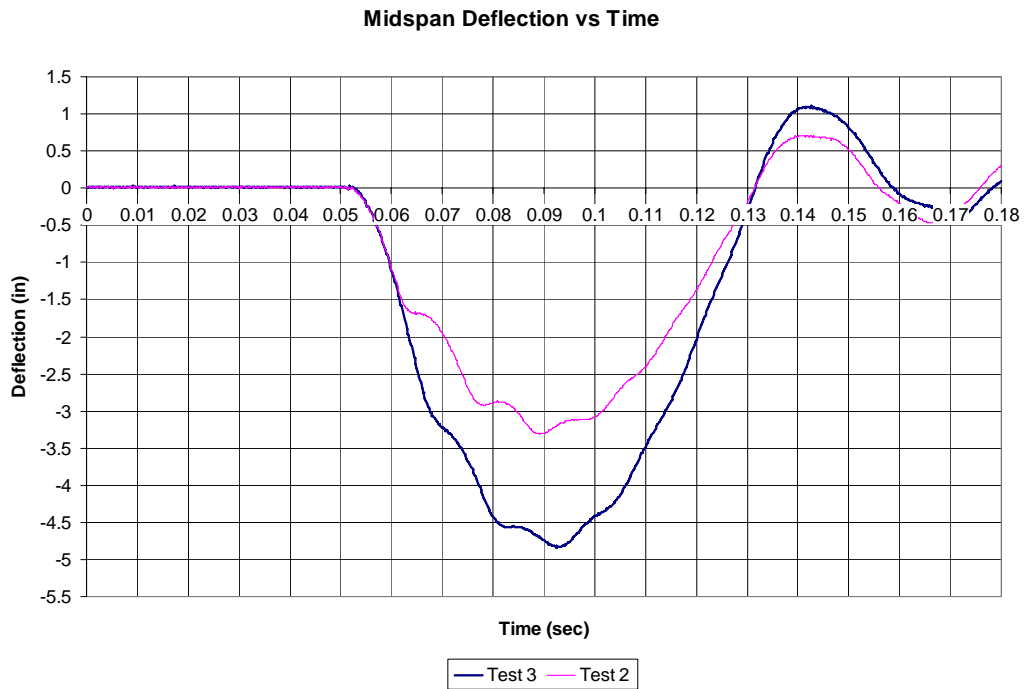
*Fig. 5-20: Midspan displacement for test 2 (6-in drop height) and test 3 (12-in drop height).*

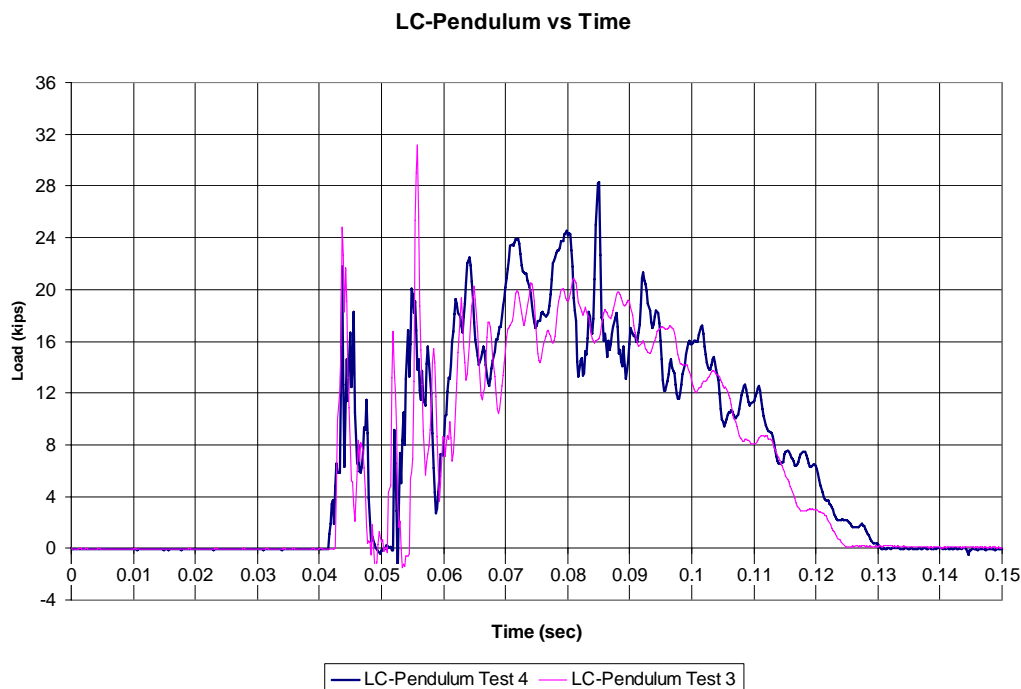
**Fig. 5-22: Load comparison between test 3 (12-in drop height) and test 4 (18-in drop height).**

For the last test performed on the laminated lumber beam, the pendulum mass was raised to 18 in. This test was the last one performed because the impact caused partial failure of the beam, and, for safety reasons, it was decided not to perform another test with the same specimen. Figure 5-22 compares the loads recorded by the load cell on the pendulum mass for test 3 and test 4. The overall behavior is similar to the previous tests, but unlike before, the maximum load occurs at a different time. This result occurs because the beam fails after the initial impact. The same behavior as the previous test was obtained for the load cells on the supports; the sum of the two forces was 1.7 kips lower than that registered by the load cell on the pendulum mass. Reasons for this difference were previously addressed.

Figure 5-23 shows the force profile obtained from the acceleration data for the three different drop heights used: 6 in, 12 in, and 18 in. Unlike the load profile presented in Figure 5-22, the maximum forces for the three tests are obtained at the same period of time, and, as expected, test 4 shows a higher force than test 3. The load profile obtained from the load cell data and the force profile obtained from the acceleration data do not show any signs of whether the specimen failed or not. Figure 5-24 shows the specimen after it partially failed.

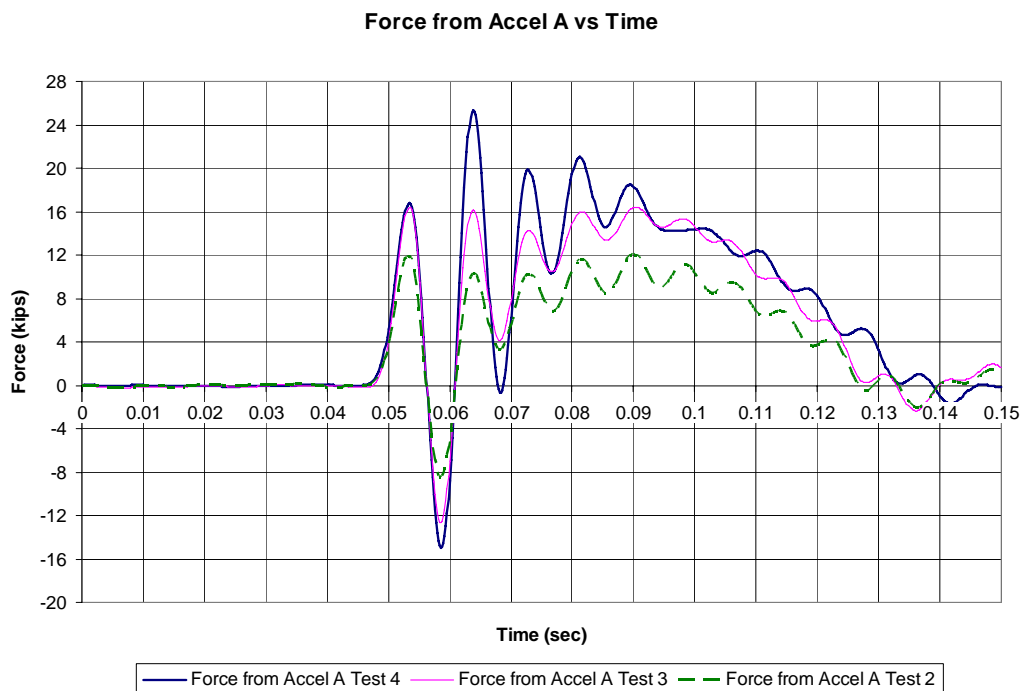
***Fig. 5-23: Force profile for test 2 (6-in drop height), test 3 (12-in drop height) and test 4 (18-in drop height).***

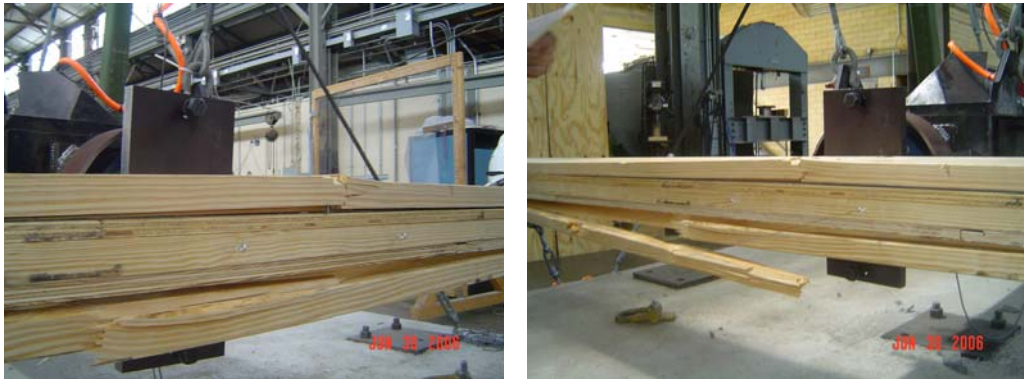
*Fig. 5-24: Pictures of laminated lumber beam after final test.*

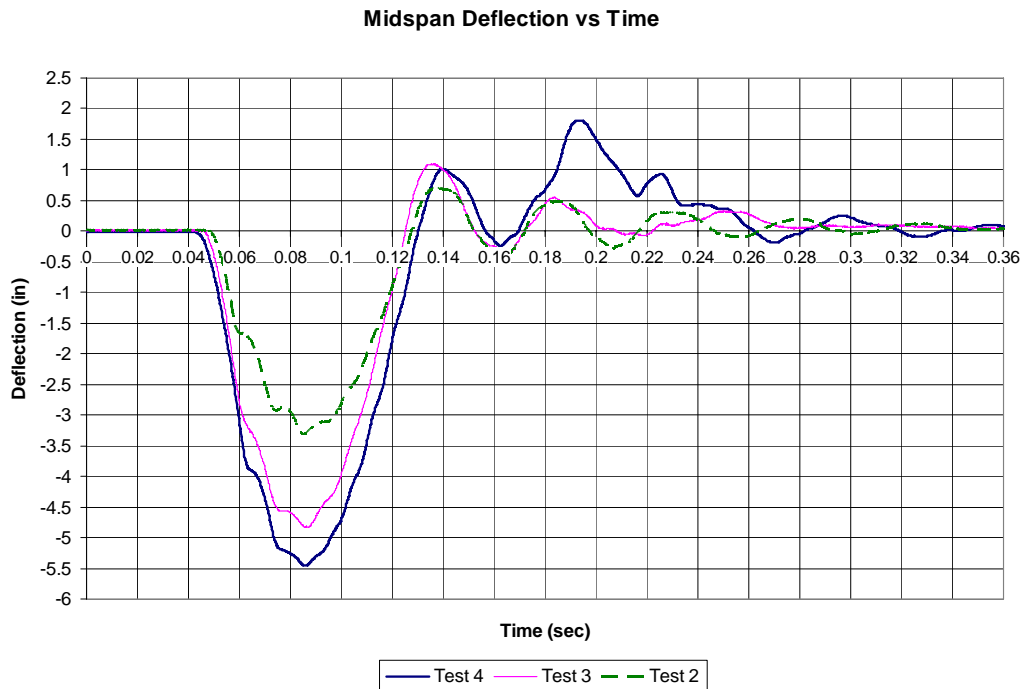
**Fig. 5-25: Midspan displacement for test 2 (6-in drop height), test 3 (12-in drop height) and test 4 (18-in drop height).**

The midspan deflections for the three different drop heights are presented in Figure 5-25. As it can be seen for all tests, after the initial impact, the beam vibrated back and forth about the zero axis until it comes to rest. However, for test four with a drop height of 18 in, the vibration does not only occur along the zero axis due to the fact that the beam partially failed. Nevertheless, it can be seen there was no permanent deformation associated with test four.

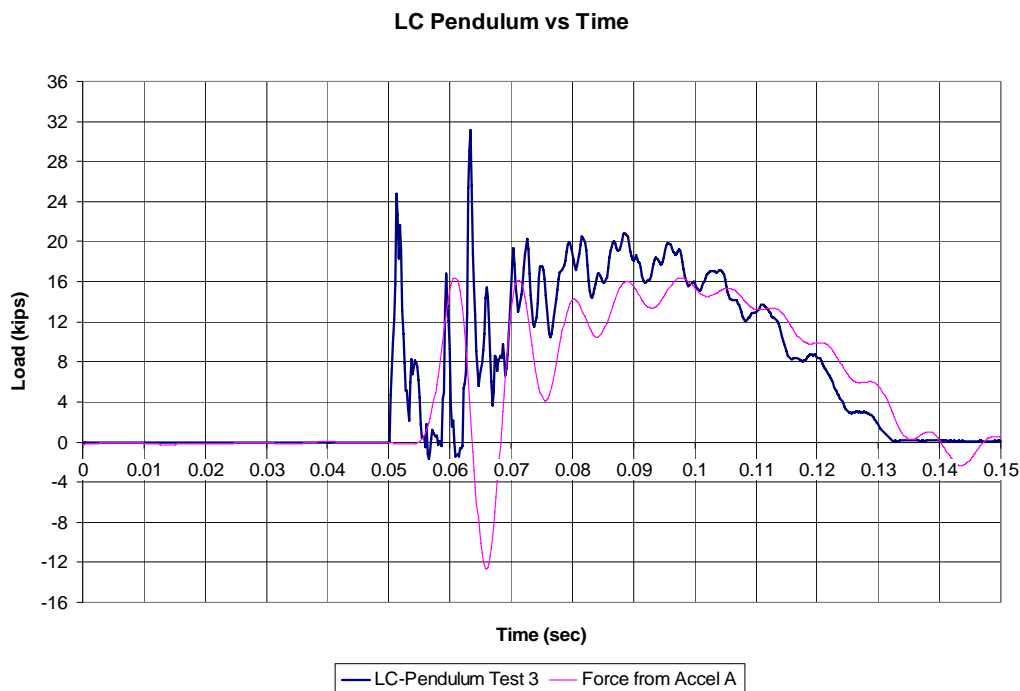
***Fig. 5-26: Load profile obtained from load cell (LC) in front of pendulum and from acceleration profile (12-in drop height).***

After analyzing the data obtained from the load cell located in front of the pendulum and comparing it with the one obtained from the accelerometer on the pendulum mass, it is difficult to conclude which one is better. However, by looking at Figure 5-12, 5-26, and 5-27 it can be seen that the load cell data has two very high peaks at the beginning of the profile, and if these two peaks are ignored, the load profiles are very similar. Therefore, any of the two can be used to compute the system response. However, as mentioned before, it is still recommended that the filter is reviewed in order to verify that response data is not being lost with this process.

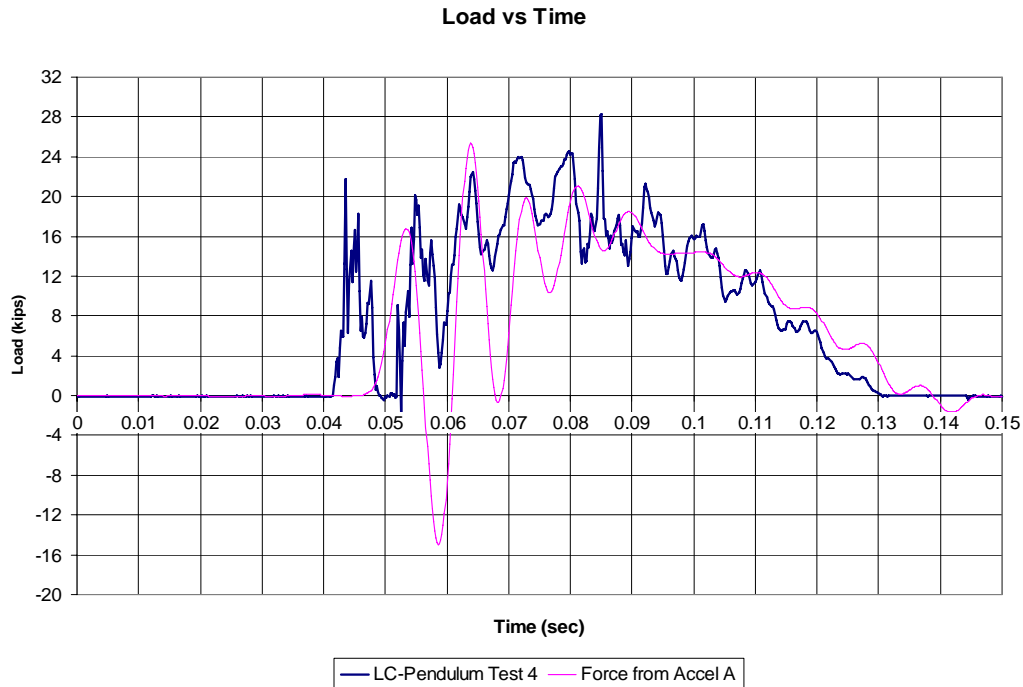
***Fig. 5-27: Load profile obtained from load cell (LC) in front of pendulum and from acceleration profile (18-in drop height).***

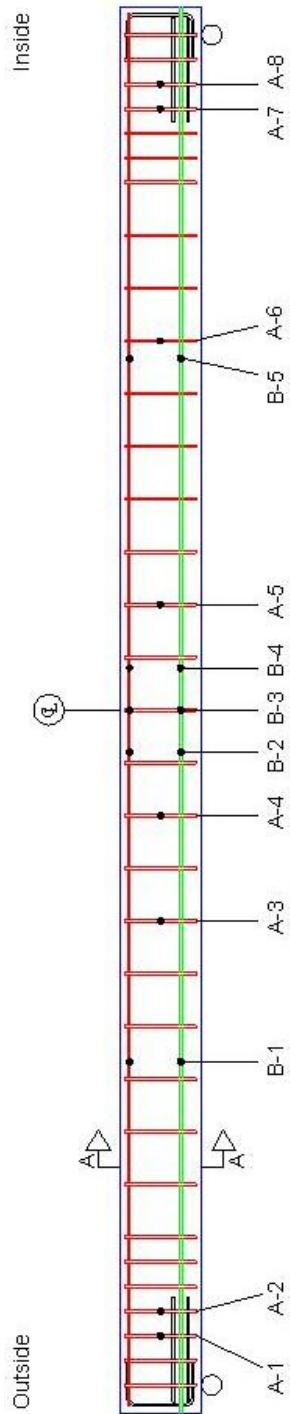
**Fig. B-3a: Location of stain gauges in prestressed beam (see Fig. B-3b).**

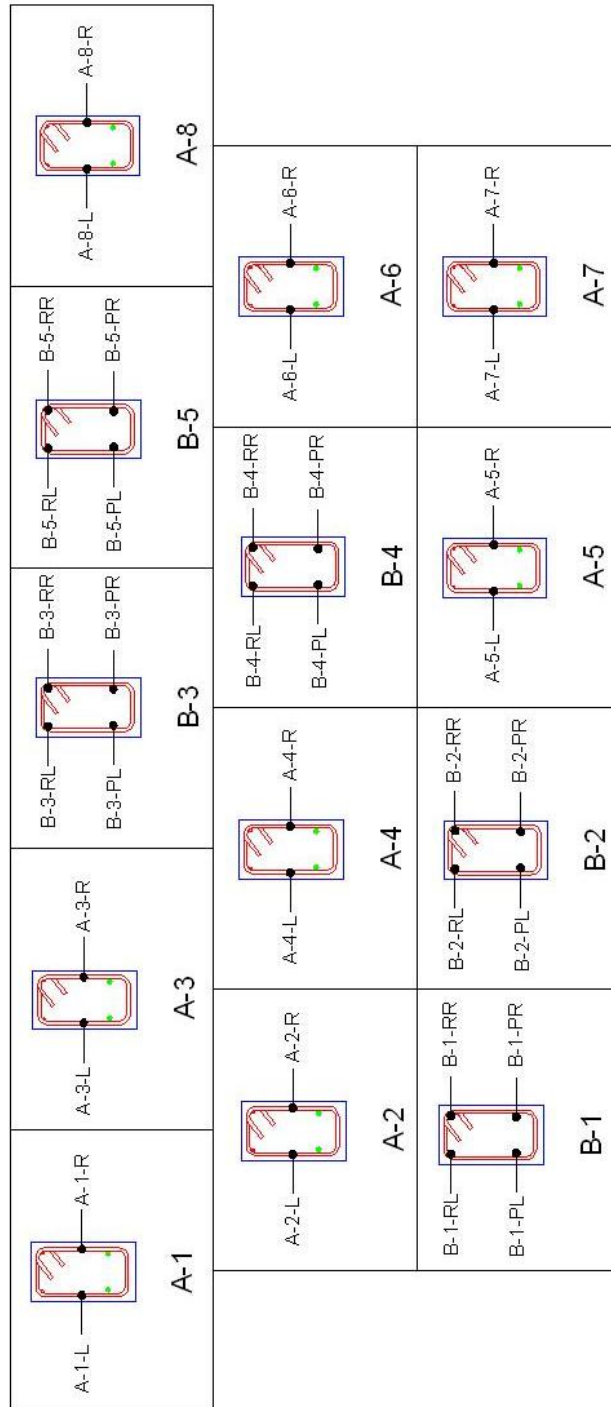
Fig. B-3b: Location of stain gauges in prestressed beam (see Fig. B-3a).

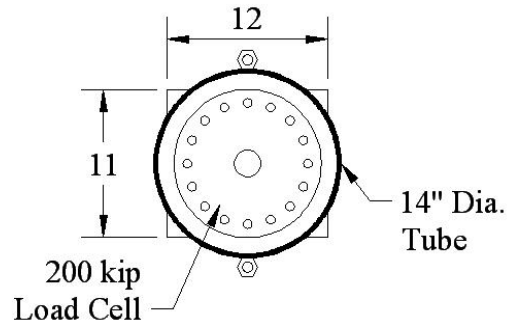
**Fig. B-4: 200 kip load cell located in front of pendulum mass.**

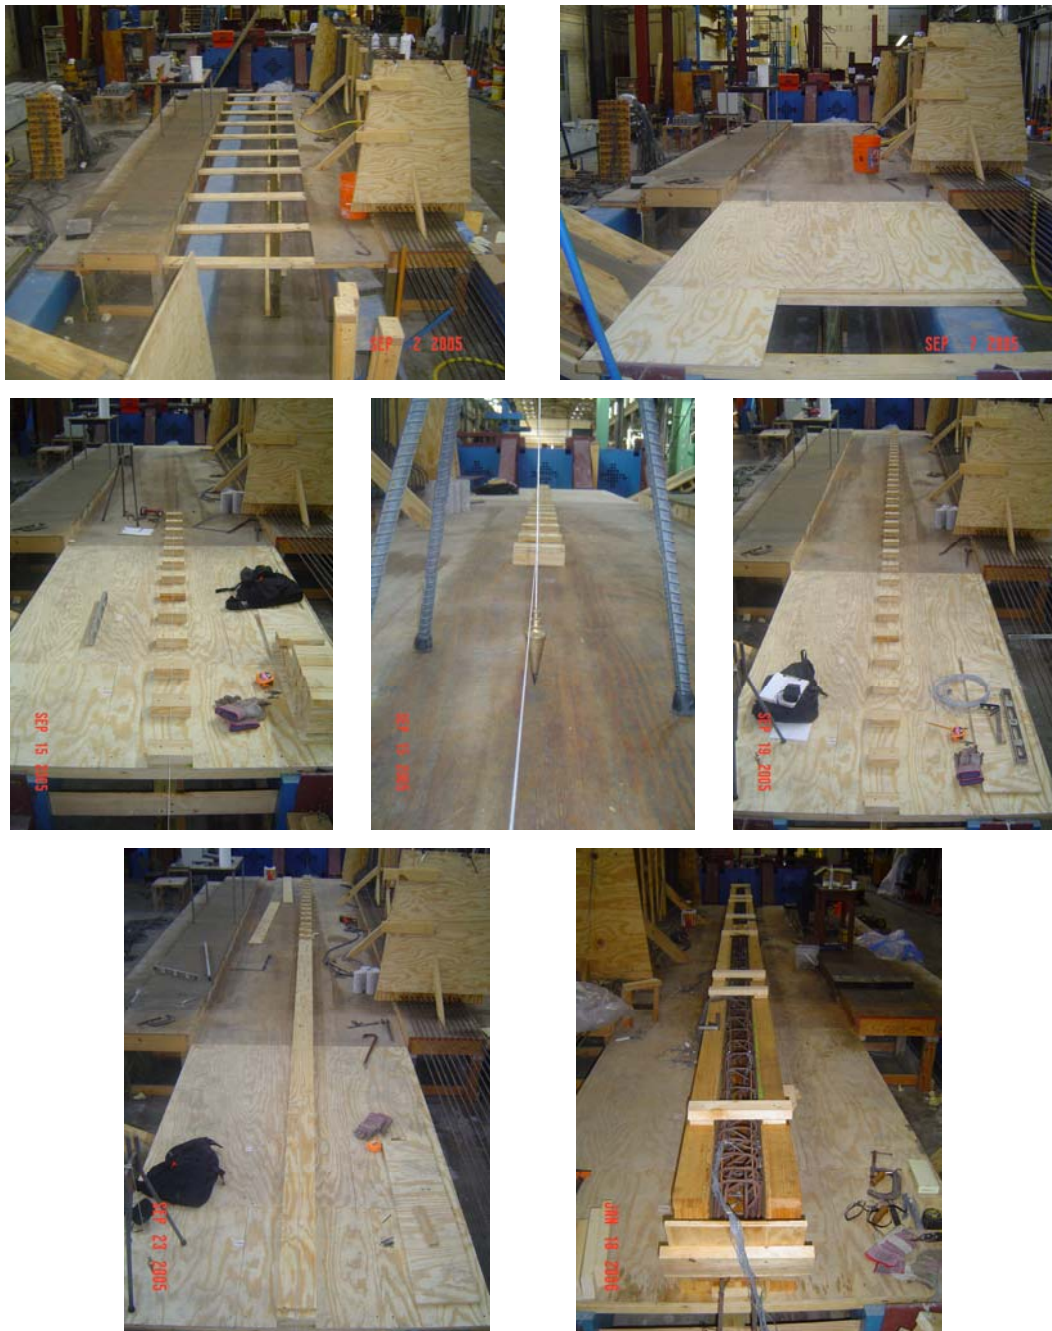
*Fig. C-6: Formwork for prestressed beams.*

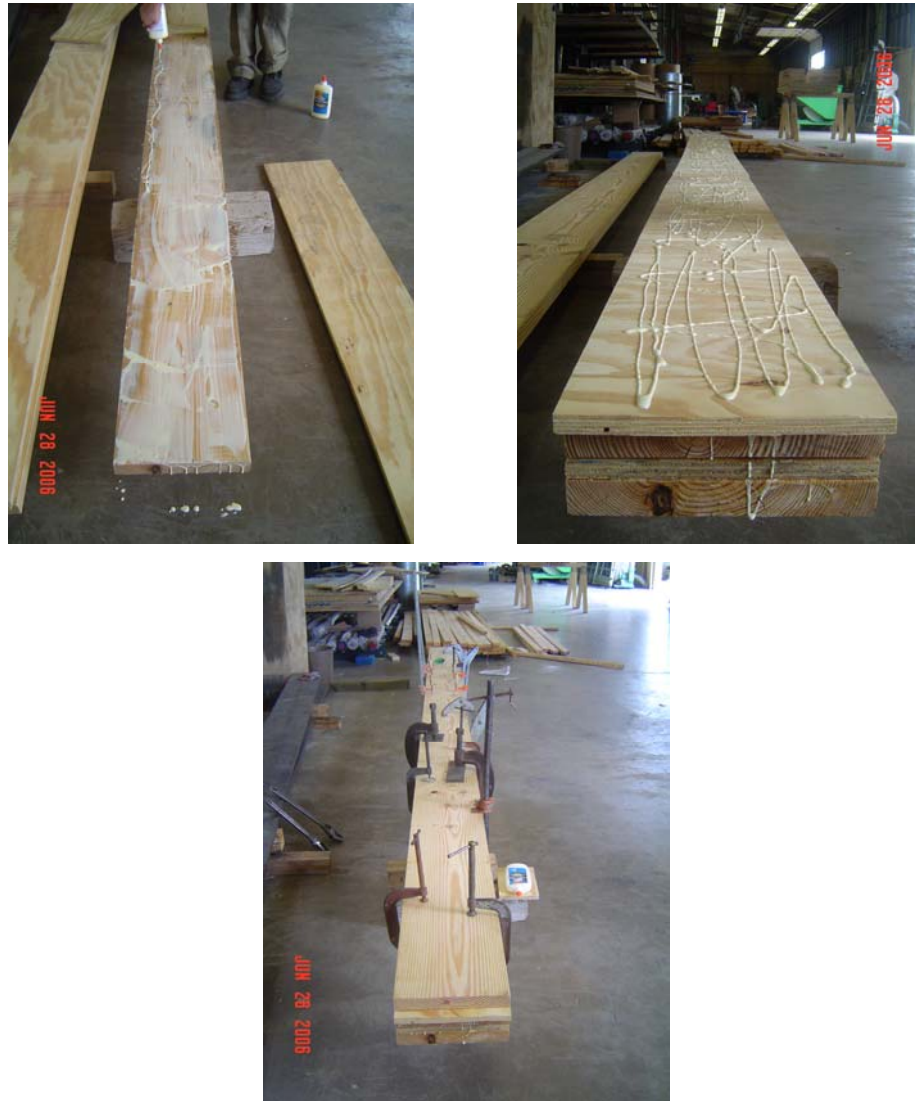
*Fig. C-17: Fabrication of laminated lumber beam.*

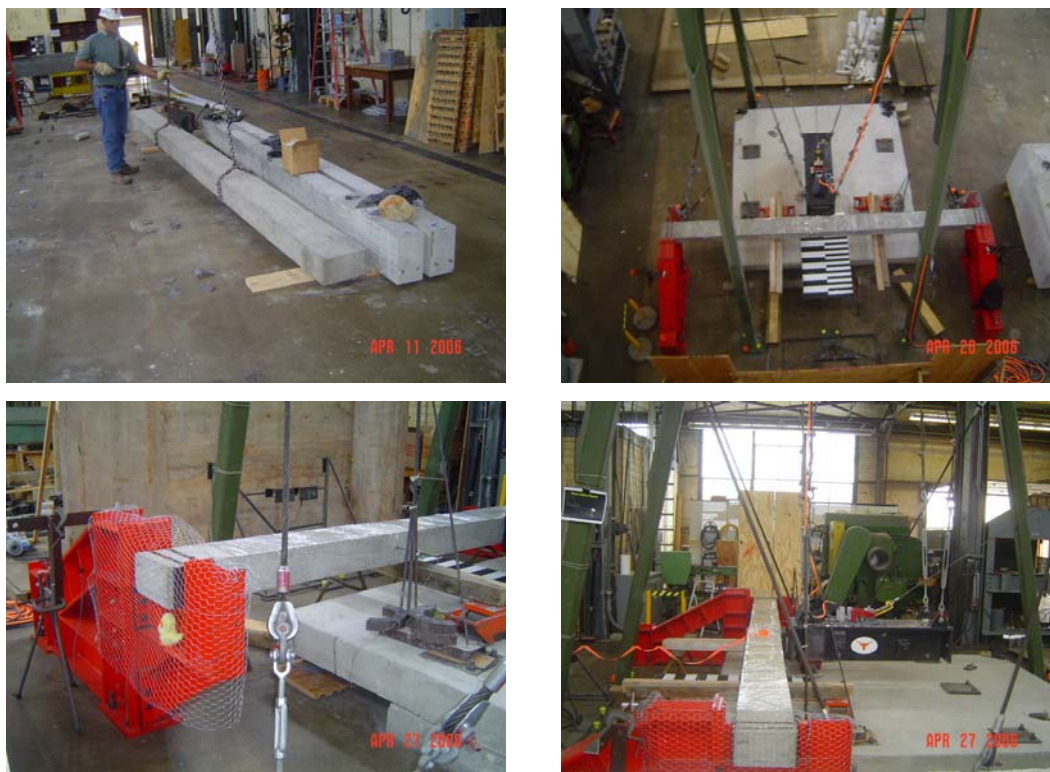
*Fig. C-18: Test setup for first specimen.*

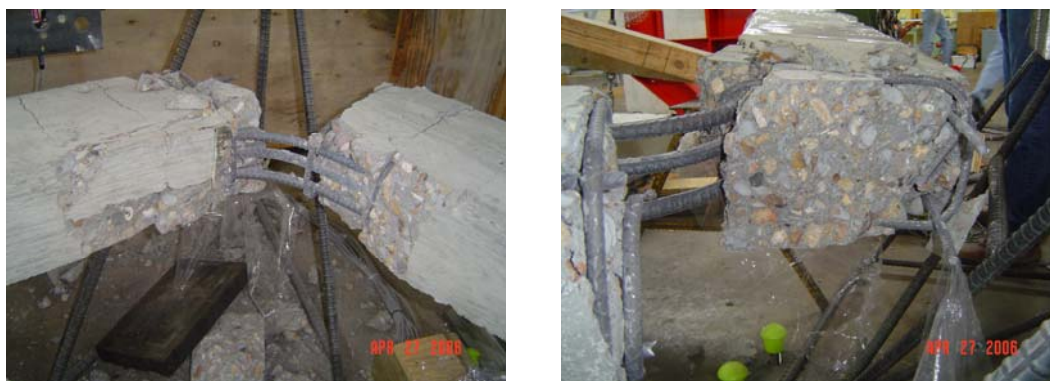
*Fig. C-19: Midspan failure.*

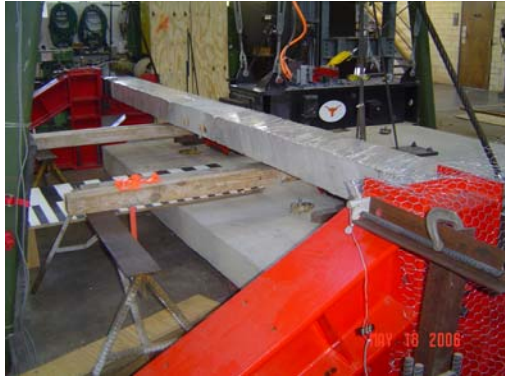
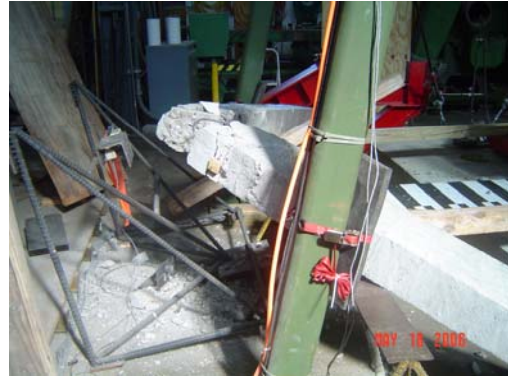
*Fig. C-20: (a) LVDT at support (b) Conditions of test setup after impact.*

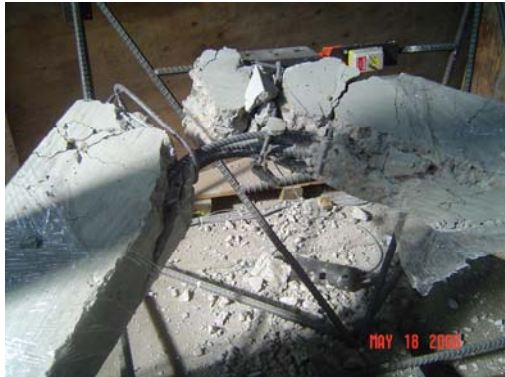
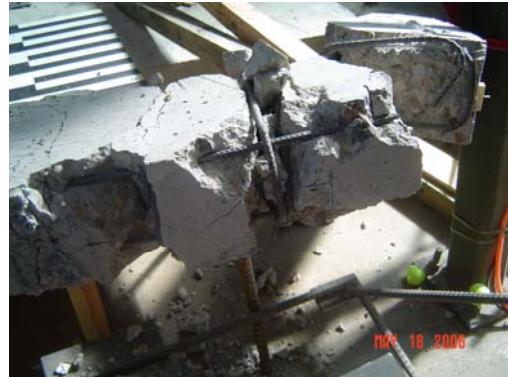
*Fig. C-21: Midspan failure.*

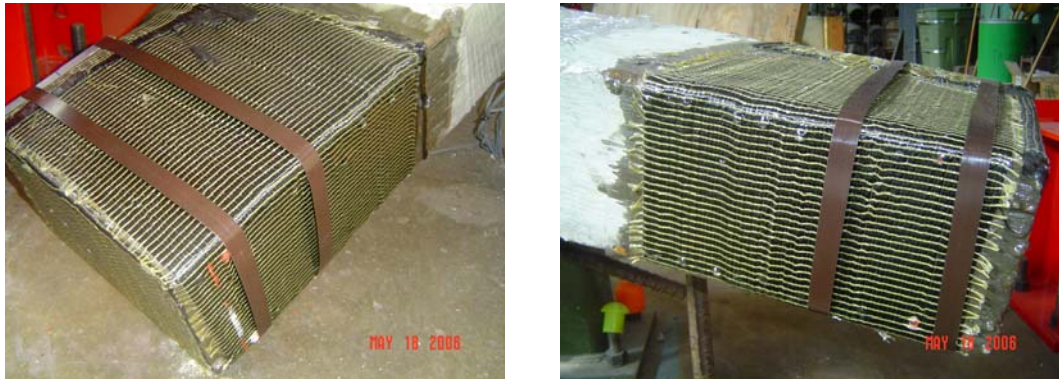
*Fig. C-22: Ends of beam after test.*

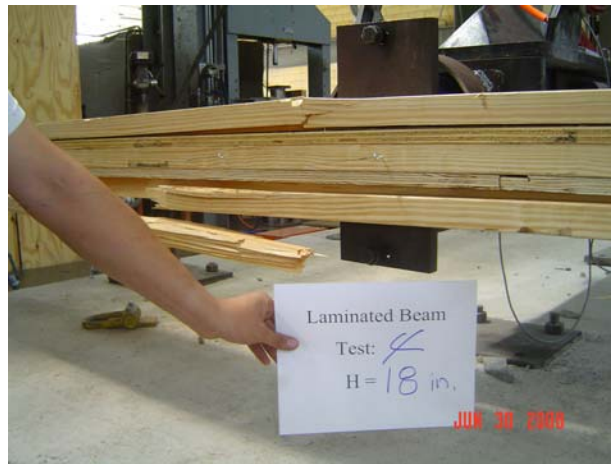
*Fig. C-26: Failure of laminated lumber beam.*

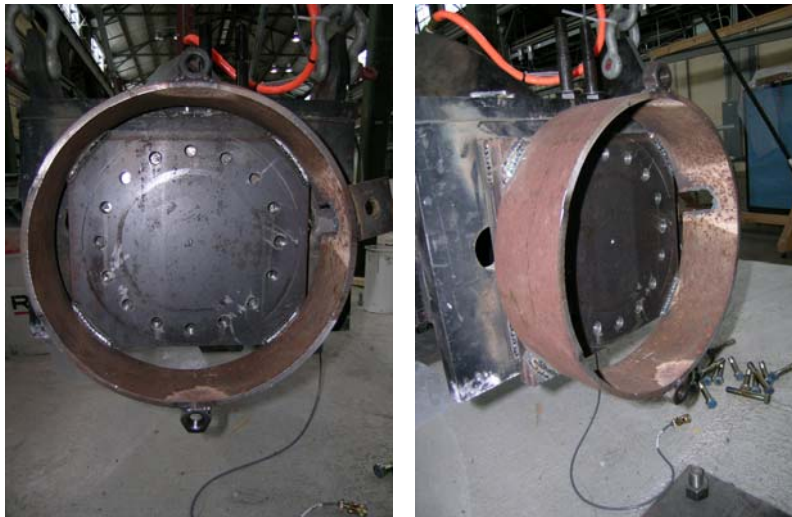
*Fig. C-27: Protection ring for load cell in front of pendulum mass.*
