**Bridges with Premature Concrete Deterioration:
Fatigue Testing of Full-Scale, Prestressed Concrete Box Girders
Failing in Shear**

Thesis

**The University of Texas at Austin
May 2001**

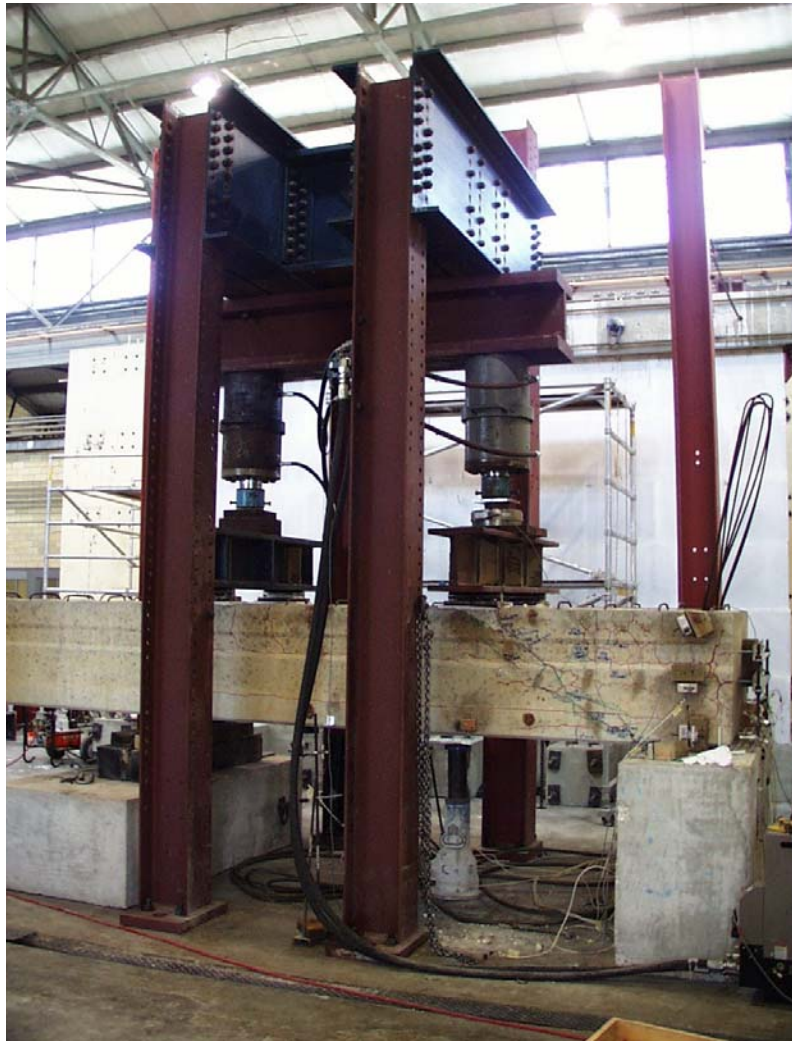
Figure 3.3 Loading setup for shear-dominated fatigue specimens

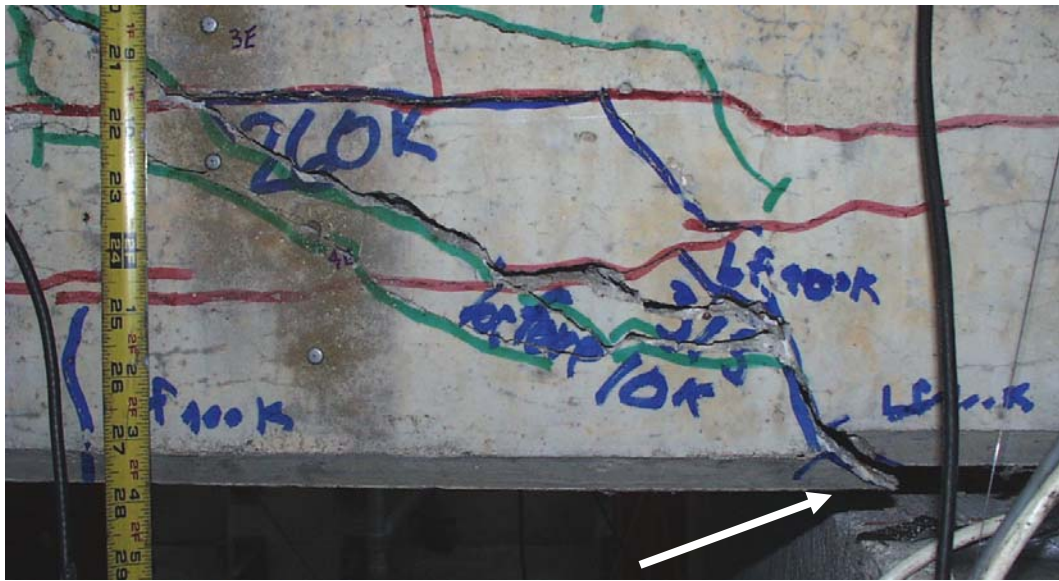
Figure 4.12 Displaced concrete section at the bottom of the east web of BG3N at failure

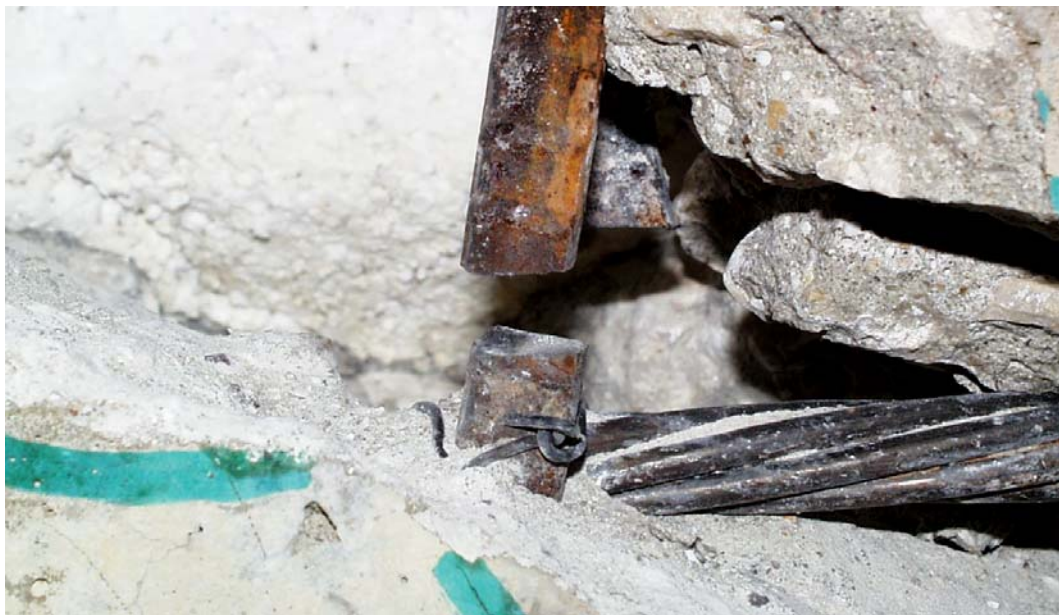
Figure 4.13 Fractured shear reinforcement (stirrup) in the east web of BG3N at failure, after removal of concrete

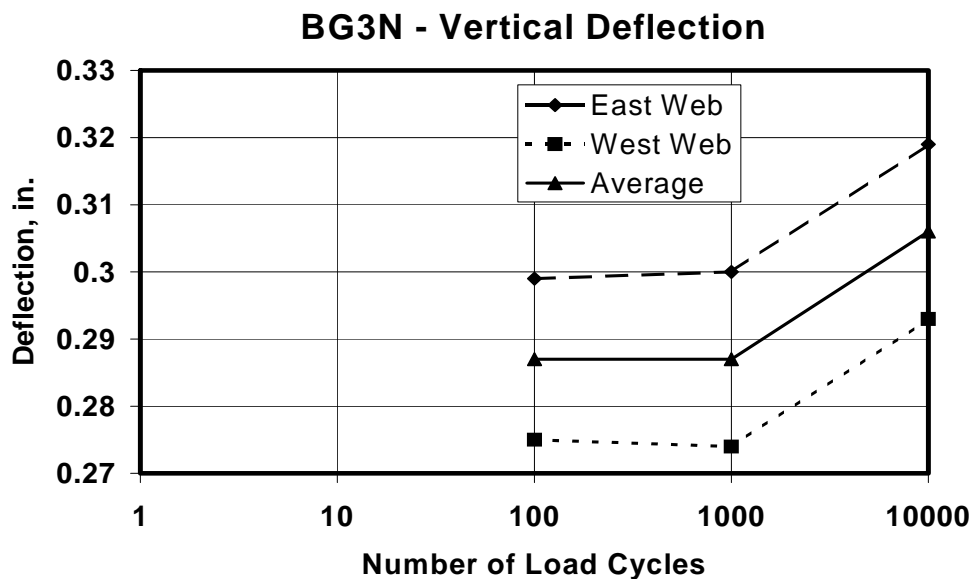
Figure 4.14 Vertical deflection vs. number of load cycles for BG3N

Vertical deflections were measured under each web at a distance 88.5 in. (2.25 m) from the girder end (midway between the two hydraulic rams) after 100, 1000, and 10,000 load cycles. Vertical deflections under each web, and the average of these two deflections, are plotted versus number of load cycles (Figure 4.14).

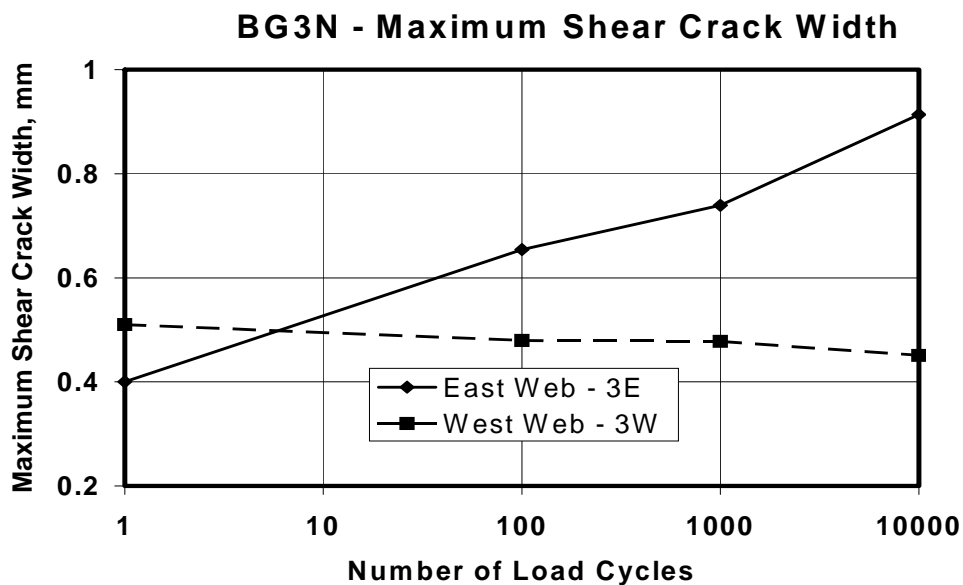
Figure 4.18 Changes in maximum shear crack widths in both webs of BG3N

Demec gauges were used to monitor changes in crack widths, specifically the changes in width of the widest cracks within the shear-critical regions of both the east and west webs (Figure 4.18). The widest initial crack in the shear-critical region of the east web was monitored with Demec Point 3E. From zero load cycles to 10,000 load cycles, the crack width at Point 3E increased by 0.020 in. (0.50 mm). The widest initial crack in the shear-critical region of the west web was monitored with Demec Point 3W. From zero load cycles to 10,000 load cycles, the crack width at Point 3W decreased by 0.002 in. (0.05 mm). Although Point 3W decreased slightly in width, Point 6W, a narrower parallel crack monitored in the same region, increased in width by 0.002 in. (0.05 mm). Width changes varied for the ten remaining cracks monitored. These crack widths increased very slightly, decreased slightly, or remained constant. Overall, there was very little change in the existing crack widths during fatigue testing. This was not unexpected, because new parallel cracks formed in the same region.

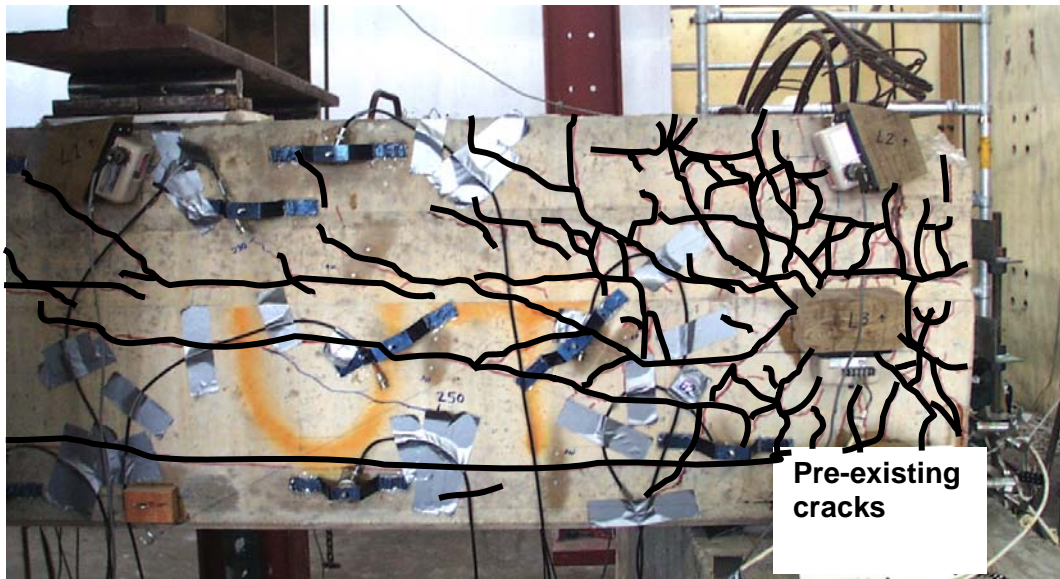
Figure 4.22 Pre-existing cracks in the west web of BG3S

The pre-existing cracks in the east and west webs of BG3S are shown in Figures 4.21 and 4.22.

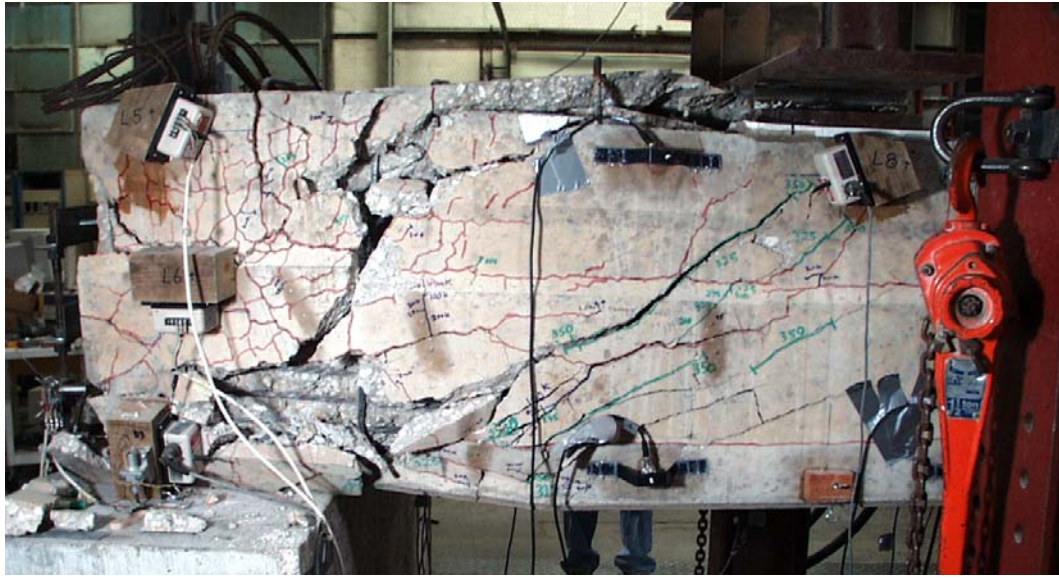
Figure 4.29 Failure of the east web of BG3S after 3,328,600 load cycles and a 365 kip (1620 kN) quasi-static load

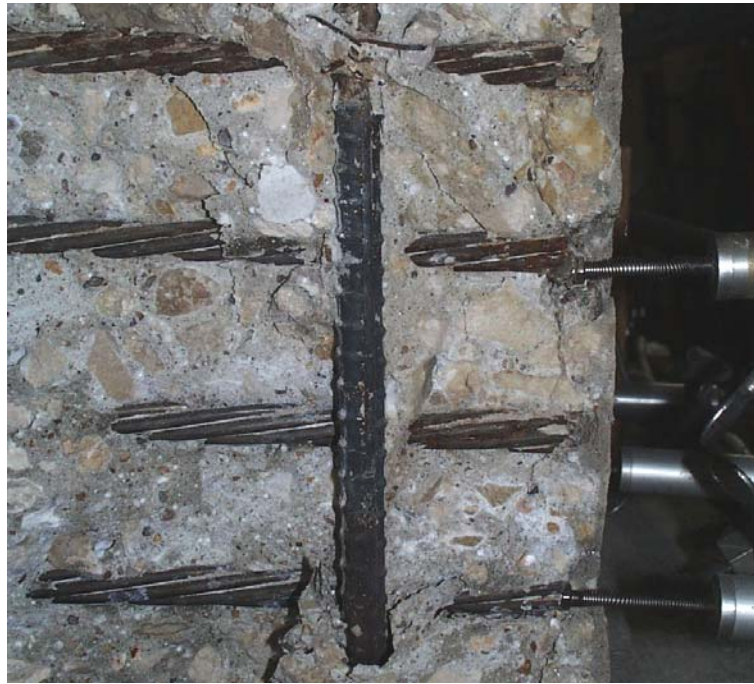
Figure 4.32 Slip of exterior prestressing strands after failure of BG3S

There was no significant slip of prestressing strands during the fatigue test. In the final moments of the quasi-static test to failure, however, as the concrete cover spalled off and the web concrete crushed, several interior prestressing strands and all of the strands nearest to the exterior surfaces of the webs slipped (Figure 4.32). The amount of slip was not measured accurately by the linear potentiometers because as the girder failed, the potentiometers slipped off of the ends of the prestressing strands. Slip was verified by visual inspection, and was manually measured to be between 0.125 in. (3 mm) and 0.25 in. (6 mm) for the
