**Shear Strengthening of Reinforced Concrete Beams with
Carbon Fiber Reinforced Polymer (CFRP) Under Fatigue and
Sustained Loading Applications**

Thesis

The University of Texas at Austin

August 2011

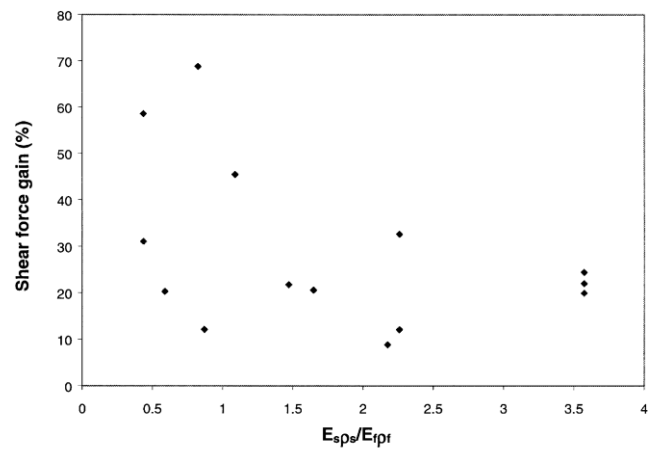
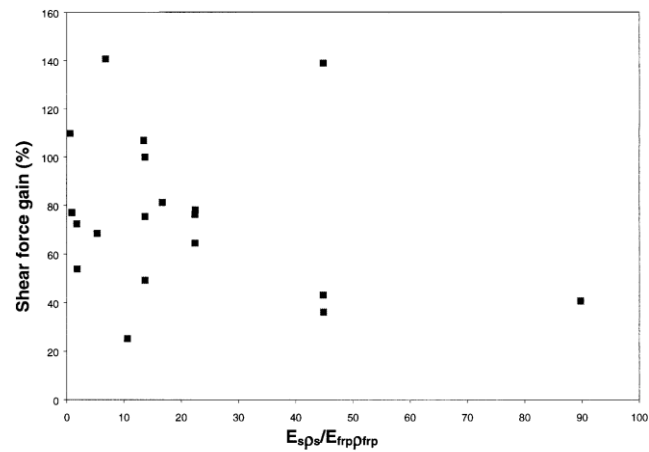
Figure 2-1 Influence of steel transverse reinforcement on shear force in reinforced concrete beams: (a) at de-bonding; and (b) at fracture of CFRP strips (Bousselham & Chaallal, 2004)

Bousselham and Chaallal (2004) attempted to gather all the available research of Fiber Reinforced Polymers (FRP). Their intent was to find conditions that affect the behavior of FRP. During the course of their study they were able to find evidence that the amount of shear reinforcement directly impacts the effectiveness of FRP.

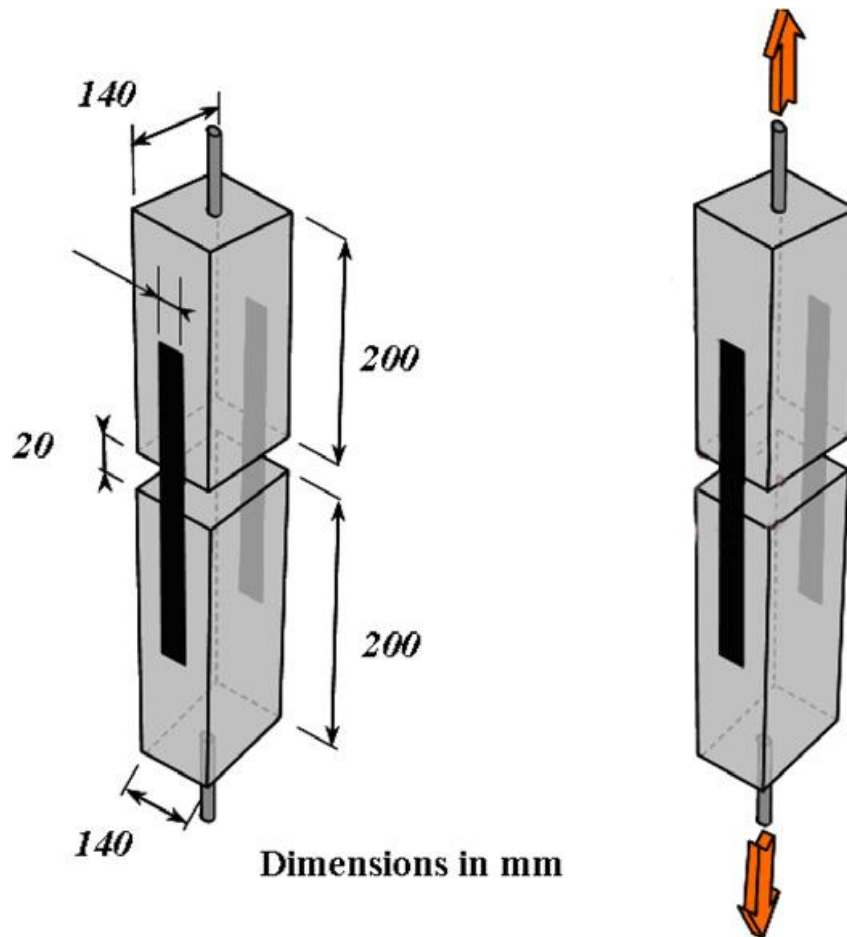
Figure 2-2 Double-lap shear test set-up (Ferrier, Bigaud, Clement, & Hamelin, 2011)

loaded specimens failed at an average shear stress of 1.5 MPa (0.22 ksi). These specimens all failed due to the delamination of the composite plate. The nine fatigue loaded specimens were cycled between a load range of 0.10 MPa (0.015 ksi) and 45%, 60%, and 80% of the shear stress at fracture under monotonic loading (0.67 MPa (0.10 ksi), 0.90 MPa (0.13 ksi), and 1.20 MPa (0.17 ksi)).

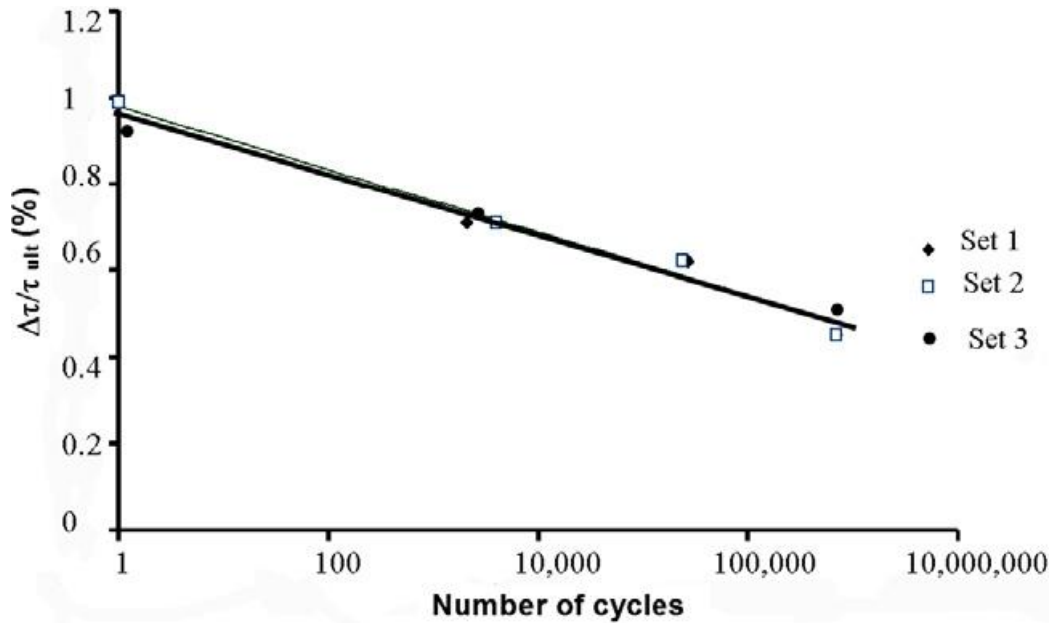
Figure 2-3 $\Delta\tau/\tau_{ult}$ as a function of the number of cycles to failure (Ferrier, Bigaud, Clement, & Hamelin, 2011)

Figure 2-3 summarizes the results of twelve tests. The figure shows that as the applied range of shear stress increases in the concrete to composite interface, the fatigue life of the specimen decreases. When the number of cycles is plotted on a logarithmic scale, a linear relationship between average shear stress and number of cycles to fatigue failure results and is expressed in Equation 2-1.

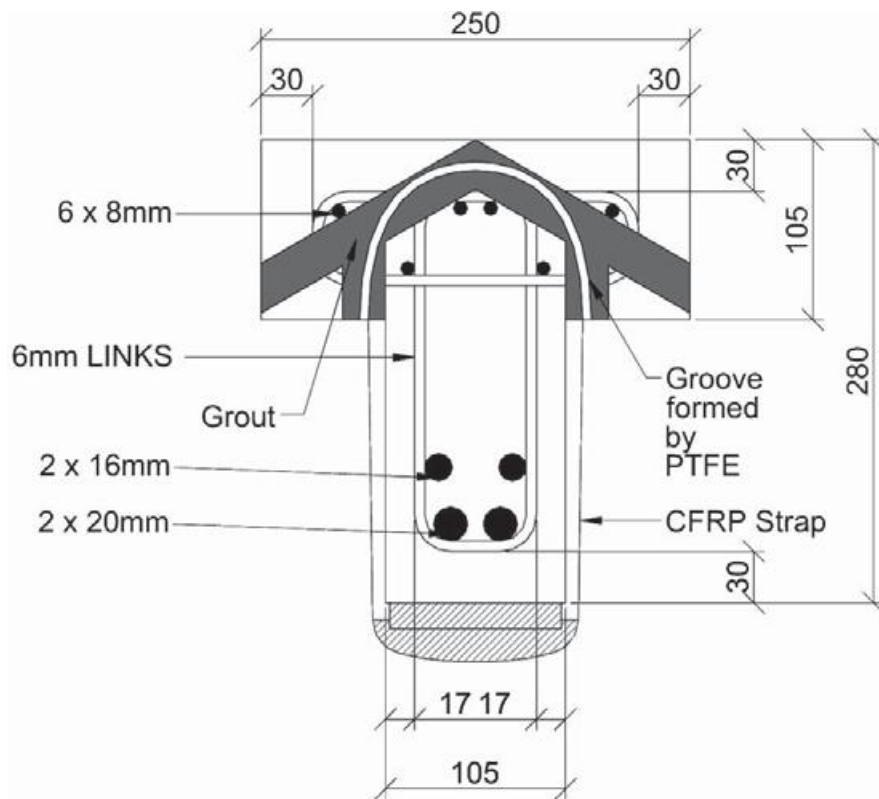
Figure 2-4 CFRP Strap Shear Strengthening System (Hoult & Lees, 2005)

It is important to note the strain behavior of FRP materials over time. Hoult & Lees (2005), along with many others, have examined the long-term behavior of CFRP strengthening systems. They tested a CFRP strap shear strengthening system shown in Figure 2-4. This system consisted of drilling four holes through the bottom and side of the top flange of a reinforced concrete T-beam. Once the holes were drilled “a strip of 3-mm (0.12-in) thick and 15-mm (0.59-in) wide polytetrafluoroethylene (PTFE) was placed in the holes to create the void that the CFRP straps would later pass through.” The holes were then filled with a high early strength concrete repair product and vibrated to minimize the voids in the grout. The CFRP straps were then inserted through the opening in the grout. A prestressing jack was placed on the bottom side of the test specimen and used to apply a prestressing force to the CFRP strap equivalent to 25% of the straps ultimate capacity. One set of beams was then left unloaded while the other set of beams was loaded for 220 days under shear loading.

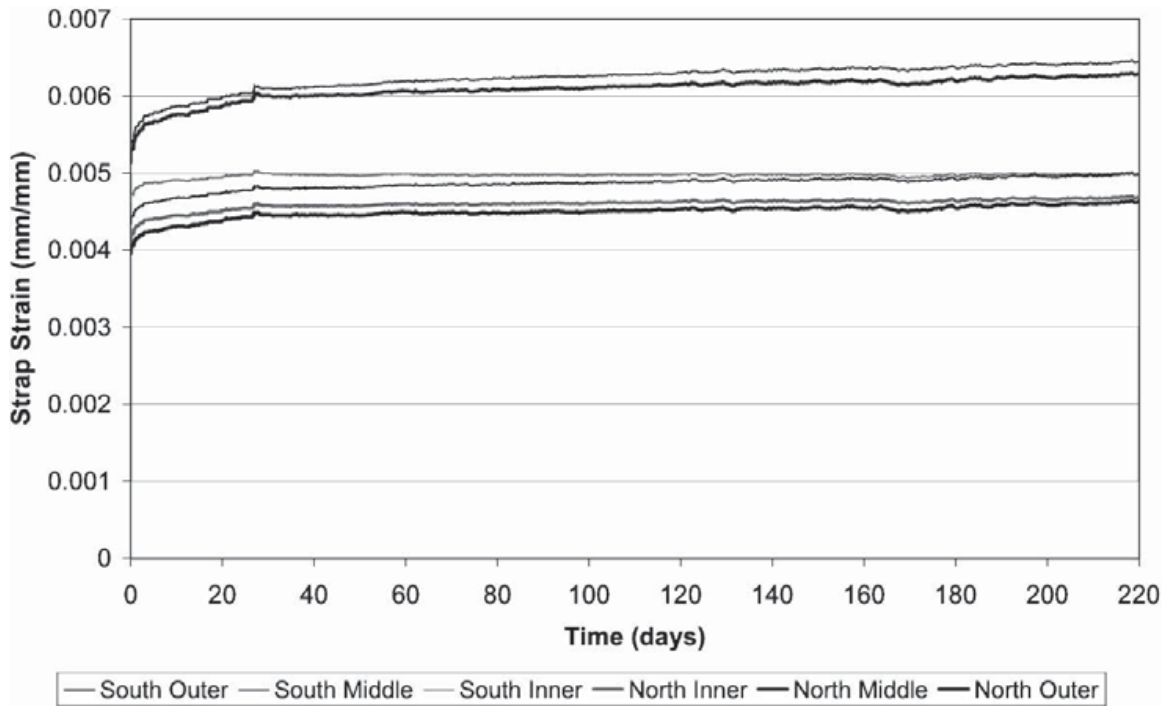
Figure 2-5 Long-term CFRP strap strain vs. time under applied load (Hoult & Lees, 2005)

The unloaded specimens demonstrated a 5% decrease in CFRP strains over the first 77 days of loading. The decreases in strain over the initial period were believed to be due to the creep in the concrete caused by the prestressing force. Additional losses in strain may have been due to relaxation of the CFRP straps. Hoult & Lees (2005) referenced work by Saadatmanesh & Tannous (1999) on CFRP prestressing rods noting that relaxation losses can range from 5-10% of the initial prestressing force over a 50 year period. The maximum strap strains increased by approximately 0.001 in/in, or 23%, in the beams loaded for 220 days. A graph of the strap strain with time results can be seen in Figure 2-5. Strain increases reached a plateau, with the most significant strain increases occurring early in the loading period. Based on these results, the straps appeared to have the satisfactory sustained load capacity.

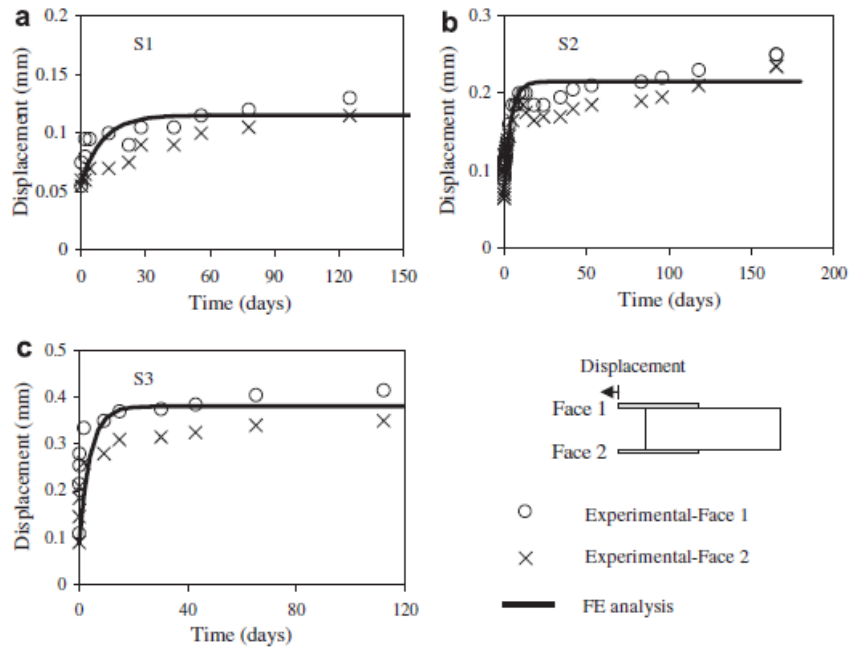
Figure 2-6 Long-term displacement of test specimens obtained from test and FE analysis (Choi, Meshgin, & Taha, 2007)

Choi, Meshgin, & Taha (2007) noted that the key factor affecting the performance of FRP laminates is bond between the FRP and concrete surface. They tested the bond between the FRP and concrete surface by conducting several double-lap shear tests similar to those found in Figure 2-2. The variables examined were the shear stress level and the thickness of the epoxy layer. The specimens were then loaded for 6 months. Specimen (a) was loaded at 15% of the ultimate shear stress with an epoxy thickness of 0.242-mm (0.0095-in), specimen (b) was loaded at 31% of the ultimate shear stress with an epoxy thickness of 0.176-mm (0.0069-in), and specimen (c) was loaded at 31% of the ultimate shear stress with an epoxy thickness of 1.50-mm (0.059-in). The results of the three tests can be seen in Figure 2-6. These results show that the creep between the FRP and concrete surface occurs within a relatively short amount of time (15-30 days), compared with the typical retardation time of concrete which ranges between 300 and 900 days. The finite element results presented in Figure 2-6 display a displacement plot that plateaus after the initial loading period, while experimental results demonstrate gradual increases in displacements throughout the testing process.

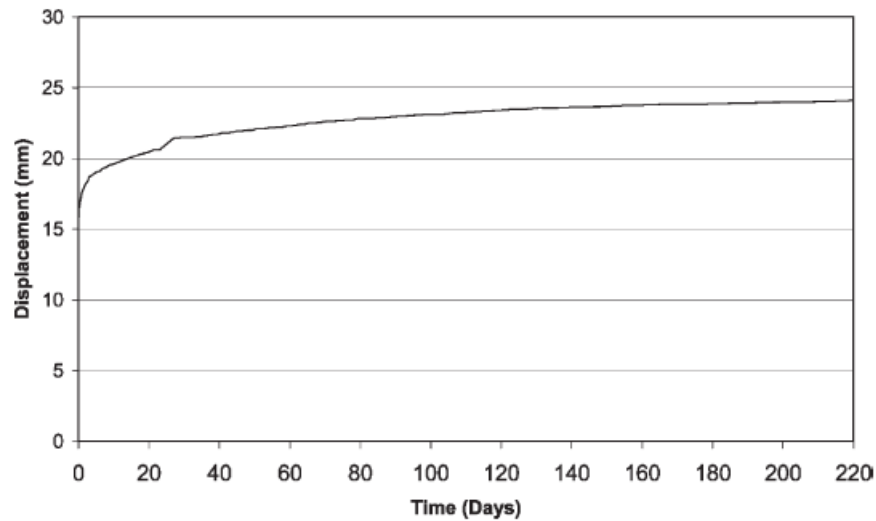
Figure 2-7 Long-term midspan deflection vs. time (Hoult & Lees, 2005)

but then the deflections continued to slowly increase for the remainder of the 220 days. The deflections appeared to be leveling out toward the end of the 220 day period. The results of the long-term load deflections can be seen in Figure 2-7.

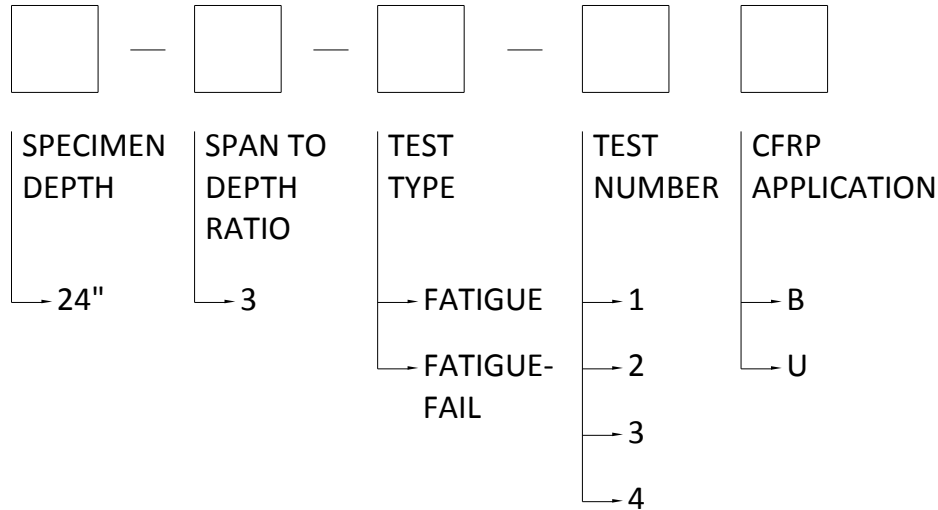
Figure 3-1 Test Nomenclature

end strengthened using unbonded CFRP. A graphical representation of this nomenclature system is presented in Figure 3-1.

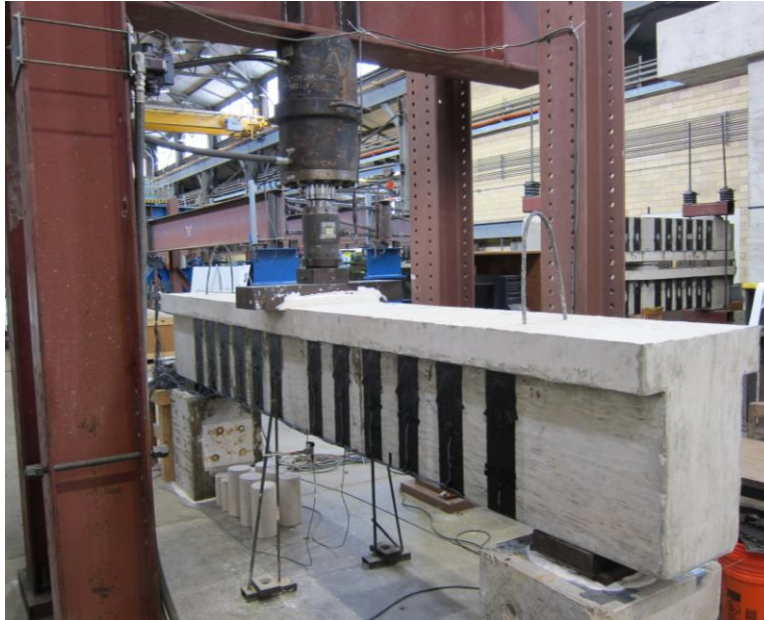
Figure 3-2 Fatigue load test setup

cycles. After this, the test specimen was unloaded and then reloaded and cycled between a load of 110-kips and 130-kips for approximately 2.5 million additional cycles.

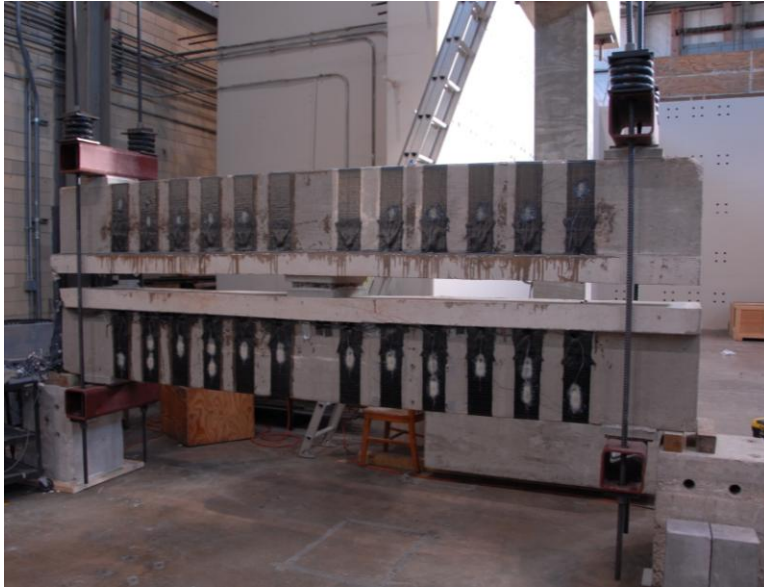
Figure 3-4 Long-term load test setup

Two test specimens were placed in the test setup displayed in Figure 3-4. The test specimens were loaded at their reaction points using hydraulic rams to a force of 80-kips. Once the 80-kip reaction force was reached, Dywidag anchor nuts were tightened down to hold the resulting force. The two 80-kip reaction forces produced an applied load of 160-kips at the midpoint of each test specimen. Therefore, each shear span experienced

an applied shear of 80-kips throughout testing. The test specimens were then moved and the load remained on the specimens for a total of 217 days.

After a period of 107 days, hydraulic rams were placed back onto the test setup and the original load was reapplied to the test specimens. This was done to assure that the proper loading level was maintained throughout testing. The reapplication of load resulted in a slight increase in steel and CFRP strains at the 107 day point of loading.

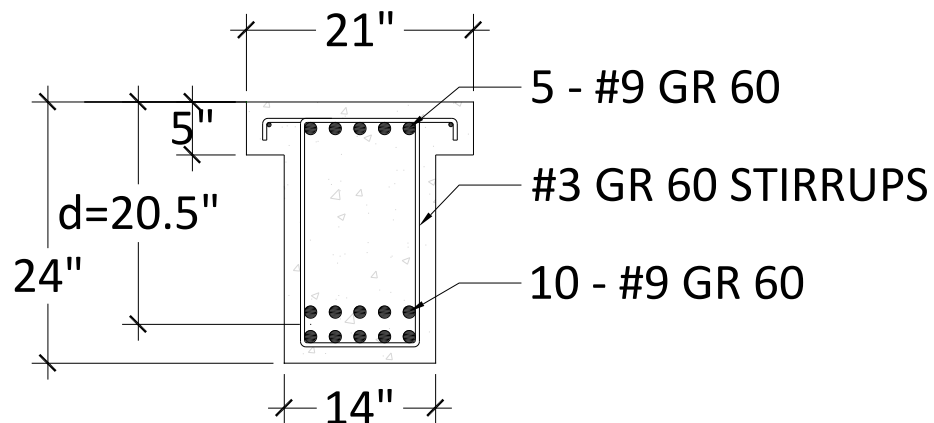
Figure 3-5 Cross section of test specimens

The T-beam geometry was chosen to compare results to beams used in monolithic floor systems or beams used in conjunction with a composite bridge deck system. It also helped to increase the area of the concrete compression block, thus providing increased flexural capacity. A cross section of the reinforced concrete test specimen can be seen in Figure 3-5. Previous monotonic tests were conducted by Quinn et al. (2009) on specimens with a top flange that was 28" wide. The size of the top flange was decreased to 21" to use steel forms readily available in the lab. The use of steel forms greatly decreased the construction time of the test specimens.

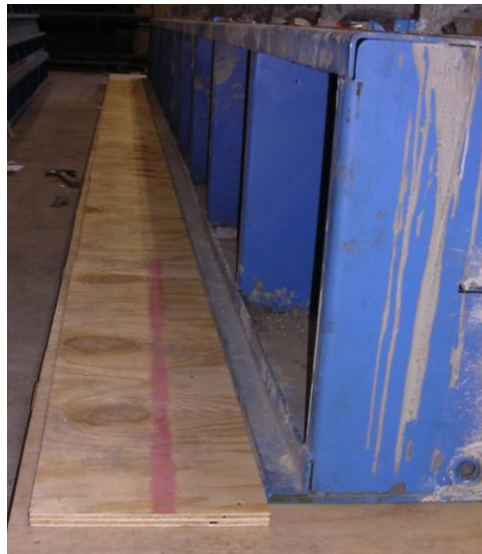
Figure 3-7 Steel side form bracing

The base of the formwork consisted of 4-ft. sections of 4x4 lumber spaced at 30-in. on center with 4-ft. wide sections of $\frac{3}{4}$ -in. plywood placed on top. After the base was constructed, two 27-ft. 8-in. steel side forms were placed 21-in. apart to provide the proper width of the top flange. These steel side forms were then attached to the base with $\frac{1}{2}$ -in. diameter lag screws into the 4x4's beneath spaced at 30-in. centers. Once the steel side forms were in place, 12-in. strips of $\frac{3}{4}$ -in. plywood were attached to the plywood base along the bottom edge of the steel formwork to act as additional restraint for the lateral hydrostatic pressure from the concrete during casting. These plywood braces can be seen in Figure 3-7.

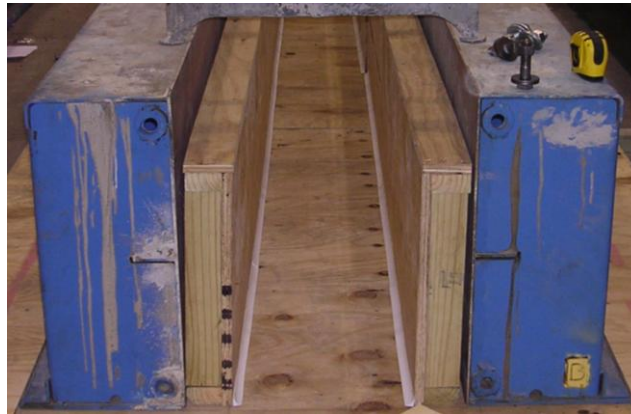
Figure 3-8 Side view of wooden panel inserts

In order to create the desired T-beam shape while using steel side forms, wooden panels were inserted to provide the appropriate void dimensions. The 3 $\frac{1}{2}$ -in. by 19-in. block-outs were constructed using 2x3-in. lumber with $\frac{3}{4}$ -in. plywood covering used to create a smooth surface. The 2x3-in. pieces of lumber were made by sawing 2x6-in. members in half. Modular construction consisting of four 8-ft. panel sections and four 5-ft. 8-in. panel sections were used to create the desired specimen lengths. A 4-in. wide internal form divider made of 2x3-in. lumber and $\frac{3}{4}$ -in. plywood was used so that two

specimens could be cast using the same formwork. The wooden inserts can be seen in Figure 3-8 and the internal form divider is shown in Figure 3-9.

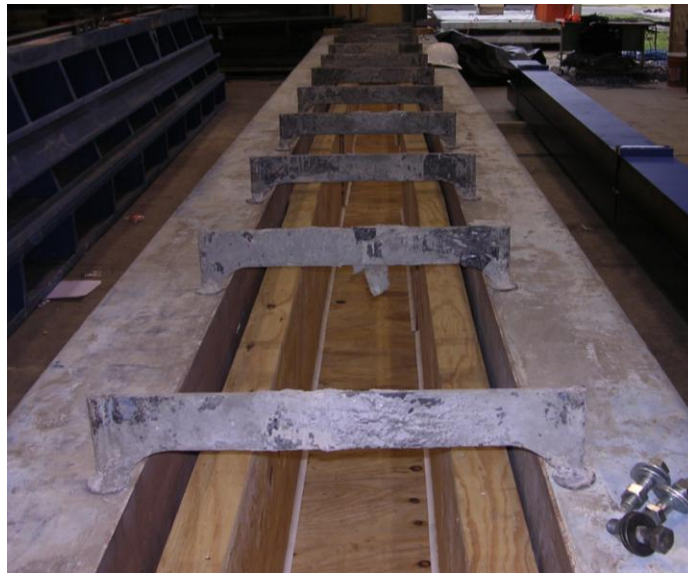
Figure 3-10 Steel cross ties

Once the panel inserts were placed inside the steel forms, end forms made of 2x4 framing and $\frac{3}{4}$ -in. plywood were bolted to the ends of the formwork. Caulking was used to seal gaps between the steel side forms and panel inserts, as well as any imperfections in the wooden formwork. Steel cross ties were placed on the steel forms to help resist the lateral hydrostatic pressure resulting from placement of fresh concrete (Figure 3-10). The completed formwork can be seen in Figure 3-11, the steel cross ties were removed prior to the photo so that the forms could be seen more clearly.

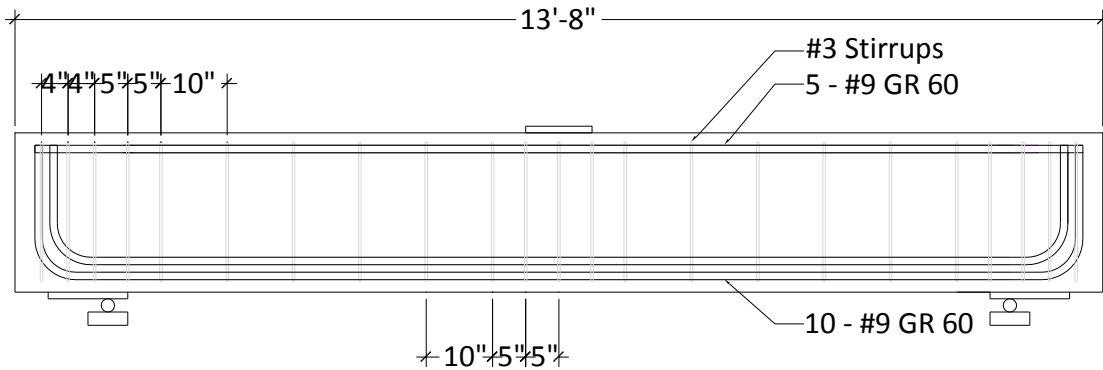
Figure 3-12 Reinforcement steel layout

shear failure in the shear span. Slab steel reinforcement consisting of #3 bars was placed in the top flange of the T-beam specimen with spacing equal to that of the transverse reinforcement. Figure 3-12 depicts the reinforcing steel layout.

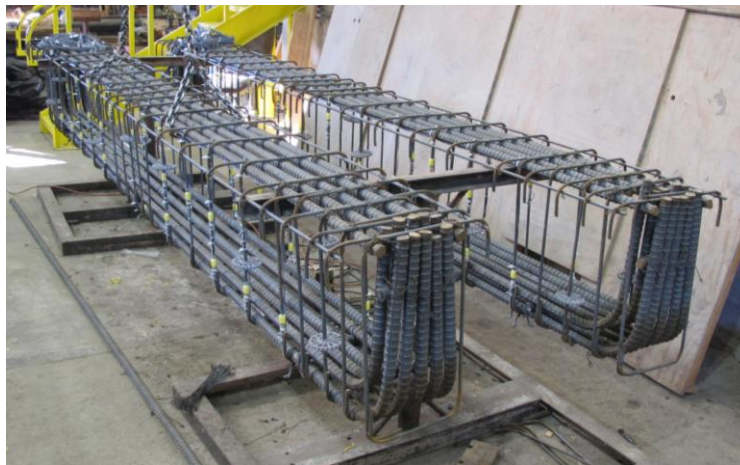
Figure 3-13 Steel reinforcement cage with stirrups spaced at 10-in.

Two reinforcement cages were constructed simultaneously on steel stands and then instrumented with the appropriate strain gauges. The completed reinforcement cages can be seen in Figure 3-13.

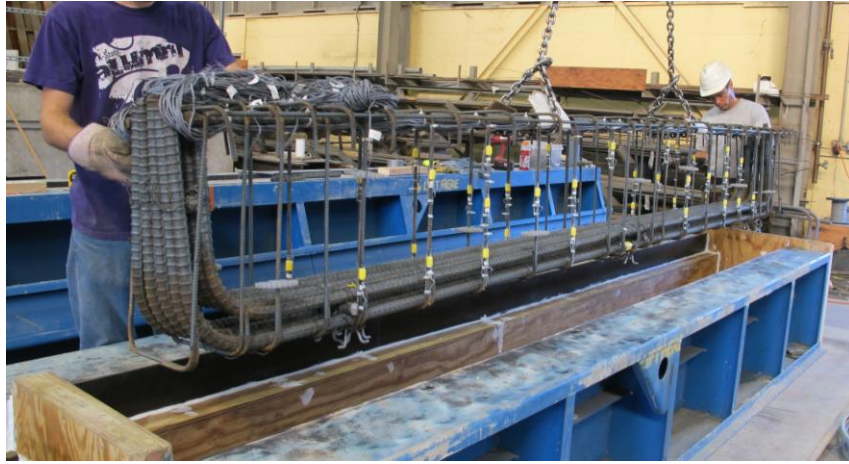
Figure 3-14 Placing of the steel reinforcement cage

The completed reinforcement cages were then placed inside the formwork using an overhead crane (Figure 3-14). Reinforcing chairs were used to help maintain the minimum concrete cover of 1.5-in. between the steel reinforcement and the forms. The

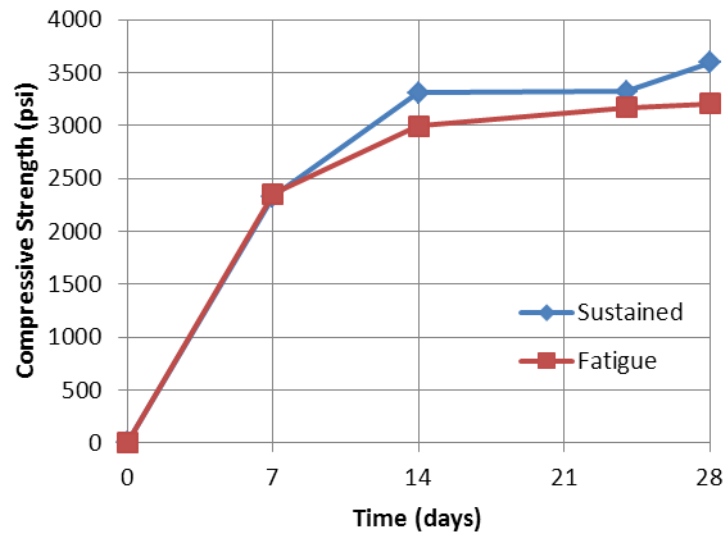
Figure 3-16 Average concrete compressive strength for each cast

The four beams were fabricated in two castings about a month apart. The first cast consisted of the two beams used for the sustained loading portion of the project. The second cast was for the two beams used for the fatigue loading portion of the project. Several 4-in. by 8-in. concrete cylinders were cast with each set of beams and were kept in a curing environment similar to the beams cast. The results of the compression tests of the cylinders can be found in Figure 3-16. The 28-day compressive strengths for each specimen were relatively close to one another and well below 4,000-psi.

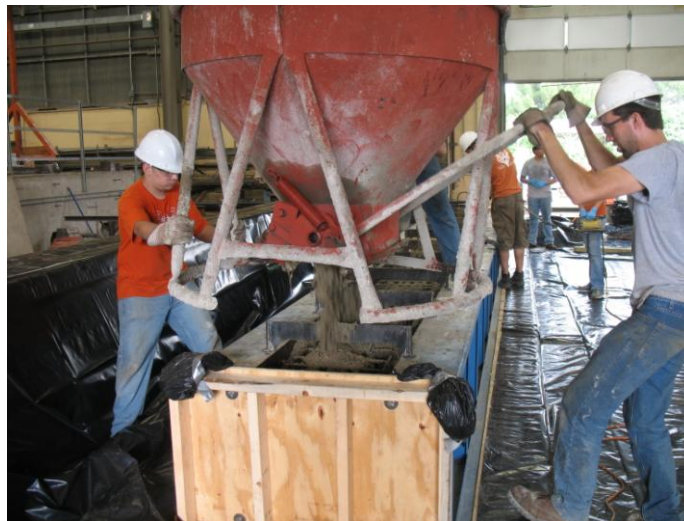
Figure 3-17 Placing of the concrete using 1 cubic yard concrete bucket

The concrete was placed using an overhead crane and a 1 cubic yard concrete bucket that moved the concrete from the delivery truck to the forms (Figure 3-17). The

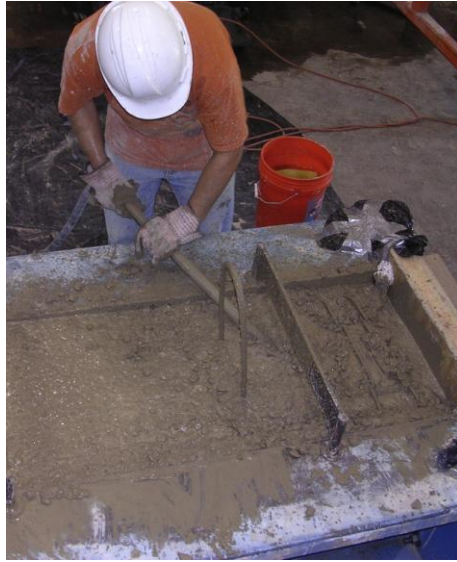
Figure 3-18 Vibrating the concrete

concrete was placed in three layers. The first layer covered the bottom layer of longitudinal steel. The second layer filled the web of the T-beam and covered the transverse steel reinforcement. The third layer covered the slab reinforcement and the

remainder of the beam. Each layer of concrete was vibrated to ensure that no voids remained in the specimen (Figure 3-18).

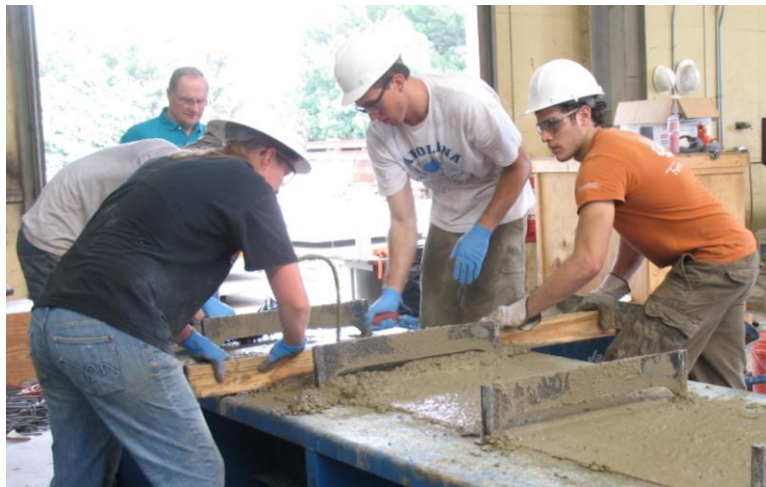
Figure 3-19 Screeding the top surface of the specimen

Once the concrete was sufficiently vibrated, the surface of the concrete was screeded using a large, smooth 2x4 to remove all excess concrete and then hand screeded to smooth out any remaining imperfections (Figure 3-19 & Figure 3-20).

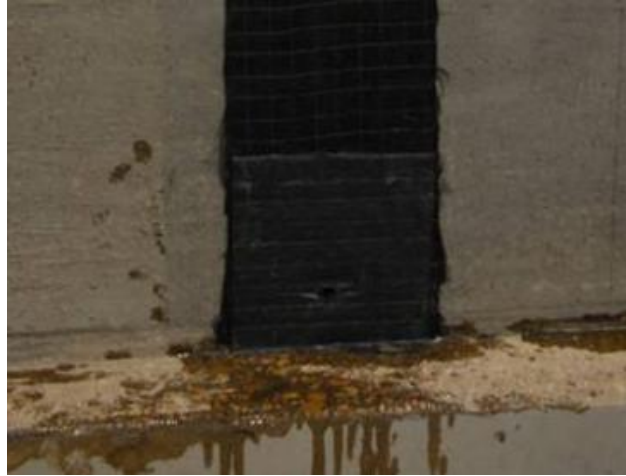
Figure 3-23 Placement of CFRP patch prior to insertion of anchor

After further examination, the previous anchor detail was modified to help transfer the stresses from the CFRP anchor to the CFRP laminate in a more efficient manner. The following procedure was then used to install the CFRP anchor. The modified anchor detail involves placing a 5-in. by 5-in. CFRP patch on top of the CFRP

sheet with the CFRP fibers in the patch running perpendicular to the CFRP fibers in the CFRP sheet. This patch is placed prior to the installation of the CFRP anchor as seen in Figure 3-23.

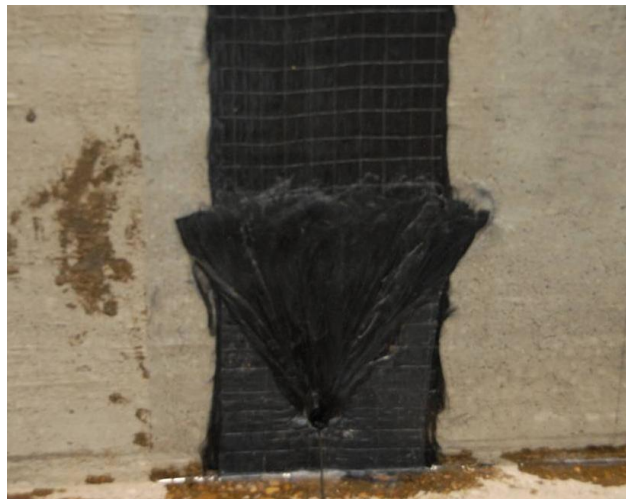
Figure 3-24 CFRP anchor with 60-degree fan angle

Once the CFRP patch is placed perpendicular to the direction of the CFRP sheet, then the CFRP anchor is inserted and fanned out to a 60-degree angle (Figure 3-24).

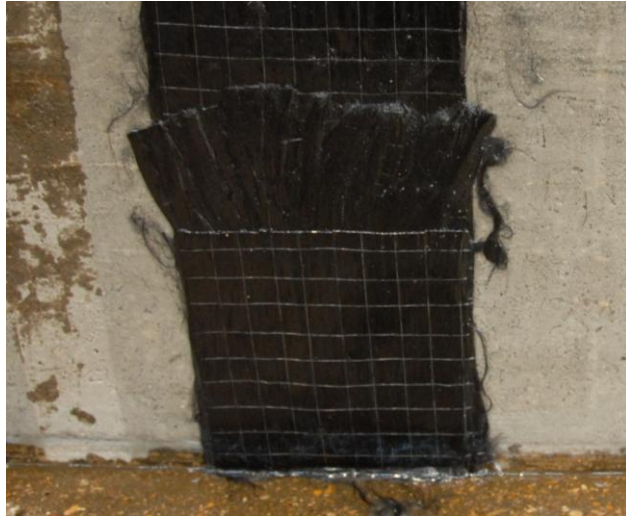
Figure 3-25 Completed CFRP anchor installation

After the placement of the CFRP anchor, an additional 5-in. by 5-in. CFRP patch is placed over the top of the CFRP anchor with patch fibers running in the same direction as the CFRP sheet beneath it. Therefore, the fibers of the two CFRP patches are oriented

perpendicular to each other with the CFRP anchor placed in between the two layers of CFRP patch material. The completed CFRP anchor detail can be seen in Figure 3-25.

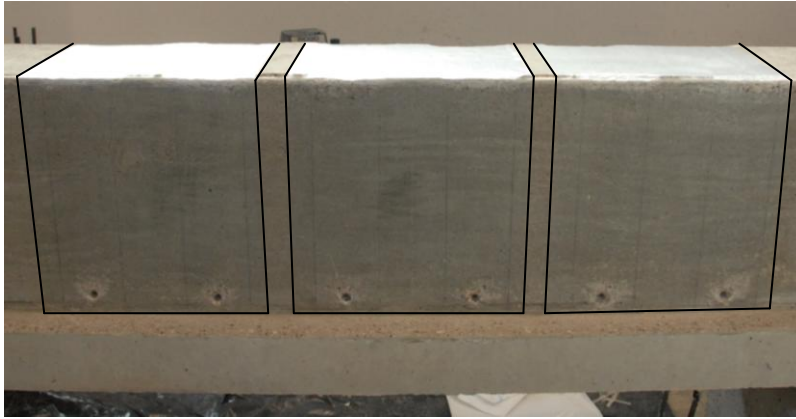
Figure 3-26 Clear plastic liner used to prevent bond between CFRP laminates and surface of the concrete specimen

Each of the four specimens tested had equal amounts of CFRP applied along each shear span. On one side of the specimen, the CFRP was bonded to the surface of the concrete as is typical in CFRP applications. On the opposite shear span, a clear plastic liner purchased at a local supermarket was placed over the surface of the concrete prior to the application of the CFRP laminates. The clear plastic liner prevented the CFRP laminates from bonding to the surface of the concrete. During testing, all forces in the CFRP laminates were transferred to the concrete through the CFRP anchor. The clear plastic liner used during the installation process can be seen in Figure 3-26.

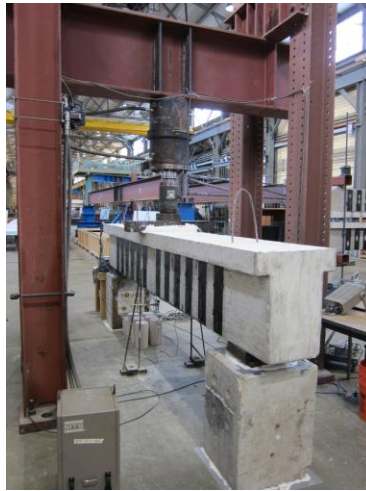
Figure 3-28 As-built fatigue load test setup

A large steel W-section was bolted to the bottom of two steel W-sections bolted to the erected columns. The large steel W-section supported a hydraulic ram capable of applying cyclic or monotonic loads. The hydraulic ram had a capacity of 235-kips when attached to a closed loop system capable of applying cyclic loads and a 784-kip capacity when attached to an open loop system capable of applying monotonic loads. For the case of fatigue loading, the closed loop system was then attached to a controller that allowed the user to program the desired applied load range and to monitor the number of load cycles applied. The beam was then loaded on the top flange. A photo of the fatigue test setup is shown in Figure 3-28 with an elevation view of the test setup displayed in Figure 3-29.

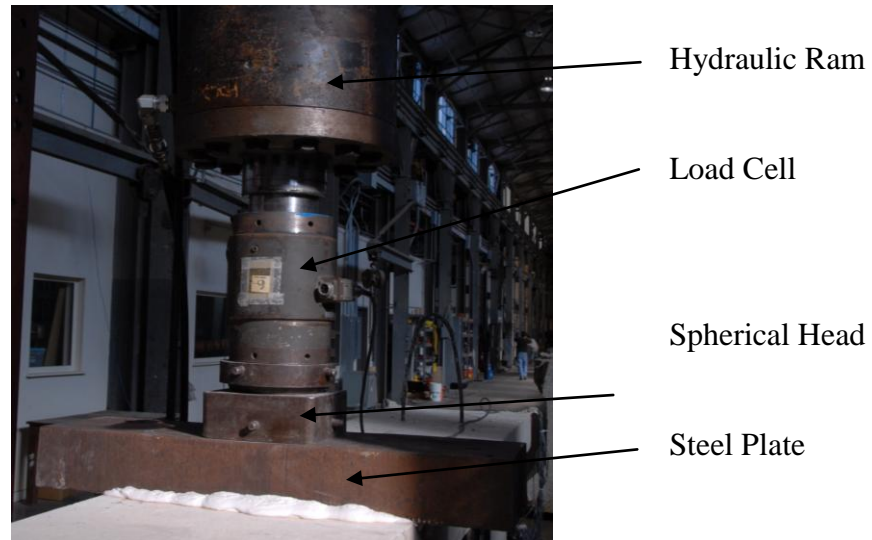
Figure 3-30 Load application System

to adjust for alignment imperfections between the hydraulic ram and the test specimen. A picture of the loading apparatus is shown in Figure 3-30.

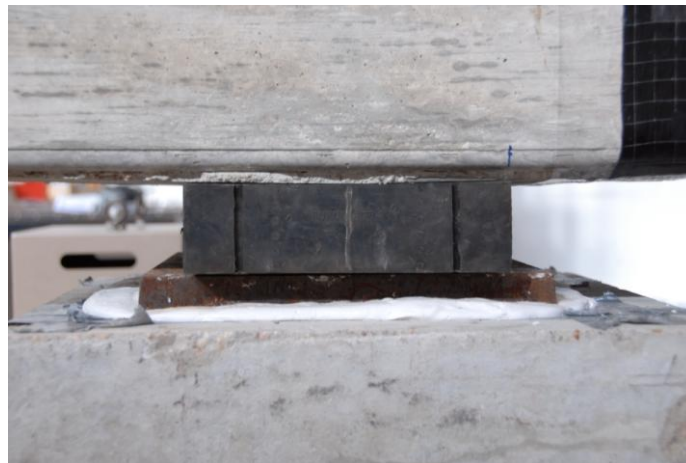
Figure 3-31 Reaction support

The reaction points consisted of neoprene bearing pads (1'-2"x9"x2 1/2") centered on steel plates (12"x12"x1"). The steel plates were grouted with hydrostone to the surface of the concrete end supports and the concrete end supports were then hydrostoned to the floor below. The hydrostone was used to help provide a level loading surface for the test specimen. Figure 3-31 shows the as-built end reaction support.

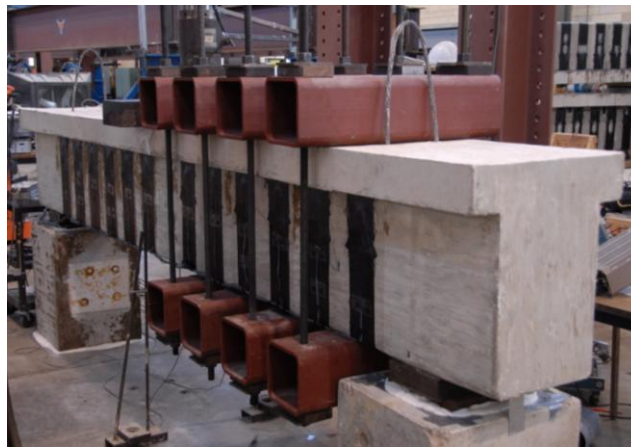
Figure 3-32 Prestressed external clamps

Following the completion of fatigue loading, the test specimens were loaded to failure to help determine the effects of fatigue loading on ultimate load capacity. The test specimens were initially loaded until failure occurred on one side of the test specimen, either on the bonded or unbonded side. Then prestressed external clamps (Figure 3-32) were used to provide external reinforcement to the already failed side. These prestressed clamps consisted of two HSS 8x8x1/2" tubes placed on the top flange of the specimen and under the bottom side of the concrete web. They were connected using two high strength, one inch diameter threaded rods. Each threaded rod was prestressed with a force of 30-kips and therefore each external clamp provided a 60-kip clamping force to the test specimen. This clamping system was very effective in providing adequate additional strength so that a shear failure of both ends could be produced.

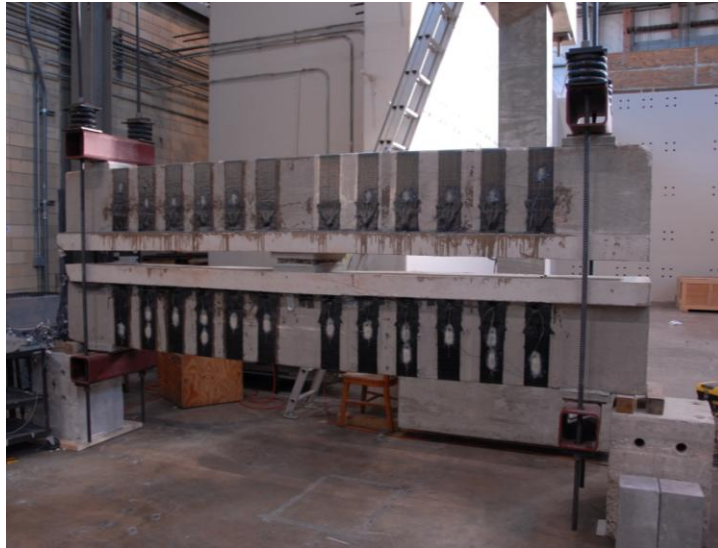
Figure 3-34 Sustained load test setup

then rotated flange down and grouted in place directly above the first test specimen. A large clamping system consisting of steel HSS tubes, high strength Dywidag rods, and springs was used to provide a reaction force of 80-kips to each end of the test specimen. This resulted in a midpoint load of 160-kips being applied to each test specimen. The tested shear spans are equivalent to those tested during the fatigue loading portion of the research project. An elevation view of the test setup is displayed in Figure 3-33 and a photo of the test setup is shown in Figure 3-34.

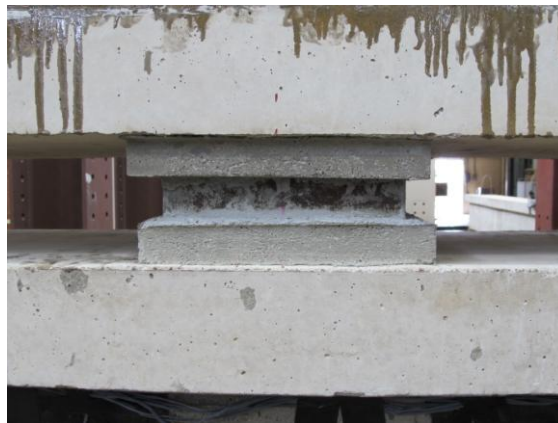
Figure 3-35 Grouted loading point

The loading point consisted of a 1'-6"x10"x5" steel plate centered between both test specimens. The steel plate was grouted in place to help prevent the beams from rotating during the loading process. It was important to center the steel plate between the two test specimens to ensure stability during loading. Figure 3-35 displays a photo of the grouted steel plate.

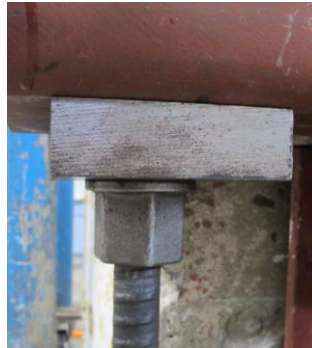
Figure 3-36 Dywidag anchorage system

The load was applied to the test specimens through the reaction points. Each reaction point consisted of a 12"x9"x2" steel plate that was grouted to the bottom surface of the concrete specimen. Then a steel HSS 8x8x1/2" tube was used to transfer the force to the steel bearing plate. Holes were drilled in each end of the steel tube to allow for a 1-in. diameter, high strength Dywidag rod to pass through the steel tube. The Dywidag rods were then anchored using a 1 1/4-in. thick steel plate and a domed anchor nut (Figure 3-36). Figure 3-37 displays a photo of the end reaction support prior to stressing.

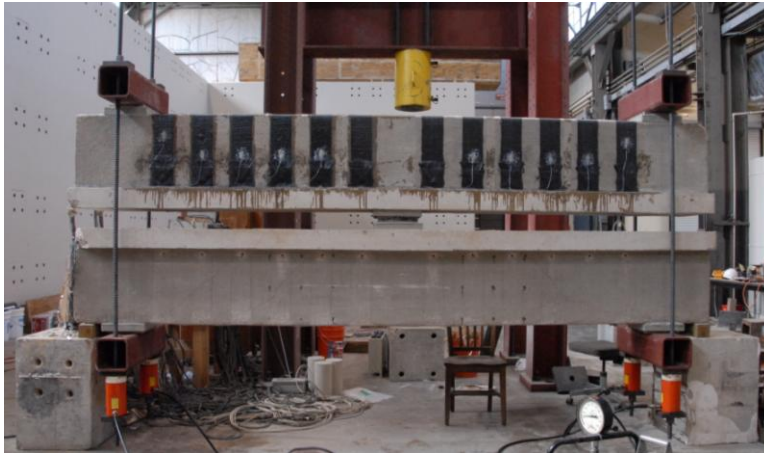
Figure 3-38 Initial loading test setup

the test setup. The bottom specimen was placed in the test setup prior to the application of CFRP and then cracked using the current test setup. Four center hole, hydraulic rams were used on the bottom side of the specimen to provide a load of 160-kips at the midpoint of the specimen (Figure 3-38). The hydraulic rams were placed on the bottom side of the test setup to provide easy access to the hydraulic pump. One hydraulic ram was placed over each Dywidag road and anchored to the bottom side of the test setup (Figure 3-39). All four hydraulic rams were then attached to the same hydraulic pump to ensure that the load was applied evenly over all four loading points. Once the bottom beam was cracked then the load was released and the hydraulic rams were removed.

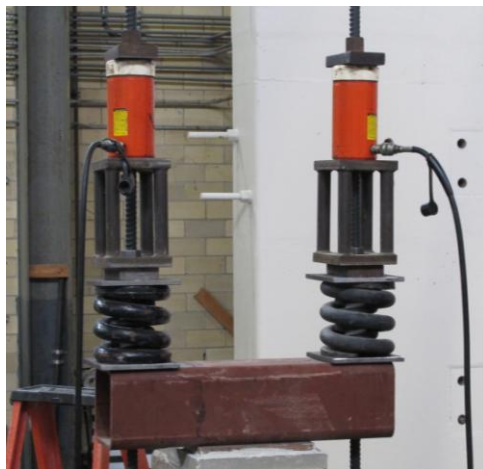
Figure 3-40 Hydraulic loading system for final loading

After the application of CFRP on the cracked specimen, the final load was applied. Four, 8-in. springs were used to reduce any losses due to relaxation or creep and to maintain a nearly constant load over the duration of the test. Four springs were used in the test. One spring was placed over each Dywidag rod with the Dywidag rod running through the center of the spring. A steel plate, 8"x8"x1/2", was placed on either side of the spring to provide a level surface to transfer the forces from the spring to the HSS tube below. Once the springs were in place, the Dywidag anchorage system was then secured to the top of the springs. Steel loading chairs were placed on top of the Dywidag anchorage system and hydraulic rams were placed above the loading chairs and secured using the previous anchorage system (Figure 3-40). Once again, the four hydraulic rams were attached to the same hydraulic pump to provide a uniform force at each loading point. An 80-kip load was applied to each end of the test specimen resulting in a midpoint load of 160-kips. Once the appropriate load was reached, the domed anchor nuts were tightened down above the spring and the load was released. The tightened nuts then held the previously applied midpoint load of 160-kips. The test setup was loaded from the top of the setup due to a lack of space beneath the specimen because of the additional height of the springs and loading chairs. A photo of the final load application can be seen in Figure 3-41.

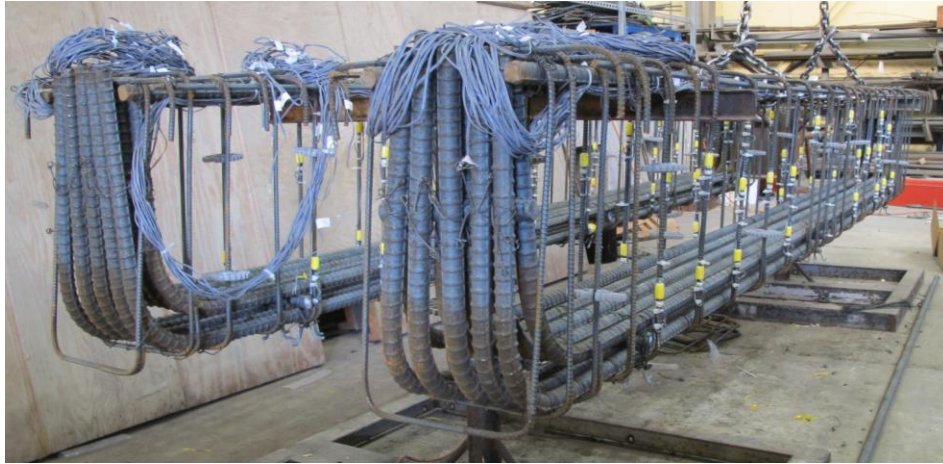
Figure 3-42 Reinforcement cages after installation of steel strain gauges

mechanical vibrators used during casting. The yellow rubber pads can be seen in Figure 3-42.

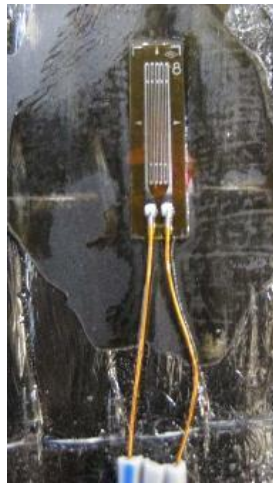
Figure 3-45 CFRP strain gauge (Pham, 2009)

CFRP strains were monitored using a system similar to that used for monitoring steel strains. The CFRP gauges consisted of a standard electrical resistor similar to the ones used in the steel gauges and displayed in Figure 3-45. A two-part composite material was placed on the surface of the CFRP in the areas where strains were to be monitored. Once cured, the composite material provided a smooth surface so that the CFRP gauge could bond cleanly to the surface of the CFRP.

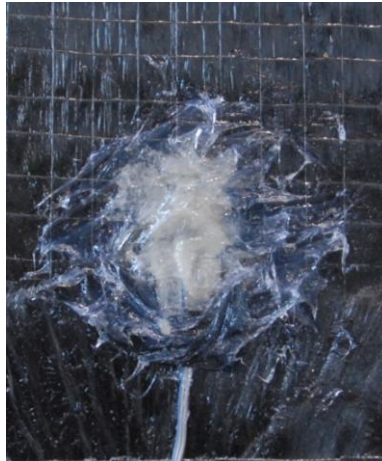
Figure 3-47 Long-term load gauge protection covering

For gauges used to monitor CFRP strains in the sustained load tests, a different protection system was used. Since the tests were going to be conducted over a long period of time, preparations were made so that the test specimens could be moved outdoors. Because of this, the CFRP gauges needed to be protected against the elements. A small wax coating was placed over the surface of the gauge to prevent water from damaging the gauge. Then a silicone coating was used to seal the wax around the gauge and to provide an additional layer of protection against any external damage throughout the course of testing. A photo of the protection system used for the long-term CFRP gauges is shown in Figure 3-47.

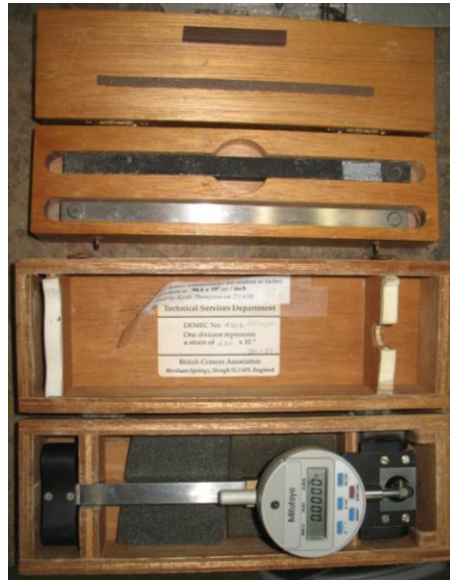
Figure 3-51 DEMEC measuring device

additional source of strain data in case the electrical strain gauges drifted or failed over time. This measurement system consisted of an extensometer equipped with a digital dial to provide on-the-spot readings and a 16-in. by 16-in. grid of DEMEC points attached to the surface of the test specimen. The DEMEC measurement device is shown in Figure 3-51.

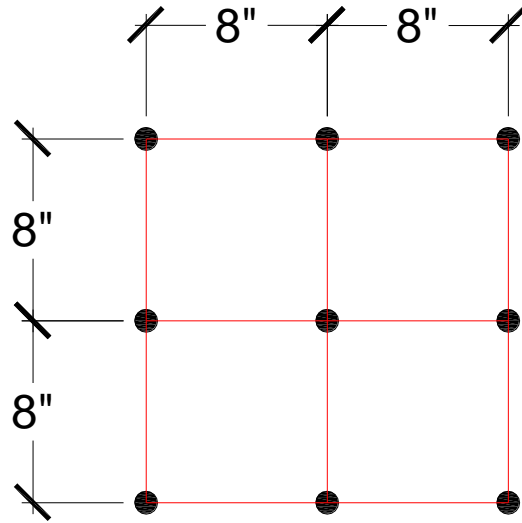
Figure 3-52 DEMEC point grid

The DEMEC measuring device was used to measure the distance between a grid of pre-drilled stainless steel discs referred to as DEMEC points. These DEMEC points were attached to the surface of the concrete specimen using a high strength, two-part epoxy to form a 16-in. by 16-in. grid with 8-in. spacing between the DEMEC points. The dimensions of the DEMEC point grid are displayed in Figure 3-52. The grid of DEMEC points was located in the center of the shear span of the test specimen as displayed in Figure 3-53. The DEMEC measuring system was used to track changes in surface strain throughout testing and also provided information about the changes in crack width over time.

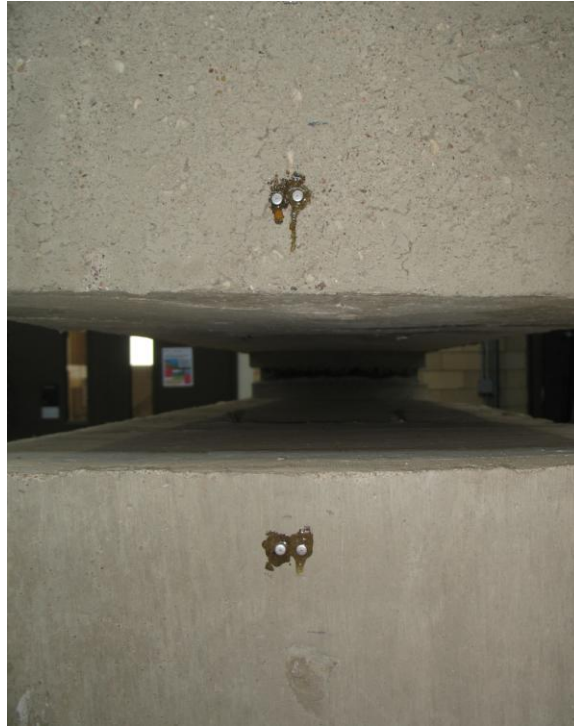
Figure 3-54 DEMEC points used to track changes in end displacements

The DEMEC measuring system was also used to track the changes in end deflections between the two test specimens during testing. DEMEC points were placed

on the surface of the end regions of the top and bottom specimens at each end of the test specimen as shown in Figure 3-54.

End displacements were monitored on each end of the test specimens using DEMEC points similar to those used to obtain surface strain values. A photo of the DEMEC points placed on the surface of the end region of the test set-up is presented in Figure 5-9. The average displacements throughout testing are presented in Figure 5-10. Displacements increased dramatically during the first several days of loading and then continued to increase slowly for the duration of the test. A large jump in displacements were recorded when the load was adjusted at 107 days.
