**Shear Strengthening of Reinforced Concrete Beams with
Carbon Fiber Reinforced Polymer (CFRP) Under Fatigue and
Sustained Loading Applications**

Thesis

The University of Texas at Austin

August 2011

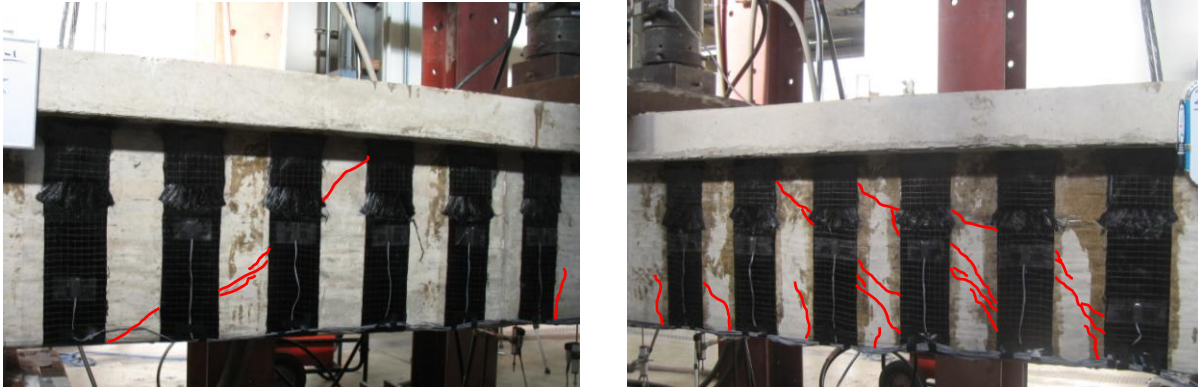
Figure 4-1 24-3-Fatigue-1&2 unbonded (left) and bonded (right) CFRP test specimen

Each specimen was subjected to two different series of cycled loads. The first series, 24-3-Fatigue-1, was cycled between a load of 70-kips and 90-kips for approximately 1 million cycles. For the second series, 24-3-Fatigue-2, the cycled load range was increased to 110-kips and 130-kips and cycled for an additional 2.5 million cycles. Photos of the test specimen after completion of the cycled load series can be seen in Figure 4-1. Concrete cracks observed during testing are outlined in red.

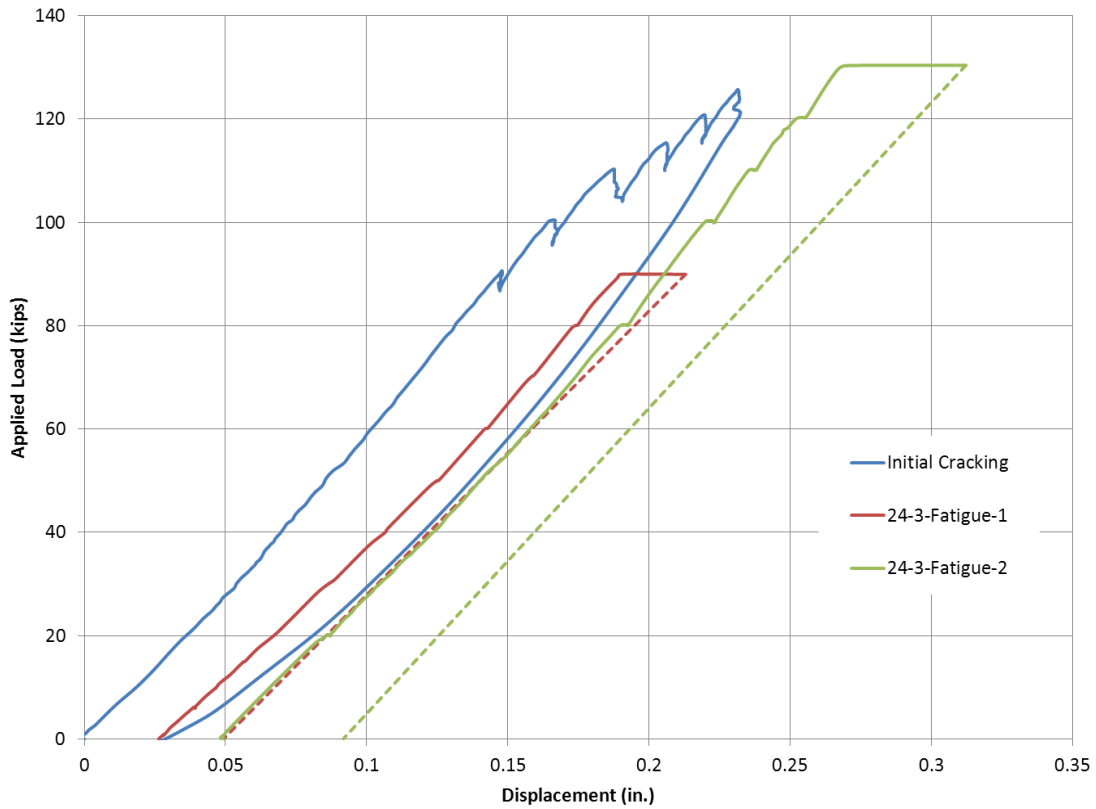
Figure 4-2 Load displacement response, test 24-3-Fatigue-1&2

The load-displacement response was recorded for the initial cracking of the test specimen as well as for both series of cycled load tests. The data for the unloading curve of the load displacement response was not recorded for tests 24-3-Fatigue-1 and 2. The load-displacement response of these tests is shown in Figure 4-2 and a linear unloading curve was assumed for tests 24-3-Fatigue-1 and 2. For the purpose of the load-displacement plot, the peak load and displacement values were used to plot the portion of the load-displacement curve during the cycled loading portion of the test. This resulted in a plateau forming at the peak of the load-displacement plot for tests 24-3-Fatigue-1 and 2.

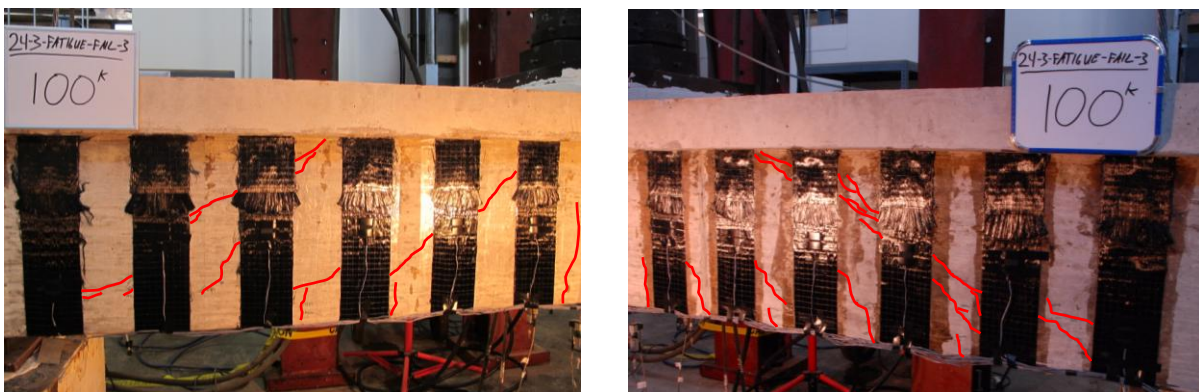
Figure 4-5 24-3-Fatigue-3&4 unbonded (left) and bonded (right) CFRP test specimen

Similar to the previous beam tested, each specimen was subjected to two different series of cyclic loads. The first series, 24-3-Fatigue-3, was cycled between a load of 70-kips and 90-kips for approximately 1 million cycles. For the second series, 24-3-Fatigue-4, the cycled load range was increased to a load between 110-kips and 130-kips and cycled for approximately 2.5 million more cycles. Photos of the test specimen after completion of the cycled load series can be seen in Figure 4-5. Concrete cracks observed during testing are outlined in red.

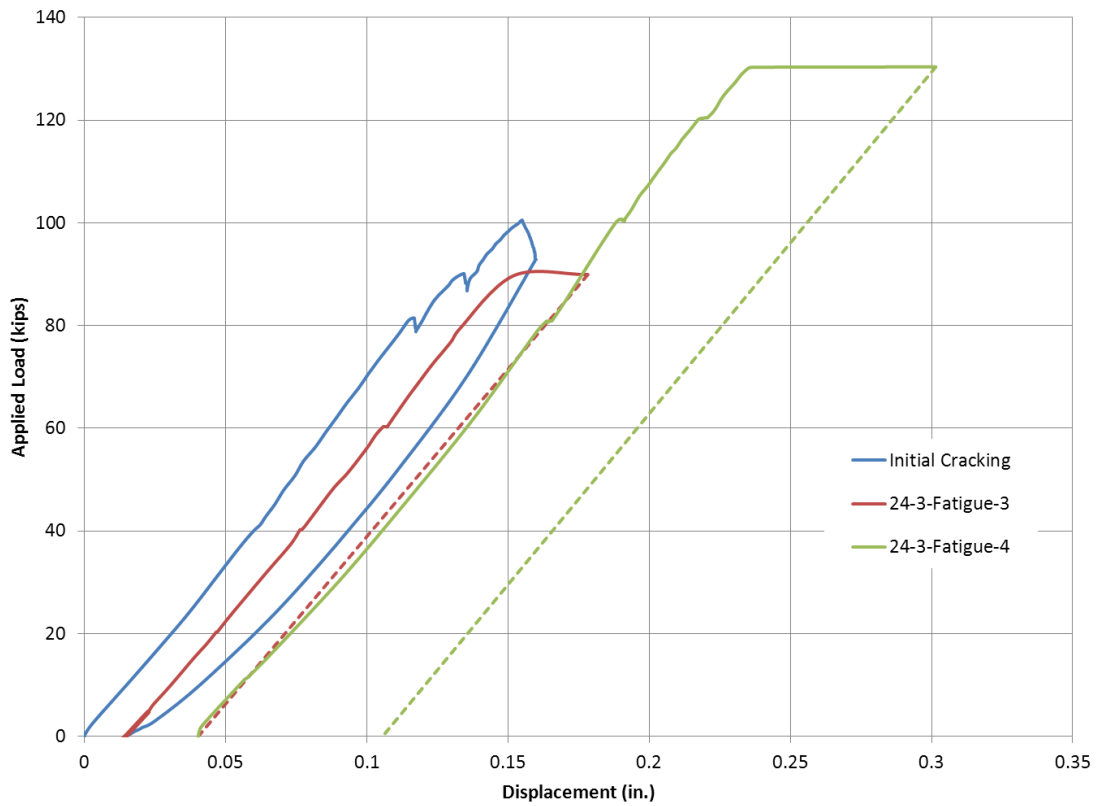
Figure 4-6 Load displacement response, test 24-3-Fatigue-3&4

Once again, the load-displacement response was recorded for the initial cracking of the test specimen as well as for both series of cycled load tests. The data for the unloading curve of the load displacement response was not recorded for tests 24-3-Fatigue-3 and 4. The load-displacement response of these tests is shown in Figure 4-6 and a linear unloading curve is assumed for tests 24-3-Fatigue-3 and 4. As stated previously, the peak load and displacement values were used to plot the portion of the load-displacement curve during the cycled loading portion of the test. This resulted in a plateau forming at the peak of the load-displacement plot for tests 24-3-Fatigue-3 and 4.

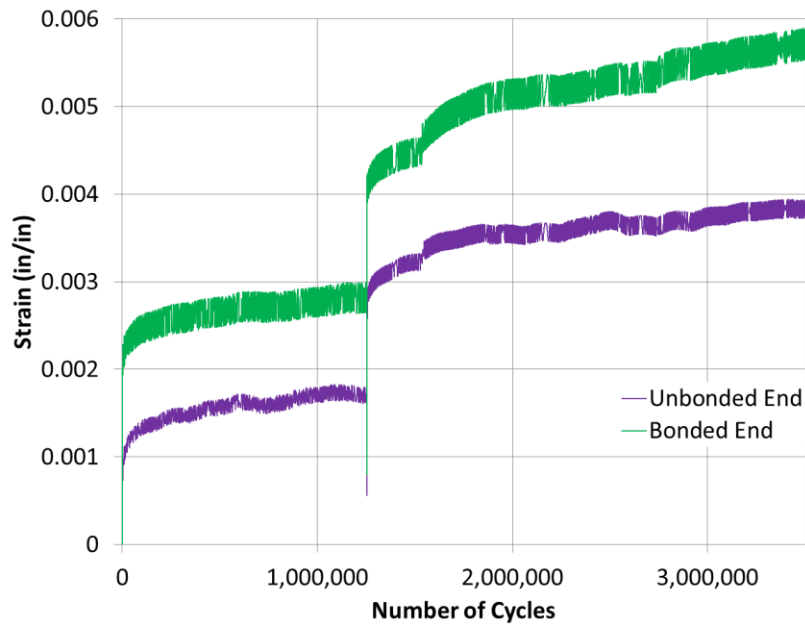
Figure 4-8 CFRP strains, Tests 24-3-Fatigue-3&4

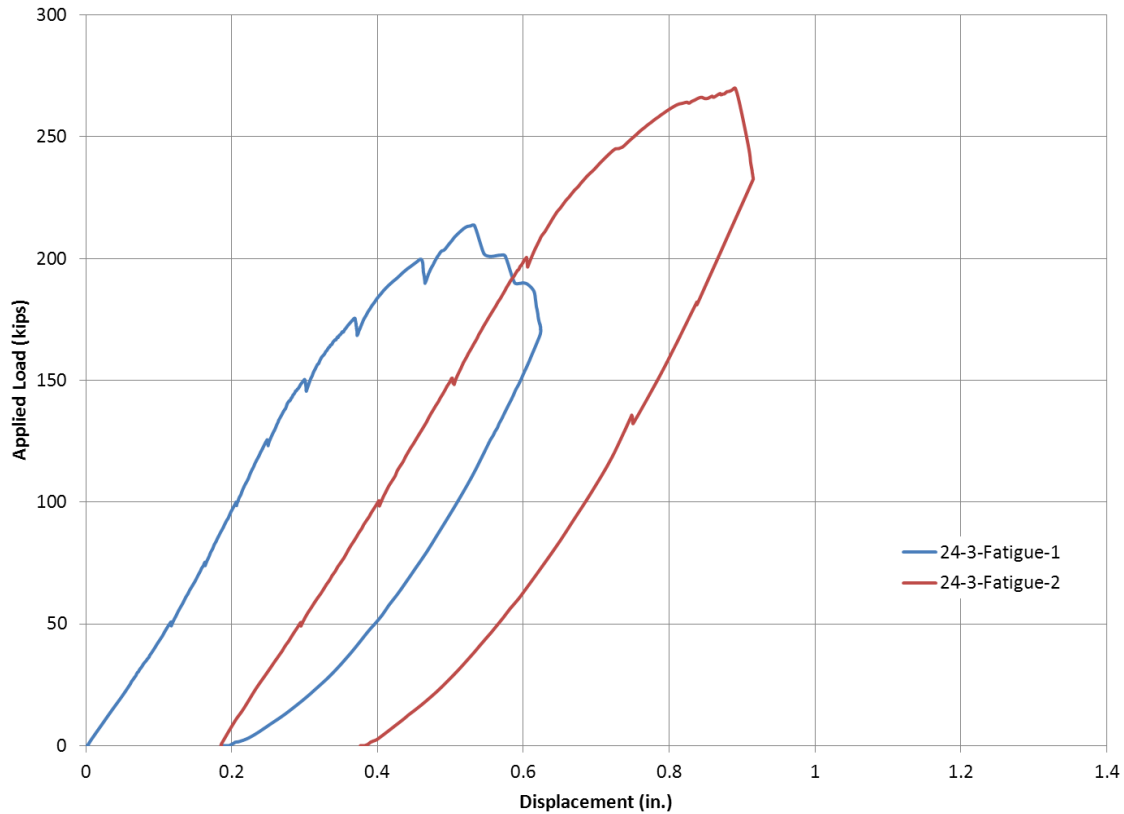
Figure 4-9 Load displacement response, test 24-3-Fatigue-Fail-1&2

the test specimen failed first at an applied load of 214-kips (applied shear equal to 107-kips). The bonded end of the test specimen failed second at an applied load of 270-kips (applied shear equal to 135-kips). The complete load-displacement response of tests 24-3-Fatigue-Fail-1 and 2 are presented in Figure 4-9.

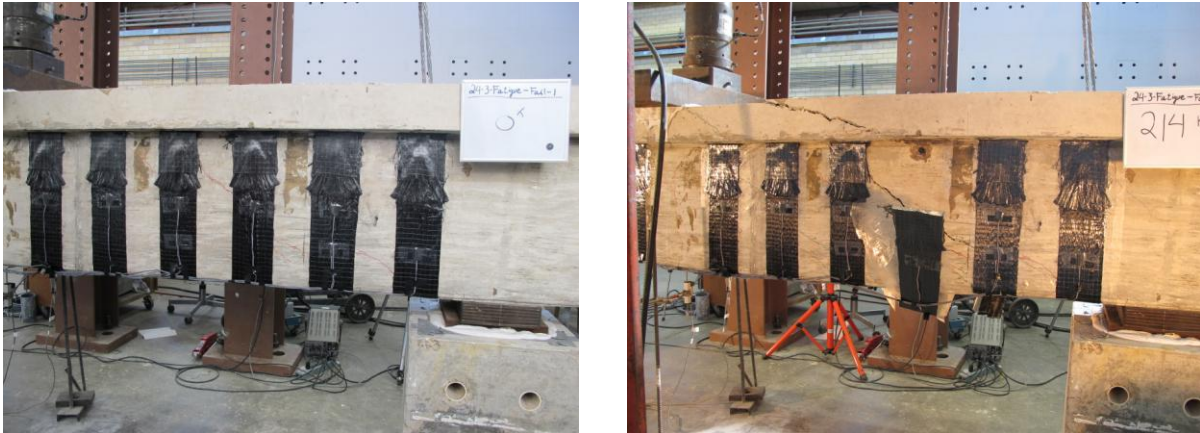
Figure 4-10 24-3-Fatigue-Fail-1 before (left) and after (right) loading

Test 24-3-Fatigue-Fail-1 failed at an applied load of 214-kips (applied shear = 107-kips). Shear failure of the test specimen was initiated by rupture of a CFRP anchor. Photos of the test specimen before loading and after failure are displayed in Figure 4-10. Concrete cracks observed during testing are marked in green, cracks marked in blue and red developed during the previous fatigue testing of the specimen.

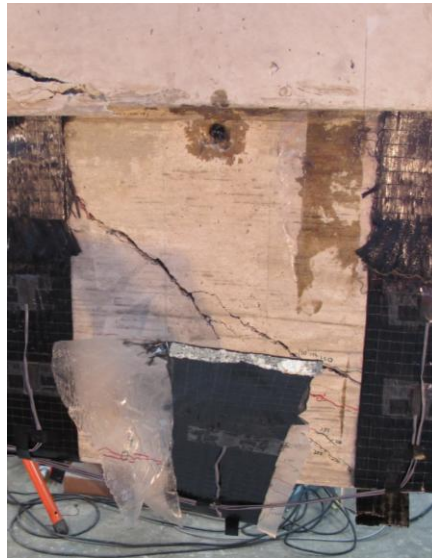
Figure 4-11 Rupture of a CFRP anchor observed during 24-3-Fatigue-Fail-1

Shear failure of the test specimen followed the rupture of the CFRP anchor (Figure 4-11). After the rupture of the CFRP anchor, the CFRP sheet adjacent to the sheet where the anchor failed ruptured at the bottom corner of the CFRP sheet (Figure 4-12). Just prior to failure, a large crack opened in the top flange of the test specimen.

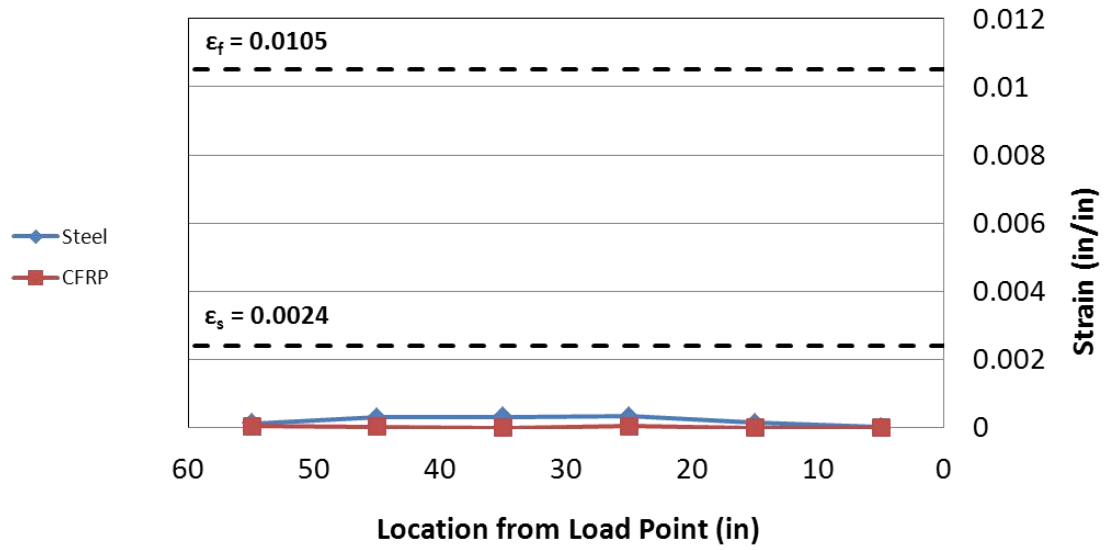
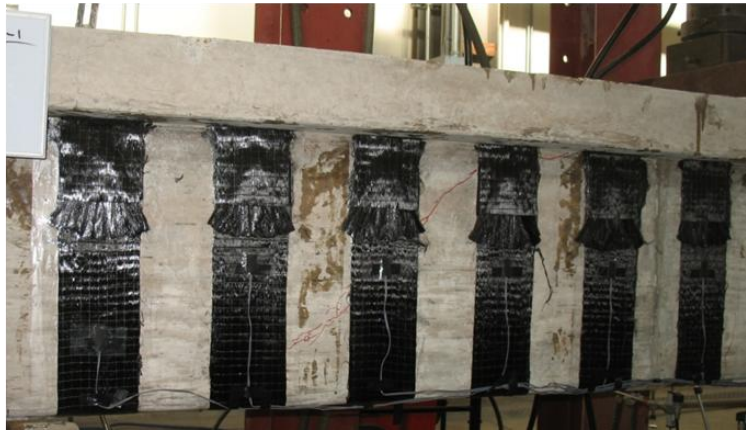
Figure 4-13 24-3-Fatigue-Fail-1 at 0-kips applied load (0-kips applied shear)

The strain values recorded in the CFRP and steel at various stages of the loading process and corresponding photos are presented in Figures 4-15 through 4-18. Strain data and photos of the specimen prior to loading are included to display the residual stresses present in the specimen following the fatigue loading of the beam. The strain values presented are the maximum strain values recorded for each material at given distances from the location of applied load.

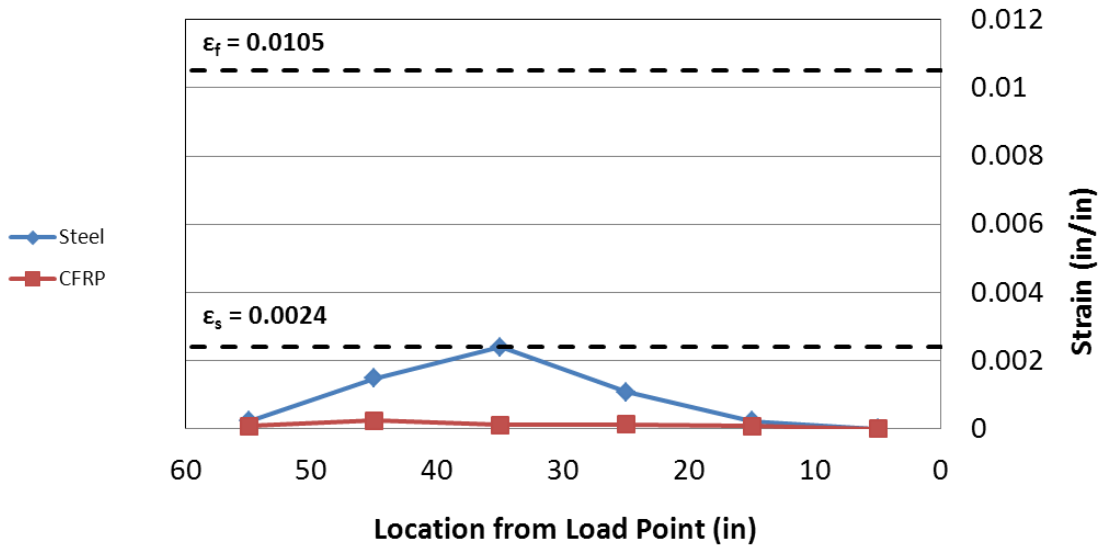
Figure 4-14 24-3-Fatigue-Fail-1 at 100-kips applied load (50-kips applied shear)

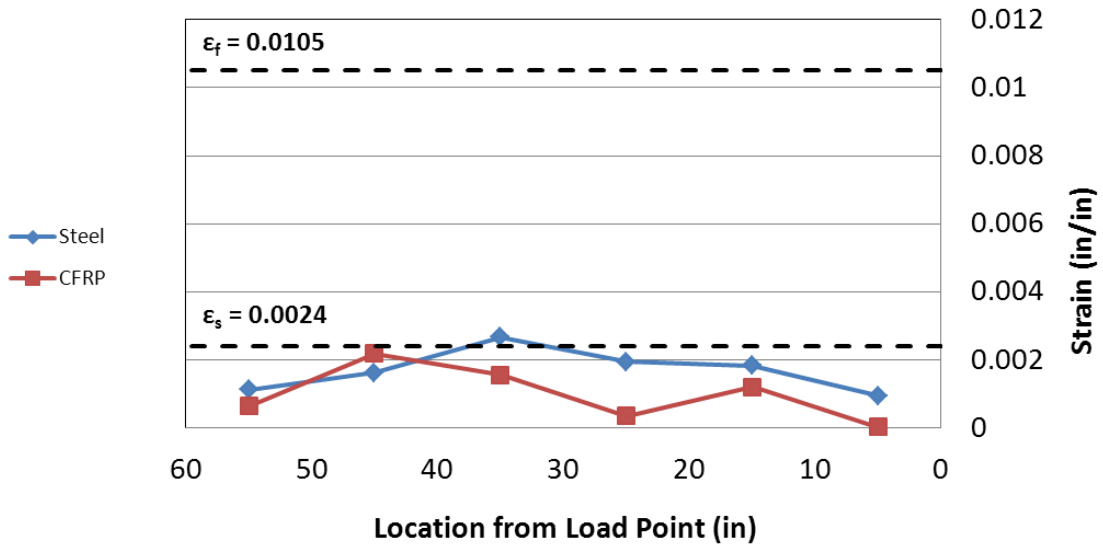
Figure 4-15 24-3-Fatigue-Fail-1 at 200-kips applied load (100-kips applied shear)

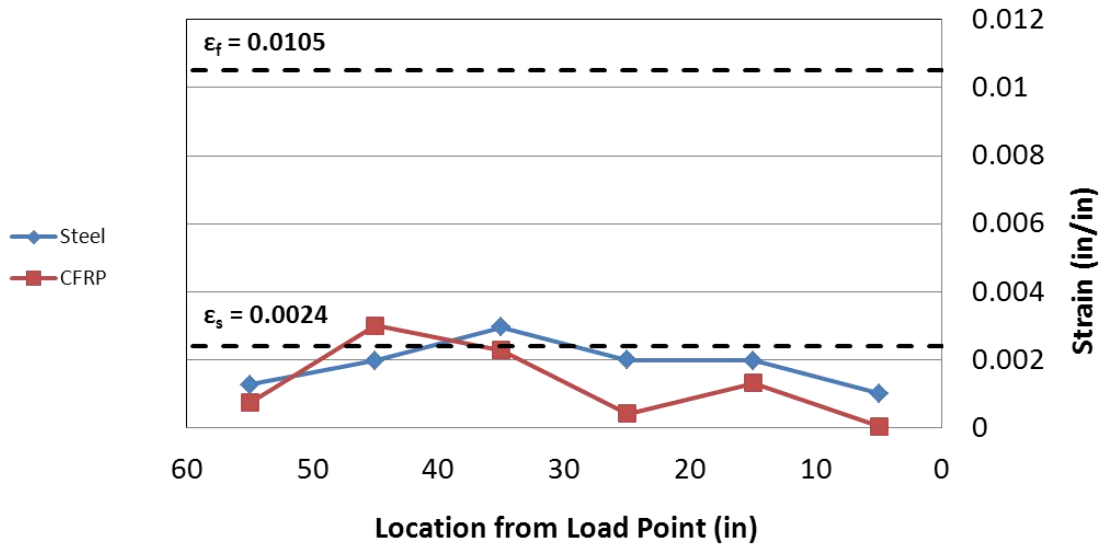
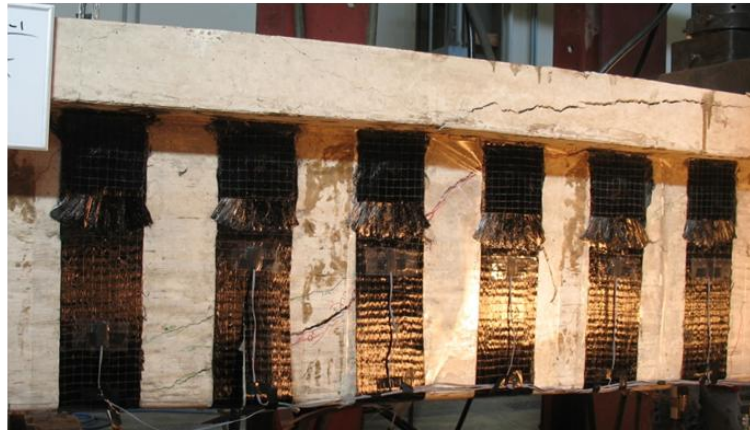
Figure 4-16 24-3-Fatigue-Fail-1 at 214-kips applied load (107-kips applied shear)

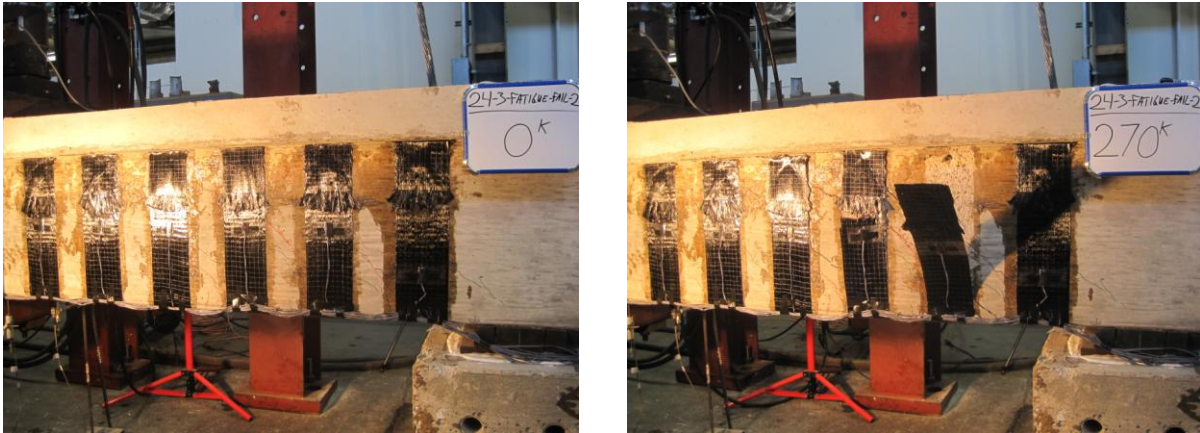
Figure 4-17 24-3-Fatigue-Fail-2 before (left) and after (right) loading

Test 24-3-Fatigue-Fail-2 failed at an applied load of 270-kips (applied shear = 135-kips). Once again, shear failure of the test specimen was initiated by rupture of a CFRP anchor. Photos of the test specimen before loading and after failure are displayed in Figure 4-17. Concrete cracks observed during testing are marked in green, cracks marked in blue and red developed during the previous fatigue testing of the specimen.

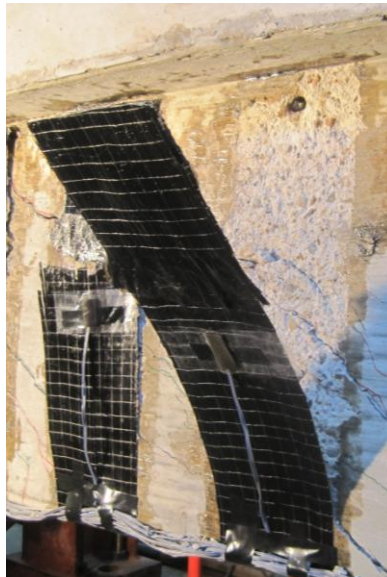
Figure 4-18 CFRP anchor failure observed during 24-3-Fatigue-Fail-2

Shear failure of the test specimen was initiated by a combination of rupture of the CFRP strips and the CFRP anchors. First, the CFRP anchor ruptured on one side of the test specimen and the same sheet fractured on the opposite side of the specimen. A photo of the failed anchor can be seen in Figure 4-18. The CFRP sheet adjacent to the initially failed strip then ruptured due to increased load from the redistribution of shear force following the initial strips failure (Figure 4-19).

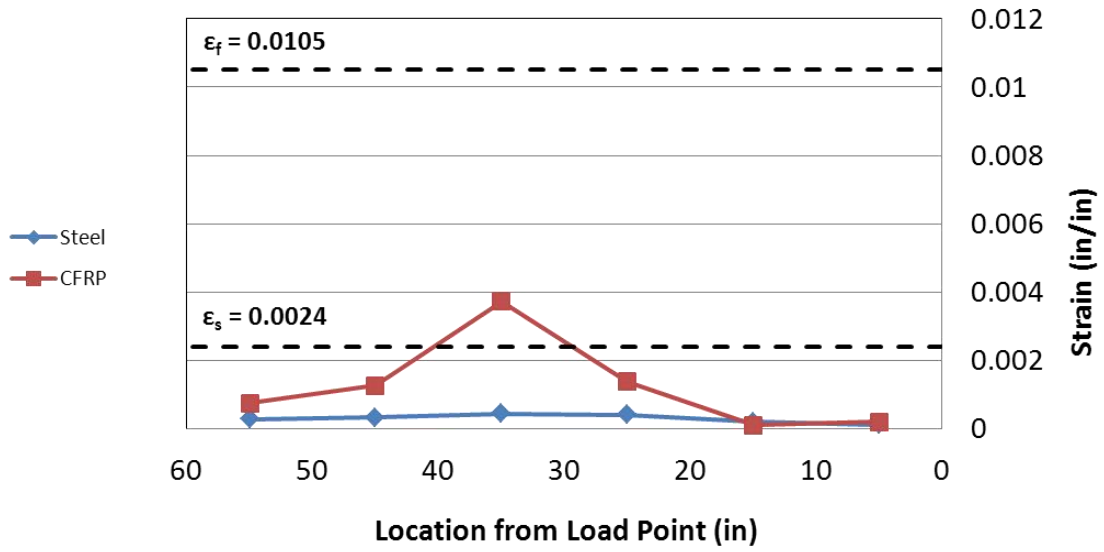
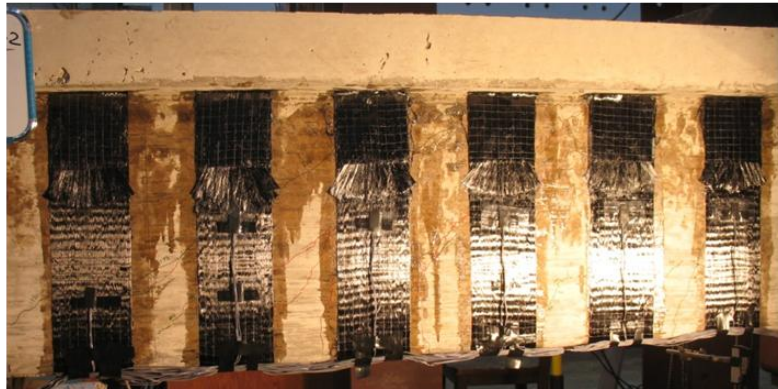
Figure 4-20 24-3-Fatigue-Fail-2 at 0-kips applied load (0-kips applied shear)

The strain values recorded in the CFRP and steel at various stages of the loading process and corresponding photos are presented in Figures 4-22 through 4-25. Strain data and photos of the specimen prior to loading are included to display the residual stresses present in the specimen following the fatigue loading of the beam. The strain values presented are the maximum strain values recorded for each material at given distances from the location of applied load.

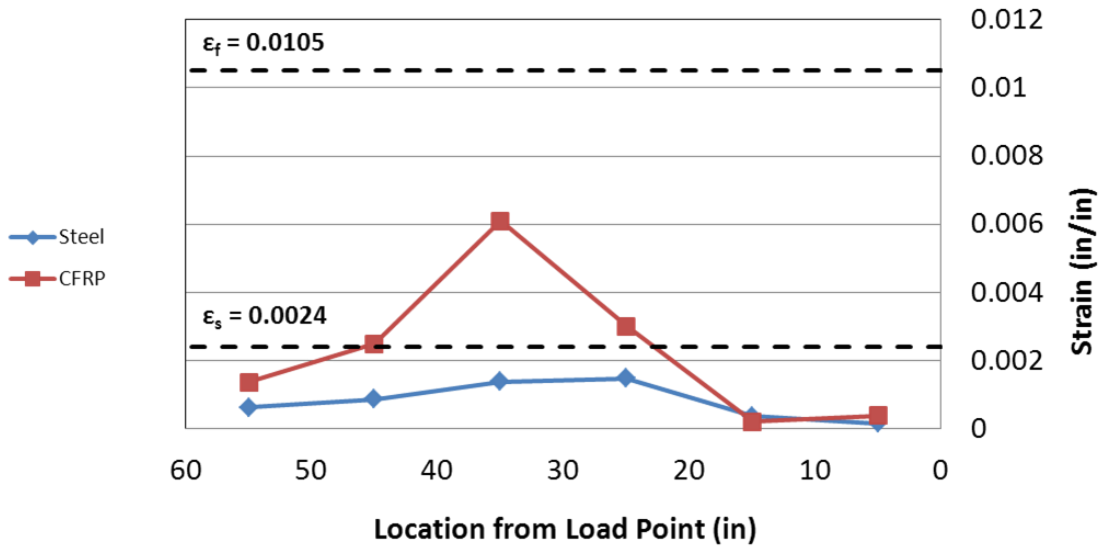
Figure 4-21 24-3-Fatigue-Fail-2 at 100-kips applied load (50-kips applied shear)

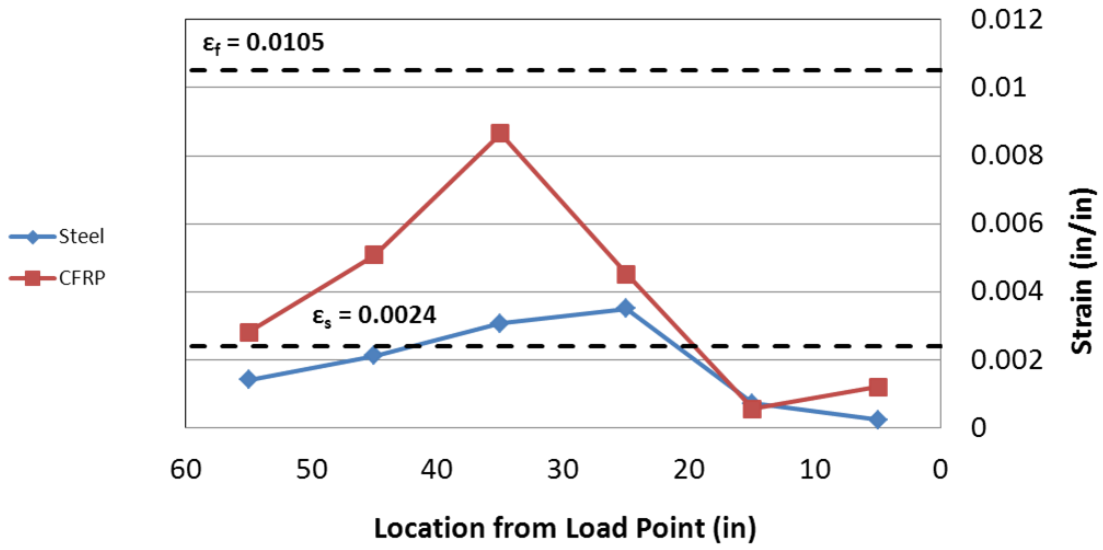
Figure 4-22 24-3-Fatigue-Fail-2 at 200-kips applied load (100-kips applied shear)

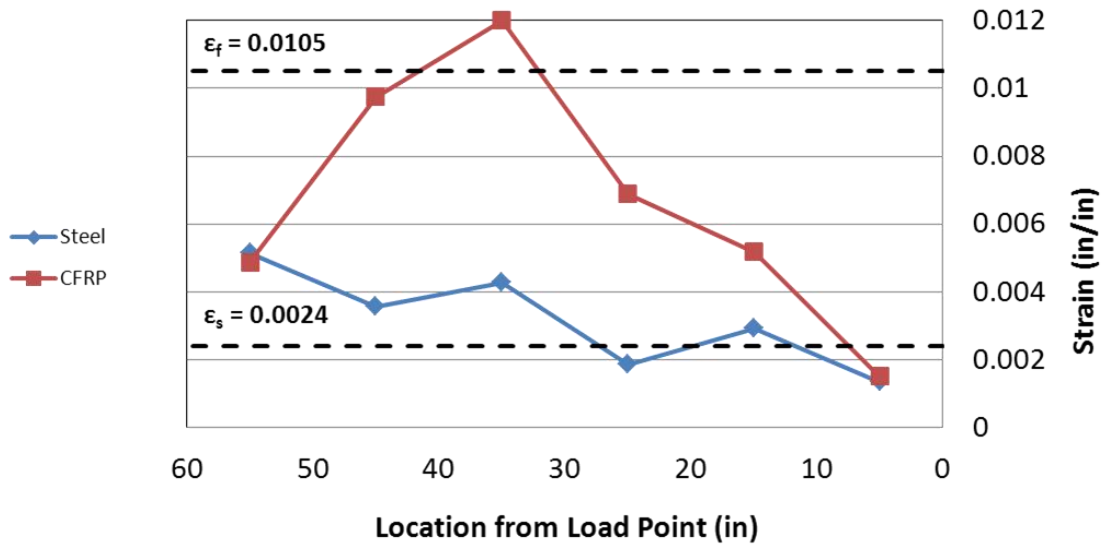
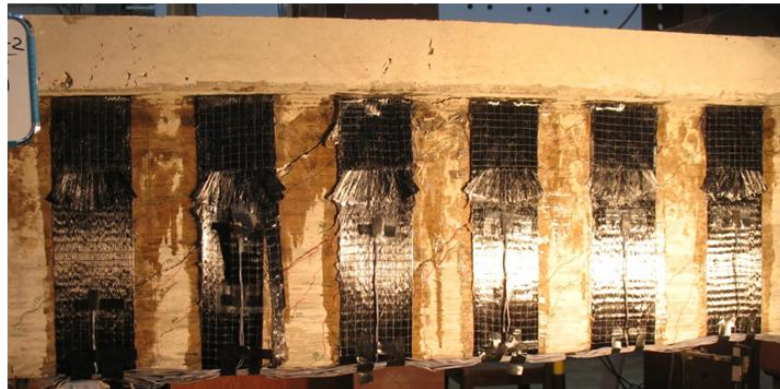
Figure 4-23 24-3-Fatigue-Fail-2 at 270-kips applied load (135-kips applied shear)

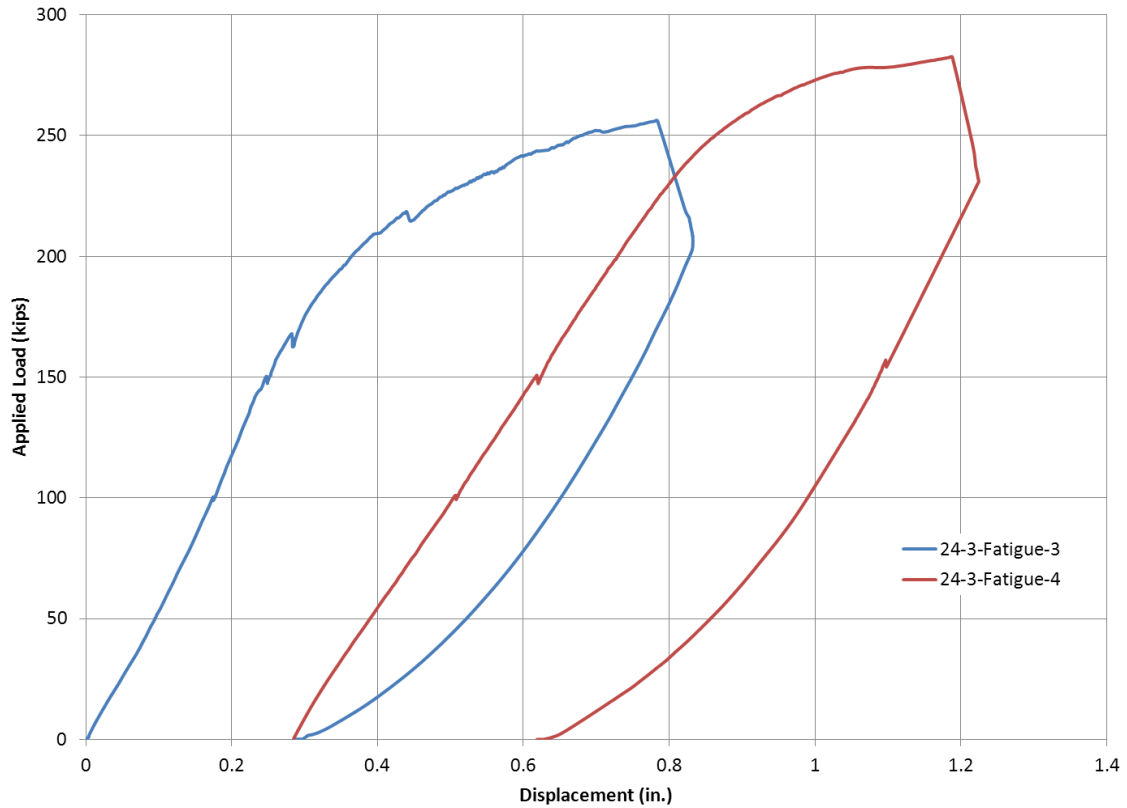
Figure 4-24 Load displacement response, test 24-3-Fatigue-Fail-3&4

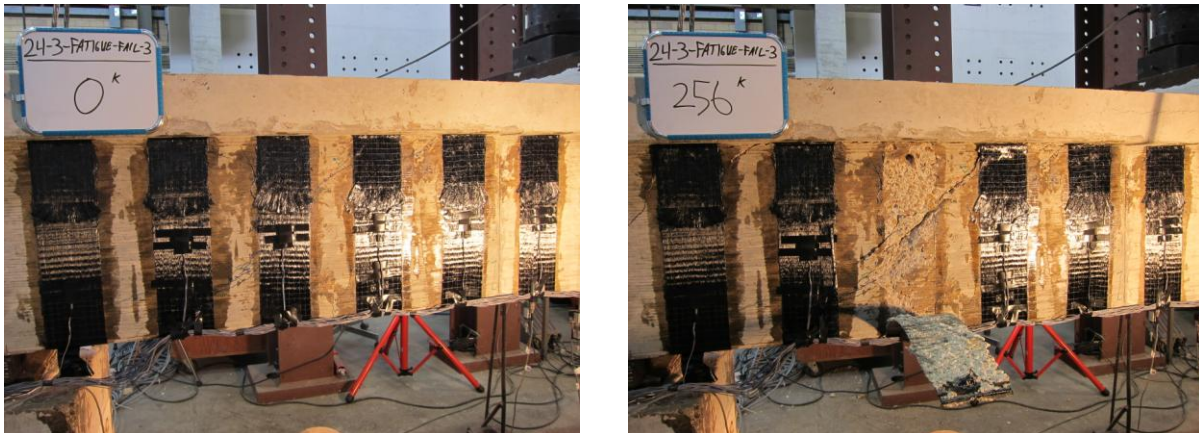
Figure 4-25 24-3-Fatigue-Fail-3 before (left) and after (right) loading

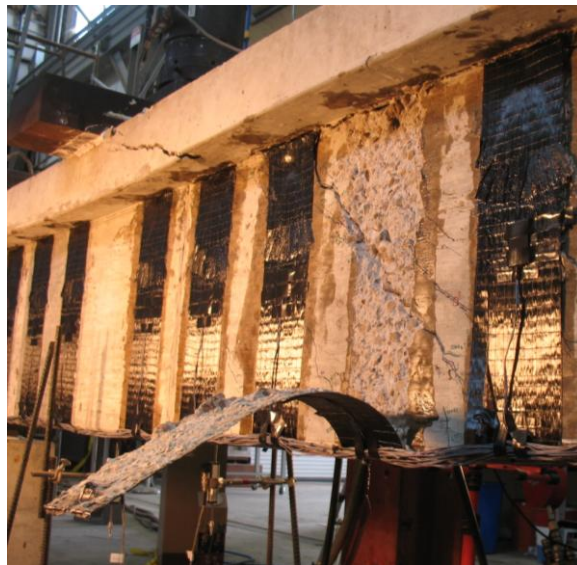
Figure 4-26 First CFRP anchor failure observed during 24-3-Fatigue-Fail-3

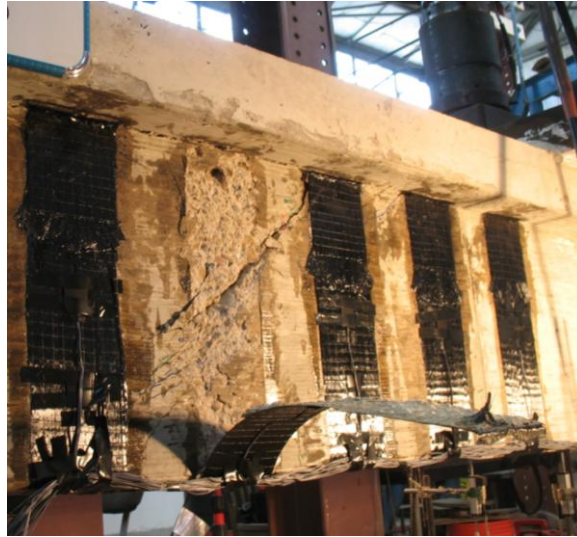
Figure 4-27 Second CFRP anchor failure observed during 24-3-Fatigue-Fail-3

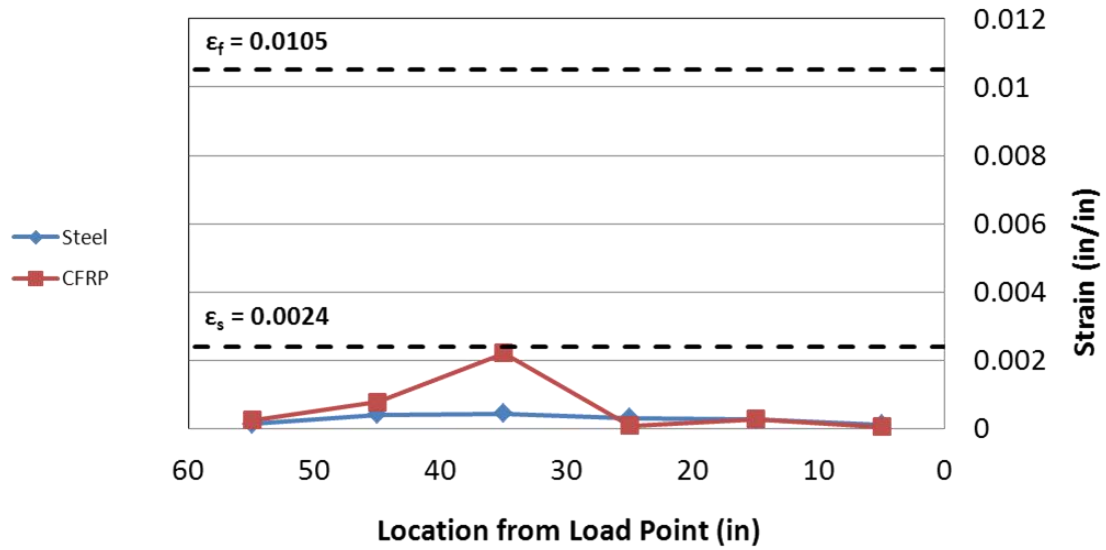
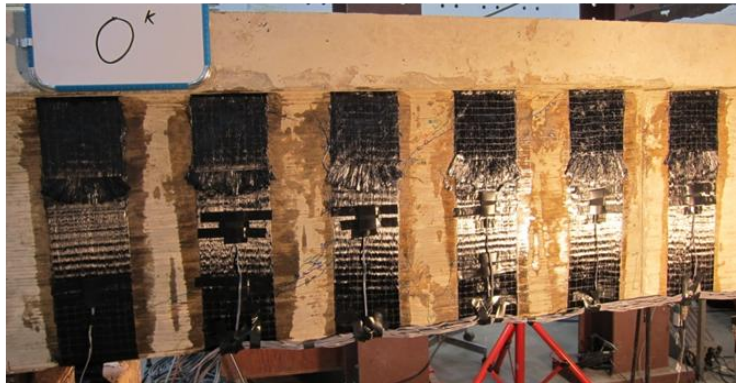
Figure 4-28 24-3-Fatigue-Fail-3 at 0-kips applied load (0-kips applied shear)

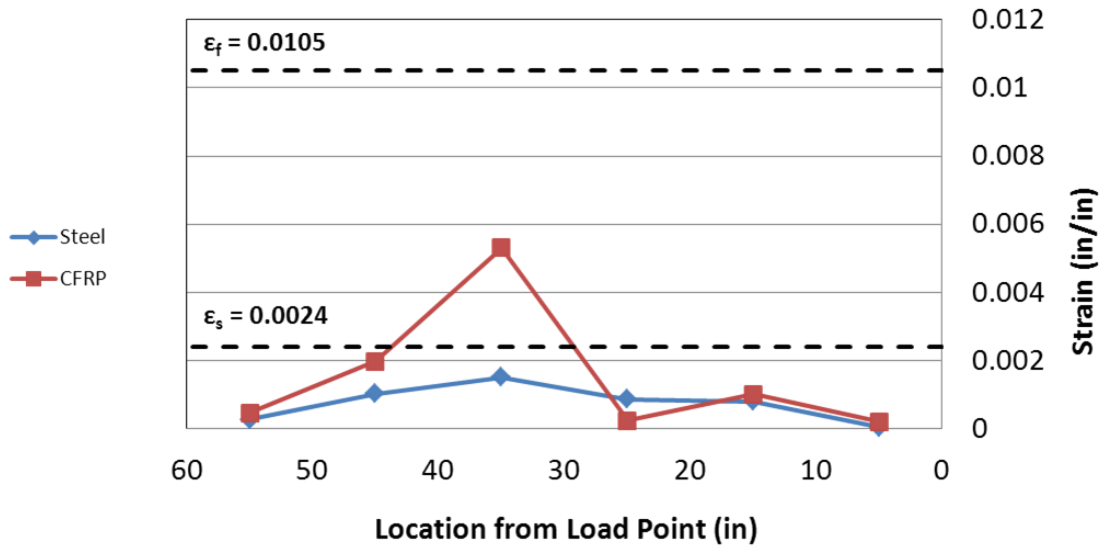
Figure 4-29 24-3-Fatigue-Fail-3 at 100-kips applied load (50-kips applied shear)

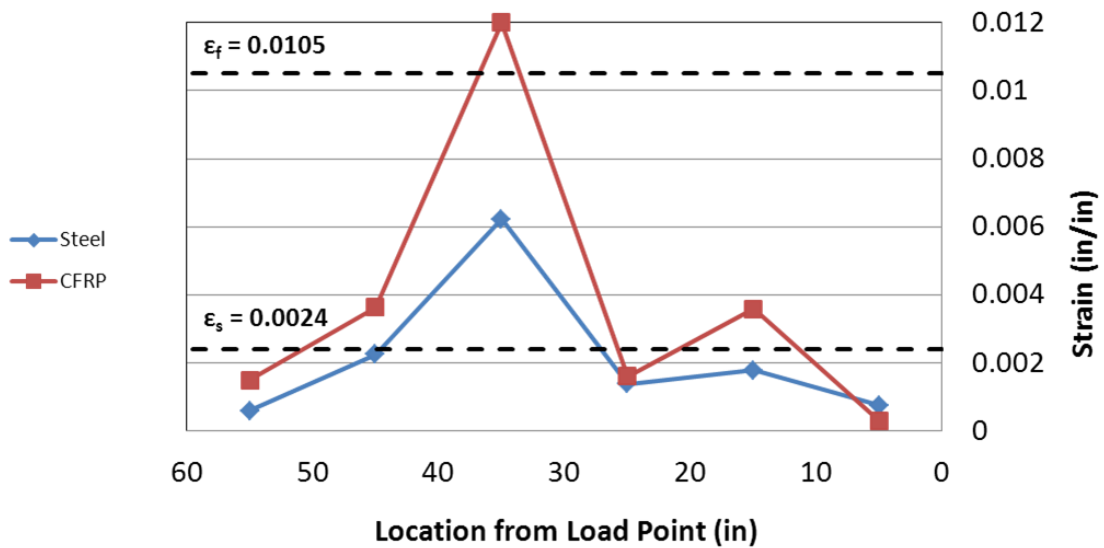
Figure 4-30 24-3-Fatigue-Fail-3 at 200-kips applied load (100-kips applied shear)

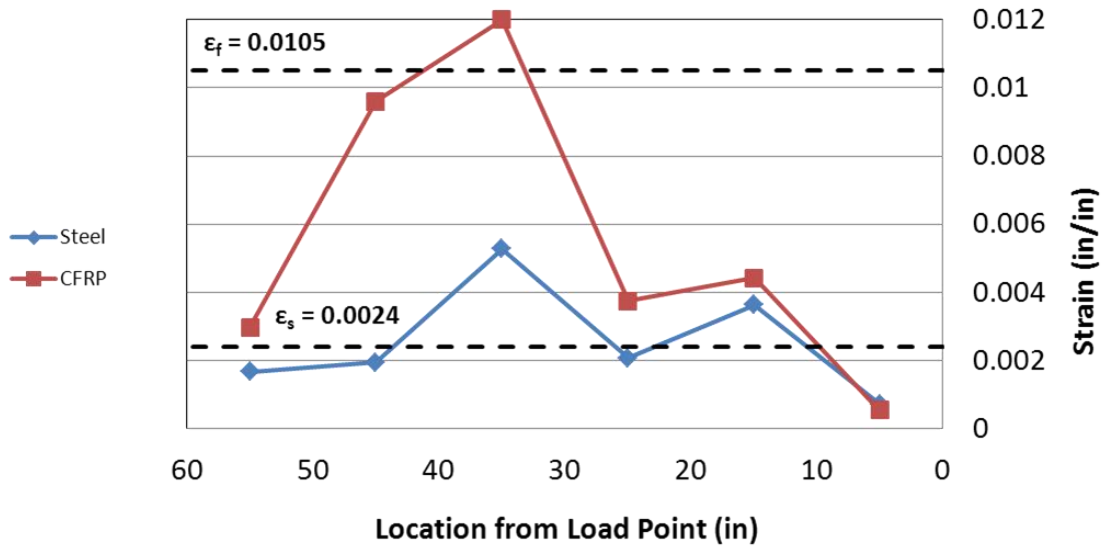
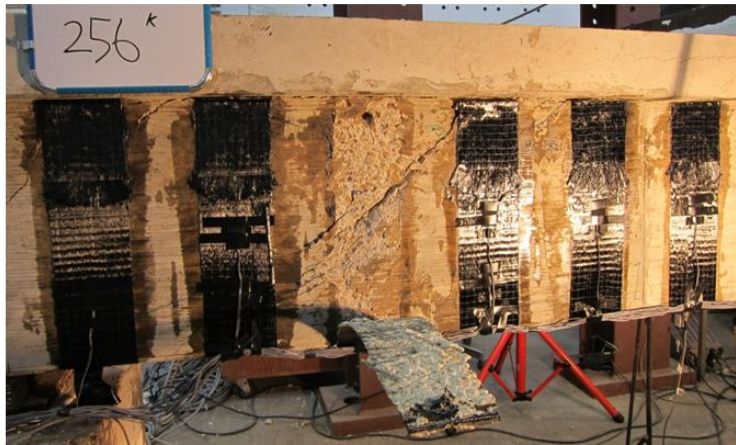
Figure 4-31 24-3-Fatigue-Fail-3 at 256-kips applied load (128-kips applied shear)

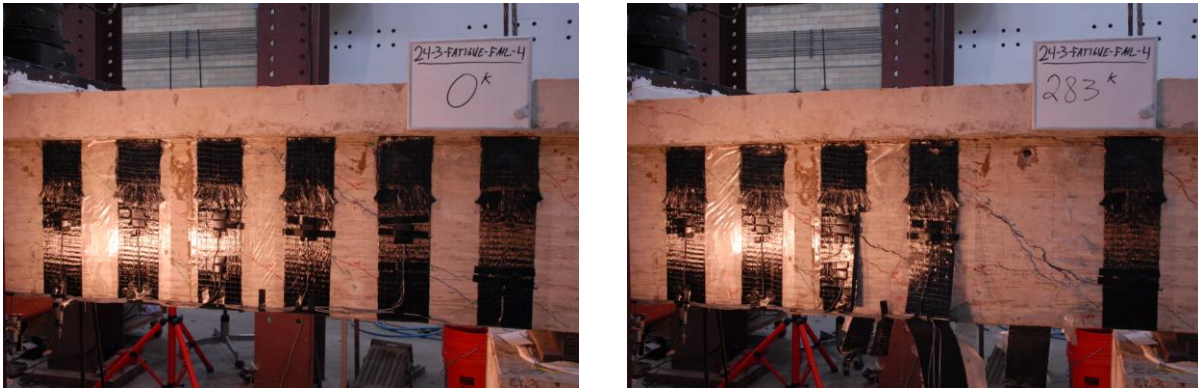
Figure 4-32 24-3-Fatigue-Fail-4 before (left) and after (right) loading

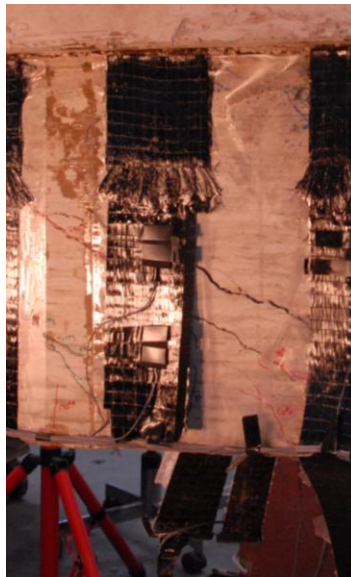
Figure 4-33 CFRP sheet rupture observed during 24-3-Fatigue-Fail-4

Shear failure of the test specimen was initiated by the rupture of a CFRP anchor in the second strip nearest to the support. Once the first CFRP anchor failed, then the adjacent strip failed due to the rupture of a CFRP anchor. After the second sheet failed due to the rupture of a CFRP anchor, then a third CFRP sheet failed due to the rupture of the CFRP sheet at the bottom bend of the CFRP sheet (Figure 4-33). A photo of one of the failed anchors can be seen in Figure 4-34. Two large shear cracks formed in the middle of the shear span with the ultimate failure resulting from the shear crack closest to the support.

Test 24-3-Fatigue-Fail-4 failed at an applied load of 283-kips (applied shear = 142-kips). Once again, shear failure of the test specimen was initiated by rupture of a CFRP anchor. Photos of the test specimen before loading and after failure are displayed in Figure 4-32. Concrete cracks observed during testing are marked in red. Cracks marked in blue and green developed during the previous fatigue testing of the specimen.

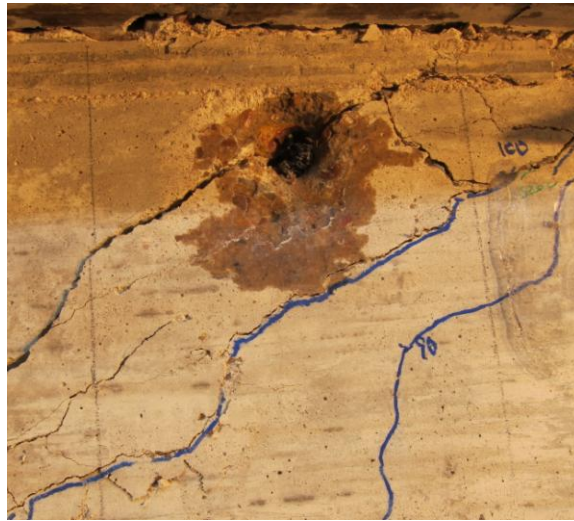
Figure 4-34 CFRP anchor failure observed during 24-3-Fatigue-Fail-4

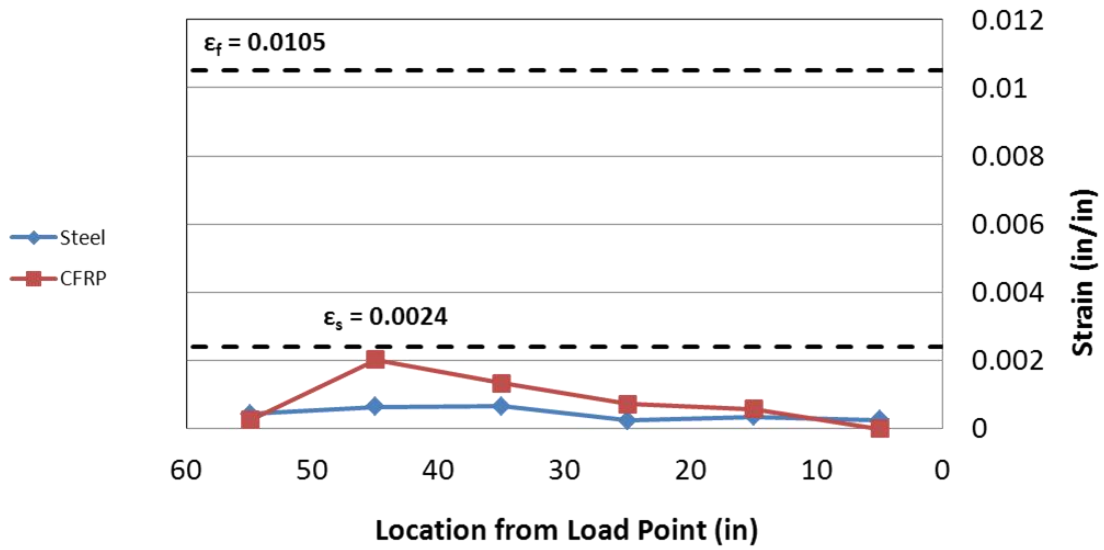
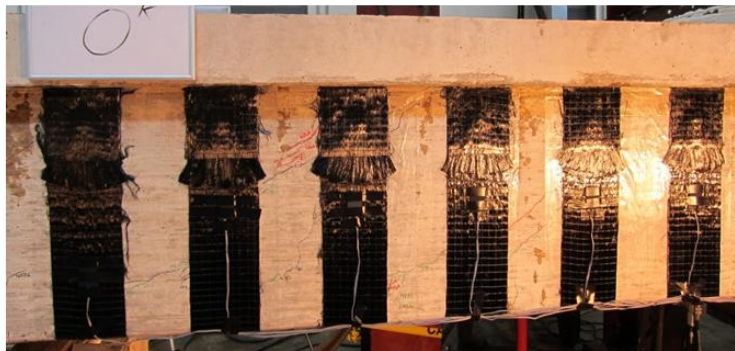
Figure 4-35 24-3-Fatigue-Fail-4 at 0-kips applied load (0-kips applied shear)

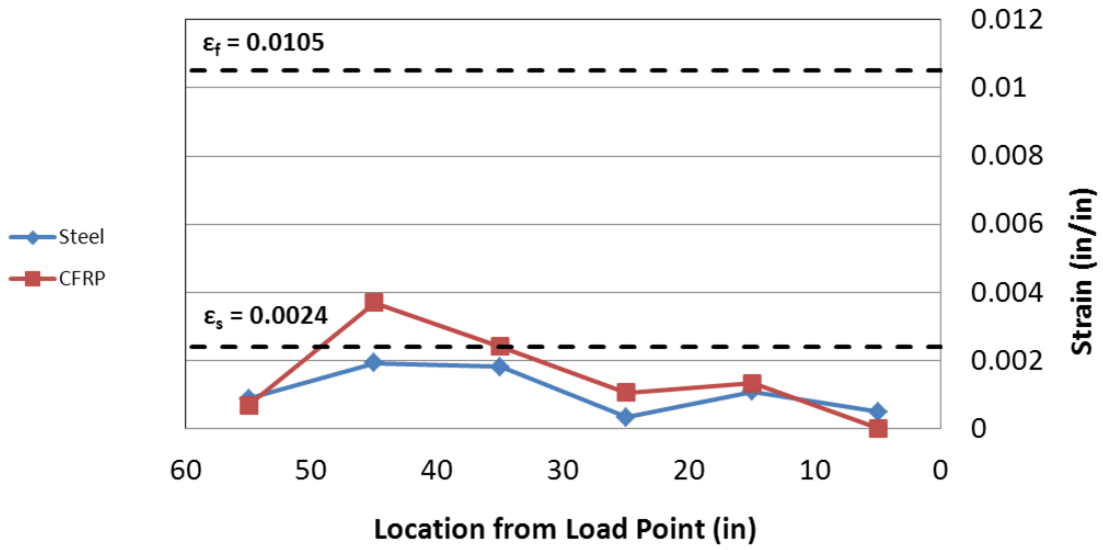
Figure 4-36 24-3-Fatigue-Fail-4 at 100-kips applied load (50-kips applied shear)

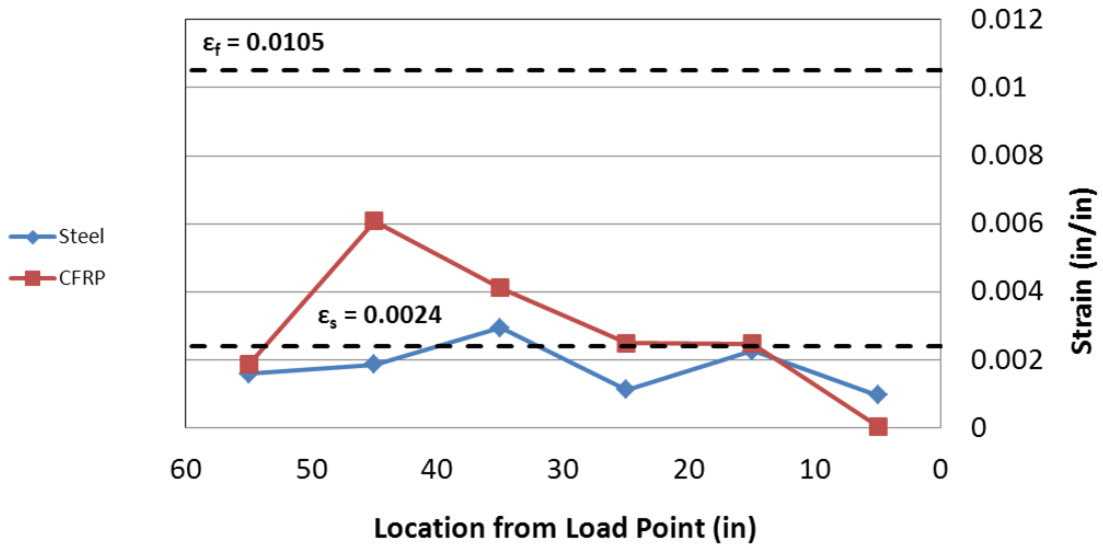
Figure 4-37 24-3-Fatigue-Fail-4 at 200-kips applied load (100-kips applied shear)
