**Shear Strengthening of Reinforced Concrete Beams with
Carbon Fiber Reinforced Polymer (CFRP) Under Fatigue and
Sustained Loading Applications**

Thesis

The University of Texas at Austin

August 2011

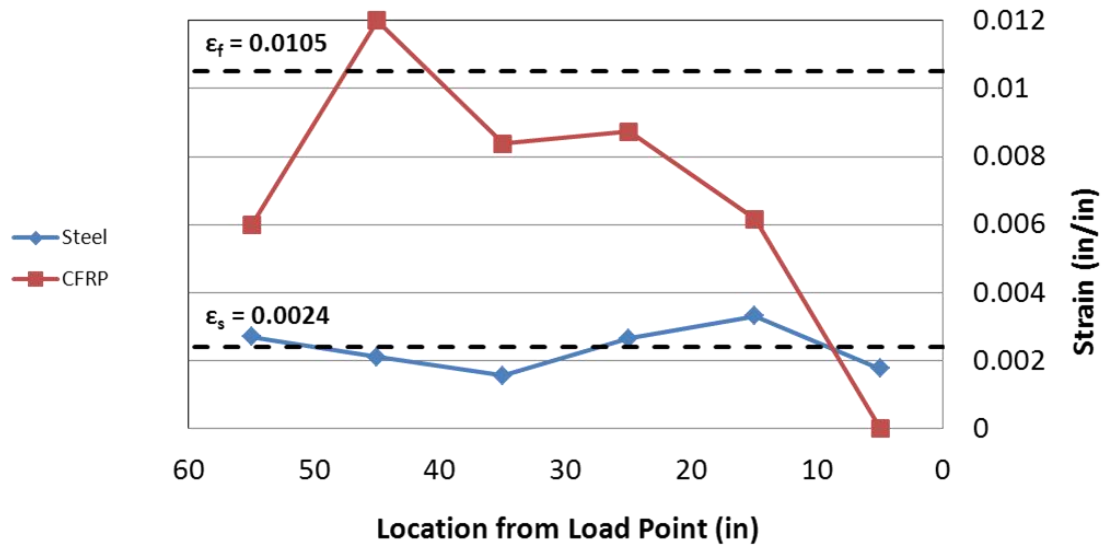
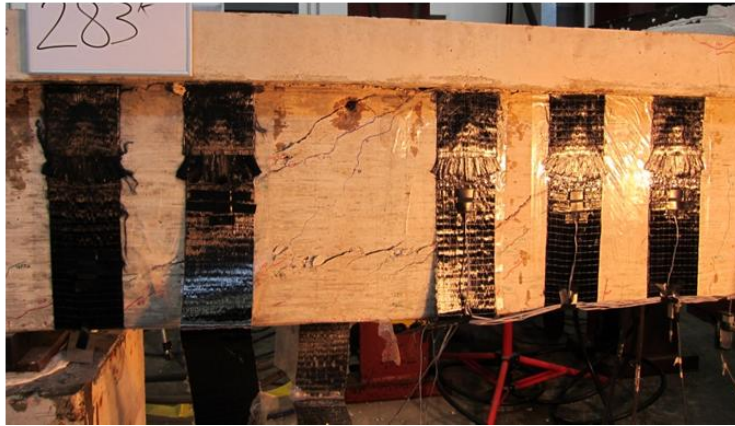
Figure 4-38 24-3-Fatigue-Fail-4 at 283-kips applied load (142-kips applied shear)

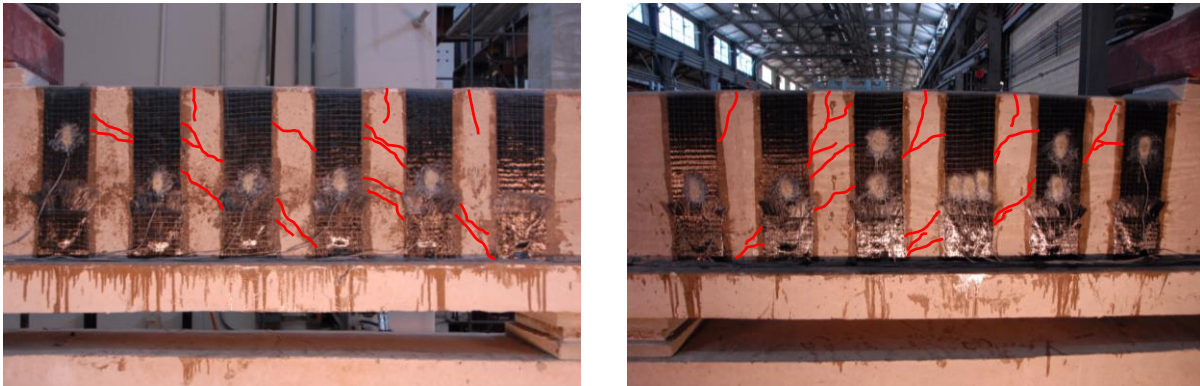
Figure 5-1 Front and back of test 24-3-Sust-1

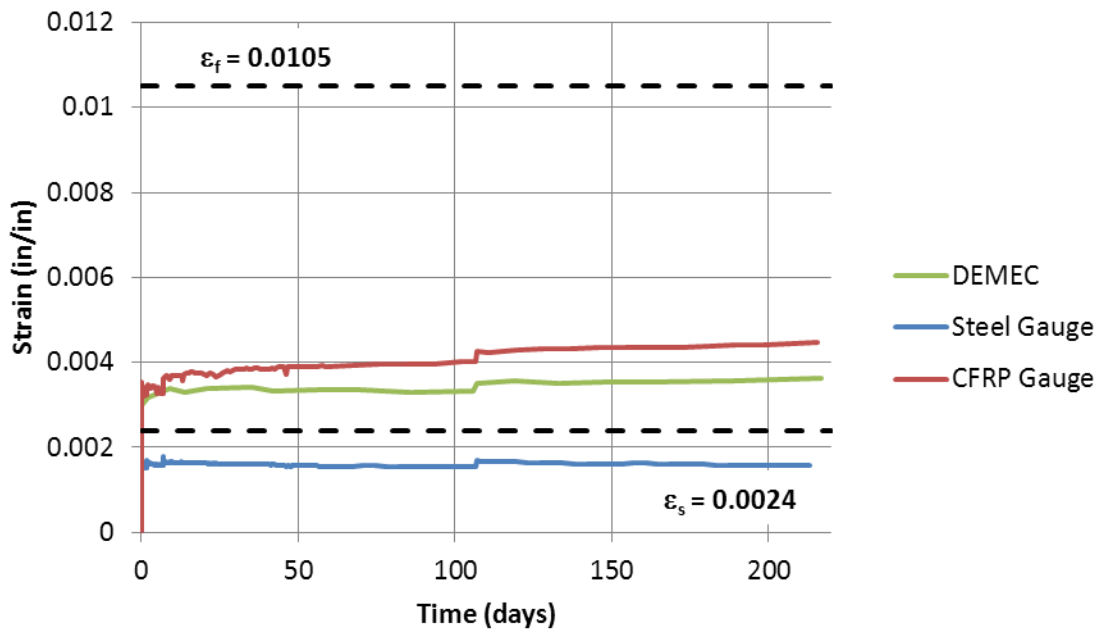
Figure 5-2 Strains, test 24-3-Sust-1

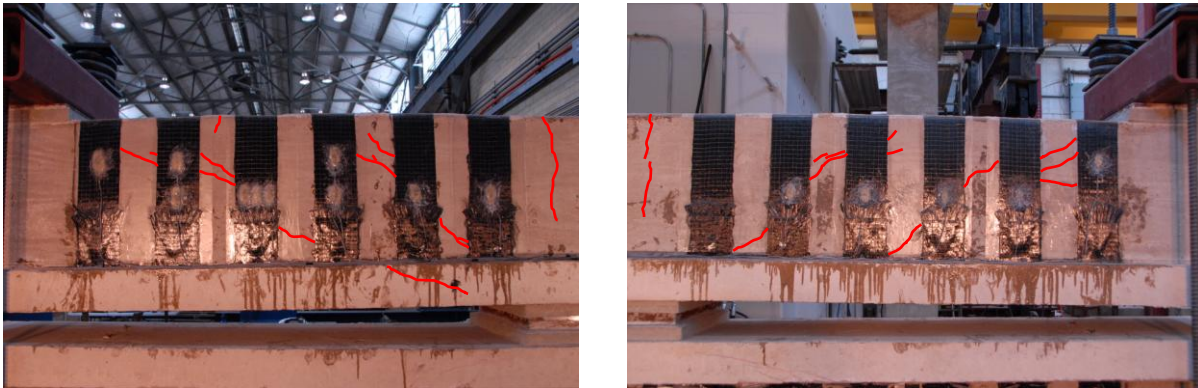
Figure 5-3 Front and back of test 24-3-Sust-2

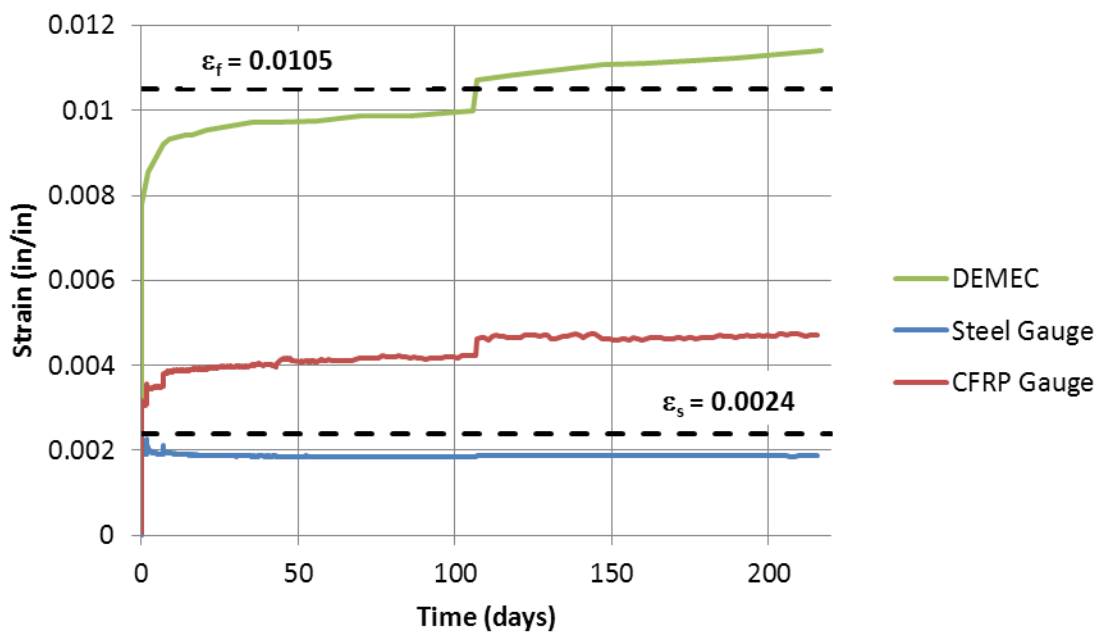
Figure 5-4 Strains, test 24-3-Sust-2

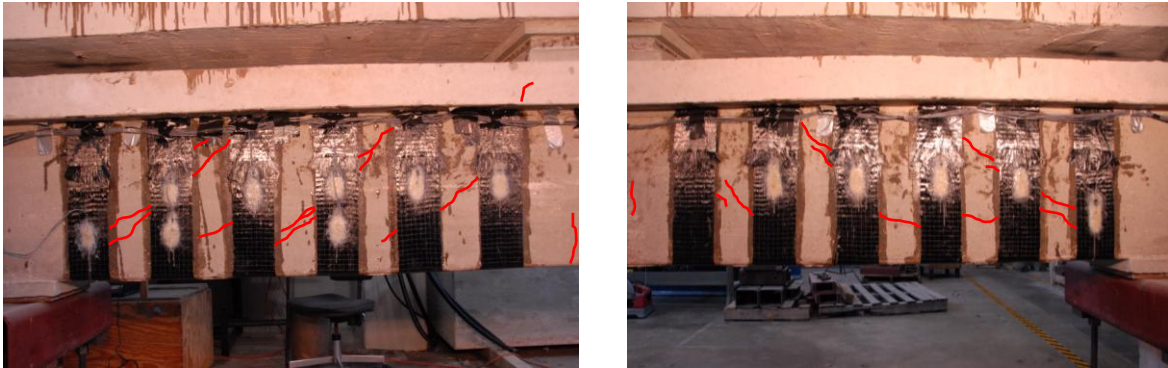
Figure 5-5 Front and back of test 24-3-Sust-3

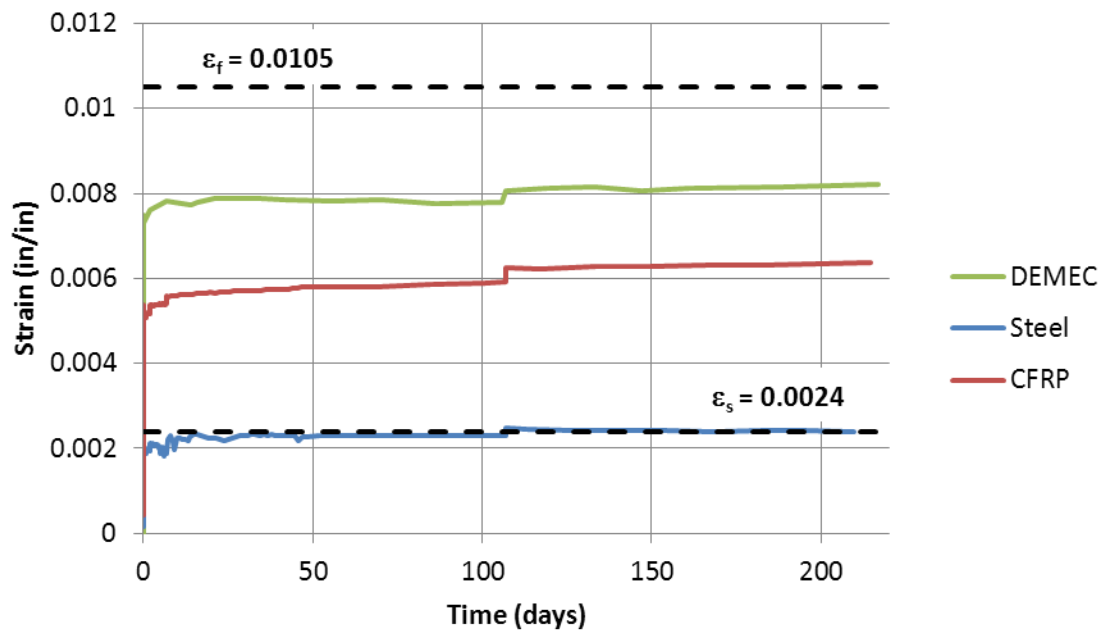
Figure 5-6 Strains, test 24-3-Sust-3

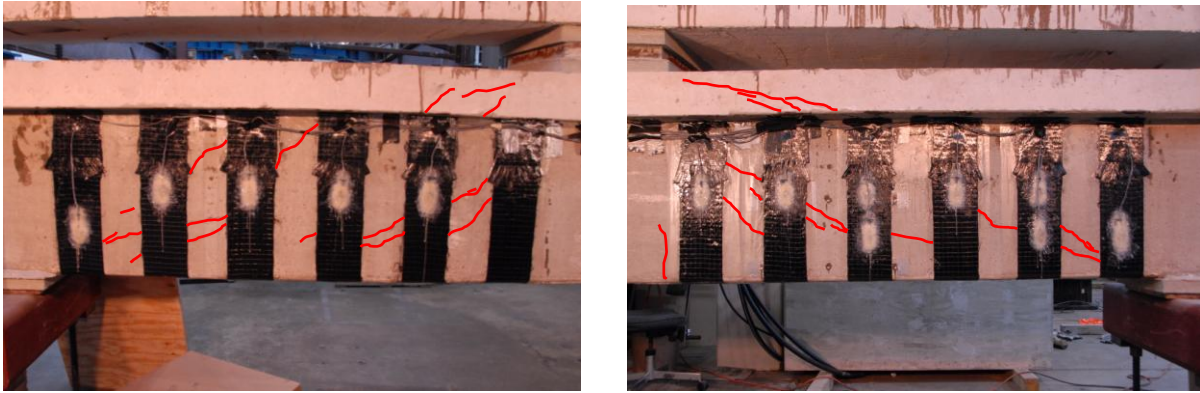
Figure 5-7 Front and back of test 24-3-Sust-4

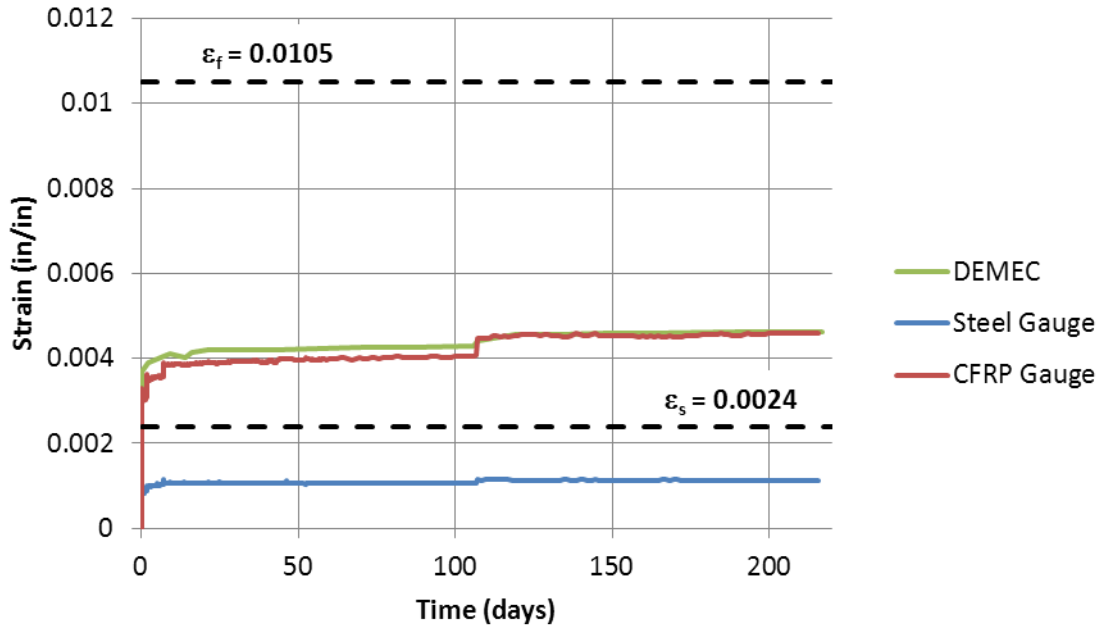
Figure 5-8 Strains, test 24-3-Sust-4

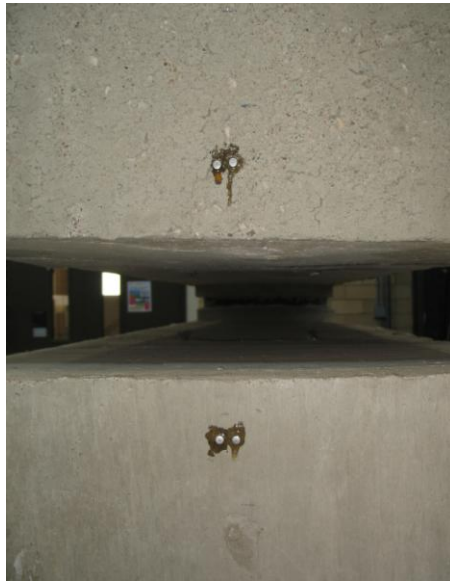
Figure 5-9 End displacement DEMEC points

End displacements were monitored on each end of the test specimens using DEMEC points similar to those used to obtain surface strain values. A photo of the DEMEC points placed on the surface of the end region of the test set-up is presented in Figure 5-9. The average displacements throughout testing are presented in Figure 5-10. Displacements increased dramatically during the first several days of loading and then continued to increase slowly for the duration of the test. A large jump in displacements were recorded when the load was adjusted at 107 days.
