**Accelerated Corrosion Testing, Evaluation and Durability Design
of Bonded Post-Tensioned Concrete Tendons**

Dissertation

The University of Texas at Austin

August 2003

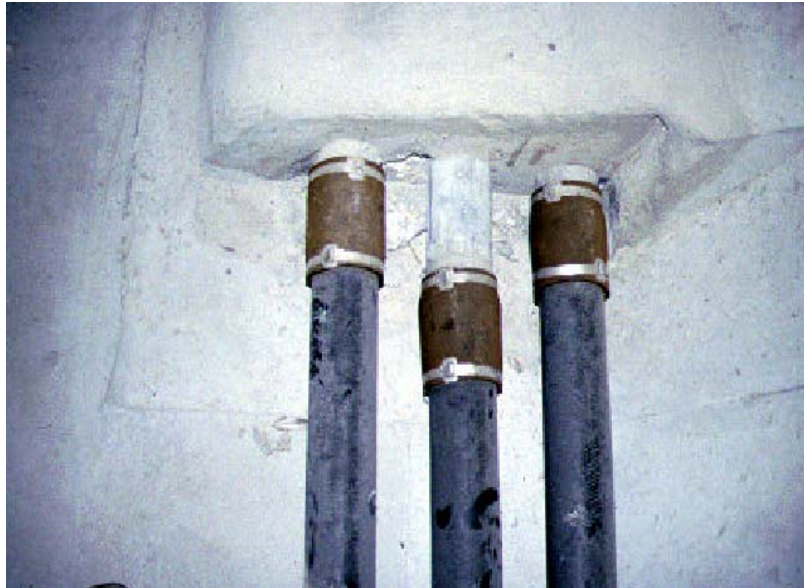
*Figure 2.5 Plan View of Slipped Tendon at Deviation Saddle
Niles Channel Bridge^{2.10}*

Recently, some tendon failures and corrosion related problems have come to light, especially in the state of Florida.^{2.5,2.10} In 1999, one of the external tendons in the Niles Channel Bridge built in 1983, failed due to corrosion at an expansion joint. A 9-inch movement of the tendon through one of the deviation saddles was noticed first. When the tendon was removed for replacement, a void in the grout and heavy pitting in the prestressing strands inside the anchor head were found. (See Figures 2.5 and 2.6). In 2000, eleven tendons out of a total of 846 were replaced in the Mid-Bay Bridge built in 1993. Ten of the eleven tendons that were replaced were located at expansion joints. (See Figures 2.7, 2.8 and 2.9) Also, in 2000, several corroded tendons were discovered in segmental piers of the Sunshine Skyway Bridge, built in 1986, where the corrosion resulted from seawater in ducts, permeable concrete anchorage protection at the top of piers and splitting of polyethylene ducts.^{2.5} (See Figures 2.10 and 2.11)

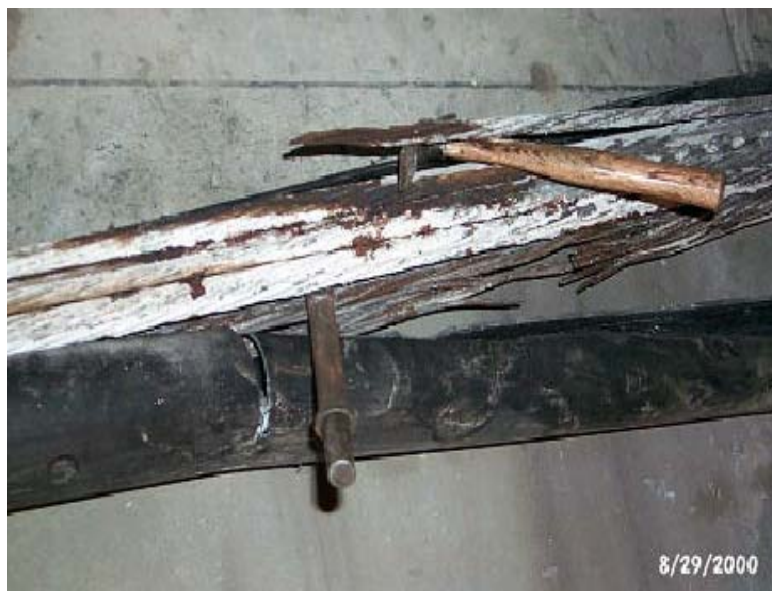
Figure 2.8 Failure of Tendon 28-6 on the Mid-Bay Bridge^{2.10}

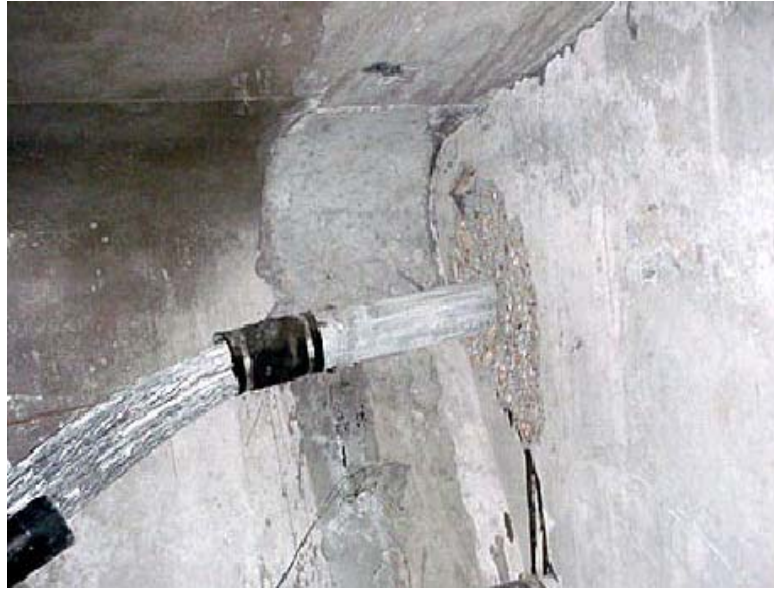
*Figure 2.9 Failure of Tendon 57-1 on the Mid-Bay Bridge-
At Expansion Joint Diaphragm-^{2.10}*

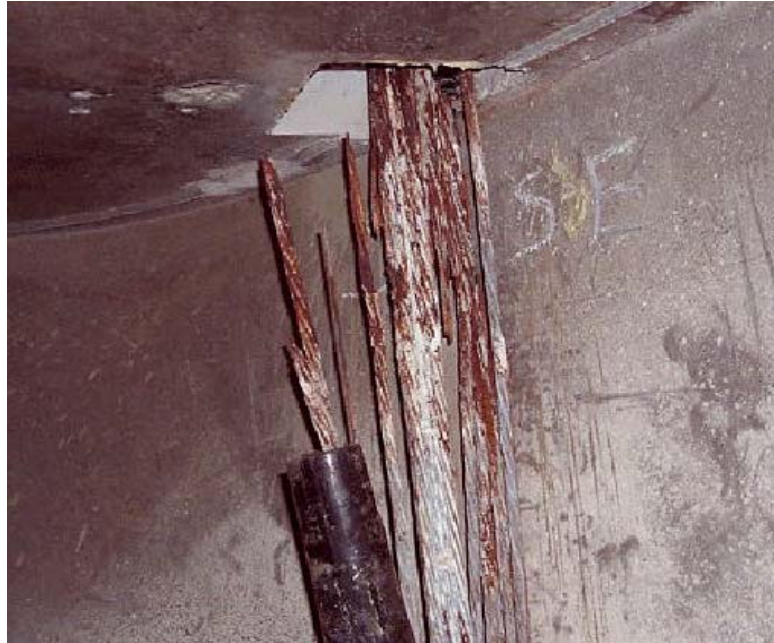
***Figure 2.11 Tendon Corrosion inside the Sunshine Skyway Bridge Piers
(Refer to Figure 2.3) ^{2.10}***

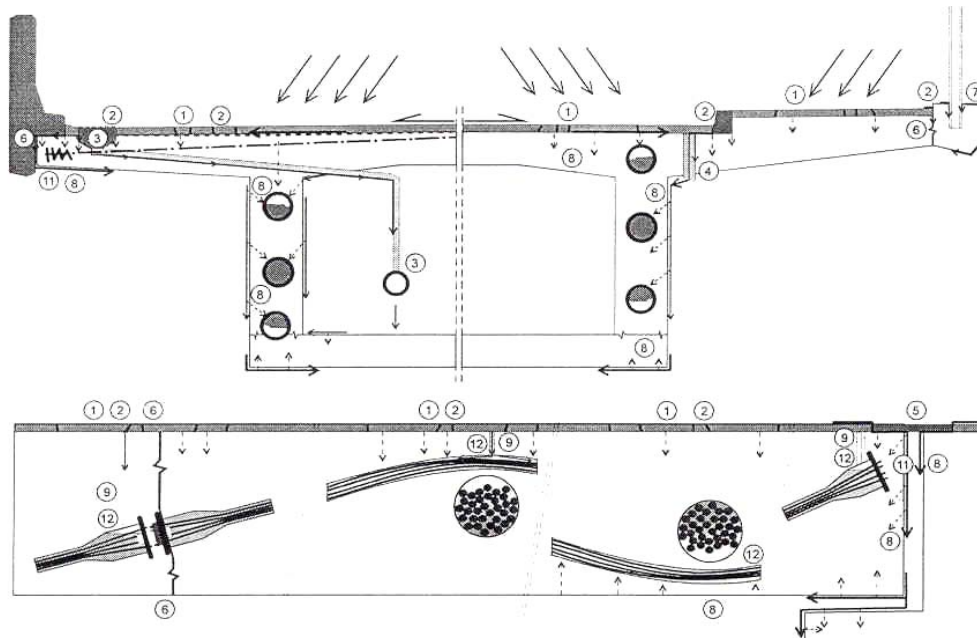
Hazard scenarios for prestressing steel in a typical box girder bridge: Indication of potentially "weak points" where water (possibly contaminated with chlorides) can gain access to the tendons and cause corrosion

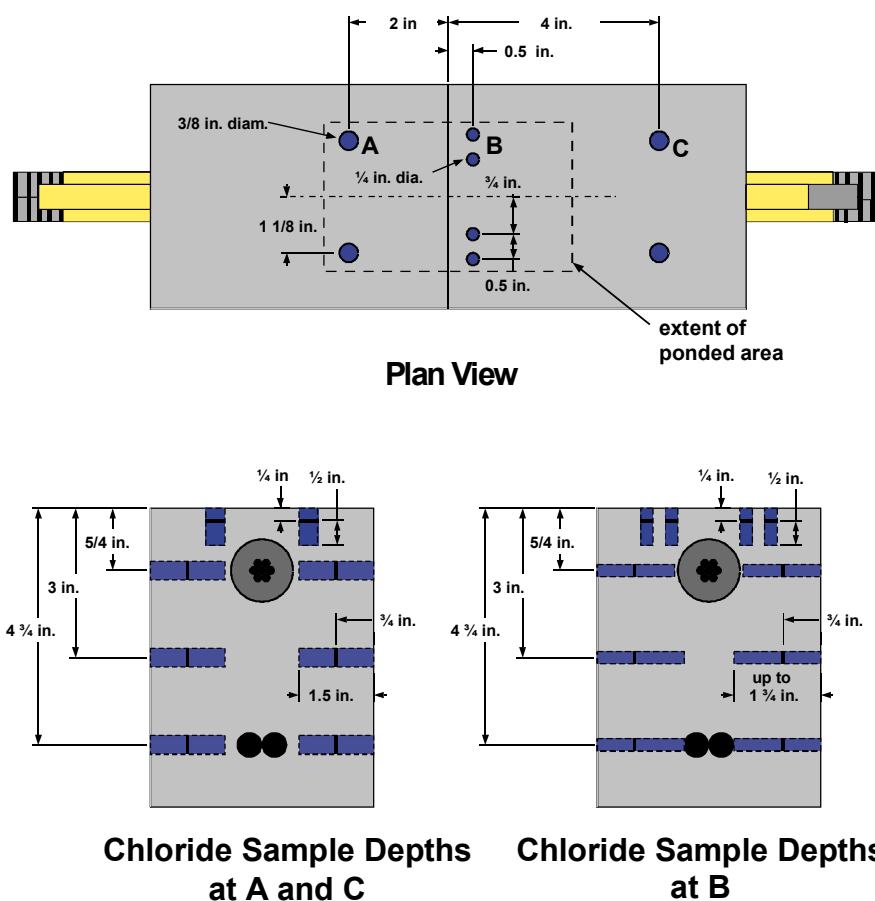
Figure 3.21 Chloride Sample Locations^{3.8}

and locations to determine chloride ion profiles adjacent to the joint and away from the joint. Sample locations are shown in Figure 3.21. Concrete powder samples were collected using a rotary hammer and following a procedure based on AASHTO T 260-94.^{3,13} Two 1.5 g samples were collected at each depth. Samples were analyzed for acid soluble chlorides using a specific ion probe (CL Test System by James Instruments).

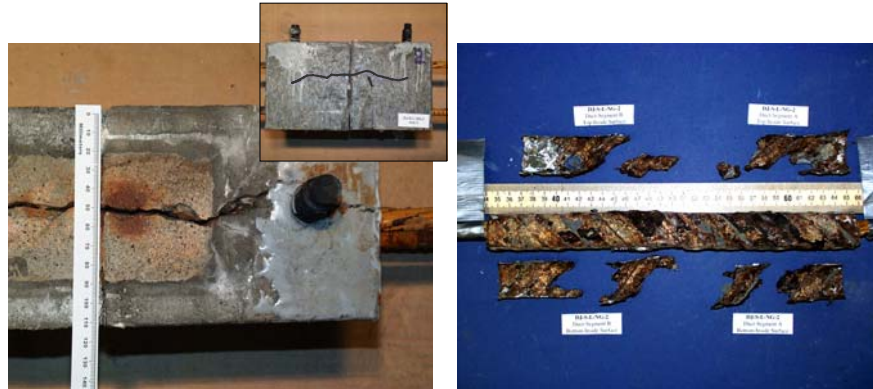
Figure 3.29 Concrete, Duct, Strand and Bar Condition for Specimen DJ-S-L-NG-2

Duct corrosion produced a crack in the top of the concrete specimen extending its whole length, as shown in Figure 3.29. The crack had a maximum top width of 0.12 in., and extended the full depth of cover to the duct, and was clearly visible when the specimen was opened at the strand cut line. Rust staining was visible around the crack.

products were mixed with a white powder (that was analyzed with X-Ray Diffraction and was found to be Zinc Oxide and Zinc Hydroxide). At the remaining areas of the duct metal, severe uniform corrosion and pitting was found, as shown in Figure 3.29. The duct corrosion rating for this specimen was the maximum of all specimens examined.

The mild steel showed moderate corrosion away from the joint, in the vicinity of the epoxy paint area, as shown in Figure 3.29. Additionally, light to moderate corrosion was found under the epoxy paint and in all those areas where the epoxy had peeled off, which represented around 15% to 20% of the epoxy area in the bars.

*Specimen condition prior to autopsy
(Top view) [Side view in detail]*

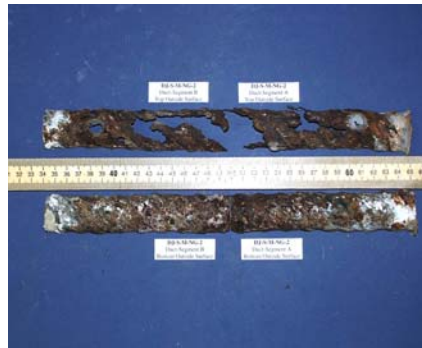
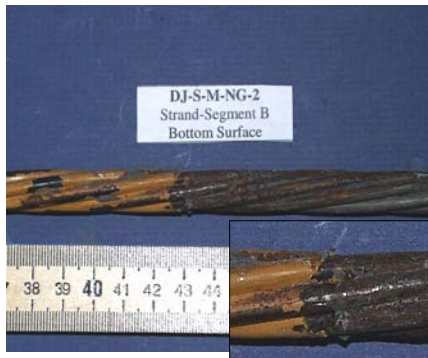
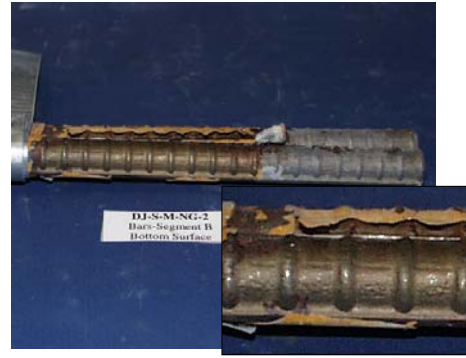
Figure 3.30 Concrete, Duct, Strand and Bar Condition for Specimen DJ-S-M-NG-2

Duct corrosion produced a 0.040 in. max. width crack at the top of the specimen, extending the whole length as shown in Figure 3.30. No cracks were found in the sides or bottom of the specimen.

Discoloration and light to moderate corrosion was found in the reinforcing bars, mainly underneath the epoxy paint, as shown in Figure 3.30. The epoxy paint seemed to have retained moisture, forcing the paint to peel off and triggering corrosion. Few small voids were found in the concrete surface underneath the reinforcing bars.

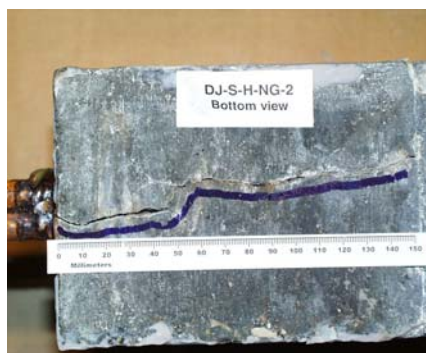
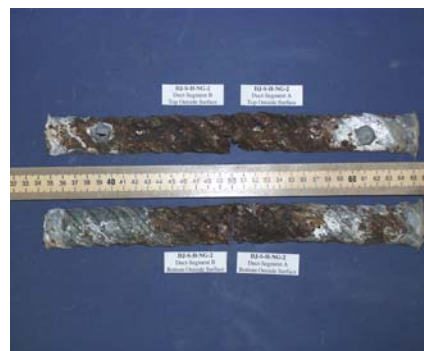
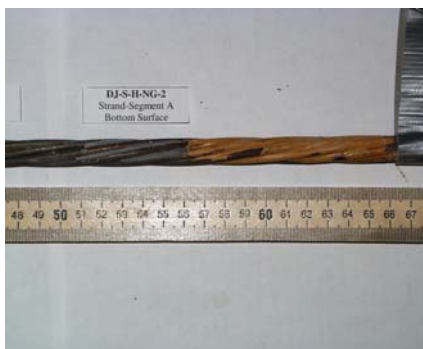
Severe uniform corrosion and pitting was found on the top and bottom of the galvanized steel duct, around the joint. Additionally, a black stain with moisture was found at approximately 2.35 in. from the joint in the top of the duct in Segment B. One hole of around 0.17 in.² was located in the duct at the joint and a 0.09 in.² hole was at approximately 1.2 in. from the joint, at the top of the duct in Segment A, corresponding to the location of a void in the grout. White stains (powder) and discoloration of the duct was evident in the bottom of the duct in Segments A and B.

Specimen condition prior to autopsy (Bottom view)

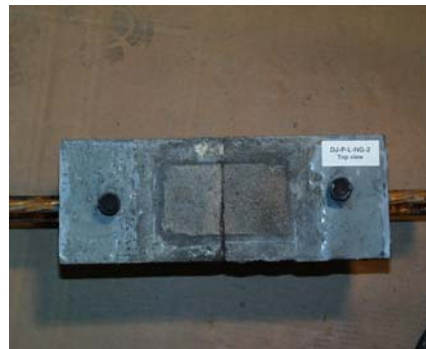
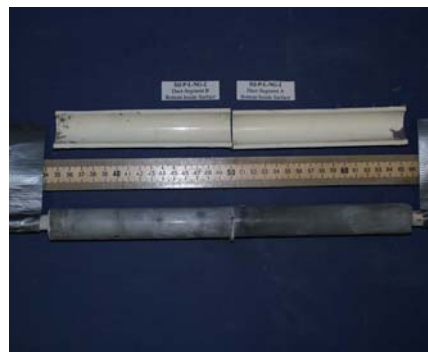
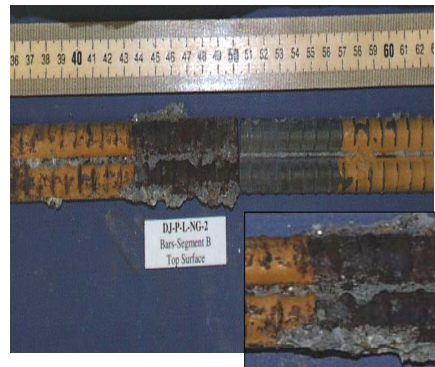
Figure 3.32 Concrete, Duct, Strand and Bar Condition for Specimen DJ-P-L-NG-2

Corrosion in the reinforcing bars produced a 0.040 in. maximum width crack in Segment B, in the bottom of the specimen as shown in Figure 3.32. No cracks were found in the top or sides of the specimen.

The mild steel had very severe corrosion and pitting in the exposed areas in Segment B, at the top and bottom of the bars. Severe corrosion and pitting was also observed in the same segment, in the areas where the epoxy paint had peeled off. The build-up of corrosion products was severe, causing the concrete cover to crack. At the adjoining segment, moderate corrosion was found at the bars, close to the joint section.

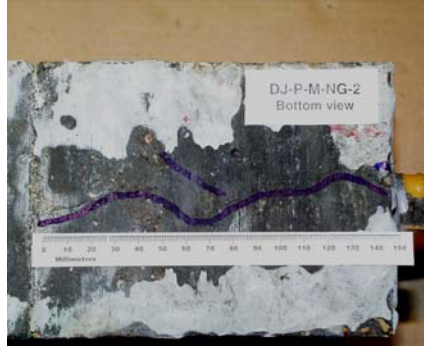
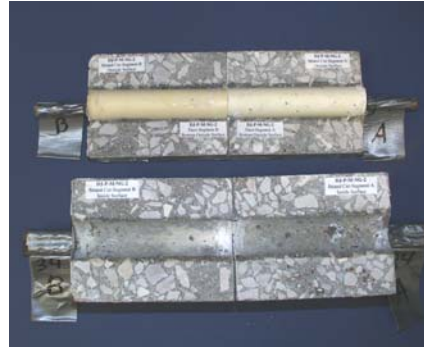
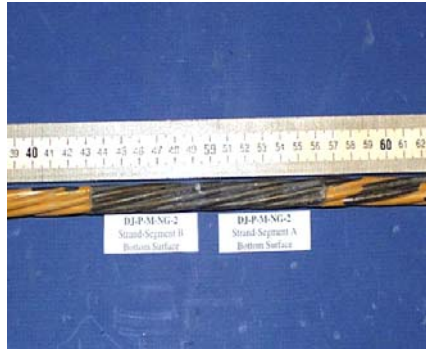
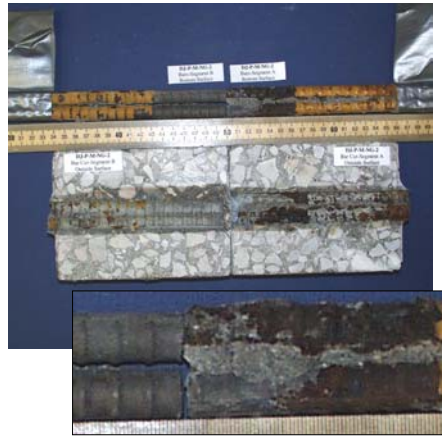
Figure 3.33 Concrete, Duct, Strand and Bar Condition for Specimen DJ-P-M-NG-2

Mild steel corrosion was responsible for a 0.020 in. maximum width crack at the bottom of the specimen in Segment A as shown in Figure 3.33. No cracks were visible at the top and sides of the specimen.

Moderate to severe corrosion was observed in the mild steel bars of Segment A, in the exposed areas close to the joint section. Additionally, light to moderate corrosion was found where the epoxy paint had peeled off. In Segment B, light corrosion was found where the epoxy paint had peeled off, and no corrosion was observed in the exposed steel areas, closer to the joint.

*Specimen condition prior to autopsy
(Bottom view, Segment A)*

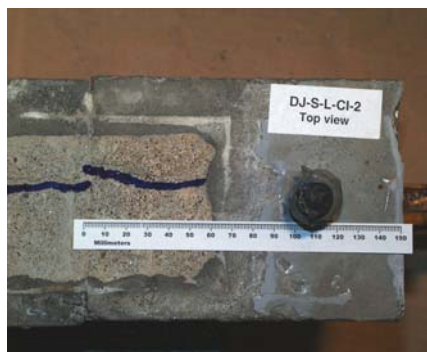
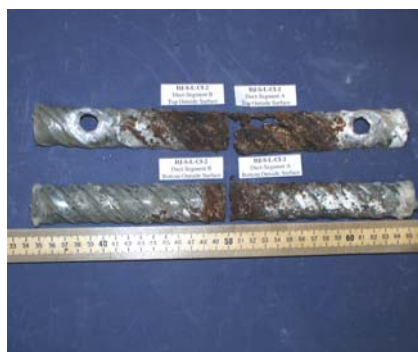
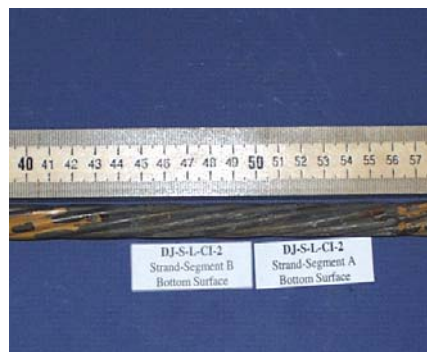
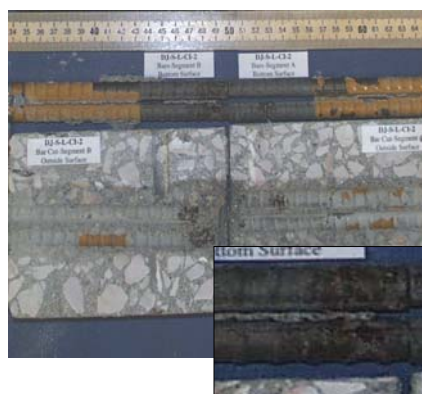
Figure 3.34 Concrete, Duct, Strand and Bar Condition for Specimen DJ-S-L-CI-2

The top of the specimen had a 0.010 in. maximum width crack, extending a length of 4.75 in., centered in the specimen as shown in Figure 3.34. No cracks or signs of corrosion were observed in the sides or bottom of the specimen.

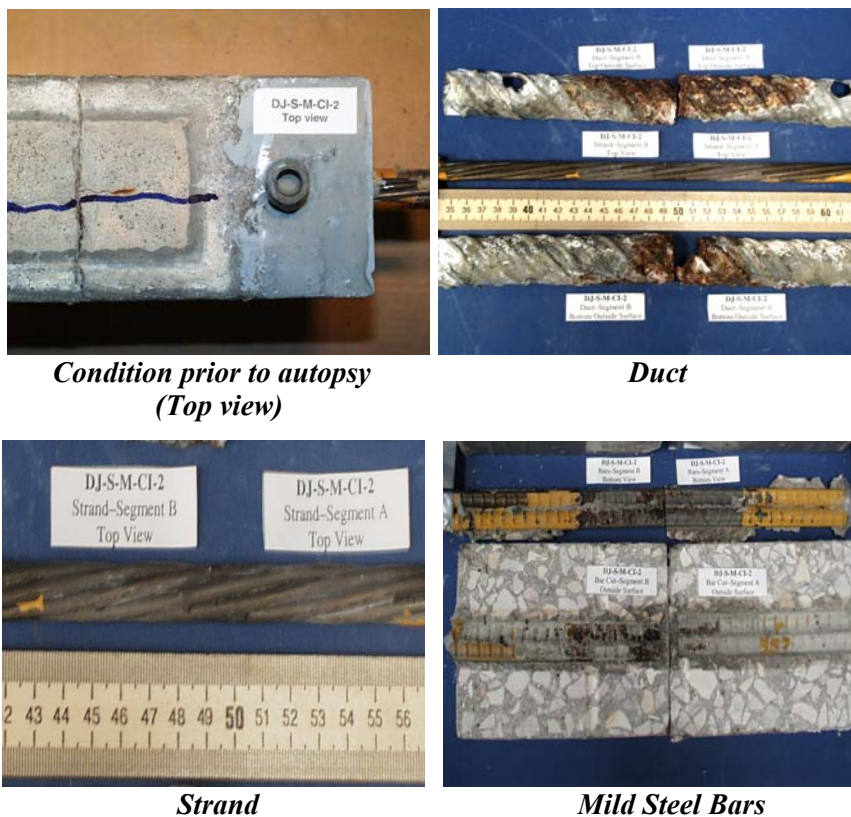
the duct in Segment B, there was a black spot of corrosion products with moisture.

Figure 3.35 Concrete, Duct, Strand and Bar Condition for Specimen DJ-S-M-CI-2

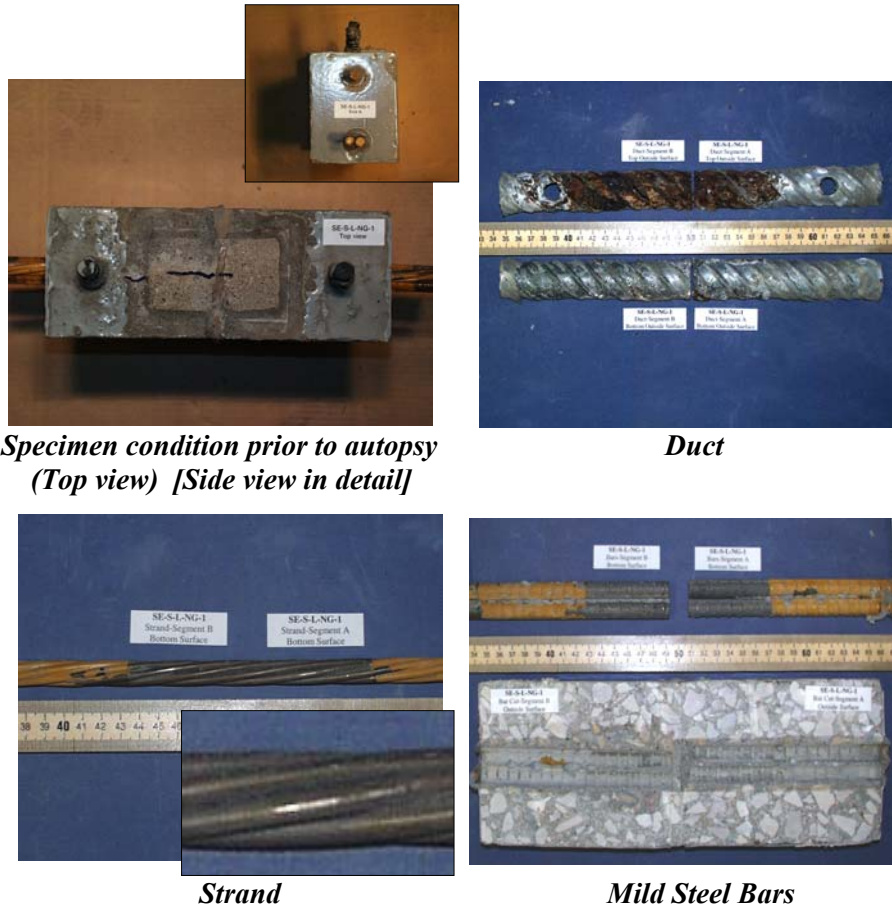
A large void of an approximate length of 4 in. and width of 0.75 in. was found in the top of the duct, extending 2.5 in. into Segment B and 1.5 in. into Segment A. Another void of approximately 0.039 in.² was found in the top of the grout in Segment B, with duct corrosion products inside.

*Specimen condition prior to autopsy
(Top view) [Side view in detail]*

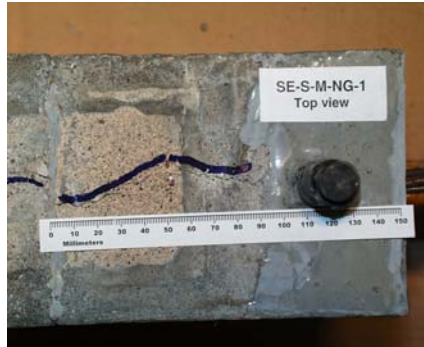
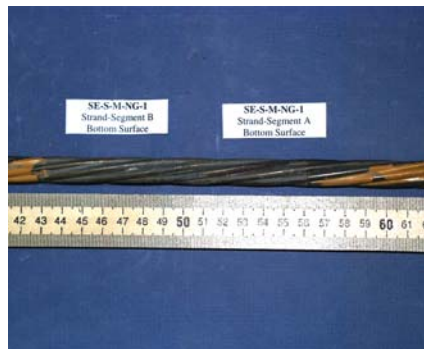
Figure 3.37 Concrete, Duct, Strand and Bar Condition for Specimen SE-S-M-NG-1

The top of the specimen had a crack with an approximate maximum width of 0.016 in., extending a length of 6.3 in., centered with the joint as shown in Figure 3.37. No cracks were found on the sides or bottom of the specimen.

At the duct/strand cut line, severe corrosion was found on the top of the galvanized steel duct, as shown on Figure 3.37. Corrosion produced several small holes through the duct in Segment B. In Segment A, one large longitudinal hole of about 0.55 in.² was centered at approximately 23.6 in. from the joint. White powder was impregnated to the duct metal in various locations, especially in the bottom of the duct in Segment A and in the top of duct in Segments A and B, around the grout vent locations, as shown in Figure 3.37.

Moderate to severe corrosion was found on one of the outer wires of the strand of the unpainted section, in Segment B. The center wire has also moderately corroded at the same place. Light to moderate corrosion was found on the rest of the wires in that segment. Light corrosion and discoloration was found under the epoxy paint.

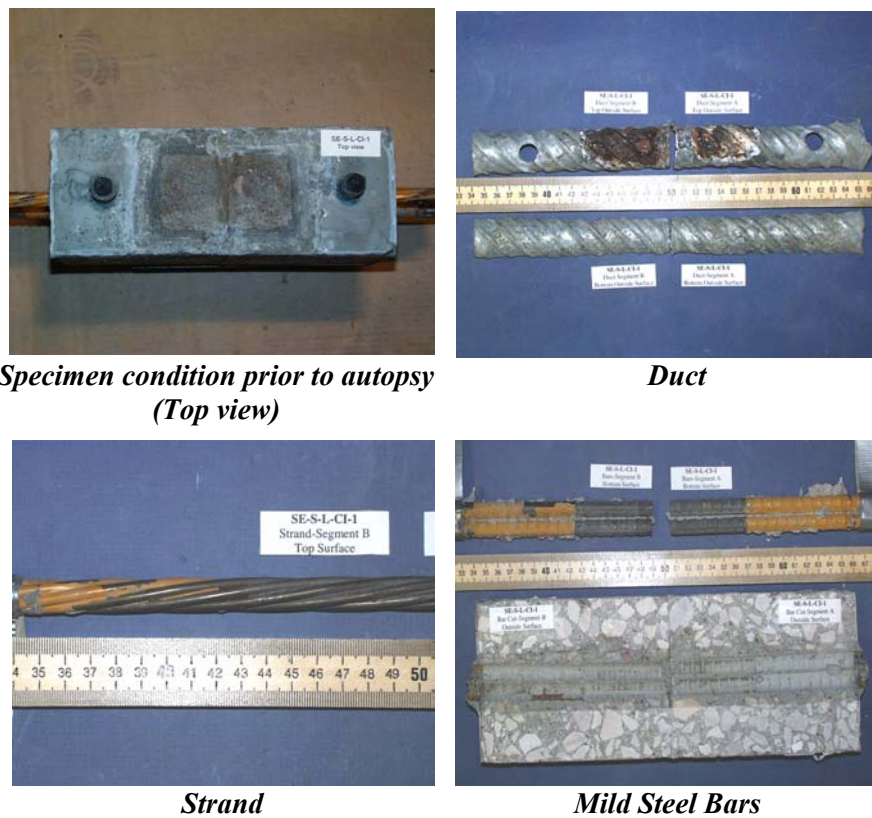
1.75 in. from the joint. Also, moderate to severe corrosion was found on the top of the metal duct in Segment A, centered at 1.75 in. from the joint, as shown in Figure 3.41. White residue (powder) was found mixed with the dark corrosion products. The bottom of the duct showed no signs of corrosion products either in the form of dark or white residues.

Figure 3.41 Concrete, Duct, Strand and Bar Condition for Specimen SE-S-L-CI-1

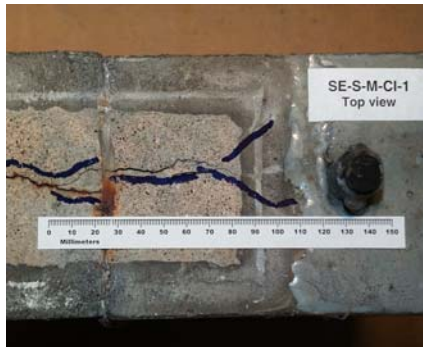
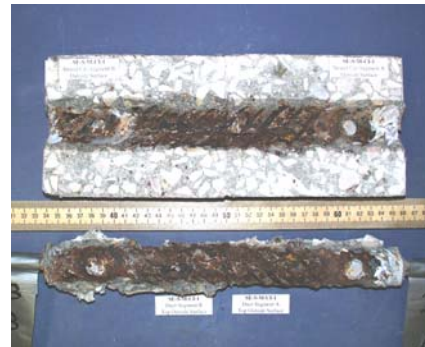
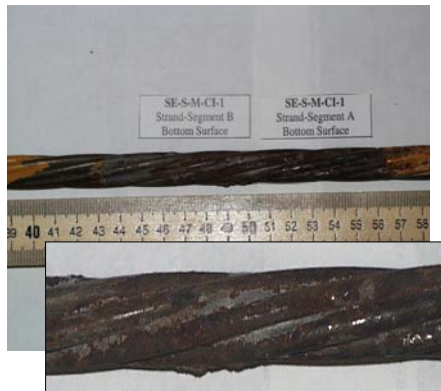
Figure 3.42 Concrete, Duct, Strand and Bar Condition for Specimen SE-S-M-CI-1

The specimen had cracks in the top with a maximum width of 0.040 in. and extending a length of 7 in., centered in the ponded region as shown in Figure 3.42. No cracks were found in the sides and bottom of the specimen.

The mild steel bars had only discoloration in the uncoated areas and light corrosion in the coated areas where the epoxy had peeled off.

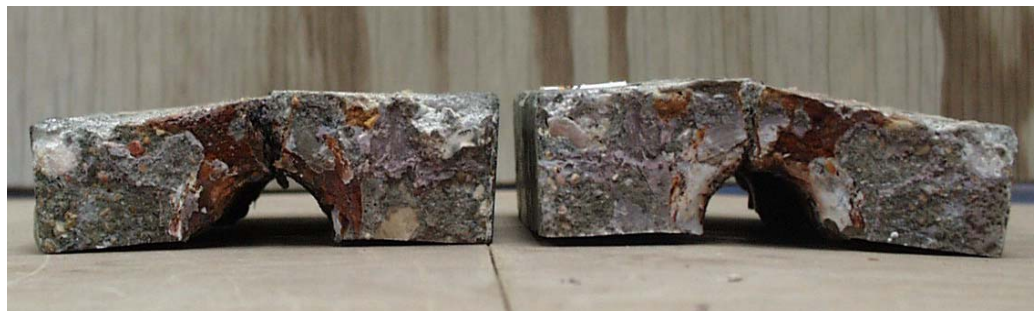
The match-cast epoxy joint was incompletely filled in the top of the strand cut line, allowing water to penetrate to the duct. The joint had corrosion stains from the duct location up to the top of the specimen as shown in Figure 3.43.

Figure 3.43 Incompletely filled Epoxy Joint (SE-S-M-CI-1)

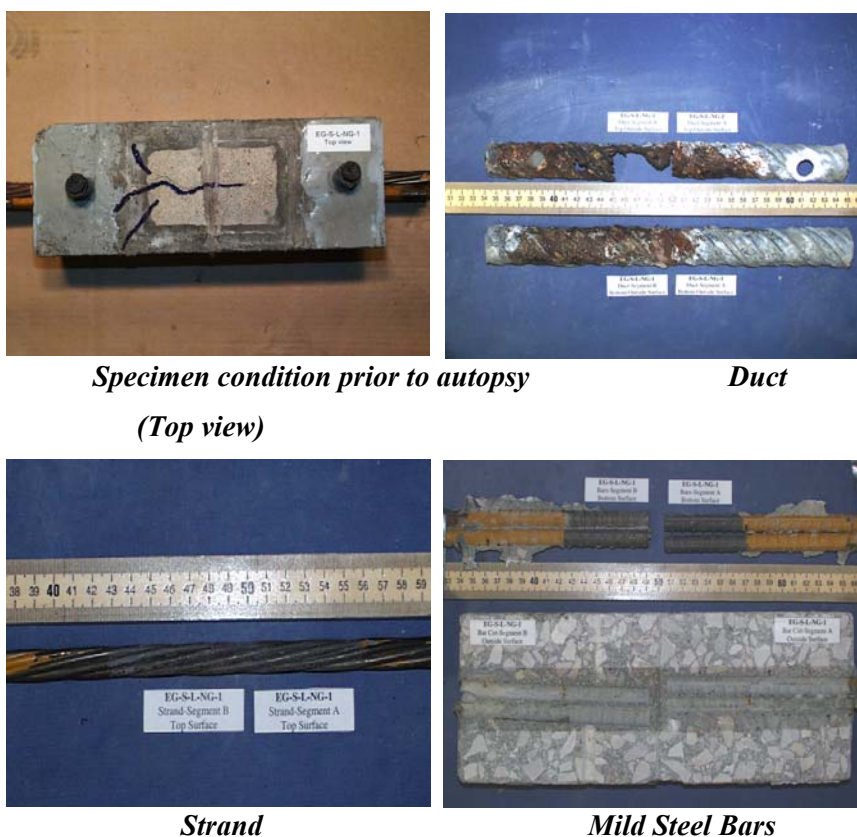
in. respectively in the top of Segment B at the border of the ponded region and extending to the sides, as shown in Figure 3.46. No cracks were found in the sides or bottom of the specimen.

*Specimen condition prior to autopsy
(Top view)*

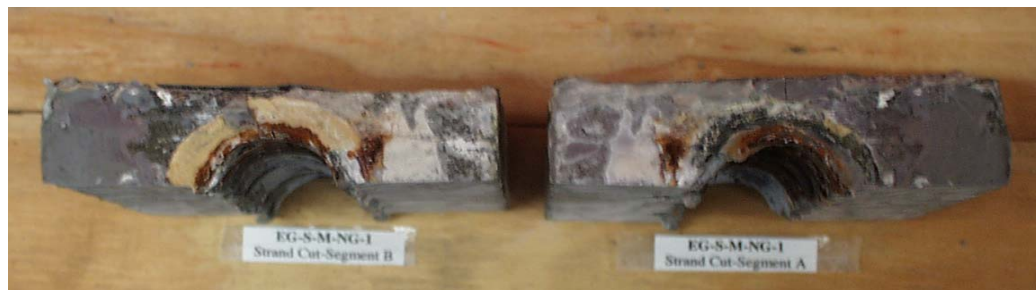
The top portion of the specimen above the strand cut line separated at the joint during autopsy. The gasket appears to have prevented complete bonding of the segments. Around the gasket there were signs of moisture, salt and rust stains. The incomplete epoxy coverage is shown in Figure 3.47.

Figure 3.47 Incomplete Epoxy Coverage in Epoxy/Gasket Joint (EG-S-M-NG-1)

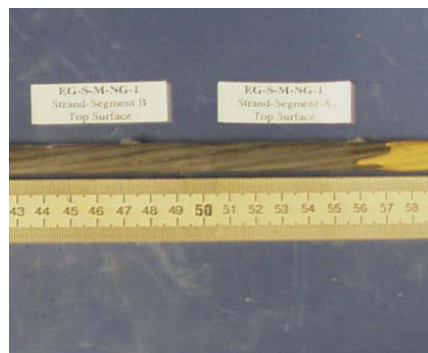
Figure 3.48 Concrete, Duct, Strand and Bar Condition for Specimen EG-S-M-NG-1

A 0.010 in. maximum width crack was at the top of the concrete specimen, extending 3 in. from the epoxy segmental joint towards face A as shown in Figure 3.48. No cracks or corrosion signs were found on the sides or bottom of the specimen.

Severe corrosion was found on the top of the duct, mainly in Segment A, as shown in Figure 3.48. The corrosion products were black, dark green and typical dark orange, mixed with white residue. The most severe corrosion was

centered at 1.6 in. from the joint towards Face A. Centered at this point there were three small holes of 0.040 in.² each in the duct. Corrosion products were in the form of flakes or very thin layers.

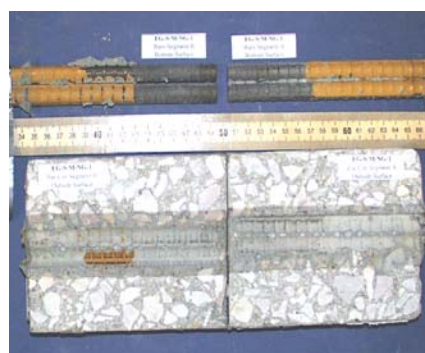
Discoloration was found on the outer wires of the strand, in the unpainted (uncoated) region. Light corrosion was found on the areas where the epoxy had peeled off. The inner wire had light corrosion.

Mild steel bars had minor discoloration under the ponded region (uncoated areas) and light corrosion in those areas where the epoxy coating had peeled off.

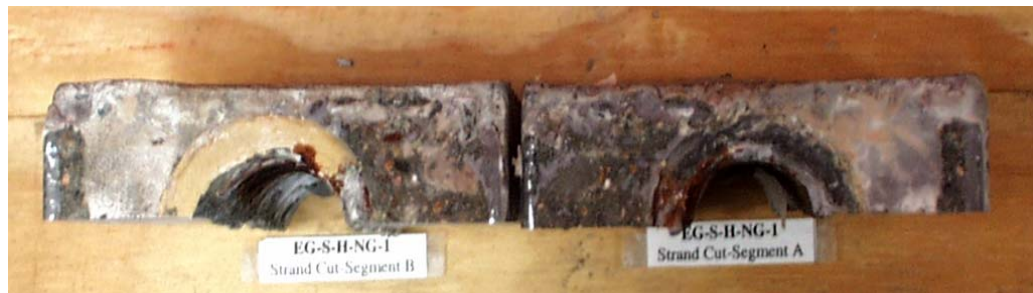
Figure 3.49 Incomplete Epoxy Coverage in Epoxy/Gasket Joint (EG-S-H-NG-1)

the specimen. Sections through the joint at the mid-height and bar and strand cut lines showed it to be completely filled with epoxy and free from voids or cracks. However, the gasket again appears to have prevented complete bonding of the segments immediately above the duct opening. Salt penetration and rust stains were visible on the joint as shown in Figure 3.49. Similar results were obtained during autopsy performed at four and a half years of exposure, to the duplicate specimens EG-S-M-NG-2 and EG-S-H-NG-2^{3,8}.

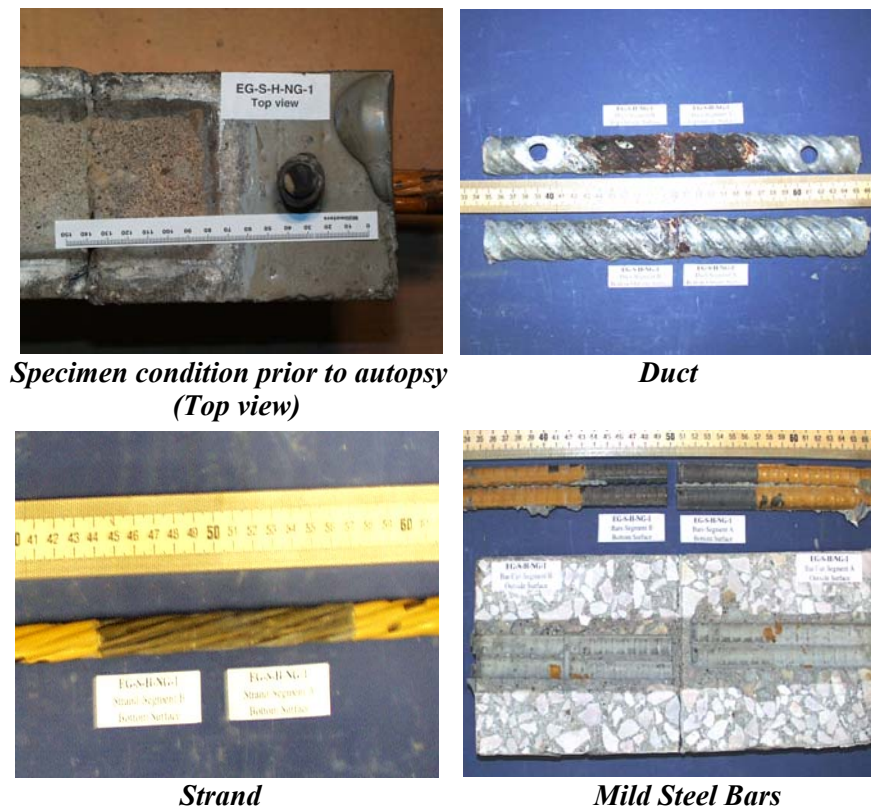
Figure 3.50 Concrete, Duct, Strand and Bar Condition for Specimen EG-S-H-NG-1

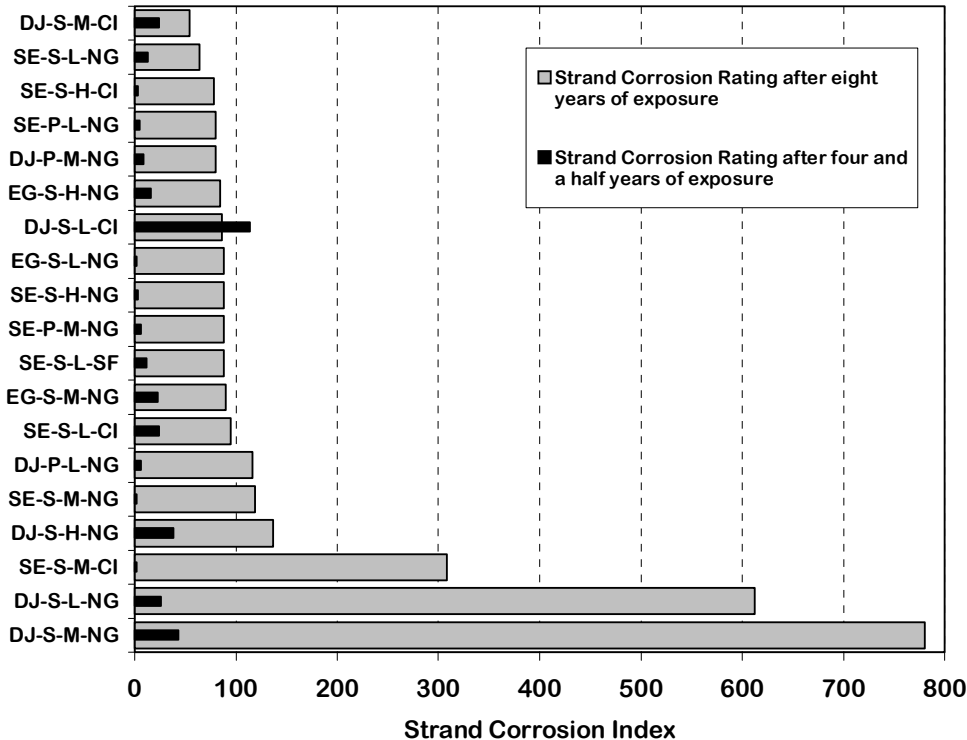
At the end of eight years of exposure all prestressing strands had experienced a corrosion rating above the value of 50, chosen as the threshold of concern. At four and a half years, only one specimen had exceeded that value.

Figure 3.69 Comparison of Corrosion Ratings for Prestressing Strand (after Four Years and Five Months, and Eight Years of Exposure Testing)

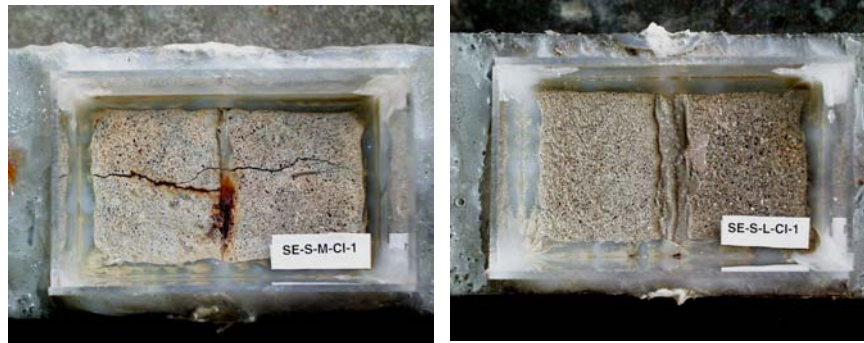
Figure 3.70 Top View of the Effect of a Faulty Epoxy Joint (SE-S-M-CI-1) Compared to a Sound Epoxy Joint (SE-S-L-CI-1)

The overall performance of the specimens is better compared by considering the total corrosion rating, obtained by summing the ratings for the strand, bars and duct, as shown in Figure 3.71 and Figure 3.72. Comparison between these two figures showed overall corrosion increased dramatically for most specimens between four and a half years and eight years of exposure. After eight years, the best performance was shown in the plastic duct specimens, while the dry joint specimens with steel ducts and normal grout showed the worst performance. The poor performance observed for specimen SE-S-M-CI-1 clearly shows the detrimental effect of faulty epoxy filling at the joint.

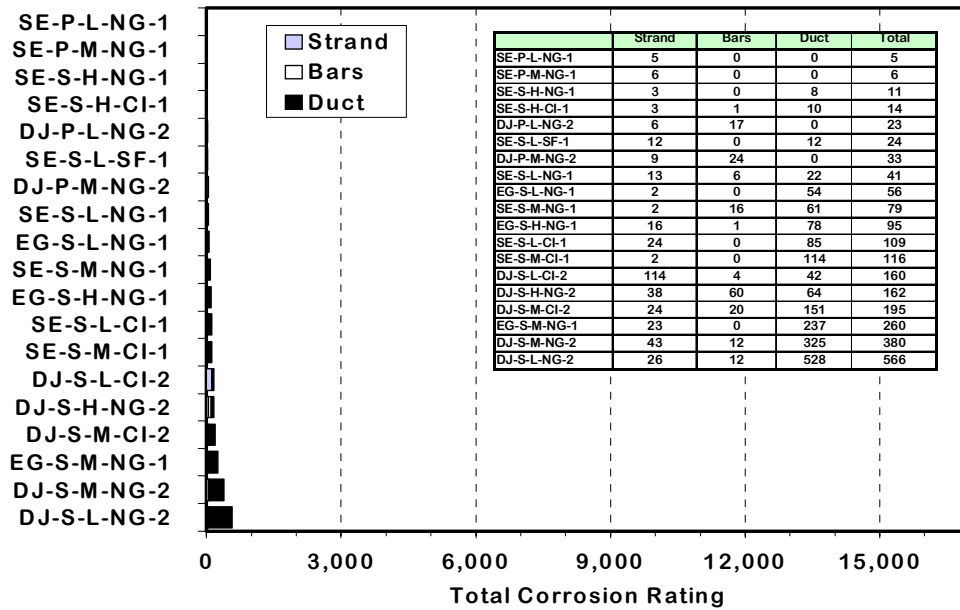
Figure 3.71 Total Corrosion Rating Ordered According to Performance (after Four Years and Five Months of Exposure)

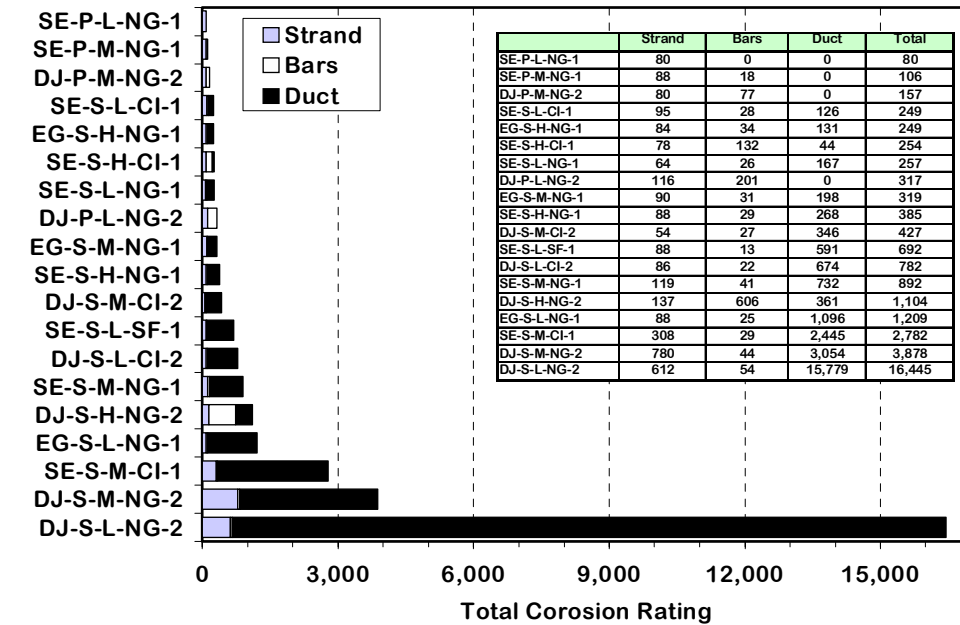
Figure 3.72 Total Corrosion Rating Ordered According to Performance (after Eight Years of Exposure)

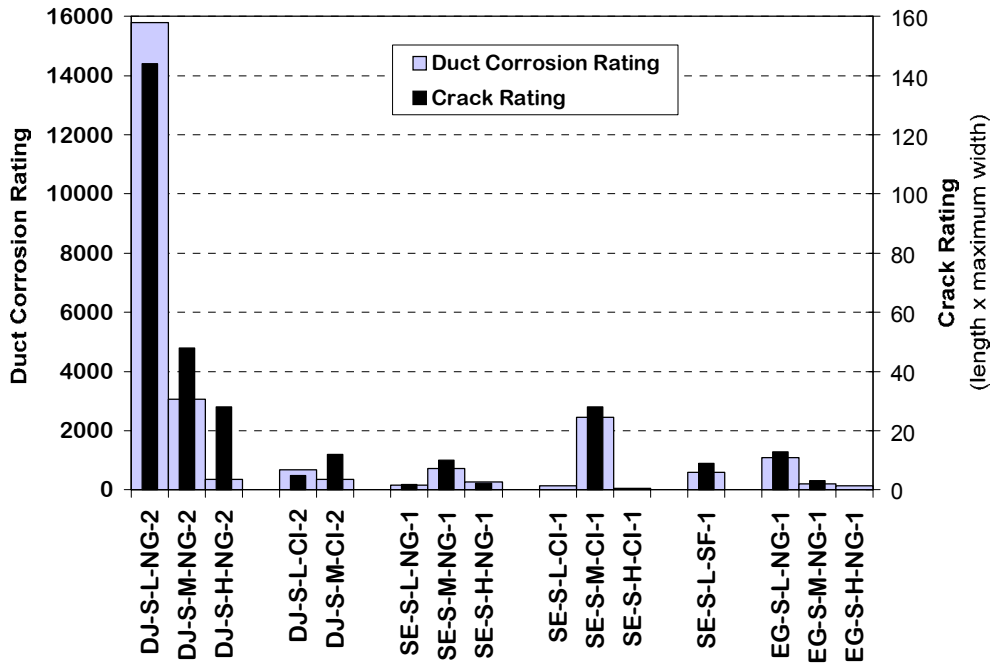
Similar results are obtained from the use of a crack rating, defined as the length of the crack in the top of the concrete specimen multiplied by the maximum crack width. This seems a valid comparison since the concrete and clear cover are the same for all specimens. Crack ratings for all autopsied specimens with steel ducts have been plotted along with duct corrosion ratings in Figure 3.74. From these results, it can be seen that crack ratings are generally proportional to duct corrosion ratings.

Figure 3.74. Effect of Joint Precompression on Duct Corrosion (after Eight Years of Exposure Testing)

Proportionality between crack ratings and duct corrosion ratings shown in Figure 3.74 after eight years of exposure, was more evident than after four and a half years of exposure as shown in Figure 3.75.

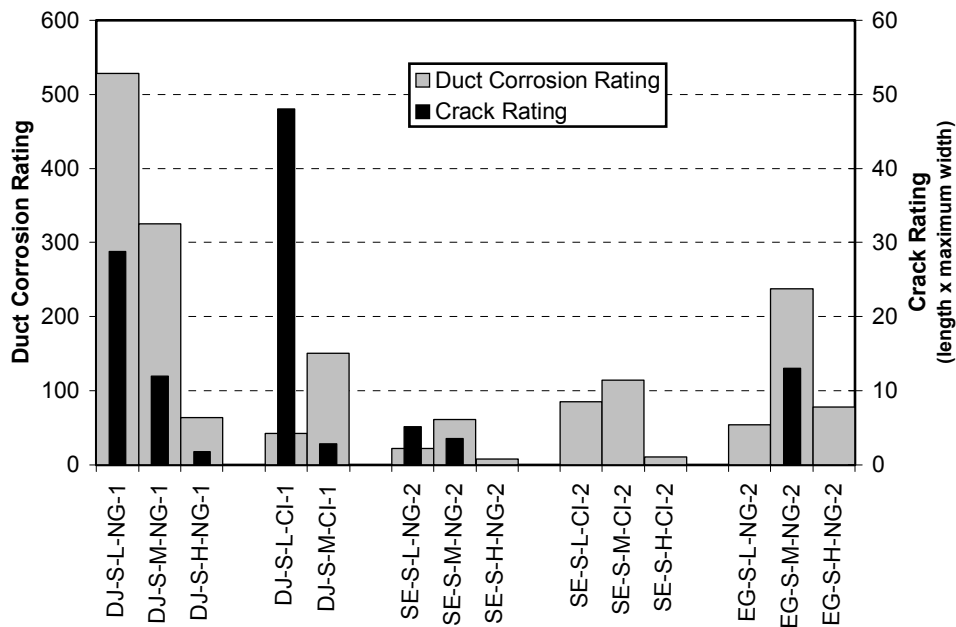
Figure 3.75 Effect of Joint Precompression on Duct Corrosion (after Four Years of Exposure Testing)^{3.8}

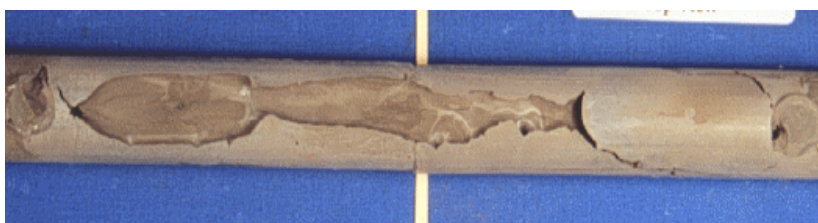
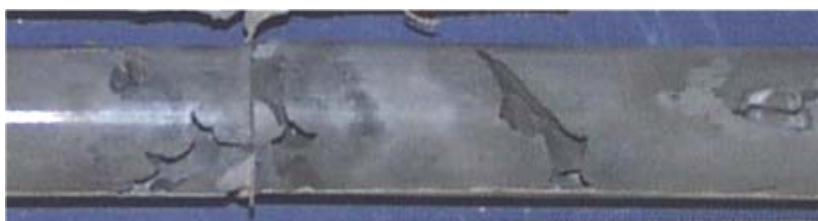
Figure 3.77 Typical Grout Voids

Grout voids were found in seventeen out of the nineteen specimens autopsied at eight years of exposure. In nine specimens the shape of the voids suggests that they resulted from lack of grout fluidity. In the remaining specimens the voids may be attributed to entrapped air, bleed water or incomplete filling. Typical voids are shown in Figure 3.77.

*Void Caused by Entrapped Air, Bleed Water or Incomplete Filling
(from Reference 3.8)*

Voids Caused by Lack of Grout Fluidity

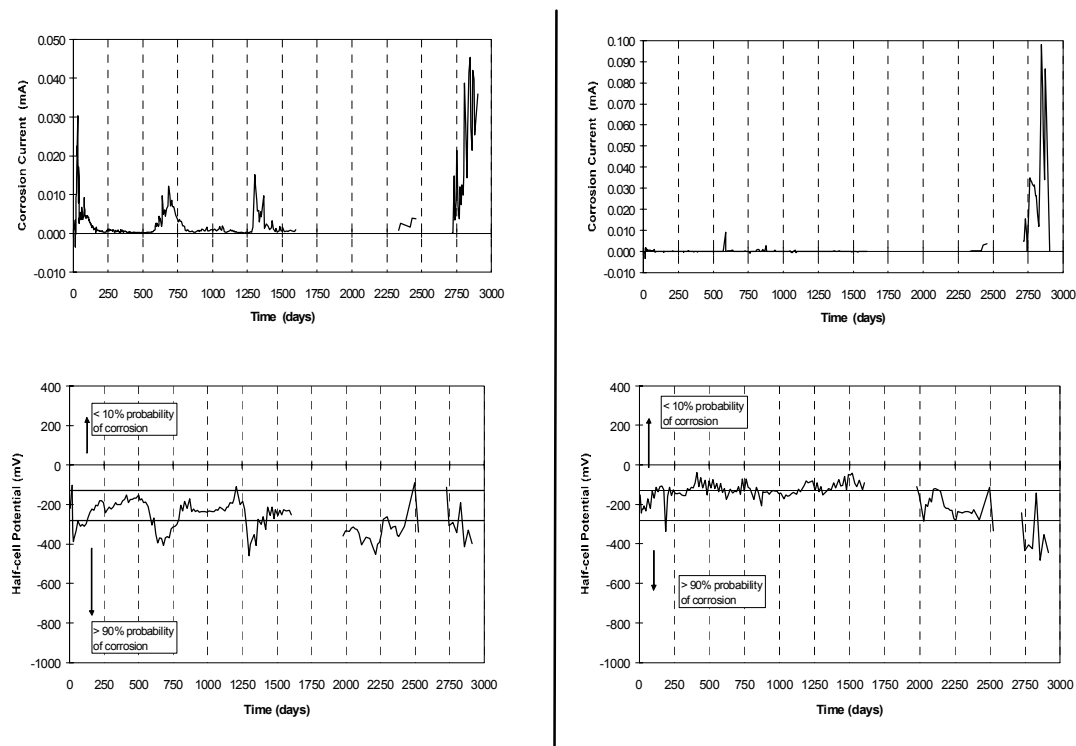
Figure 3.81 shows the comparison between Corrosion Currents and Half Cell Potentials for specimen DJ-S-M-NG-2 and specimen SE-S-M-CI-1. As can be observed, Half-Cell potentials (above 90% probability of corrosion as per ASTM C876^{3.7}) showed very good correlation with corrosion currents, with regard to the onset of corrosion and corrosion activity.

Figure 3.81 Comparison Between Corrosion Current and Half-Cell Potential Readings

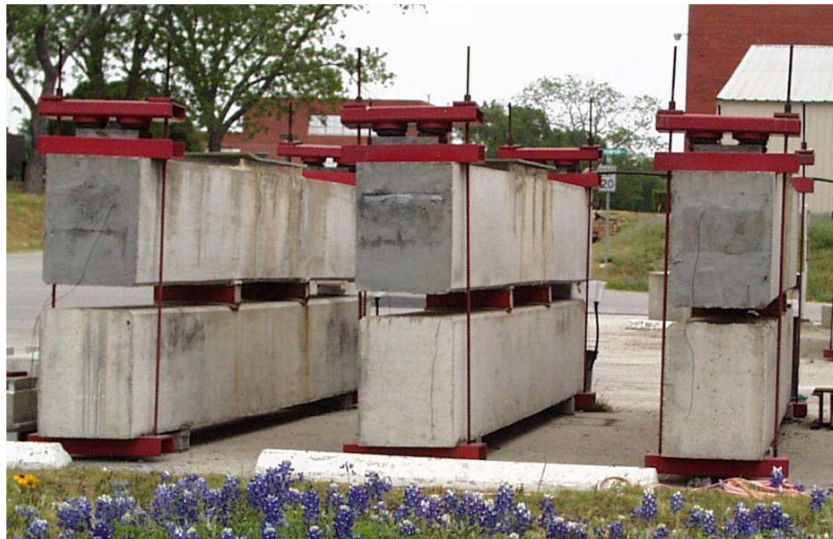
Figure 4.1 Linear Rectangular Beam Specimens (on Top of Reaction Beams)

The specimens used in this experimental program are not patterned after a prototype structure. Linear rectangular flexural elements, as shown in Figure 4.1, were chosen for the following reasons:

- results can be applied to bent cap and beam elements directly and some results may be qualitatively applied to other elements such as pile caps.
- all desired variables can be readily incorporated into design
- ease of construction, handling and placement
- simplicity of controlling and maintaining loading

The beams subjected to combined structural loading are tested outside the Ferguson Structural Engineering Laboratory and are exposed to cyclic wetting and drying with a 3.5% NaCl solution to provide and highly aggressive corrosive environment.

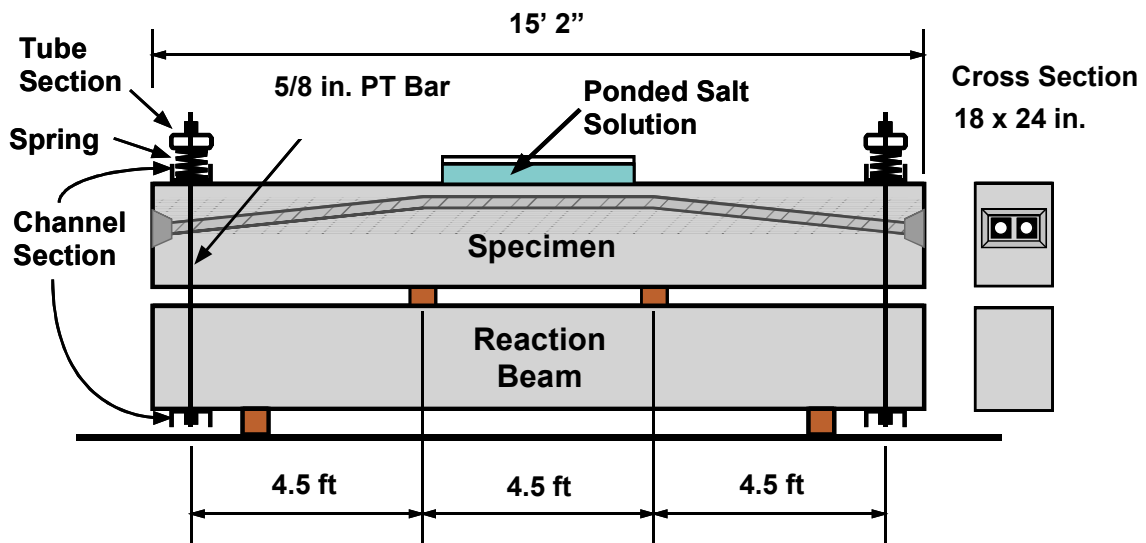
Loading was applied through a system of post-tensioning bars and railroad springs (5% maximum force loss during first year).

Figure 4.12 Test Setup^{4.2}

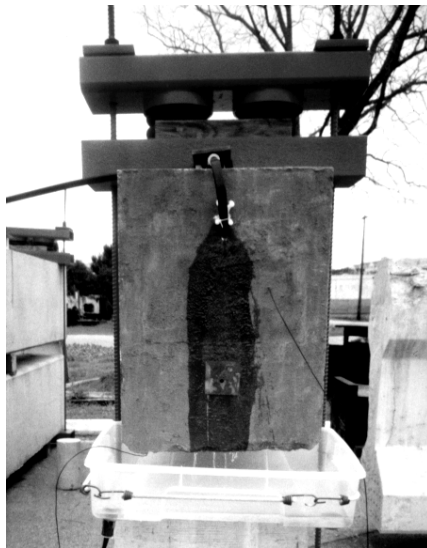
Figure 4.18 Beam End Dripper System^{4.3}

Three specimens were selected to evaluate the effect of saltwater dripping in the anchorage area, at the top of the nonshrink grout: Specimen 2.7 (epoxy-coated strand), Specimen 2.9 (poorly grouted) and Specimen 2.12 (encapsulated system / plastic duct). The trickle saltwater system is shown in Figure 4.18.
