**Accelerated Corrosion Testing, Evaluation and Durability Design
of Bonded Post-Tensioned Concrete Tendons**

Dissertation

The University of Texas at Austin

August 2003

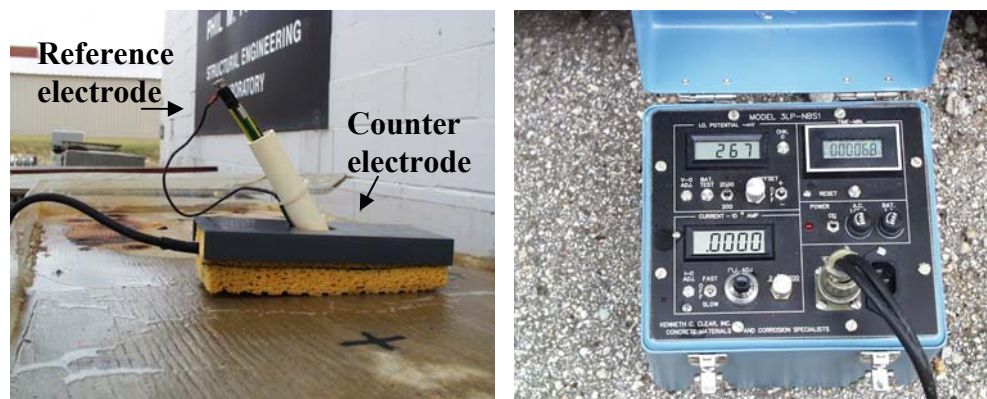
Figure 4.22 3LP Equipment and Setup

The 3LP Equipment was developed by Kenneth C. Clear, Inc., USA. A photograph of the equipment and setup is shown in Figure 4.22. The 3LP device is manually operated, and polarization scan data are recorded by hand. The counter electrode is rectangular and current confinement is not provided. The equipment measures the half-cell potential of the reinforcement (working electrode) and the applied polarization current. The polarization scan uses three

steps of 4 mV, starting at the free corrosion potential and ending at +12 mV. The concrete resistance is not measured by the 3LP device. The linear regression analysis on the polarization scan data must be performed using a hand calculator or computer to determine the total resistance, R_{tot} , as the slope of ΔE versus $\Delta I_{applied}$. No correction is made for the concrete resistance, and the polarization resistance, R_p , is simply taken as equal to the total resistance. The manufacturer recommends a proportionality constant, B , of 40.76 mV for calculating corrosion current. The manufacturer also provides guidance for relating corrosion current densities to expected corrosion damage. The SHRP Procedure Manual for Condition Evaluation of Bridges^{4.18} indicates a proportionality constant, B , of 26 mV can be used with the 3LP device. The interpretation guidelines listed in Table 4.8 are appropriate for the 3LP device if $B = 26$ mV is used.^{4.18}

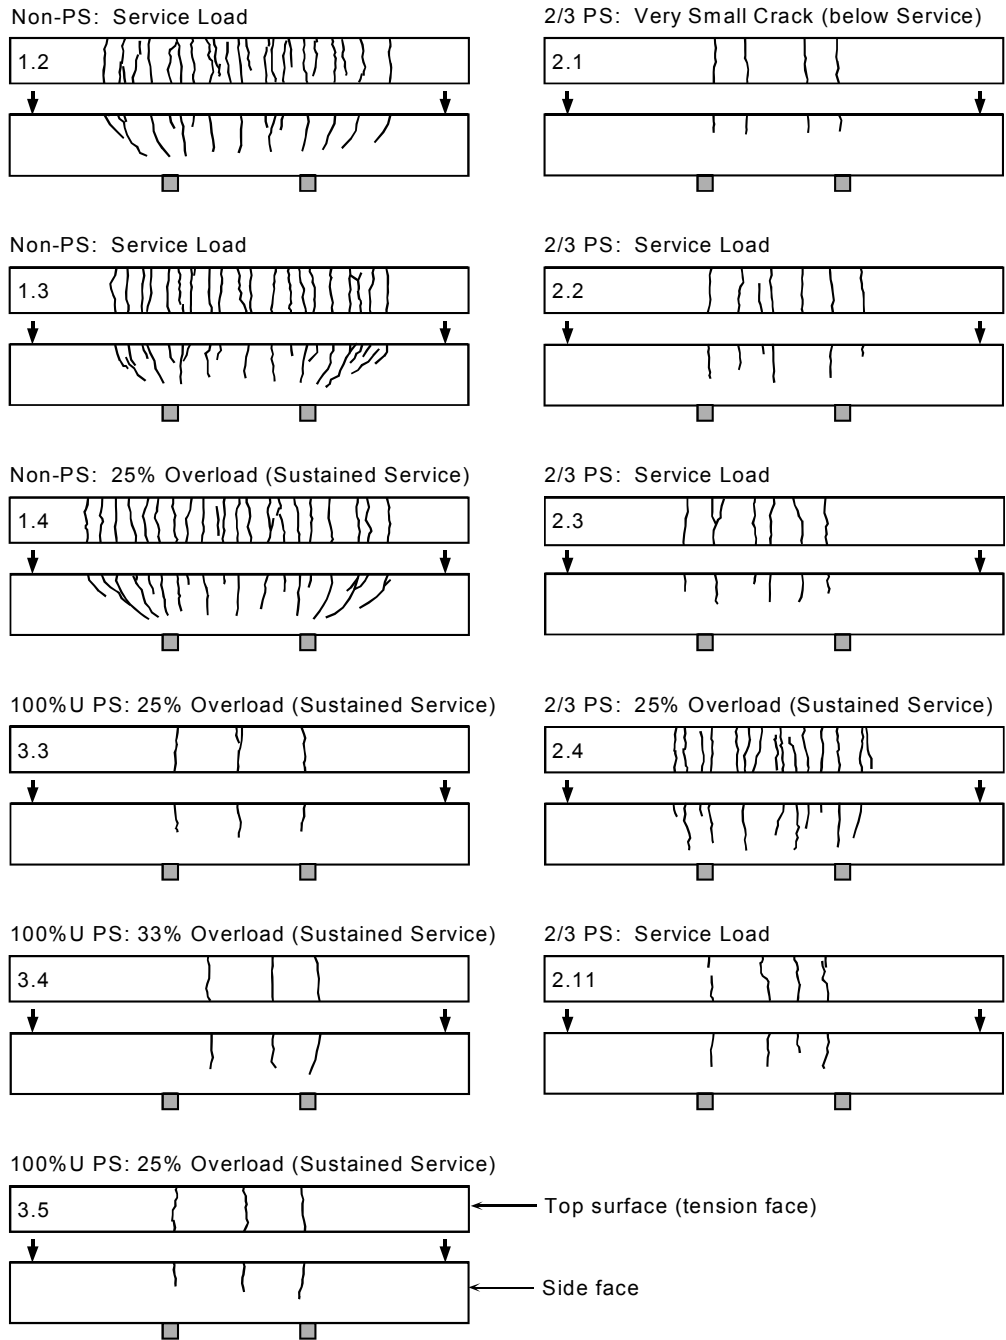
- The number of cracks and extent of cracking was drastically reduced as the level of prestress increased.
- The extent of cracking along the beam was well predicted by the cracking moment for the three beam types. See Reference 4.2 for a detailed description of crack prediction and theory.
- Cracks commonly occurred at stirrup locations.
- The maximum surface crack widths were reduced as the level of prestress increased.

Figure 4.25 Phase I Beam Specimens Crack Patterns^{4.2}

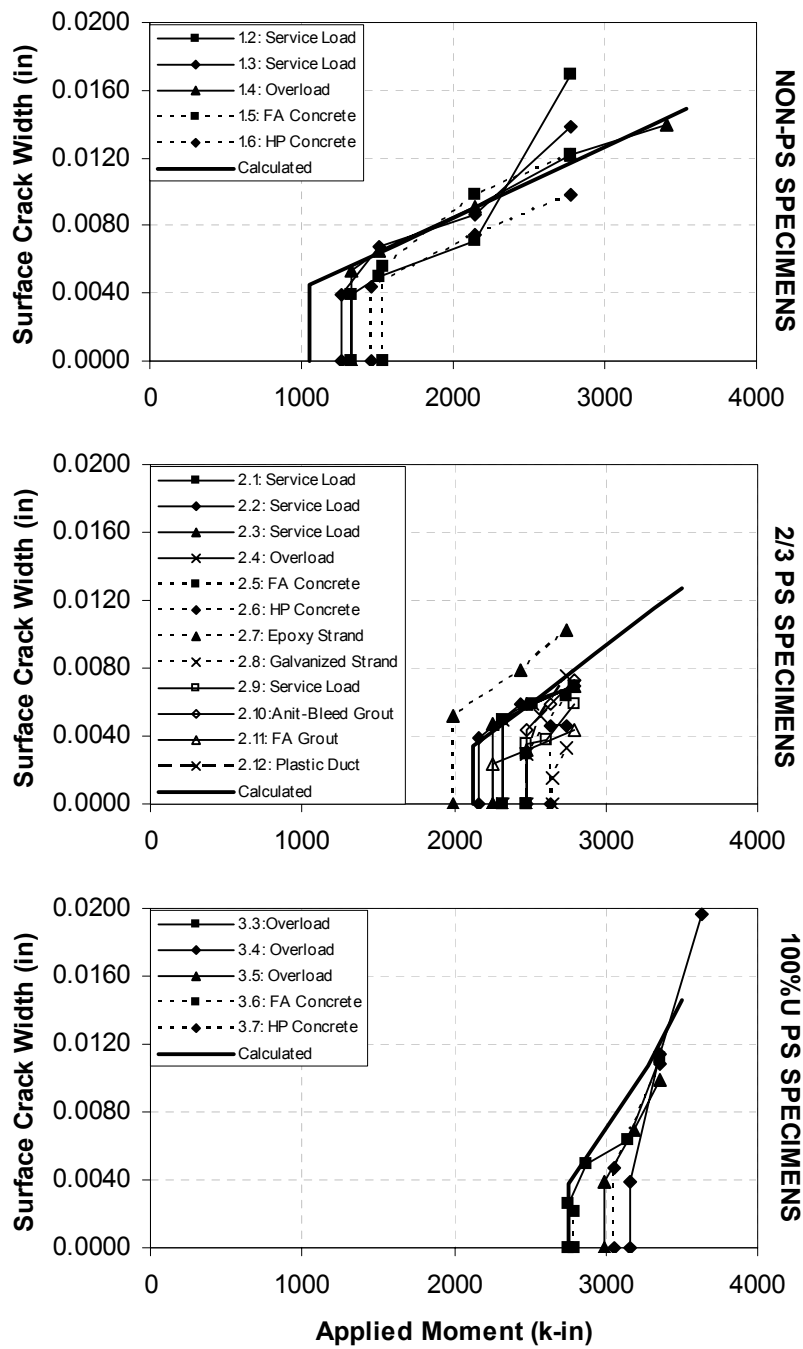
Figure 4.27 shows the measured maximum crack widths versus moment for each section type. The plots corresponding to the specimens with TxDOT standard concrete and control variables show excellent agreement with the estimated crack width values calculated prior to loading, using the Gergely-Lutz method with modifications for post-tensioned sections.^{4.1} Plots of specimens with high performance concrete, high performance grout and epoxy-coated strand slightly deviated from the estimated crack width plots.^{4.3}

Figure 4.27 Measured Maximum Crack Widths ^{4.3}

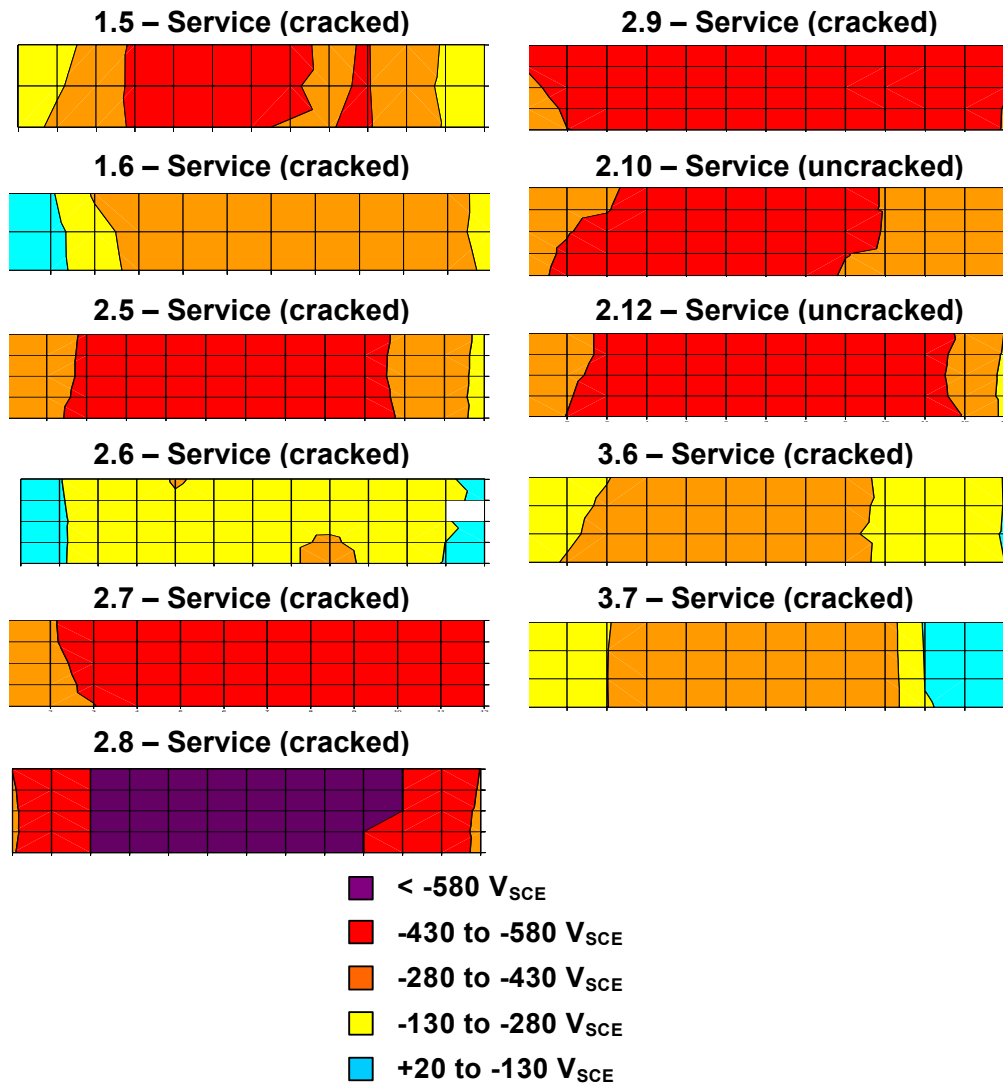
Figure 4.48 shows the half-cell potential contours maps for all Phase II specimens after 1235 days of exposure testing. Contour maps at 139 days of testing are shown in Reference 4.4.

Figure 4.48 Half-Cell Potential Contour Maps at 1235 Days for All Phase II Beams

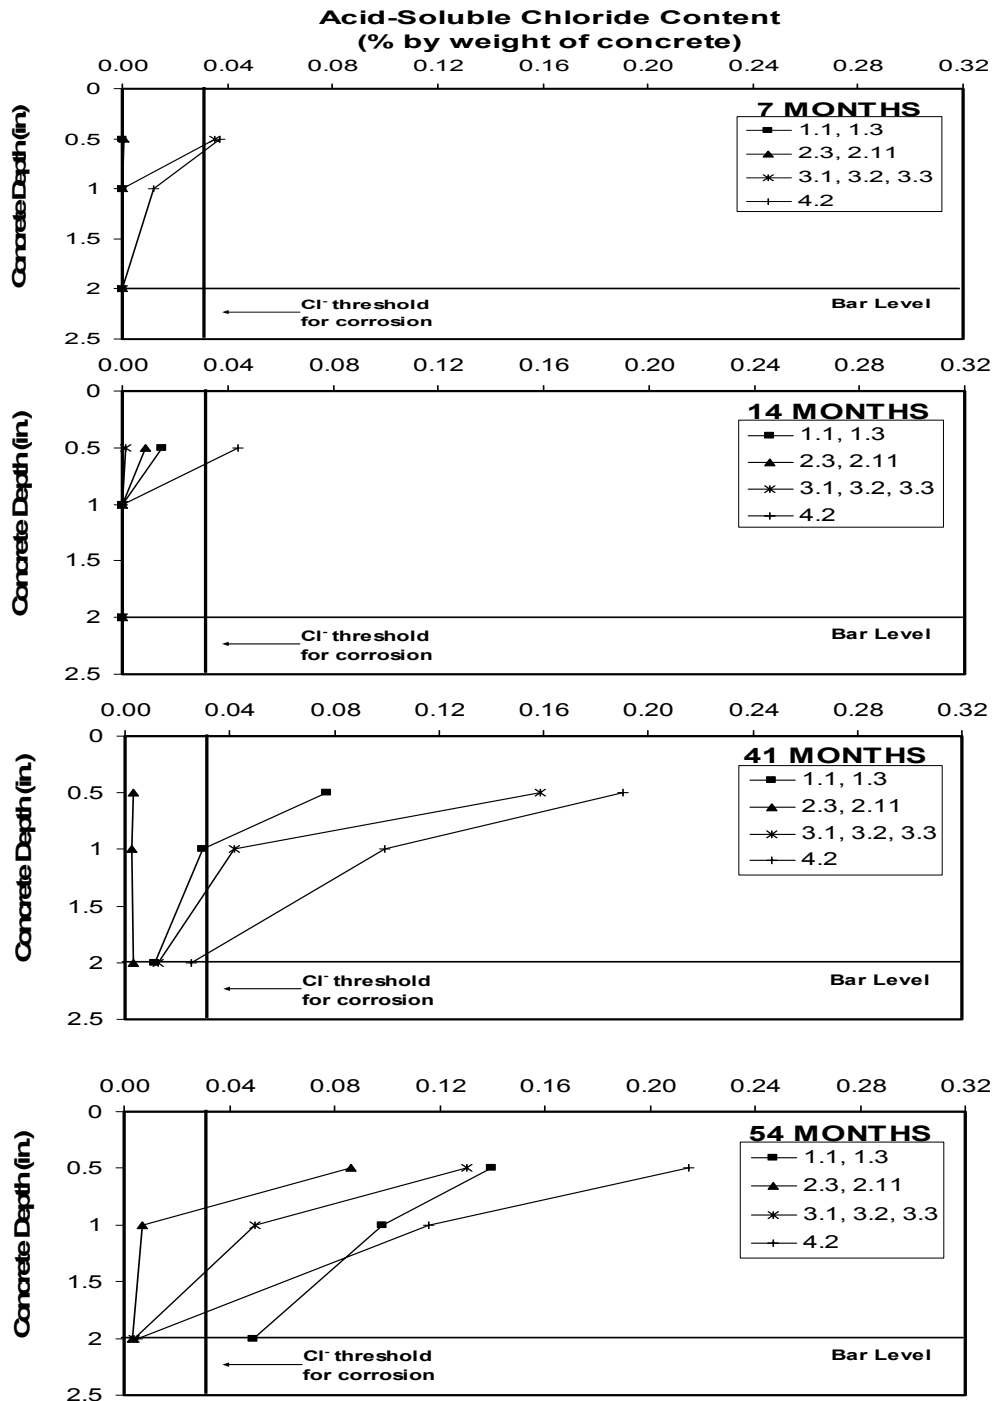
- Chloride content decreases with depth.
- All the chloride contents at the bar level are below the threshold for corrosion, except for Specimen 1.1 and 1.3 after 54 months.
- Although all specimens were made of TxDOT Class C Concrete (same concrete mix), concrete in Beam 4.2 consistently shows the highest permeability, and that used in Beams 2.3 and 2.11 consistently shows the lowest permeability.

Figure 4.53 Acid-Soluble Chloride Content for Phase I Poned Block Specimens^{4.5}

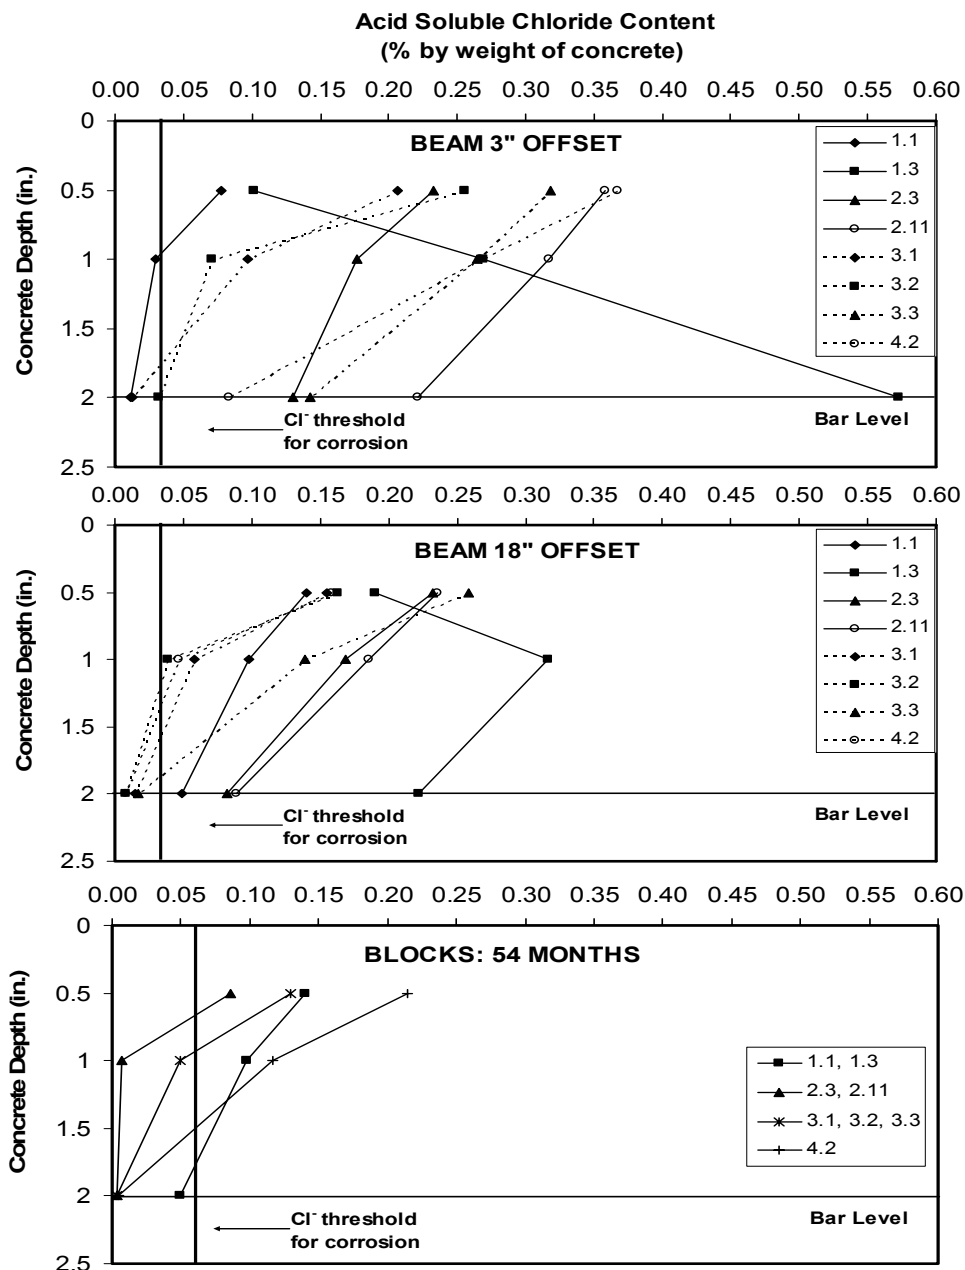
inch offset. This is not observed in the 100% PS beam, which suggest that the horizontal propagation of chlorides decreases with increasing levels of prestress.

Figure 4.55 Beam and Block Chloride Penetration at 1594 Days for Phase I – Ponded Region on Beams^{4.5}

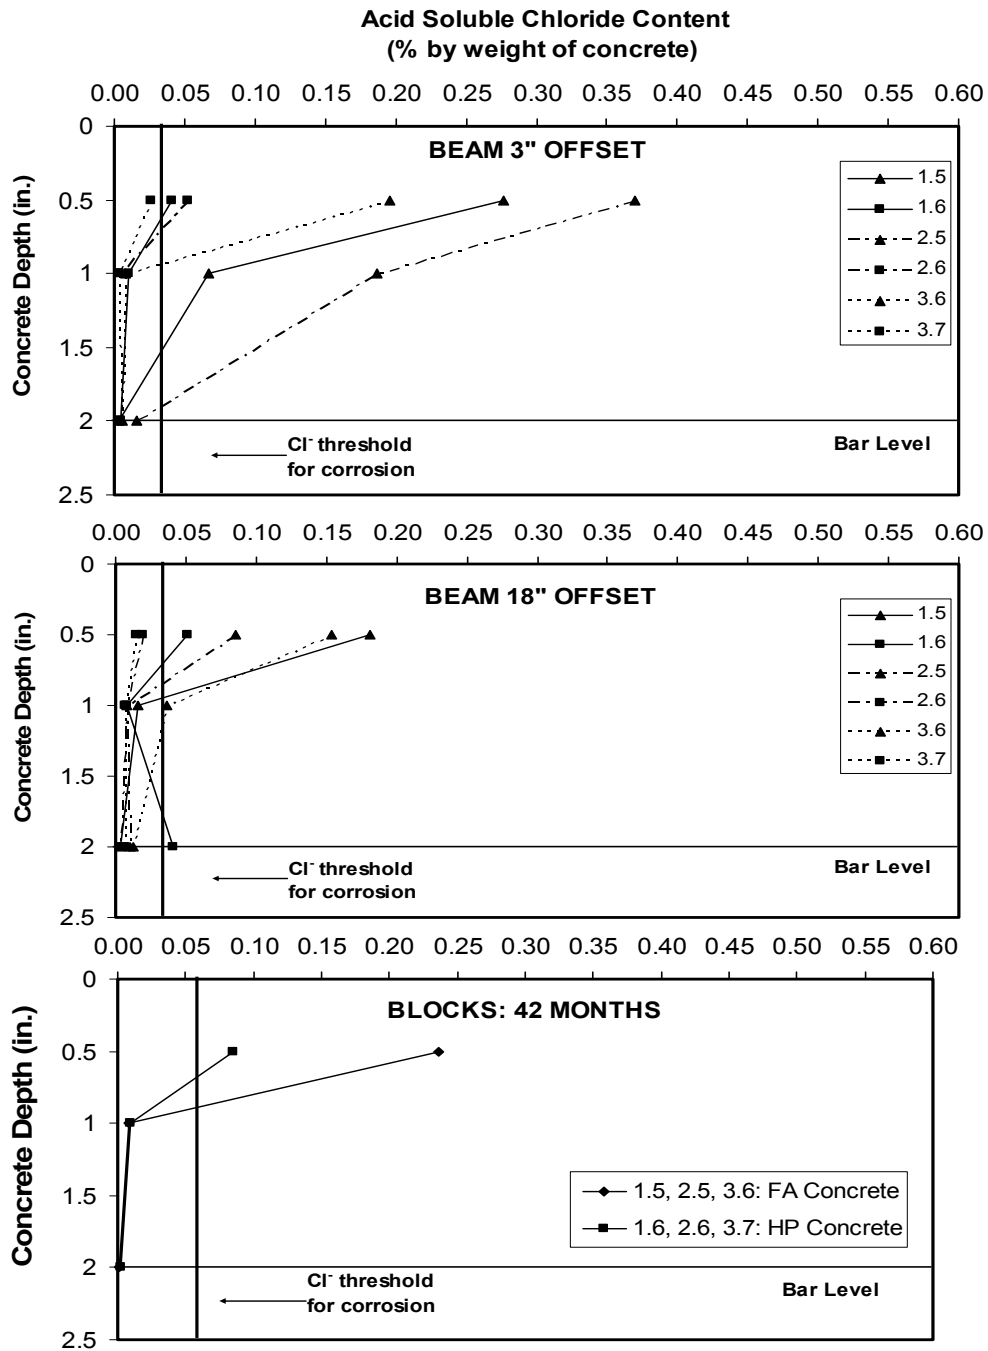
When comparing concrete block results with beam results, it is observed that inside the ponded region, chloride contents from the blocks are unconservative for beams 1.5 (Non-PS, Fly Ash Concrete) and 2.5 (2/3 PS, Fly Ash Concrete), at the one-inch depth, but very approximate at all depths for beams 1.6 (Non-PS, High Performance HP Concrete), 2.6 (2/3 PS, HP Concrete) and 3.7 (100%U PS, HP Concrete). In general, actual chloride contents at the two-inch depth were slightly higher than those measured from the concrete blocks.

Figure 4.58 Beam and Block Chloride Penetration at 1235 Days for Phase II – Ponded Region on Beams^{4,5}

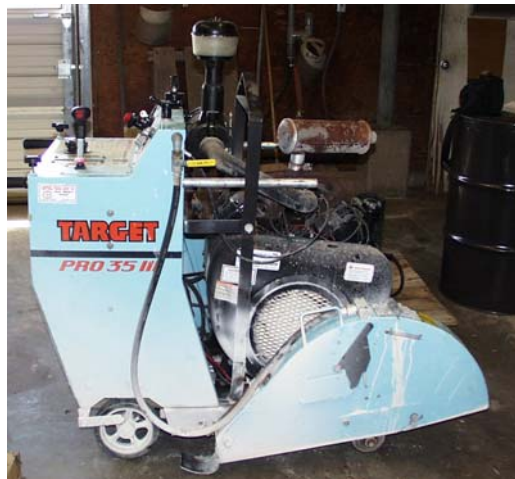
Figure 4.63 Concrete Saw Used in Autopsy

The concrete saw with a 27-inch circular blade shown in Figure 4.63 was used to make all the cuts in the specimens. Two eight-inch deep vertical cuts were made on the top of the beam, and a horizontal cut was made on each side of the beam, below the duct line. These cuts separated the portion of the beam to be analyzed from the rest of the specimen, allowing the area of interest to be removed with a forklift.

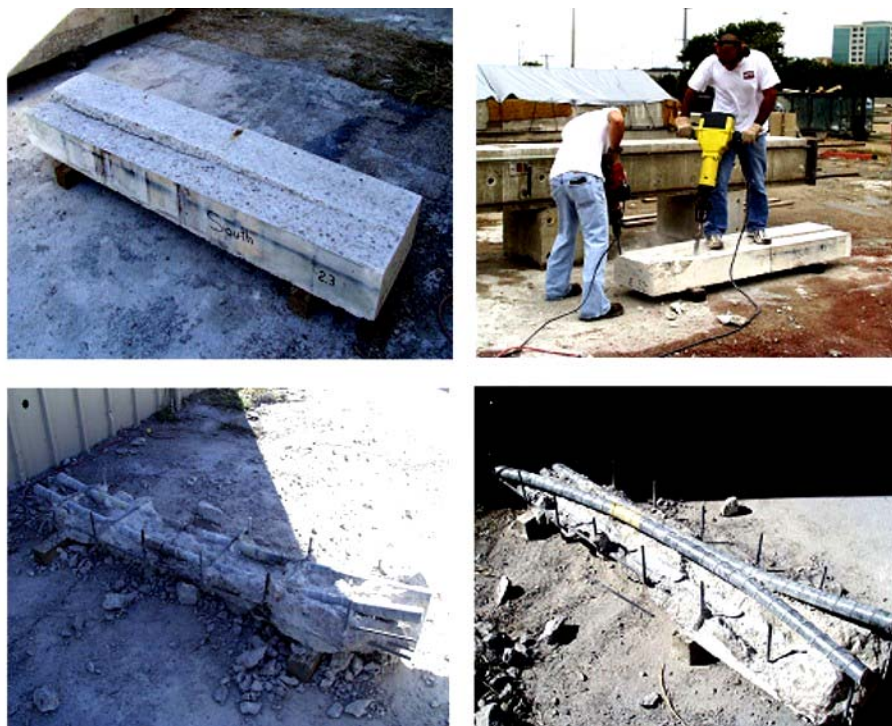
Figure 4.64 Concrete Removal to Expose Duct and Mild Steel

Jack hammers and chipping hammers were used to carefully remove all existing concrete around post-tensioning ducts and mild steel reinforcement, as illustrated in Figure 4.64.

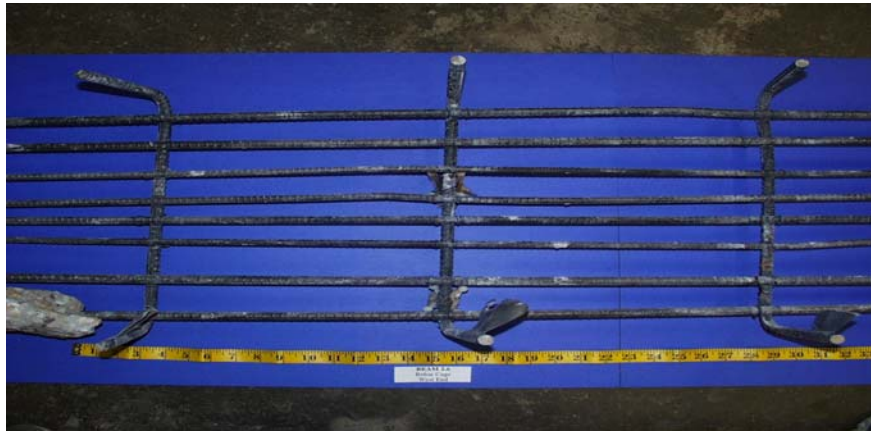
Figure 4.66 Mild Steel Reinforcement Cage

The mild steel bars and stirrups were removed after ducts had been removed, using the jackhammers and chipping hammers. Analysis of longitudinal steel was limited to 72 in. corresponding to the same analysis length used for the post-tensioning ducts and strands. Stirrups were analyzed only in the top portion and two 3 in. legs at each side, as shown in Figure 4.66.

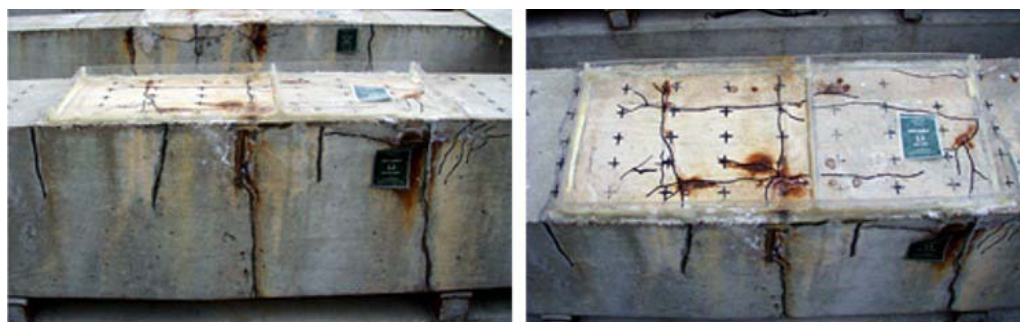
Figure 4.75 Specimen 2.3 – Condition Prior to Autopsy

top of the specimen in the ponded region. Salt deposits and large rust stains were visible on the sides of the beam, as shown in Figure 4.75.

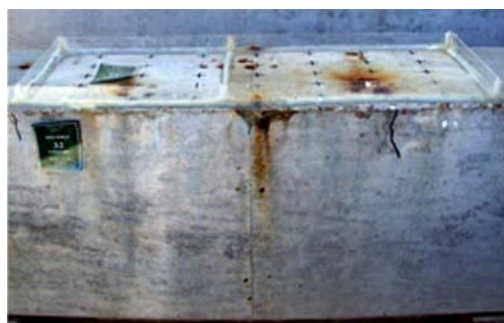
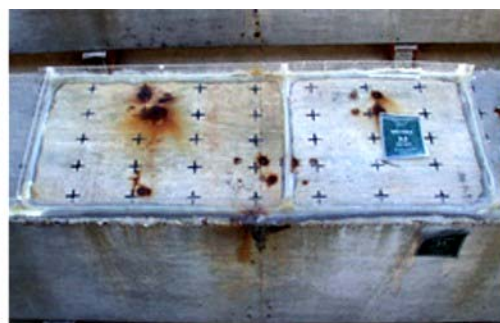
Figure 4.87 Specimen 3.2 – Condition Prior to Autopsy

A visual inspection found that Specimen 3.2 had one transverse crack (See Figure 4.87) across the top of the beam at the end of exposure even though this specimen was designed to remain uncracked. The crack had a maximum width of 0.01 inches and was located 12 inches to the west of the centerline of the

beam. This location was directly above a stirrup. As seen in Figure 4.87, any rust staining was due to the bolster strips.

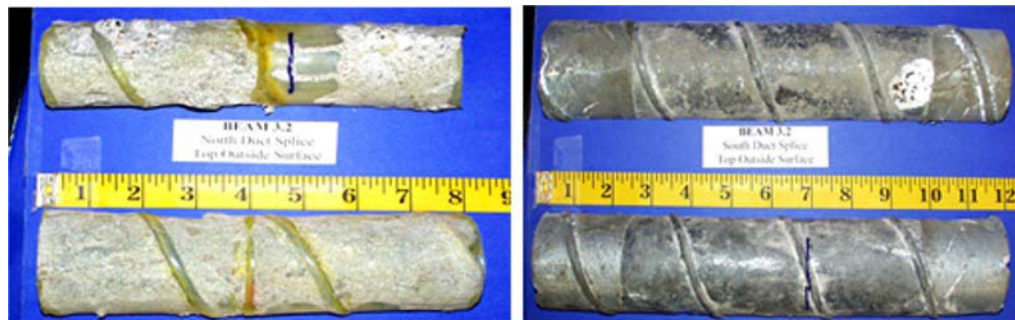
Figure 4.89 Specimen 3.2 – Duct Splices

Specimen 3.2 had two duct splices. The south duct had an industry standard splice and the north duct had a heat-shrink splice. Both splices were located at the centerline of the beam. Figure 5.89 shows the condition of the duct splices at the end of exposure. Both splices showed no signs of corrosion, with only a minor salt stain on the industry standard splice.

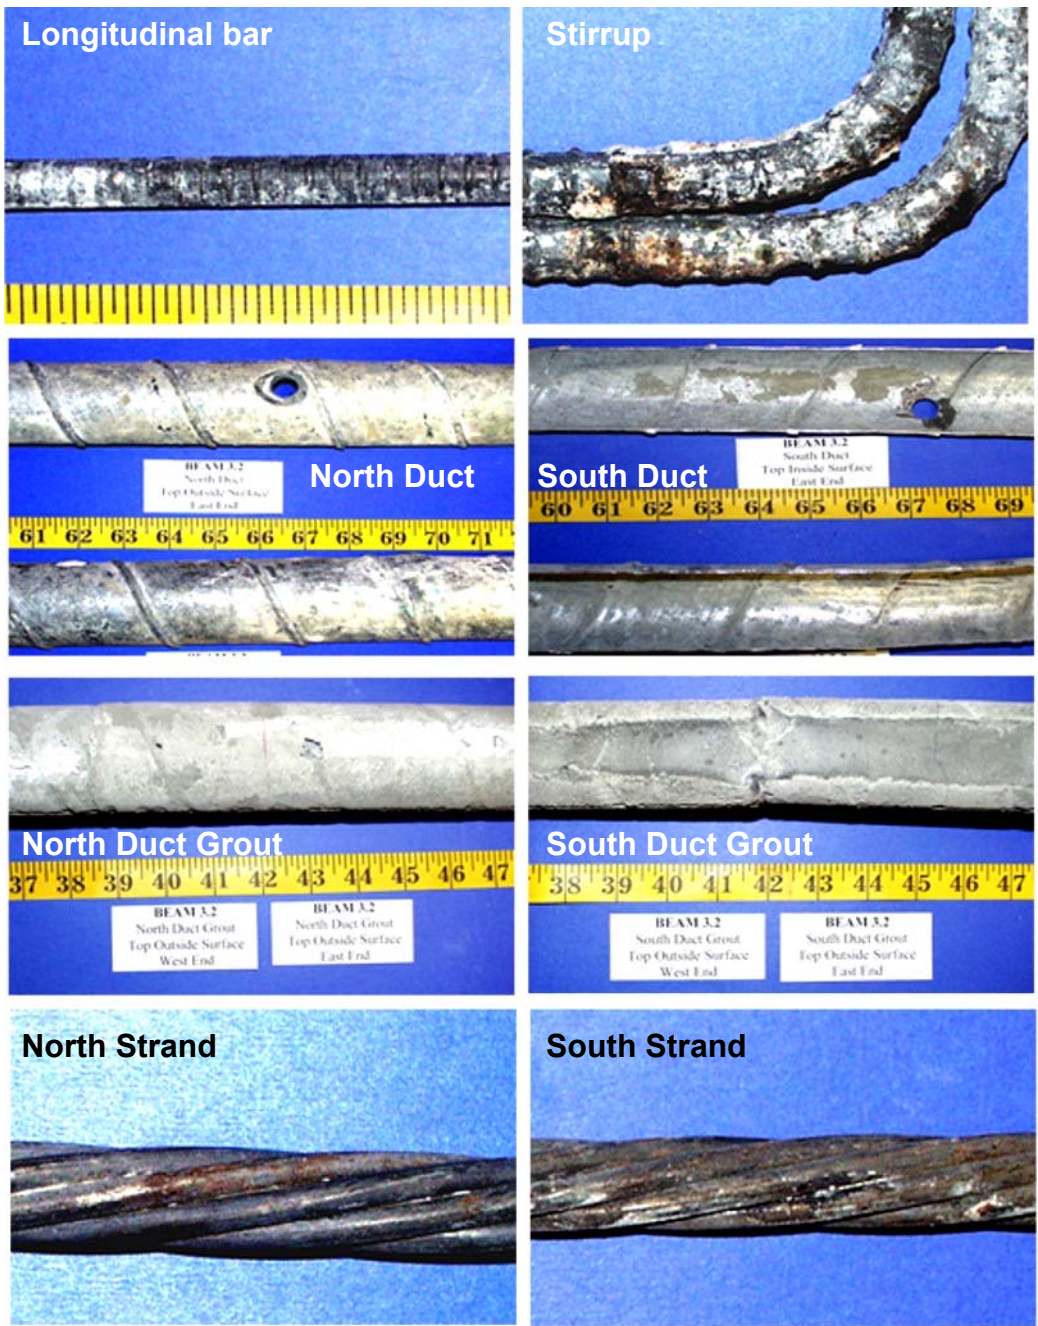
Figure 4.90 Specimen 3.2 – Reinforcing Elements

A full autopsy of Specimen 3.2 was performed, providing a total length of 72 inches of the longitudinal bars, ducts, grout and strands and six stirrups to be analyzed. (See Figure 4.90) Forty-two inches of the analysis length extended to the west of the centerline of the beam and the remaining 30 inches extended to the east.

The only corrosion found on the north duct was located under the heat-shrink splice at the centerline of the beam. It showed two very light spots of corrosion. The south duct showed no signs of corrosion. (See Figure 4.90)

The grout in the north duct showed multiple small voids over the entire length. The south duct grout had three large voids. A 14-inch long void was located at the centerline, as shown in Figure 4.90. Two six-inch long voids were found 24 inches to the east and to the west of the centerline. Figure 4.88 was included to illustrate the good grouting quality of both ducts in Specimen 3.2. The acid soluble chloride content in the north and south duct grout was negligible. Chloride samples were taken at 6-inch intervals within the forensic analysis length and chloride content plots were obtained, as shown in Figure 4.91.

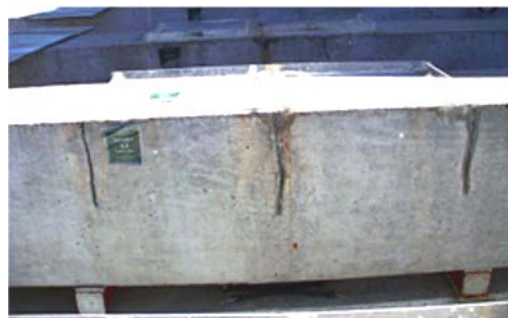
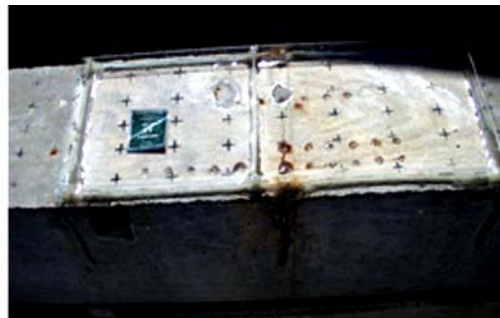
Figure 4.92 Specimen 3.3 – Condition Prior to Autopsy

As shown in Figure 4.92, specimen 3.3 had three transverse cracks across the top of the beam at the end of exposure. The largest crack had a maximum width of 0.013 inches and was located at the centerline of the beam. This location was directly above a stirrup. The other two cracks had a

maximum width of 0.01 inches. They were located 24 inches to the east and west of the centerline. Both of these cracks also coincided with stirrup locations. As seen in Figure 4.92, there was minor rust staining around the cracks on the sides of the beam. A majority of the rust spots on the top were from the bolster strips.

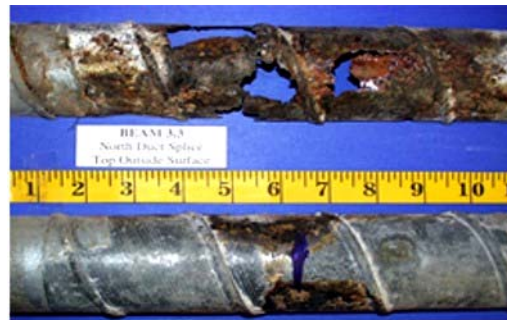
Figure 4.93 Specimen 3.3 – North Duct Splice

Specimen 3.3 had one duct splice. It was an industry standard splice located on the north duct at the centerline. Figure 4.93 shows the condition of the duct splice at the end of exposure testing. The top of the north duct splice was found to be severely corroded with significant section loss.

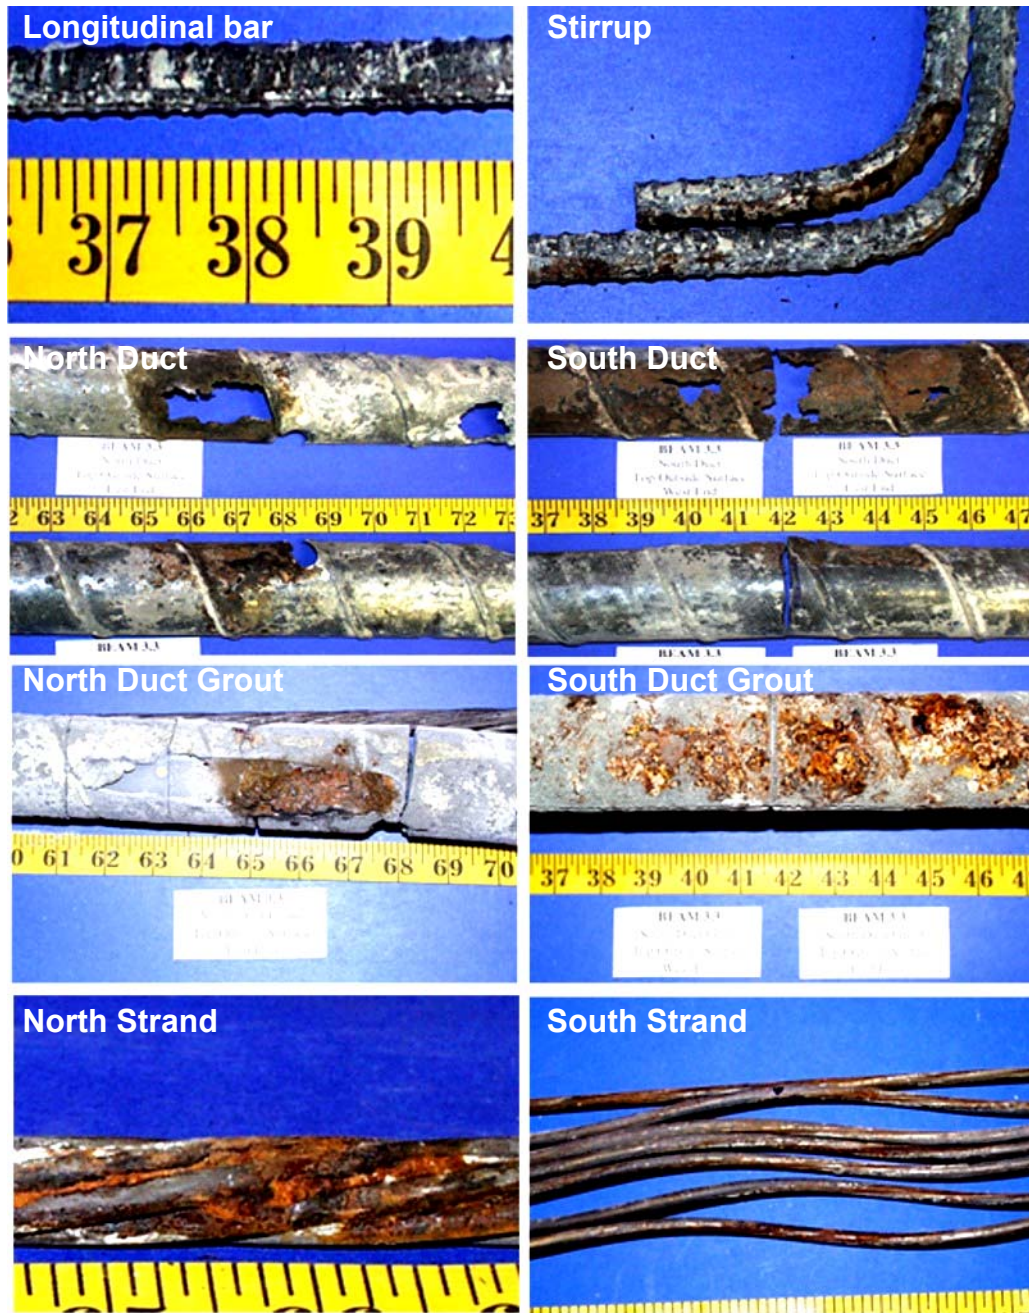
Figure 4.94 Specimen 3.3 – Reinforcing Elements

A full autopsy of Specimen 3.3 was performed, providing a total length of 72 inches of the longitudinal bars, ducts, grout, and strands and six stirrups to be analyzed. Forty-two inches of the analysis length extended to the west of the centerline of the beam and the remaining 30 inches extended to the east. (See Figure 4.92)

Severe corrosion and area loss corresponding to the three crack locations was found on the north duct. The south duct also showed signs of severe corrosion and area loss at the centerline, and moderate corrosion under the other two cracks. (See Figure 4.94) The remainder of the ducts showed no signs of corrosion.

Moderate to severe uniform corrosion was found on all three prestressing strands in the north duct. As shown in Figure 4.94, severe localized corrosion was found 24 inches to the west of the centerline, which again coincides with a crack location. Moderate to severe uniform corrosion was also found on all three prestressing strands in the south duct.

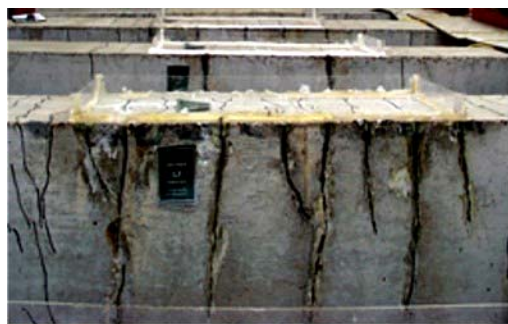
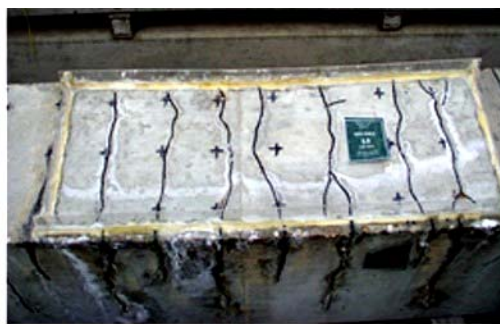
Figure 4.100 Specimen 1.5 – Condition Prior to Autopsy

At the end of exposure, Specimen 1.5 had a large number of cracks on the top face and both sides. (See Figure 4.100) A majority of the cracks were confined to the constant maximum moment region. There was a large amount of rust staining, corresponding to the cracks, on both

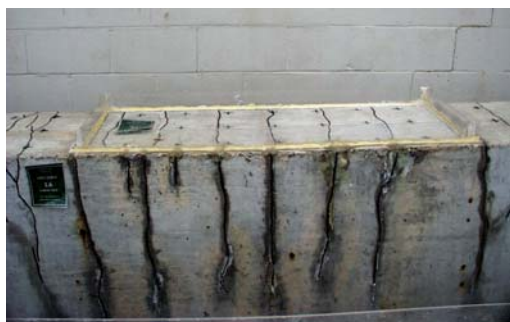
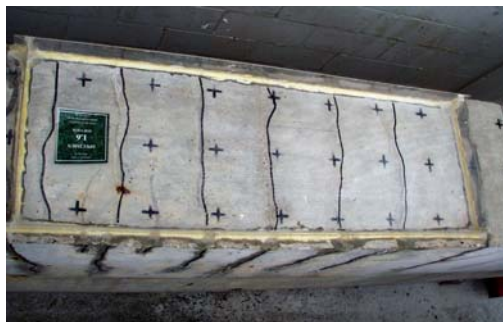
Figure 4.103 Specimen 1.6 – Condition Prior to Autopsy

Specimen 1.6 had a large number of cracks on the top face and both sides at the end of exposure. (See Figure 4.103) A majority of the cracks were confined to the constant maximum moment region. There was minimal rust staining around a few of the cracks. Figure 4.103 shows moisture surrounding the cracks, indicating that the chlorides are traveling through the cracks. Specimen 1.6 had a maximum crack width of 0.016 inches on the crack located 13 inches to the west of the centerline.

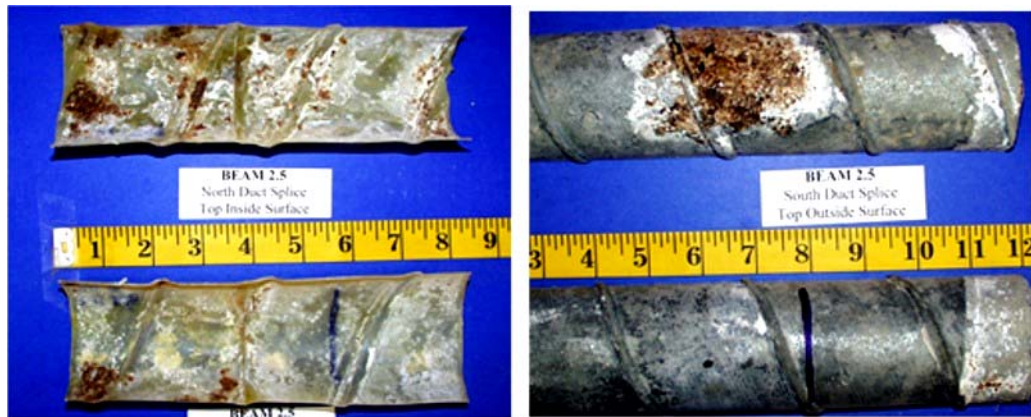
Figure 4.107 Specimen 2.5 – Duct Splices

Specimen 2.5 had two duct splices. The south duct had an industry standard splice, and the north duct had a heat-shrink splice. Both splices were located at the centerline of the beam. Figure 4.107 shows the condition of the duct splices at the end of exposure. Severe corrosion and minor section loss were found on the center half of the top of the oversized piece of the industry standard splice. The heat-shrink splice on the north duct showed signs of rust staining on one side. This is due to the lack of sufficient adhesion between the steel duct and splice, allowing moisture to be trapped under the splice.

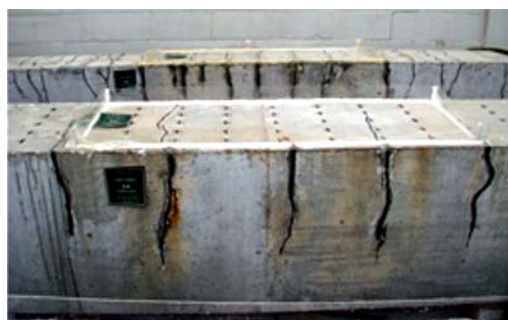
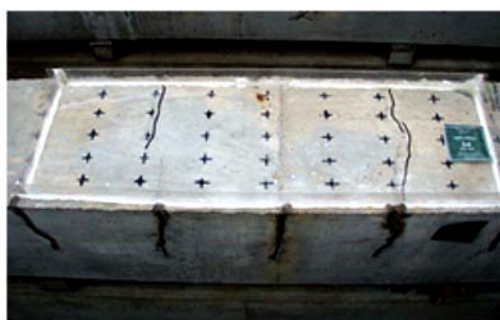
Figure 4.110 Specimen 2.6 – Condition Prior to Autopsy

Figure 4.110 shows Specimen 2.6 as having five major cracks at the end of exposure. Each of these cracks coincided with the stirrup locations. (See graphs in Figure 4.113) The maximum crack width was 0.016 inches, located 26 inches to the east and 23 inches to the west of the beam

centerline. As seen in Figure 4.110, rust staining on the concrete was present around a few of the cracks.

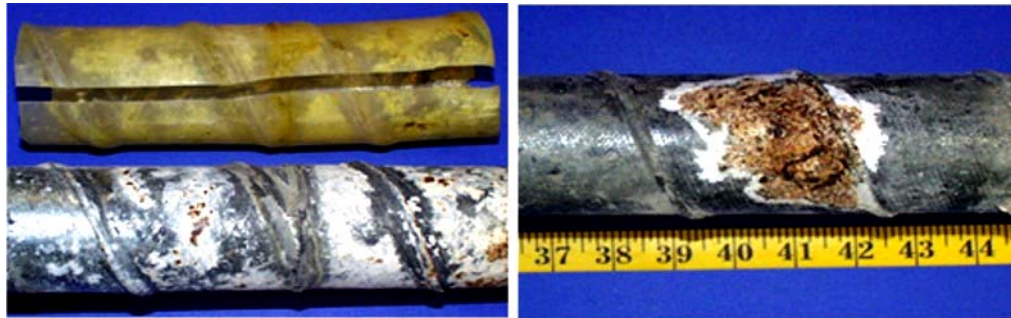
Figure 4.111 Specimen 2.6 – Duct Splices

Specimen 2.6 had two duct splices. The south duct had an industry standard splice, and the north duct had a heat-shrink splice. Both splices were located at the centerline of the beam. Figure 4.111 shows the condition of the duct splices at the end of exposure testing. Severe corrosion and minor section loss was found on the center two inches of the top of the oversized piece of the industry standard splice. The heat-shrink splice, pictured with the north duct, showed minor signs of rust staining on the inside only.

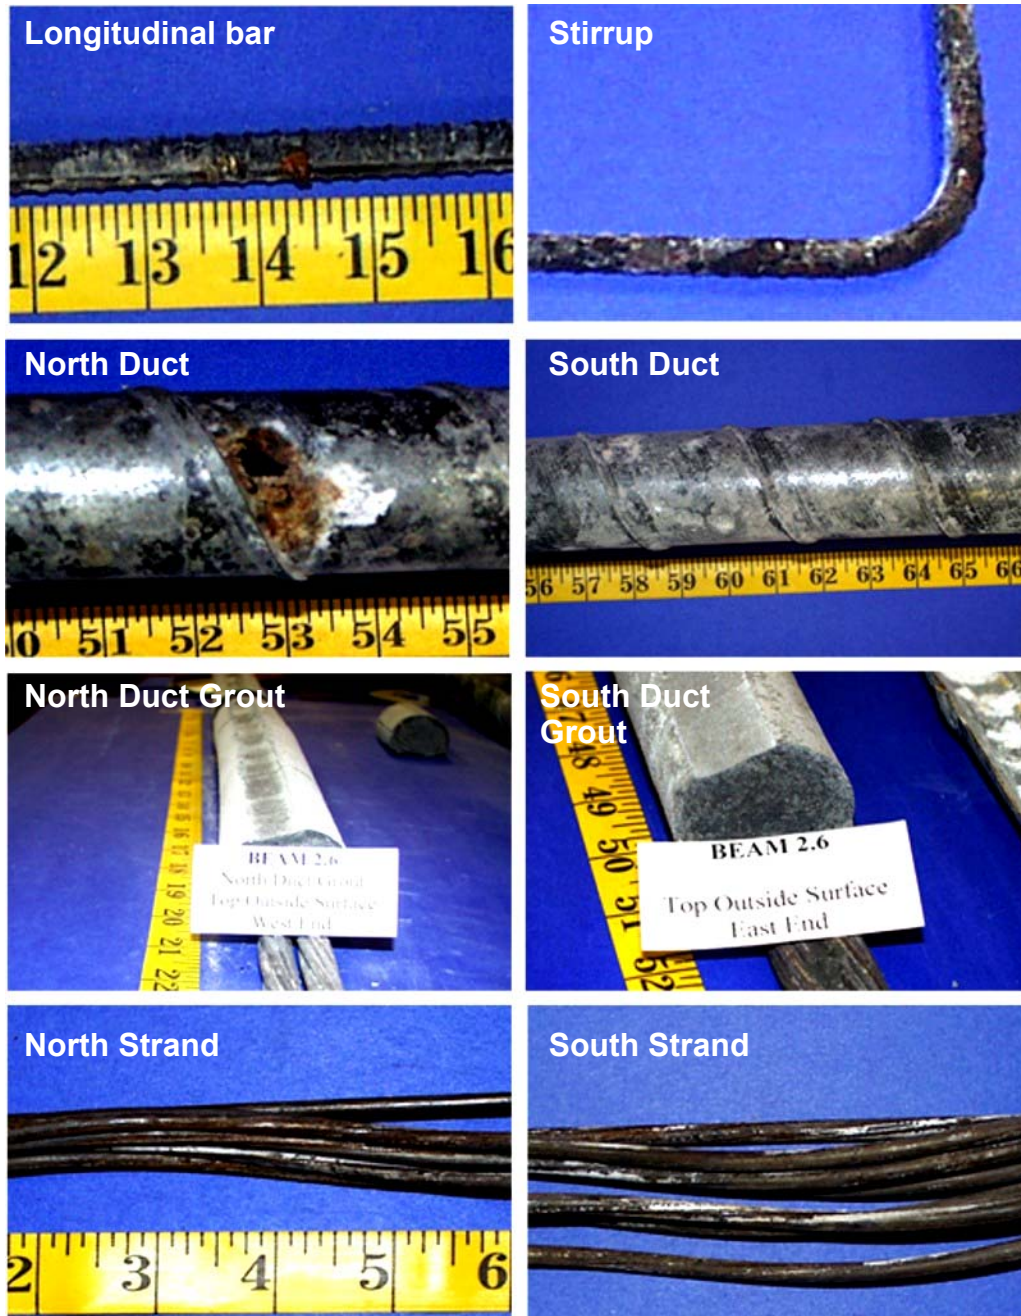
Figure 4.112 Specimen 2.6 – Reinforcing Elements

A full autopsy of Specimen 2.6 was performed, providing a total length of 72 inches of the longitudinal bars, duct, grout and strands, and six stirrups for analysis. Forty-two inches of the analysis length extended to the west of the centerline of the beam and the remaining 30 inches extended to the east. (See Figure 4.112)

Light uniform corrosion was found on all the strands located in the north and south ducts.

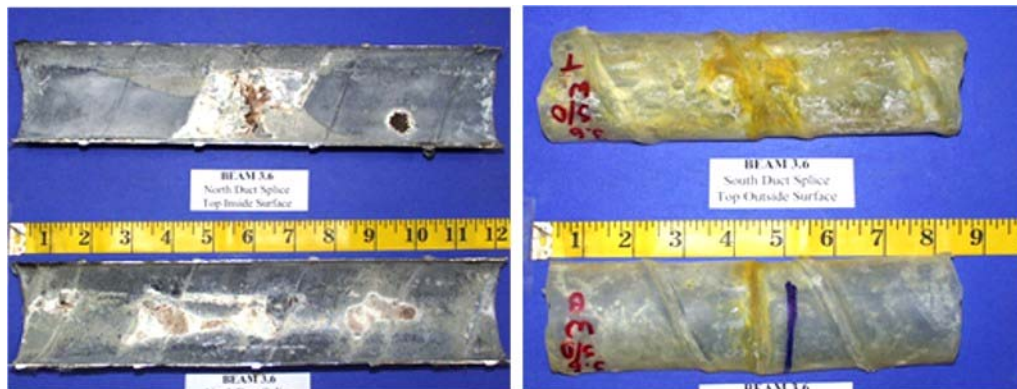
Figure 4.115 Specimen 3.6 – Duct Splices

Specimen 3.6 had two duct splices. The north duct had an industry standard splice, and the south duct had a heat-shrink splice. Both splices were located at the centerline of the beam. Figure 4.115 shows the condition of the duct splices at the end of exposure. Minor corrosion and salt staining was found on the center of the oversized piece of the industry standard splice. The heat-shrink splice showed no signs of rust staining or corrosion.

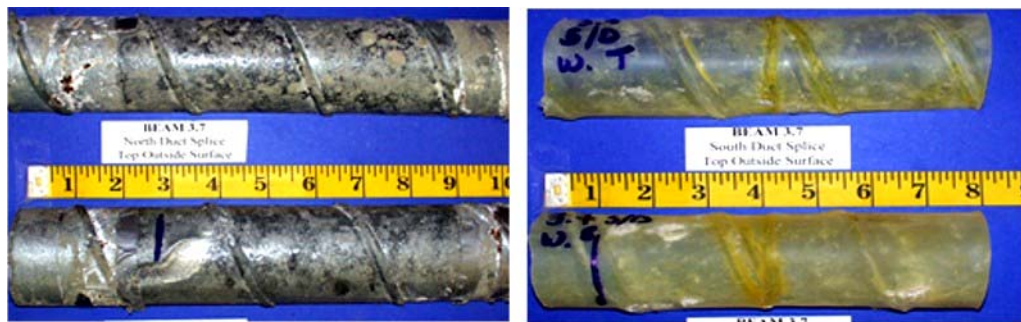
Figure 4.119 Specimen 3.7 – Duct Splices

Specimen 3.7 had two duct splices. The north duct had an industry standard splice, and the south duct had a heat-shrink splice. Both splices were located at the centerline of the beam. Figure 4.119 shows the condition of the duct splices at the end of exposure. The only corrosion found on the industry standard splice was located under the duct tape. The heat-shrink splice showed no signs of rust staining or corrosion.

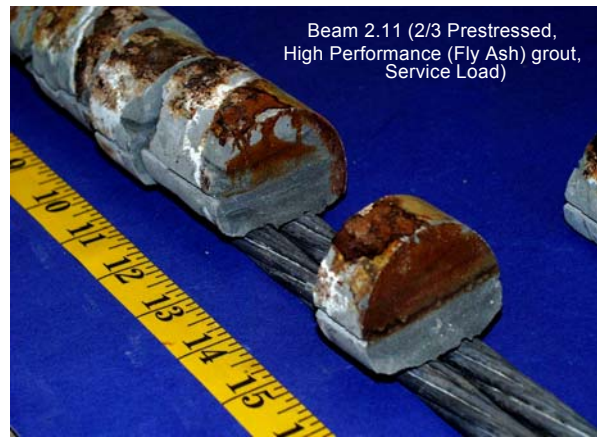
Figure 4.145 Effect of Grout Cracking

Since grout is injected after post-tensioning of the element, it is susceptible to cracking due to deflections from loading and vibrations. Cracking in the grout may serve as direct paths for moisture and chlorides to the strands.

Figure 4.145 shows the grout condition found during forensic examination for Specimen 2.11. As shown in this figure, moisture and corrosion stains coming from the galvanized duct were present in many grout transverse slices. At the time of forensic examination, it appeared that only a short time would have been required for the moisture to get to the strand level. Similar findings were also reported before by Hamilton.^{4.26} However, this aspect in the multilayer strand corrosion protection concept has not received enough attention to date.

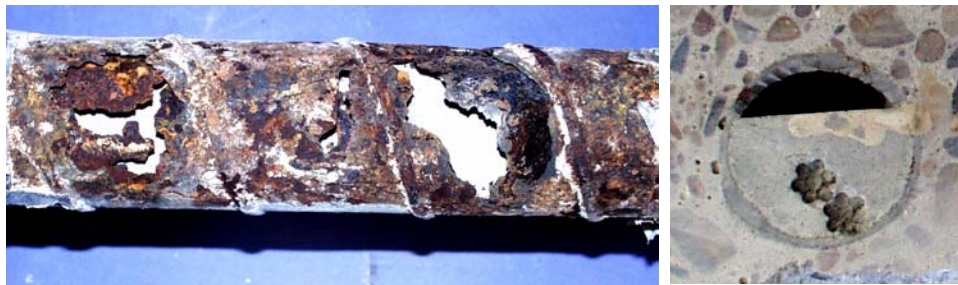
Figure 4.146 Bleed Water Void and Duct Corrosion

Bleed water voids were also found inside the ducts on a few specimens, even when they were supposed to have been grouted following correct procedures. Figure 4.146 shows the negative effects of a bleed water void. It was found that grout voids do not only affect the corrosion protection of the strands, but they also appear to be detrimental to the duct.

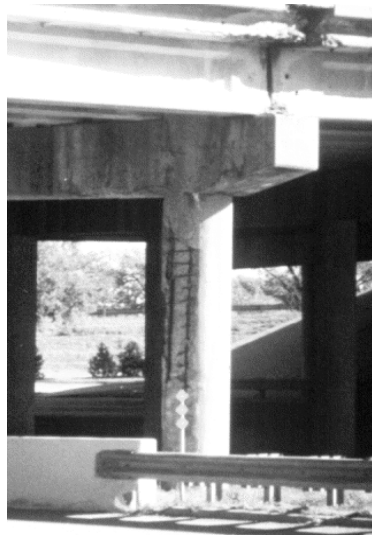
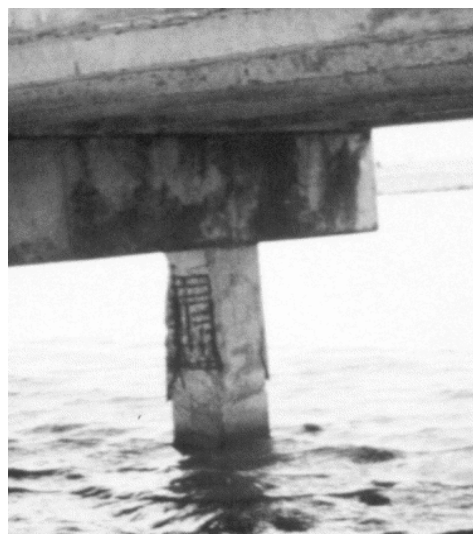
Figure 5.2 Typical Corrosion Damage in Bridge Substructures.^{5.1}

*(a) Deicing Chemical Exposure
"Attack from Above"*

*(b) Coastal Saltwater Exposure
"Attack from Below"*
