**Accelerated Corrosion Testing, Evaluation and Durability Design
of Bonded Post-Tensioned Concrete Tendons**

Dissertation

The University of Texas at Austin

August 2003

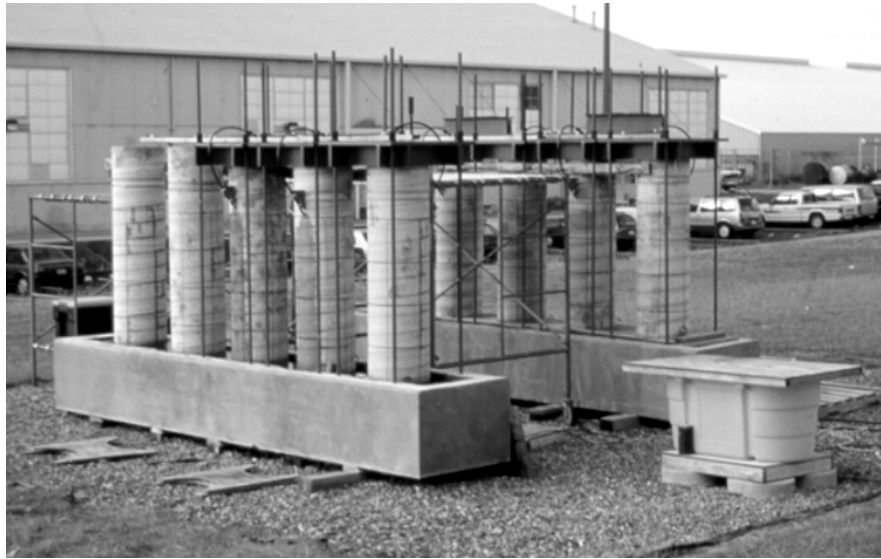
Figure 5.11 Column Corrosion Test Setup.^{5.1}

The dimensions of the reinforced concrete foundation (designed using a strut and tie model) were 15.33 ft long, 36 in. wide and 18 in. high, with a 6 x 6 in. curb along the perimeter of the top surface to contain ponded saltwater. Loading was applied on the columns using a stiffened loading plate on top of the column and four-one inch threaded prestressing bars. The forces in the bars were adjusted to apply the desired moment and axial force.

The experimental setup is shown in Figures 5.10 and 5.11. The dripper system is shown in Figure 5.12.

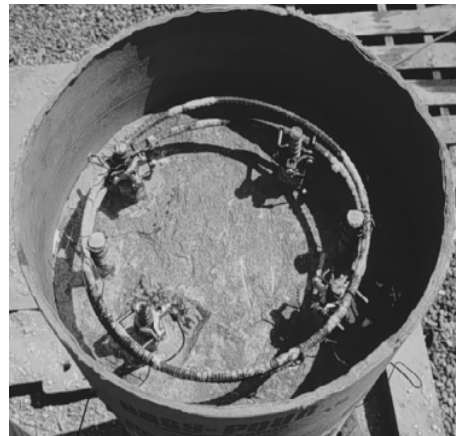
Figure 5.16 Column Post-Tensioning Details.^{5.2}

As shown in Figure 5.16, short lengths of post-tensioning bar were cast into the foundation to provide anchorage for the column post-tensioning bars. Shallow, square pockets were formed around each bar to accommodate rubber gaskets to seal the “dead end” of the post-tensioning ducts. The column post-tensioning bars were coupled to the protruding bars prior to placement of the ducts. Ground clamps were used to attach ground wires for measurements of potentials to the post-tensioning bar ends prior to capping.

Top of Column Prior to Capping

A rubber gasket was placed around the protruding PT-bars in the top of the foundation to seal the dead ends of the ducts as shown in Figure 5.16. As it is discussed in Section 5.5 it was a serious error in the specimen definition not to splice ducts at this location.

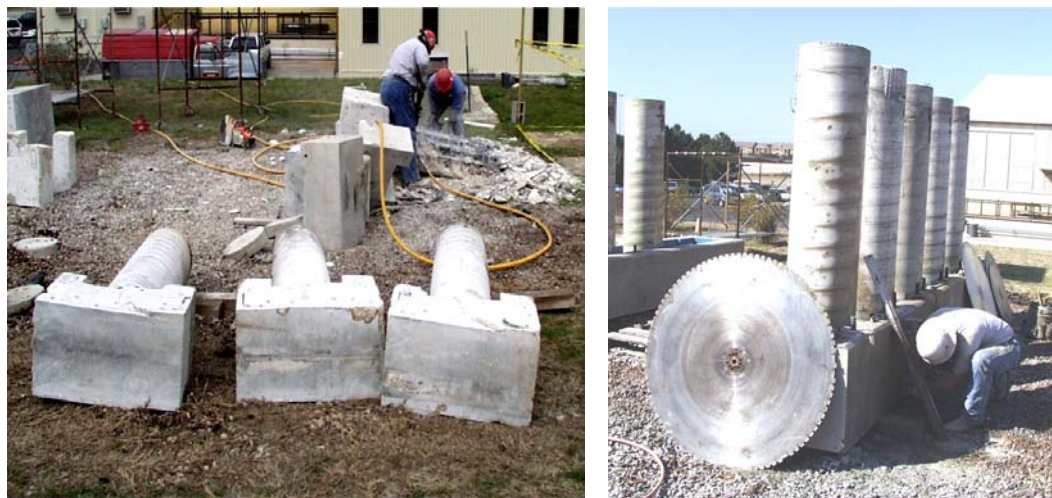
Figure 5.46 Saw Cutting of Column Foundation.

Prior to concrete removal, column specimens sharing the same foundation were separated by saw cutting as shown in Figure 5.46. Due to special saw cutting equipment requirements, saw cutting had to be contracted with an external concrete demolition company.

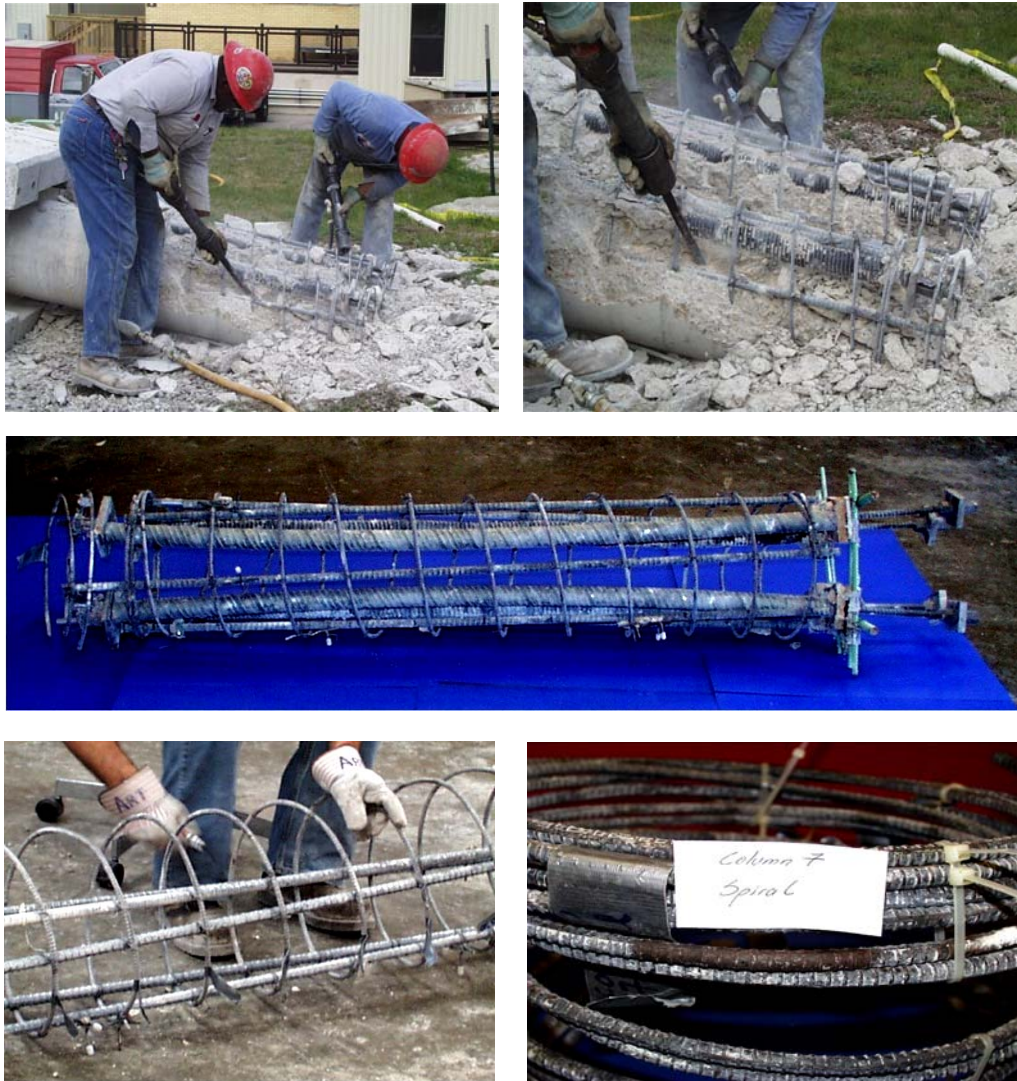
Figure 5.47 Concrete Removal and Reinforcement Dismantling.

Concrete in column specimens was carefully removed using pneumatic equipment, as shown in Figure 5.47. Care was exercised to ensure total exposure and removal of spiral and longitudinal mild steel reinforcement and post-tensioning duct/PT bar systems. Reinforcement was immediately inspected for any color changes due to drying of the corroded steel surfaces, if any. Reinforcement cages were dismantled for careful reinforcement inspection and rating.

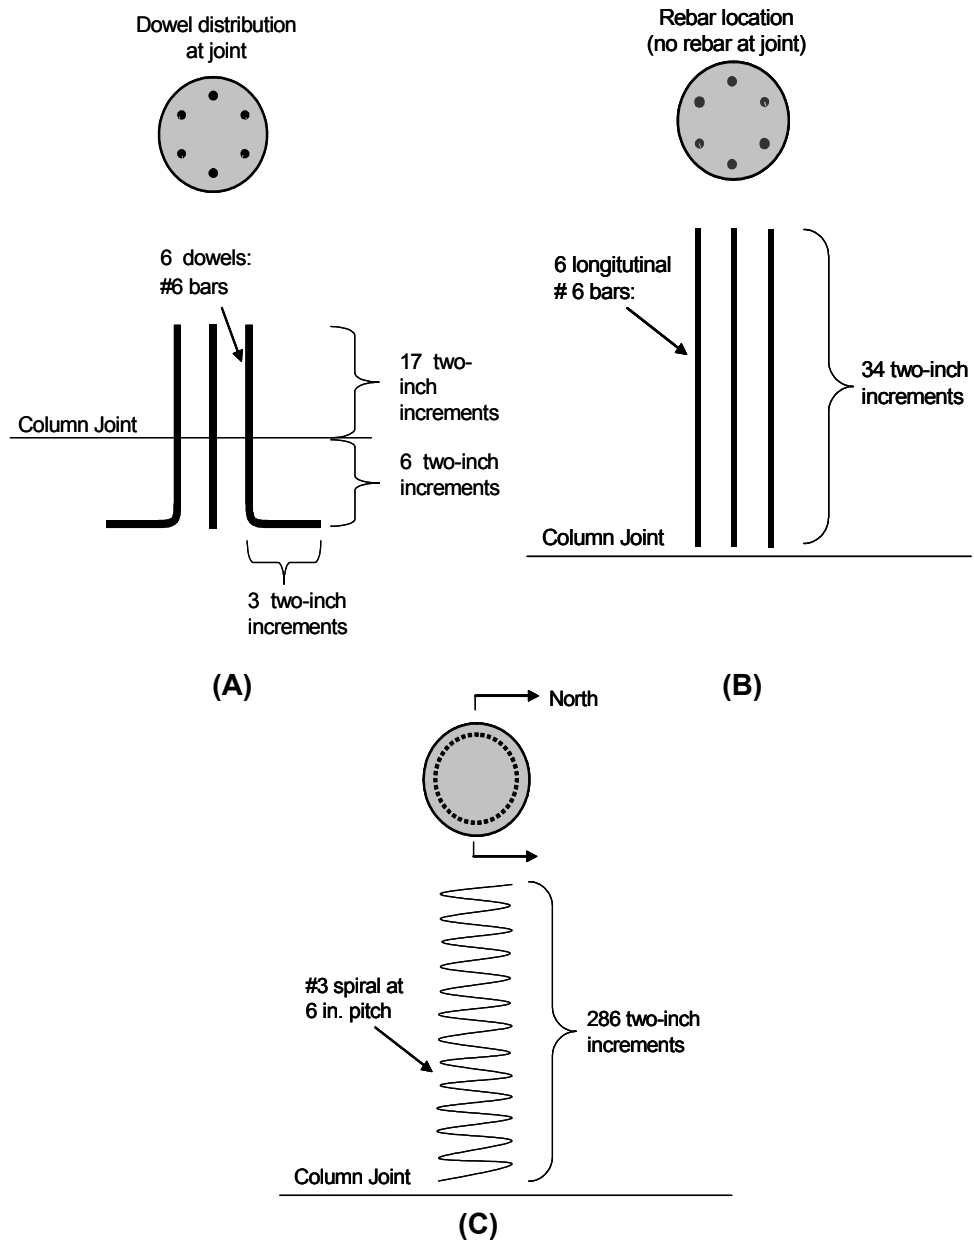
Figure 5.48 Intervals for Corrosion Ratings on (A) dowels, (B) mild steel longitudinal bars, and (C) spiral

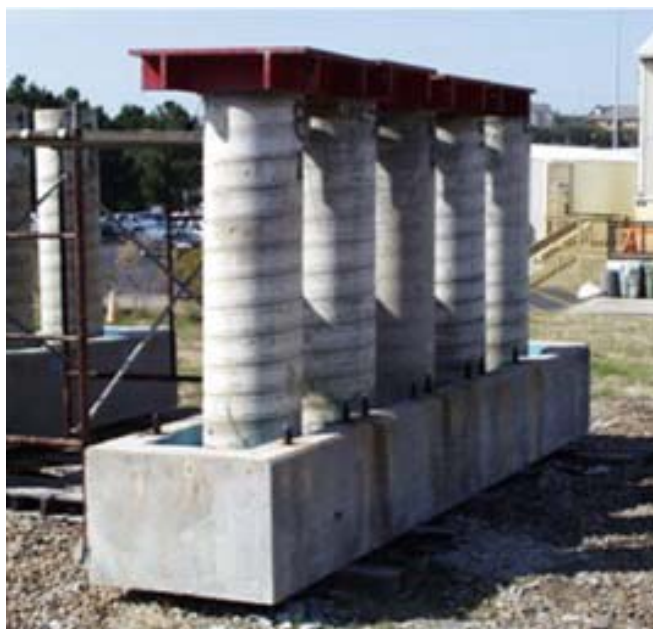
Figure 5.51 Specimen Condition at the End of Testing.

A brief summary of forensic examination results after six and a half years of exposure is provided for each column specimen in the following sections. In general, at the end of testing rust stains were only visible in the base of the columns, in the bottom 12 inches. No signs of cracking were observed in the column surfaces. Figure 5.51 shows the condition of the specimens after unloading and tie down bar cutting.

Tie down bars had uniform corrosion at the column base level, which stained the foundation, but no severe pitting was observed on these high-strength bars.

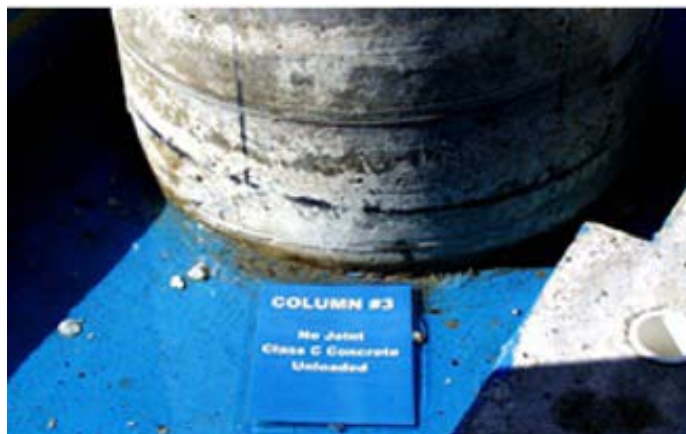
Figure 5.52 Condition of Specimen NJ-TC-N at the End of Testing

No signs of cracking were visible in the column surfaces and no corrosion stains were present at the column base, as observed in Figure 5.52.

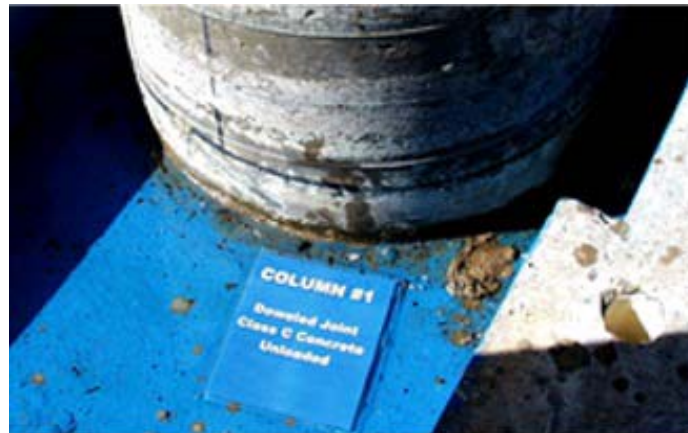
Figure 5.54 Condition of Specimen DJ-TC-N at the End of Testing

Spiral reinforcement had pitting in the North side at the base of the column in the center three two-inch segments, as shown in Figure 5.54. Light to moderate corrosion extended up to a height of 14 inches from the column base, in

both the North and the South sides. In the dripper side, light corrosion was concentrated in the center six inches of the total height of the spiral. In the non-dripper side, only discoloration and few areas of light corrosion were visible in the total spiral height.

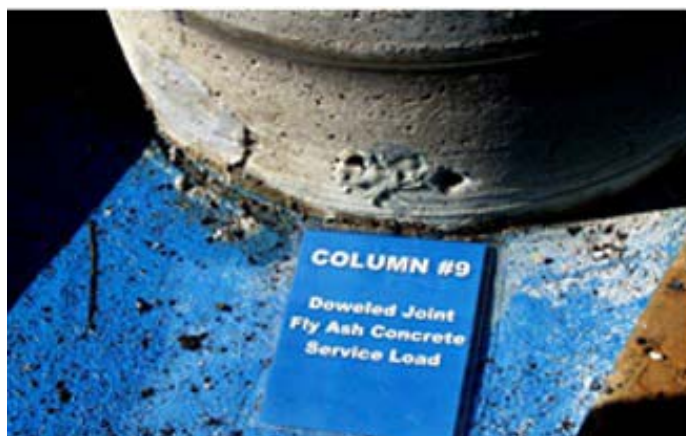
Figure 5.56 Condition of Specimen DJ-FA-S at the End of Testing.

The specimen surface had no signs of corrosion stains or cracking. Concrete was in excellent condition at the end of testing. See Figure 5.56.

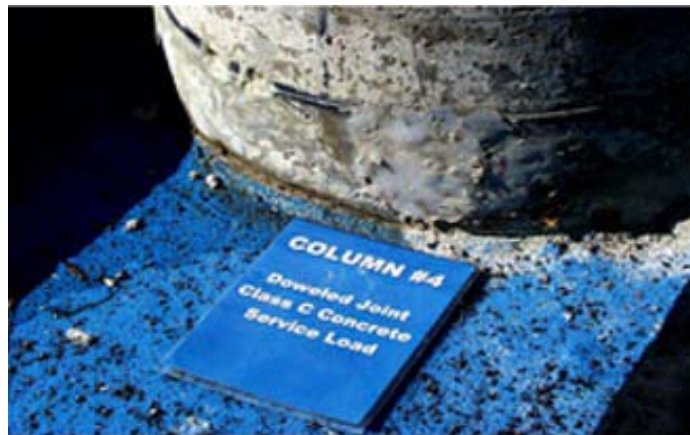
Figure 5.58 Condition of Specimen DJ-TC-S at the End of Testing

Spiral reinforcement showed very similar corrosion ratings in the non-dripper and dripper sides. Light to moderate corrosion was concentrated in the first 22 inches from the column base; and, also some areas of moderate corrosion were observed in a few segments at the 46-inch and 53-inch levels.

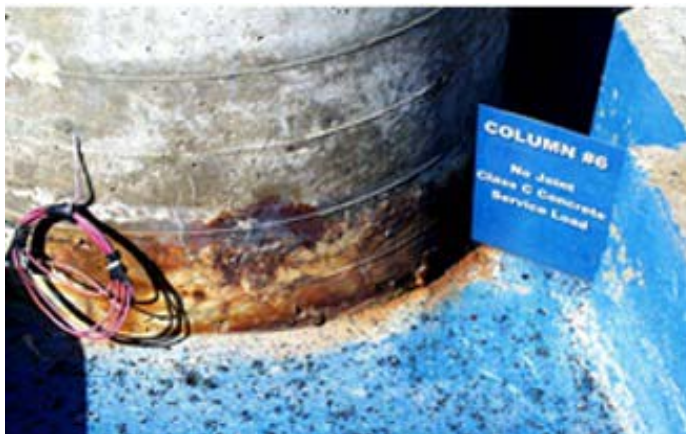
Figure 5.60 Condition of Specimen NJ-TC-S at the End of Testing

No signs of cracking or spalling were visible on the column surfaces. Rust stains extended the first 5 inches, from the column base, as shown in Figure 5.60. No other signs of corrosion were visible in the specimen.

After six and a half years of exposure, Figure 5.78 shows that in the dripper side, specimen NJ-TC-S (No dowel, type C concrete, service load) showed extremely severe spiral corrosion rating, over 400 times the threshold value. With applied loading the epoxy joint used in non-joint specimens could have opened up in the North side (refer to applied moment direction in Figure 5.13) and moisture and chlorides could have been able to penetrate the joint (see Figure 5.60). In addition, it appears that the concrete cover was between half to one inch at the base of the column, instead of the design value of two inches, and therefore moisture could have penetrated rapidly to the spiral level.

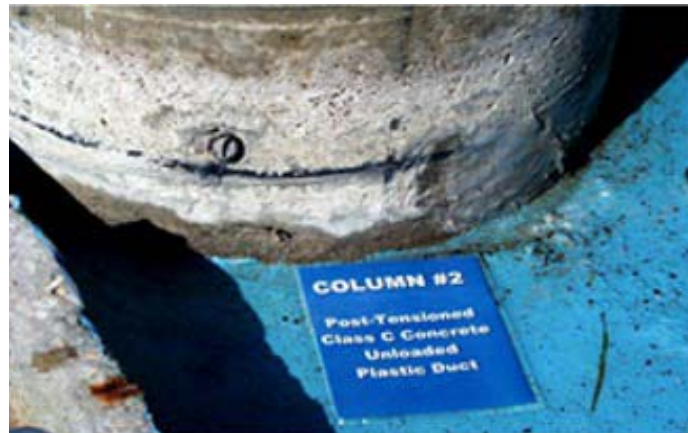
Figure 5.62 Condition of Specimen PT-TC-N-PD at the End of Testing

As shown in Figure 5.62, the concrete surface was in excellent condition at the end of testing. No signs of corrosion stains or cracking were visible.

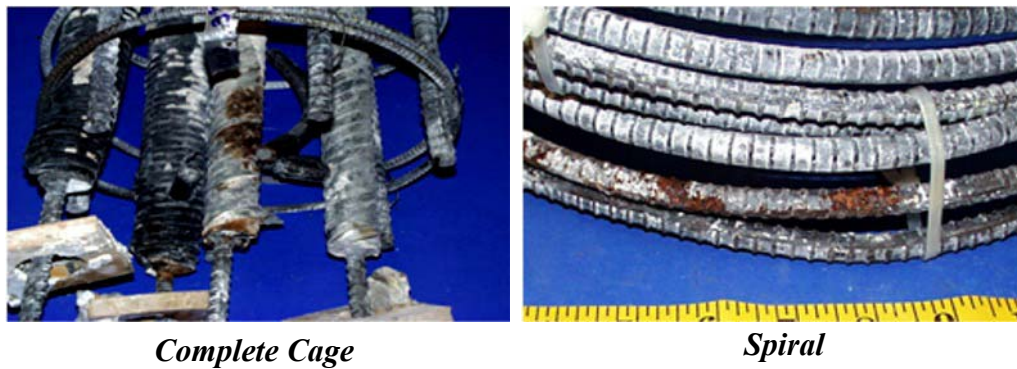
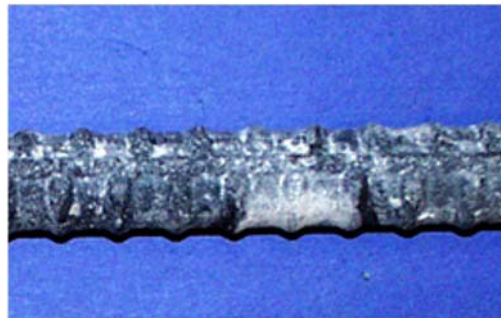
Figure 5.63 Reinforcement Condition for Specimen PT-TC-N-PD

As shown in Figure 5.63, the spiral reinforcement showed light to moderate uniform corrosion in the first two steps (up to a height of nine inches). From this level to the top of the

spiral (corresponding to the top of the column), the reinforcement only showed discoloration.

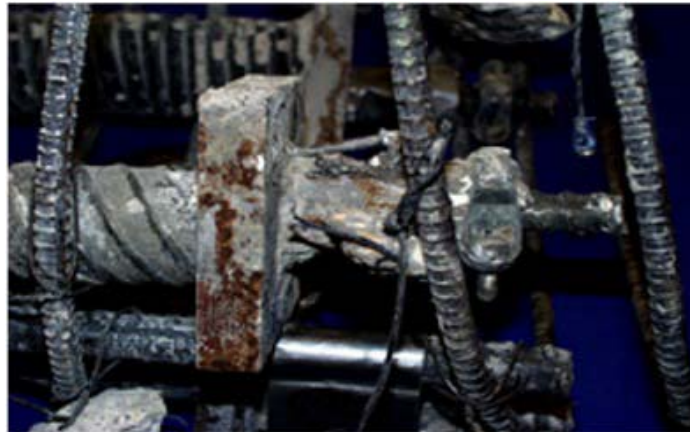
Figure 5.64 PT Bar Top Anchorage Condition for Specimen PT-TC-N-PD

The anchorage plate in the top of the column, below the pour-back, was found with moderate to severe corrosion, as shown in Figure 5.64. This finding was typical for all Post-Tensioned specimens.

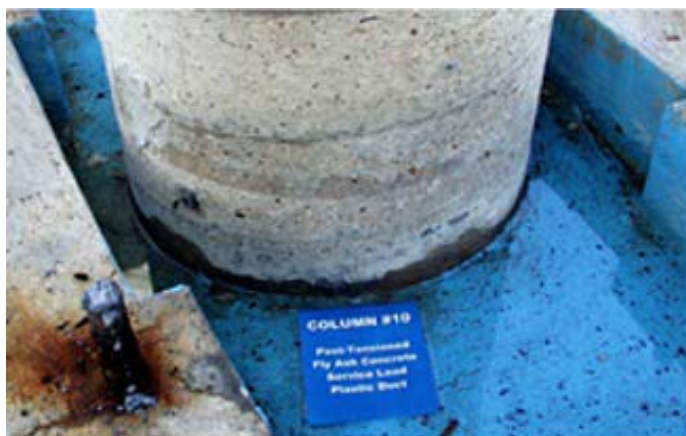
Figure 5.69 Condition of Specimen PT-FA-S-PD at the End of Testing

The concrete surface was in excellent condition at the end of testing as shown in Figure 5.69.

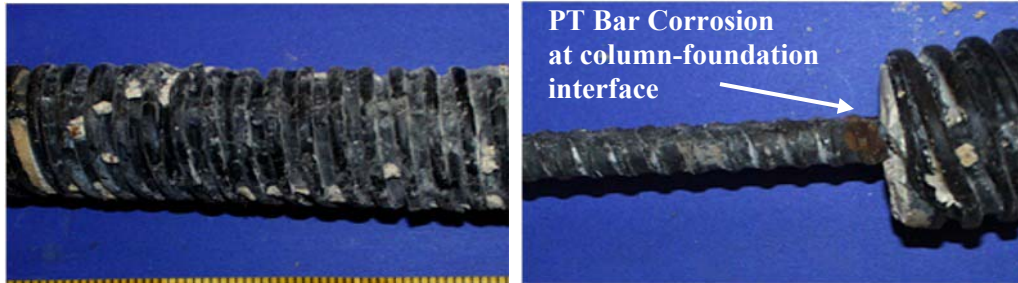
Plastic ducts were in good condition and galvanized steel ducts showed moderate to severe corrosion in the first two inches from the column base level, in the rubber gasket location, as shown in Figure 5.71. Post-tensioned bars also showed moderated corrosion concentrated around the column-foundation joint section.

Figure 5.84 showed that specimen PT-TC-S-GB had the most extensive maximum duct corrosion rating; however this corrosion was mostly concentrated in the first two-inch increment, and was mostly due to the negative conditions given by the use of the rubber gasket at the column-foundation interface. The rubber gaskets were found to be detrimental for the performance of galvanized ducts, since moisture was trapped in the inner gasket faces and corrosion was accelerated. This result shows that a better splicing method is required. For the same reasons, specimens PT-TC-S-EB and PT-TC-S-PD showed high duct corrosion ratings in the first and second two-inch increments. Specimen PT-FA-S-PD showed maximum duct corrosion ratings equal to the threshold value; however this specimen was also starting to have severe localized corrosion due to the use of the gasket. Figure 5.71 (PT bar #3 and duct #3) clearly shows this situation.

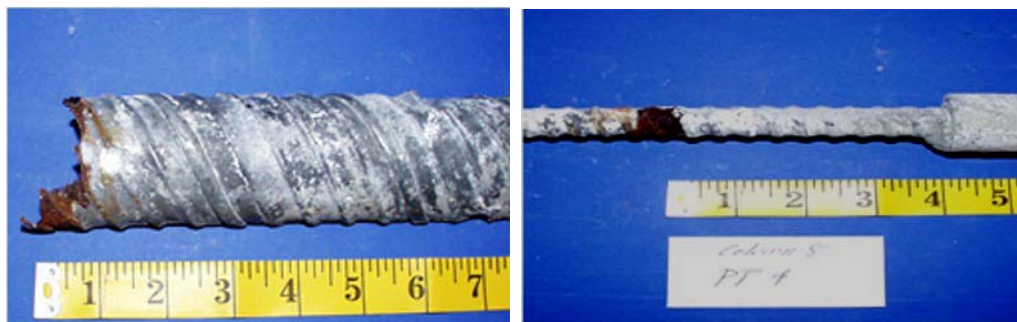
Figure 5.77 shows that ducts were corroded with extensive area loss in the first two inches from the column base level, at the rubber gasket location.

Galvanized PT bars (PT Bars #3 and #4) showed localized corrosion and pitting at the column base level. Black steel bars showed a more uniform corrosion in the vicinity of the joint section (the region defined between 12 inches at each side of the joint).

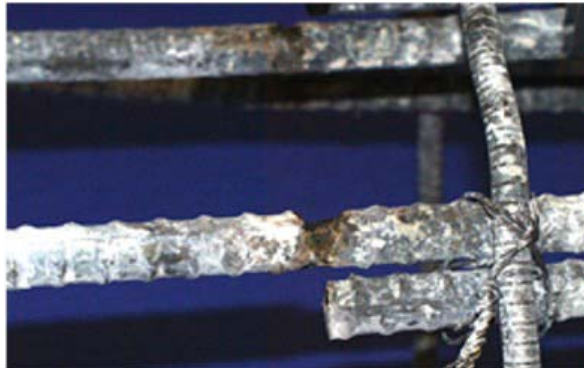
Figure 5.93 Typical corrosion and section loss found on dowels at the column-foundation interface

One of the objectives for this research program was to investigate the effect of typical the cold joint between foundation and columns on chloride ion movement and corrosion activity. After autopsy, corrosion in dowels, ducts and post-tensioning bars was mostly found concentrated at the column-foundation interface. The joint acted as a weak link in corrosion protection, behaving as a pre-formed crack, which could have opened under loading. Specimen NJ-TC-N (No dowel-Class C concrete – unloaded) showed very low spiral and rebar corrosion with respect to the other specimens, which could be explained by the epoxy bonding agent used to prepare the foundation surface on no-joint specimens prior to casting. Figure 5.93 shows the severe section loss due to corrosion in a dowel crossing the joint location.

The wicking effect (migration of chlorides upward in the concrete from ponded base) was typically observed in the first 18 inches from the base of the columns. Spiral, rebar, duct dowel and post-tensioned bar corrosion was very severe at or near the column-foundation interface and decreased with increasing column height.

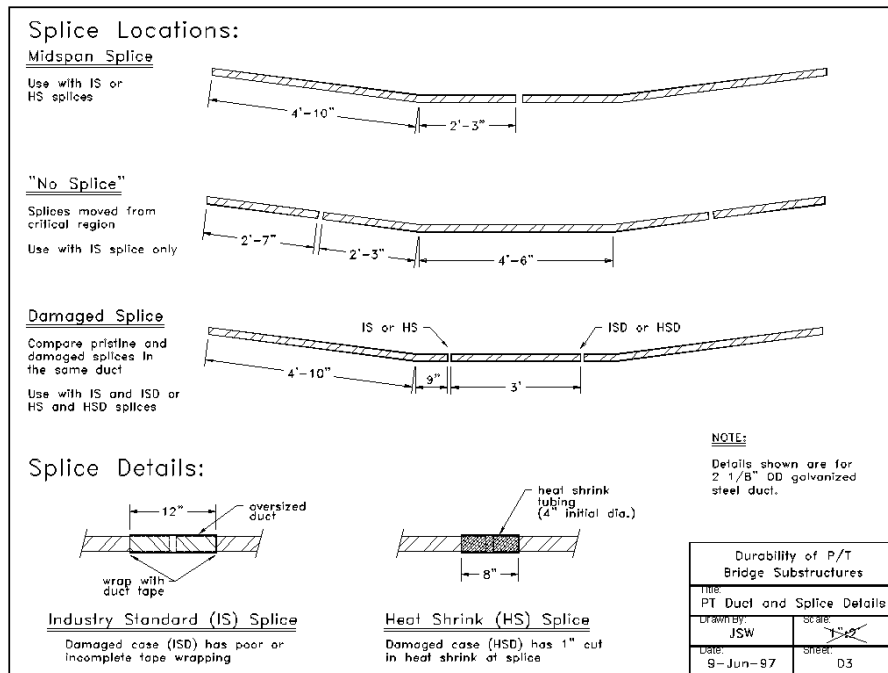
Figure B.20 Sheet D3: Post-Tensioning Duct and Splice Details ^{4.2}
