**Fatigue Strength of Fillet-Welded Transverse Stiffeners  
With Undercuts**

**Joseph Richard Spadea, B.S.C.E.**

**Thesis**

The University of Texas at Austin

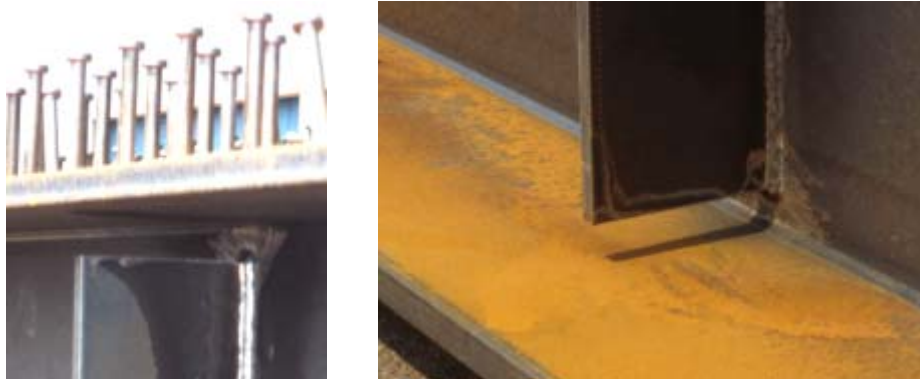
***Figure 1-7: Wrapped Intermediate Stiffener Welds***

Figure 1-7 shows a close-up view of the intermediate stiffener weld detail. The web-to-stiffener welds were carefully wrapped around the top and bottom edges of the stiffener. It should be noted that the stiffeners were welded to the web prior to the attachment of the flanges. The stiffener-to-flange weld shown in Figure 1-6 was made last.

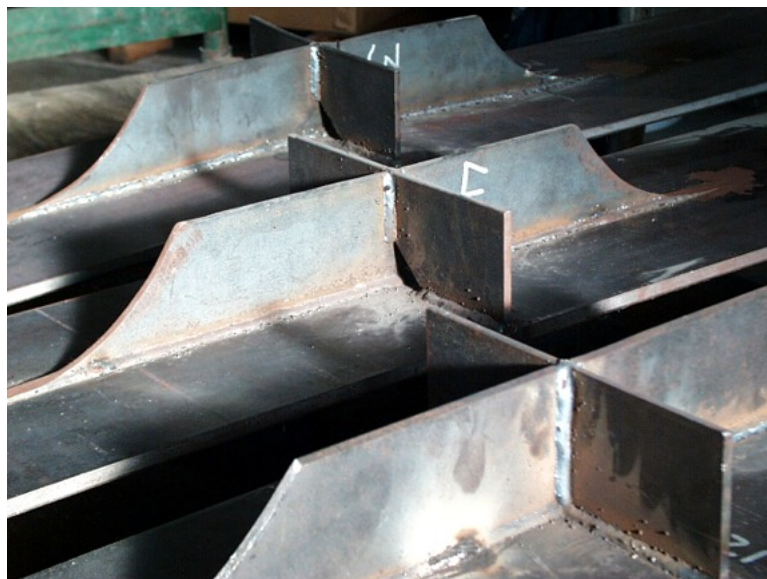
***Figure 2-4: Photo Showing Variety of Specimens***

Four different types of specimens were used to investigate the possible effects of the undercutting caused by wrapping the fillet welds around the stiffener. These specimens, designated type A through type D, were designed to evaluate the fatigue performance based on undercutting at the interior stiffener clip weld wrap and undercutting at the edge of the stiffener-to-flange weld. Figure 2-3 illustrates the cross-section geometry at the stiffener-to-flange connection. Undercut locations and other points of interest are highlighted with circles in the figure. The different specimen types are also shown in Figure 2-4.

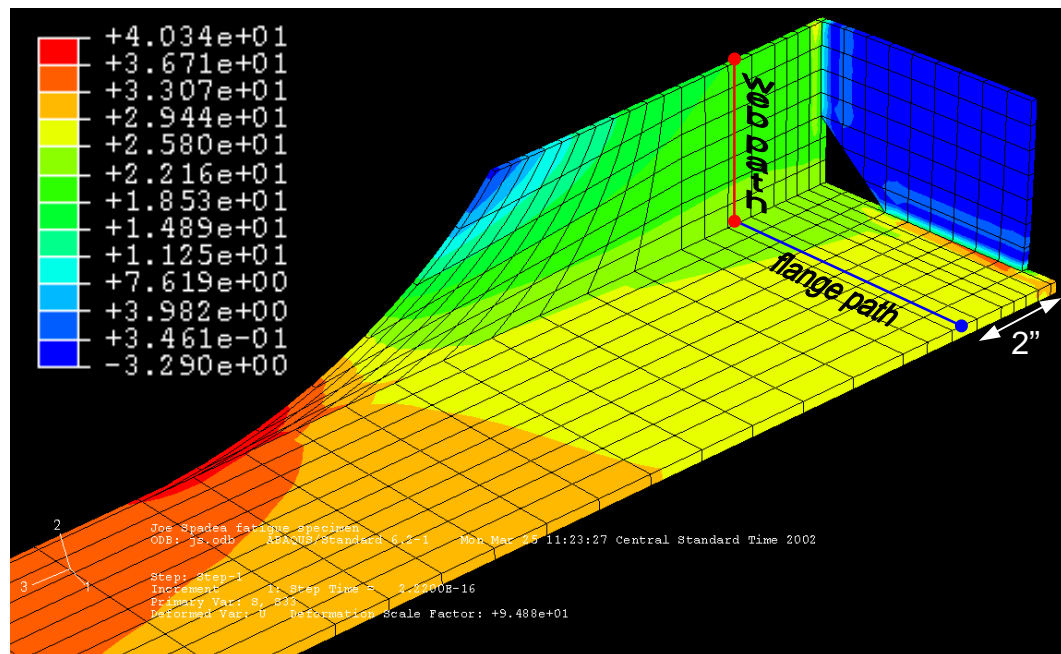
*Figure 2-10: Finite Element Principal Stress Results (ksi)*

Figure 2-10 shows the results of the finite element analysis. Recall that the nominal upper limit stress at the stiffener-to-flange connection is 25 ksi (172 MPa). The stresses shown in Figure 2-10 caused by the maximum static load of 175 kips (778 kN) were generated in Abaqus by applying a uniformly distributed tensile load at the plate end (gripped portion of specimen). The analysis shows that the stress in the flange plate was higher than the stress in the web plate.

One-eighth (1/8) of the specimen was modeled in Abaqus using symmetry boundary conditions and a modulus of elasticity of 29,600 ksi ( $20.4 \times 10^4$  MPa). Three-dimensional continuum brick elements were used to model the specimen. Brick elements C3D15 were used for the web and stiffener. Brick elements C3D20 were used for the flange. The C3D15 elements have 15 nodes and the C3D20 elements have 20 nodes. Both elements use full integration and quadratic interpolation. The mesh size varied depending on the flange, web, and stiffener

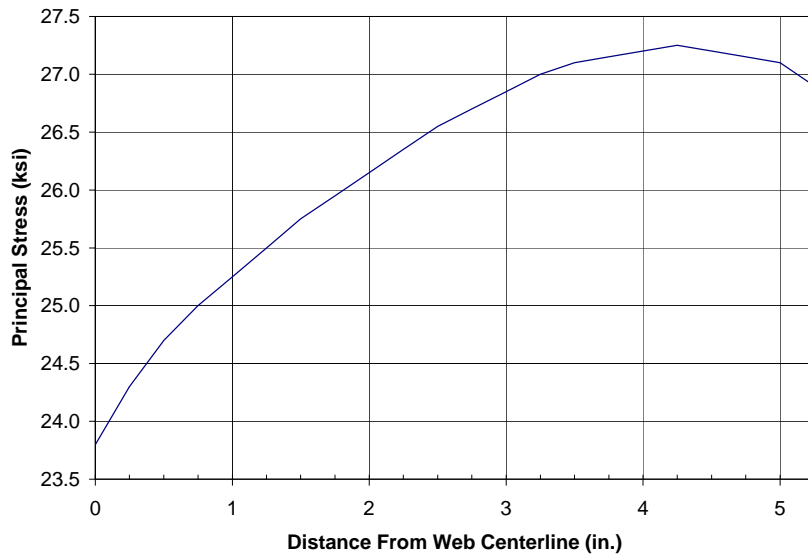
**Figure 2-11: Principal Stress Along Flange Path**

Figure 2-11 shows a plot of principal stress along the flange surface corresponding to the “flange path” labeled in Figure 2-10. A maximum stress of approximately 27.3 ksi (188 MPa) occurs near the edge of the flange. A minimum stress of 23.8 ksi (164 MPa) occurs at the web connection. The average upper limit stress in the flange is 26.2 ksi (181 MPa).

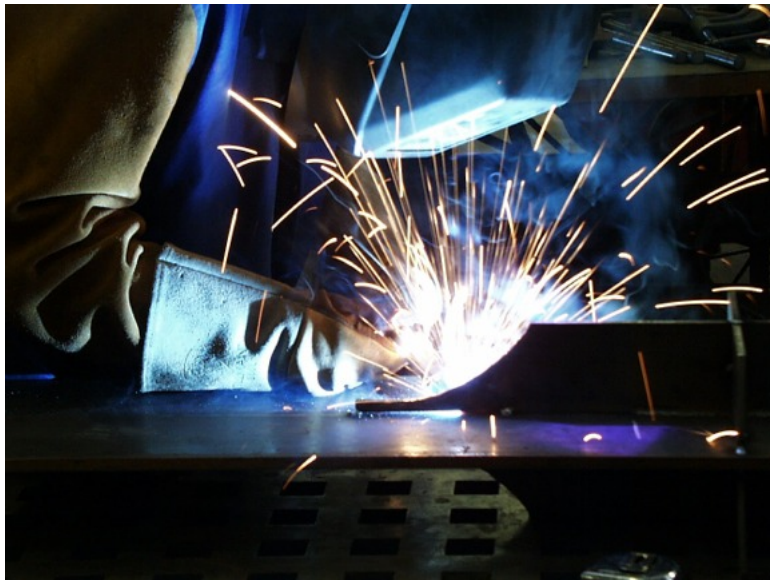
*Figure 2-13: Welding the Web to the Flange*

The materials and welding procedure used to fabricate the test specimens are discussed in this section. The materials and welding process reflect those used by TxDOT manufacturers of steel plate girders. Figure 2-13 shows a specimen being welded by a certified welder at Ferguson Structural Engineering Laboratory.

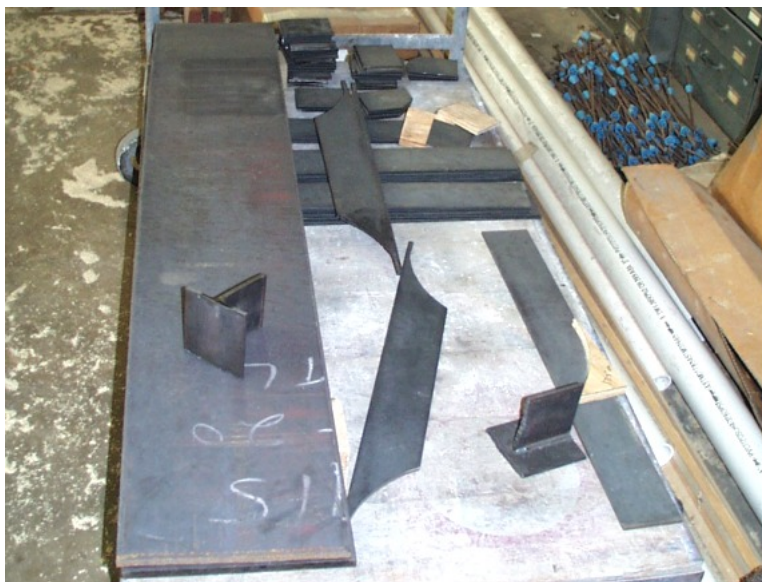
***Figure 2-14: Steel Parts Prior to Welding***

Figure 2-14 shows several A572 Gr 50 steel flange, web, and stiffener parts used for the specimens prior to welding. Stiffener and flange undercuts were intentionally created during the welding process to produce worst-case scenarios.

The 0.5 in. thick (13mm) flange used for the specimen was cut from 120 in. by 10.5 in. (3048 mm by 267 mm) plates using a band saw. The 0.25 in. thick (6.4 mm) web and stiffener parts were cut from 240 in. by 3.5 in. (6096 mm by 89 mm) bar stock using a band saw. The web section radius was then cut using a plasma torch.

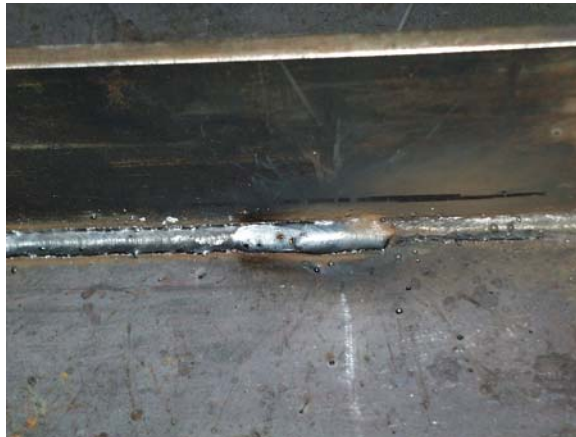
**Figure 2-15: Weld Start-Stop Repair**

The welding sequence varied throughout the project relative to each specimen type. This variation was due to the efforts to eliminate defects that occurred at weld starts and stops. Figure 2-15 shows a photo of a start-stop that was repaired by grinding and rewelding the web-to-flange weld.

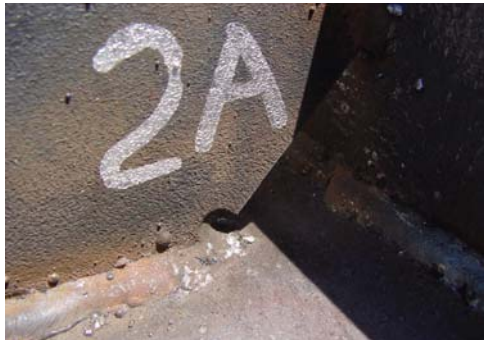
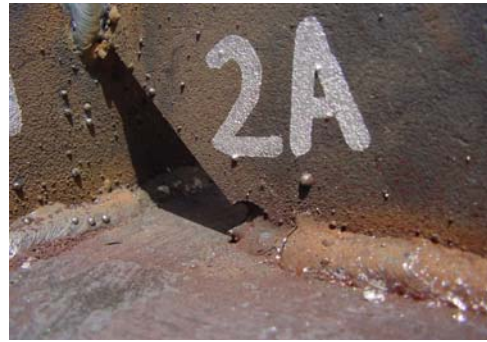
***Figure 2-20: Large Circular Interior Stiffener Undercuts***

Interior stiffener undercuts varied in size and shape. Some undercuts were large and circular as pictured in Figure 2-20. Other undercuts were small, narrow, or invisible to inspection as shown in Figure 2-21. Minimal to no undercutting occurred at the exterior edge of the stiffener as shown in Figure 2-22.

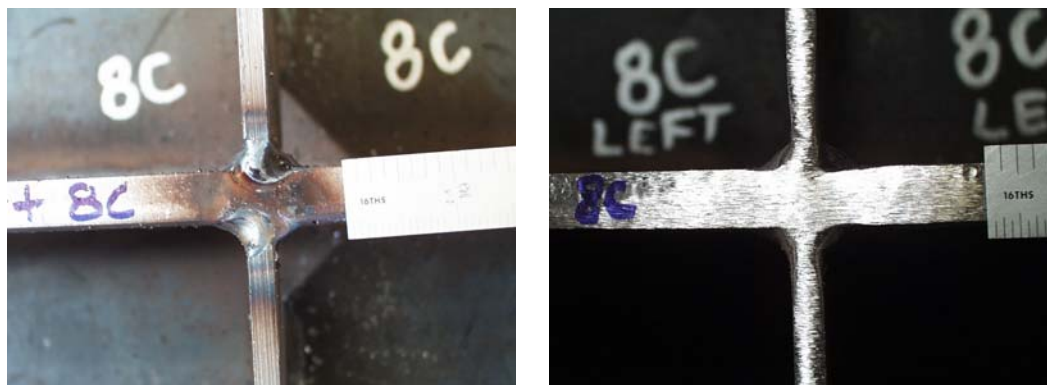
**Figure 2-27: Before and After Flange Grinding**

finished surface slope not greater than one in ten in the direction of loading. Grinding marks were finished parallel to the direction of loading as pictured in Figure 2-27.

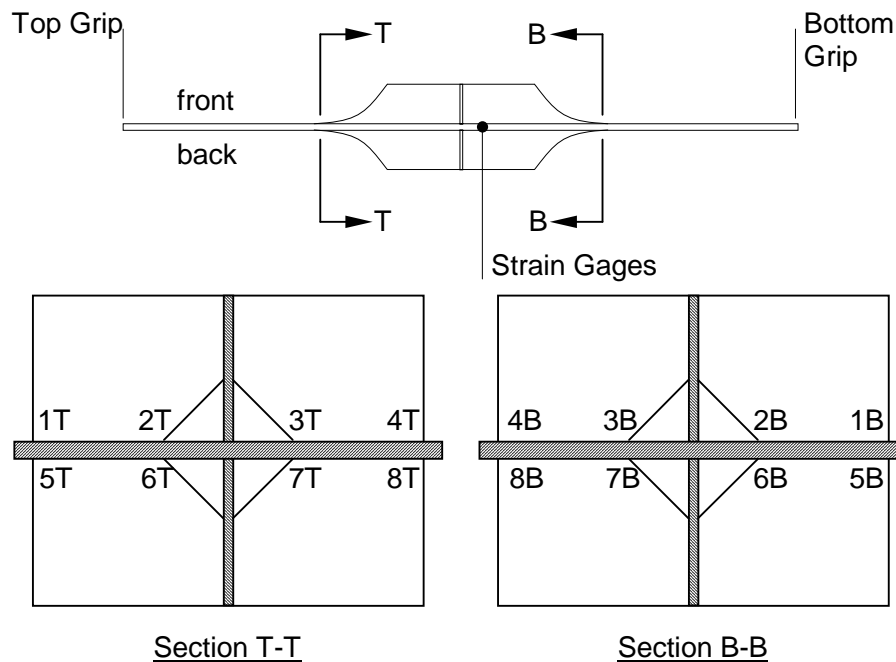
*Figure 2-29: Specimen A Undercut Identification*

Undercut locations were labeled based on their orientation with respect to their location in the test frame. Figure 2-29 shows the location and nomenclature used for classification of type A specimen undercuts. The interior and exterior stiffener undercuts were located on the top half (T) or bottom half (B) of the specimen midsection.

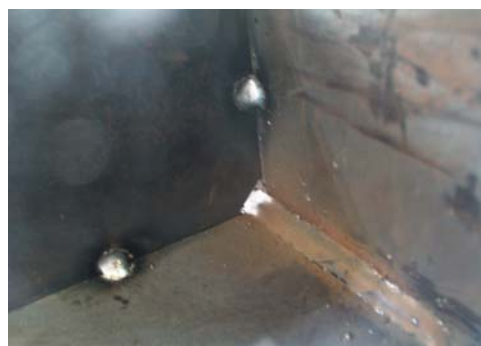
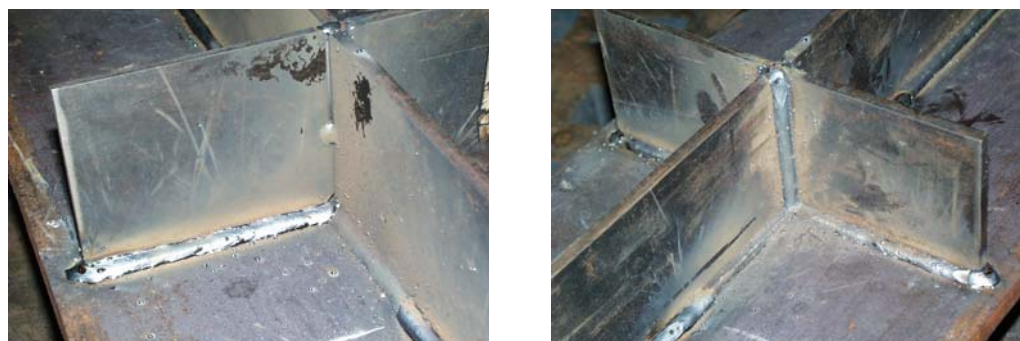
*Figure 2-35: Full Welding of Interior Clip*

Undercuts occurred exclusively at the exterior edge of the stiffener because the interior clip was fully welded as illustrated in Figure 2-35. The clip was minimized and then stiffener, flange, and web welds were overlapped to close the clip gap. Figure 2-36 shows the location and numbering of type D specimen undercuts.

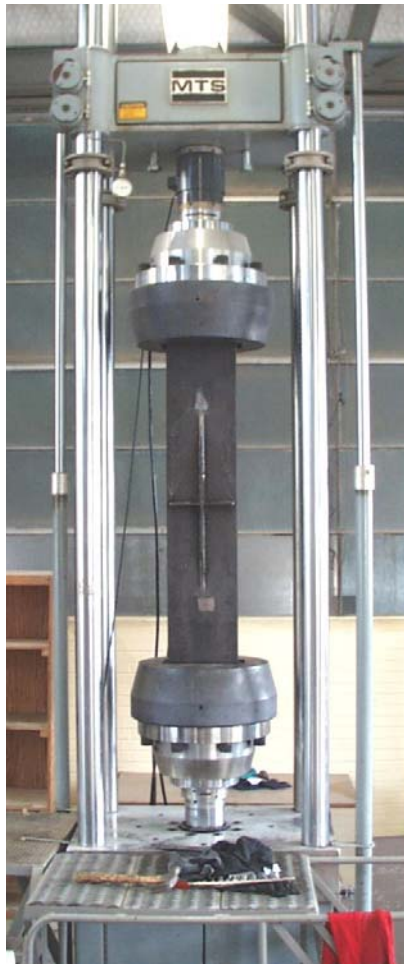
*Figure 3-2: MTS Uniaxial Testing Machine with Specimen*

An MTS uniaxial hydraulic testing machine was employed to test the specimens under cyclic loading. Pictured in Figure 3-2, the testing machine consists of a load frame, actuator, and upper and lower grips. The hydraulic ram is located below the lower grip and is out of view in Figure 3-2. A constant pressure hydraulic pump provides the power for the system.

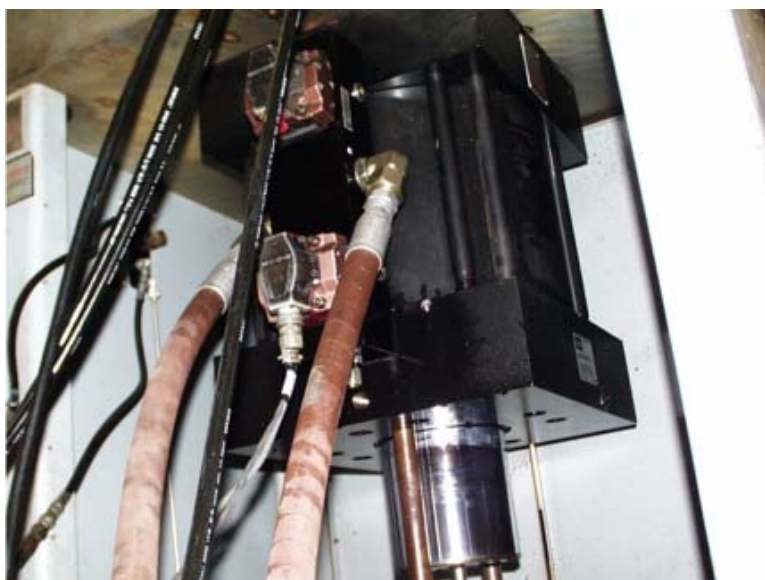
*Figure 3-3: MTS Hydraulic Actuator*

Pictured in Figure 3-3, an MTS hydraulic actuator with a 220 kips (979 kN) capacity was used to apply the test load. The actuator has a total stroke of 6 in. (152 mm), which was controlled by either a remote POD or the computer via the Testar II software. The actuator can be operated in either force or displacement control. Force control was used for all the tests.

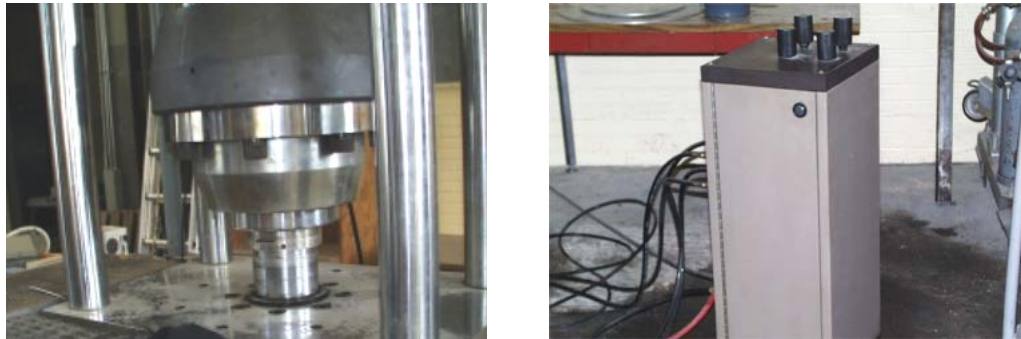
***Figure 3-4: Hydraulic Grip and Pressure Control Module***

The test frame is equipped with custom upper and lower hydraulic grips (model 641.385) that have a load rating of 220 kips (979 kN). The grips are controlled using a hydraulic control module that regulates the gripping pressure. The specimens were gripped using a pressure of approximately 2500 psi. (17.2 MPa). Figure 3-4 displays photographs of both the hydraulic grip and the pressure control module.

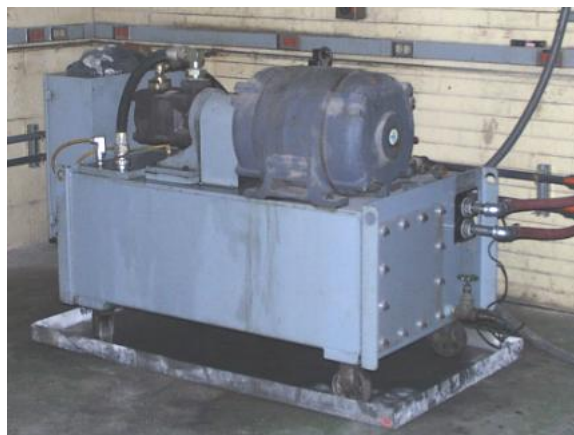
***Figure 3-5: MTS Hydraulic Supply Unit***

An MTS hydraulic supply unit (model 506.20) was used to maintain pressure to the system throughout testing. The pump, pictured in Figure 3-5, supplies 20 gallons per minute (76 L/min.) at a constant pressure of 3000 psi (20.7 MPa). The pump was water cooled.

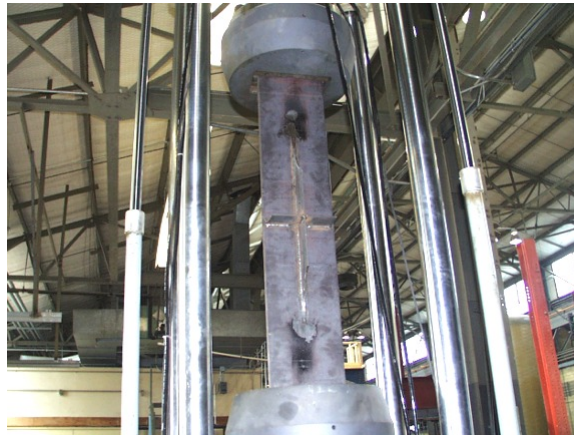
*Figure 3-9: Specimen Installed in Test Frame*

Several steps were taken during the testing of each specimen in order to achieve accurate and consistent data. Each test consisted of preparation, specimen installation, testing and data monitoring, and specimen removal. Figure 3-9 shows a specimen installed in the test frame prior to loading.

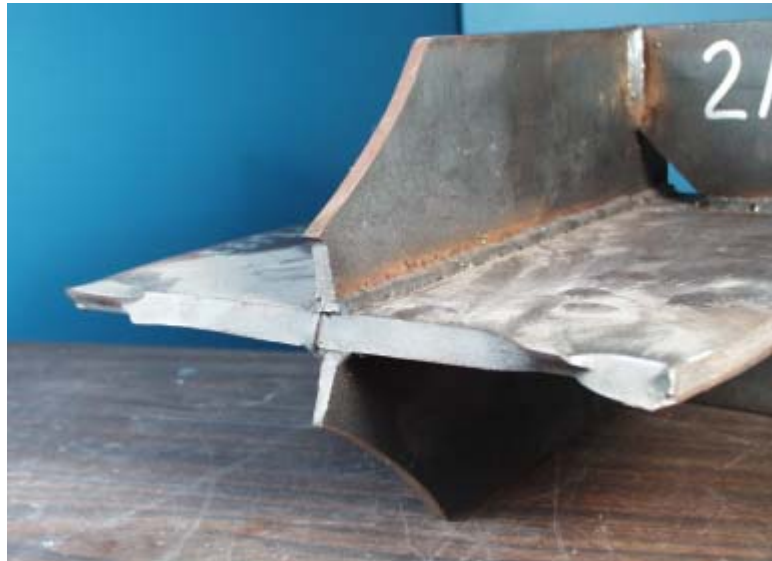
***Figure 4-12: Fracture Surface 2A-1***

Specimen 2A was tested at a nominal stress range of 20 ksi (138 MPa). The actual stress range for specimen 2A was not measured. Specimen 2A failed at 439,185 cycles due to a fatigue crack at the bottom radial web taper as Shown in Figure 4-12. No visible cracks were found at an undercut location.

The crack propagated into the flange from a weld start-stop. The start-stop acted as an initial flaw in the web-to-flange weld and continued to grow during testing. Figure 4-13 shows the initiation points at the weld start-stop. The crack was believed to grow downward into the flange from these initiation points causing a severe decrease in area resulting in rupture of the specimen.

Failure at the radial tapers in specimens 2A and 3A led to revisions in the welding sequence. A new welding sequence and repairs were employed to eliminate failures at weld start-stop locations. Refer to Chapter 2.3.2 for details.

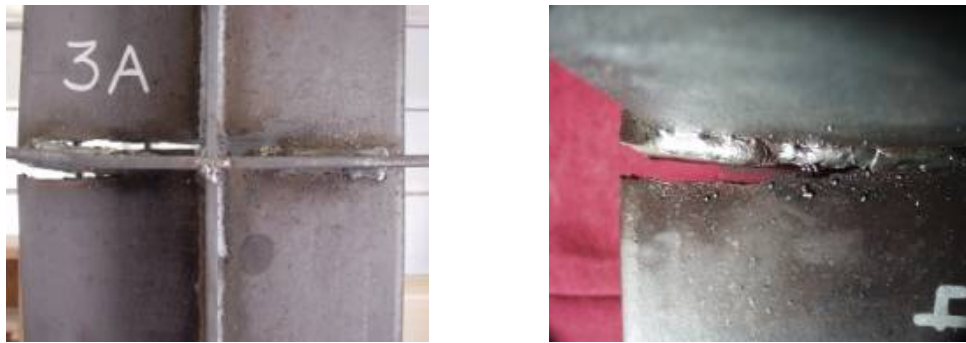
***Figure 4-14: Multiple Cracks at Toe of Welds 4T and 4B***

Specimen 3A was tested at a nominal stress range of 20 ksi (138 MPa). The actual stress range for specimen 3A was not measured. Specimen 3A failed at 430,429 cycles due to fatigue cracks at the toe of the stiffener-to-flange weld locations 4T and 4B as shown in Figure 4-14. In addition, a third crack formed at the upper radial web taper as shown in Figure 4-15. This crack formed due to a weld stop-start in the web-to-flange weld (similar to specimen 2A). A specimen displacement over the 0.10 in. limit halted the actuator prior to total rupture of the specimen. No cracks were found to have initiated at an undercut location.

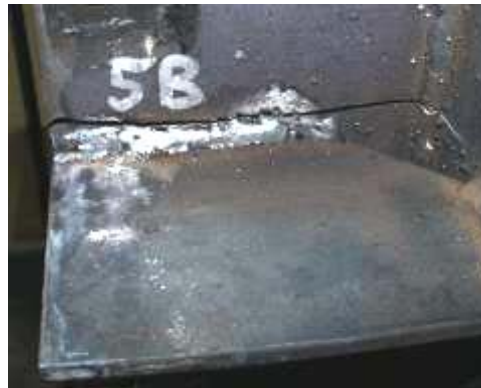
*Figure 4-16: Crack at Toe of Weld 2T*

Specimen 5B was tested at a measured stress range of 21.1 ksi (145 MPa). Specimen 5B failed at 628,377 cycles due to fatigue cracks at the toe of the stiffener-to-flange weld locations 2 and 4. Figure 4-16 shows the toe crack along weld location 2T. A displacement over the 0.10 in. limit halted the actuator prior to total rupture of the specimen.

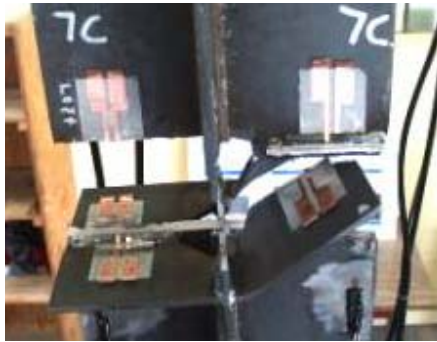
***Figure 4-21: Failure of Specimen 7C***

Specimen 7C was tested at a measured stress range of 20.9 ksi (144 MPa). Specimen 7C failed at 574,097 cycles due to fatigue cracks at the toe of the stiffener-to-flange weld locations 2T, 4T, 1B, and 3B. Failure occurred as these cracks propagated into the flange causing total rupture of the cross-section by yielding. Some stiffener welds were also ruptured during failure as shown in Figure 4-21. No cracks were found to have initiated at an undercut location.

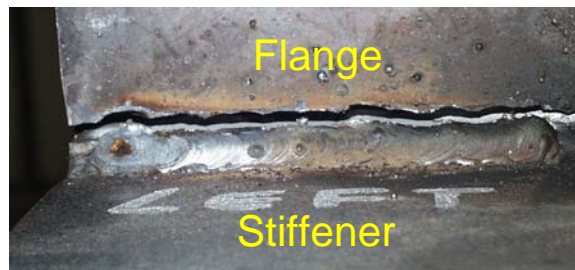
***Figure 4-25: Specimen 8C Weld 2T Toe Crack***

Specimen 8C was tested at a measured stress range of 21 ksi (145 MPa). Specimen 8C failed at 435,863 cycles due to fatigue cracks at the toe of the stiffener-to-flange weld locations 2T and 4T. Figure 4-25 shows the toe crack along weld location 2T. A displacement over the 0.10 in. limit halted the actuator prior to total rupture of the specimen. No cracks were found to have initiated at an undercut location.
