**Durability Examination of Bonded Tendons in Concrete Beams  
Under an Aggressive Corrosive Environment**

**Thesis**

**The University of Texas at Austin**

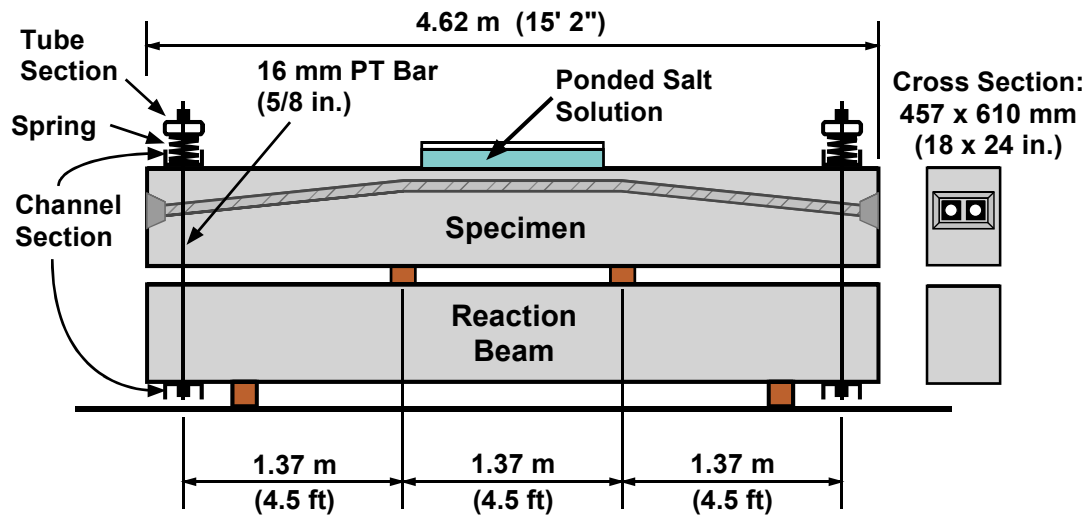
*Figure 3.1: Beam Specimen Test Setup<sup>1</sup>*

In addition to subjecting the test specimens to a sustained structural loading, to achieve the goal of this experimental program it was also necessary to expose them to an accelerated corrosive environment. A Plexiglas barrier, fastened to the concrete surface using a marine sealant/adhesive, was constructed on top of the center four feet of each test specimen (the constant moment and cracked section) to create a ponded region. This ponded region was filled with a 3.5% salt (NaCl) solution. The salt concentration was determined based on the recommendations of ASTM G109<sup>9</sup> to achieve the most aggressive exposure. The specimens were placed on a two-week wet-dry cycle to accelerate the corrosive effects. The cycle consisted of the ponded region of each beam being filled with the salt solution for a period of two weeks followed by a two-week dry period. The ponded region was covered during the wet interval to prevent contamination of the salt solution and limit evaporation. The wet-dry cycling of the specimens continued until their final autopsy and analysis. The duration of exposure testing for the beams examined in this document was four and a half years for the Phase I specimens and three and a half years for Phase II. (See Appendix B for timeline) A diagram of the test setup is shown in Figure 3.1.

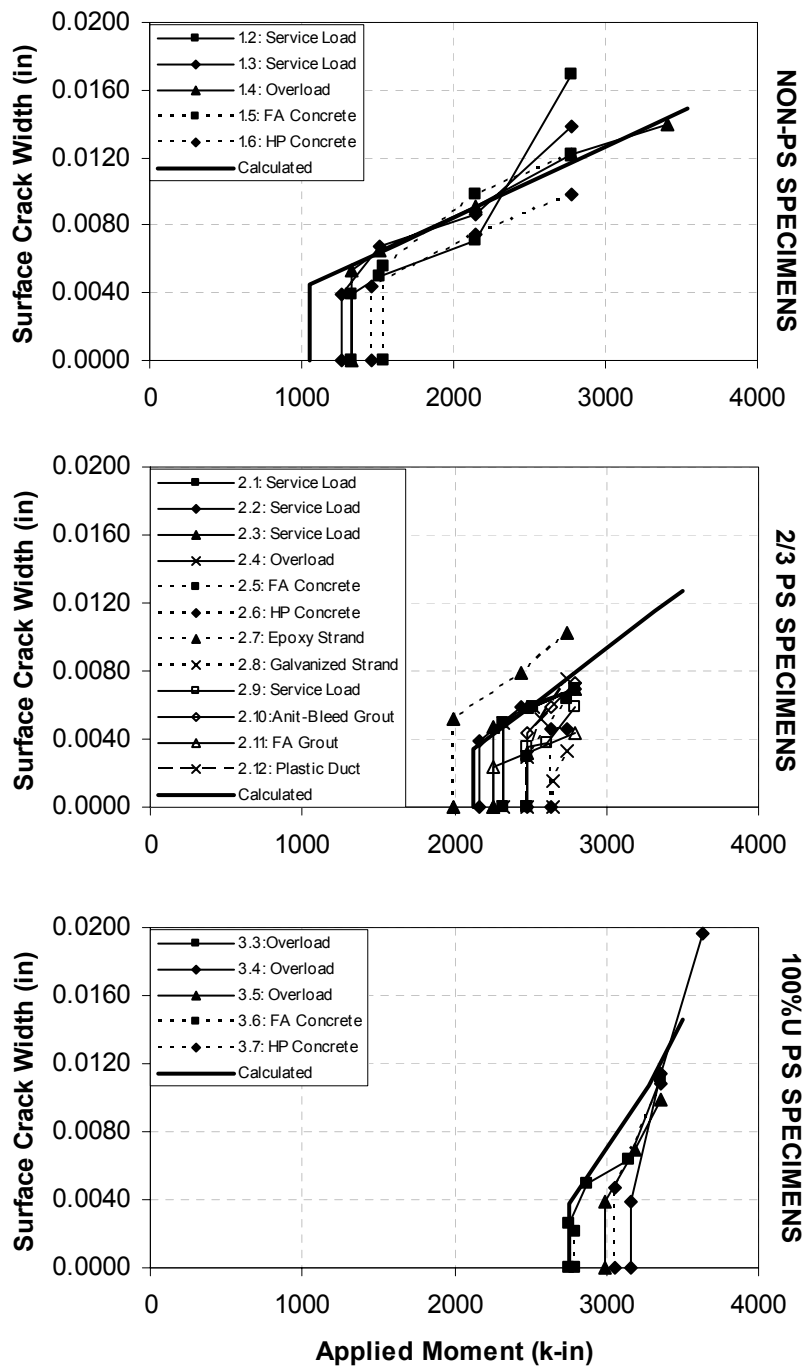
Figure 4.2: Measured Maximum Crack Widths<sup>2</sup>

Plots of measured maximum crack width versus moment for each cracked specimen are shown in Figure 4.2. The plots corresponding to the specimens with TxDOT standard concrete and control variables show excellent agreement with the estimated crack width values calculated prior to loading, using the Gergely-Lutz method. As expected, plots of specimens with variables such as high performance concrete, high performance grout and epoxy-coated strand slightly deviated from the estimated crack width plots.<sup>2</sup> The plots show that as the level of prestress increases, so does the cracking moment. Additionally, as the level of prestress increases, the rate of crack width growth also increases.

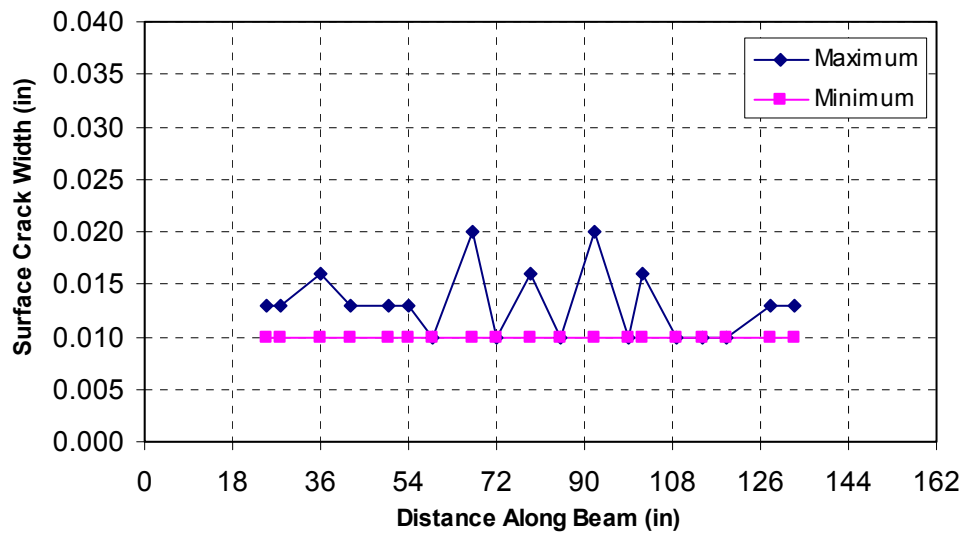
**Beam 1.5: Non-PS - Constant Service Load**

**Figure 4.3: Non-PS Section – Crack Patterns and Measurements**

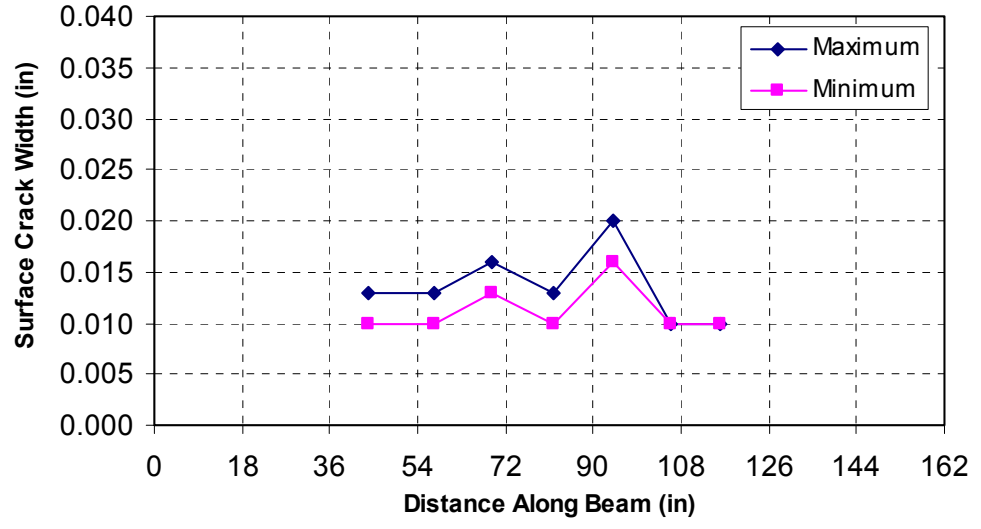
**Beam 2.5: 2/3 PS - Constant Service Load**

**Figure 4.4: 2/3 PS Section – Crack Patterns and Measurements**

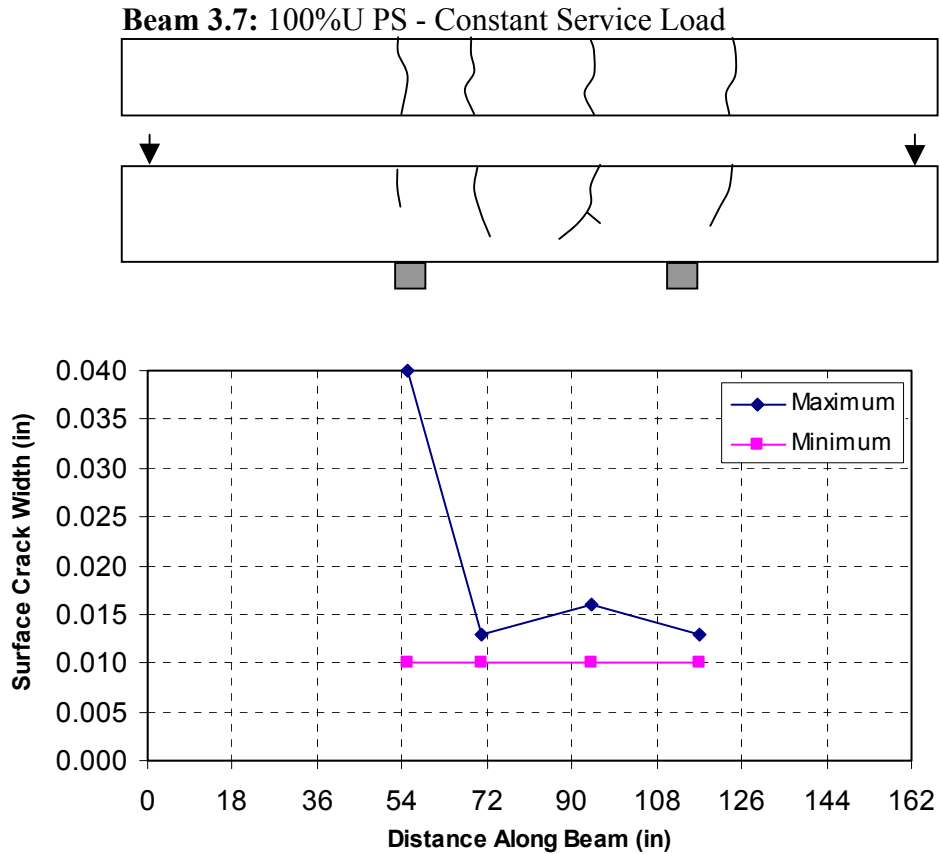
**Figure 4.5: 100%U PS Section – Crack Patterns and Measurements**

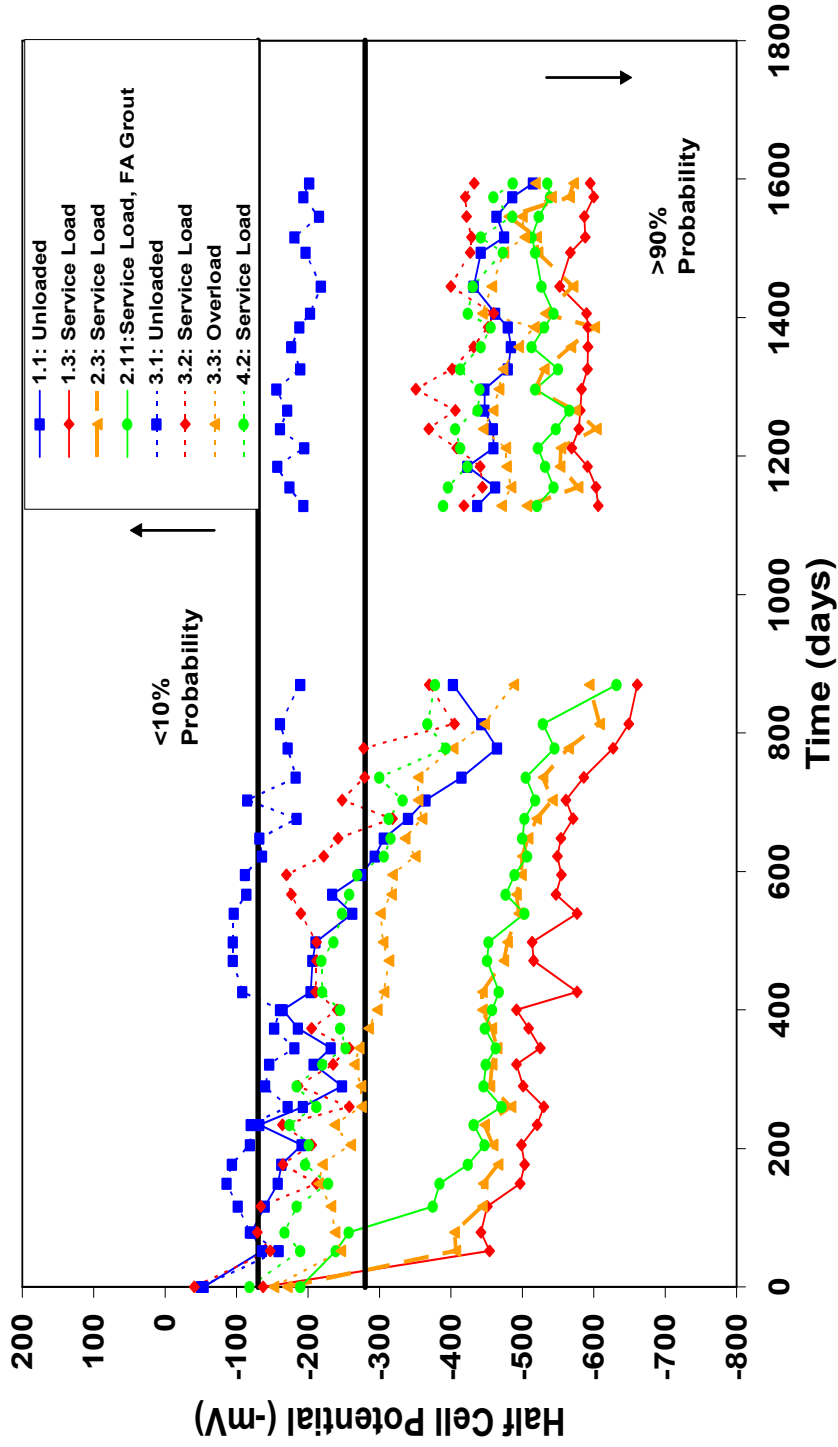
Figure 4.8: Half-Cell Potential Readings  
(Phase I Autopsy Beams)

This section discusses the half-cell potential readings of the Phase I autopsy beams only. Half-cell potential plots for all of the Phase I beams can be found in Appendix D. The Phase I autopsy specimens began exposure testing in December of 1997 and concluded in May 2002 after 1594 days of testing. Figure 4.8 is a plot of the Phase I autopsy beams. It shows that after 1594 days of exposure, all of the Phase I beams, with the exception of Specimen 3.1, have a greater than 90% probability of corrosion. It is difficult to determine additional trends among the specimens from this plot. Therefore, plots separating the autopsy specimens according to the main variables examined in Phase I of the experimental program are given in Figures 4.9-4.13 for ease of analysis.

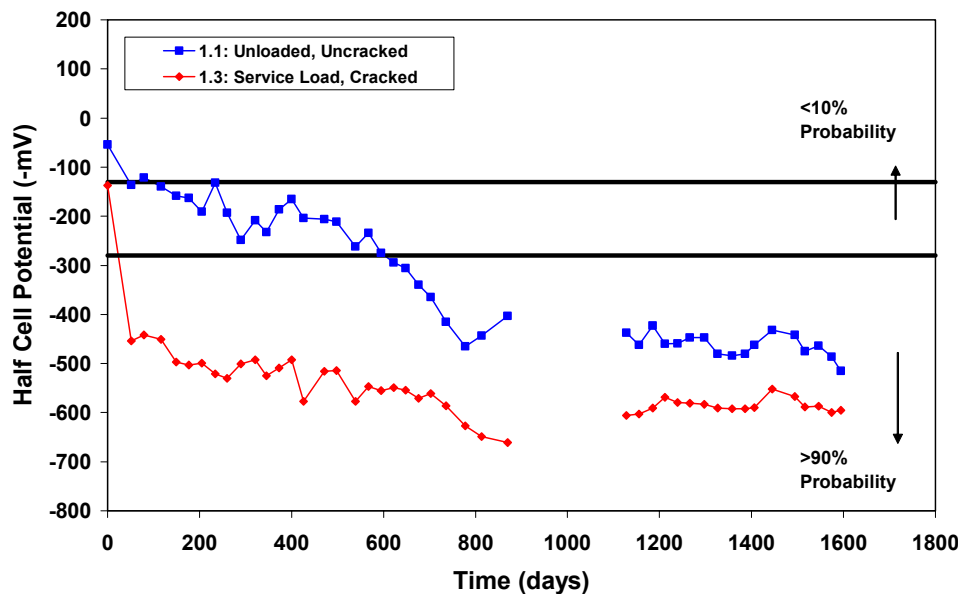
**Figure 4.9: Half-Cell Potential Readings  
(Phase I Autopsy Beams – Non-PS)**

Figure 4.9 shows a plot of the Non-PS beams in Phase I. All the details of Specimens 1.1 and 1.3 are identical, with the exception of the applied load and cracking. It clearly shows a decrease in corrosion protection performance when the beam is loaded through the significant difference in time to initiation of corrosion and final half-cell potentials. It is impractical to assume any structural element would be completely unloaded. Specimen 1.1 was only used to illustrate the effect of cracking on corrosion protection in comparison to an identical loaded specimen.

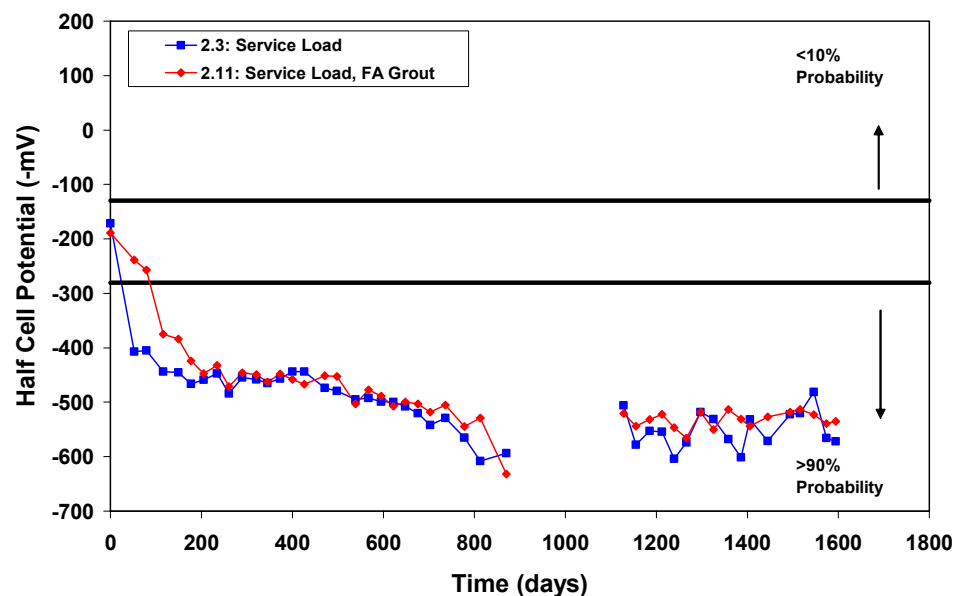
**Figure 4.10: Half-Cell Potential Readings  
(Phase I Autopsy Beams – 2/3 PS)**

Figure 4.10 shows a plot of the 2/3 PS beams in Phase I. All the details of Specimens 2.3 and 2.11 are identical, with the exception of the grout type. It does not show that the grout type has any effect on corrosion protection. While this may be true, it is also possible that the readings were measuring the potential of the mild steel reinforcement. If this is the case, then it would be expected that the specimens perform similarly since the grout type does not effect the protection of the mild steel. The results from the forensic examination will either confirm or disprove this conclusion.

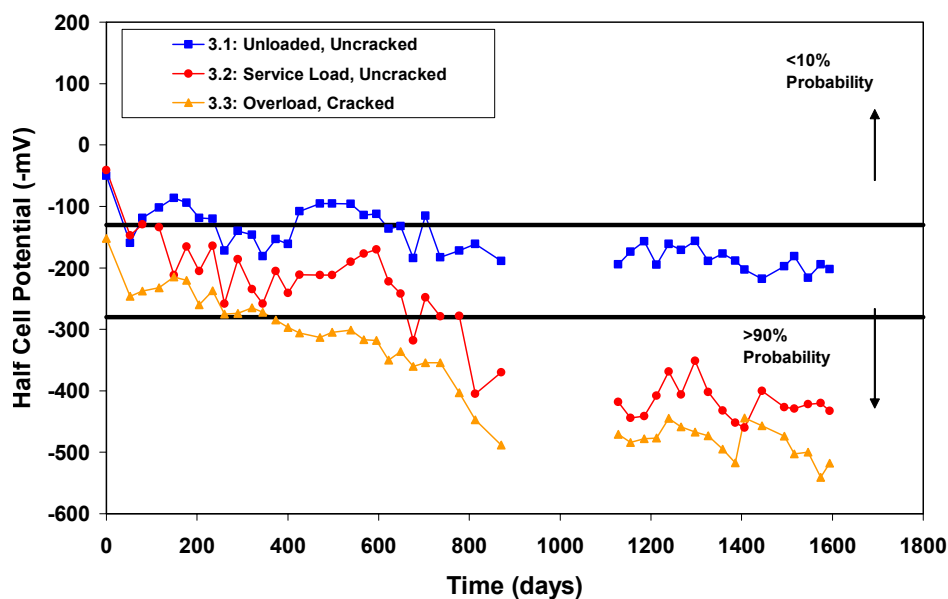
**Figure 4.11: Half-Cell Potential Readings (Phase I Autopsy Beams – 100%U PS)**

Figure 4.11 shows a plot of the 100%U PS beams in Phase I. All the details of Specimens 3.1, 3.2 and 3.3 are identical, with the exception of the applied load and cracking. As expected, the performance of the specimens decreases as the load applied increases. Specimen 3.1 never crosses the greater than 90% probability of corrosion threshold. Comparison of Specimens 3.2 and 3.3 again shows an increase in corrosion protection when the specimen is uncracked through both time to initiation of corrosion and final potential readings. Note that, although Specimen 3.2 was designed to be uncracked, final crack width measurements found one crack on the specimen. The possible effect of this one crack on the corrosion protection of the specimen will be determined from the forensic examination.

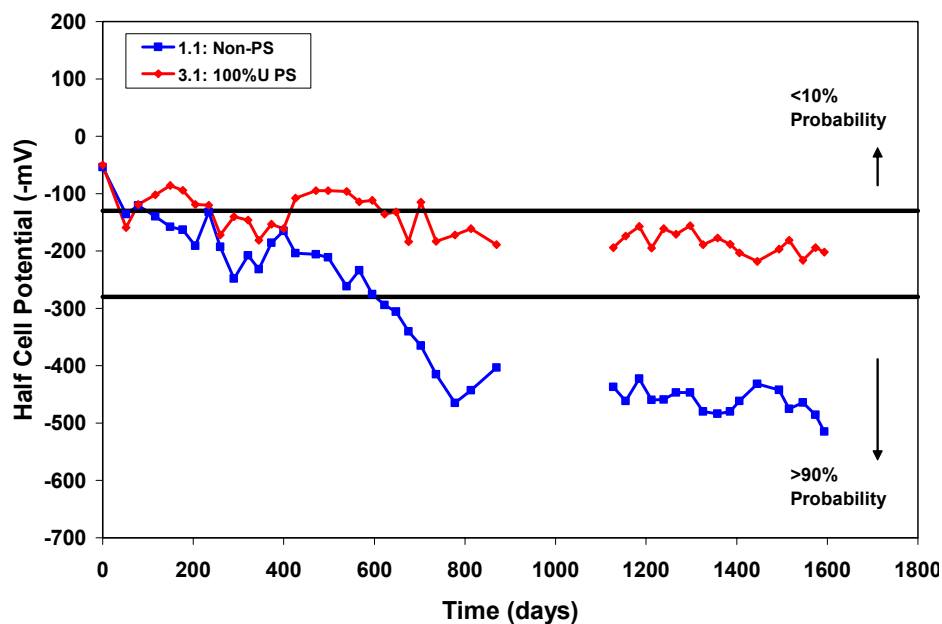
**Figure 4.12: Half-Cell Potential Readings  
(Phase I Autopsy Beams – Unloaded)**

Figure 4.12 shows a plot of the unloaded beams in Phase I. All the details of Specimens 1.1 and 3.1 are identical, with the exception of the level of prestress. As expected, the 100%U PS beam performed better than the Non-PS beam as it did not even cross the greater than 90% probability of corrosion threshold. It is interesting to note the significantly high potential readings for Specimen 1.1 since it is unloaded and uncracked. This could suggest importance of concrete permeability and the effect of increased compressive stresses in the concrete prestressing since the only possible form of chloride ingress for this specimen is through the concrete.

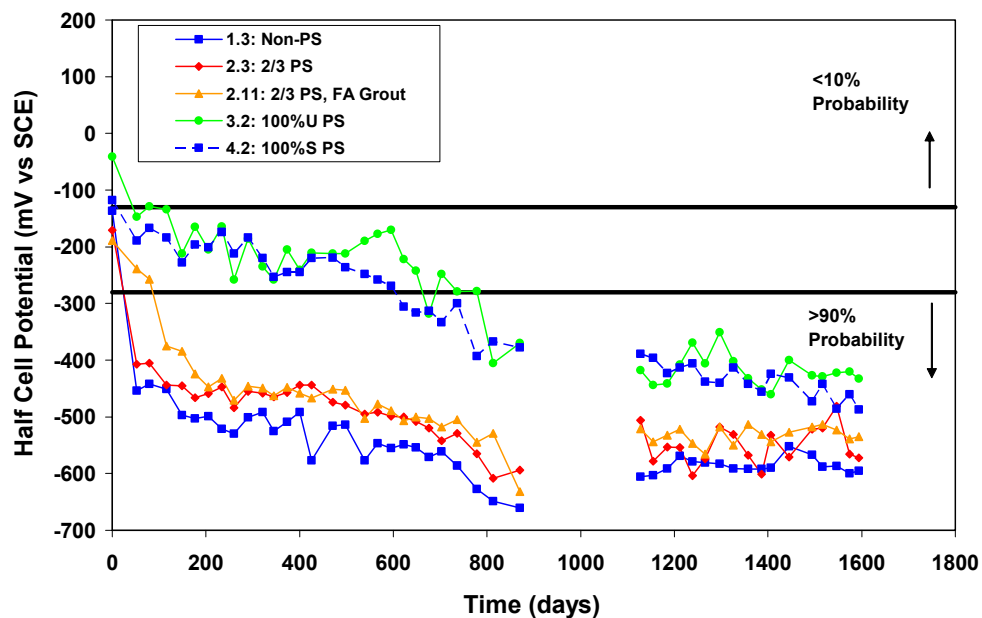
**Figure 4.13: Half-Cell Potential Readings (Phase I Autopsy Beams – Service Load)**

Figure 4.13 shows a plot of the service load beams in Phase I. All the details of Specimens 1.3, 2.3, 3.2 and 4.2 are identical, with the exception of the level of prestress. As expected, performance increases as the level of prestress increases. The difference in the time to the initiation of corrosion for the 2/3 PS and 100%U and S PS is significant. The trend shows that a 2/3 PS beam performs more similarly to a Non-PS beam than a 100% PS beam. Comparison of Specimens 3.2 and 4.2 shows a slightly better performance of the 100%S PS design as opposed to the 100%U PS through the final potential reading. However, both designs have the same time to initiation of corrosion.

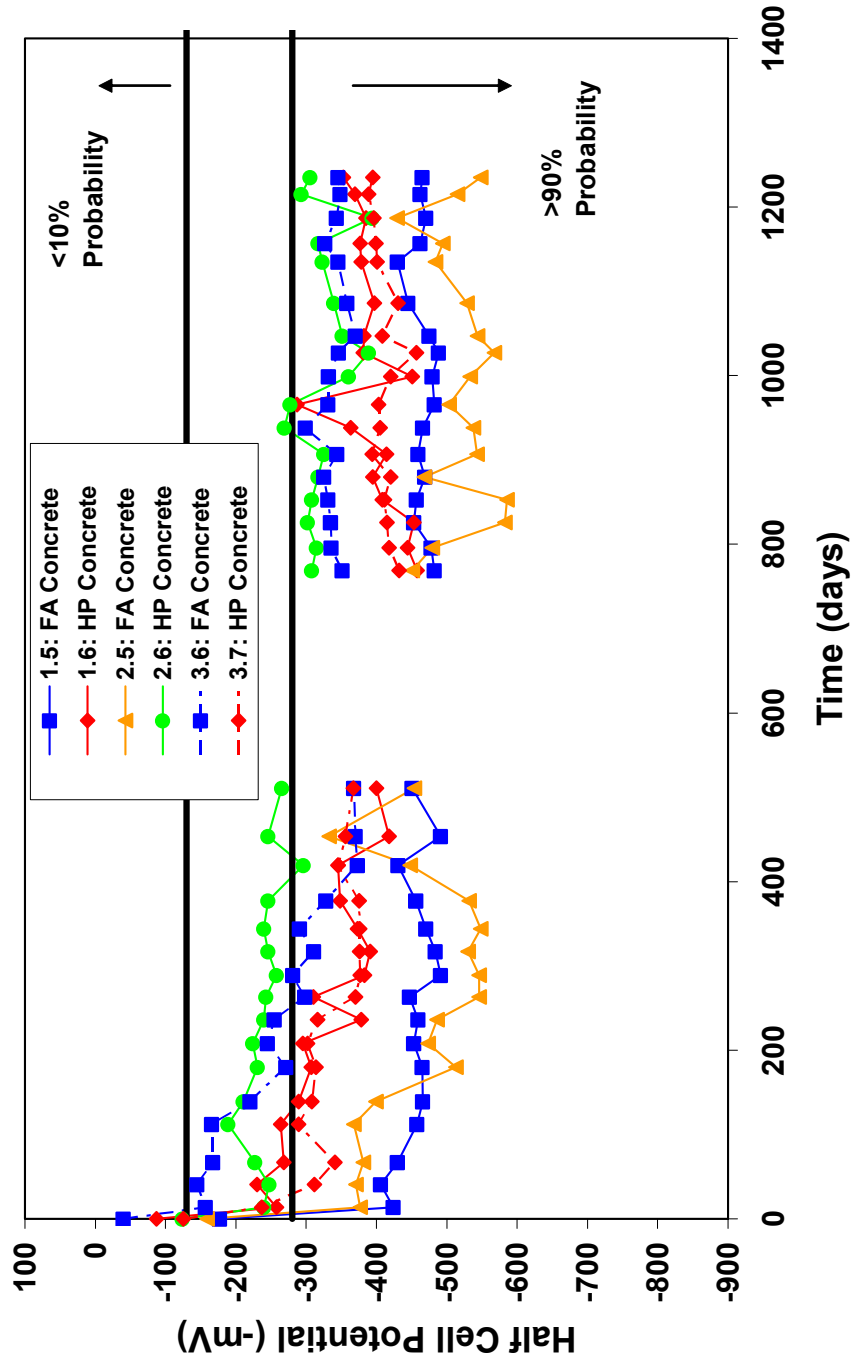
Figure 4.17: Half-Cell Potential Readings  
(Phase II Autopsy Beams)

This section discusses the half-cell potential readings of the Phase II autopsy beams only. Half-cell potential plots for all of the Phase II beams can be found in Appendix D. The Phase II autopsy specimens began exposure testing in December of 1998 and concluded in May 2002 after 1235 days of testing. Figure 4.17 is a plot of all of the Phase II autopsy beams. It shows that after 1235 days of exposure, all of the Phase II beams have a greater than 90% probability of corrosion. It is difficult to determine additional trends among the specimens from this plot. Therefore, plots separating the autopsy specimens according to the main variables examined in Phase II of the experimental program are given in Figures 4.18-4.22 for ease of analysis.

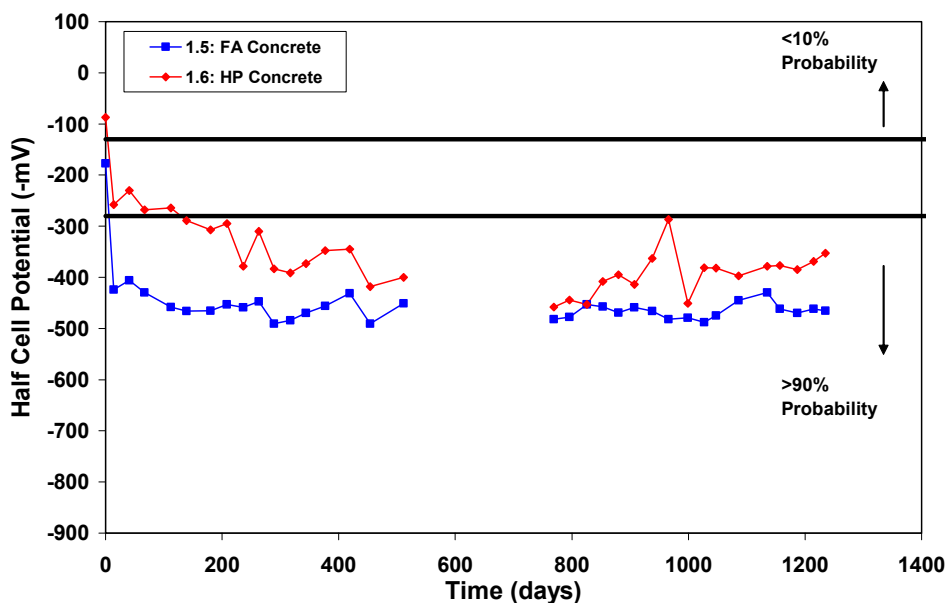
**Figure 4.18: Half-Cell Potential Readings (Phase II Autopsy Beams – Non-PS)**

Figure 4.18 shows a plot of the Non-PS beams in Phase II. All the details of Specimens 1.5 and 1.6 are identical, with the exception of the concrete type. According to the potential readings and time to initiation of corrosion, the high performance concrete performed better than the fly ash concrete. However, it appears that over time they begin to merge to follow the same trend.

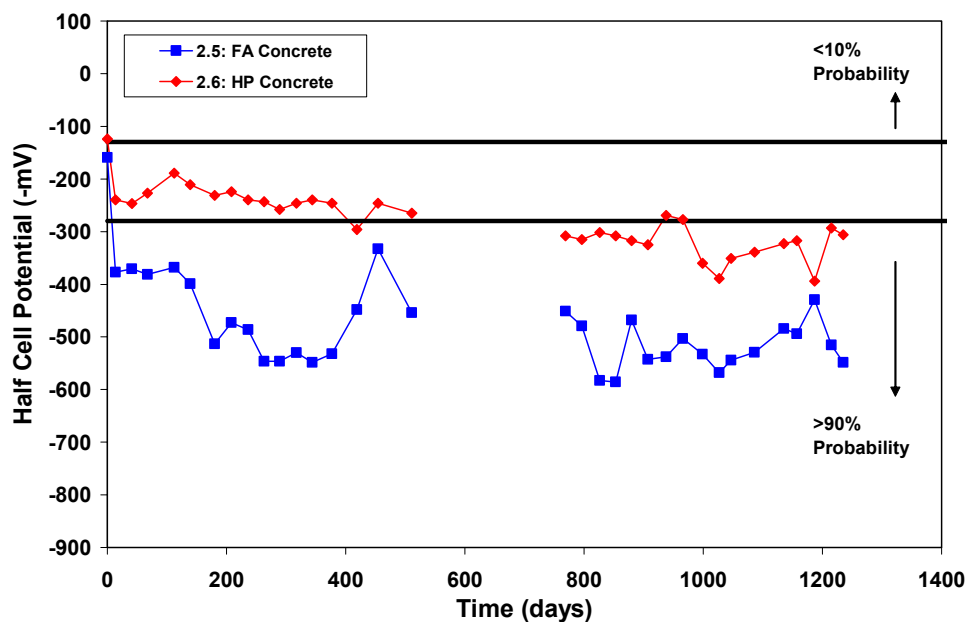
**Figure 4.19: Half-Cell Potential Readings  
(Phase II Autopsy Beams – 2/3 PS)**

Figure 4.19 shows a plot of the 2/3 PS beams in Phase II. All the details of Specimens 2.5 and 2.6 are identical, with the exception of the concrete type. According to the potential readings and time to initiation of corrosion, the high performance concrete performed better than the fly ash concrete. These specimens do not appear to be merging together as much as in the previous plot. (Readings taken at 1187 days appear to be outliers since they do not follow the trend of the rest of the plot.)

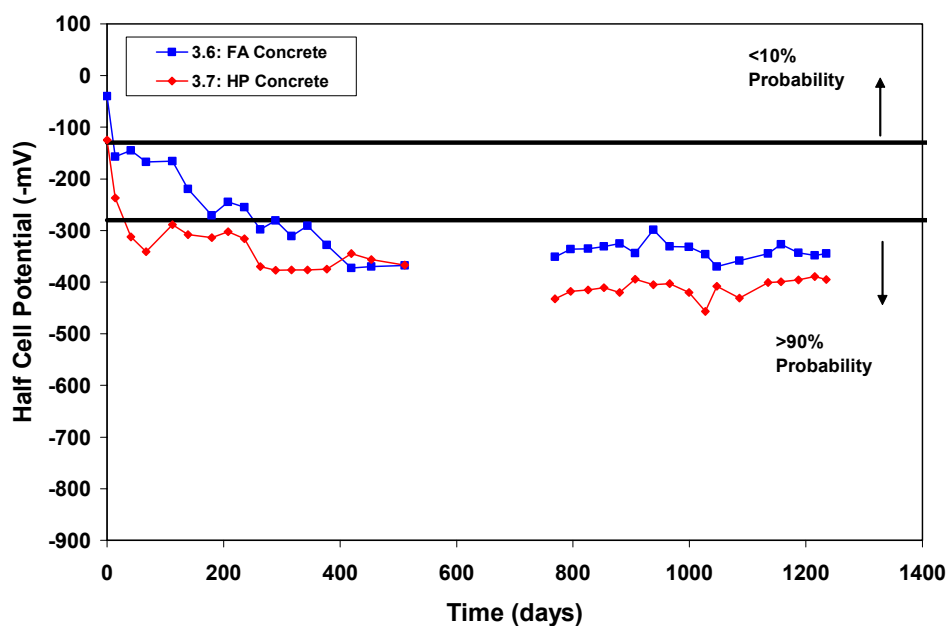
**Figure 4.20: Half-Cell Potential Readings (Phase II Autopsy Beams – 100%U PS)**

Figure 4.20 shows a plot of the 100%U PS beams in Phase II. All the details of Specimens 3.6 and 3.7 are identical, with the exception of the concrete type. The results of the comparison of these two specimens differs from the previous two. According to the potential readings and time to initiation of corrosion, the fly ash concrete performed better than the high performance concrete. However, the difference between them is not significant and they appear to be merging together.

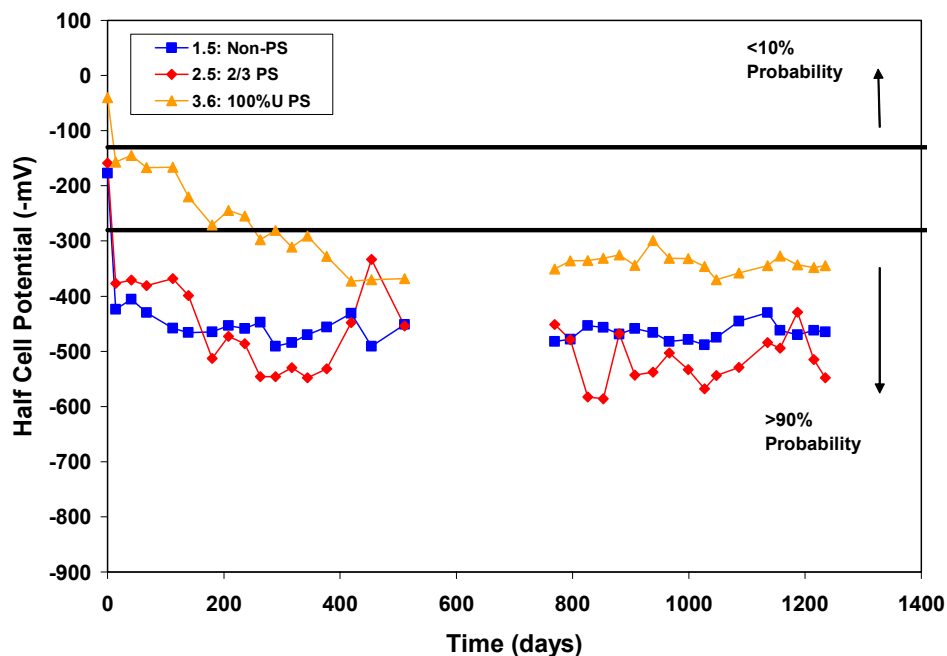
**Figure 4.21: Half-Cell Potential Readings (Phase Autopsy II Beams – Fly Ash Concrete)**

Figure 4.21 shows a plot of the fly ash concrete beams in Phase II. All the details of Specimens 1.5, 2.5 and 3.6 are identical, with the exception of the level of prestress. According to the potential readings and time to initiation of corrosion, the 100%U PS beam performed much better than the Non-PS and 2/3 PS beams. Both the Non-PS and 2/3 PS beams have the same time to initiation of corrosion. Although the final potential reading of the 2/3 PS beam is more negative than that of the Non-PS beam, the difference between the potentials is minimal and the superior level of prestress between the two varies with time.

A comparison of Figures 4.21 and 4.22 implies that the overall performance of the high performance concrete was slightly better than the fly ash concrete, as the final potential readings of the high performance concrete beams was close to or less negative than the least negative final reading of the fly ash concrete beams.

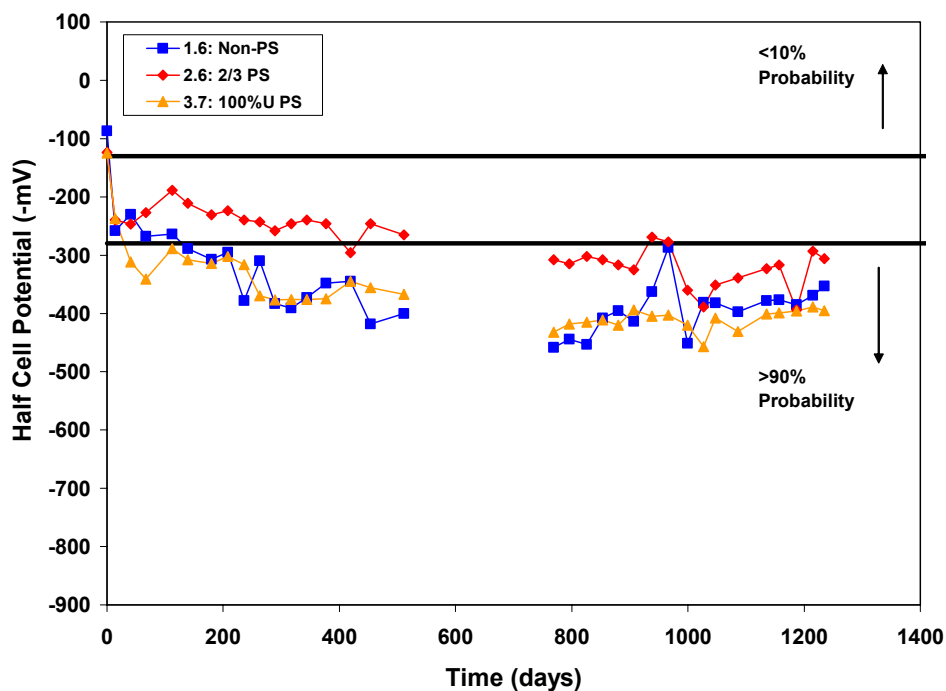
**Figure 4.22: Half-Cell Potential Readings  
(Phase II Autopsy Beams – High Performance Concrete)**

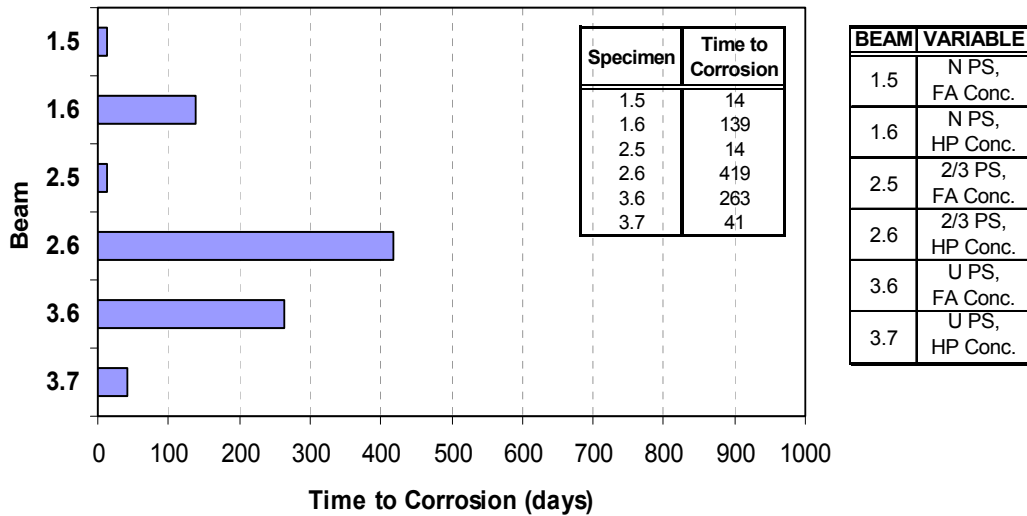
**Figure 4.25: Time to Initiation of Corrosion (Phase II Beams)**

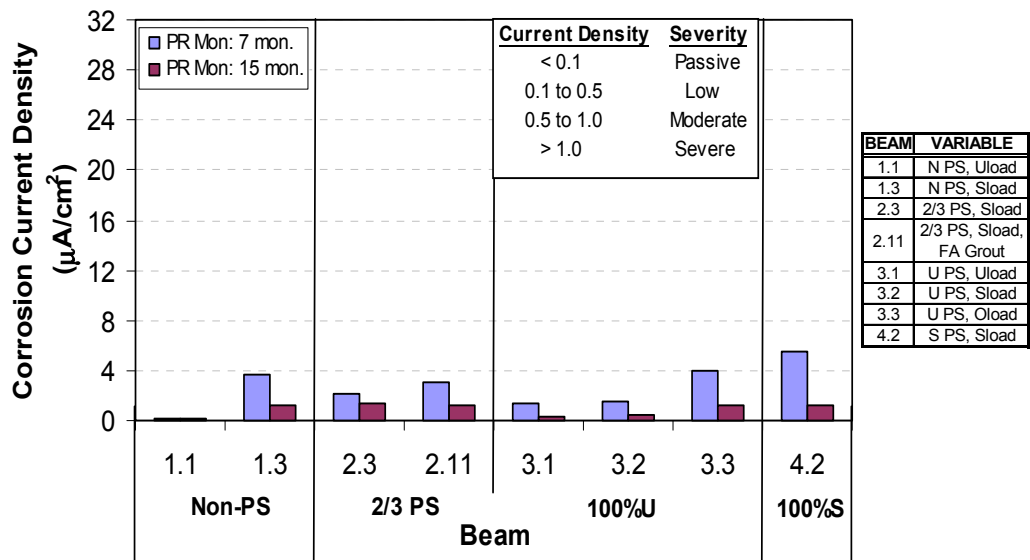
**Figure 4.26: Maximum Corrosion Rate Readings Using PR Monitor (Phase I Autopsy Beams)**

be made after the forensic examination to determine the reliability of the use of the PR Monitor equipment as a means of assessing corrosion rate. Through comparison of the three 100%U PS beams, both sets of readings show that the corrosion rate increases as the applied load, and thus crack width increases.

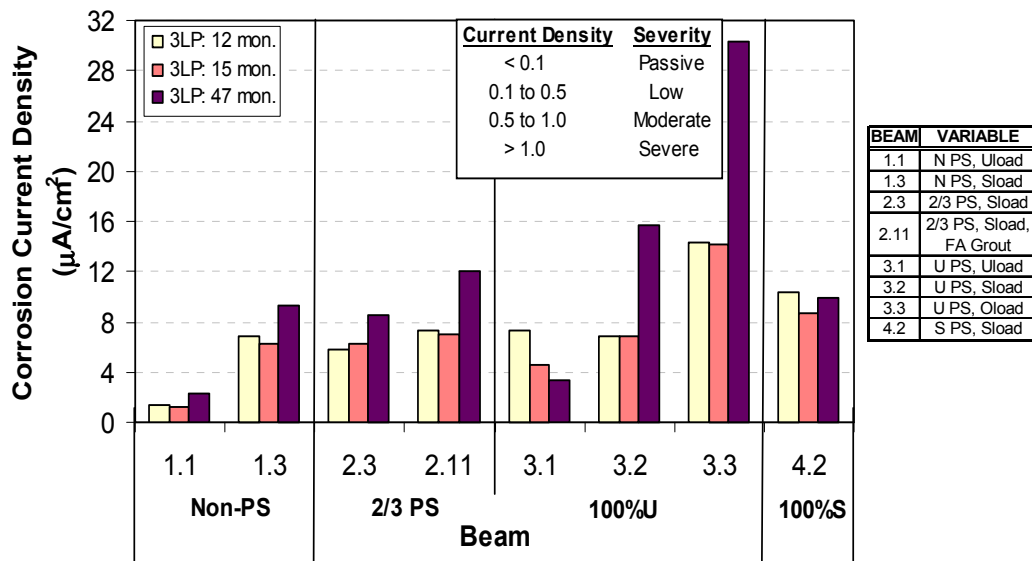
**Figure 4.27: Maximum Corrosion Rate Readings Using 3LP (Phase I Autopsy Beams)**

Figure 4.27 is a graph of all the maximum corrosion rate readings taken of the Phase I autopsy beams using the 3LP equipment. The graph shows a consistent trend that the corrosion rate increased over time, with the exception of Specimen 3.1. Again, comparison of the 100%U PS sections show increasing corrosion rates with increasing applied load. There is a significant increase from Specimen 3.2 (uncracked) to Specimen 3.3 (cracked).

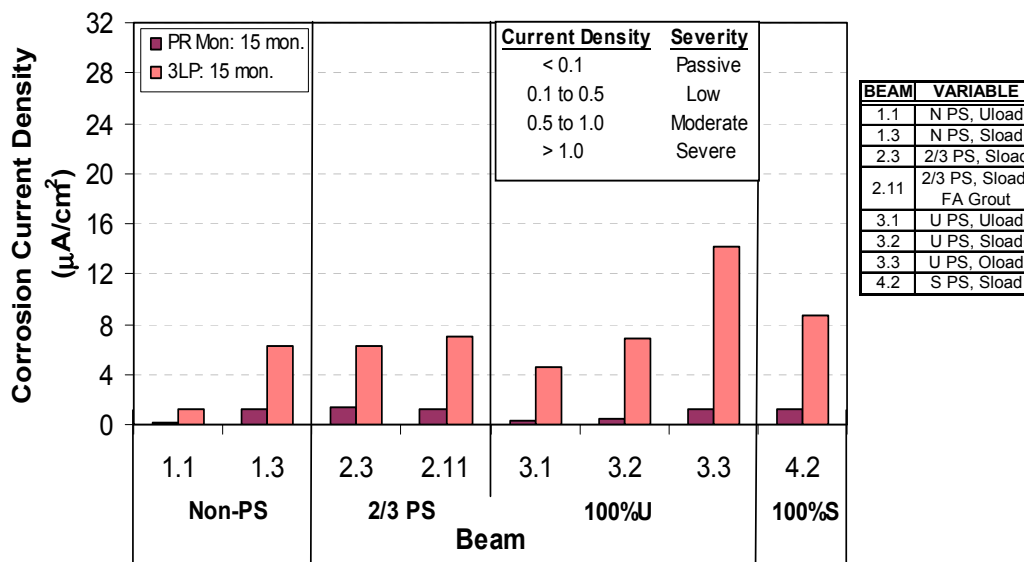
**Figure 4.28: Comparison of Corrosion Rate Measurement Equipment**

equipment used for taking the readings over the duration of this experimental program. The 3LP corrosion rates measured after fifteen months of testing are significantly higher than the PR Monitor corrosion rates. Other research and field experience with various devices for corrosion rate measurement have consistently shown that the 3LP equipment indicates higher corrosion rates than other devices.<sup>1</sup> Although there is a large difference in the readings from the two types of equipment, the trends in corrosion activity are similar. This suggests that the large discrepancy in magnitude is likely due to inherent differences between the two devices. Although the magnitude measured by the 3LP equipment may not be reliable, it is a good method for determining corrosion trends of individual specimens and comparing these trends among multiple specimens.

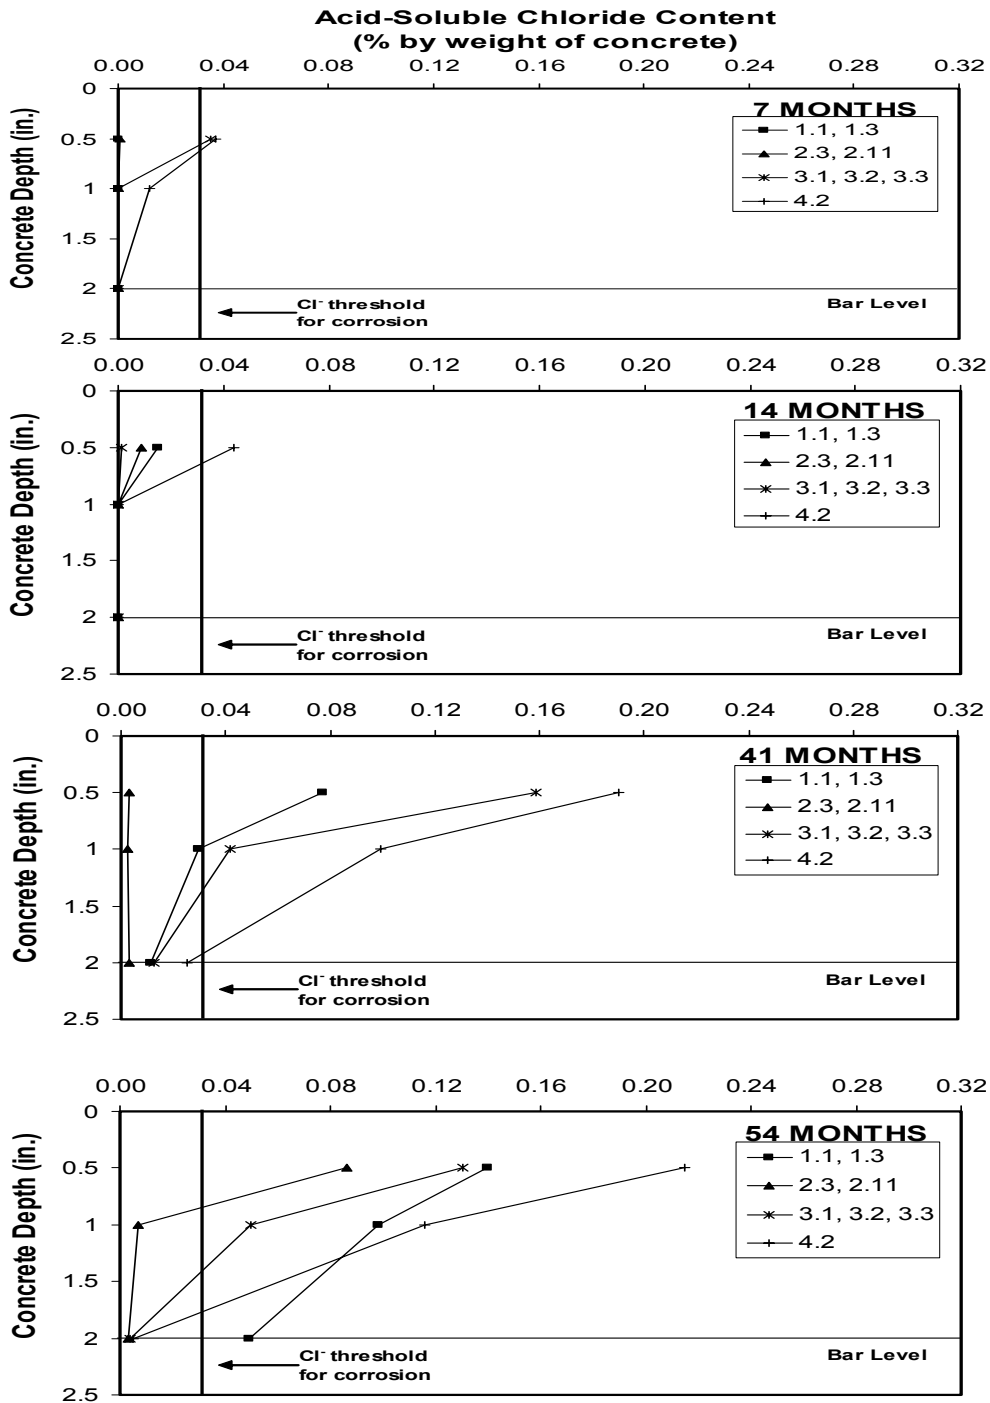
**Figure 4.30: Chloride Penetration (Phase I Poned Block Specimens)**

The plots in Figure 4.30 show the trends that the chloride content progressively increases over time and decreases with depth, as expected. All chloride contents at the bar level are below the threshold for corrosion, with the exception of the samples taken from Specimen 1.1 and 1.3 after 54 months. Although all specimens were made of TxDOT Class C concrete, the actual concrete mixtures varied a little, which was the purpose of casting and testing the block specimens. The TxDOT Class C concrete mix used in Beam 4.2 consistently shows the highest permeability, and that used in Beams 2.3 and 2.11 consistently show the lowest permeability.

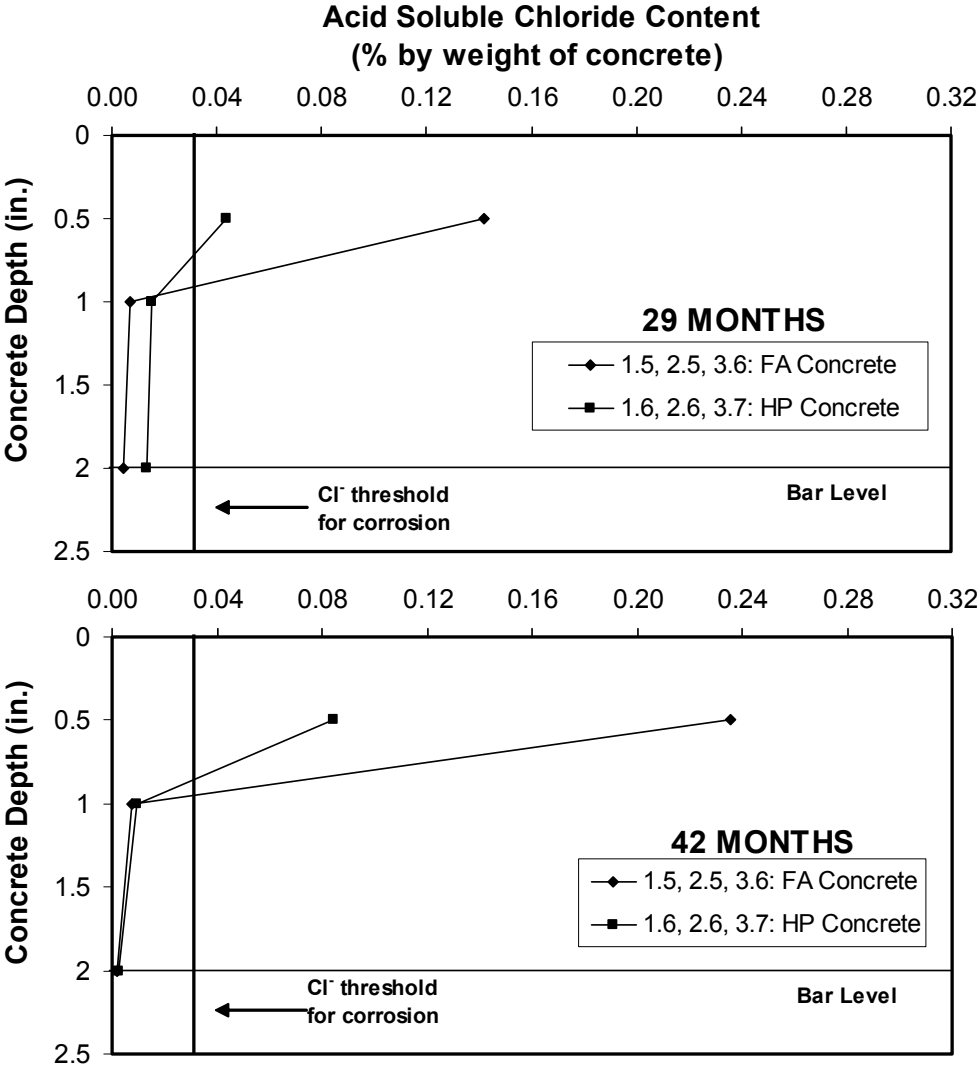
*Figure 4.31: Chloride Penetration (Phase II Ponded Block Specimens)*

the threshold for corrosion and show little variation between the concrete types. Samples taken at a depth of 0.5 inches after 29 and 42 months of exposure both show that the high performance concrete was less permeable.

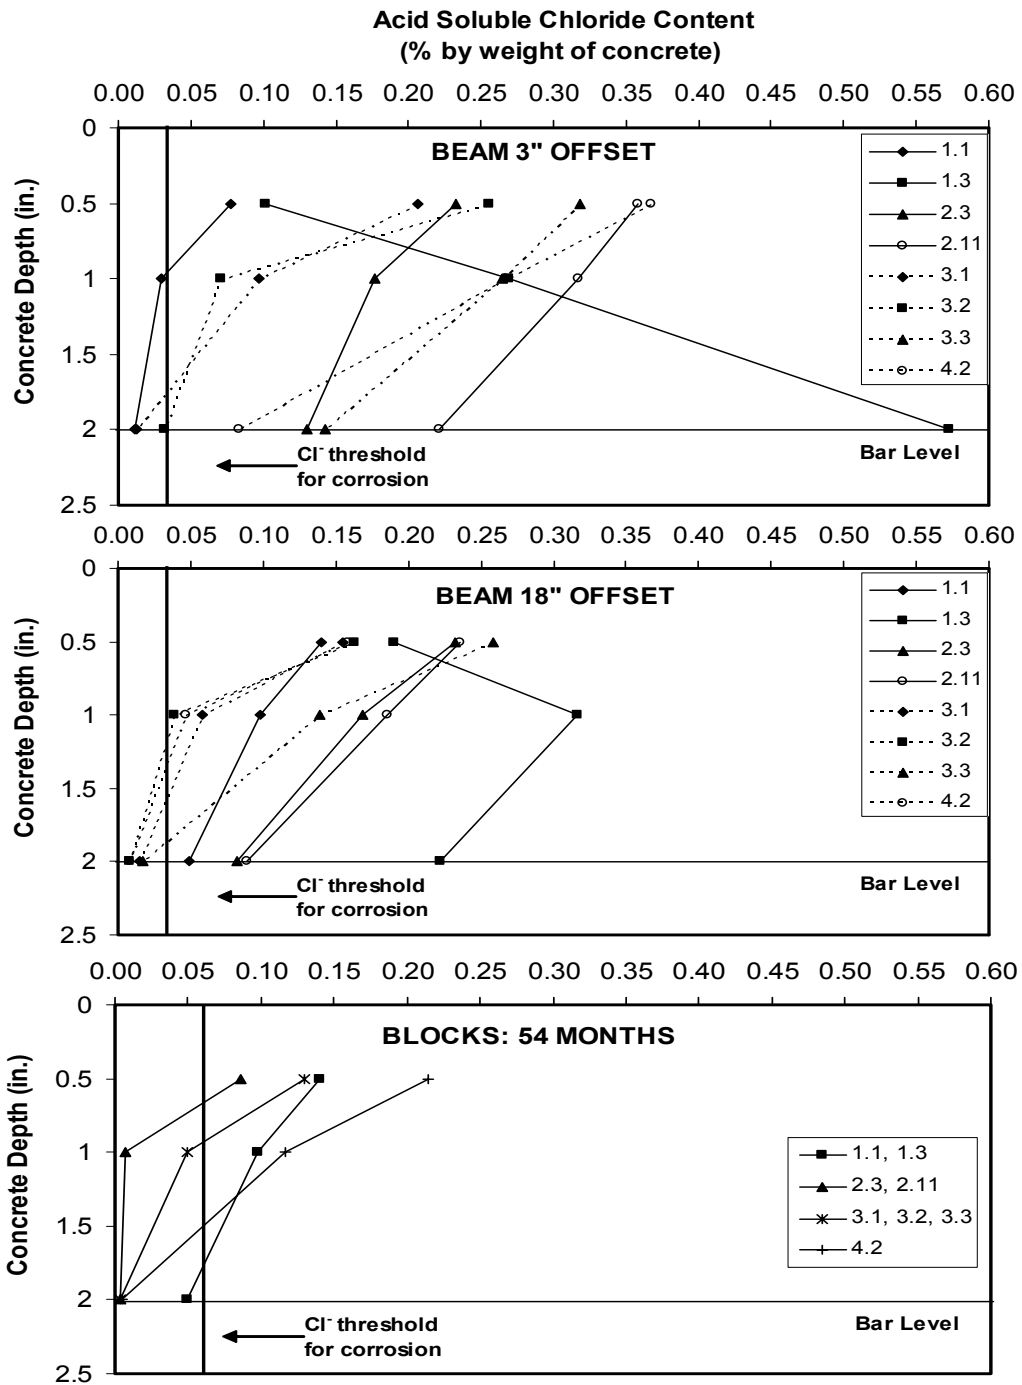
**Figure 4.32: Beam and Block Chloride Penetration at 54 Months  
(Phase I – Ponded Region on Beams)**

All Phase I beams have TxDOT Class C concrete. The results of the chloride analysis for the Phase I autopsy beams and blocks (shown again for comparison) after fifty-four months of exposure are shown in Figures 4.32 and 4.33 and listed in Table 4.6. The samples of greatest interest are those taken at the two-inch depth because these samples give the chloride content in the concrete at the bar and top-of-duct level of the beams. Figure 4.34 shows the results for each sample at this critical level for the specimens. Additional plots showing chloride content at all offsets and depths for each individual beam can be found in Appendix D.
