**Durability Examination of Bonded Tendons in Concrete Beams  
Under an Aggressive Corrosive Environment**

**Thesis**

**The University of Texas at Austin**

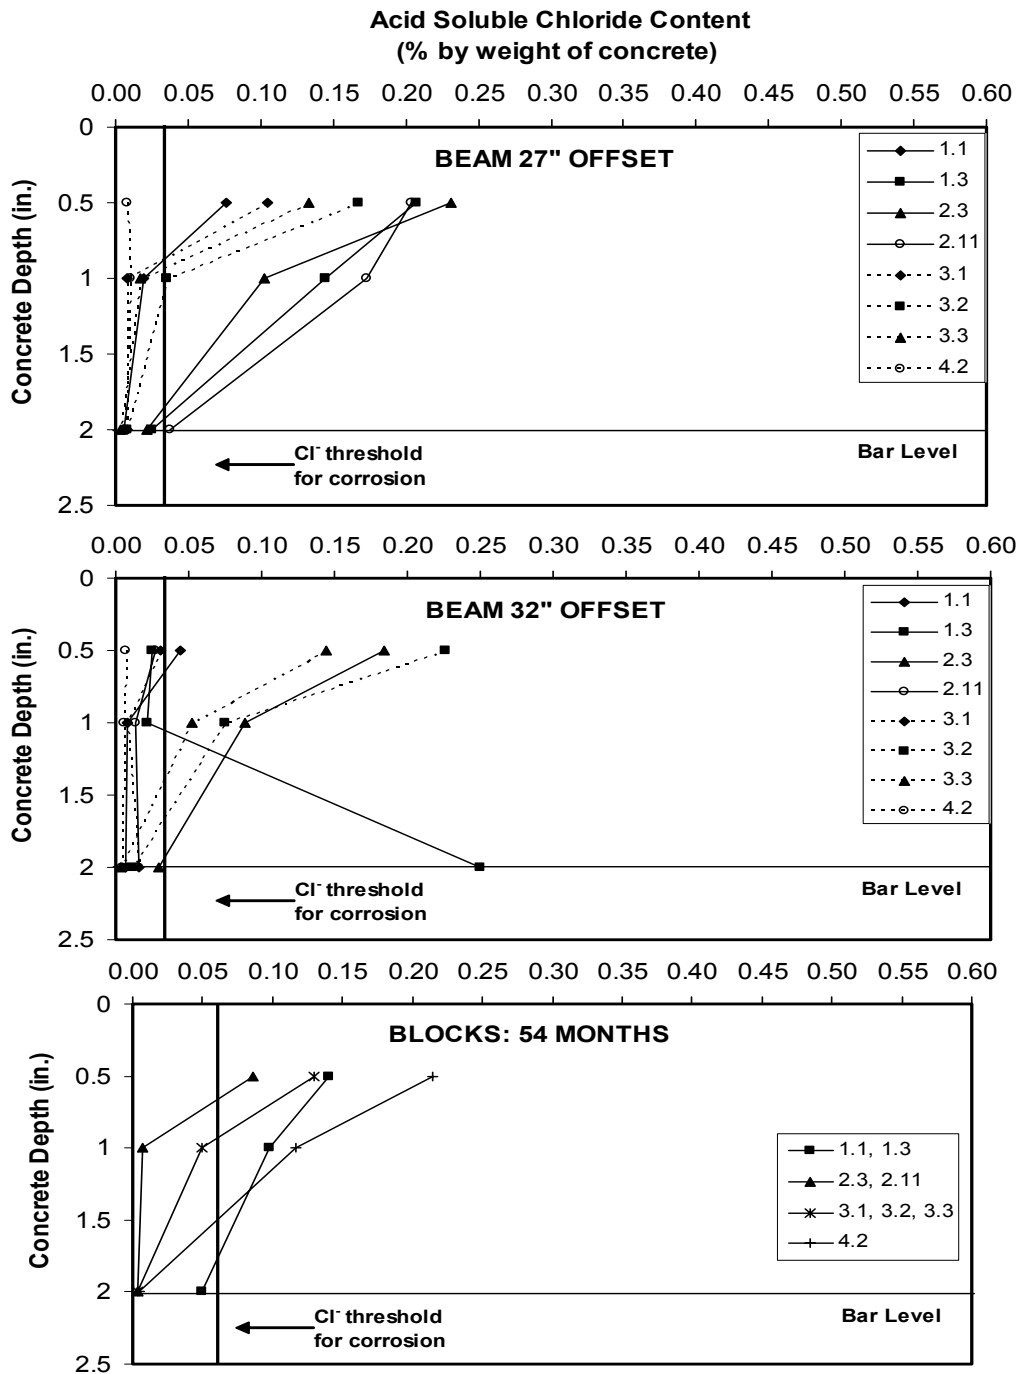
**Figure 4.33: Beam and Block Chloride Penetration at 54 Months  
(Phase I – Unponded Region on Beams)**

The beam samples shown in Figure 4.33 are those taken at locations outside of the ponded region of the Phase I beams. Most measurements at the bar level at both locations are at or below the threshold, with the exception of Specimen 1.3 whose 32-inch sample was taken at a crack location. Generally, chloride levels at the one-inch depth of the Non-PS and 2/3 PS beams are significantly higher at the 27-inch offset (immediately outside the ponded region) in comparison with those from the 32-inch offset. This is not true of the 100% PS beams, suggesting that a lower prestress level (lower compressive stresses in the concrete) allows more horizontal chloride penetration.

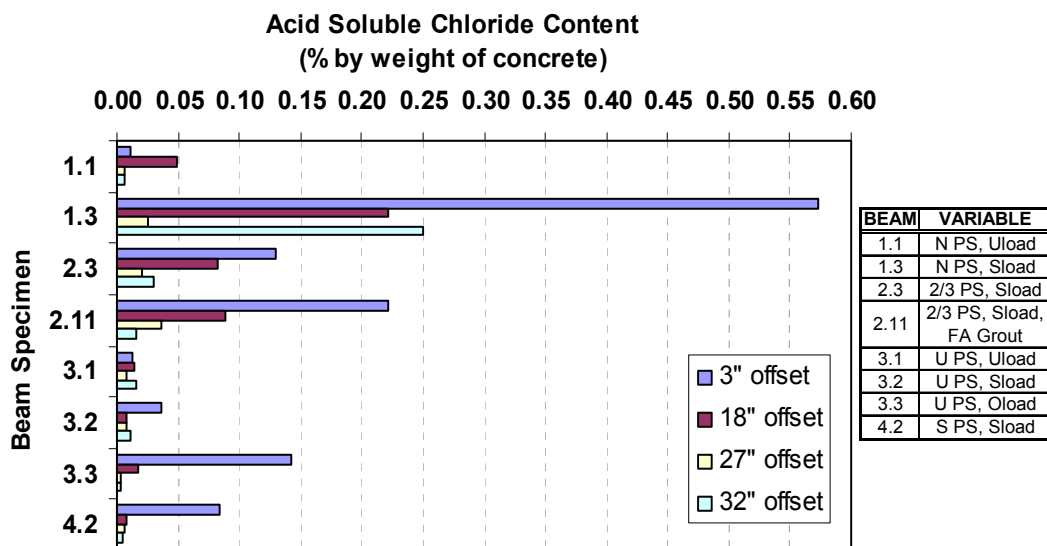
***Figure 4.34: Chloride Content at Bar and Top-of-Duct Level  
(Phase I Beams)***

Figure 4.34 illustrates that samples taken in the ponded region consistently have higher chloride contents at the bar level. Unloaded and therefore uncracked Specimens 1.1 and 3.1 show very low measurements at all locations. The significantly larger values for Specimens 1.3 and 2.3 at the three-inch offset are due to the fact that the samples were taken at crack locations. As expected, an increase in the level of prestress results in lower chloride contents due to fewer cracks and higher compressive stresses in the concrete which decrease its permeability. There appears to be minimal difference in the performance of the 100%S and U PS beams. The noticeably larger value from the 100%U PS beam at the three-inch offset location is due to the small crack at the sample location.

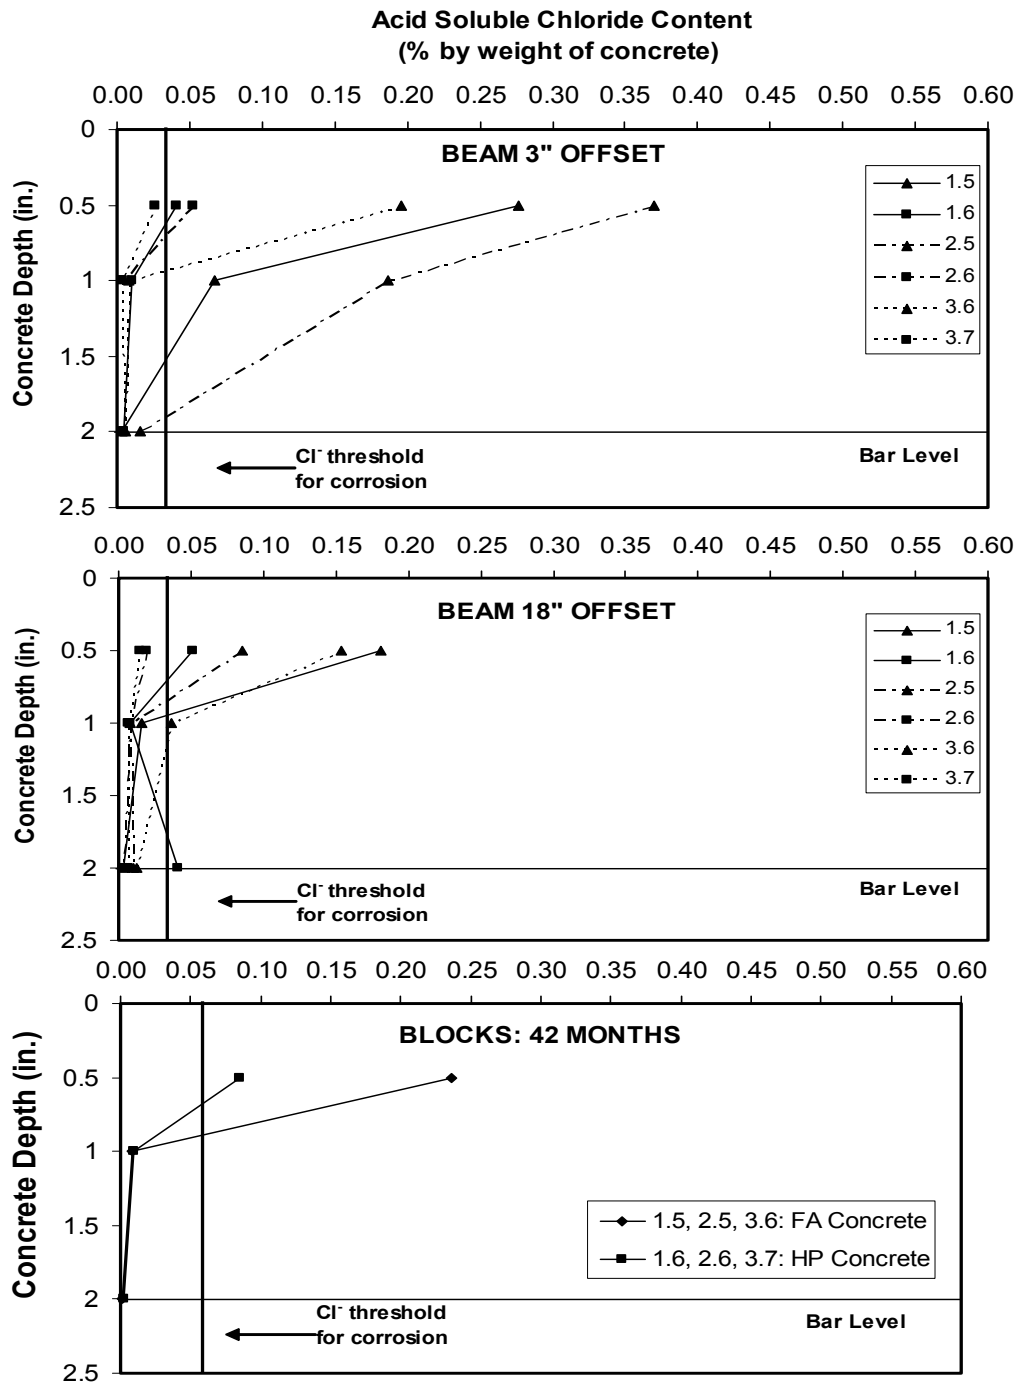
**Figure 4.35: Beam and Block Chloride Penetration at 42 Months  
(Phase II Autopsy Beams – Ponded Region on Beams)**

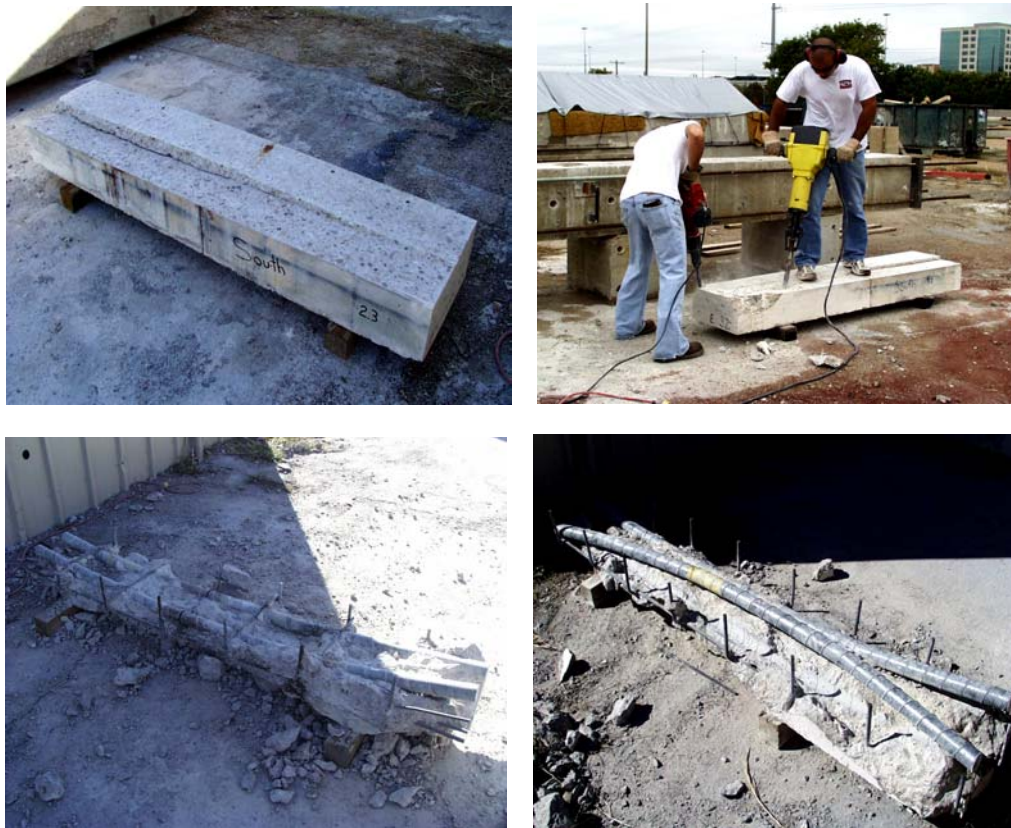
*Figure 5.4: Concrete Removal and Reinforcement Exposure*

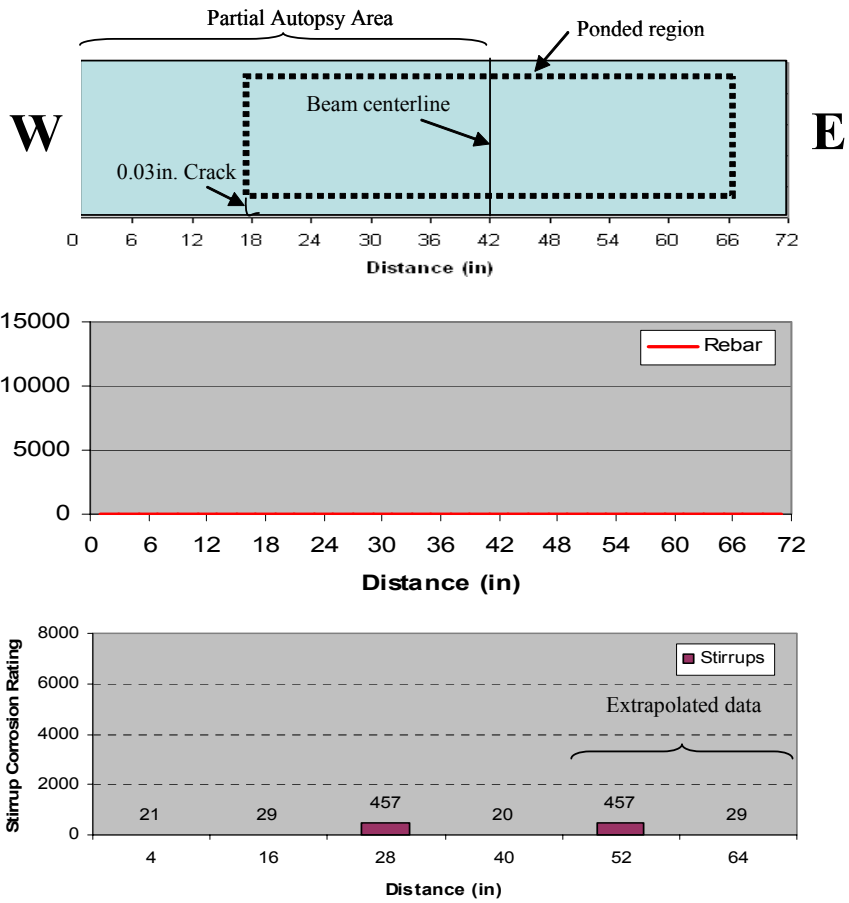
**Figure 5.10: Specimen 1.1 – Crack Pattern and Specimen Corrosion Rating Graphs**

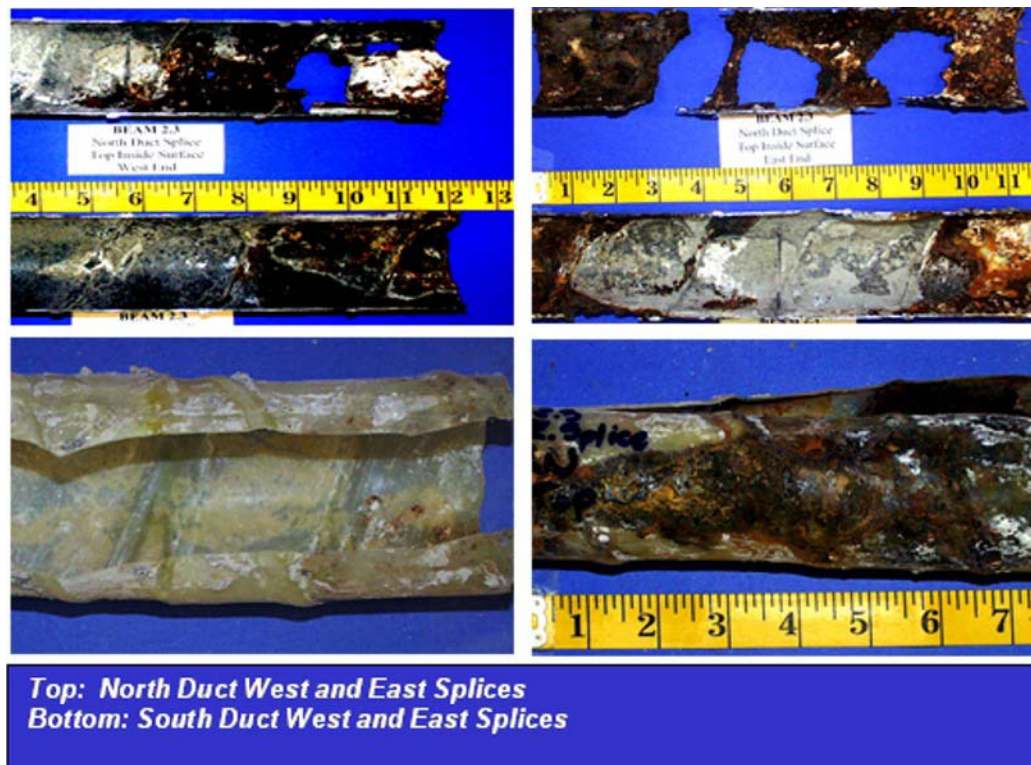
*Figure 5.15: Specimen 2.3 – Duct Splices*

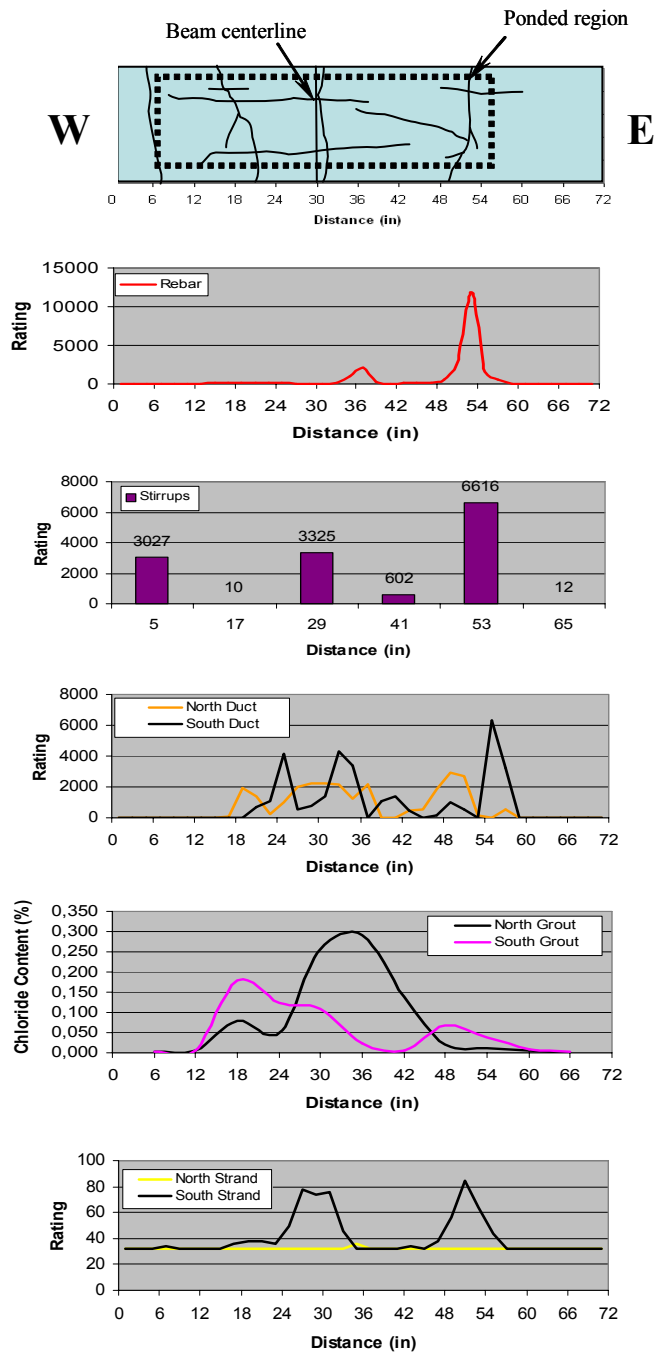
**Figure 5.17: Specimen 2.3 – Crack Pattern and Specimen Corrosion Rating Graphs**

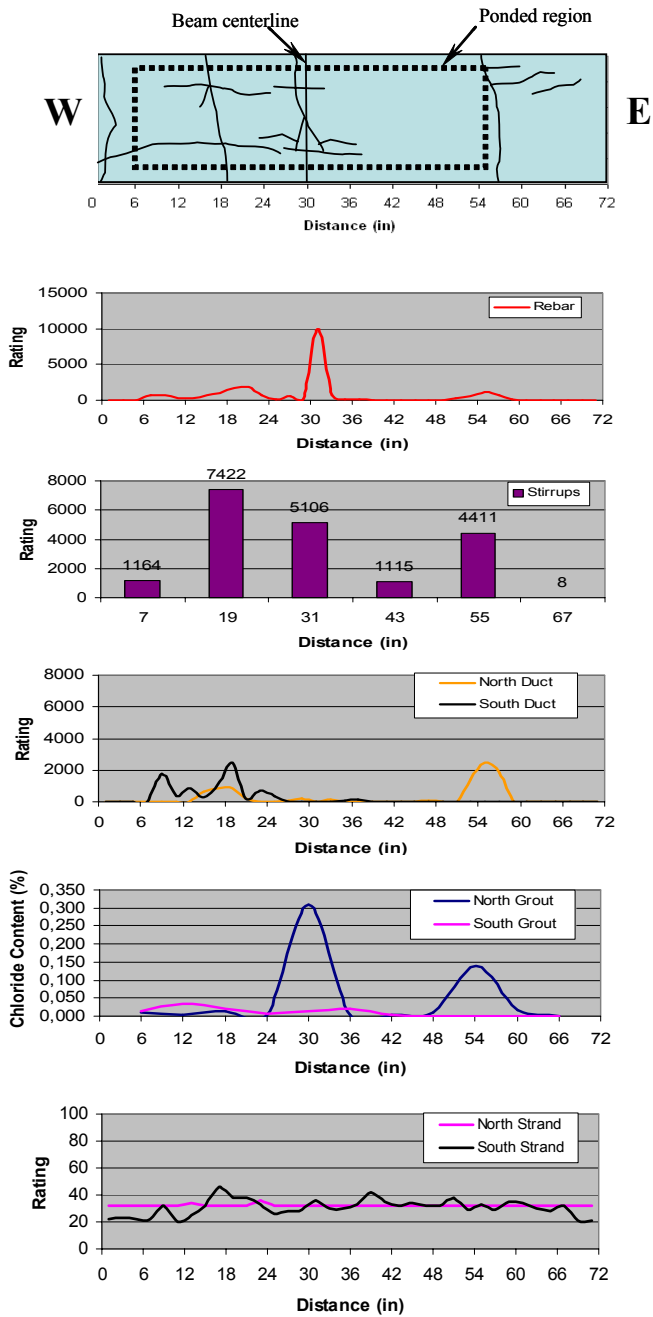
**Figure 5.21: Specimen 2.11 – Crack Pattern and Specimen Corrosion Rating Graphs**

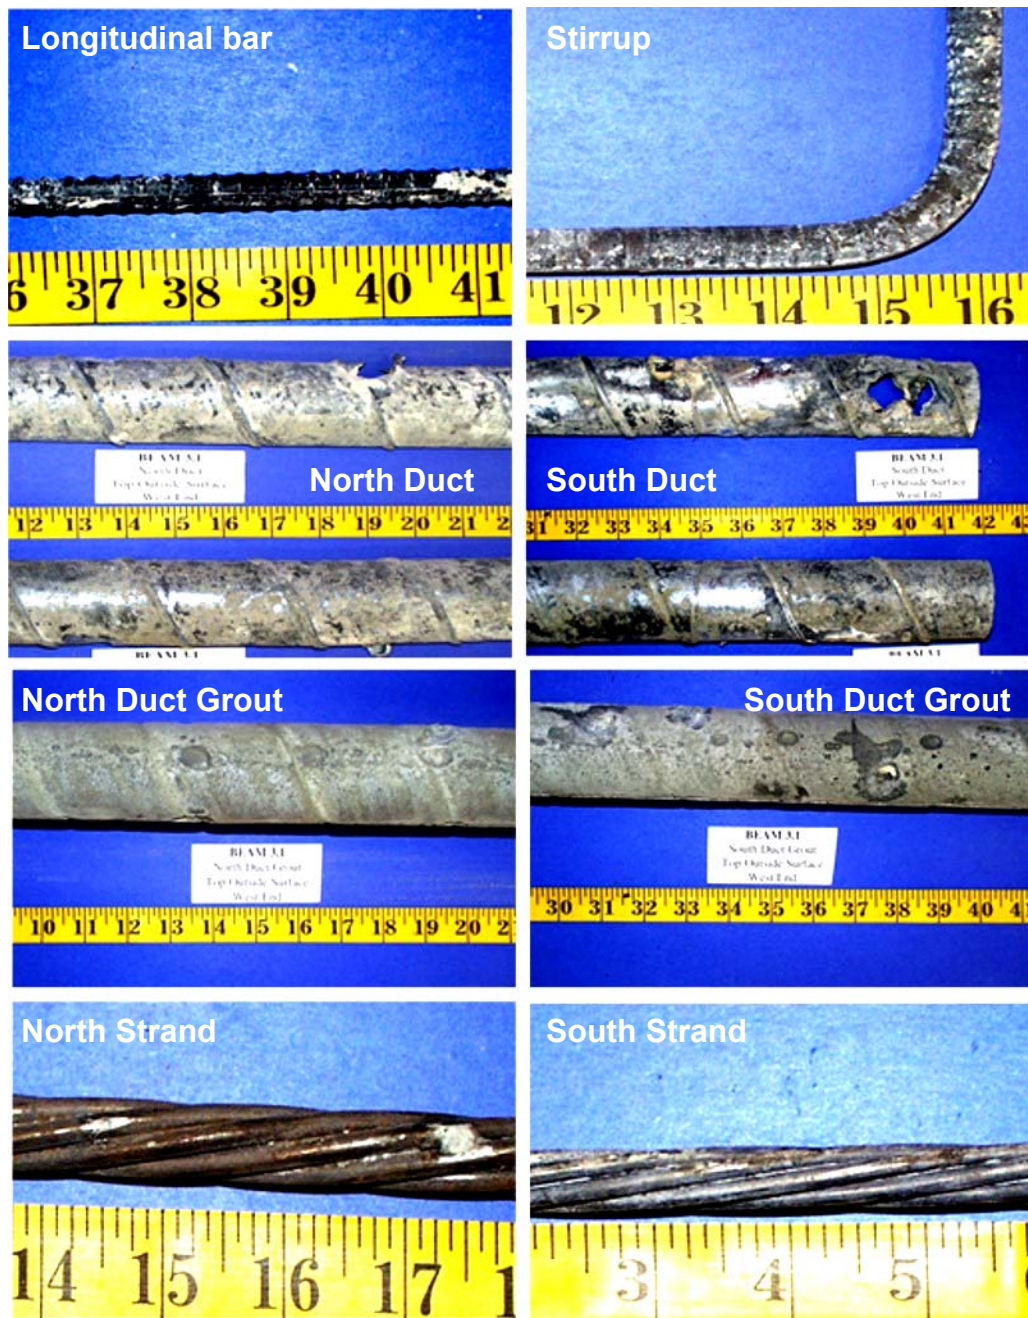
*Figure 5.24: Specimen 3.1 – Reinforcing Elements*

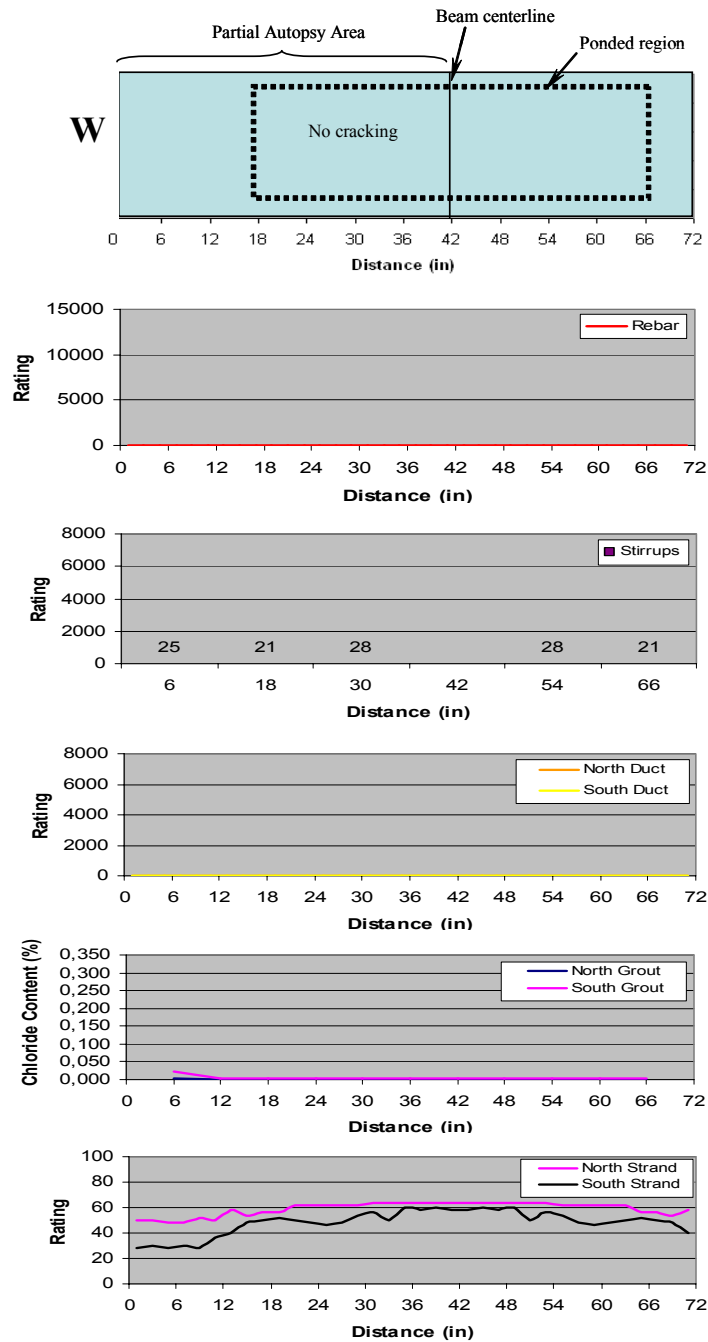
**Figure 5.25: Specimen 3.1 – Crack Pattern and Specimen Corrosion Rating Graphs**

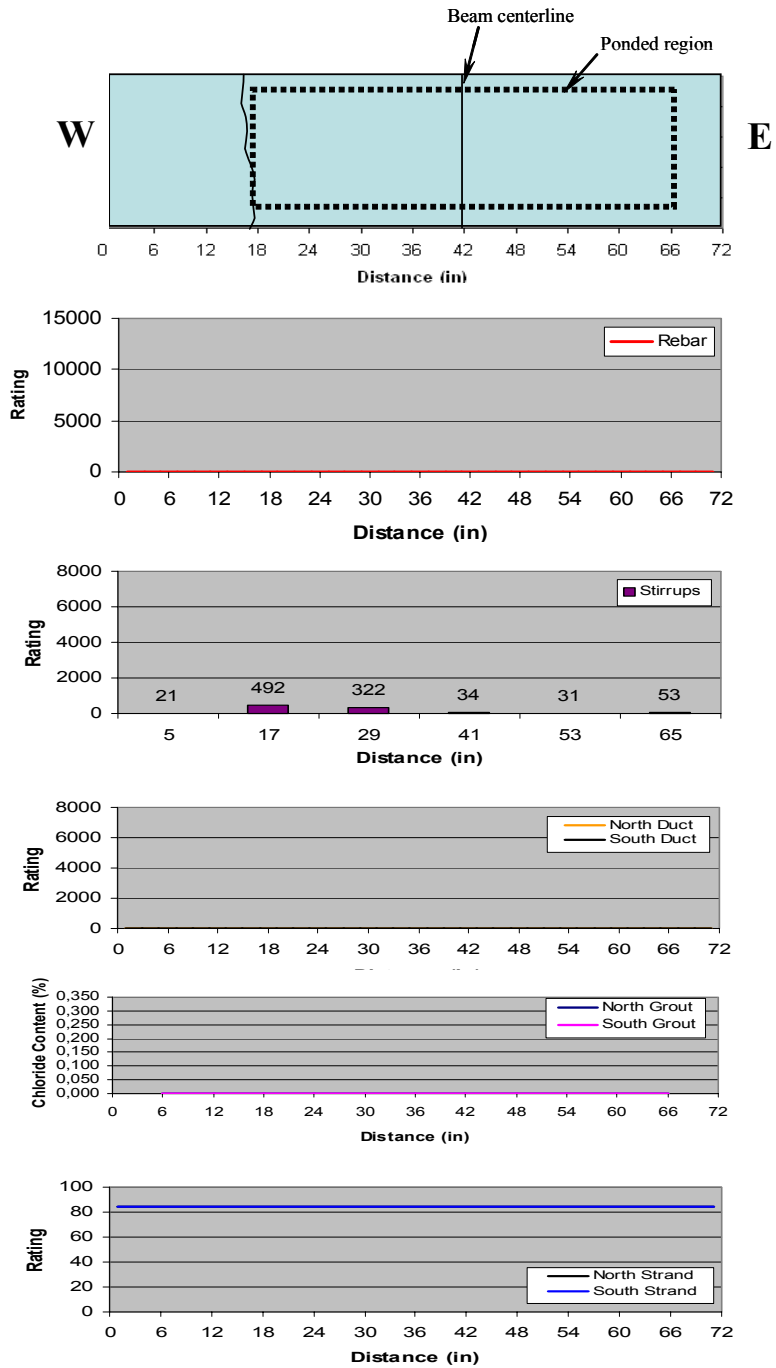
**Figure 5.30: Specimen 3.2 – Crack Pattern and Specimen Corrosion Rating Graphs**

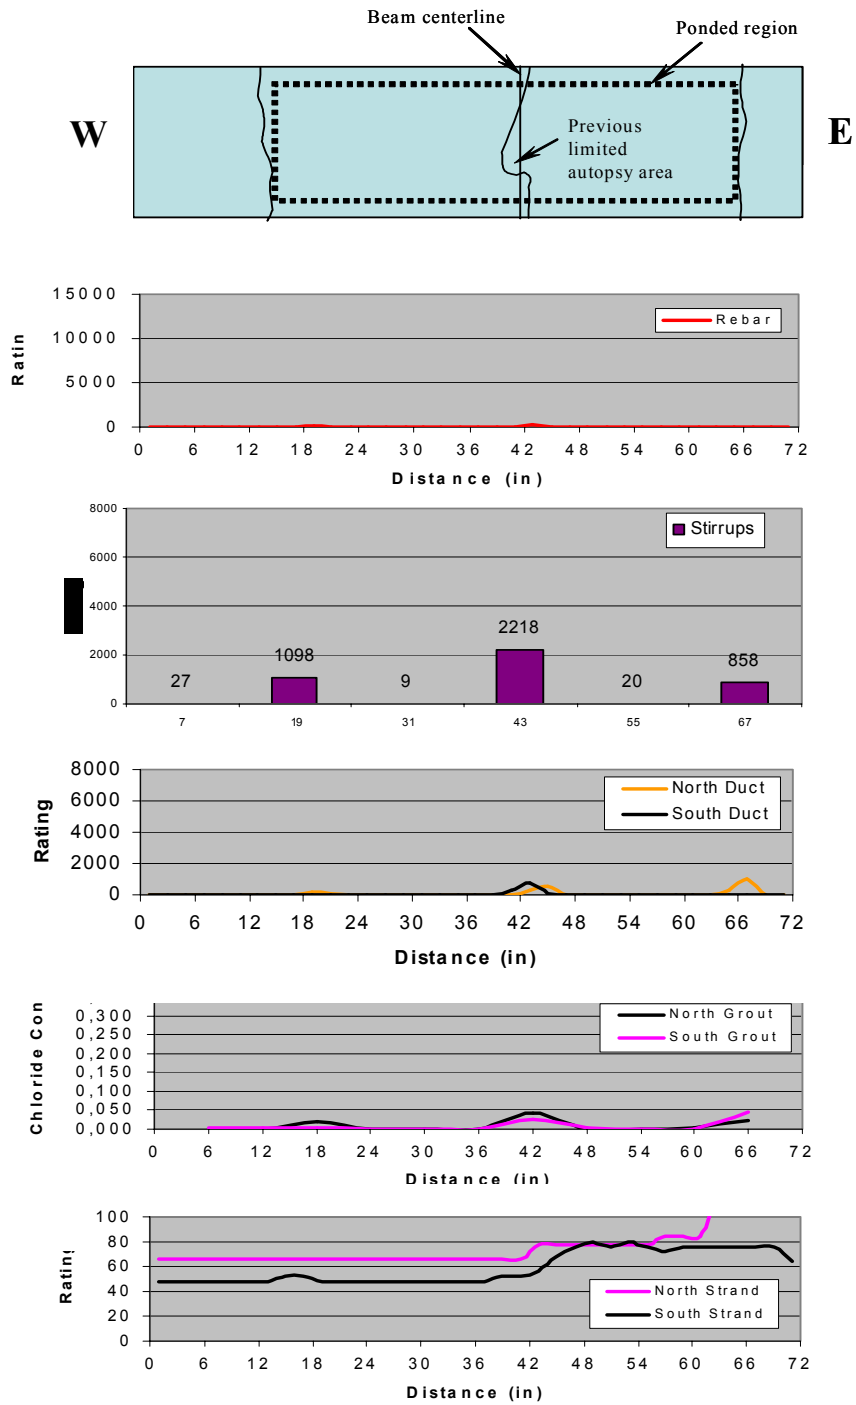
Figure 5.34: Specimen 3.3 – Crack Pattern and Specimen Corrosion Rating Graphs

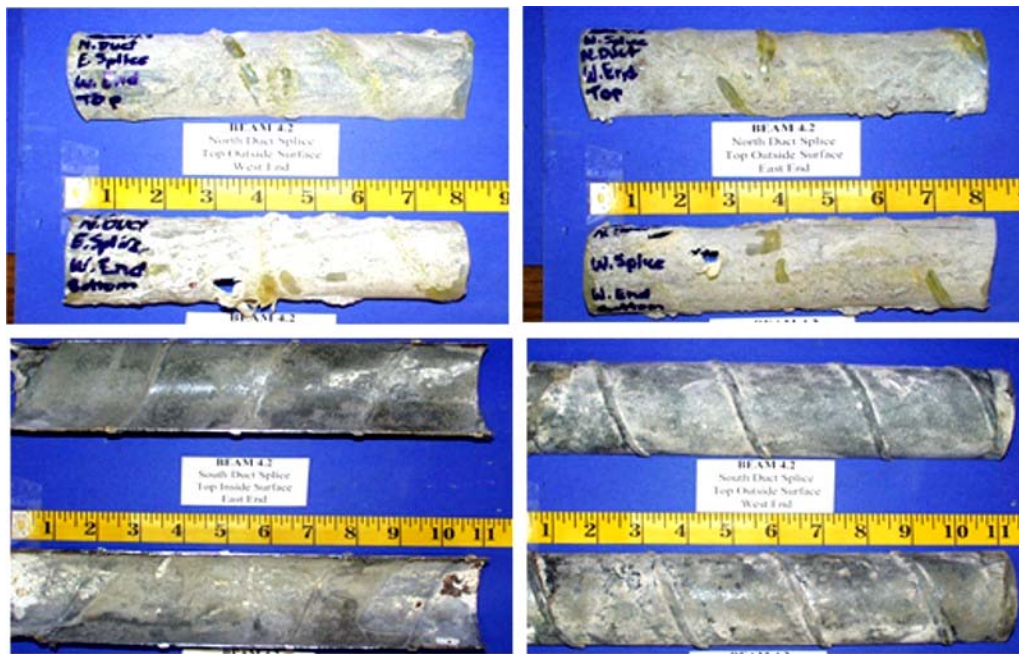
*Figure 5.36: Specimen 4.2 – Duct Splices*

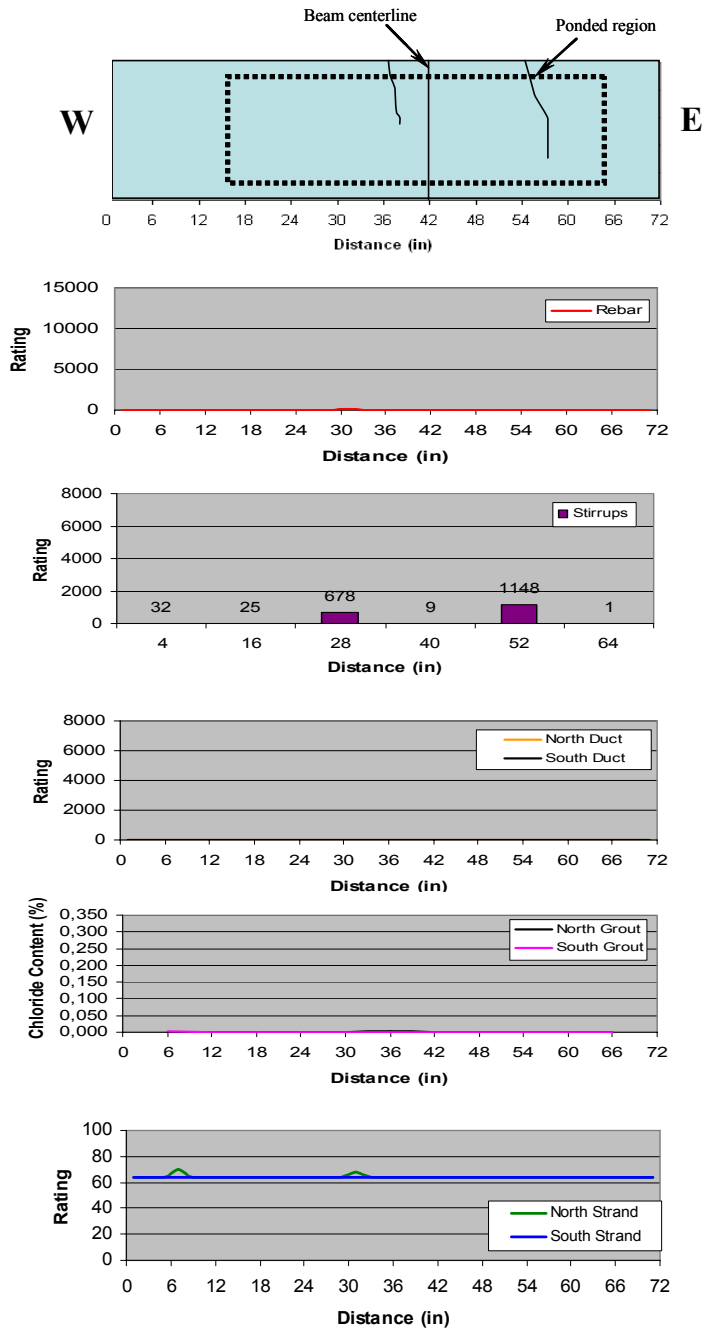
**Figure 5.38: Specimen 4.2 – Crack Pattern and Specimen Corrosion Rating Graphs**

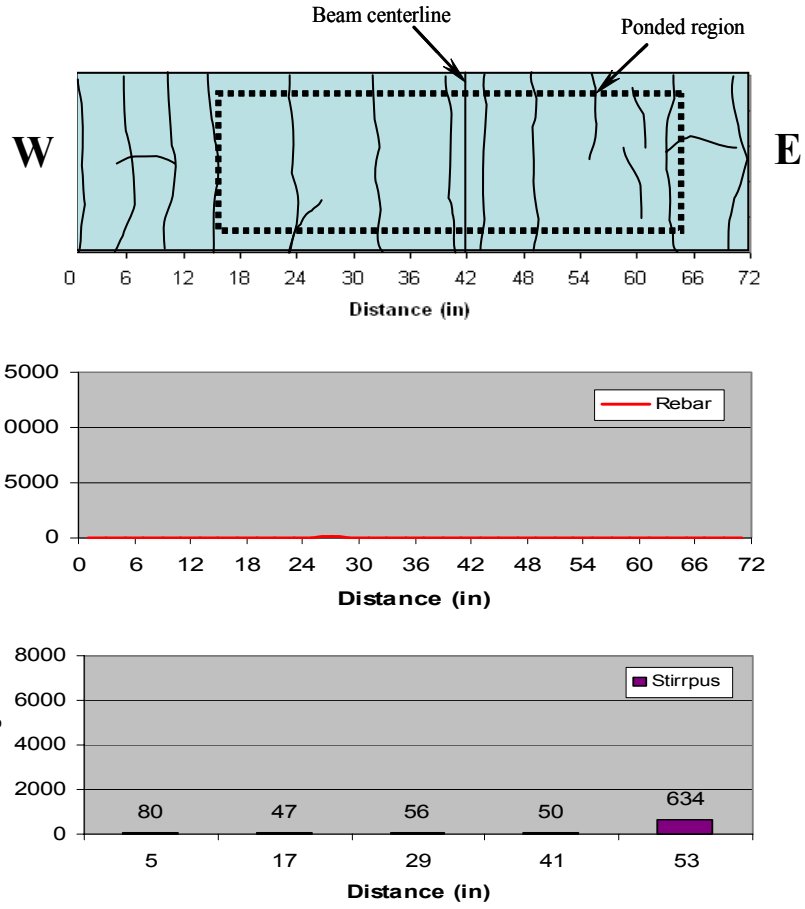
**Figure 5.44: Specimen 1.6 – Crack Pattern and Specimen Corrosion Rating Graphs**

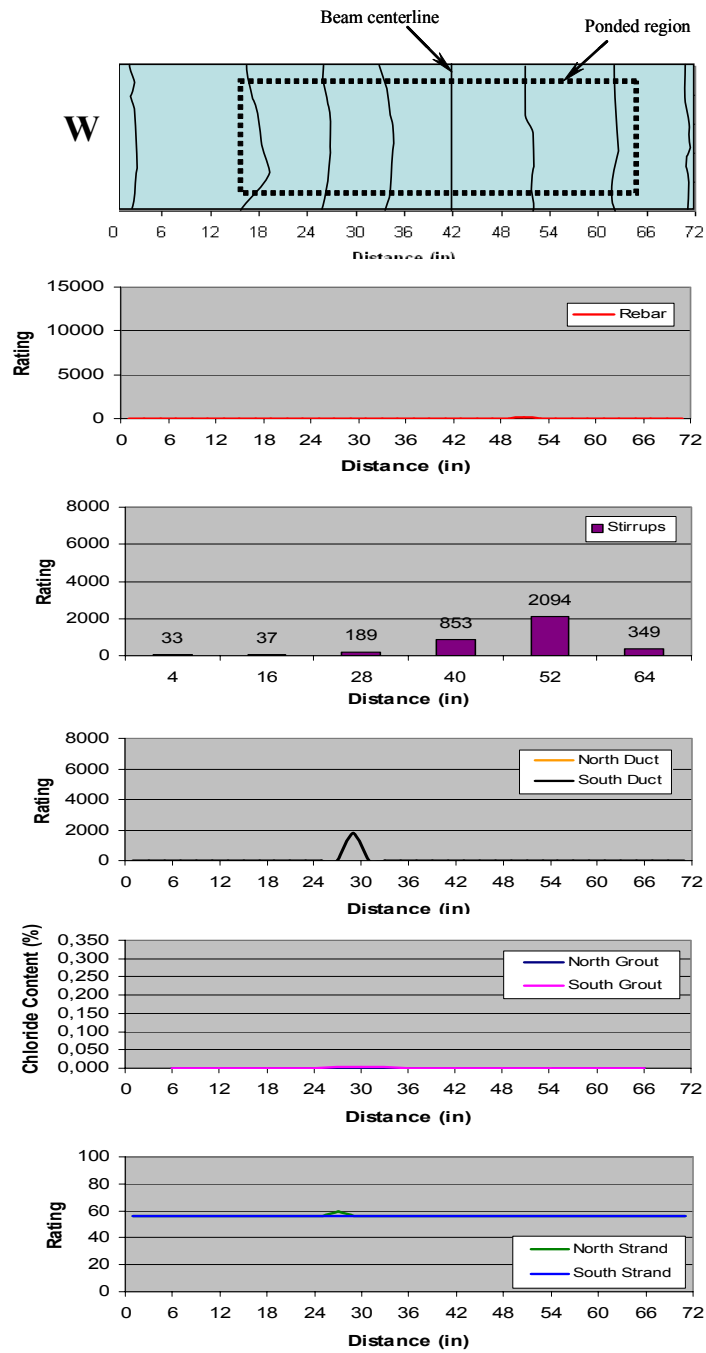
**Figure 5.48: Specimen 2.5 Crack Pattern and Specimen Corrosion Rating Graphs**

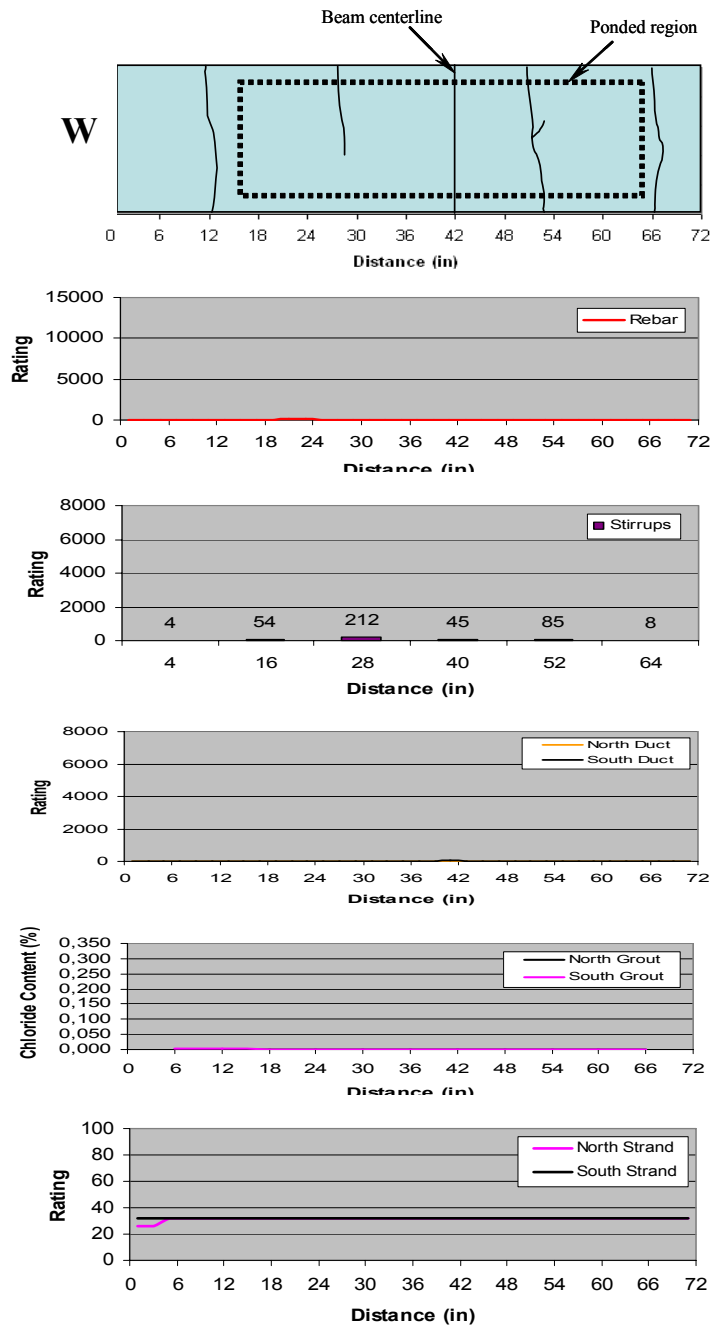
**Figure 5.52: Specimen 2.6 – Crack Pattern and Specimen Corrosion Rating Graphs**

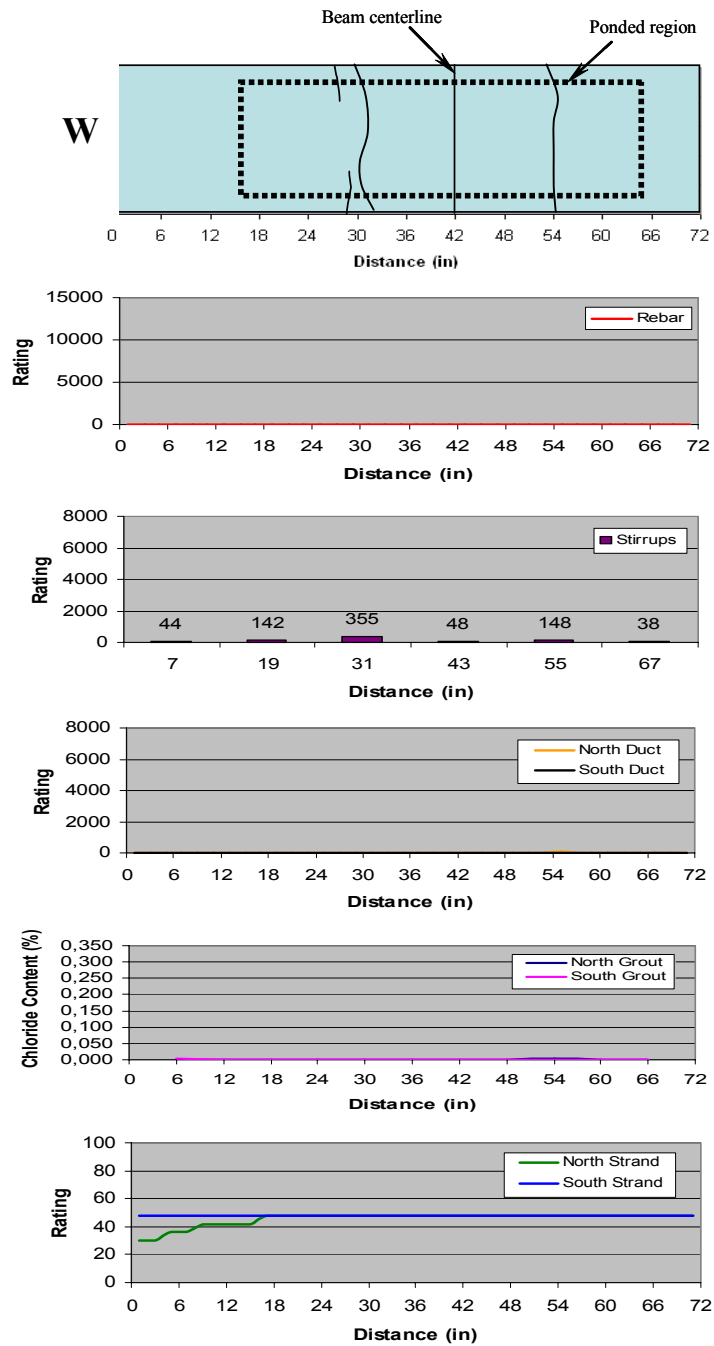
**Figure 5.56: Specimen 3.6 – Crack Pattern and Specimen Corrosion Rating Graphs**

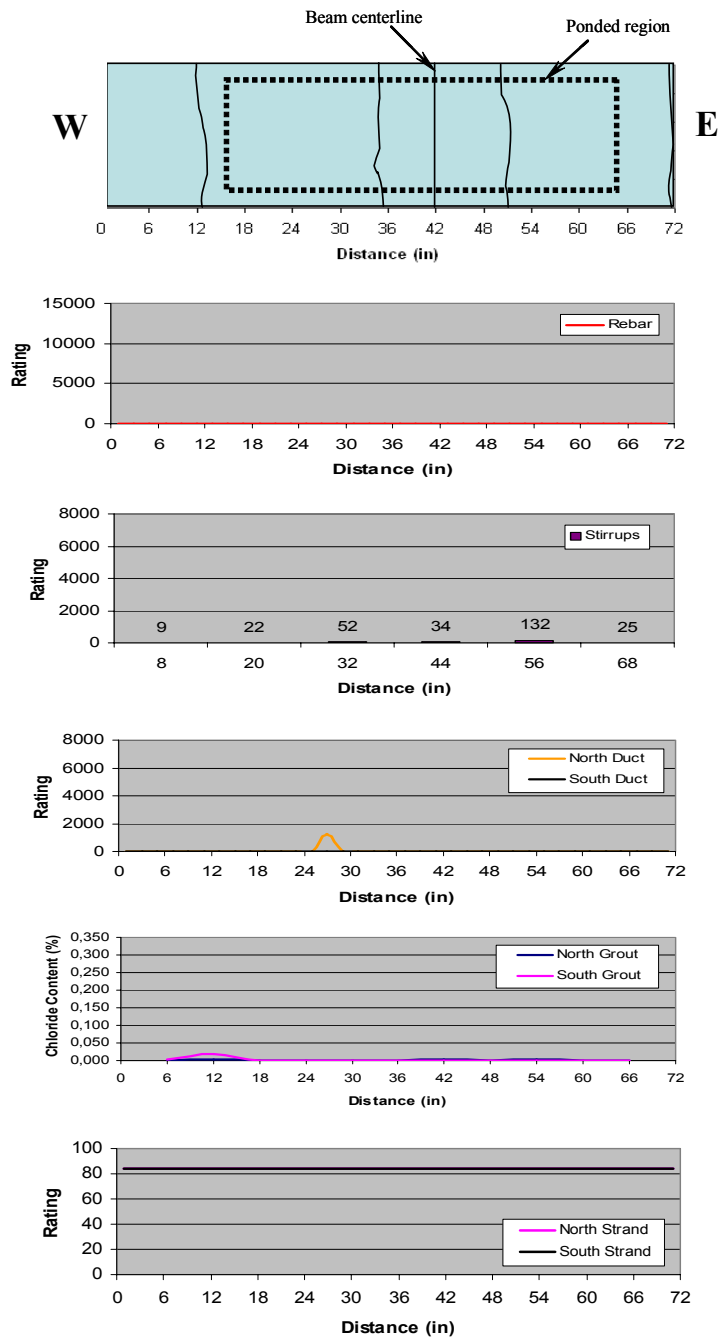
**Figure 5.60: Specimen 3.7 – Crack Pattern and Specimen Corrosion Rating Graphs**

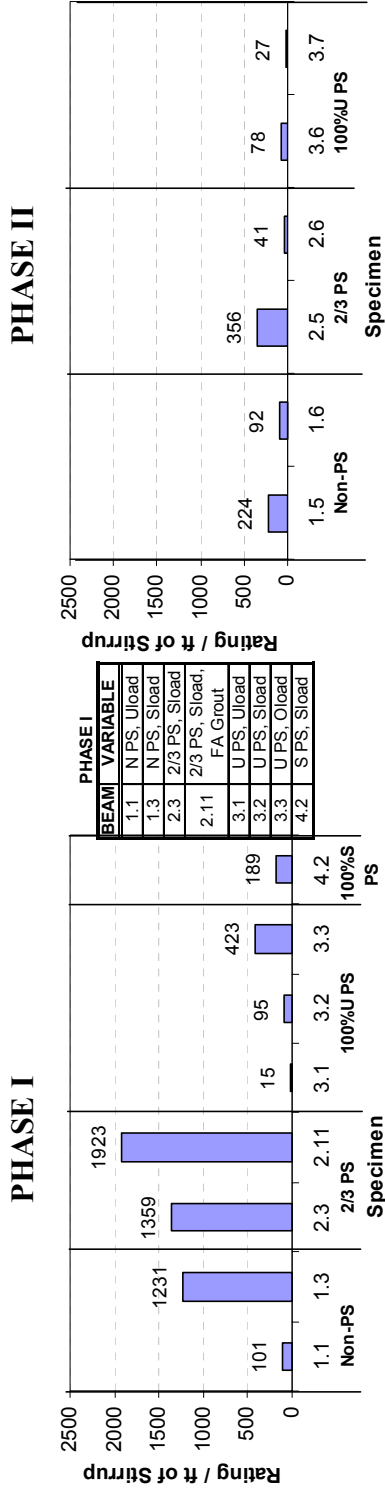
**Figure 5.61: Generalized Stirrup Corrosion Ratings**

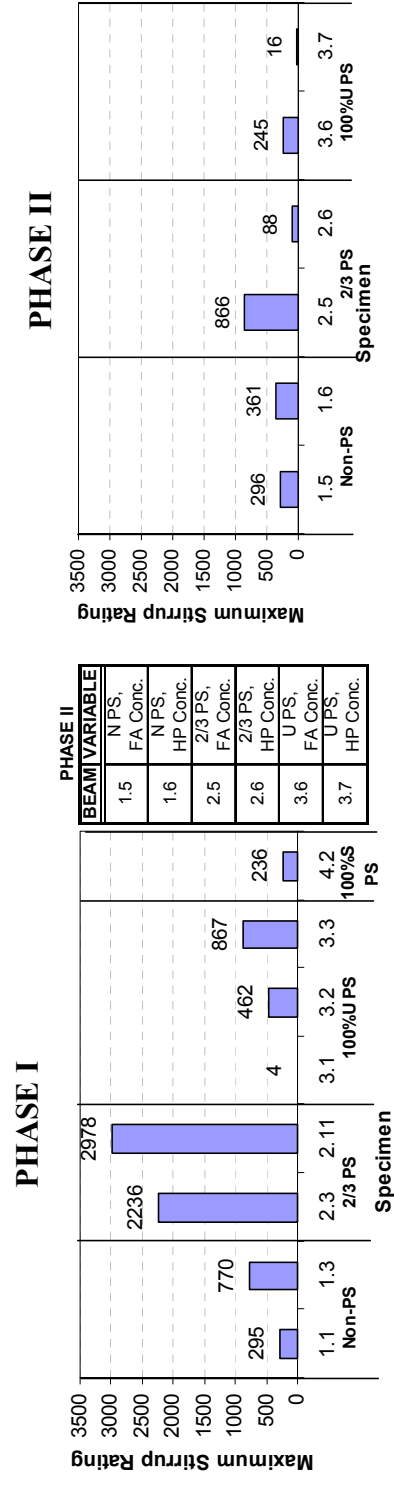
**Figure 5.62: Localized Stirrup Corrosion Ratings**

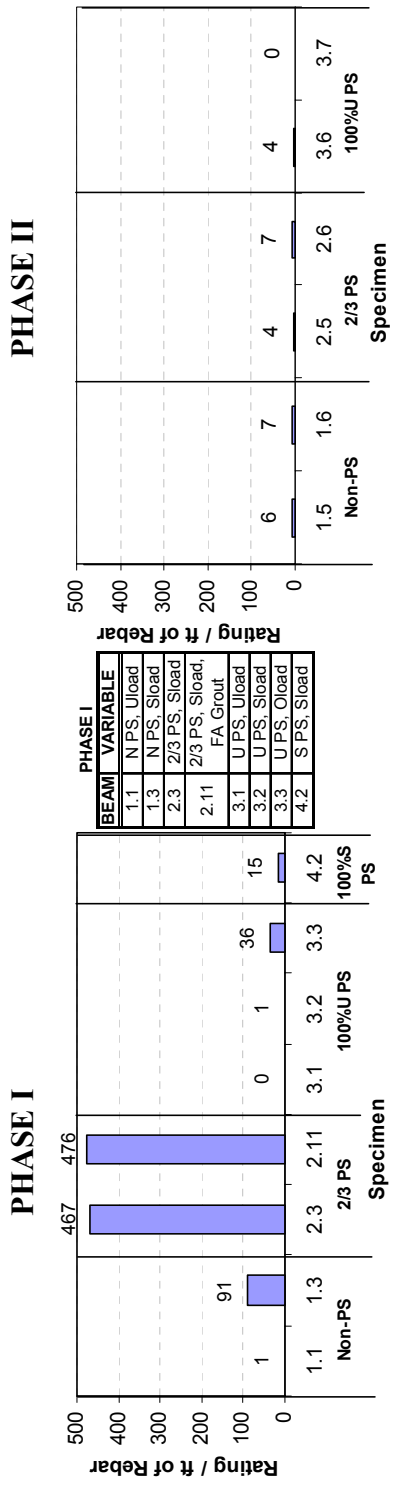
*Figure 5.63: Generalized Bar Corrosion Ratings*

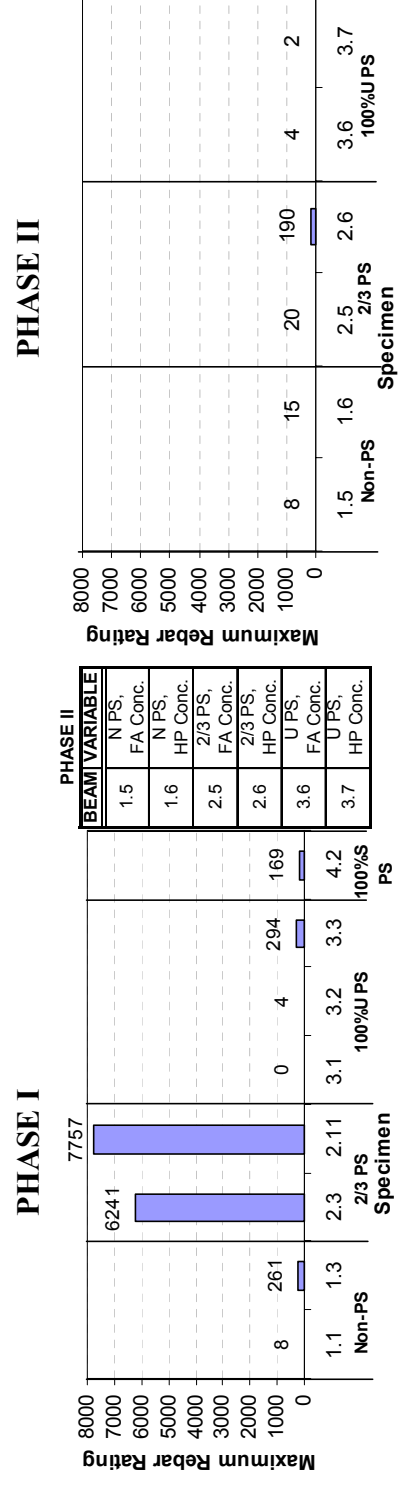
*Figure 5.64: Localized Bar Corrosion Ratings*

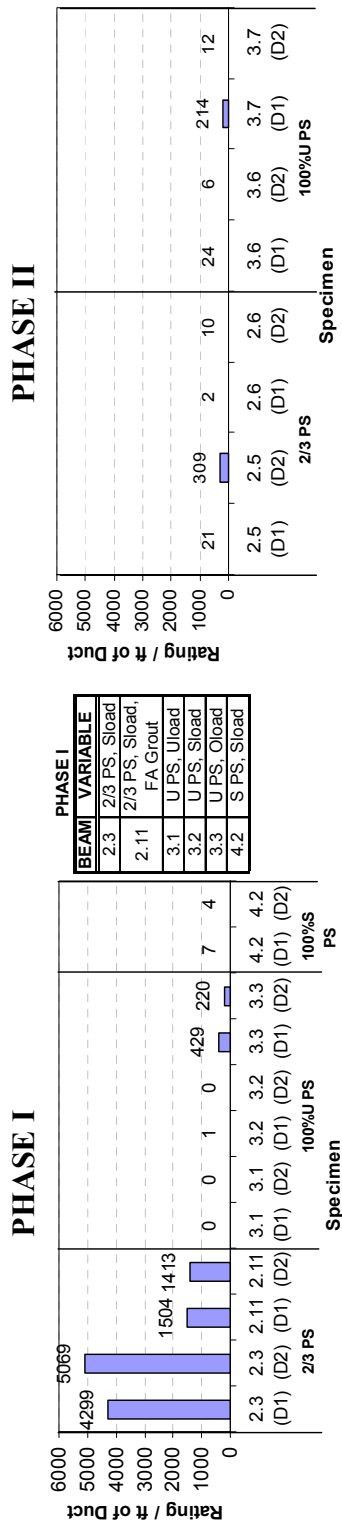
**Figure 5.65: Generalized Duct Corrosion Ratings**

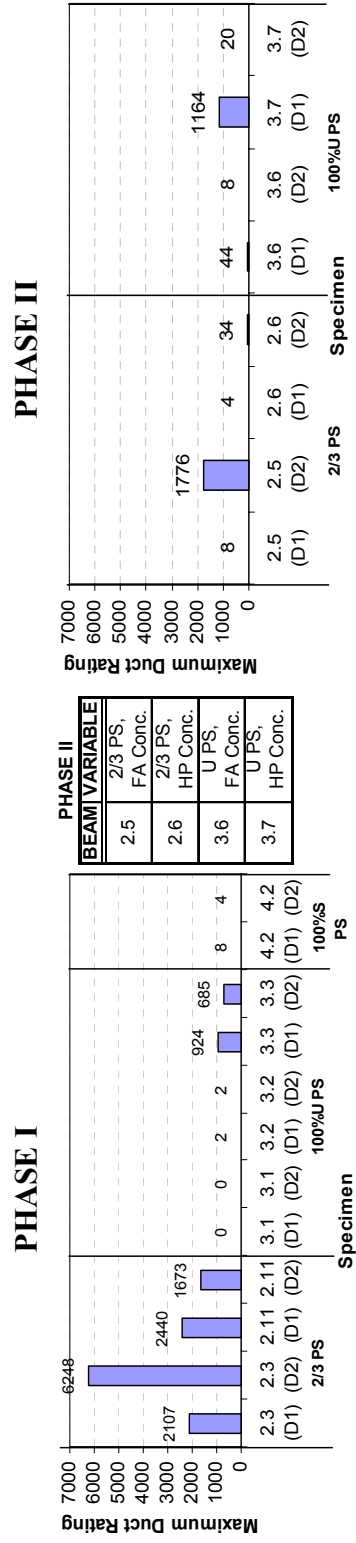
**Figure 5.66: Localized Duct Corrosion Ratings**

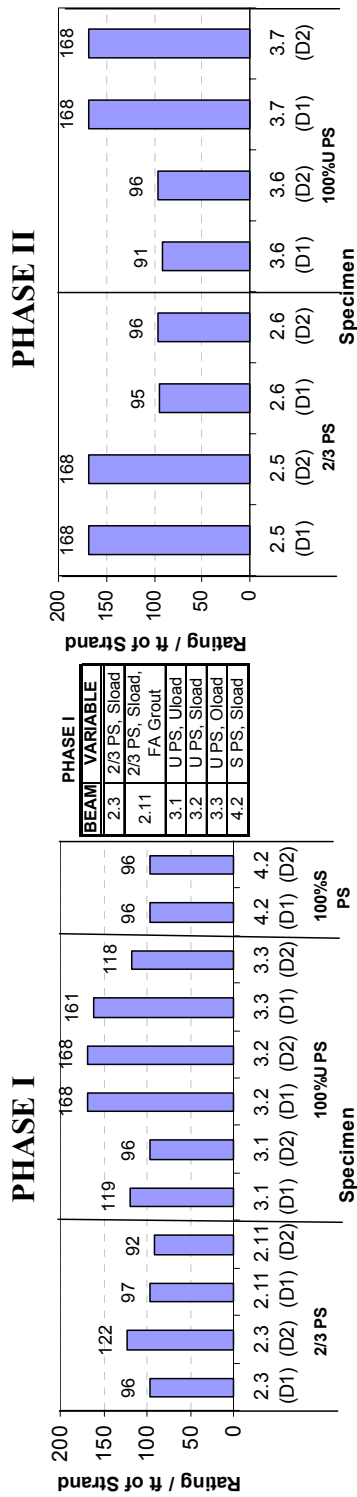
**Figure 5.67: Generalized Strand Corrosion Ratings**
