**Durability Examination of Bonded Tendons in Concrete Beams  
Under an Aggressive Corrosive Environment**

**Thesis**

**The University of Texas at Austin**

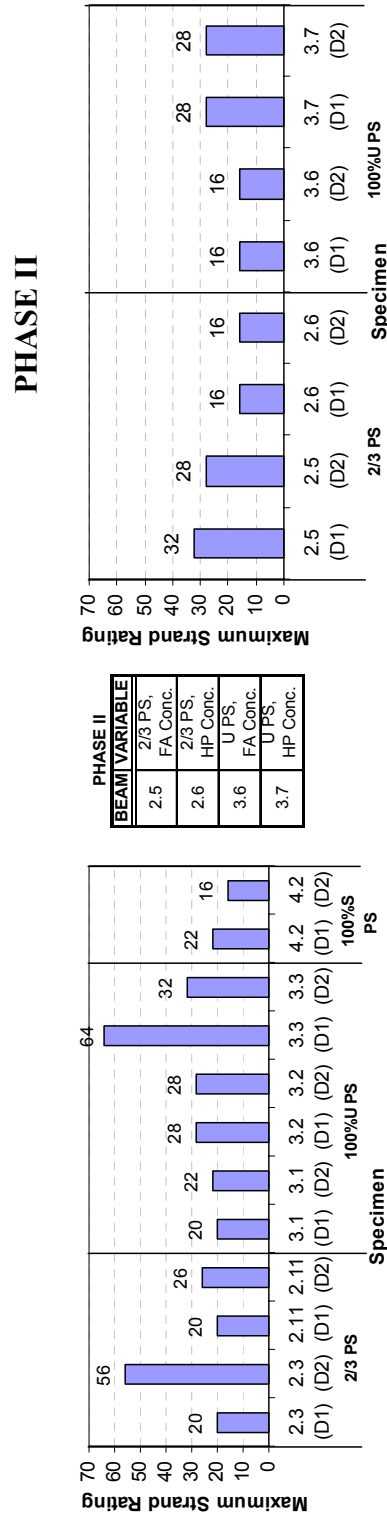
**Figure 5.68: Localized Strand Corrosion Ratings**

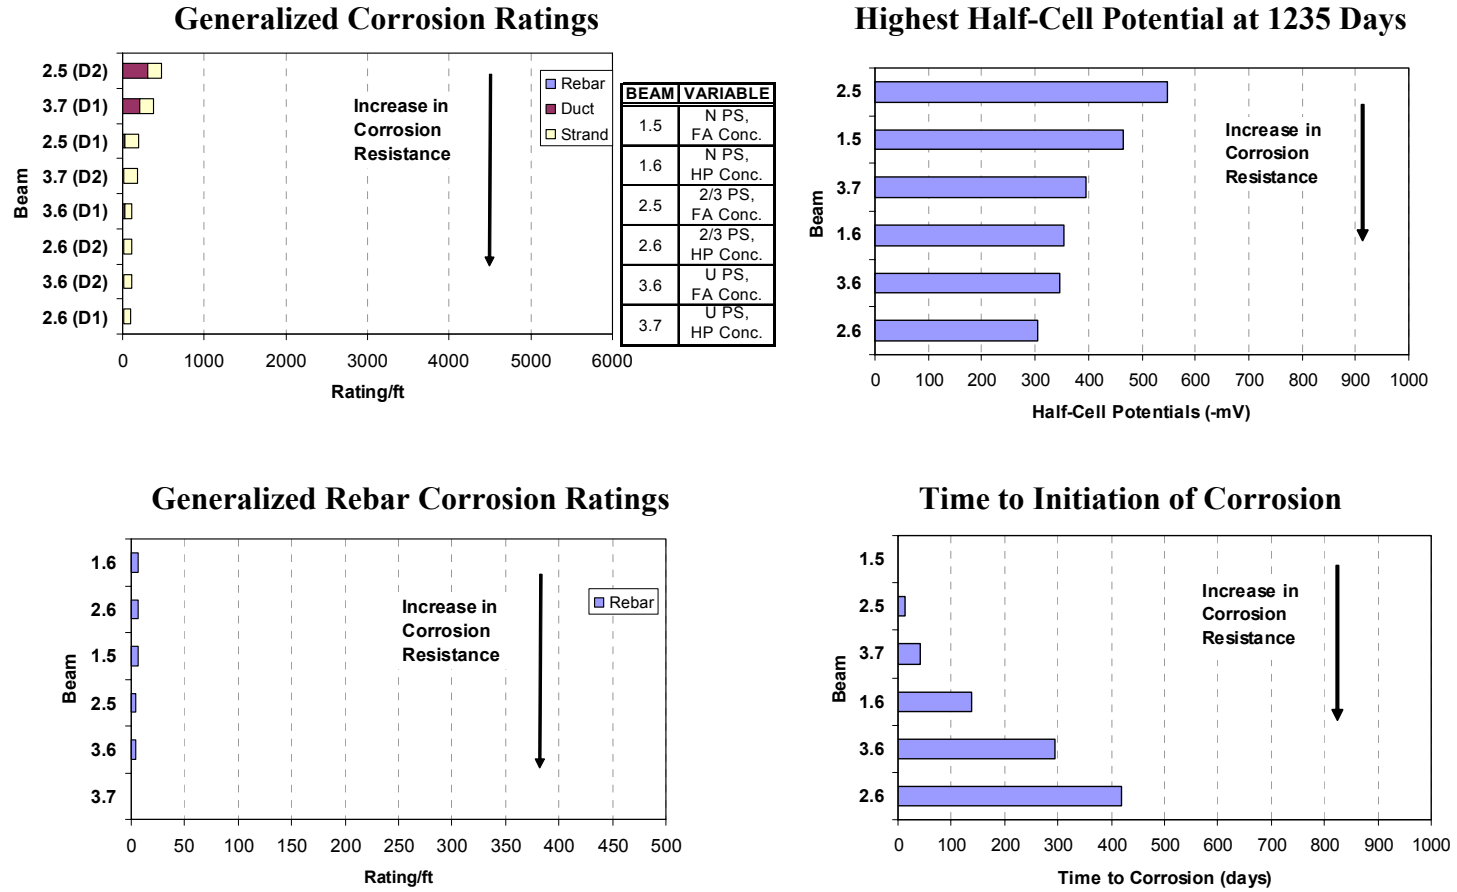
Figure 6.2: Corrosion Ratings vs. Half-Cell Potential Readings – Phase II Beams

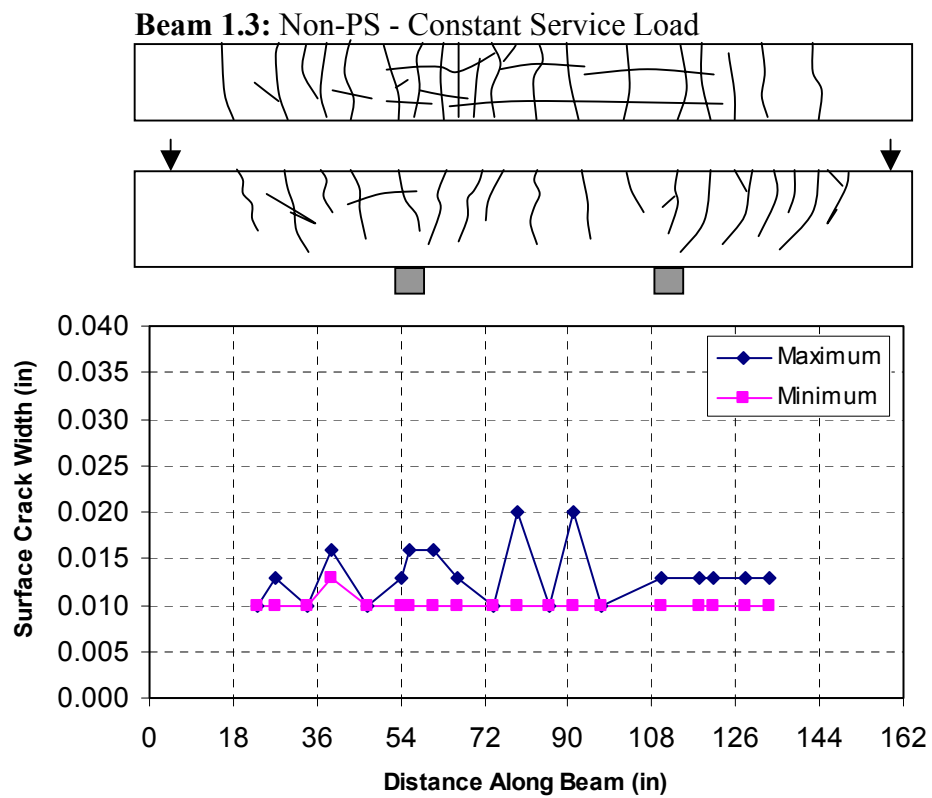
*Figure C1: Final Crack Pattern and Measurements – Beam 1.3*

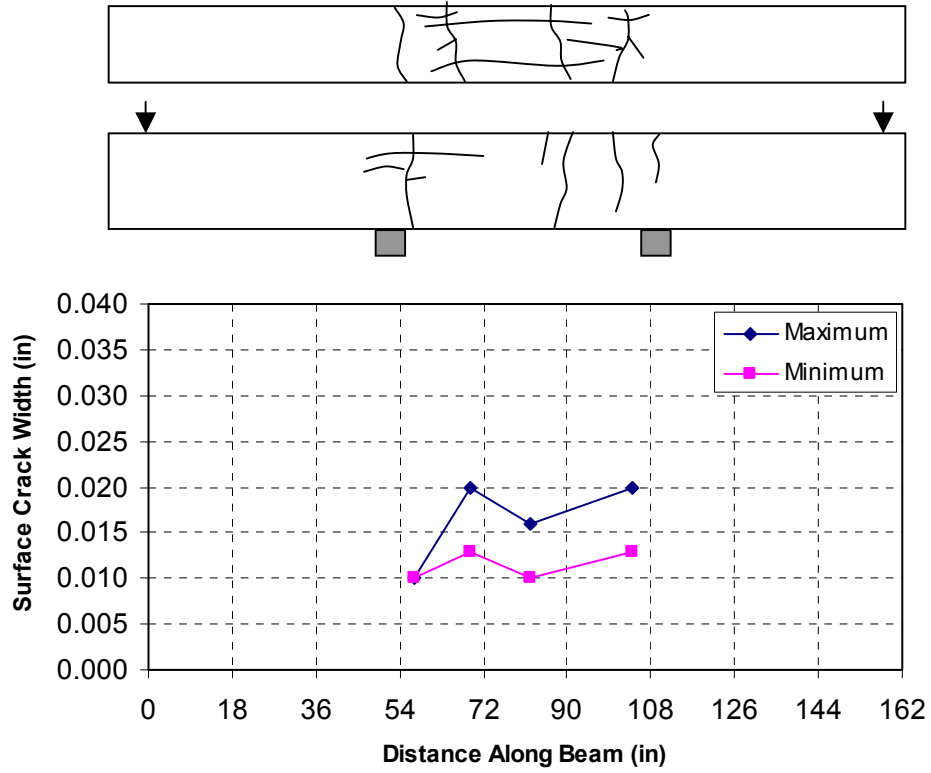
**Figure C2: Final Crack Pattern and Measurements – Beam 2.3**

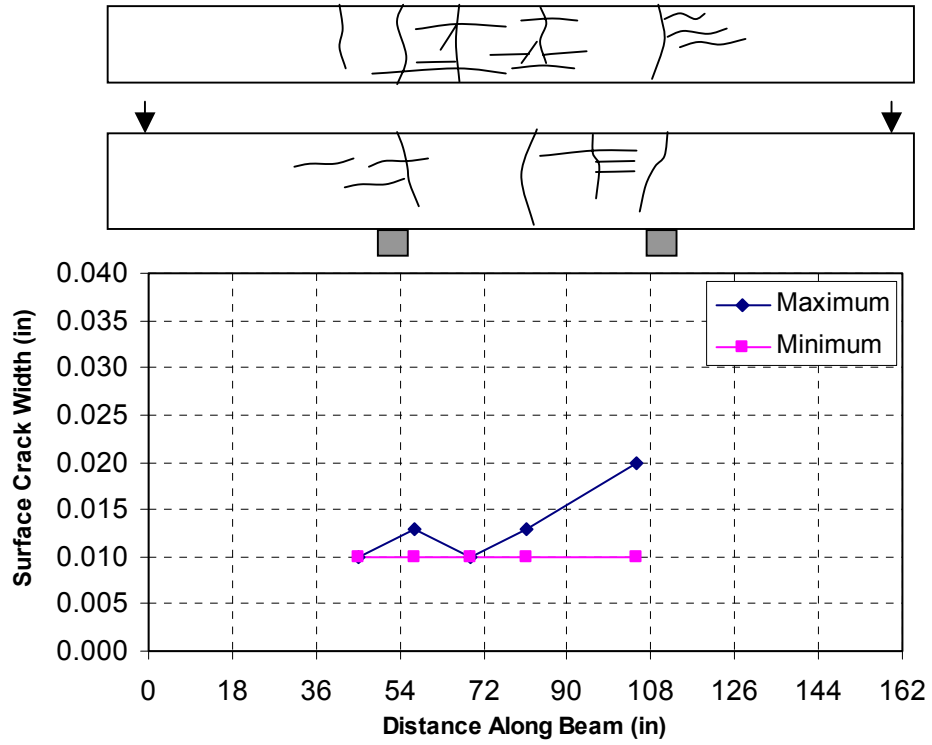
**Figure C3: Final Crack Pattern and Measurements – Beam 2.11**

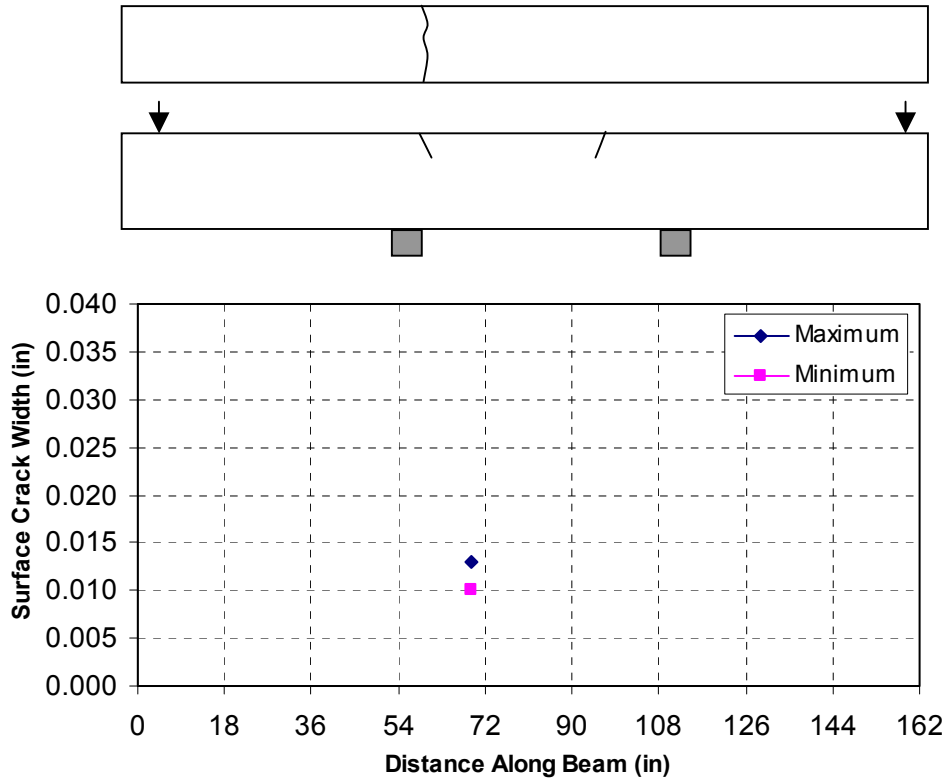
*Figure C4: Final Crack Pattern and Measurements – Beam 3.2*

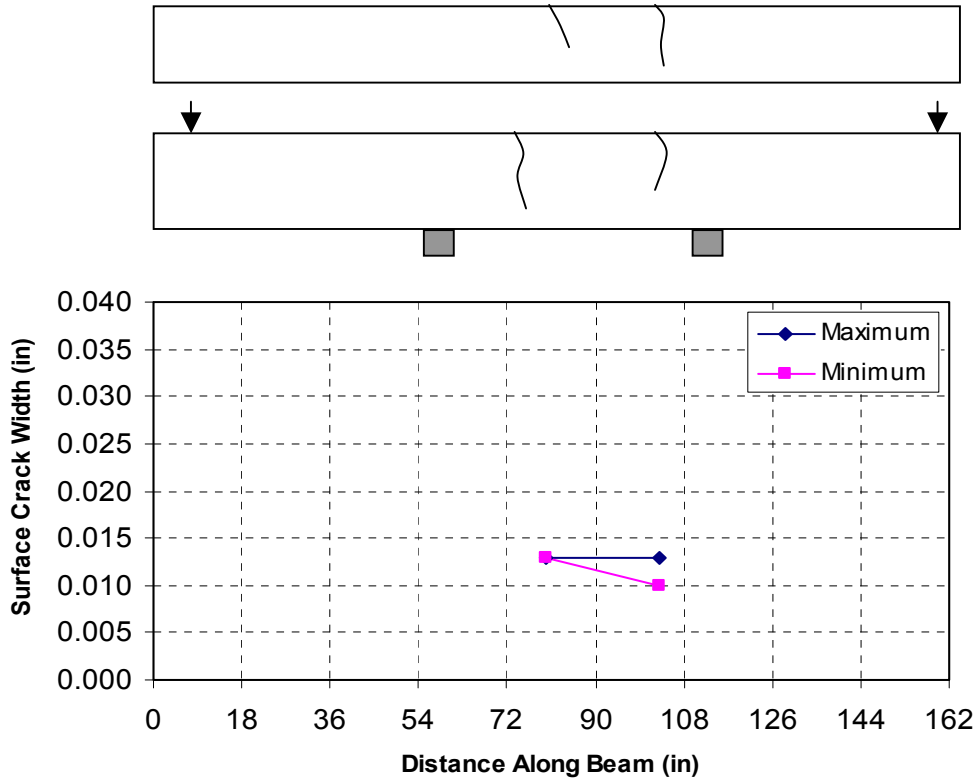
**Figure C6: Final Crack Pattern and Measurements – Beam 4.2**

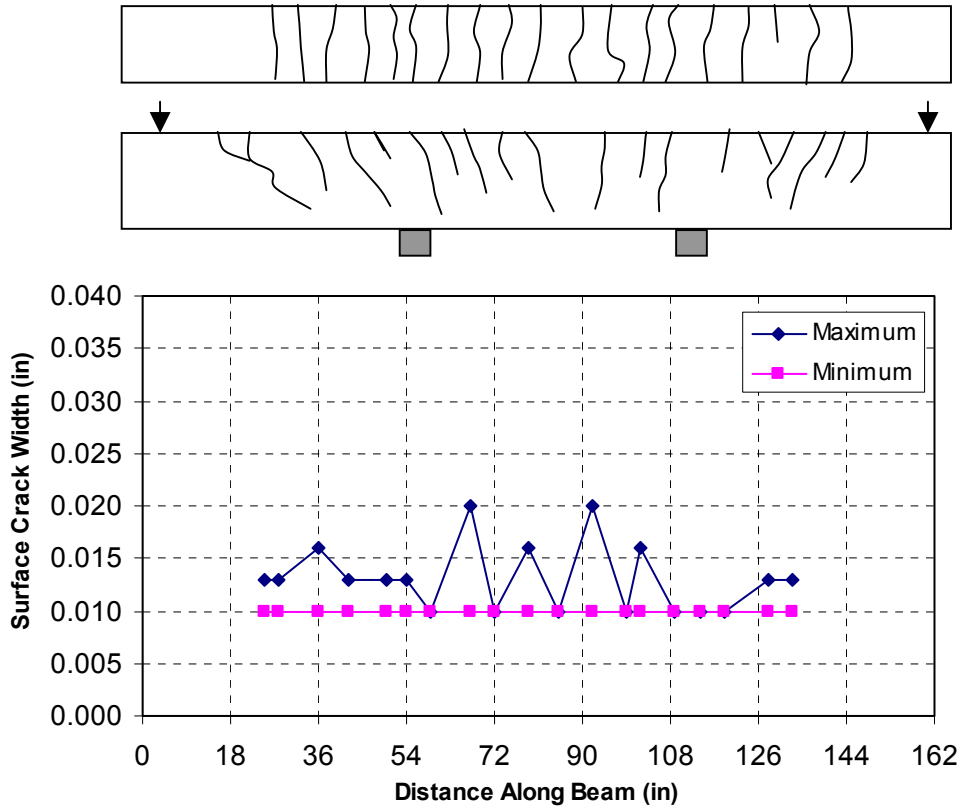
**Figure C7: Final Crack Pattern and Measurements – Beam 1.5**

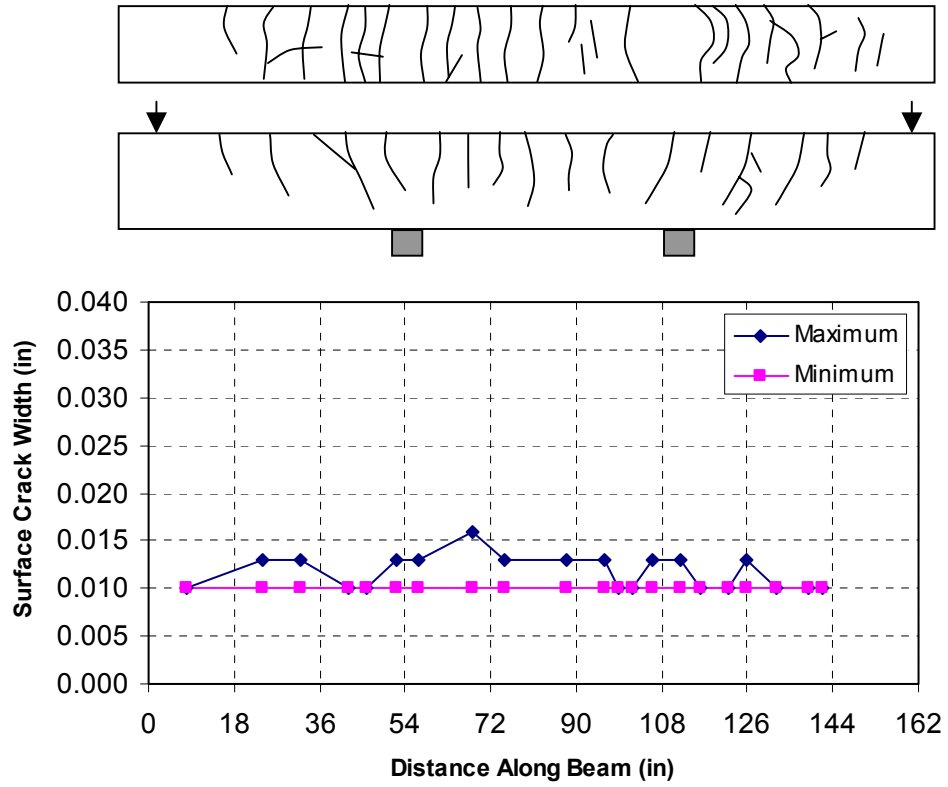
**Figure C8: Final Crack Pattern and Measurements – Beam 1.6**

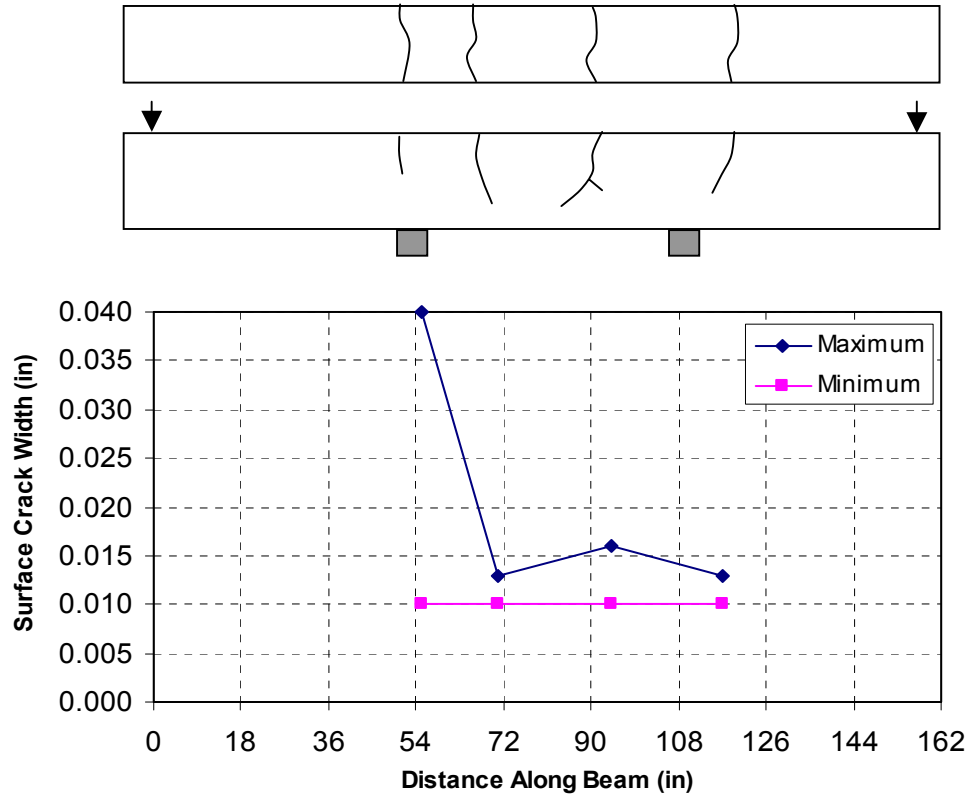
**Figure C12: Final Crack Pattern and Measurements – Beam 3.7**

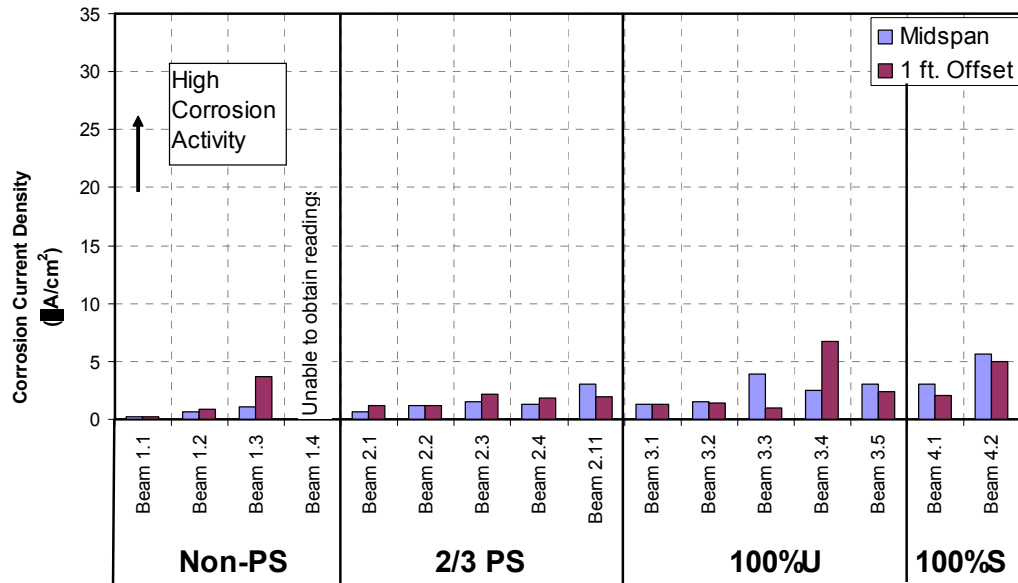
***D17: Phase I Beams - Measured Corrosion Rates  
(Seven Month Exposure Duration - PR Monitor Equipment)***

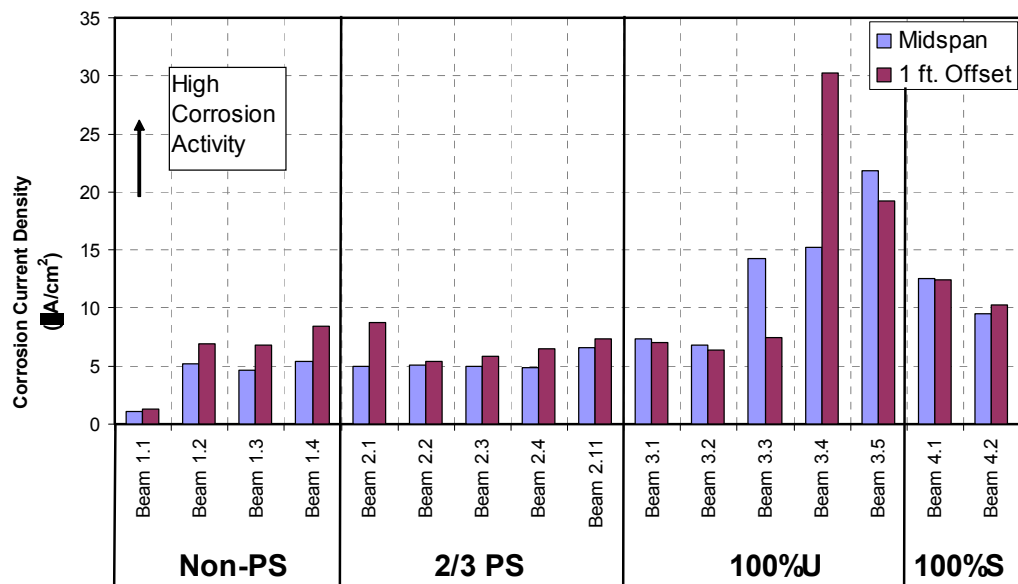
***D18: Phase I Beams - Measured Corrosion Rates  
(Twelve Month Exposure Duration - 3LP Equipment)***

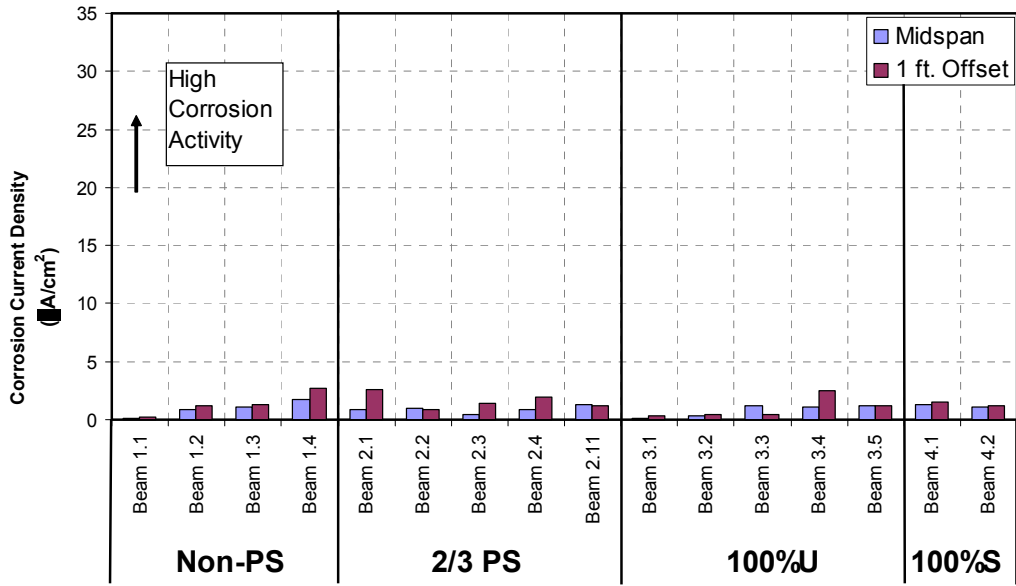
***D19: Phase I Beams - Measured Corrosion Rates  
(Fifteen Month Exposure Duration - PR Monitor Equipment)***

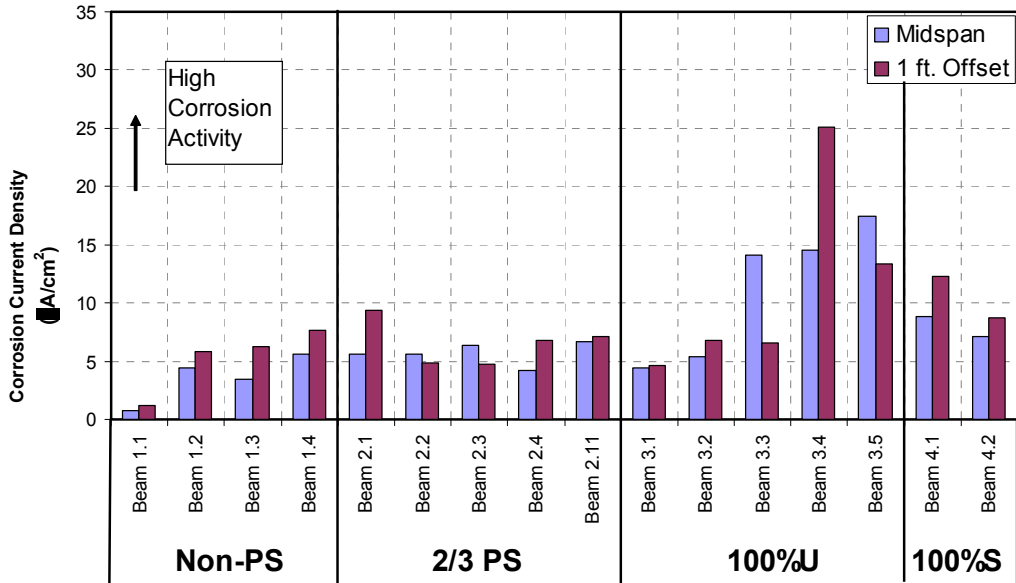
***D20: Phase I Beams - Measured Corrosion Rates  
(Fifteen Month Exposure Duration - 3LP Equipment)***

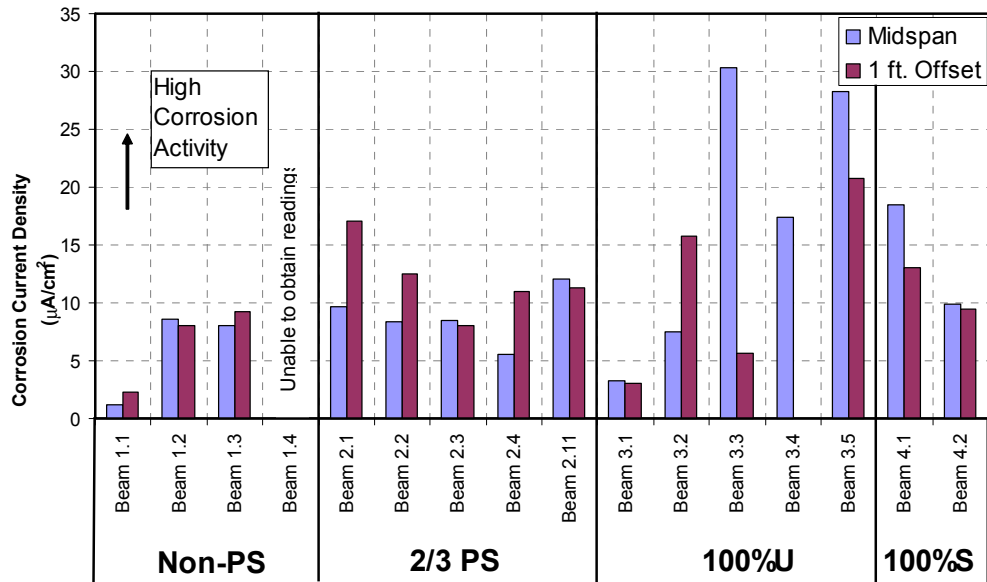
***D21: Phase I Beams - Measured Corrosion Rates  
(47 Month Exposure Duration – 3LP Equipment)***

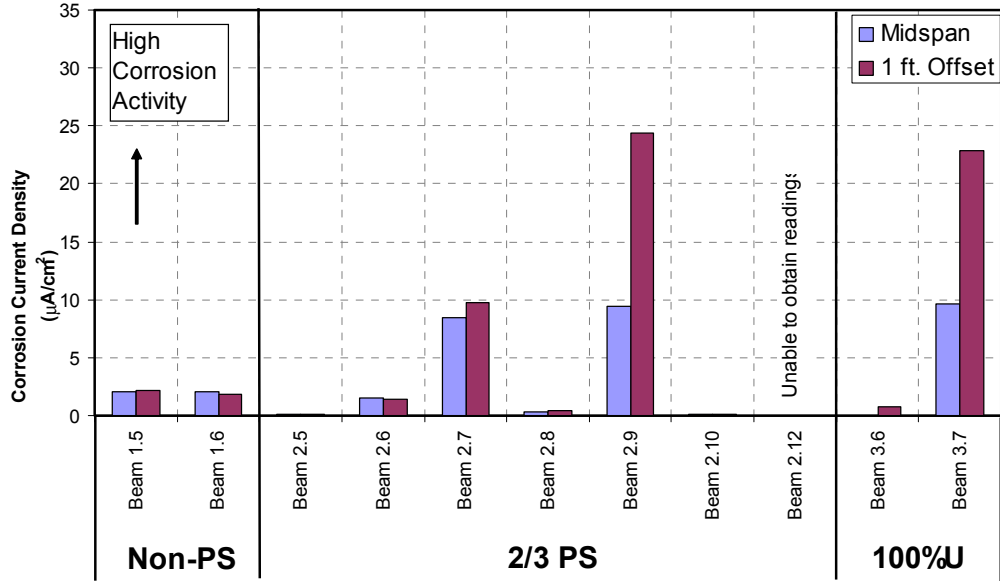
***D22: Phase II Beams - Measured Corrosion Rates  
(35 Month Exposure Duration – 3LP Equipment)***

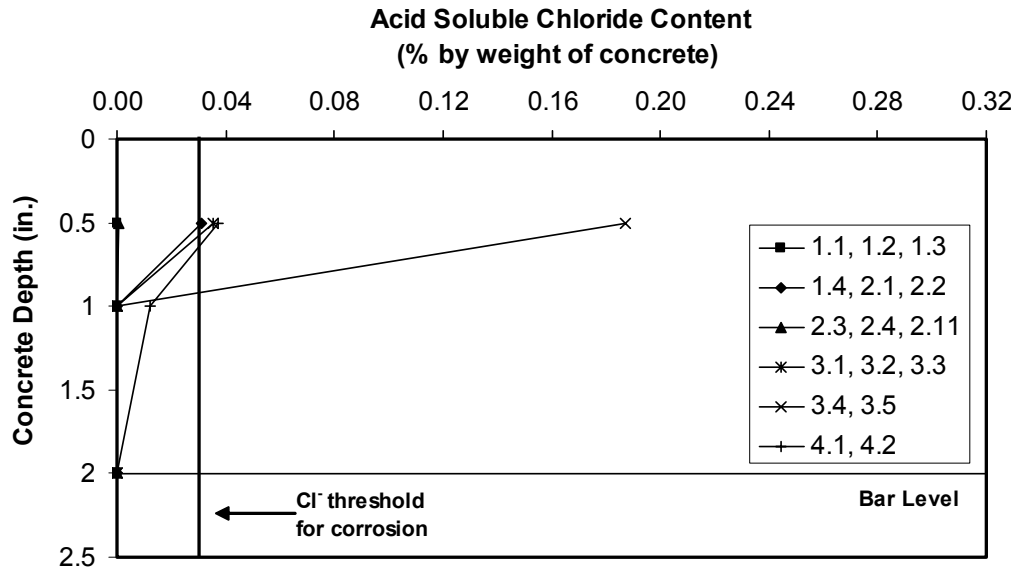
*Figure D23: Block Chloride Penetration at 7 Months  
(Phase I Ponded Block Specimens)*
