**SEISMIC PERFORMANCE OF LINK-TO-COLUMN
CONNECTIONS IN STEEL ECCENTRICALLY BRACED FRAMES**

Dissertation

The University of Texas at Austin

December, 2004

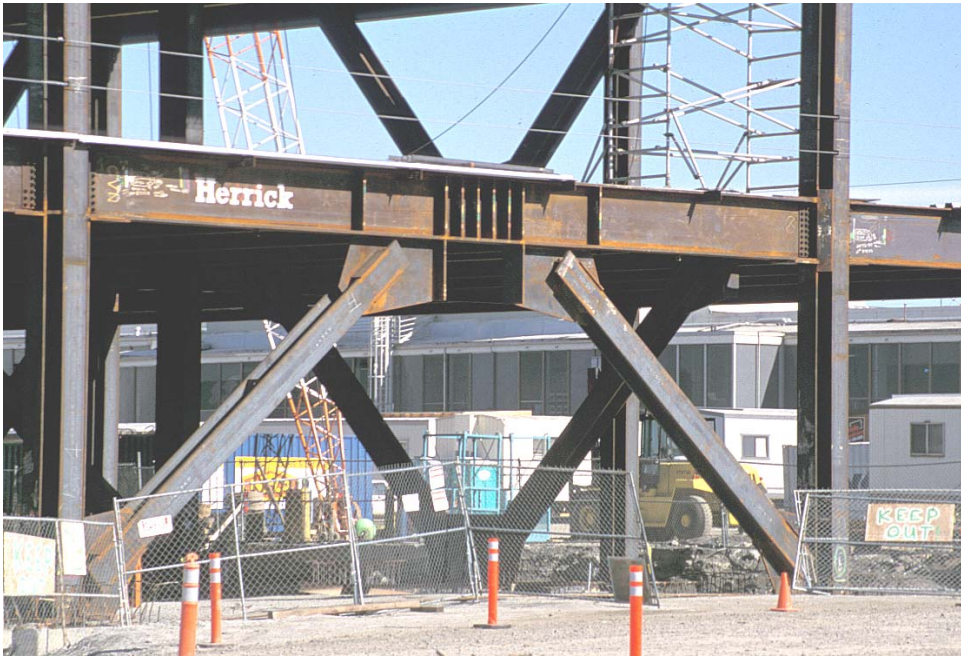
Figure 1.1 Example of recently constructed EBF

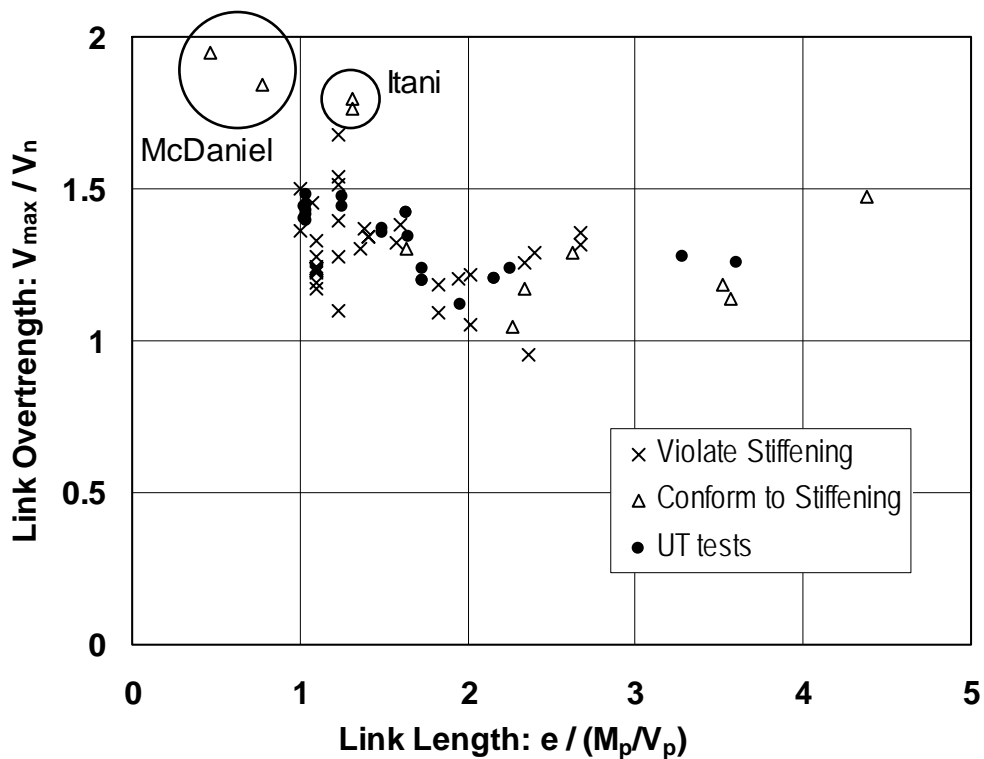
Figure 2.6 plots the relation between the link overstrength, V_{\max}/V_n , and non-dimensional link length, $e/(M_p/V_p)$. The same database used for Figure 2.5 is used, except that the links with a composite slab tested by Ricles and Popov (1987b; 1989) are excluded. Figure 2.6 suggests that, in the link length range of $e < 2M_p/V_p$, link overstrength tends to increase with decreasing link length. The lower overstrength factor for intermediate links is attributed to shear-moment interaction (Engelhardt and Popov 1989a). In the range of $M_p/V_p < e < 2.7M_p/V_p$, where comparative test data are available, no clear correlation can be drawn

Figure 2.6 Link overstrength

between the link overstrength and stiffening criteria. It is possible that prior to strength degradation induced by flange and/or web buckling, specimens violating the current stiffening criteria had already developed much of their inherent overstrength capacity.

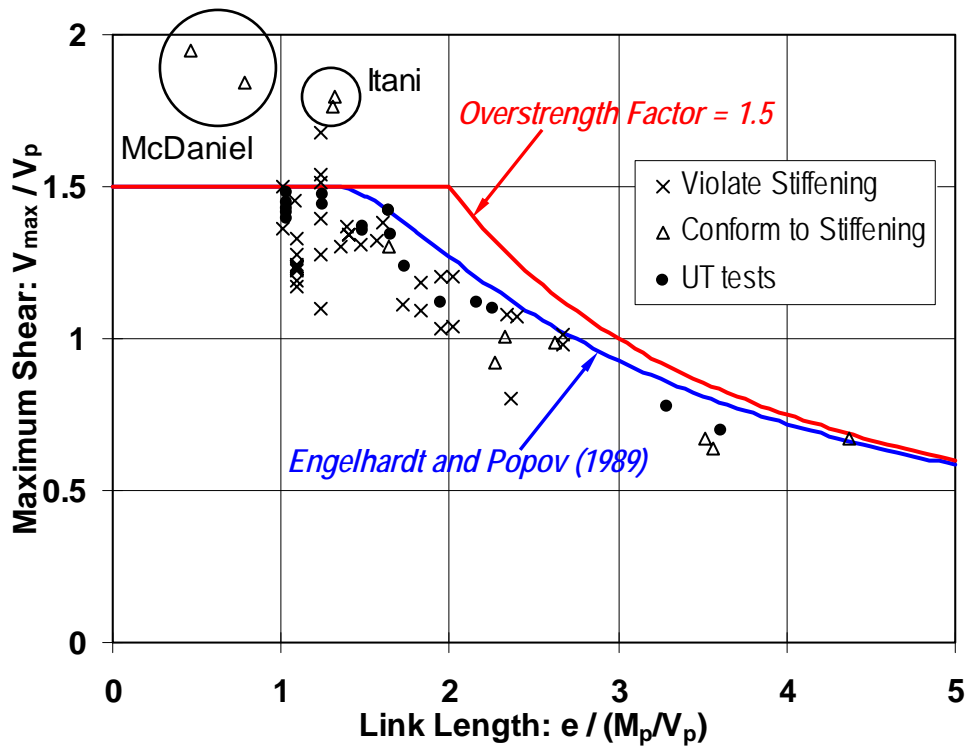
Figure 2.7 plots the relation between maximum link shear and link length. The same dataset used for constructing Figure 2.6 is used. The two solid lines represent the overstrength factor evaluated as $1.5V_n$, as implied in the *2002 AISC Seismic Provisions*, and the theoretical link strength proposed by Engelhardt and Popov (1989a). Comparison of the two lines suggests that the theoretical strength incorporating shear-moment interaction provides a better estimation than the overstrength factor defined in the *Provisions*. The increase in shear strength with decrease in length for links shorter than $2M_p/V_p$ is well accounted for by the theoretical correlation, except for the very high overstrength observed in large built-up sections (Itani *et al.* 1998, 2003; McDaniel *et al.* 2003). The theoretical strength depends on the assumed ratio between ultimate stress and yield stress (a ratio of 1.5 is assumed for both normal stress and shear stress in Figure 2.7), and assumes that no shear force is carried by the flanges. The second assumption can be false for built-up sections with relatively thick flanges and thin webs. Figure 2.7 also shows that the *Provisions* are likely to give conservative overstrength factors for links of near $e = 2M_p/V_p$ as a result of neglecting significant shear-moment interaction in this length range.

Figure 2.7 Link maximum shear strength

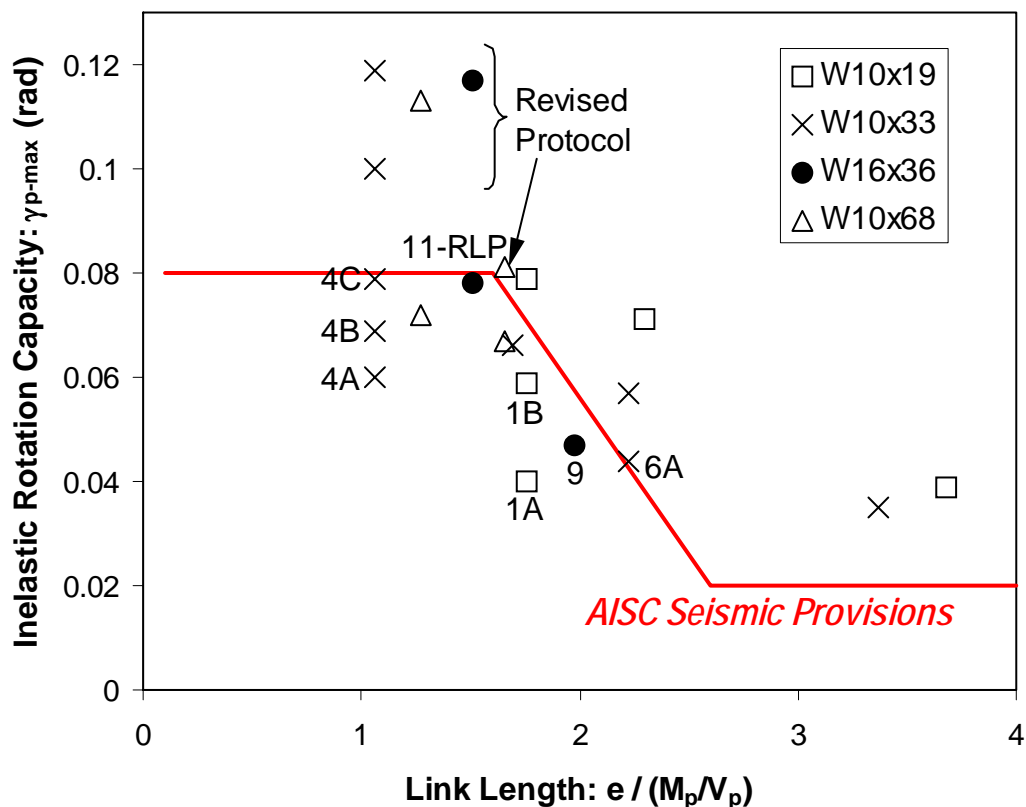
Figure 2.8 summarizes the test results, by plotting the inelastic rotation capacity, γ_{p-max} , against the normalized link length, $e/(M_p/V_p)$. The inelastic rotation angle required in the *2002 AISC Seismic Provisions* is shown in a solid line. Failure of the link was defined as the point when the specimen failed to maintain shear force corresponding to 80% of the maximum magnitude achieved

Figure 2.8 Test results from Arce (2002) and Ryu et al. (2004)

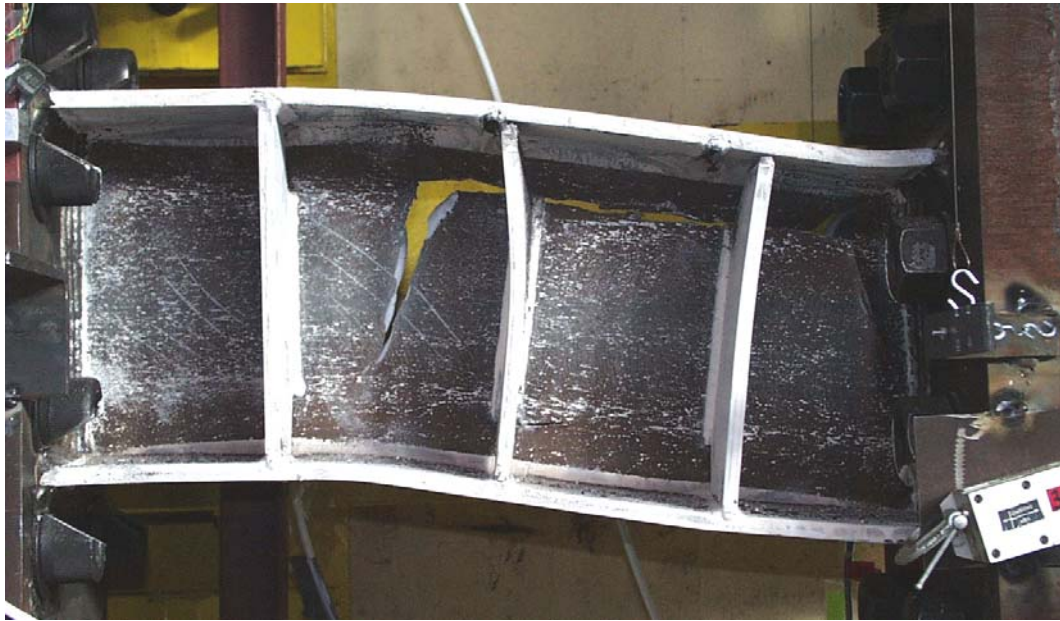
Figure 2.9 Specimen 4B after test (Arce 2002)

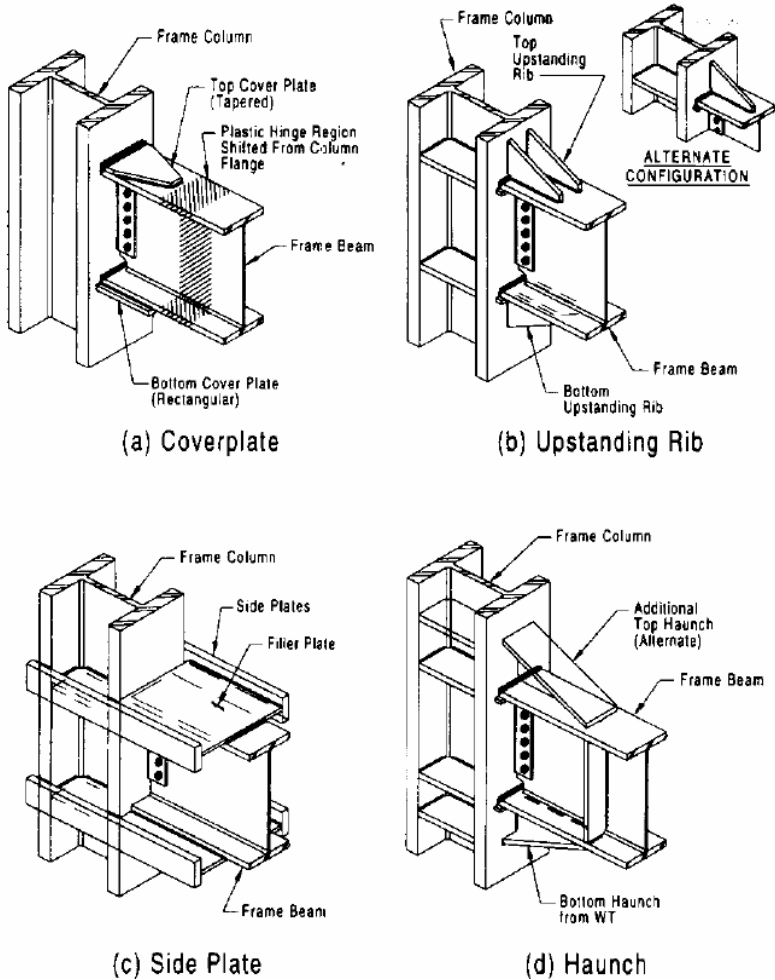
Figure 2.15 Examples of connection reinforcement (from Engelhardt and Sabol 1998)

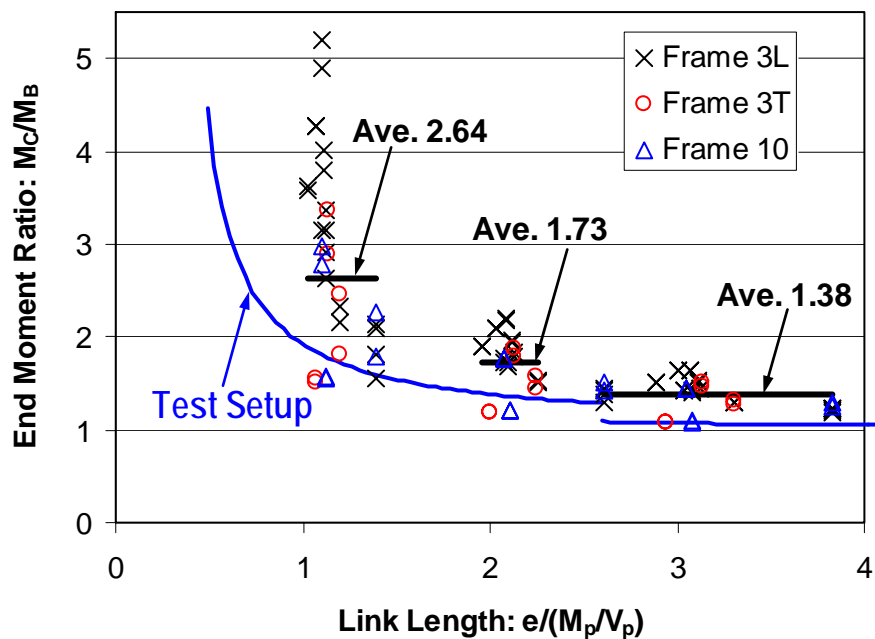
A series of 2-D elastic frame analyses were conducted on sample EBFs to study the range of realistic link end moment ratios. In these analyses, rigid beams with length equal to half the depth of the column section were inserted between links and columns to represent the column panel zones. Lateral loads were applied at each story level, with magnitude increasing proportionally with height. All other loads were neglected. Results of the analyses are shown in Figure 2.23. The figure plots the end moment ratio for all links in the frames against their non-dimensional length. The notations, 3L, 3T, and 10, correspond to three frames, two three-story frames and one ten-story frame, presented by Richards and Uang (2003). All links in the original frame analyzed by Richards and Uang were shear links. The link length in each original frame was altered to generate three frames with intermediate links, and another three frames with all moment links. The

Figure 2.23 End moment ratios estimated from elastic frame analyses.

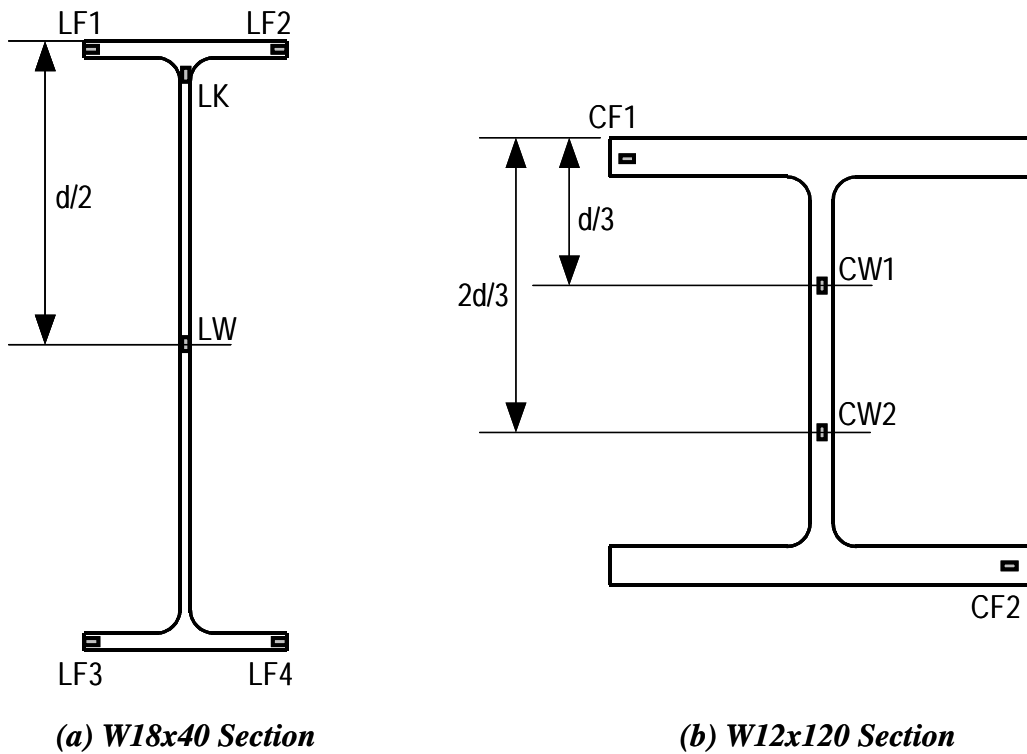
Figure 3.16 Tension coupon locations

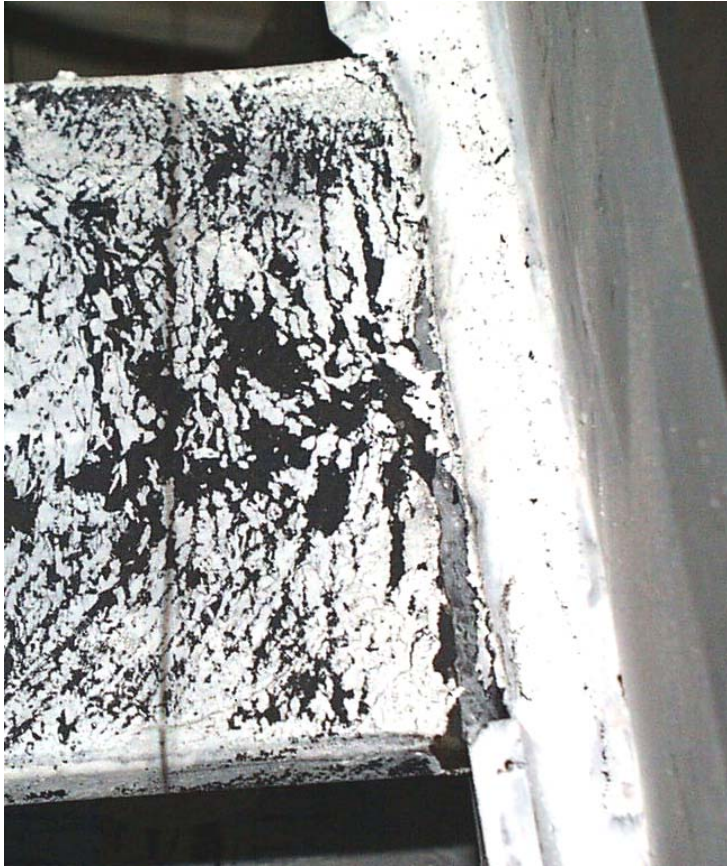
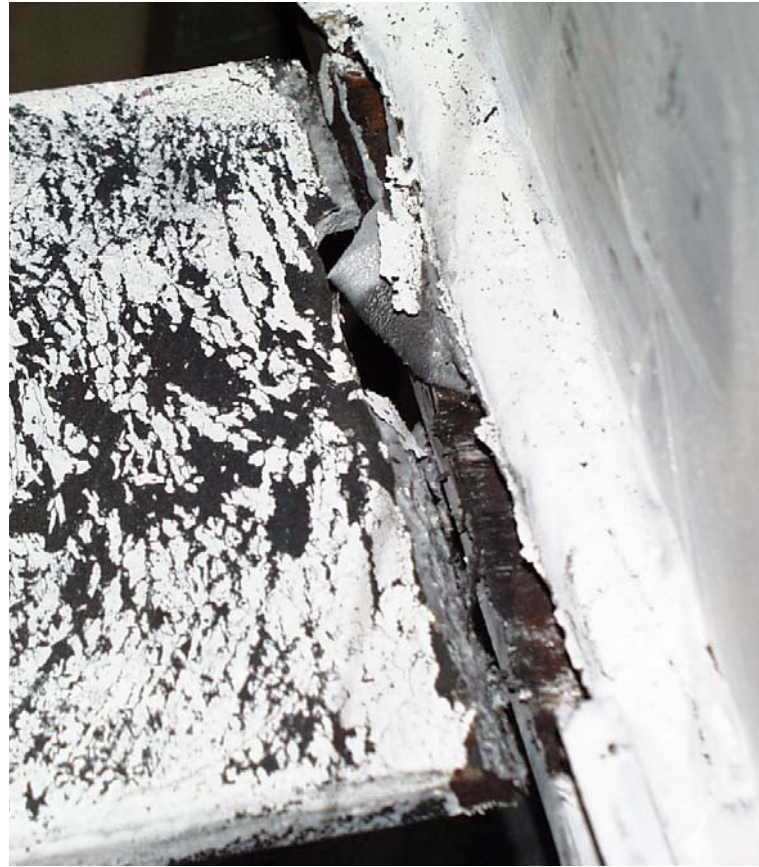
(a) Fracture in link top flange (0.03-2P)

(b) Link top flange separated from column flange (0.04-1P)

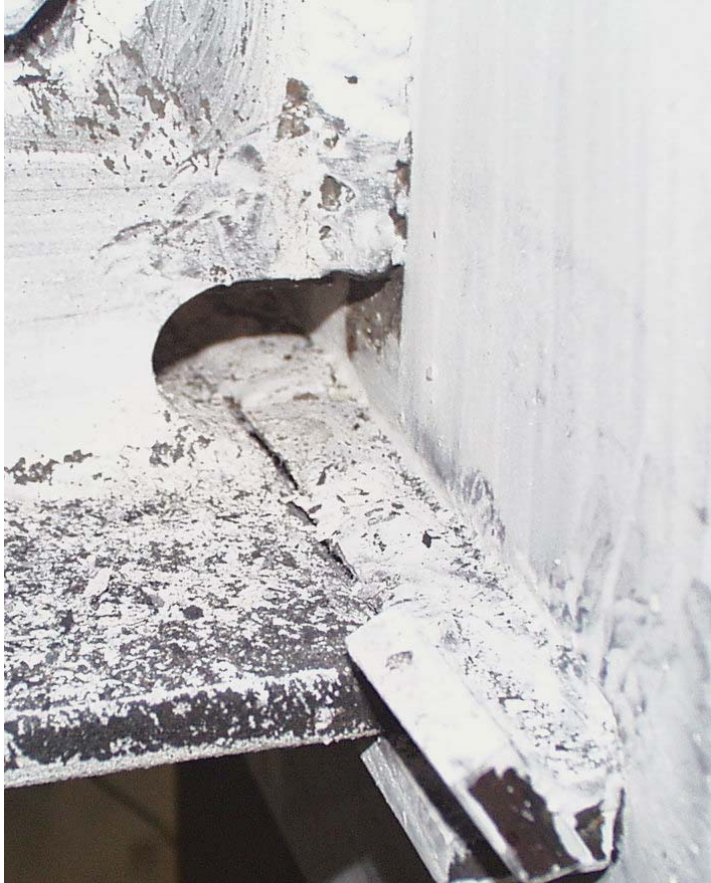
(a) Fracture in link bottom flange (0.02-2N)

(b) Link-to-column connection after test

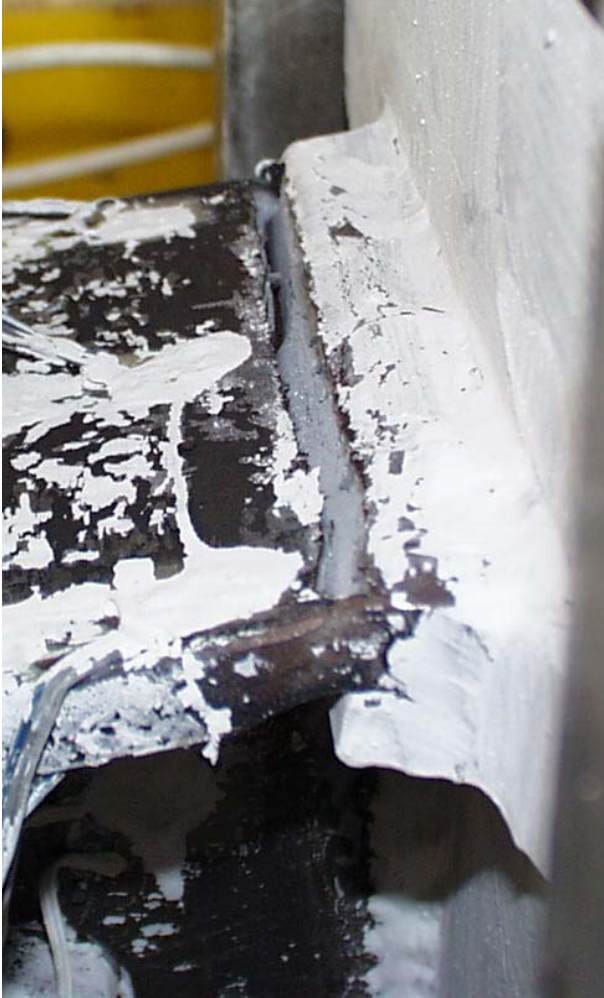
Figure 4.10 Photographs of Specimen MWS (Continued):
(c) (Left) Link top flange separated from column face (0.07-2P);
(d) (Above) Link after test

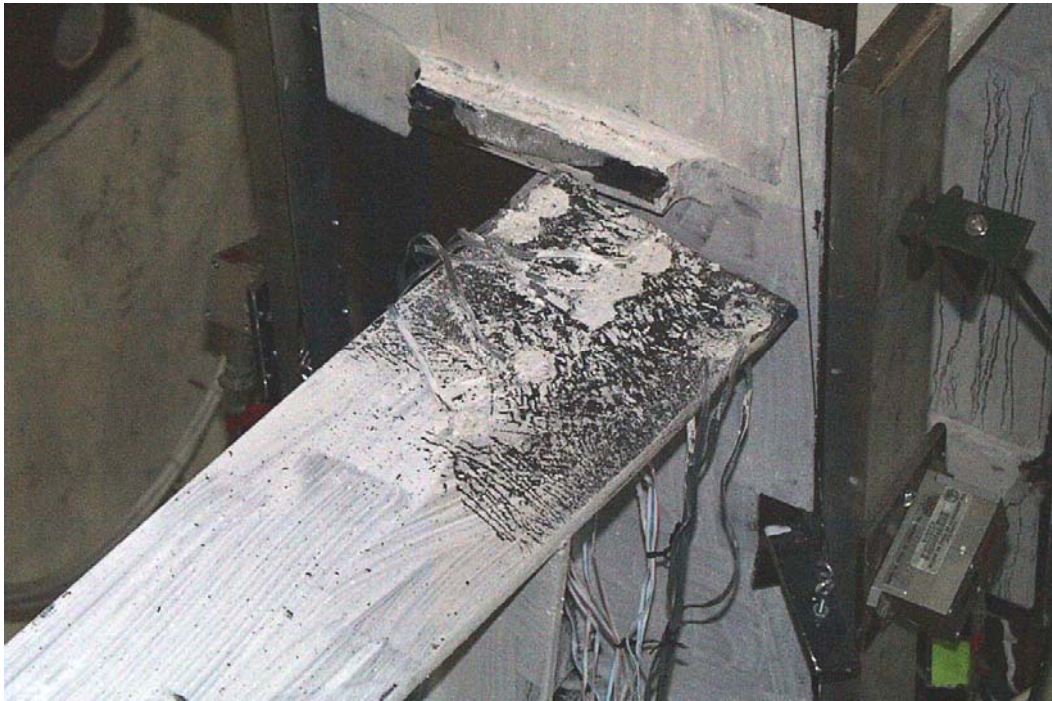
(c) Torsional deformation of link viewed from above the link (0.04-2N)

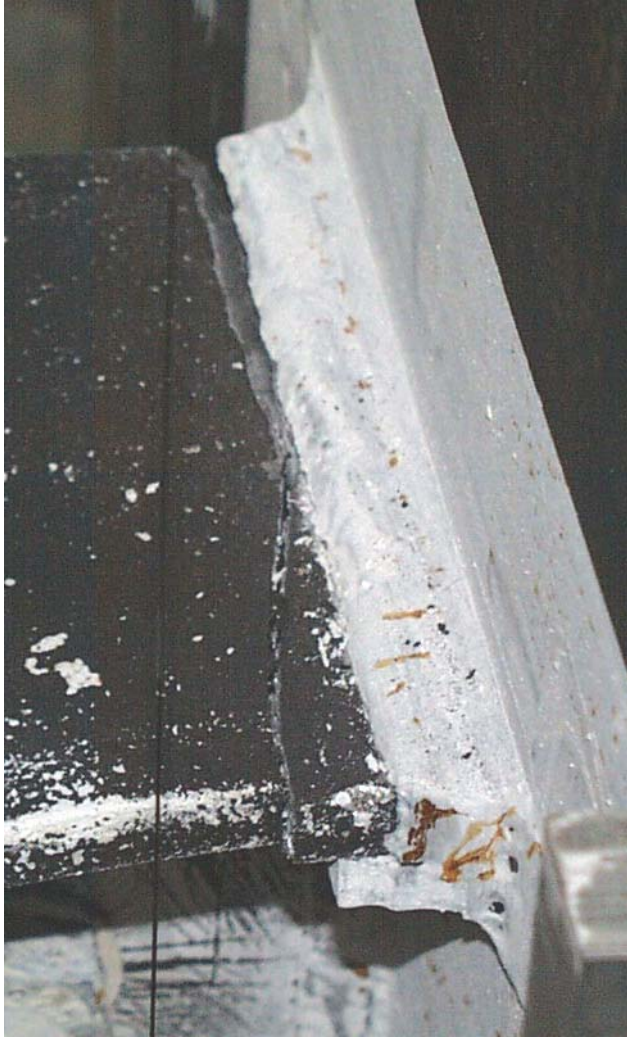
Figure 4.20 Photographs of Specimen FFI (Continued):
(c) (Left) Link top flange separated from column flange (0.06-2P); (d) (Above) Link-to-column connection after test

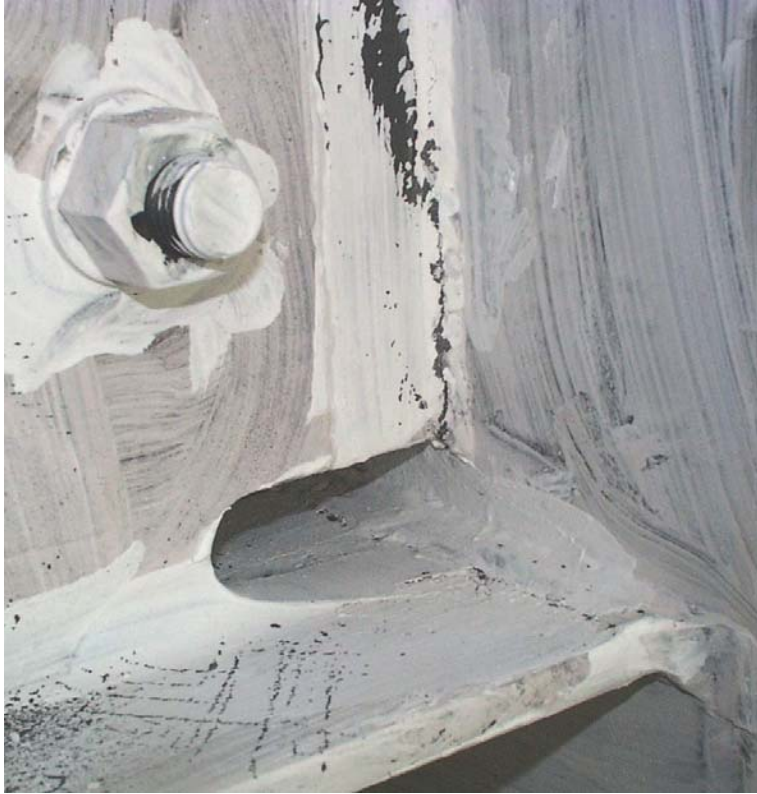
Figure 4.24 Photographs of Specimen FFS-RLP
(Continued):
(c) (Above) Fracture in bottom edge of shear tab weld
(0.04-1N); and (d) (Right) Link-to-column connection
after test

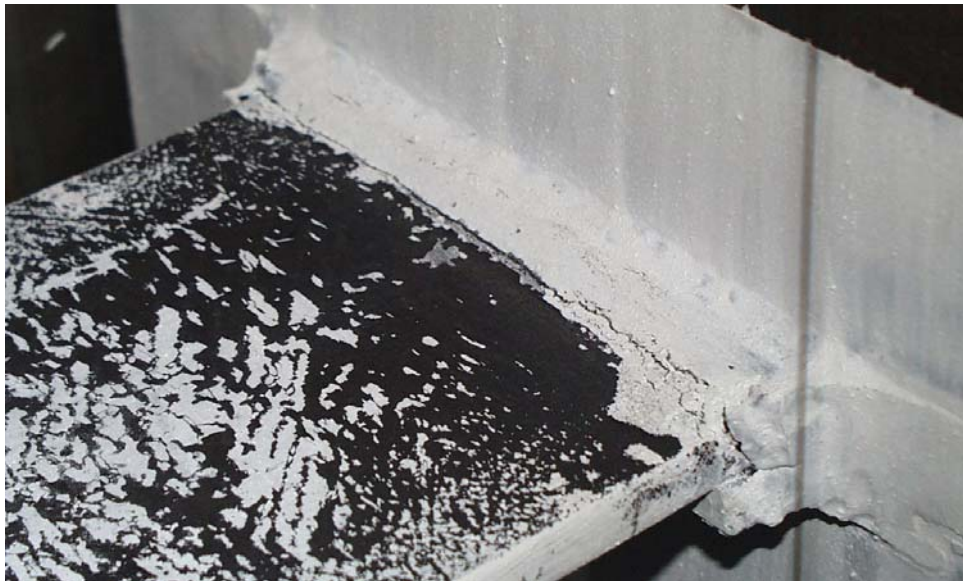
(a) Horizontal fracture in link web (0.09-1P)

(b) Fracture in link top flange (after test)

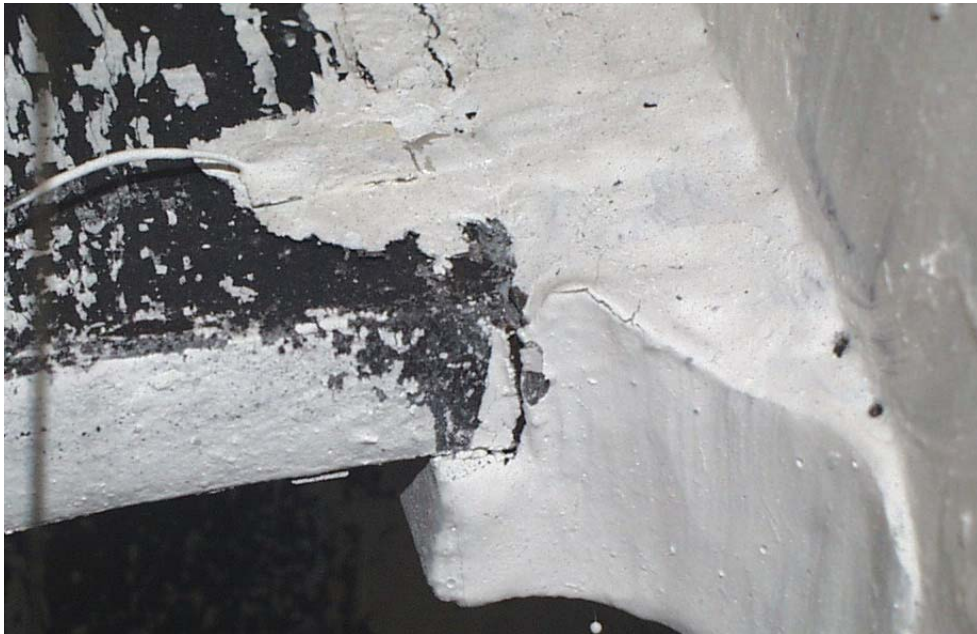
(b) Fracture initiation at west edge of top flange (0.13-1P)

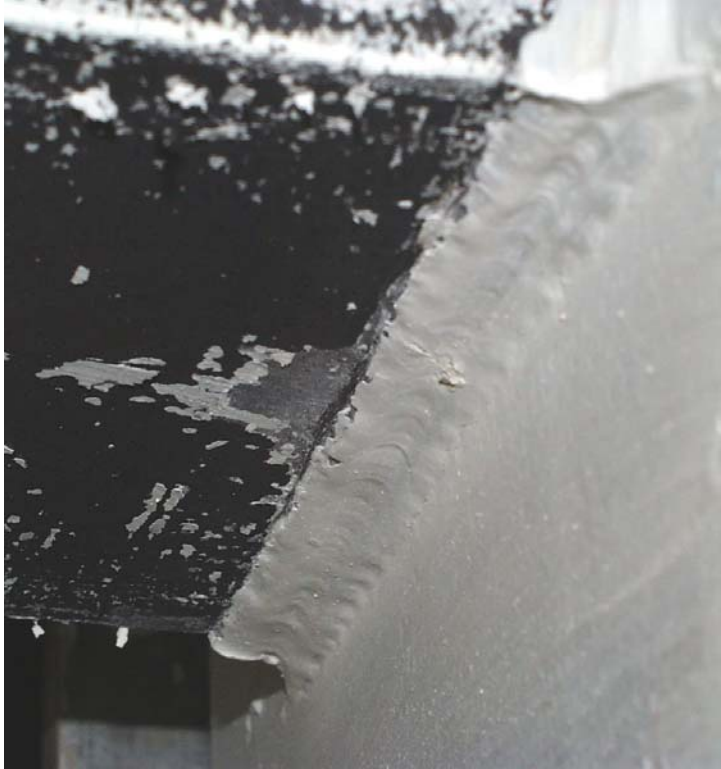
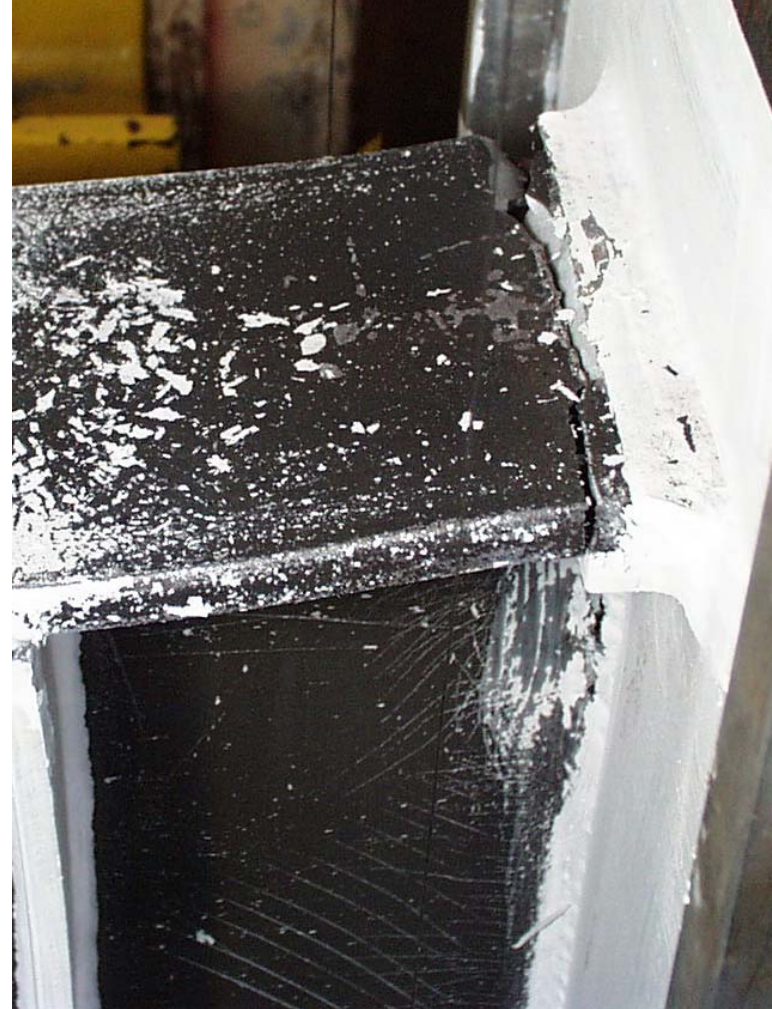
Figure 4.37 Photographs of Specimen NASL-RLP:
(a) (Above) Fracture across link bottom flange (0.07-1N); and (b) (Right) Link top flange separated from column flange (0.09-1P)

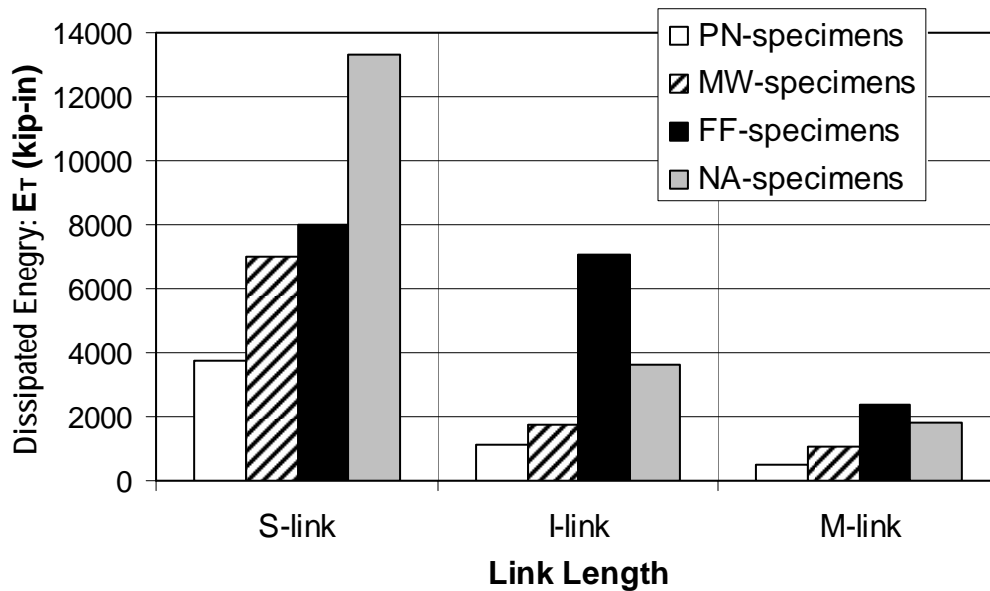
Figure 5.4 illustrates the relation between the link length and dissipated energy, E_T . Only the twelve specimens tested under the AISC loading protocol are included in this figure. The figure indicates that shorter shear links are significantly more efficient energy dissipating elements than longer moment links. S-links dissipated roughly twice the energy dissipated by I-links with the same connection type; I-links dissipated twice the energy dissipated by M-links with the same connection type. In terms of dissipated energy, Specimen NAS performed the best for S-links, out-performing the other specimens by 70 to 250%. Specimen FFI performed the best for I-links, out-performing the other specimens by 90 to 500%. For M-links, Specimen FFM performed somewhat better than Specimen NAM. The PN-specimens performed the poorest for all link lengths, dissipating only a quarter or less energy of the best performing specimen. The MW-specimens dissipated roughly twice the energy dissipated by the PN-specimens with the same link lengths. With the exception of Specimen FFS, all FF- and NA-specimens dissipated twice or more energy than the corresponding PN- and MW- specimen with the same link lengths.

Figure 5.4 Dissipated energy

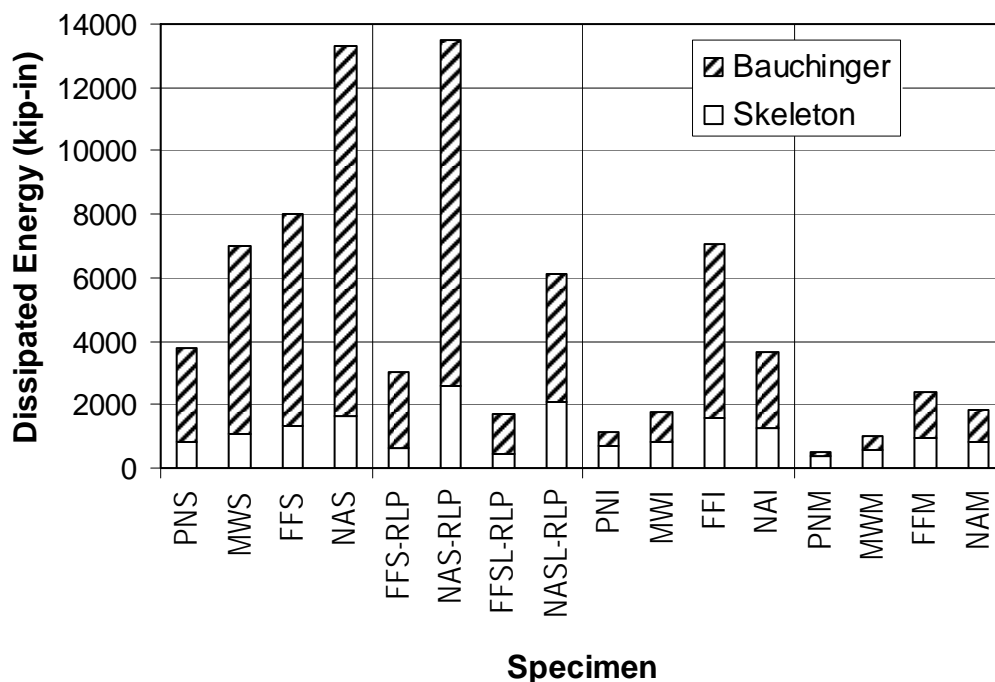
Figure 5.10 illustrates the dissipated energy decomposed into the skeleton and Bauschinger components. The skeleton energy represents the energy dissipated by an equivalent monotonic loading curve, while the Bauschinger energy represents the energy dissipated through fatigue cycles, without generating any strain hardening. For a monotonic loading case, $E_B = 0$, and hence, $E_T = E_S$. Figure 5.10 shows that the Bauschinger energy decreases drastically with link length, and increases moderately with dissipated energy. The skeleton energy

Figure 5.10 Skeleton energy and Bauschinger energy

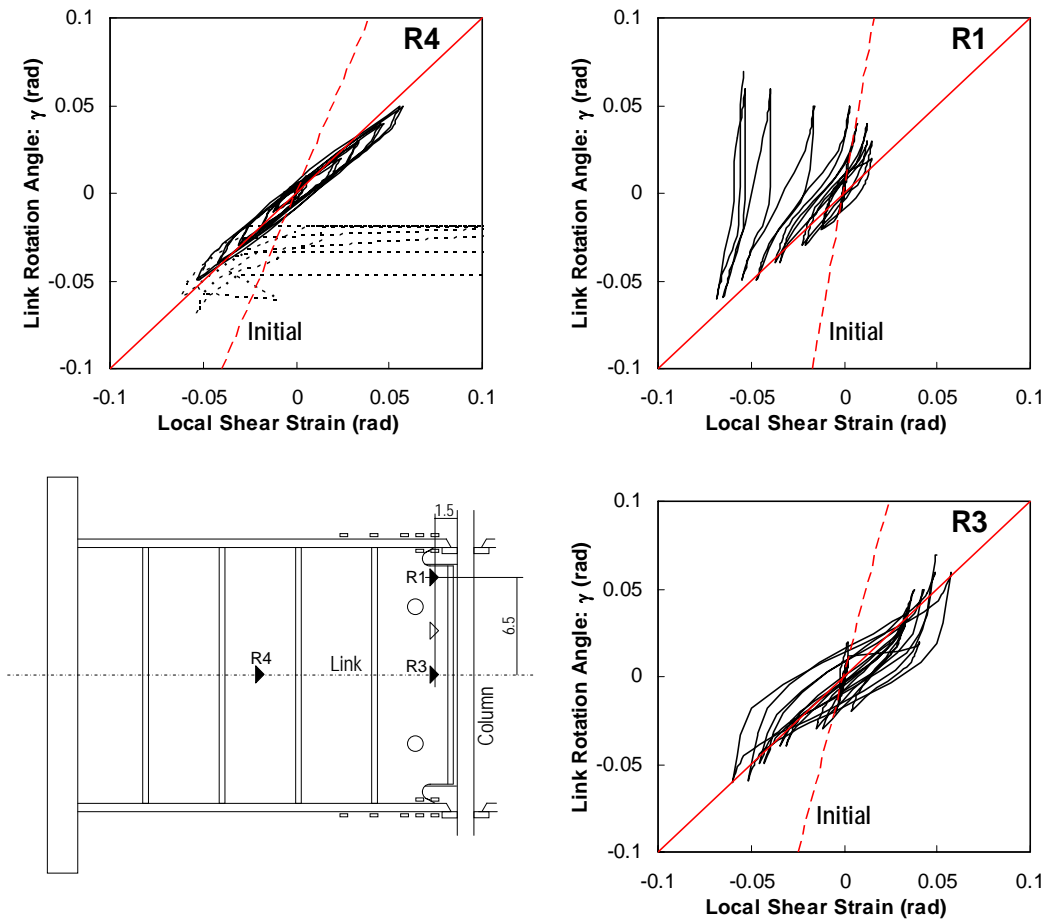
Figure 5.25 shows the hysteretic relation between the link rotation angle, γ , and shear strain measured at three locations in the link web of Specimen MWS. The three strain gauges are indicated in the figure. Should the link deform solely in shear, and shear deformation be distributed uniformly in the entire depth of the link web, the shear strain measured at any point in the link web would be equal to the link rotation angle. The solid line in the figure corresponds to such uniform shear. The hysteresis is included up to the last completed half cycle.

Figure 5.25 Shear strain history in Specimen MWS

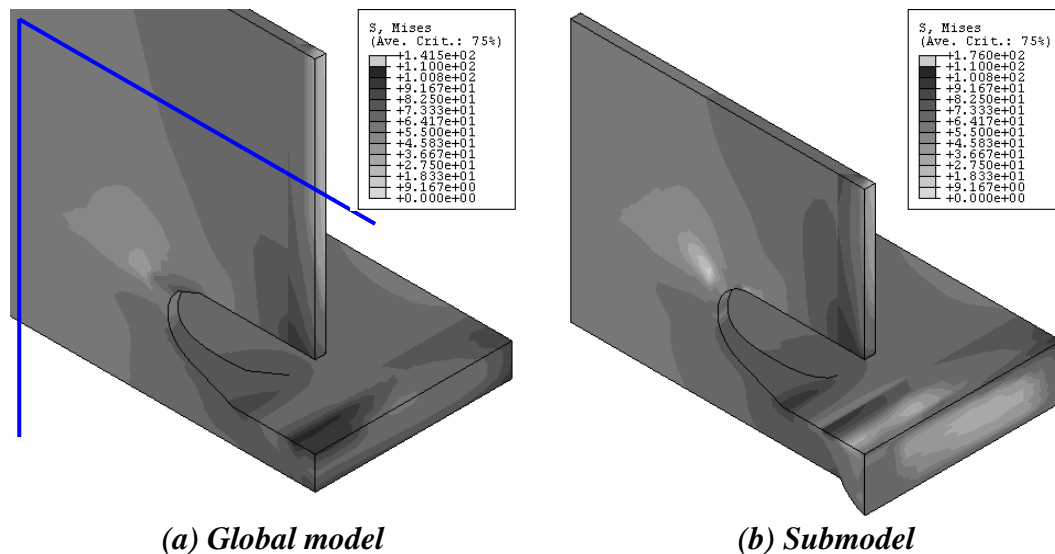
Figure 6.15 compares the Mises stress distribution between the global model and submodel at $\gamma = 0.058$ rad. The stress distribution is shown on the surfaces of the link segment cut by a plane parallel to the link web. The boundary that drove loading of the submodel is indicated in the global model (see Figure 6.15a) by solid lines. As in Figure 6.14, the Mises stress distribution near the driving boundary agreed well between the submodel and the global model. In all models, elevated Mises stress values are found at the following locations: (a) near the interface of the link flange and the groove weld; (b) the toe of the weld access hole; and (c) the bottom edge of the link web near the interface of the link web and the groove weld. Since fracture of test specimens was frequently observed at these locations, the Mises stress distribution is in line with the test observations. The Mises stress distribution differed significantly between the global model and submodel in the link flange near the face of the column. The submodel, which included the fillet weld (see Figure 6.15b) shows regions with notably lower Mises stresses in the groove weld. The global model (see Figure 6.15a) shows high Mises stresses in the entire groove weld. This difference was likely caused by the presence and absence of the reinforcing fillet weld at the root of the link flange groove weld. Both models show a region of very low Mises stresses near

Figure 6.15 Mises stress distribution in global model and submodel

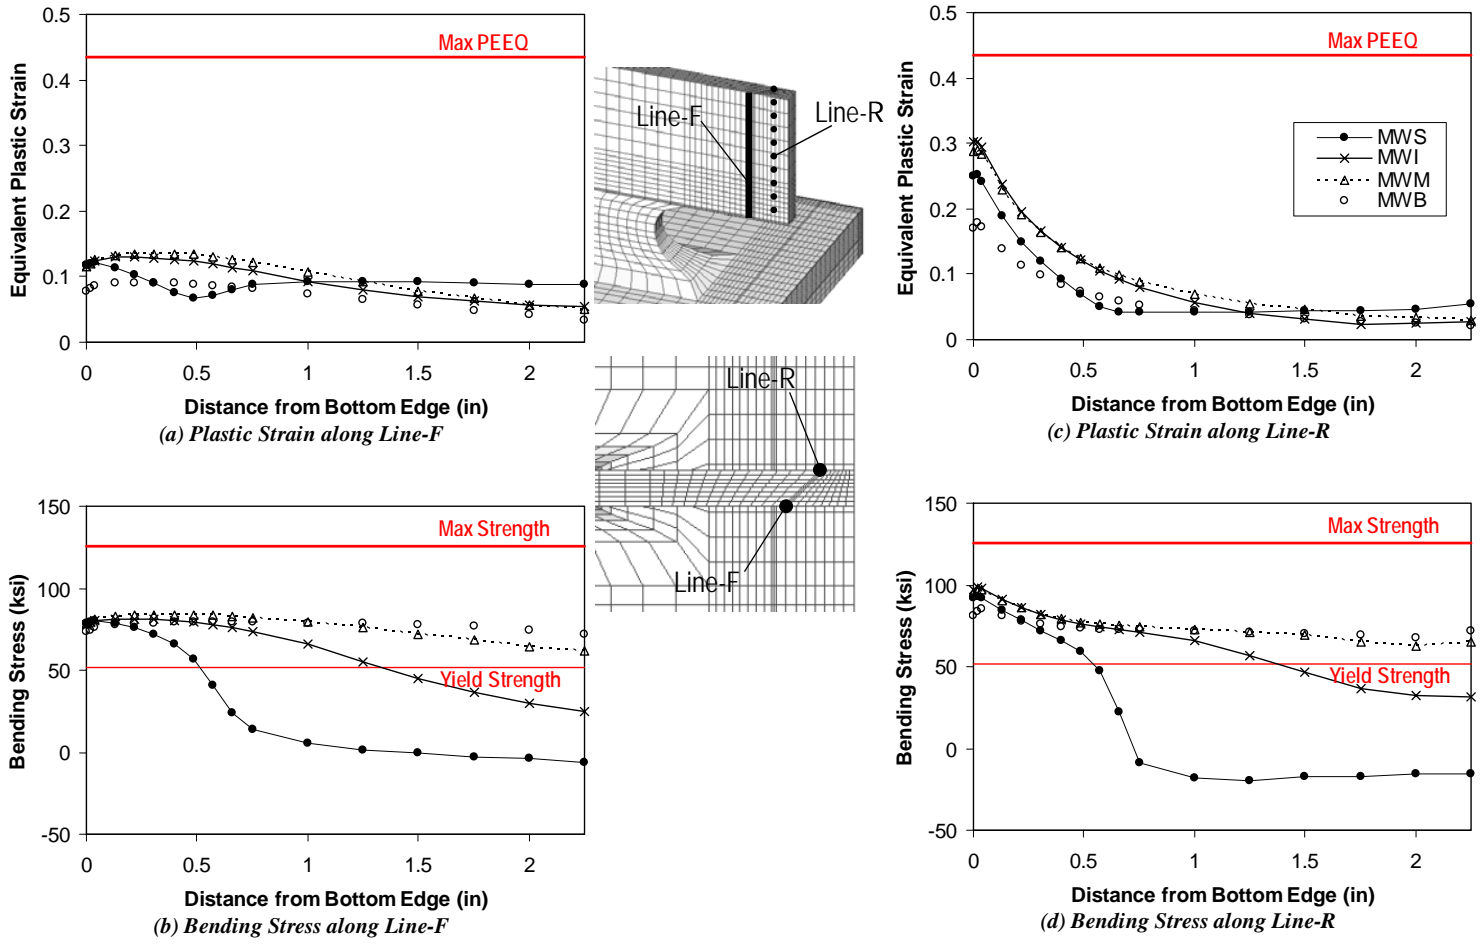
Model MWS shows appreciable bending stress values only in the region within 0.7-inches from the bottom edge of the link web. The remaining region of the link web in Model MWS was controlled by shear yielding. Shear-flexure

Figure 6.24 Effect of link length on the link web-groove weld interface

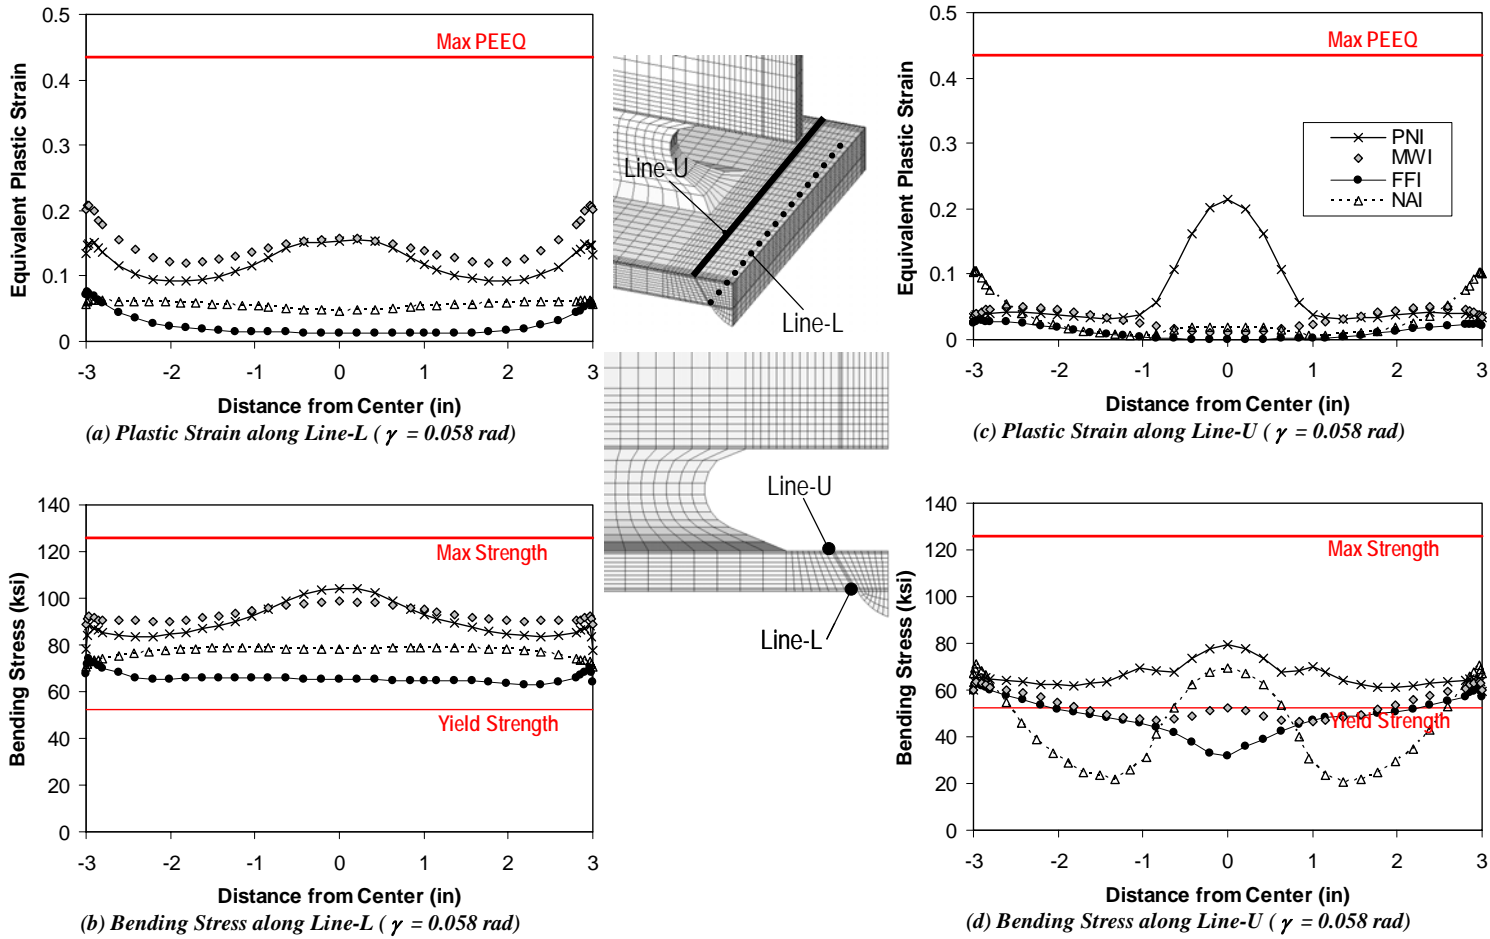
Figure 6.26 compares Models PNI, MWI, FFI, and NAI, at a link rotation of $\gamma = 0.058$ rad. The difference in bending stress values between Lines-L and U was roughly 30 ksi in Models PNI, MWI, and NAI, and 15 ksi in Model FFI. Similar to Model FFS, Model FFI was successful in reducing the link shear transmitted to the link flange, and thereby reduced the secondary bending in the link flange. As discussed above, the PN-connection produces stress and strain concentration in the middle of Line-U, at the toe of the weld access hole. The MW-connection is clearly more beneficial than the PN-connection in removing the large concentration in the middle of Line-U. Elevated equivalent plastic strain and bending stress values are seen at the edges of Line-L in Model PNI, MWI, and FFI, and at the edges of Line-U in Model NAI. The largest equivalent plastic strain values in Models FFI and NAI were roughly one-third of the values in Model PNI and MWI.

Figure 6.26 Link flange-groove weld interface in I-links

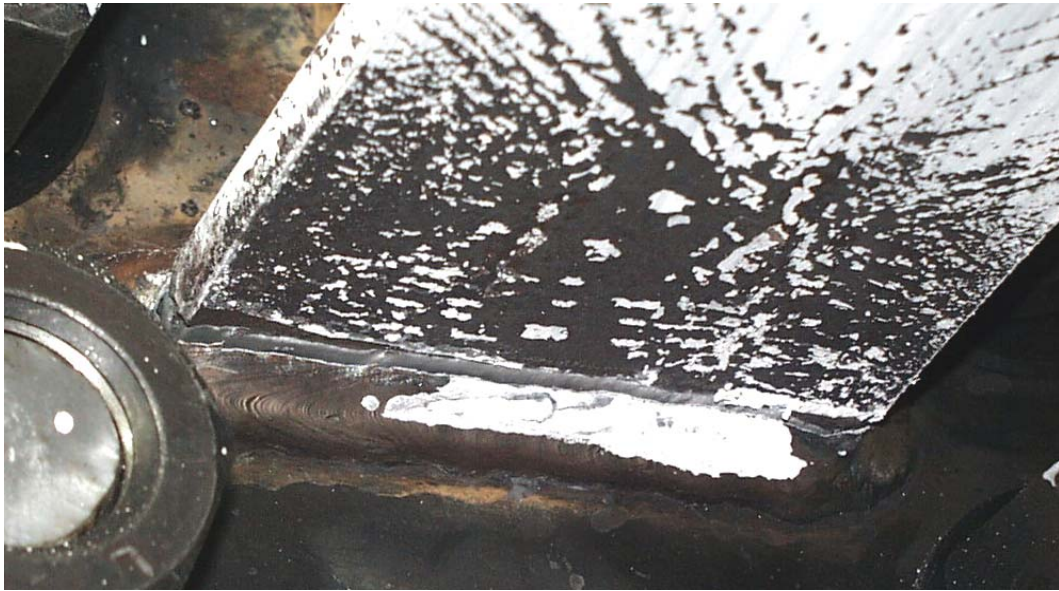
Figure A1 Fracture in Specimen 1A

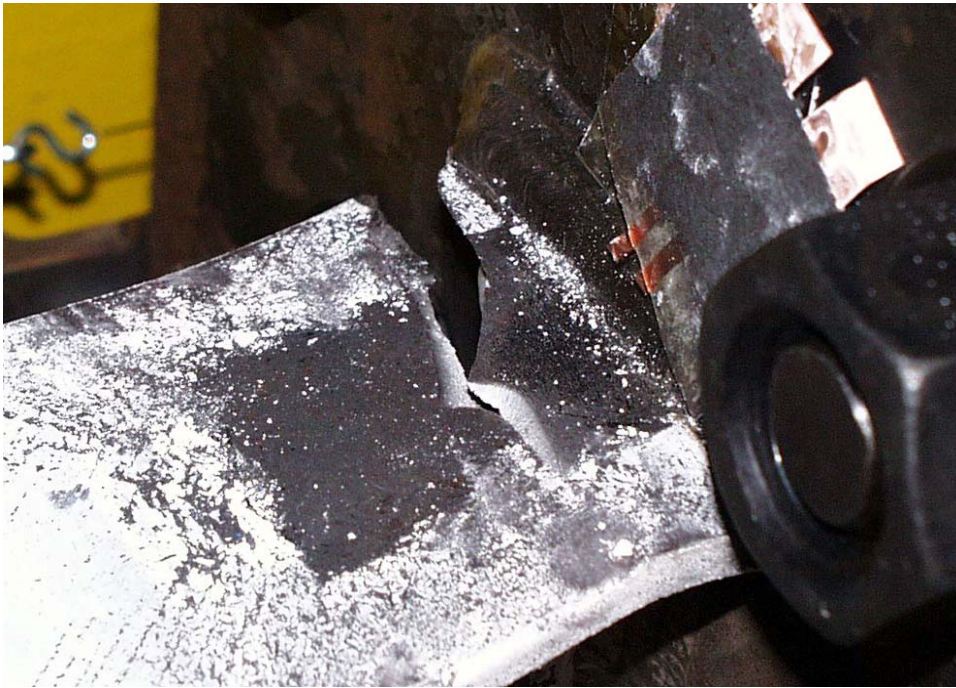
Figure A2 Fracture in Specimen 1B
