**SEISMIC PERFORMANCE OF LINK-TO-COLUMN
CONNECTIONS IN STEEL ECCENTRICALLY BRACED FRAMES**

Dissertation

The University of Texas at Austin

December, 2004

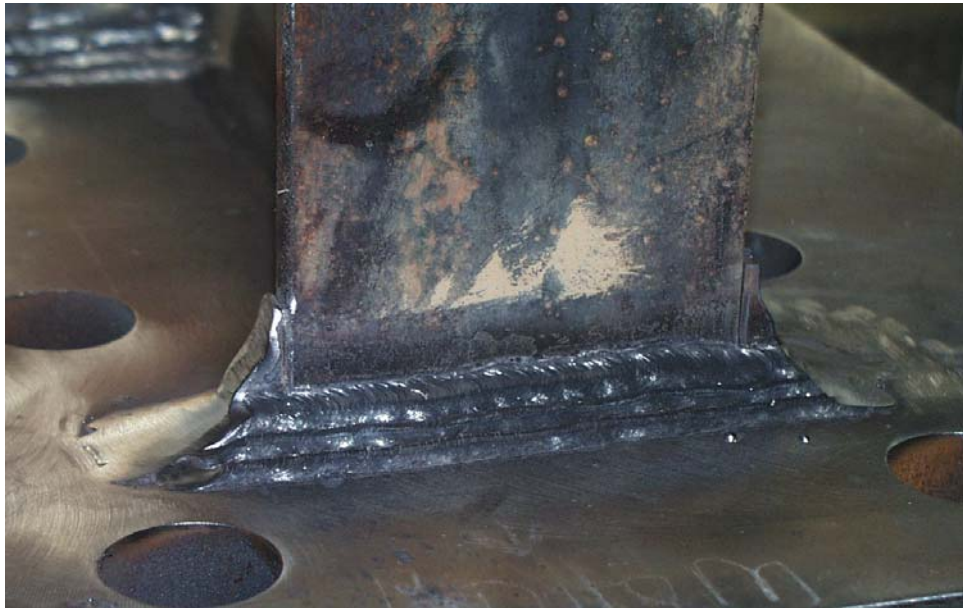
Figure A3 Fillet weld made for Specimen 1C

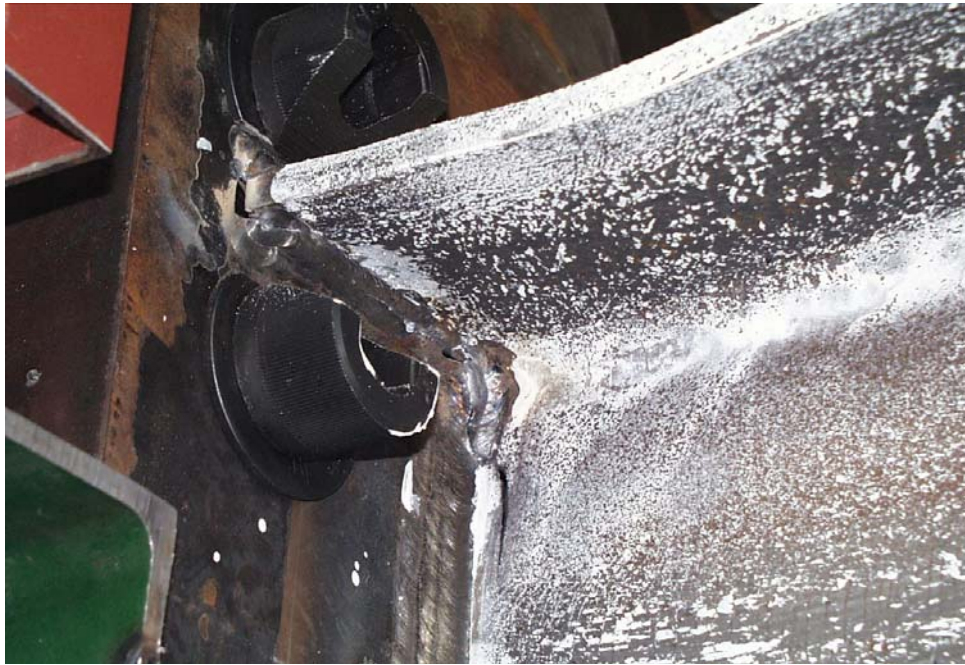
Figure A4 Fracture in Specimen 6A

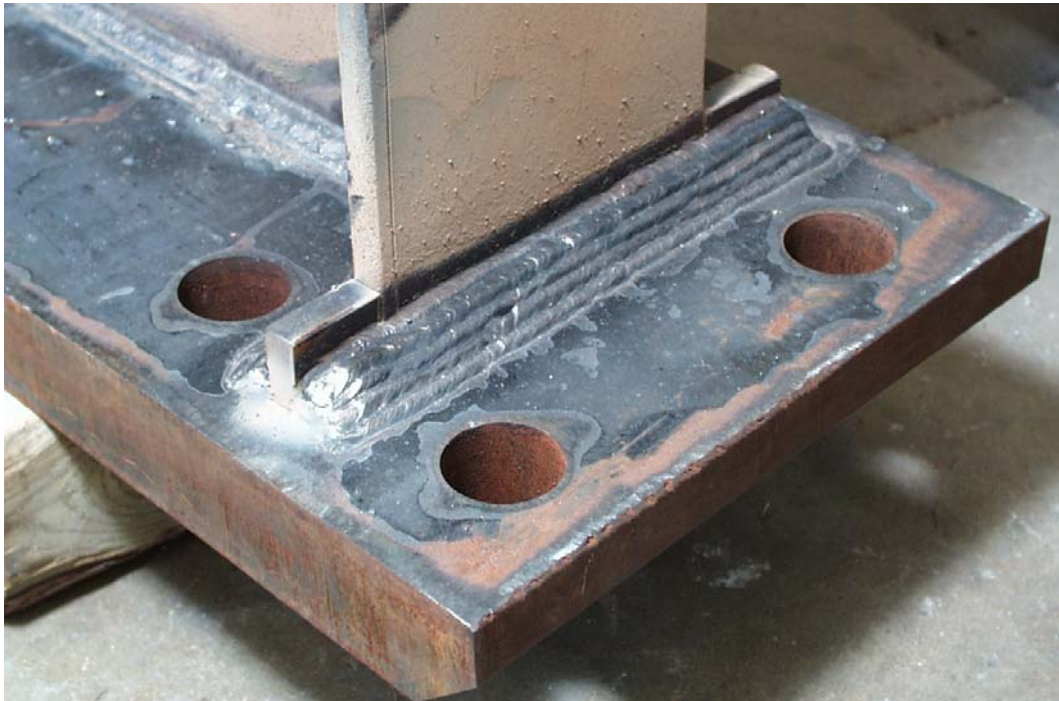
Figure A6 Typical end plate weld (Specimen PNI)

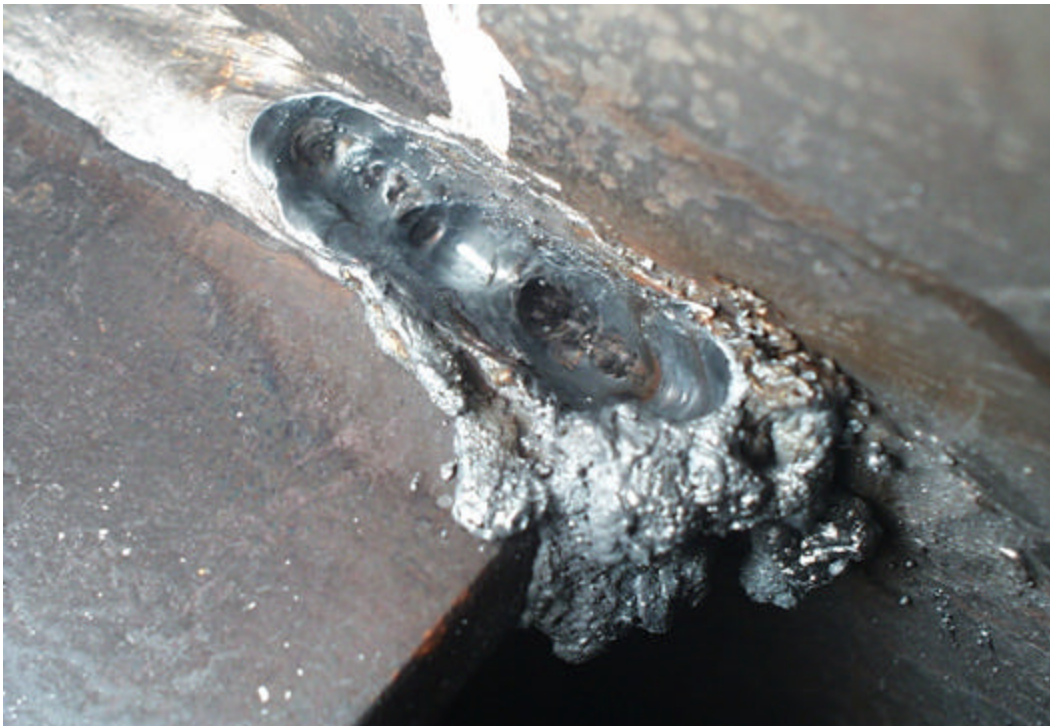
Figure E12 Discontinuity in link top flange of Specimen FFS-RLP
