**Field Tests and Analytical Studies of the Dynamic Behavior and the
Onset of Galloping in Traffic Signal Structures**

Thesis

Presented to the Faculty of the Graduate School of
The University of Texas at Austin
in Partial Fulfillment
of the Requirements
for the Degree of

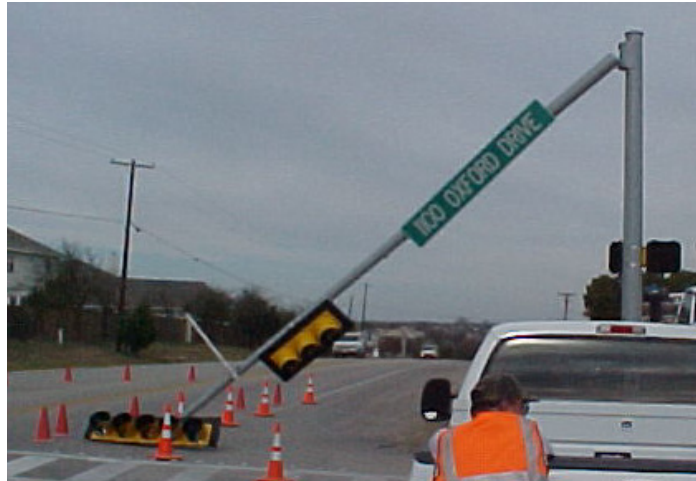
Figure 1.1: Failure of traffic signal structure in Pflugerville

Unpredictable fatigue failures of many cantilever mono-tube traffic signal structures around the country over the past several years have created a need to study traffic signal fatigue behavior. In the state of Missouri, a dozen traffic signal mast arms failed in a recent 5-year period, most of which occurred after only 1 to 2 years in service (Wu et al., 2000). A visual inspection of 840 signal structures in Wyoming determined that over a third of them had fatigue cracks at the pole-to-arm connection, ranging from $\frac{1}{4}$ in to 20 in in length (Hamilton et al., 2000). Texas has also witnessed several recent fatigue failures, including one each in the cities of Pflugerville and Lubbock. The Pflugerville failure can be seen in Figures 1.1 and 1.2. Several studies over the past decade have addressed

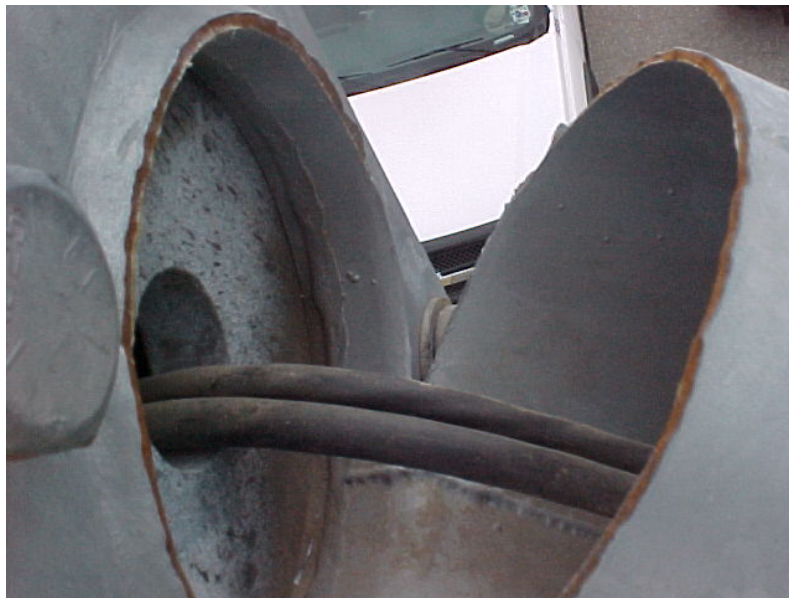
Figure 1.2: Failure due to fatigue crack initiated at top of mast arm

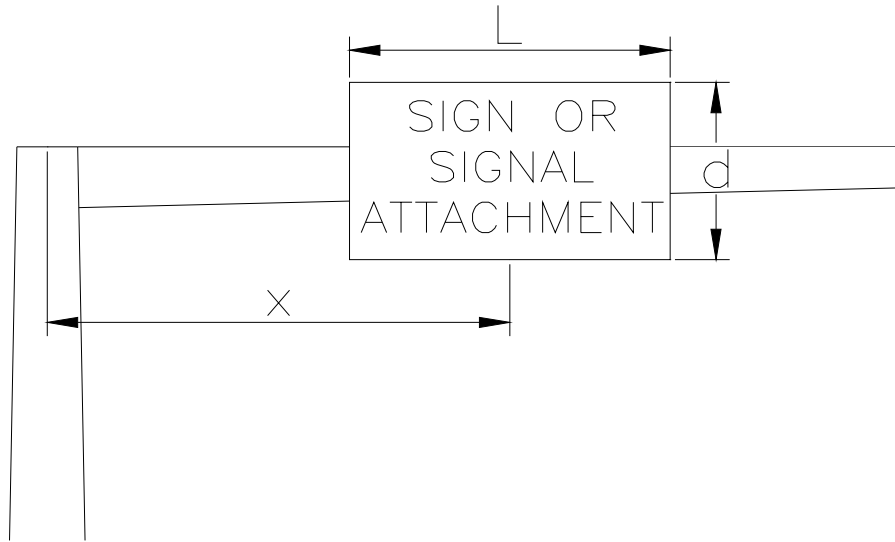
Figure 2.16: Nomenclature for dimensions of mast arm attachments at the three field sites

Attachment Number	Pflugerville			Round Rock			Lubbock		
	x (in)	L (in)	d (in)	x (in)	L (in)	d (in)	x (in)	L (in)	d (in)
Attachment 1	68	102	16	189	78	11	86	90	18
Attachment 2	166	52	23	325	50	23	209	50	23
Attachment 3	263	52	23	419	50	23	362	50	23
Attachment 4	348	80	23	N/A	N/A	N/A	443	29	33
Attachment 5	N/A	N/A	N/A	N/A	N/A	N/A	526	80	23

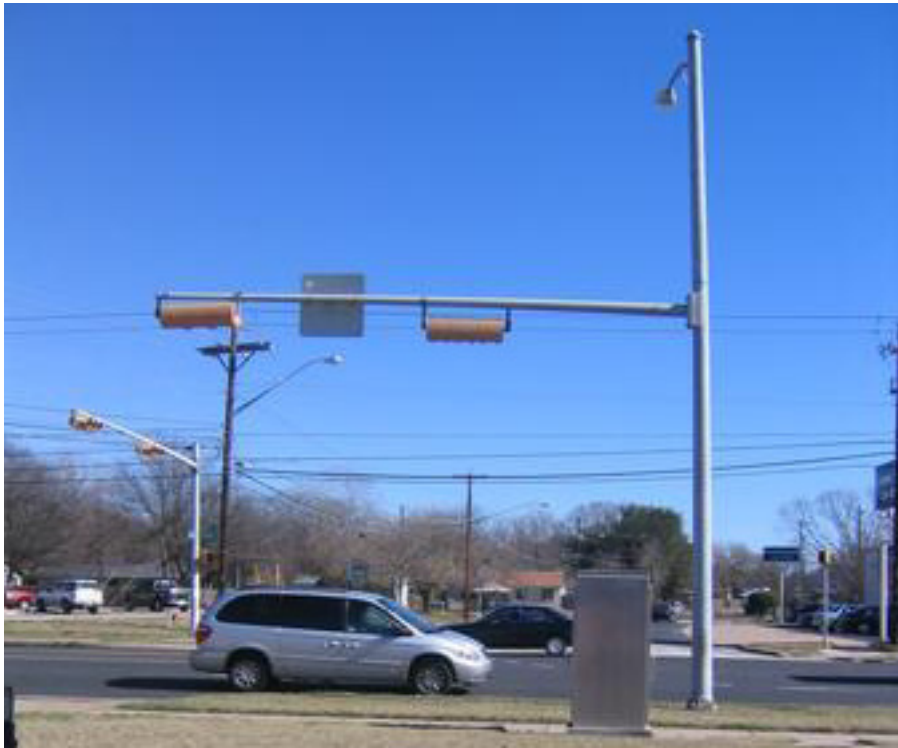
Figure 3.2: Traffic signal structure in Austin utilized for preliminary test setup

In February 2004, a data acquisition system was prepared and installed on a traffic signal structure at the intersection of Burnet Road and Ohlen Road in Austin. The signal structure can be seen in Figure 3.2. The installation was intended to test the functionality of the equipment, streamline the installation procedure for future field tests, and gather data samples to analyze. A Campbell Scientific CR9000 Datalogger was used to gather information from four strain gauges, two 3-axis accelerometers, and one 3-axis ultrasonic anemometer, placed on the structure as shown in Figure 3.3 and Figure 3.4. Vertical pluck tests were performed by hanging a weight from the tip of the mast arm. After the weight came to a rest, the wire holding the weight was cut, allowing the structure to undergo free vibration motion. Through a series of checks, all of the instrumentation appeared to be operating correctly. The strain gauges located opposite each other on the mast arm measured equal and opposite data. Figure 3.5 and Figure 3.6 show the strain data from one of the strain gauges plotted against the corresponding reversed-sign strain from the opposite side. Figure 3.5 is for strains on the two sides and Figure 3.6 is for strains at the top and bottom of the mast arm. Due to the well-correlated behavior observed in diametrically opposite gauges, only two strain gauges were used in future tests: one on top of the mast arm and one on one side.

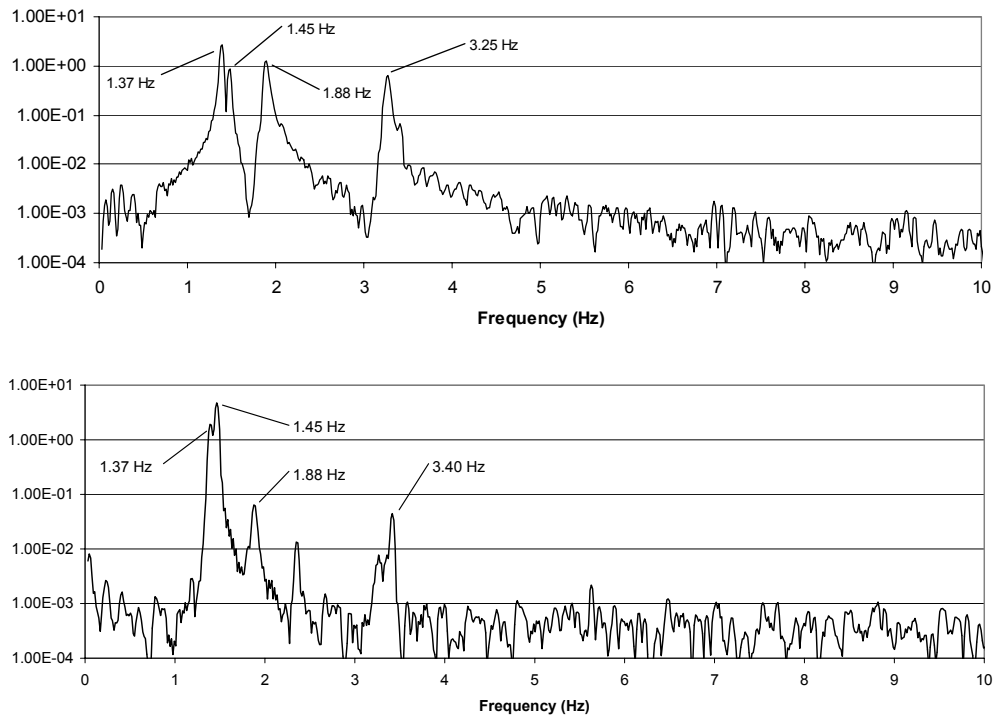
Figure 3.8: Smoothed power spectra of acceleration data at the tip of the mast arm in the vertical direction (top), and lateral out-of-plane direction (bottom)

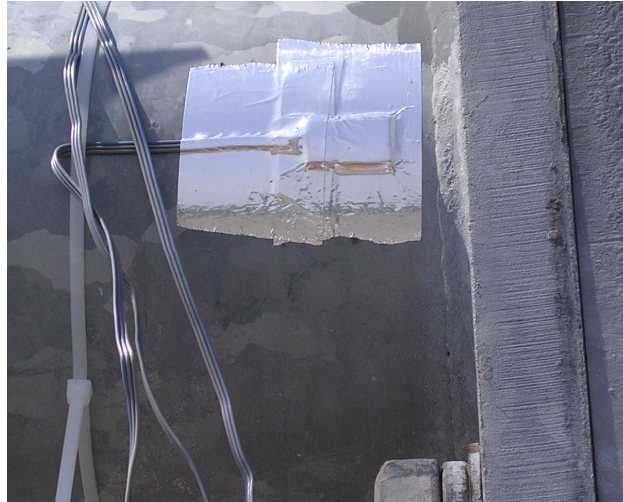
Figure 4.4: Strain gauge attached to mast arm and weatherproofed

To attach the strain gauges, a small area of the mast arm was sanded to remove the galvanization and then cleaned thoroughly with acetone. The gauges were carefully lined up and initially attached to the mast arm with a special type of Scotch tape, which was not affected by the adhesive. Peeling the tape back to reveal the gauge, a couple of drops of the adhesive, cyanoacrylate, was placed on the gauge, and then it was pressed on the mast arm for 30 seconds to cure. To waterproof and protect the gauges, the Scotch tape was removed and an acrylic coating was applied. Then the gauges were covered with a small piece of elastomeric pad and finally sealed with HVAC foil tape, as shown in Figure 4.4.

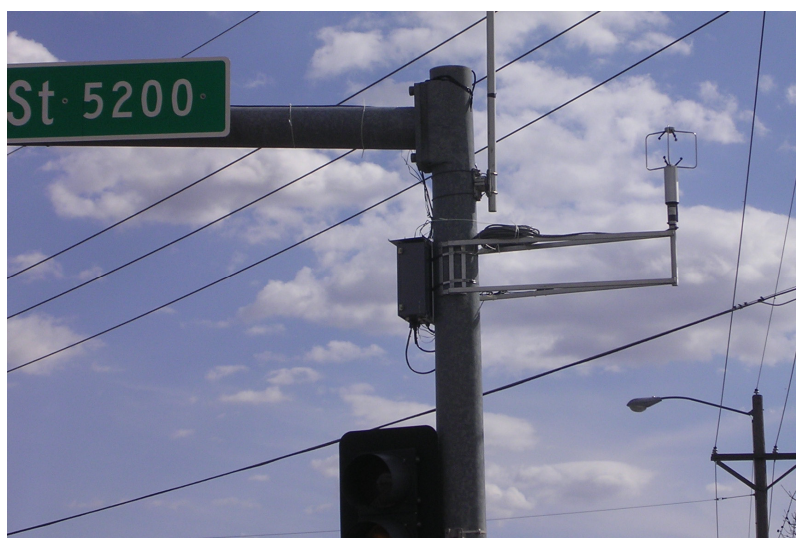
Figure 4.6: Anemometer and data acquisition unit connected to pole

An RM Young 81000 Ultrasonic Anemometer was used to capture wind speed data. The 3-axis ultrasonic anemometer was chosen for its ability to capture instantaneous wind velocity changes, which could play an important role in the determination of galloping potential. Since wind velocity varies with height, the anemometer was placed at the same height as the mast arm. It was attached in a direction opposite to the mast arm and 4 feet from the pole (as can be seen in Figure 4.6 and Figure 4.7), a distance chosen to minimize both the turbulent effects that may be caused by the pole and the effects of relative velocity caused by the movement of the structure on recorded wind speeds. The anemometer was always instrumented so that north was aligned with the front side of the traffic signals and parallel to the roadway, as seen in Figure 4.2. Therefore, a “north” wind would come from the front of the traffic signals perpendicular to the mast arm, while an “east” wind would come from the side of the mast arm and act parallel to the arm.

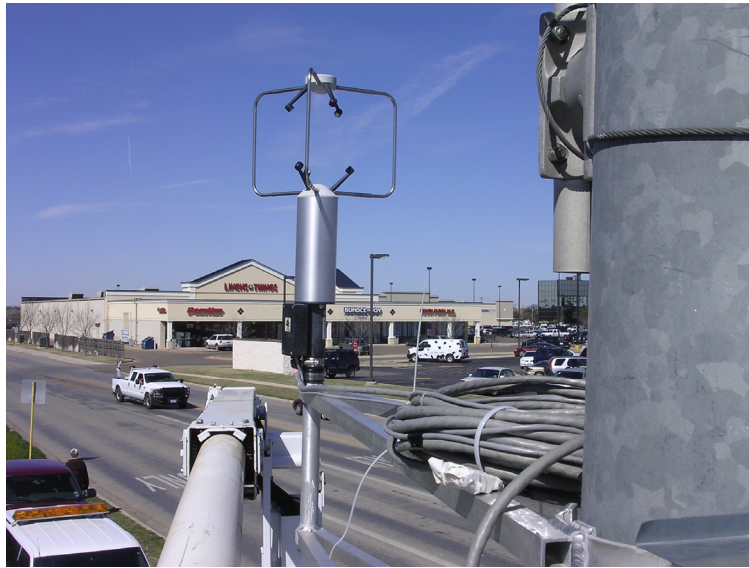
Figure 4.7: Ultrasonic anemometer attached to the pole

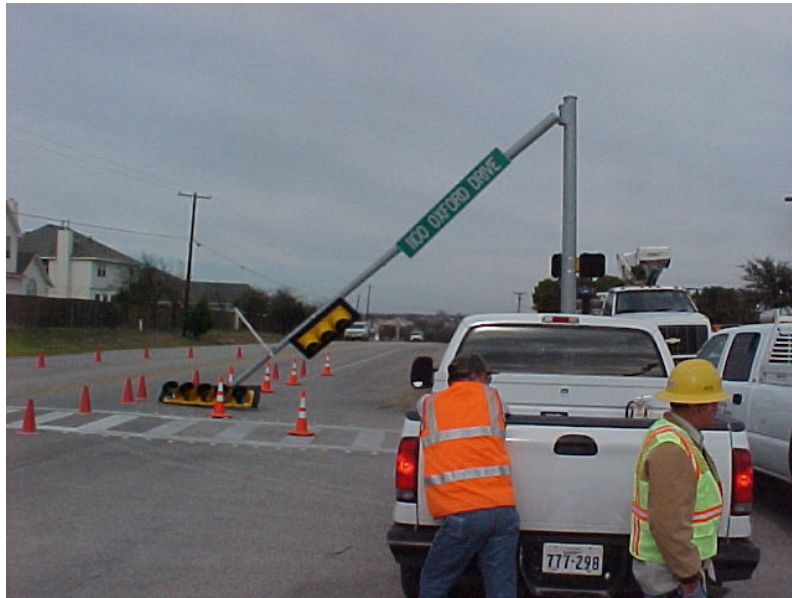
Figure 4.10: Failure of traffic signal structure in Pflugerville in December 2003

The traffic signal structure in Pflugerville, shown in Figure 4.9, was located at the intersection of Oxford Drive and Immanuel Road, at the entrance of Pflugerville Elementary School. The structure that was monitored served southbound traffic on Immanuel Road, and was located at the southwest corner of the intersection. The site was chosen because the traffic signal structure across the street, with its arm parallel to this one, failed in December 2003, as seen in Figure 4.10. The failure was due to fatigue, which is evident from rust that had

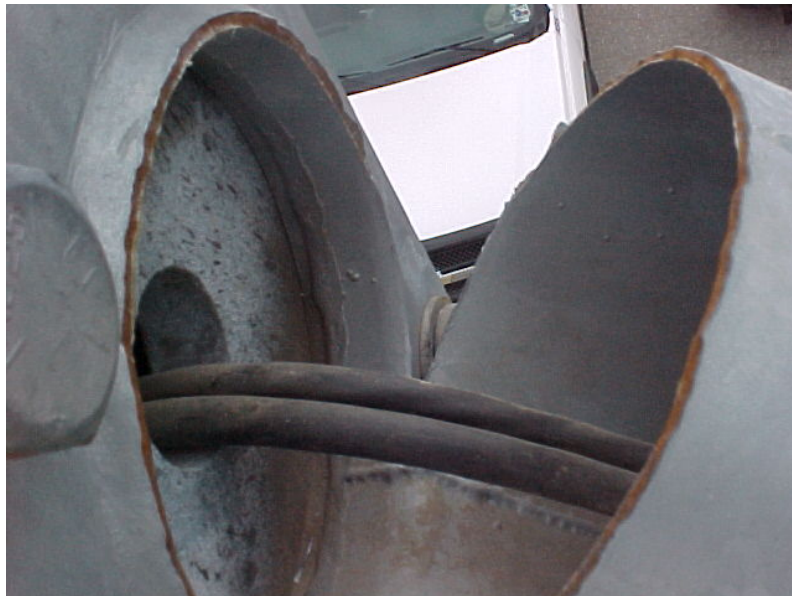
Figure 4.11: Rust is apparent in December 2003 fatigue failure

formed in the crack around the upper half of the mast arm as noted in Figure 4.11. It was assumed that the failed structure had seen large-amplitude cyclic displacements. The signal structure that was chosen for monitoring was assumed to have a similar loading history, and therefore was a good candidate for studying the potential for galloping.

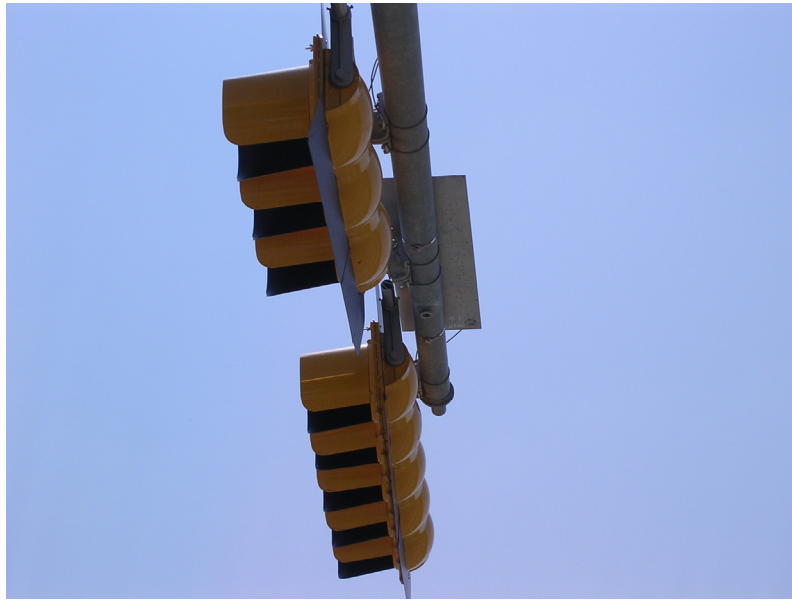
Figure 4.12: The traffic signals have rounded backs and are below the mast arm

The mast arm was approximately 28 feet long and had one sign and three traffic signals hanging from it. The traffic signals had rounded backs and each one had a back plate. This configuration with signals mounted below the mast arm, as is evident in Figure 4.12, has been shown to be one of the most likely candidates for galloping, especially when the wind comes from the back of the signals (McDonald et al, 1995). This structure was monitored from August 5, 2004 to January 3, 2005.

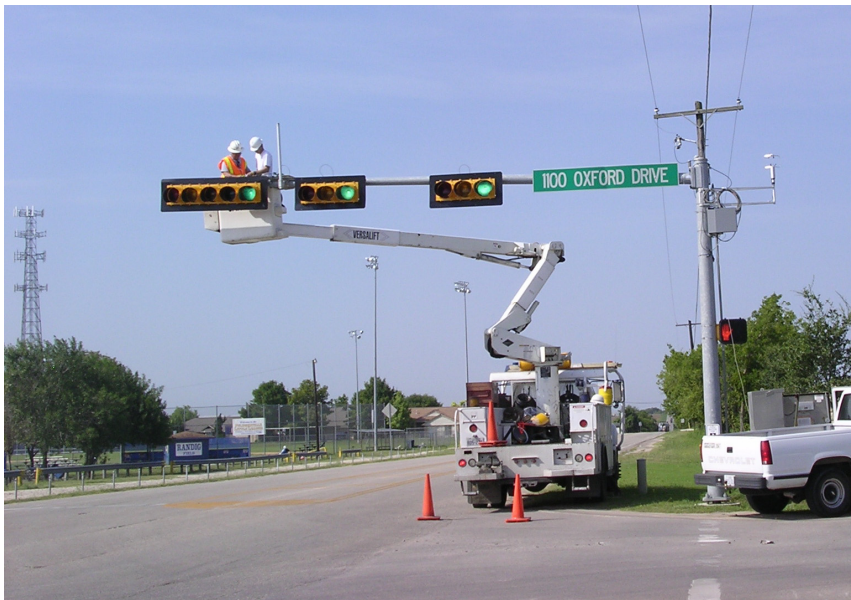
Figure 4.13: A bucket truck is utilized to pluck the structure

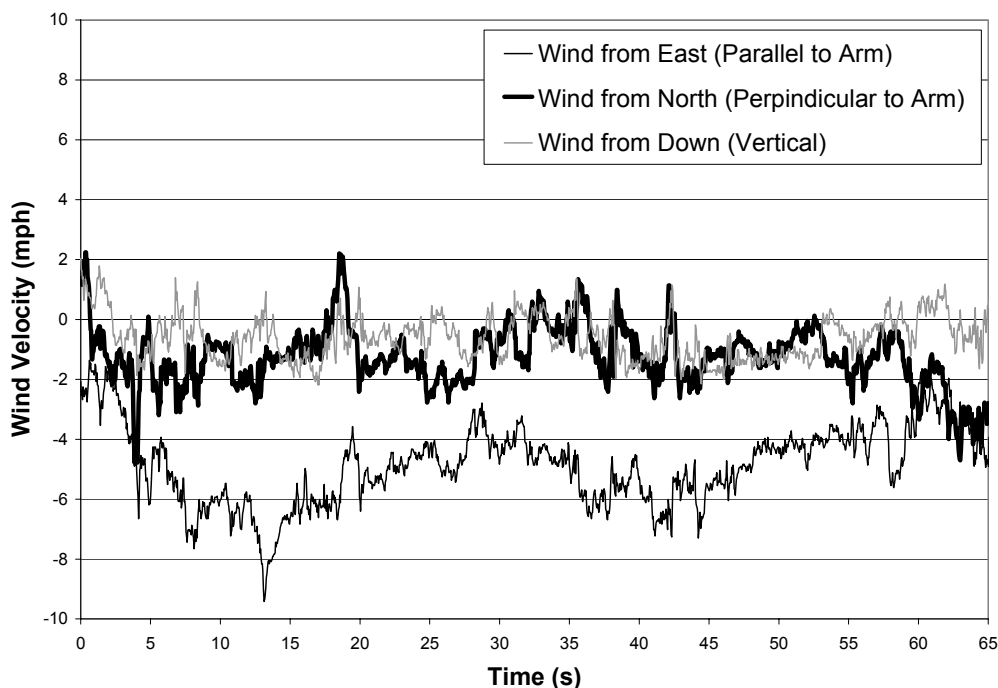
Figure 4.15: Wind velocities during the pluck test

For traffic signal structures, the presence of wind during a free vibration test can affect the estimation of the damping ratio of the structure. If the wind velocity, especially perpendicular to the mast arm, is high during the pluck test, the aerodynamic damping ratio could be a part of the measured damping ratio, and lead to inaccurate conclusions regarding the structure's own damping properties. Therefore, the pluck test was performed when the perpendicular wind speeds were very low, as can be confirmed by studying Figure 4.15.

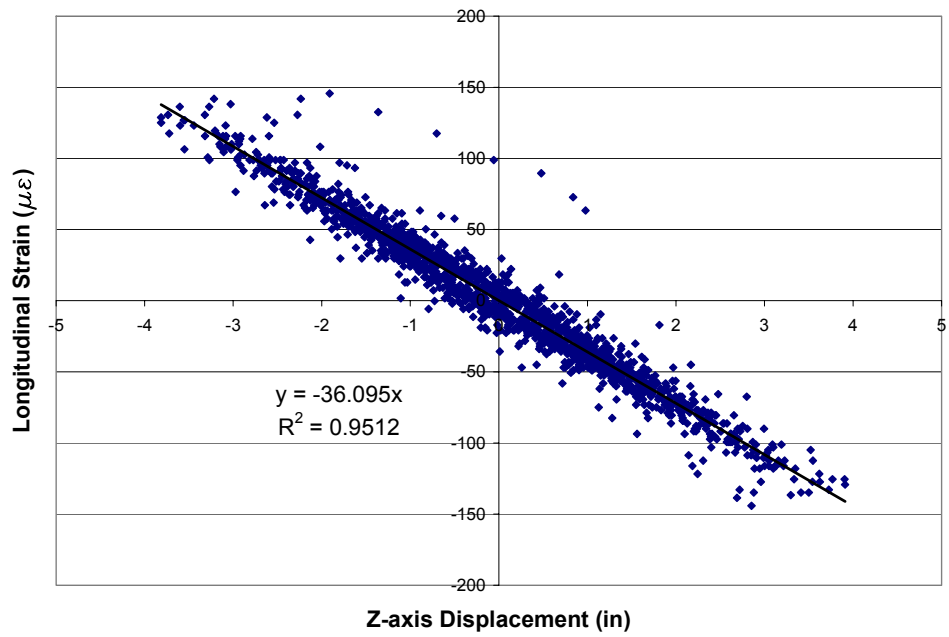
Figure 4.16: Relationship between the longitudinal strain at the top of the mast arm at the pole-to-arm connection and the vertical tip displacement

Figure 4.16 suggests that there is strong correlation between the vertical displacement at the tip of the arm and the longitudinal strain at the top of the arm at the pole-to-arm connection. The pluck test suggested roughly 36 microstrain per inch of tip displacement, whereas the finite element model calculated 39 microstrain per inch of tip displacement. This suggests that the tip of the mast arm needed to repeatedly displace vertically a total of about 2.75 inches for 15 seconds in order to initiate a “galloping” event as defined per our data collection protocol (see Section 4.2). Although this may not appear to require significant displacement amplitudes compared to previously witnessed galloping events, it was determined to be a good place to begin. It was felt that if the threshold were triggered too often for events that were not considered galloping, that the threshold would be raised at a later time.

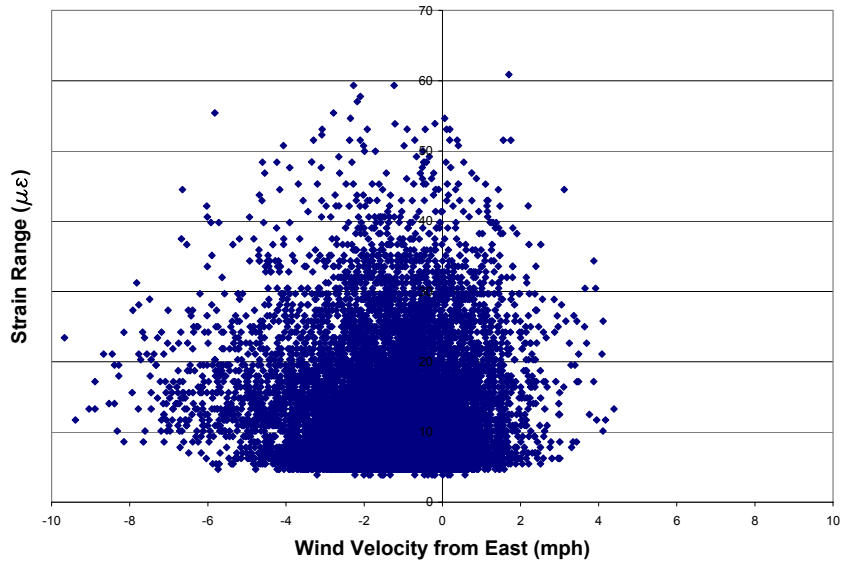
Figure 4.22: Plot of data from October 8, 2005, showing the relationship between the strain range and the wind parallel to the mast arm

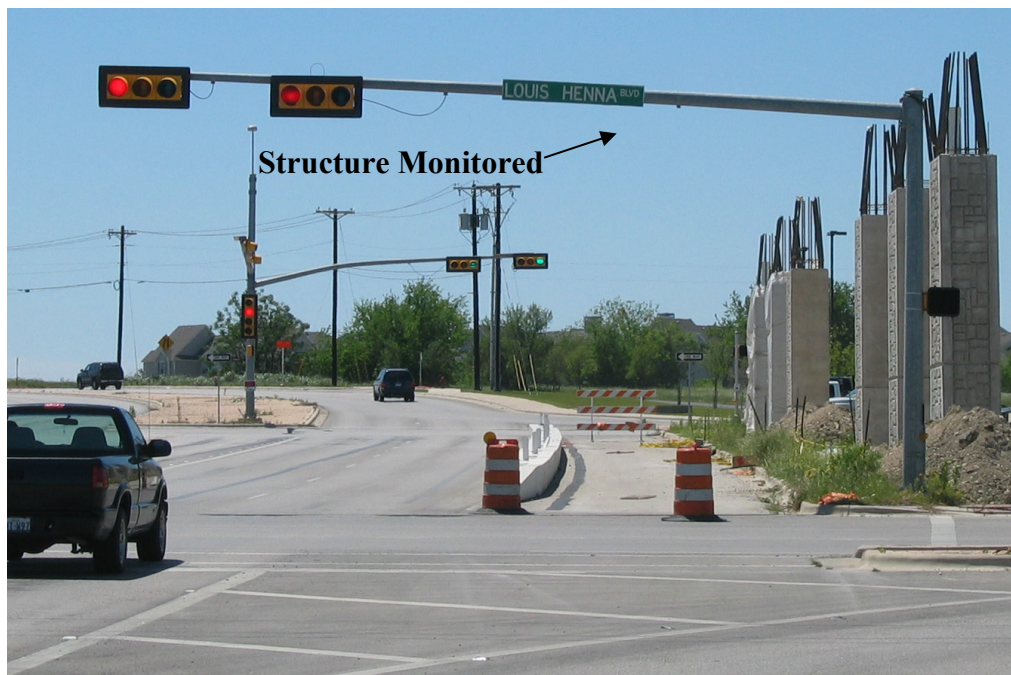
Figure 4.36: Traffic signal structure monitored in Round Rock

The traffic signal structure in Round Rock is shown in Figure 4.36. It was located at the intersection of Louis Henna Boulevard and AW Grimes Boulevard. In particular, the signal structure served southbound traffic on A.W. Grimes where it intersected with westbound traffic on Louis Henna. This structure was recommended by TxDOT because it had received called-in complaints due to large-amplitude displacements. Before moving all of the equipment to the site, the site was monitored for 4 days with a Microsafe fatigue rainflow cycle counting unit to determine the strain sizes reached on the top of the mast arm. Strains were sampled at 32 Hz, and strain ranges less than 5 microstrain were discarded. In one particular hour during the four days, the strain range equaled or exceeded the 155 microstrain bin 177 times. The histogram for the 4-day period can be seen in Figure 4.37. This histogram, combined with the fact that all of the adjacent roads contained the word “wind” in their names, such as Windy Park Circle, Windrift Way, Windsong Trail, and Windy Terrace Park, gave hope for galloping events at the Round Rock site.

The mast arm was approximately 34 feet long and had one sign and two traffic signals hanging from it. The traffic signals had more squared-off backs, visible in Figure 4.38, and each one had a back plate. Their configuration, mounted below the mast arm, was similar to the configuration of Pflugerville and presented a similar likelihood that galloping would occur with wind from the rear of the signals. This structure was monitored from January 7 to March 3, 2004. However, the accelerometer was not installed until January 19 because a bucket truck could not be obtained. Also due to the very limited time the bucket truck was available, no pluck test could be performed, and the damping ratio is not

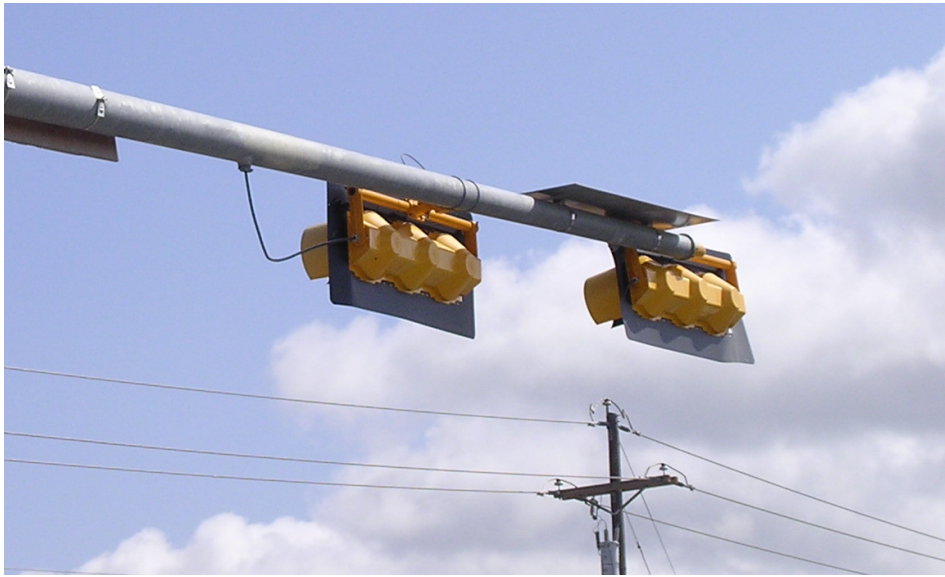
Figure 4.38: Traffic signals with squared-off backs attached to mast arm

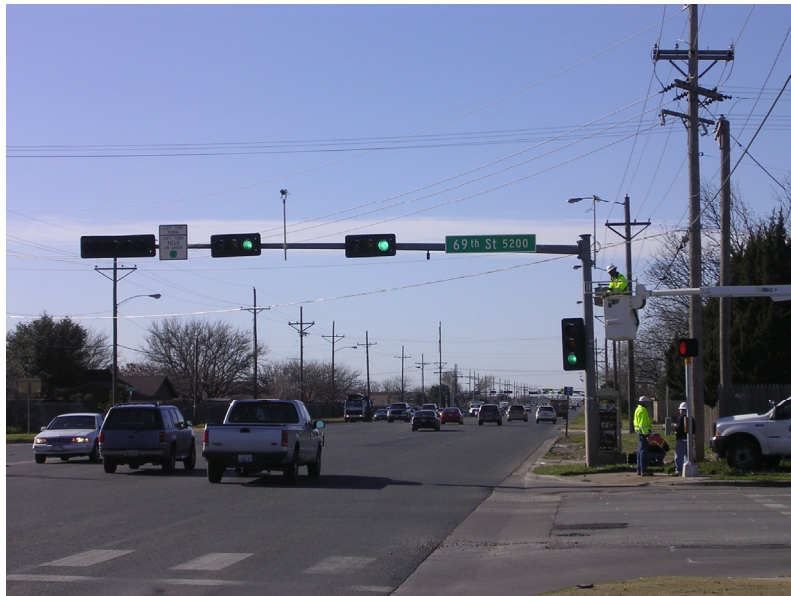
Figure 4.44: Traffic signal structure monitored in Lubbock

The traffic signal structure in Lubbock is shown in Figure 4.44. It was located at the intersection of Slide Road and 69th Street, just south of Loop 289. The signal structure served southbound traffic on Slide Road. This site was recommended by Dr. Letchford at Texas Tech University and the City of Lubbock because of its history of frequently reported large-amplitude displacements. The City of Lubbock was especially helpful and interested in this research because they had a traffic signal structure fail in service due to fatigue a short time earlier. The author, accompanied by research partner, Matt Albert, traveled to Lubbock to install the equipment on March 7, 2005.

The mast arm was approximately 45 feet long and had two signs and three traffic signals hanging from it. The traffic signals had V-shaped backs, visible in Figure 4.45, and each one had a back plate. Based on limited prior research, their configuration, mounted out in front and level with the mast arm was expected to have a higher probability of galloping with horizontal wind from the front of the signals. However, if the wind carried a large steady vertical component, it could cause galloping from the rear of the signals (McDonald et al., 1995). This structure was monitored from March 9, 2005 until the time this report was published. A pluck test determined the structure to have a damping ratio of 0.3%, and the in-plane frequency to be the same as displayed in Figure 4.50, which was taken during the galloping events.

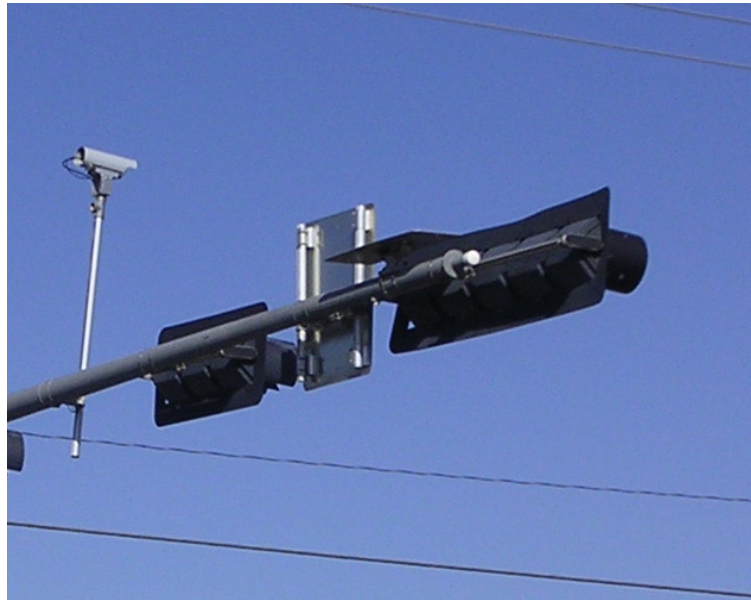
Figure 4.45: Traffic signals with V-shaped backs attached to mast arm

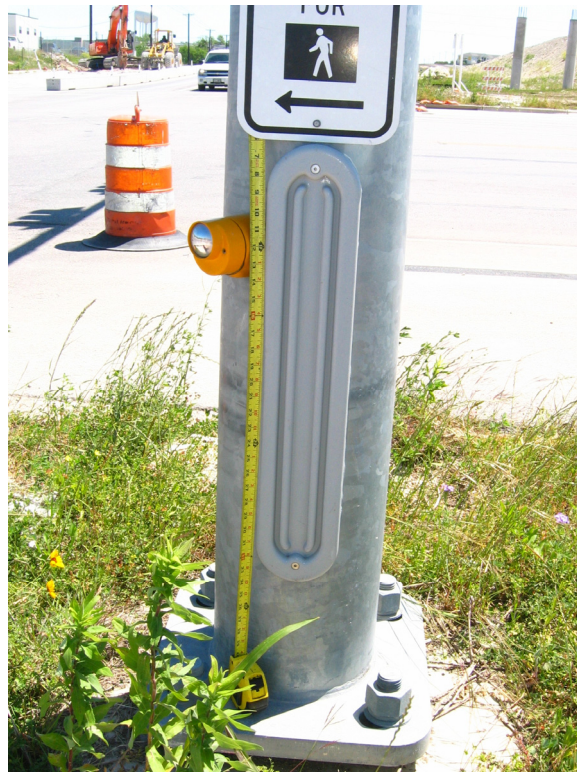
Figure 5.2: A handhole is typically cut out of the steel pipe near the base of the pole
