Rehabilitation of Poorly Detailed RC Structures Using CFRP Materials

Thesis

The University of Texas at Austin

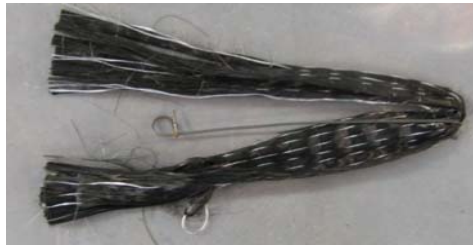
Figure 2.2 CFRP Anchor before Installation

A CFRP anchor is shown in Figure and consists of a roll of CFRP sheet inserted into the concrete and splayed out over the CFRP sheet. Pictures of the CFRP anchor are shown in Figure 2.2 and Figure 2.3.

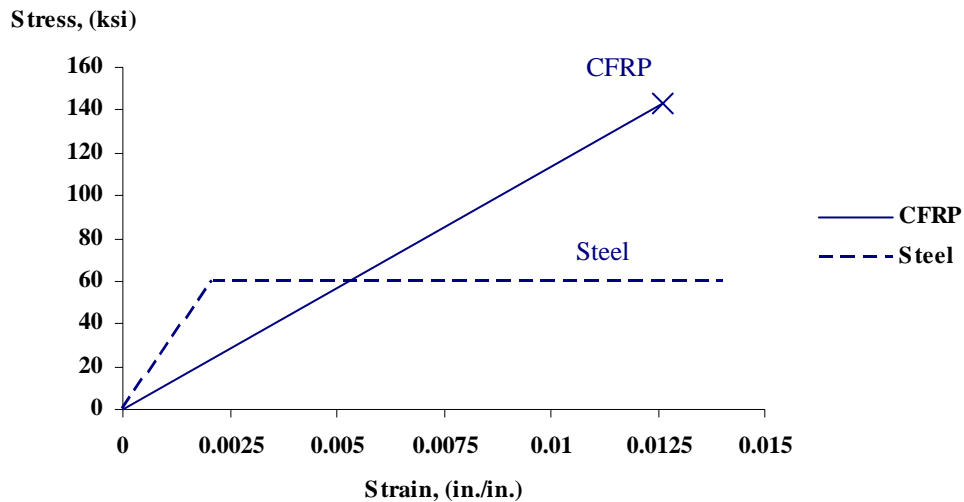
Figure 2.6 Stress - Strain Curves of the CFRP Material and the Steel bar

The stress-strain curves of the CFRP materials and the steel bars are shown in Figure 2.6. Although the CFRP materials had higher strength than the steel bar, the CFRP materials were less stiff than the steel bars. The CFRP material had a linear stress-strain relationship up to fracture.

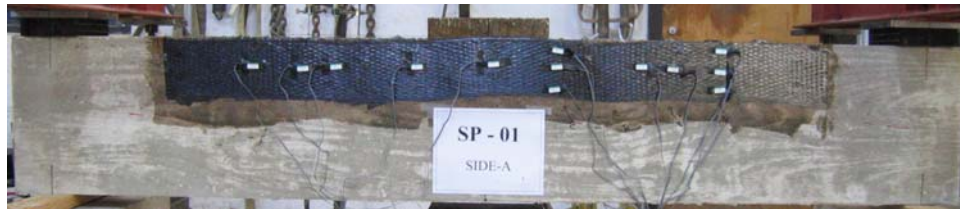
Figure 3.4 One Layer of CFRP sheet, 5.5 in. wide

. . In this research, The *CFRP sheet* was attached using two different sheet arrangements. In one case, a CFRP sheet 5.5 in. wide x 66 in. long was attached on the both sides of the beam (Figure 3.4). In the other case, two CFRP sheets 2.75 x 66 in. were placed on top of one another (Figure 3.5). The area of the CFRP materials in both cases was the same. The area and strength of the CFRP sheet were selected to provide an ultimate tensile force the same as that for two #6 bottom bars at yield. The length of the CFRP sheet was determined considering the development length of the steel bar. The development length of a #6 bar was 30.4 in. for the geometry of test specimen. The distance from the end of bar in the column to the end of CFRP sheet was 31.5 in..

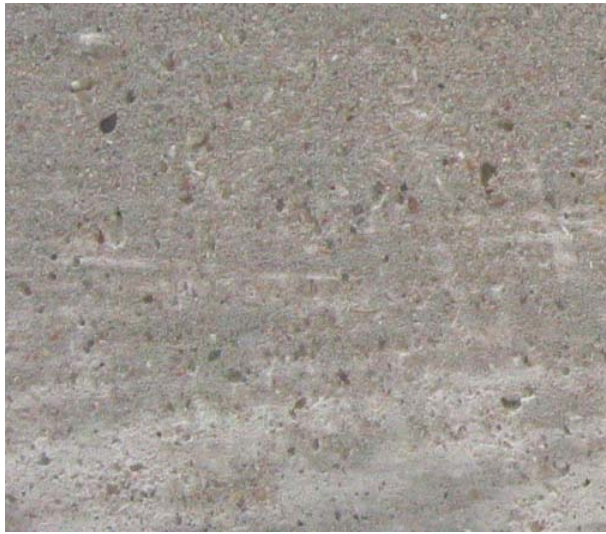
Figure 3.13 Regularly Blasted Surface

The concrete surface was prepared to meet the requirement for a minimum concrete surface profile (CSP) 3 as defined in the International Concrete Research Institute (ICRI)-surface-profile-chips. However, it was not possible to maintain the same surface condition for all the specimens because the concrete quality was different in the specimen. Some specimens were over blasted because of the poor quality of the concrete. The surface preparation conditions are shown in the Figure 3.13 and 3.14.

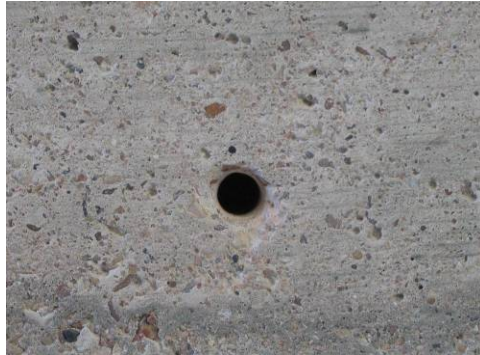
Figure 3.15 Hole for CFRP Anchor

A CFRP anchor requires a hole in the concrete for installation. The holes were drilled with 5/8 in. diameter masonry drill bit, and they were cleaned with air compressed. The edge of hole was ground to smooth perimeter transition of the CFRP materials from the hole to the sheet. An anchor hole prior to installation of the CFRP materials is shown in Figure 3.15.

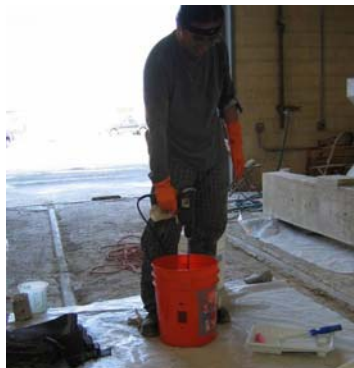
Figure 3.16 Preparation of Epoxy Resin

Epoxy resin was used for bonding the carbon fabric to the concrete surface. The epoxy resin used in this study was Tyfo[®] S Epoxy and it was a two component epoxy matrix material. The specified mix ratio between two components was 100 parts of the component A to 42 parts of the component B by volume. They were mixed for five minutes at 400 ~ 600 RPM until uniformly blended (Figure 3.16).

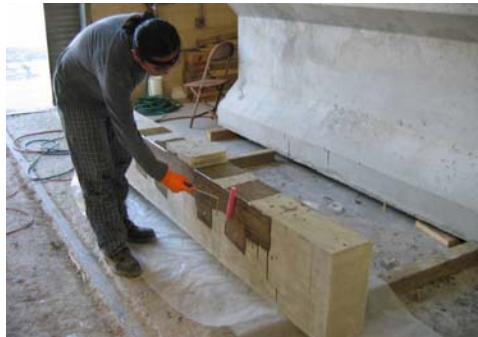
Figure 3.17 Saturation of Concrete Surface with Epoxy

The concrete surface and holes were saturated with epoxy before the CFRP materials were applied. The concrete surface and holes were saturated with the epoxy resin by a small paint roller (Figure 3.17) and an injector.

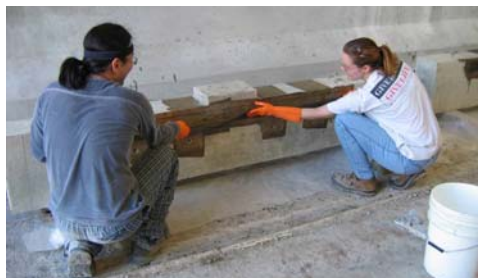
Figure 3.18 Placement of CFRP Materials

Pieces of carbon fabric for the CFRP sheet and additional anchorage were saturated with epoxy resin and squeezed with a roller. Then the CFRP fabric saturated with epoxy resin was placed on the specimen and smoothed by hand to remove air pockets (Figure 3.18).

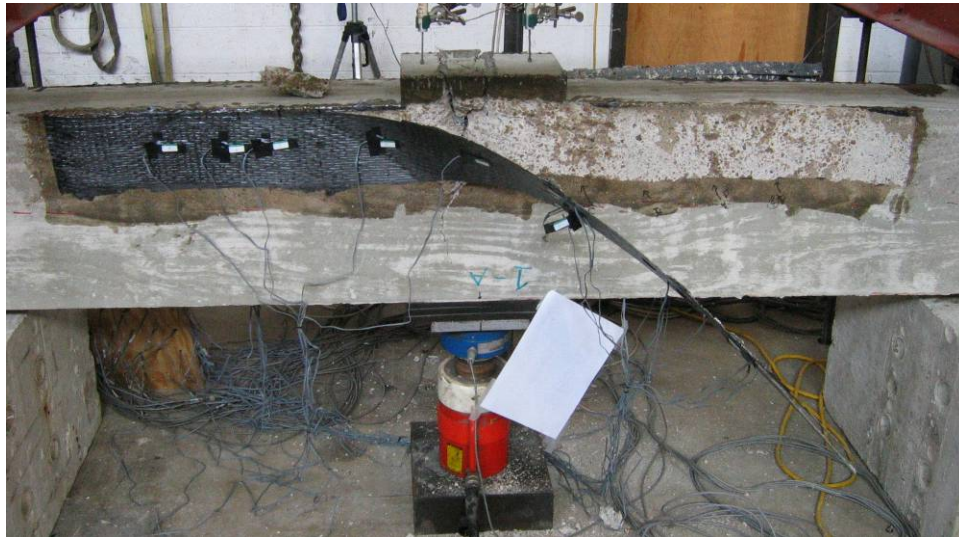
Figure 4.2 Failure mode of Specimen No.1, Delamination of CFRP Sheet

The failure mode of specimen was delamination of the CFRP sheet from the concrete surface because no additional anchorage existed in specimen No.1. Both sides showed the same failure mode, and one side failed right after the other (Figure 4.2).

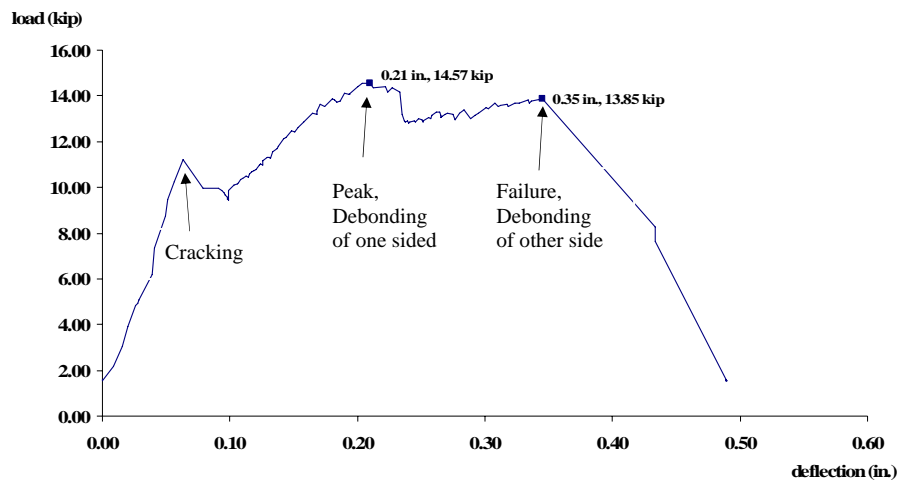
Figure 4.3 Load - Deflection Relationship of Specimen No.1

Three key points were noted in the load - deflection curve for specimen No.1 (Figure 4.3). The first key point corresponded with the occurrence of the first concrete crack at the mid span. Delamination of the CFRP sheets on the both sides started from this crack. Applied load increased until total debonding of the CFRP sheet on one side of

the specimen occurred. After the peak point, the load was carried by the CFRP sheet on the other side. The specimen maintained nearly the same load carrying capacity for a short duration until the total debonding occurred the other side. Debonding of the CFRP sheet in the other side proceeded rapidly when the third key point in the curve was reached. Comparing load-strain relationships of the CFRP sheets in from strain gages placed in symmetric positions, almost the same load - strain relationship was found.

The curve begins above the origin because reactions had some play in them before they seated.

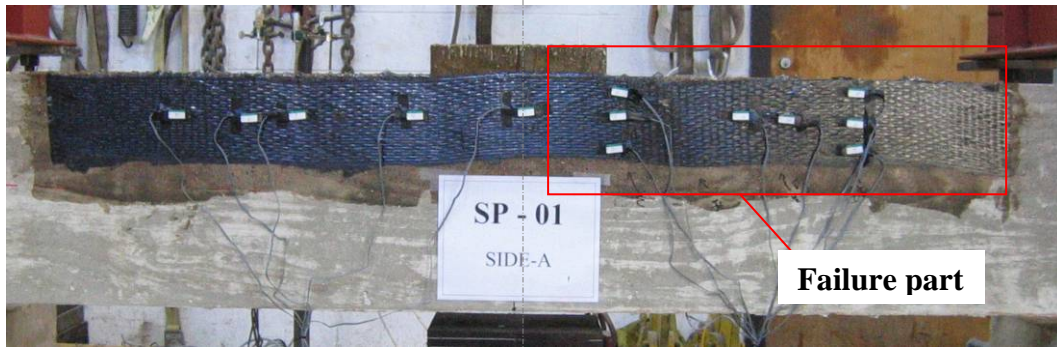
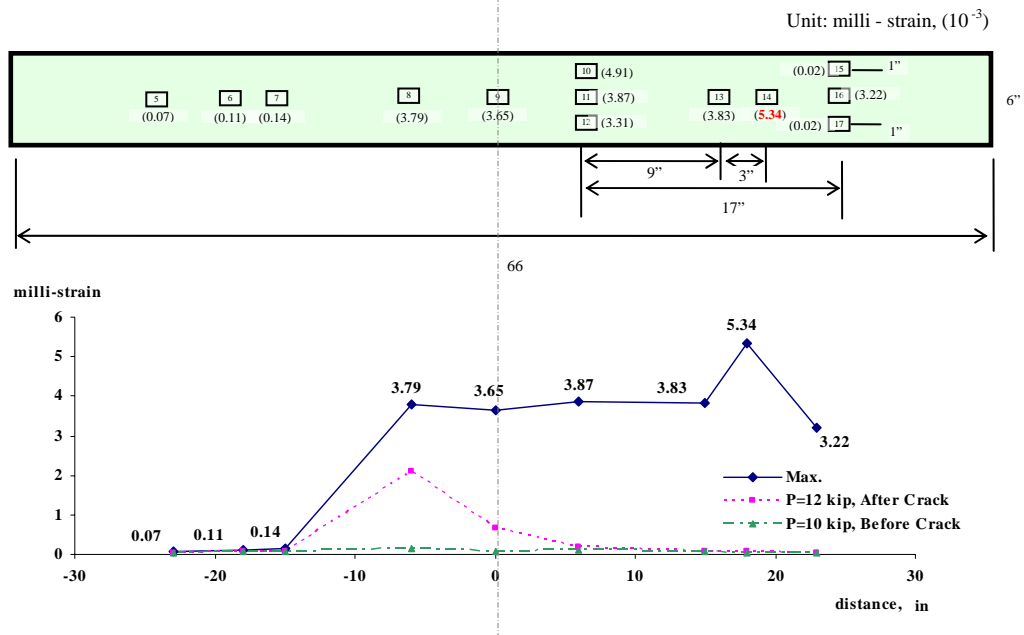
Figure 4.4 Strain in CFRP Sheet in Specimen No.1, Side-A

From the data of the horizontal distribution of strains on the CFRP sheet, the part of the CFRP sheet developed the highest strain was where debonding failure occurred, and the same pattern was observed on the both sides of the specimen (Figure 4.4 and 4.5).

The horizontal strain distribution at 10 kip load (before the cracking) and middle load (12kip) between 10 kip and the peak load (after the cracking but before reaching the peak load) are also shown in Figure 4.4 and 4.5.

Vertical distribution of strains in the CFRP sheet was observed by strain gages No.10, 11 and 12 (Figure4.4). As indicated in the figure, the strain was 0.0049 closest to the extreme fiber of the beam and reduced to 0.0039 and 0.0033 as the distance from the extreme fiber increased. The highest strain was observed in the strain gage closest to the extreme tension fiber, strain gage No.10, and it was smaller at strain gages below that point. Vertical distribution of strains in the CFRP sheet was also observed using gages No.15, 16 and 17 but rapid delamination of the CFRP sheet occurred at that location, so the strain data did not properly indicate the vertical distribution of strains.

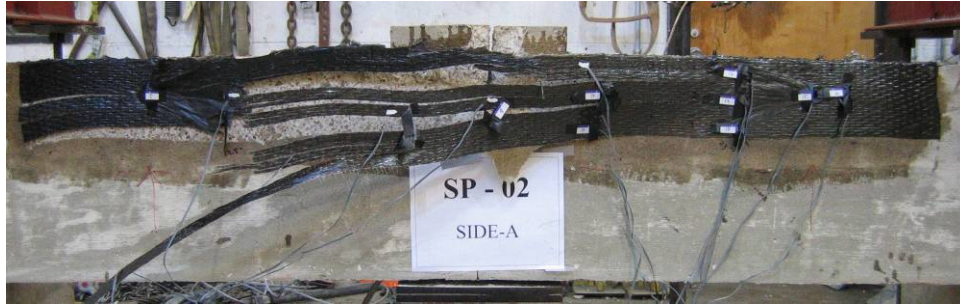
Figure 4.10 Failure mode of Specimen No.2, Side-A

The failure mode of specimen No.2 involved split-and-fracture of the CFRP sheet. Both sides showed the same failure mode (Figure 4.10 and 4.11).

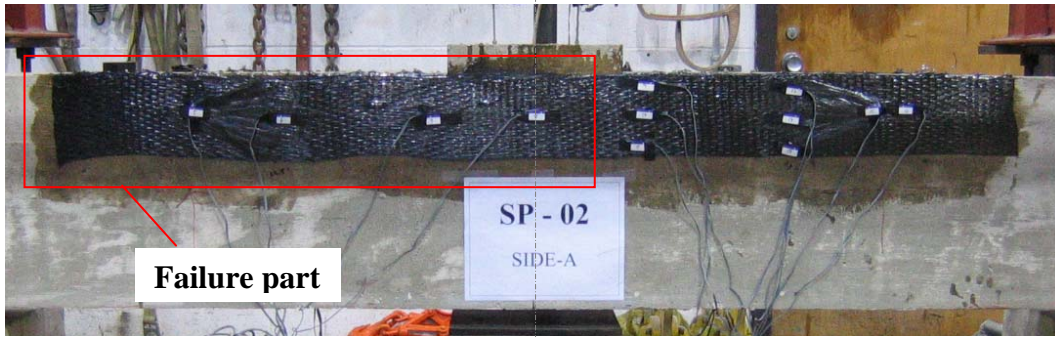
Figure 4.13 Strain in CFRP Sheet in Specimen No.2, Side-A

From horizontal distribution of strain in the CFRP sheet, the highest strains indicate where failure occurred on both sides of specimen (Figure 4.13 and 4.14)

The horizontal strain distribution at 10 kip load (before the cracking) and middle load (14 kip) between 10 kip and the peak load (after the cracking but before reaching the peak load) are also shown in Figure 4.13 and 4.14.

The vertical distribution of strains in the CFRP sheet was observed by strain gages No.9, 10, 11 and 12, 13 and 14 (Figure4.13). The highest strain was observed in the strain gages closest to the extreme tension fiber, strain gage No.9 and 12, and reduced near the neutral axis of the beam.

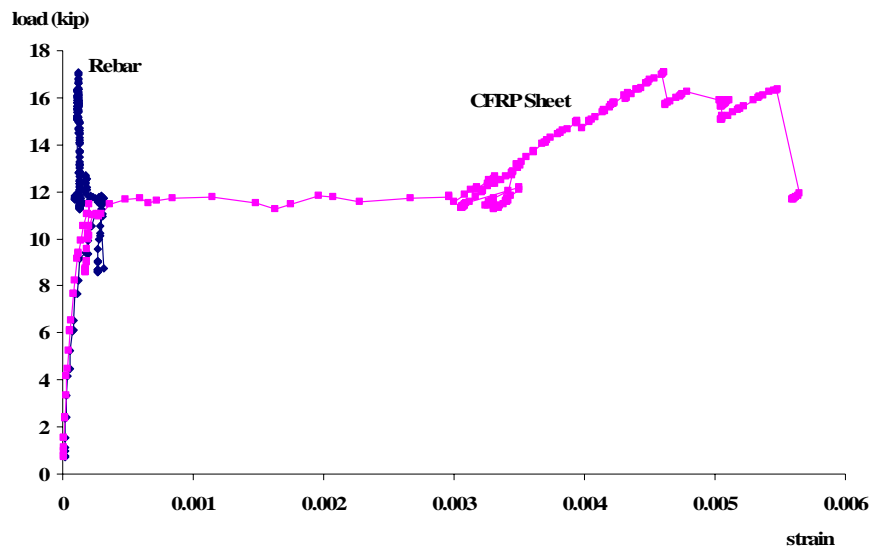
Figure 4.17 Load - Strain Relationship between Bar and CFRP Sheet, At the Column Face

Load - strain relationships of the bar and the CFRP sheet were similar before crack of the specimen as shown in Figure 4.17.

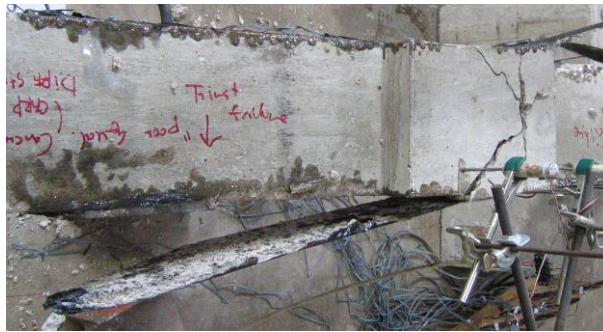
Figure 4.20 Failure Mode of Specimen No.3

The failure mode of specimen No.3 was failure of the inserted part of the CFRP sheet near the hole. Both sides showed the same failure mode. The failure mode of specimen No.3 is shown in Figure 4.19 and 4.20

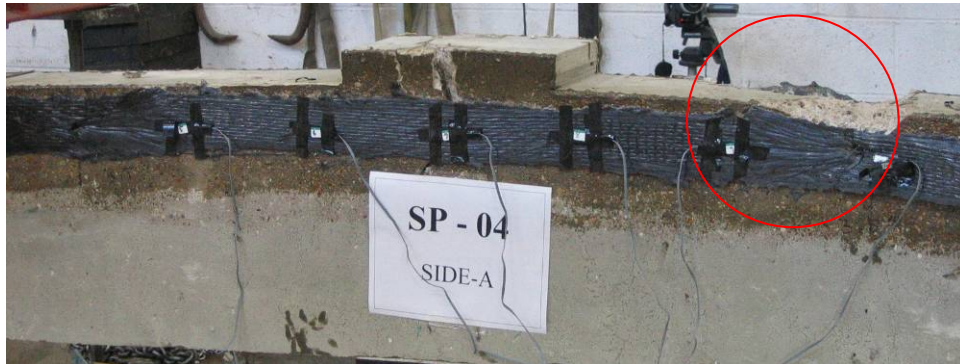
Figure 4.28 Failure mode of Specimen No.4

The failure mode of specimen No.4 involved of the additional anchorage, and it was not the failure of the CFRP materials but the failure of the concrete around the CFRP anchors. Both sides showed the same failure mode (Figure 4.28 and 4.29).

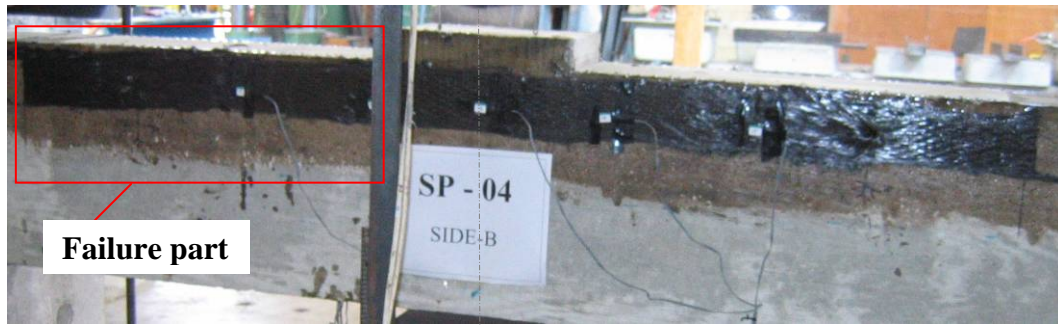
Figure 4.32 Strain in CFRP Sheet in Specimen No.4, Side-B

The location of the strain gages installed on the both sides of specimen No.4 and the maximum measured strain in each strain gage are shown in Figure 4.31 and 4.32.

From the horizontal distribution of strains in the CFRP sheet, the highest strains indicate where failure occurred on both sides of the specimen (Figure 4.31 and 4.32).

The horizontal strain distribution at 10 kip load (before the cracking) and middle load (14 kip) between 10 kip and the peak load (after the cracking but before reaching the peak load) are also shown in Figure 4.31 and 4.32

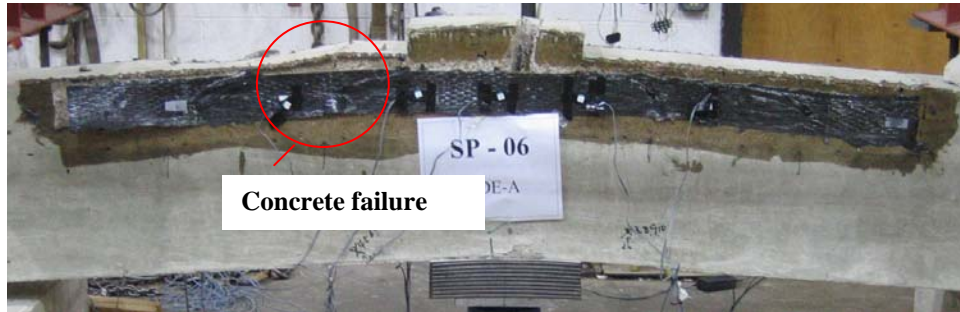
Figure 4.46 Failure Mode of Specimen No.6

The failure mode of specimen No.6 involved of the additional anchorage and was not material failure of the CFRP anchors but the failure of the concrete around the CFRP anchor (Figure 4.46). Both sides showed the same failure mode. It was similar to the failure mode of specimen No.4. The CFRP sheet on the specimen was cut after the test in

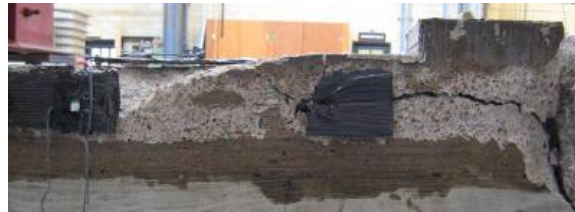
Figure 4.47 Failure Mode of Specimen No.6, After Cutting CFRP Sheet

order to see the concrete crack and failure shape (Figure 4.47), and then the cover concrete was removed because the crack propagated along the longitudinal bar from the mid span to the anchor holes located at 6 in. from the column face (Figure 4.48).

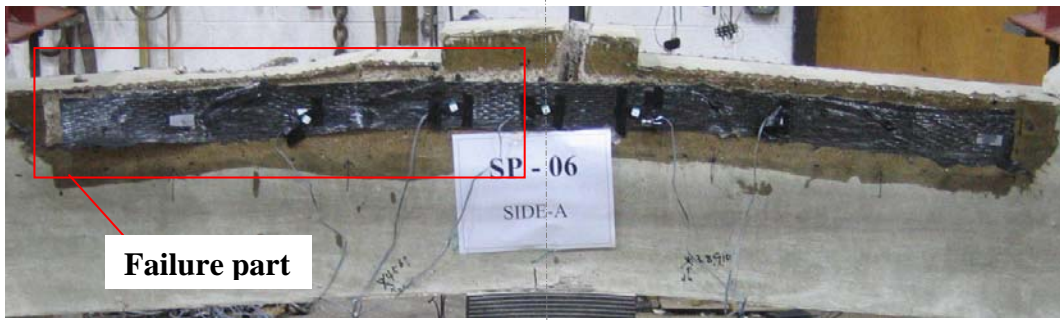
Figure 4.52 Strain in CFRP Sheet in Specimen No.6, Side-A

The strain of the CFRP sheet behind the CFRP anchor (gages No.16 and 24) was much less than that of the sheet in front of the anchor.

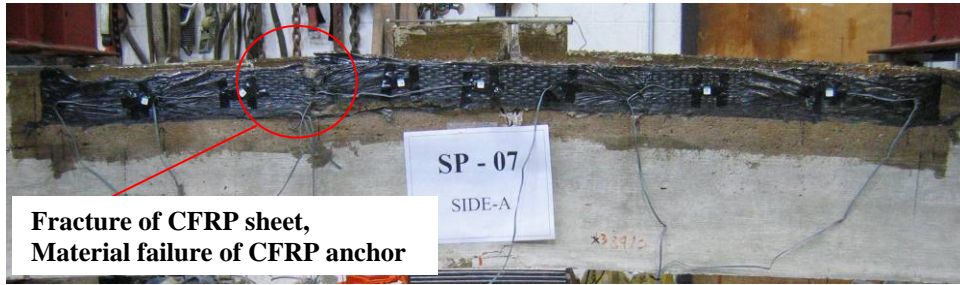
Figure 4.58 Failure Mode of Specimen No.7, Side-A

Various failure modes were observed in specimen No.7 as shown in Figures from 4.58 to 4.63.

The failure modes of specimen No.7 was a failure of both anchorage and CFRP sheet. The failure pattern of CFRP sheet was a whole-sheet-fracture. The location of the fracture was near the anchor hole closest to the column face on both sides (Figure 4.59 and 4.62). However, the failure mode of anchorage was different between side-A and side-B. The CFRP anchor in side-A fractured (Figure 4.60), and the concrete crushing occurred around the CFRP anchor in side B (Figure 4.63). Specimen No.7 was the first specimen showed a material failure of the CFRP anchor.

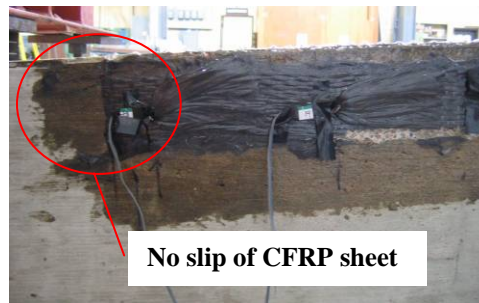
Figure 4.64 Slip Condition of CFRP Sheet

The CFRP sheet in specimen No.7 did not slip because the additional CFRP anchors held the far ends of the CFRP sheet (Figure 4.64). The deformation capacity of specimen No.7 was less than that of specimen No.6 because slip did not occur. The strength of specimen No.7 was also less than that of specimen No.6 although specimen No.7 had one more CFRP anchor at each end of the sheets than specimen No.6. A possible reason of the less strength was stress concentration due to this additional anchor.

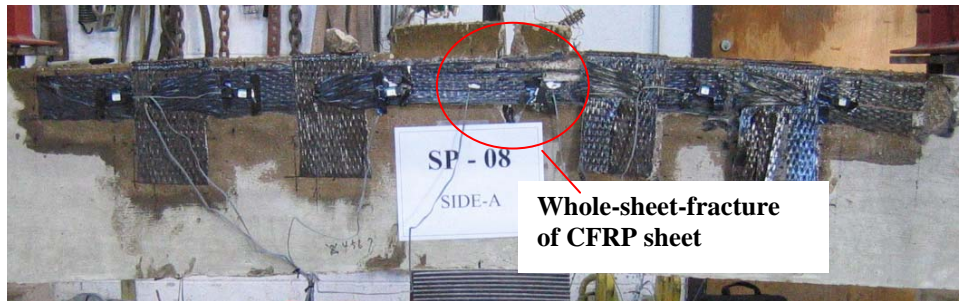
Figure 4.72 Failure Mode of Specimen No.8

The failure mode of specimen No.8 was a whole-sheet-fracture (Figure 4.72 and 4.73). Both sides showed the same failure mode. Although delamination of the CFRP U-wrap occurred, the CFRP anchor held both CFRP sheet and U-wrap. The U-wrap prevented the concrete around the anchor hole from crushing (Figure 4.74).

The fracture of CFRP sheet did not occur around the anchor hole but in front of the CFRP anchor closest to the column face. The U-wrap helped the anchor collect the tensile force efficiently and prevented the sheet from the stress concentration around the anchor hole.

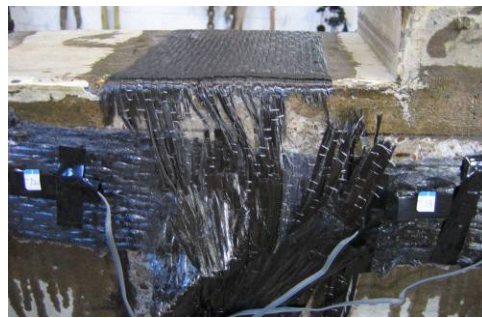
Figure 4.84 Failure Mode of Specimen No.9

The failure mode of specimen No.9 was material failure of the CFRP U-wrap (Figure 4.83, 4.84). Both sides showed the same failure. Although the CFRP anchor held the U-wrap after delamination of both the U-wrap and sheet, the U-wrap failed by shear (Figure 4.84).

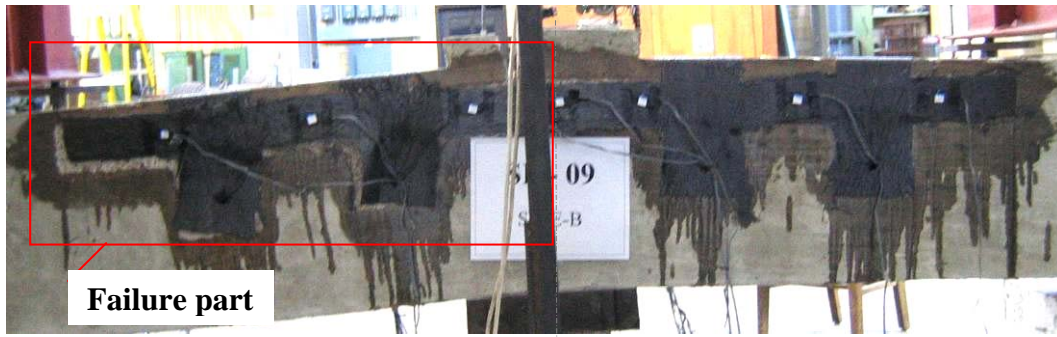
Figure 4.88 Strain in CFRP Sheet in Specimen No.9, Side-B

The location of strain gages installed in both sides of specimen No.9 and the maximum measured strain in each strain gage are shown in Figure 4.87 and 4.88. Gage No.14 did not work.

The horizontal strain distribution at 10 kip load (before the cracking) and middle load (13 kip) between 10 kip and the peak load (after the cracking but before reaching the peak load) are also shown in Figure 4.87 and 4.88
