**Simple Design Details using Precast Concrete Panels at Skewed  
Expansion Joints**

**Thesis**

The University of Texas at Austin

**May 2008**

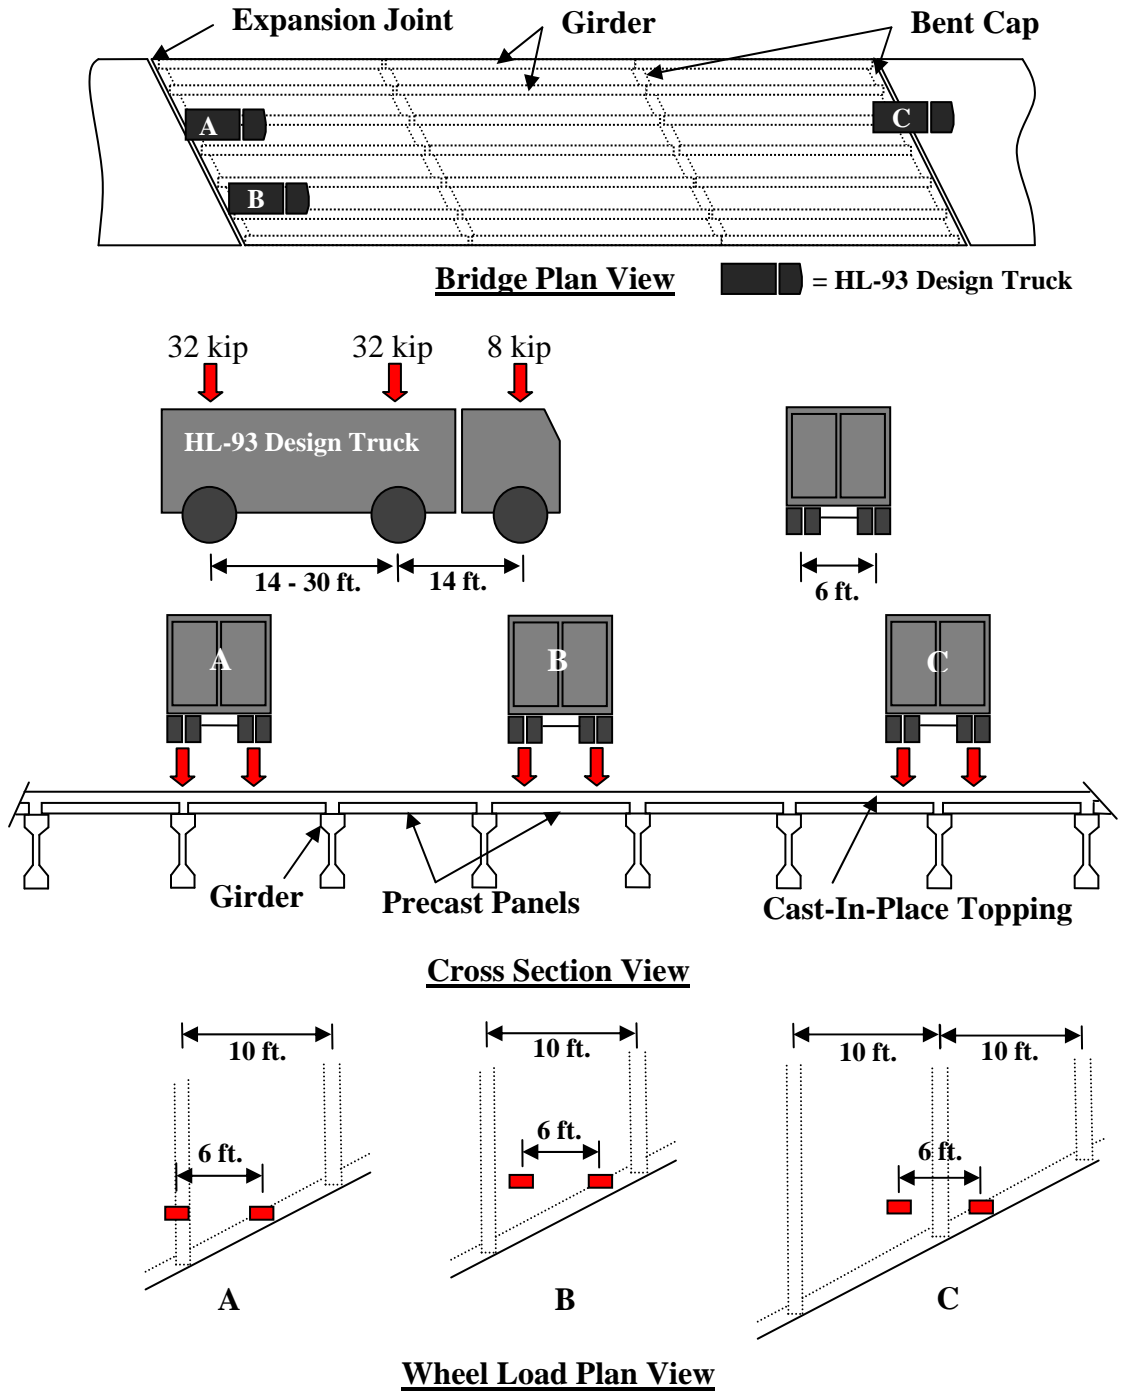
Figure 3.1 – HL-93 Design Truck Loads on Bridge Deck

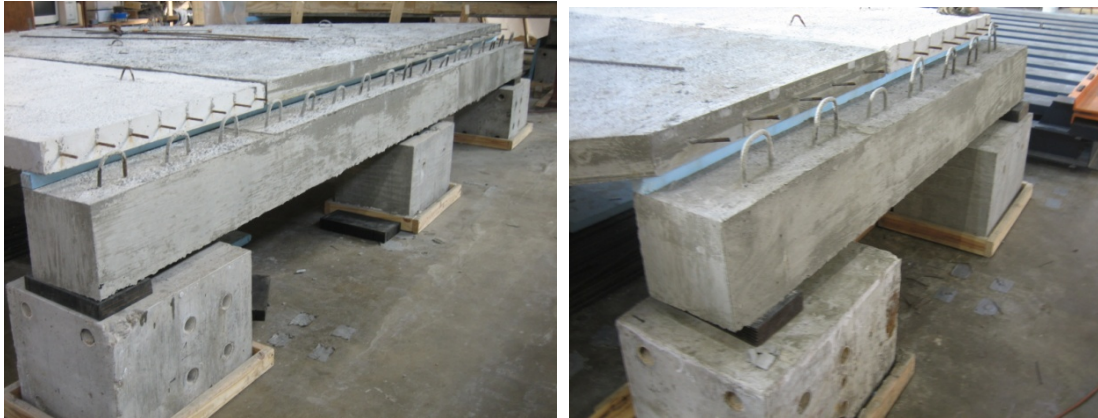
*Figure 3.12 - Long Side Support Beam (left) and Short Side Support Beam (right)*

The precast panels described in Section 3.4.1 were supported by reinforced concrete beams with rectangular cross sections. Two beams were used for each specimen – one to support the long side and one to support the short side of the precast panel. The

long side beam was supported at the ends and in the middle by elastomeric bearing pads resting on concrete blocks. These elastomeric bearing pads measure 9" x 13" x 2-1/2" and model the bearing pads that are used to support prestressed concrete girders in TxDOT bridges. The short side beam was only supported at its ends. Figure 3.12 illustrates the beam configuration. The transverse reinforcement in the beams extended into the cast-in-place topping slab to resist horizontal shear. In the early specimens, these U-bars were oriented square to the longitudinal axis of the beams (Figure 3.2) to simulate the orientation of shear reinforcement in prestressed girders. However, in later specimens, U-bars were rotated 90° (Figure 3.12) to facilitate construction.

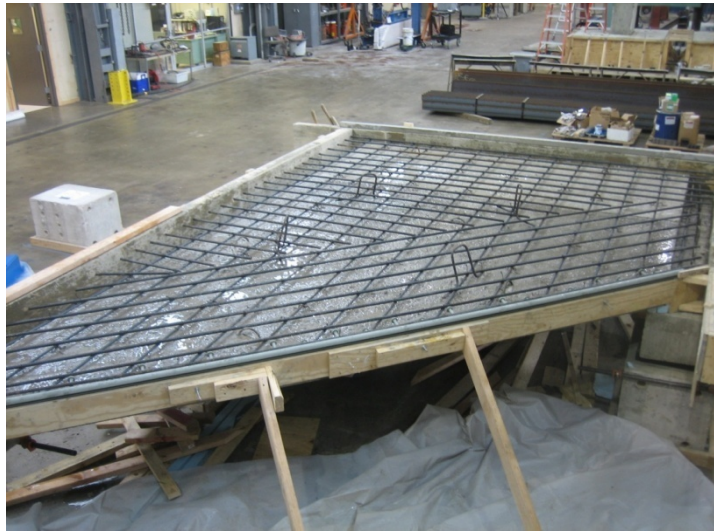
**Figure 3.14 – Cast-in-Place Topping Reinforcement**

A 4-in. cast-in-place topping slab was placed on top of the panels and longitudinal beams. Formwork was erected around the beams and panels so that the topping slab would be 4" over the panels and 10" over the beams, as shown in Figure 3.13. Reinforcement was provided in the topping slab to represent standard TxDOT details (Figure 3.14). The vertical leg of the sealed expansion joint rail was fastened to the

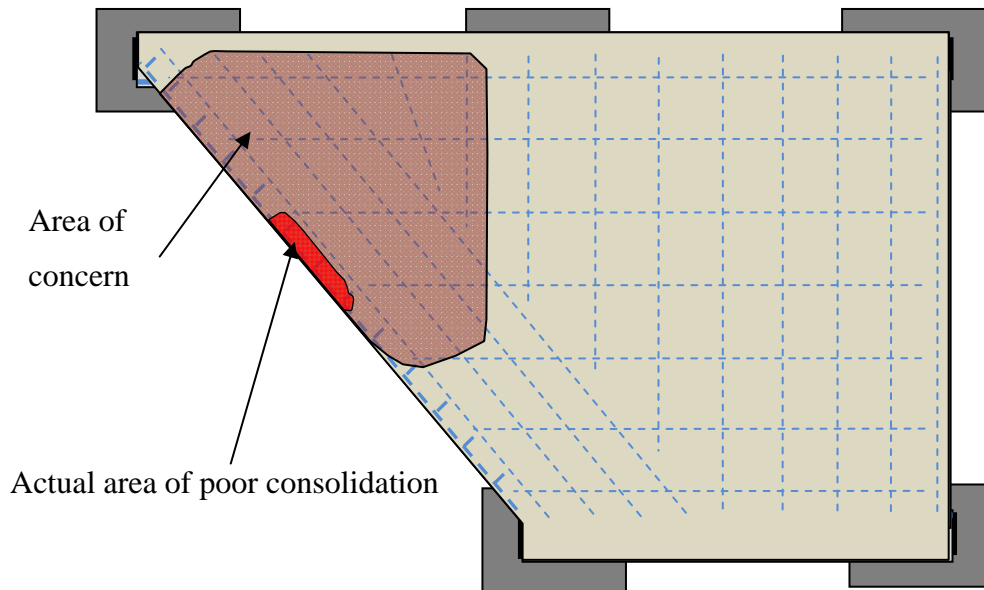
The results of the nondestructive tests are provided in Appendix A. In summary, it was determined that the extent of the poorly consolidated concrete did not extend into the panel past the studs in the SEJ (Figure 3.16). The specimen was tested without any attempt to repair the area, and the test results, presented in Chapter 5, indicate that the lack of consolidation did not influence the static strength of the specimen.

*Figure 3.16 – Extent of Poor Consolidation in Specimen P45P2*

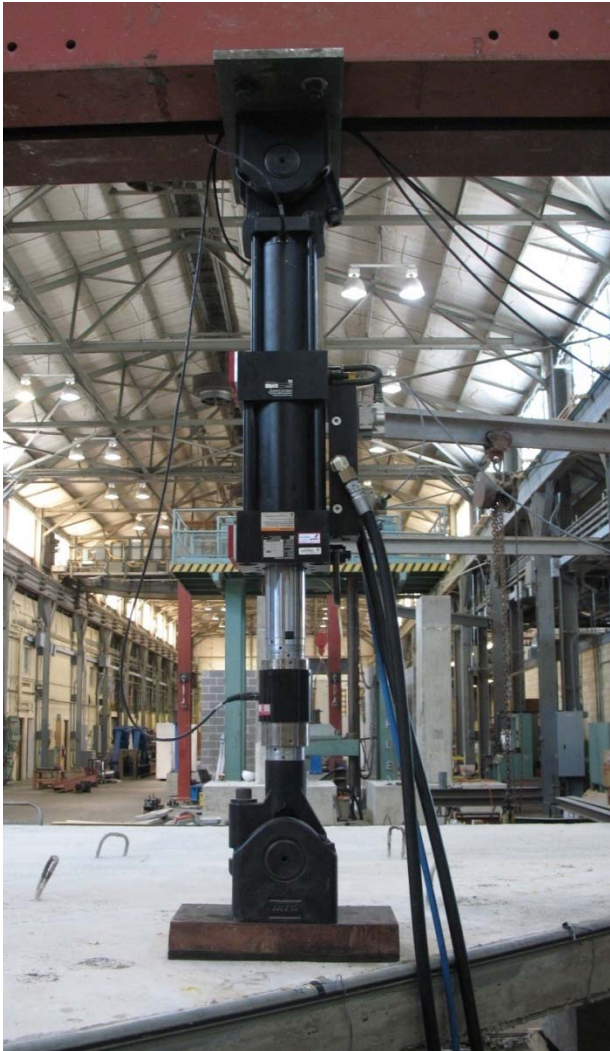
*Figure 4.5 – MTS Hydraulic Actuator*

The same loading frame used for the static tests was used for the fatigue test of Specimen P45P3. A 50-kip, MTS hydraulic actuator was used to apply the cyclic loading (Figure 4.5). The actuator had a 10-in. stroke and an internal load cell.

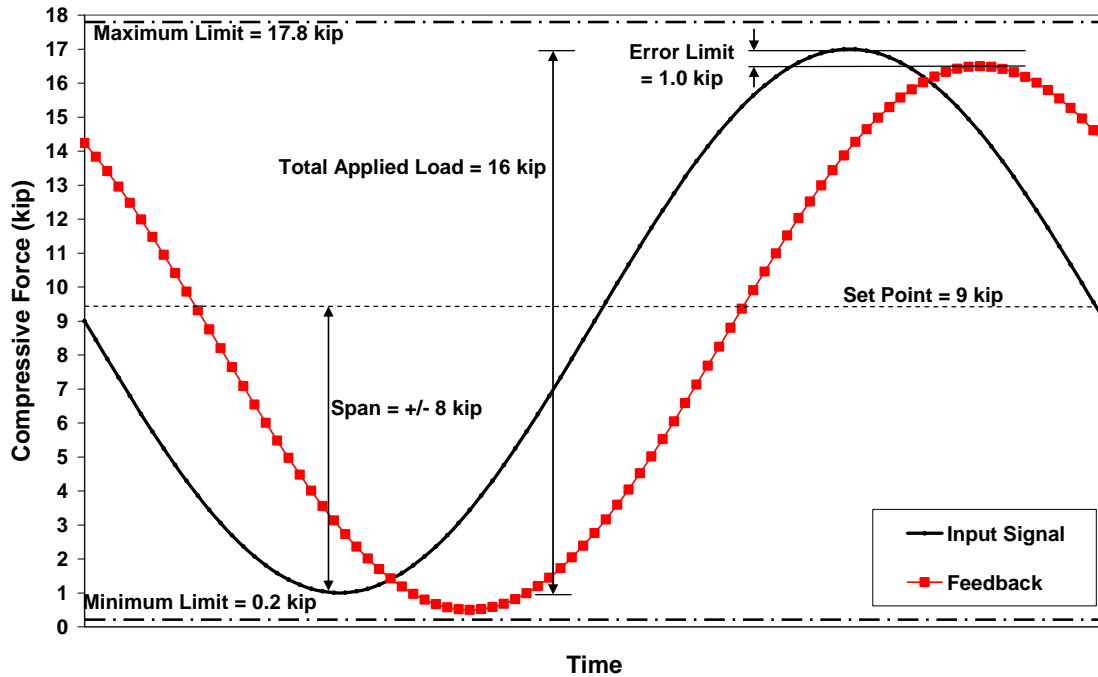
overloaded. The upper and lower load limits were 17.8 and 0.2 kip, respectively. A summary of these parameters with a plot of the input and feedback signals is provided in Figure 4.6.

**Figure 4.6 – Fatigue Loading Input and Feedback Signal**

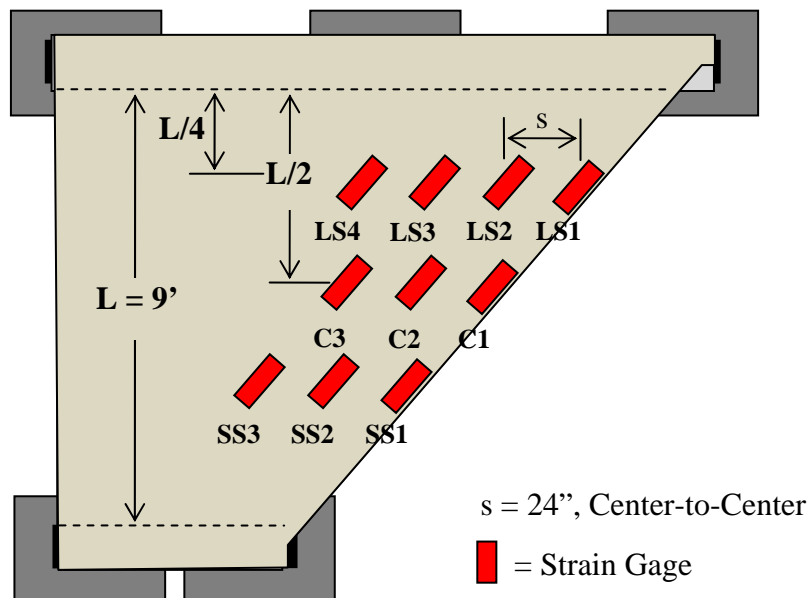
Strain gages were used to measure strain on the bottom of the precast panel and strain on the top surface of the SEJ. The concrete strain gages are labeled in Figure 4.7, and the SEJ gages are shown in Figure 4.8. All the strain gages were spaced 24" on center starting from the skewed end. Strain gages were attached to the strands in the panel when the panel was fabricated, but they were damaged during panel fabrication. Therefore, no data were collected during the static test.

*Figure 4.7 – Concrete Strain Gage Locations and Labels for Specimen P45P1*

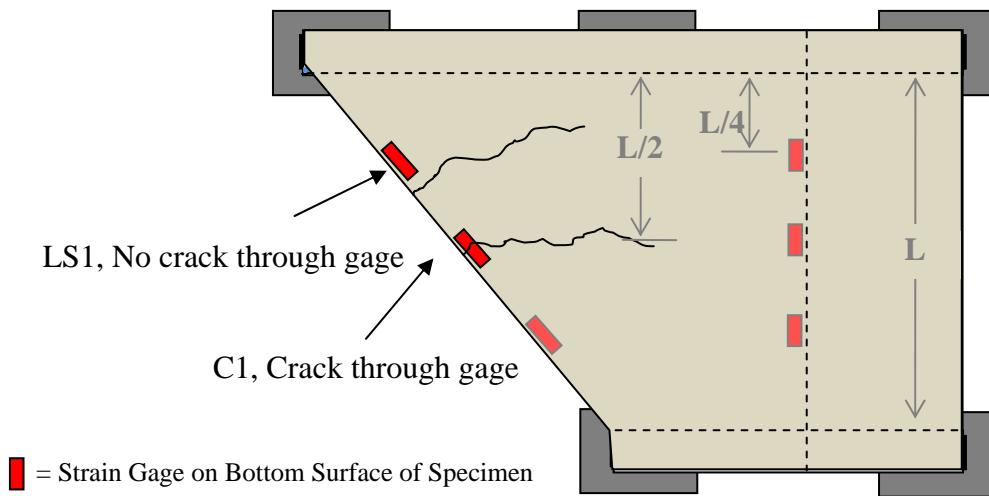
In some cases, strain gages were damaged during the test due to events such as formation of a crack at the location of a strain gage on the surface of the concrete or debonding of the gage from the reinforcement. When this occurs, the data for that strain gage are unreliable beyond that point. An “X” was used to identify the load at which the damage occurred. Figure 5.2 provides an example using concrete strain gages to show how the data are displayed when the strain gage was damaged during loading.

*Figure 5.2 – Presentation of Strain Gage Data*

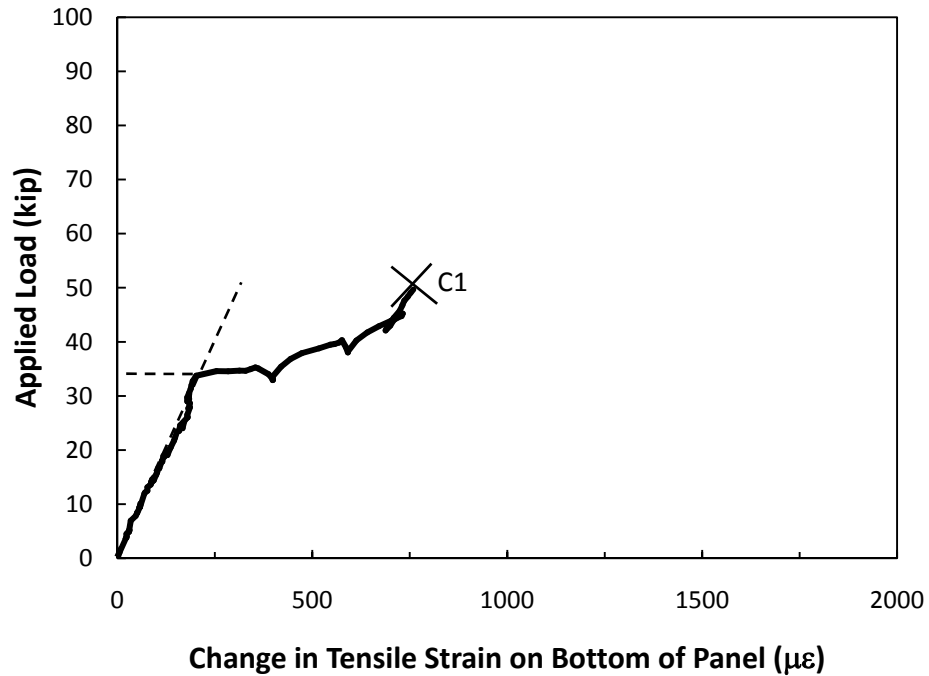
The change in strain at midspan of the loaded end is shown in Figure 5.5. Strain data from the bottom of the panel show a cracking load of approximately 33 kip. The strain variation along the loaded end is presented in Figure 5.6. At each of the characteristic load levels ( $P_W$ ,  $P_L$ , and  $P_U$ ), strains were highest at midspan under the load point, and the lowest strain was recorded at the quarter-span location near the long side.

*Figure 5.5 – Change in Tensile Strain on Bottom of Precast Panel for Specimen P45P1 for Load Applied at Midspan of Skewed End*

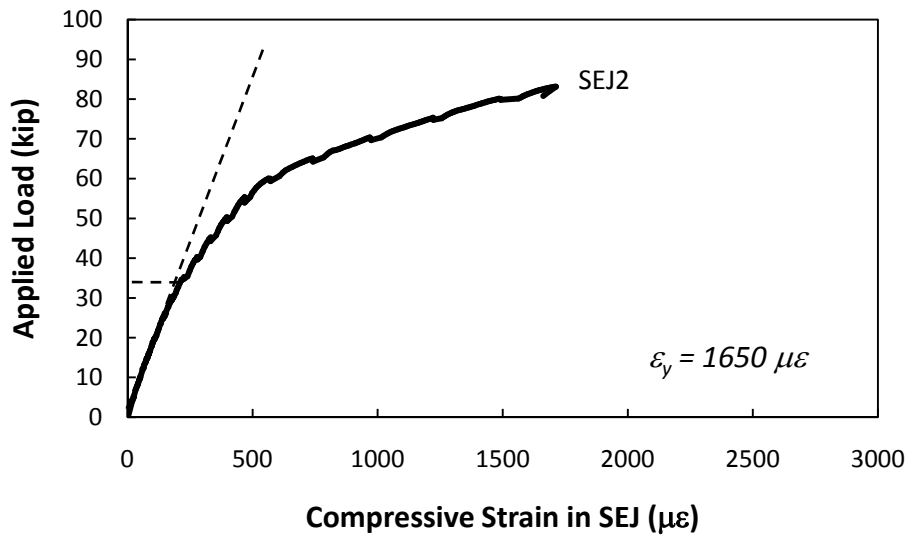
Compressive strain data at midspan of the SEJ is shown in Figure 5.7. The SEJ shows a cracking load of approximately 33 kip. The strain variation along the SEJ is shown in Figure 5.8. Again, the strain is highest at midspan, followed by lower strains at the quarter-span location near the short side and the lowest strains near the long side.

*Figure 5.7 – Measured Compressive Strain at Midspan of SEJ for Specimen P45P1 for Load Applied at Midspan of Skewed End*

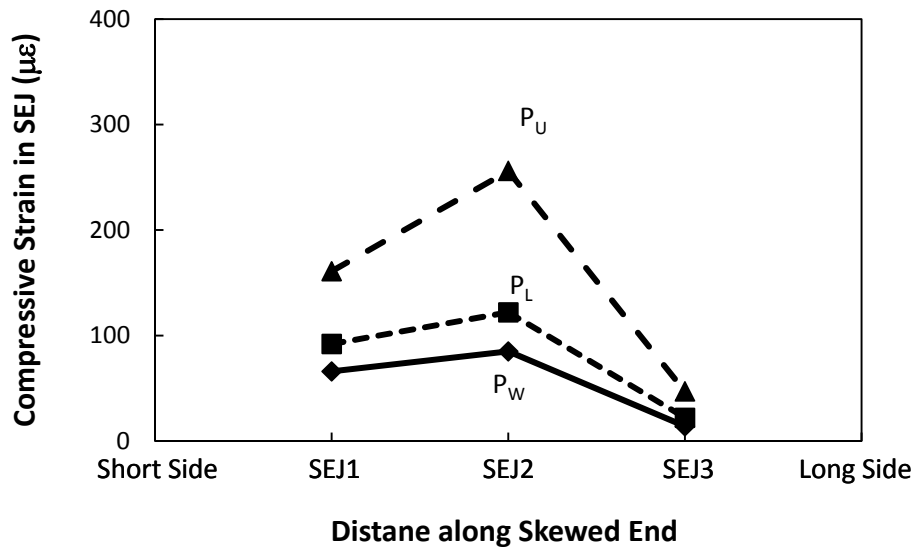
*Figure 5.8 – Variation of Strain in SEJ along Skewed End of Specimen P45P1*

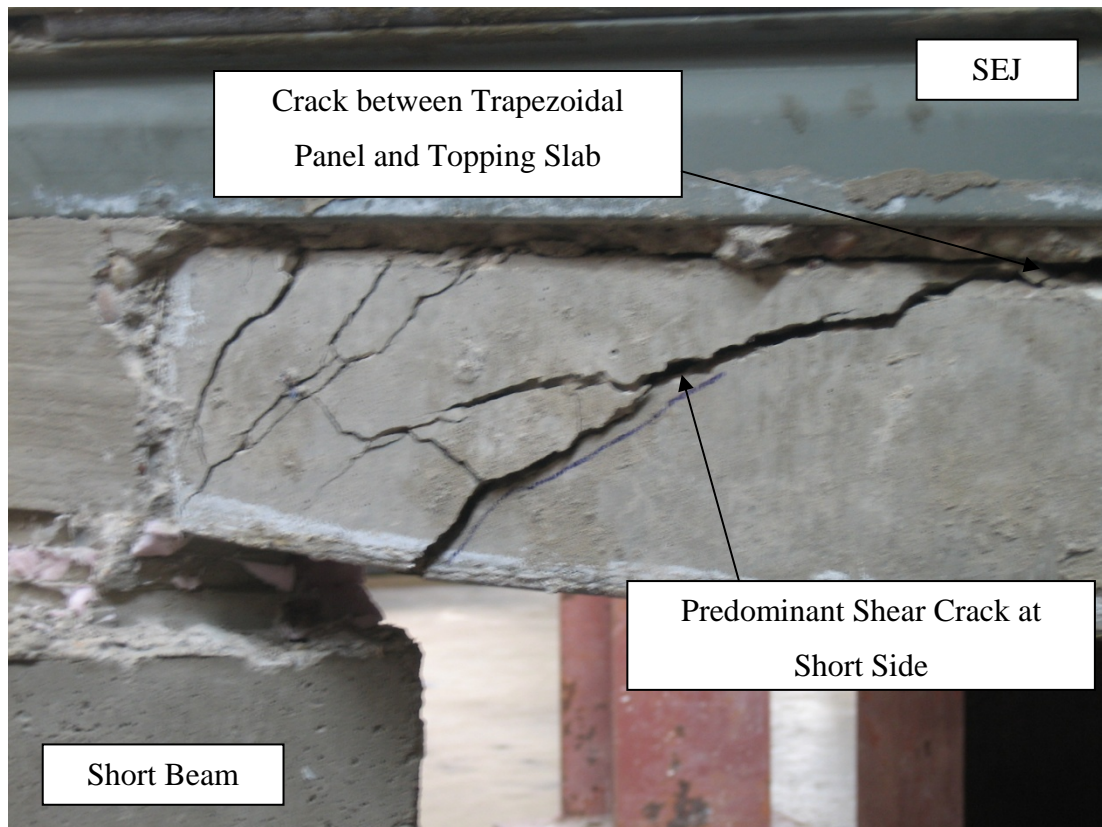
*Figure 5.10 – Photograph of Specimen P45P1 at Conclusion of Static Test*

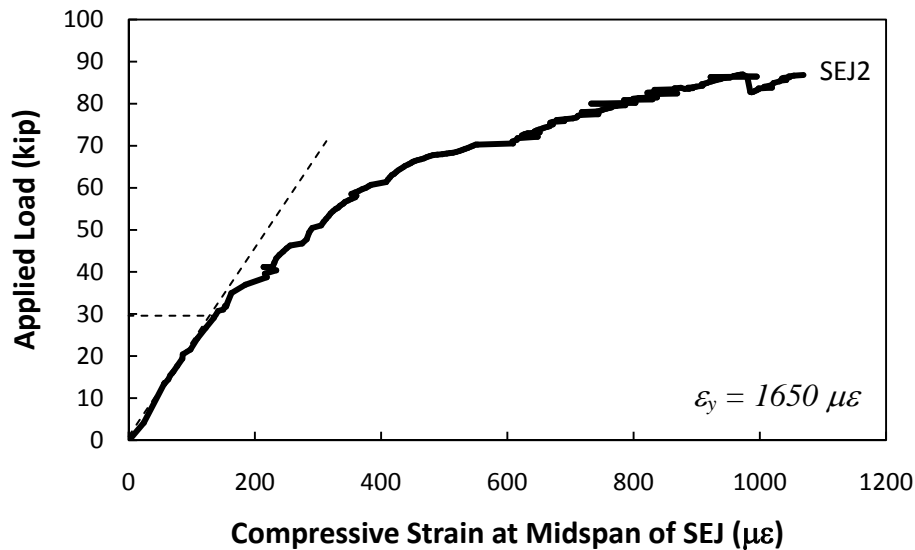
Compressive strain gage data for the SEJ show that expansion joint did not yield under the applied load. It also shows that the specimen cracked around 30 kip (Figure 5.15). Figure 5.16 shows the variation in SEJ strain along the loaded end. The same trend is seen here as in the displacement and concrete strain data. The highest strain was measured at midspan, followed by the quarter-span location near the short side, and the lowest strain was recorded at the quarter-span location near the long side.

**Figure 5.15 - Measured Compressive Strain at Midspan of SEJ for Specimen P45P2 for Load Applied at Midspan of Skewed End**

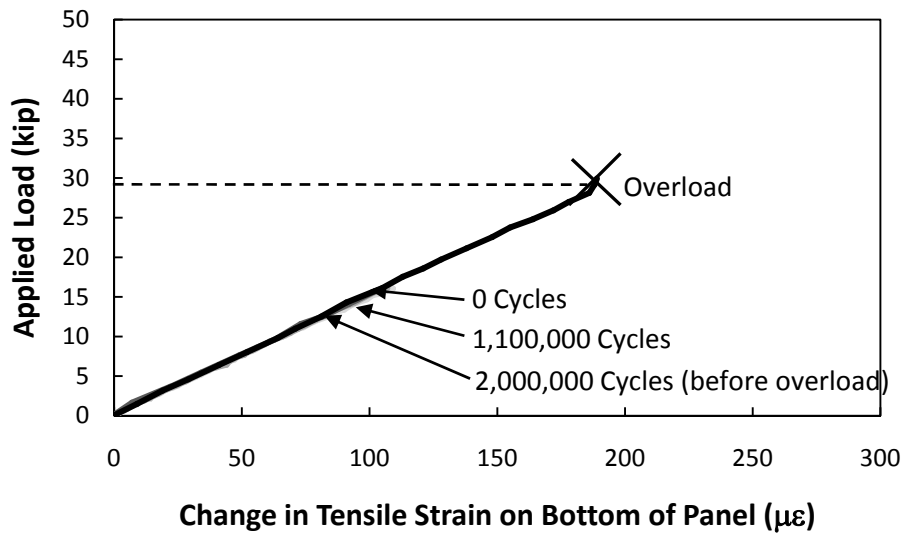
Live load induced tensile strain data along the bottom of the panel at the skewed end are presented for static tests before the static overload test in Figure 5.33, and live load induced strains for periodic static tests after the overload are provided in Figure 5.34. The figure shows that a crack passed through the strain gage on the concrete at an applied load of approximately 29 kip. Because no change in stiffness occurred before the gage was destroyed, no cracking load can be inferred from live load induced strain data during the static over load test. No significant change in stiffness along the loaded end occurred during the fatigue loading. Periodic tests after the overload show a nonlinear strain response that is likely due to opening of cracks during the overload test. Variation in strain along the bottom end of the panel for the static overload test is provided in Figure 5.35.

*Figure 5.33 – Measured Change in Concrete Strain on the Bottom of Panel at Midspan of Skewed End for Specimen P45P3 during Periodic Static Tests before Overload Test*

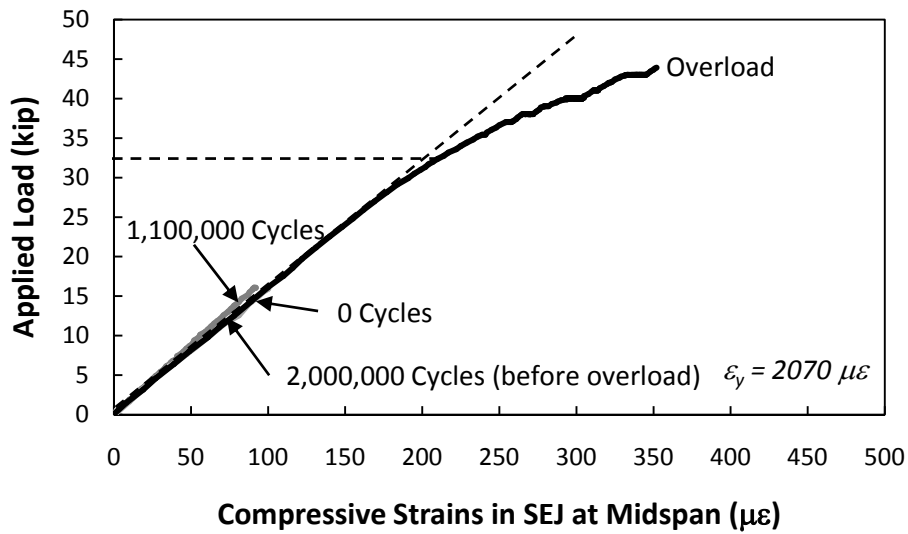
Compressive strain data from midspan of the SEJ (Figure 5.36) indicate a cracking load of approximately 32 kip. Periodic static tests before and after the overload are shown in Figure 5.36 and Figure 5.37 respectively. The SEJ data also indicate no significant change in stiffness during the fatigue process. Variation of SEJ strain along the loaded end, Figure 5.38, again shows highest strains at midspan and lowest strains at the quarter-span location near the long side.

*Figure 5.36 – Measured Strain at Midspan of SEJ for Specimen P45P3 for Periodic Static Loads Applied before Static Overload Test*

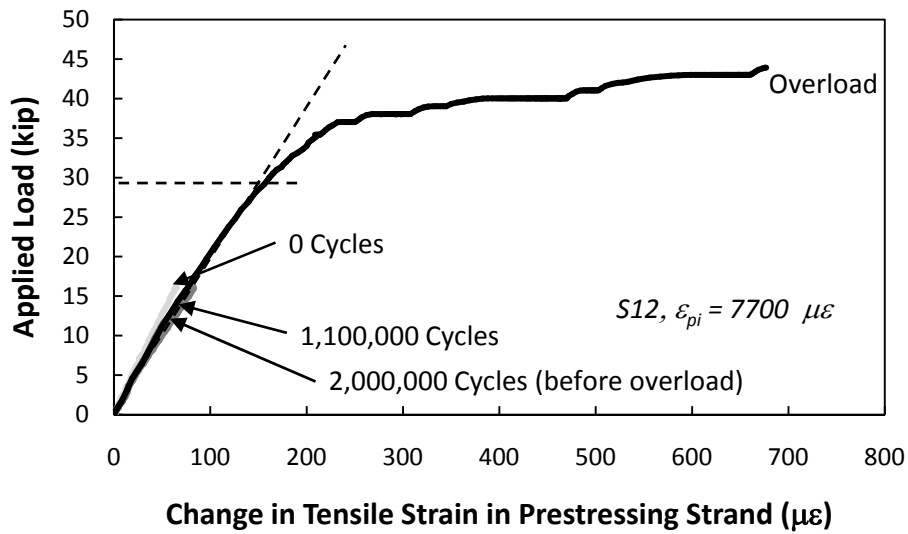
Live load induced tensile strain data for strand S12 are presented for periodic tests conducted before the static overload test in Figure 5.39 and after the static overload test in Figure 5.40. Again no significant changes in stiffness were observed with the fatigue loading. Variation of strain in the prestressing strands during the overload test from the loaded end towards the interior of the panel is shown in Figure 5.41. The largest changes in strain were observed directly beneath the load point, at the skewed end and then quickly drop off as distance from the loaded end increases.

*Figure 5.39 – Measured Change in Strain Response of Strand S12 during Periodic Static Tests before Overload for Specimen P45P3 for Loads Applied at Midspan of Skewed End*

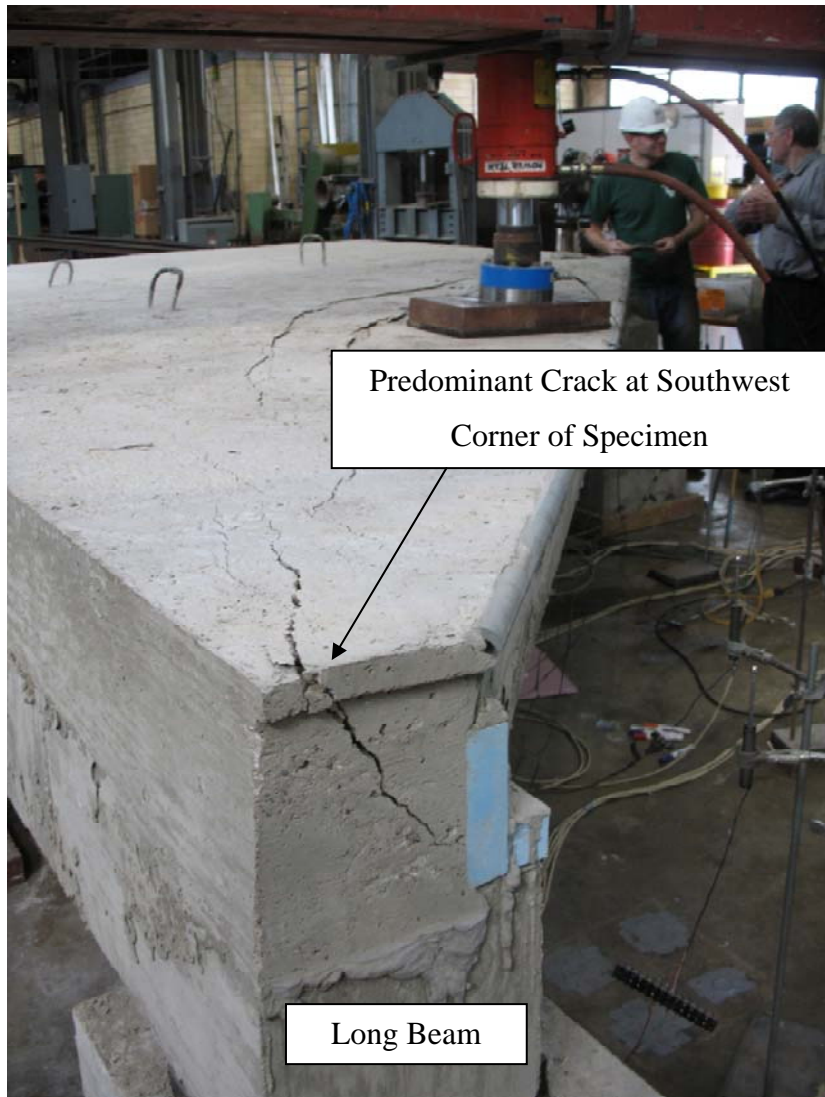
*Figure 5.52 – Predominant Cracks at Southwest Corner of Specimen at Conclusion of Static Test to Failure of Specimen P45P3*

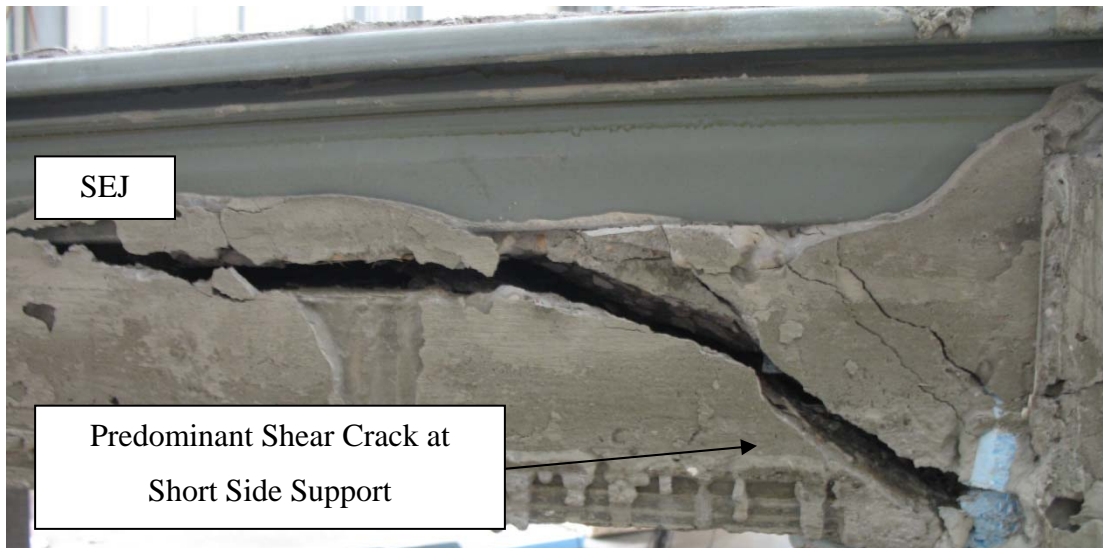
(a) Southeast Corner of Specimen P45P3 Viewed from Side

and no delamination between the panel and topping slab was observed at the maximum applied load. Spalling on the bottom of the panel was observed at the maximum applied load, but no panel reinforcement was exposed. Photographs of the specimen at the conclusion of the test are provided in Figure 5.52, Figure 5.53, and Figure 5.54.

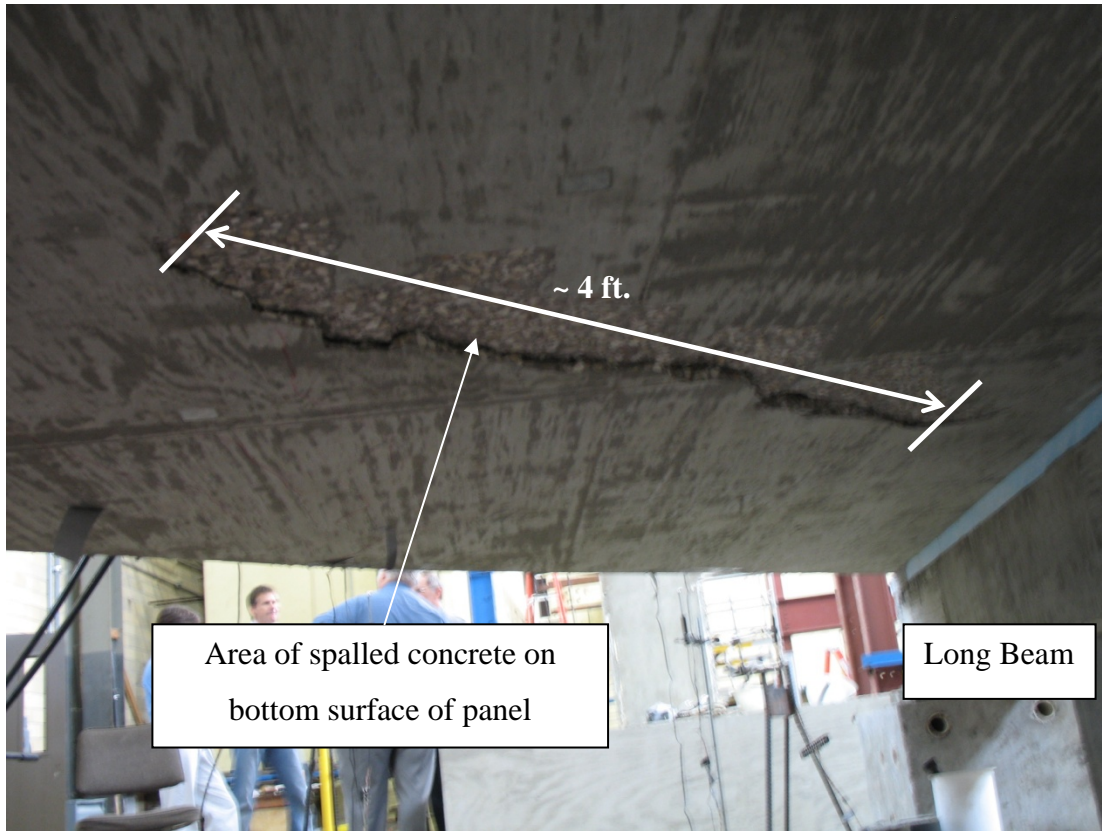
*Figure 5.54 – Spalling on Bottom Surface of Specimen P45P3 at Conclusion of Static Test to Failure*

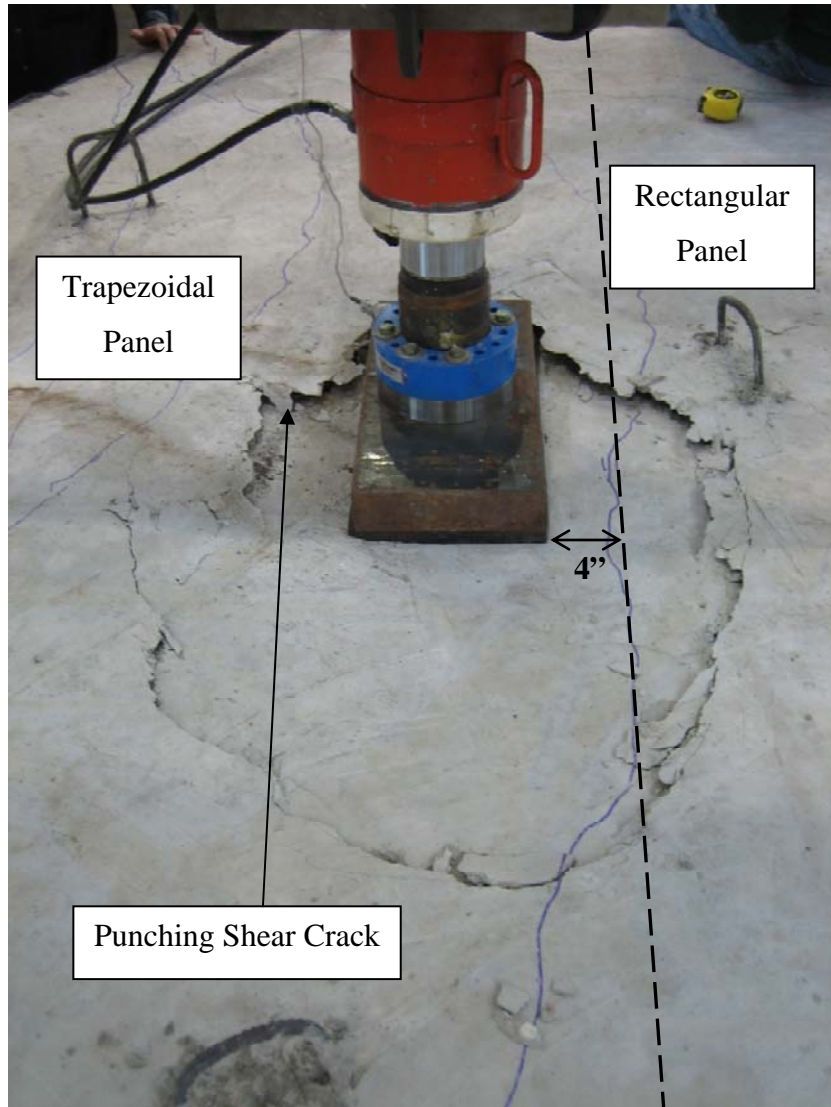
*Figure 5.65 – Photograph of Punching Shear Failure for Specimen P30P1 for Load Applied at Midspan of Square End*

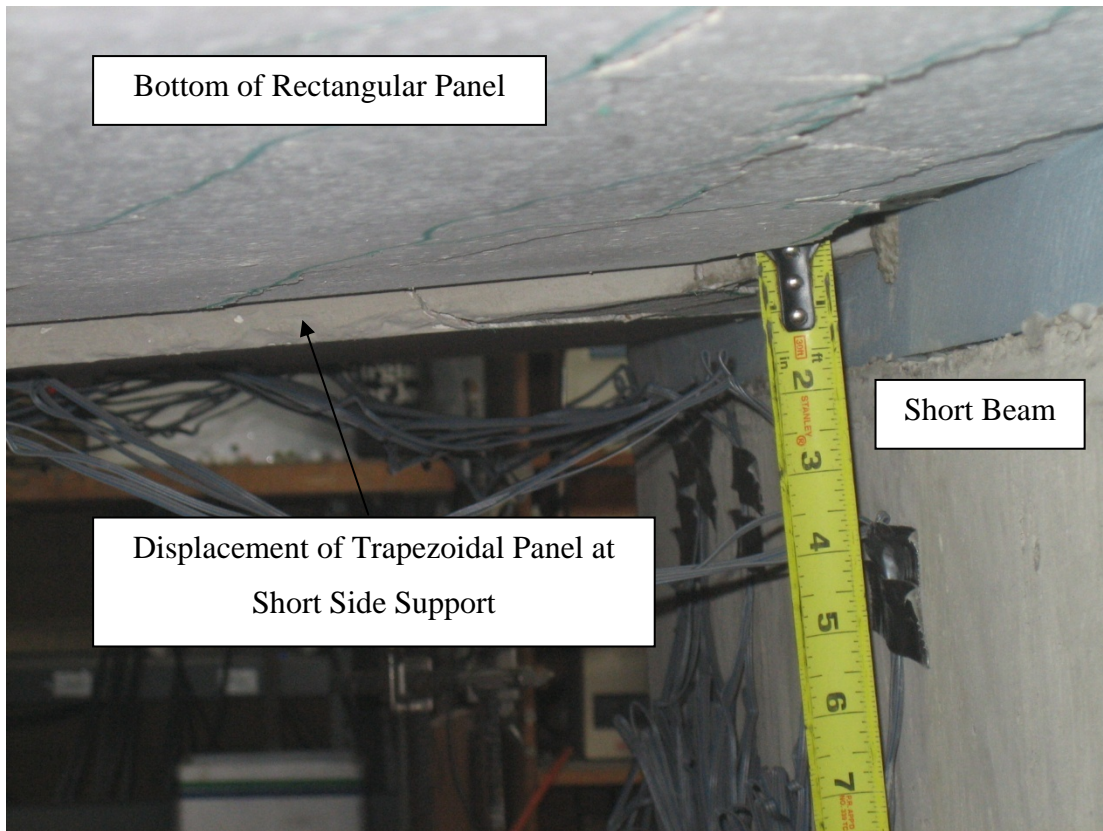
**Figure 5.66 – Photograph of Trapezoidal Panel Displacement at Conclusion of Test of Specimen P30P1 for Load Applied at Midspan of Square End**

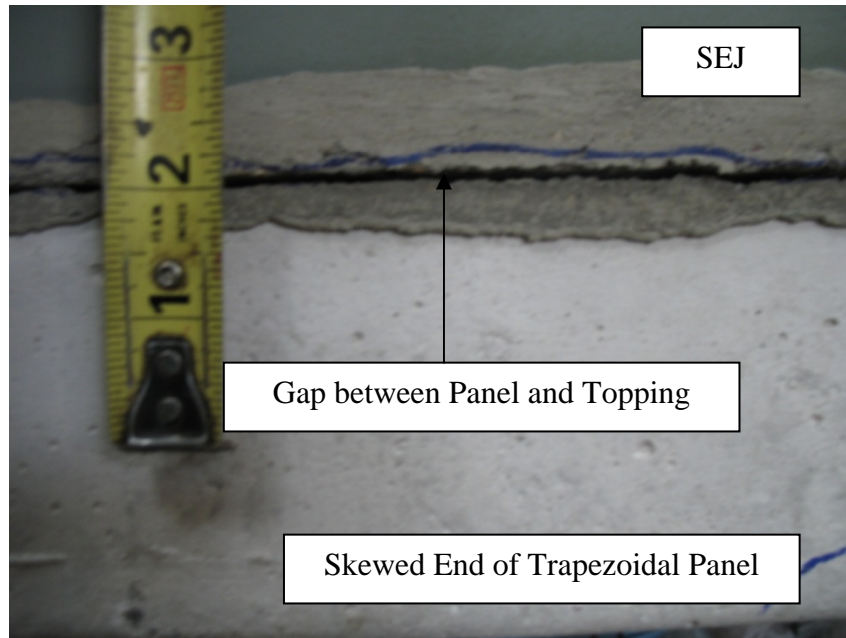
***Figure 5.74 – Photograph of Delamination of Trapezoidal Panel from Topping Slab for Specimen P30P2 for Load Applied at Midspan of Skewed End***

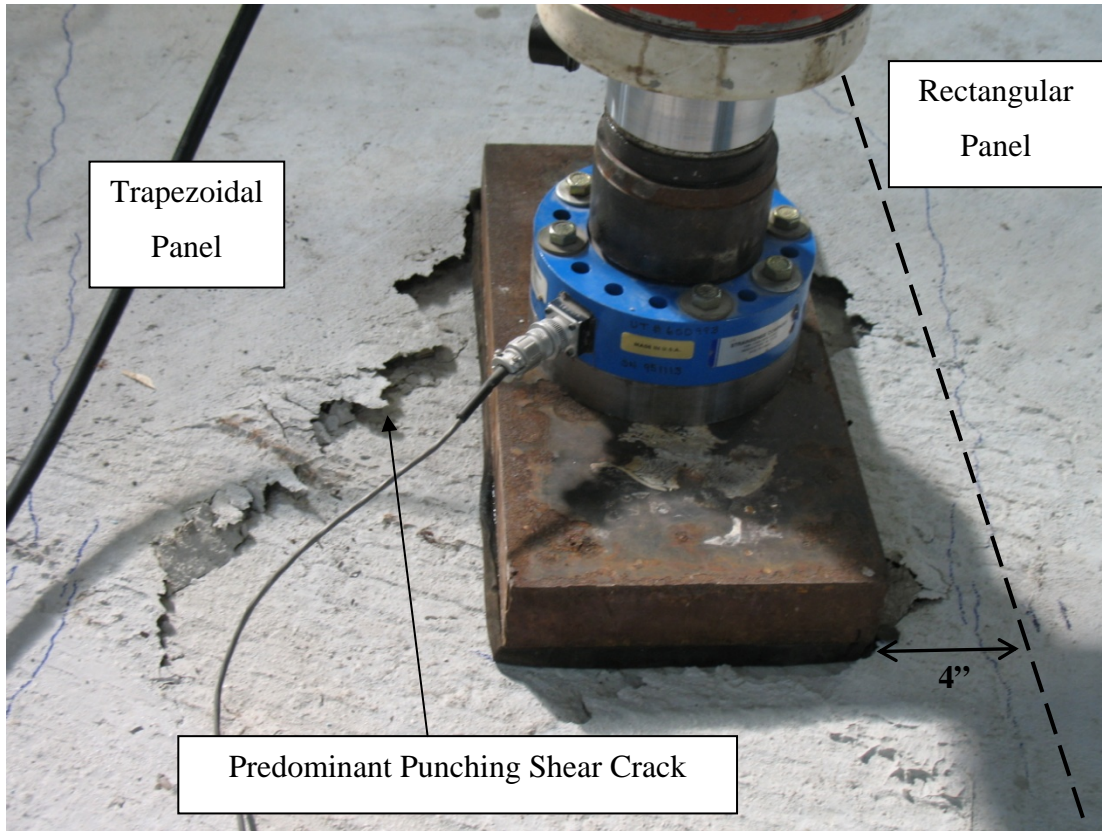
***Figure 5.77 – Photograph of Punching Shear Failure for Specimen P30P2 for Load Applied at Midspan of Square End***

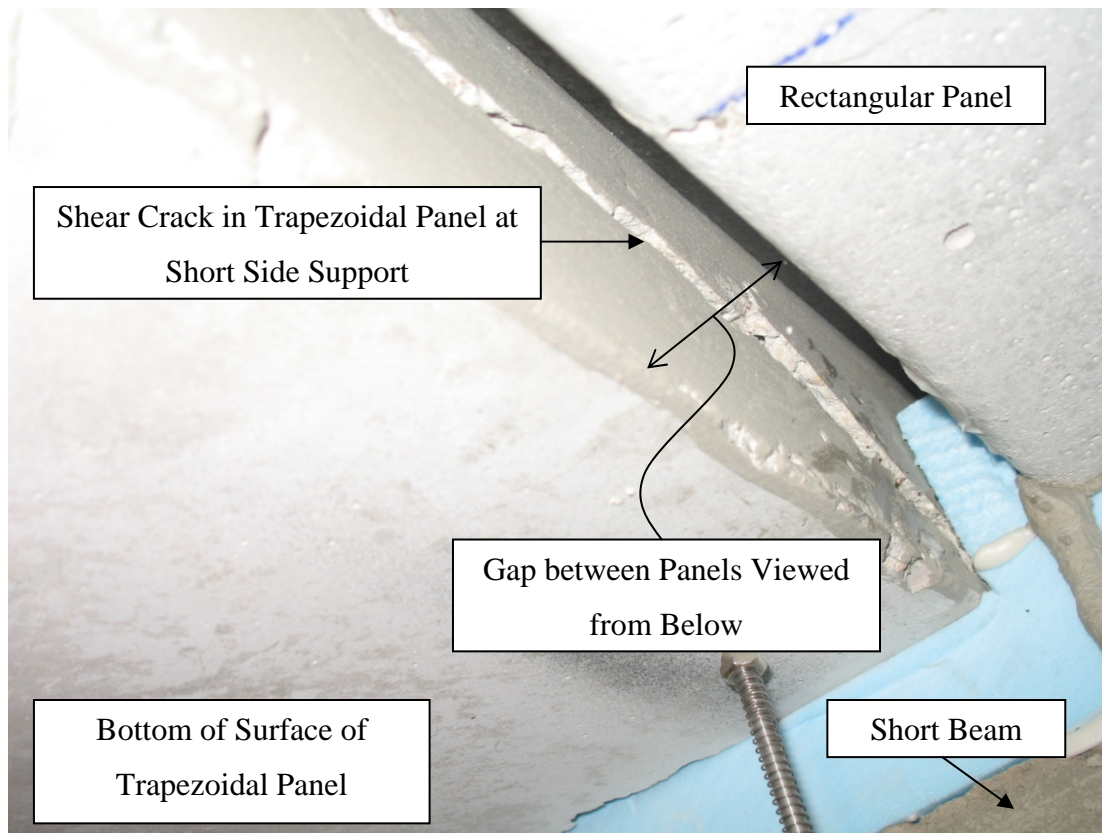
***Figure 5.78 – Photograph of Shear Crack in Trapezoidal Panel at Short Side Support in Specimen P30P2 for Load Applied at Midspan of Square End***
