**Measured Behavior of a Balanced Cantilever Erected Curved  
Segmental Concrete Bridge**

**Thesis**

The University of Texas at Austin

**May 1998**

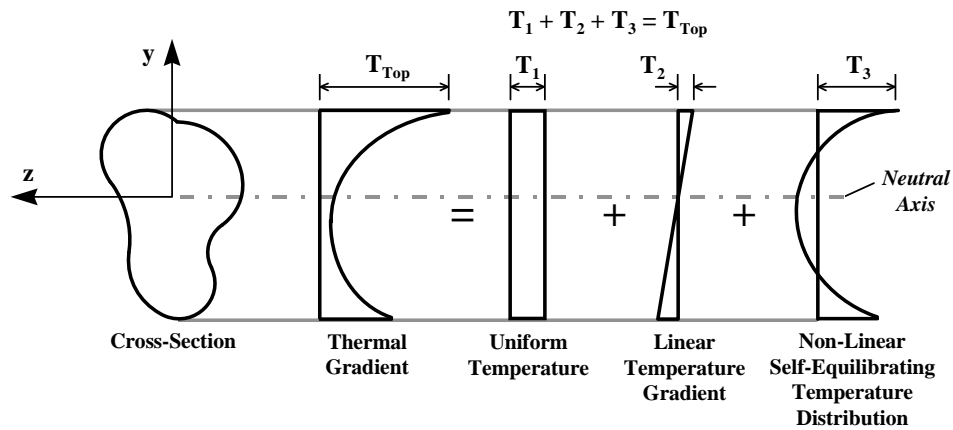
For analysis purposes, non-linear thermal gradients are typically divided into three components. First, a uniform temperature component is removed from the initial gradient. Second, a linear thermal gradient is removed. The remainder after removing these first two components is a self-equilibrating temperature distribution. Figure 2.13 shows the three components of the non-linear thermal gradient. The effects of these components on the bridge structure depends on three factors: the statical determinacy of the structure, the susceptibility of the cross-section to warping, and the stress range of the concrete under which the loading occurs which determines whether the behavior will be elastic or inelastic.

**Figure 2.13 - Components of a non-linear thermal gradient**

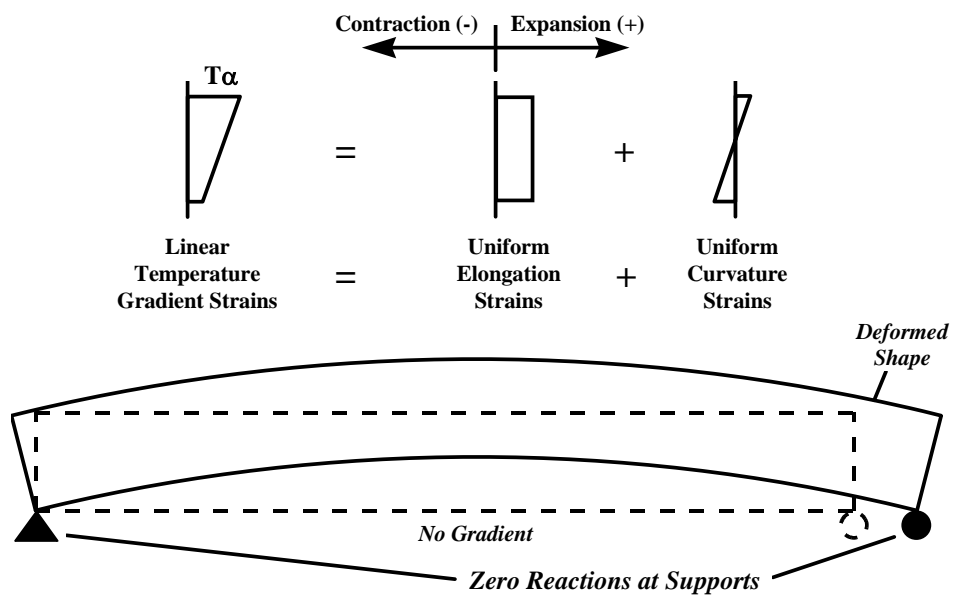
The effects of the first two components of the thermal gradient depend primarily on the statical determinacy of the structure. The first component, the uniform temperature, causes a uniform expansion or contraction of the unrestrained superstructure. Generally, this phenomenon is accommodated by expansion joints or rolling bearings. If the structure is continuous and two or more of the interior supporting piers are rigidly fixed to the superstructure, they will provide restraint against such movement. This restraint will produce moments and axial forces in the structure. The second component, the linear thermal gradient, will produce a uniform curvature in the unrestrained superstructure. Only if the superstructure is a simply supported single span can the bridge deform freely (Figure 2.14). Otherwise, if the structure is continuous over two or more spans, the internal piers will restrain the superstructure from deforming in such a manner. Thus, secondary moments are introduced into the structure. This effect is shown in Figure 2.15.

Figure 2.14 - Effect of linear thermal gradient components on a statically determinate span

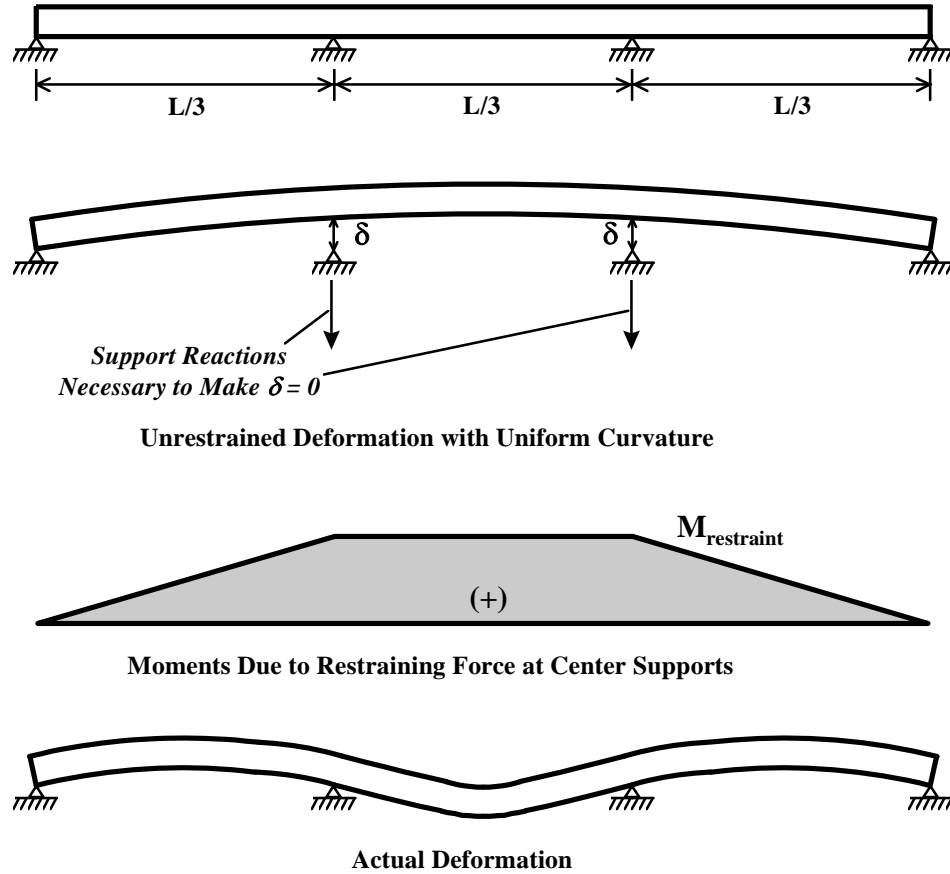
*Figure 2.15 - Effects of linear thermal gradient components on a statically indeterminate bridge structure*

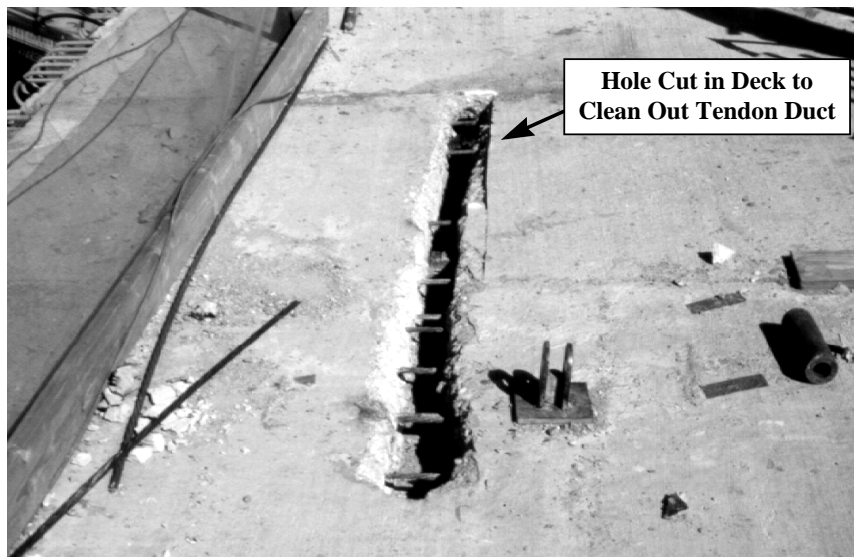
During the grouting of one of the transverse post-tensioning ducts in the top flange of the interior anchorage segment for P16, grout leaked out of the duct within the concrete and into one of the ducts for a top flange cantilever tendon. The transverse duct passed directly over the longitudinal cantilever duct and they were probably in contact with each other. Holes must have also been present in each of these ducts where they crossed. The grout had to be removed from the longitudinal duct because the tendon for that duct had not been placed yet, and the grout was creating an obstruction that would prevent any tendon from being threaded through the duct. The contractor was forced to chisel through the concrete deck to get to this duct and clean it out. Figure 4.39 shows the resulting damage. Many of the transverse prestressing strands in segments P16-1a and P16-2 were damaged during this process.

*Figure 4.39 - Damage done to the top deck because the cantilever tendon duct became obstructed*

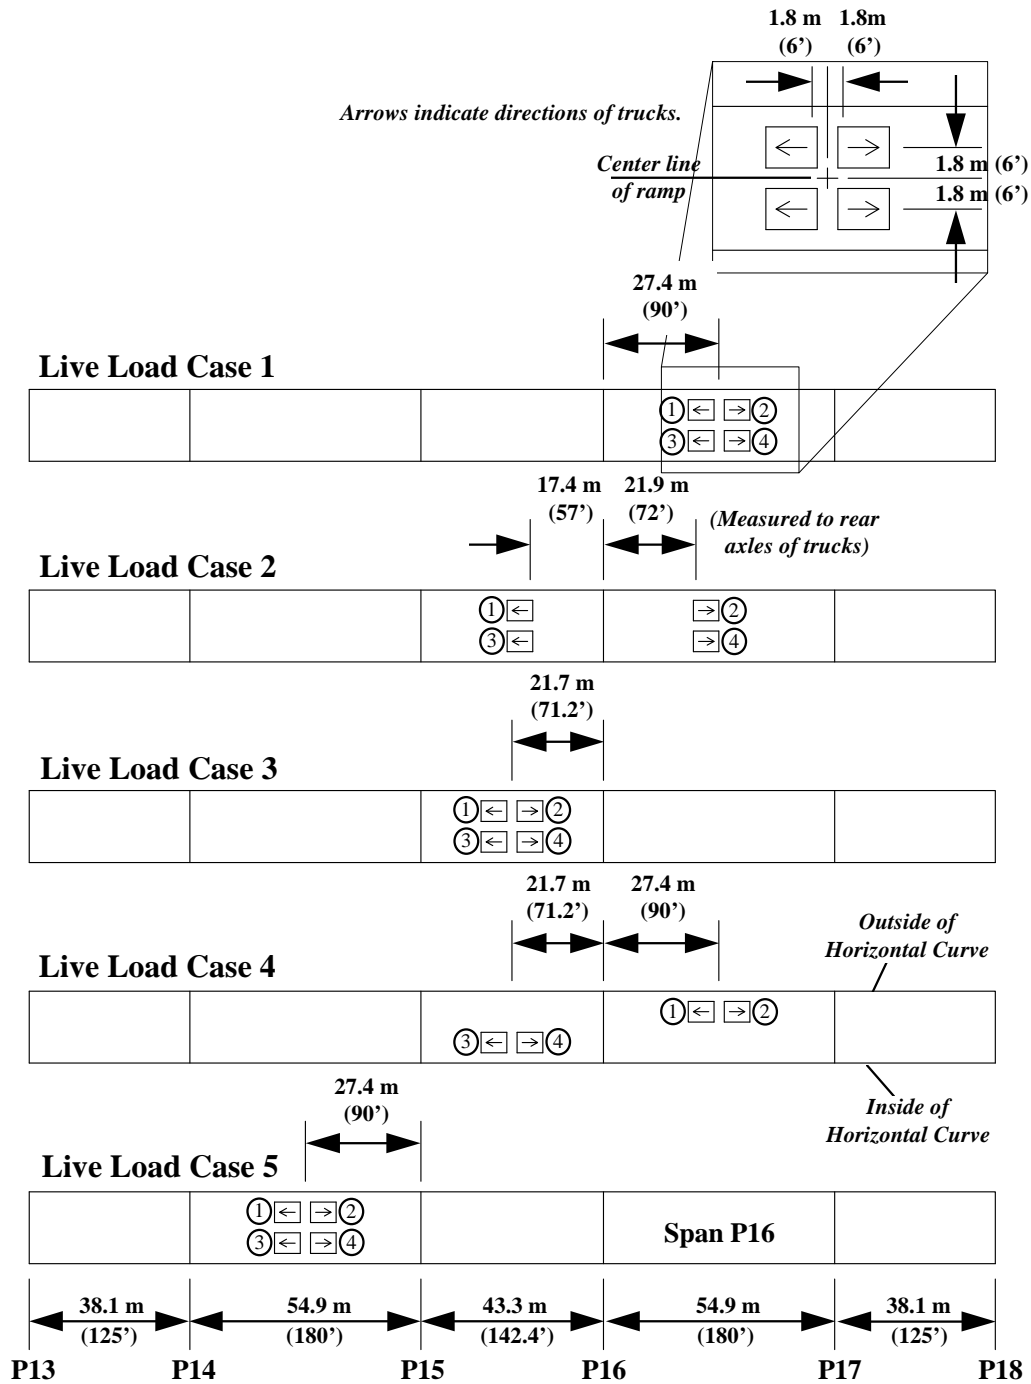
Figure 6.1 - Live load test cases
