**Constructing a Full-Scale Horizontally-Curved Twin Steel
Trapezoidal Box Girder Bridge Segment to Determine
Redundancies in Fracture Critical Bridges**

Departmental Report

The University of Texas at Austin

December 2006

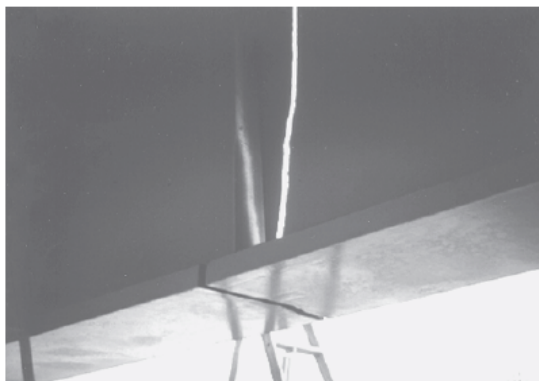
Figure 2.2: Girder fracture on a bridge on I-79 at Neville Island in Pittsburgh, Pennsylvania (Connor, Dexter, and Mahmoud, 2005).

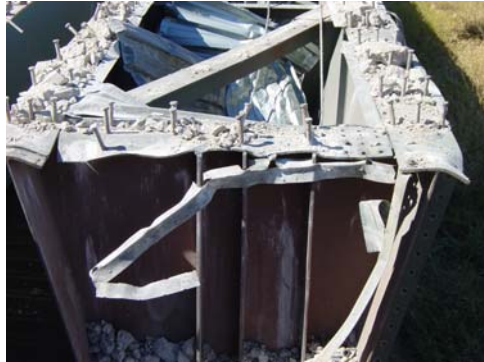
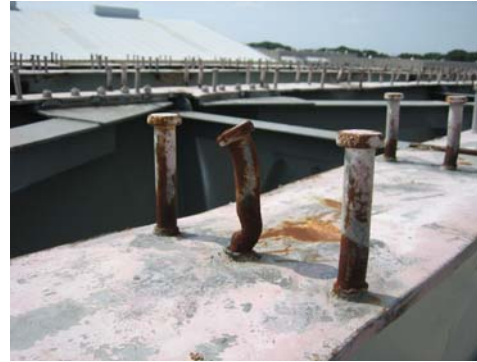
Figure 3.1: a) Post removal damage of flange and shear studs prior to shipping to Trinity b) shear stud damage repaired at Ferguson lab

During the removal of the bridge girders from I-10, the contractor damaged the flanges and shear studs extensively (Figure 3.1). The girders had to be sent to Trinity steel fabricators in Houston to have the flanges and some shear studs

straightened. The repairs were made mostly by using heat and applying large forces to reshape the distorted steel close to its previous shape. Once Trinity made the repairs possible for the funds that were available, the girders were transported to the Phil M. Ferguson Structural Engineering Laboratory at the J.J. Pickle Research Center campus.

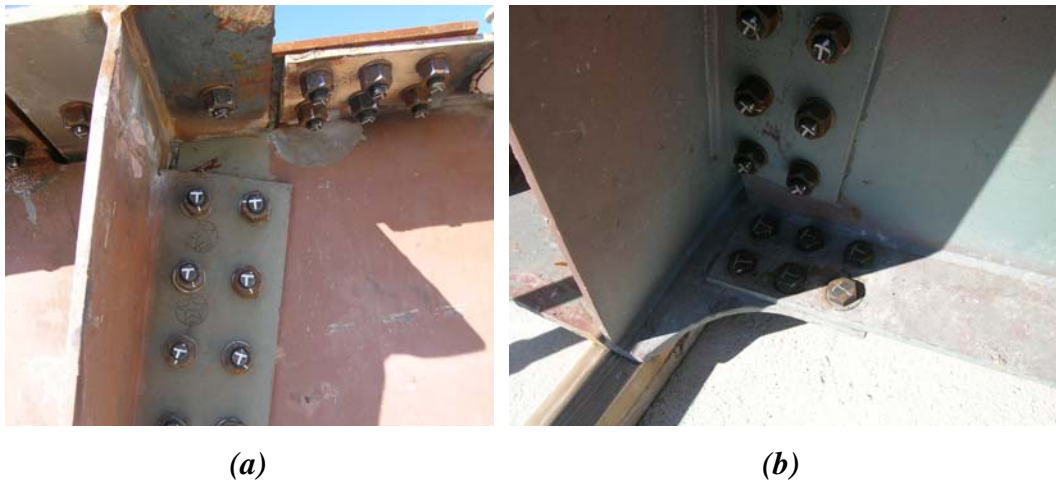
Figure 3.2: a) South end diaphragm top corner connection b) north end lower corner connection

Once placed on the pier foundations, which are discussed in the next section, the girders were assembled. The 7/8-in. diameter A490 bolts that were specified on the structural drawings were installed in the diaphragms that connect the two girders. The bolts were tightened following the *Turn-of-Nut Pretensioning* guidelines from the AISC Steel Construction Specifications (ASCI, 2003). As an internal quality assurance measure, each bolt was marked with a “T” after it was tightened to provide a visual check that all of the diaphragms and top plate bolts were installed correctly (Figure 3.2). Once the girders were secured together, repairs to the girders could be finished.

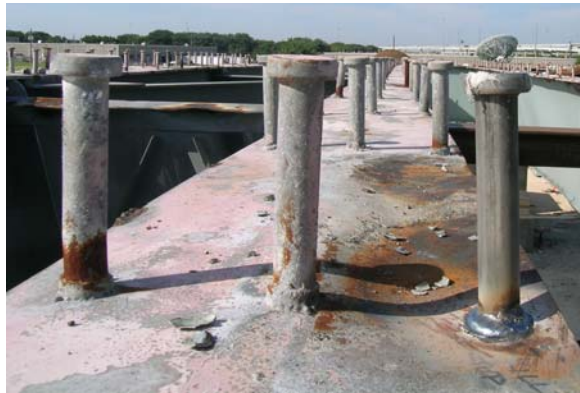
Figure 3.3: New stud welded on to the inner flange of the interior girder

The middle third of the girders were inspected for the shear studs that showed any sign of damage. There were a total of 29 studs that had been badly damaged, similar to that shown in Figure 3.1b above, or that were bent enough to possibly affect their ability to transfer the load from the concrete deck to the undamaged girder. These studs were cut from the flange, and the surface was ground flat to accept new studs. Shear studs with the same dimensions, 7/8 in diameter and 5 inches tall, were welded on the flanges as close to the old position as possible (Figure 3.3). The studs were attached with a 1/2-in. fillet weld at the

base. The remaining studs were either in good condition or outside the middle third of the girder and were not expected to influence the results of the test.

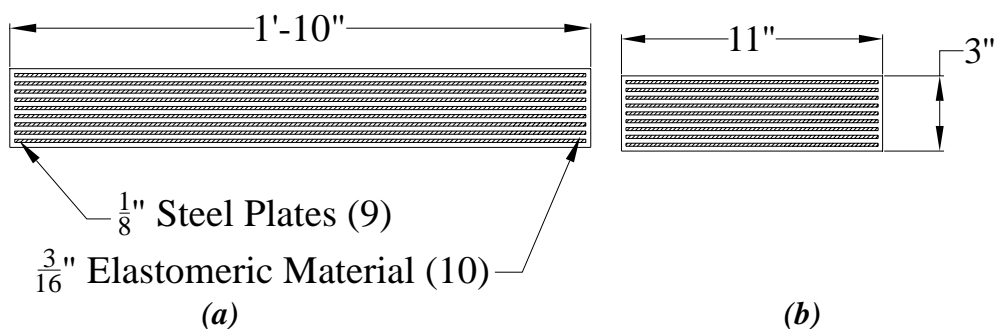
Figure 3.4: a) Bearing pad plate and elastomeric layer thickness b) side view of pad.

determine the specifications for the bearing pads. The loads from the girders were taken to be the 220 kips per bearing pad specified on the plans (Figure B.3-1). The size was limited to a minimum of 220 square inches by the 1000 psi maximum bearing pressures in the manual. Bearing pads from another research project were found that met the bearing pressure limitations and were used rather than purchasing new ones to prevent delays and save funds. The pads were 22 in. long, 11 in. wide and 3 in. height. They had 9 reinforcing steel plates 1/8 in. thick with 10 layers of neoprene material in 3/16 in. layers top, bottom and in between the steel plates (Figure 3.4).

The pads were checked against TxDOT and AASHTO standards in order to verify that they would function within the same parameters as expected from those in the field (Appendix A.1). The bearing pads were not designed for the deflections that might be experienced during the fracture test because this is not done in normal bridge design. Once the pads were sized, the foundations were designed.

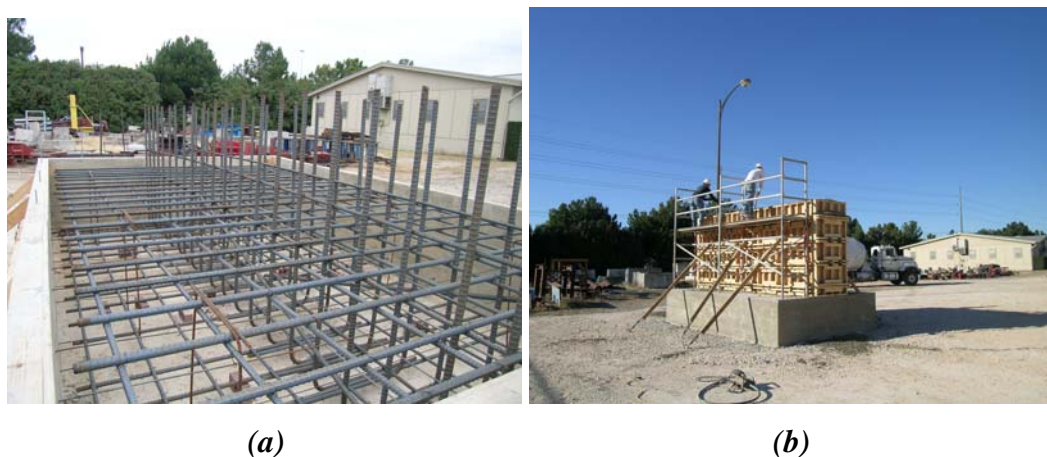
Figure 3.5: a) Bottom of north foundation b) stem wall for south foundation

square feet, which would support 510 kips with the assumed soil pressure. The height was selected such that the girders would be 10 feet above the ground to provide room for instrumentation, installation, and removal of the external braces and deflection after the fracture event. The foundations were built according to the final design, shown in Appendix B in Figure B.2, on site prior to the girders arriving (Figure 3.5).

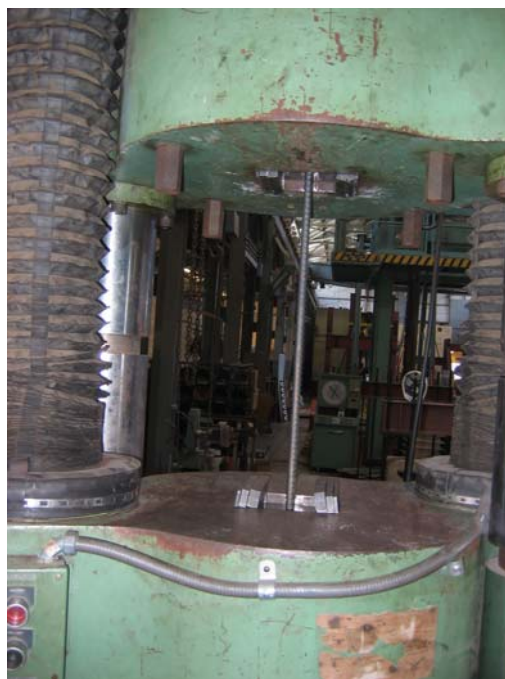
Figure 3.8: Tensile test of reinforcing steel

occurred. The load-displacement curves for each steel specimen indicate that both samples had a yield strength at or above 60 ksi, which meets or exceeds the required yield strength (Figure 3.9 and 3.10). The results are listed below in Table 3.4.

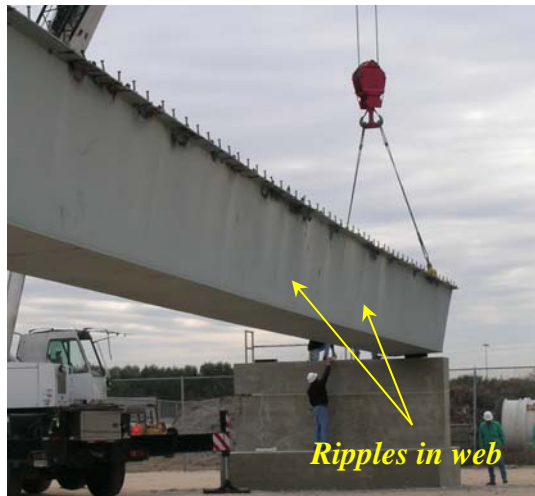
Figure 4.1: Out-of-plane imperfections in the web

The plates of the box girders came from the field with out-of-plane imperfections in the web that were noticeable (Figure 4.1). Measurements were made by other graduate students to determine the out-of-flatness condition of the webs after they were erected. They recorded out-of-plane displacements of over 1/8-in. in some locations. As the girders are loaded, the imperfections can increase.

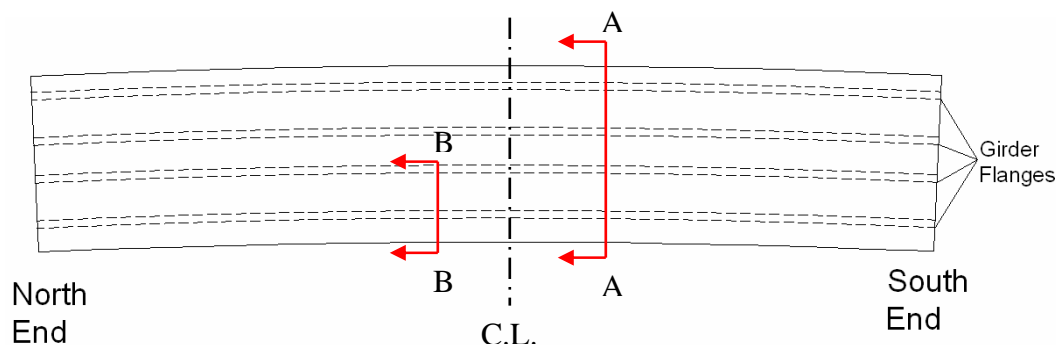
Figure 4.2: Instrumented cross-section locations

The girders were instrumented at three locations (Figure 4.2). The gages placed near the midspan in the exterior girder were offset 72 in. to the south to limit the damage they would experience during the fracture event. The gages in the interior girder were offset on both sides of the midspan, 70 in. north and 72 in. south, from the transverse centerline of the bridge. The single-direction foil gages are designated with “F” before their number (Figure 4.3a). The rectangular 0-45-90 rosette gages are designated with “R” before their number (Figure 4.3b). The web plates were instrumented with 12 single-direction foil gages 0.2362 in. (6 mm) long with a resistance of 350 ohms (Figure 4.4a). Also, the bottom flanges were instrumented with 6 rectangular 0-45-90, stacked rosette gages 0.2362 in (6 mm) long with a resistance of 120 ohms (Figures 4.4b).

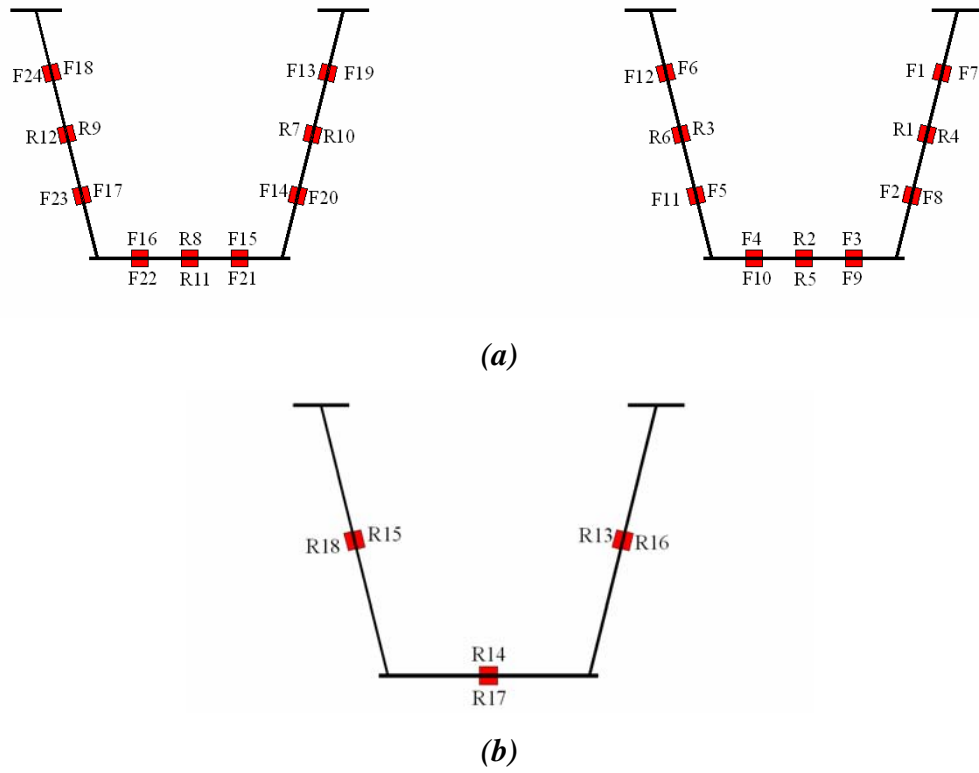
Figure 4.3: a) Gages at cut A-A b) gages at cut B-B

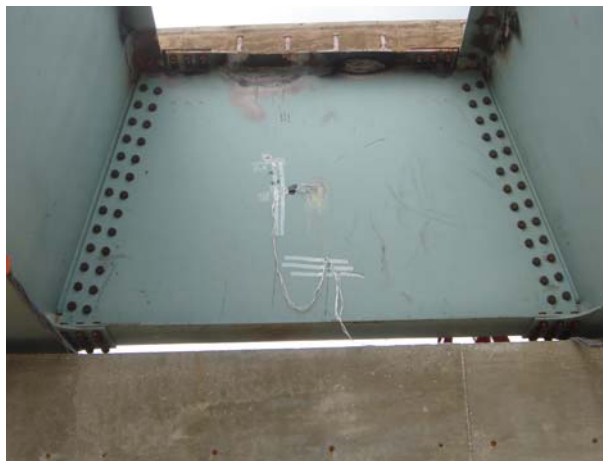
Figure 4.5: Inside of the north end diaphragm

The end diaphragms were expected to transfer some of the load from the exterior girder to the interior girder after the fracture event. The high-speed data collection system to be used during the fracture event had a limited number of available channels. Consequently, the system limitation only allowed 6 channels of data for each diaphragm; which meant two rosette gages for both the north and the south diaphragms. As stated previously, the gages were placed on the inside and outside to account for plate bending. The assumption was made that the shear in the center of the diaphragm would represent the average shear stresses that were transferred between the girders (Figure 4.5).

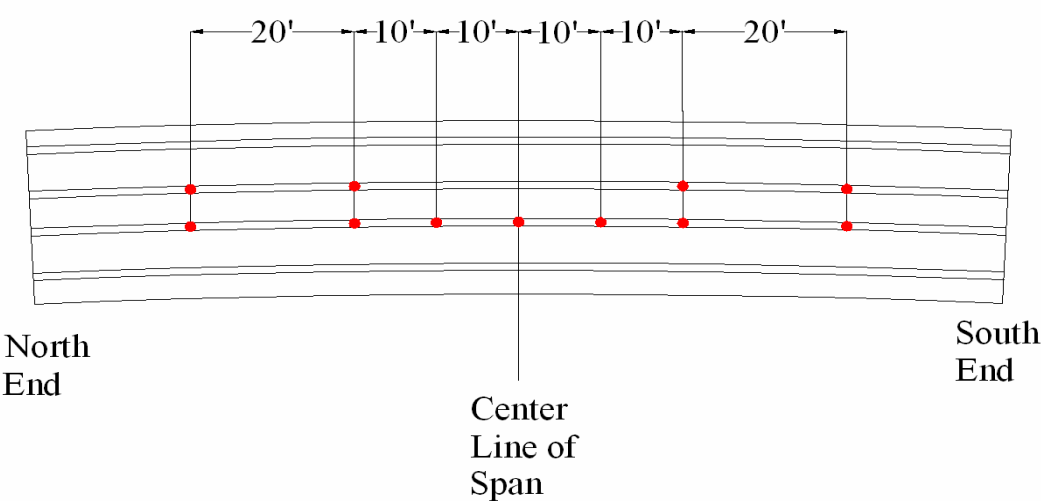
Figure 4.6: Strain gage locations for the deck reinforcement

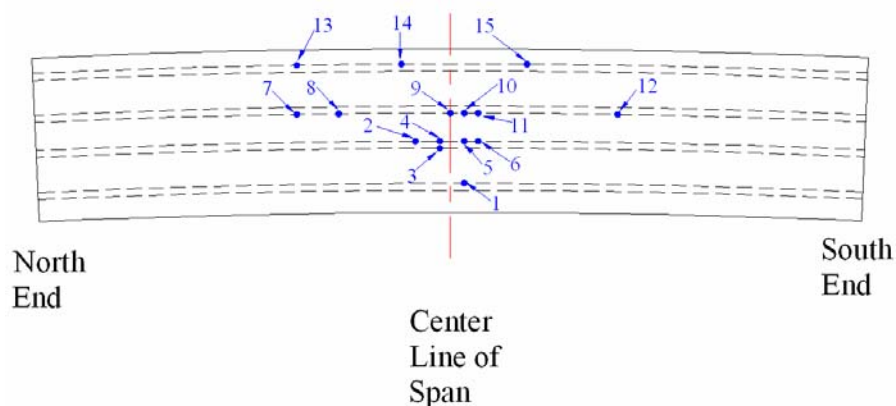
Figure 4.8: Shear stud strain gage locations

The shear studs were instrumented with bolt gages to measure the tension that develops between the studs and the deck as the girders deflect. The bolt gages were 0.2362 in. (6 mm) in length with a resistance of 120 ohms. As mentioned earlier, 15 out of the 29 damaged studs were instrumented. The studs with gages were placed along the flanges, to the greatest extent possible, where the tension force was expected to exceed the calculated pullout capacity (Figure 4.8). The distance from the centerline and the flange locations are listed in Table 4.1.

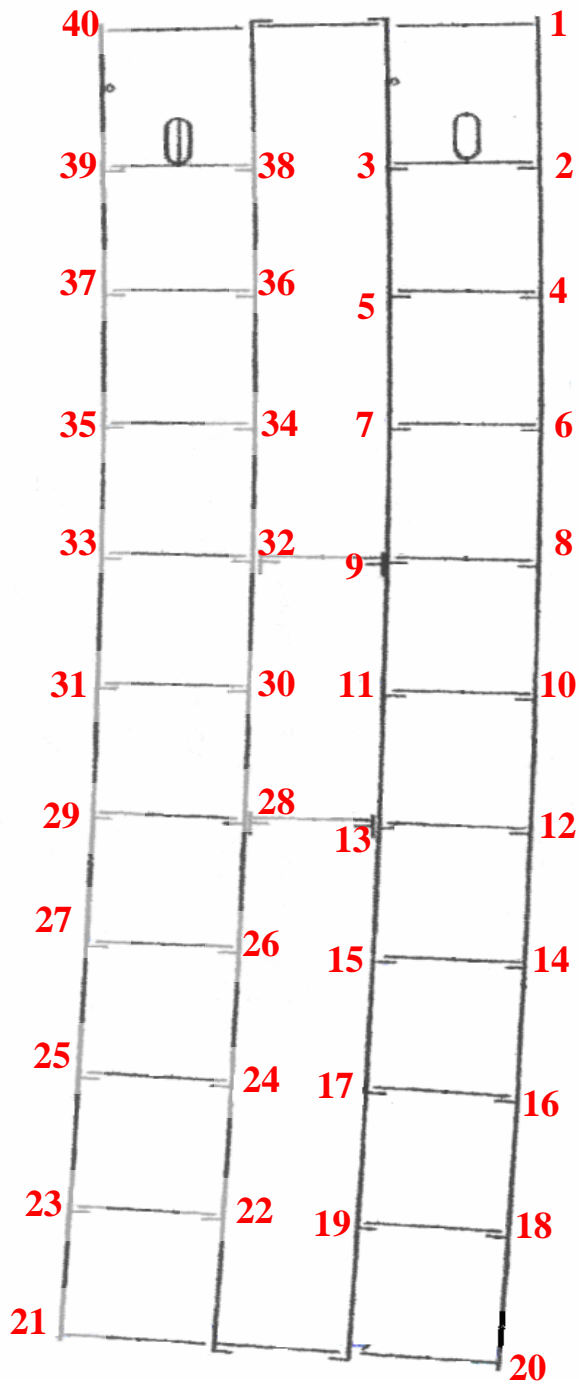
Figure 5.2: Deflection measurement locations

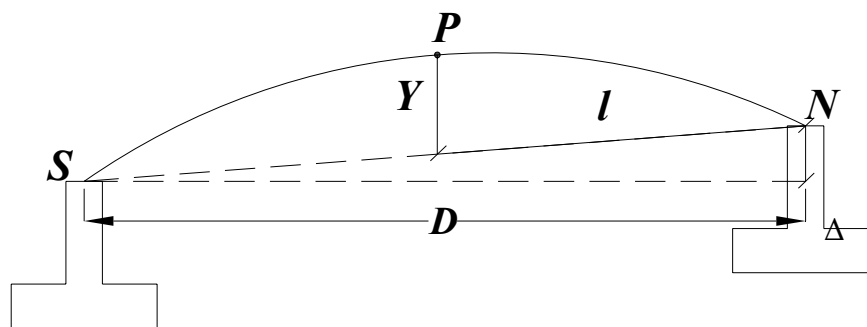
Figure 5.3: Diagram of girder curvature

These elevation measurements were averaged over the width of the bottom flange to determine the centerline elevation. The position of these values relative to the chord that extends for the north to the south bearing pad was calculated using the geometric relationship shown in figure 5.3. The results are plotted in Figure 5.4 for each event.

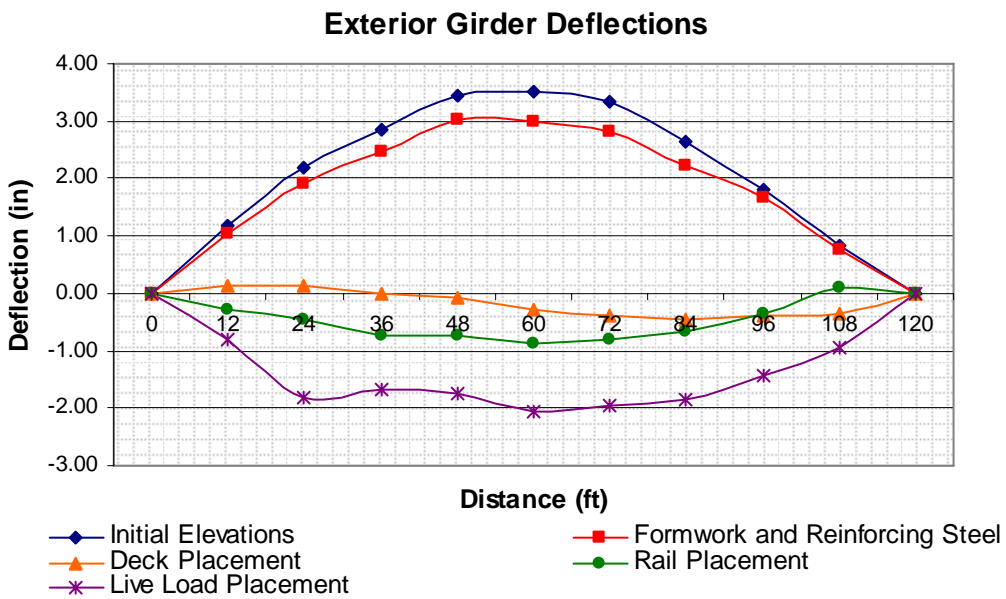
Figure 5.5: Centerline deflections of the exterior girder

The deflection of the exterior girder taken the morning after the deck casting was compared to the deflections obtained by UTrAp, software developed for designing trapezoidal box girders (Figure 5.6), and the finite element model being developed (Figure 5.7). Because the only deflections that UTrAp displays are those for the exterior girder, the interior girder deflections were not discussed. Also, it should be noted that neither model includes any initial camber, the geometry for the base model is slightly different than the actual bridge. To account for this difference, the deflection due to the self-weight was determined for both programs. UTrAp had a deflection due to the self-weight of the girders of 1.11 in. The finite element model predicted a deflection due to self-weight of the girders of 1.27 in. After subtracting the self-weight deflections from the total reponse after the deck was poured, the UTrAp deflection was 4.47 in. and the finite element model was 3.93 in. The observed deflection was 3.82 in. after the deck was poured. The prediction of the finite element model is within 3 percent and the UTrAp model was within 20 percent. The difference in the UTrAp result could be due to the fact that the model did not include stiffness in the deck as the casting took place.

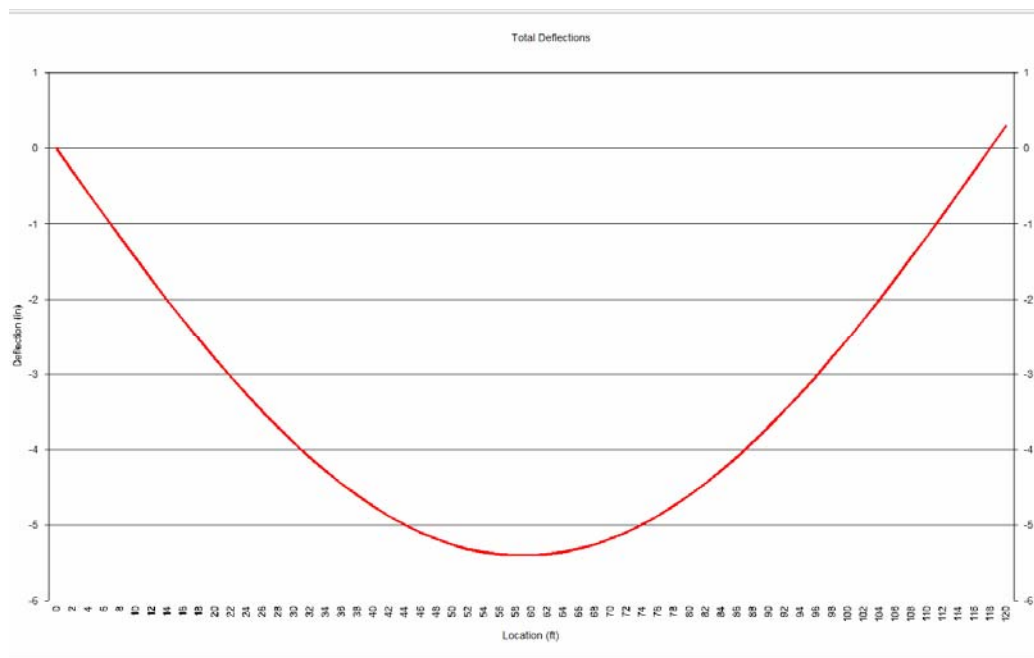
Figure 5.6: Deflections from UTrAp just after deck casting

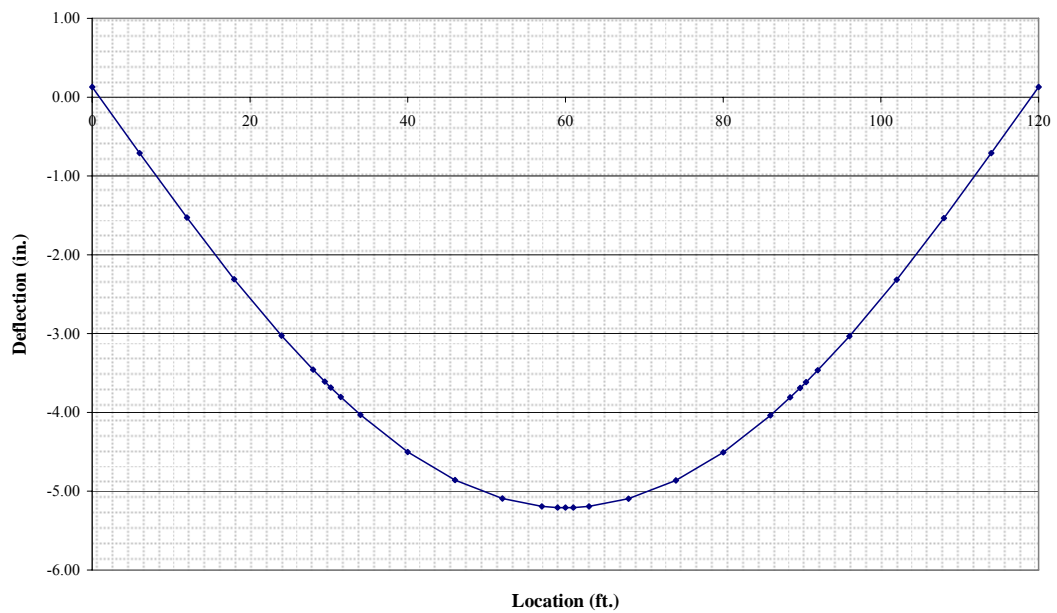
Figure 5.7: Deflections from finite element model after deck casting

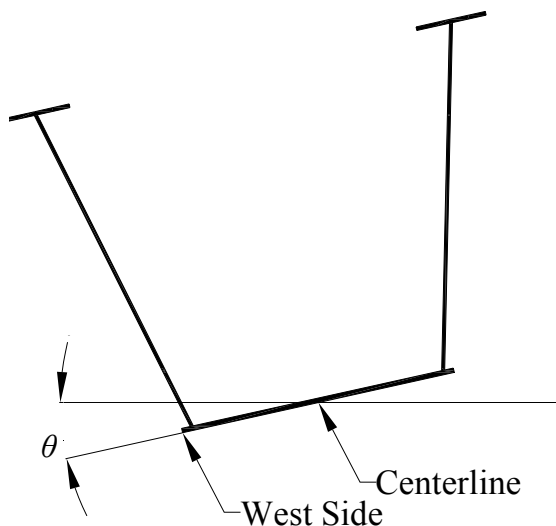
Figure 5.8: Example of the rotation of the girder cross section

Finally, it should be noted that the observed rotations are small and the small displacement assumption to calculate the angles was valid.

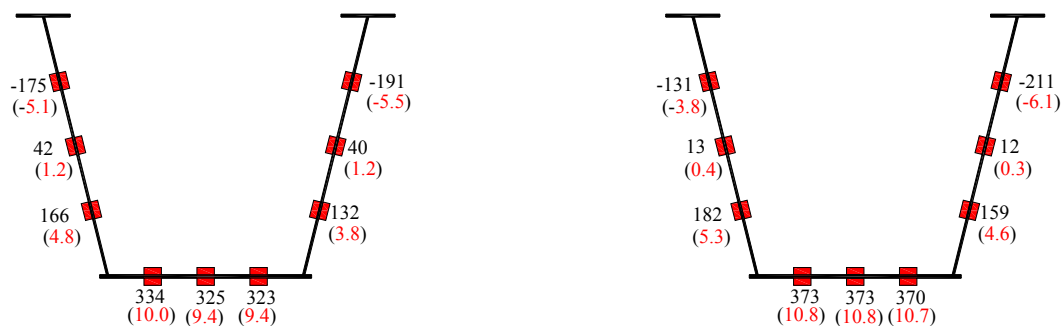
Figure 5.13: Average microstrains and stresses (ksi) south of midspan after deck casting

ksi. The strain data indicated that the neutral axis of the cross section appears to be between the upper foil gage and the middle rosette gages on the web. Assuming the strains vary linearly up the webs, the neutral axis was determined to be at 31 in and 30 in. above the bottom flange for the interior and exterior girders respectively. This is lower than the calculated location of 48 in. for the girder cross-section.

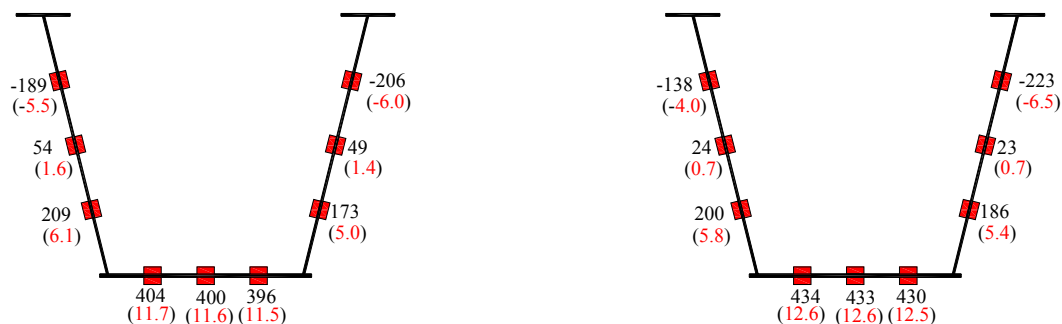
Figure 5.14: Average microstrains and stresses (ksi) after casting rails

flanges after the rails were pour. Using the same assumptions in the previous section, the change was determined to be only about 1/2-in. for both girders.

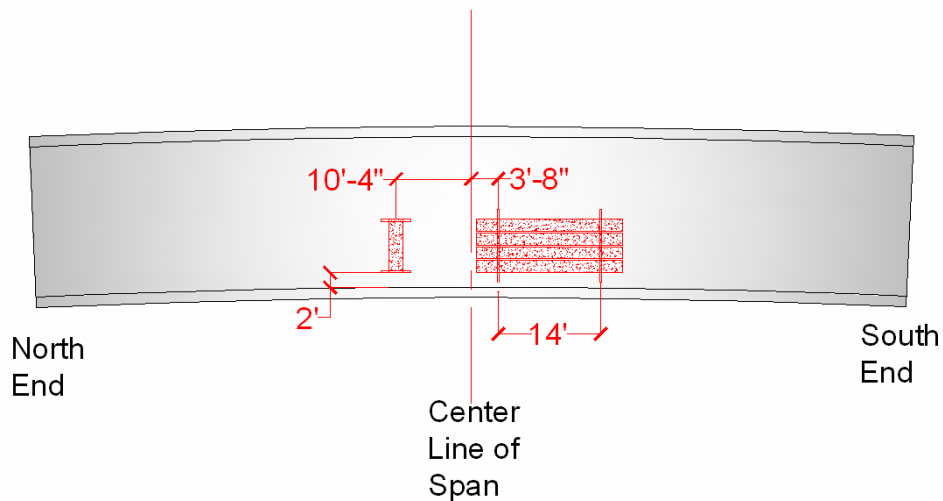
Figure 5.17: Live load position 1

The live load test was performed by placing the simulated truck in three positions across the width of the bridge to determine the response of the bridge to the lateral position of the load on the bridge. The first part of the test was to place the load 2 feet away from the rail of the interior girder with the front axle of the truck 10.33 feet forward of the centerline (Figure 5.17). The longitudinal position was found by using the general rules for simple supported beams carrying concentrated moving loads as prescribed by AISC (AISC, 2005). Once the load was in place, the data collection system was sampled once every second for approximately 5 minutes. After the data was collected, the load was moved to position 2, which is centered across the width of the bridge (Figure 5.18). Finally, the load was placed with the edge 2 feet from the exterior girder rail to produce the maximum vertical and torsional moment in the bridge (Figure 5.19). The load was removed from the bridge after the readings were taken at each position on the bridge..

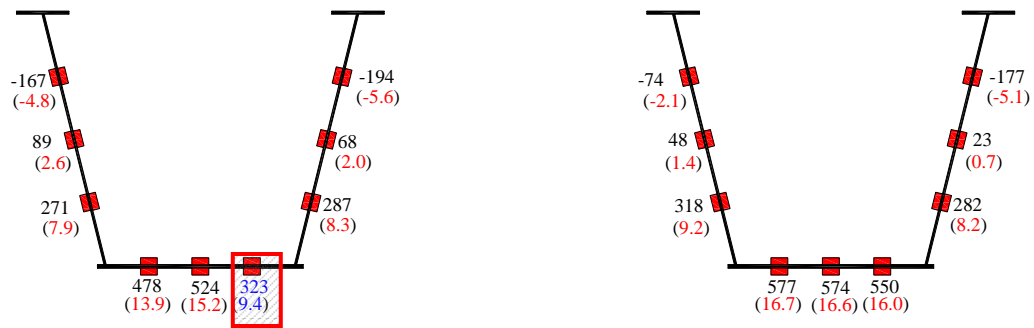
Figure 5.20: Final microstrains and stresses (ksi) prior to the fracture test

averaged, as before, and added to the dead load strains that were previously determined. The stress increased to approximately 15 ksi in interior bottom flange and 16 ksi in the exterior bottom flange, which do not include the stress from the self-weight dead load (Figure 5.20). The computed stresses from the finite element model were 16.0 ksi for the interior bottom flange and 17.7 ksi for the exterior bottom flange after subtracting the stress for the self weight of the girders. The additional strain in the east side of the interior bottom flange, highlighted by the rectangle, could not be determined because of the noise in foil gage 16 as pointed out above. Even with the additional stress of the live load, the steel is well below its estimated yield stress.

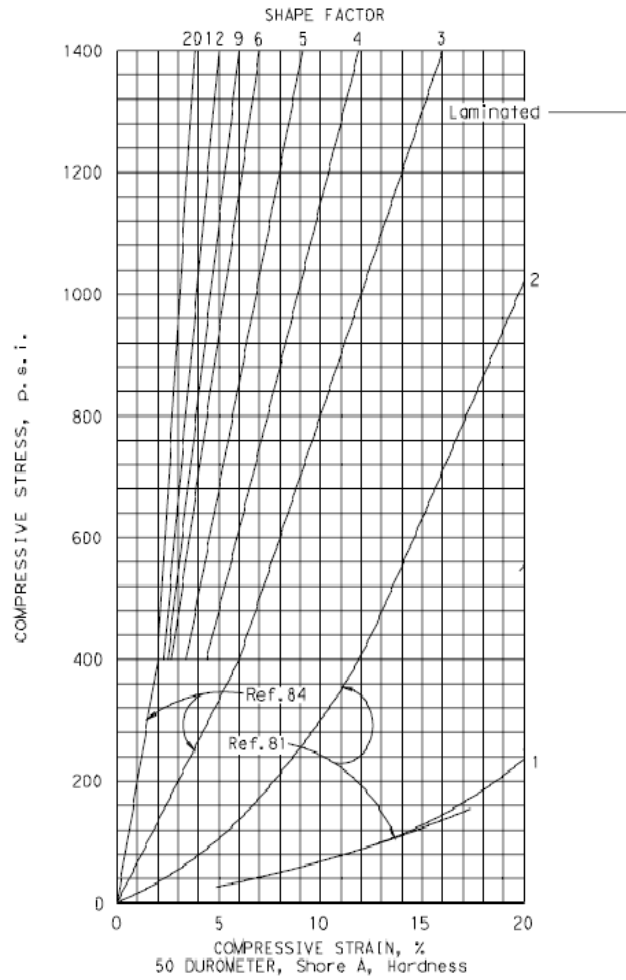
Figure A.1-2: Elastomeric Bearing Performance Chart (TxDOT Bridge Design Manual, 2006)

The calculated compression deflections were larger than the lift off. The bearing pads meet all the requirements and were used to transfer the load from the girders of the test bridge.

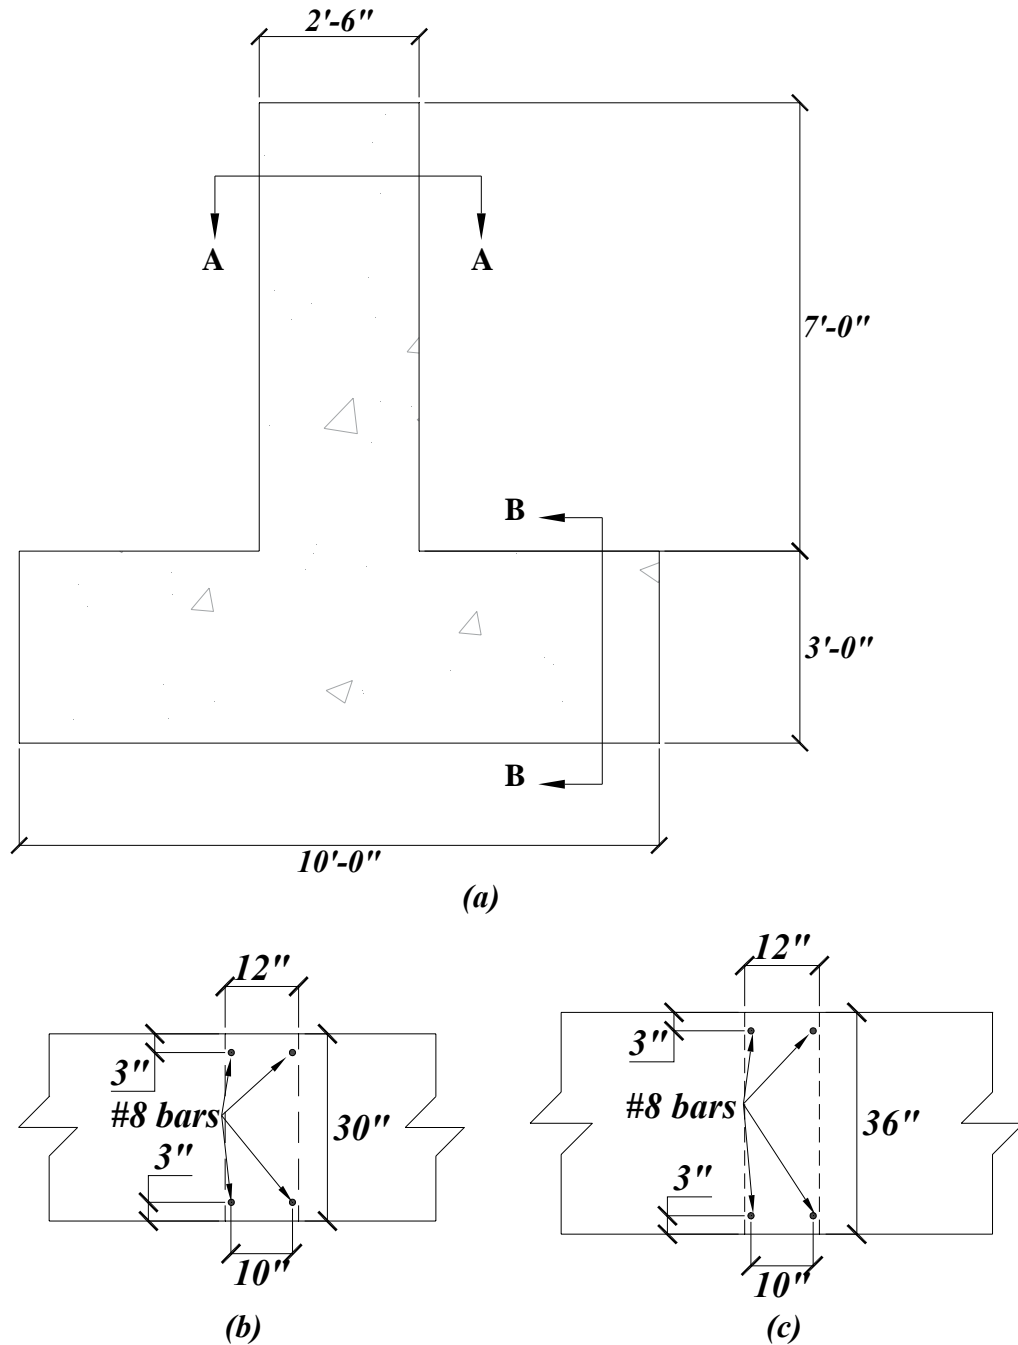
Figure A.2-1: a) Cross-sectional view; b) Cut A-A through stem wall per foot; and c) cut B-B through footing per foot

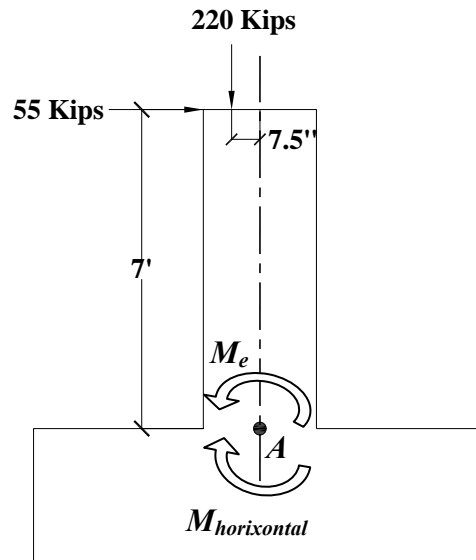
Figure A.2-3: Horizontal and vertical loads applied to foundation

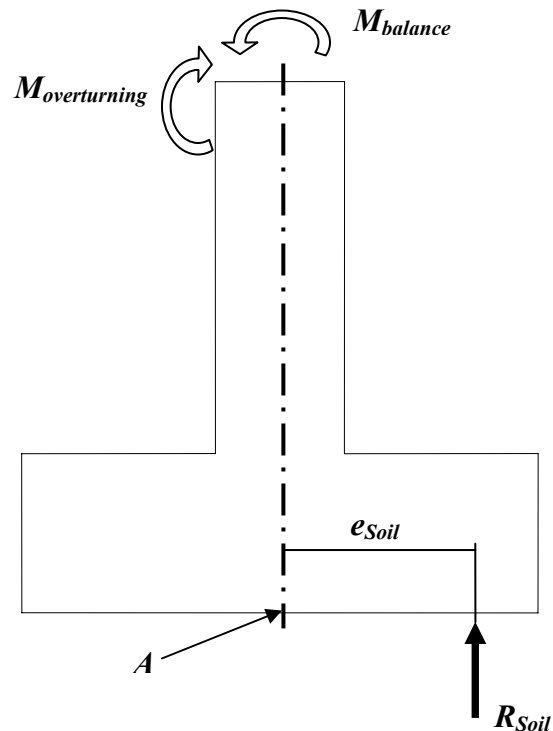
Figure A.2-5: Overturning and balancing moments

The moments generated after the fracture event were calculated about the centerline of the foundation at point A (Figure A.2-5). It was determined from simple statics that overturning would be prevented if the resultant of the soil pressure acted within a distance that was at least one-half the width of the footing.

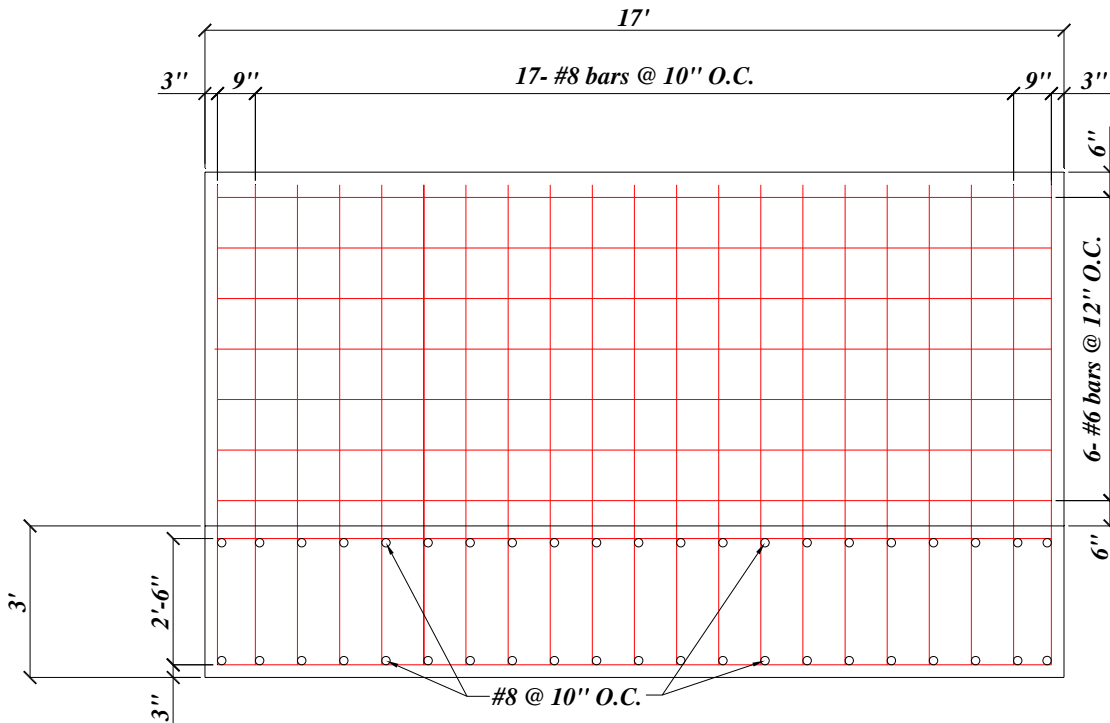
Figure B.2: a) Cross section of Pier Foundation for Test Bridge b) elevation view

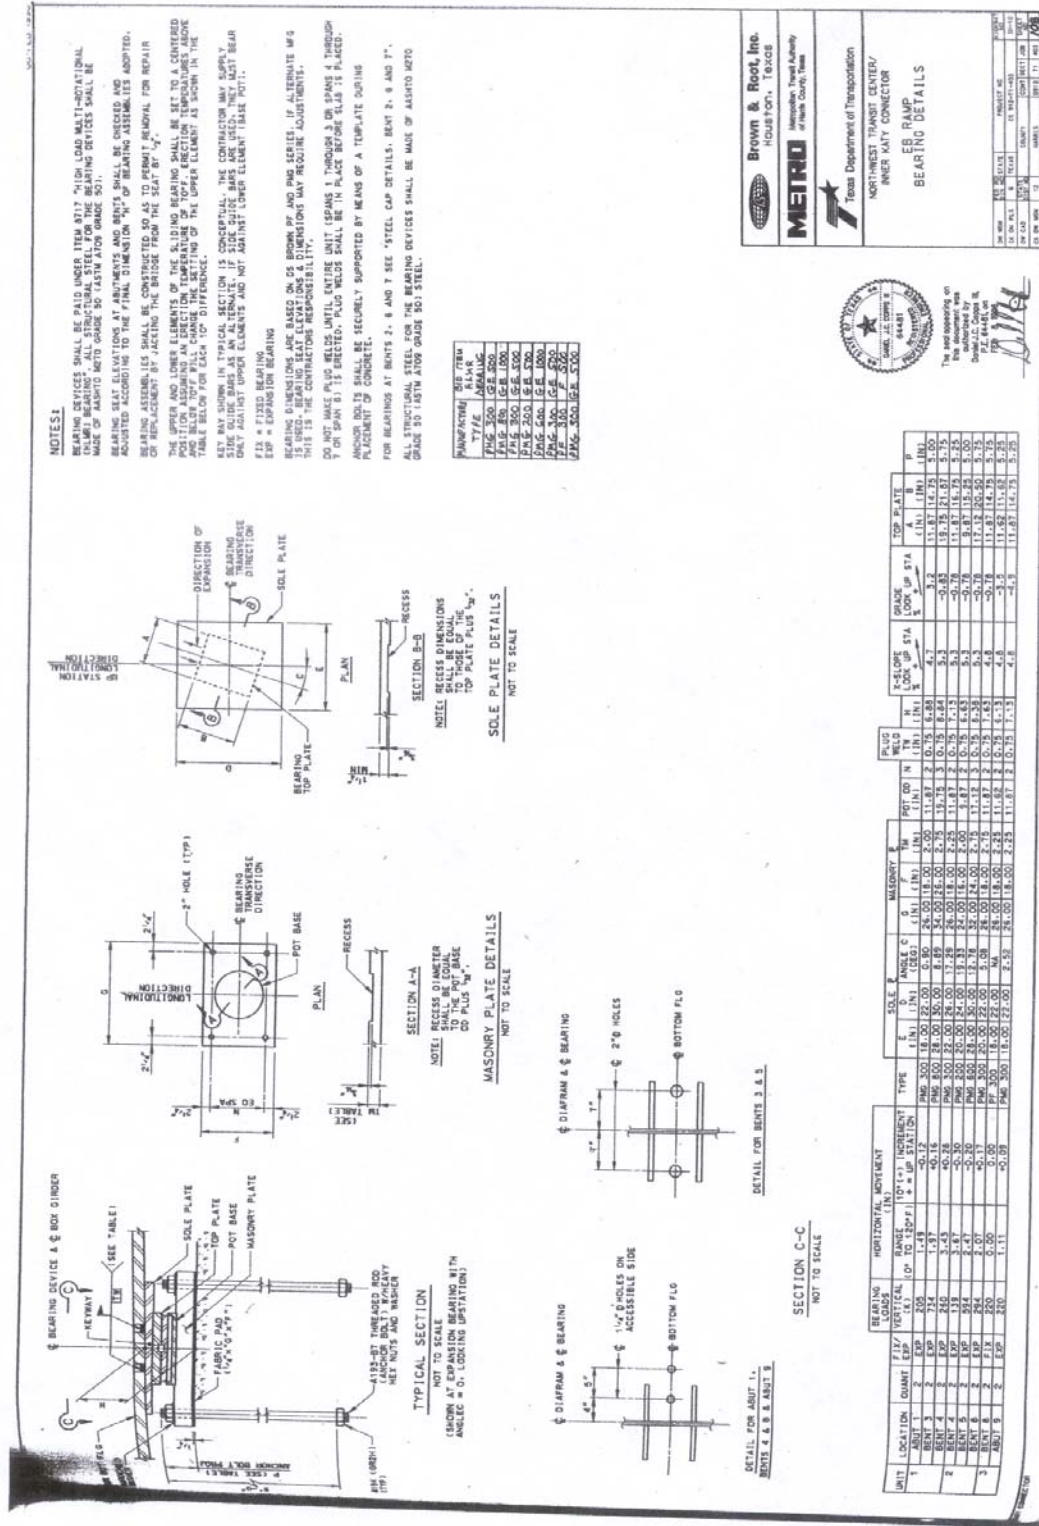
Figure B.3-1: Bearing details from design drawings

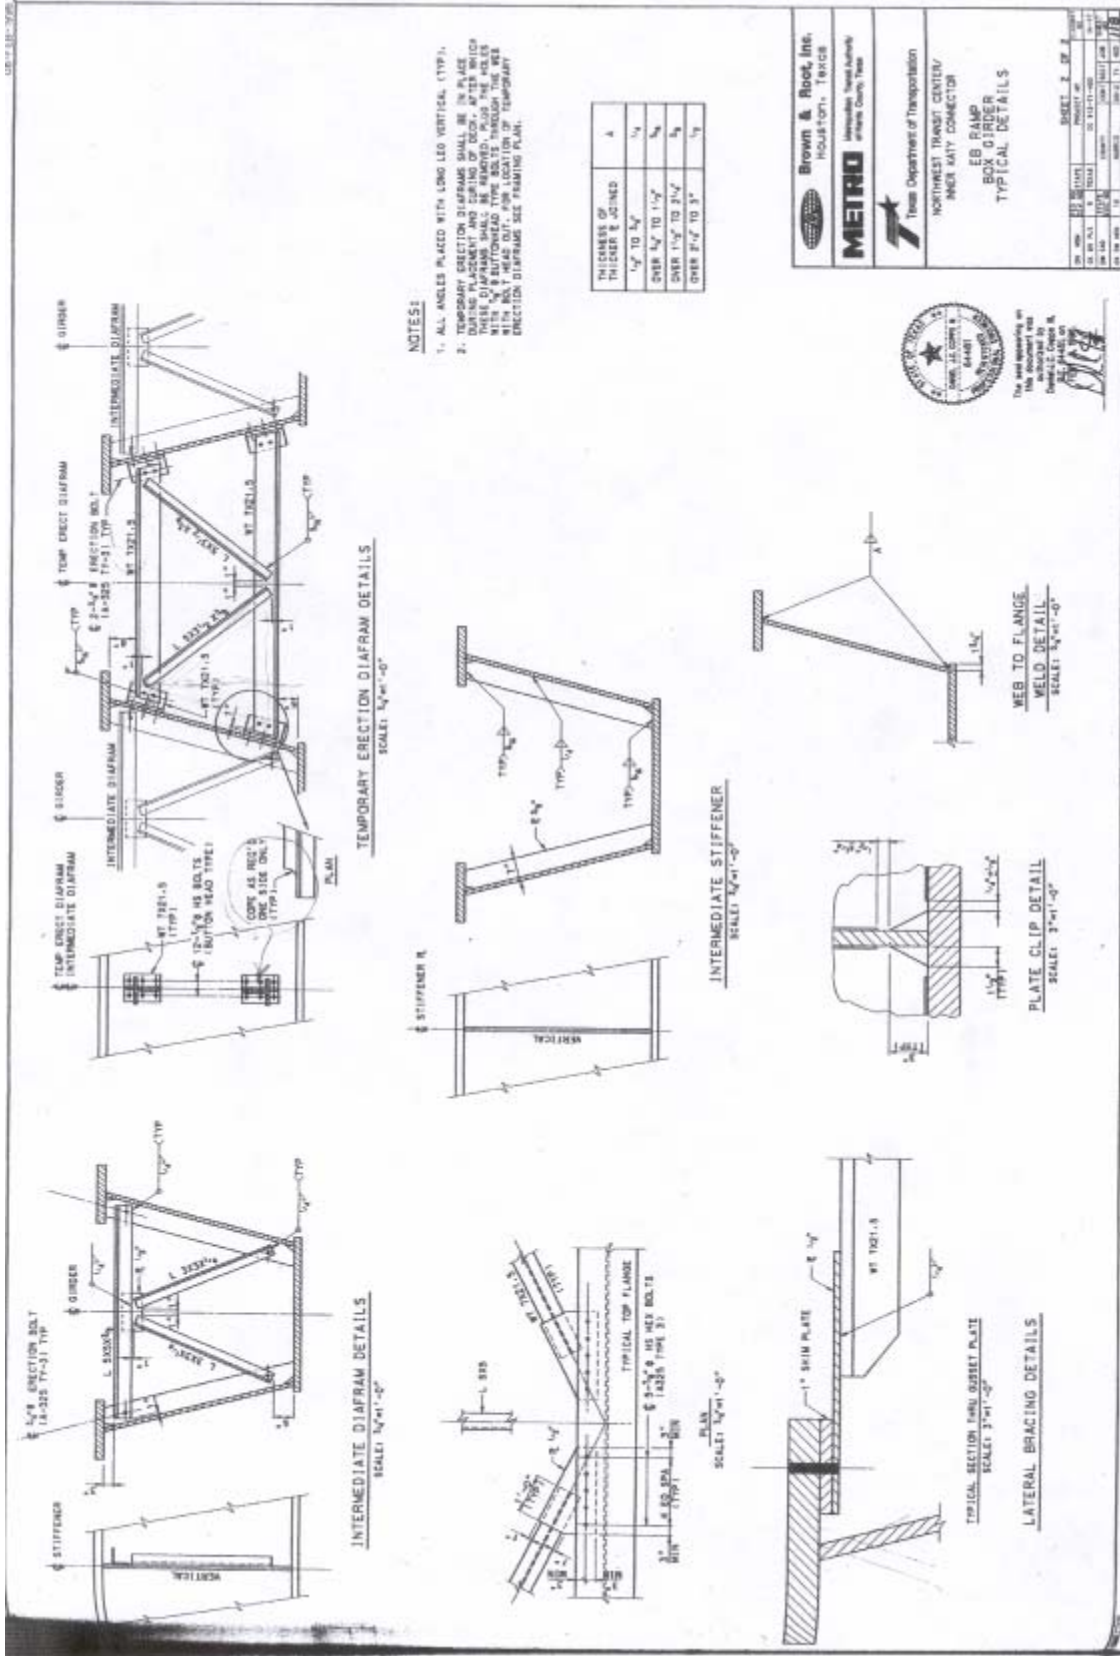
Figure B3-4: Internal and external bracing details from design drawings

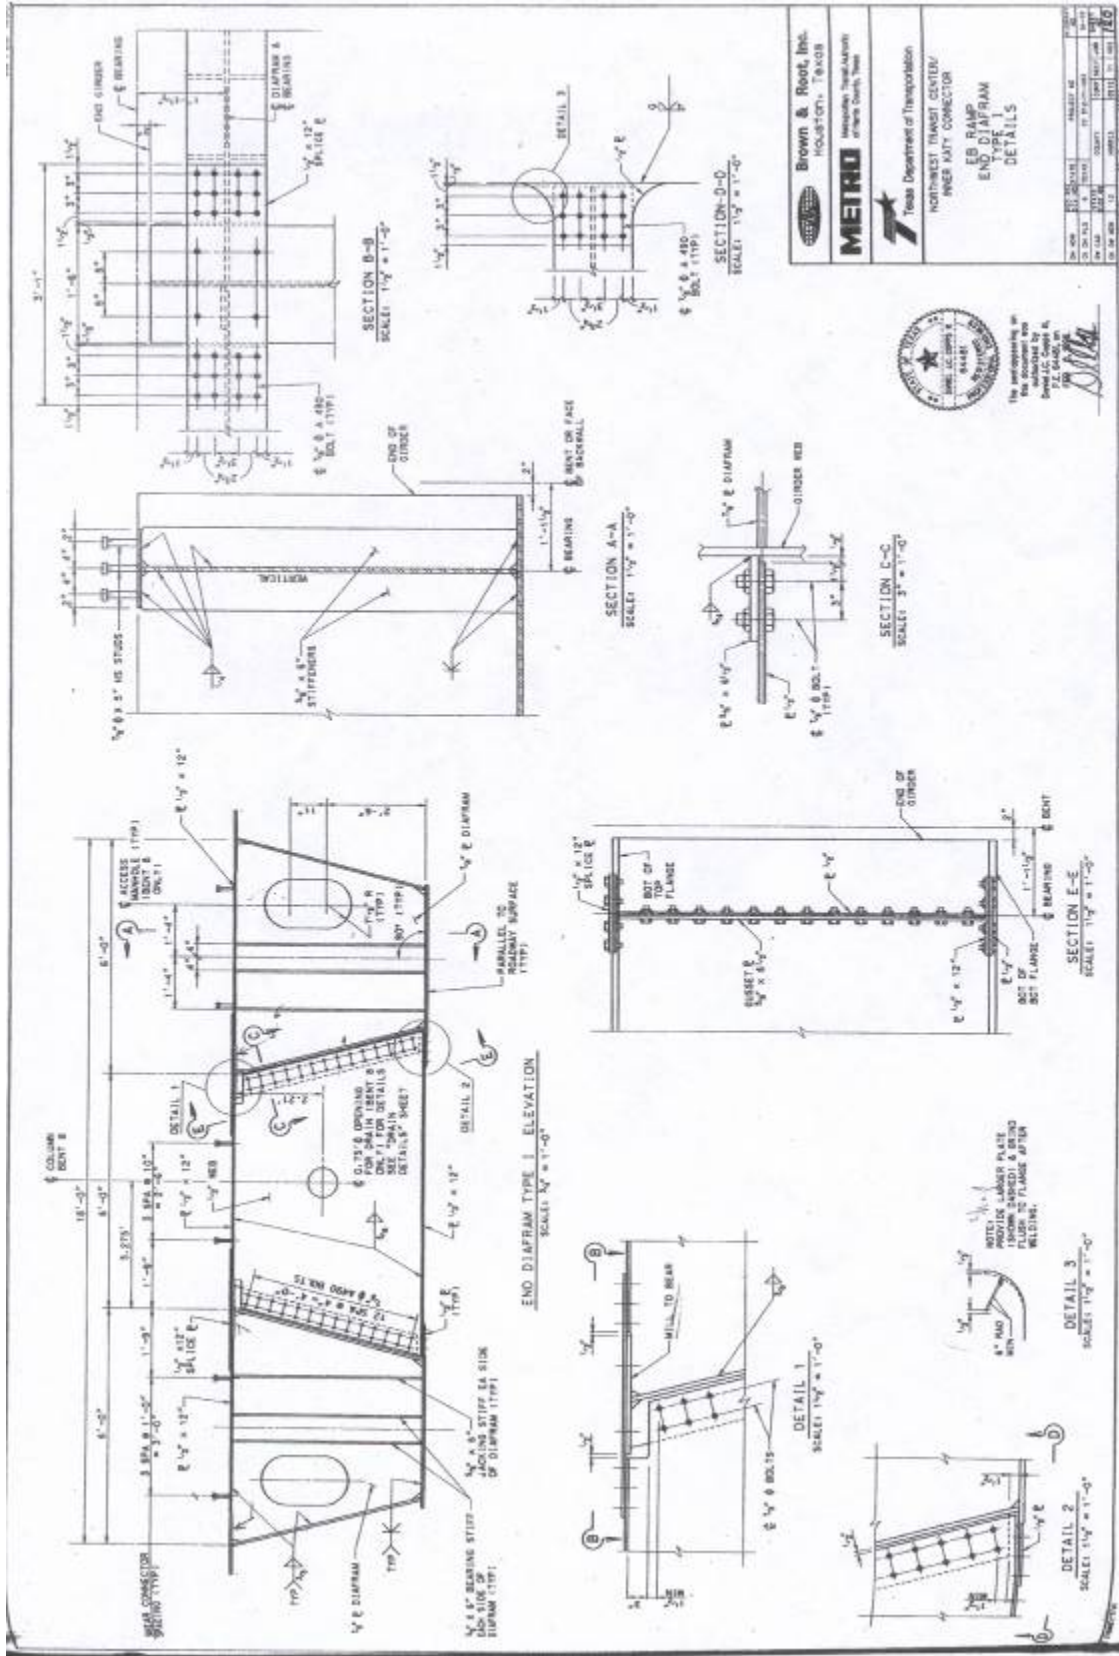
Figure B.3-5: End diaphragm, flange, and stiffener details
