**Constructing a Full-Scale Horizontally-Curved Twin Steel
Trapezoidal Box Girder Bridge Segment to Determine
Redundancies in Fracture Critical Bridges**

Departmental Report

The University of Texas at Austin

December 2006

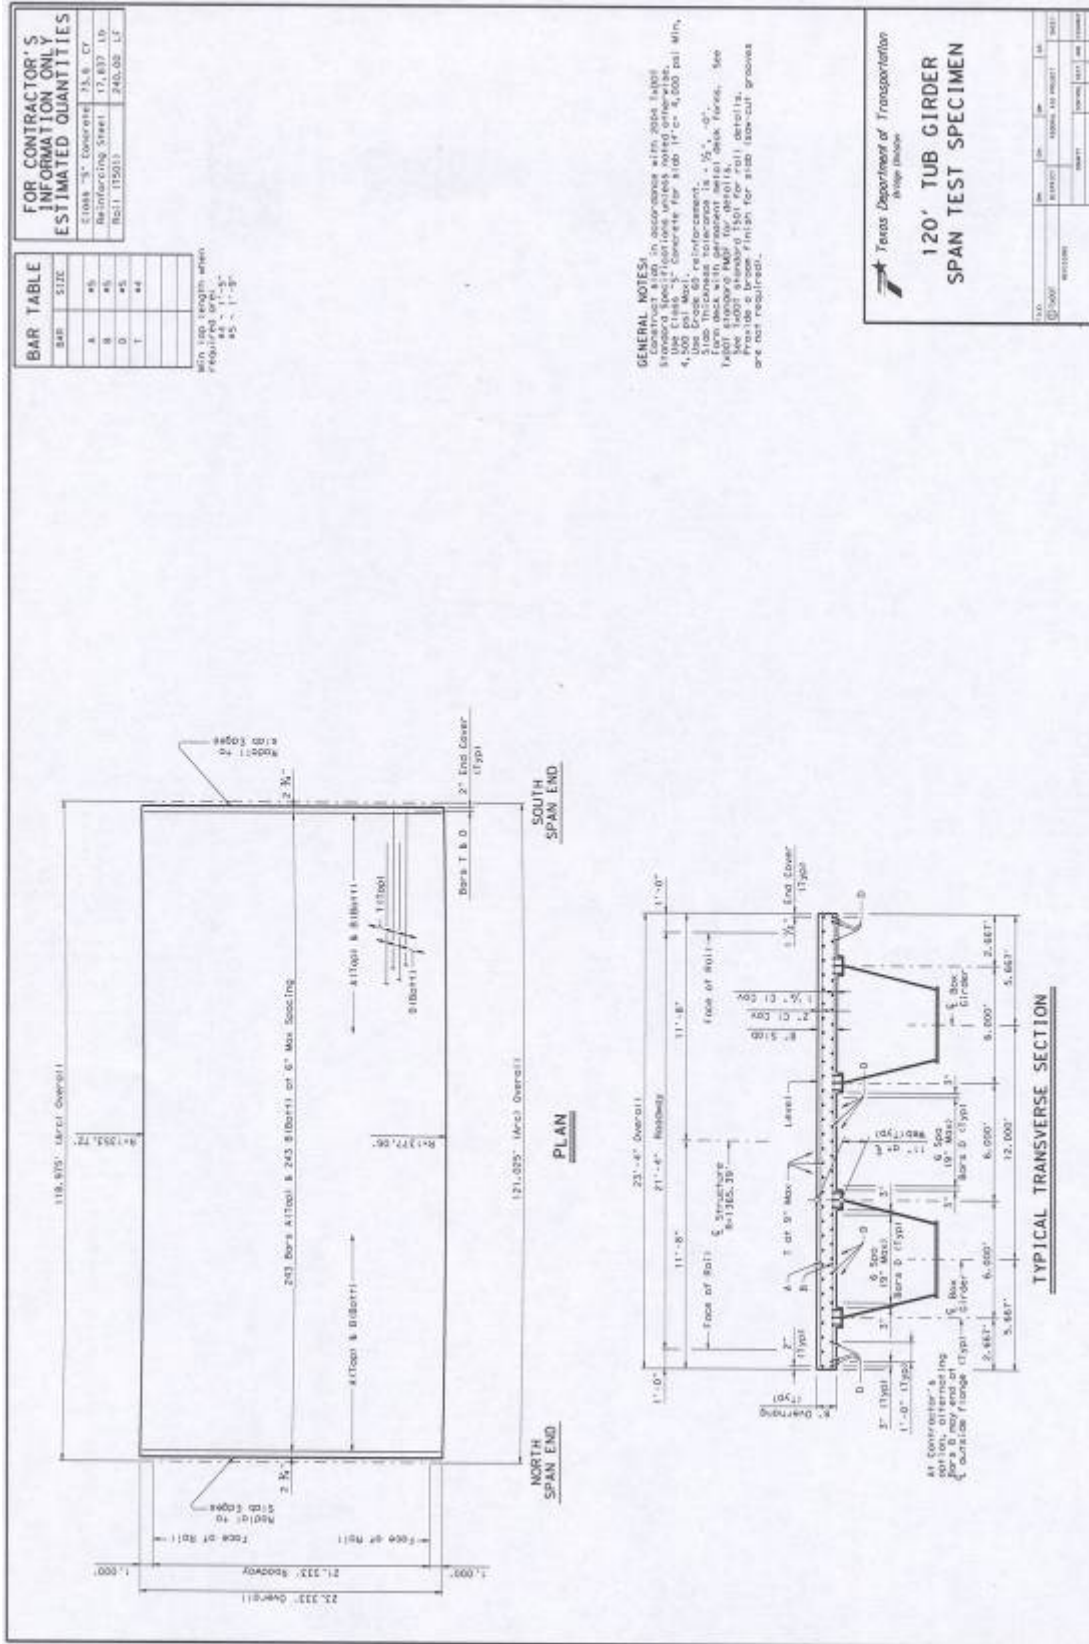
Figure B.4-1: Deck details

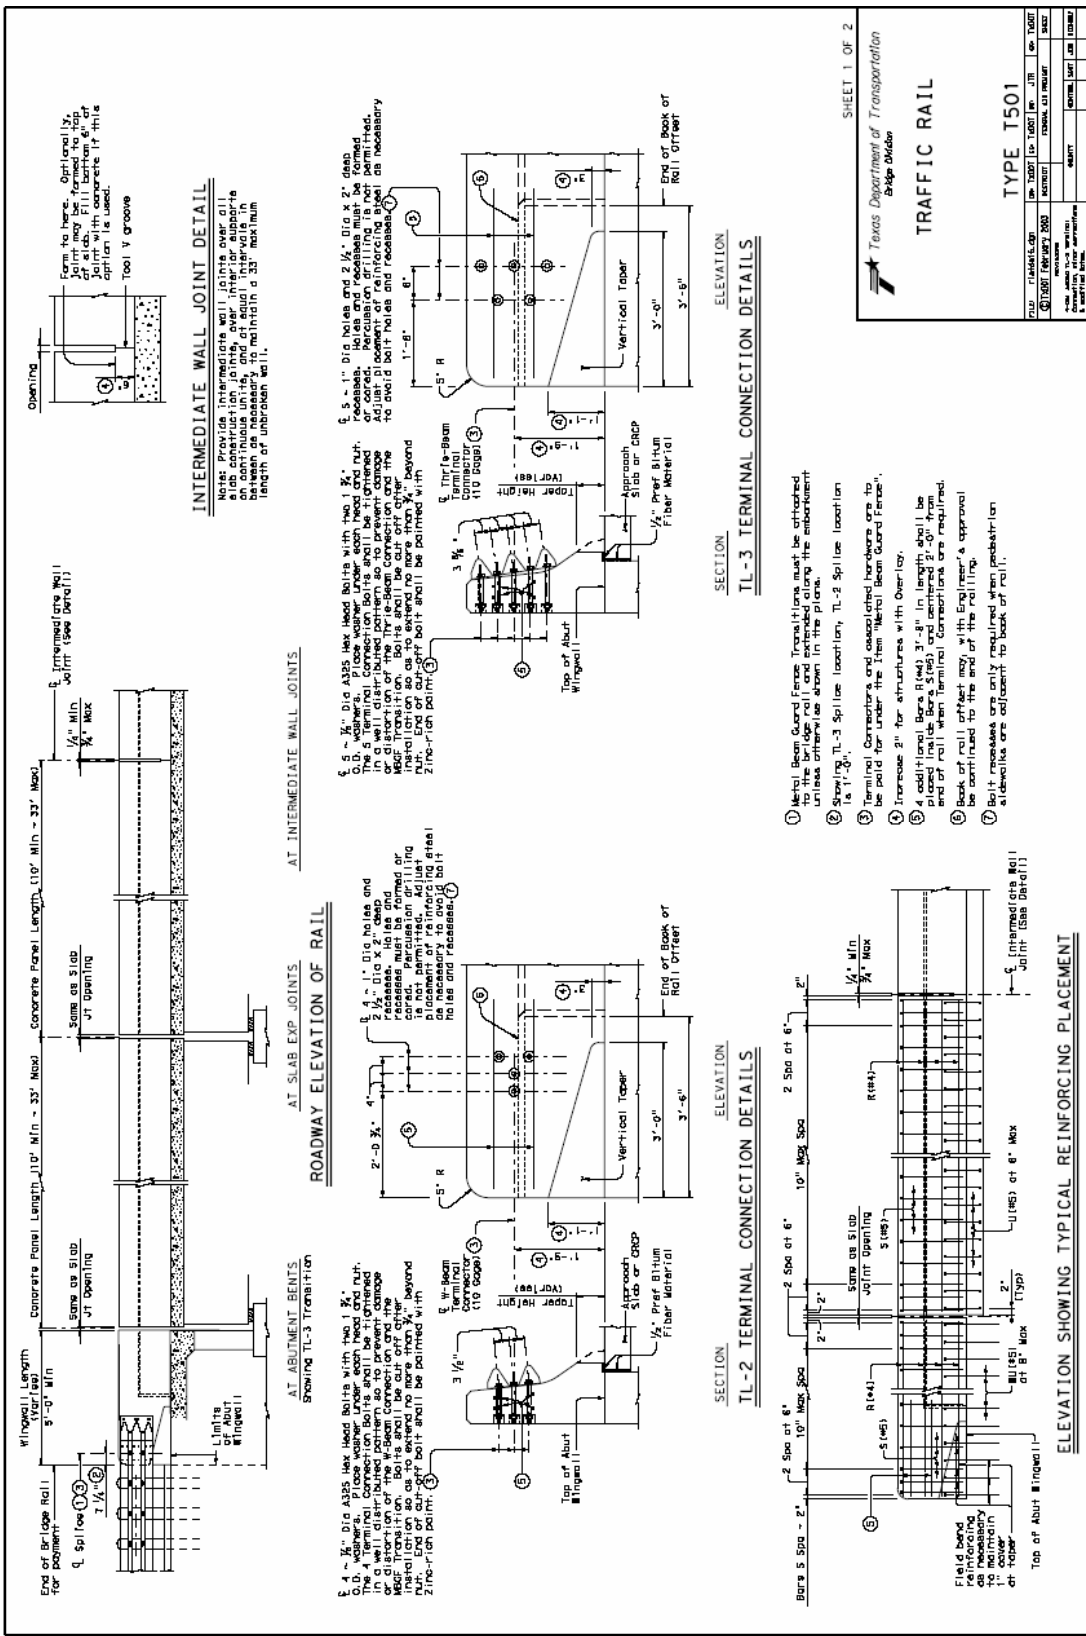
Figure B.5-1: Standard T501 Railing drawings

The TxDOT standard T501 rail (Figure 3.11) was chosen due to its prevalent use in the field. The rails were constructed according to the details provided by TxDOT with the exception of the optional slotted drains. Because drainage will not affect the performance of the bridge before or after the fracture test, none was provided. The rails were formed and poured in place after the deck had wet cured for 4 days to provide as much strength as possible and still mimic standard practice in the field. The plans call for the rails to be constructed

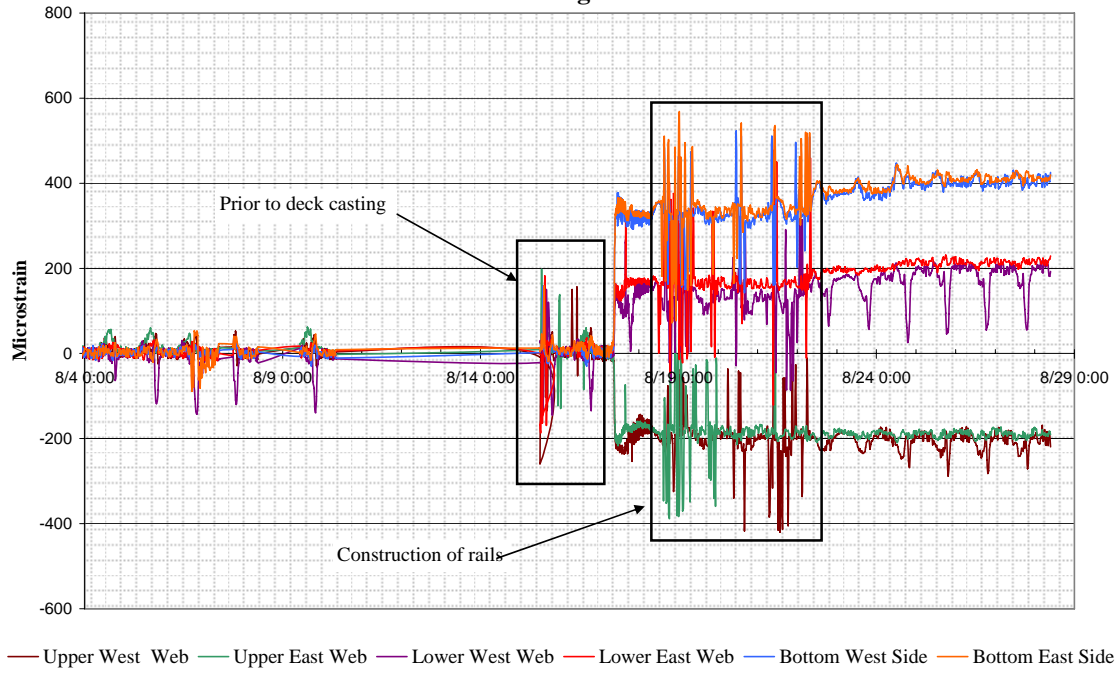
Figure C.1: Noise in strain data

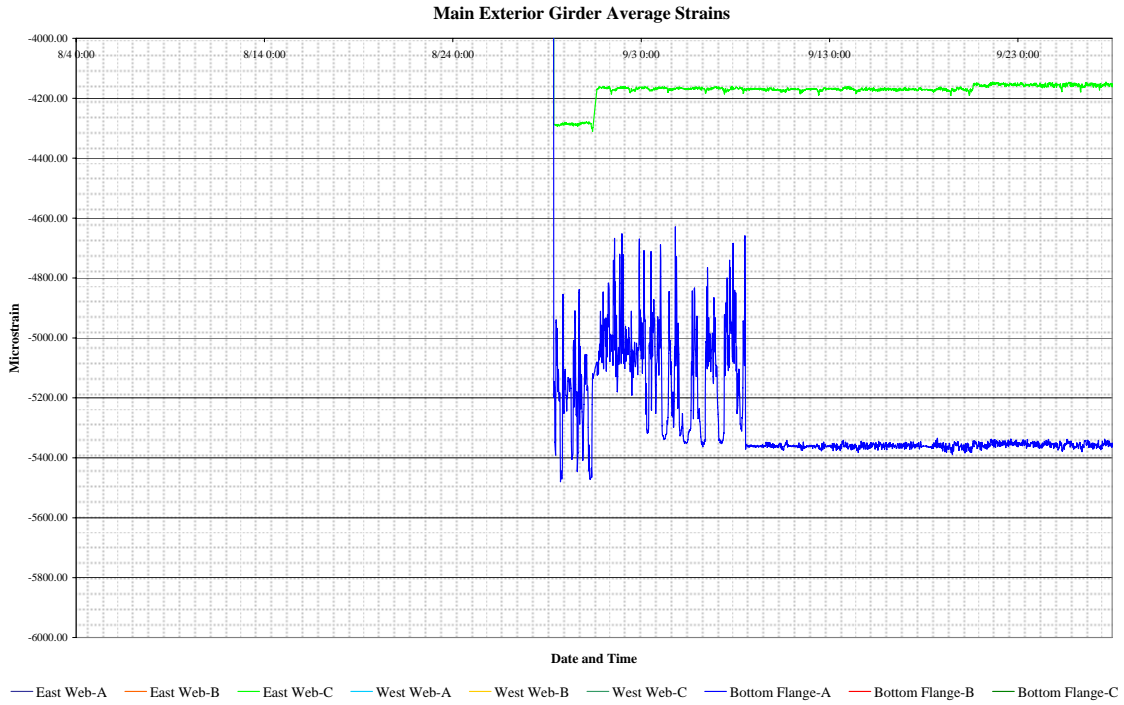
Figure C.2: Average strains at the main cross-section of the exterior girder

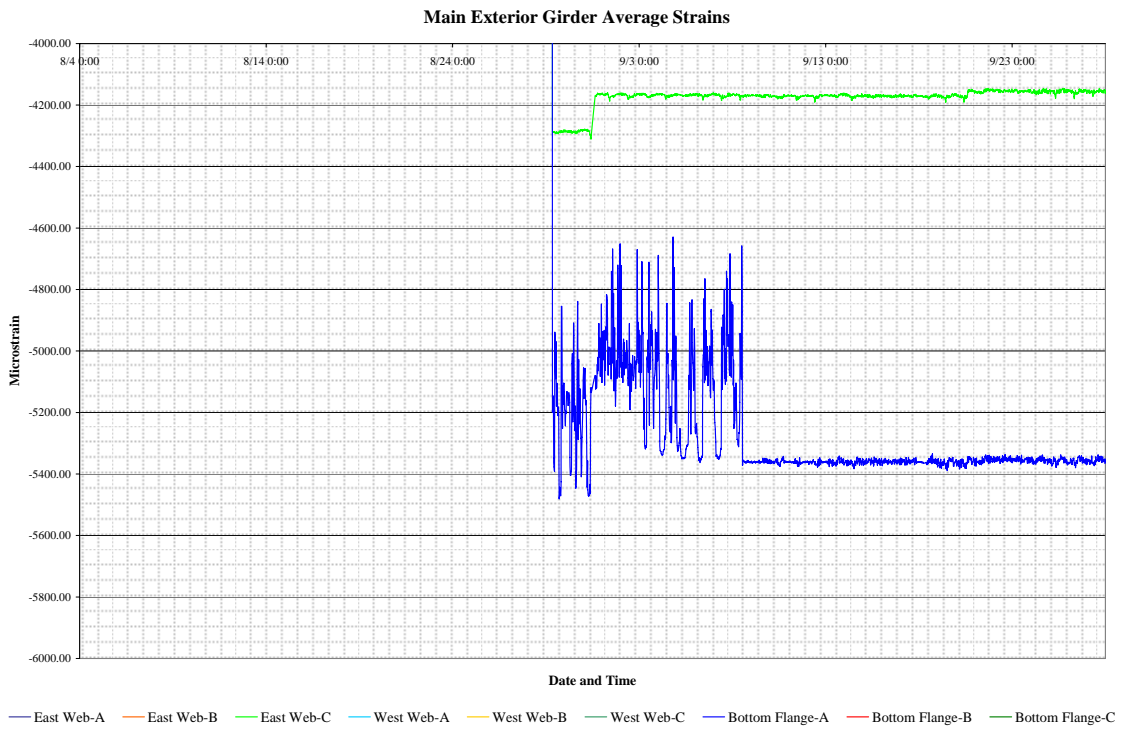
Figure C.3: Sudden drop in the average strains level out and remain steady

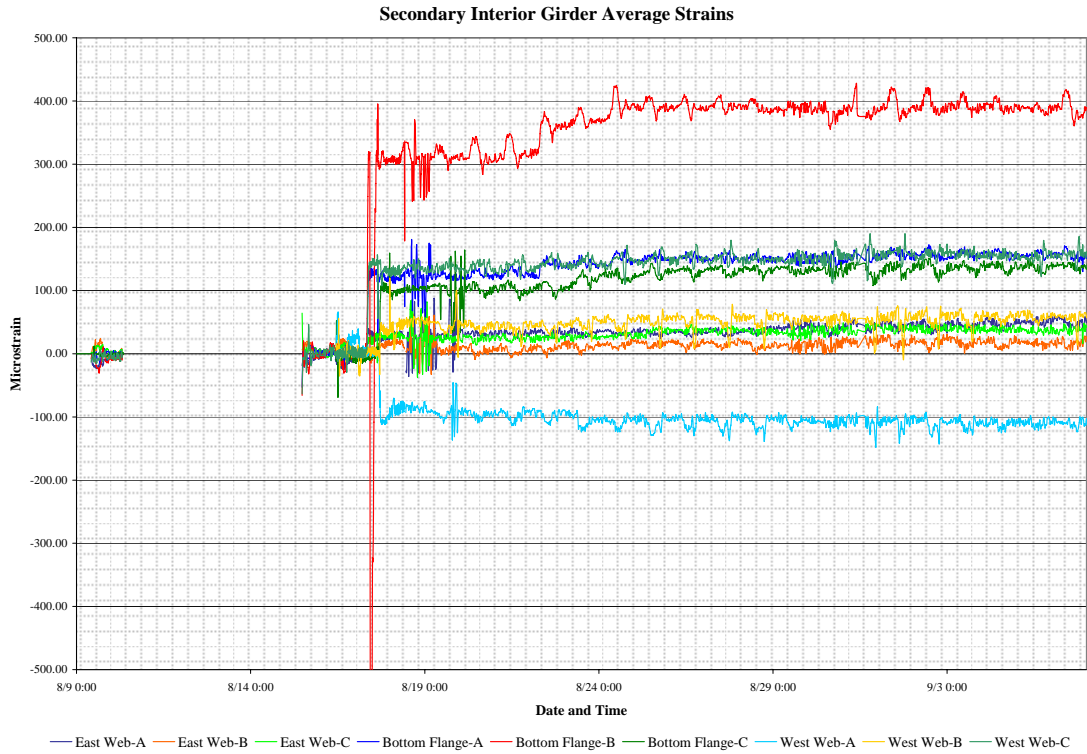
Figure C.5: Average strains at the secondary cross-section of the interior girder.

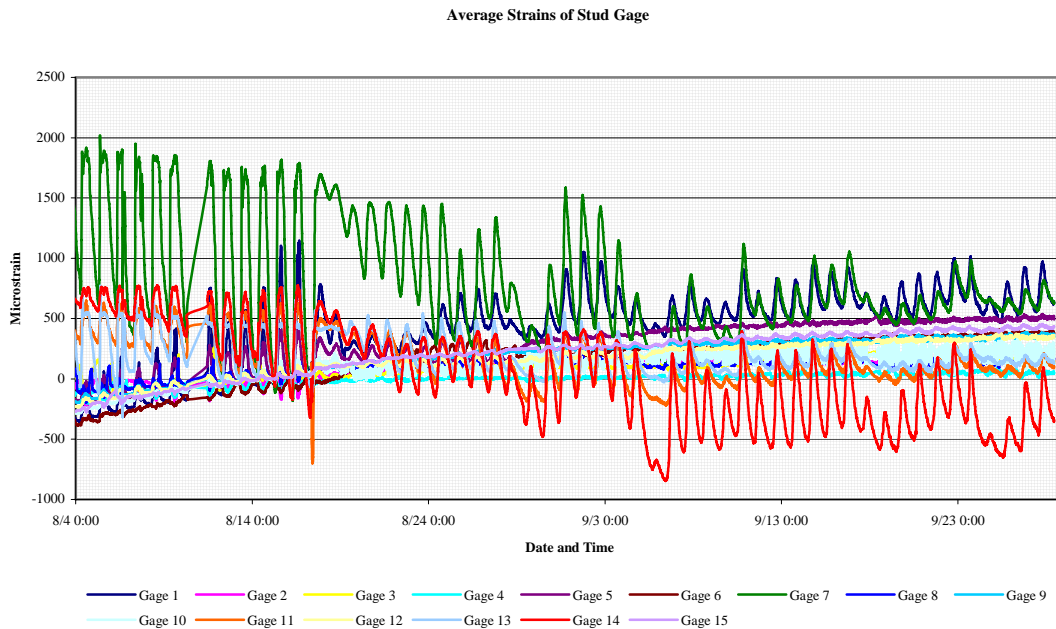
Figure C.6: Average strain in shear studs

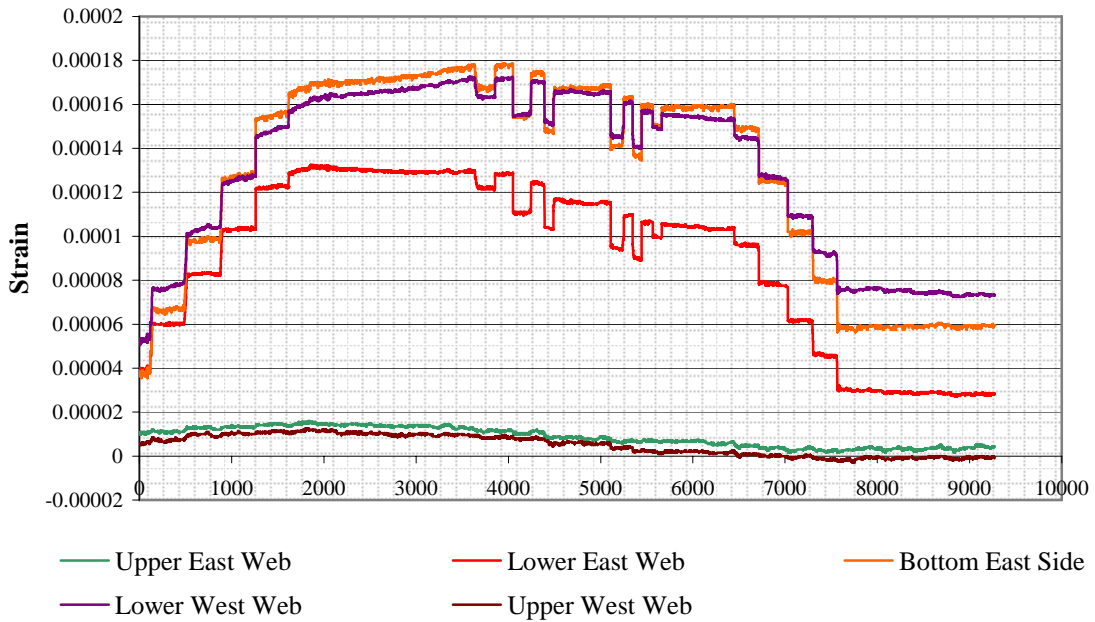
Figure C.10: Interior girder foil gage response during live load testing

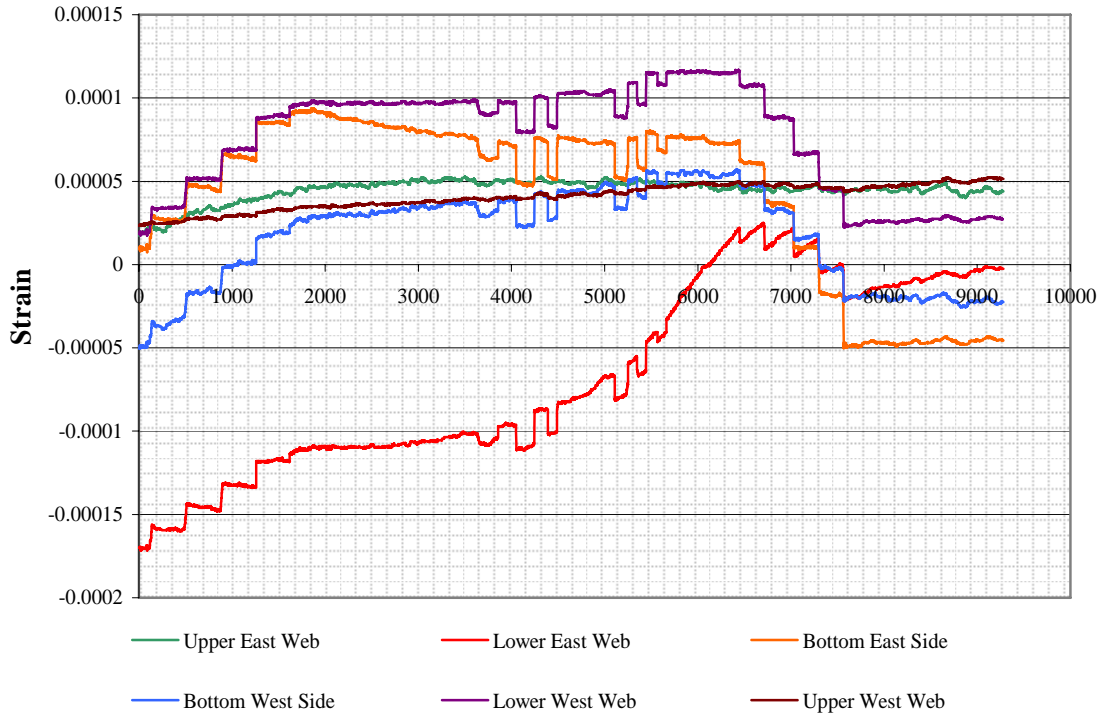
Figure C.11: Exterior girder foil gage response during live load testing

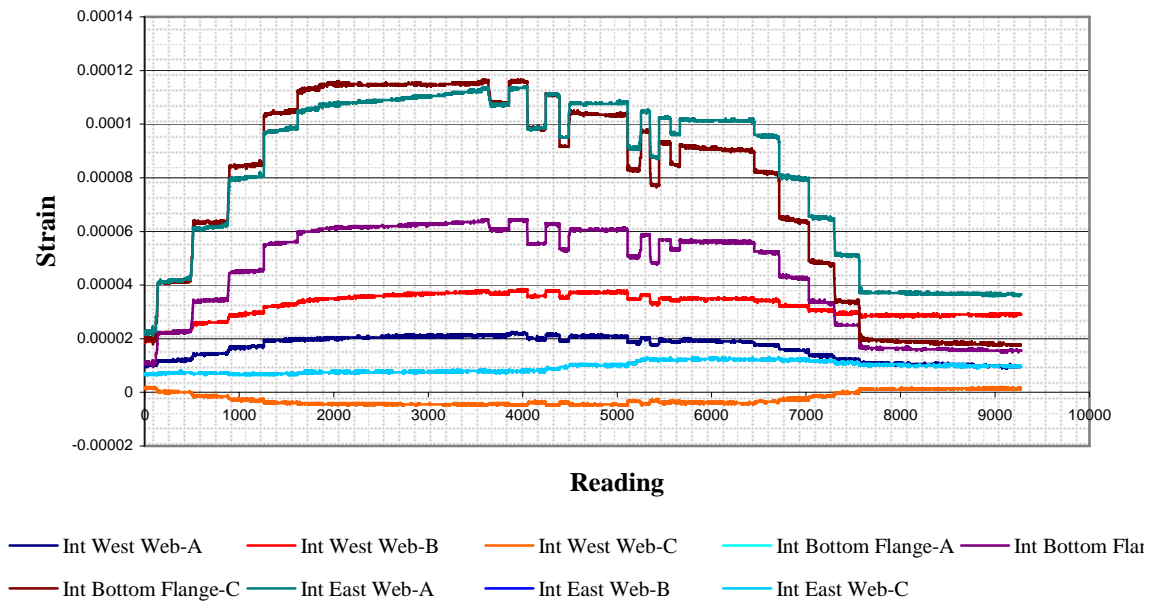
Figure C.12: Interior girder rosette gage response during live load testing

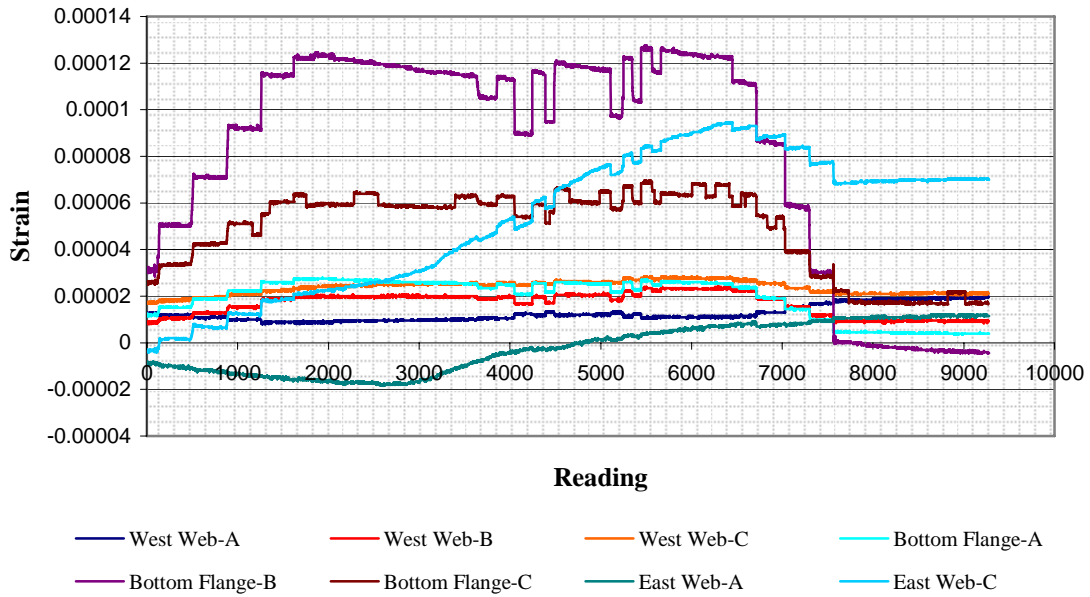
Figure C.13: Exterior girder rosette gage response during live load testing

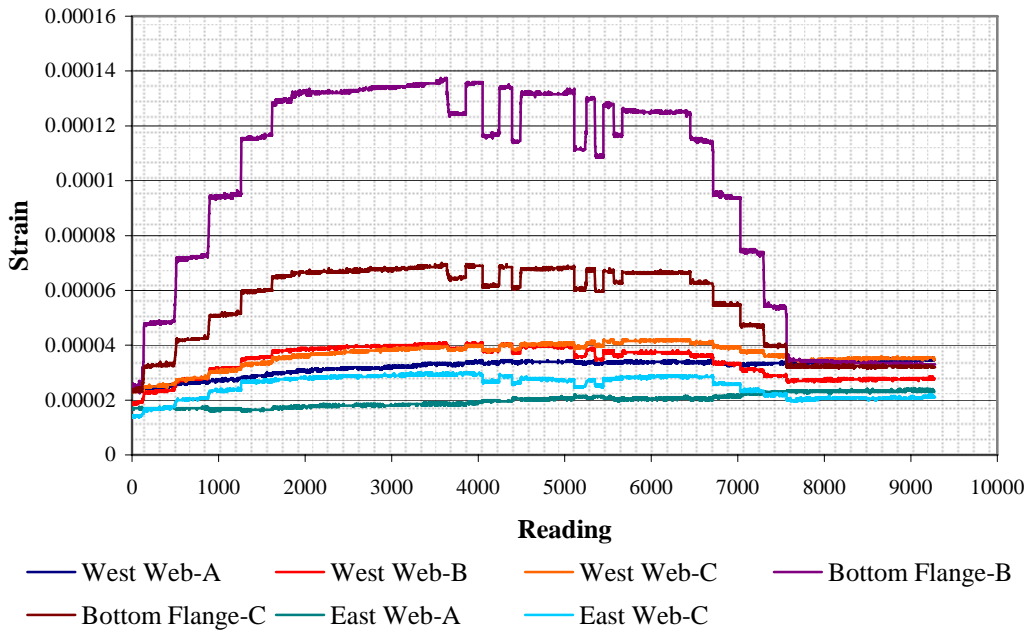
Figure C.14: Interior girder rosette gage response north of midspan during live load testing

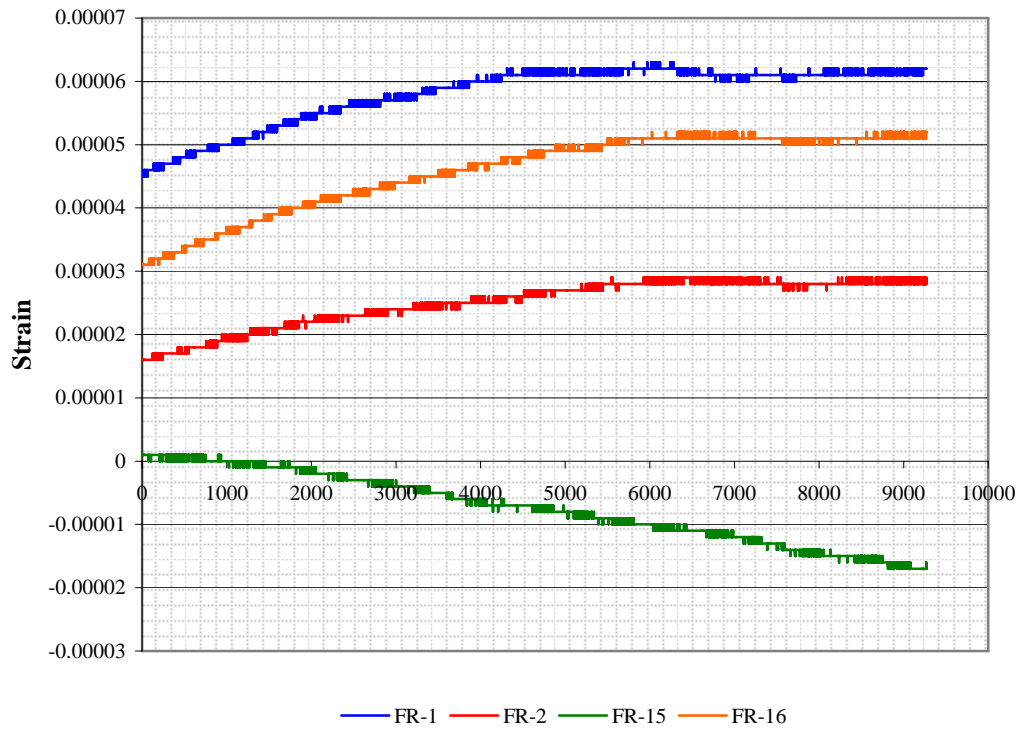
Figure C.16: Rebar gage response 40' North of center line during live load testing

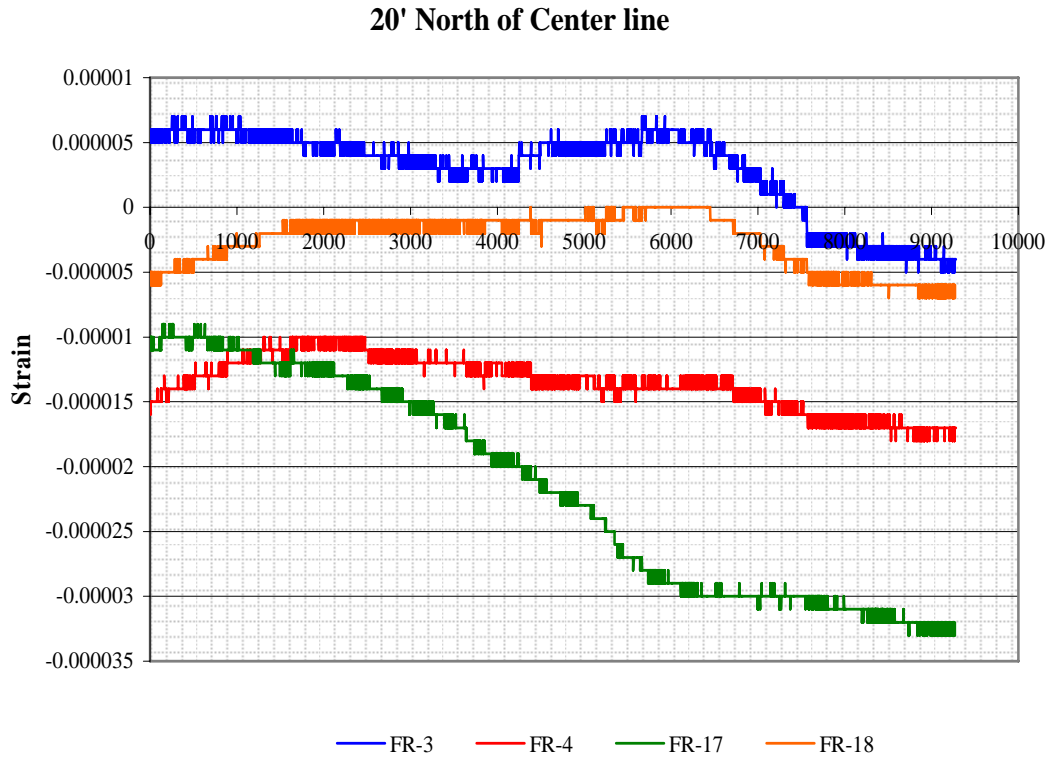
Figure C.17: Rebar gage response 20' North of centerline during live load testing

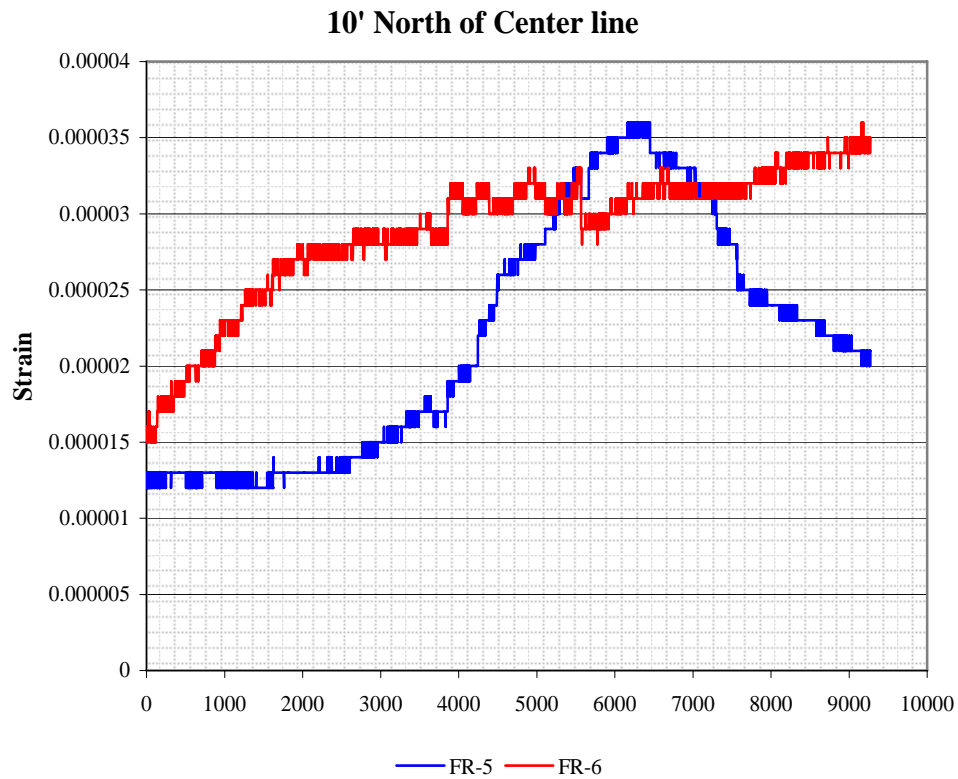
Figure C.18: Rebar gage response 10' North of centerline during live load testing

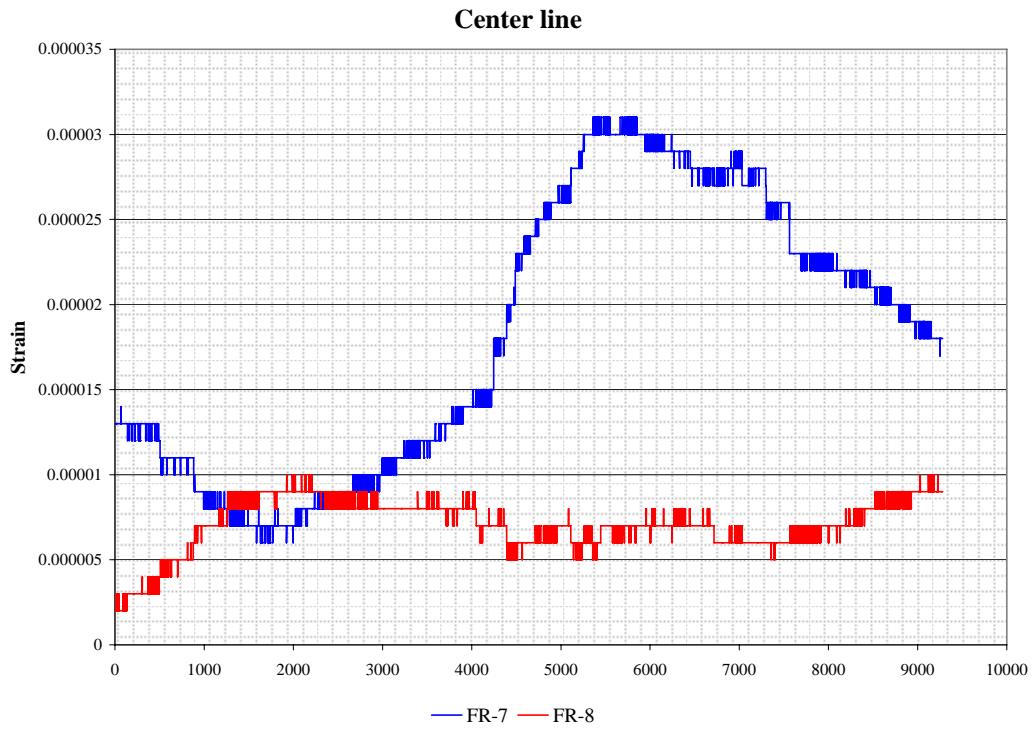
Figure C.19: Rebar gage response at centerline during live load testing

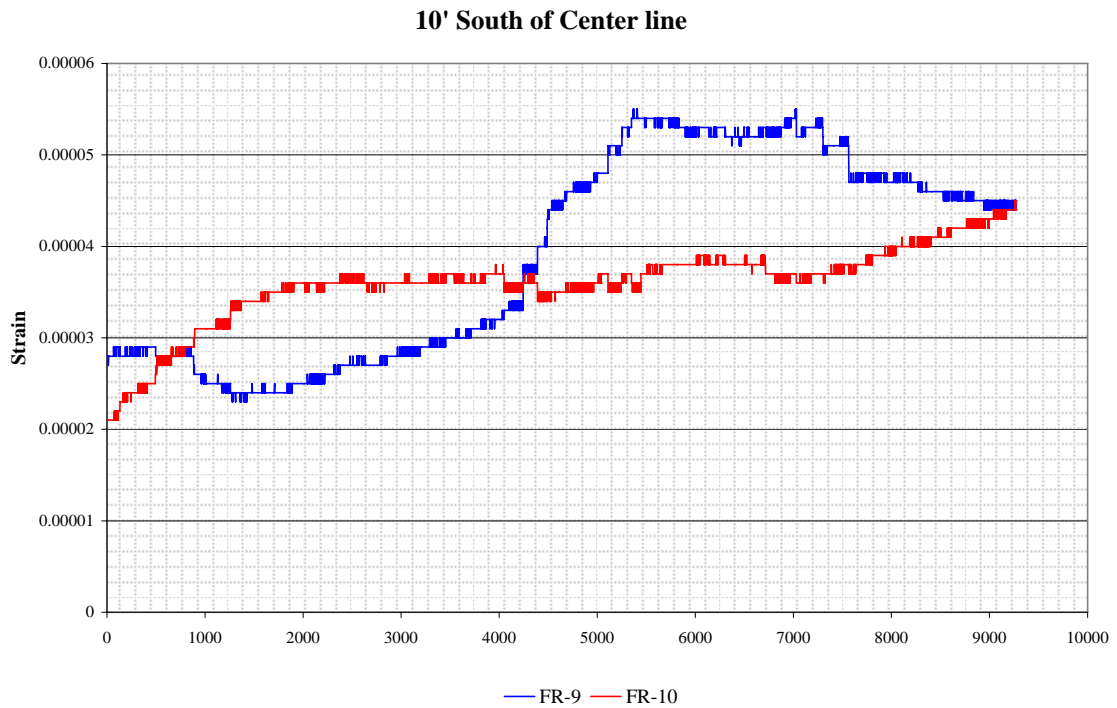
Figure C.20: Rebar gage response 10' South of center line during live load testing

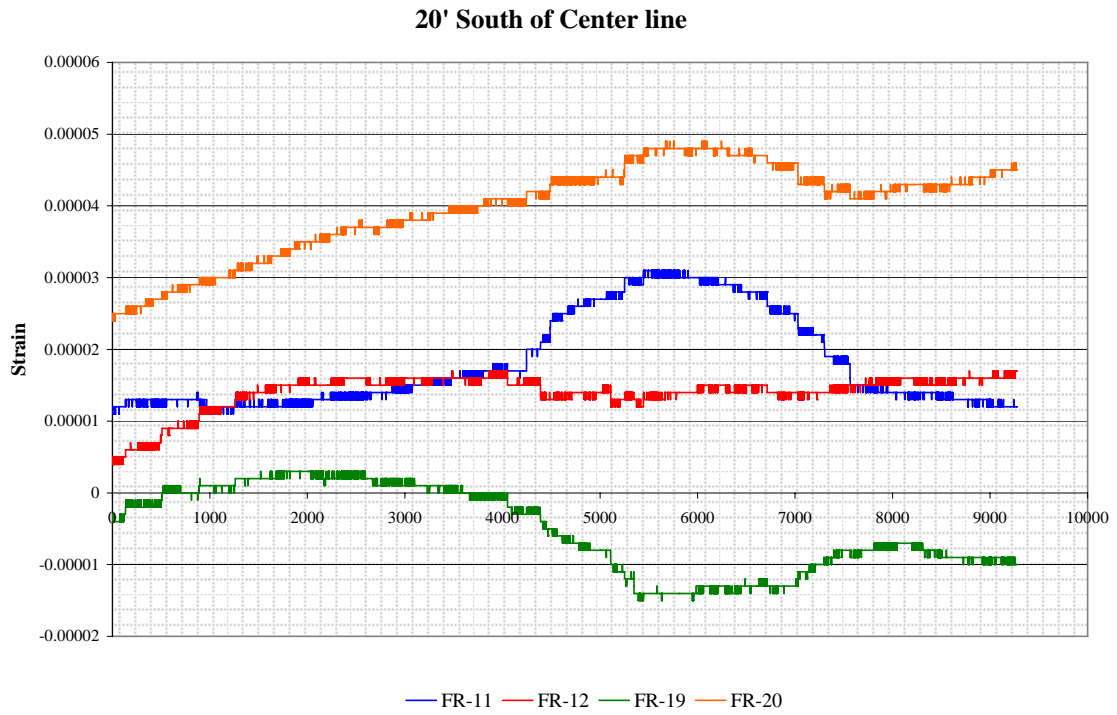
Figure C.21: Rebar gage response 20' South of center line during live load testing

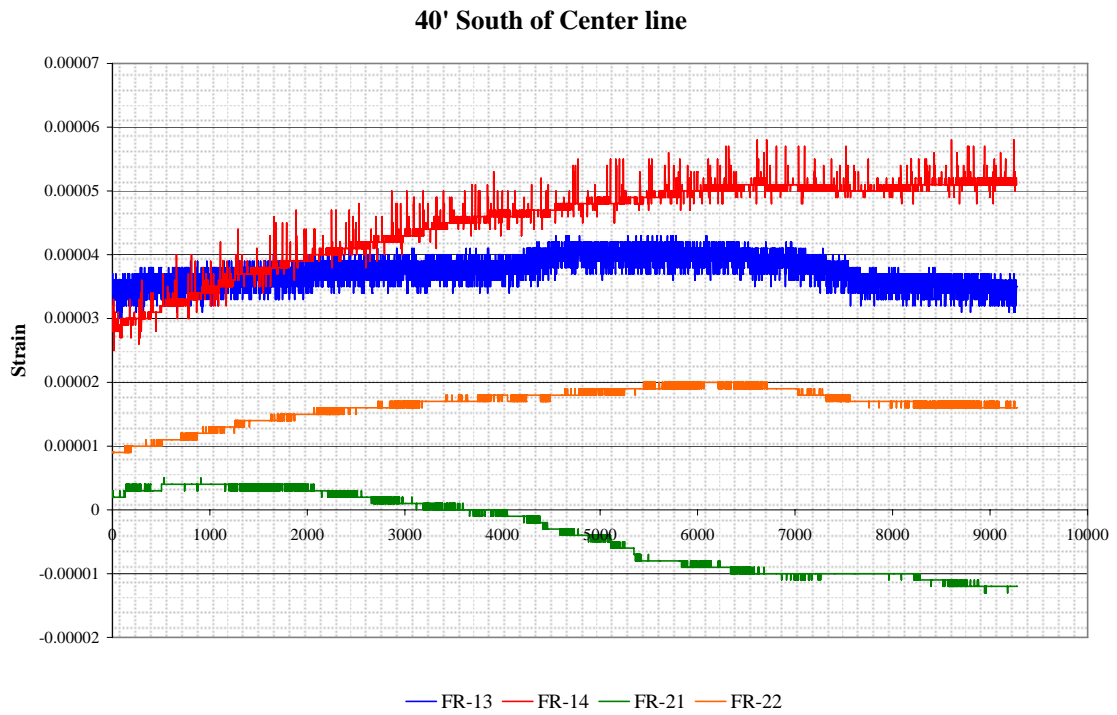
Figure C.22: Rebar gage response 40' South of center line during live load testing

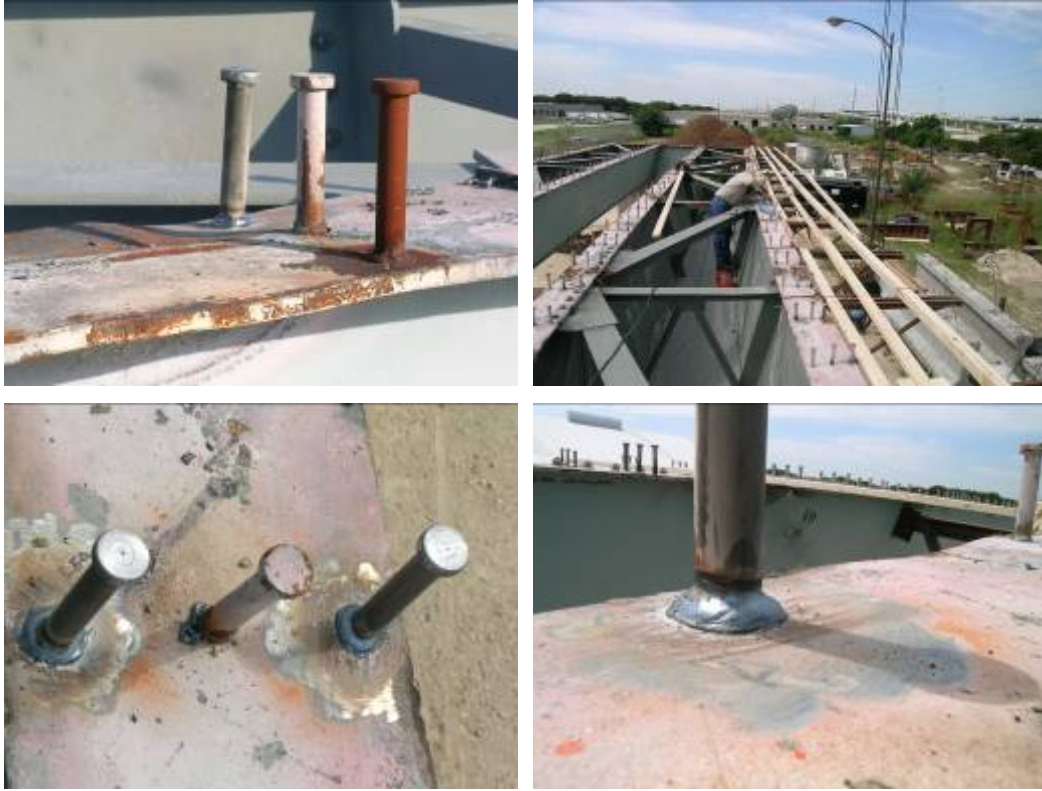
Figure D.5: Stud replacement

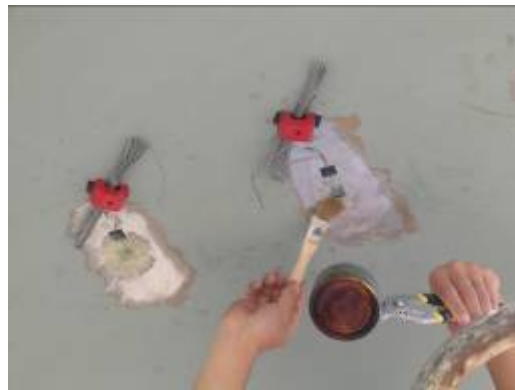
Figure D.6-3: a) Installing a rosette gage, b) checking the resistance to ensure proper reading, and c) protecting the gages from moisture with wax

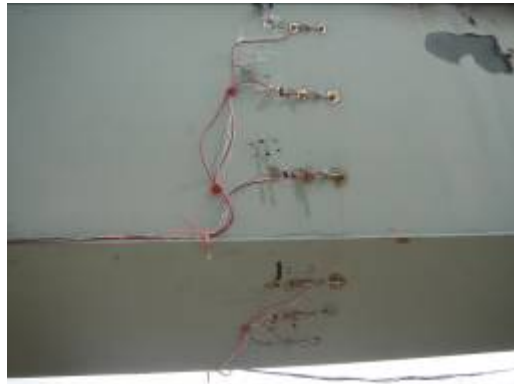
Figure D.6-4: External gages on the girder cross-section

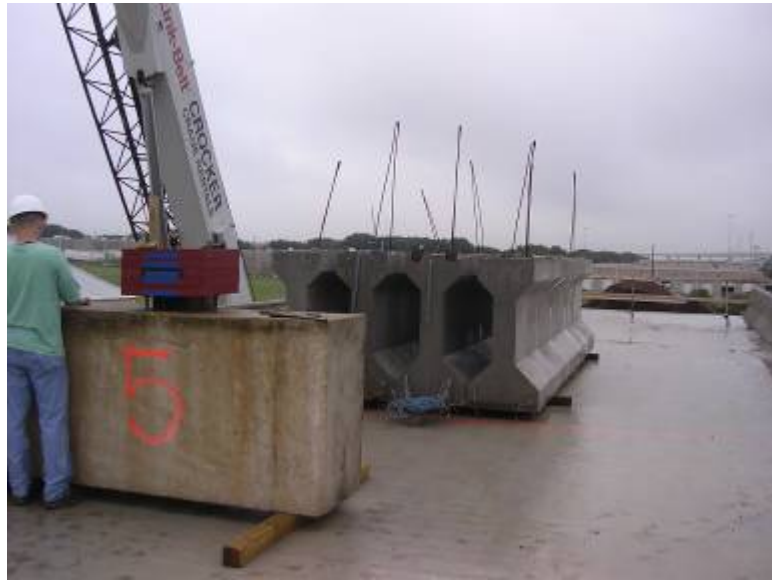
Figure D.12-6: Position 3 during live load testing and the final position for fracture testing
