**Diagnostic Load Tests of a Reinforced Concrete Pan-Girder  
Bridge**

**Thesis**

**The University of Texas at Austin  
August 1998**

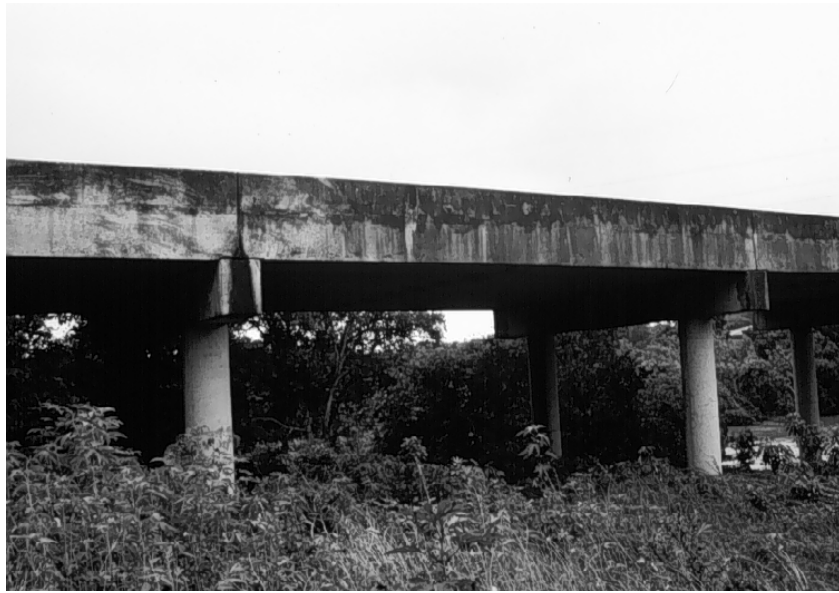
*Figure 3.1 Instrumented Span Viewed from the South*

Pictures of the bridge, viewed from the side and below, are shown in Fig. 3.1 and 3.2, respectively. Figure 3.2 shows a black stripe across mid-span. This stripe is due to staining caused from run-off that travels through holes located at the top of each crown. As discussed in Chapter 2, the holes are from the pan forms used to cast the slab and the beams.

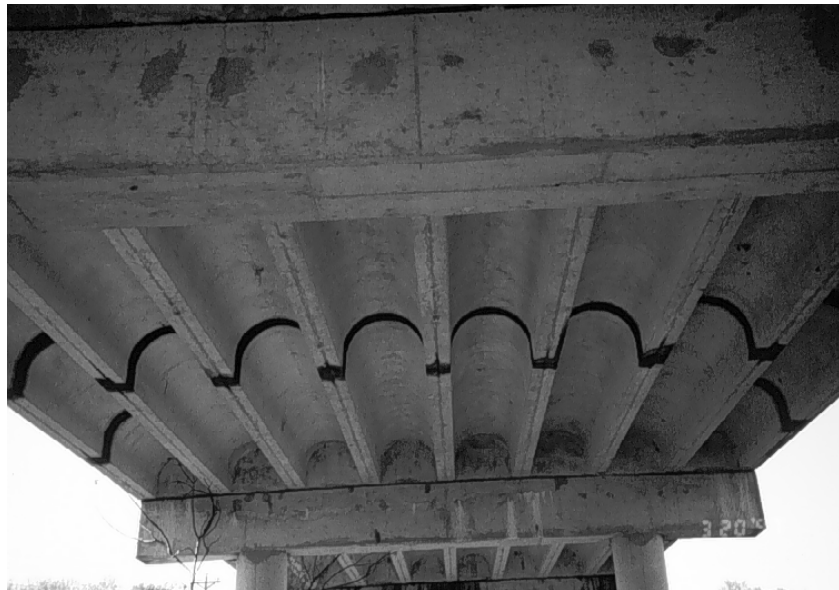
*Figure 3.2 Instrumented Span Viewed from Below*

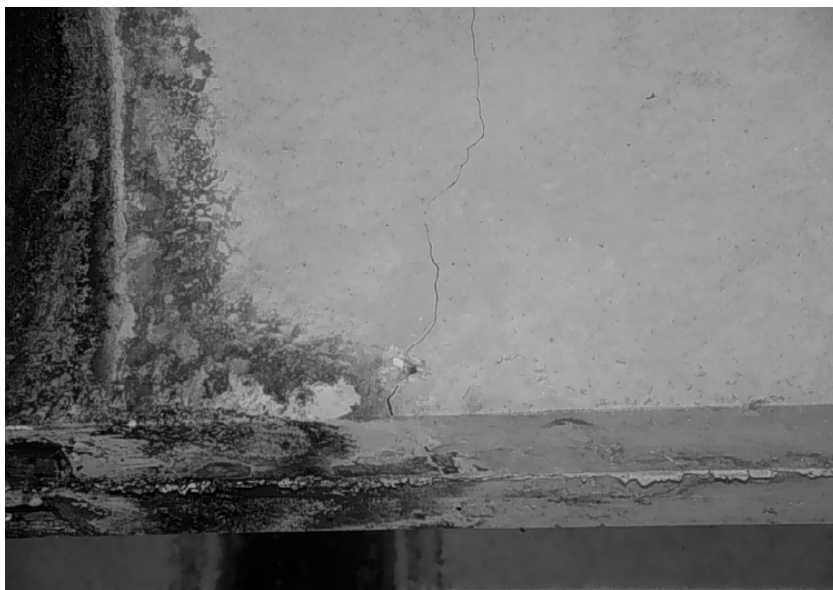
*Figure 3.3 Vertical Crack in Girder*

The pan-girder bridge on FM 967 was in good physical condition. No signs of corrosion, spalling, honeycombed concrete, or significant cracking of the girders were observed. There were some vertical cracks located at the mid-span and quarter-span of all girders, as shown in Fig. 3.3. The average crack width was 0.009 in. at mid-span. Smaller hairline cracks, with crack widths less than 0.002 in., were observed approximately ten inches from the mid-point and the quarter-point of the girders. Longitudinal cracks were also observed in most crowns of the bridge. These cracks were continuous along the length of the span and located near the top of the crowns. The average width of the cracks was 0.008 in. Longitudinal cracks were not observed in the crowns adjacent to the curb however.

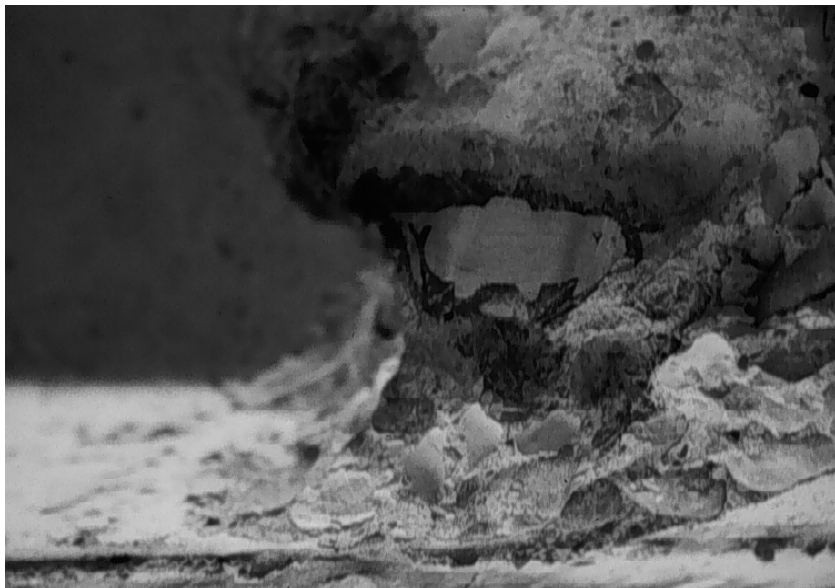
*Figure 3.11 Exposed Reinforcing Bar at Mid-span*

In order to instrument each reinforcing bar, a volume of concrete approximately 4 x 6 x 2 in. was removed, as shown in Fig. 3.11. The surface of the reinforcing bar was then ground until a flat surface was obtained. Next, the bar was cleaned with acetone to remove any dirt from the surface of the bar. The foil gage was then glued on the bar with a special adhesive. In order to weatherproof the foil gage, white acrylic and silicone rubber were placed on top of the gage.

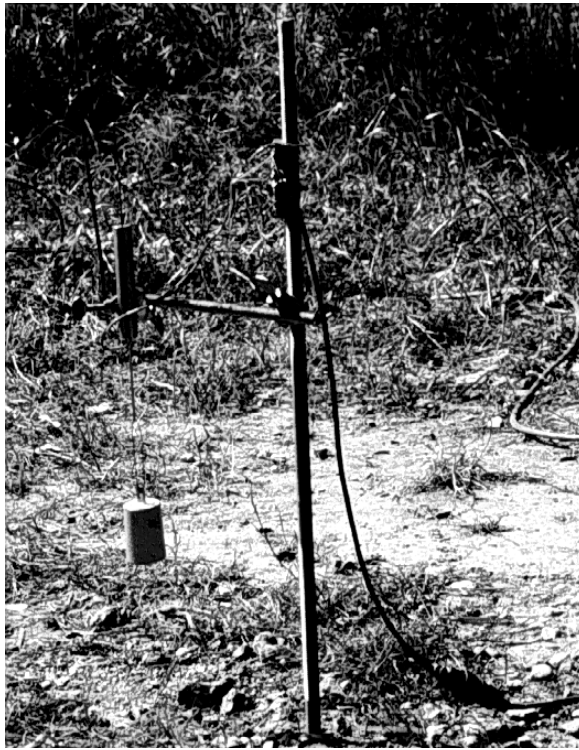
*Figure 3.13 DCDT Mounted on Rod*

Direct Current Differential Transformers (DCDT) were used to monitor the vertical deflection response of the bridge. Five DCDTs were located at mid-span (Fig. 3.5). Figure 3.13 shows a DCDT during the test. The DCDT was clamped to a rod that was anchored in the ground. The core of the DCDT was attached to fishing wire, which was connected to the bottom of the girder. A weight was suspended from the bottom of the core in order to keep the fishing wire taut.

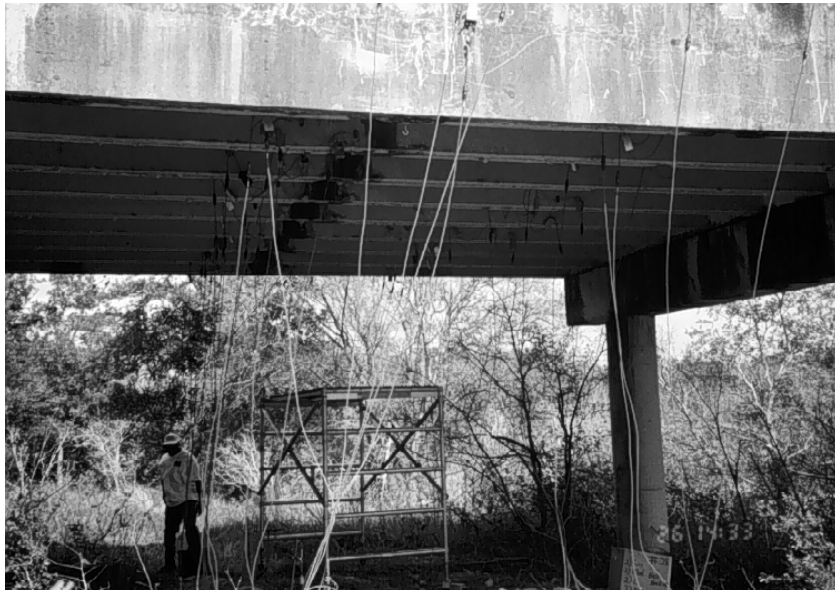
*Figure 3.15 Cables Suspended from Bottom of Bridge*

A Campbell Scientific CR9000 data-acquisition system (Fig. 3.14) was used to collect data during the test. This data-acquisition system was configured so that 55 channels could be recorded simultaneously. The system was designed such that five instruments were connected to a single junction box. Cables from eleven junction boxes attached directly to the CR9000. The advantage of the junction boxes was that they reduced the number of cables running from the individual instruments to the data-acquisition system. Figure 3.15 shows two rows of cables suspended from the bottom of the bridge deck. The acquisition

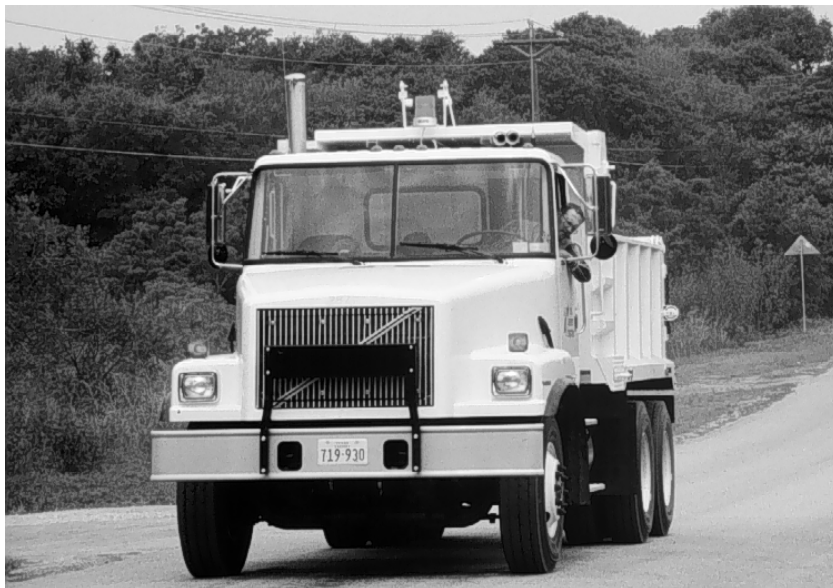
*Figure 3.16 TxDOT Loading Vehicle*

The two loading vehicles used for the diagnostic load test were provided by the TxDOT maintenance office in San Marcos, Texas. The trucks were ten-cubic-yard dump trucks filled with roadway base material and weighed approximately 43 kips each. Figure 3.16 shows a view of one of the trucks, and Fig. 3.17 and 3.18 show the dimensions and axle weights of the two vehicles.

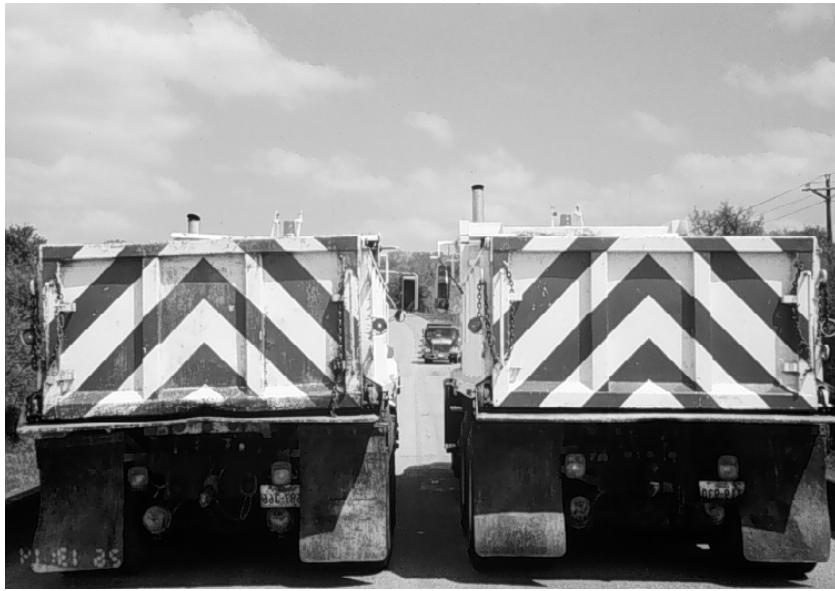
*Figure 3.22 Loading Vehicles in Test Series 1*

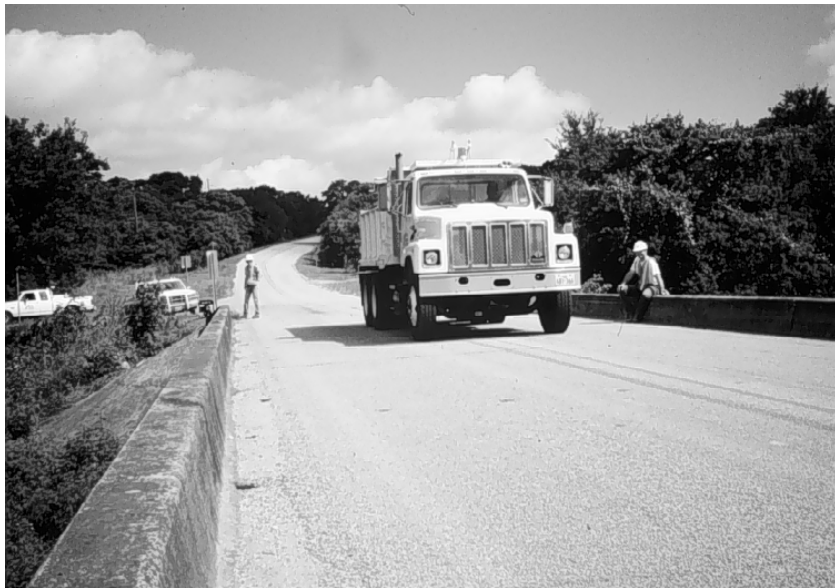
*Figure 3.23 Test Series 3 in Progress*

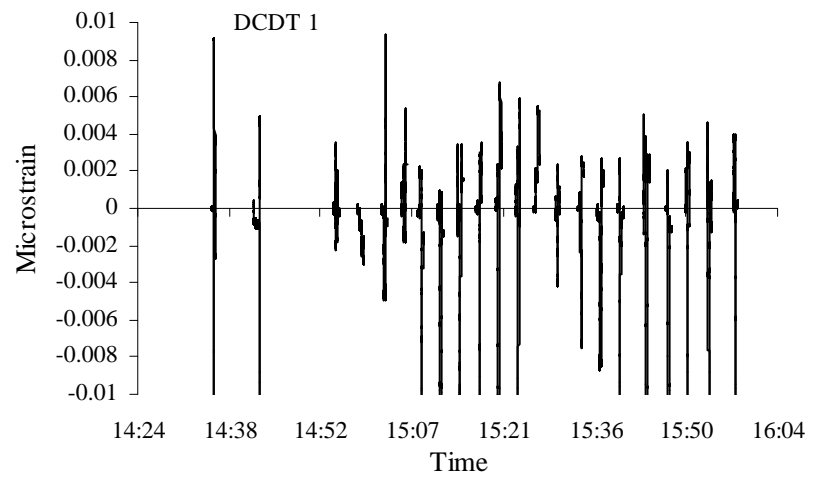
Figure 4.5 Drift in DCDT, Test Series 1 through 3

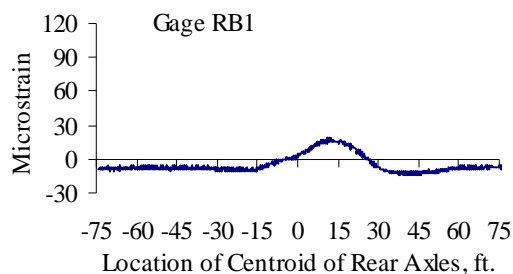
*Figure 4.6 Unadjusted Response History for Gage RB1*

Each response history for each gage was plotted and adjusted so the readings began at zero. The data were shifted by a constant value so the initial data points began at zero. For example, Fig. 4.6 shows the unadjusted response history for gage RB1 obtained during pass 1 of truck location 4 in Test Series 2. The figure shows the data to begin at approximately  $-8$  microstrains. Therefore, adding 8 microstrains to all values shifts all data points so the initial data points begin at zero. Figure 4.7 shows the adjusted response history.

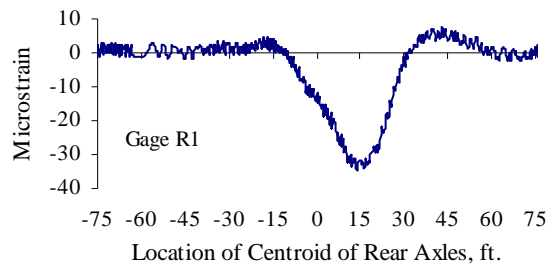
*Figure 4.8 Response History for Gage R1 during Test Series 2, Truck Location 5, Pass 1*

Once this shift was performed on all readings, the behavior of each instrument as a function of rear axle location was analyzed to determine the reliability of the data. Two approaches were used to identify reliable data. A response history in which the initial and final values were the same two satisfied the first approach. Figure 4.8 shows a reading for gage R1. As shown, the final strain data values at a location of 75 ft. are very close to the initial strain data values located at -75 ft. This response history is considered reliable and used to compare with other readings.

behavior of Fig. 4.8. Therefore, this response history was considered reliable. In addition, the downward shift of the response history overestimated the maximum compression strain readings, which should lead to conservative results.

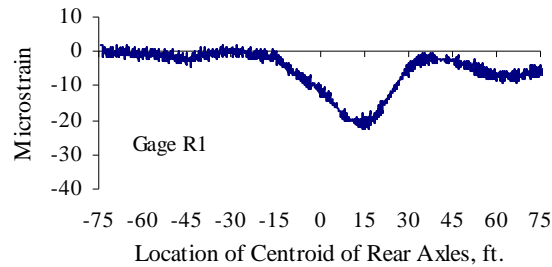
*Figure 4.9 Response History for Gage R1 during Test Series 2, Truck Location 4, Pass 1*

Response histories which tended to drift linearly with time were not considered to be ideal but appeared to be reliable. Figure 4.9 depicts the response history of gage R1 during a different run. The strain data at the end of the test display a permanent offset of approximately -5 microstrain. If all the points in the response history were adjusted by an equation which was a function of longitudinal truck location, then the adjusted response history would resemble the

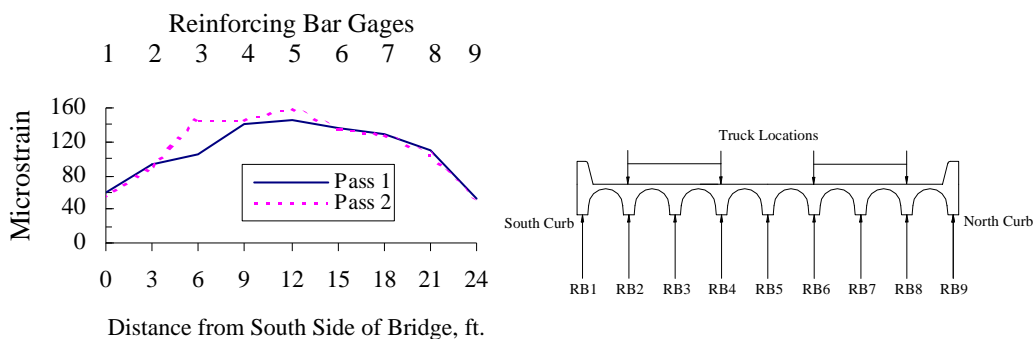
Figure 4.12 Profile of Maximum Reinforcing Bar Strains at Mid-span for Test Series 1

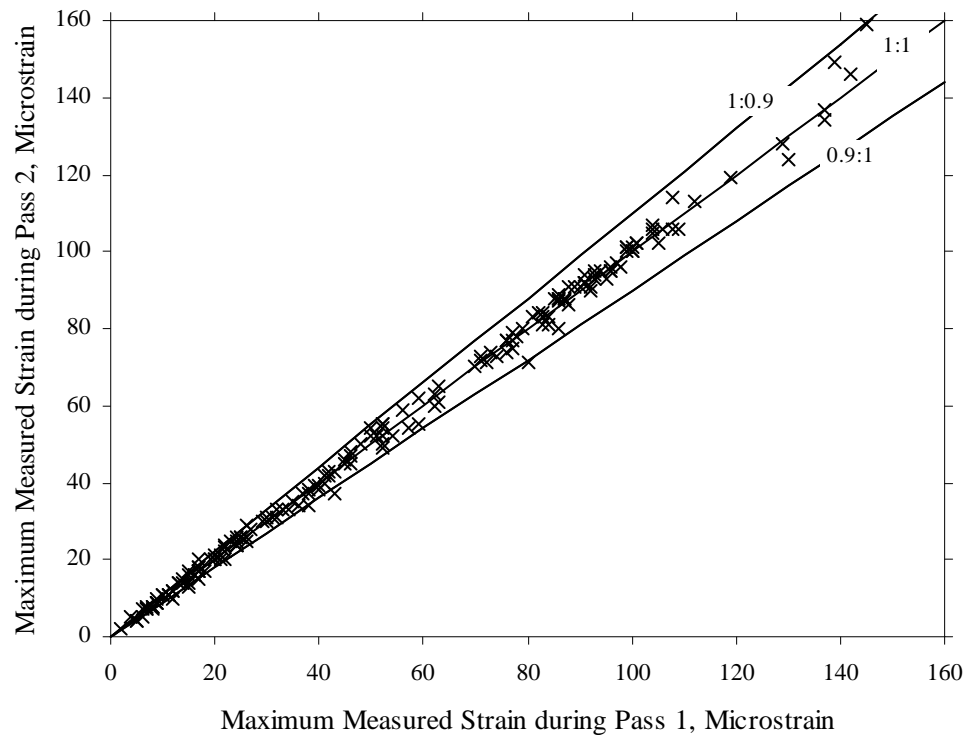
*Figure 4.21 Repeatability of Maximum Reinforcing Bar Strains at Mid-span and Quarter-span*

As indicated in all of the tables and figures presented, two passes were made at each transverse position during each test series. This was done to obtain information on the repeatability of the data. Slight variations in the data obtained for each pass were observed and are attributed to the variations in the truck position. Many times the truck was positioned a few inches to the right or left of the line marker. Figure 4.21 compares the maximum strains for all reinforcing bar gages during all runs. As shown in the figure, all the data points fall within a  $\pm 10\%$  range.

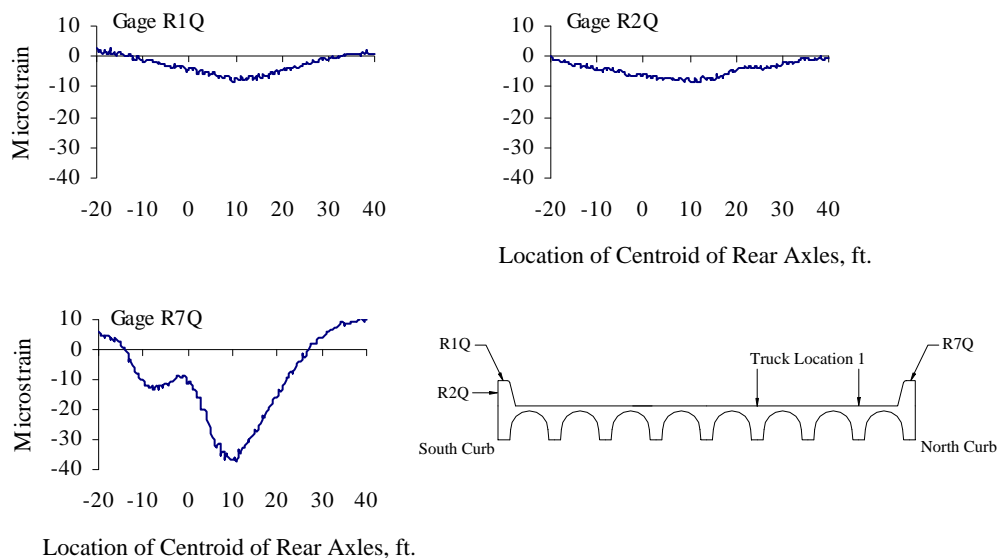
Figure 4.23 Curb Strains at Quarter-span, Test Series 2, Truck Location 1, Pass 1

Strain data recorded during the first pass of truck location 1 for Test Series 2 are shown in Fig. 4.23. These strain data are representative of most of the response histories obtained for wire strain gages on the curb monitored during all test series. All of the gages are in compression because these strain gages are located within the top ten inches of the curb. Strain gage R7Q in Fig. 4.23 is shown drifting at rear axle locations  $-20$  and  $40$  ft. As mentioned, this trend is observed in many of the gages located on the curb and exposed to the sunlight. On the otherhand, some response histories for strain gage R7Q are reliable and are used in the analysis of the bridge behavior. All gages experienced a reversal in strain when the truck was located on an adjacent span.

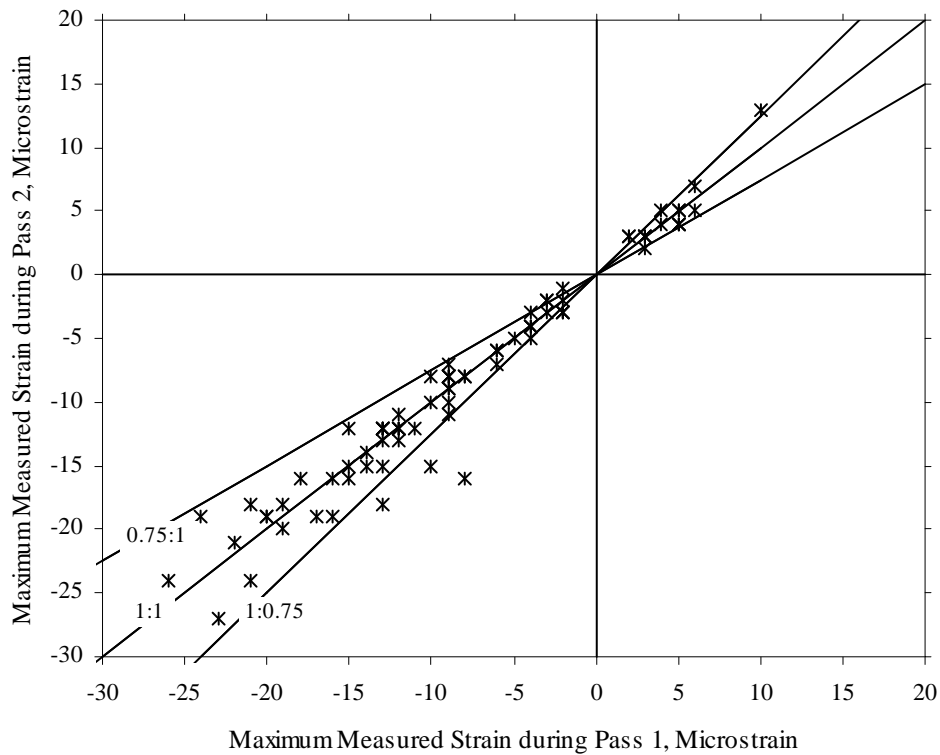
*Figure 4.27 Repeatability of Maximum Strains on Surface of Crowns at Mid-span and Quarter-span*

The repeatability of the data for the gages located on the crowns is presented in Fig. 4.27. As shown, significant scatter is observed in all of the gages. This scatter indicates that the gages are sensitive to any slight change in the positioning of the truck. Such behavior is most likely due to the small readings measured by the gages, and thus variations within a  $\pm 25\%$  range are shown in the figure.

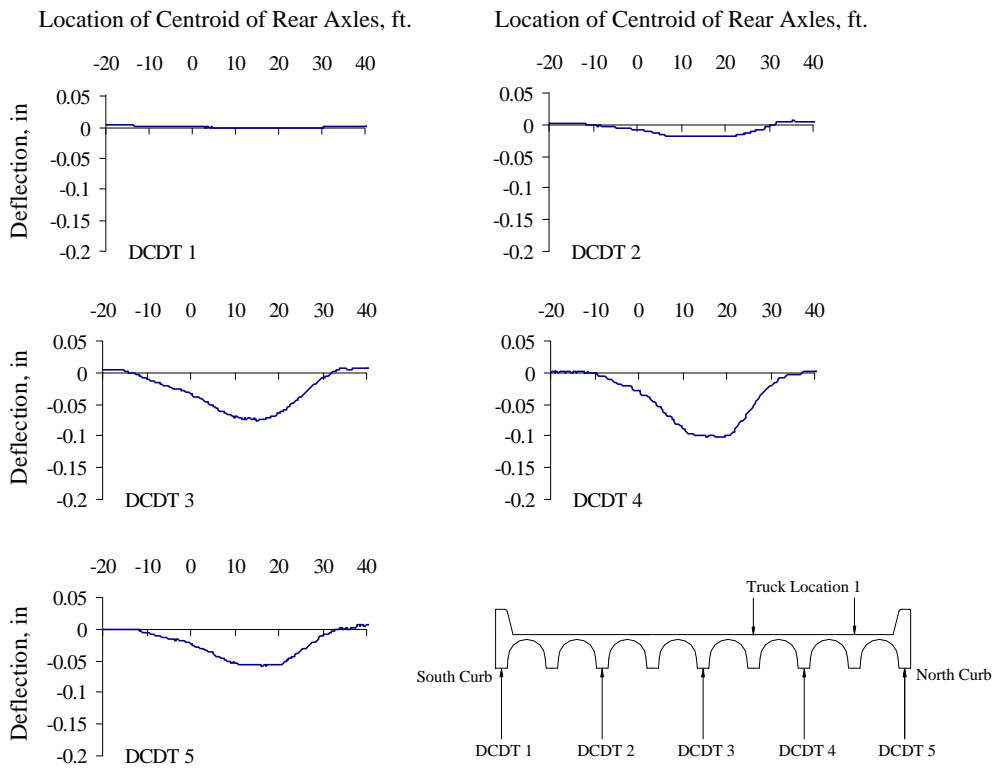
Figure 4.32 Vertical Deflections Measured at Mid-span, Test Series 2, Truck Location 1, Pass 1

Displacement data recorded during the first pass of truck location 1 for Test Series 2 are shown in Fig. 4.32. These displacement data are representative of the response obtained from the DCDTs during the three test series. As observed in the figure, the readings tend to flatten out at the location where maximum displacement is expected. Such response is usually attributed to the flexibility in the connection between the wire and the DCDT. Shown in Fig. 4.32, a change in displacements from downward to upward as the truck moves onto the adjacent span is observed. The response was dominated when the centroid of the rear axles was located at mid-span.

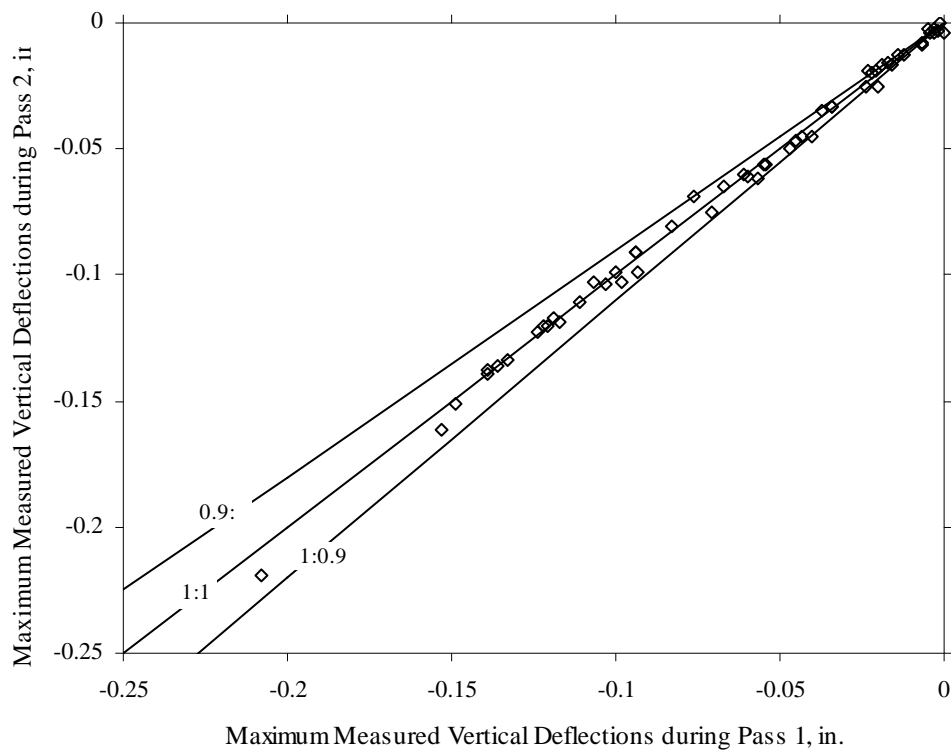
Figure 4.36 Repeatability of Maximum Vertical Deflections at Mid-span

Figure 4.36 compares the maximum deflections obtained from pass 1 with those from pass 2. Very small differences are observed which indicate that the deflection readings are not sensitive to slight changes in the position of the truck during pass 2. The data fall within a range of  $\pm 10\%$ , probably even within a  $\pm 5\%$  range.

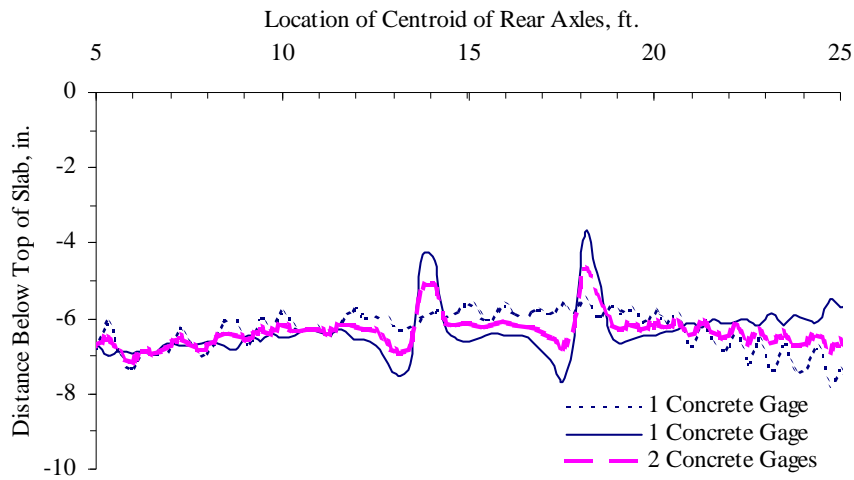
*Figure 5.9 Comparison of Neutral Axis Depths in an Interior Girder Calculated using a Different Number of Concrete Strains, Test Series 2, Truck Location 3, Pass 2*

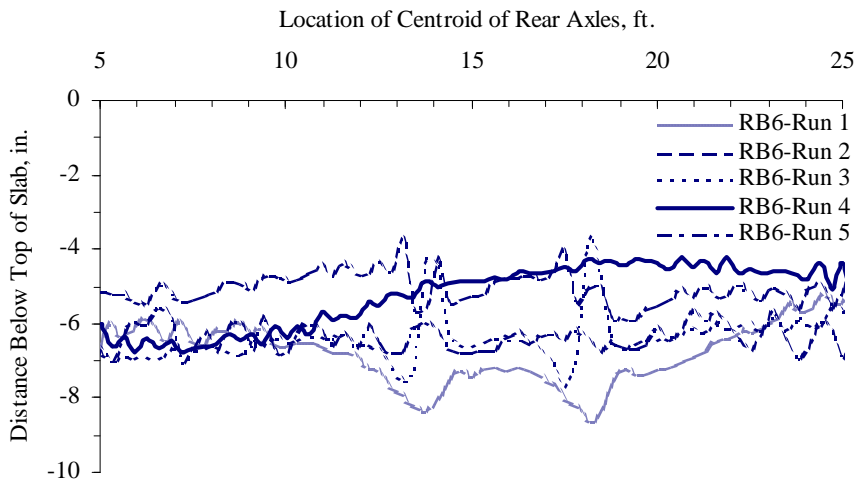
Figure 5.12 Variation in Neutral Axis Depth Calculated from Measured Strains for an Interior Girder at Mid-span

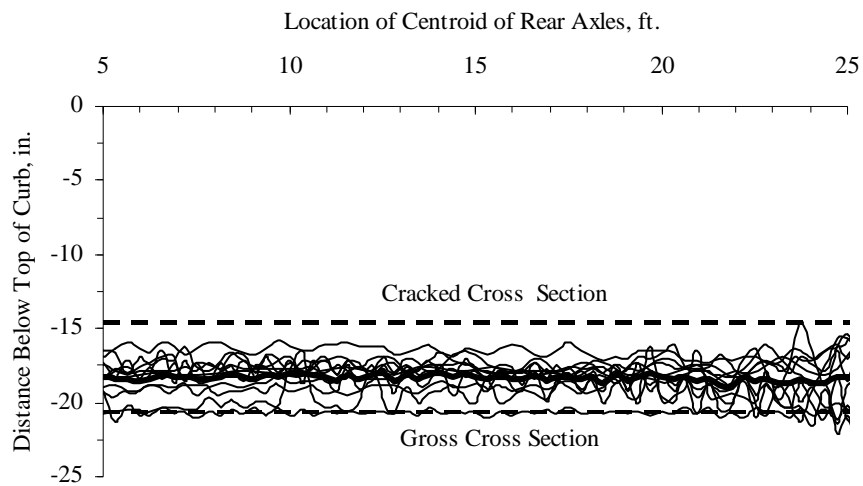
*Figure 5.13 Average Neutral Axis Depth for Exterior Girders*

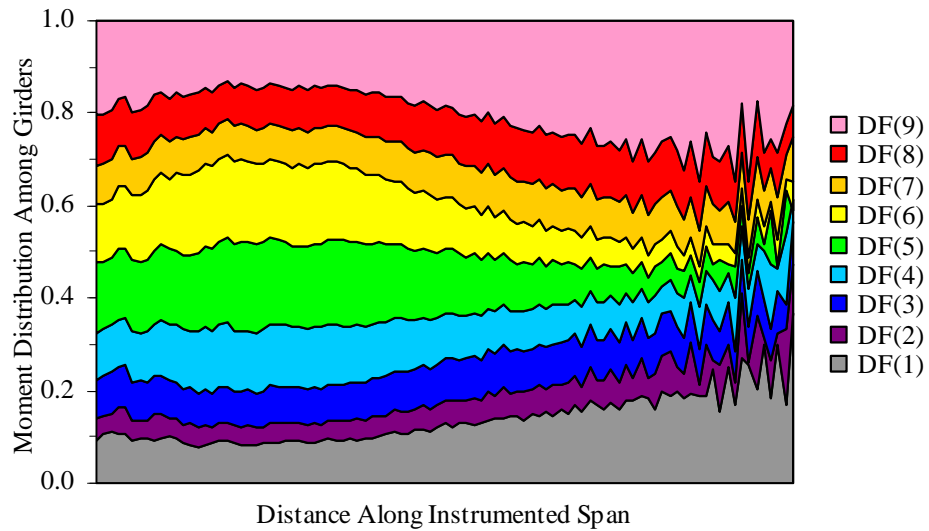
Figure 5.37 Moment Distribution at Quarter-span, Test Series 2, Truck Location 3
