**EVALUATION AND PERFORMANCE MONITORING OF CORROSION  
PROTECTION PROVIDED BY FIBER-REINFORCED COMPOSITE  
WRAPPING**

**THESIS**

Presented to the Department of Civil Engineering of  
The University of Texas at Austin  
in Partial Fulfillment  
of the Requirements  
for the Degree of

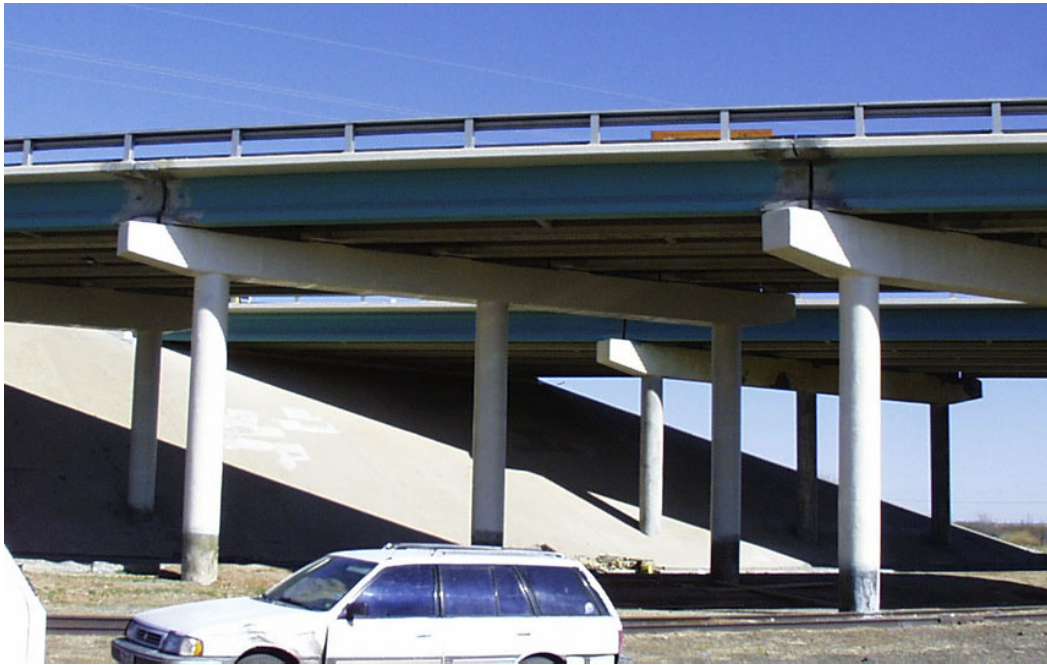
**Figure 1.1** Structure wrapped with FRP.

In recent years, FRP composite wrapping has been considered and implemented (on a few projects) for corrosion protection. Corrosion due to chloride ingress is purportedly arrested by the prevention of further chloride contamination and penetration by the oxygen and water needed to continue a corrosion process that has begun or has caused damage. Figure 1.1 shows a structure that has been repaired with a composite wrapping system.

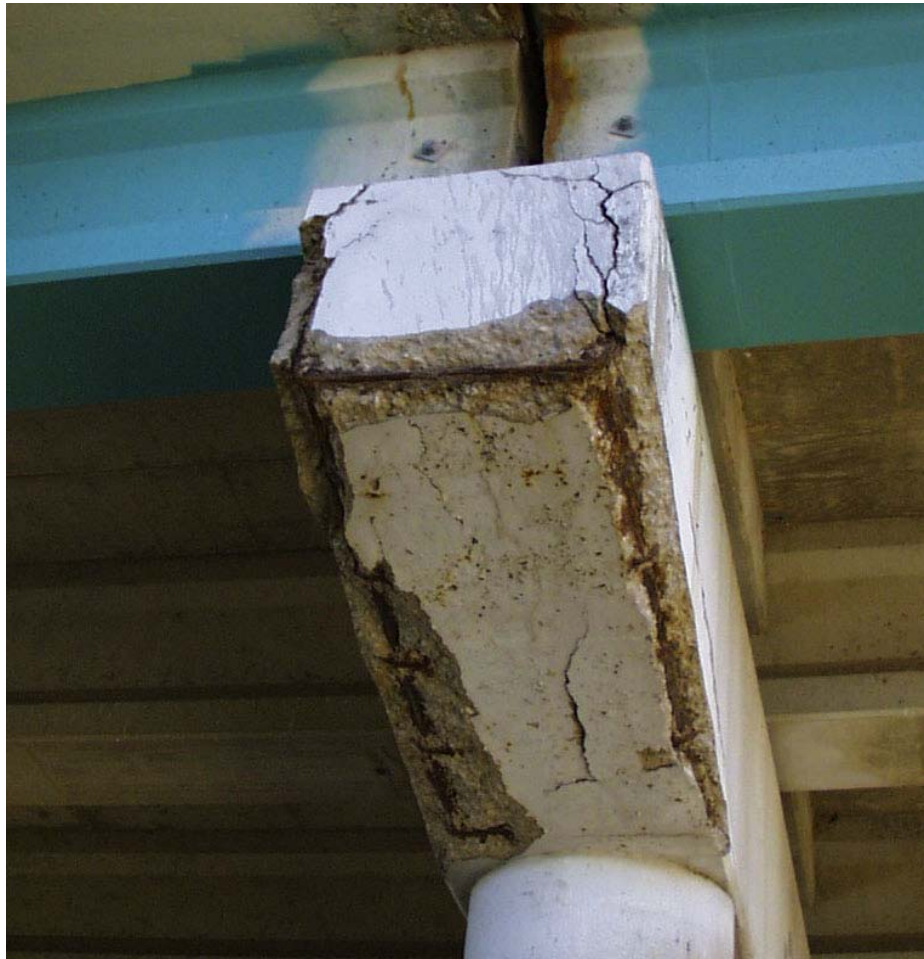
**Figure 1.2** Typical Corrosion Damage on Project CSR 783-2-66.

To characterize the condition of the structural elements before Project CSR 783-2-66 began, a number of field tests were carried out. These tests included visual inspection, corrosion rate measurement, chloride content testing, and concrete permeability testing. Tests were performed at selected locations with the exception of visual inspection, which was performed at each structure designated for repair.

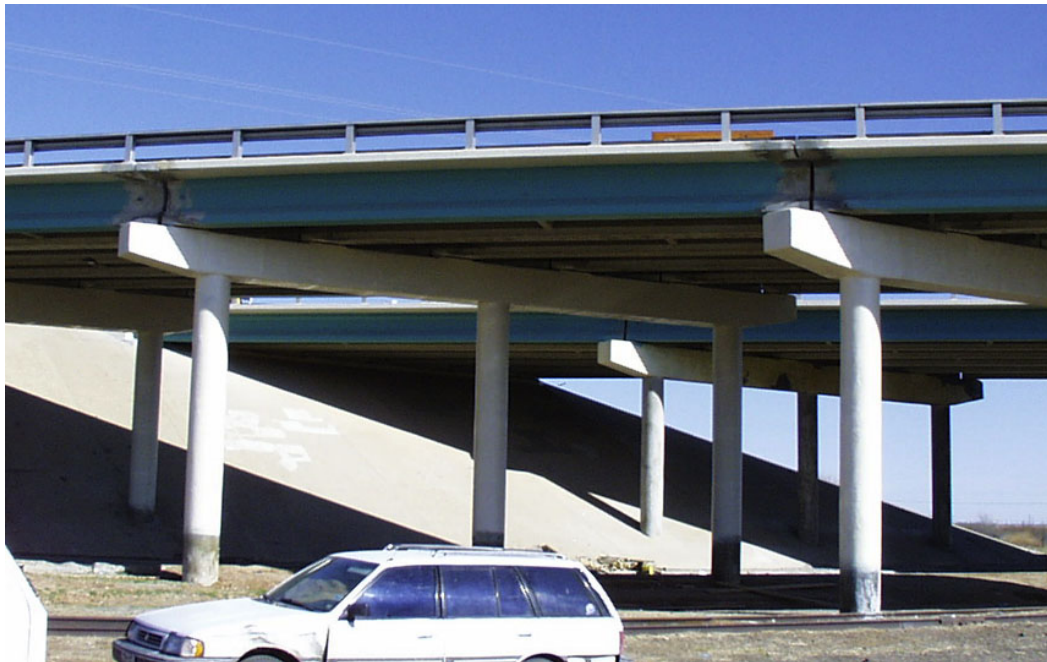
**Figure 1.1** Structure wrapped with FRP.

In recent years, FRP composite wrapping has been considered and implemented (on a few projects) for corrosion protection. Corrosion due to chloride ingress is purportedly arrested by the prevention of further chloride contamination and penetration by the oxygen and water needed to continue a corrosion process that has begun or has caused damage. Figure 1.1 shows a structure that has been repair with a composite wrapping system.

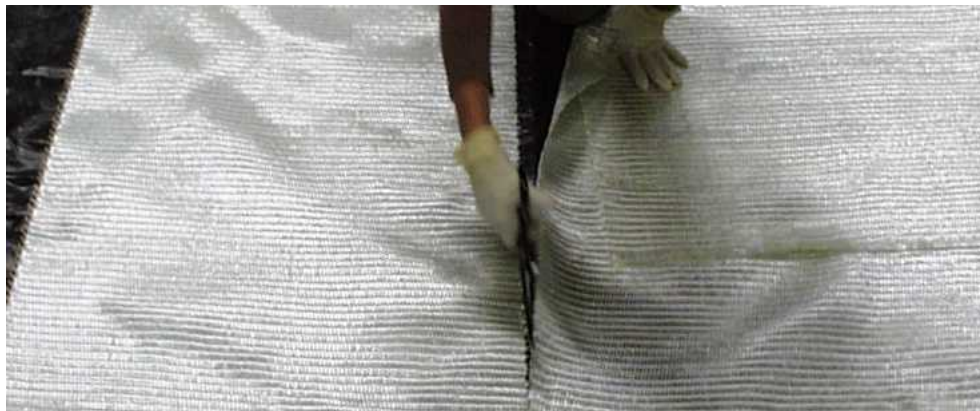
**Figure 3.2** Tyfo<sup>®</sup> S Fibrwrap<sup>®</sup> primary glass fabric.

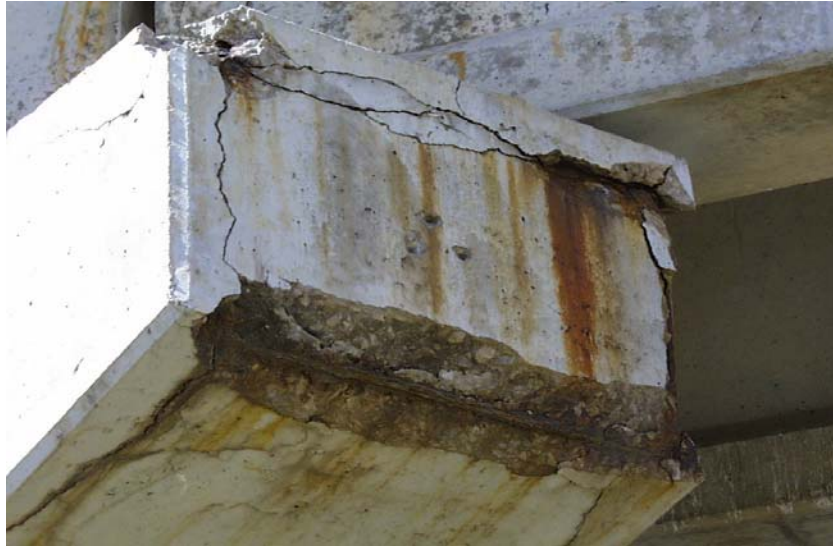
**Figure 4.1** Endcap damage to Structure #5.

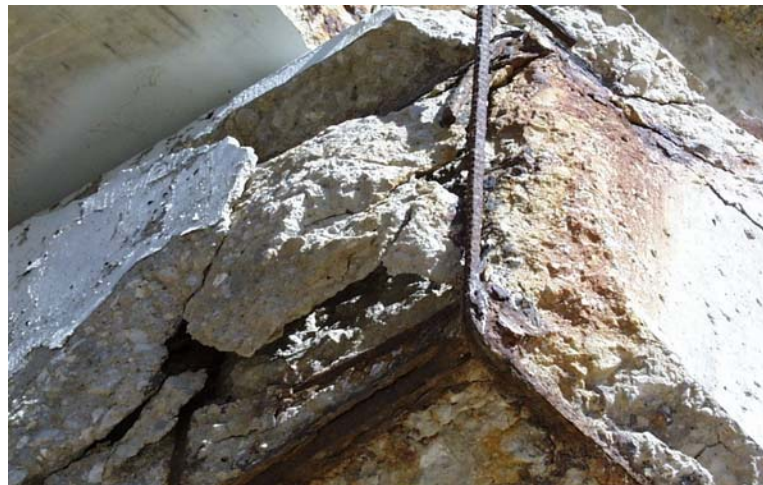
**Figure 4.2** Closeup of corrosion damage on Structure #8.

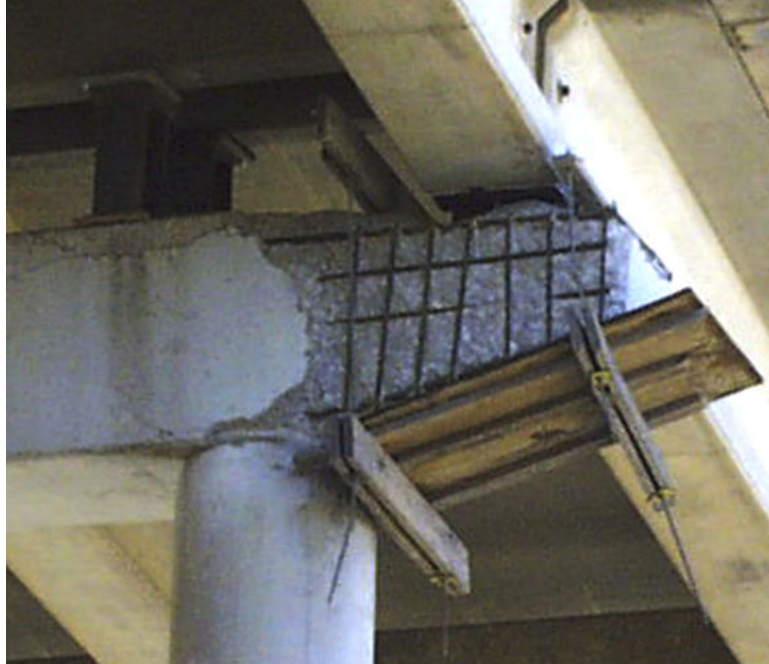
**Figure 4.3** Endcap prepared for application of repair material on Structure #3.

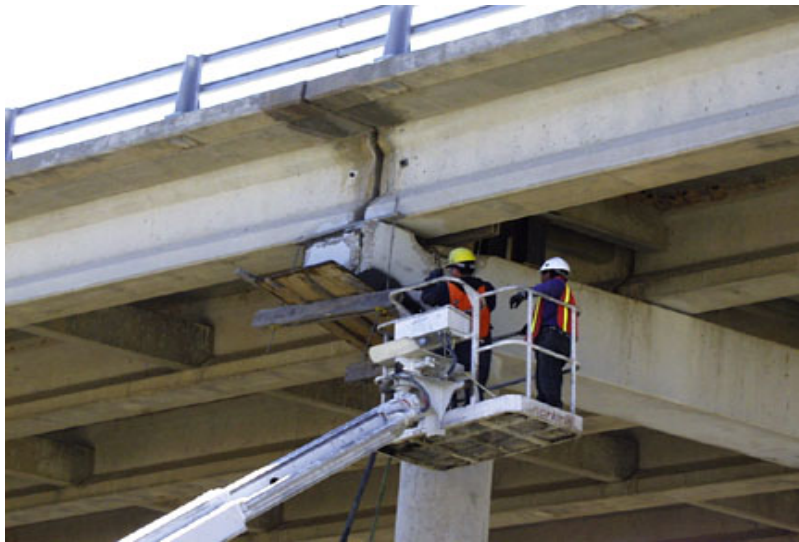
**Figure 4.4** Application of Shotpatch<sup>®</sup> 21F to Structure #3.

Shotpatch<sup>®</sup> 21F is applied by a shotcrete process. This application and the temporary formwork are shown in Figure 4.4. Figure 4.5 illustrates a typical endcap after the formwork has been removed. It is evident that the concrete cover was removed to just inside the outer column face at this particular location (Structure #3).

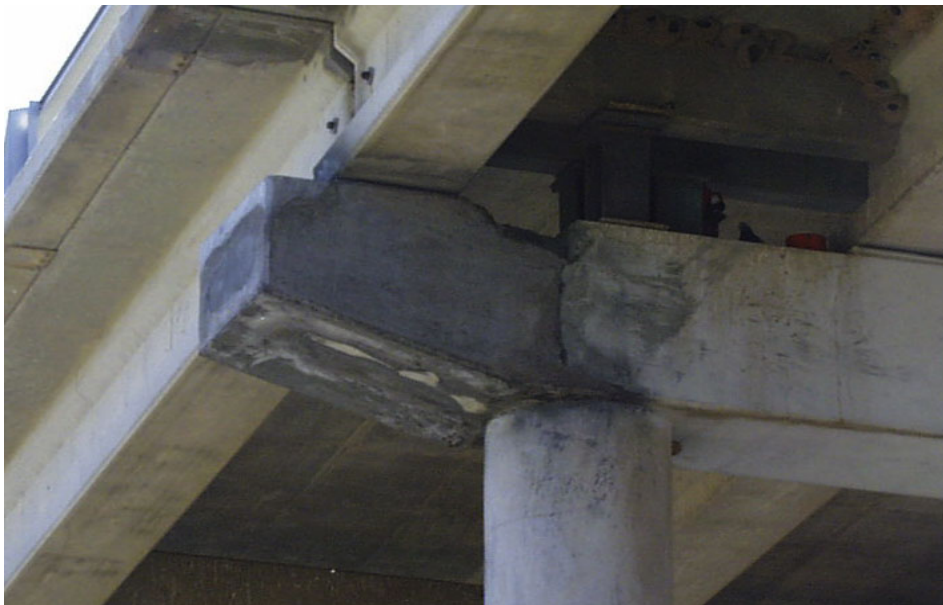
**Figure 4.5** Endcap repair material on Structure #3.

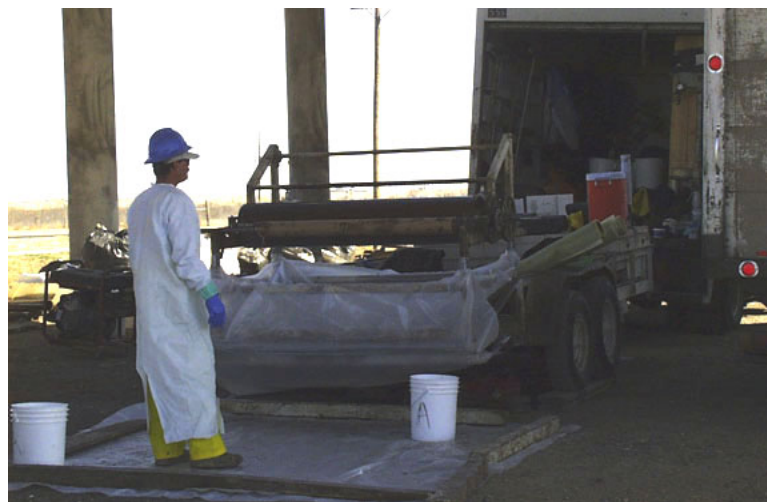
**Figure 4.6** Saturation machine used by Delta Structural Technology, Inc.

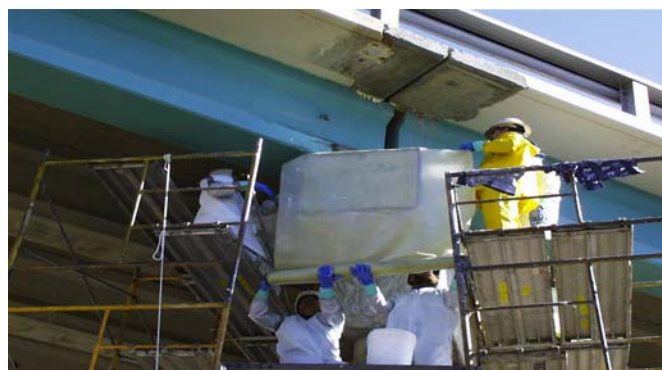
**Figure 4.7** Application of Fibrwrap<sup>®</sup> to endcap on Structure #2.

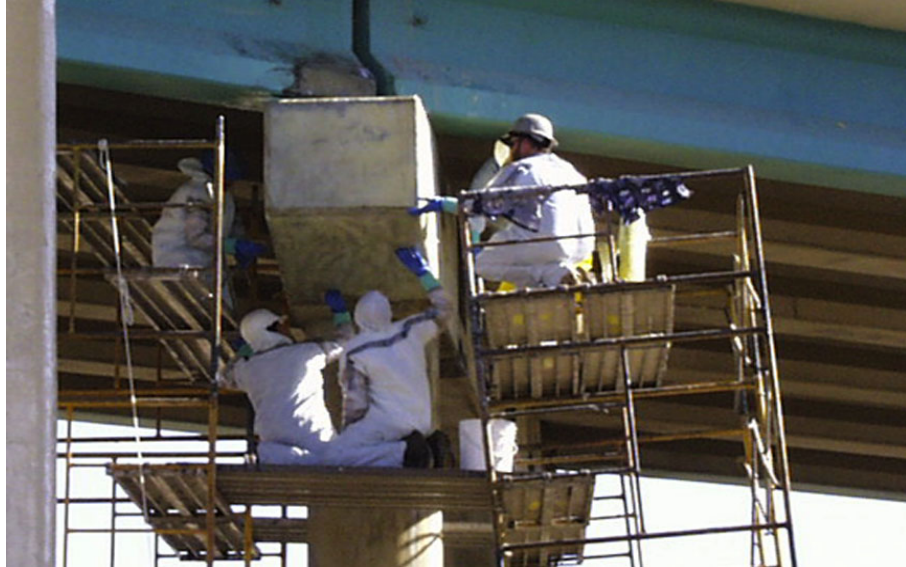
**Figure 4.8** Removal of air pockets beneath a layer of Fibrwrap<sup>®</sup>.

demonstrated in Figure 4.8. About 24 hours after the final layer is applied, the entire surface is painted with a high-solids paint to provide UV protection for the wrapping system and to match the color to that of the existing structure. An example of a finished and painted endcap is shown in Figure 4.9. The Fibrwrap<sup>®</sup> system can be applied at a rate of about 2 bents in 2 days on skewed bridges, and a little faster on structures with more orthogonal geometry.

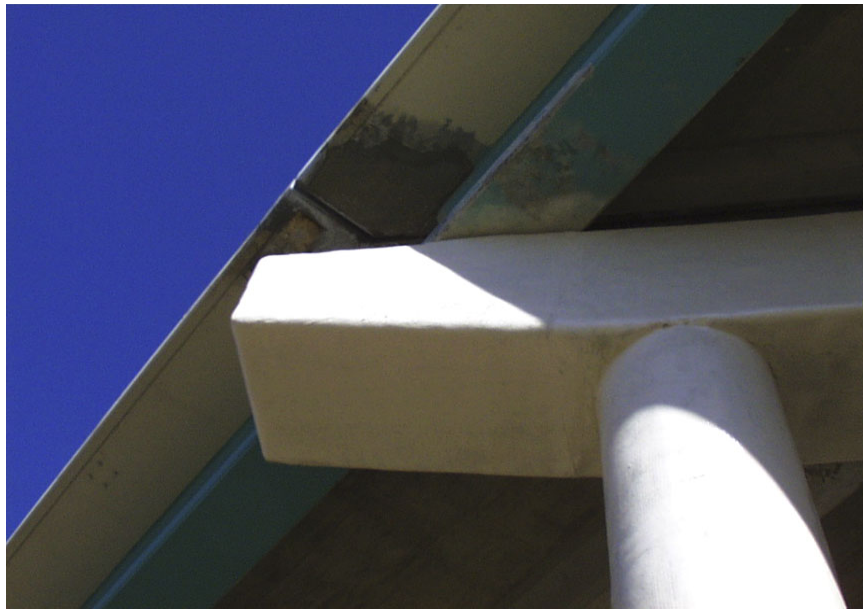
**Figure 4.9** Wrapped and painted endcap on Structure #2.

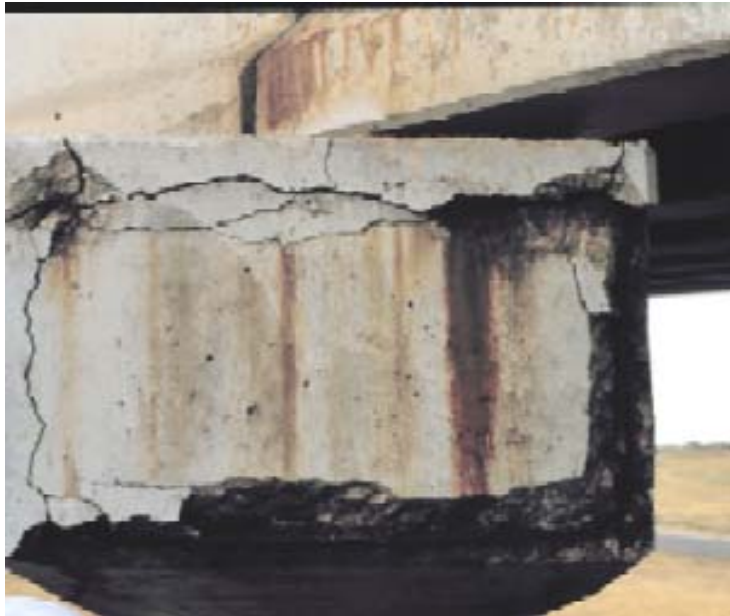
**Figure 5.1** Corrosion damage on downstream endcap.

Many of the corrosion-related problems on the structures being repaired for Project CSR 783-2-66 occur on the low or “downstream” end, toward which all water and water-borne particles are drained. Of particular concern are the end sections on the substructure bridge bents. Many of the downstream end portions of these bents have experienced severe cracking, delamination, and spalling, as shown in Figures 5.1 and 5.2.

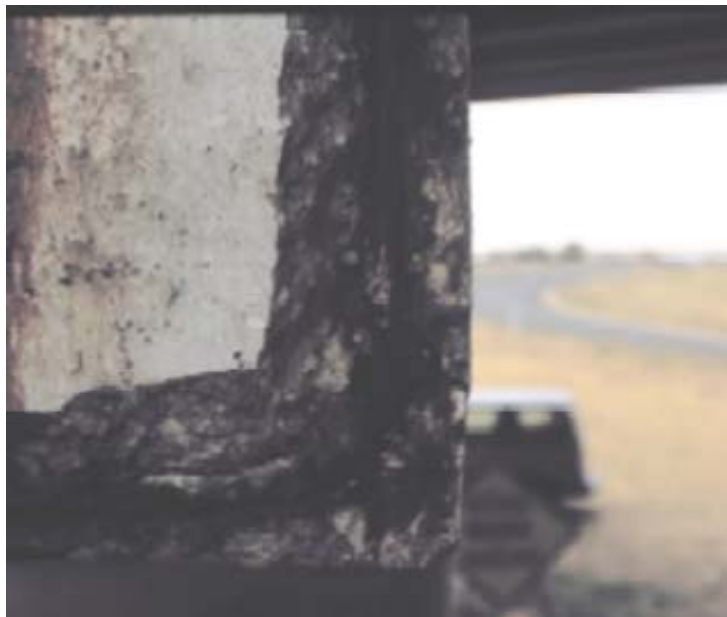
**Figure 5.2** Closeup of area with severe concrete spalling.

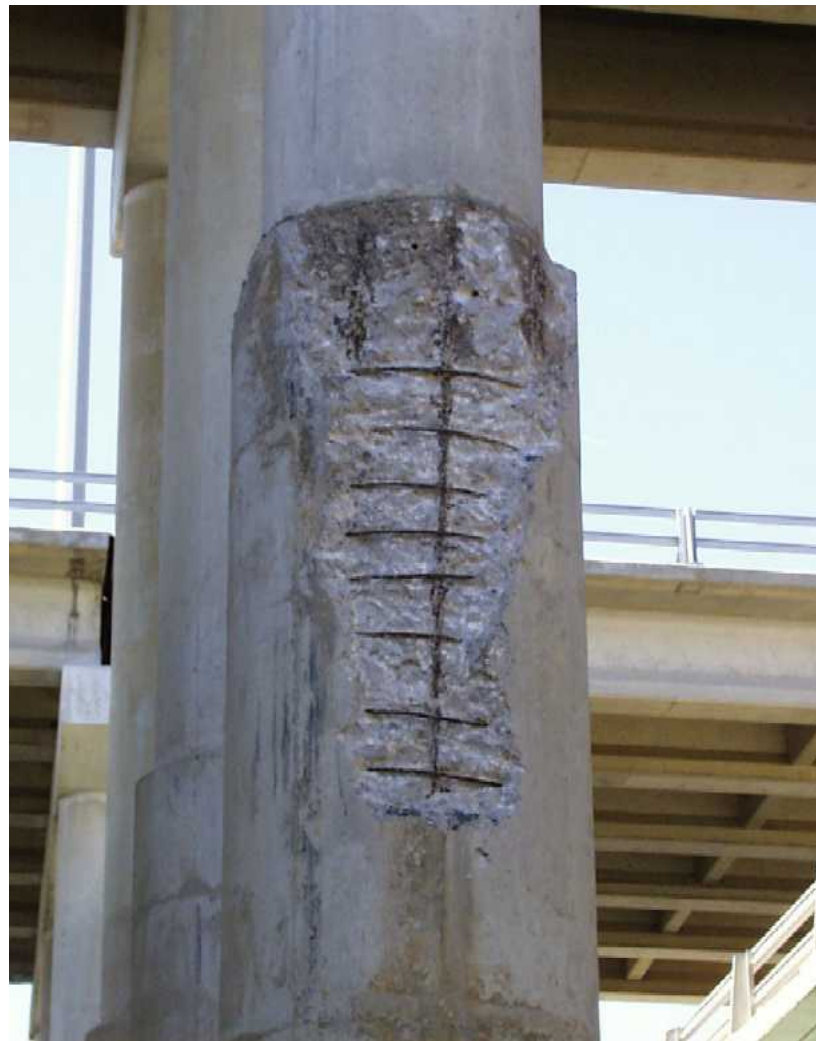
**Figure 5.3** Concrete spalling on a bridge support column.

Just as the substructure beams show distress in the areas subjected to drain water, the columns in the drainage path exhibited cracking and delamination. Figure 5.3 shows the damage on one such column located on structure #3, at the interchange of US Highways 62 and 82 and Loop 289.

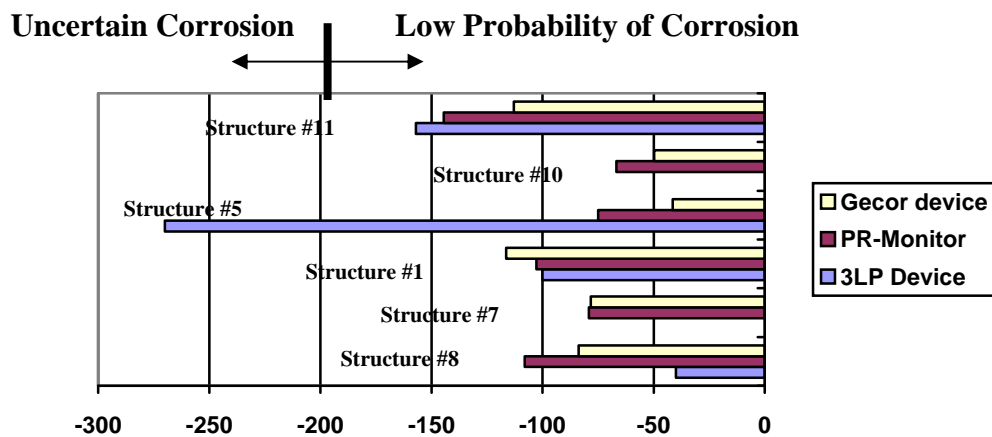
**Figure 5.4** Corrosion Potential (mV vs. CSE) values from different equipment.

-200 mv vs. CSE, which indicates a low probability of corrosion according to ASTM C 876 (ASTM).

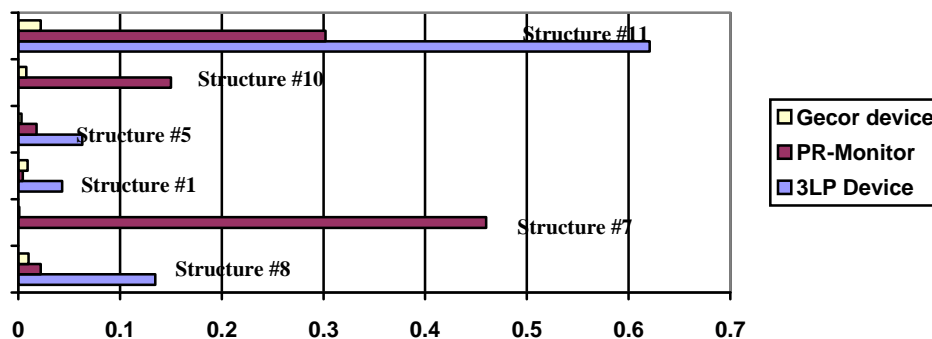
**Figure 5.5** Corrosion current density ( $\mu\text{A}/\text{cm}^2$ ) values from different equipment.

Each of the devices also gives a value of current density, shown in Figure 5.5. There is large disparity between the output values from each device. Table 5.2 gives some guidelines for corrosion rate evaluation (Scannell, Sohahngpurwala, and Islam 1996).

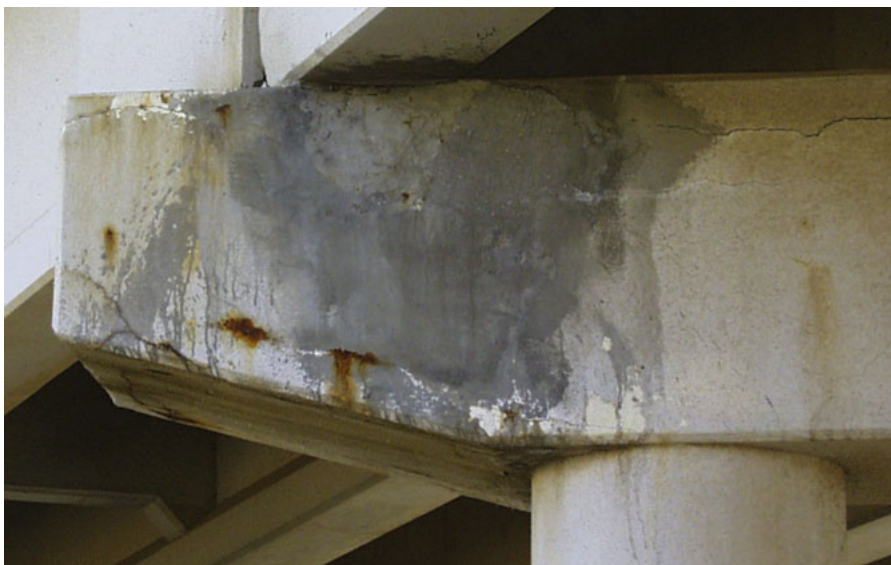
**Figure 5.6** Delaminations and corrosion stains on a downstream endcap.

The presence of delaminations, such as those shown on Structure #10 in Figure 5.6, made the corrosion rate device difficult to stabilize in some areas. This is because of a high solution resistance caused by the discontinuous medium between the working electrode and the reference electrode.

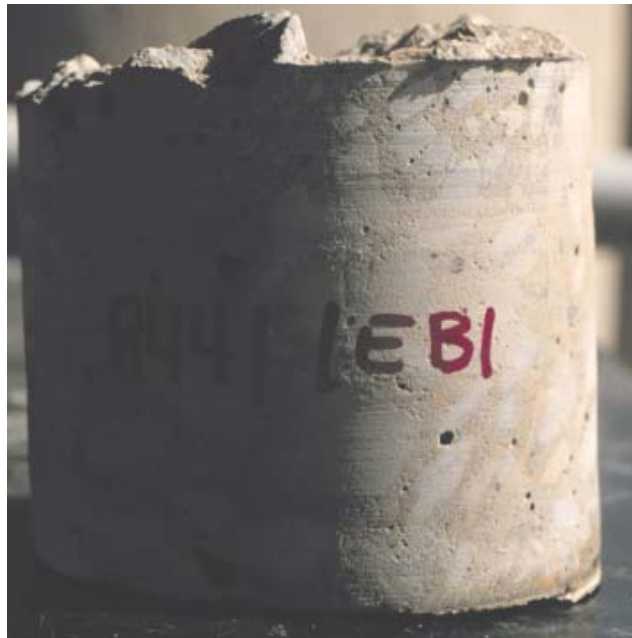
**Figure 5.7** Permeability core taken from Structure #10.

The cores were drilled with a 4-in. nominal diameter and then cut to thicknesses of 2 in. before being subjected to electrical current according to ASTM C 1202-94. They were then evaluated for chloride ion penetrability based on the amount of charge passed through the sections (ASTM 1994). An example of a core sample (prior to cutting) taken from Structure #10 is shown in Figure 5.7.

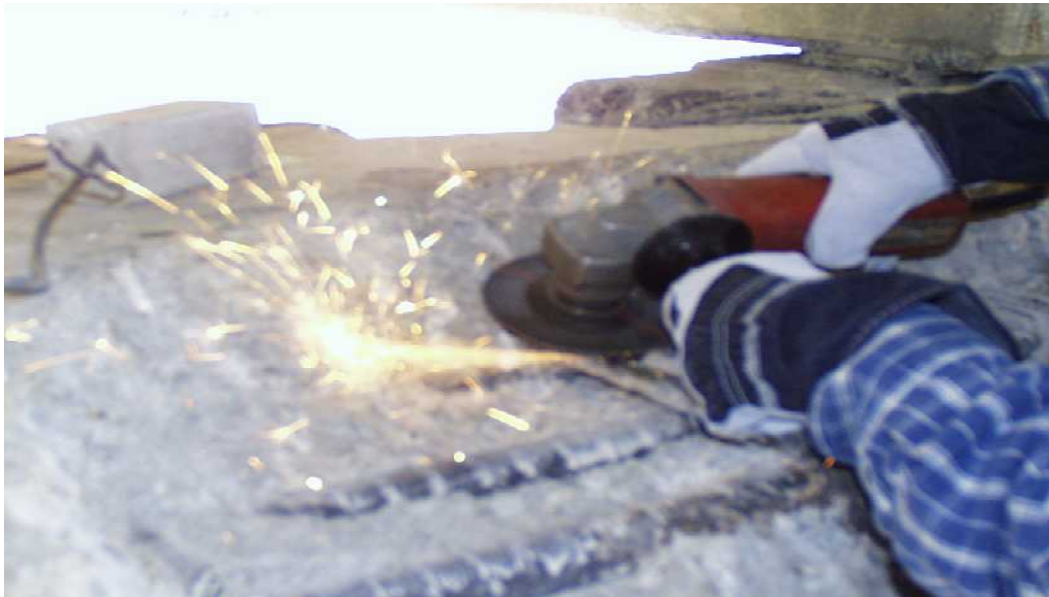
**Figure 5.8** Grinding of the reinforcement to prepare for soldering.

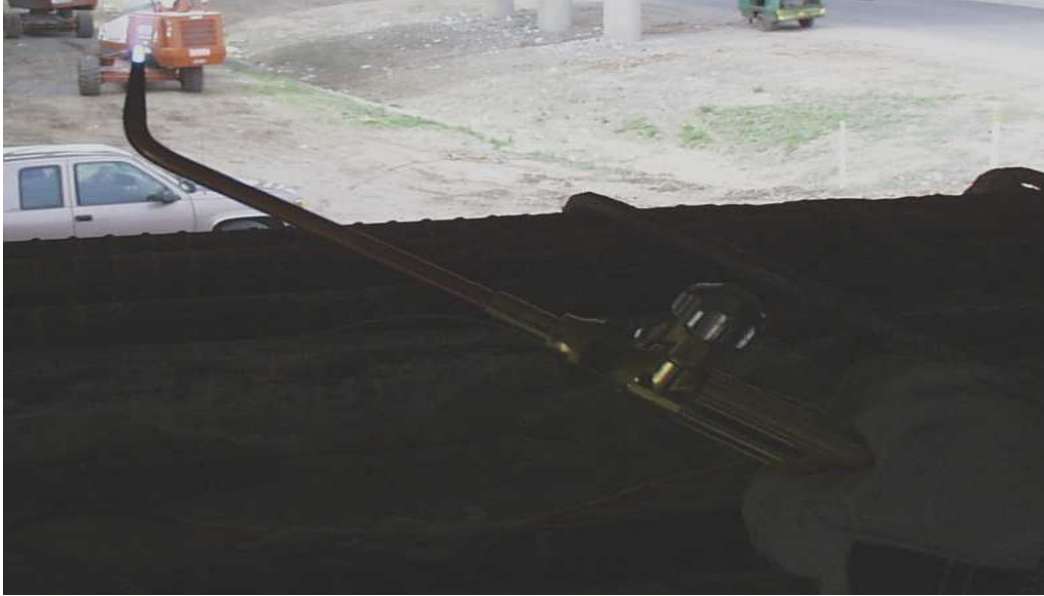
**Figure 5.9** Torch flame for solder application.

To operate the torch for soldering, first the oxygen valve was opened and the flame was started with a striker. The flame was adjusted to the point where no black smoke was emitted. The acetylene was then added to the flame until a small, defined inner cone of flame was achieved near the nozzle as shown in Figure 5.9. The flame was applied to the steel and copper attempting to keep the tip of the inner cone, which was the hottest part of the flame, on the surface as shown in Figure 5.10. When the metals at the interface were sufficiently heated and the flux had melted and cleaned the surfaces, the silver solder was applied to the junction between the copper and steel. A connection of about 1 in. was provided to prevent detachment during subsequent construction. A 56 percent silver solder alloy was used for all probe installations and is recommended for connecting copper and steel.

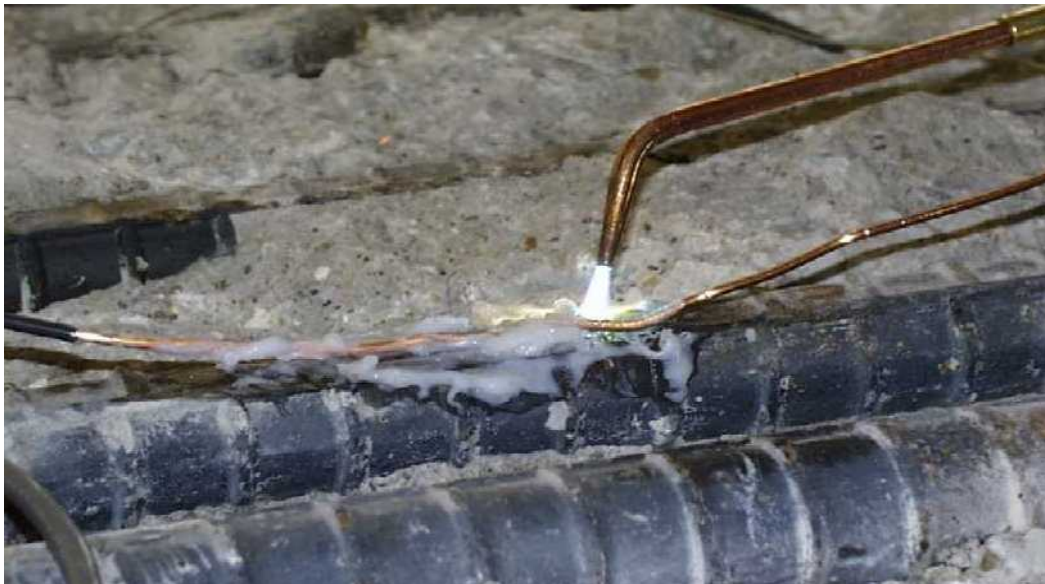
**Figure 5.10** Application of flame to the copper-steel interface.

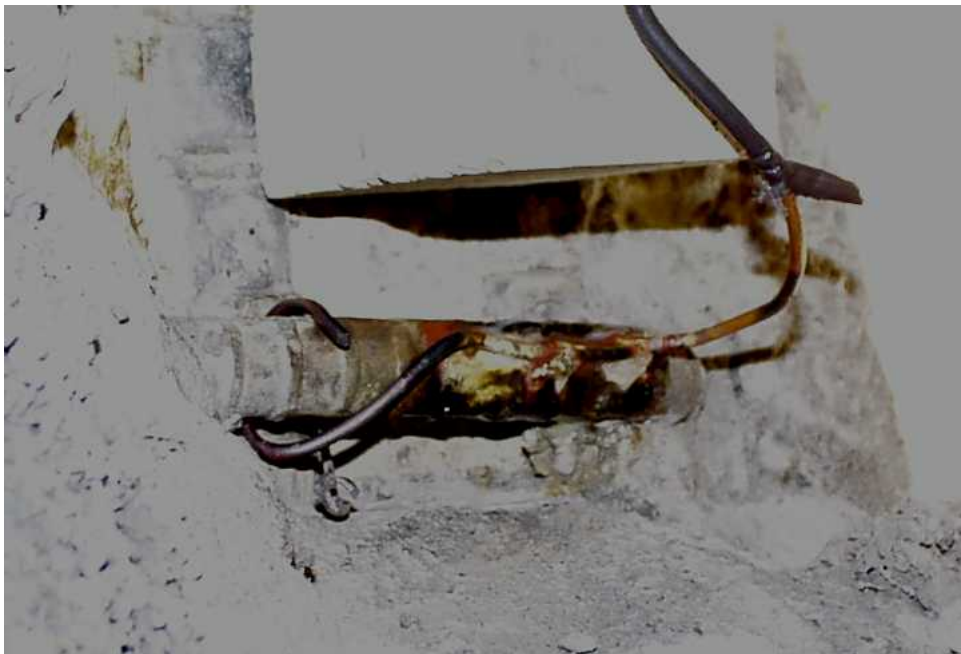
**Figure 5.11** Typical silver soldered electrical connection.

Figure 5.11 shows a typical finished soldered connection. The probe is installed some distance away from the solder point to prevent the erroneous measurement of corrosion due to the other metals and the heat-treated steel. Figure 5.12 displays a fully installed embedded corrosion rate probe.

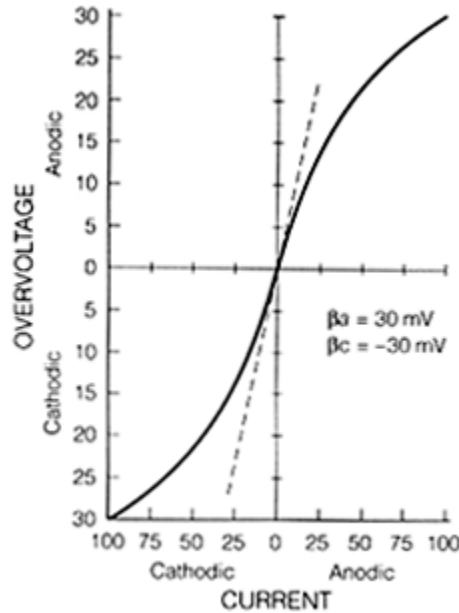
**Figure 6.1** Hypothetical anodic and cathodic polarization curves (Jones 1996).

$\varepsilon_c$  and  $\varepsilon_a$  are the cathodic and anodic overvoltages and  $i_c$  and  $i_a$  are the current densities applied during the polarization (Jones 1996).

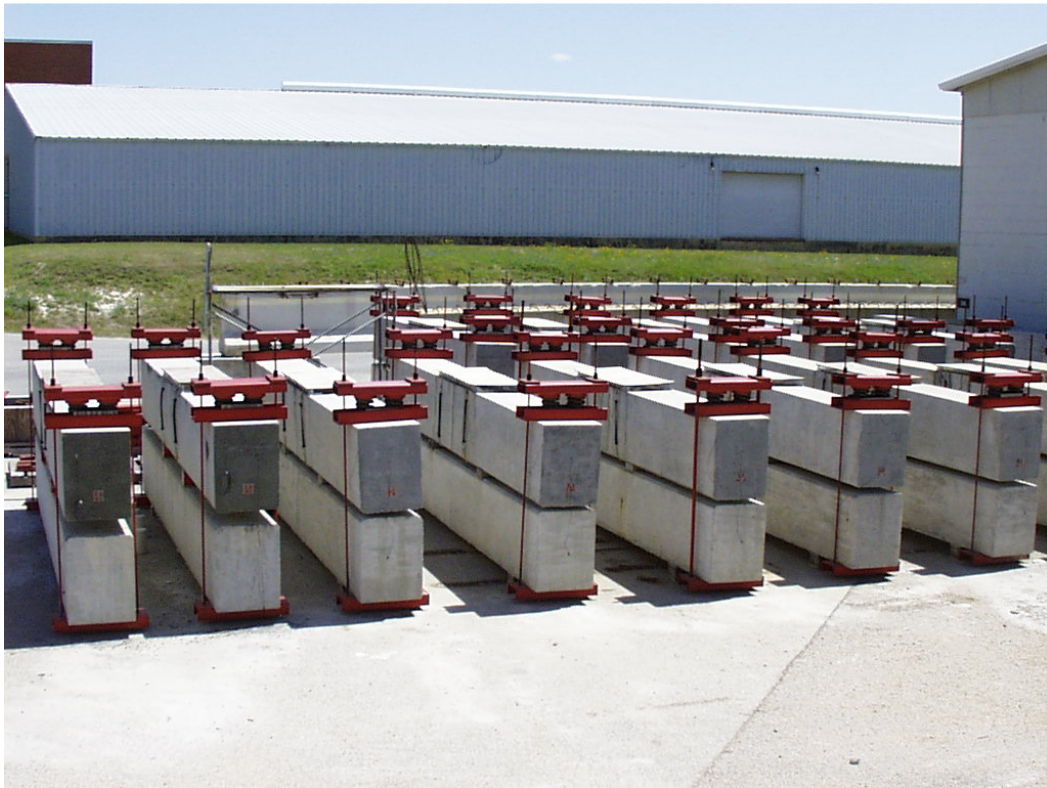
**Figure 6.2** The saltwater ponding beams (from an ongoing project at Ferguson Structural Engineering Laboratory) used for corrosion rate testing.

After the field testing was completed, further tests were conducted with the 3LP device and with the PR-Monitor. These tests were carried out on several beams, shown in Figure 6.2, which underwent continuous wet/dry (two weeks wet and two weeks dry) cycling in a saltwater ponding condition and had previously been examined only with half-cell potential measurements. The Gecor device was not available for this evaluation.

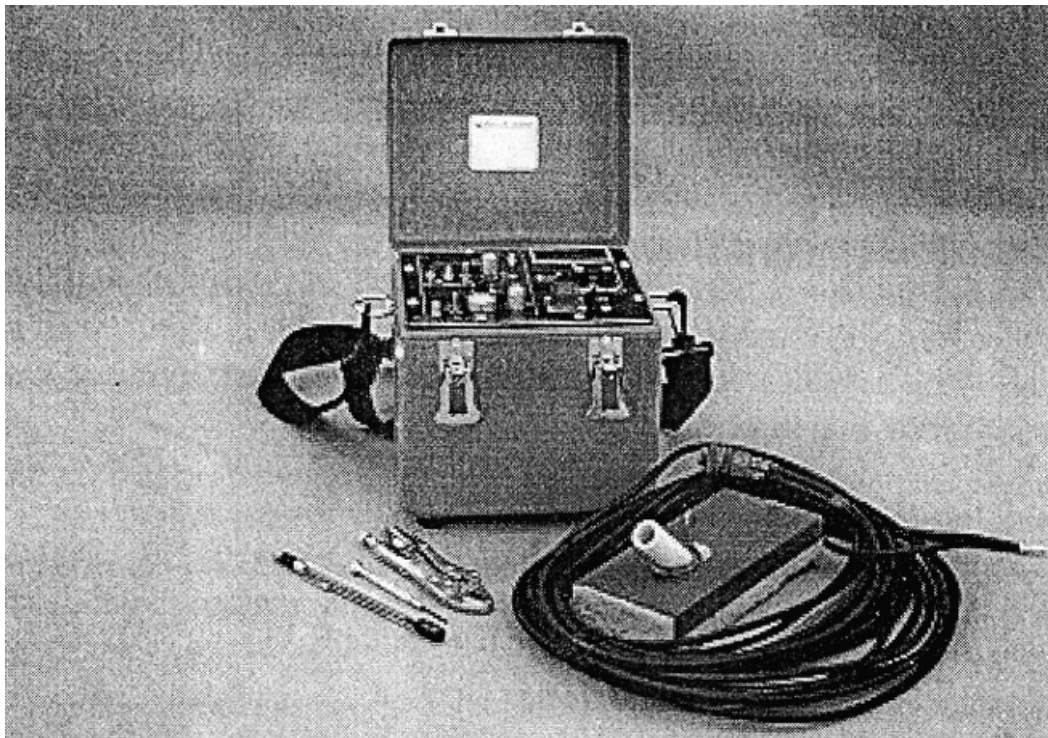
**Figure 6.3** The 3LP device.

Kenneth C. Clear, Inc. of Virginia. The device was introduced in the 1980's as a method for the non-destructive determination of corrosion rate. The ultimate goal of testing with the 3LP device is to quantify corrosion deterioration and predict the remaining life of a structure in service (Kenneth C. Clear 1990). Figure 6.3 shows the layout of the 3LP device, which consists of a self-contained power source and polarization console connected by wire to the electrodes. A sponge serves as the medium for electrode contact.

The name of the 3LP device is taken from the three-electrode linear polarization setup of the instrument. The setup consists of a reference electrode, a counter electrode, and a working electrode in the same system. Only the

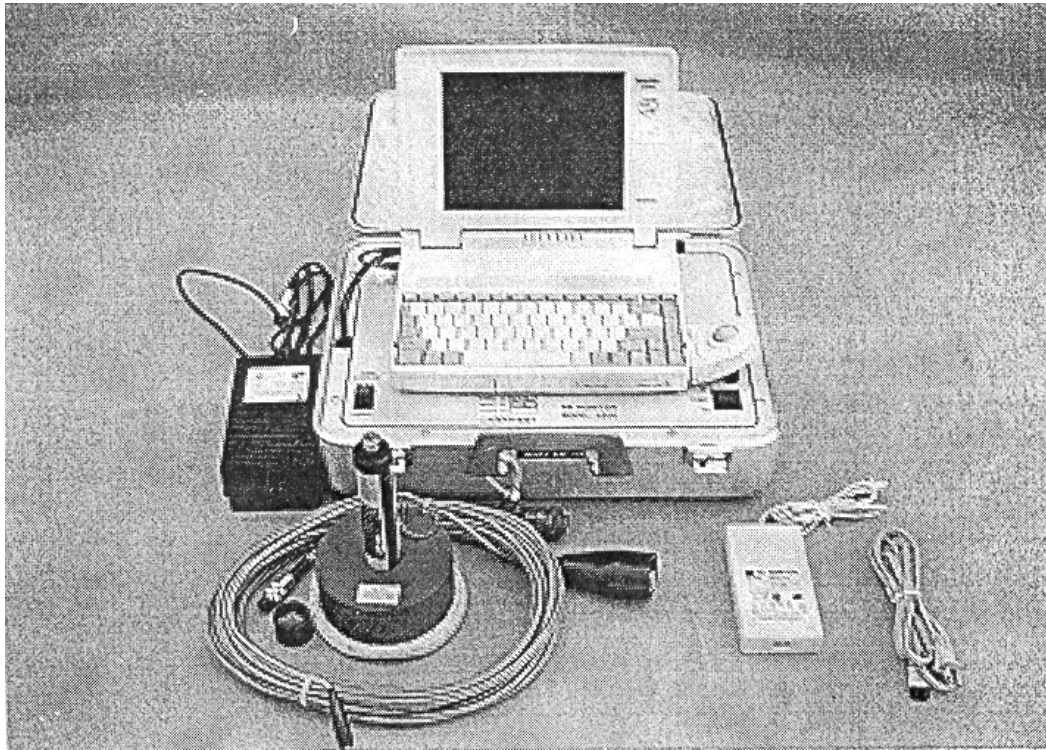
**Figure 6.4** The PR-Monitor device (Scannell, Sohangpurwala, and Islam 1996).

In addition to the computer console, the PR-Monitor system includes a 120 volt AC power supply and the reference and counter electrodes with the necessary wiring. The PR-Monitor is displayed in Figure 6.4.

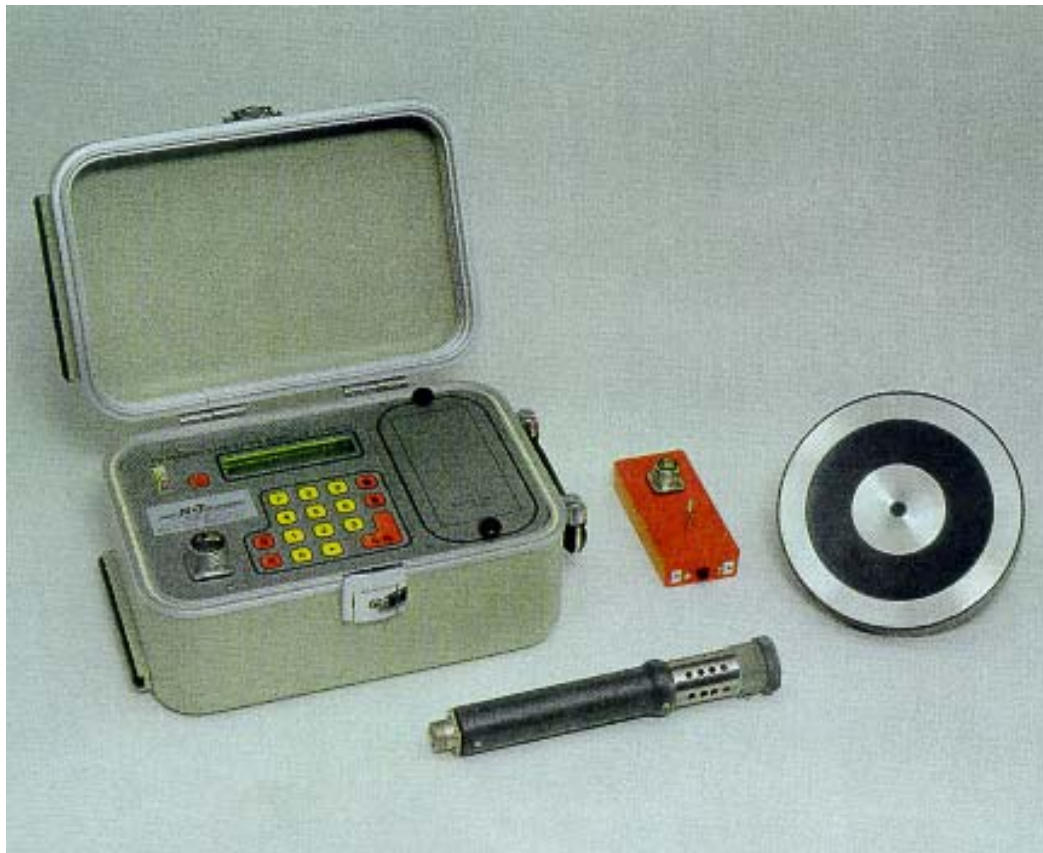
**Figure 6.7** Gecor 6 device – sensors and rate meter (James Instruments).

manufactured by James Instruments, Inc. This device uses the polarization resistance method for measurement of corrosion rate. The value used for the proportionality constant is 26 mV. Gecor 6 is shown in Figure 6.7.

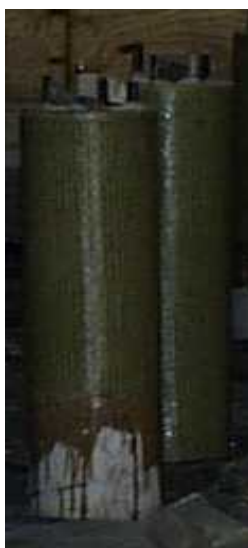
**Figure G.1** Specimens of different wrap lengths.

The length of the wrap is a variable to study the effect of different exposed surface areas in the circular (pier application) specimens. The wrap length for the rectangular (endcap exposure) specimens was kept constant at about 27 to 30 in. from the downstream end and is not a variable for these members. Three different wrap lengths are considered for the circular sections (all are measured from the top of the specimen down toward the base): 24 in., 30 in., and 36 in. or full wrap. The 24-in. length represents a wrap extending to the waterline. The 30-in. wrap extends below the waterline and represents specimens wrapped with the wet surface condition. The 36-in. wrap encloses the entire surface in an attempt to completely prevent chloride ingress along the length of the specimen. Even on the fully wrapped members the bottom surface is not wrapped to better represent field conditions, where the end of the pier is a foundation or the sea bed. Examples of specimens with the 24-in. and 36-in wraps are shown in Figure G.1.

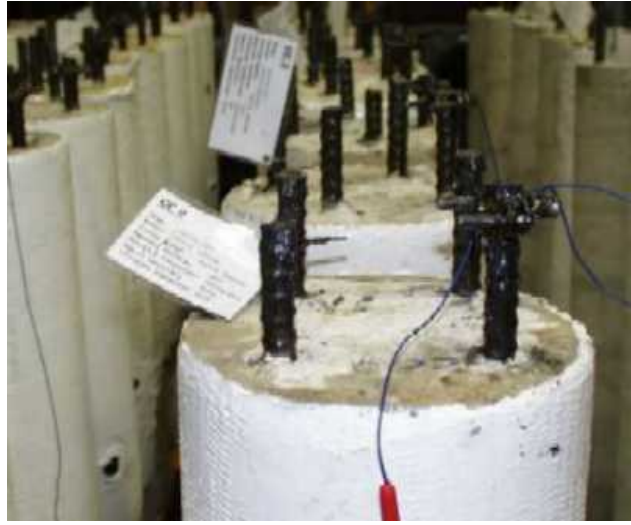
**Figure G.2** The exposure environment for the circular specimens.

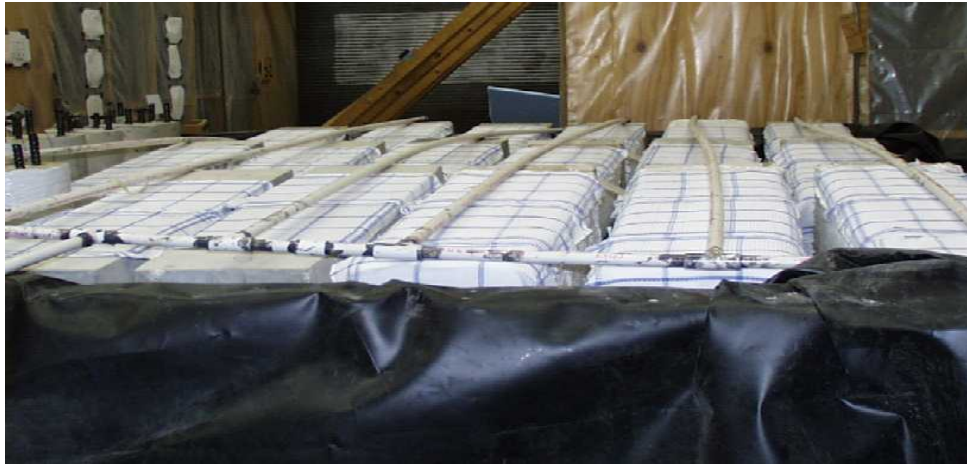
**Figure G.3** The exposure environment for the rectangular specimens.

The rectangular specimens are exposed in a situation replicating the downstream endcap of a bridge beam. To achieve this condition, water is distributed along all sides on the enclosed end of the specimens during the wet cycles. The members are set at an angle to promote saltwater flow toward the enclosed end. The exposure environment of the rectangular specimens is shown in Figure G.3.
